## **Cell 1 Regional Coastal Monitoring Programme Walkover Inspection Surveys 2020**

**Northumberland County  
Council**

## Walkover Inspection Surveys 2020

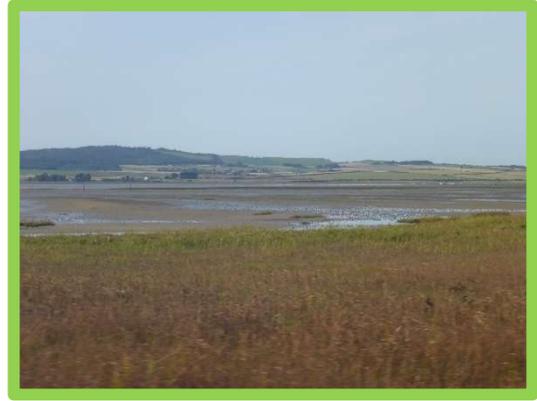
Chare End where the road bends away towards the main tourist car park, the road is protected by a width of salt marsh and wide sand flats to the south and the dunes and wide beach to the north.

*Salt marsh (/5001c011).*

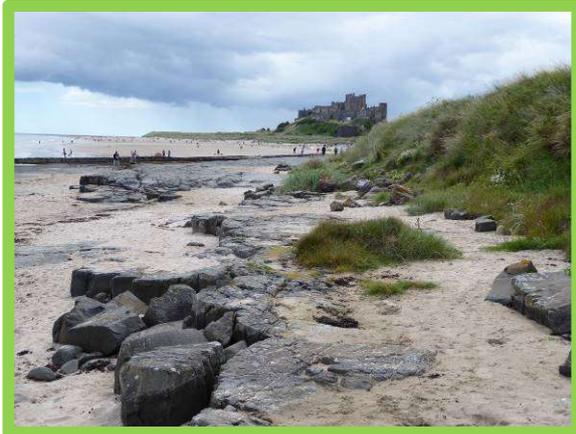
Despite relatively low foreshore levels, evidenced by exposure of the rock platform, there has been no evidence of erosion of the dune /coastal slope north of Bamburgh since 2018.

*General view showing exposed rock platform north of Bamburgh 2020.*

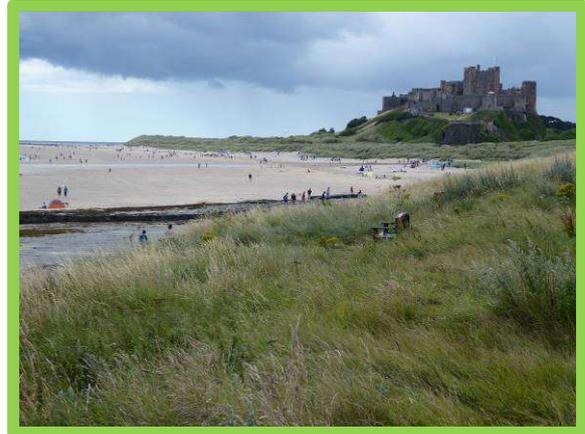
*Embryo dune growth evident just north of castle and along main dune frontage 1601/ C05. 2020*

Along much of the frontage down to Islestone Rocks (121AA901A1601C05) there continues to be embryo dune growth. Where slight local cliffing of the dune towards Islestone Rocks was noted in 2018, the upper beach at the toe of the dune has rebuilt in 2020.

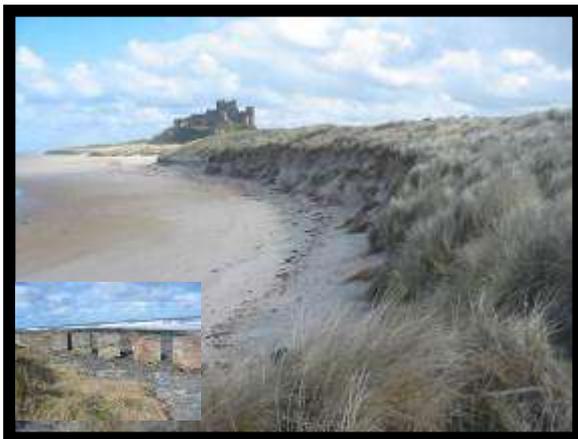
“The Dice” provide a useful reference point for this frontage and as shown below highlight: the steep cliffing in 2006, the slight growth of the dune immediately to the Dice in 2008, slight improvement generally to the dunes in 2010 and the significant growth of embryo dunes behind and to the south of the Dice in 2016. This has been further consolidated since 2018.

*View of the dune at “the Dice” 2006*

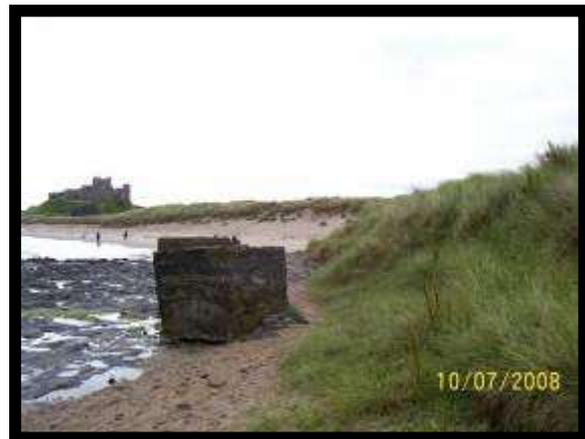
*View of the dunes at “the Dice” 2008*

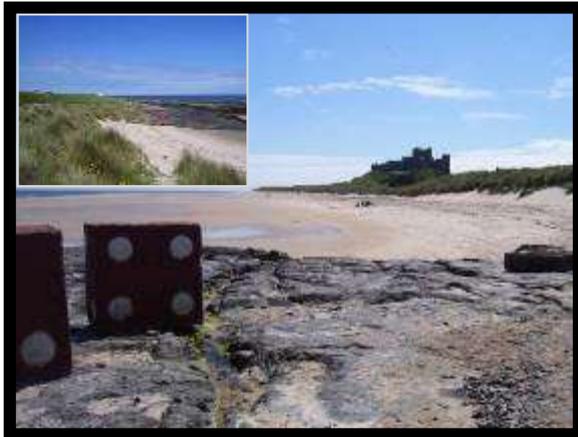
View at "the Dice" 2010.

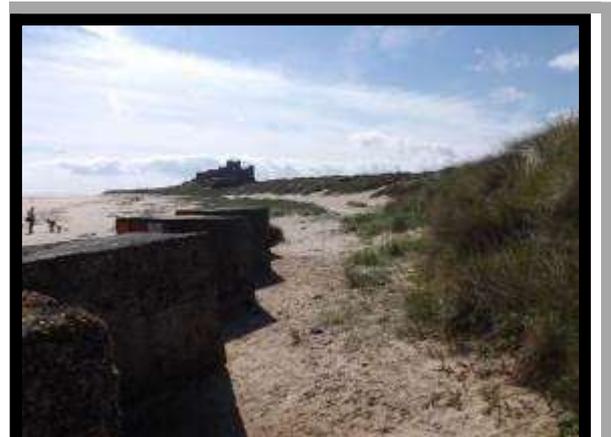
View at "the Dice" 2016, 1601/ C05

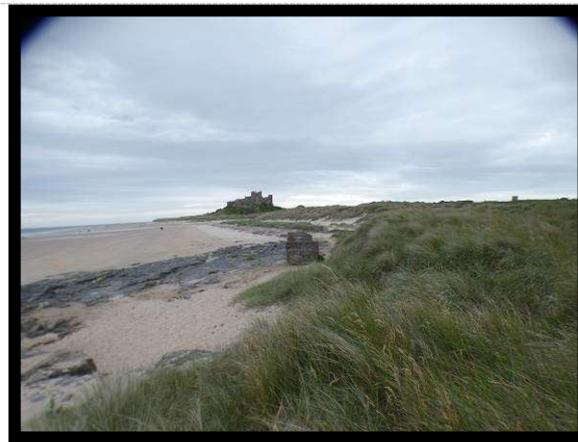
View at "the Dice" 2018.

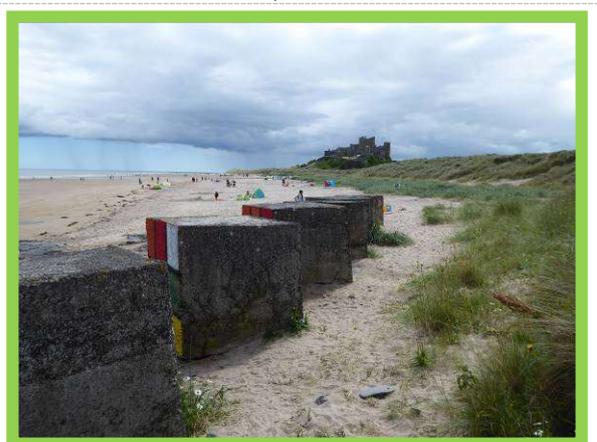
View at "the Dice" 2020

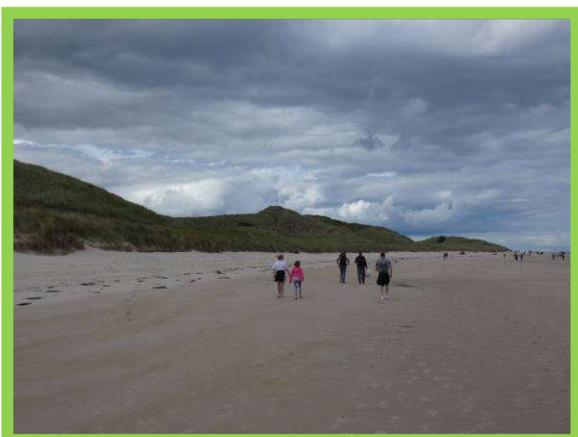
1601/ C02. Little change from 2018

Over 1601/C02 there has been little apparent change, while to the northern section of 1601/C03 there has been some minor embryo dune growth.

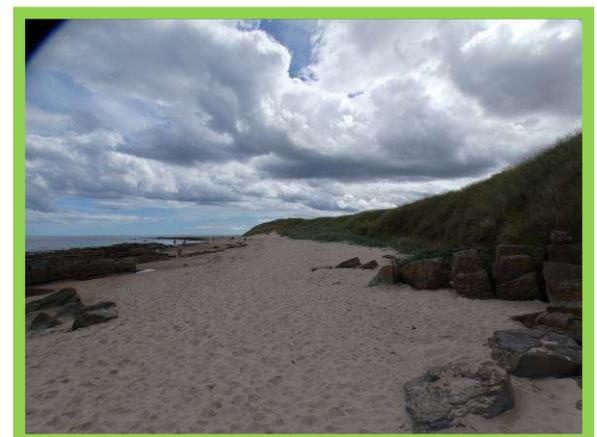
1601/ C03 continued embryo dune growth

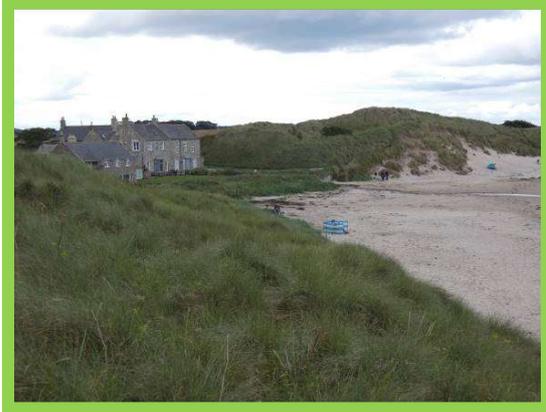
*1601/C03 some erosion to north of Monks House but embryo dune growth in front of properties*

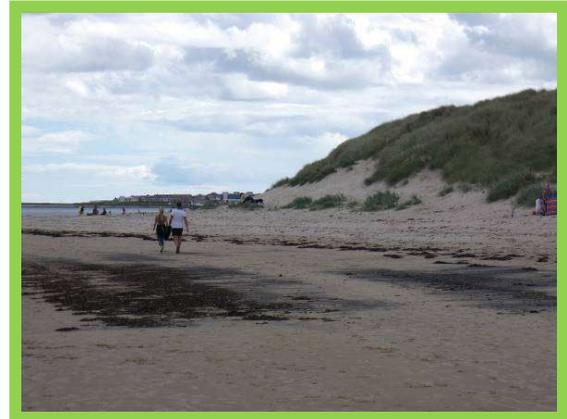
*1601/ C03 Locale growth of upper beach south of Monks House compared to erosion in 2018*

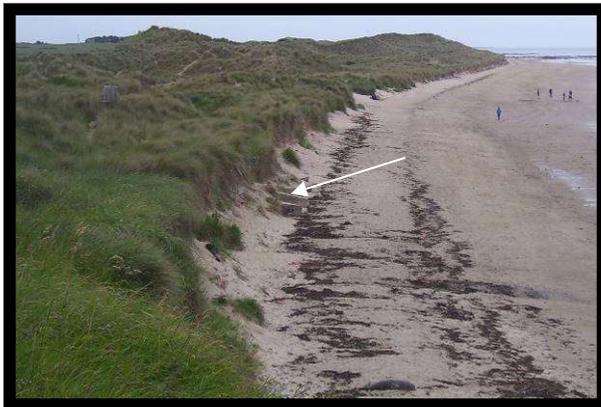
Certainly, further south towards the southern end of St Aiden's Dunes, although the dune face appears to be healthier than the steep cliffing seen in 2018, the actual line of the dune has eroded by between 1m and 2m. This is highlighted in the images below in comparison of the position of the dune face and the position of the tank trap blocks.

*1601/C04. 2018 showing dune cliffing*

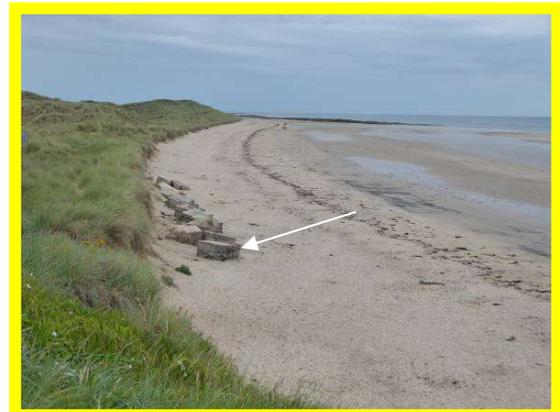
*1601/C04. 2020 erosion compared to 2018 but wider upper beach.*

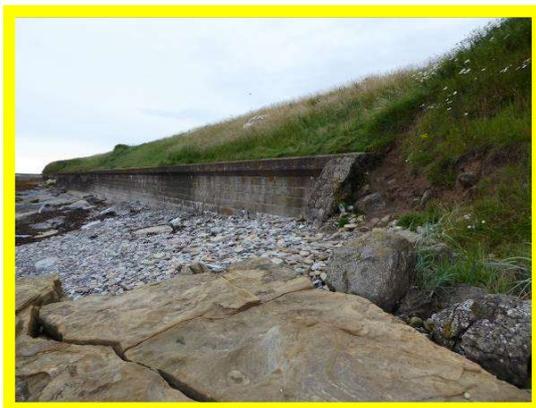
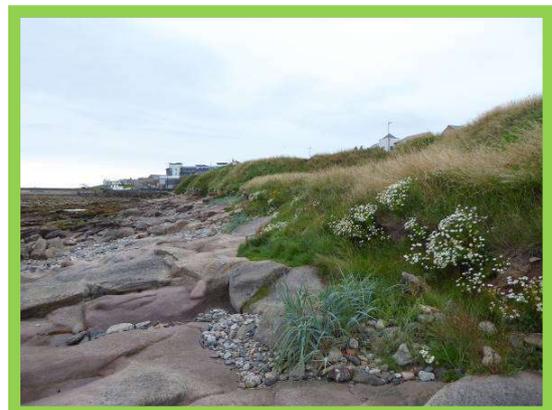
*1701/C54 – no change*

As identified in the 2014 and 2016 inspections there is general separation of the coping and the upper section of the wall. However, there is no loss of coping nor further displacement. While there is some outflanking to the northern end of the wall this has not significantly worsened since 2006. The slight erosion of the bank at the southern end has not worsened.

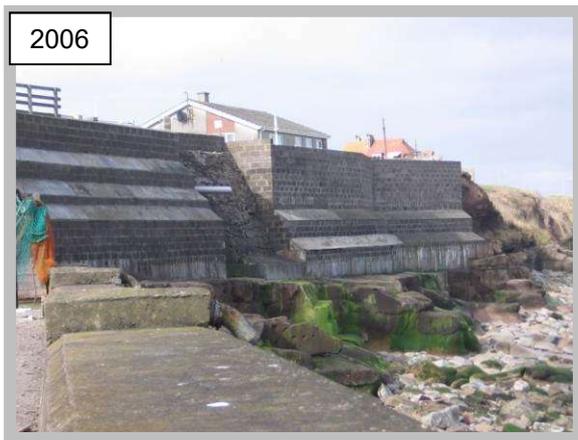
1701/C02 to 04

The defences immediately to the north of Seahouses harbour (121AA901A1701C02 to C04) remain unchanged since 2018 and are still in fair condition. The northernmost of the Seahouses harbour walls (1701C02) has a section of its lower coping stone missing, but appears not to have deteriorated further since 2018. It is recommended that it is repaired to prevent further damage to the wall. Other defects throughout this section include the ongoing loss of mortar from the masonry wall (1701C03), spalling of the concrete blockwork beneath the outfall pipe protruding from the north end of 1701C04 and minor abrasion to the concrete toe of 1701C04.

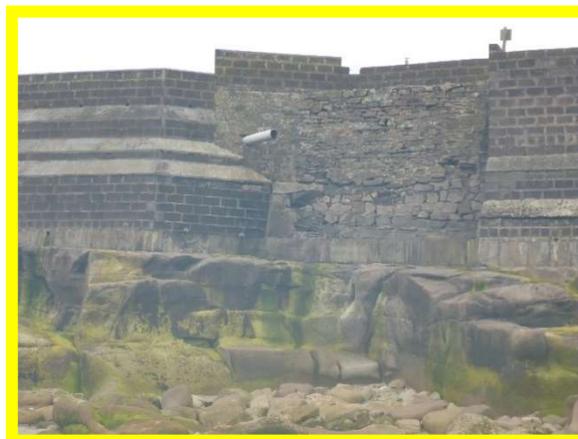
1701/C03, Masonry requires repointing.

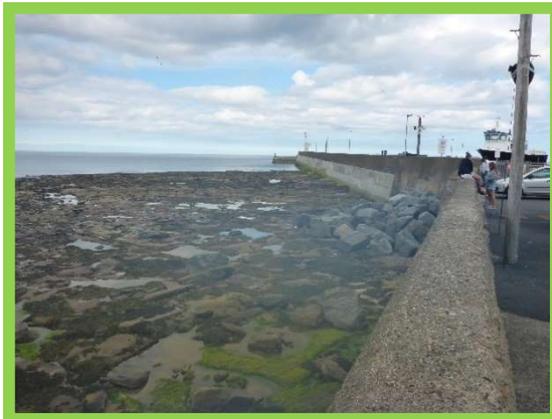
In 2018 it was reported that some further flattening of the wave reduction rock feature had occurred. There was no noticeable changes to the wave reduction rock feature in 2020. The need for any improvement should be reviewed against whether the structure still reduces wave impact.

*Rock armour wave reduction 1701/C06 – C07*

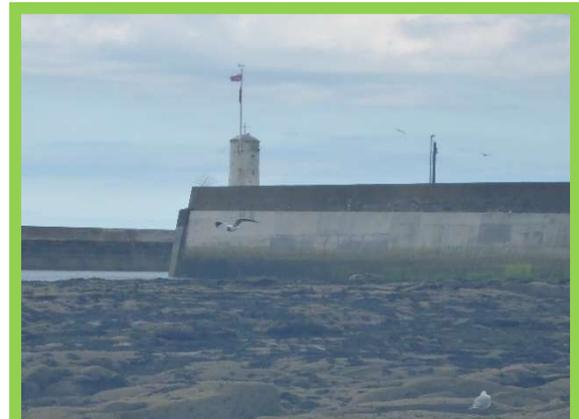
Since 2018, the outer main north Pier has been repaired with concrete encasement along its full length. It is now in good condition. A detailed inspection as part of the aforementioned works, revealed the pier head was in good condition and did not require any repairs. Underwater repairs have been complete to the stub of asset 1701C08, addressing the undermining and scouring reported in the previous inspections.

*Repaired outer wall 1701/C07*

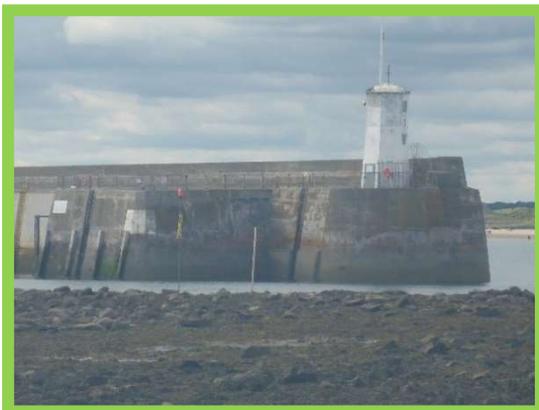
*Pier head 1701/C08*

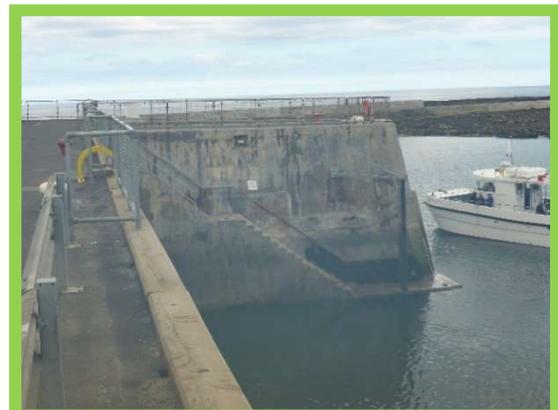
*South East corner to stub, underwater repairs not visible 1701/C08*

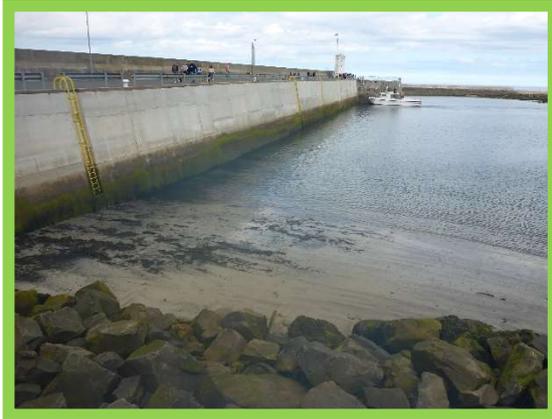
*Concrete encasement and cope repair to inner face of north breakwater. 1701/C09*

The inner face of the north pier has been repaired with a concrete encasement. The damaged cope stones and handrails have been replaced. It is now in very good condition.

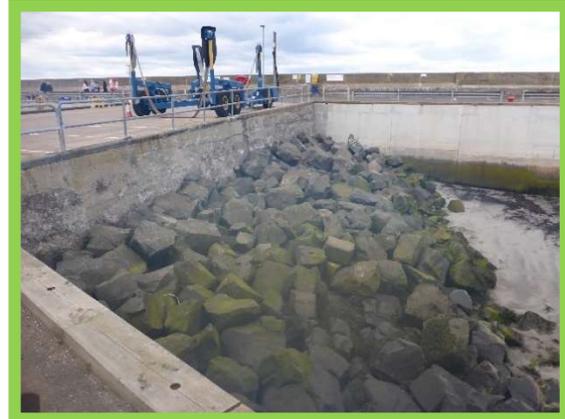
*Rock armour in good condition, concrete sea wall behind is heavily abraded. 1701/C10*

The rock armour revetment which lies along the inner face of the Inner Pier remains in good condition. The smaller stones which have been placed along the crest of the revetment remain in position, however some movement was evidenced by a slight drop in the crest level. The concrete wall behind the revetment, forming part of asset 1701/C10, is heavily abraded.

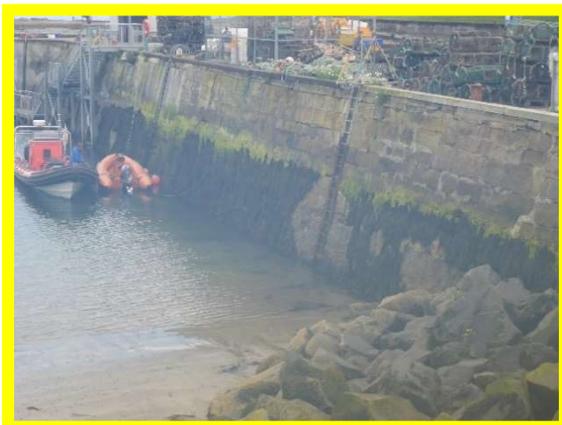
*Inner face of the Inner Pier 1701/C10*

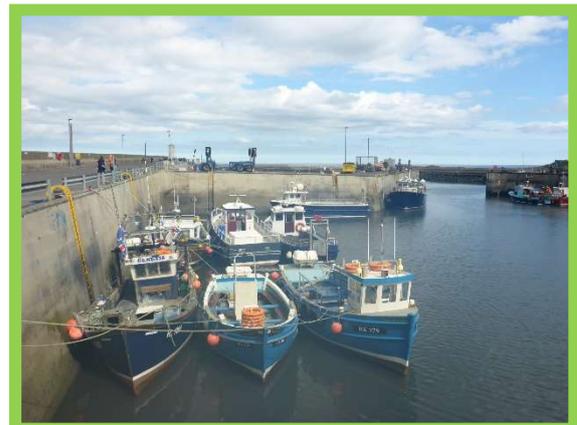
*Inner face to North Pier 1701/C11*

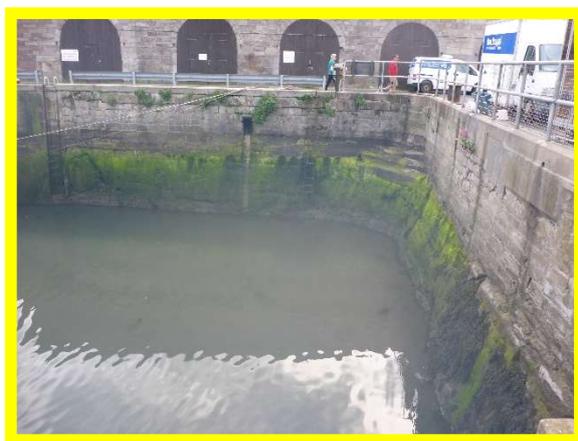
*No signs of deterioration 1701/C12*

The masonry wall (1701C12) to the west of the inner pier remains in fair condition, with some open joints, loss of mortar and some localised damage to blockwork. Although marine vegetation and silt obscures

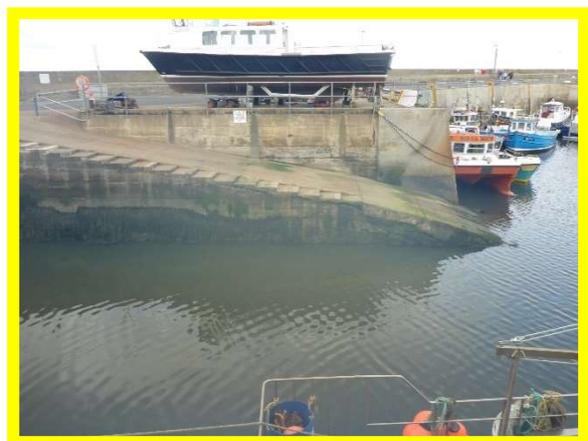
*Undercutting of slipway 1701/C12*

much of the lower reaches of the wall. The undercutting of the slipway did not appear to have worsened since 2018 inspection. undercutting of the end of the slipway was noted during the 2018 inspection.

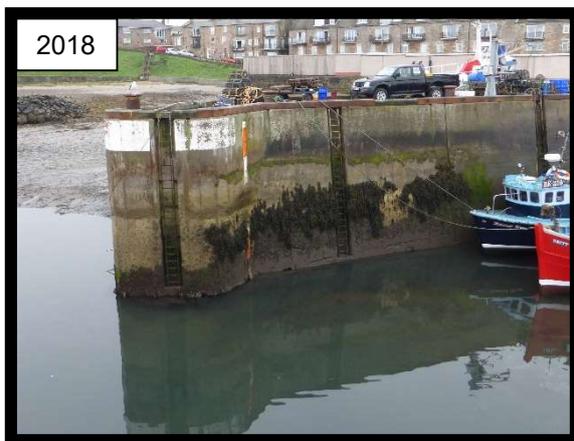
The undermining of the main pier head and the scour holes identified during the 2018 inspection did not appear to have deteriorated in 2020. This said, much of the lower extents of the toe were partly submerged in water (even when inspected around low tide) or concealed by marine growth. It is therefore recommended that a dive survey is undertaken to establish the extent of these voids.

*Scour holes and possible undermining around low water mark – 2018 1701/C14*

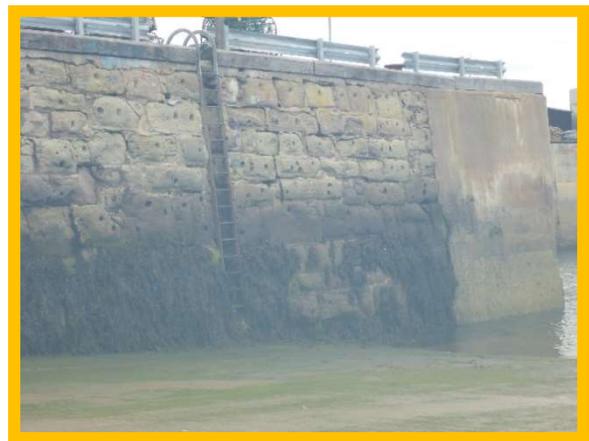
The outer face of the Main Pier comprises of a historic masonry wall with adjoining slipway. The masonry wall is heavily abraded in places and large areas are noted to have mortar missing, especially towards the pier head where vegetation was noted to be growing through the masonry. Heavy marine growth on the lower extents may conceal further damage. One full height (toe to deck) open joint / crack, reported in 2018, did not appear to have worsened.

*Heavily abraded outer face 1701/C14*

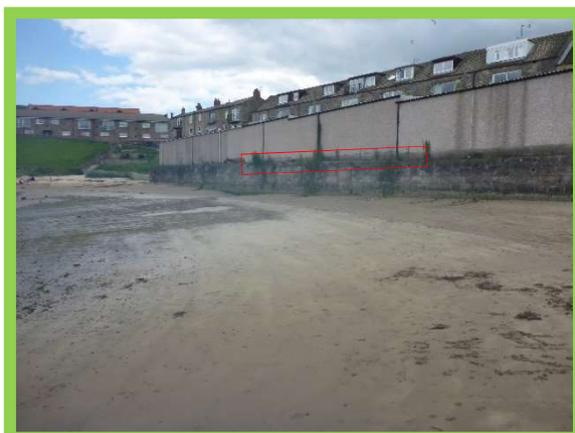
As reported in the previous inspections, the wall to the south of the main harbour area was noted to have remained in good condition overall. However, gaps were observed to be opening between the cope and masonry wall with vegetation growing through. The undercutting of the seaward facing corner of the concrete access steps to the north end of 1701C16 has deteriorated further and requires attention.

*1701/C15 Good condition overall – areas of fair condition where cope is breaking away with vegetation growing through.*

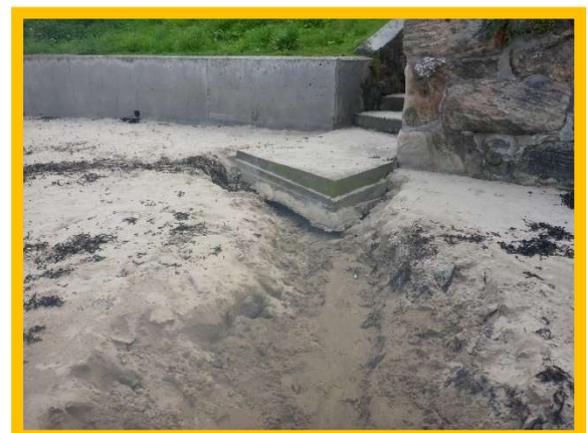
*1701/C16 Undercutting of toe of steps, adjacent wall remains in good condition.*

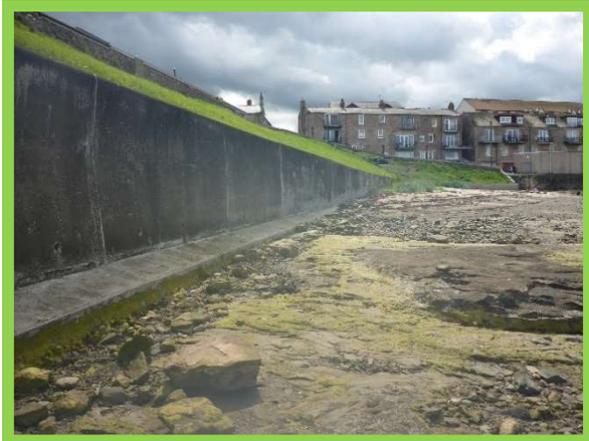
*1701/C17 Wall in good condition*

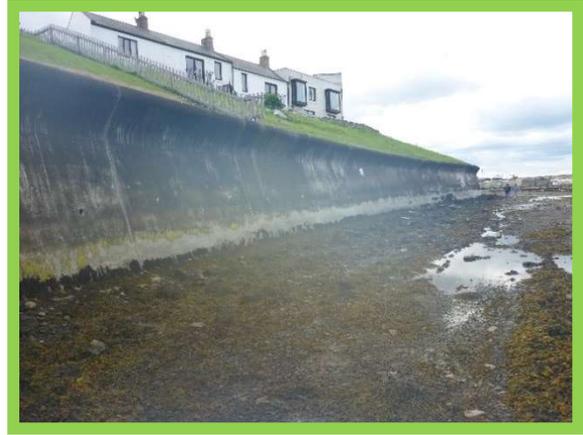
*1701/C18 Wall and slope in good condition*

No change was observed to the concrete walls and slope fronting Crewe Street in the 2020 inspections. The assets remain in good condition with no obvious signs of cracking or deterioration. The slope remains well vegetated and stable. Joint sealant which has been recently replaced on these assets remains in good condition.

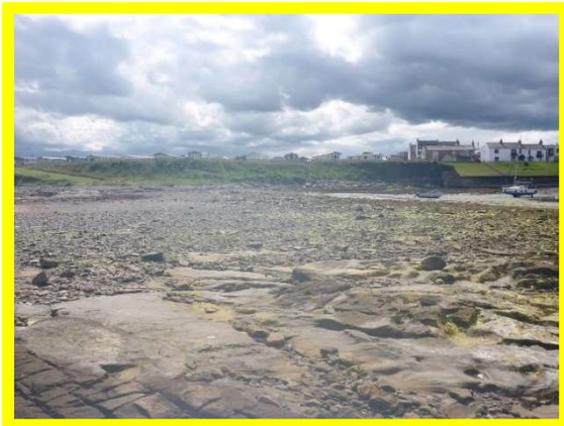
*1701/C19 minor erosion above rock armour*

To the south of the concrete recurve wall lies a tipped rubble slope with a vegetated upper slope to its rear. No further erosion was noted in this section since 2018. However in order to improve the effectiveness of the defence it is recommended that the tipped rubble slope is reprofiled in order to better defend the properties and caravan site to its rear.

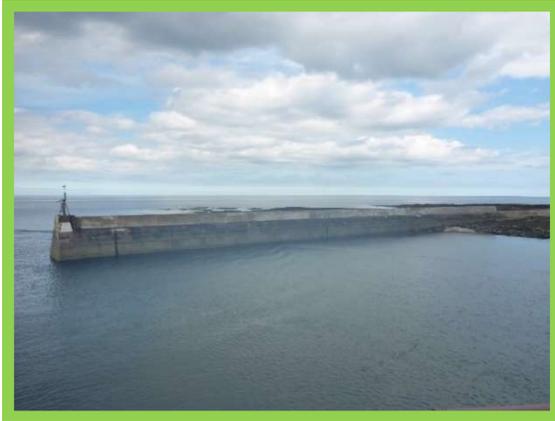
The Outer Breakwater was reinforced and encased in 2008. This structure has suffered no significant damage and remains in good condition. It was not possible to access the seaward end of the breakwater (1701C21) due to a security gate and warning sign. A general assessment of the condition of the inner face could be made from across the harbour, however due to the distance, tide and extensive marine vegetation growth it was not possible to examine the toe of the structure. Evidence of spalling of the concrete cope was observed.

1701/C20 No significant signs of damage

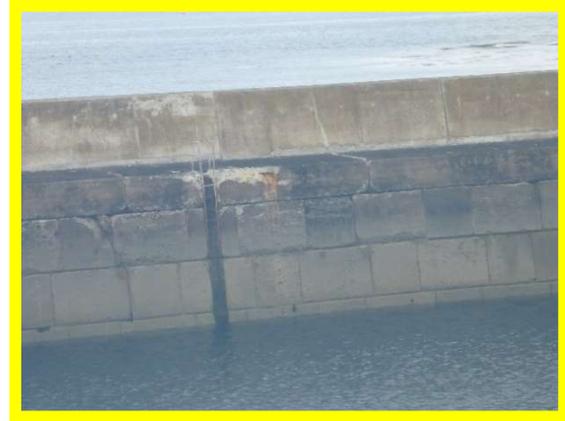
1701/C21 Some spalling visible on concrete cope.

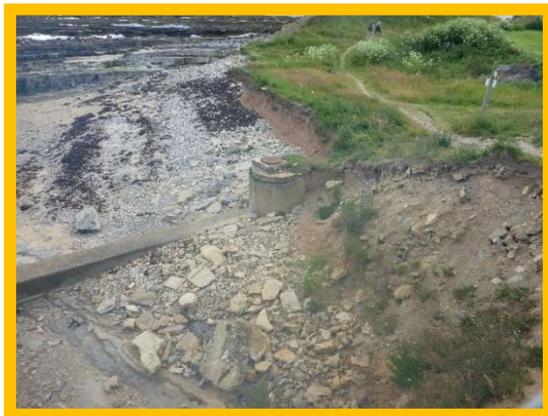
At North Sunderland Point, an assumed long sea outfall (LSO) manhole chamber is at risk of becoming detached from the cliff due to the ongoing erosion. Although this is not a formal coastal defence asset it is vulnerable wave damage and may require intervention.

Manhole for Long Sea Outfall (LSO) at risk of being detached from cliffline. 1701/ C22

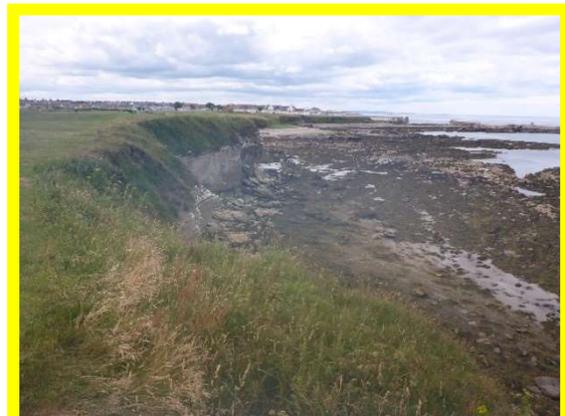
To the south of Seahouses 120AA901A1701C22 the continued erosion to the crest of the access ramp was noted as in previous inspections. It is believed that this does not pose a significant risk at present, although it is recommended that this is monitored. Further along the frontage there is the ongoing development of embryo dunes giving way to the slowly eroding cliffs around North Sunderland Point. The areas of cliff undercutting should be monitored.

Embryo dunes within bay with slow erosion to cliffs to the south, eroding access ramp in the background. 1701/ C22

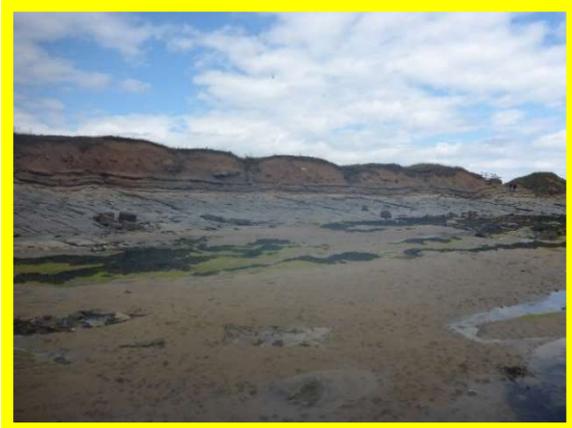
Beyond North Sunderland Point erosion continues to the thin boulder clay ridge, running along the seaward face of the golf course to the Annstead Burn. Access along the ridge has been closed off and the ridge is no longer passible, with the eastern most of the golf club ponds at being at risk of tidal encroachment. There is an ongoing erosion and recovery cycle around the north bank of Annstead Burn. This poses no significant risk to the road or bridge.

*1701/C23 Narrowing and retreat of ridge*

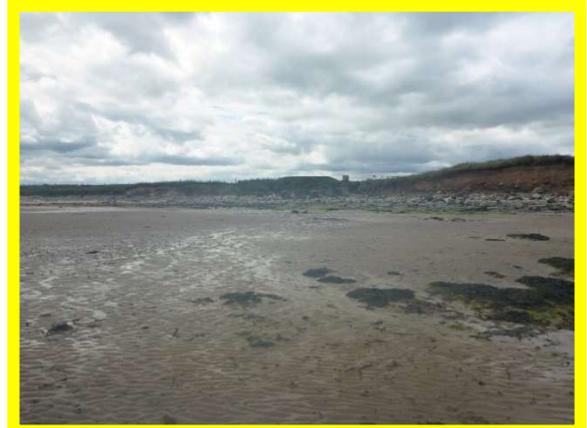
*1701/C23 limited erosion to golf course*

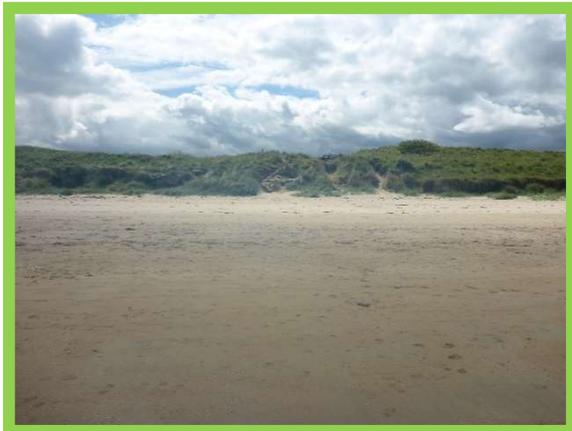
*1701/C23 Formal beach access (left) localised evidence of erosion at beach due to informal access (right)*

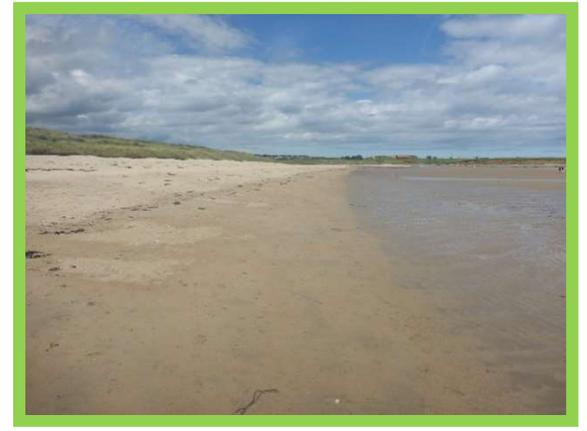
*1701/C23 Stable fully vegetated dunes to the south of Annstead Burn.*

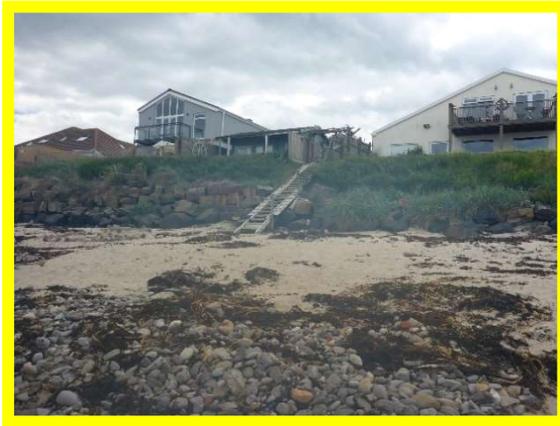
At Beadnell Haven there are private defences, consisting of dumped rock and rock armour revetments, which remain largely intact but do not provide a robust defence and would need improvement to adequately protect the properties immediately behind. In one area, a property frontage appears to have no defence, and the retreat of the small slope is now at risk of outflanking the defences on either side of it.

*rock armour fronting properties at Beadnell Haven. (/1701C24)*

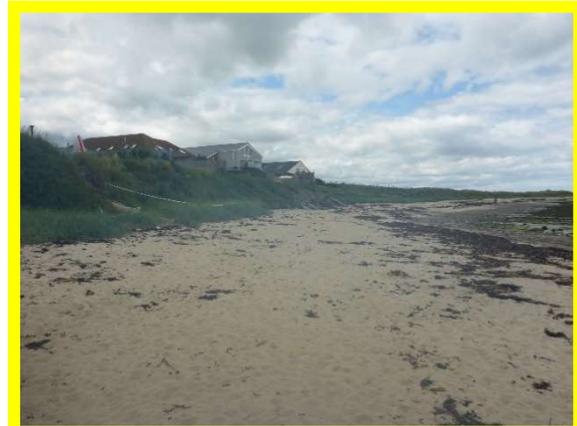
*Retreat of slope, risk of out-flanking adjacent defences. (/1701C24)*

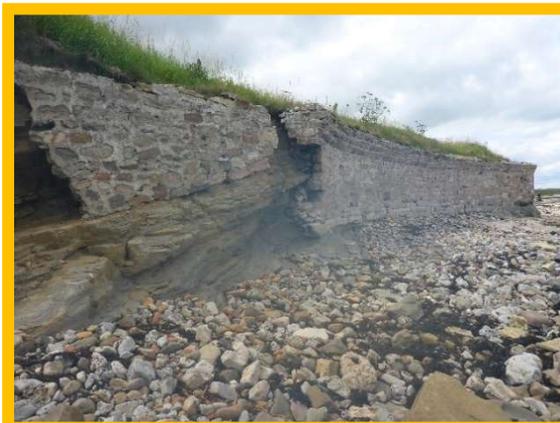
The masonry and concrete seawalls to the north of Dell Point (Red Brae) are generally in fair to poor condition with some cracks and loss of mortar evident, but the outflanking issues warrant a poor overall classification. The masonry blockwork wall is now being outflanked at both ends end of the and a large void has been exposed behind the wall and the small cliff to its rear. Minor erosion to the soft upper cliff layer was noted in the undefended area between the seawalls.

*Masonry blockwork wall in poor condition. (1701/C25)*

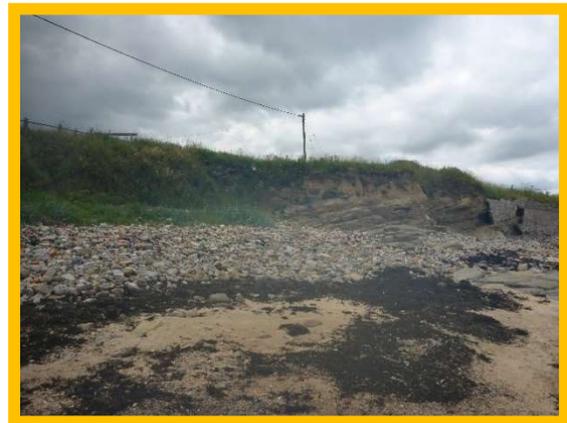
*Erosion evident in undefended area between assets (1701/C26)*

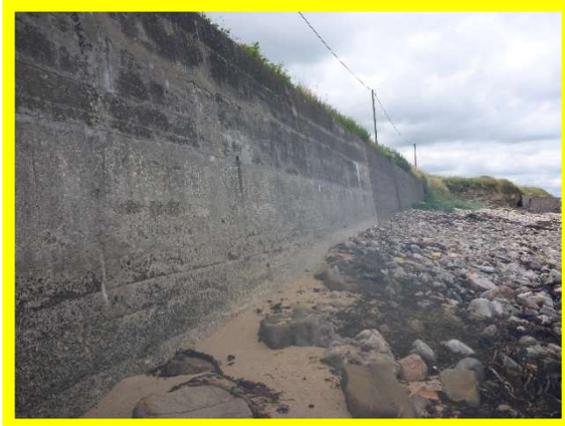
*Fair classification of wall north of Dell Point, minor outflanking at southern end (/1701C27)*

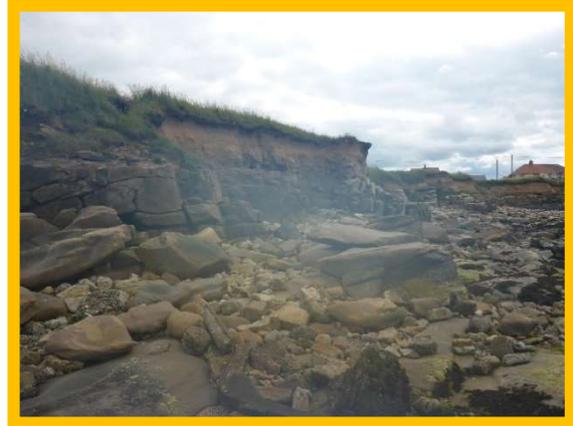
The soft earth cliffs around Dell Point (Red Brae) appear to be experiencing a consistent ongoing retreat, with the soft upper slope retreating at a faster rate, particularly at the most easterly point of the headland.

*Ongoing erosion of cliffs around Dell Point (/1701C28)*

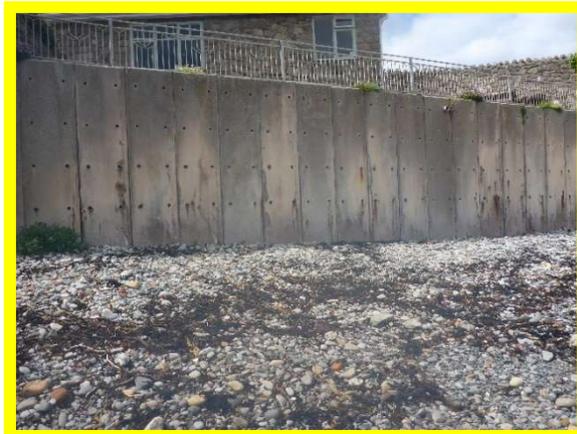
The concrete seawall fronting the property at the north end of the main Beadnell North bay remains in good condition with only minor signs of cracking and rust staining. However, it should be noted that the wall is being outflanked particularly at its southern end, this should be monitored due to the proximity of the road in this location. Further erosion in this location was observed in 2020, the private access gate at the top of the cliff is backed by a steep, almost vertical, drop.

*Precast vertical seawall in good condition overall – minor cracking observed. (/1701/C31)*

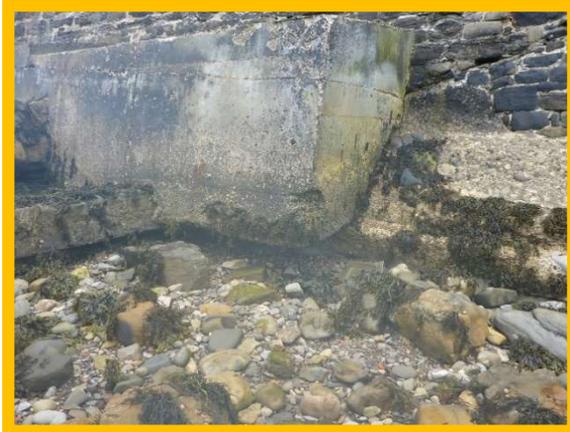
The various masonry seawalls at Nacker's Hole remain generally in poor condition with significant abrasion and gaps between blocks. In one area, missing blocks has resulted in a sizable void. Undermining and voids are prevalent along much of the length, particularly beneath the concrete toe as shown below. There appears no overtopping damage since the previous repairs c2011. It is recommended that the improvement works proposed in the Beadnell North PAR (also covering Lady's Hole) be implemented as soon as funding becomes available to prevent failure of this seawall.

*Undermining of seawall at Beadnell North (Nacker's Hole) (/1701C36)*

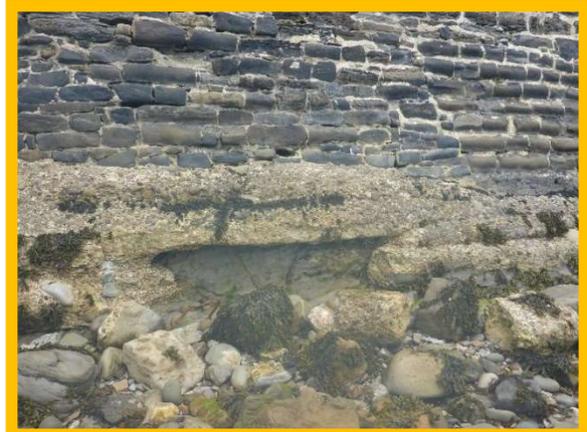
*Loss of mortar, damage to blockwork of seawall and abraded concrete toe at Beadnell North (Nacker's Hole) (/1701C36)*

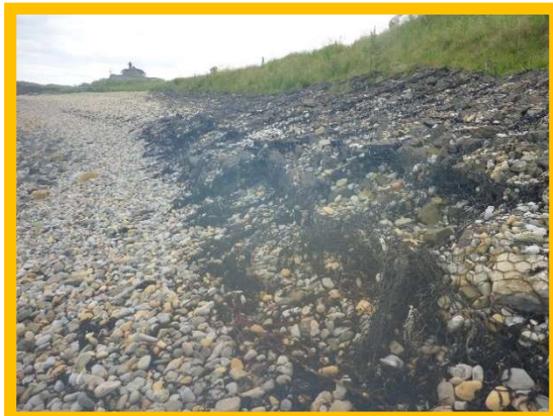
Further south at Lady's Hole, the rock-filled mattresses remain in poor condition and in need of repair with burst baskets along the toe, with the worst of the damage occurring around the access points. As was recommended following the 2016 inspection, the improvement works proposed in the Beadnell North PAR (also covering Nacker's Hole) should be implemented as soon as funding becomes available to prevent failure of this seawall.

*Failed mattresses at Beadnell North (Lady's Hole) (/1701C39)*

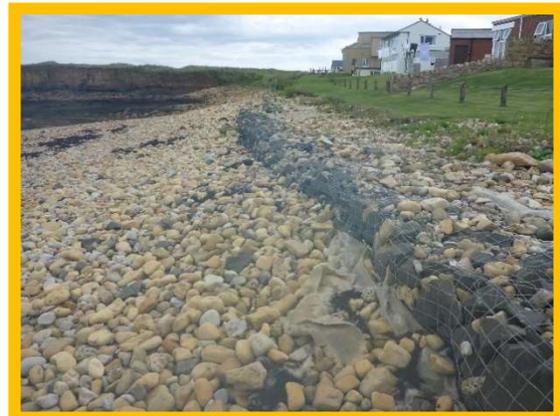
*Damage to gabion basket wall at (Lady's Hole) gabion wall – partially submerged to high sediment levels. (/1701C40)*

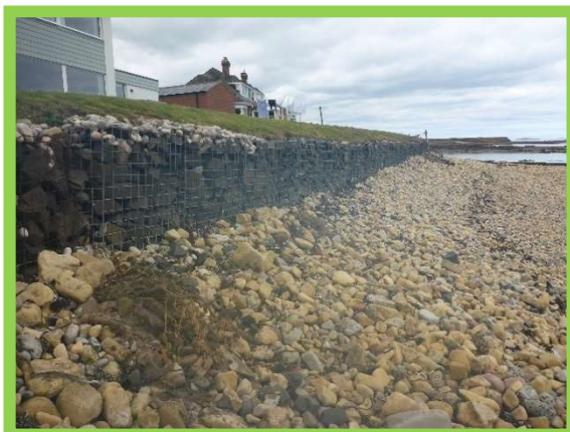
*New gabion basket wall in good condition. (/1701C41)*

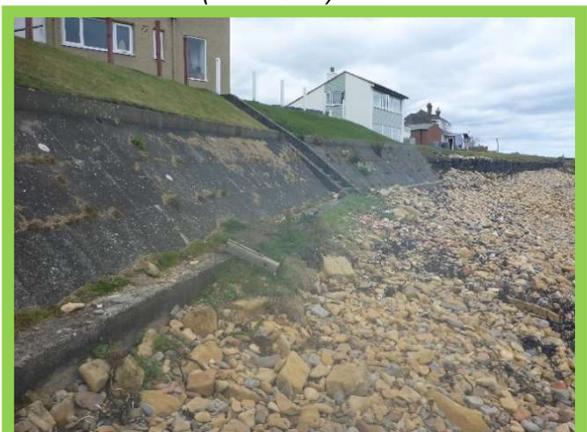
*Concrete revetment in good condition, evidence of grout repairs at southern end (/1701C42)*

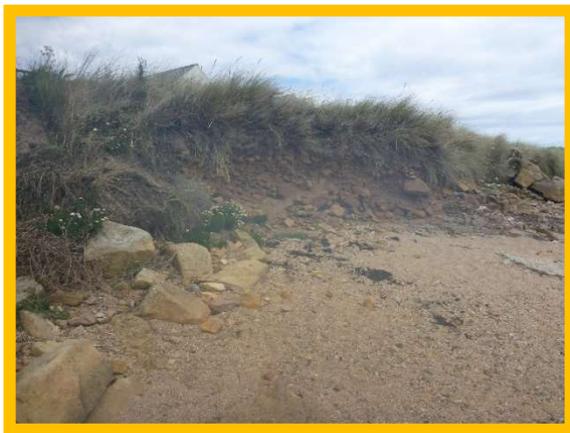
The headland of Beadnell Point (Ebb's Nook) remains in a stable condition. Further erosion was observed in 2020 to the small cliffs fronting the properties on Harbour Road. It is recommended that a formal defence is considered here due to the proximately to the houses behind. A stone retaining wall near the Lime Kilns appears stable however the ongoing loss of blocks (particularly to the west) and stability of the slope to its rear should be monitored. The old gabions at the intersection with revetment are heavily corroded and are at risk of failing. Notably high beach levels were observed in front of the masonry wall in 2020. The rock revetment at the intersection of the coastline and the harbour also appears to be effective and stable with a consistent profile throughout.

*Ongoing erosion to slopes fronting properties (/1701C44)*

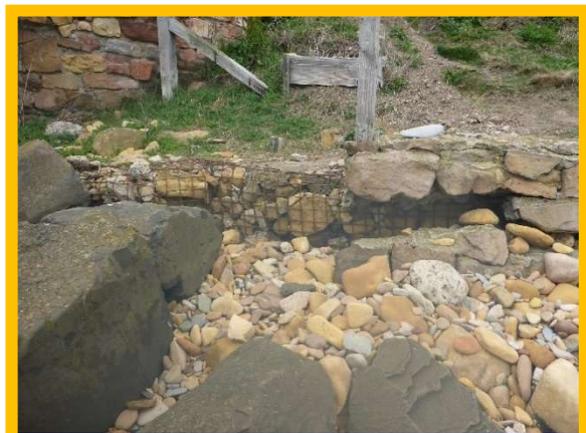
*Damage to retaining wall adjacent lime kiln. Possible slumping of slope to rear (/1701C45)*

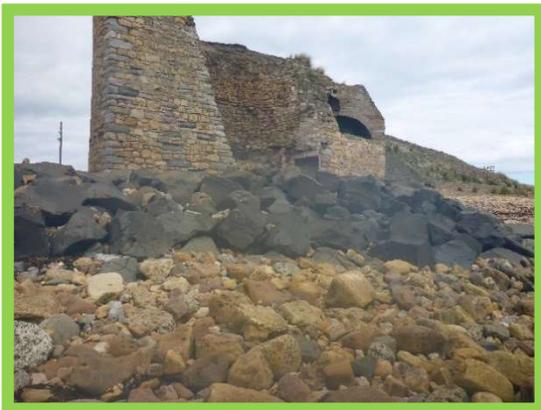
*Rock revetment in good condition (1701C46)*

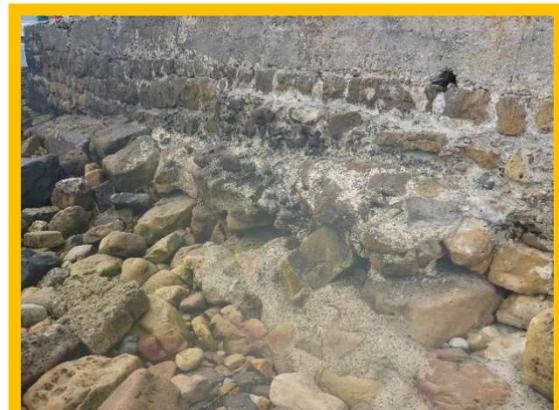
*Heavily abraded Beadnell Harbour wall (outer face of eastern wall) (1701C47)*

The structures at Beadnell Harbour are generally in fair to poor condition with masonry walls and concrete coping showing signs of abrasion and cracking. As was reported in 2016 there is ongoing evidence of toe undermining and several open joints and missing blockwork on both the outer and inner face of several of the structures. It is highly recommended that the undermining is monitored closely and a more detailed structural inspection is undertaken, possibly including a dive survey. Particularly as a recent breach

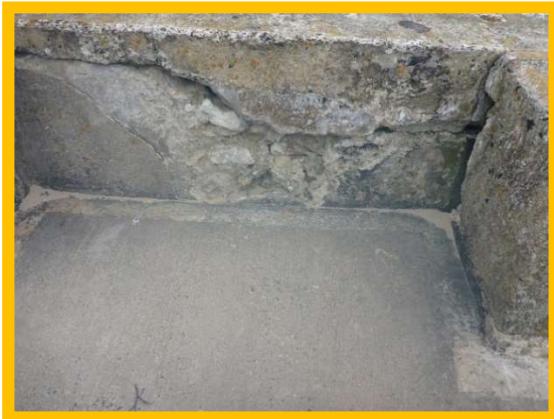
required emergency repair works. The repairs to the deck appear to be effective, however further cracking of the deckslab and splash wall were noted during the 2018 inspection.

*Damage to splash wall (1701C47)*

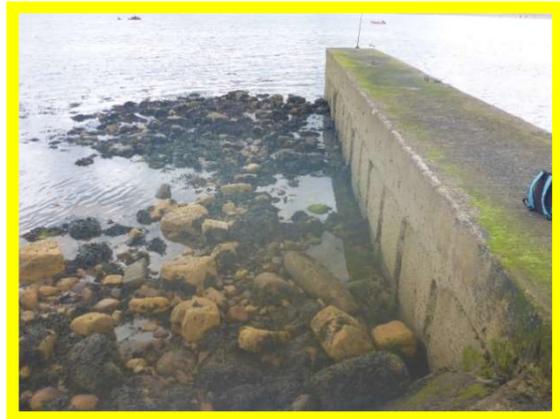
*Fair condition (1701C50)*

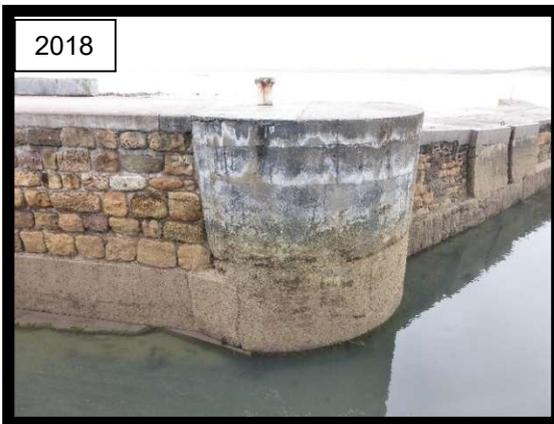
*Undermining of Beadnell Harbour wall (inner face of southern wall) 2018 (1701C51)*

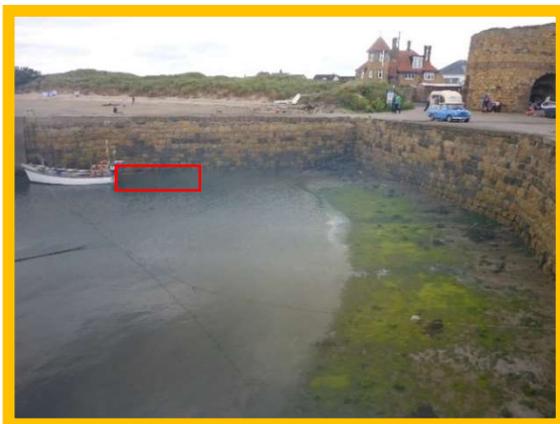
*Missing blocks at Beadnell Harbour wall (inner face of northern wall) (1701C52)*

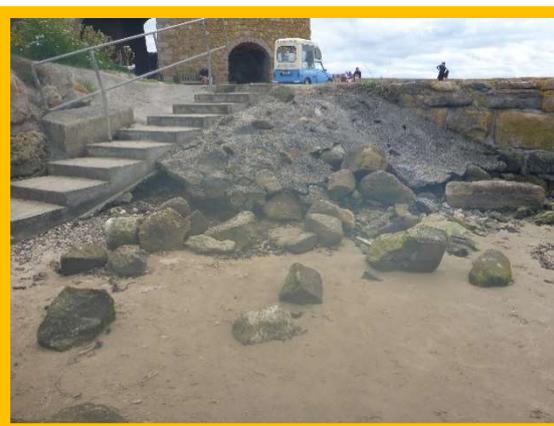
At the northern end of Beadnell Bay, adjacent to the harbour, the poured concrete revetment protecting the access steps is in poor condition, is undercut and partially collapsed in places. Elsewhere within Beadnell Bay, the dunes appear to be suffering ongoing erosion, particularly around beach access points. Due to the high volume of visitors who visit this beach throughout the summer months it is recommended that the condition of the dunes is monitored over the coming winter to ensure healthy recovery.

*Undermining and partial collapse of grouted stone revetment adjacent access steps. (1701C53)*

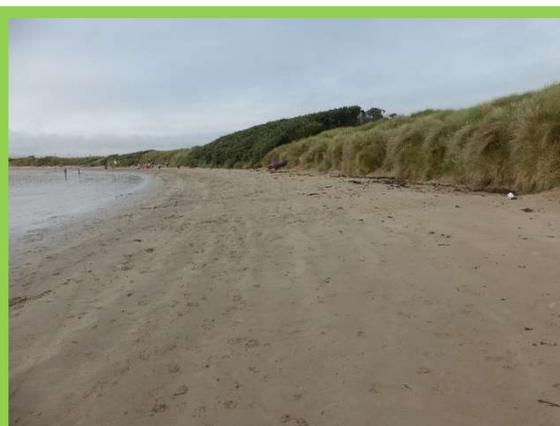
*Healthy dunes in Beadnell Bay (1701C53)*

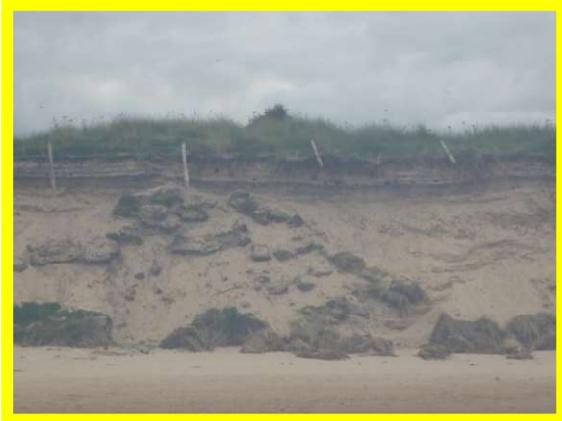
Coastal asset 121AA901A1801C01 lies to the north of Brunton Burn / Long Nanny outfall and is comprised of a small steep cliff fronting a wide vegetated plateau. The dunes looking onto Brunton Burn are actively eroding and have become habitat to nesting sandmartins. To the south of the watercourse outlet itself a shallow well vegetated marshland area is developing. The southern section Beadnell Bay is covered by 121AA901A1901C01 and comprises of large vegetated dunes fronted by a wide sandy beach. Sections of the foreshore are fenced off in the summer months due to nesting Little Terns. There are signs of ongoing erosion, seemingly exacerbated by public access, however generally dunes remain healthy and well vegetated with beach levels remaining reasonably high along the toe of the dunes. The rock headland to the south of the asset (Snook Point) appears to be stable with no signs of erosion and a reasonable accumulation of large beach material along its northern flank.

*Ongoing erosion of the dunes to the north of Brunton Burn / Long Nanny highlighted by displaced post fence. Nesting sandmartins in upper layers. (1901C01)*

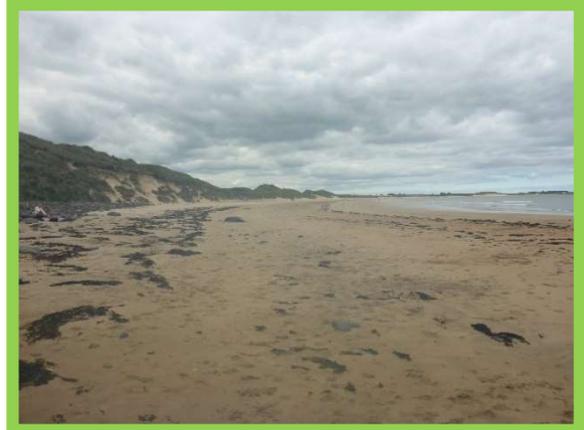
*Larger dunes to the south of Brunton Burn / Long Nanny (1901C01)*

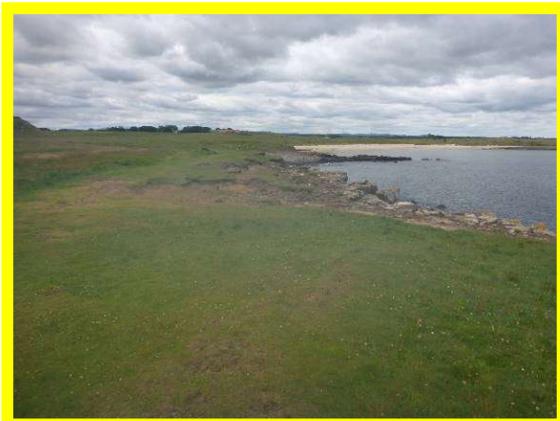
The vegetated dunes in Football Hole remain in good condition, with embryo dune growth at the toe of the dunes. Around the headlands at either end of Football Hole larger beach material has accumulated offering some protection to the dunes and headland in this area. Very minor erosion to upper soft layers of the cliff is still observed to the Southern headland, aggravated by footfall along the coastal path..

*Erosion observed to upper till layer on Southern headland. Stable dunes in Football Hole in background.(/1901C02)*

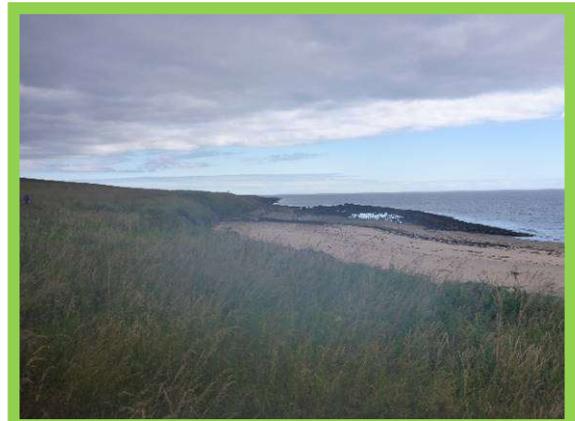
Following the 2016 inspection it was reported that there had been some localised erosion of the coastal slope at Newton Point headland with the National Trust having to reposition the adjacent fence line accordingly. Continuing from 2018, through to 2020 the slope appeared generally more stable and well vegetated throughout its entire length.

*Vegetated slopes to the south west of Newton Point headland (/2001C01)*

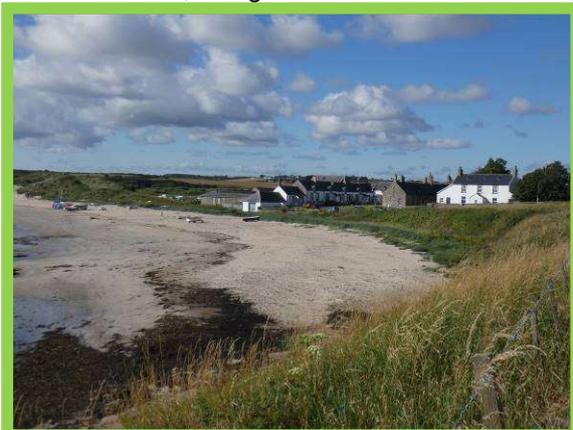
The dunes within Newton Haven have been subject to quite severe erosion in the past. However, since 2014 the dunes have recovered with accreting sand levels and embryonic vegetation growth at the toe identified in 2016, this growth has continued through to 2020.

*2001/C02 continued development of dunes 2020*
