## **Cell 1 Regional Coastal Monitoring Programme Walkover Inspection Surveys 2020**

**Northumberland County  
Council**

## Walkover Inspection Surveys 2020

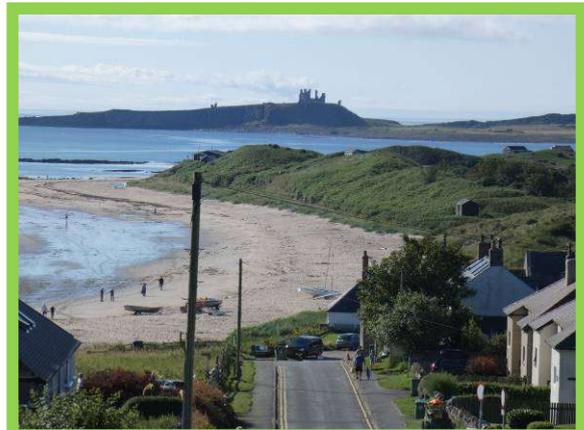
*2001/C03 good growth at toe of dunes 2020*

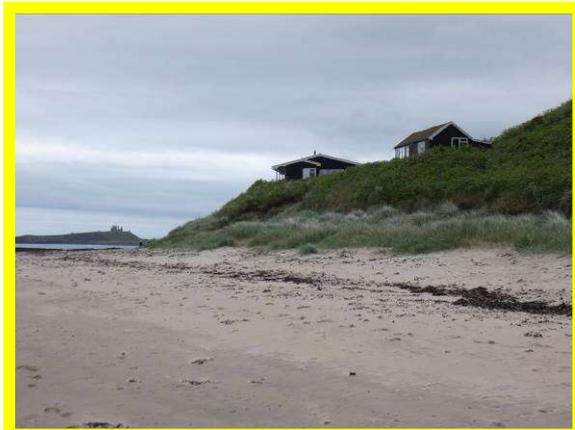
*2001/C03 initial growth of toe of dune 2018*

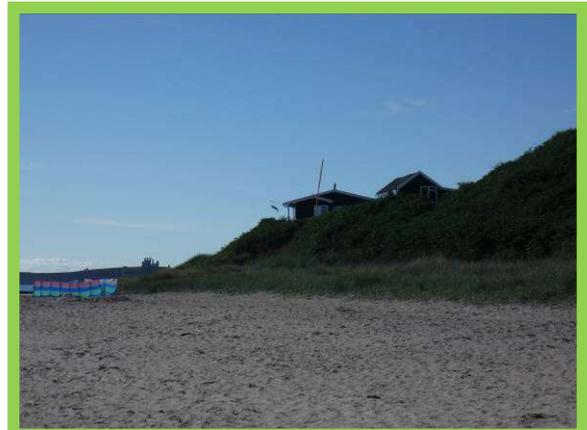
*2001/C03 continuing growth 2020*

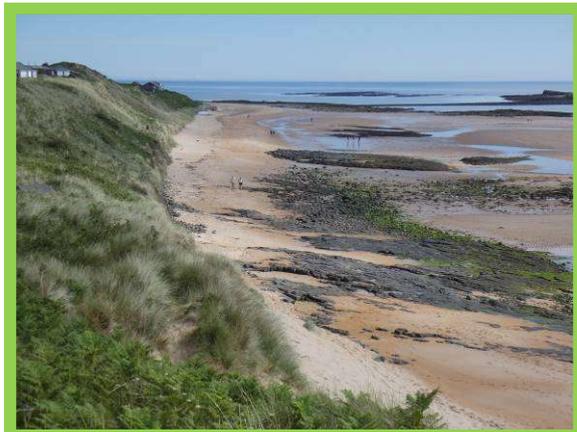
There has been general accretion of the dune toe around Embleton Bay since 2018, with the exception of the areas north and south of the burn outlet. Over the area to the north of the burn the dune face remains very similar to that in 2018. To the south of the Burn there has been a local section of erosion caused by the change in position of the outlet. This change in the outlet appears to have been driven by the building of the beach into the area of the Burn.

*2001C04 2020 dune growth to the north*

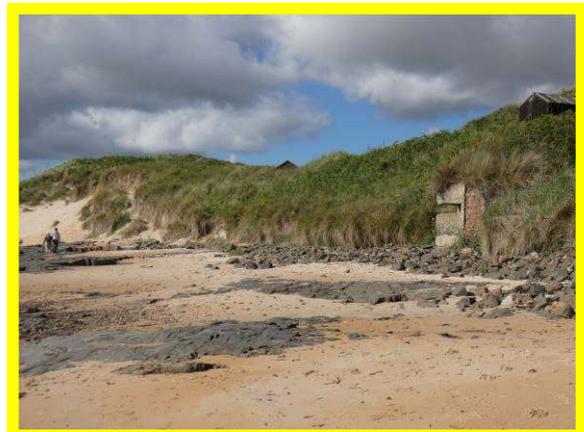
*2001C04 2020 little change since 2018 to the south*

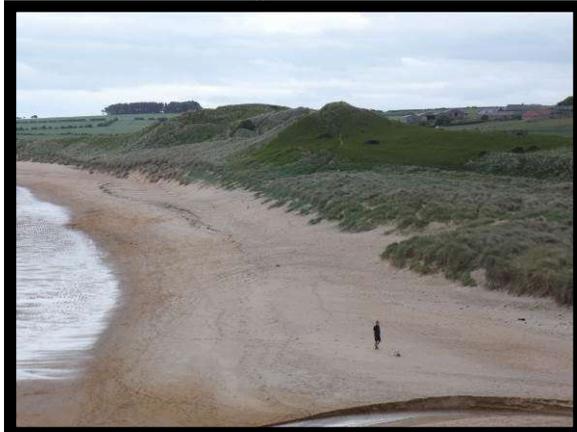
*2001C04 2018 Intermittent erosion and dune growth).*

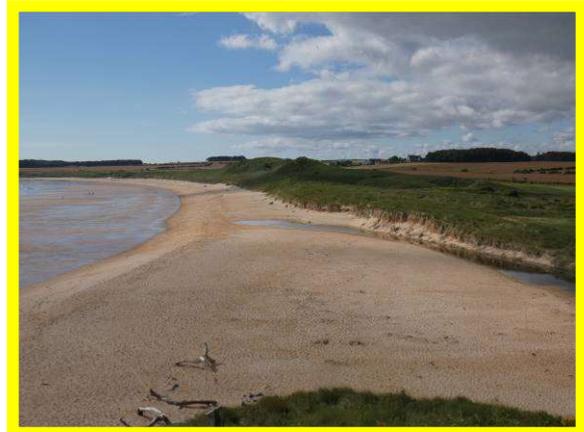
*2001C04 2020 local erosion of dune due to configuration of the outfall channel*

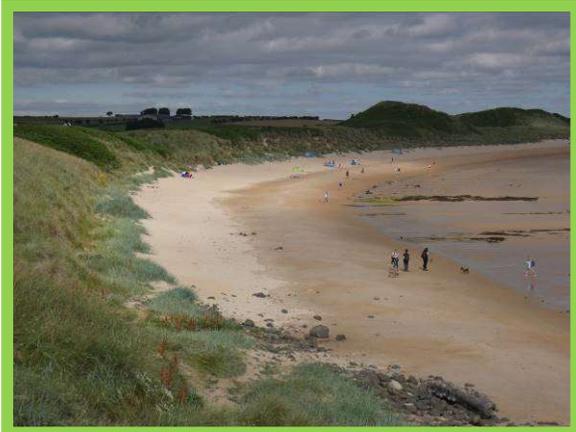
*2001/C03 embryo dune growth to southern end*

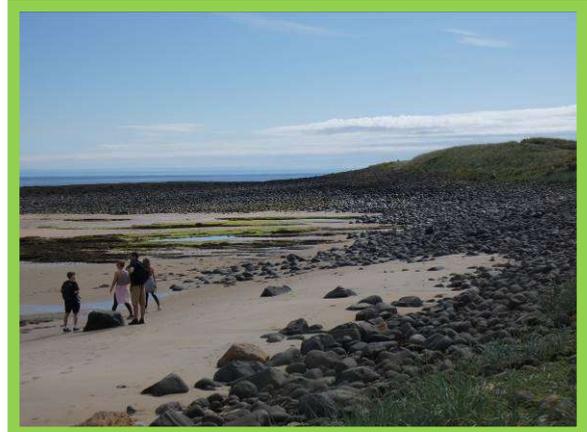
*2001/C03 cobble bank remains stable*

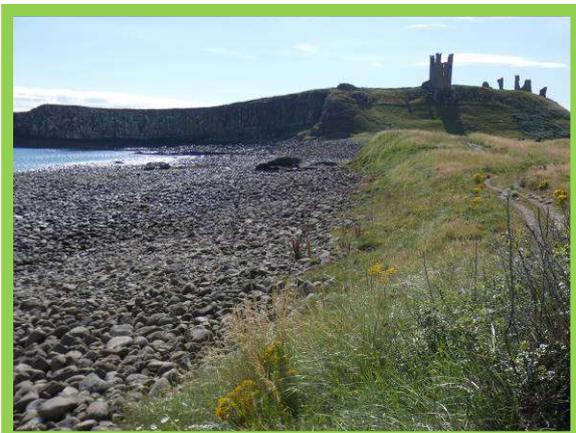
*2001C05 stable cobble bank*

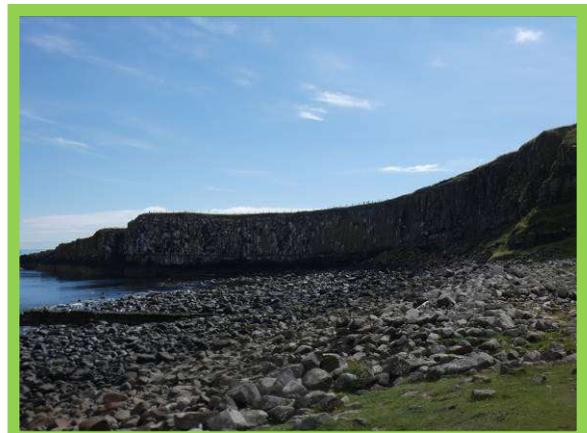
*2001C05 no change to Castle Point*

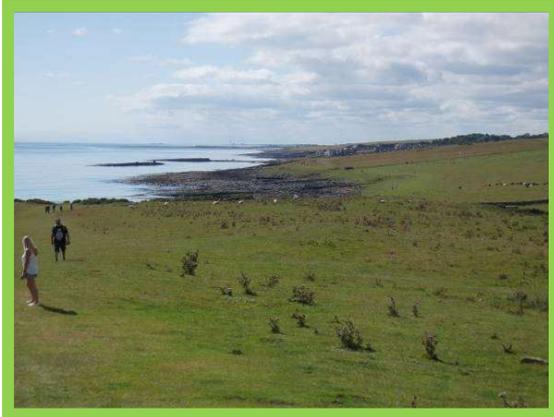
2101C01 no change

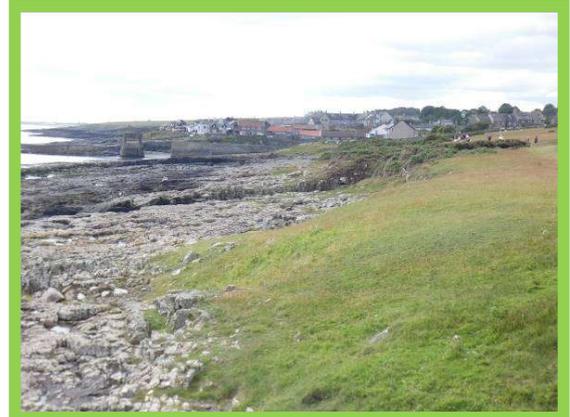
2101C02 no change

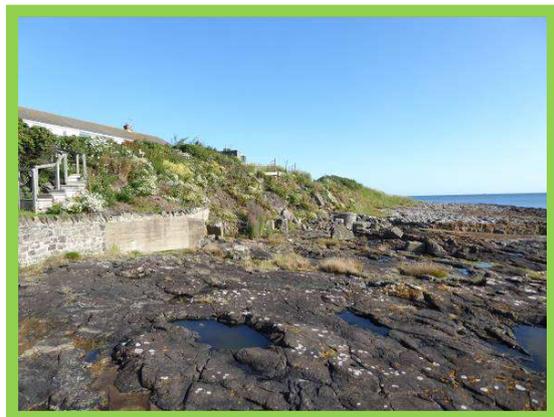
To the north of the Craster harbour, the low wall remains in fair condition and there has been no further erosion around the outfall manhole.

2201C01 / C02 no change

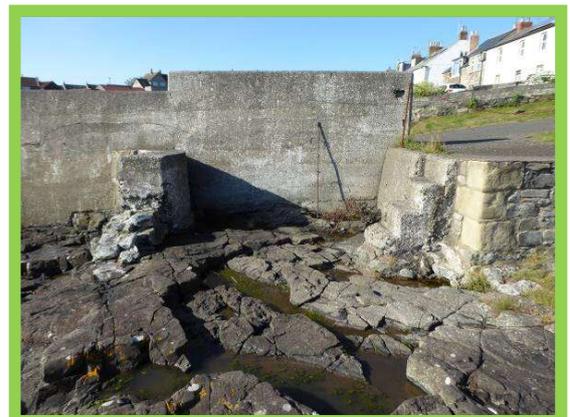
Wall and start of Pier (/2201C02 / C03)

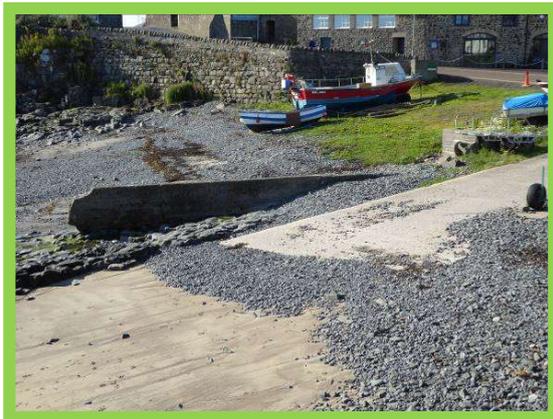
There is very slight undermining of the new blockwork wall to the outfall by the slipway, but no further undermining of the slipway.

2201/C06 Slipway no change

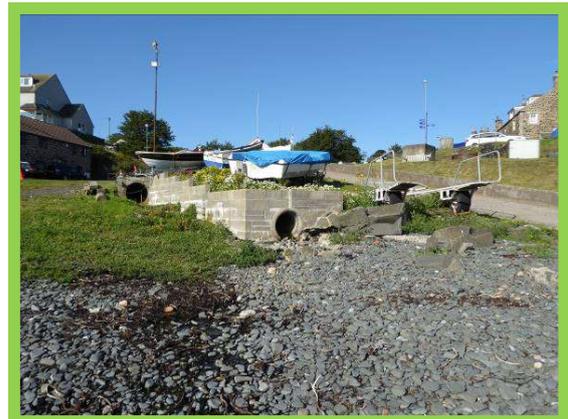
2201/C06 Blockwork wall

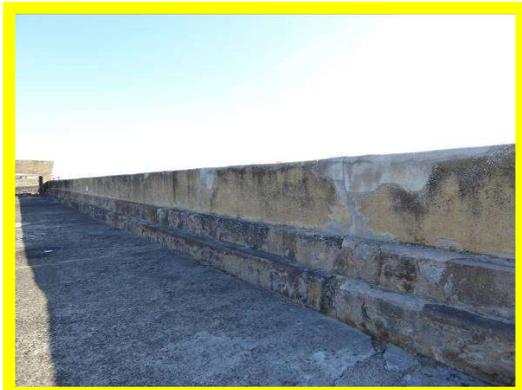
Further repairs have been undertaken to the inner facing crest wall of the South Pier. In places the outer coat of these repairs has fallen off. This appears to be a continuing problem. The outer face of the South Pier has minor undermining at its toe but this is not considered serious. Not change to the head of the pier.

201/C11 repairs undertaken

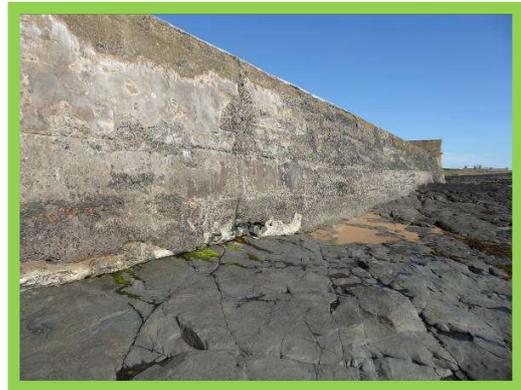
2201C11 Front face of Pier

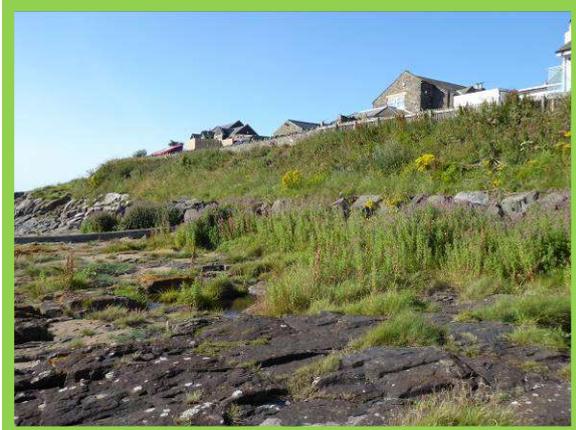
2201/C12 rock revetment at toe of slope

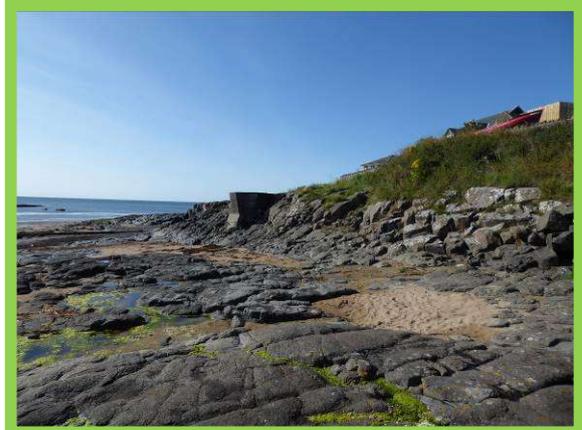
2201/C13 no change

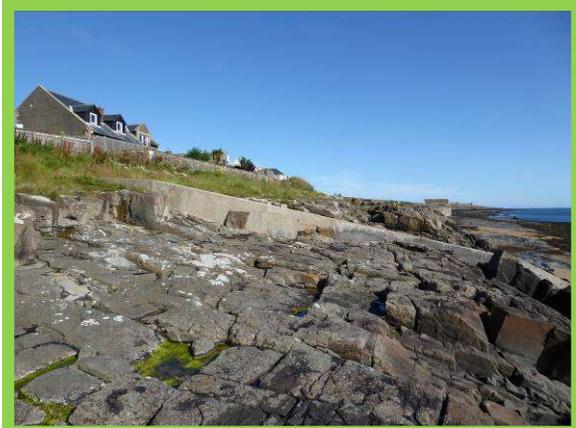
2201/C14 minor erosion to natural cliff

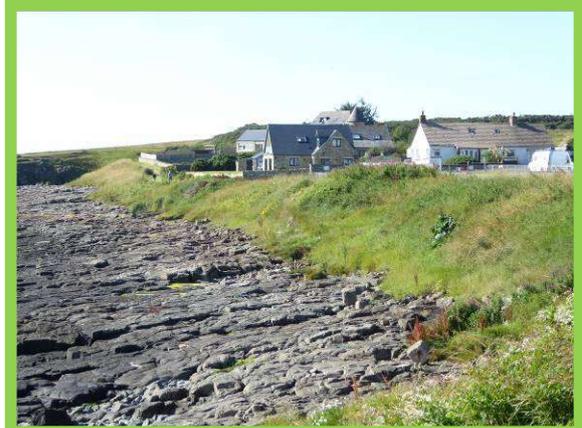
2201/C15 no erosion.

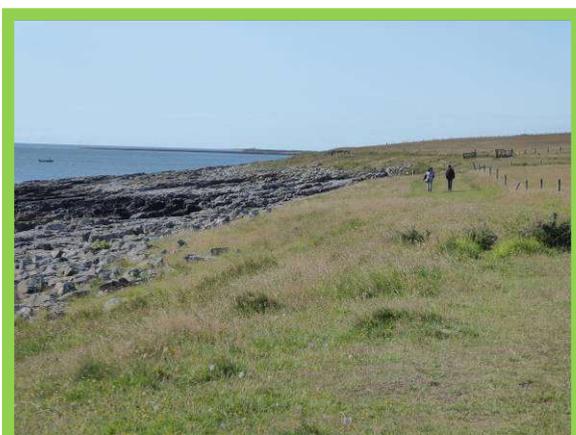
2301/C01 no change

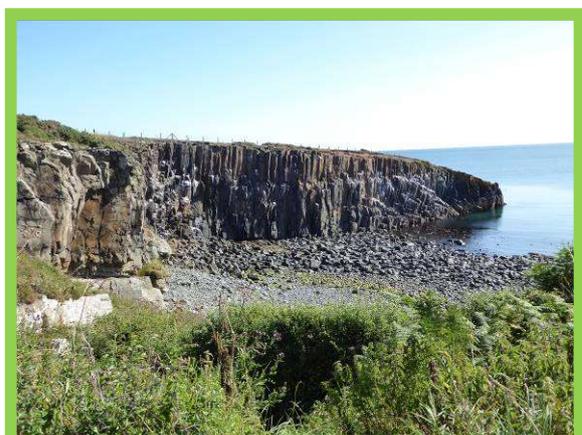
2301/C02 Cullernose Point.

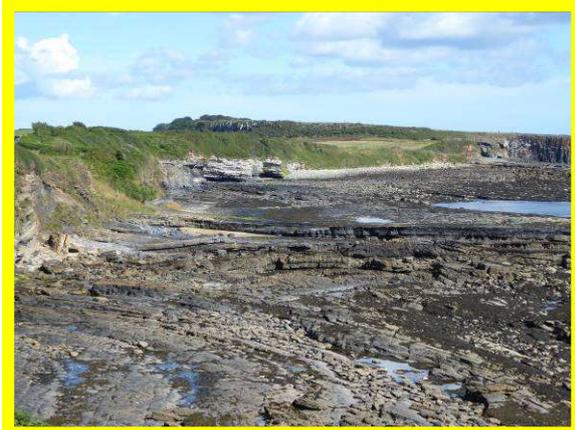
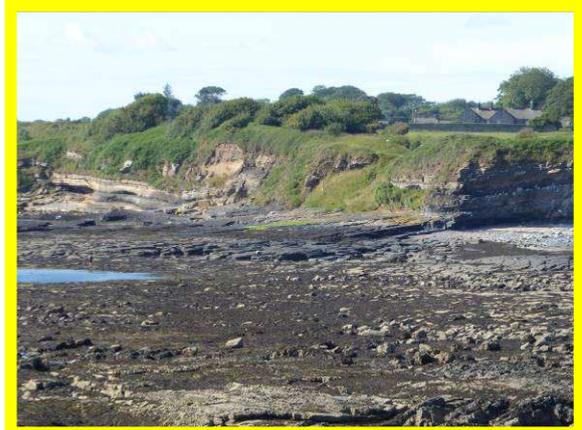
There continues to be slow undercutting of the cliffs south of Cullernose Point, where the road comes close to the cliff line. At present, there does not appear to be a major issue at this point.

2401/C01 slow undercutting of cliff

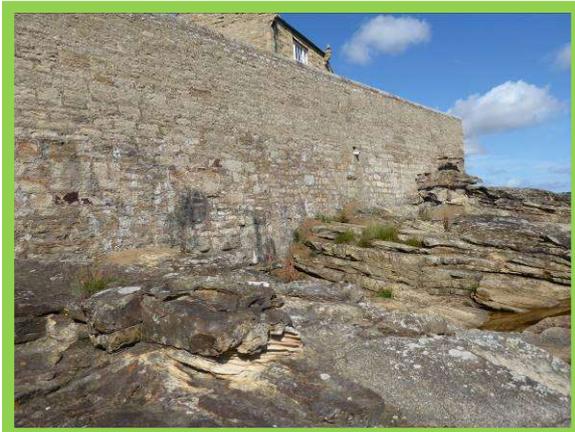
The high masonry wall around The Bathing House near Howick is in good condition with no signs of undermining, abrasion or loss of mortar. To the south of the Rumbling Kern headland there is a short length of masonry wall that is being outflanked by erosion. The main coastal path is set well back from this defence.

2401/C02 Bathing House wall

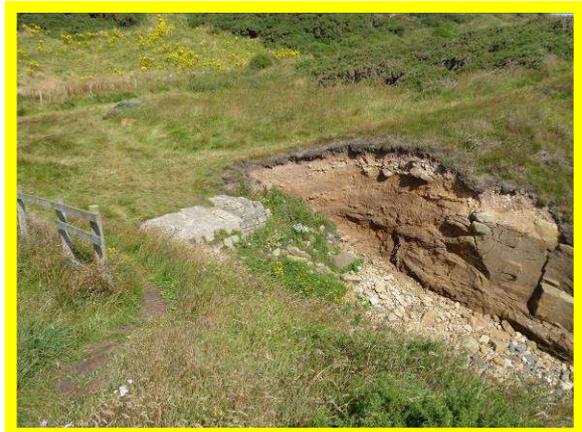
2401/C02 outflanking of local masonry wall to south of Rumbling Kern.

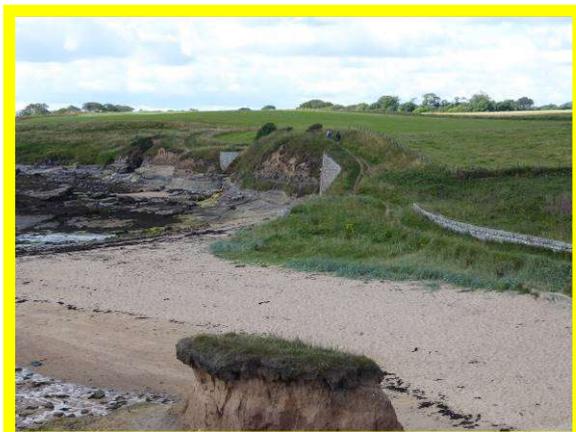
South of Rumbling Kern, at Howick Haven, there are several short sections of old masonry wall that continue to deteriorate. These are slowly deteriorating but do not appear critical in terms of significant risk. However, locally, failure of sections of wall could impact on the coastal path. The rest of this frontage consists typically of low clay cliff with no serious erosion.

2501/C01 series of masonry walls to coastal path.

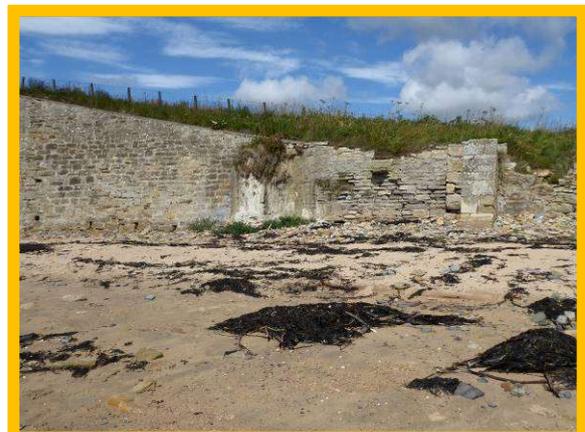
2501/C01 masonry wall in poor condition.

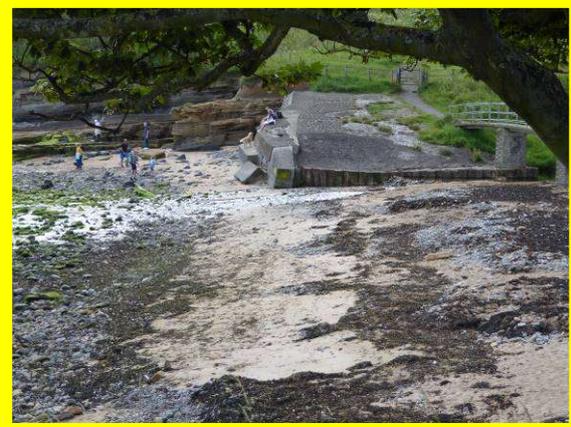
The footbridge just to the north of Iron Scars has various defects associated with its piers and toe protection to the piers. While not at risk of failure the structure is in need of some maintenance. Beach levels within the area have recovered since 2018.

2501/C01 Undermining of concrete at southern bridge abutment. Higher beach levels since 2018.

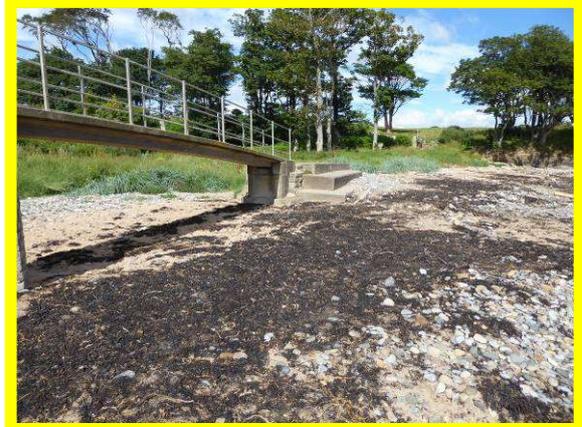
2501/C01 higher beach levels around supports to northern side..

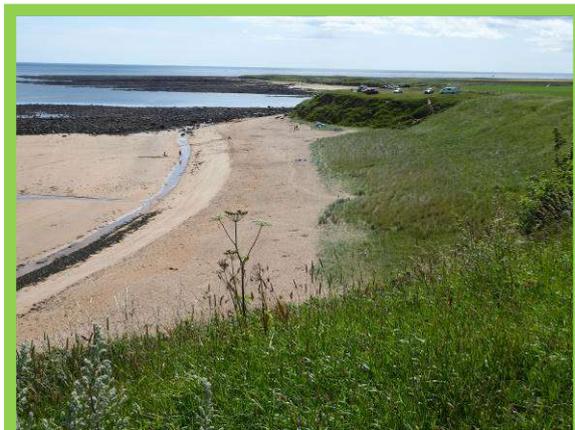
2501/C01 Sugar Sands with growth of dune toe

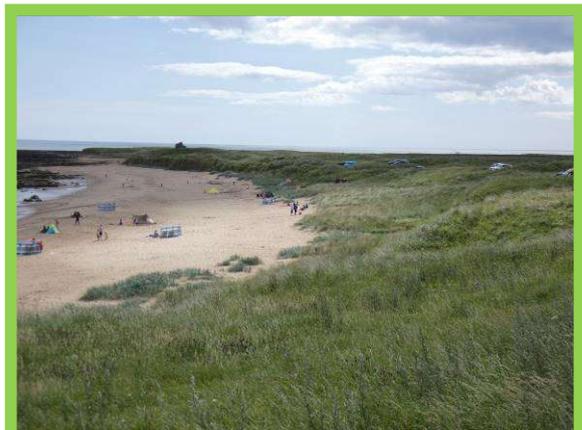
2501/C01 Howdiemont Sands dune toe growth

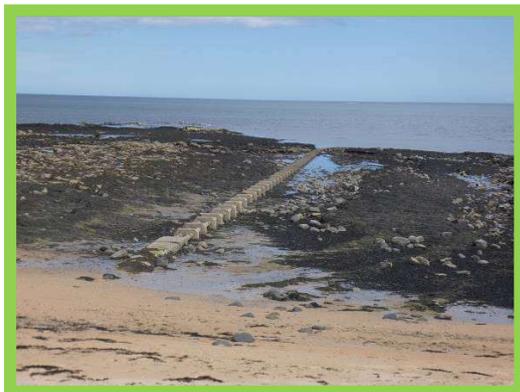
2501/C02 outfall pipe

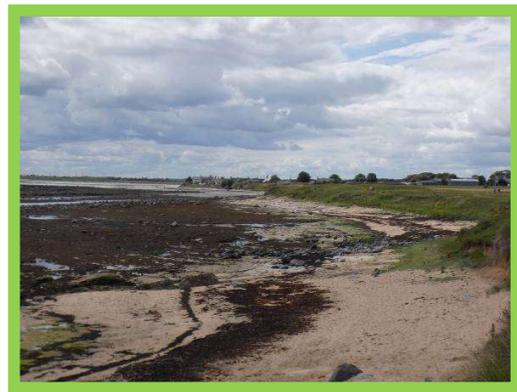
2501/C02 no significant change

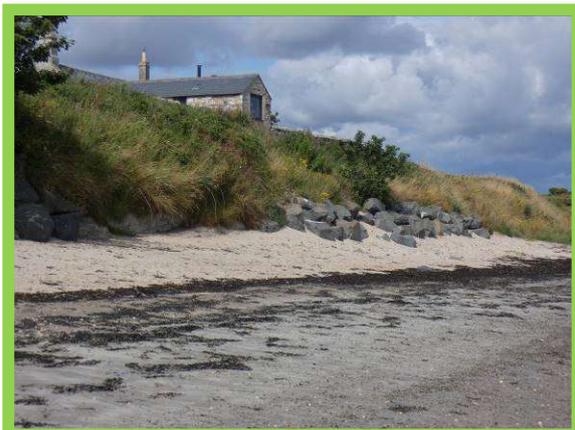
2601/C01 local rock revetment, higher upper beach.

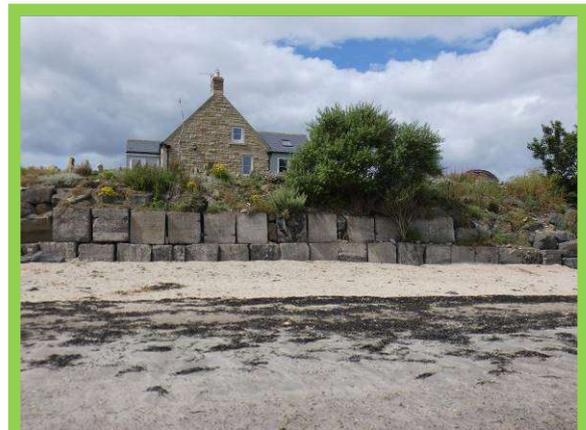
2601/C02 Block revetment, no change

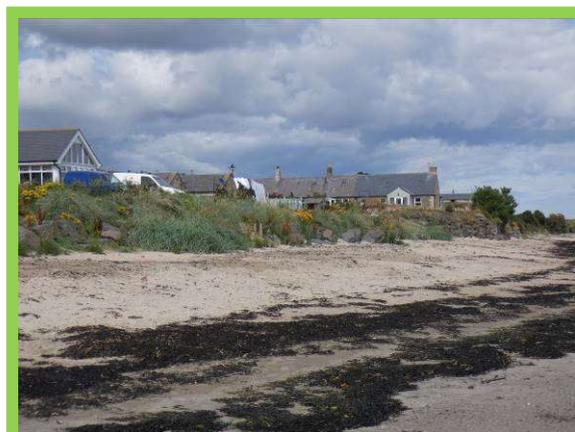
A scheme involving the placement of more rock armourstone as a defence toe to the coastal slope and backfilling and reprofiling with beach sand above the rock toe was constructed in May 2016. There has been some accretion of the upper beach over much of the area since 2018, with the rock revetment to the central area of the frontage becoming vegetated.

2601/C03 New rock revetment toe (2016) well vegetated.

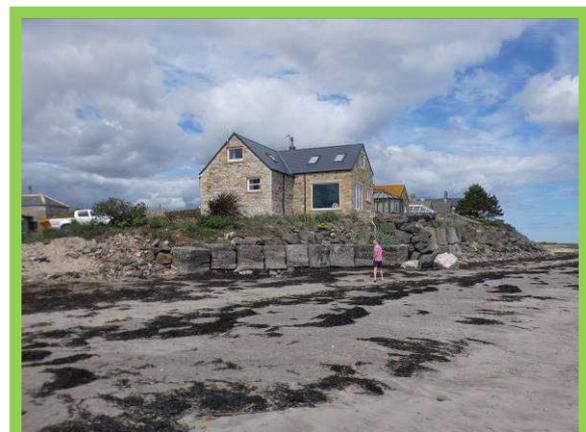
2601/C05 (blocks) and C04 (rock), no change

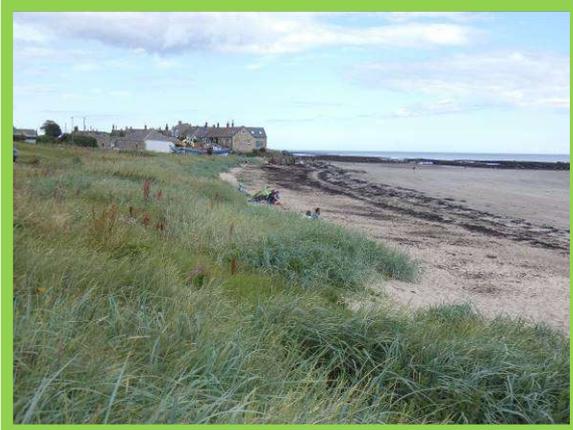
To the south of the village is a length of low natural dunes. These remain in fair condition with further growth of embryo dunes since 2018, particularly to the northern end. It was noted in 2018 that there was embryo dune development to the southern end. There is less evidence of this growth.

*2601/C06 dunes with toe growth since 2018*

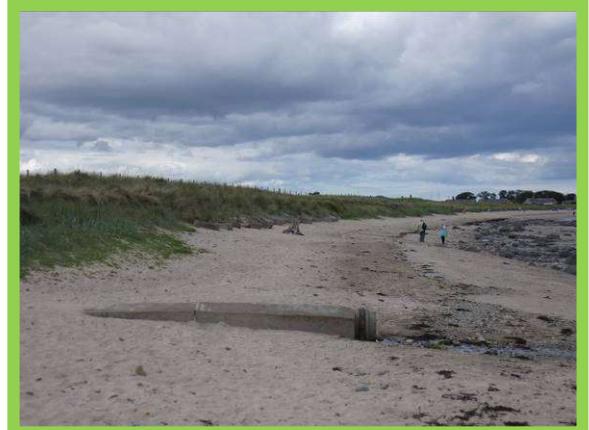
*2601/C06 (southern end) Local toe growth*

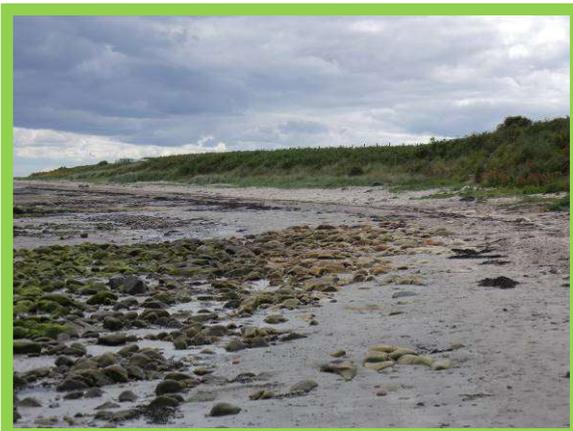
Further south, towards Seaton Point, there is evidence of toe dune growth over much of the 2601/C07 frontage. However, at Seaton Point itself there is no change since 2018.

*2601/C07 stable dunes with toe growth.*

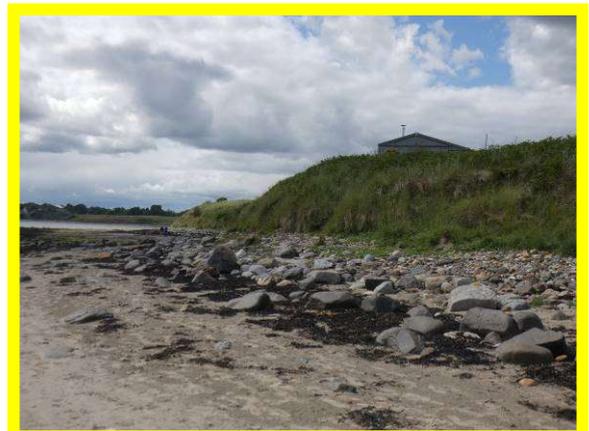
*2601/C07 no change to Seaton Point*

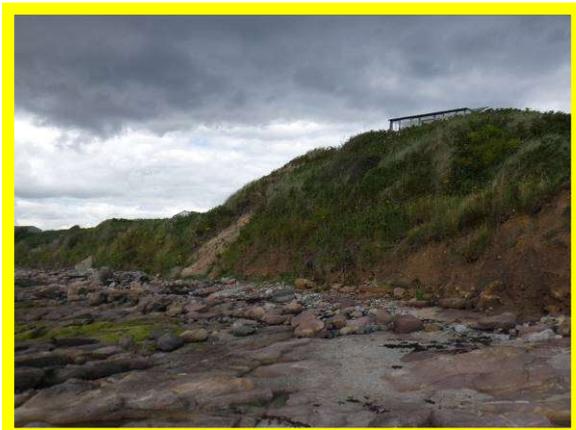
Where there is a rock platform around the northern part of the bay there are dunes and coastal slopes suffering moderate erosion, this has continued in 2020. Local attempts at protection have failed. There have been further cliff failures particularly at the northern end where the cliff is higher. While beach levels are higher in the area north of the steps, there is slight further erosion.

2601/C08 continuing erosion

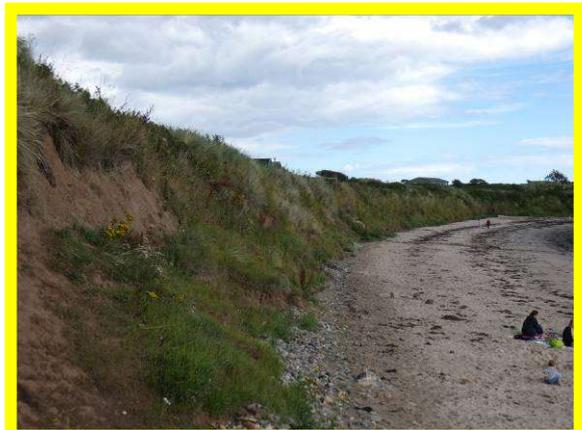
2601/C08 higher beach level but continuing erosion

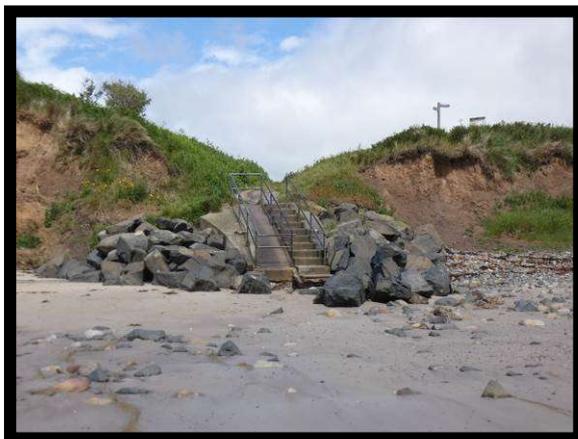
The access steps to Foxton Bay are protected by rock armour. Erosion of the cliffs either side continues as noted in 2016 and previously. The beach levels are slightly higher in 2020 and this addresses the problem of local undermining of the lowest step.

2601/C09 2018 low beach level and undermining.

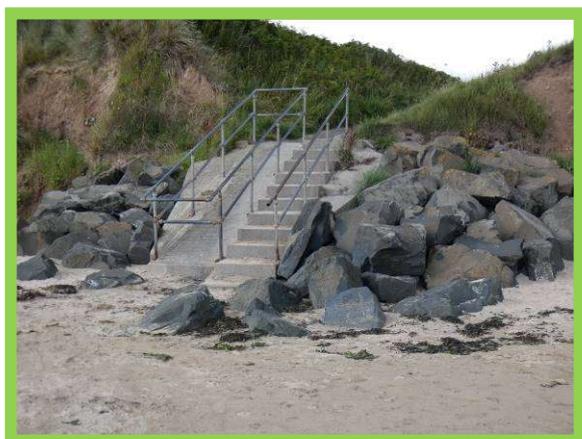
2601/c09 higher beach levels to toe of steps.

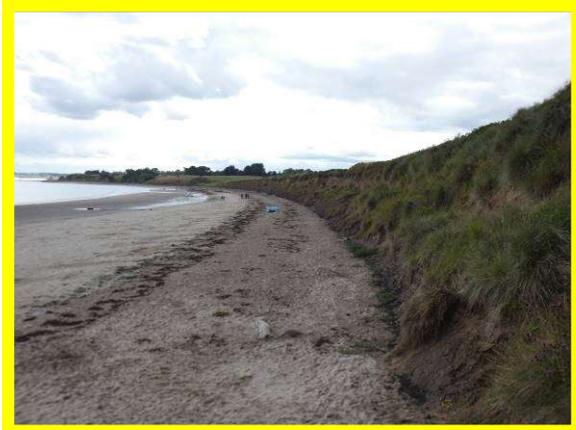
Just to the south of the access steps, the eroding cliffs are largely bare of vegetation on their face and sand martins are nesting in the upper sections of cliff. The ongoing erosion has caused the fence to become lost in places. Over the main cliff frontage to the south of the access point, erosion continues in 2020 with removal of lower slumped material. This has been a long-term problem, investigated in the past by the Golf Club. As noted in 2016, erosion is now cutting back to the fencing.

*2701/C01 Eroding cliff to golf course*

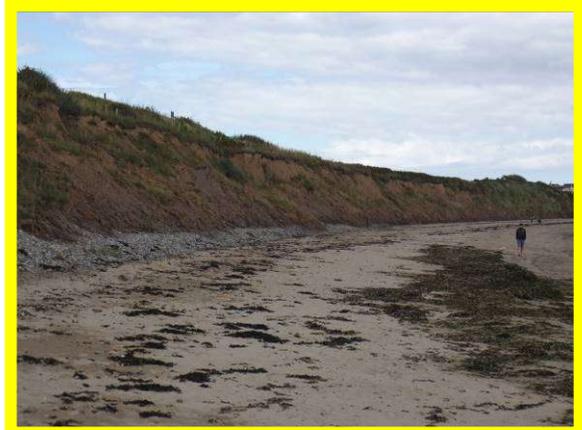
*2701/C01 further cliff erosion since 2018*

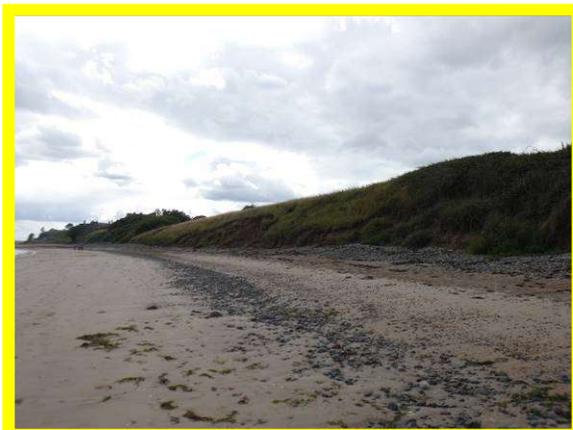
At Foxton Hall, the eroding cliffs reduce to a well vegetated earth slopes that are protected by a shingle and cobble berm. There has been slight slippage in the face of the slope between 2018 and 2020. In front of the properties there is localised timber breastwork. Remnants of an earlier concrete structure remain on the shore.

*2701/C02 some slope failure since 2018.*

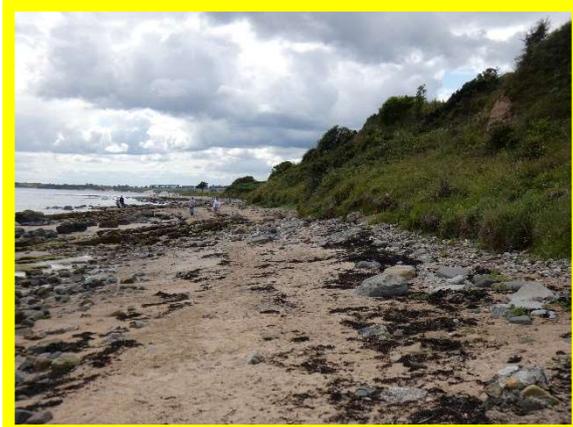
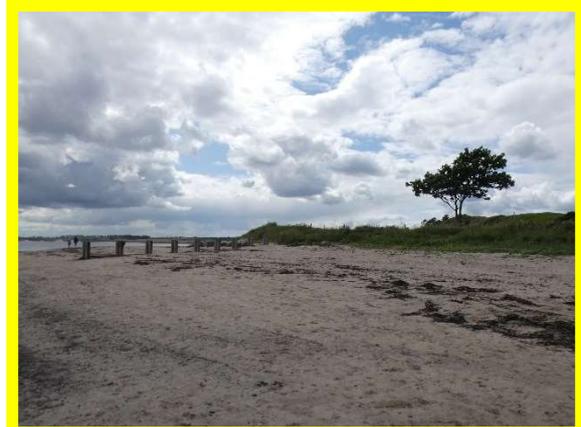
South of Foxton Hall, the backing slopes are well protected by foreshore boulders and rocky shore platform, although slumping has occurred locally. In contrast to many other areas, beach levels in this section have fallen and there is slight erosion at the toe compared to 2108.

*2701/C04 slope remains relatively stable but lower beach with slight erosion. 2701/C04 loss of embryo dunes just north of groyne.*

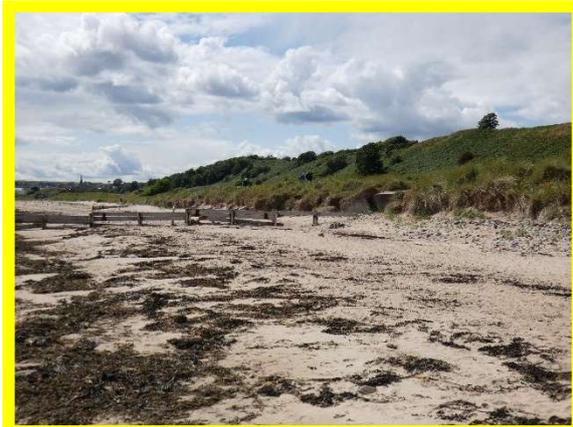
Over the northern section of 2710/C05 there has been significant erosion of the dune face, back to the tank block defence at the toe of the dune. Further south, the upper beach has changed little with little evidence of erosion. Given the broader scale processes, there is a question over the effectiveness of the groynes and this should be examined before any improvements to the groynes are made.

*2701/C05 northern, significant erosion to dune toe.*

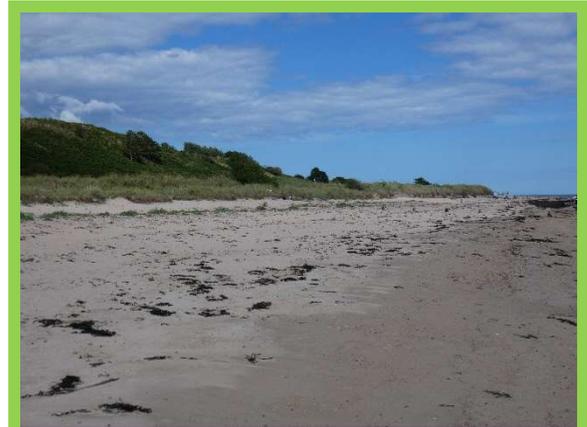
*2701/C05 southern, little change since 2018.*

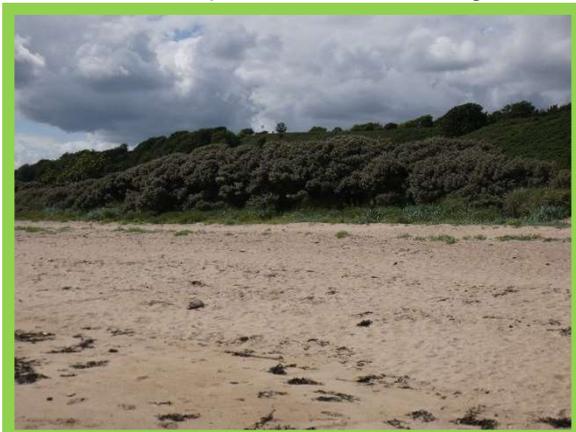
Further south, into 2701/C06, there has been more major accretion, reversing the erosion noted between 2016 and 2018. The concrete blocks to the dune face have been buried and further south the accretion has allowed development of a forward ridge, developing as an embryo dune.

*2701/C06 northern, concrete blocks buried.*

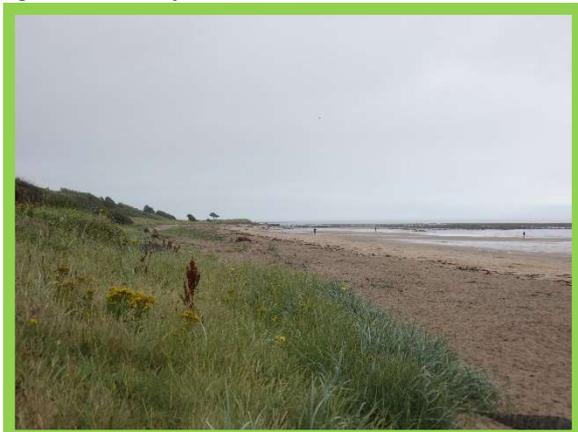
*2701/C06 southern, development of forward embryo dune ridge.*

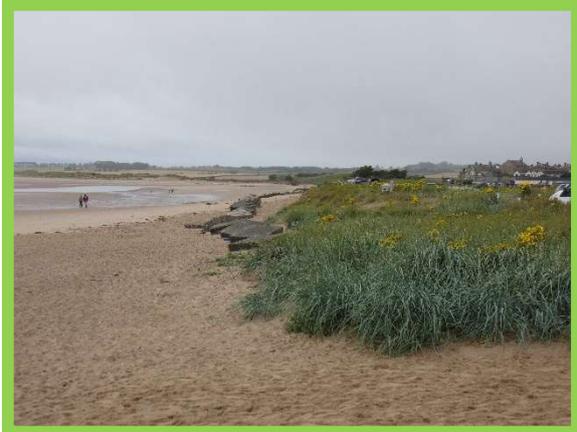
This variation in behaviour is further highlighted in the response of the shoreline moving south towards the Aln Estuary. At the start of the car park frontage (2701/C07) there has been some growth around the access point by the Boathouse, but with quite severe erosion of the dunes towards the end of the car park. There is little evidence that the concrete tank blocks have a significant influence of this. Erosion to the southern end of the car park continues from that seen in 2018.

2701/C07 growth of dune at northern end of car park.

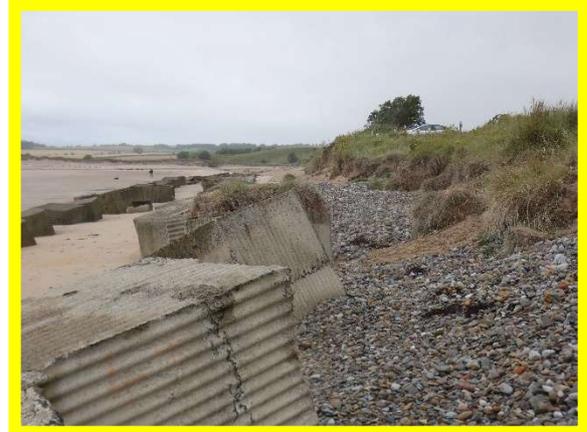
2701/C07 Continued severe erosion to southern end of car park.

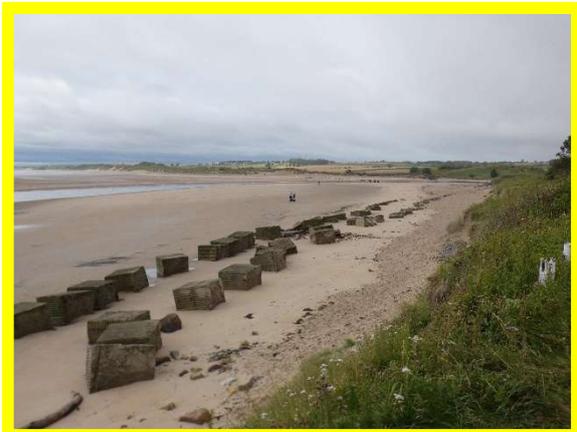
Erosion continues over much of 2701/C08. To the southern end of this frontage, while there is still evidence of erosion, this appears to reduce, such that, while the timber steps are still exposed, they are not considered to be at immediate risk.

2701/C08 Further erosion since 2018.

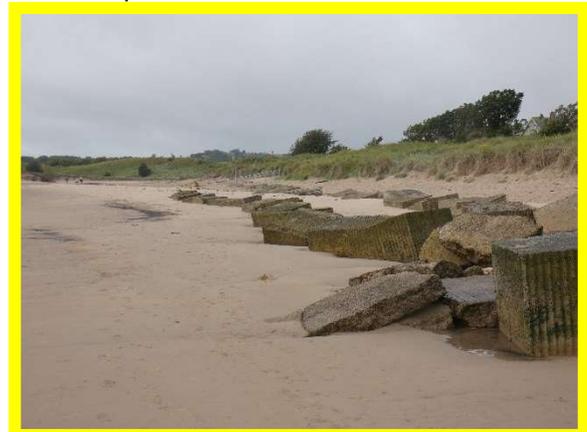
2701/C08 Minor erosion to south of frontage.

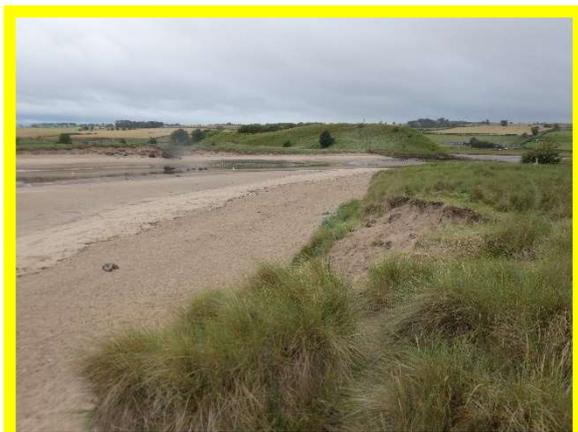
Slow erosion continues over the seaward face of 2801/C01, with some growth of embryo dunes at the apex or "nose" at the mouth of the Estuary. Growth in the area of the nose is reflected in continued pressure on the frontage to the south side of the Estuary.

2801/C01, erosion to seaward face but slight growth at the nose.

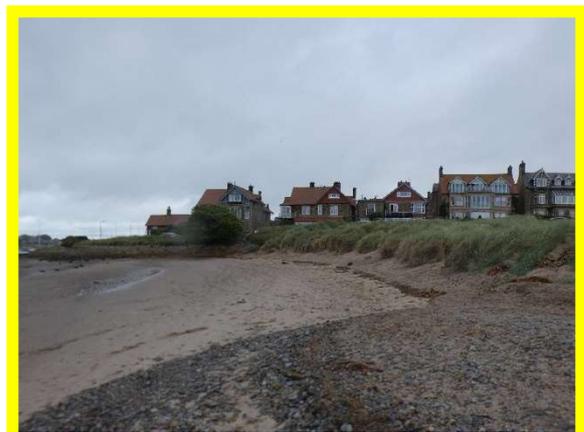
2801/C01, Flow pressure on Estuary face, with erosion.

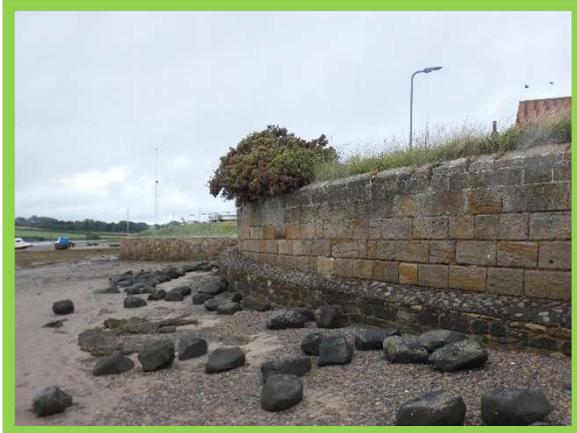
Associated with this, there appears to have been slight lowering of the beach levels against the two walls 2801/C02 and C03. This is not critical in relation to C02 but has resulted in very minor undercutting of the

*2801/C02 Masonry wall with concrete and cobble toe apron. Little change.*

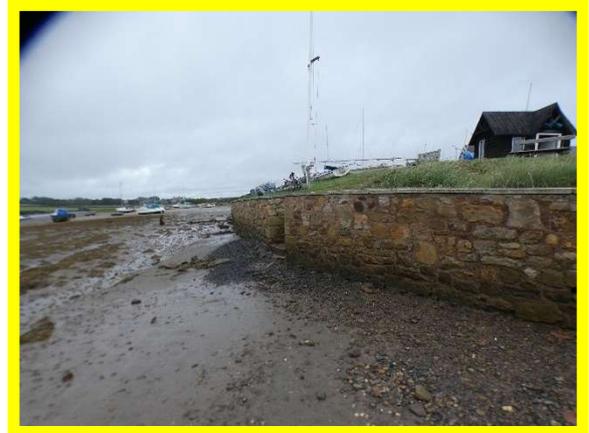
concrete toe of the newer River Aln Boat Club wall (C03). This does not appear to threaten the wall at the present.

*2801/C03. Masonry wall at Boat Club with slight undercutting.*

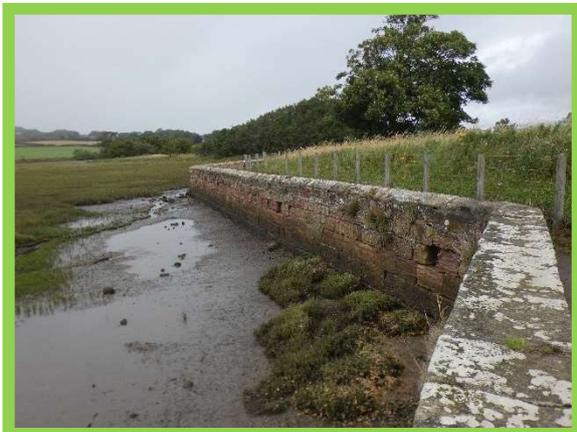
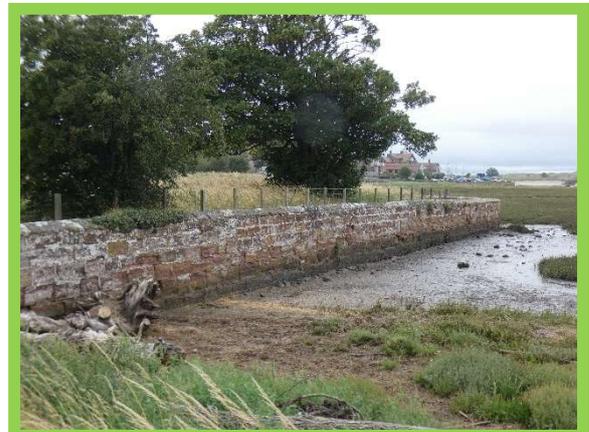
the footpath along the estuary extends away from Peases Park and is protected by an older low masonry wall which has benefited from repointing and local rebuilding of a collapsed section (reported during the 2014 inspections). The wall is still missing some blocks and further repointing may be required. However, in general the wall seems to be in fair condition. Salt marsh in front of this wall is in good condition, although generally low and muddy in front of wall itself.

*2801/C06 Masonry wall fronted by salt marsh, no change*

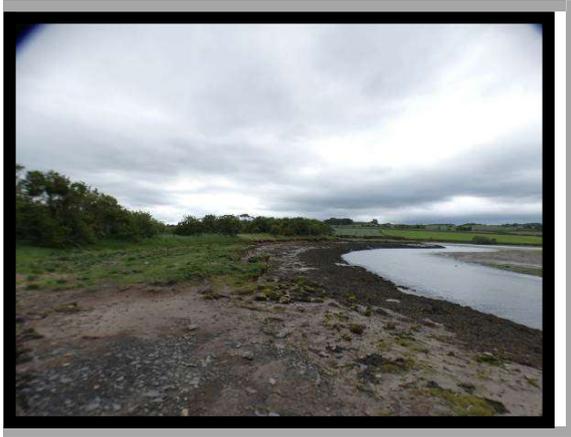
A small spit of land comprised of natural ground extends into the estuary. This may exist over harder sediments as it causes the channel to meander around it. Along its northern face there continues to be significant erosion.

*2801/C09 Eroding face of raised area in 2018*

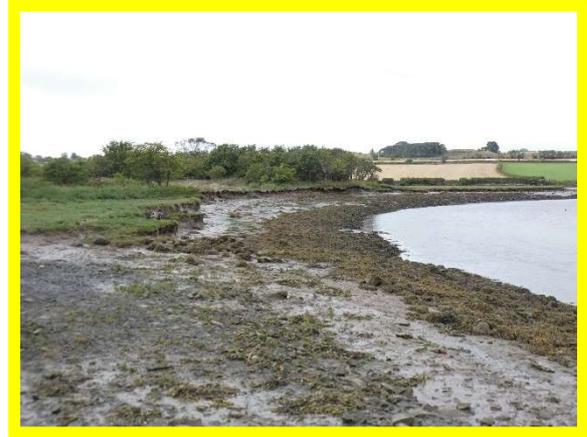
*2801/C09 increased erosion*

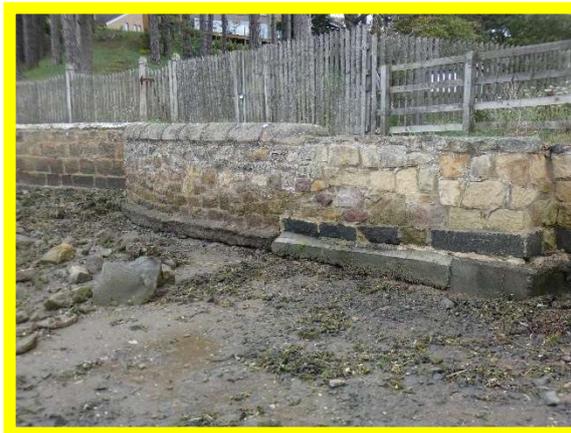
Between the spit of land and the B1338 road bridge over the River Aln, the wall to the riverbank footpath has undergone substantial repair prior to the 2018 inspection. Over the repaired section there has been some local minor undermining of the concrete toe. To the downstream end of the defence there is slight damage to the wall. These areas of concern need to be monitored but repairs are not considered to have any urgency.

*2801/C10 Local undercutting of concrete toe to repaired section*

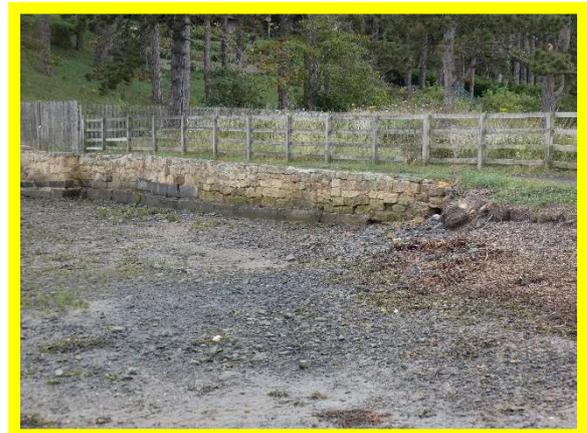
*2801/C10, slight damage to downstream end.*

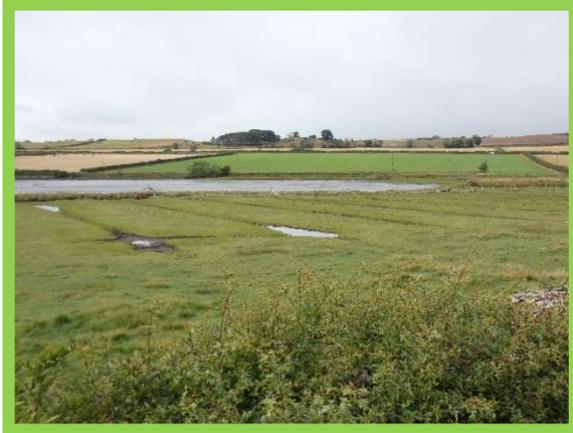
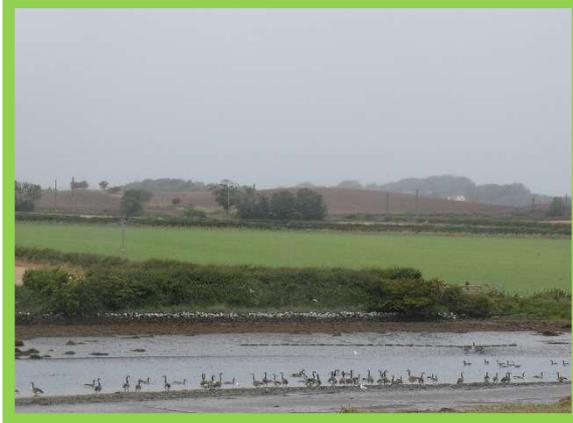
*Area of managed realignment (/2801C11)*

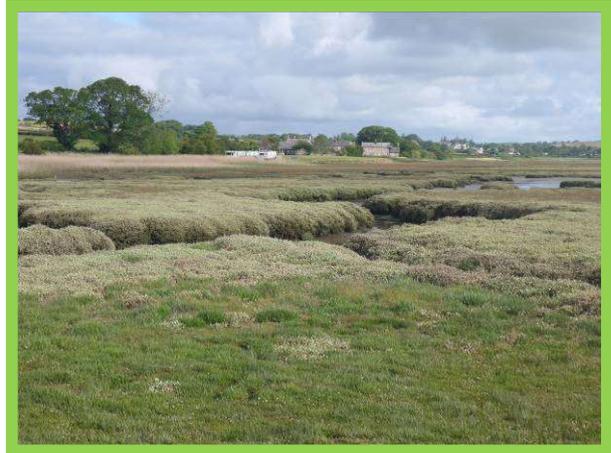
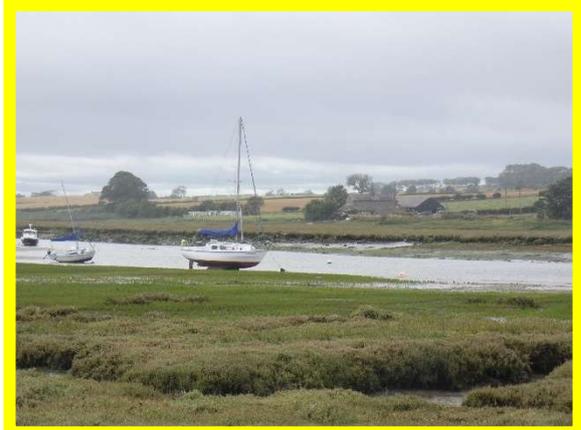
*Healthy saltmarsh (/2801C12)*

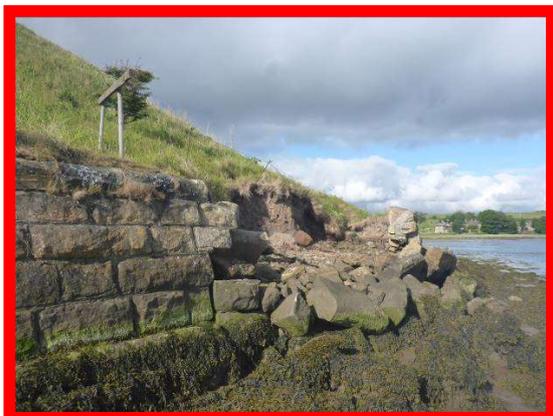
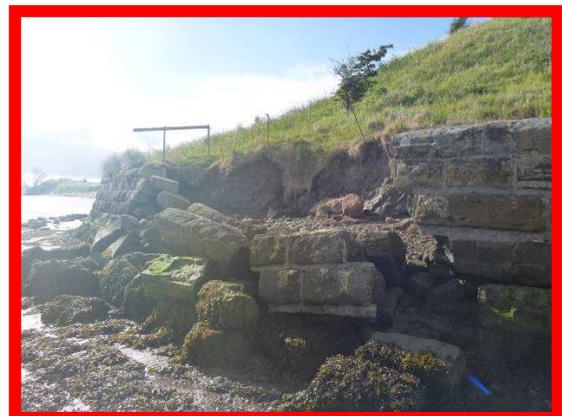
The low masonry wall around the bottom of Church Hill collapsed prior to the 2016 inspection along a length of approximately 10m, with erosion of the land behind occurring since. This situation is known, since the eroded area has been fenced-off since 2018 to prevent public access. The situation does not appear to have deteriorated significantly since the 2018 inspections, but it remains concerning this remains unrepaired and that adjacent sections are also in very poor condition with five other areas of notable defects. Work should be undertaken to avoid a larger scale collapse that potentially could lead to slumping of Church Hill. Whereas at the time of the 2018 inspections the channel of the River Aln adopted a central alignment, well away from either shore, it now occupies a more southerly alignment, cutting close to the toe of the wall around Church Hill.

*Collapsed section of wall at Church Hill with erosion of the land behind (/2801C13)*

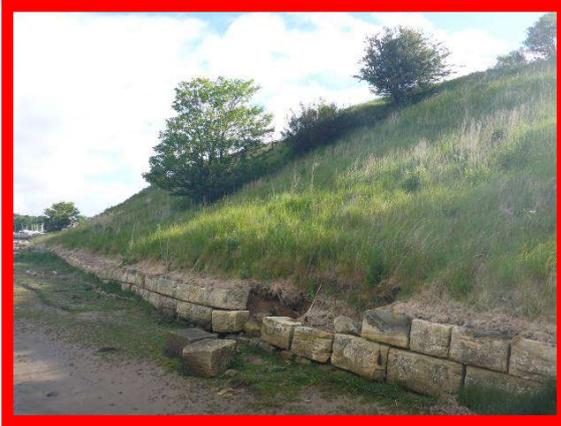
*Displaced blockwork in wall at Church Hill (/2801C13)*
