## **Cell 1 Regional Coastal Monitoring Programme Walkover Inspection Surveys 2020**

**Northumberland County  
Council**

## Walkover Inspection Surveys 2020

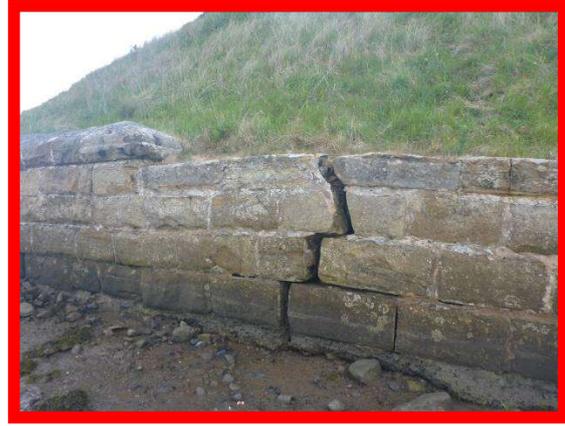
The low masonry wall around the bottom of Church Hill collapsed prior to the 2016 inspection along a length of approximately 10m, with erosion of the land behind occurring since. This situation is known, since the eroded area has been fenced-off since 2018 to prevent public access. The situation does not appear to have deteriorated significantly since the 2018 inspections, but it remains concerning this remains unrepaired and that adjacent sections are also in very poor condition with five other areas of notable defects. Work should be undertaken to avoid a larger scale collapse that potentially could lead to slumping of Church Hill. Whereas at the time of the 2018 inspections the channel of the River Aln adopted a central alignment, well away from either shore, it now occupies a more southerly alignment, cutting close to the toe of the wall around Church Hill.

*Cracked section of wall at Church Hill (/2801C13)*

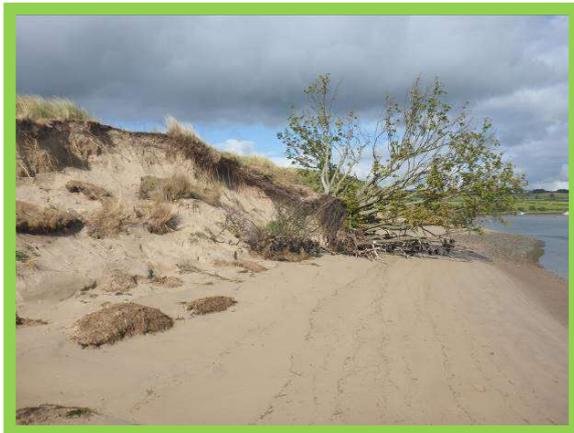
The dunes along the south bank of the River Aln are principally stable but there is one location, centred around a tree, where the channel of the River Aln comes closest to shore and has caused erosion along a length of around 20 metres. At the mouth of the river, the channel deflects away from the south shore to a more northerly alignment and the dunes become stable, with signs of accretion and embryonic dune growth at their toe.

*Eroding dunes by tree on south bank of River Aln (/2901C01)*

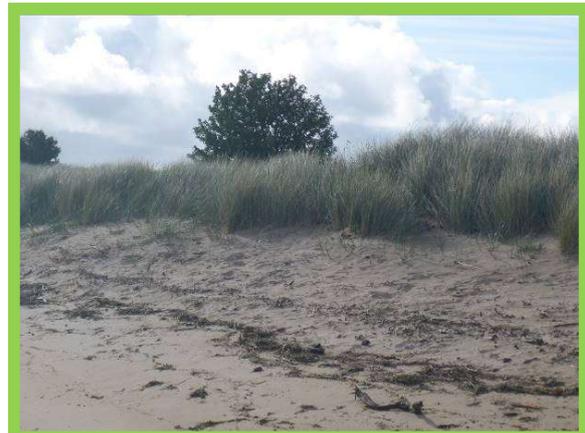
*Otherwise generally stable dunes on south bank of River Aln (/2901C01)*

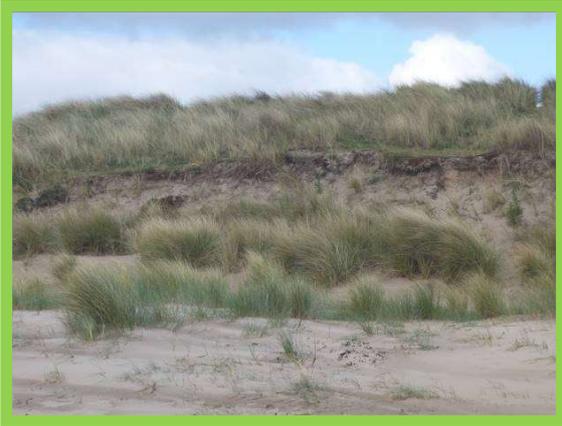
The dunes along the open coast between the River Aln and the rock platform at Birling Carrs were observed in the 2016 inspections to have suffered erosion and in the 2018 inspections to have become more stable, with signs of recovery. This trend has continued to the 2020 inspections, with mostly stable and well vegetated dunes or higher, sparsely vegetated but stable dunes. There appears to be almost completed 'recovery' of the dunes after the pre-2016 inspection damage, with now significant quantities of accumulated sand on the upper beach and dune toe and face. Despite this, the very highest sections of some of the dunes still show the historic 'cliffing' caused by the past erosion event.

*Significantly recovered dunes (with historic storm damage evident as 'cliffing') at northern end of Alnmouth Dunes frontage (/2901C01)*

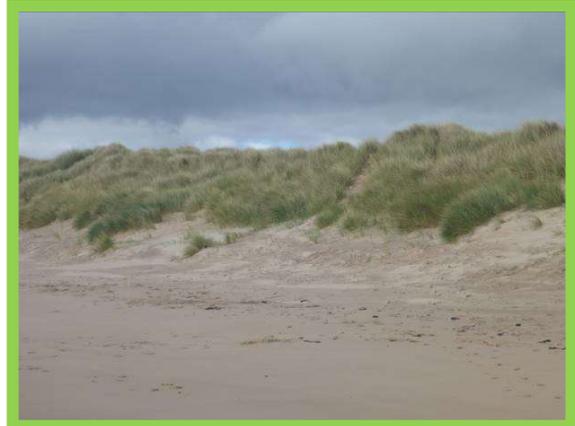
*Naturally recovery of past storm damage along Alnmouth Dunes frontage(2901C01)*

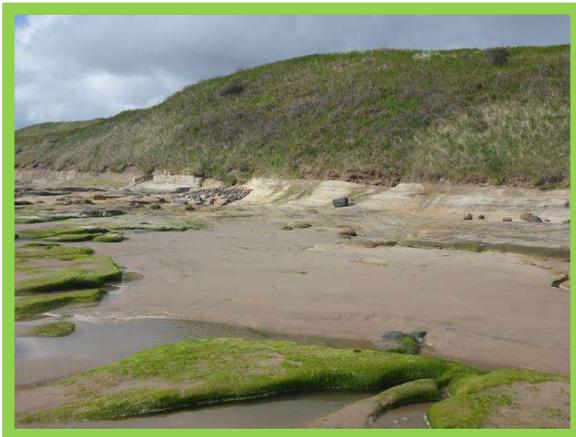
The dunes immediately north of the rocky outcrop of Birling Carrs are currently relatively stable, sitting atop a rock ledge and behind a rocky shore platform. Previous rockfalls in the ledge and around the headland remain present, although have not worsened since the last inspections nor triggered and slumps in the dunes above. There is a pillbox in the dunes on the northern side of the headland and two informal access tracks through the dunes from the caravan park to the beach. One small void in the cliff has been boarded-off with a warning sign to prohibit access by small children.

*Rock platform and ledge at Birling Carrs (/2901C02)*

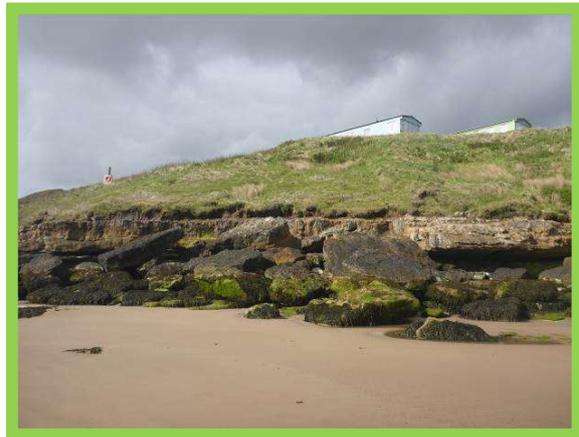
*Naturally recovered dunes to north of Birling Carrs (2901C02)*

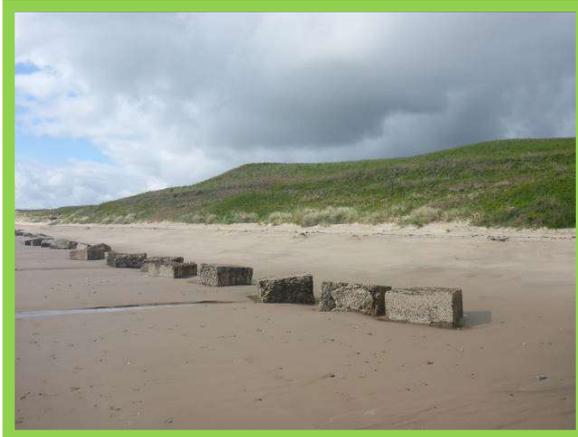
In the northern section of the Warkworth Dunes (which extend south from Birling Carrs to Warkworth Harbour), the dunes are highly stable. The section between Birling Carrs and the access track through the dunes from Warkworth Dunes Car Park has 134 no. concrete anti-tank blocks on the upper shore (set-off from the due toe by around ten metres), and the section from the access track south as a further 164 no. concrete anti-tank blocks. Behind these blocks, the upper beach has accreted sediment and the dunes have been stabilised or are accreting, whereas on previous inspections, some areas have been slumping. Some of the concrete blocks are very heavily abraded, but re-bar is only exposed in three of the blocks. Due to relatively low mid beach levels, remnants of three concrete / bagwork / brickwork structures can be seen on the foreshore. As the frontage approaches Warkworth North Pier, the beach widens and the dunes are in extremely healthy condition.

*Warkworth Dunes with fronting anti-tank blocks (/2901C02)*

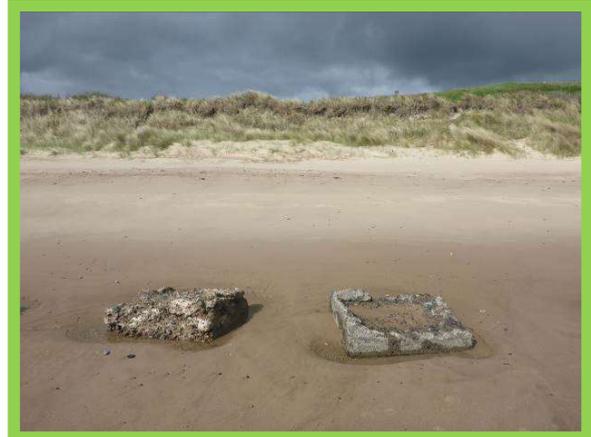
*Warkworth Dunes recovering well from pre-2016 storm damage (2901C02)*

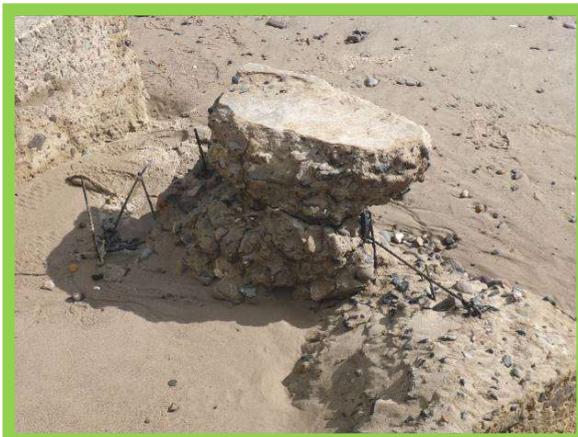
*Heavily abraded concrete anti-tank block with exposed rebar (/2901C02)*

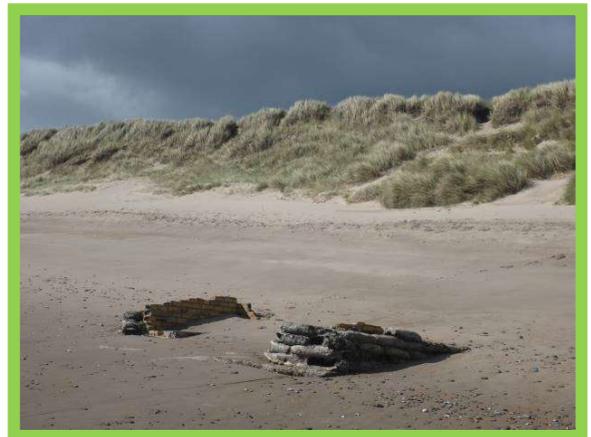
*Remnants of one (of three) brickwork/ bagwork/ concrete structures on the foreshore (2901C02)*

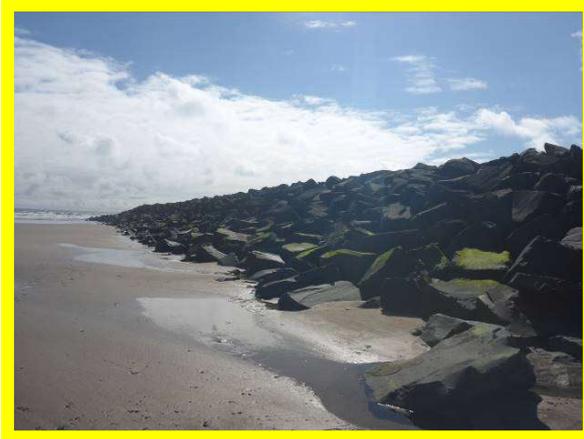
The large armourstones along the exposed north face of the North Pier continue to appear in fair condition. The masonry blockwork at the seaward end is also in fair condition with no obvious gaps or cracks. The revetment on the south face of the Pier is also in fair condition as is the concrete deck. However, the seaward end of the North Pier remains in very poor condition with extensive abrasion of the concrete and a missing section of deck. The large crack (~1m wide) and rotation of the tip of the pier identified during the previous inspections is still a cause of concern although no further movement appears to have occurred. It is understood that this crack and rotation occurred in the end of the structure soon after its construction. The spending beach between the North Pier and the (dilapidated) North Jetty is wide and healthy, with rock armourstone at the toe of the dunes along part of the length and natural dune elsewhere. Although not formally defined as a coastal defence asset, the North Jetty is in a largely dilapidated condition.

*Rock armourstones on north face of North Pier (/3001C01)*

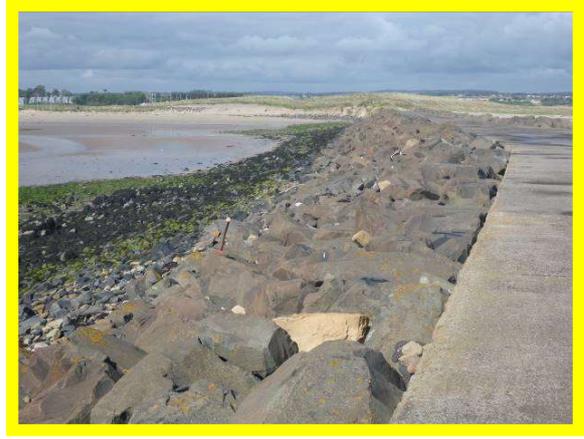
*Rock armourstones on south face of North Pier (/3001C03)*

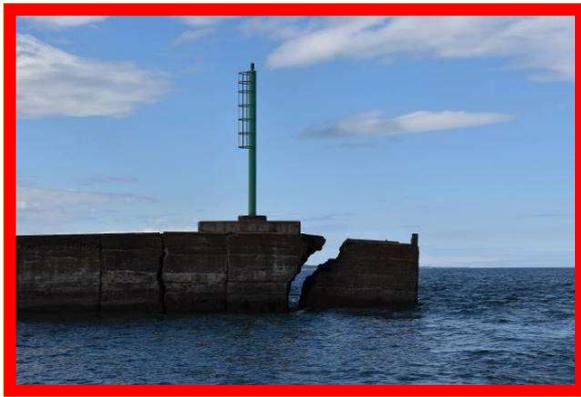
*Seaward end of North Pier in very poor condition (/3001C02)*

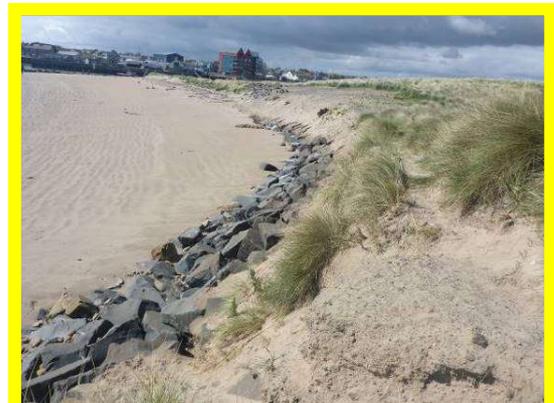
*Revetment and dunes along wide spending beach in lee of North Pier (/3001C04)*

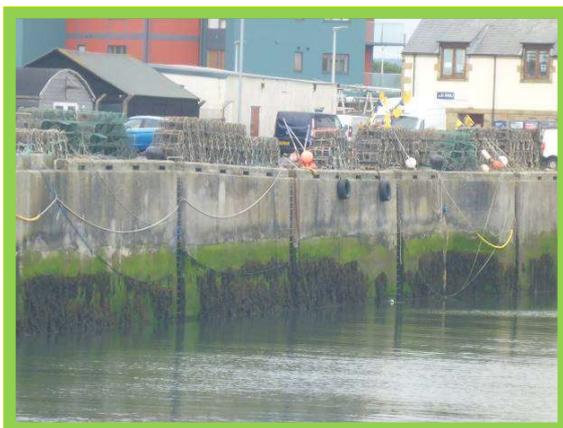
The concrete quay wall at the western end of Amble quayside (/3001C05) is generally in good condition with only minor localised cracks visible in the concrete deck. The masonry walls in the small dock basin (/3001C05 & C06) are generally in fair condition, but have several open joints between blocks which would benefit from repointing and one area of concrete spalling. At the eastern end of Amble quayside, the previously repaired Broomhill Quay (/3001C06) appears in good condition with no cracking or settlement of the deck or obvious defects in the face of the wall.

*Quay wall in good overall condition (/3001C05)*

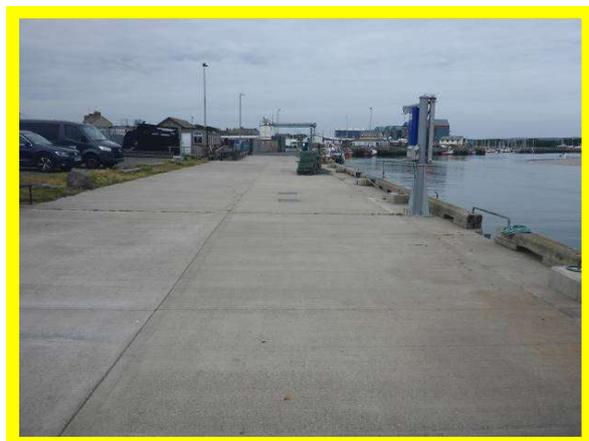
*Quay wall in fair overall condition (/3001C06)*

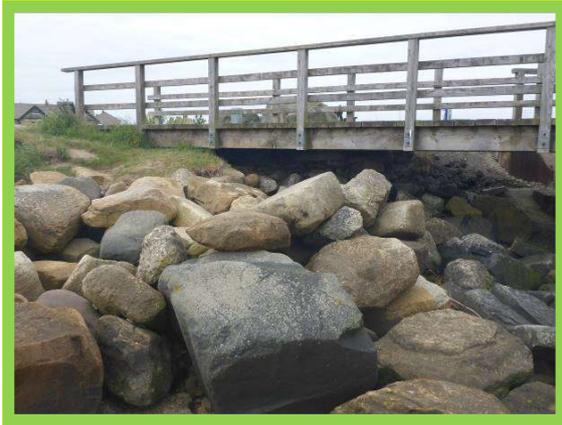
At the east end of Broomhill Quay the timber linkspan bridge erected 2008/09 is still in very good condition. Previously the low vegetated bank that was eroding at the intersection of South Jetty and Little Shore Wave Basin (/3001C07) had been protected, to a degree, by rock armour and tipped construction waste. In around 2015, the area was improved with the construction of some beach huts and the provision of more formalised defence in the form of gabion baskets and fronting rock armour. Although the area looks in good condition and is now much improved, there appears to be erosion around some of the gabions. The low masonry wall along the back of the enclosed bay is generally in good condition although one or two missing stones were noted. This wall is protected by a well vegetated area of healthy dunes/links (/3001C08 & 09). The South Jetty is in good condition along the length enclosing the Little Shore Wave Basin (/3001C11), with no gaps in the timber decks, all hand railing intact and the steel sheet piling forming the half-tide barrier remaining effective.

*Rock and boulders provide additional erosion protection at root of linkspan bridge (/3001C07)*

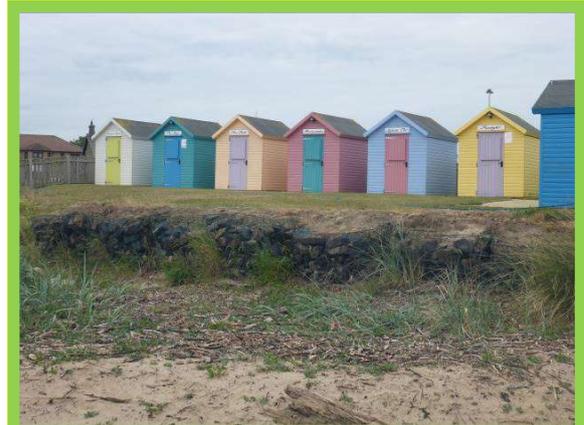
*Gabions fronting beach huts (/3001C08)*

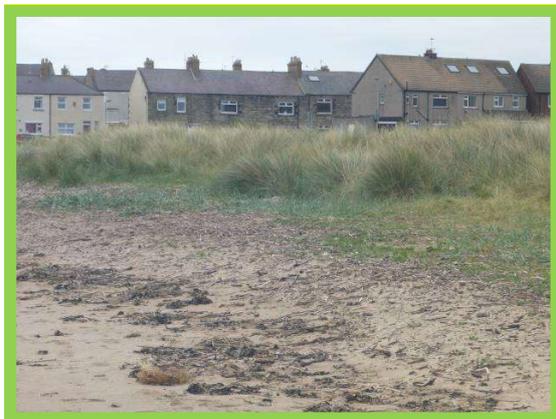
*Wide sandy beach and healthy low dunes (/3001C09)*

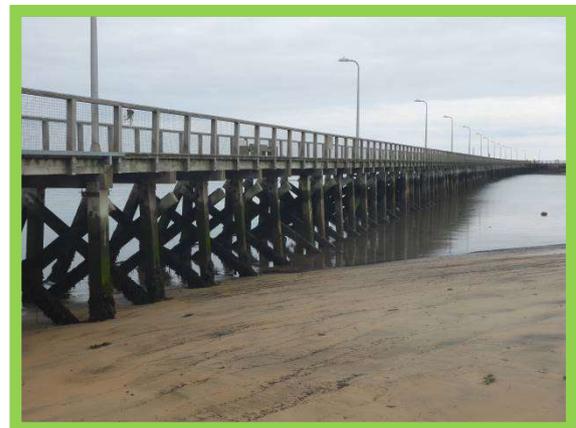
*Good condition of South Jetty (/3101C11)*

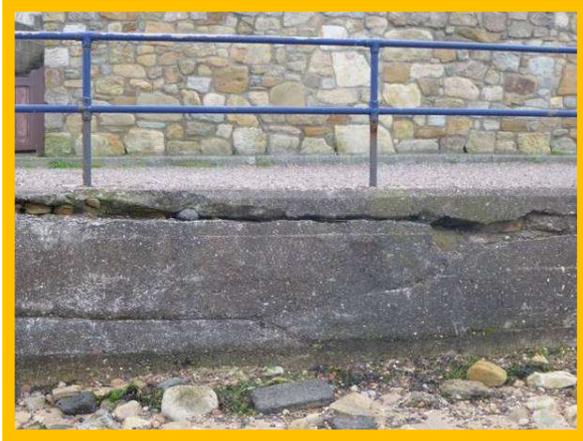
The concrete seawall (/3001C10) along Bay View road, to the rear of Little Shore Wave Basin, had been recorded as being in poor condition in previous surveys up to 2018, with horizontal cold joints and vertical cracking, toe undermining, missing sections of coping, corroded hand railing and voids in the access ramp. Safety issues needed to be addressed urgently at the access ramp and capital improvement works were recommended. These works were completed in 2018/19 and the wall is now in good condition, with previous defects repaired. The failing access ramp has been replaced with new access steps and the whole frontage is improved.

*Seawall at Little Shore Wave Basin in poor condition in 2018 (/3001C10)*

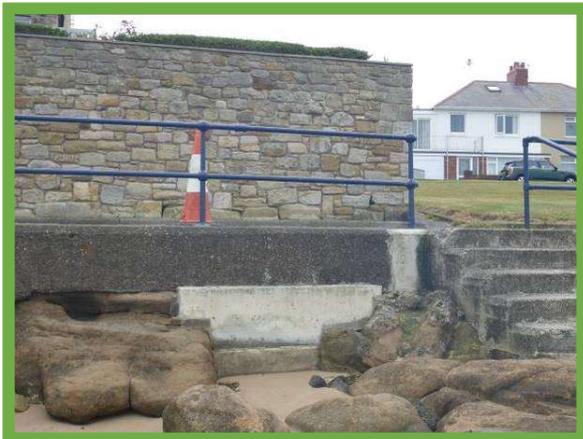
*Repairs return sea wall along Bay View to good overall condition in 2020 (/3001C10)*

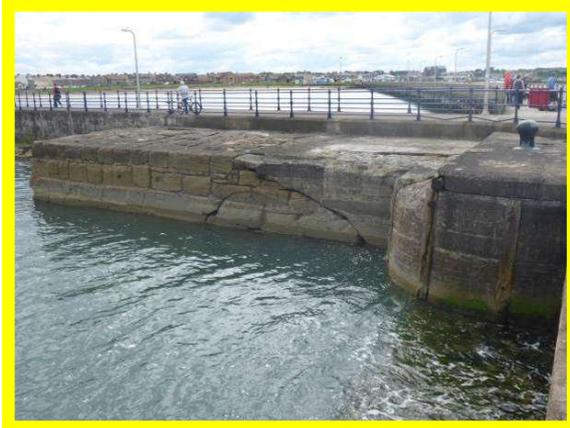
There was significant damage at the junction (/3101C01) between South Pier and South Jetty on the seaward face over the winter of 2017/18 and repairs were made in 2018. The pier head itself (/3101C01) is not accessible for close inspection but appears in fair condition when viewed through the gate.

*Poor condition at junction of South Pier and South Jetty (seaward face) in early 2018 (/3101C01)*

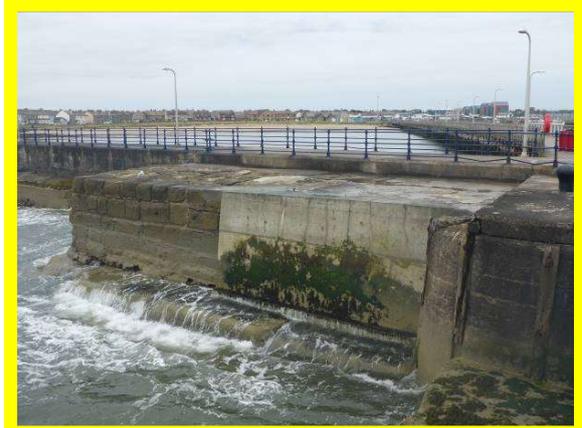
*Repairs at junction of South Pier and South Jetty (seaward face) made in 2018 (/3101C01)*

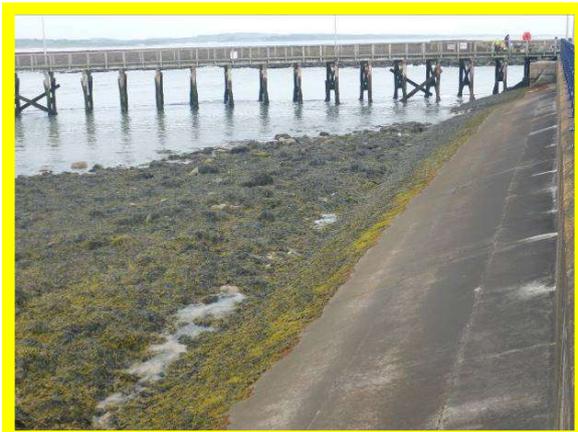
The condition of the inner face of South Pier (/3101C02) does not appear to have changed significantly since the last inspection and remains in fair condition along most of its length. The seaward face of the South Pier (/3101C02 & C03) is generally in fair condition with frequent horizontal cracking at the south end. The access steps at the south end of the Pier (/3101C03) are highly abraded and, as these provide the only access to the beach, present a public safety hazard. Although the concrete stub groyne is also highly abraded it still serves its current function to retain the rock armour on the north side.

*Inner face of South Pier in fair condition (/3101C02)*

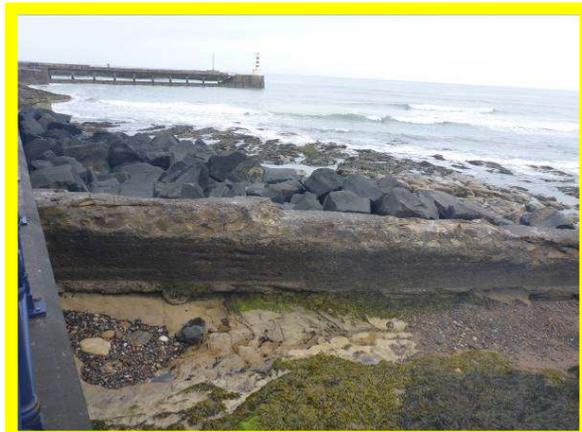
*Abraded but functional stub groyne (and rock armour) on seaward face of South Pier (/3101C02)*

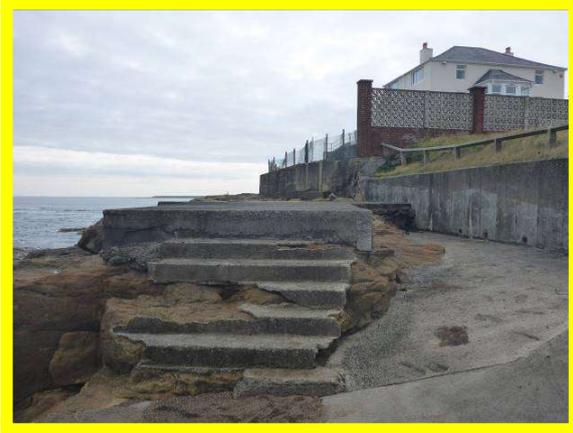
*Heavily abraded access steps to Pan Point  
(/3101C02)*

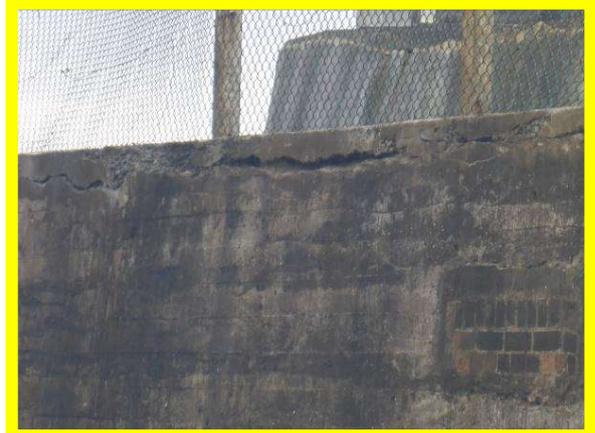
There is no noticeable change in the condition of the concrete wall protecting Cliff House and Pan Point (/3101C04). This structure continues to show numerous cracks and cold joints throughout. Some cracks expose corroded and broken reinforcement bars, and toe undermining is still observed at the westerly end.

*Cracks in private seawall around Pan Point  
(/3101C04)*

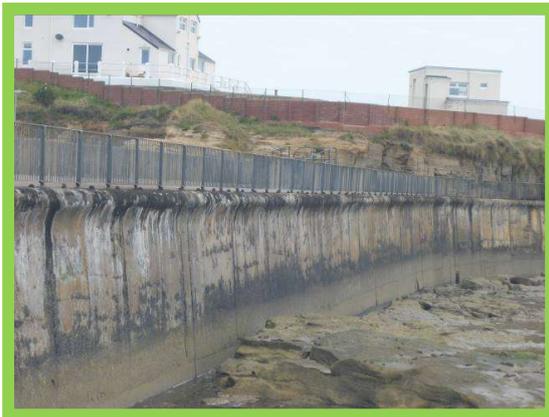
The seawall fronting Paddler's Park children's play area (/3101C05) to the south of Pan Point is generally in good to fair condition, despite being heavily stained. It shows no signs of undermining or movement. Some minor abrasion, localised cracks and spalling to the wave return wall and setback wall were noted. The previously damaged bitumen surfacing was replaced with a concrete decking in 2013/14 and this remains in very good condition with all joints well sealed.

*Seawall in good condition despite rust-staining (/3101C05)*

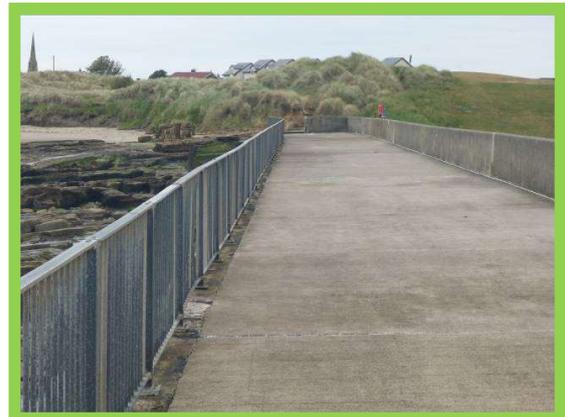
*Promenade deck remains in very good condition following previous repairs (/3101C05)*

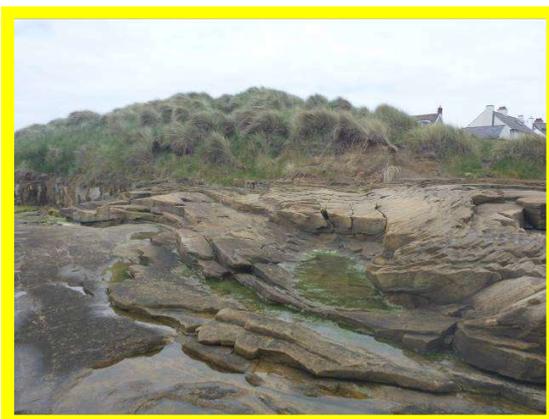
The earth slopes and dunes along Amble Links (/3101C06) have previously been reported as showing signs of erosion, with cliffing along much of the frontage. However, at the time of the present inspections the earth slopes and dunes appeared generally stable with only local areas of very minor slumping (as in 2016 and 2018) and some accretion indicating recovery. Rock armourstone has been placed at the centre of the embayment and adjacent to the seawall at the south end.

*Dunes and low slopes above rock ledge (/3101C06)*

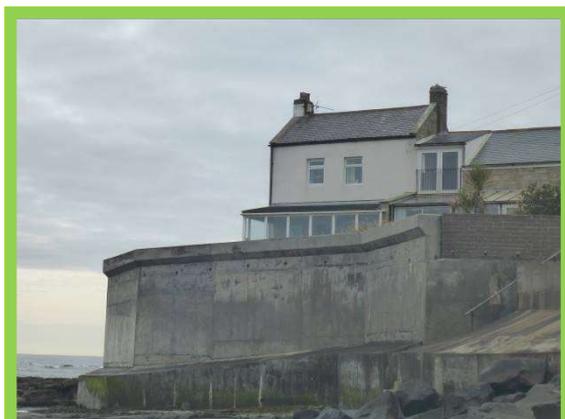
The concrete seawall at Island View headland (/3101C07; constructed in 2003) at the south end of the dunes is substantial and remains in good condition. Previous evidence of the onset of outflanking at both ends has been addressed by concrete tie-in structures.

*Substantial seawall in overall good condition (/3101C07)*

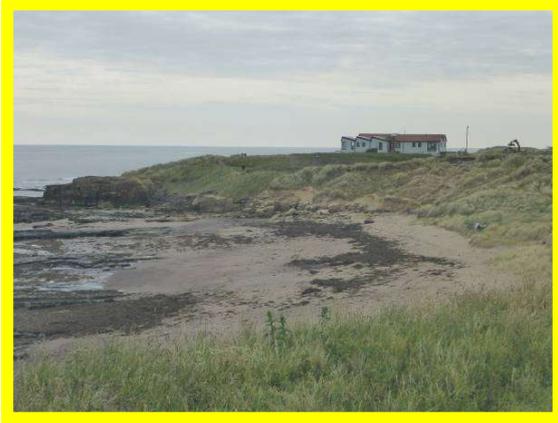
*Low dunes north of Wellhaugh Point (/3101C09)*

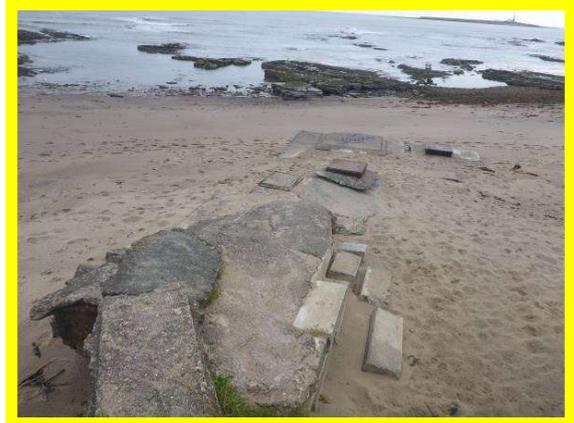
The low vegetated cliffs and dunes north of Wellhaugh Point (/3101C08 & C09) were reported to be subject to erosion on some previous inspections but were stable at the time of the present inspection (as in 2016 and 2018). The outfall structure remains in a dilapidated condition and previous recommendations for either removal or repair remain valid, although much of the structure was buried below high beach levels (as in 2018).

*Dilapidated but largely buried outfall (/3101C09)*

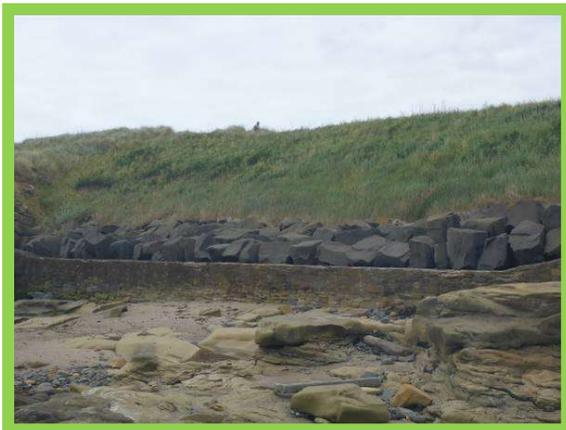
*Low dunes north of Wellhaugh Point (/3101C10)*

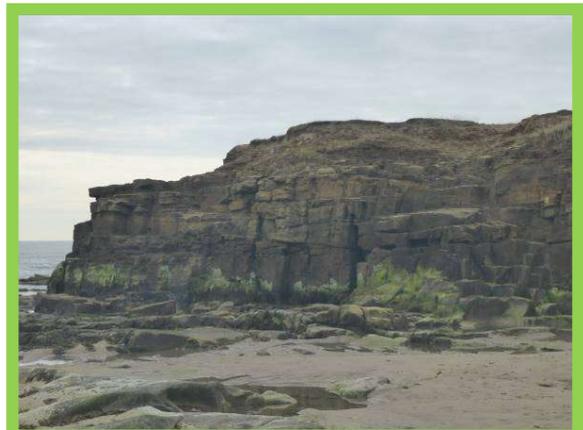
The seawall at Wellhaugh Point has rock armour along the crest and remains in good condition. The rocky cliffed headland around Wellhaugh Point (/3101C11) is stable and protected by a wide rock shore platform. As the cliffs blend into low dunes, a rock ledge is present at the base and the frontage remains relatively stable. In 2020, a new large house was being constructed, set back from the cliff top on the plot of an original, smaller, house (now demolished). In one location, a set of timber steps has been provided to enable access to the foreshore through the low dunes. Only occasional and small-scale falls of friable rock are noted from the ledge. There is one short blockwork wall with rock armour, both elements are in good condition.

*Rock headland around Wellhaugh Point (/3101C11)*

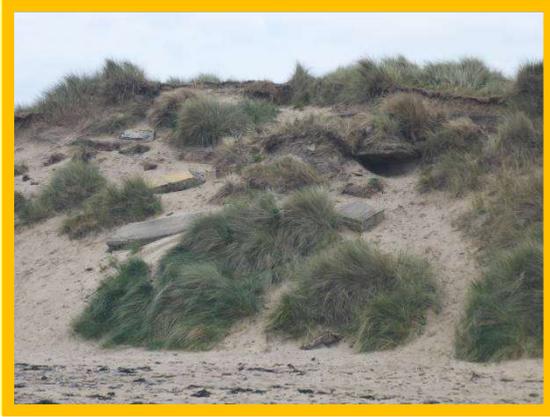
Further to the south, the dunes (/3101C12) are generally stable initially except for a few discrete areas suffering from localised slumping in the face. In one of these areas the concrete rubble noted in the 2016 inspections on the dune crest appears to have fallen to the foreshore, where it now resides. With progression south, a cobble berm is notable at the upper beach, overlaying sand. This helps to stabilise these dunes further, although some local slumping in the front face continues and nearer towards the Beacon Hill headland the erosion worsens and peat layers and petrified tree stumps are visible due to low beach levels.

*Dunes slumping, exposing concrete rubble (/3101C12)*

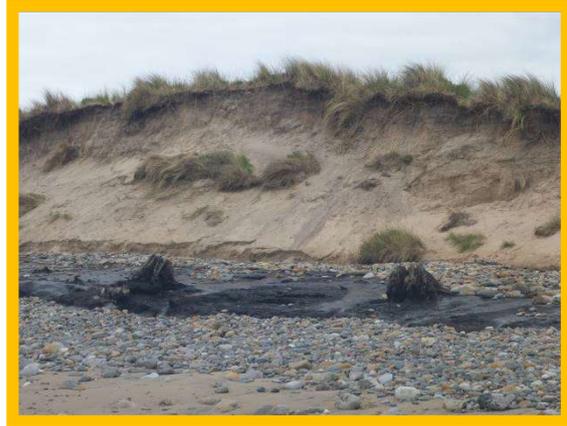
*Cobble berm fronting dunes. Petrified tree stumps at base. Dunes slumping (/3101C12)*

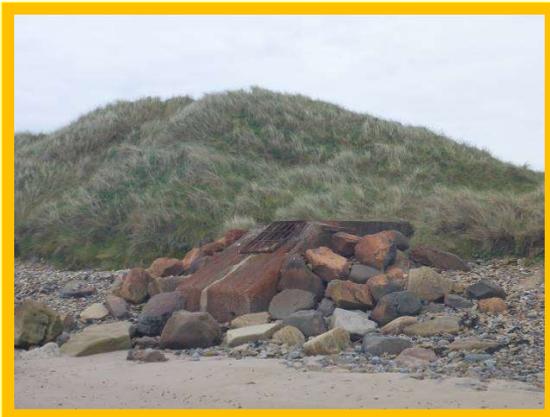
At one location within these dunes is a rust-stained outfall with concrete encasement and rock armour side protection. At another location is a set of access steps with gabion protection and rock armour. However, because the rock is small and too light to remain stable on the upper beach it has become scattered around.

*Rust-stained outfall within generally stable dunes (/3101C12)*

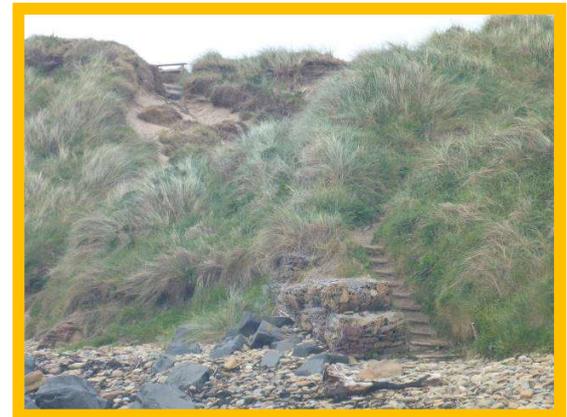
*Access steps through dunes protected at base with gabions (/3101C12)*

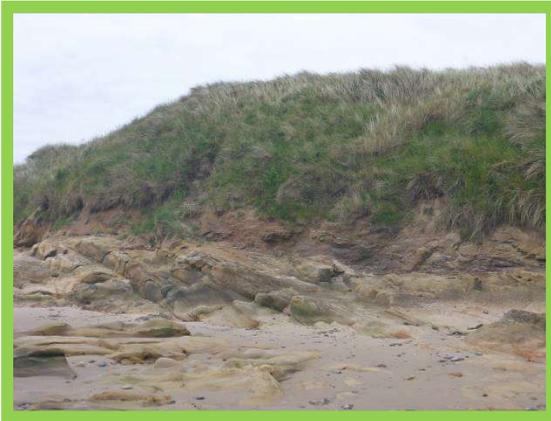
*Stable dunes on rock ledge around Beacon Hill (/3101C13)*

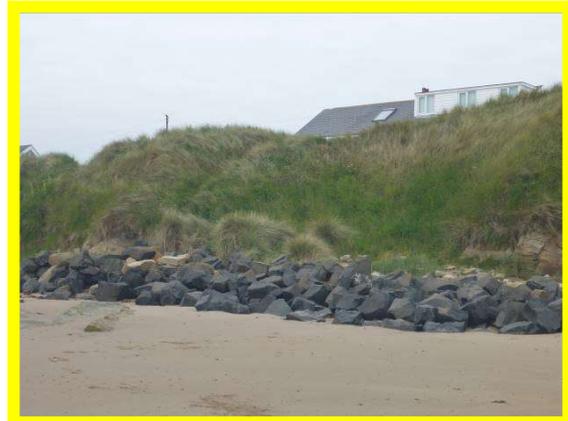
Around Beacon Hill, the dunes are formed on top of a rock ledge base and initially are stable. However, where the rock base ends, south of Beacon Hill, the dunes become less stable and there is a section of informally dumped rock armour aimed at reducing risks to properties near the cliff top at Low Hauxley. This armour is loosely packed but appears in fair condition, although occasional slippages remain ongoing in the cliffs behind.

*Loosely placed rock armour at Low Hauxley (/3101C14)*

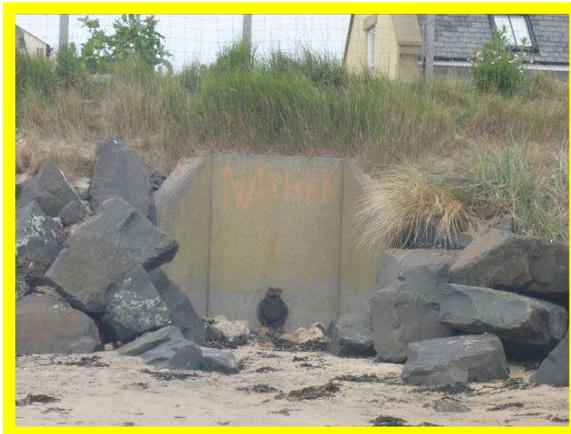
*Outfall with large headwall at Low Hauxley (/3201C02)*

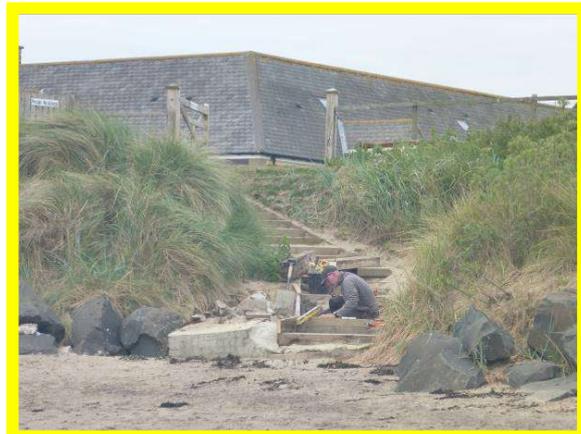
There is a short length of low, undefended dune which has an outfall in one location and some informal access routes through to backing properties (one set of timber steps was being replaced at the time of the inspections).

*Access steps being replaced through dunes at Low Hauxley (/3201C02)*

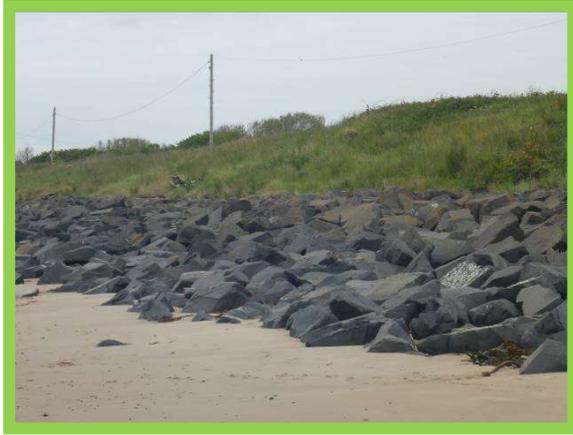
*Wide rock revetment in good condition (/3201C03)*

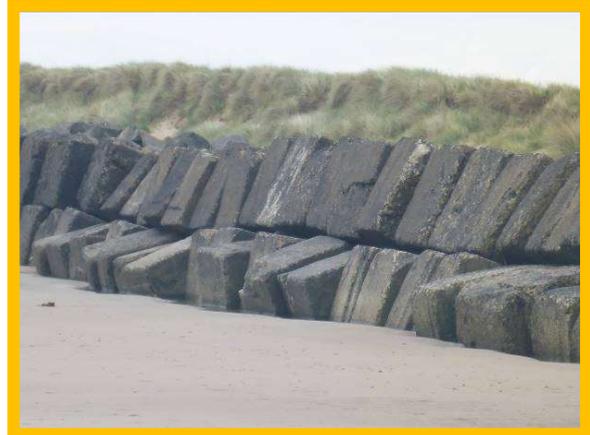
South of here (down to and beyond the beach access ramp) the coastal margin is protected by rock revetment in front of further properties. This is in good condition and towards its southern end forms an overlap to the subsequent concrete block revetment which extends further south. This has a number of large gaps between the blocks, with some rotational displacement apparent at the southern end. Erosion and cliffing of the low earth bank above the blocks continues, with ongoing dumping of construction waste.

*Rotational displacement at southern end of concrete block revetment (/3201C04)*

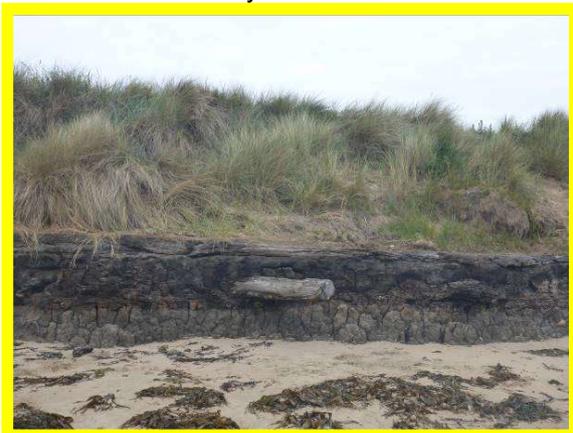
The dunes merge into low cliffs sitting on top of a lower exposed peat layer. The peat has been subject to erosion, with toe slumping and formation of mini 'clifflets' in the face of the peat. Numerous sections reveal petrified timbers in the peat or on the foreshore, exposed by the March 2018 storms. Despite this, the upper beach is now healthy and the dunes/low cliffs are relatively stable. The telegraph pole which makes a distinctive marker at the crest of the low cliffs is now undercut around its concrete foundation base and will ultimately be lost to erosion.

*Petrified timbers exposed in base of dunes (/3201C07)*

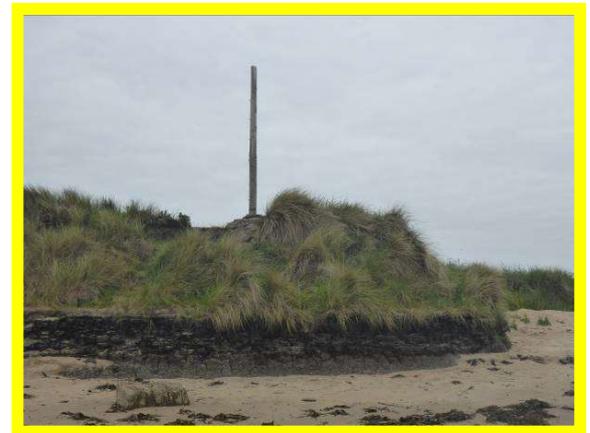
*Telegraph marker pole becoming undermined at base through erosion (/3201C07)*

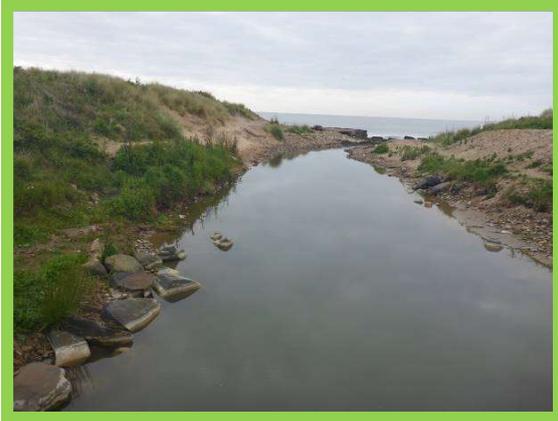
The outfall of Hauxley Nature Reserve was 'daylighted' by Northumberland Wildlife Trust (although seaward parts of the structure and the adjacent concrete blocks remain on the beach), creating a more natural aesthetic in line with the recommendations of the *Druridge Bay Adaptation Study*. The drainage from the reserve now occurs along a natural open channel and then alongside the remnant outfall structure, across gravel, cobbles and boulders. It is understood that ultimately the remnant structural sections will be removed. At the present time, the drainage is working well, and exposed geotextile seen in 2016 has been covered.

*View from landward to seaward of 'daylighted' open channel section of outfall from Hauxley Nature Reserve (/3201C09)*

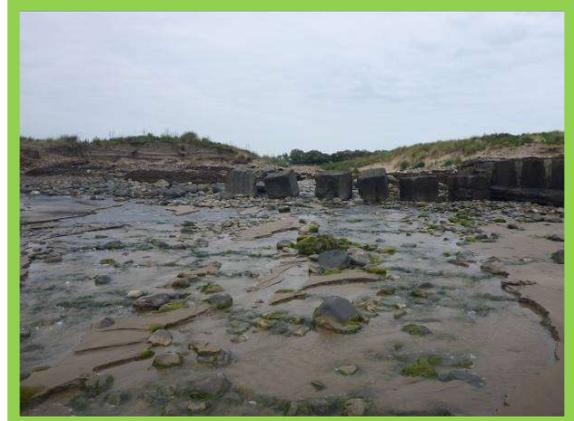
*Drainage occurring alongside of remnant outfall structure through gravel, cobbles and boulders (/3201C09)*

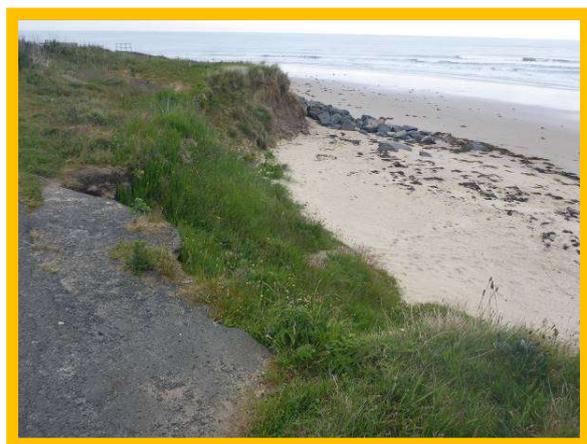
*Terminal erosion beyond end of defended section of dune (/3201C14)*

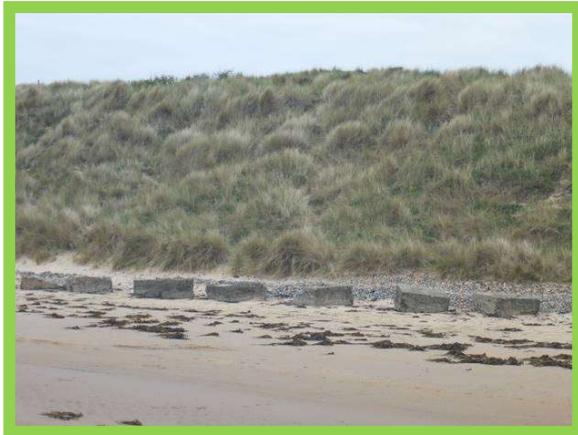
*Healthy dunes in Druridge Bay with concrete blocks over short length (/3201C15)*

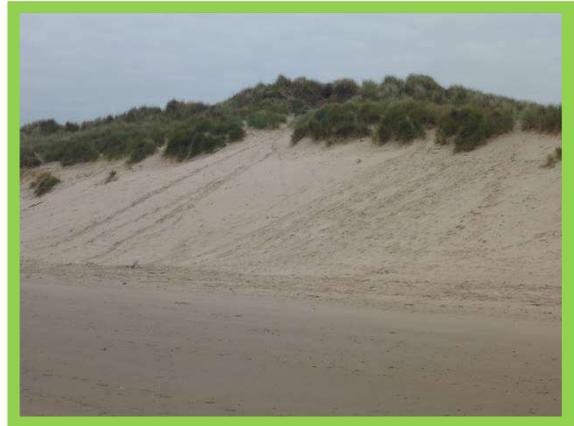
Around 100m south of the rock revetment, the wide vegetated dunes become less active and are protected by a cobble berm along the toe. Where the berm ends the protection is provide instead by concrete blocks. Generally, throughout Druridge Bay, the dunes were stable and healthy at the time of the inspections and

*Healthy dunes in Druridge Bay (/3201C15 & C16)*

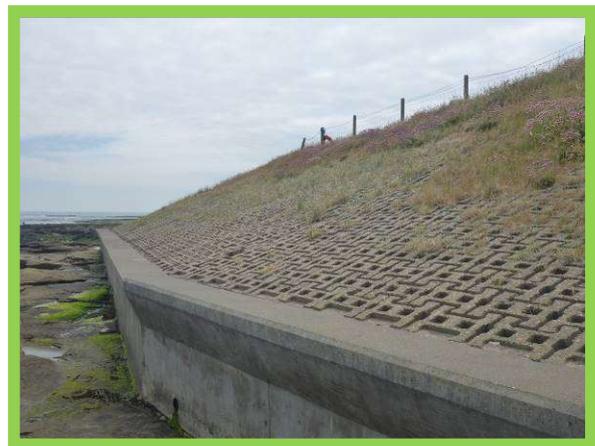
To the south of Cresswell the low concrete wall and interlocking concrete unit revetment is largely in good condition and the area of apparent settlement towards its southern end has not worsened since it was first observed.

*Low concrete wall and interlocking concrete unit revetment at Cresswell (/3201C19)*

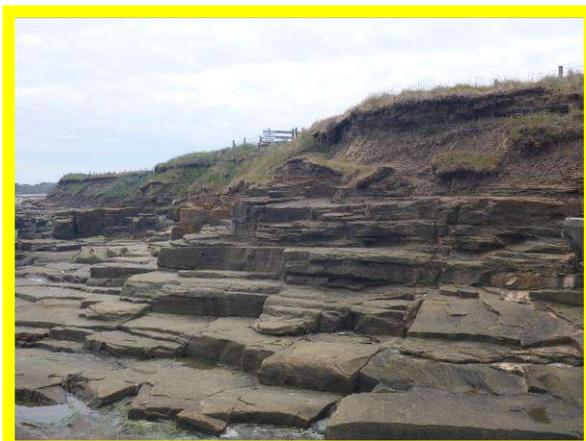
The low earth cliffs backing Stank Letch Rocks continue to show evidence of slumping along much of their length although this does not appear to be recent. There has been previous loss of fencing and timber access steps at this location and a new warning sign has been erected by the land owners.

*Low earth cliffs backing Stank Letch Rocks (/3201C20)*

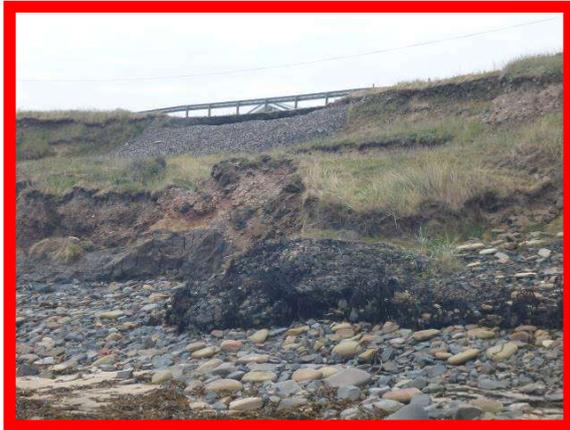
Further south still, fronting the Golden Sands Holiday Park just north of Snab Point, the cliffs become more active once again, where the cobble berm at the toe is sparser. There is one area where a slippage has previously occurred, cutting the headscarp back to the road edge. The rock-filled mattresses at the toe are now so broken as to be almost obsolete. It is likely that further recession at this point will occur, thus affecting the coast road. Immediately south of this former landslip area, the cliffs are composed of harder rock, but there have been several local rock falls/topples and other areas look vulnerable.

*Failed section of cliff adjacent to coast road (/3201C22)*

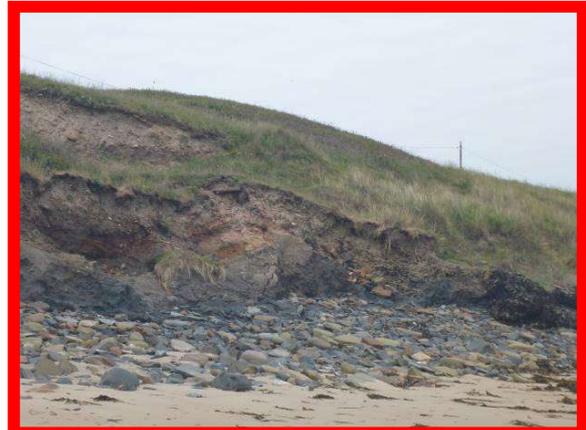
*Failed section of gabion and slumping cliff (/3201C22)*

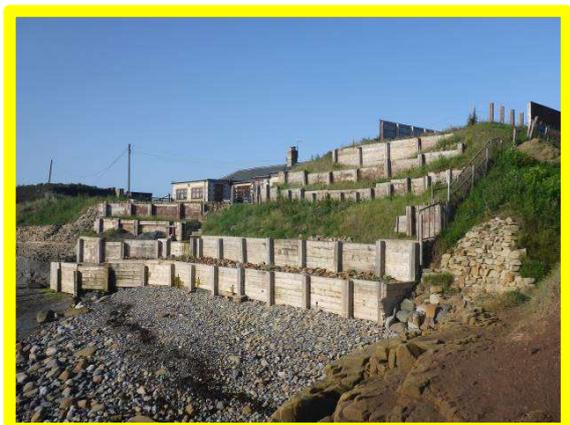
There are private defences north of Snab Point comprising timber breastwork retaining walls. These were initially built around 2008 but have been further developed over time and remain in good condition. Generally, further south around the end of Snab Point, there are frequent local rock falls caused by notching by marine action in the underlying rock ledge and occasional local slumps/ cliffing of the upper softer material as a consequence.

*Private timber/rubble retaining defences north of Snab Point (/3301C01)*

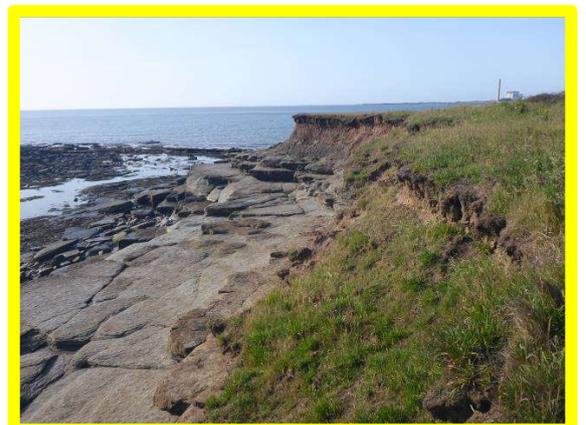
*Slumping soft cliffs above rock ledge around Snab Point (/3301C01)*

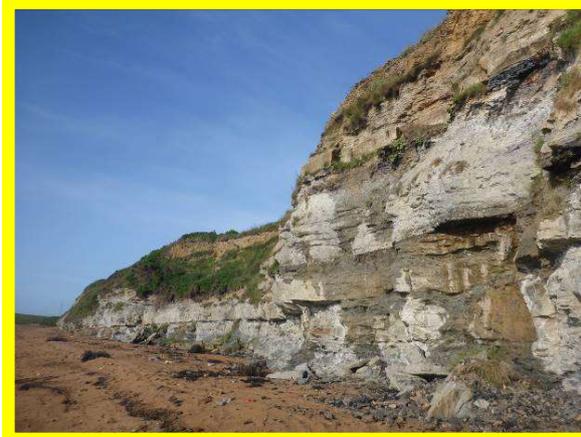
*High stable rock cliffs at northern end of Lynemouth Bay (/3301C02)*

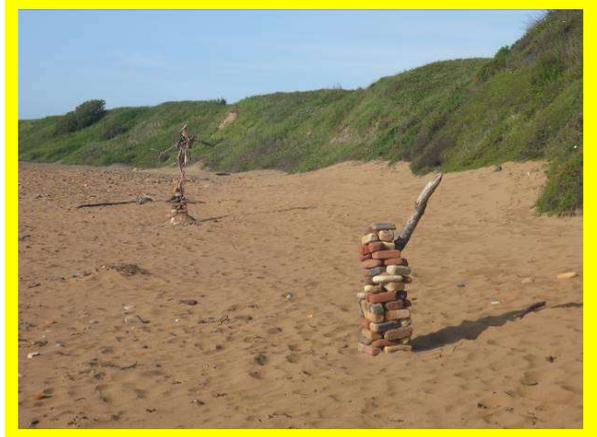
*Gently sloping softer cliffs towards northern sections of Lynemouth Bay (/3301C02)*

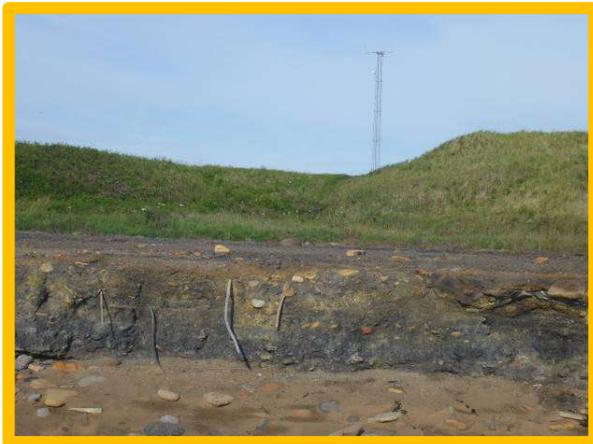
With progression south towards the rock outcrops at Headagee, there becomes some occasional evidence of refuse within the beach / colliery spoil on the foreshore, but much less than when previously visited in February 2019. At Headagee, the colliery spoil has built out to form a small tombolo in the lee of the rock outcrops and remnants of a former brackish pond remain on the upper foreshore. The seaward edge of the colliery spoil above the natural sandy beach has formed a small cliff, approximately 1m high, at around the high water mark and refuse becomes more frequent from here south, both in the cliffed edge of the colliery spoil beach and at two locations in the cliff top, infilling shallow depressions.

*Discarded refuse visible in the cliffed edge of the colliery spoil beach (/3401C01)*

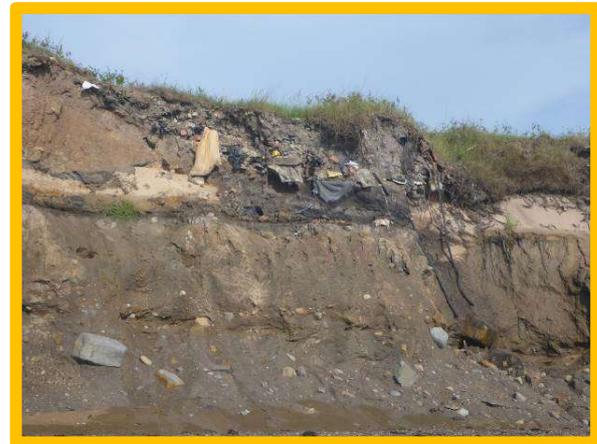
*Discarded refuse visible in the cliff top at the back of the colliery spoil beach (/3401C05)*

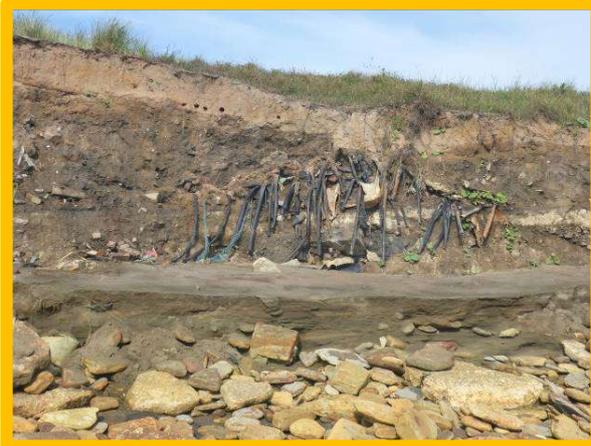
However, the shoreline fronting Lynn Hill, from the centre of Lynemouth Bay to the River Lyne, is less well protected by the rapidly receding spoil beach. Where the spoil beach tapers out the man-made (spoil) cliffs are actively eroding, releasing spoil and, in many places, refuse to the foreshore. This is also evident along the south bank of the River Lyne and, albeit less frequently, along the open coast south of the River Lyne to the Power Station.

*Rapidly eroding colliery spoil beach north of River Lyne leading to erosion of backing man-made cliffs, releasing colliery spoil and refuse to the foreshore (/3401C05)*

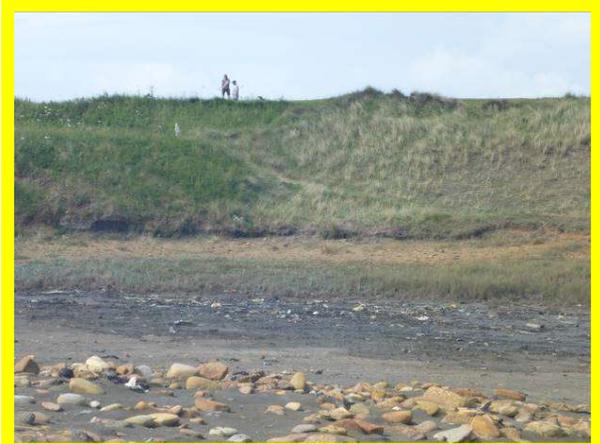
*Natural dunes behind wide spoil beach (/3501C01)*
