## **Cell 1 Regional Coastal Monitoring Programme Walkover Inspection Surveys 2020**

**Northumberland County  
Council**

## Walkover Inspection Surveys 2020

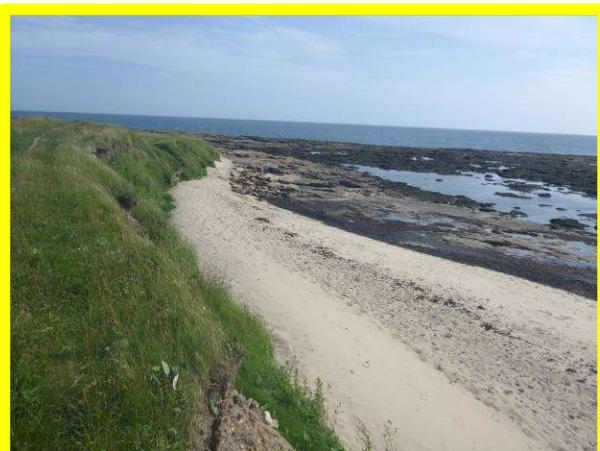
At Newbiggin Moor, within the shallow bay fronting the golf course, the cliffs are unprotected by rock platform and have no rock base. Despite this, sand levels were high at the toe of the cliffs/dunes and there were signs of recovery (sand accumulation and vegetation growth) following previous storm damage.

*Cliffs/dunes at Newbiggin Moor golf course (/3501C04)*

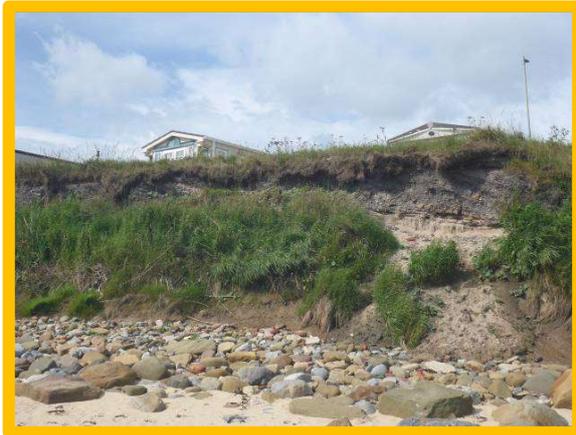
1. The northern section is unprotected by coastal defences or rock platforms and is in poor condition with active erosion continuing through a series of regular local slumps. The Caravan Park has previously erected warning signs along the cliff top footpath and realigned short lengths of its boundary fencing.

*Active slumping at northern section fronting caravan park (/3501C05)*

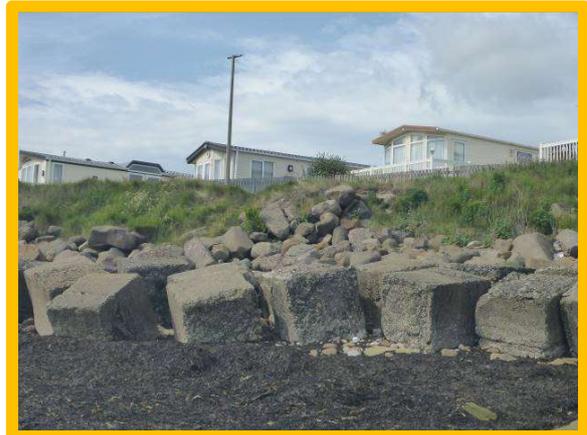
2. The central section is protected by concrete blocks and remains in fair condition. Despite some localised slumps having continued, this section of cliff is considerably less active than the undefended section to the north.
3. The southern section is protected by a rock ledge but, despite this, frequent local slumps remain evident. Two pill boxes are located on the rock ledge and erosion of the surrounding soft cliff material has left these structures perched precariously. However, this erosion has not worsened since the previous inspection.

*More stable central section fronting caravan park (/3501C06)*

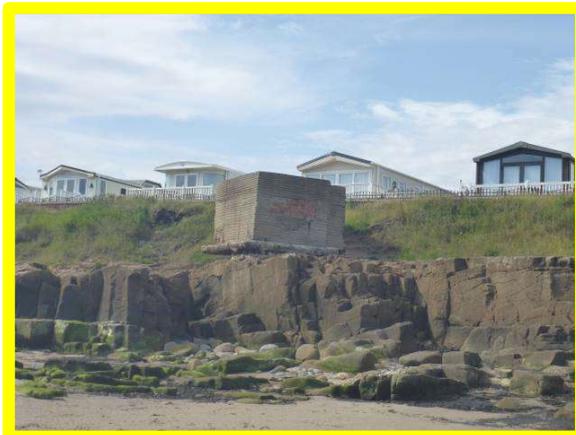
*Concrete pill box perched on rock ledge (/3501C07)*

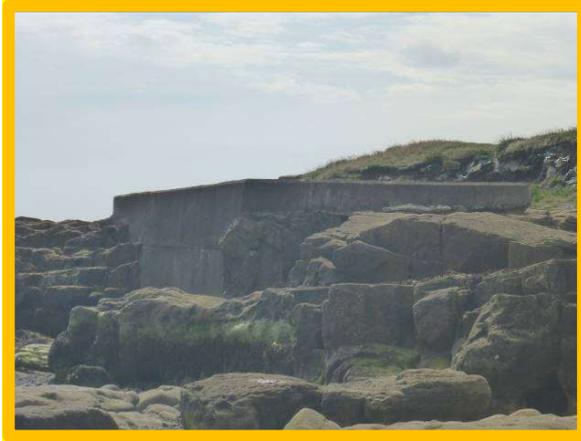
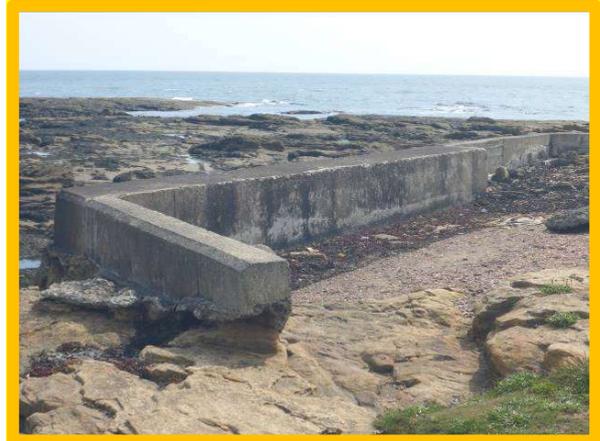
Extending between Newbiggin Point and Church Point is a continuation of the rock ledge, with overlaying softer material, interspersed with a series of ad-hoc defences to 'patch' local areas. At Beacon End a short length of concrete seawall is present which appears in fair condition on the seaward face. However, abrasion and initial undermining of the toe was observed as well as undermining of the south return wall, reducing its overall condition to poor. Active erosion, cliffing and slumping of the soft cliff material behind the structure has continued since the previous inspection.

*Seawall with undermining and outflanking (/3501C08)*

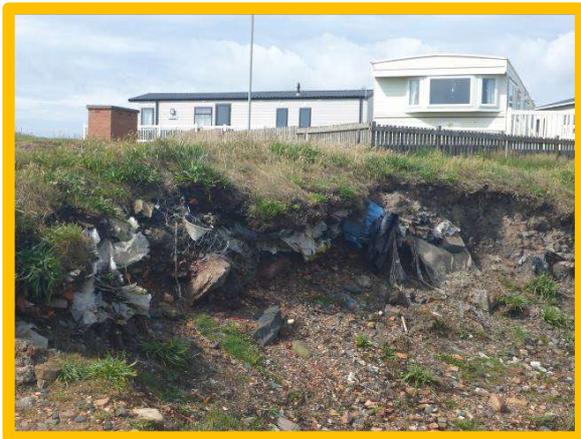
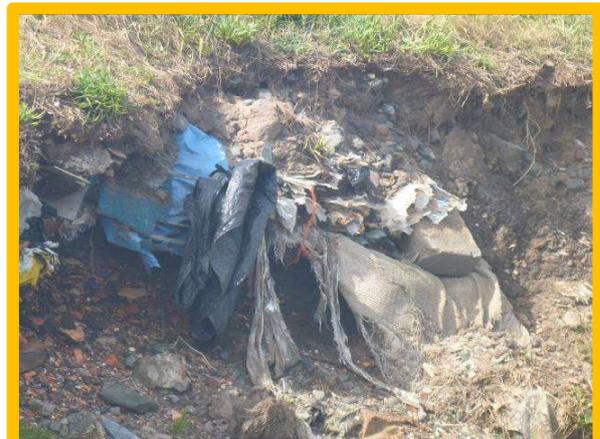
The second length of concrete wall is further south around Newbiggin Point and remains in very poor condition. The tie-in sections are actively breaking-up. Although the damage at the northern tie-in looks recent, this situation was first noted in 2008. Erosion of the soft earth cliffs behind the structure continues, now releasing refuse that was buried in the made-ground of which these cliffs are composed.

*Refuse buried in eroding coastal slope above seawall (/3501C08)*

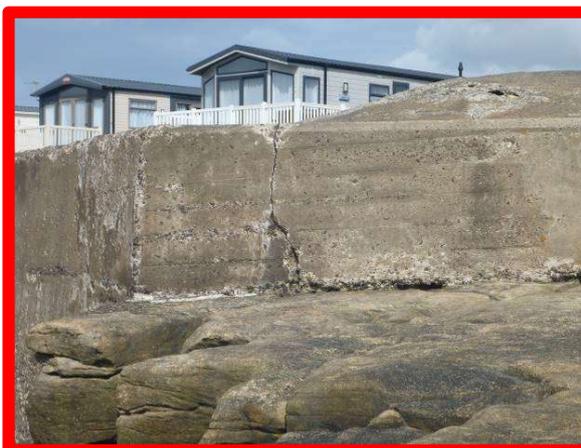
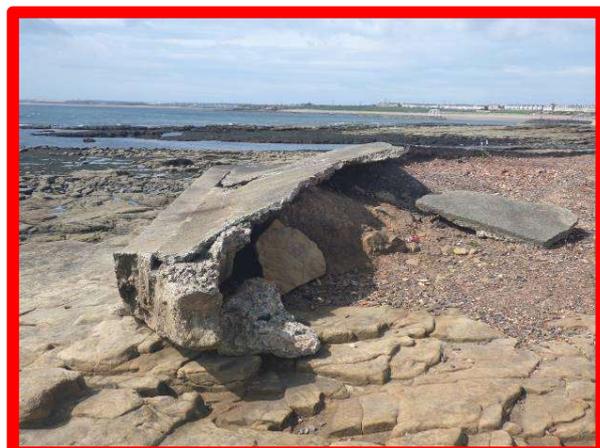
*Second length of seawall with undermining and outflanking (/3501C10)*

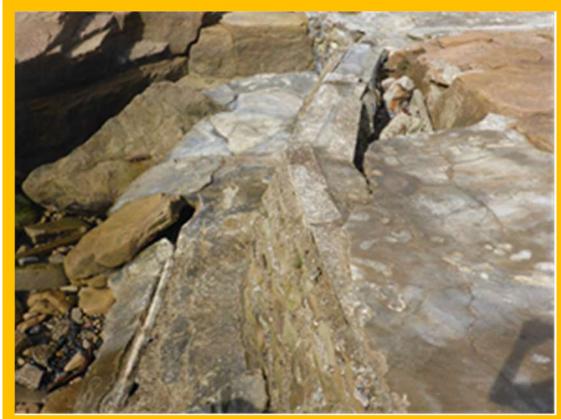
*Voiding at crest of small wall in 2018 (/3601C01)*

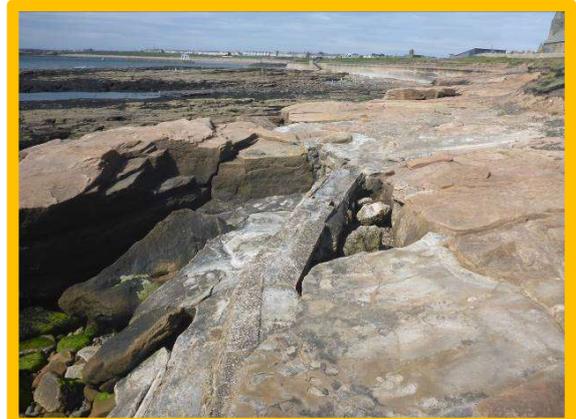
Between Newbiggin Point and the church the cliffs are composed of a continuation of the low irregular rock ledges with overlaying soft material which remains actively slumping locally. The soil netting and gravel used in an attempt to stabilise the low earth cliffs continues to unravel. Where the rock ledge has become locally eroded, short sections concrete and masonry walls have been built to infill crevices in a number of areas. All of these structures are experiencing undermining and toe abrasion. The second wall (from the north) also now has voids in the sloping crest, although this has not worsened in the past 2

years. Several other walls have cracking in the deck or voids opening between the concrete and the rock and all would benefit from some local maintenance.

*Voiding at crest of small wall in 2020 (/3601C01)*

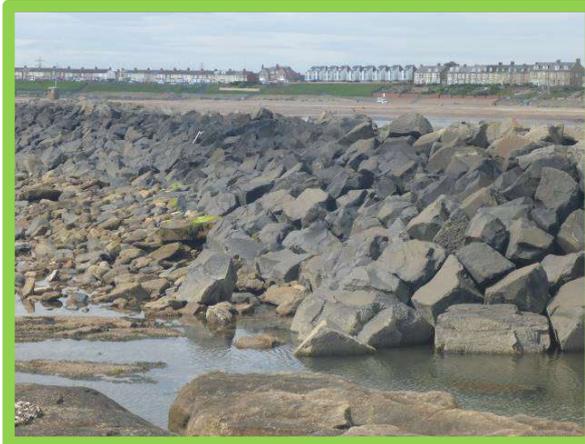
The start of Newbiggin Bay is marked by a rock armour breakwater, built along the edge of Hully Rocks and extending from just offshore of Church Point. This structure is in good condition though there are some smaller rocks displaced across the foreshore on the seaward side. The profile and crest level along the structure appears stable with no signs of displaced rock, toe erosion or settlement.

*North breakwater in Newbiggin Bay in overall good condition (/3601C14)*

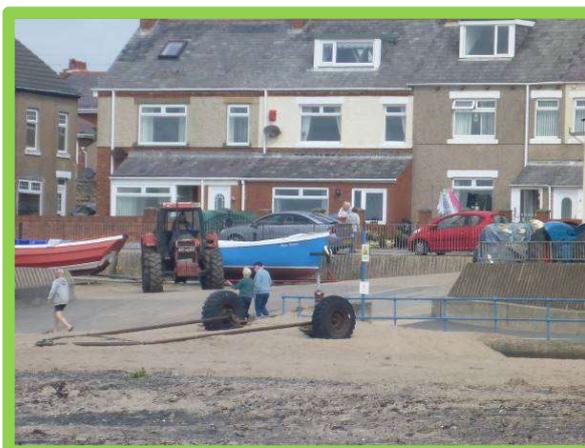
*High beach levels and wind-blown sand to rear of promenade in northern sections of Newbiggin Bay (/3601C06)*

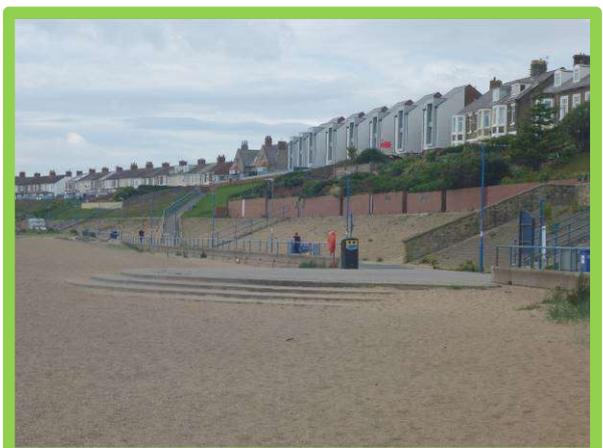
*High beach levels in central sections of Newbiggin Bay (/3601C07)*

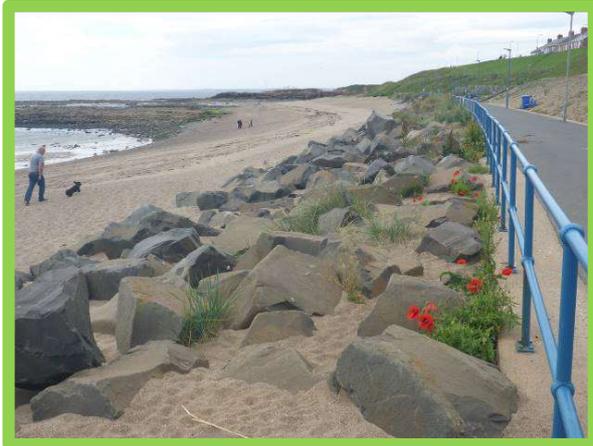
*High beach levels fronting rock revetment (/3601C08)*

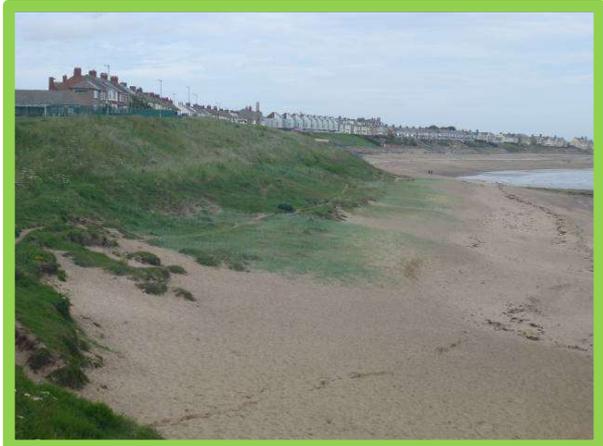
*High beach levels and embryo dune vegetation growth at southern end of Newbiggin Bay (/3601C09)*

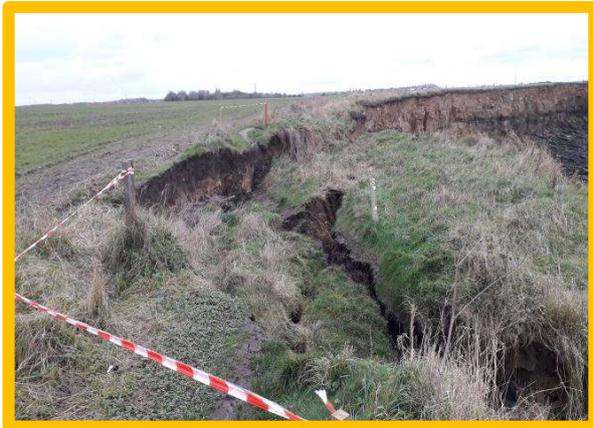
Hawks Cliff is known to typically experience gradual, local erosion caused by occasional rock falls in the harder rock base leading to subsequent slumping in the upper soft material. The rock falls are caused by preferential erosion along a mudstone layer leading to undercutting and collapse of the overlying sandstone. Previously, over the severe winter of 2009/10, the whole length of these cliffs had been active. A number of local rock falls, fractures, overhangs, slump in some of the overburdening till and a noticeable section of partially collapse cliff was evident. In 2018, the footpath along this section of cliffs was closed in the interest of public safety due to previous severe erosion episodes. The England Coast Path was then implemented and new signage erected, advising walkers to keep to the path which was well away from the cliff edge. Despite this, a section of cliff collapsed in November 2019 (taking away the England Coast

*Collapse of section of Hawks Cliff in November 2019, with temporary fencing erected (/3701C02)*

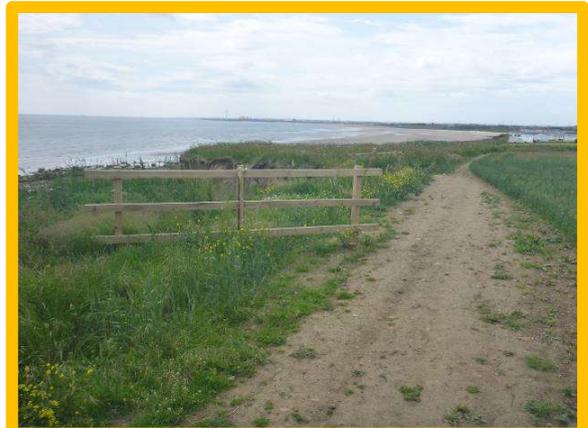
Path waymark with it) and this local area has since been fenced off (initially temporarily and then more permanently) and the footpath diverted further inland still, into the adjacent fields. New signs are erected warning of the eroding cliffs.

*Collapsed section of Hawks Cliff in June 2020, with permanent fencing erected (/3701C02)*

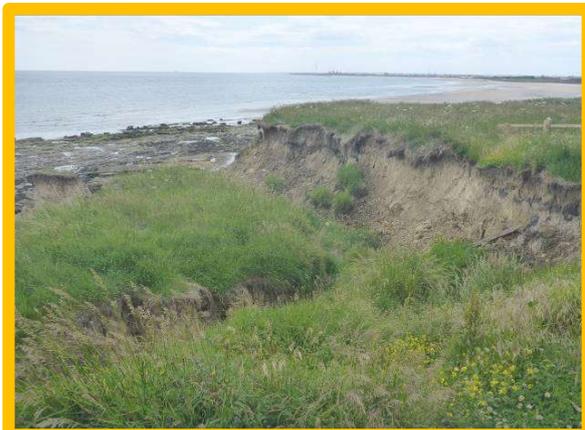
*Collapse of section of Hawks Cliff in November 2019, with temporary fencing erected (/3701C02)*

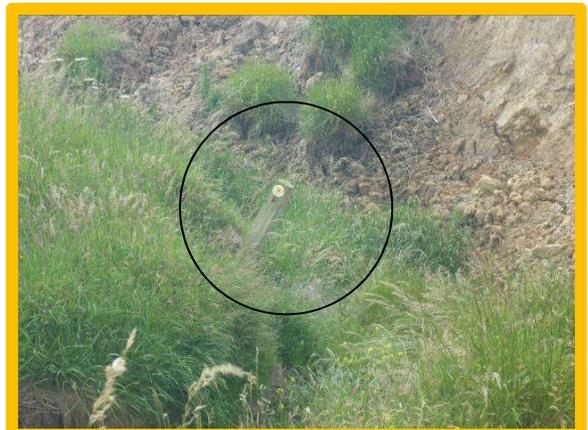
*Collapsed section of Hawks Cliff in June 2020, with permanent fencing erected (/3701C02)*

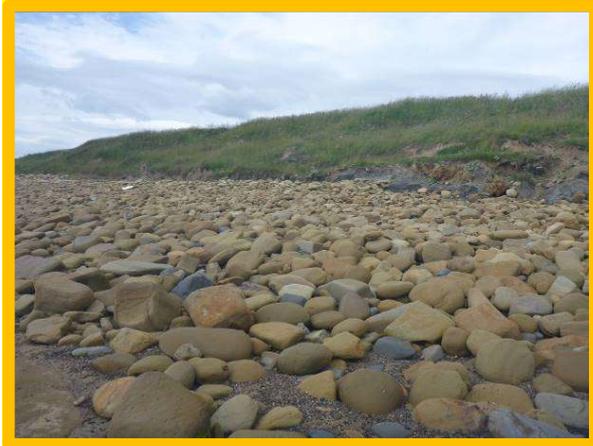
*Slopes stabilised due to protection by sandstone boulder berm at toe (/3701C02)*

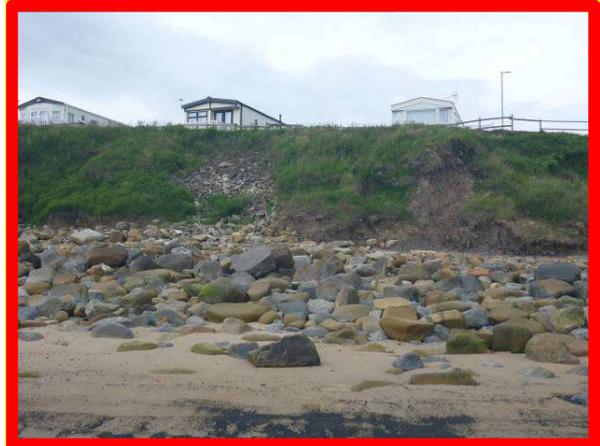
*Erosion recommences to immediate south of rock berms (/3701C03)*

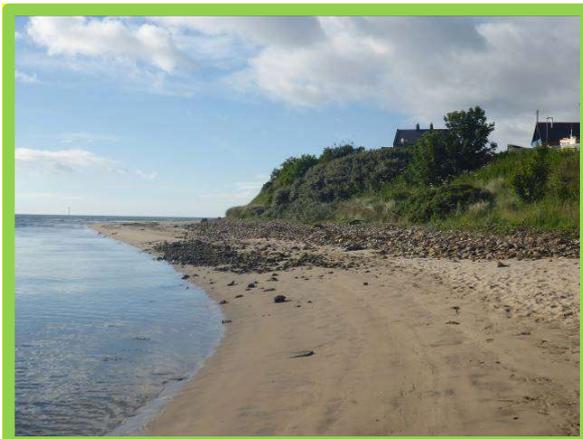
*Estuary channel not directly at cliff toe (/3801C02)*

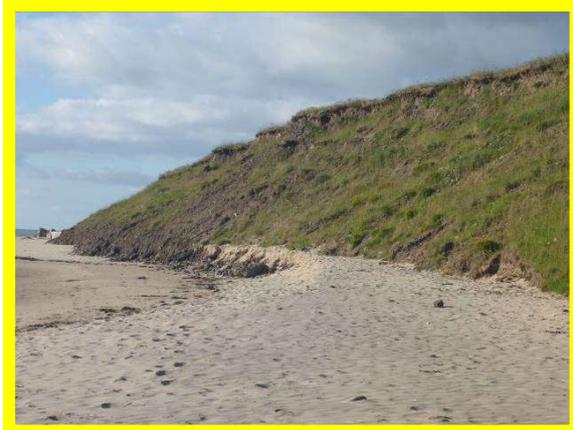
*Sand accumulation protecting cliffs at Cambois House from further slippages (/3901C01)*

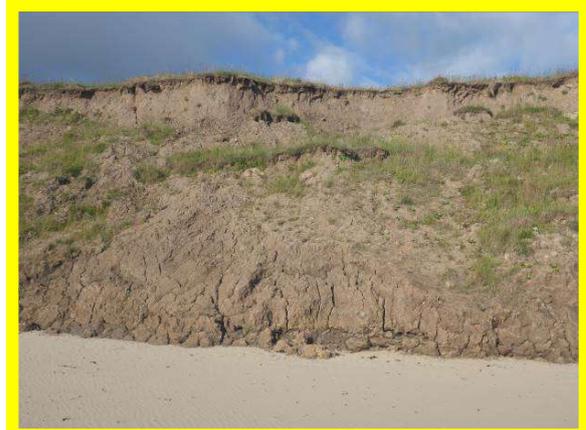
*Ongoing slippages in cliffs further south of Cambois House (/3901C01)*

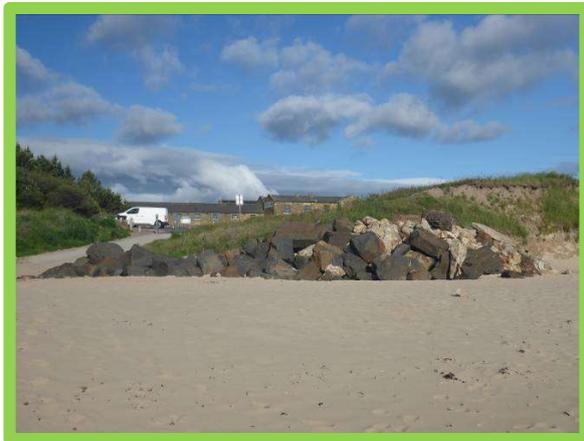
*Reinstated and improved rock revetment protecting slipway (/3901C05)*

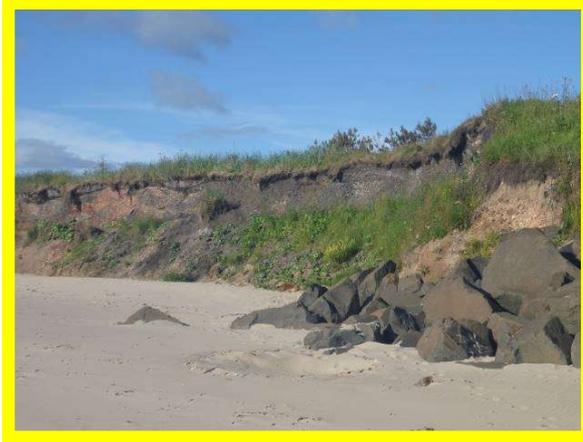
*Erosion of cliffs at terminal end of rock revetment (/3901C03)*

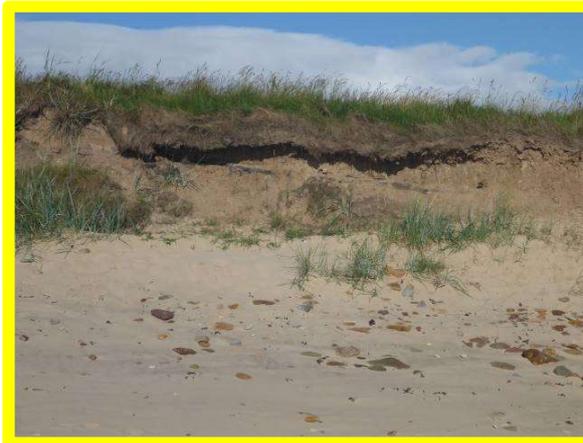
*Partial recovery of previous storm damage at dunes (/3901C04)*

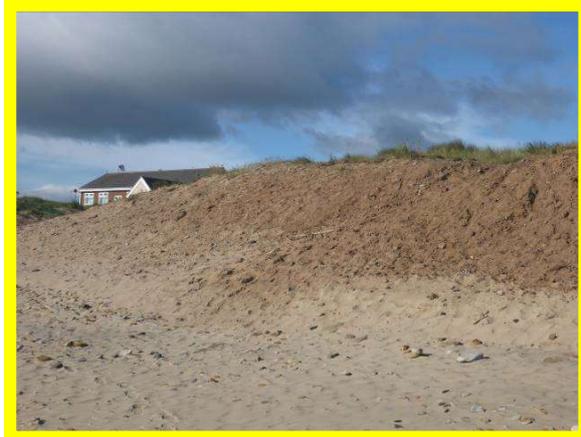
*Reinstated dunes at cable landfall (/3901C04)*

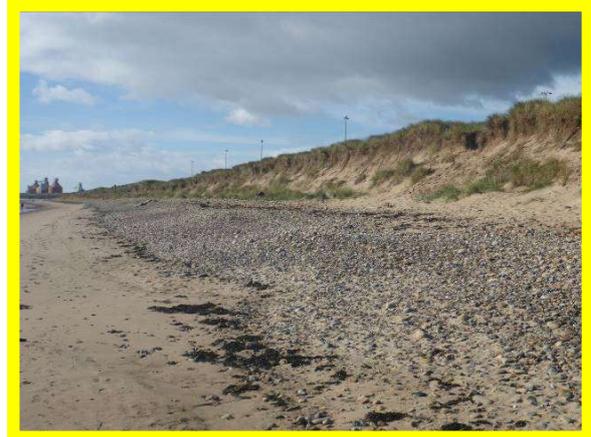
*Partial recovery of previous storm damage at dunes (/3901C04)*

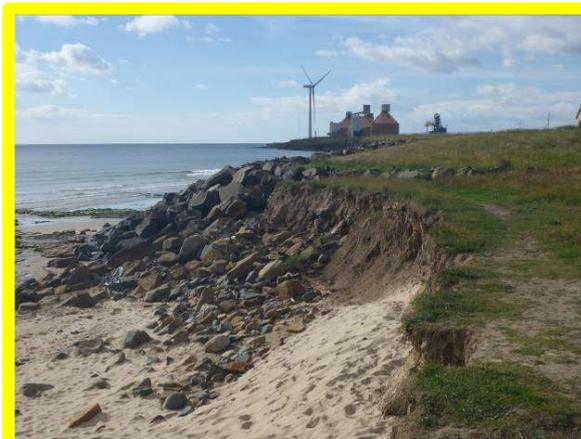
*View of terminal erosion at northern end of rock revetment (/4001C01)*

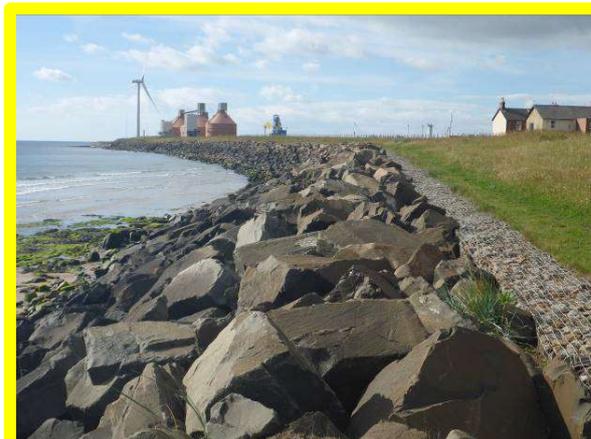
*Rock revetment with gabion baskets at rear (/4001C01)*

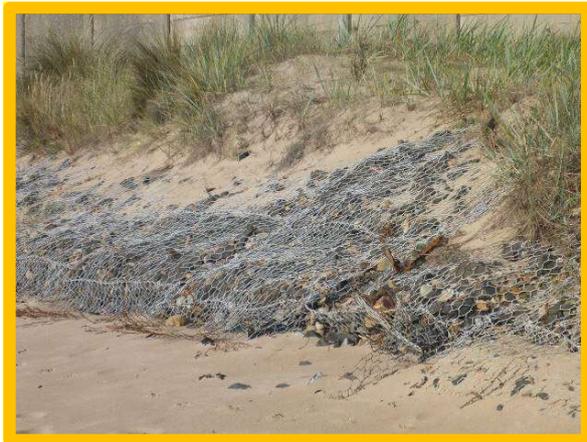
Along the southern-most section of the port boundary wall, the dunes are protected along the seaward face and toe by cobble-filled gabions. These are in poor condition. Replacement of broken gabions in conjunction with consideration of management options for the undefended dunes further north therefore remains urgent to prevent loss of the dune and collapse of the boundary wall.

*Failing gabions protecting very narrow strip of dunes (/4201C03)*

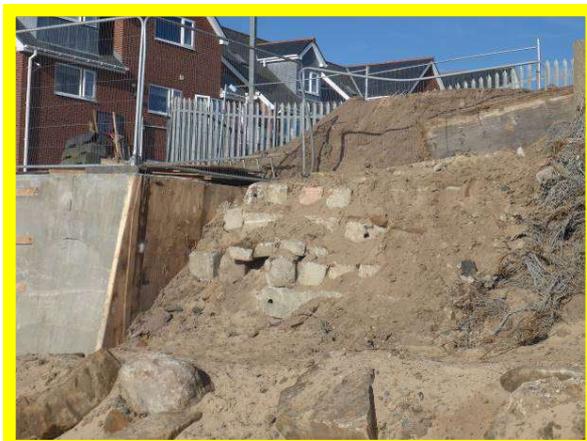
*Tie-in section of wall at failing gabions (/4201C04)*

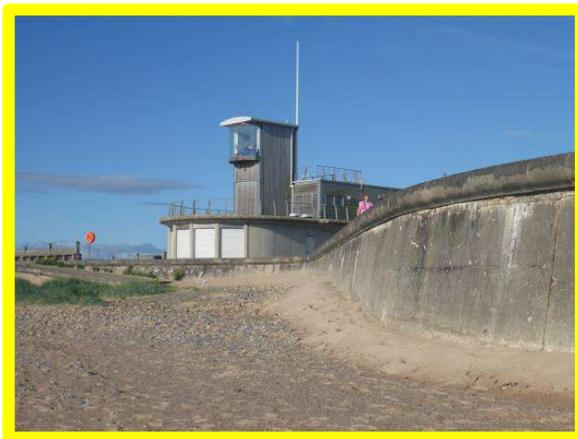
*Seawall leading to the regenerated Blyth seafront (/4201C06)*

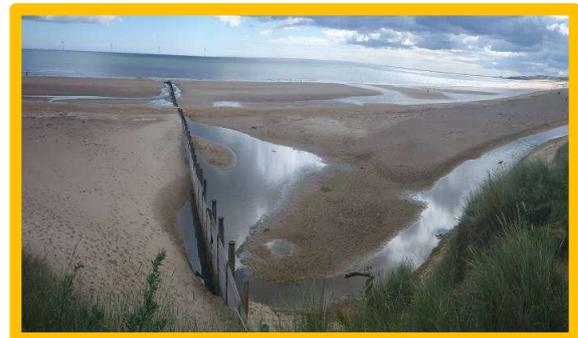
*Meggie's Burn channel undermining southern groyne (/4301C01)*

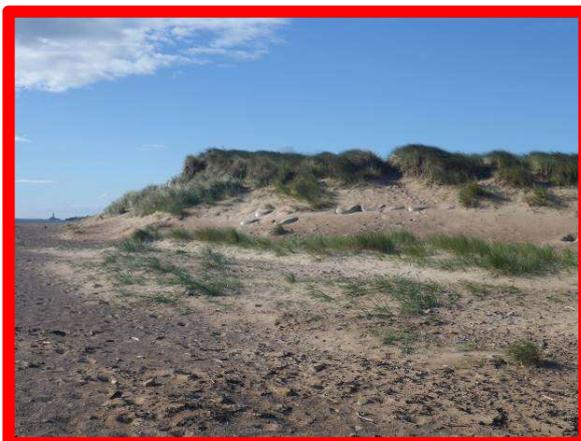
*Exposure of sand bags on dunes near Meggie's Burn (/4301C01)*

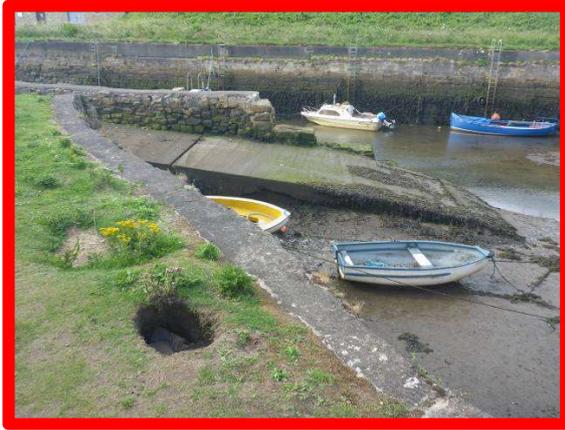
*Undermining at toe on inner face of boat ramp (/4401C05) – locally very poor*

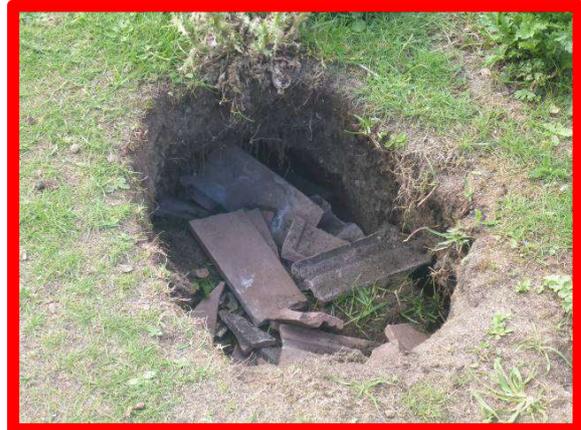
*Sink hole above harbour wall (/4401C05) – locally very poor*

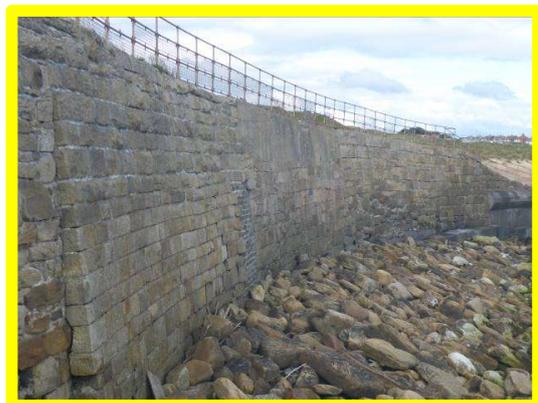
Extending eastwards from the pier, along the northern side of Rocky Island, is a length of masonry sea wall fronted by a rock platform. There is missing mortar and gaps between blocks along much of its length. In one or two areas, there are missing blocks and in many locations, there are abraded blocks. On the landward side of the wall the poured concrete slurry continues to break up and soil erosion of the land is continuing.

*High masonry wall (/4401C11)*

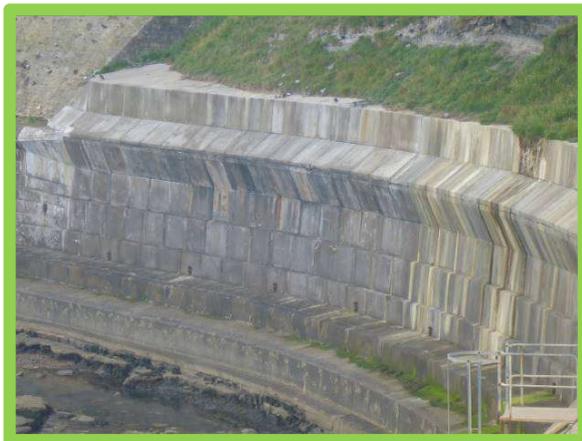
Collywell Bay comprises several different seawall types. At the north end, the near vertical concrete wall continues to remain generally in good condition with some minor cracks and staining with more significant spalling along the upper protruding section.

*Near-vertical seawall (/4401C14)*

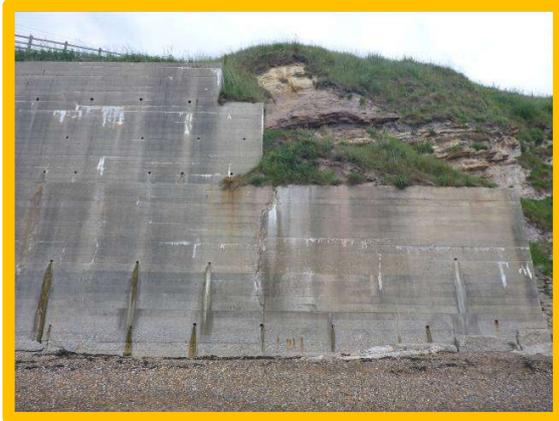
The high vertical concrete sea wall at the centre of Collywell Bay is generally in fair condition, tending to poor in local areas of defects. Maintenance work to fill three notable vertical cracks is still required, however no movement was apparent at these locations and they do not appear to have worsened since the previous inspection. The toe apron and access steps remain highly abraded and cracked in places.

One of three notable vertical cracks in the sea wall (/4401C17)

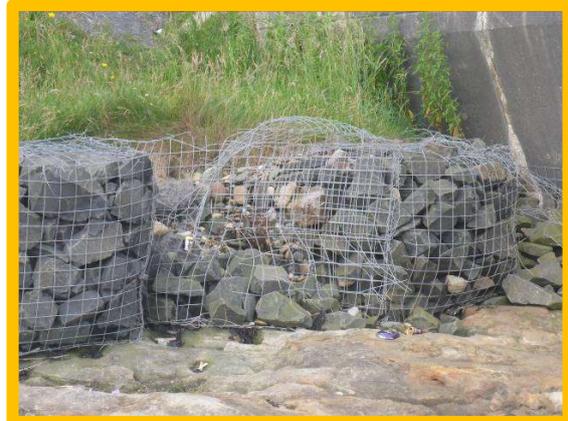
At the south end of Collywell Bay gabions protect the toe of the coastal slope above the beach access ramp. The relatively new replacements for previously failed gabions were noted to already be splitting in 2016 and this continues. The access ramp itself has some undermining where it joins the rocky shore platform, although this has not worsened since the previous inspection. There is also some undermining and onset of outflanking where the ramp joins the undefended cliffs at its other end.

Break-up of gabion baskets (/4401C19)
