Cell 1 Regional Coastal Monitoring Programme Walkover Inspection Surveys 2022

Durham County Council

June 2022

Walkover Inspection Surveys 2022

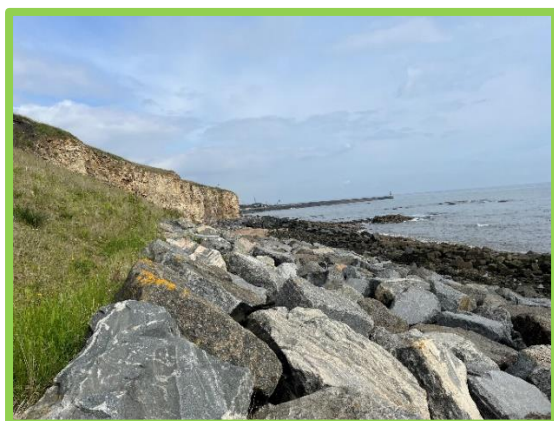
The frontage between Seaham Harbour's South Pier and Seaham Fleet Rock is protected by a continuation of the rock armour revetment extending southwards from the South Pier. In most places the armour is against the cliff toe, but where there is evidence of a former vertical wall, it is placed as a bund slightly seaward of the cliff. Restricted access means that the full length of the rock armour cannot be inspected, but where it can, it is in good condition.

Rock revetment from South Pier to Chemical Beach (/0105C01)

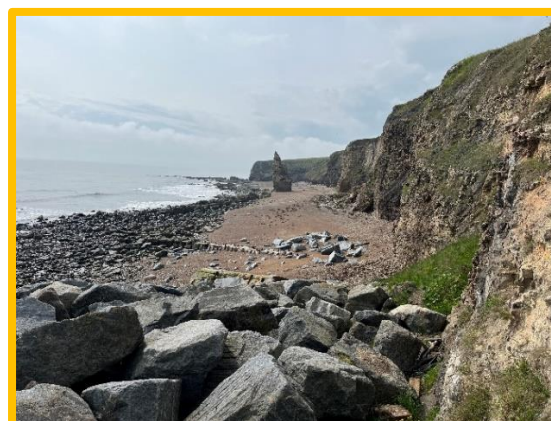
South of the revetment between Seaham Fleet Rock and Nose's Point, the unprotected cliffs were previously fronted by a colliery spoil beach (known as Chemical Beach) but this has now been virtually completely eroded and there are an increasing number of local slumps in the backing cliffs, some of which consists of colliery waste. Debris exposed by the eroding beach should be removed routinely. The erosion appears greatest towards the south of Chemical Beach, just to the north of Nose's Point. No significant changes were observed along Chemical Beach since 2020.

Little remaining spoil on beach (/0106C01)

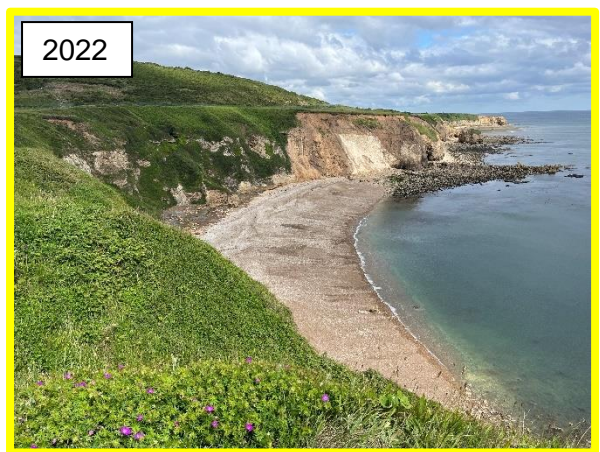
Residual spoil at Shippersea Bay – 2022 (/0201C01)

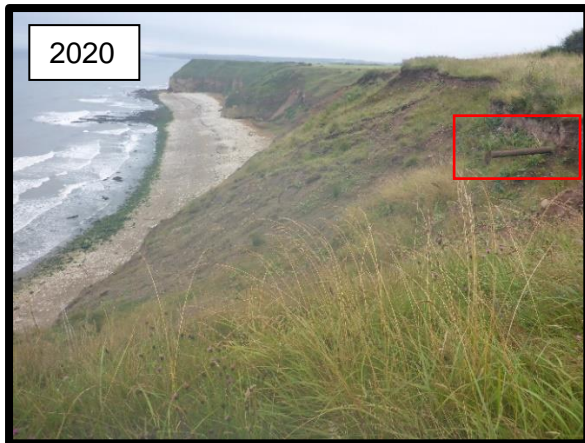
Unnamed Bay fronting Easington Colliery - 2020 (/0201C01)

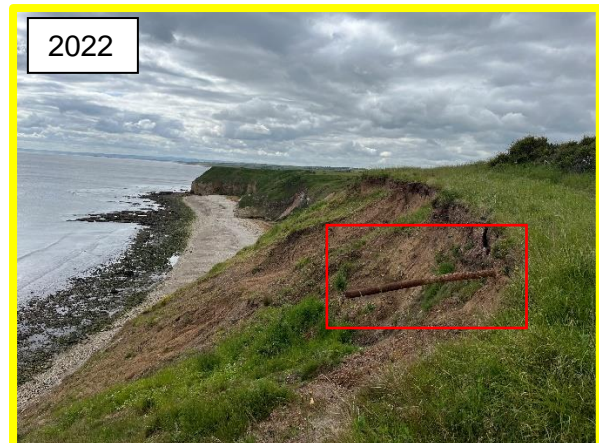
Unnamed Bay fronting Easington Colliery - 2022 (/0201C01)

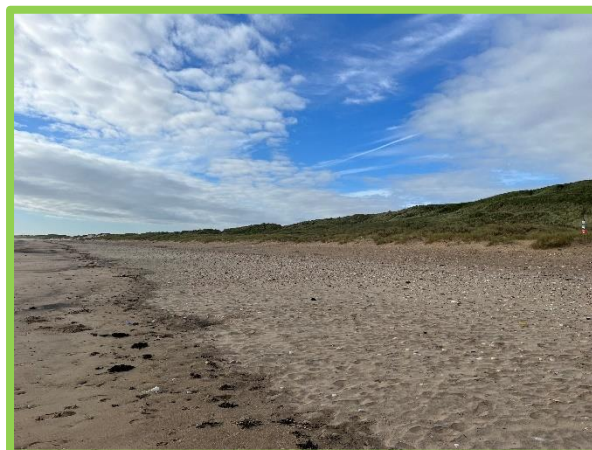
Stable dunes at Crimdon (/0301C02)
