**Cell 1 Regional Coastal Monitoring Programme
Walkover Inspection Surveys 2016**

Hartlepool Borough Council

Walkover Inspection Surveys 2016

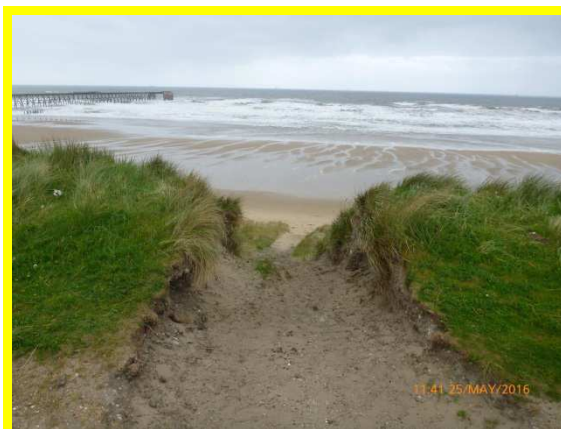
There was evidence of local lowering of the dune crest and lack of vegetation caused by trampling at informal access points, such as that fronting Spion Kop cemetery. The dunes at the landward end of the historic pier were lower than adjacent dunes, with erosion here likely exacerbated through access and scour around the timber elements. Embryo dunes were present with initial establishment of vegetation. The backing slope formed from made-ground along the former Steetley industrial site remained largely clear of vegetation.

Informal access at Spion Kop cemetery (/C0302C01)

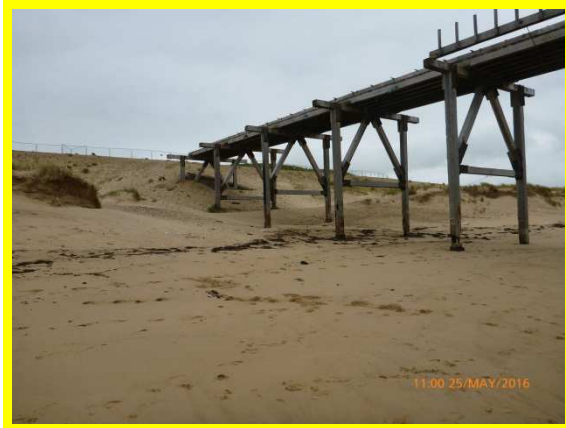
Dunes lowered with less vegetation around historic pier structure (/C0302C02)

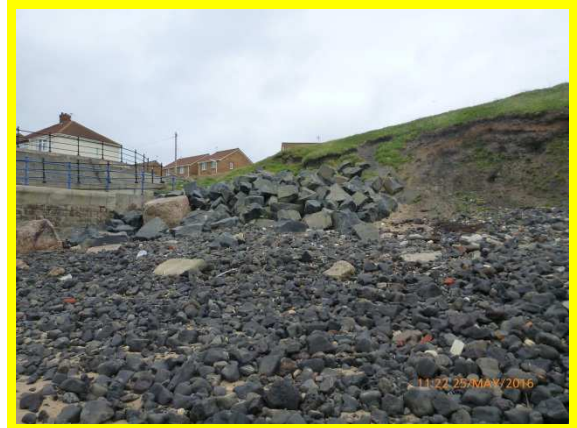
The embankment to the north of Marine Drive appears to comprise made ground /slag /rubble. Local undercutting and overhanging was observed, with this being more prevalent towards the southern extent of the asset. However, the slopes were generally vegetated. Large pieces of slag material previously poured to form a protective apron had continued to break up although the material is likely to remain *in situ*. Rock armour revetment (also incorporating several concrete tank blocks) at the interface with Marine Drive sea wall appeared in fair condition.

Rock armour revetment at Marine Drive seawall (/C0302C03)

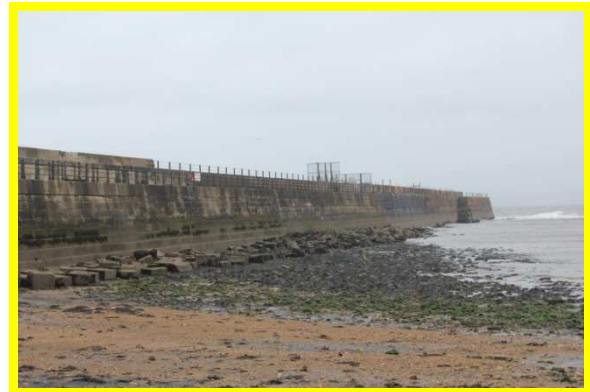
Heugh Breakwater – South aspect (/C0401C01)

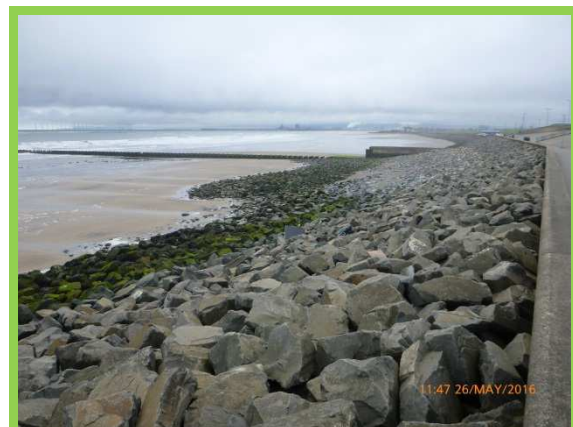
Possible displacement of rock (/C0401C33)

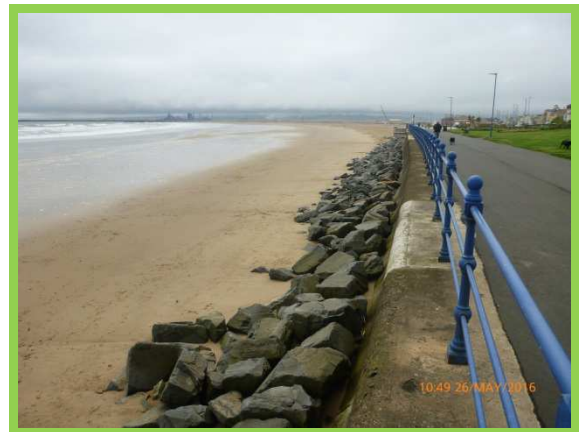
View looking south (/C0501C05)

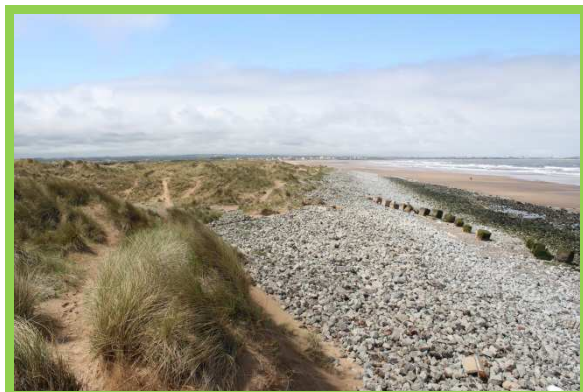
To the south of the sewage pumping station, the frontage is undefended over approximately 1 kilometre and comprises a relatively stable dune system (which includes the Seaton Dunes Nature Reserve) and a wide, healthy beach. The dunes were well established and had a good coverage of vegetation. Erosion was evident locally due to trampling from members of the public walking amongst the dunes, with dune crest heights lowered locally on the most heavily trafficked routes. As in previous inspections, local cliffing is evident towards the south of the frontage, in close proximity to the North Gare breakwater.

Mature dunes viewed from North Gare (/C0502C01)

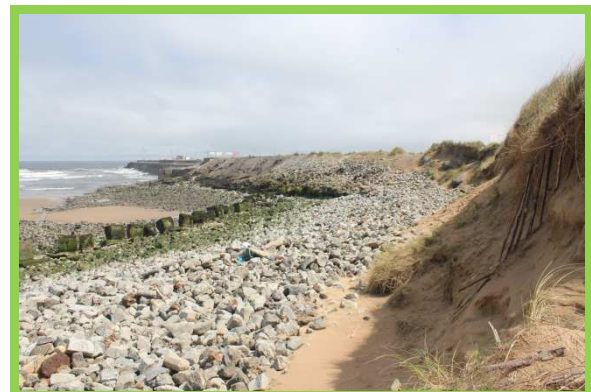
Cliffing at southern extent of dunes (/C0502C01)
