Cell 1 Regional Coastal Monitoring Programme Walkover Inspection Surveys 2020

Hartlepool Borough Council

Walkover Inspection Surveys 2020

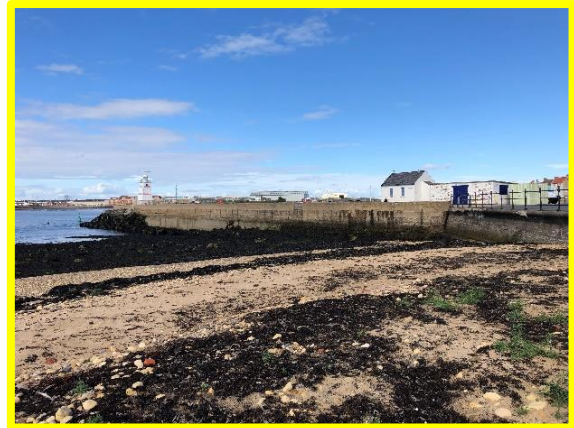
Southern aspect of the Old Pier (Pilot Pier) (/C0401C34)

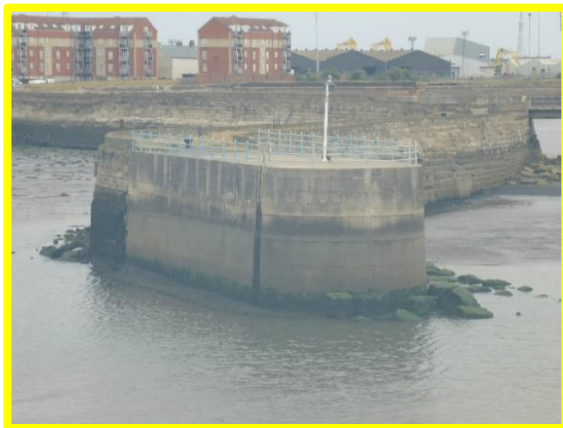
Inner arm pier head (C0401C21)

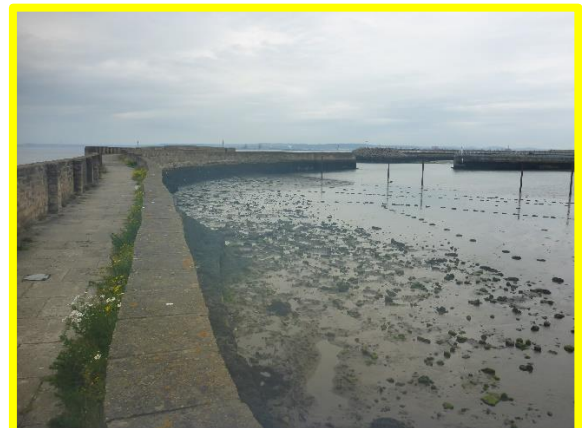
Inner arm south face (C0401C21)

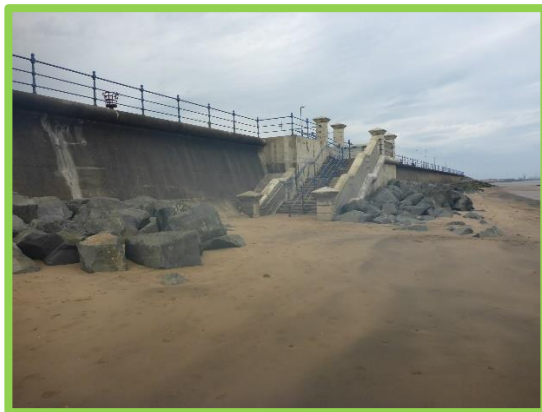
Minor defects were observed along the asset, these will require attention, and consisted of localized cracking and spalling of the cope and face of the wall and missing or damaged joint sealant. There was evidence of historic repairs, including grouting / filling of spalled sections and cracks. Some of these repairs appeared to be in poor condition and should be revisited.

Northern access steps (/C0501C05)

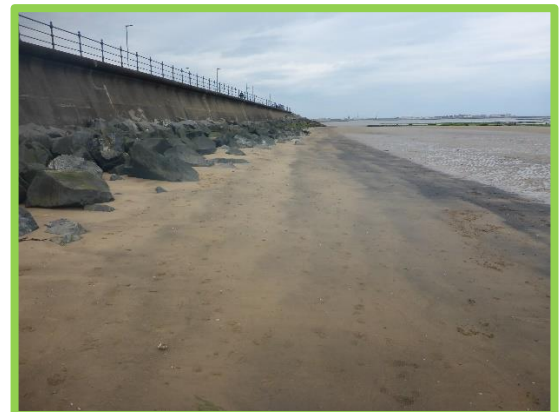
The coverage and interlock between rock armour units was good, although very high beach levels concealed much of the toe of the revetment structure. As a result, the displacement of rock armour identified in 2018 was not visible. This displacement should be monitored as it may indicate a loss of interlock between units.

View looking north. High beach levels concealing toe of revetment structure. (/C0501C05)

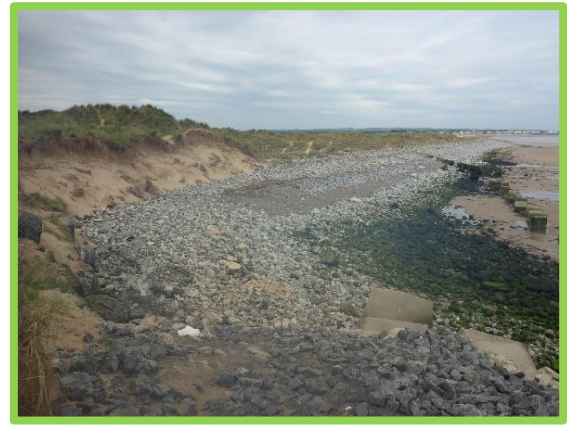
Cliffing at southern extent of dunes not worsened since 2018 (/C0502C01)
