NECAG Coast Protection Assets and Coastal Slope Condition Analysis

**Scarborough Borough Council
Final Report**

April 2009

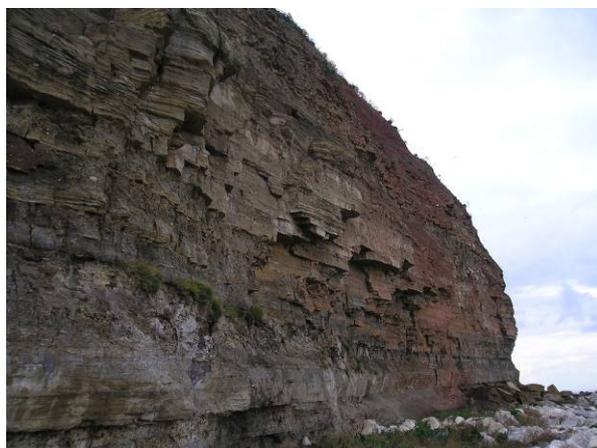
Mu4/1a exposed, bedded and jointed rock face at Cowbar Nab, Staithes (Totally Active)

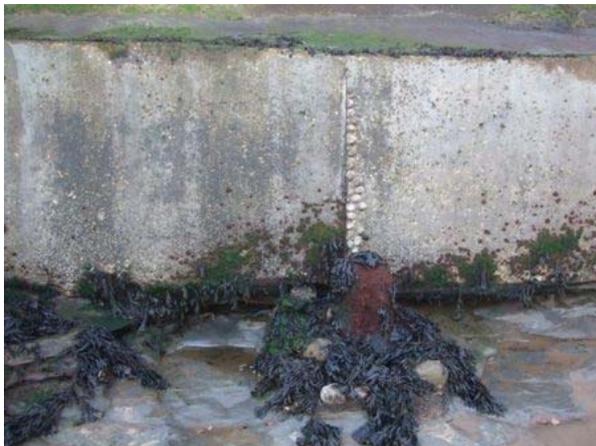
Undercutting at the toe of some parts of the harbour wall (Asset Ref No. 1221D901D0402C04)

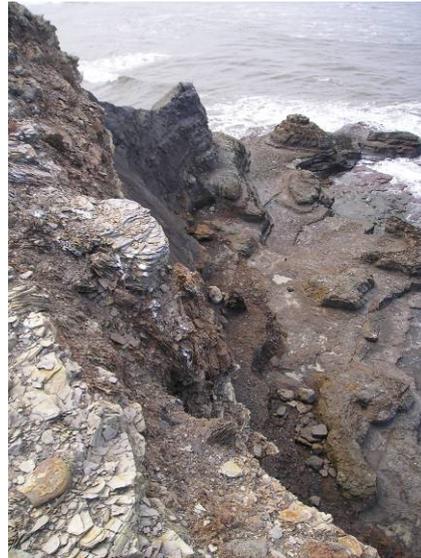
Mu5/1 Old Nab headland (Partly Active)

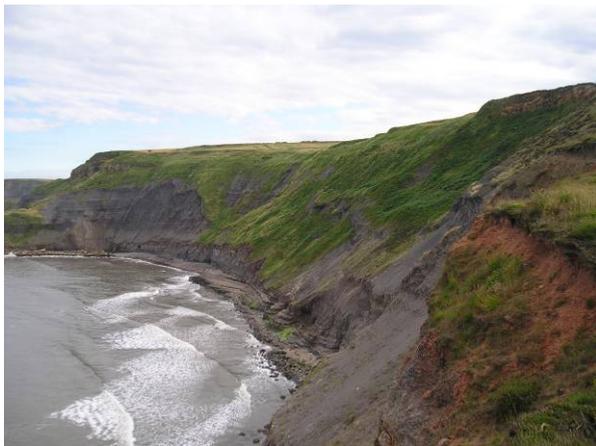
This section of cliffline is Partly Active (Mu6/1). Marine erosion is cutting into the hard stratified rock at the base of the cliffs. The cliffs support some vegetation cover but shale exposed in many areas, indicating on-going erosion, which is especially intense around the east facing side of Old Nab.

Mu6/1 looking southeast from Old Nab (Partly Active)

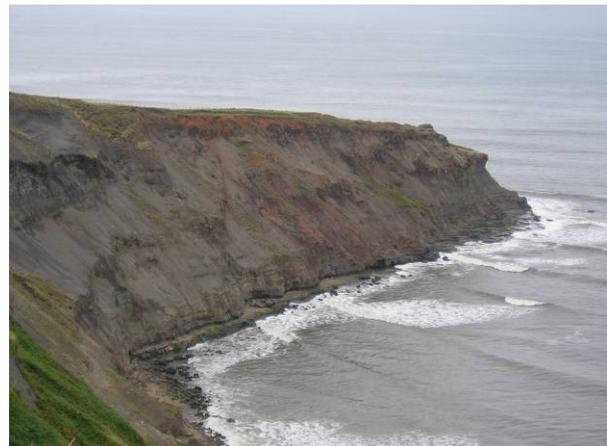
Mu6/1 east facing side of Old Nab (Partly Active)

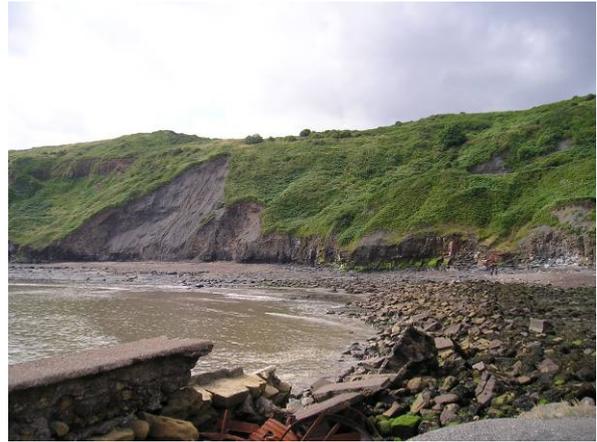
The undefended cliffs to the north of Port Mulgrave show signs of recent activity and are classified as Partly Active (Mu6/2). There is evidence of recent failures and erosion of the cliffs. Further south, the CBUs are Locally Active, with large areas covered by dense vegetation and some areas of activity (Mu6/3, Mu6/4, Mu6/5).

Mu6/4 cliffs south of Port Mulgrave (Locally Active)

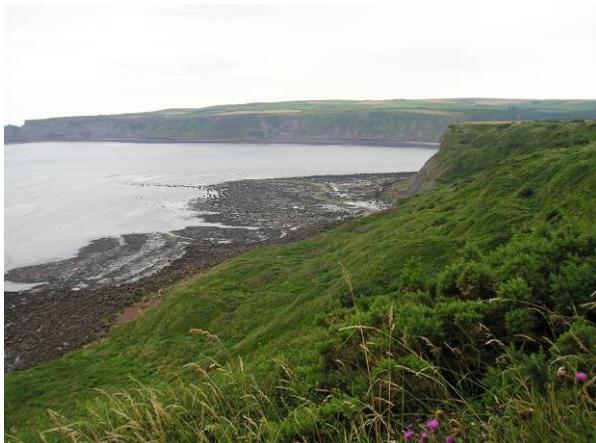
The central part of this area (Mu6/7) consists of a large debris run-out lobe fronting cliffs and is classified as Locally Active. The stepped terrain is well vegetated and shows only localised evidence of activity at the toe. Immediately to the north and south of this unit, the cliffs are much higher, steeper and are Partly Active (Mu6/6, Mu6/8).

Mu6/7 looking southwards across Lingrow Cliffs (Locally Active)

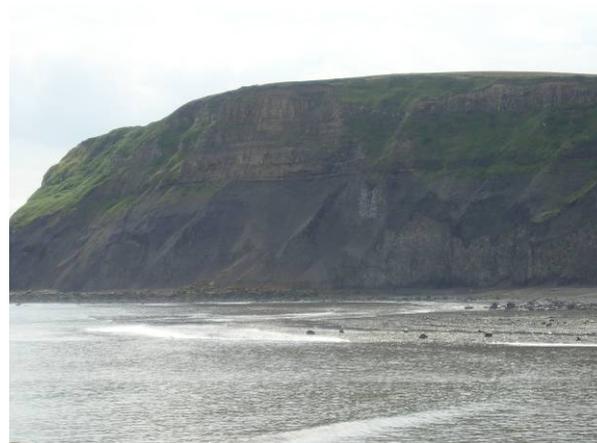
Mu6/6 looking south from Port Mulgrave (Partly Active)

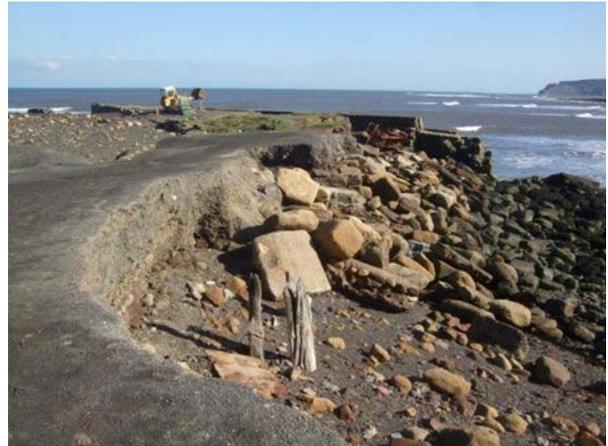
Sub-Management Unit 6B features relict assets at Port Mulgrave. This is a former port and ironstone mine which has been derelict for 70 years. Virtually all coastal defences have been lost to the sea. What is left of the breakwater is undergoing large scale cracking, deformation, undercutting and outflanking. It is estimated that half of its original length has now been eroded (Asset Ref No. 1221D901D0502C01). As a result, the launching and retrieval of boats would be difficult here. If regular access by sea was required, a regeneration project to remove the breakwater ruins and build a new access point would be of benefit.

Outflanking and erosion occurring behind the breakwater

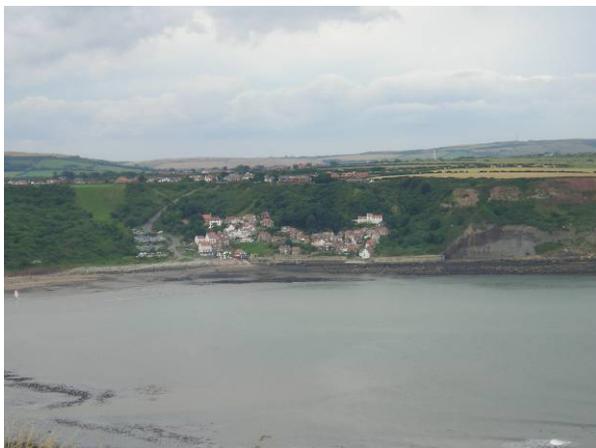
The area in and around the settlement of Runswick Bay is classified as Inactive (Mu7/1). The toe is defended by a sea wall with some rock armour to the south. The outflanking of these defences to the north (within Mu6C) indicates the nature of the erosion which may be occurring here if it were not for the protective influence of these structures. There is some minor evidence of very localised, small scale erosion on the engineered slopes to the south of the village, but this does not appear to be significant (Mu7/1).

Mu7/1 looking west across Runswick Bay (Inactive)

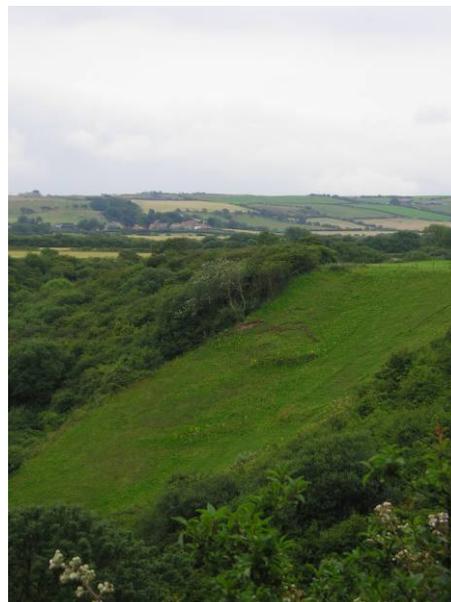
Mu7/1 slopes south of Runswick Bay village (Inactive)

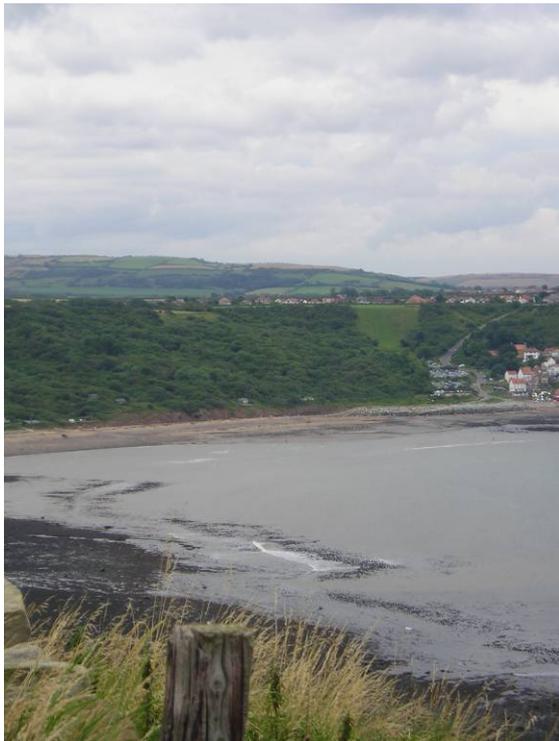
(MU7/3, Mu7/4). The toe is generally steep, does not support any vegetation cover and there is evidence of recent slumping and sliding activity.

Overview of Mu7B showing well vegetated slopes and active erosion at the toe

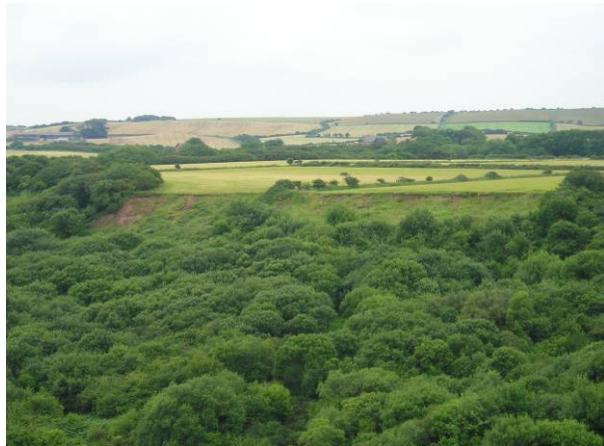
The cliffs around Nettle Dale are well vegetated, partly protected by the rock armour extending south from Runswick Bay village and are classified as Inactive (Mu7/2). Further round the bay there is no toe protection and the slopes are Locally Active

Mu7/3 minor activity at the headscarp (Locally Active)

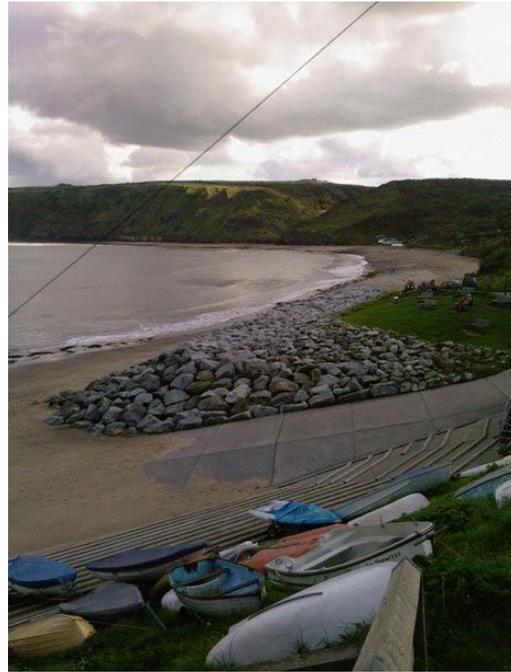
Runswick Bay has recently undergone the installation of new coastal defences inline with the building of a new pumping station (adjacent to the lifeboat station). Rock armour defences are tightly packed with extremely sound coverage. They are in very good condition with no evidence of deformation or settling. Near Runswick Sailing Club there is a new concrete slipway and revetment. These are also both in a very good condition displaying few defects (Asset Ref No. 1221D901D0602C01). The Sailing Club itself, located just south of the village, has been constructed on timber struts and features a mix of coastal defences (Asset Ref No. 1221D901D0602C03).

Looking southeast away from Runswick Bay village across the new rock armour defences
(Asset Ref No. 1221D901D0602C01)

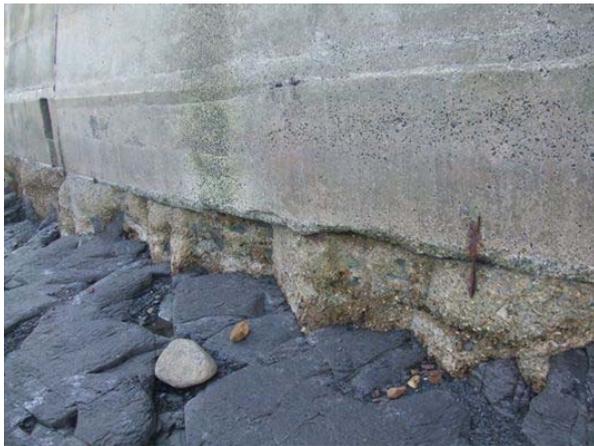
The sea wall defences to the north of the new pumping station are showing defects. These range from minor to quite significant issues. The northern coastal sea wall, which gives direct protection to private property, is suffering from surface cracking and erosion. Erosion of the underlying bedrock is causing undercutting of the sea wall and the reinforcing bars are also visible in places. Further investigation is required to determine the rate of undercutting. Further defects include washed out sealant joints and weep holes which have seized shut. It is recommended that these issues are addressed (Asset Ref No. 1221D901D0601C01).

Undercutting of the northern coastal sea wall
(Asset Ref No. 1221D901D0601C01)

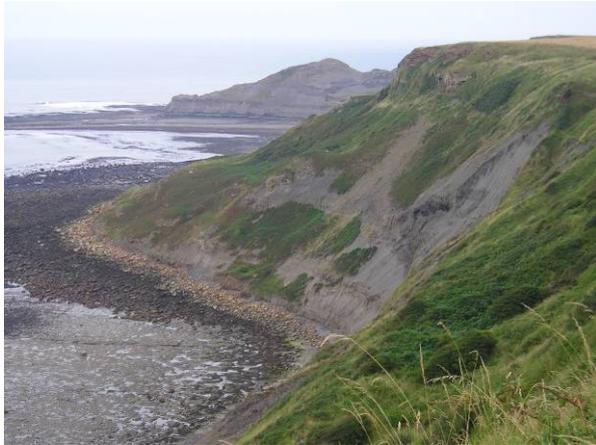
The CBUs behind and adjacent to Runswick Sands are Locally Active (Mu8/1, Mu8/2). The toe is steep with little vegetation cover and evidence of recent falls and

Mu8/2 looking east (Locally Active)

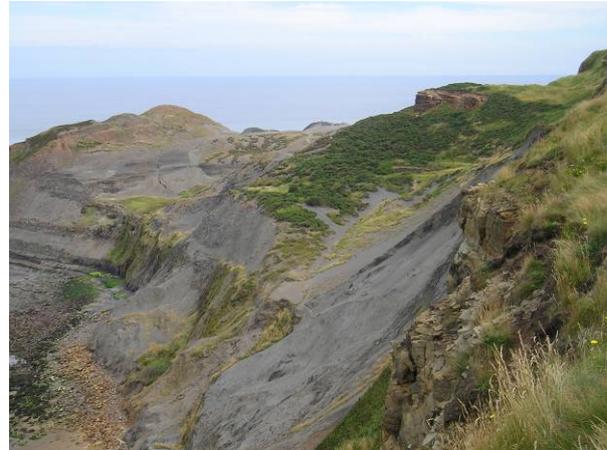
slides. The mid and upper slopes are more densely vegetated with localised patches of erosion. Further south, closer to Kettle Ness, units become more active. The sparsely vegetated slopes are undergoing intense weathering and erosion and are Partly Active (Mu8/3, Mu8/4).

Mu8/4 Kettle Ness (Partly Active)

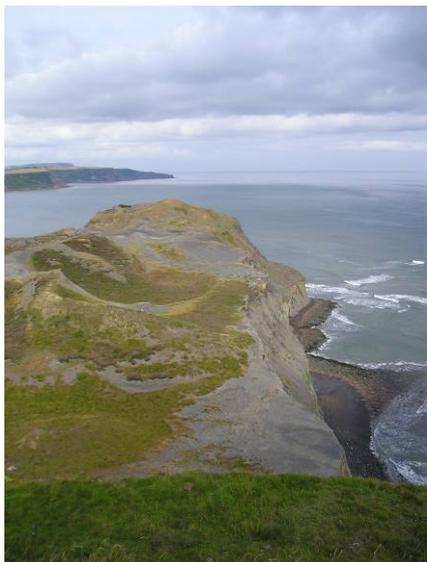
In the north-western part of this Sub-Management Unit is the headland of Kettle Ness, which has been extensively quarried for alum in the past, and is classified as Partly Active (Mu8/5). Further east around the headland there is evidence of recent rock fall activity near a vertical exposed cliff face (Mu8/6). The southern part of this Sub-Management Unit from Keldhowe Steel to Sandsend is also Partly Active (Mu8/12, Mu8/13, Mu8/14, Mu8/15). The steep cliffs are being eroded by marine activity at the toe. There is some evidence of rockfall on the shore platform and extensive erosion of the mid-slopes. Like Kettle Ness, Sandsend Ness is also undergoing severe weathering (Mu8/14). In between these two areas there is a zone of lesser activity (Locally Active- Mu8/7, Mu8/8, Mu8/10, Mu8/11). This mainly comprises a large relict debris lobe which is densely vegetated (Seavey bog Hill- Mu8/7). There is minor localised erosion at the headscarp and toe.

Mu8/5 Kettle Ness headland (Partly Active)

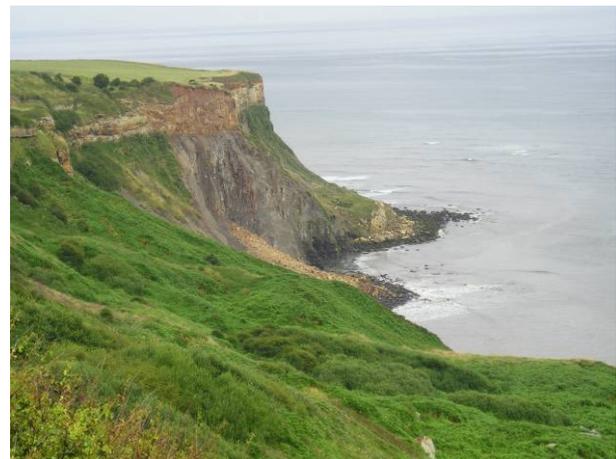
Mu8/6 Rock fall near Holmsgrove Sand (Partly Active)

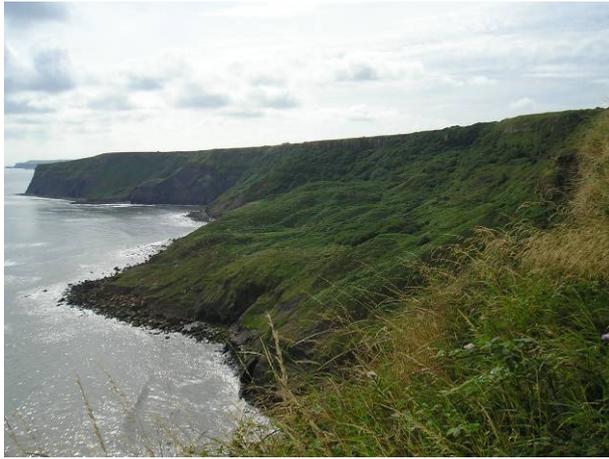
Mu8/7 Relict debris lobe at Seaveybog Hill, with on-going erosion of the toe (Locally Active)

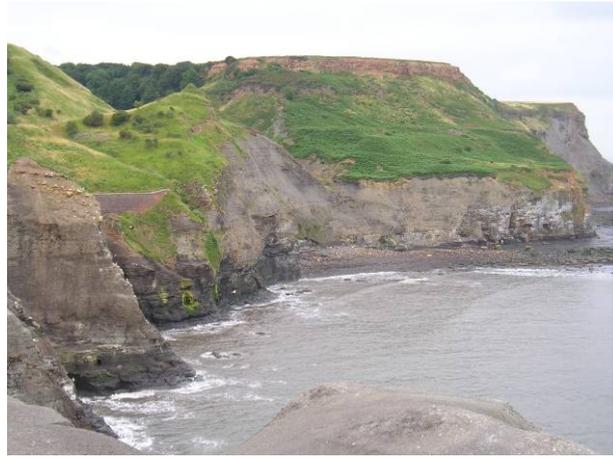
Mu8/15 Cliffs north of Sandsend (Partly Active)

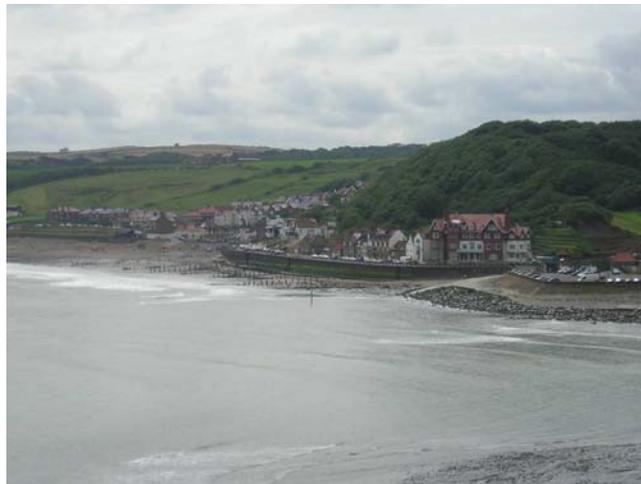
These CBUs are classified as Dormant (Mu9/1, Mu9/2). They are defended by the sea wall, groyne and some rock armour and as a result there is no evidence of recent activity.

Mu9/1 and Mu9/2 (Dormant)

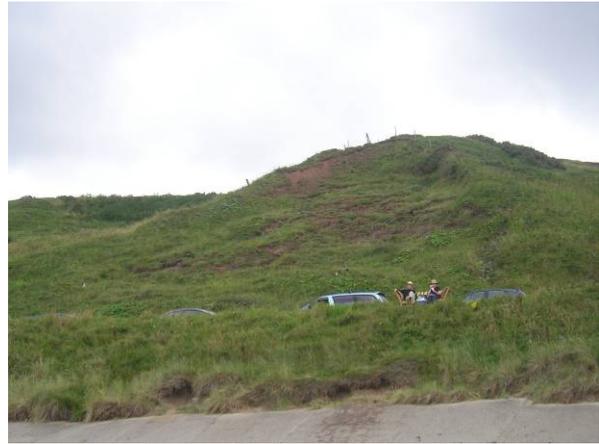
Above the concrete sea defences the slopes of this unit are Partly Active (Mu9/3). There has been some effort to stabilise the slopes; however the presence of tension cracks and rilling and gullying in exposed materials provides evidence of ongoing instability.

Mu9/3 looking up from Sandsend Beach (Partly Active)

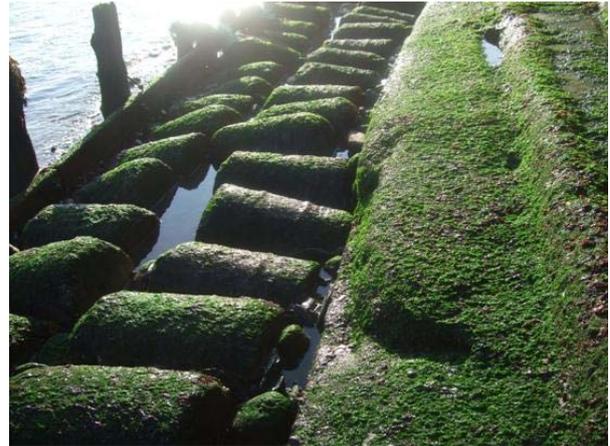
Timber groynes in front of Sandsend (Asset Ref No. 1221D901D0702C01)

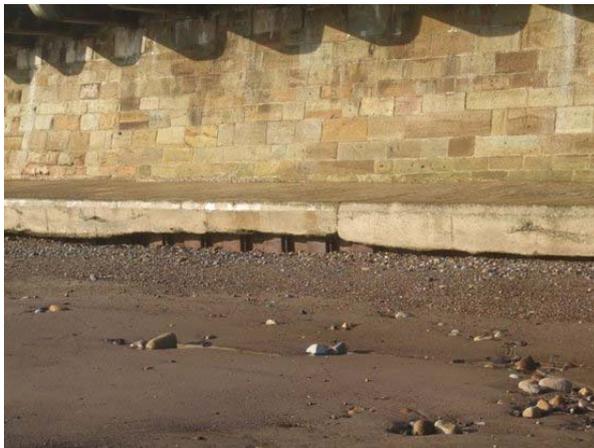
Relatively new blockwork sea wall with undercutting at the toe (Asset Ref No. 1221D901D0702C04)

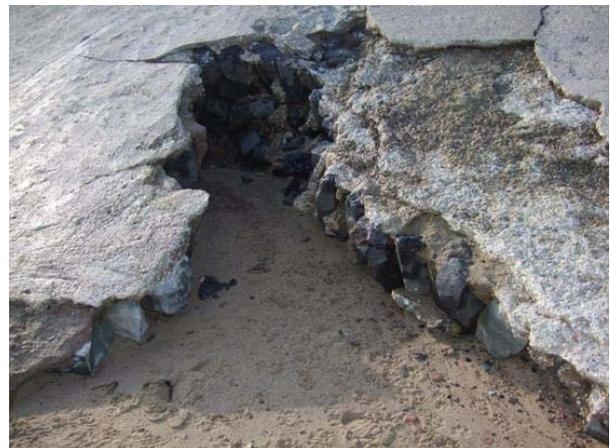
Undercutting and erosion of the concrete revetment backing Sandsend Beach (Asset Ref No. 1221D901D0702C04)

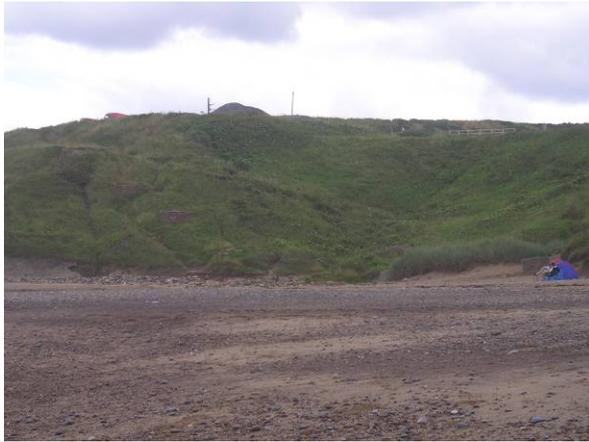
Mu10/1 looking across the western end of Upgang Beach (Inactive)

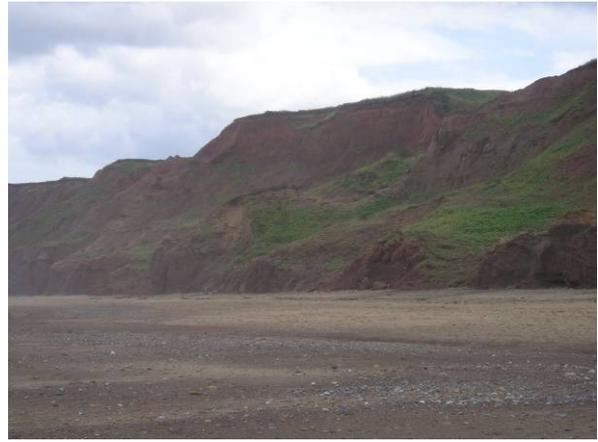
Mu10/2 looking eastwards across the eastern end of Upgang Beach (Partly Active)

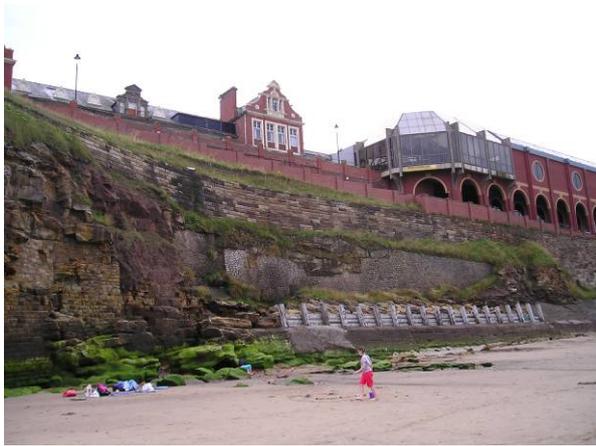
This Management Sub-Unit is generally protected by a variety of coastal structures and the cliffs are Inactive (Mu11/3). In units where defences are absent the exposed rock faces show minor erosion and the cliffs are Locally Active (Mu11/4).

Mu11/3 sporadic defence structures (Inactive)

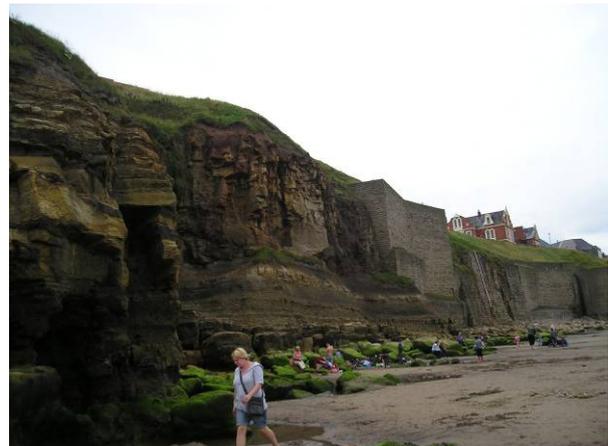
Mu11/4 exposed rock faces above Whitby Sands (Locally Active)

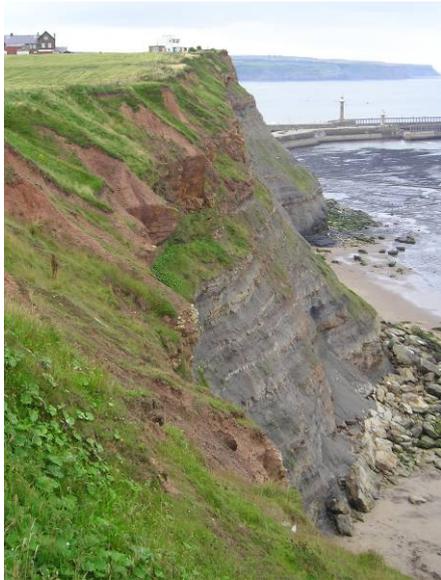
The CBUs within this Sub-Management Unit are a combination of Locally (Mu13/3, Mu13/5, Mu14/1) and Partly Active cliffs (Mu13/1, Mu13/2, Mu13/4, Mu13/6). Saltwick Nab (Mu13/2) is undergoing intense erosion, with rilling and gulying evident on exposed surfaces. Further south the cliffs alternate between being Locally and Partly Active. The Locally Active CBUs (such as within the bay at Saltwick (Mu13/3) and the relict debris lobe near Black Nab (Mu13/5)) are much more densely vegetated with minor erosion at the head and toe. The Partly Active CBUs are subject to marine erosion at the toe, with sliding and rock falling occurring on much of the steep, exposed slopes (Mu13/4, Mu13/6).

Mu13/1 looking west (Partly Active)

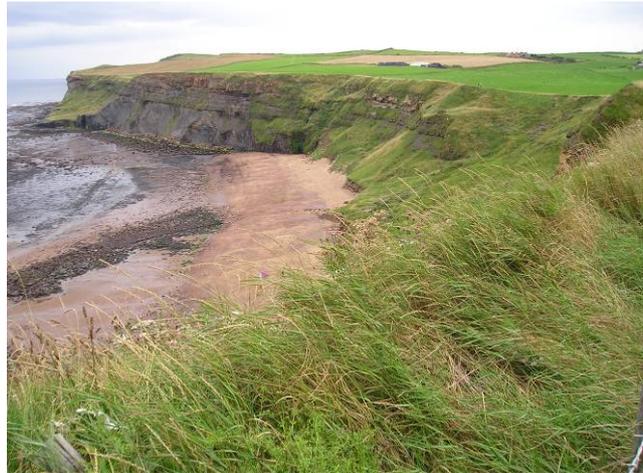
Mu13/3 and Mu13/4- showing alternating zones of Locally and Partly Active cliffs

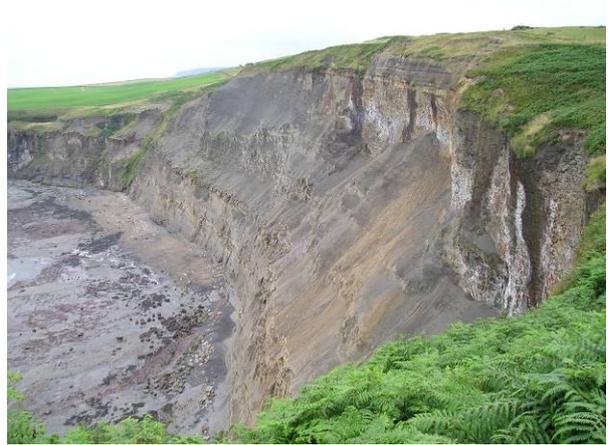
Mu15/2 looking southeast across Far Jetticks (Totally Active)

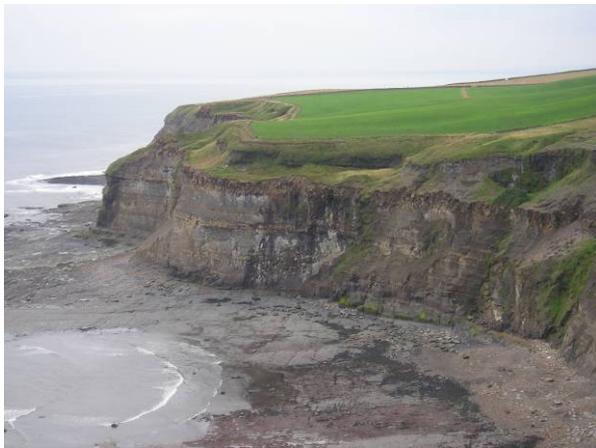
Mu15/3 looking south (Partly Active)

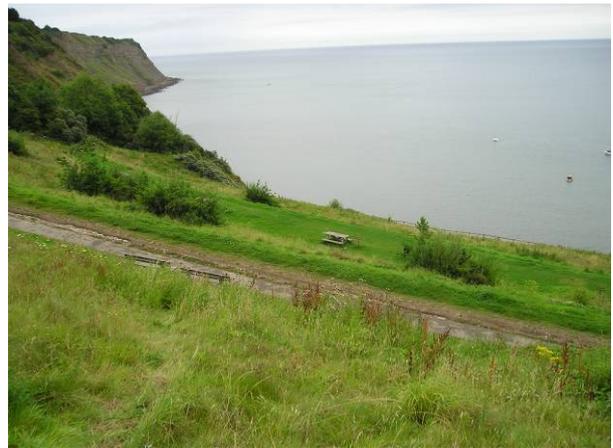
Mu16/2 (Dormant)

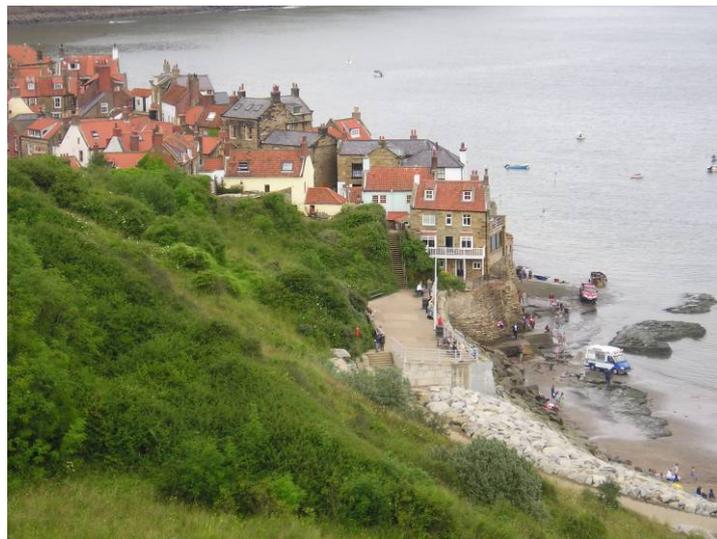
This Sub-Management Unit is classified as Inactive and is defended at the toe by a sea wall and rock armour (Mu17/1). The slopes are densely vegetated with trees and shrubs and show little evidence of recent activity.

Mu17/1 looking north towards Robin Hood's Bay Village (Inactive)

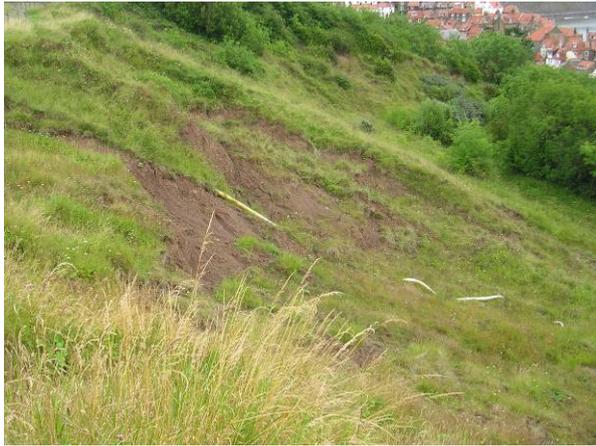
The northern part of this Sub-Management Unit is protected in part by rock armour at the toe. The slopes are generally well vegetated with some exposed areas at the head and mid-slope where sliding and some rilling is occurring (Locally Active- Mu17/2). Further south defences are absent and the cliffs are more active. There is significant slumping and sliding activity at beach level as well as at the cliff head and mid-slopes (Partly Active- Mu17/3).

Mu17/2 mid-slope activity (Locally Active)

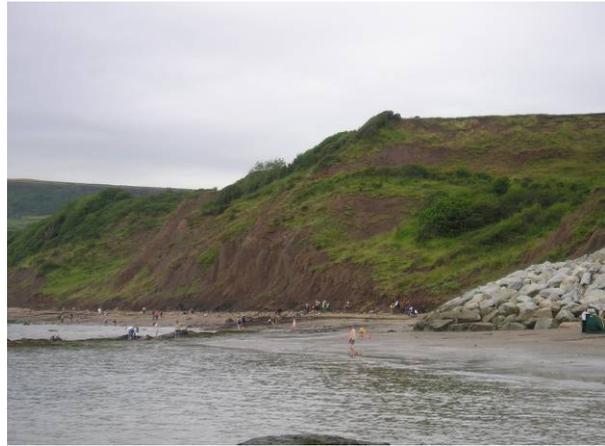
Mu17/3 looking south (Partly Active)

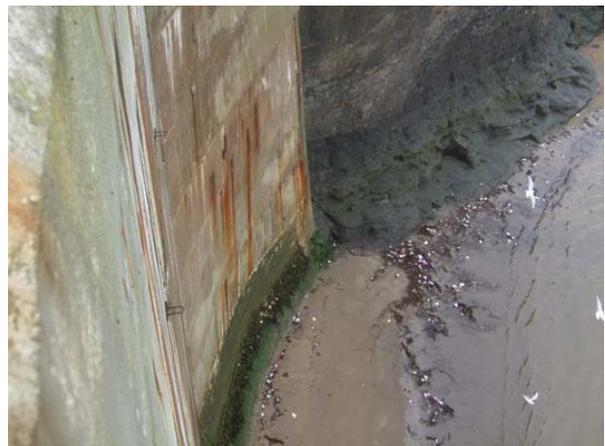
Further south there is a large vertical defence wall, directly protecting houses located behind. The concrete is in a fair to poor condition, showing evidence of surface cracking, rust marks and seepage, and cracking to the crest of the wall. However, the toe appears to be in a stable condition with no visible undercutting (Asset Ref No. 1221D901D1003C02).

Large vertical wall at Robin Hood's Bay (Asset Ref No. 1221D901D1003C02)

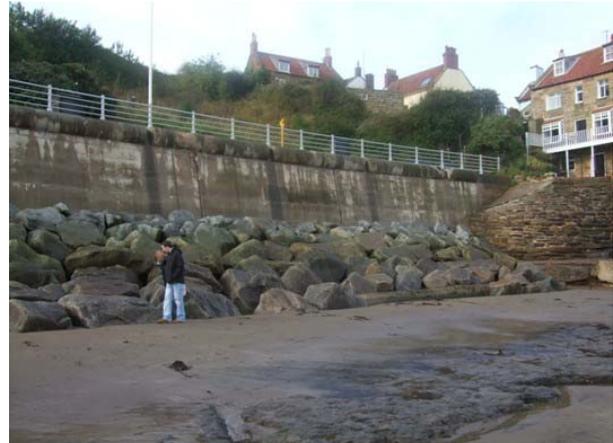
The rock armour is in a good condition. It is tightly packed and giving good protection to the toe of the sea wall behind. The upper sections of the sea wall itself show some evidence of seepage through the blockwork joints, rather than visible cracking. The promenade above the sea wall is in a good condition, with only minor defects present (Asset Ref No. 1221D901D1003C09).

The rock armour just south of the short sea defence, sea wall and promenade above (Asset Ref No. 1221D901D1003C09)

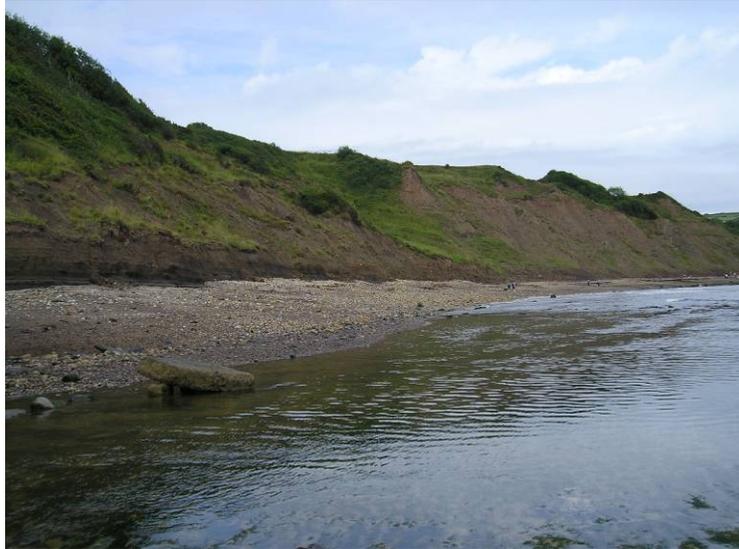
This Sub-Management Unit has been classified as Partly Active (Mu17/3). The cliffs are commonly free of vegetation with evidence for activity at all parts of the cliff.

Mu17/3 looking north (Partly Active)

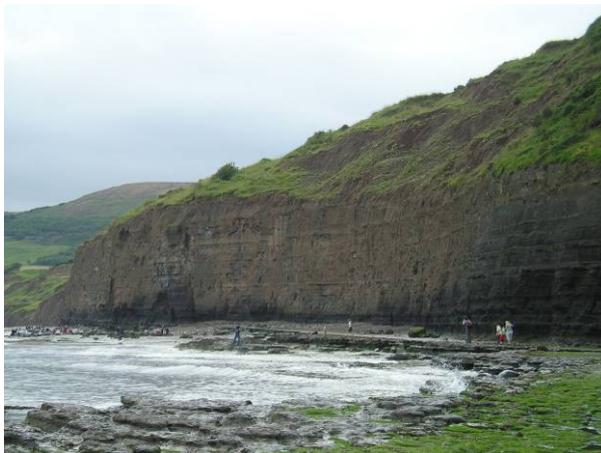
The northern part of this Sub-Management Unit is Partly Active (Mu17/4, Mu17/5). The lower cliff face is near vertical and lacking in vegetation cover. The upper cliff is a shallower gradient, composed of softer, glacial sediments, and is better vegetated. Further south, the upper cliff becomes more stable with more continuous vegetation cover. Some activity at the headscarp and toe is evident, but to a lesser extent and the cliffs are classified as Locally Active (Mu17/6, Mu17/7). Towards Peak Steel the cliffs become more active, particularly in the upper, softer sediments. Debris is present at the base of the cliffs, which are classified as Partly Active (Mu17/8, Mu17/9).

Mu17/4 looking south (Partly Active)

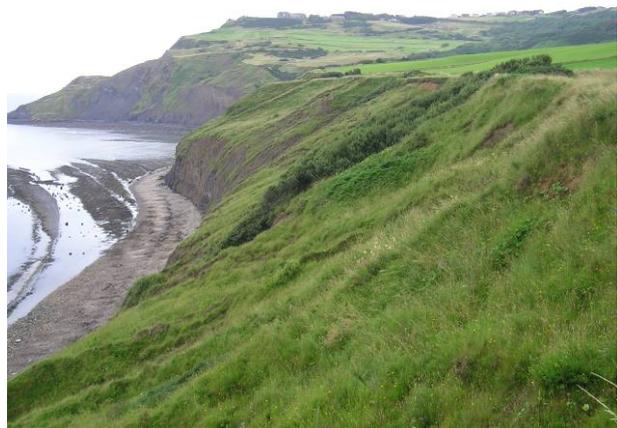
Mu17/6 looking south towards Peak Steel (Locally Active)

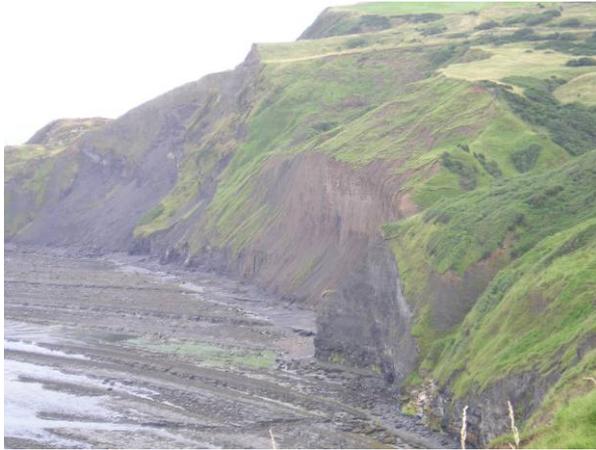
Mu17/8 looking south (Partly Active)

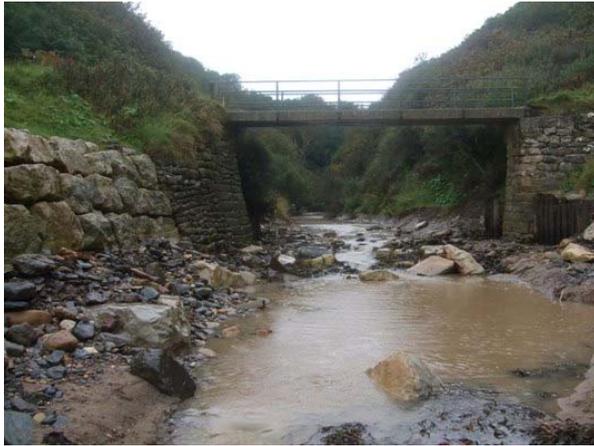
A short section of rock armour revetment and concrete and timber piling are providing protection to the mouth of the Stoupe Beck (Asset Ref No.1221D901D1003C08), however these are fluvial rather than coastal sea defences.

Mouth of Stoupe Beck
(Asset Ref No.1221D901D1003C08)

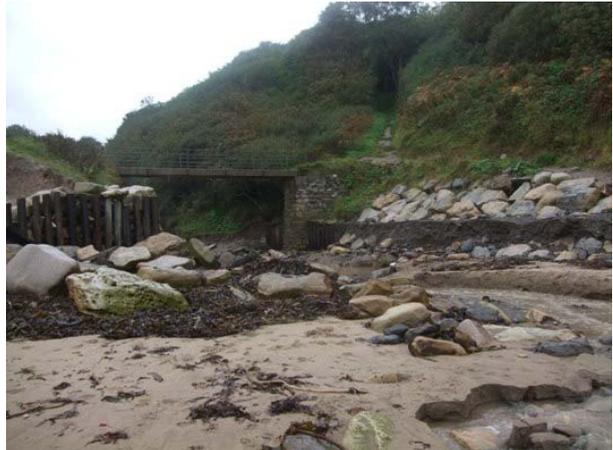
Rock armour revetment at the mouth of Stoupe Beck
(Asset Ref No.1221D901D1003C08)

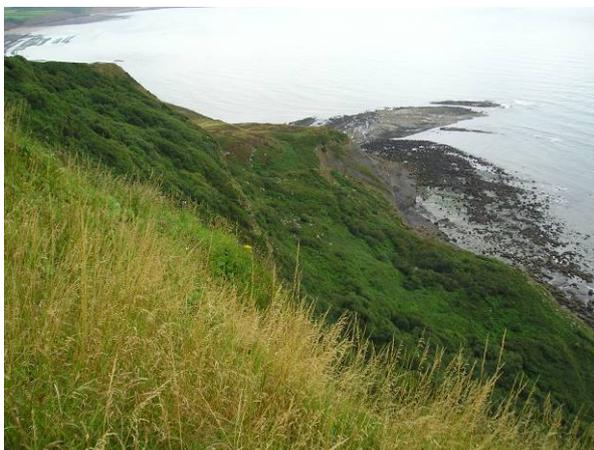
The northern part of this Sub-Management Unit is Locally Active (Mu18/1). The cliffs in this region have a distinct two-tiered form. Much of the upper headscarp is densely vegetated with little evidence of recent activity. The lower headscarp, exposed to the sea, is more active with slides and falls evident. The southern part of the Sub-Management Unit is well vegetated with no signs of instability and is classified as Inactive (Mu18/2).

Mu18/1 looking north (Locally Active)

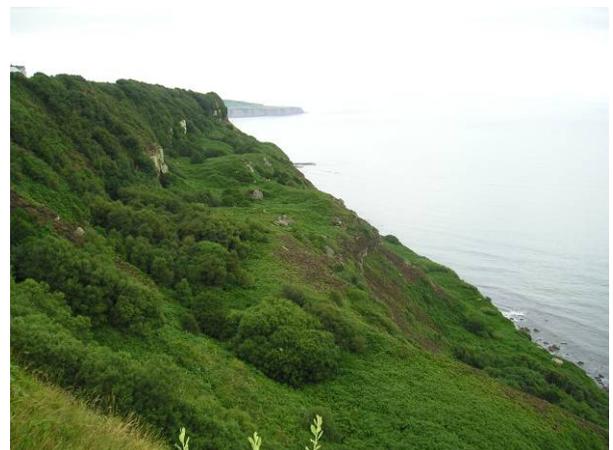
Mu18/2 looking north (Inactive)

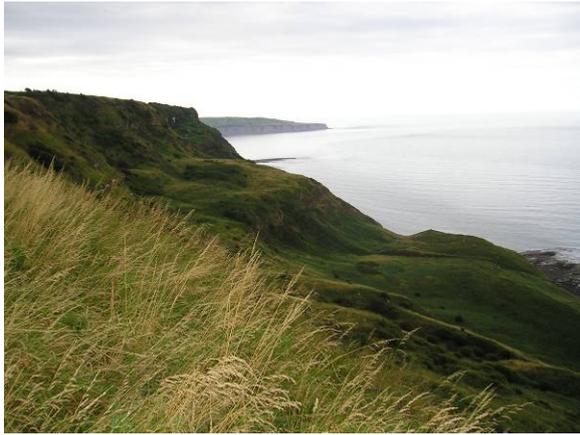
The entirety of this Sub-Management Unit is classified as Locally Active (Mu18/3, Mu18/4). The stepped terrain is a likely relict of former slumps or debris flow events. It is well vegetated with only localised patches of activity evident at the slope toe.

Mu18/3 looking north (Locally Active)

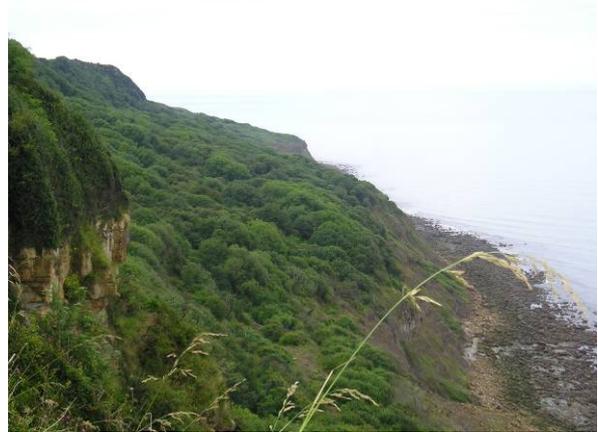
Mu18/3 looking north across Beast Cliff (Locally Active)

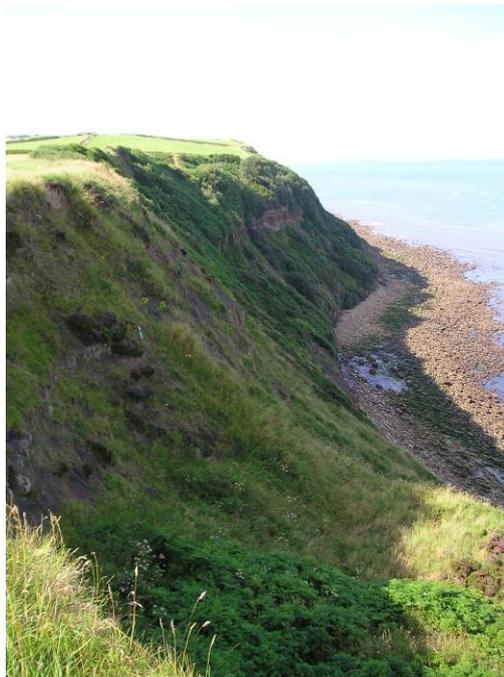
This Sub-Management Unit is Locally Active (Mu19/1). The cliffs are well vegetated, with minor localised patches of erosion.

Mu19/1 looking north (Locally Active)

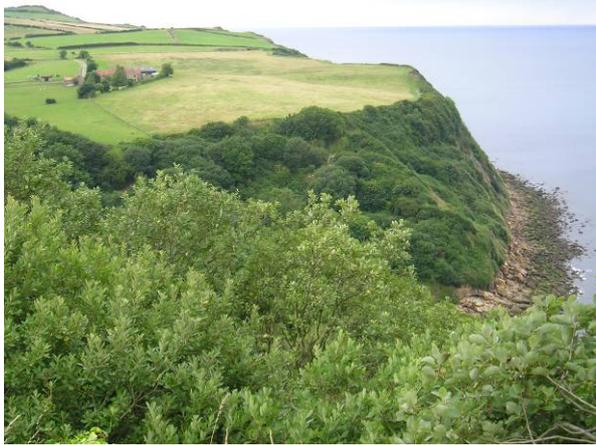
This Sub-Management Unit has been classified as Locally Active (Mu19/1, Mu19/2, Mu19/3). There is minor activity at the headscarp and some evidence of past rock falls at the toe. The slopes around the footpath on the northern side of Hayburn Wyke itself have been susceptible to instability in the past, but recent stabilisation works have remedied immediate problems.

Mu19/2 looking north across Hayburn Wyke
(Locally Active)

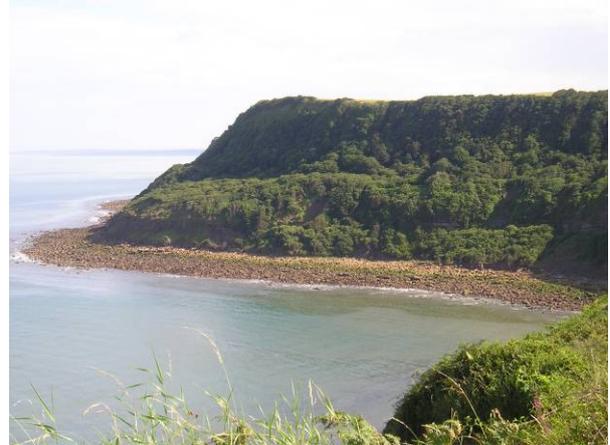
Mu19/3 looking south past Hayburn Wyke
(Locally Active)

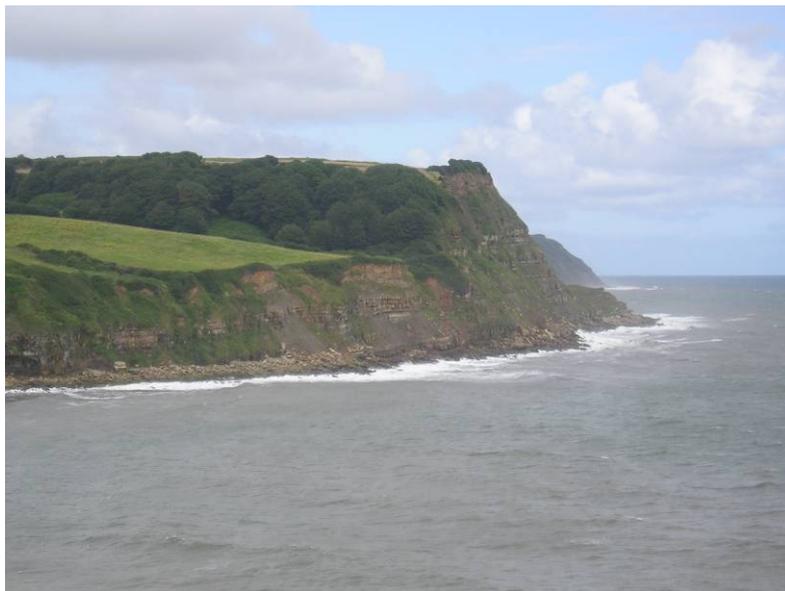
The northern part of this Sub-Management Unit is characterised by stepped, well vegetated terrain classified as Locally Active (Mu19/3). There are minor localised patches of activity. The southern part consists of higher, steeper cliffs which are more active (Partly Active- Mu19/4). These cliffs are undergoing some recession of the headscarp, sliding and falling of materials down the mid-slopes to form debris cones and rock fall deposits at the cliff base.

Mu19/4 looking northwest (Partly active)

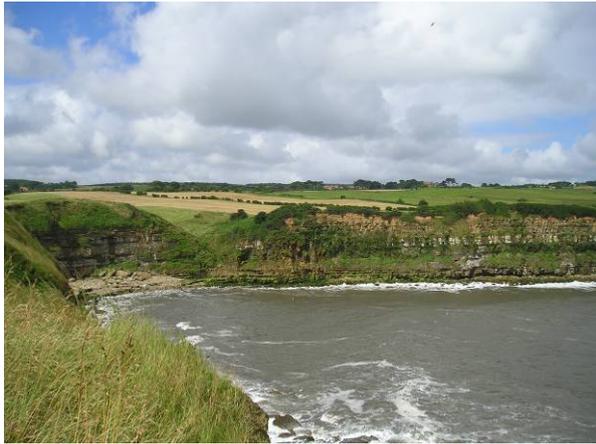
The majority of this Sub-Management Unit is classified as Locally Active (Mu19/5, Mu19/6). The near vertical cliffs support some vegetation cover. Marine action is eroding the toe and there is some evidence of past small rock fall events on the shore.

Mu19/5 the east facing part of Cloughton Wyke (Locally Active)

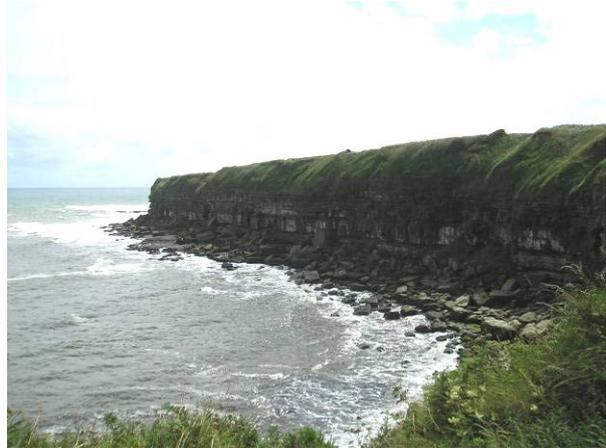
Mu19/6 the north facing part of Cloughton Wyke (Locally Active)

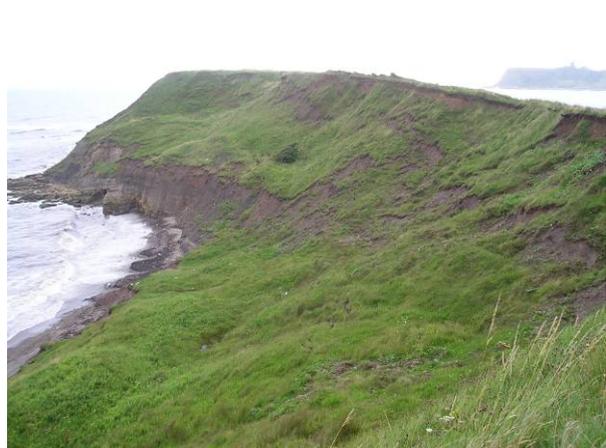
Mu19/10 looking south (Partly Active)

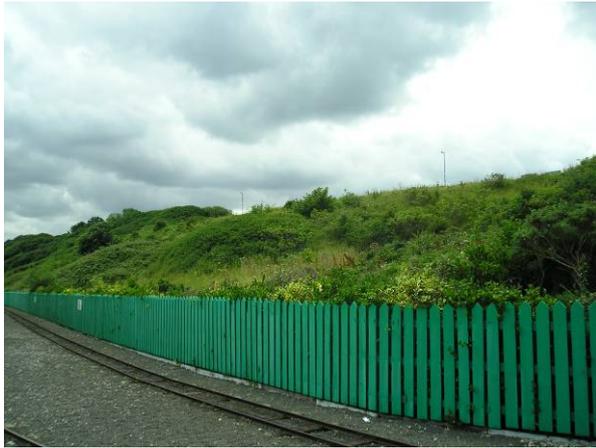
The CBUs within this section are defended by the sea wall which runs the entire length of North Bay. There is no obvious evidence of recent activity, thus they are classified as Dormant (Mu20/1, Mu20/2).

Mu20/1 above the miniature railway (Dormant)

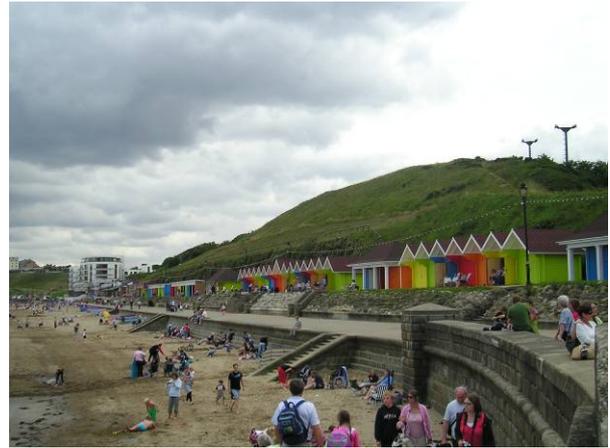
Mu20/2 looking south towards Scarborough (Dormant)

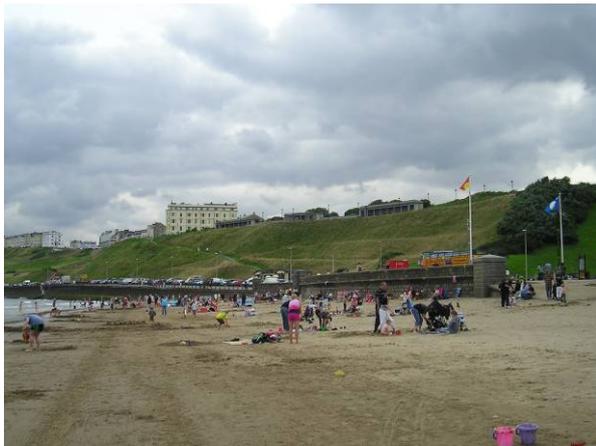
The northern end of this Sub-Management Unit shows no obvious evidence of recent instabilities and therefore is classified as Dormant (Mu20/3). Further south, the area of Clarence Gardens is showing some minor signs of activity in the form of small surface sliding on the mid-slopes and exposed rock near the head (Locally Active-20/4b).

Mu20/3 looking south (Dormant)

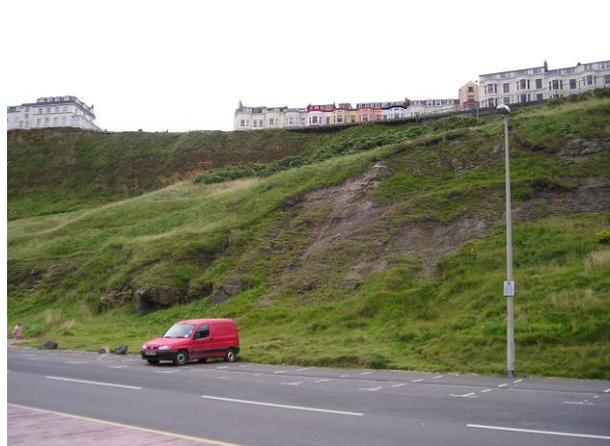
Mu20/4b looking up in the region of Clarence Gardens (Locally Active)

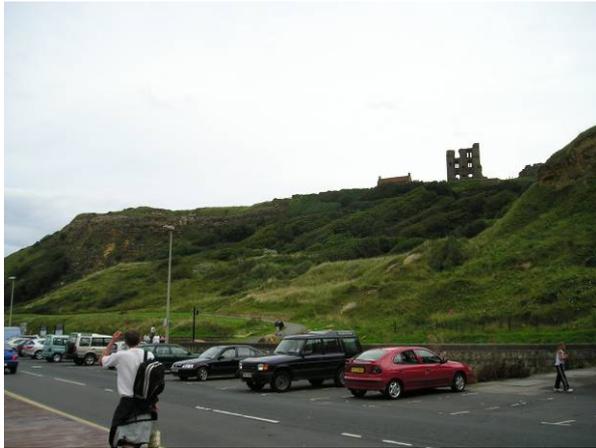
The cliffs within this Sub-Management Unit are Locally Active (Mu21/1, Mu21/2). They are generally well vegetated with small patches of exposed material. In the region of 'The Holms' there is evidence of recent rock fall from an exposure of well jointed hard rock, resulting from on-going weathering of the exposed rock face (Mu21/1).

Mu21/1 looking across The Holms (Locally Active)

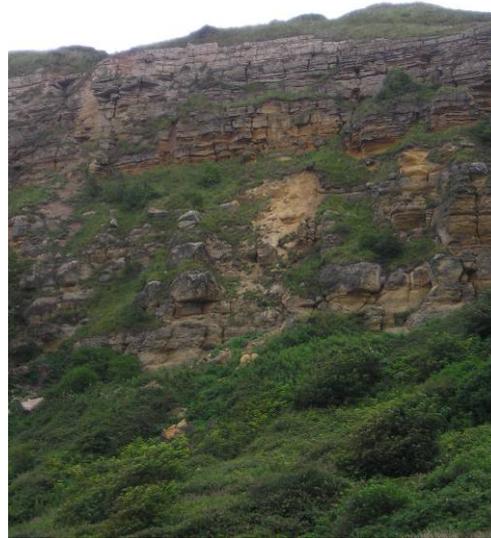
Mu21/1 local rock fall activity at northeast end of The Holms (Locally Active)

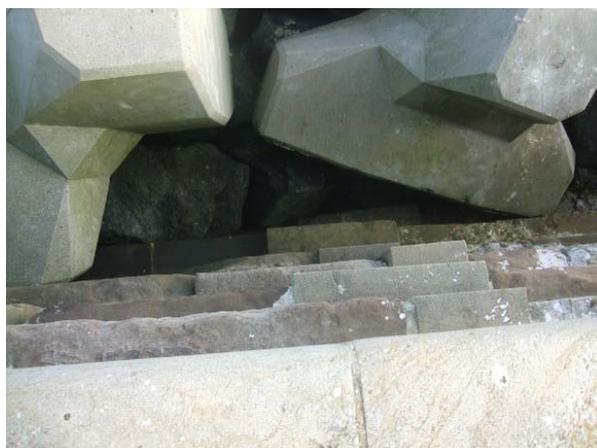
The harbour wall (Asset Ref No. 1221D901D1301C01) is in very good condition, with only minor cracking to the crest wall and individual tetrapods. A raised section has recently been added to the top of the existing defence along almost the entire length (see photo below, top left). At one point at the seaward end of the harbour arm there are signs of deformation within the rock armour and at another location rock armour is not present in such quantities behind the tetrapods as is present along the rest of the headland (see photo below, top right).

Lack of rock armour present behind the tetrapods (Asset Ref No. 1221D901D1301C01)

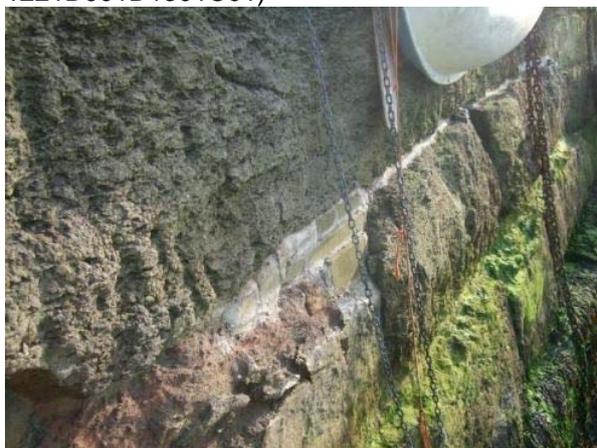
The faces of many blocks are missing or cracked at the seaward end of the original harbour wall (Asset Ref No. 1221D901D1301C16, see photo below, middle left). The landward part of the arm shows recent maintenance work- many cracks and joints have been repaired or repointed. The timber fenders also appear newer on the landward side of the arm than they do on the seaward side.

The original harbour wall (Asset Ref No. 1221D901D1301C16)
