NECAG Coast Protection Assets and Coastal Slope Condition Analysis

**Scarborough Borough Council
Final Report**

April 2009

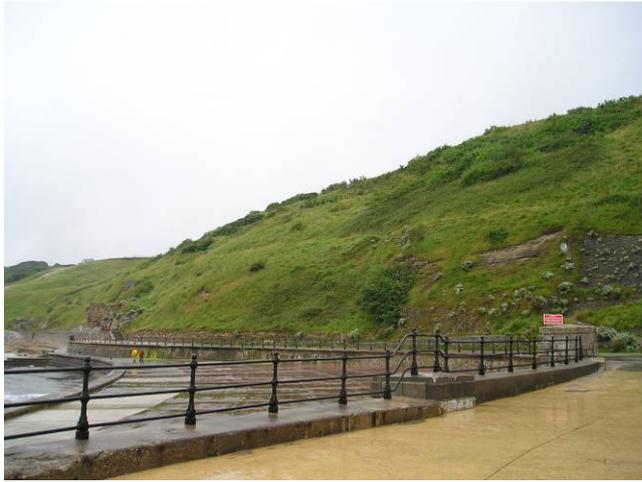
This Sub-Management Unit consists of a number of small CBUs which are all classified as Inactive (Mu22/1, Mu22/3, Mu22/4, Mu22/5, Mu22/7) or Locally Active (Mu22/2, Mu22/6, Mu22/8) and are protected at the toe by a sea wall. The Inactive CBUs appear to be largely stable with occasional evidence of activity such as minor cracks in footpaths and exposed rock faces. Within the Locally Active CBUs there is evidence of localised recent instability which has resulted in the loss of footpaths in some places. Cracks in footpaths and slumping provide further evidence of ongoing activity. The regraded slopes of the former Holbeck Hall landslide are well vegetated but are very hummocky and there is evidence of localised activity at the headscarp (Mu22/8).

Mu22/7 looking south (Inactive)

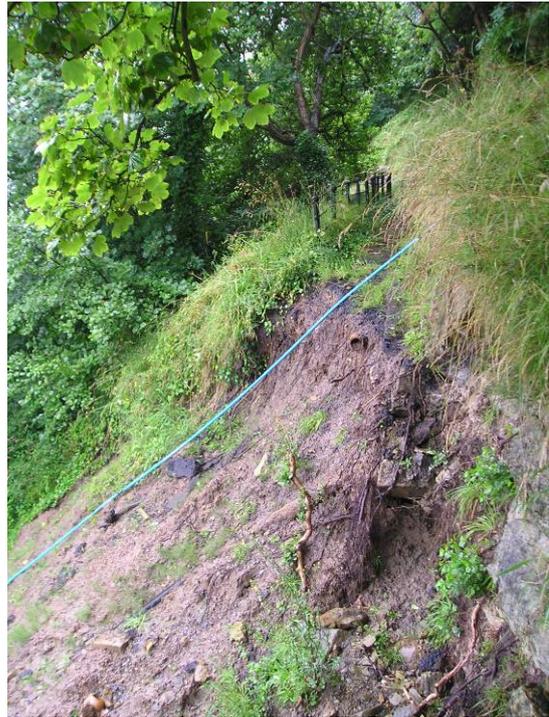
Mu22/2 recent landslide activity on the steep wooded slopes of South Cliff Gardens (Locally Active)

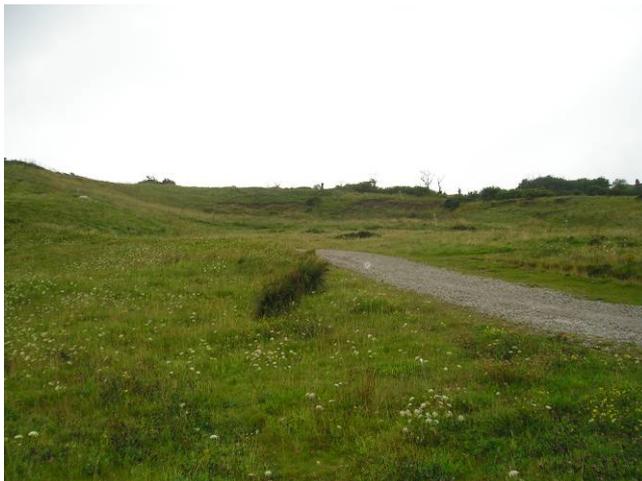
Mu22/8 looking up the Holbeck stabilised landslide run out lobe to localised erosion at the head (Locally Active)

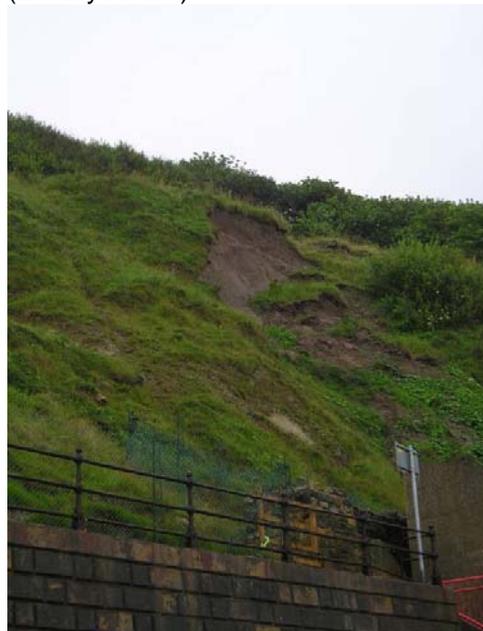
Mu22/6 recent slumping (Locally Active)

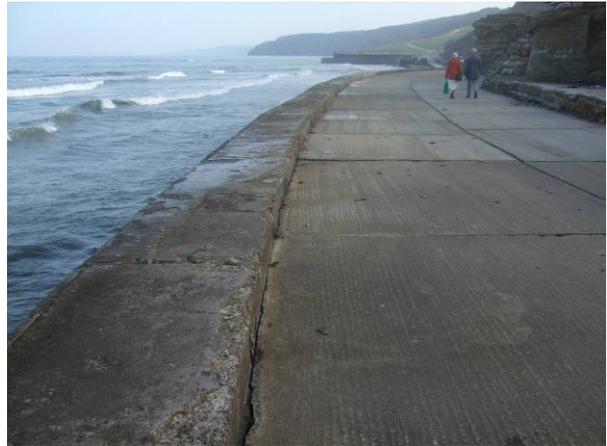
At the southern end of the sea wall the blockwork is in fair condition (Asset Ref No. 1221D901D1302C02, see photo below, top right). There is a section of concrete where rebar is exposed and corroded. Many large cracks and poor areas are evident in the back wall and the coping. Furthermore, expansion joints within the promenade have been washed out and need re-sealing.

Concrete promenade (Asset Ref No. 1221D901D1302C02)

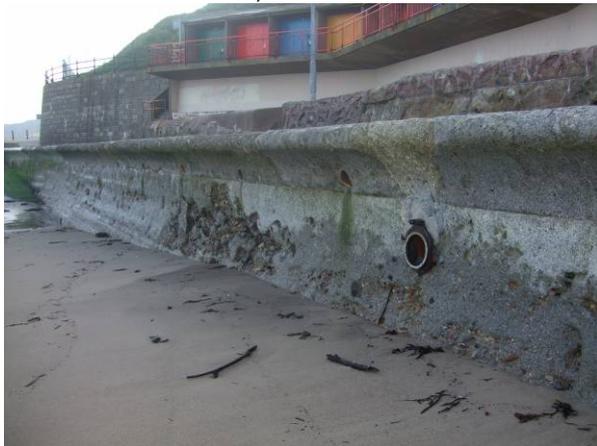
The lower section of the concrete wall is showing evidence of significant surface erosion (see photo below, bottom left). It is recommended that the wall needs re-surfacing. It is probable that the localised erosion results from a weaker mix of concrete used to create the defence (Asset Ref No. 1221D901D1303C01).

Lower section of concrete wall with significant surface erosion

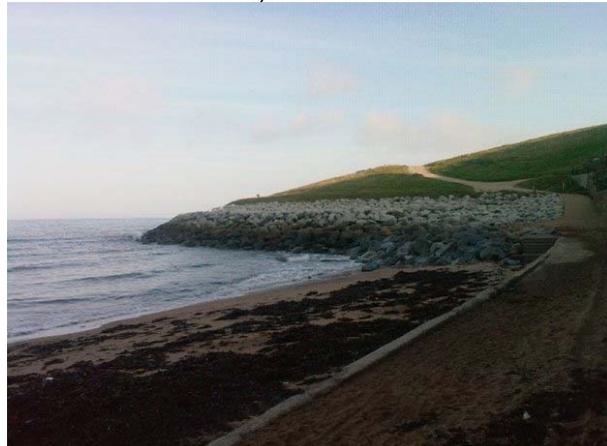
A relatively new rock armour revetment defends the relict debris flow lobe at Holbeck. This is in good condition, is tightly packed and has good coverage. There are no signs of deformation or rock movement (Asset Ref No. 1221D901D1304C01, see photo below, bottom right).

Rock armour revetment at Holbeck (Asset Ref No. 1221D901D1304C01)

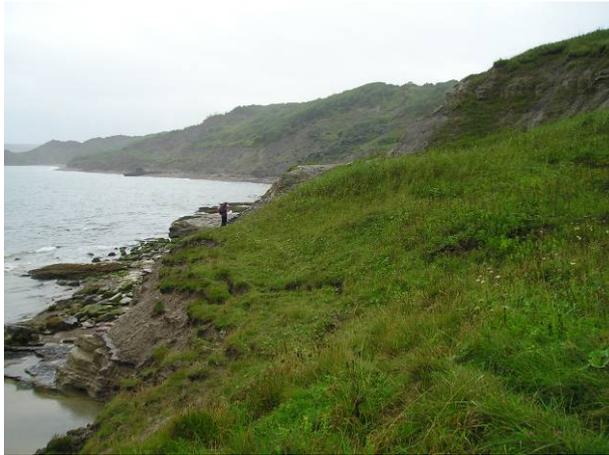
Mu23/E looking south from White Nab (Locally Active)

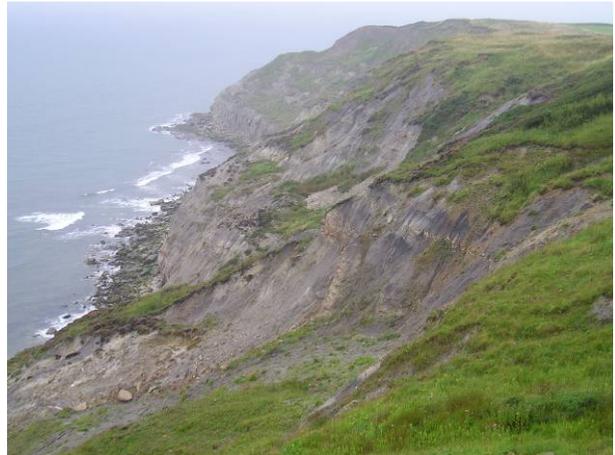
Mu23/D1 looking east from Black Rocks (Partly Active)

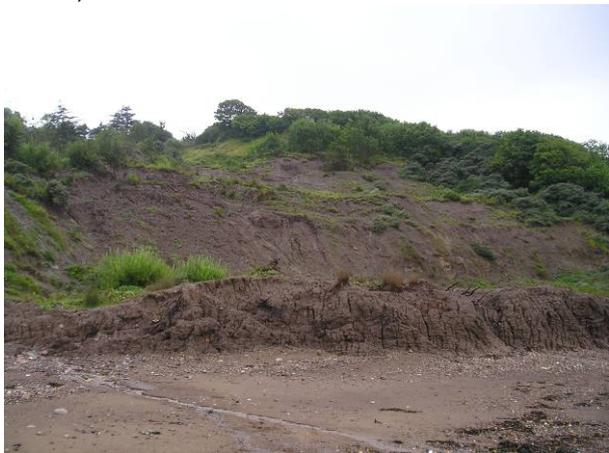
Mu23/G2 toe uplift on the beach within Cornelian Bay (Partly Active)

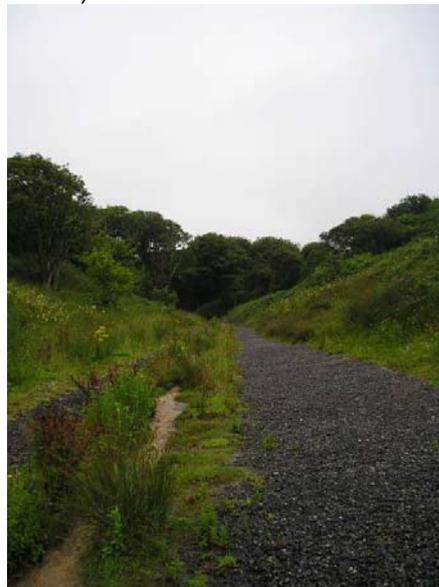
Mu23/F looking up the well vegetated valley (Inactive)

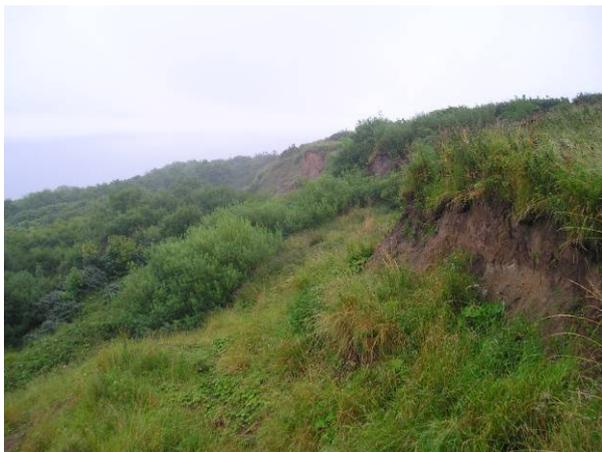
Mu23/I the headscarp of the back most units within Cornelian Bay (Locally Active)

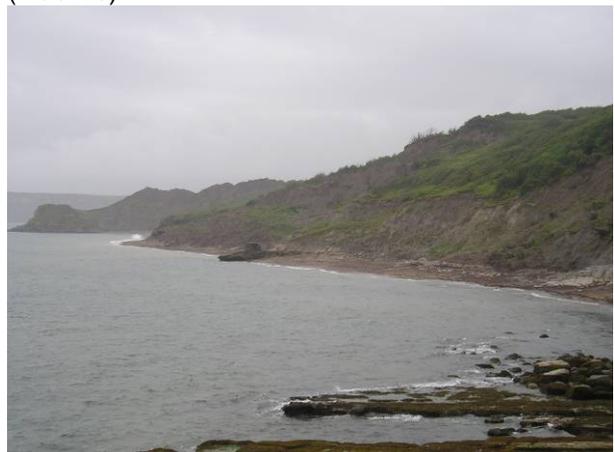
Overview of basal units Mu23/H1 (closest) to Mu23/I1 in the distance (combination of Totally and Partly Active)

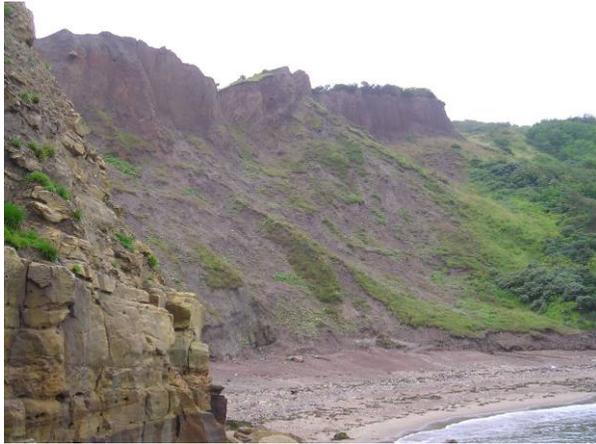
Mu23/14 north facing side of Knipe Point (Totally Active)

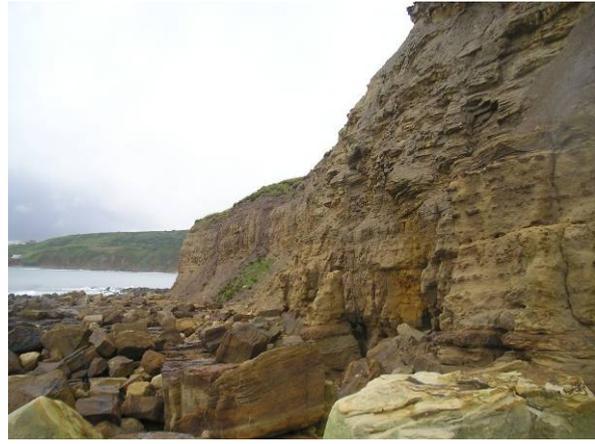
Mu24/A8 Knipe Point headland with evidence of rock fall (Partly Active)

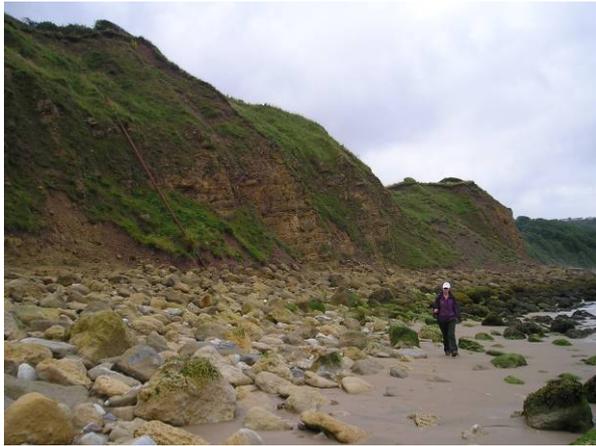
Mu/B8 to Mu/B10 basal units of Tenants Cliff
(Locally Active)

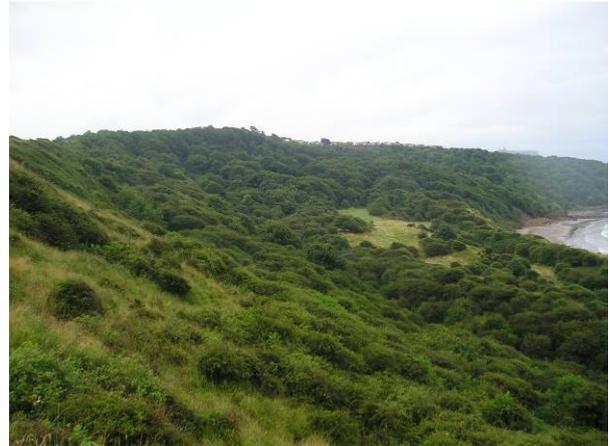
Mu24/B back unit of Tenants Cliff (Inactive)

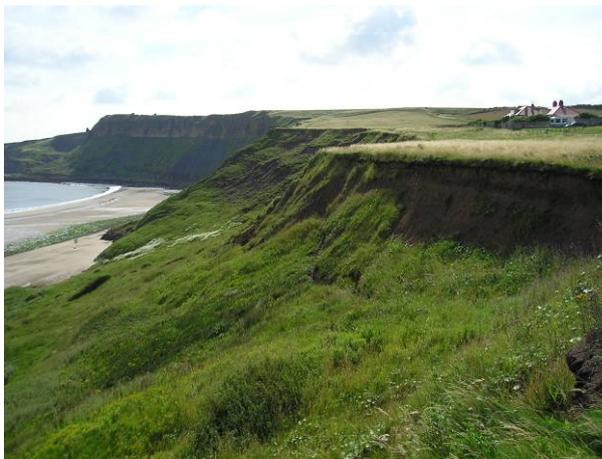
Mu24/J looking south across southern part of Cayton Bay (Locally Active)

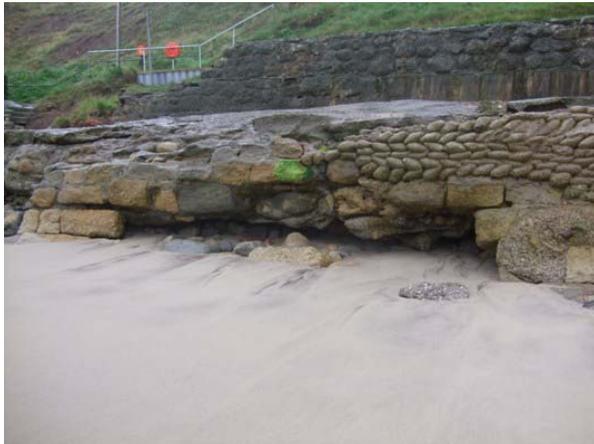
The southern end of the pumping station defences consist of a patchwork of makeshift additions which lack unity (Asset Ref No. 1221D901D1402C04, see photo below, bottom left). This has resulted in major undercutting, blockwork washout and significant damage. Repair work is required to prevent further block work washout and collapse.

Patchwork of makeshift defences to the south of the pumping station (Asset Ref No. 1221D901D1402C04)

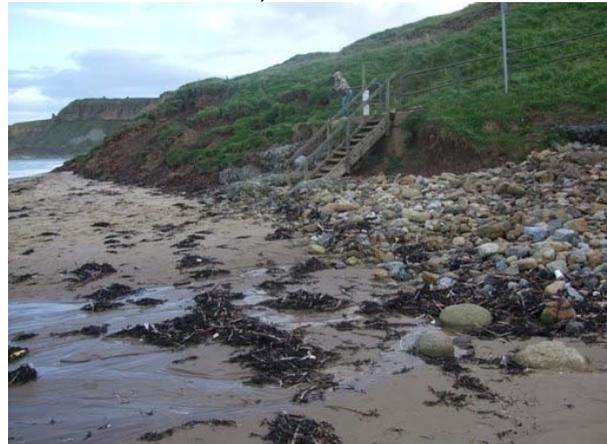
To the south of the pumping station, footpath access to the beach is provided by a wooden staircase (Asset Ref No. 1221D901D1402C01). This footpath is regularly used by walkers and surfers. The toe of the stairwell is protected by gabion baskets which will need to be replaced in the near future to maintain a useable footpath.

Staircase with gabion baskets located to the south of the pumping station (Asset Ref No. 1221D901D1402C01)

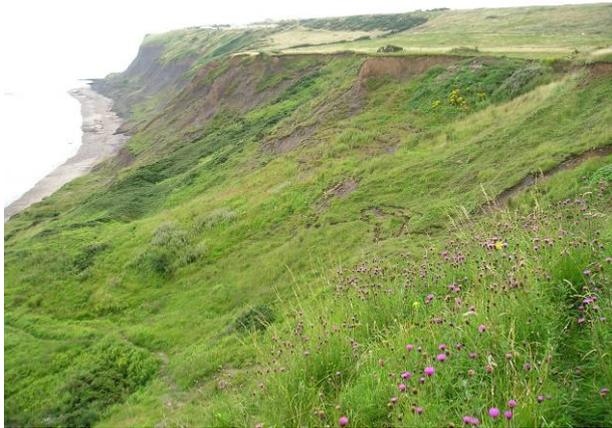
Mu25/Y looking southeast from Lebberton Cliff
(Locally Active)

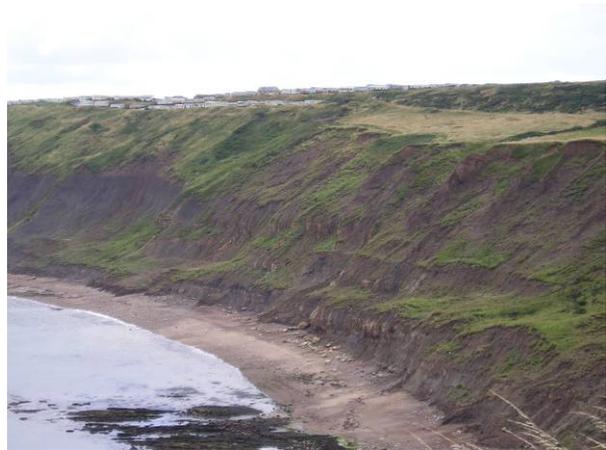
Mu25/AA and Mu25/AB looking southeast across
Gristhorpe Sands (Partly Active)

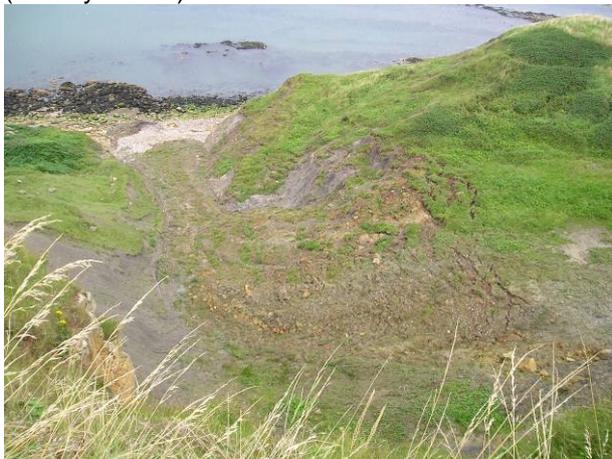
Mu25/W looking down at lower part of debris flow
(Totally Active)

- Lebberston Cliff (Mu25/W) A large debris flow is situated to the base of Lebberston Cliff, with evidence of cracking, rock fall and toppling. This is a clearly defined feature which is approaching the high water mark. (See Map 22 - Cayton Bay to North Cliff Change Analysis)

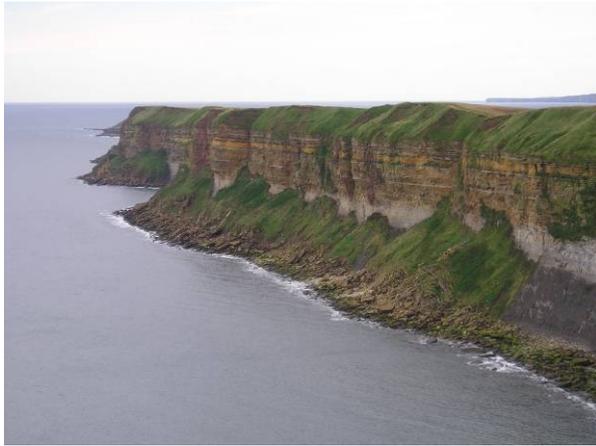
Mu25/AM to Mu25/AP looking eastwards towards Filey Brigg (Locally Active)

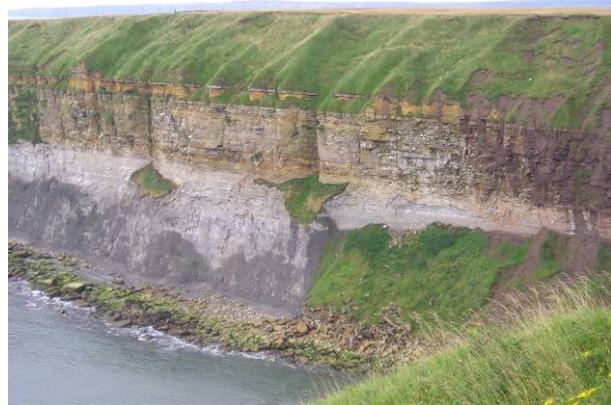
Mu26/AK (Partly Active)

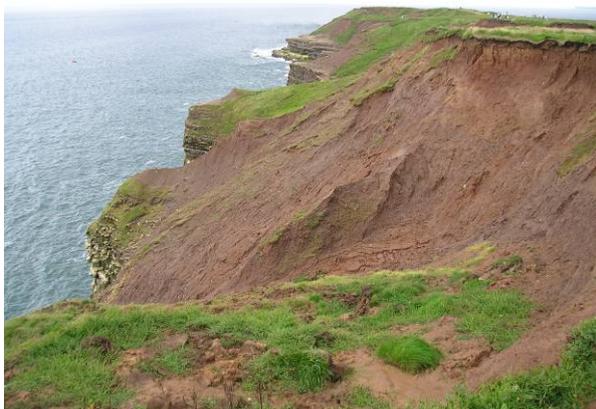
Mu27/BA looking east along northern side of Filey Brigg (Totally Active)

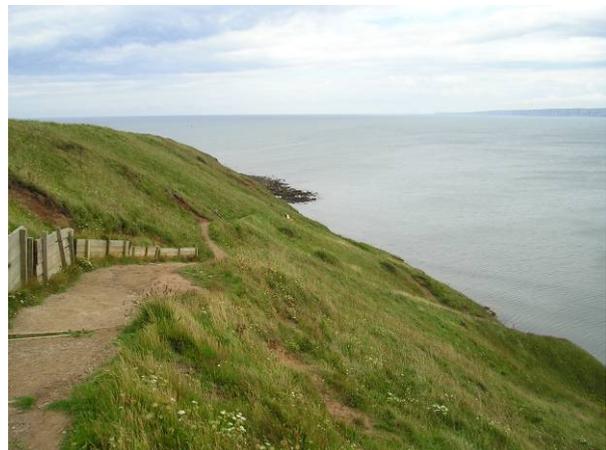
Mu27/E to Mu27/I looking east along southern side of Filey Brigg (Locally Active)

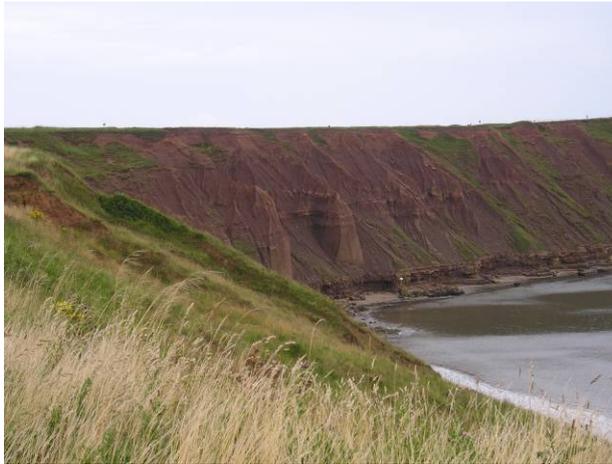
Mu27/K to Mu27/O looking north from Filey Bay
(Totally Active)

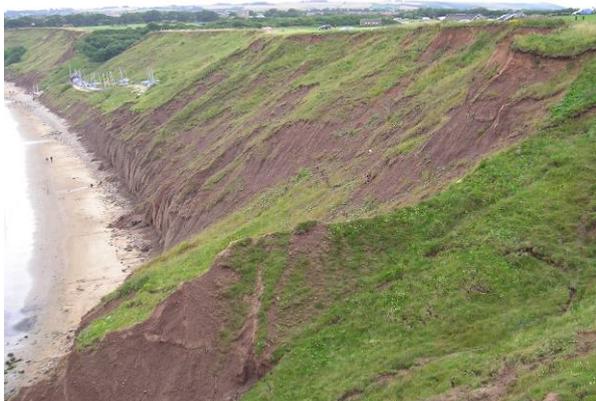
Mu27/P to Mu27/S looking south towards Filey
(Partly Active)

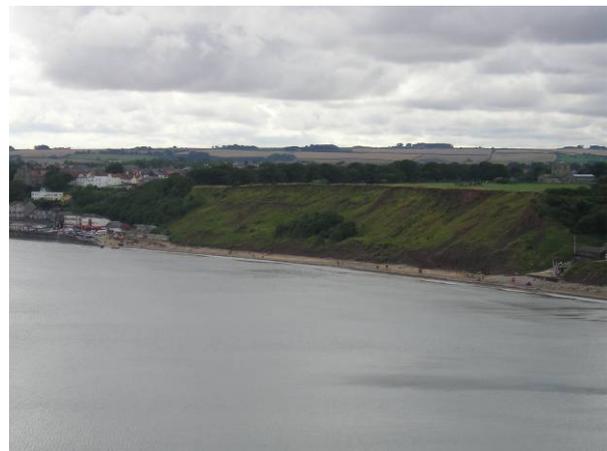
Overview of Mu27/V to Mu27/X (mostly Locally Active)

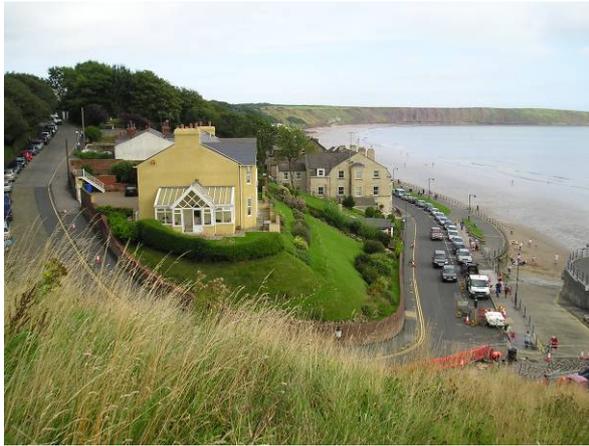
Mu28/Y looking north across Filey (Inactive)

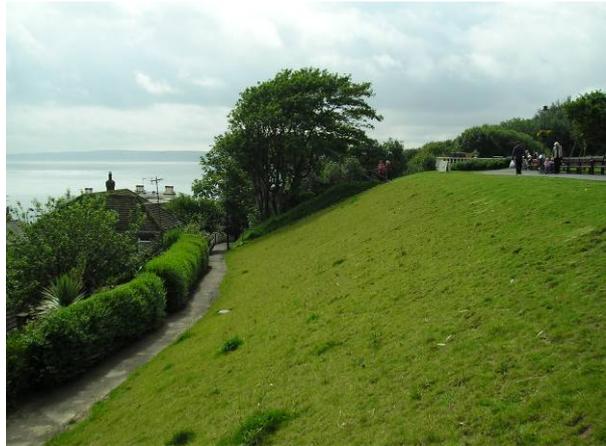
Mu28/Y recently re-engineered slope (Inactive)

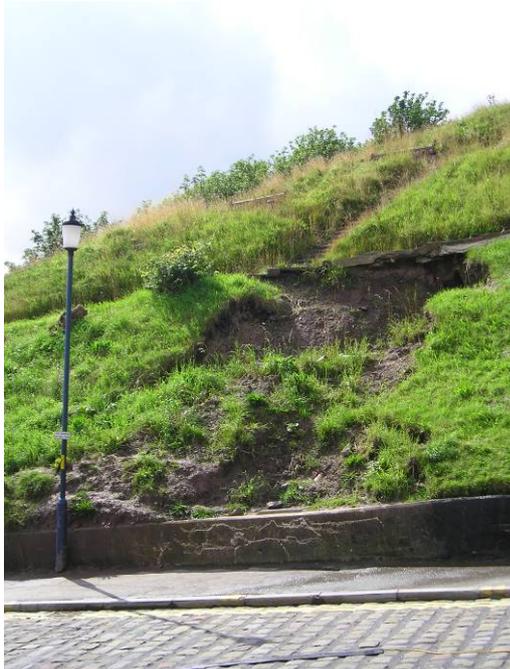
Mu28/Z recent minor landsliding activity (Locally Active)

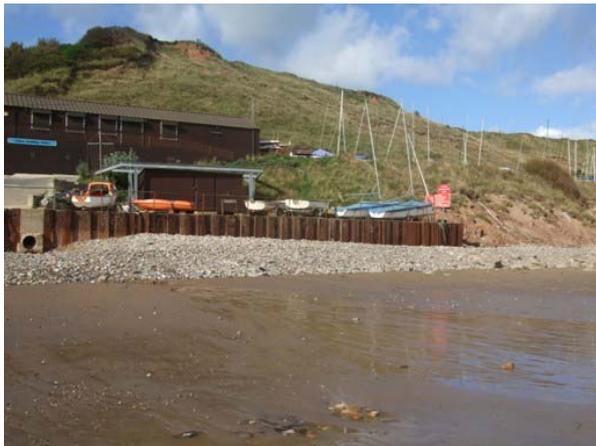
To the north of the town, Filey Sailing Club is located at the back of the beach and receives protection from a primitive concrete and sheet pile construction (Asset Ref No. 1221D901D1601C01). The piles at the northern end of the Sailing Club show surface corrosion but are generally in a sound condition. At this location there is also a concrete slipway giving access to the beach and a natural accumulation of pebbles in front of the structures (see photo below, middle left). The sheet piles at the southern end of the Sailing Club are not in a sound condition (see photo below, middle right). The piles have corroded away, leading to undercutting of the slipway and outflanking of adjacent piles. It is recommended that repair work is needed to prevent any further undercutting.

Concrete and sheet pile defences at the northern end of the Sailing Club

1221D901D1601C01	Filey	Medium	Repair toe.
1221D901D1603C01	Hunmanby Sands	Medium	Monitor and replace protection when required. Rectify hanging outfall pipe - either reduce length of pipe or rebuild protection around pipe and down slope to beach.

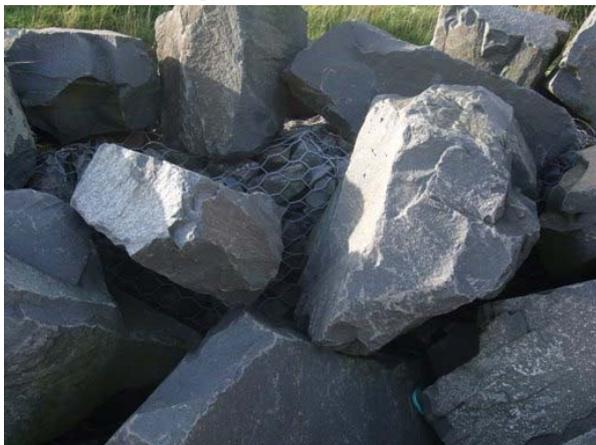
Rock revetment with gabion baskets beneath

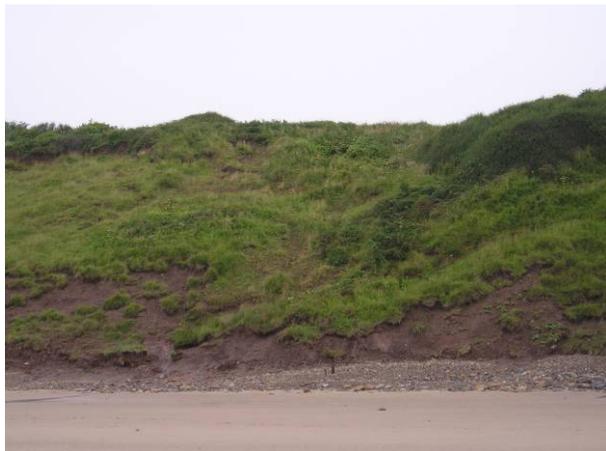
Mu29/AH low lying well vegetated cliffs (Locally Active)

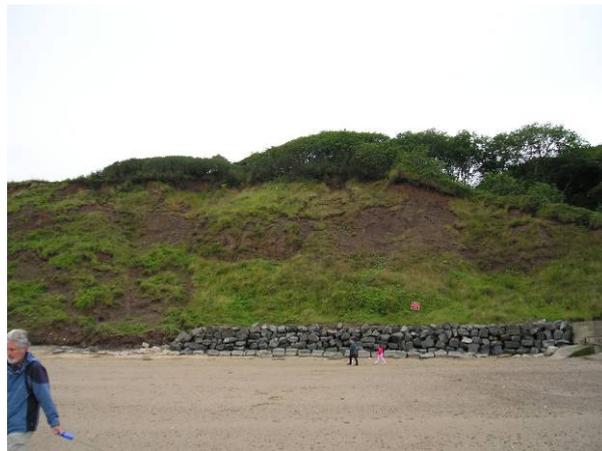
Mu29/AA just south of Filey town frontage (Partly Active)

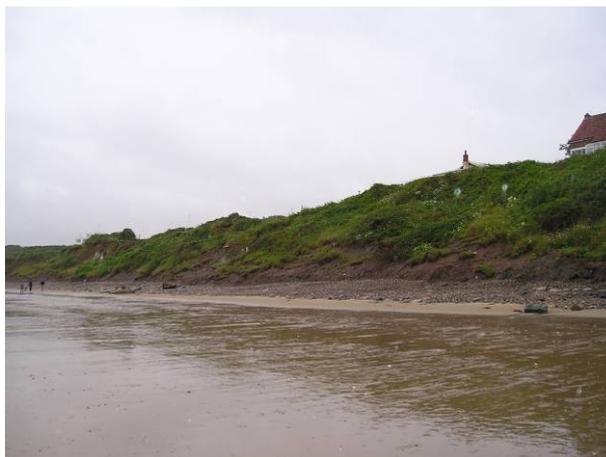
Mu29/AS looking southwards along Flat Cliff (Locally Active)

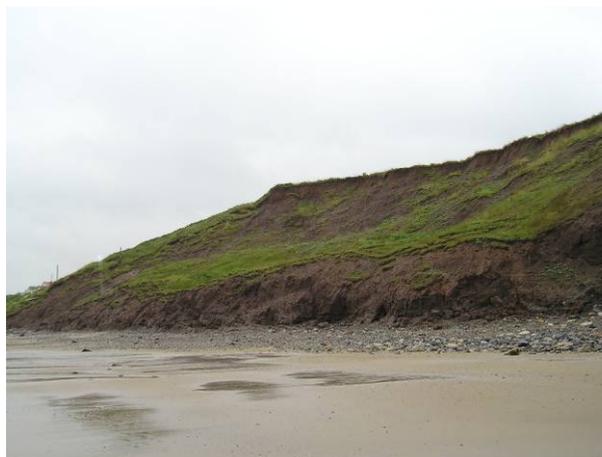
Mu29/BE looking southwards near Hunmanby Gap (Partly Active)

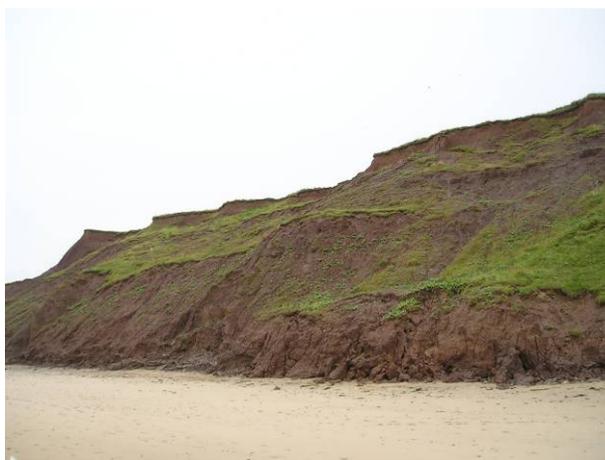
Mu29/N and Mu29/O Cliffs above Reighton Sands (Partly Active)

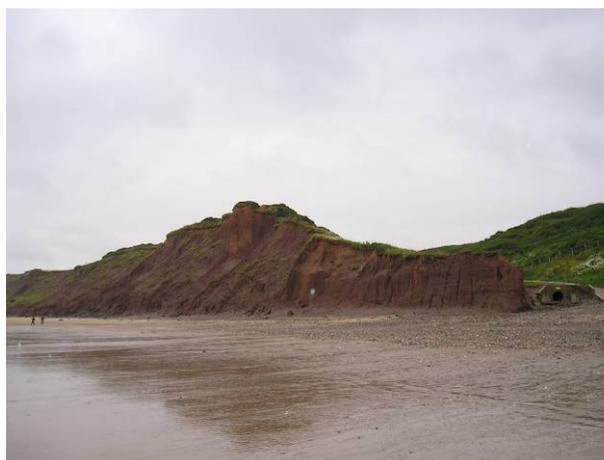
Mu29/BF and Mu29/BG looking south past Hunmanby Gap (Totally Active)

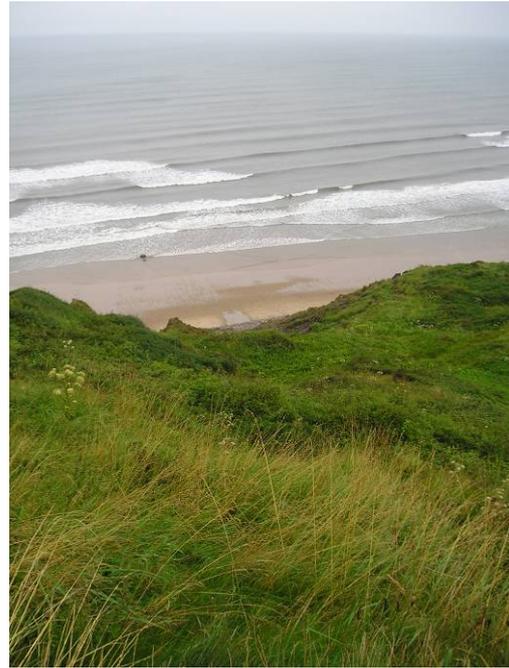
Mu30/CCa looking down (Locally Active)

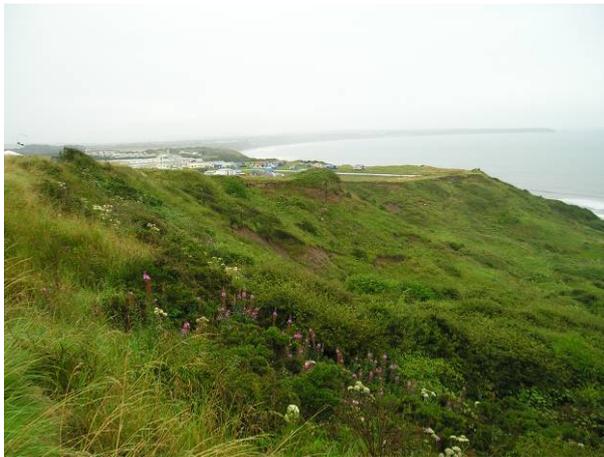
Mu30/CC looking northwest towards Reighton Sands Holiday Village (Locally Active)

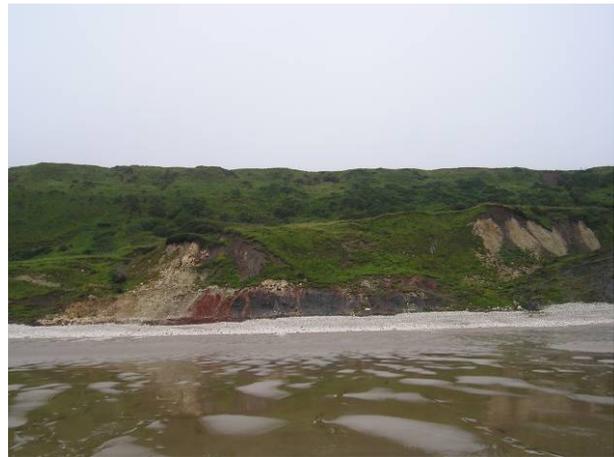
Mu30/CF Speeton Cliffs (Partly Active)
