Coast Protection Assets and Coastal Slope Condition Analysis

**Scarborough Borough Council
Final Report**

March 2010

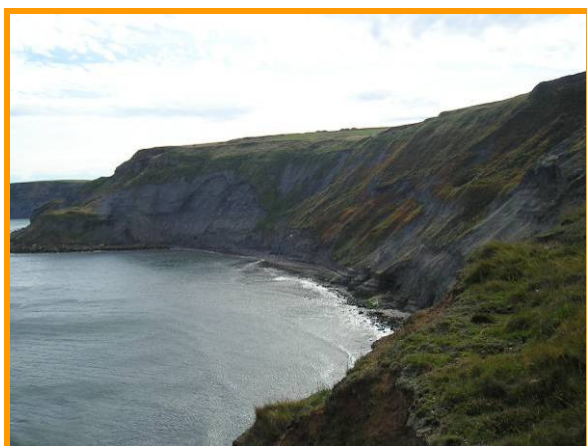
MU6/1 – Looking southeast across Brackenberry Wyke from Old Nab (Partly Active)

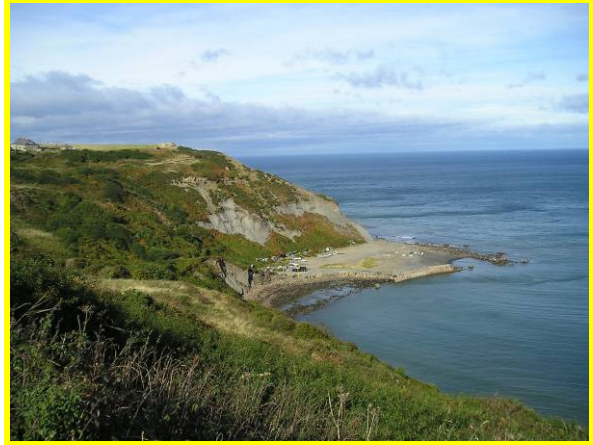
MU6/3 – Localised activity of the cliffs behind Port Mulgrave (Locally Active)

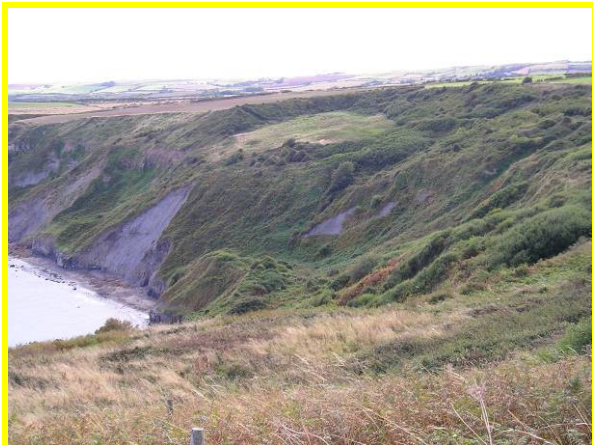
Unit MU6/4 consists of the Rosedale Cliffs, immediately south of Port Mulgrave, which extend landward by about 250m. The majority of the unit is well covered with grasses and other dense vegetation. However localised activity is observed, particularly at the toe of the unit where there are large exposed faces subject to erosion, rilling, gullyng and marine action. As a result, this unit is classified as Locally Active.

MU6/4 – Rosedale Cliffs, south of Port Mulgrave (Locally Active)

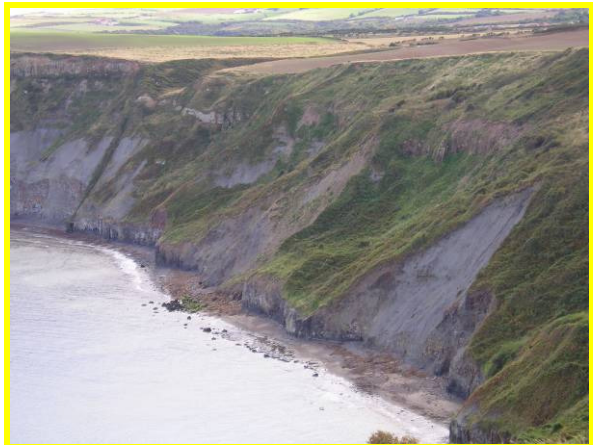
MU6/5 – Local activity on the lower slopes, looking southwards (Locally Active)

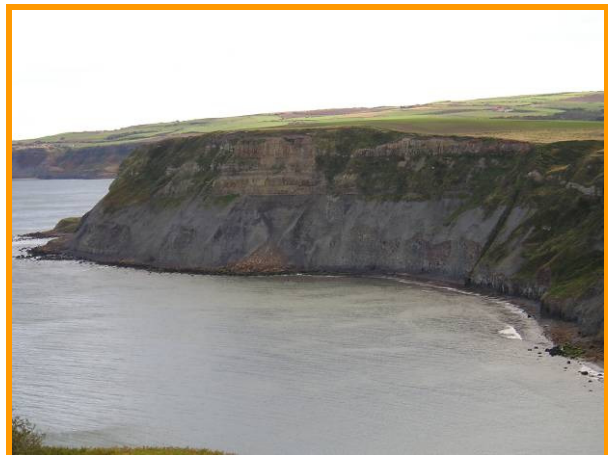
MU6/6 – The steep northern part of the Lingrow Cliffs (Partly Active)

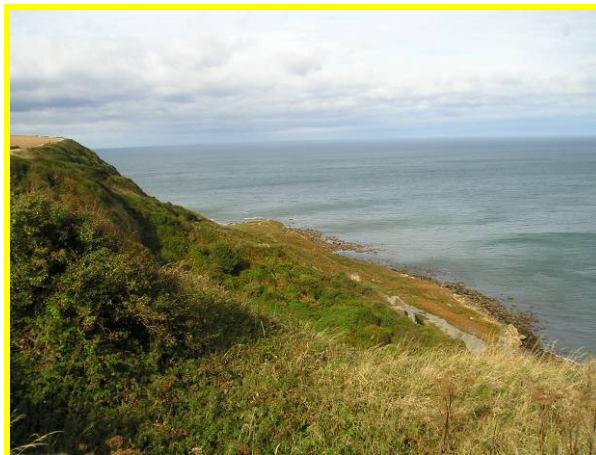
MU6/7 – Well vegetated, large relict run out lobe (Locally Active)

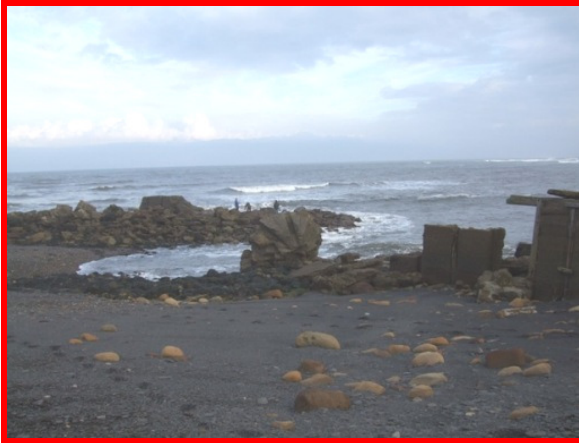
Sub-Management Unit 6B features relict assets at Port Mulgrave. As noted during the 2008 inspection, this is a former port and ironstone mine which has been derelict for 70 years. Virtually all coastal defences have been lost to the sea. What is left of the breakwater is undergoing large scale cracking, deformation, undercutting and outflanking. It is estimated that half of its original length has now been eroded (Asset Ref. 1221D901D0502C01). As a result, the launching and retrieval of boats would be difficult here. If regular access by sea was required, a regeneration project to remove the breakwater ruins and build a new access point would be of benefit. There has been no significant change since 2008.

Looking at the end of the breakwater with evidence of erosion and failure
(Asset Ref. 1221D901D0502C01)

Outflanking and erosion occurring behind the breakwater
(Asset Ref. 1221D901D0502C01)

Visible failure
(Asset Ref. 1221D901D0502C01)

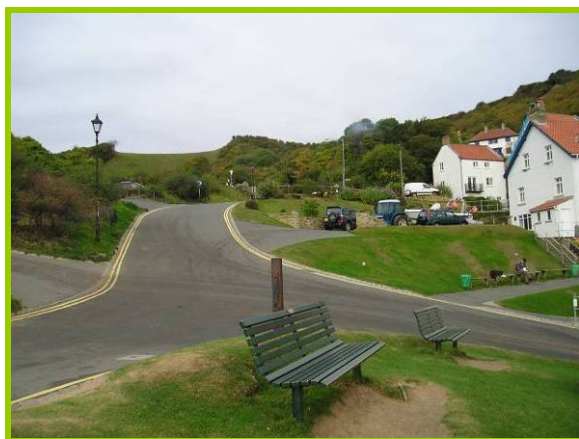
MU7/1 – The slopes of Runswick Bay village
(Inactive)

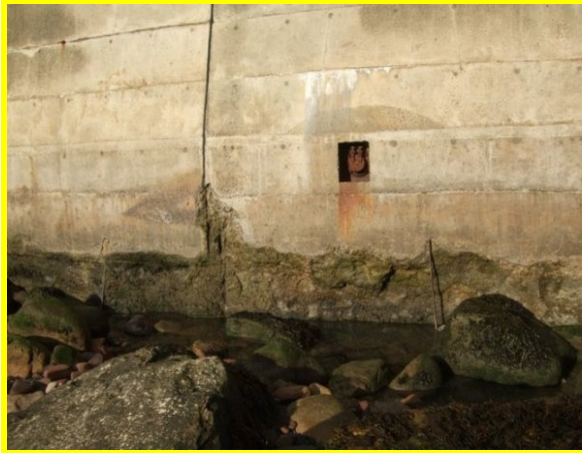
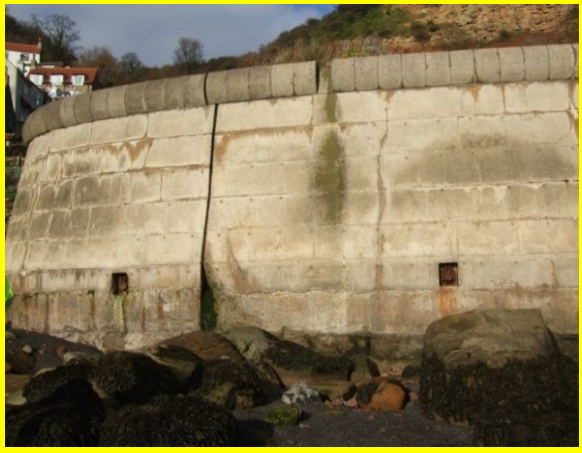
The sea wall defences to the north of the new pumping station show a variety of defects ranging from minor to more significant issues. The northern coastal sea wall, which gives direct protection to a private property, is suffering from surface cracking and erosion. Erosion of the underlying bedrock is causing undercutting of the sea wall. Further investigation is required to determine the rate of undercutting. Further defects include washed out sealant joints, flap valves on weep holes which have seized shut, wash out of the joints under the

<p>Undercutting of the northern coastal sea wall (Asset Ref. 1221D901D0601C01)</p>

<p>Wide void at joint and large vertical crack through wall (Asset Ref. 1221D901D0601C01)</p>

capping beam, vertical cracks through the wall and wide voids emerging. It is recommended that these issues are addressed (Asset Ref. 1221D901D0601C01 and 1221D901D0601C03).

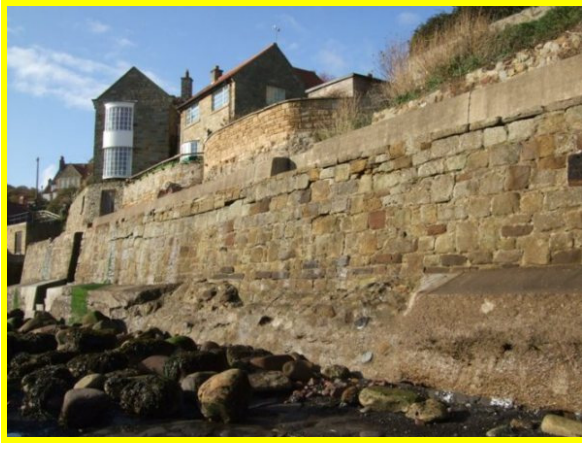
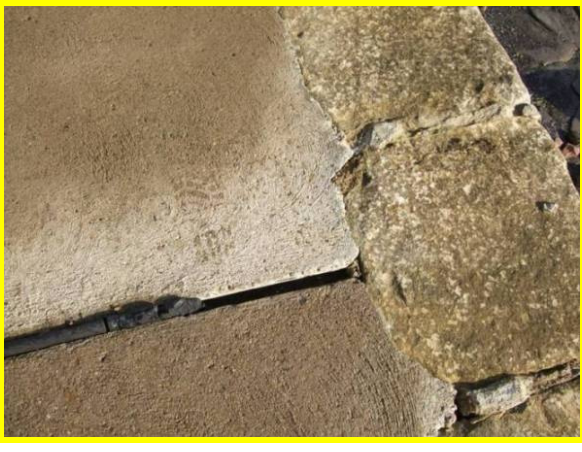
<p>Overview of wall showing gaps and erosion at joints (Asset Ref. 1221D901D0601C03)</p>

<p>Top of wall showing gaps at joints (Asset Ref. 1221D901D0601C03)</p>

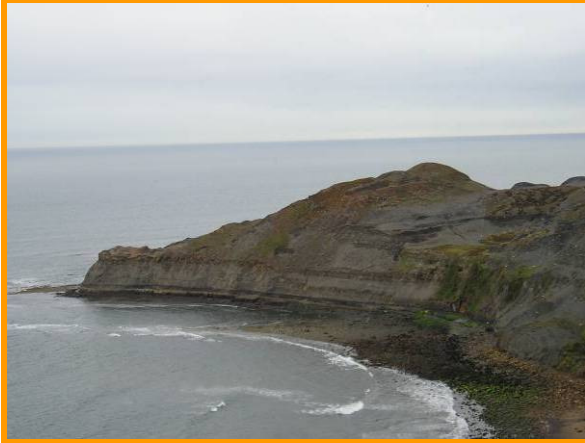
<p>MU8/5 The ongoing erosion of the Kettle Ness headland (Partly Active)</p>

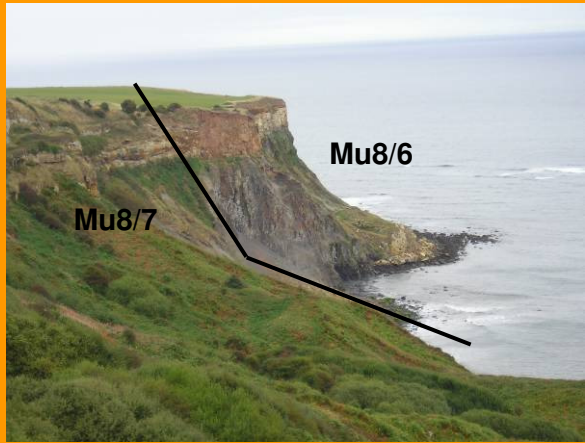
<p>MU8/6 (mid-distance) Steep, exposed slopes (Partly Active) (approx. extent shown)</p>

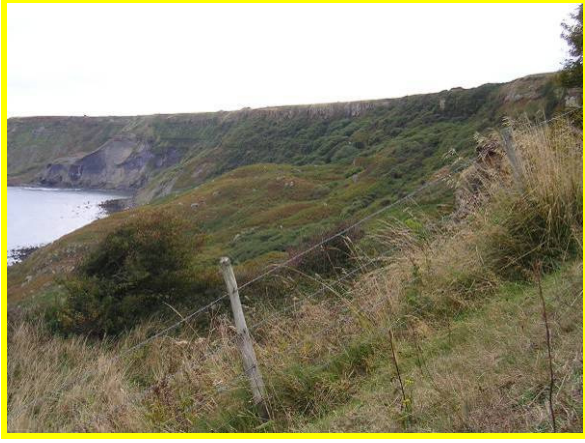
<p>MU8/7 and MU8/8 The well vegetated relict debris flow lobe at Seaveybog Hill (Locally Active)</p>

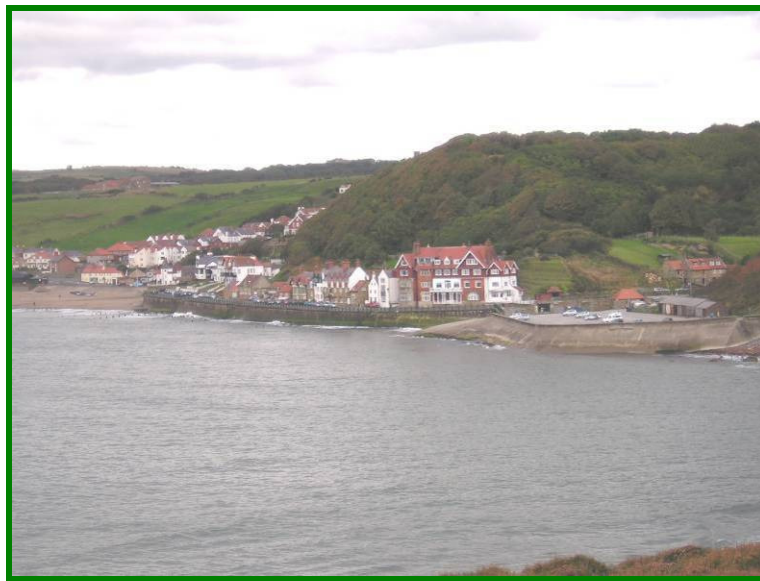
These management units comprise **units MU9/1 and MU9/2**. Both units are defended at the toe by the Sandsend sea wall, groynes and some rock armour. As a result there is no evidence of recent activity and the units are both classified as Dormant, as they were in 2008.

MU9/1 and MU9/2 located at Sandsend (both Dormant)

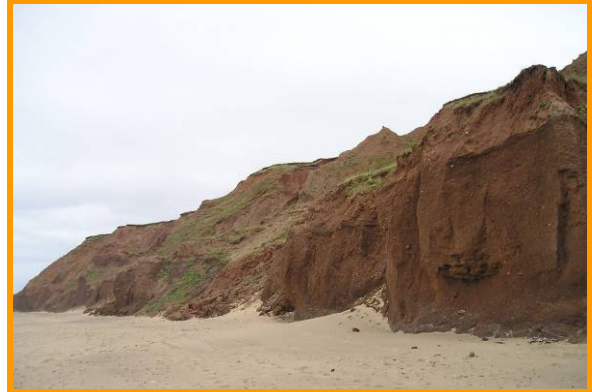
Unit MU10/2 comprises the glacial till cliffs behind Upgang Beach. These cliffs are prone to episodic failure in the form of localising mudsliding and block failure onto the beach. Vegetation cover is sporadic and is most likely related to the landslide cycles. This unit is classified as Partly Active.

MU10/2 Activity onto Upgang Beach (Partly
Active)

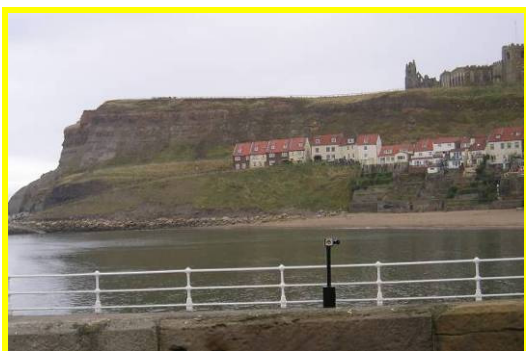
This Management Unit consists of **unit MU12/1** only and is situated below Whitby Abbey. The slopes are generally well vegetated with localised activity at the toe and headscarp. For example, there is some rock exposure just below the headscarp which is supported by wire netting. This unit is classified as Locally Active – this does not represent a change in activity class since the 2008 walkover survey.

MU12/1 Below Whitby Abbey (Locally Active)

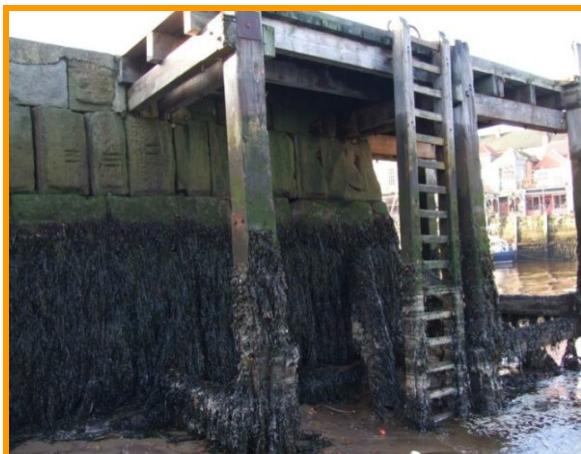
Timber pontoon on RNLI pier platform
(Asset Ref. 1221D901D0803C08)

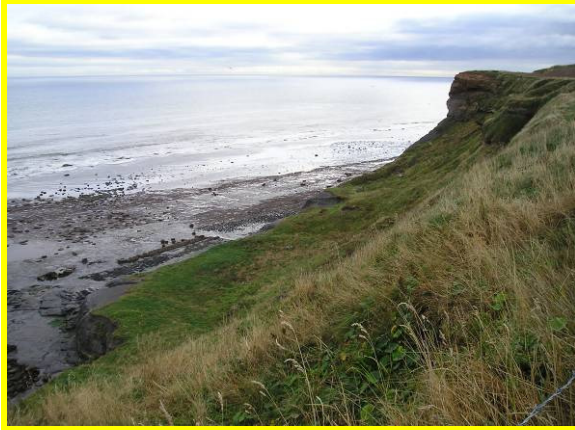
MU13/5 Well vegetated debris flow lobe at Black Nab (Locally Active)

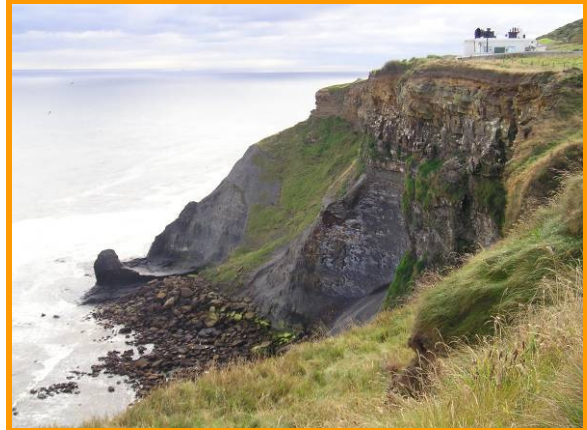
Unit MU13/6 is a long, steep-faced unit which sits below the Whitby Fog Signal and the former lighthouse. There is some intermittent vegetation cover however; the slopes are largely exposed with evidence of rockfall from the upper strata and ongoing weathering and marine erosion of the lower layers. This unit is classified as Partly Active.

MU13/6 Steep faces below the Whitby Fog Signal (Partly Active)

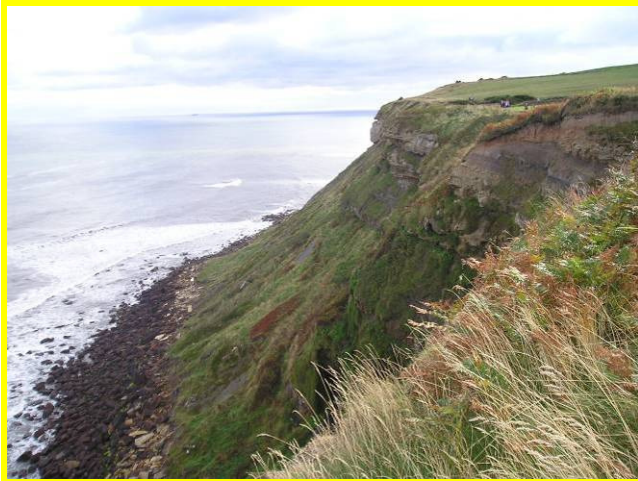
MU15/1 Well vegetated slopes (Locally Active)

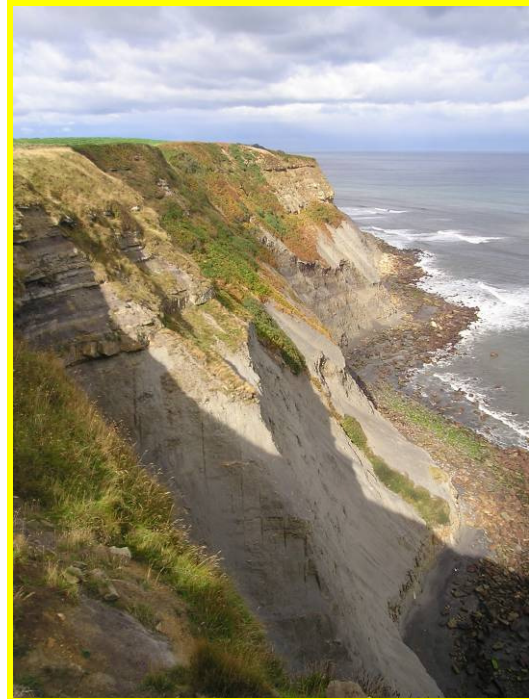
MU51/1 An area of intense erosion (Locally Active)

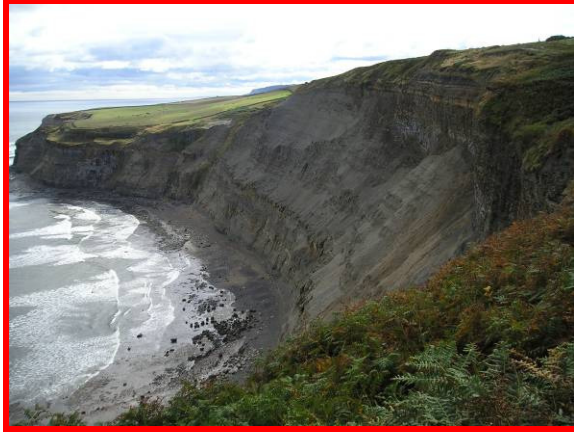
MU15/2 Far Jetticks (Totally Active)

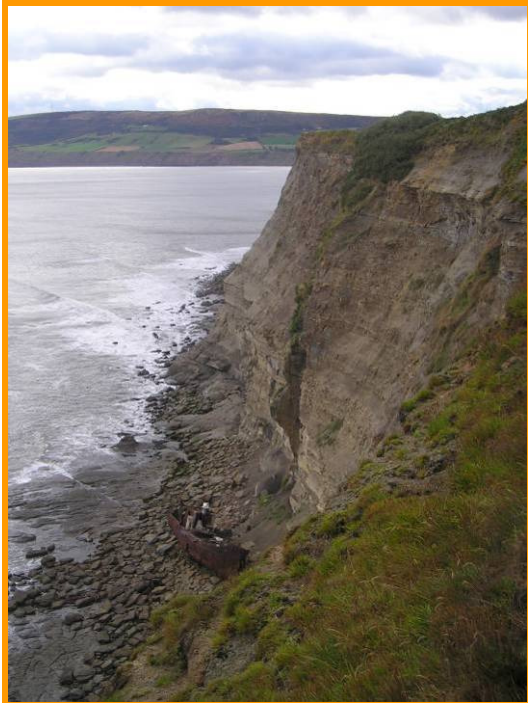
MU15/3 (Partly Active)

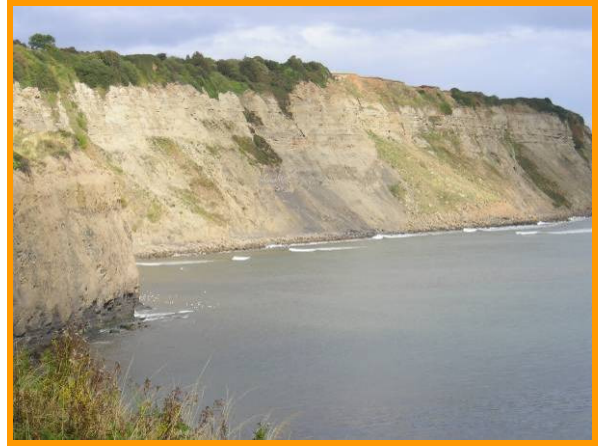
Just north of Robin Hood’s Bay Village is **unit MU15/4**. The cliffs have a general absence of vegetation cover and are eroding down much of their length. There is evidence of sliding, rilling and weathering with active recession of the headscarp. The toe is mantled by a narrow boulder strip which is insufficient to protect against marine action. This unit is classified as Partly Active.

MU15/4 Exposed cliffs with boulders at the toe (Partly Active)

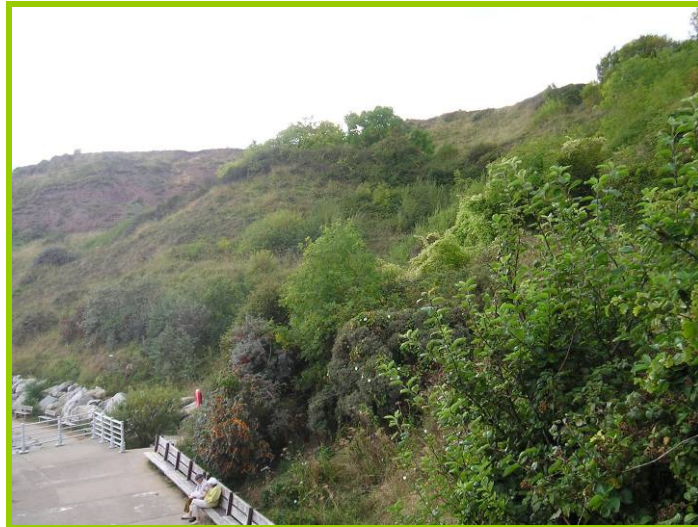
This Sub-Management Unit consists of **unit MU17/1** only. This unit is defended at the toe by a sea wall and rock armour. The slopes are densely vegetated with trees and shrubs and show little evidence of recent activity. As a result this unit is classified as Inactive, as it was in 2008.

MU17/1 Looking south from Robin Hood's Bay Village (Inactive)

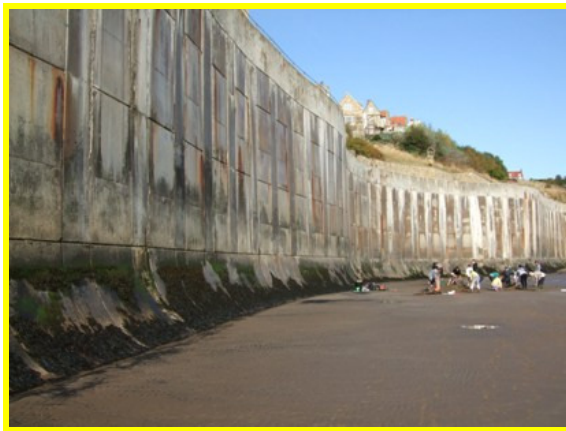
Further south there is a large vertical defence wall, directly protecting houses located behind at high level. The concrete is in a fair to poor condition, showing evidence of surface cracking, rust marks, mineral encrustation, seepage, cracking and repair work to the crest of the wall. There is some evidence of undercutting at the toe (Asset Ref. 1221D901D1003C02).

Large vertical wall at Robin Hood's Bay
(Asset Ref. 1221D901D1003C02)

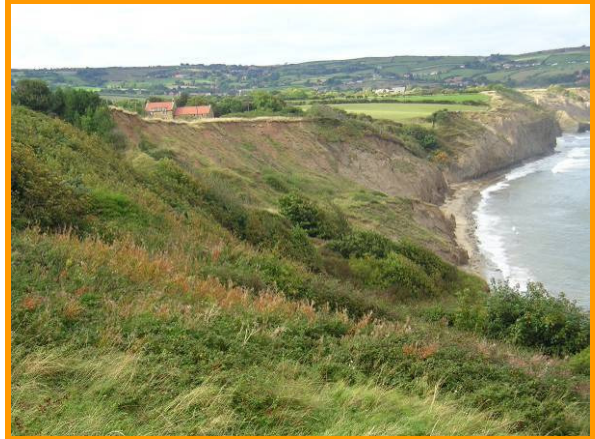
MU17/5 Looking northwards (Partly Active)

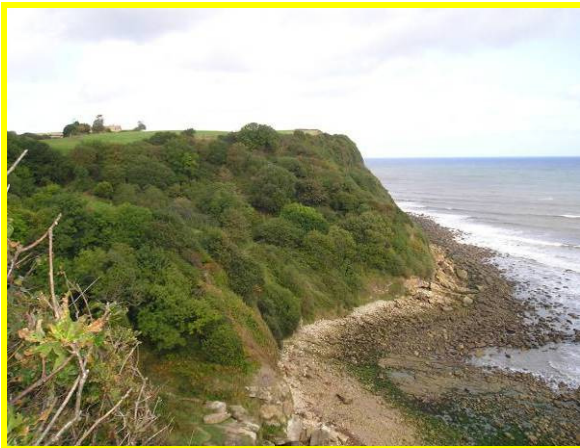
MU19/2 Looking north across Hayburn Wyke
(Locally Active)

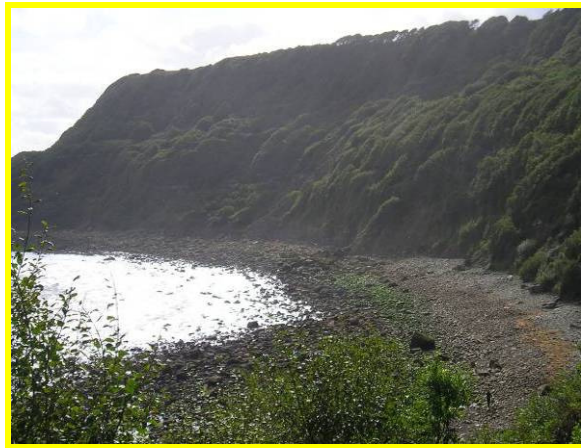
Unit MU19/3 is located around and to the south of Hayburn Wyke. These cliffs are well vegetated in most places, with only minor localised erosion evident at the toe and headscarp.

MU19/3 Looking south across Hayburn Wyke
(Locally Active)

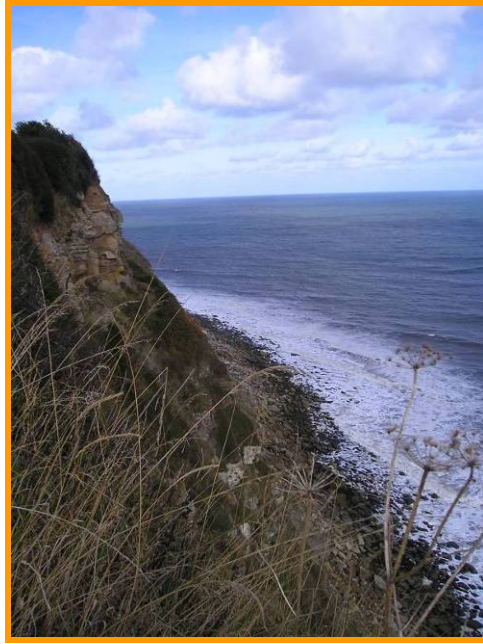
Unit MU19/4 is located just north of Cloughton Wyke. The unit is characterised by high, steep cliffs which are more active than those cliffs further north. There is some recession of the headscarp, sliding and falling of materials down the mid-slopes to form debris cones and rock fall deposits at the cliff base. This unit is classified as Partly Active, as it was in 2008.

Mu19/4 Looking north (Partly active)

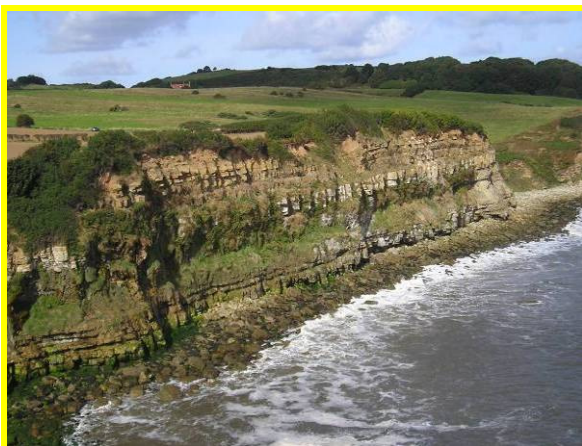
MU19/5 Northern side of Cloughton Wyke
(Locally Active)

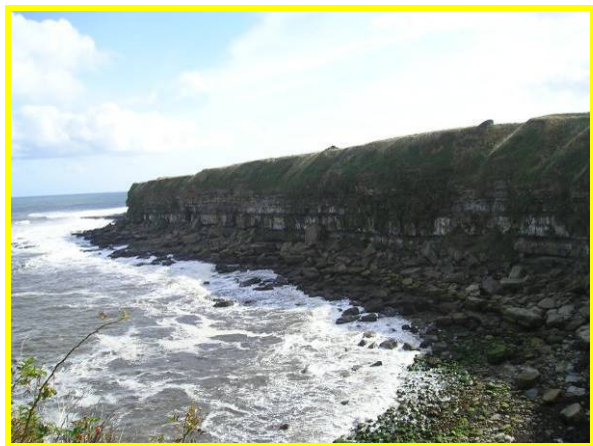
Unit MU19/6 forms the southern part of Cloughton Wyke and extends southwards to Long Nab. The lower cliff is near vertical with a general absence of vegetation cover. There is evidence of rockfall from this layer onto the shoreline below. The upper part of the cliff is shallower, composed of softer material and is fairly well vegetated. This unit is classified as Locally Active.

MU19/6 Southern side of Cloughton Wyke
(Locally Active)

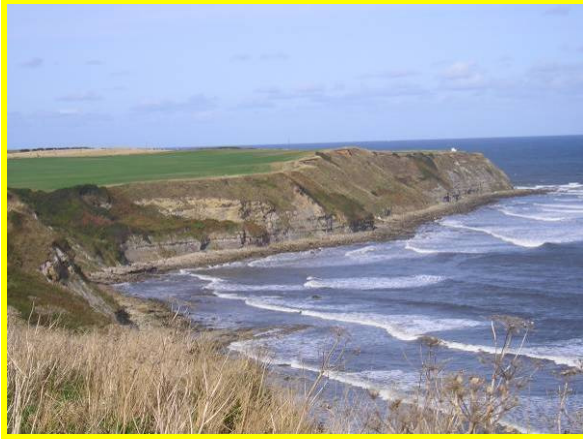
MU19/7 Looking north towards Long Nab
(Locally Active)

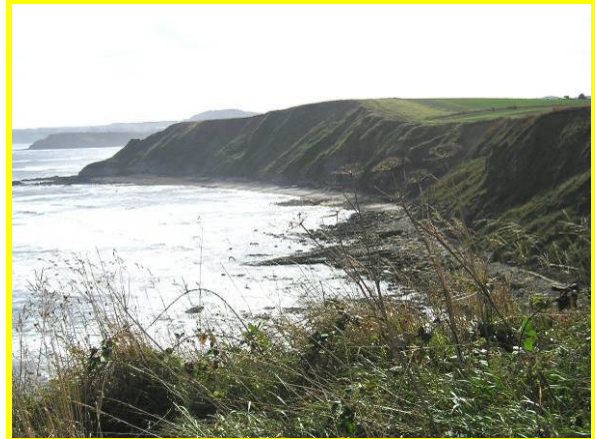
MU19/8 Looking south towards Cromer Point
(Locally Active)

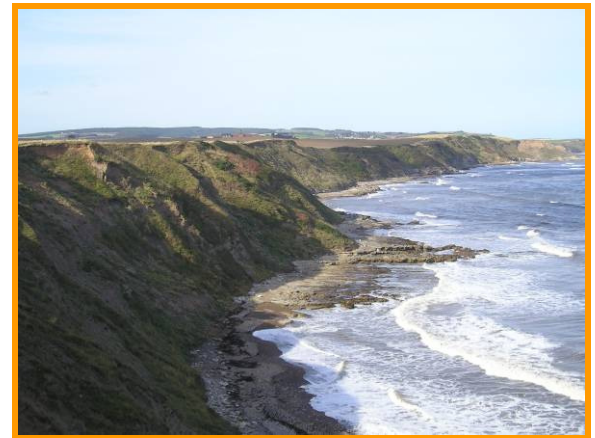
MU19/9 Partly Active

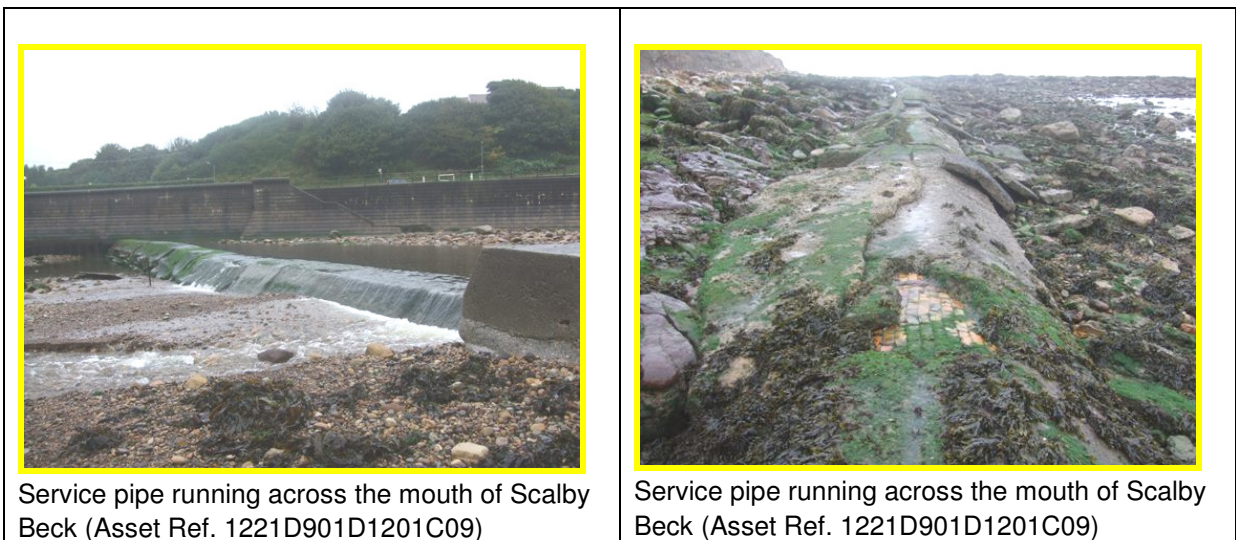
There are no formal sea defences within the Scalby Mills area. However there is a coastal asset - a service pipe which has been laid across the mouth of Scalby Beck (Asset Ref. 1221D901D1201C09). This acts as a fixed crest weir controlling the flow of the beck at low tide. In a high tide situation this would have minimal affect on water dynamics, be they tidal or fluvial. At low tide, the pipe can be inspected throughout its length. It is in fair condition, with localised cracking and spalling. Repair work is recommended in order to prevent potential sewage pollution in the future.

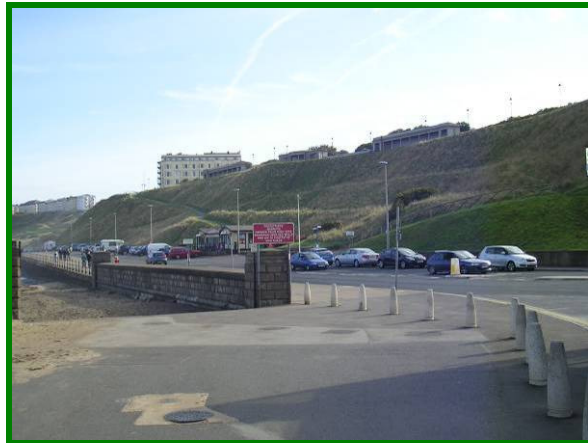
MU20/3 Well vegetated slopes (Dormant)

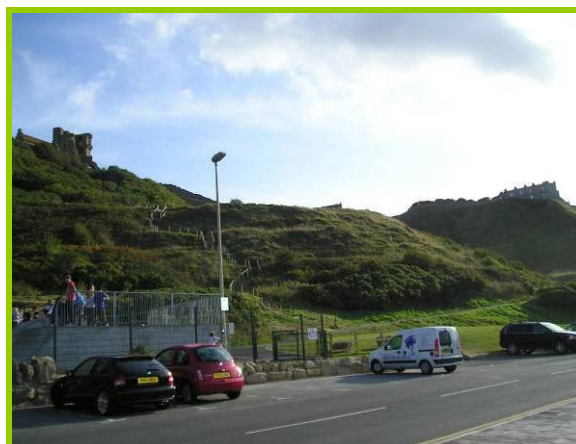
MU21/1 Well vegetated slopes of most of this unit (Inactive)

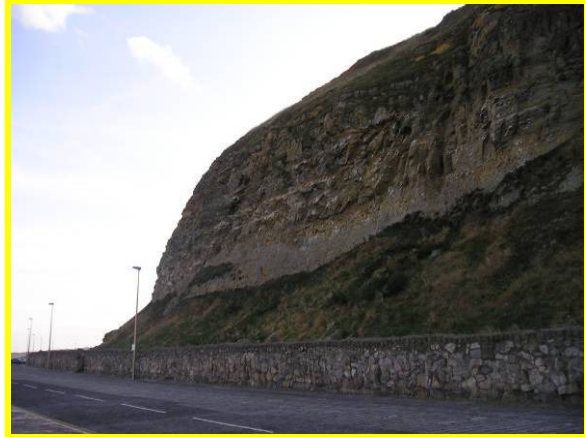
MU21/2 Steep, exposed cliff (Locally Active)

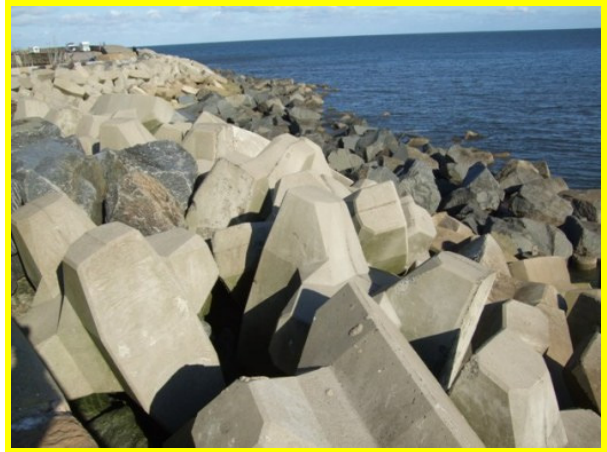
There is a large extent of rock armour and tetrapods around the south end of North Bay which continues around the headland (from Management Unit 20A into Management Unit Mu21A) and towards the harbour (Asset Refs. 1221D901D1202C04 and 1221D901D1202C02 respectively). These were built in approximately 2005 and are, on the whole, in good condition with some evidence of cracking and erosion along the arm edges. Several individual blocks forming the crest wall show full height cracks, these are currently of no concern, but monitoring may be useful to detect further deterioration. It was not possible to inspect the toe as it was below water in all tide conditions.

Overview of armour looking north
(Asset Ref. 1221D901D1202C02)

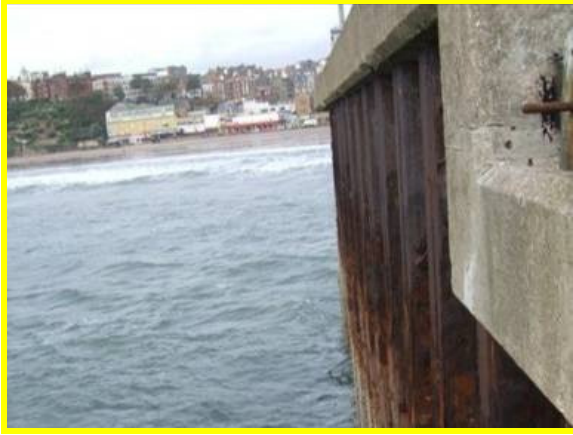
Overview of asset
(Asset Ref. 1221D901D1301C17)

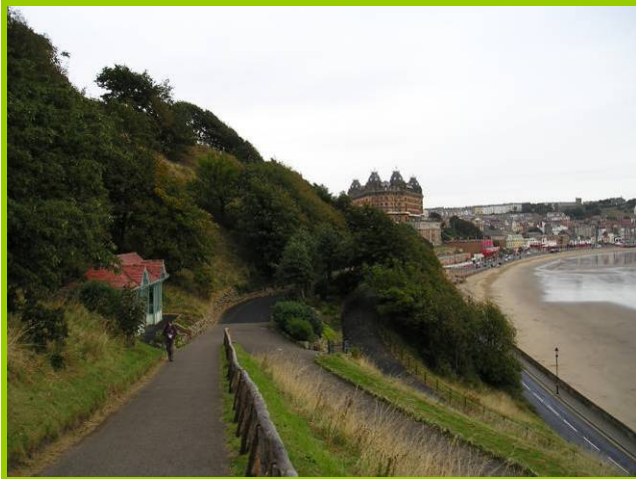
Unit MU22/1 is the most northerly unit located in Scarborough's South Bay and is classified as Inactive. It is well vegetated with only minor, localised activity evident as footpath cracks.

MU22/1 Well vegetated slopes (Inactive)

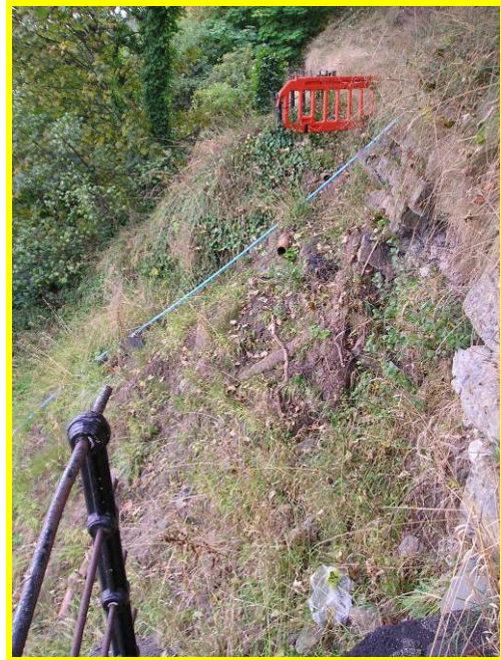
Unit MU22/2 comprises the area around and to the north of the Spa Complex. This unit is classified as Locally Active as a result of evidence of recent and ongoing instability and loss of footpaths. There is also significant cracking to the remaining footpaths within this area.

MU22/2 Recent activity and footpath closure (Locally Active)

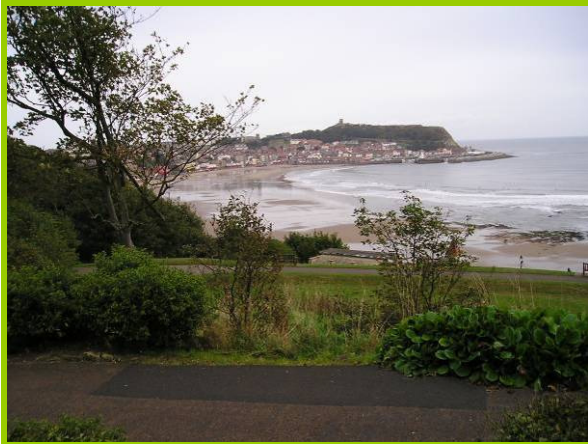
MU22/4 Well vegetated and largely stable
(Inactive)

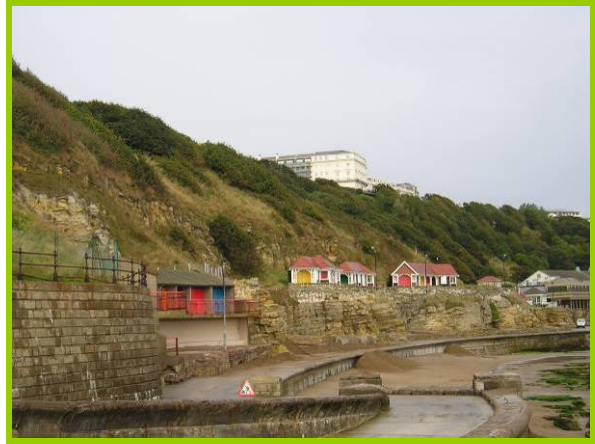
MU22/5 Exposed rock faces near the unit toe
(Inactive)

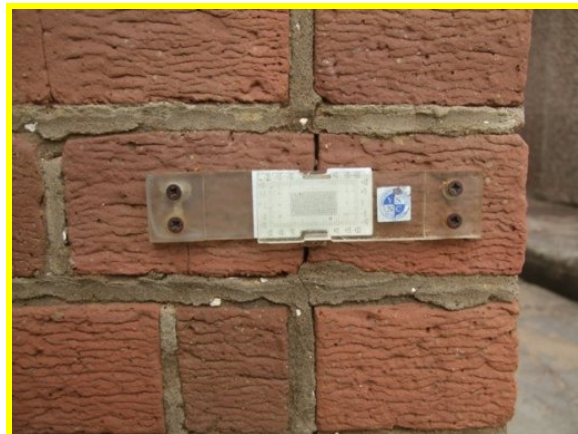
Tell tale on wall of life boat station
(Asset Ref. 1221D901D1301C08)

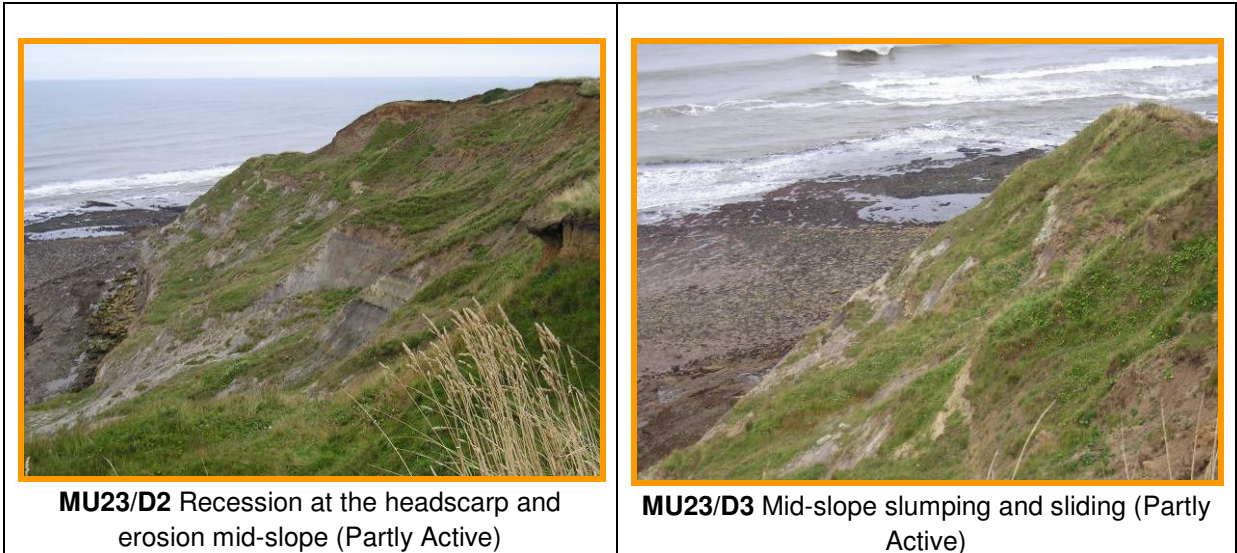
Units MU23/D1, MU23/D2 and MU23/D3 are located at Wheatcroft Cliff, above Black Rocks and are all classified as Partly Active. These units are active down much of their length, with ongoing recession of the headscarp, slumping and sliding mid-slope and active marine erosion of the toe.

<p>MU23/A Well vegetated slopes, looking north (Partly Active) (more active section not visible here)</p>	  <p>MU23/C Localised erosion of the unit toe (Locally Active)</p>
  <p>MU23/D1 and MU23/D2 Ongoing erosion down most of unit lengths (Partly Active)</p>	  <p>MU23/D1 Less active upper slopes, looking north (Partly Active)</p>

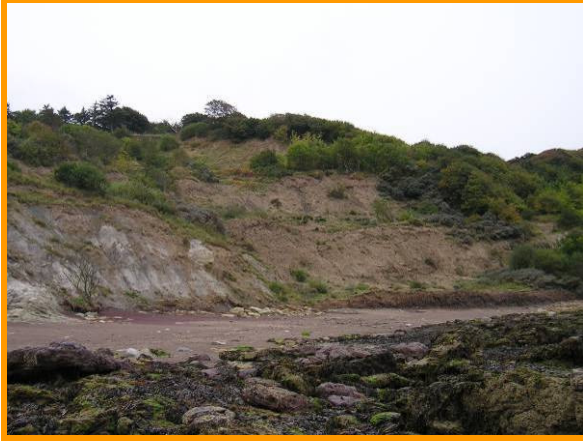
Units MU23/G1 and MU23/G2 form the northern part of Frank Cliff and are both classified as Partly Active. The upper slopes of these units support some vegetative cover. The unit toes are highly active with evidence of rockfalls, slumping and sliding onto the beach below. This classification represents an increase in activity observed within unit MU23/G1 between the 2008 and 2009 walkover surveys.

<p>MU23/G1 Highly active toe section (Partly Active)</p>

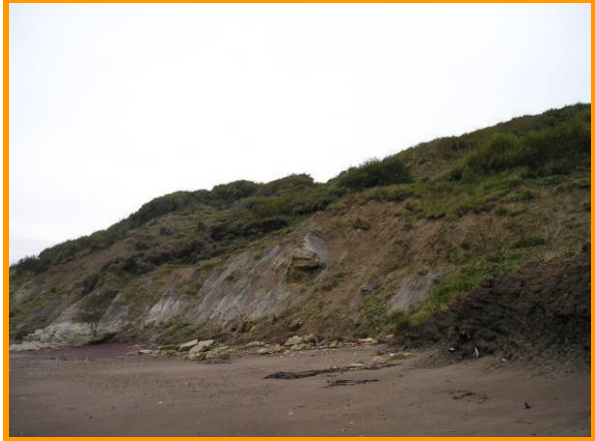
<p>MU23/G2 Erosion of the unit toe (Partly Active)</p>

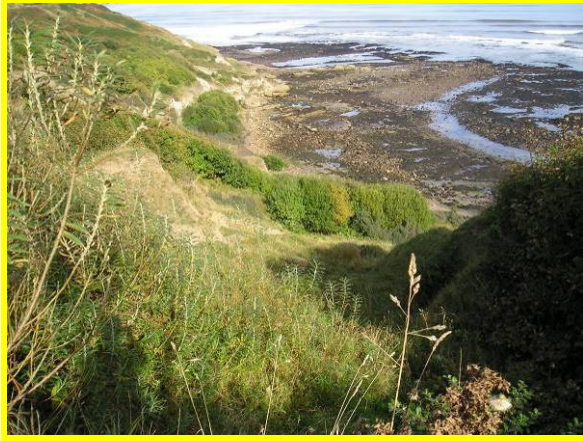
Unit MU23/H forms the back of a large mudslide embayment of Frank Cliff. It is largely well vegetated with local areas of erosion and is therefore classified as Locally Active. **Unit MU23/H2** sits beneath and is displaying a greater level of activity, with reduced presence of vegetation. It is classified as

<p>MU23/H Well vegetated upper part of embayment (Locally Active)</p>

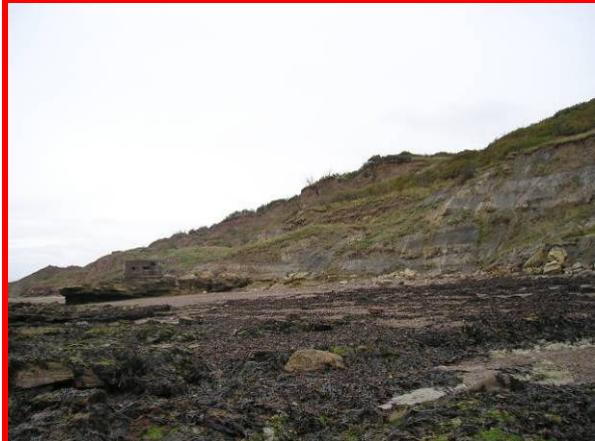
Partly Active. At the very base of the embayment are **units MU23/H1, MU23/H2a, MU23/H2b and MU23/H3** all of which are Totally Active. They are displaying intense erosion, likely resulting from marine action, and ongoing recession of the unit head by slumping and sliding.

<p>MU23/H2, H2a and H2b Intense erosion at lower part of embayment (mix of Totally and Partly Active)</p>

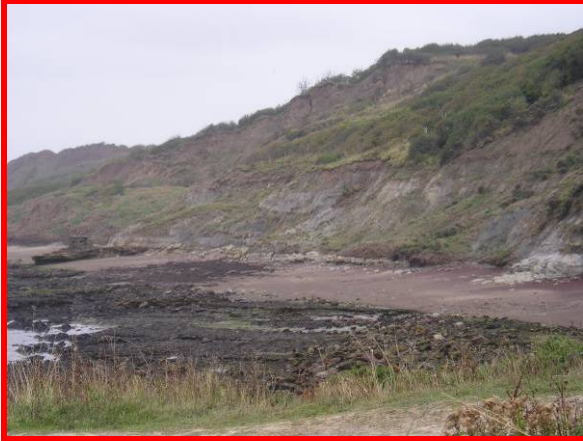
<p>MU23/H1 Lower unit almost entirely affected by intense erosion (Totally Active)</p>

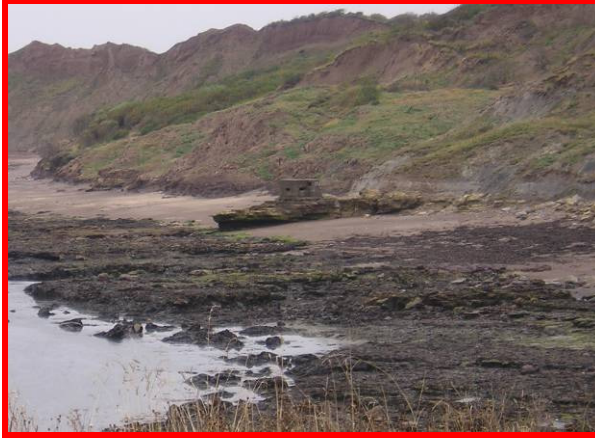
<p>MU23/H2b and H3 Lower units almost entirely affected by intense erosion (Totally Active)</p>

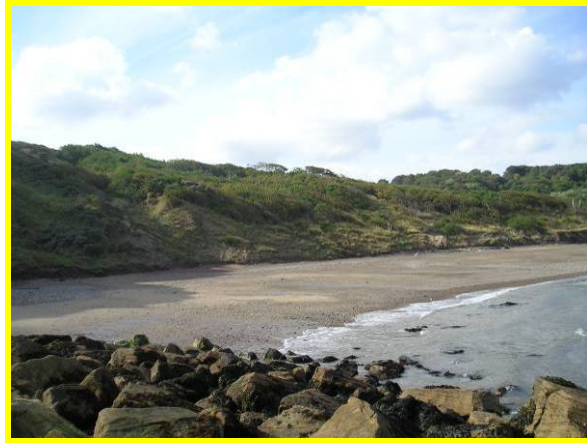
MU23/I3 Less active toe unit within Cornelian Bay
(Locally Active)

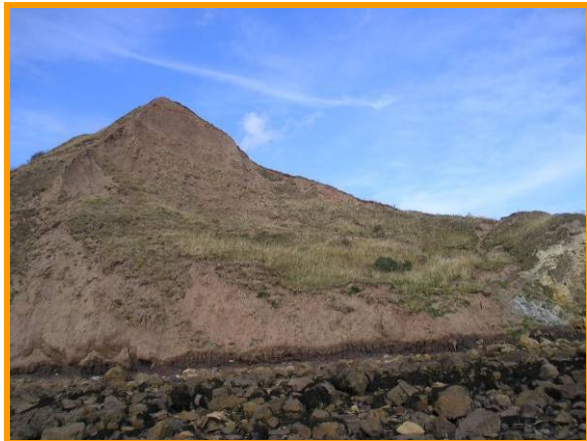
Units MU24/A8 and MU24/A7 are situated on the east and south facing sides of Knipe Point respectively and are both classed as Partly Active. The unit frontages are almost entirely exposed and experiencing intense erosion. There is some evidence of past rockfall activity.

MU24/A7 Exposed slopes (Partly Active)

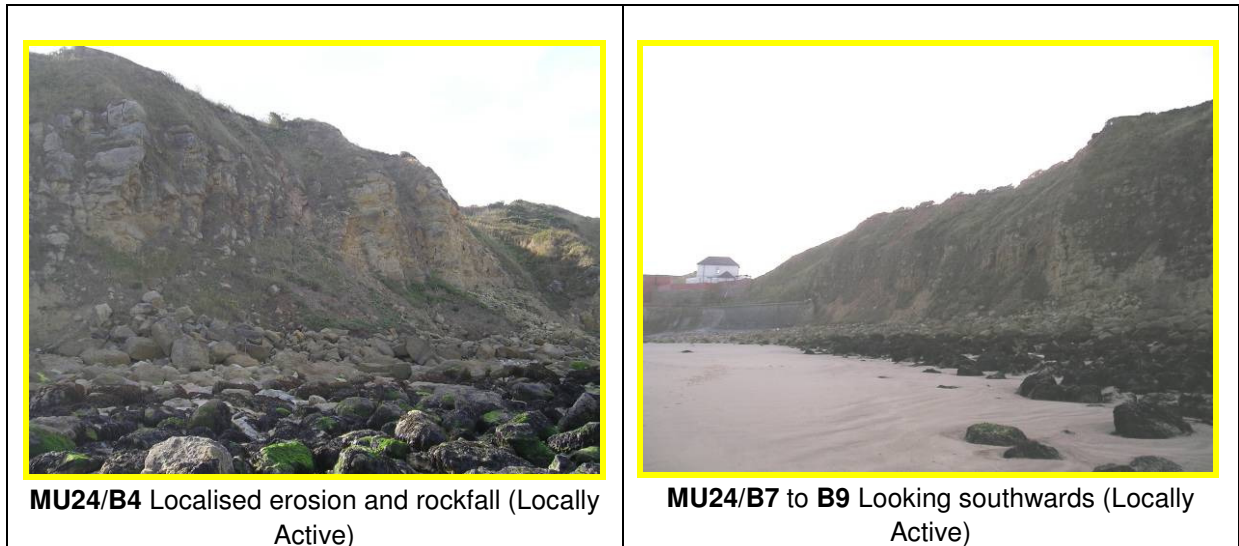
Unit MU24/A comprises the main body of the Cayton Cliff landslide and **unit MU24/A2** forms the landslide toe, including sea cliff and uplifted sections. This landslide is the subject of an on-going investigation by Halcrow on behalf of Scarborough Borough Council and the National Trust following reactivation of the system in April 2008. Significant recession of the headscarp was observed at this time resulting in the loss of land and property at Knipe Point Drive. During 2009, headscarp recession and activity within the body of the landslide appear to have slowed and the system has become more stable. As a result, the classification of the main unit has been reduced from Totally to Partly Active. The landslide toe unit remains Totally Active. The potential for further significant activity in the future however, should not be ruled out.

Unit MU24/B forms the main part of Tenants' Cliff and is classified as Inactive. The unit supports dense vegetation cover and shows very few signs of recent activity. The lower part of Tenants' Cliff is comprised of a number of small toe units **MU24/B1 to B10**, all of which are classified as Locally Active. There is variable vegetation cover within these units and evidence of localised erosion and rockfall. None of these units have changed activity status since the 2008 walkover survey.

<p>MU24/A Headscarp of Cayton Cliff (Partly Active)</p>	  <p>MU24/A2 Cayton Cliff toe unit (Totally Active)</p>
  <p>MU24/B Upper slopes of Tenants' Cliff (Inactive)</p>	  <p>MU24/B1 A toe unit of Tenants' Cliff (Locally Active)</p>

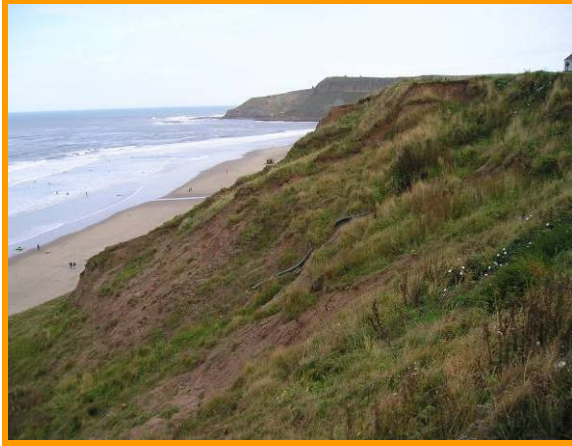
Units MU24/C, MU24/D and MU24/E are located just southeast of the Pumping Station in Cayton Bay and are cut into the soft glacial till cliffs. All units show active recession of the headscarp and slumping and cracking mid-slope. At the unit toes there is evidence of slumping, and possible beach uplift. These units are classified as Partly Active. This classification represents an increase in activity for units MU24/C and D between the 2008 and 2009 walkover surveys.

MU24/C Headscarp recession and mid-slope activity (Partly Active)

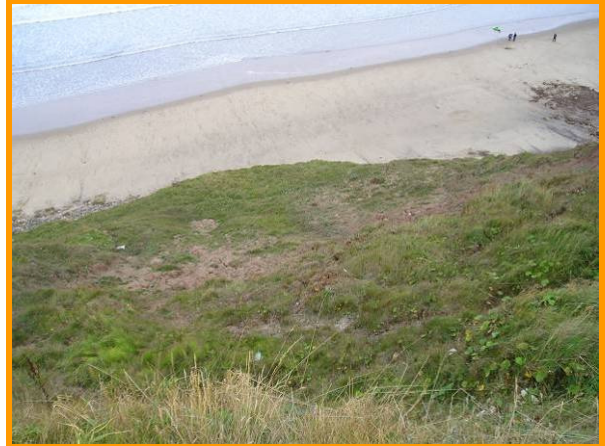
MU24/D Toe slumping (Partly Active)

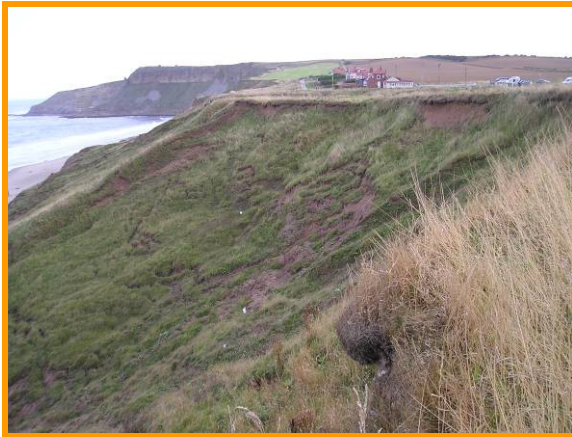
MU24/E Looking south (Partly Active)

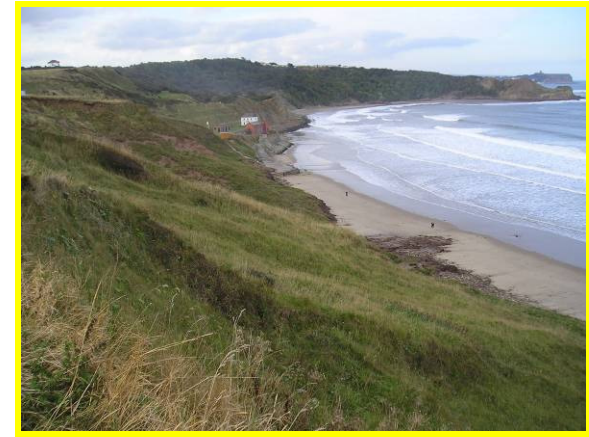
MU24/F Well vegetated slopes (Locally Active)

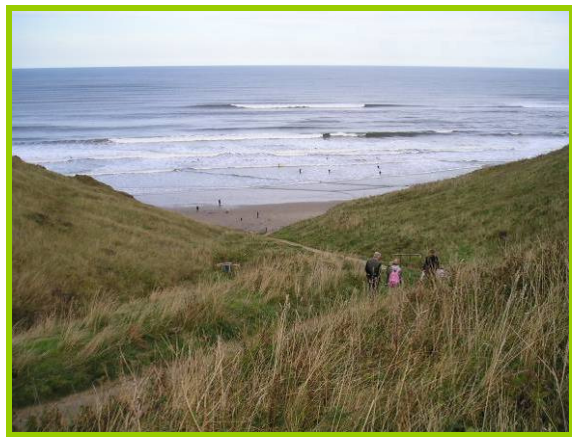
MU24/H Access route to Cayton Sands (Inactive)

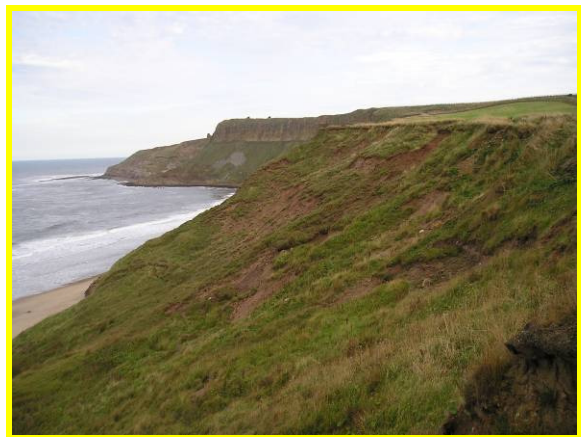
MU24/J Localised headscarp recession (Locally Active)
