Coast Protection Assets and Coastal Slope Condition Analysis

**Scarborough Borough Council
Final Report**

March 2010

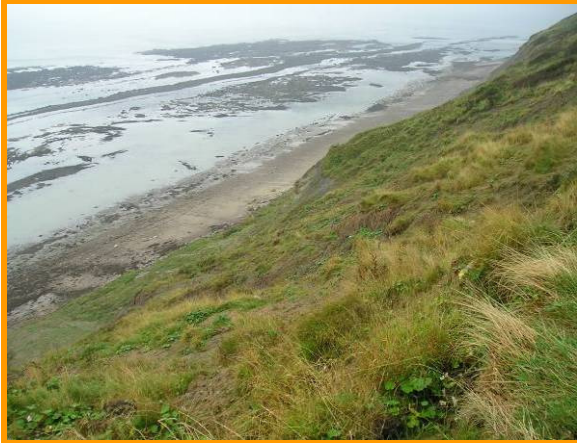
A photograph showing a steep, grassy slope overlooking a rocky coastline with tide pools. The vegetation is dense and green.	  A wide-angle photograph of a steep cliff face meeting a rocky beach. The sky is overcast and grey.
<p>MU25/AB Upper vegetated slopes (Partly Active)</p>	<p>MU25/AC Steep, exposed lower cliffs (Partly Active)</p>
  A photograph taken from a high vantage point looking northwest down a steep, grassy slope towards a rocky coastline. The sky is overcast.

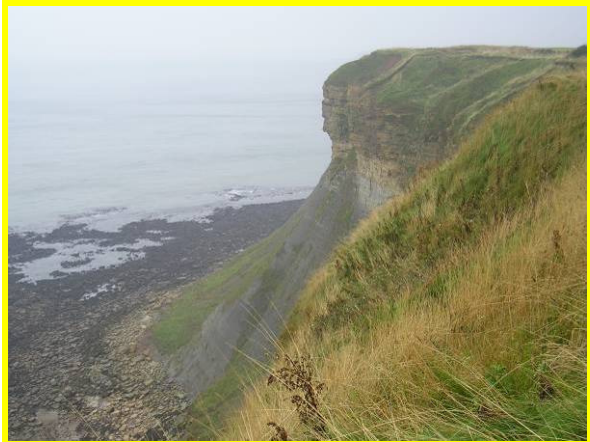
A photograph showing a steep cliff face with a rocky beach below. The cliff face shows signs of erosion and is partially covered in vegetation.
<p>MU25/AD Looking northwest (Locally Active)</p>	<p>MU25/AE Localised activity on lower slopes (Locally Active)</p>

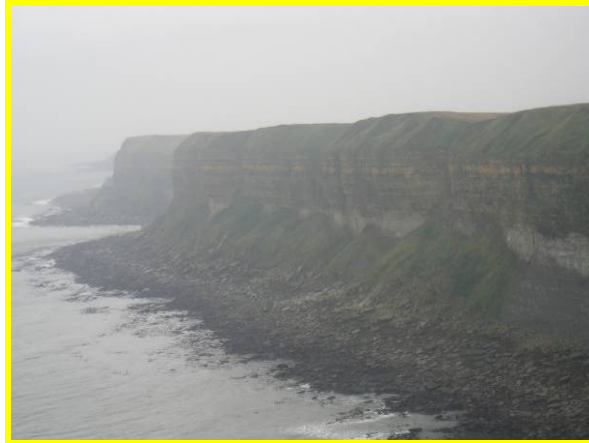
Units MU26/AM, MU26/AN and MU26/AO form the main part of Newbiggin Cliff and are classified as Locally Active. These cliffs are again characterised by a soft upper layer, a hard rock middle layer and series of debris cones at the unit base. There is localised activity within these units, especially within the soft upper layer.

MU26/AM to MU26/AO Locally Active

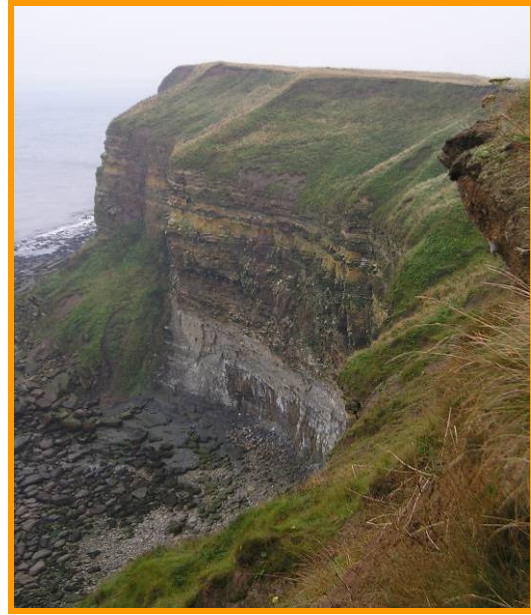
Units MU26/AP and MU26/AQ are classified as Partly Active. These units feature localised erosion of the soft upper till layer and a largely exposed, vertical lower layer. This lower layer is devoid of vegetation cover and is subject to marine erosion at the toe. This classification represents an increase in activity within unit MU26/AP since the 2009 walkover survey.

MU26/AQ Exposed, vertical lower cliff (Partly Active)

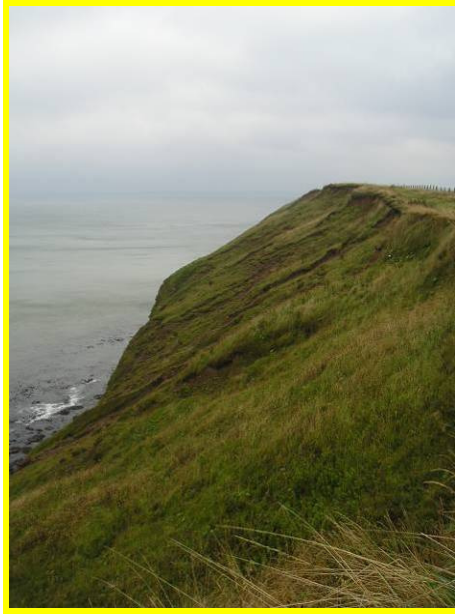
MU27/AY Well vegetated upper slopes
(Locally Active)

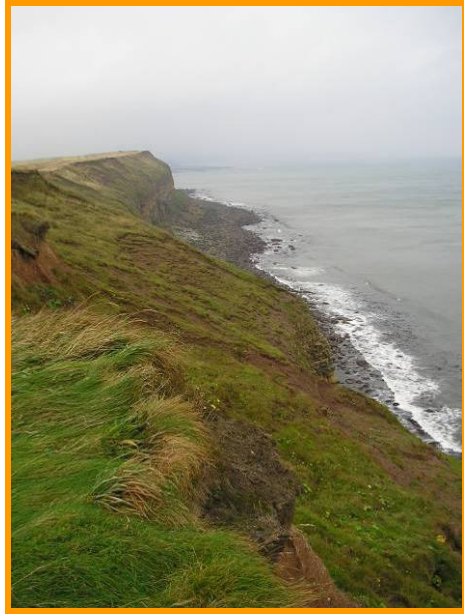
MU27/AZ Common areas of intense erosion
(Partly Active)

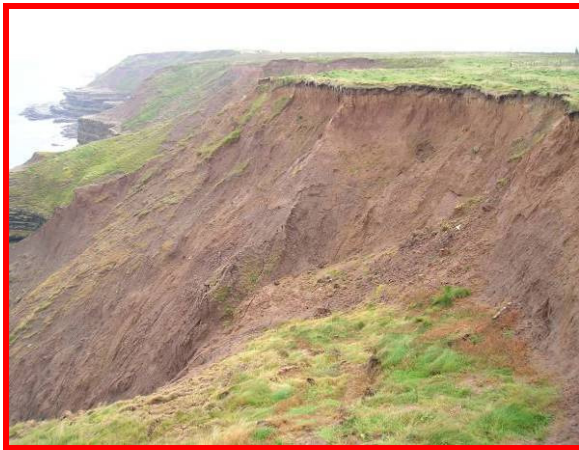
Unit MU27/BA is composed of an upper layer of erodible glacial sediment and a lower more resistant rock layer. The upper layer is undergoing mass failure at this location. There is little vegetation cover and the headscarp is receding. This unit is therefore classified as Totally Active.

MU27/BA Mass failure of upper layer
(Totally Active)

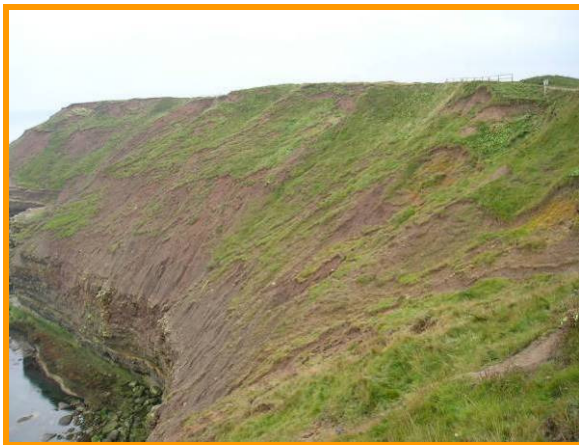
MU27/BD Erosion of the upper layer
(Partly Active)

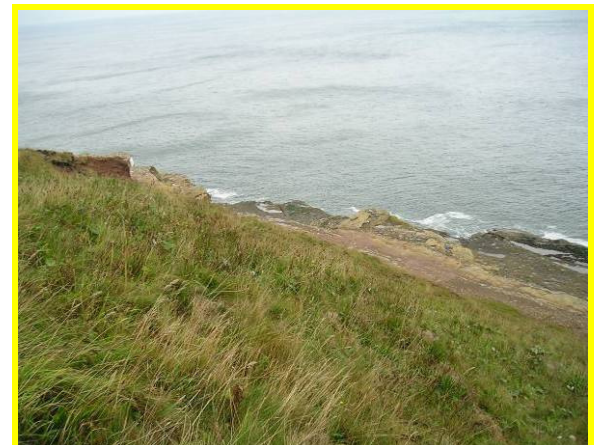
MU27/BF Well vegetated slopes (Locally Active)

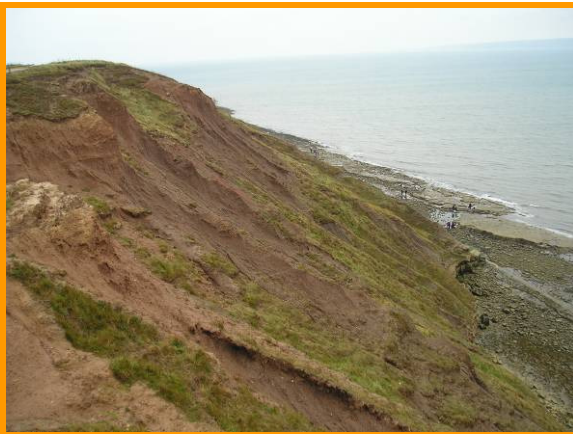
With the exception of **unit MU27/J**, none of the other units within this Management Unit have changed activity status between the 2008 and 2009 walkover surveys. Despite this, all units around Filey Brigg are experiencing significant and ongoing erosion which is likely to continue, if not increase in the future.

MU27/J Intense erosion (Partly Active)

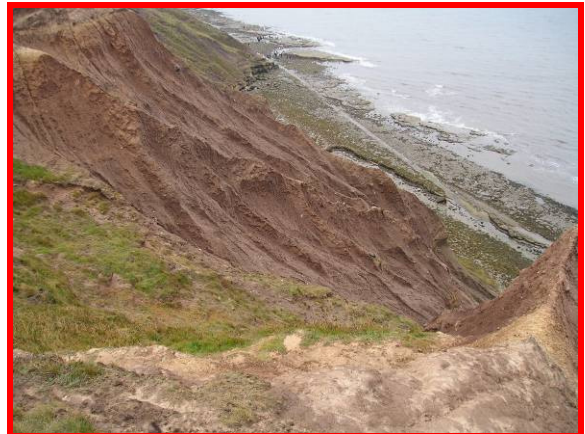
The southwest corner of Filey Brigg comprises units **MU27/L to MU27/O**, all of which are classified as Totally Active. These units are almost entirely affected by intense erosion in the form of rilling, gullying and sliding.

MU27/L Intense rilling and gullying (Totally Active)

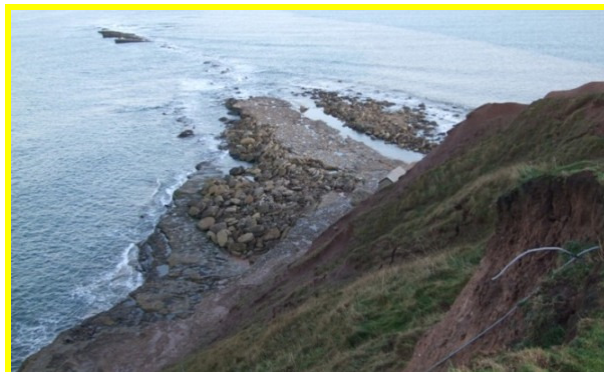
View of wall from Filey Brigg
(Asset Ref. 1221D901D1502C01001)

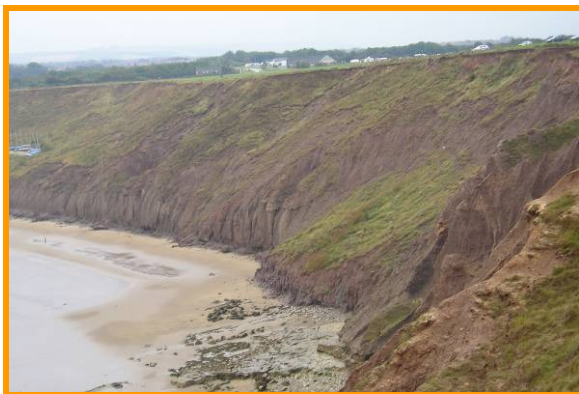
Units MU27/P to MU27/S are situated below the North Cliff Country Park and are all classified as Partly Active. These cliffs are composed of glacial till and are undergoing erosion down much of their length. This erosion is particularly intense at the steep unit toe area where the cliffs are subject to marine action. Up slope, there is greater vegetation cover with areas of sliding, cracking and recession at the unit heads.

MU27/Q to MU27/S Erosion of glacial till cliffs (Partly Active)

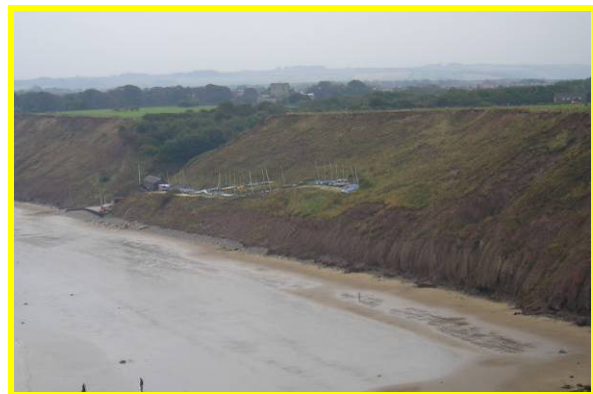
MU27/T Slopes around Filey sailing club (Locally Active)

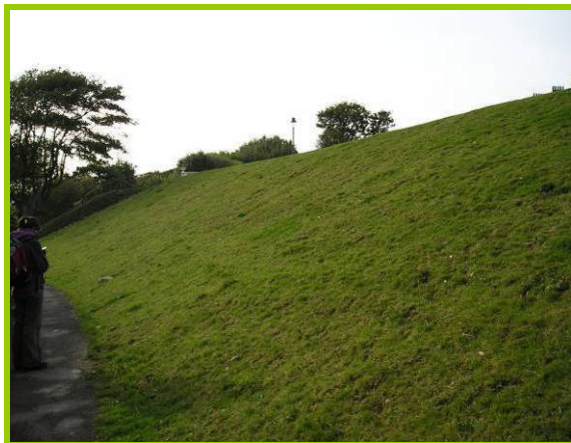
MU28/Y Regraded slopes, no current signs of instability (Inactive)

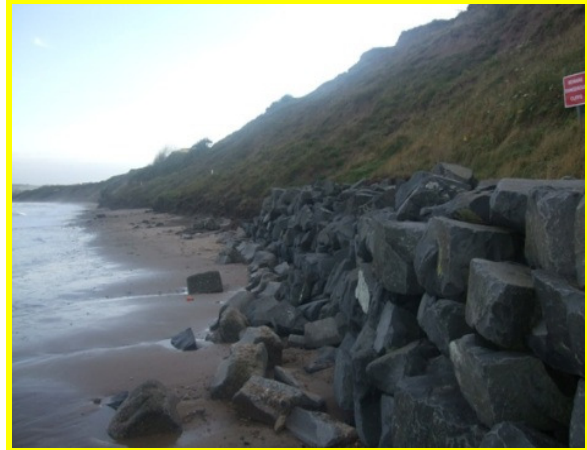
Rock revetment with gabion baskets beneath
(Asset Ref. 1221D901D1602C02)

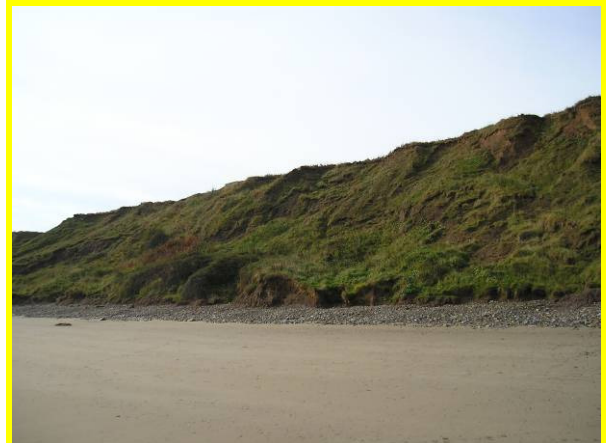
MU29/AK Fairly well vegetated low lying cliffs
(Locally Active)

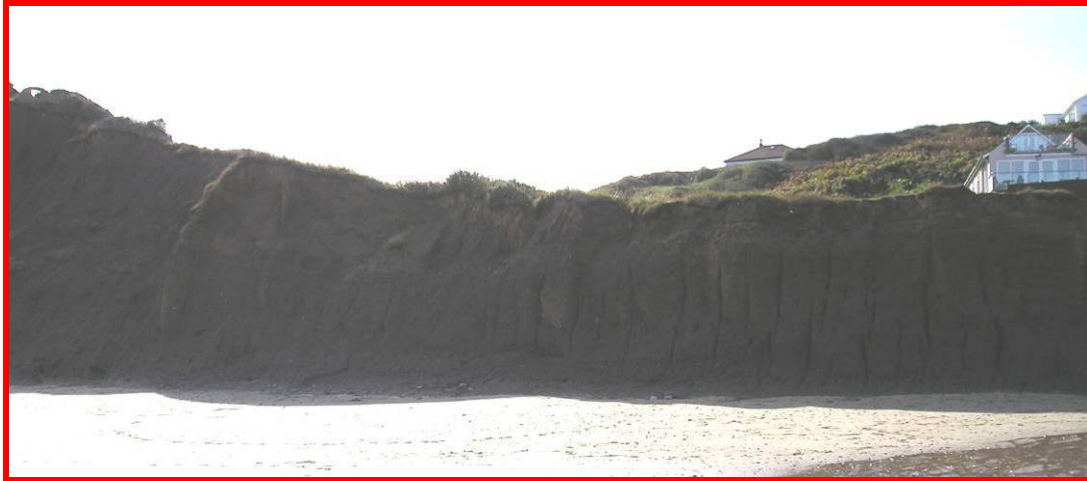
MU29/BF and MU29/BG Steep, intensely eroding cliffs (Totally Active)

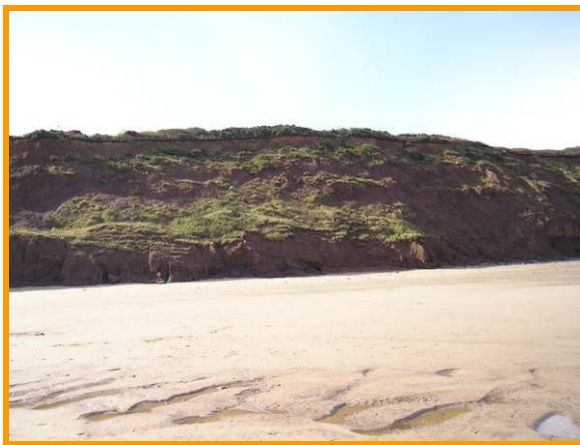
None of the units within this area have changed activity status since 2008, with the exception of unit **MU29/BI**. This unit has shown a minor decrease in activity from Totally to Partly Active.

MU29/BI Steep slopes with some vegetation cover (Partly Active)

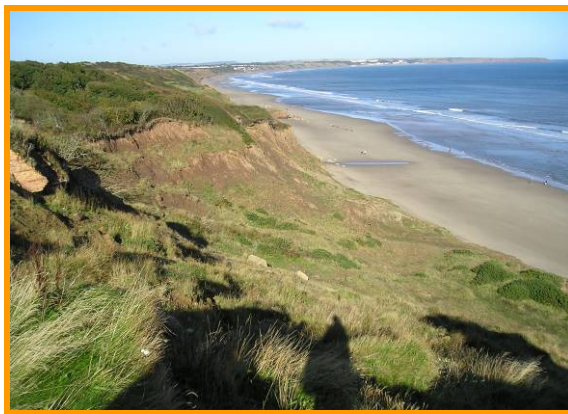
MU29/BS Headscarp recession (Partly Active)

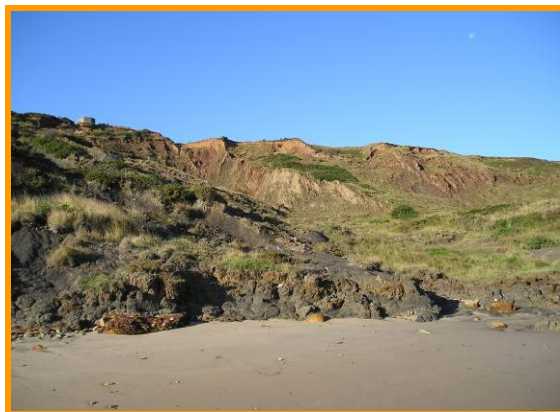
MU29/CA Slumping onto the beach (Partly Active)

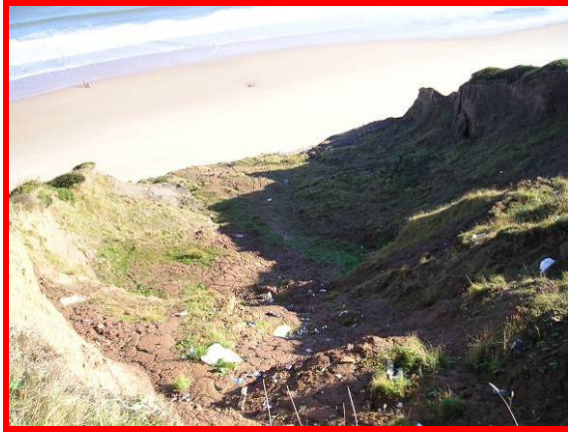
Unit MU29/CB forms a small mudslide embayment at the eastern end of the Holiday Village. The entire system is active with a retreating headscarp and cracking down the entire length. As a result, this unit is classified as Totally Active.

MU29/CB Mudslide system (Totally Active)

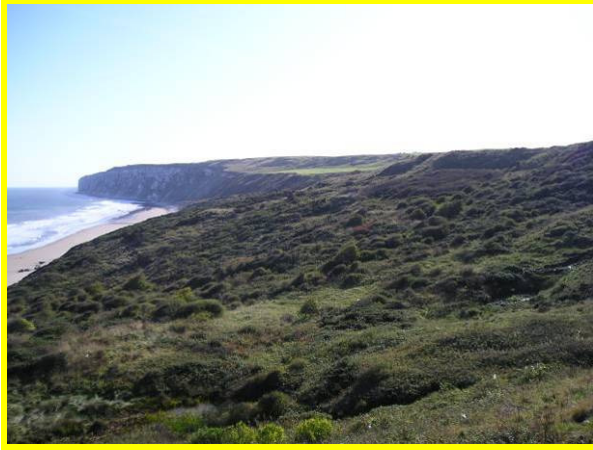
MU29/CC Middle Cliff embayment
(Locally Active)

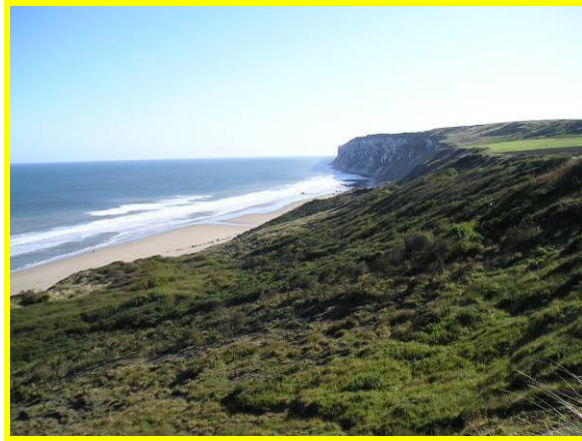
MU29/CE Well vegetated cliffs (Locally Active)

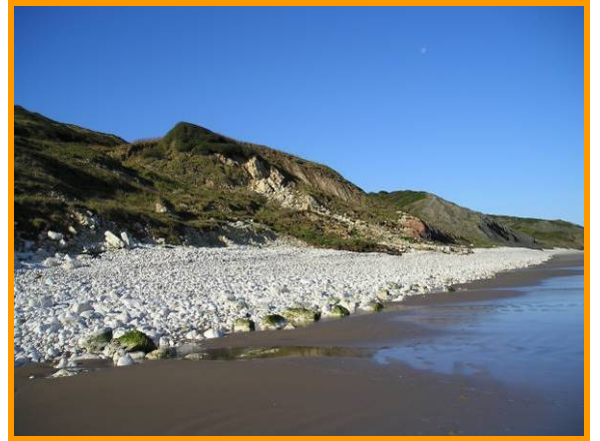
MU29/CF Chalk outcrops at beach level
(Partly Active)

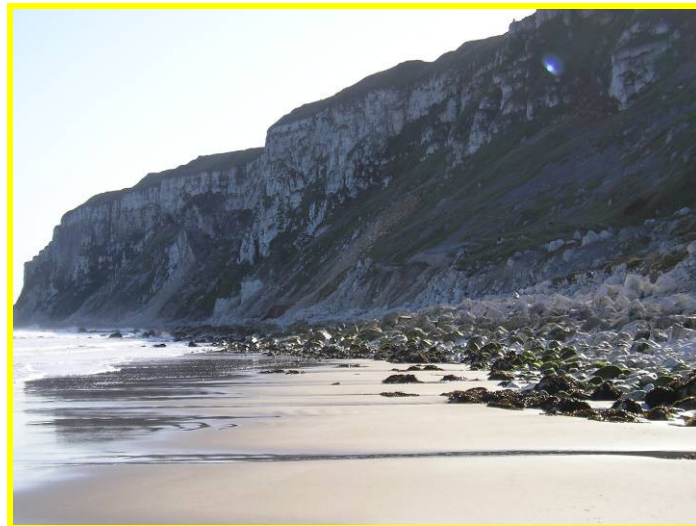
The high chalk cliffs within unit **MU29/CJ** are much steeper than those to the north, with large mantles of slumped material at the unit toe. There is some evidence of rockfall and marine erosion at the cliff base but otherwise the cliffs appear fairly stable. Therefore, this unit is classified as Locally Active.

MU29/CJ High, chalk cliffs (Locally Active)
