**Walk-over Visual Inspections of Assets
including Coastal Slopes**

**Scarborough Borough Council
Final Report**

November 2014

Coast Protection Assets and Coastal Slope Condition Analysis

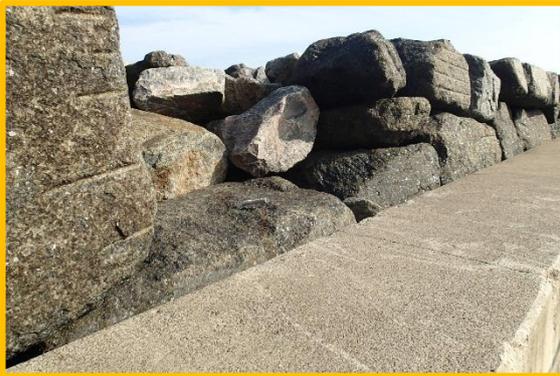
The North Breakwater is in fair condition overall, but certain elements are poor. The rock armour added in 2002 mostly remains tightly packed and in good condition, however, two of the stacked & pinned crest blocks adjacent to the walkway are missing and others have moved, presumably evidence of damage during wave overtopping in a major storm. The sheet piling on the inner face of the east end of the breakwater is heavily corroded and as noted in previous inspections the coping piece (horizontal) on the landward side of the breakwater has corroded and failed. Whilst at the head of the breakwater, waves could be heard entering the structure, indicating that there may be significant voids in the structure behind the piles. Undercutting is still apparent to the landward (south) side of the north breakwater wall, as well as corrosion to the sheet piling which has caused displacement of a pile. It is recommended that the sheet piling coping is repaired / replaced (Asset Ref. 1221D901D0402C01, element 4).

Missing crest armour unit on the north breakwater at approx. 1/3 way along crest (Asset Ref. 1221D901D0402C01/2)

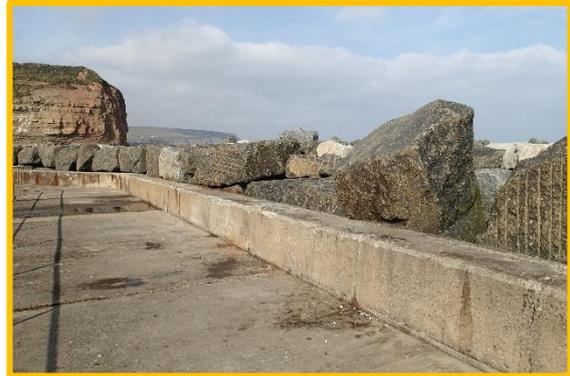
Displaced crest armour near roundhead (Asset Ref. 1221D901D0402C01/2)

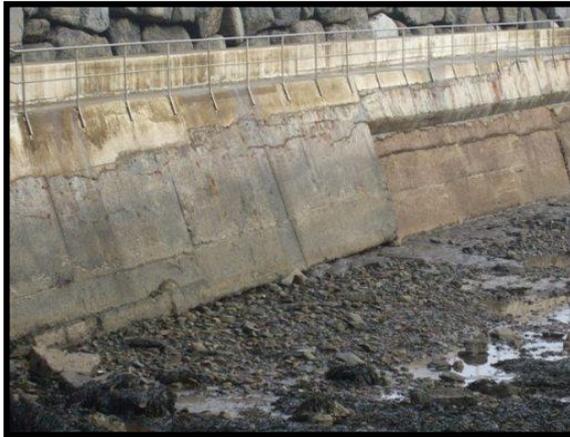
Undercutting to landward facing of north breakwater (photo from 2009 inspection)
(Asset Ref. 1221D901D0402C01)

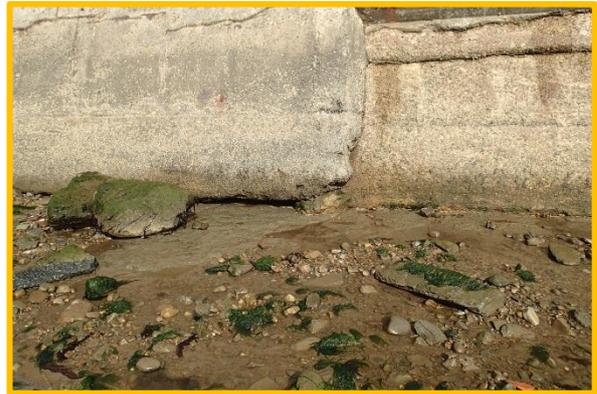
No change since 2009 to undercutting at landward facing of north breakwater (12/09/2014)
(Asset Ref. 1221D901D0402C01)

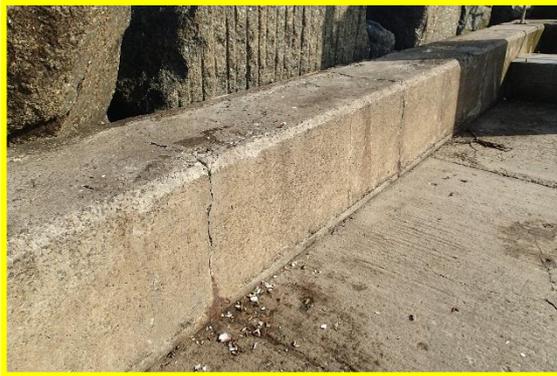
There is cracking in the promenade deck slab on the north breakwater, as previously reported, and loss of concrete at the top of the inner face, see below right. There is also extensive horizontal cracking and rust staining of the outer section of the crest wall. Vertical cracking in the crest wall adjacent to rock armour near the head of the breakwater, (photo below left) may be coincident with storm damage causing nearby displacement of crest rock armour (photo above, top right).

North breakwater crest wall showing cracking and damage from rock movement. (Asset Ref. 1221D901D0402C01)

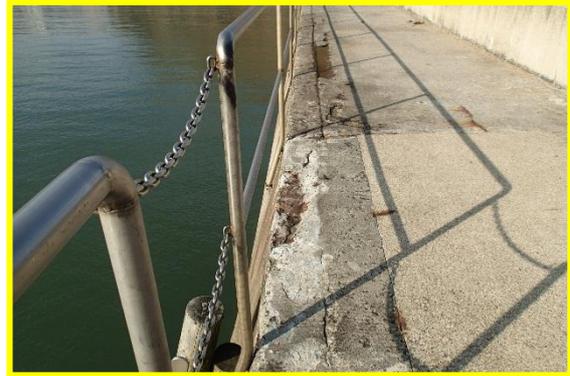
North breakwater promenade showing damage to coping. (Asset Ref. 1221D901D0402C01)

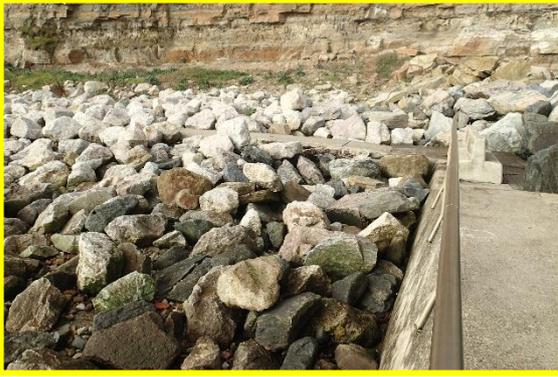
The rock armour defence running south from the north breakwater to the end of Cowbar Lane (Asset Ref. 1221D901D0402C02) was constructed after the 2002 upgrade to the main breakwaters and was recorded as being in overall good condition in 2012, has been downgraded to fair. It appears to have suffered some storm damage with some armour stones having been displaced at the crest near the north end by wave overtopping through the pedestrian access way at the root of the north breakwater, see photo below left. At the north end, as previously reported there is cracking and spalling of the concrete walkway / promenade, possibly related to movement of the rock armour. At the south end the original promenade at the end of Cowbar Lane has surface erosion and exposed aggregate, and there is cracking and spalling to the blockwork wall, see below lower right.

Area of displaced armour stones near root of north breakwater
(Asset Ref. 1221D901D0402C02)

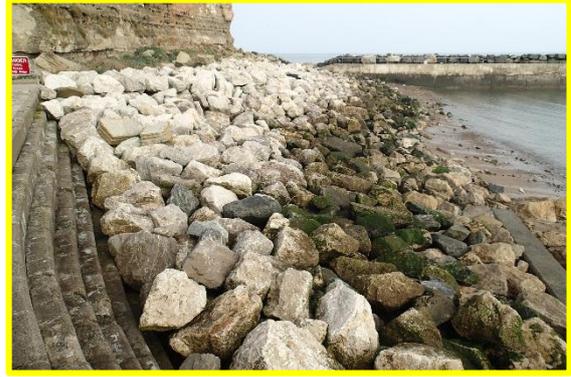
Rock armour which in fair condition adjacent to stepped wall at end of Cowbar Lane. (Asset Ref. 1221D901D0402C02)

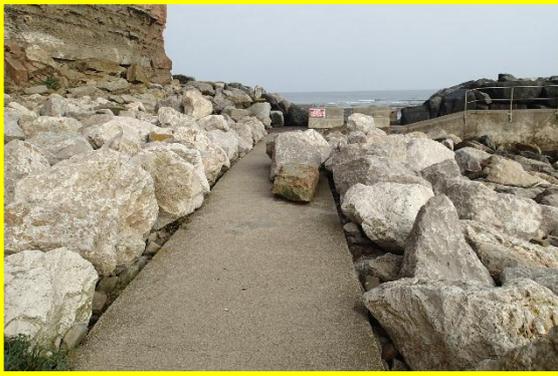
Storm damage displaced armour stones near root of north breakwater
(Asset Ref. 1221D901D0402C02)

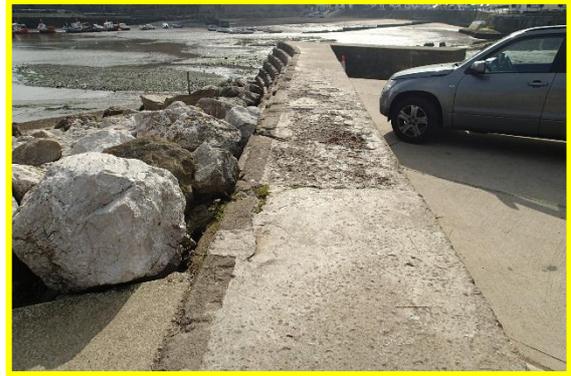
Surface erosion and exposed aggregate to southern end of promenade.
(Asset Ref. 1221D901D0402C02)

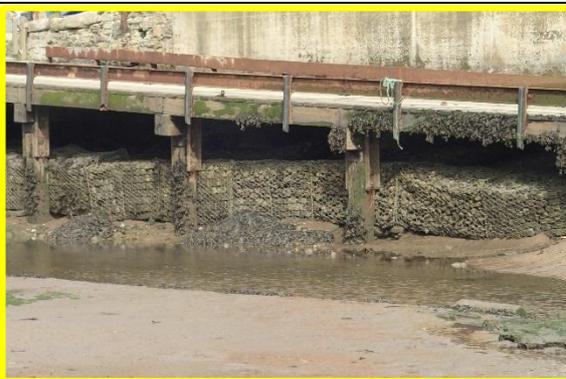
The seawall that extends into the northern side of Staithes Beck is split into two assets, 1221D901D0402C03 and 1221D901D0402C06, with the intersection at the west side of the RNLI slip. The eastern section, which is in fair overall conditions includes the slipway with gabion baskets beneath and a vertical concrete wall. The gabions are in a fair condition although as noted in the 2012 inspection, one section has settled, see photo below top left.

Gabion wall below slipway has settled
(Asset Ref. 1221D901D0402C03)

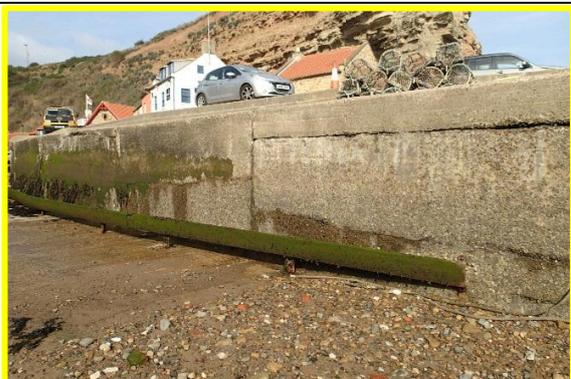
Cracks in wall adjacent to slipway
(Asset Ref. 1221D901D0402C03)

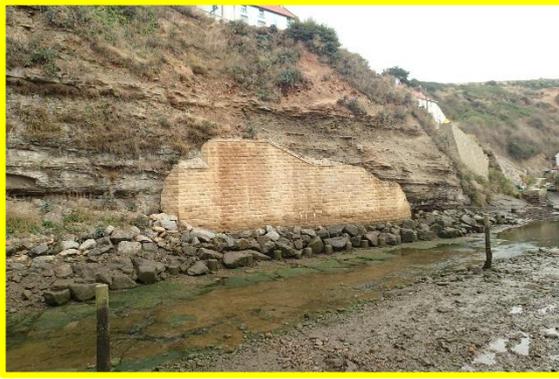
Reinforcement to cliff upstream of footbridge
(Asset Ref. 1221D901D0402C06)

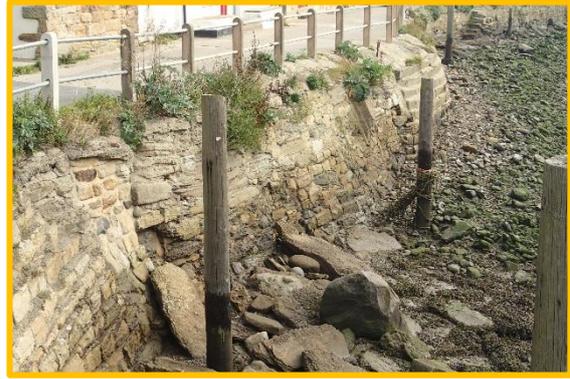
The repair and reinforcement to the cliff toe upstream of the footbridge that was underway at the time of the 2012 inspections appears to be holding well. The wall between the footbridge and the RNLI slipway (Asset ref 1221D901D0402C06) is in a poor condition with missing pointing, settlement of blockwork and exposure of the toe. The small size rock toe protection that was placed as part of the 2002 works has been scattered in the beck or removed and no longer provides any protection.

Missing pointing and voids in wall and displacement of toe armour.
(Asset Ref. 1221D901D0402C06)

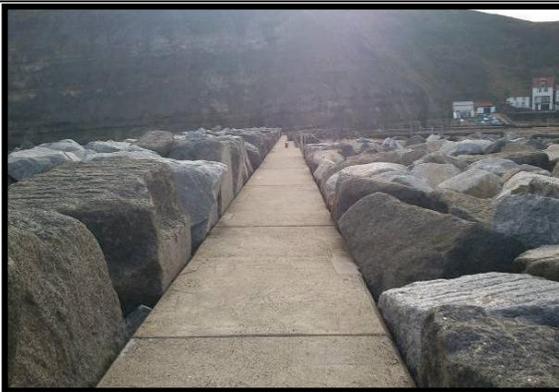
South breakwater promenade and rock armour –
photo from 2012
(Asset Ref. 1221D901D0403C03)

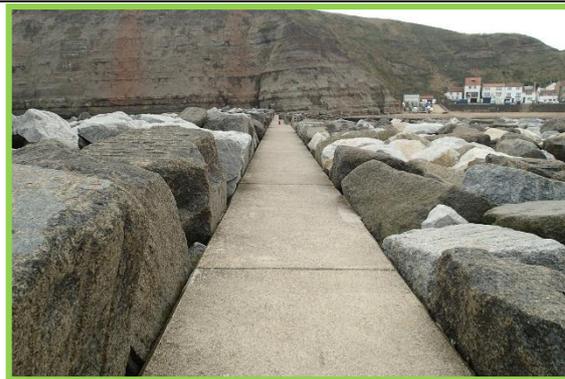
The main Staithes south breakwater (Asset Ref No.1221D901D0403C03), originally had a spur at the northern tip, but the section between main breakwater and the spur is filled with rock armour. The breakwater is in good overall condition. The rock armour is in very good condition. As noted in previous inspection reports there is minor cracking in concrete crest units in the middle of the breakwater length, but there were no obvious changes to these elements since last inspection. Exposure to aggregate and construction joints to the old, lower part of the wall (inner face, photo below lower right) was also similar to that in 2012.

South breakwater promenade and rock armour
(12/09/2014) (Asset Ref. 1221D901D0403C03)

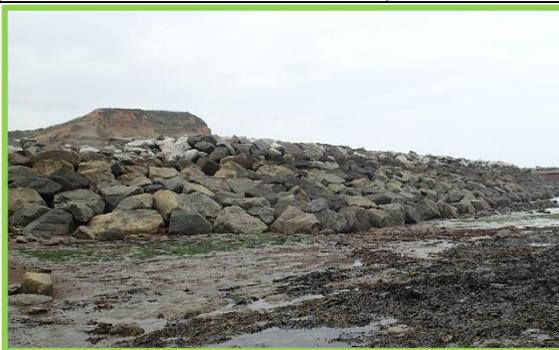
South breakwater outer face rock armour in good
condition. (Asset Ref. 1221D901D0403C03)

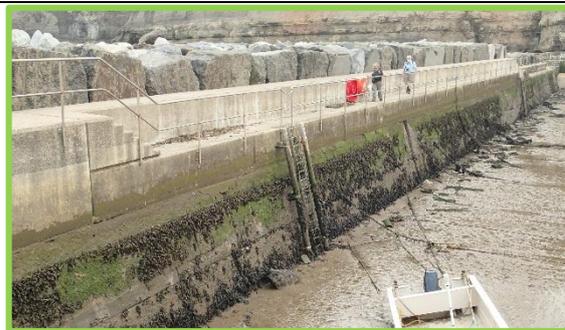
South breakwater inner face armour in condition.
(Asset Ref. 1221D901D0403C03)

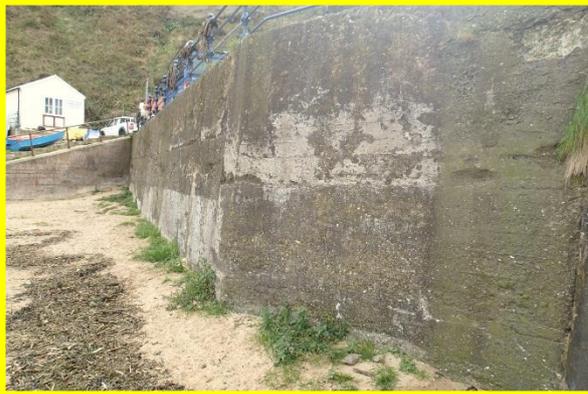
The southern harbour wall around the Staithes frontage from the slipway at the Harbour office through to the footbridge in Staithes Beck, comprises 4 main assets 1221D901D0403C01, C02, C05, C22 and C04, plus a concrete groyne, C07. The rear wall of the harbour is generally in fair condition, with locally poor sections. A number of the defects reported in the 2009 and 2012 inspection reports have been repaired. The large crack to the east of the harbour near Leech Bank (Asset Ref. 1221D901D0403C01), photo below right, has been filled since the 2012 inspections.

Cracking and surface damage to wall west of harbour office. (Asset Ref. 1221D901D0403C01)

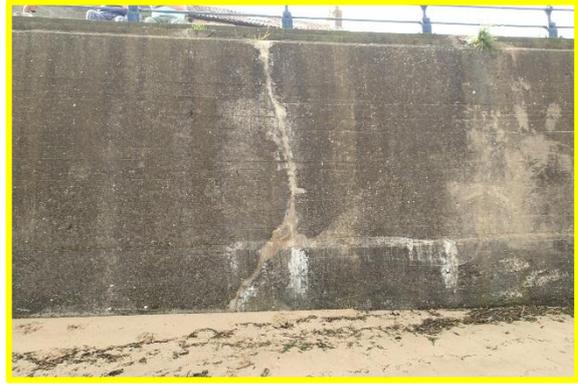
Recent repairs to vertical crack through rear harbour wall (Asset Ref. 1221D901D0403C01)

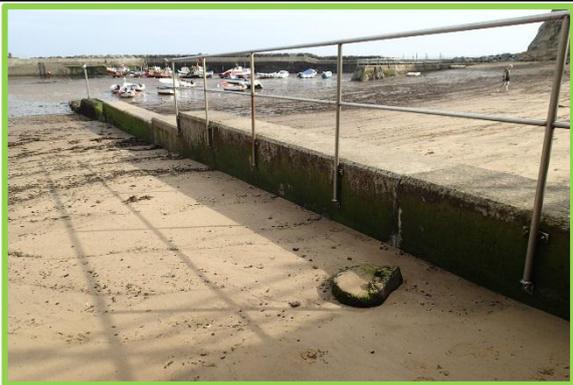
The concrete groyne (1221D901D0403C07) limiting sediment movement within the harbour is also in fair condition with only a minor cracking to the steps at the landward end in need of repair, photo below top left. Repairs had been undertaken to reinforce a damaged section of wall west of the Cod and Lobster, photo below top right. The masonry blockwork side walls to the slipway are in poor condition, with missing blocks and undermining (see photo below lower left).

Concrete groyne in fair condition (Asset Ref. 1221D901D0403C07)

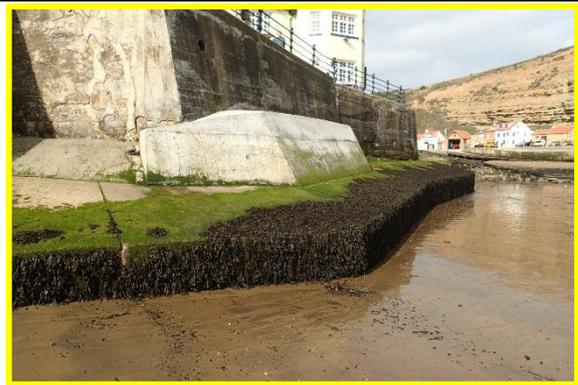
Additional section of toe berm placed since 2012 to stabilise wall (Asset Ref. 1221D901D0403C05)

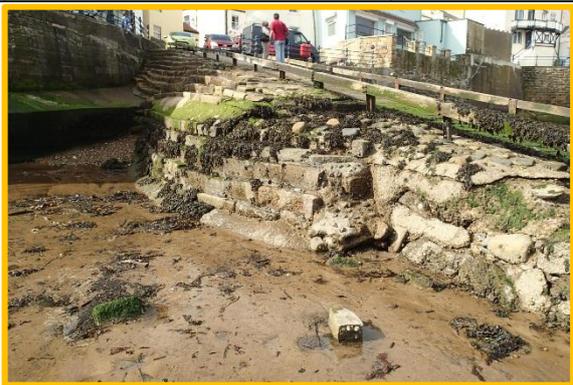
Damaged and missing blockwork to slipway (Asset Ref. 1221D901D0403C05)

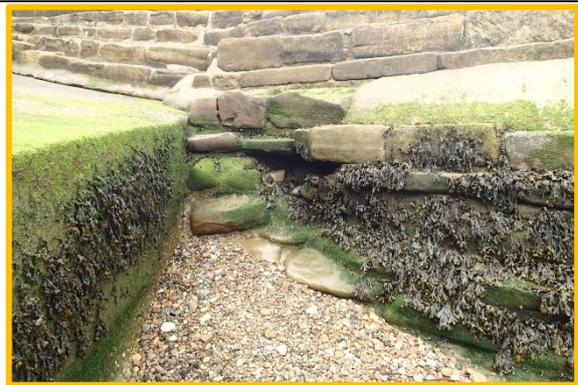
Void at toe of wall (Asset Ref. 1221D901D0403C05)

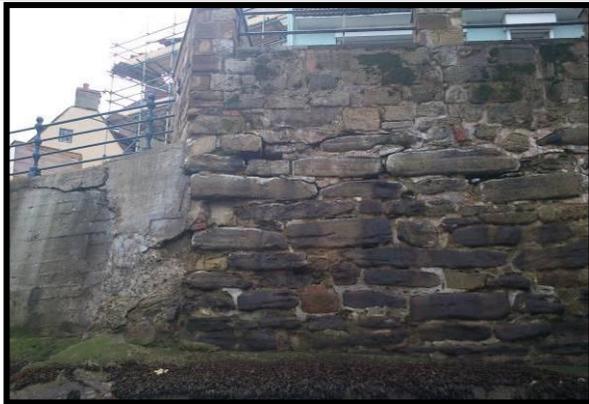
Older sections of the wall, towards the west side of the harbour and into Staithes beck, consist of masonry blockwork and are often exterior walls of private properties. As noted in previous inspections, these display visible loss of mortar and missing blocks, see below right. There is also undercutting of the toe in several locations, exposing timber piling. A number of defects

Older sections of harbour wall in need of regular maintenance photo from 2012 (Asset Ref. 1221D901D0402C22)

previously observed had been repaired, particularly in the lower parts of the wall, however, maintenance needs to be implemented at regular intervals (Asset Ref. 1221D901D0402C22). Should these minor repairs continue to fail, larger scale repairs or replacement of the assets should be considered.

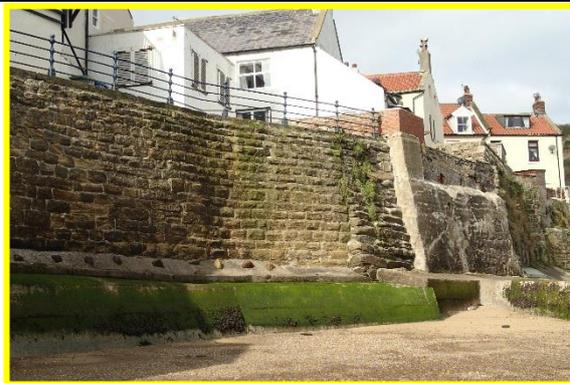
Repairs evident to cracks and missing blocks replaced, but repairs continue to be required. (Asset Ref. 11221D901D0402C22)

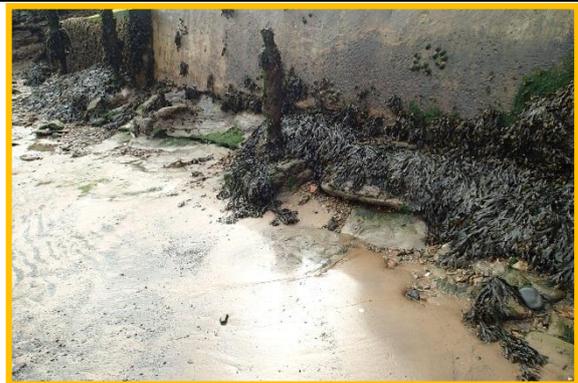
Undercutting at the toe of some parts of the harbour wall (no change since 2009) (Asset Ref. 11221D901D0402C22)

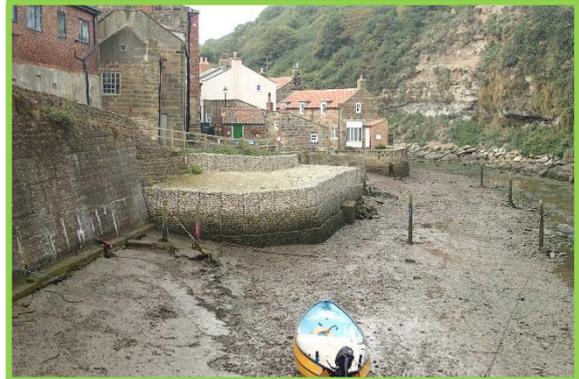
A new wire gabion wall & berm has been constructed upstream from the foot bridge, see photo below right. The gabions appeared to be in good condition, but should be monitored closely in future as they may be susceptible to corrosion of the wire and loss of fill.

New gabions and berm upstream of footbridge (Asset Ref. 1221D901D0403C01)

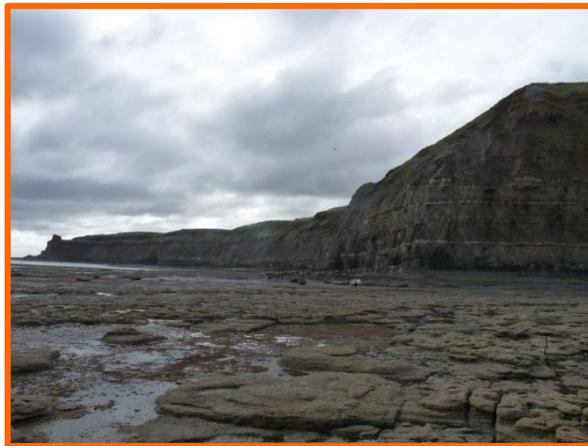
Jet Wyke forms the embayment between Penny Steel and Old Nab and consists of unit MU5/1, which is classified as Partly Active in 2014. The lower slopes of the cliff are very steep, unvegetated and subject to gradual marine erosion. The upper cliff is composed of softer material and supports some vegetation cover.

At the eastern extent of the unit is the western side of Old Nab, a headland composed of highly weathered shales. This unit has not changed activity status and remains as Partly Active in 2014.

MU5/1 – The including the highly weathered headland at Old Nab (Partly Active). August 2014.

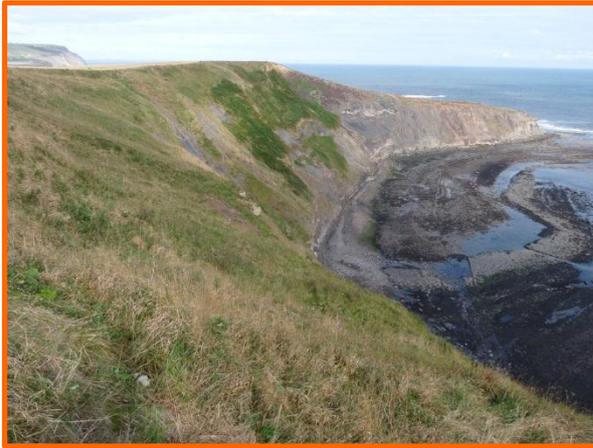
This sub-management unit consists of unit MU6/1 only. This section of cliff line is classified as Partly Active in 2014, unchanged since 2012. Marine erosion is cutting into the hard stratified rock at the base of the cliffs. Some vegetation is supported on the upper slopes with exposed shales lower down showing evidence of on-going erosion. A number of small failures were noted in the centre of the management unit as coastal erosion continues.

MU6/1 – Looking southeast across Brackenberry Wyke from Old Nab (Partly Active). August 2014.

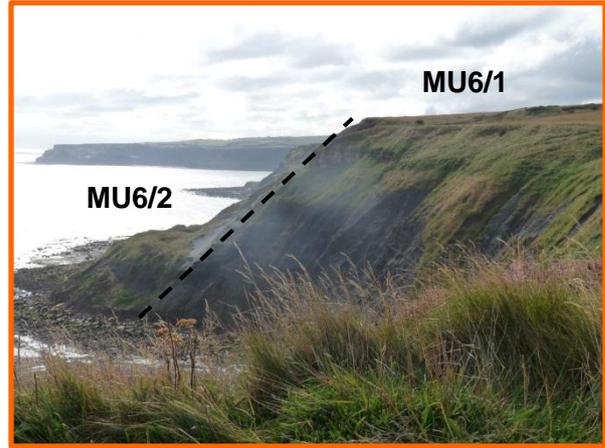
MU6/1 – The eroding shales of the east facing side of Old Nab (Partly Active). The stabilised lobe of material in the background is MU6/2. August 2014.

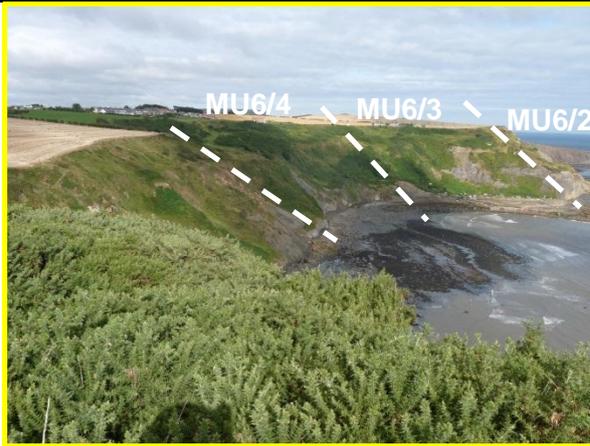
Unit MU6/4 is Rosedale Cliffs, immediately south of Port Mulgrave. The majority of the unit is covered with vegetation and shows little activity. In some places the cliff face has been prone to collapse where the cliff has been eroded and the failure has propagated up the cliff face. The unit is classified as Locally Active.

MU6/2, MU6/3 and MU6/4– All these slopes show evidence of localised instability but also are substantially vegetated (Locally Active). August 2014.

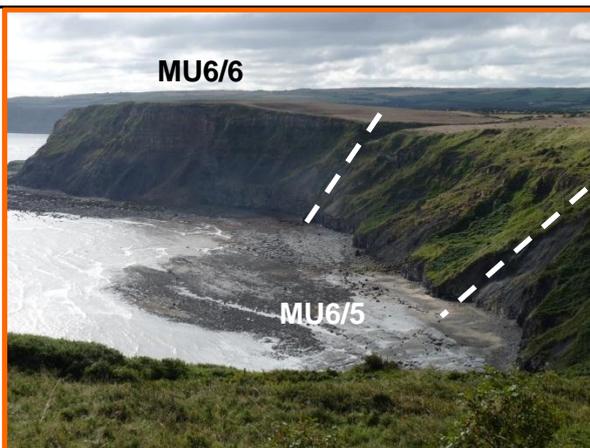
MU6/6 – The cliffs are vegetated on the upper slopes while the lower slopes are exposed and are subject to marine erosion. (Partly Active). August 2014.

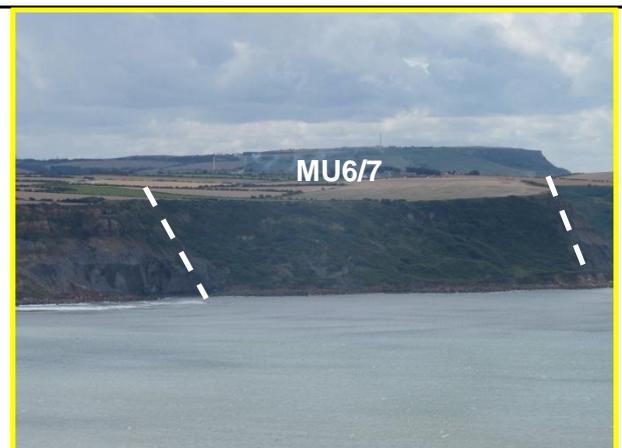
MU6/7 – The cliffs continue to be densely vegetated on the upper slopes while the sea cliff is subject to wave attack (Locally Active). August 2014.

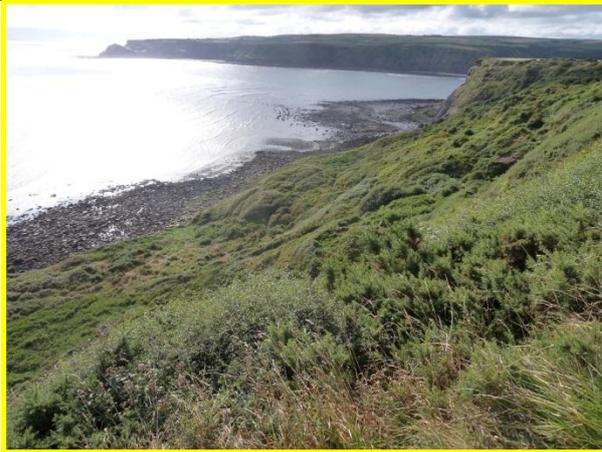
MU6/7 – view from cliff top at northern end of unit showing dense vegetation (Locally Active). August 2014.

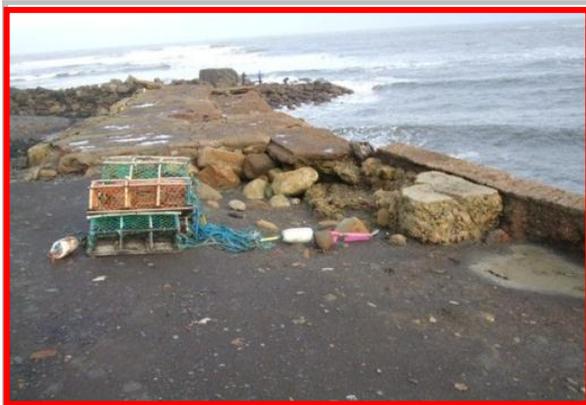
As noted during the 2008 and 2009 inspections, this is a former port and ironstone mine that has been derelict for 70 years and is considered to be redundant (Appendix B, Map 1). Virtually all coastal defences have been lost to the sea. What is left of the southern breakwater is undergoing large scale cracking, deformation, undercutting and outflanking. It is estimated that more than half of its original length has now been eroded (Asset Ref. 1221D901D0502C01). The breakwater appeared to have suffered further damage and lowering of the crest since the 2012 inspection. The photos below include post storm inspection from December 2013.

Looking at the end of the breakwater with evidence of erosion and failure in 2009 (Asset Ref. 1221D901D0502C01)

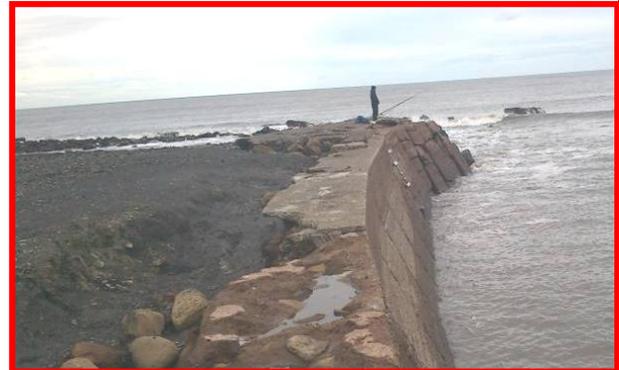
View of breakwater 30/10/2012 (Asset Ref. 1221D901D0502C01)

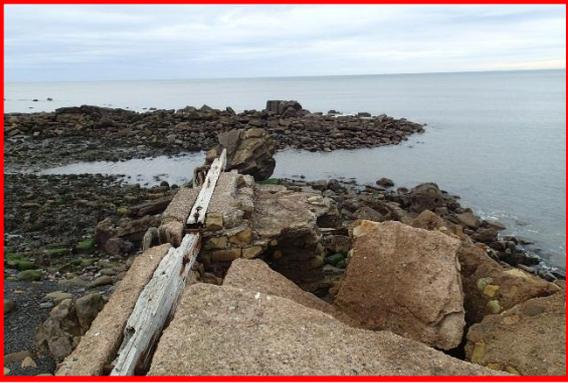
Seaward end of breakwater 25/09/2014
(Asset Ref. 1221D901D0502C01)

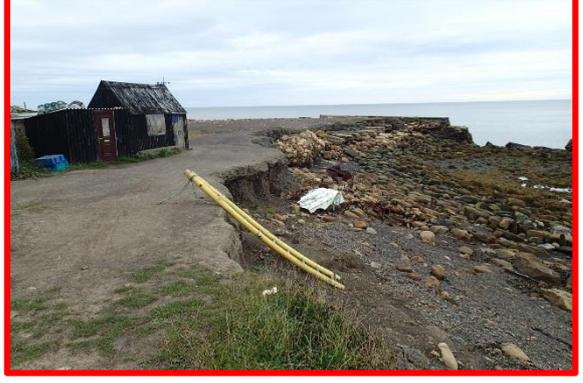
Erosion adjacent to fishermen's huts 25/09/2014
(Asset Ref. 1221D901D0502C01)

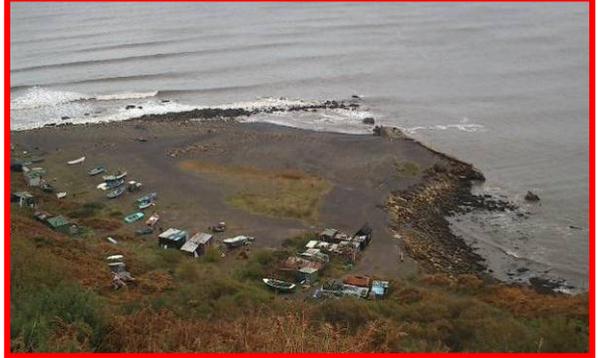
Overview of asset in 2012
(Asset Ref. 1221D901D0502C01)

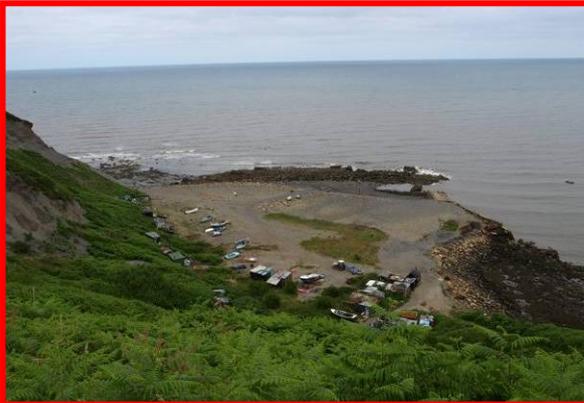
Overview of asset in July 2013
(Asset Ref. 1221D901D0502C01)

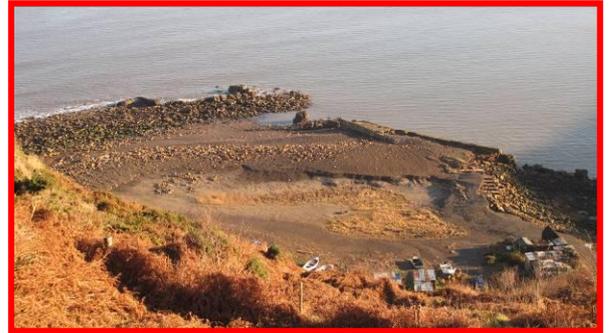
Overview of asset in Dec 2013 following storm surge of 5th Dec 2013. Significant loss of fill material adjacent to the breakwaters since July 2013 (left). (Asset Ref. 1221D901D0502C01)

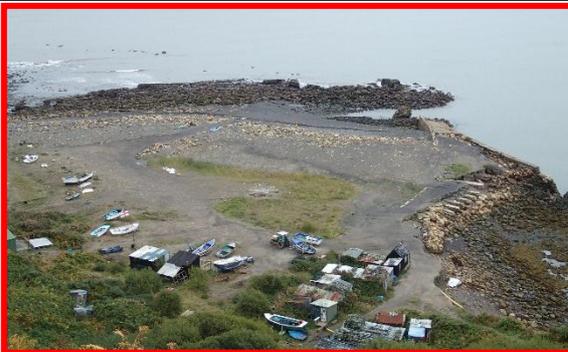
Overview of asset in September 2014
(Asset Ref. 1221D901D0502C01)

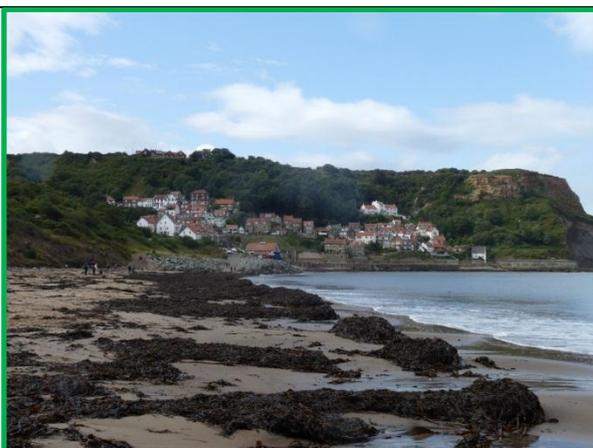
Unit MU7/1 includes Runswick Bay village and the adjacent slopes. It is well vegetated and defended at the toe by a sea wall and rock armour that is being outflanked at the north. The unit is classified as Dormant in 2014, unchanged since 2012.

MU7/1 – The slopes of Runswick Bay village (Dormant). August 2014.

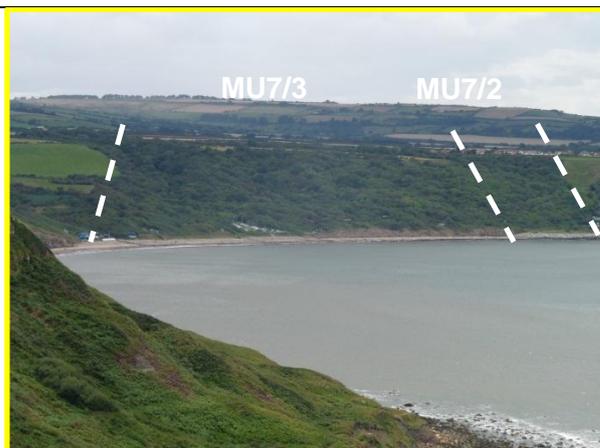
Unit MU7/2 is a narrow unit located to the south of Runswick Bay village representing a periodically active landslide complex. The slopes are relatively shallow and well vegetated. The only activity evident is at southern end of the unit toe, where the cliffs are subject to marine erosion where protection measures are more easily overtopped. This unit was upgraded from Inactive to Locally Active in December 2013 and this status has been retained in 2014.

MU7/2 (right of image with rock armour at toe - Inactive) **MU7/3** (left with eroding toe – Locally Active). August 2014.

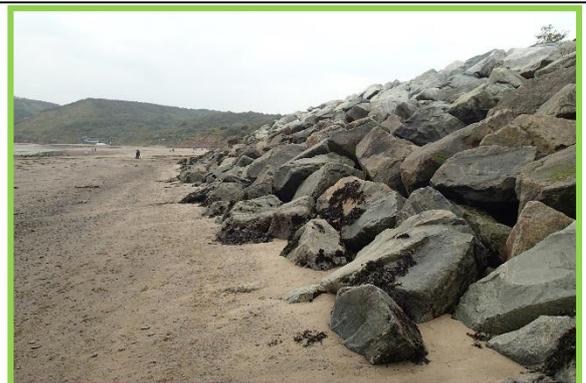
The rock armour defences (Asset ref: 1221D901D0602C01) remain generally in very good condition, with the rocks tightly packed with good coverage. However, there has been some movement resulting in loose blocks at both sides of the southern slipway and so the overall rating has been amended to good. The associated slipway towards the south from the end of the road and boat park is also in good condition. Beach levels appeared relatively high at the time of the inspection, so the toe was not visible. There is ongoing erosion of the undefended cliff at the southern end of the defence and some of the locally sourced smaller rock used at the tie in appears to have been reconfigured since the previous inspections, see lower photos below.

Runswick Bay village rock armour defences Photo 12/09/2014 (Asset Ref. 1221D901D0602C01)

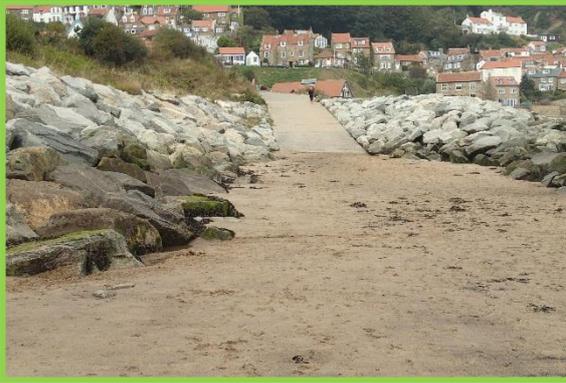
View of armour at southern slipway.
(Asset Ref. 1221D901D0602C01)

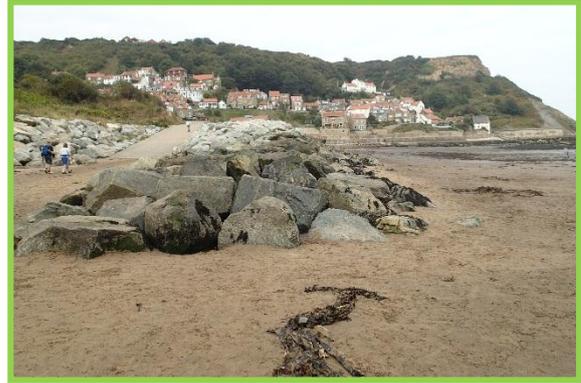
Some movement of armour units has occurred adjacent to the southern slipway
(Asset Ref. 1221D901D0602C01)

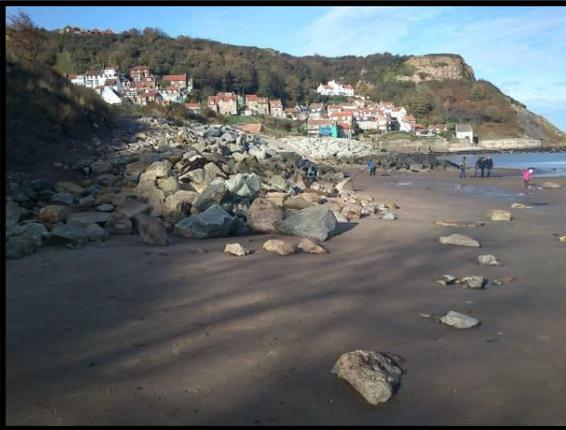
Southern end of Runswick bay rock armour defences Photo from 2012
(Asset Ref. 1221D901D0602C01)

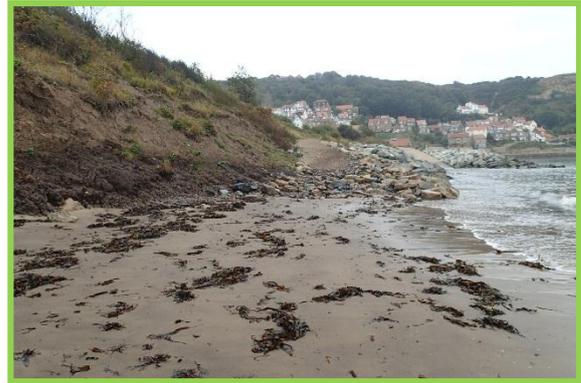
Southern end of Runswick bay rock armour defences Photo 12/09/2014.
(Asset Ref. 1221D901D0602C01)

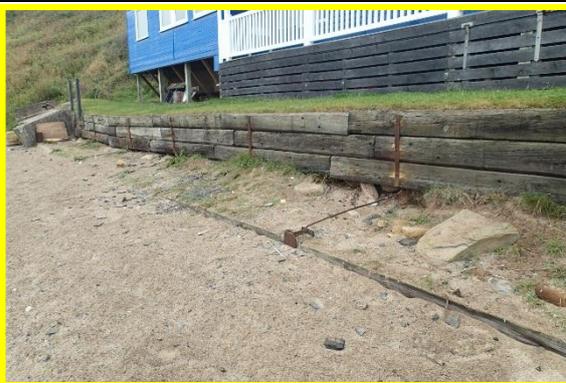
The Sailing Club, located in the bay some 600m south of the village, where the beach is wider has been constructed on timber struts and features a mix of coastal defences (Asset Ref. 1221D901D0602C05), photos below. The informally placed relic tank trap blocks at the south end show extensive cracking. The timber defences across the front of the main building are showing signs of rot and will need replacement in future. The defences were in similar condition to the 2012 and 2013 inspections, although there has been undercutting of the Timber sleeper retaining wall, see below, top left.

Runswick Bay sailing club timber defences at south end, 12th September 2014.
(Asset Ref. 1221D901D0602C05)

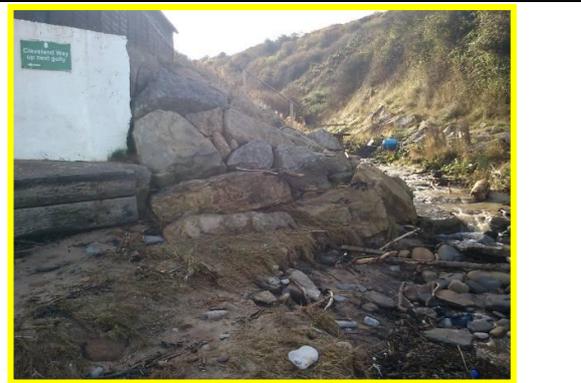
Northern end of defences at Runswick Bay sailing club. Photo from 2012.
(Asset Ref. 1221D901D0602C05)

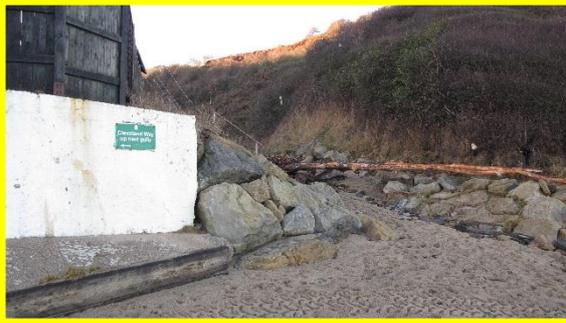
Northern end of defences at Runswick Bay sailing club, 17th December 2013. Note higher beach levels compared to 2012. (Asset Ref. 1221D901D0602C05)

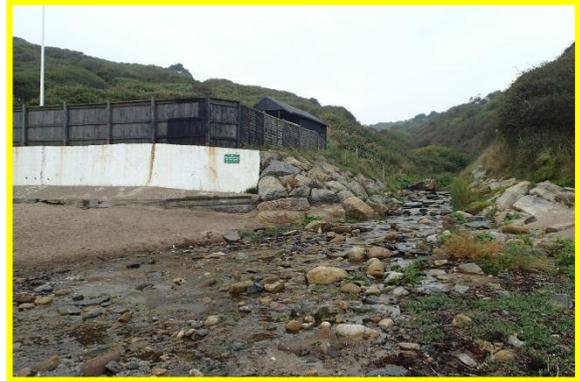
Northern end of defences at Runswick Bay sailing club, 12th September 2014. Beach levels similar to 2012. (Asset Ref. 1221D901D0602C05)

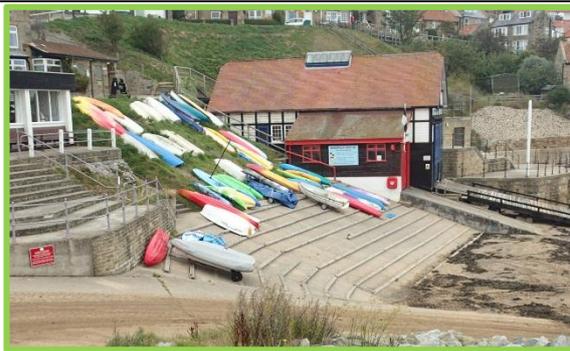
At the northern end of the rock armour, the slipway adjacent to the RNLI building remains in good overall condition, although the timber strips to support the small boats are rotting in many places and some are now missing. Joints between slabs in the slipway still need resealing. The timber slipway at the old RNLI building was damaged in the December 2013 storms, and many planks have been replaced, however the support timbers show signs of rot. The seawall around the pumping station to the north of the RNLI building is in very good condition, below lower right, although the standards for all of the handrails are showing corrosion and need cleaning and repainting, as noted in 2012.

Northern slipway adjacent to the RNLI. Some timbers missing. (Asset Ref. 1221D901D0601C04)

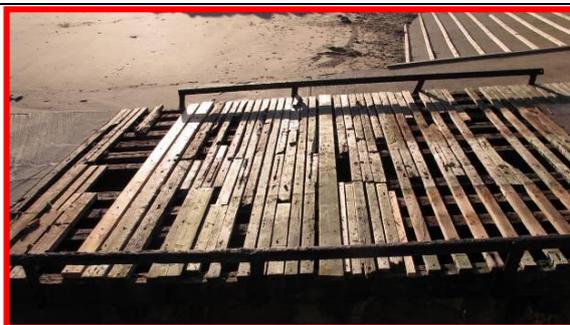
RNLI slipway storm damage viewed from the pumping station, 17th December 2013. (Asset Ref. 1221D901D0601C04)

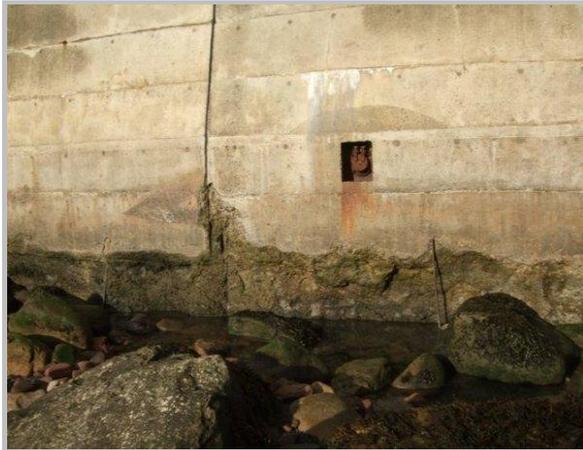
Undercutting of the northern coastal sea wall
(Photo taken from 2009 report)

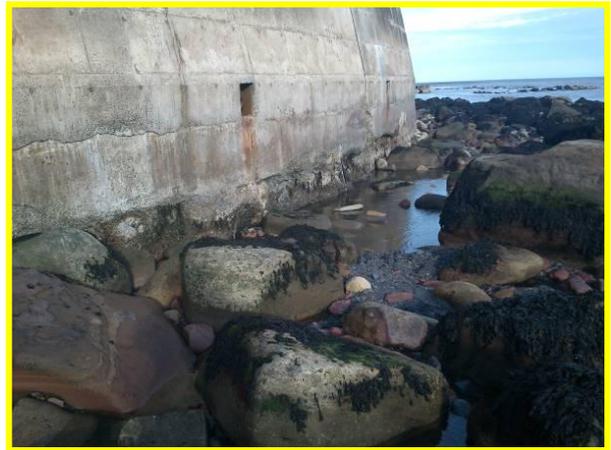
Foreshore scour at toe of seawall, photo from
30/10/2012 (Asset Ref. 1221D901D0601C01)

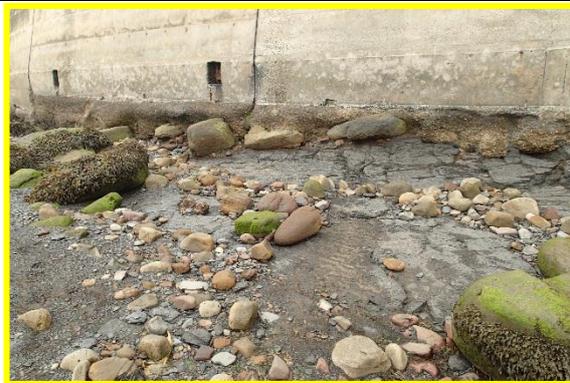
The most northern coastal sea wall (Asset Ref. 1221D901D0601C01) is suffering from surface cracking and erosion. Erosion of the underlying rocky foreshore continues to cause undercutting of the sea wall. Further investigation is required to determine the rate of undercutting. Further defects include washed out sealant joints, flap valves on weep holes which have seized shut, wash out of the joints under the capping beam, vertical cracks through the wall, missing joints and filler in the seawall face and promenade surface with vegetation growth, and outflanking at tie in to eroding cliff at northern end, see photos below. Although changes are limited since the 2009 inspection it is recommended that these issues are addressed. At the time of the 2014 inspection parts of the mudstone shore platform had been cleared of sediment and boulders, presumably by wave action, see central photos below.

Foreshore scour at toe of seawall, photo from
12/09/2014 (Asset Ref. 1221D901D0601C01)

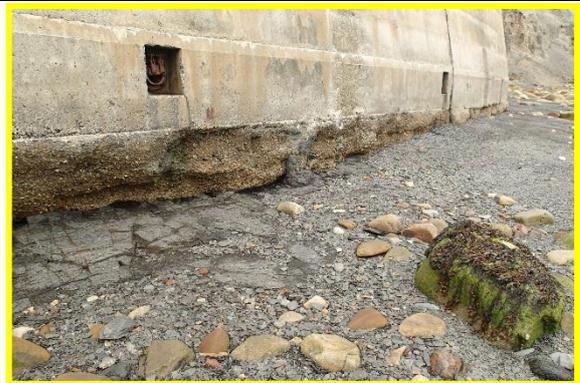
Foreshore scour at toe of seawall, photo from
12/09/2014 (Asset Ref. 1221D901D0601C01)

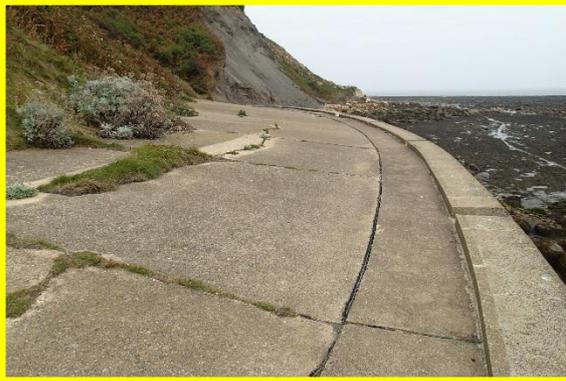
Promenade on top of northern seawall, showing movement of crest slabs and vegetation growth in damaged areas, 12/09/2014 (Asset Ref. 1221D901D0601C01)

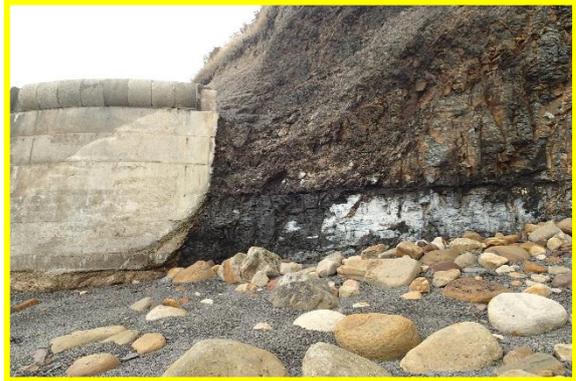
Erosion of cliff adjacent to north end of seawall, 12/09/2014 (Asset Ref. 1221D901D0601C01)

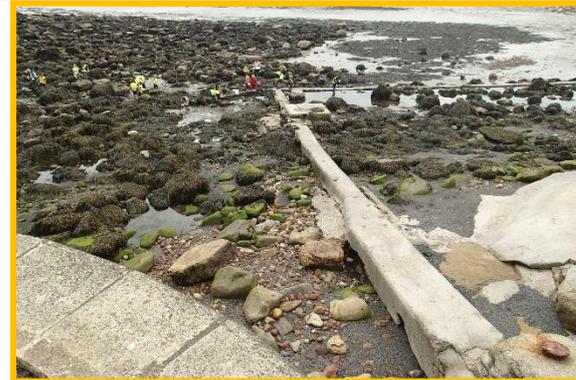
View of low foreshore levels and undermining of sewer pipe surrounds on foreshore at Runswick Beck, 12/09/2014

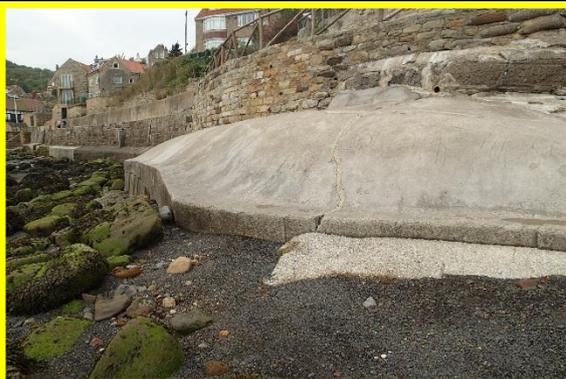
Moving south, the protruding section of wall (1221D901D0601C06) protecting the thatched cottage is in fair condition. There are signs of repairs to the large vertical cracks in the wall and toe apron. However there are cracks in the top of the concrete bagwork part of the wall.

Repaired vertical cracks to toe of wall, and horizontal cracks holding (Asset Ref. 1221D901D0601C06)

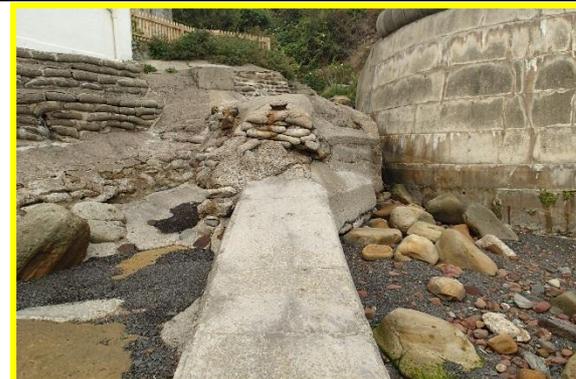
View of northern end of wall and Runswick Beck outfall with cracked concrete bagwork. (Asset Ref. 1221D901D0601C06)

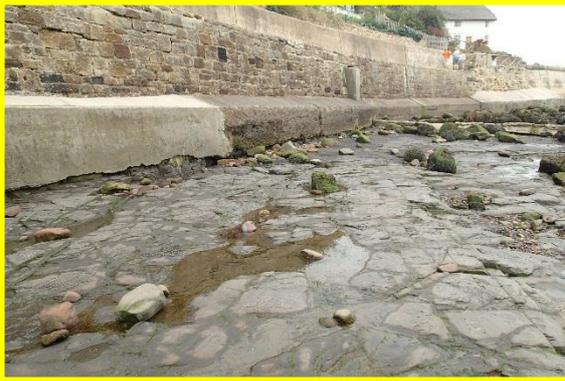
The main length of wall below the properties, Asset Ref. 1221D901D0601C03 is in variable condition. Although there are signs of repair work there are significant cracks in the wall and undercutting of the toe in several locations, see photos below. The beach level was lower than at the time of the 2012 inspection but similar to the December 2013 post storm inspection.

Exposed mudstone platform and undermining of wall toe 12/09/2014
(Asset Ref. 1221D901D0601C03)

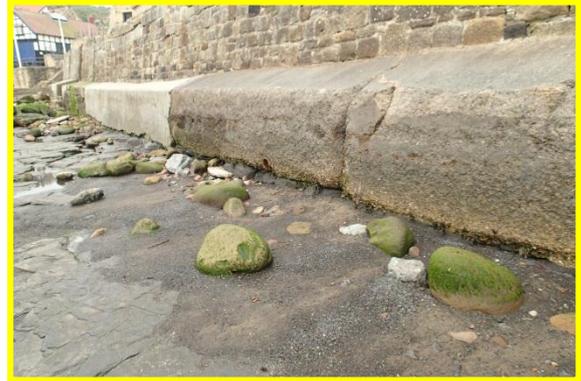
Undermining of wall toe 12/09/2014
(Asset Ref. 1221D901D0601C03)

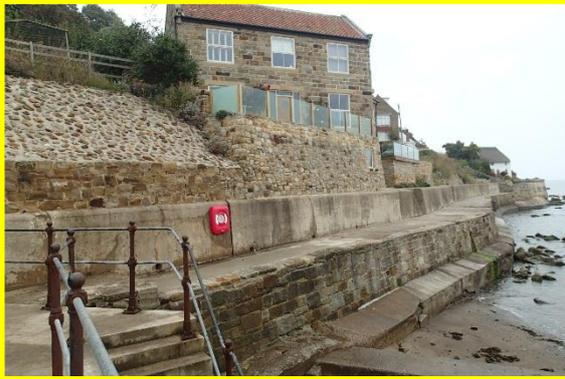
Overview of wall 12/09/2014
(Asset Ref. 1221D901D0601C03)

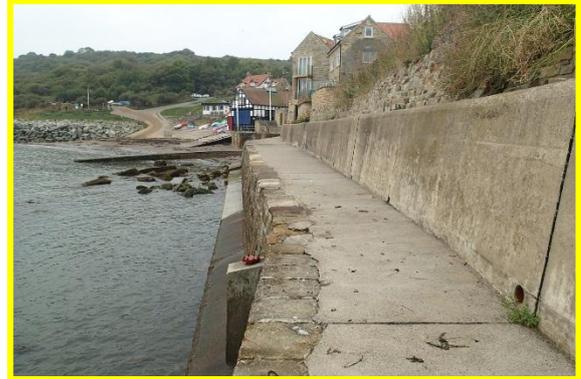
Damage to promenade cope 12/09/2014
(Asset Ref. 1221D901D0601C03)

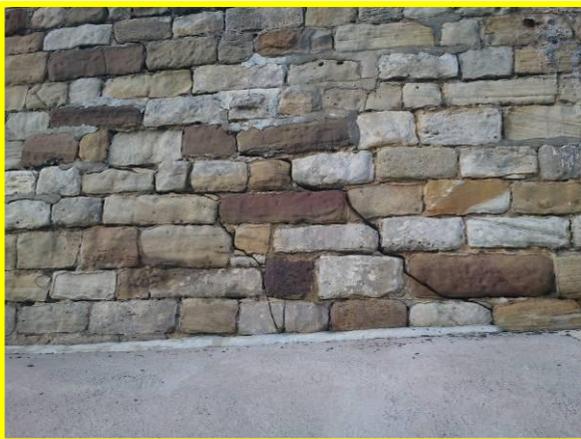
Diagonal cracks in wall **Photo from 2012** (Asset Ref. 1221D901D0601C03)

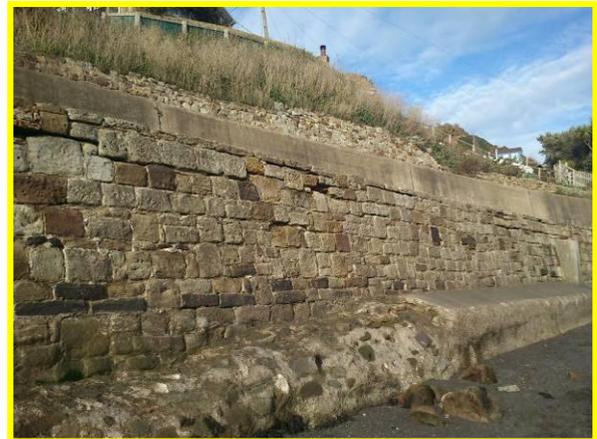
Gaps at joints and missing blocks **Photo from 2012** (Asset Ref. 1221D901D0601C03)

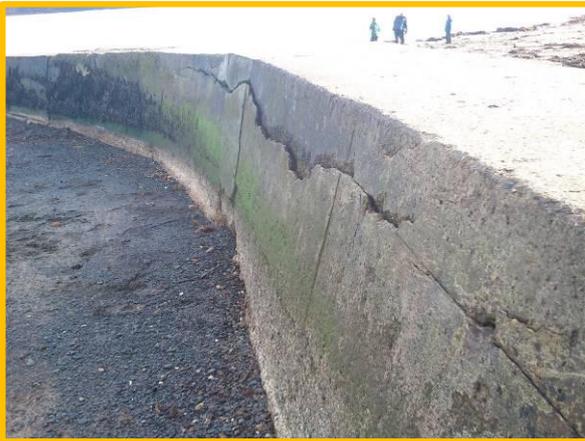
The concrete breakwater or groyne (Asset Ref. 1221D901D0601C02) to the north of the pumping station and old RNLI slip was noted to be in need of repair during the 2009 survey, with large horizontal and vertical cracks on both sides propagating through the defence. The large deep horizontal cracks through breakwater have worsened since 2012 and the crest slab may have moved.

Large horizontal crack to breakwater photo from 2012. (Asset Ref. 1221D901D0601C02)

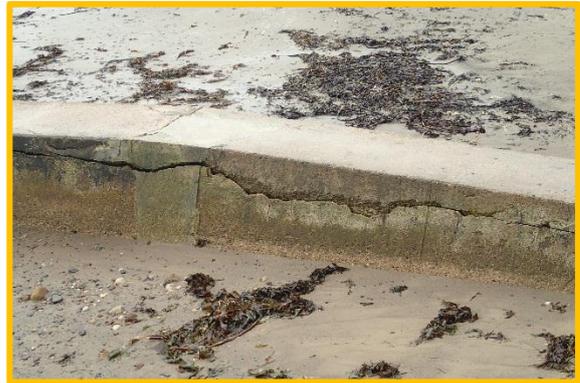
Large horizontal crack to breakwater photo from 12/09/2014 (Asset Ref. 1221D901D0601C02)

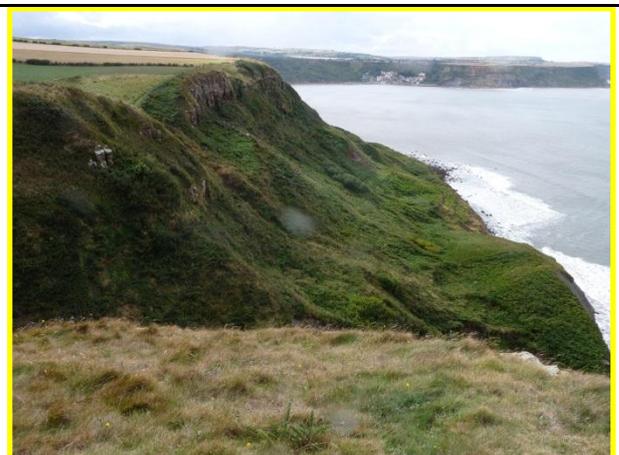
MU8/2 Relict debris run out lobe adjacent to Runswick Sands (Locally Active). August 2014.

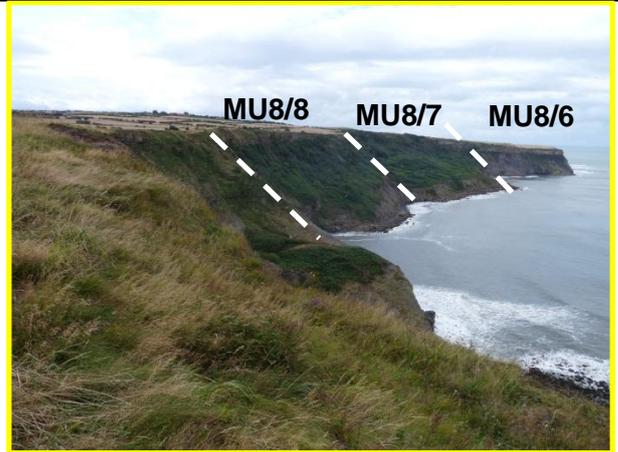
MU8/6, MU8/7 and MU8/8. MU8/6 (furthest headland) is Partly Active and MU8/7 and MU8/8 are both Locally Active. August 2014.
