**Walk-over Visual Inspections of Assets
including Coastal Slopes**

**Scarborough Borough Council
Final Report**

November 2014

Coast Protection Assets and Coastal Slope Condition Analysis

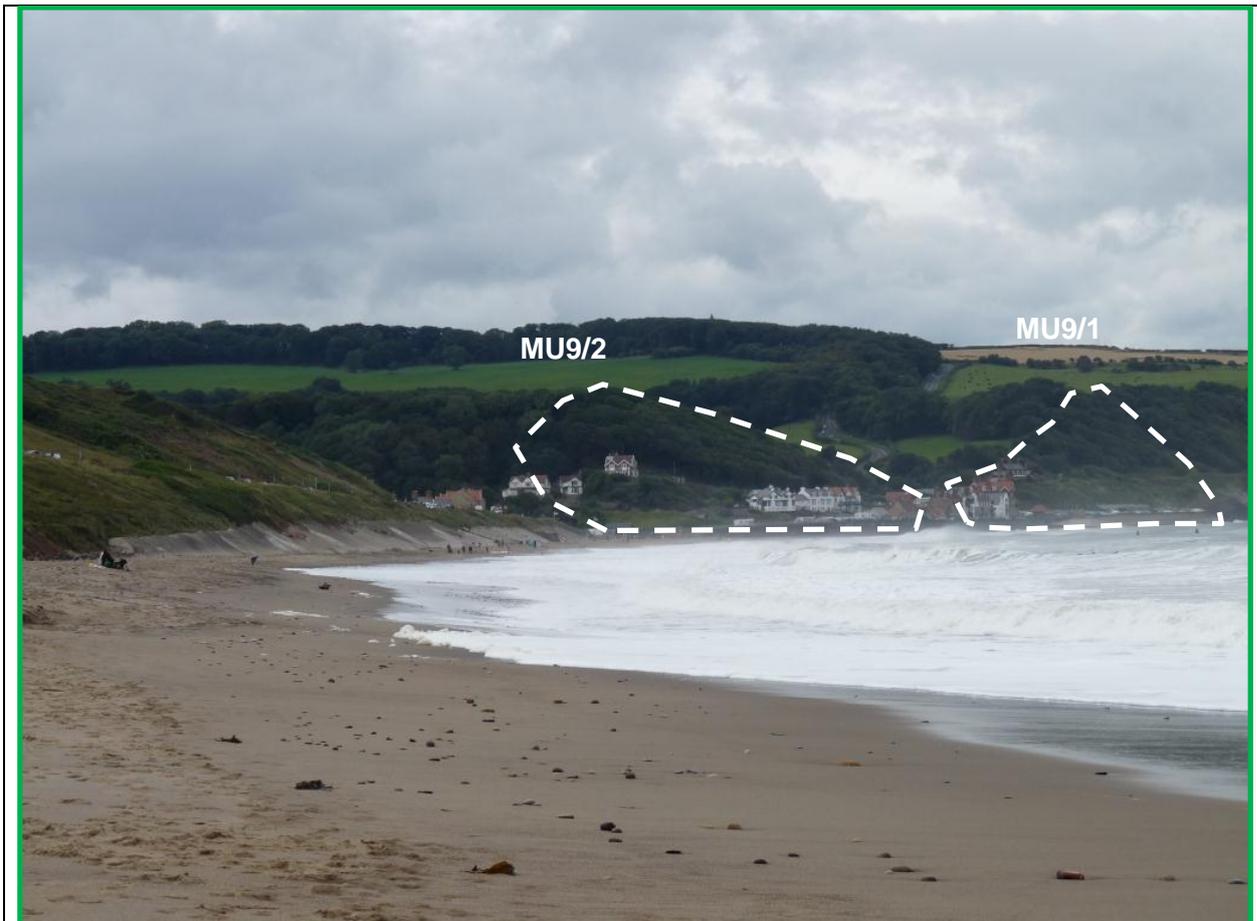
Management units MU9/1 and MU9/2 are Dormant cliffs behind Sandsend village. They are defended at the toe by a sea wall, groynes and rock armour. No evidence of activity was seen in 2014.

MU9/1 and MU9/2 are located close to Sandsend and show no signs of activity (Dormant). August 2014.

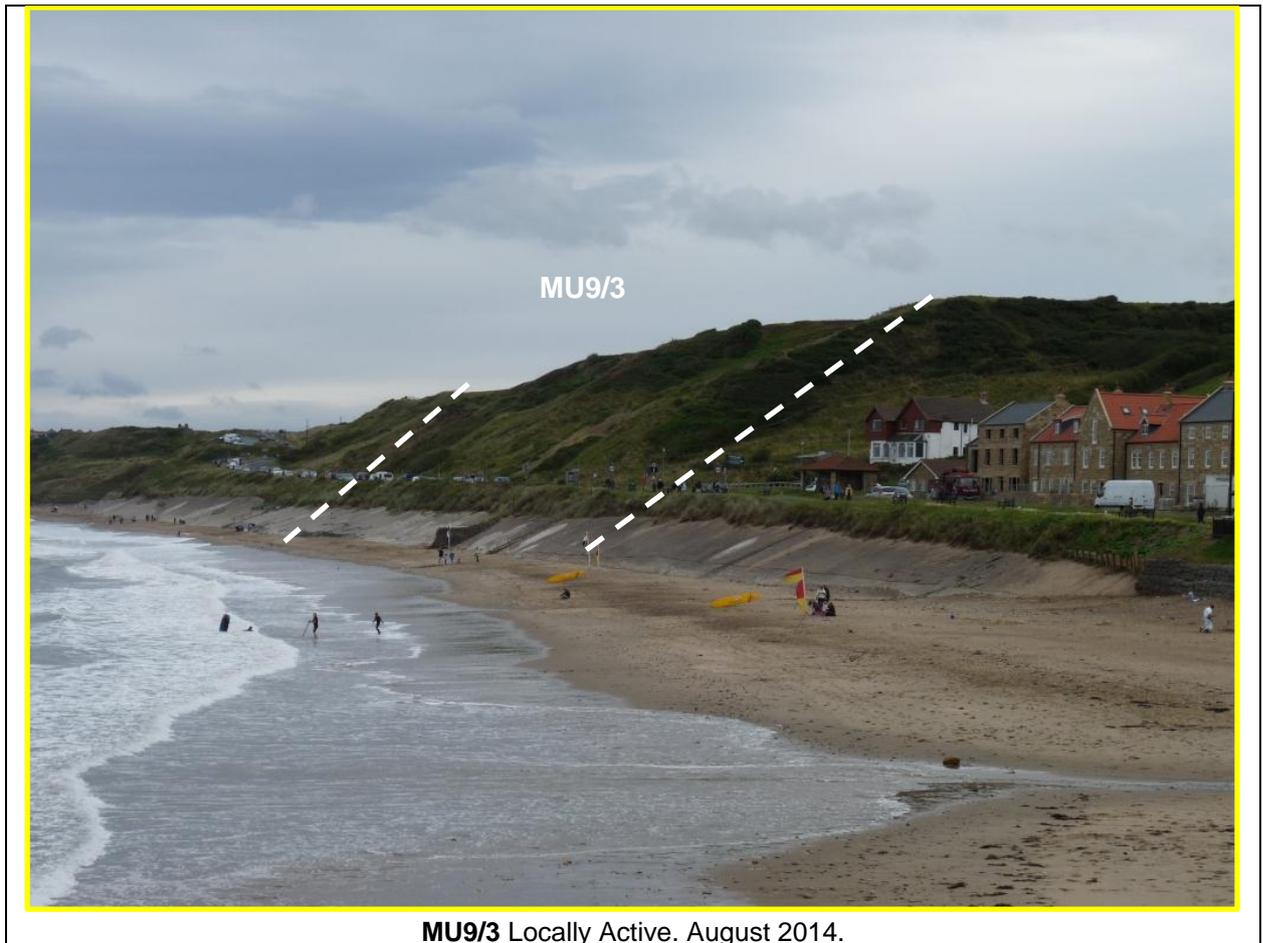
This sub-management unit consists of unit MU9/3 only. This unit is located above the concrete sea defences immediately to the east of Sandsend. There has previously been some effort to stabilise the slopes within this unit, which reduced the level of activity. This unit is was classified as Locally Active in 2012 following completion of stabilisation works. The defences suffered damage during the December 2013 storm surge, and there was evidence of failure just above the sea defences. The defences have since been repaired, but evidence of shallow failures in the upper slope persists and the unit is classified as Locally Active.

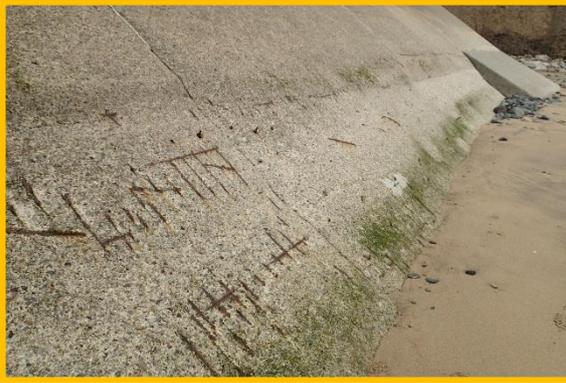
The most northerly defence at Sandsend car park area, is a sloping concrete revetment with recurve crest wall and rock armour toe protection (Asset Ref No.1221D901D0701C02). The concrete wall is in fair condition with minimal damage to the surface. There is some minor cracking and surface erosion which is typical of concrete defences such as this. The north end of the revetment has lost thickness of concrete at the base through abrasion, with exposure of reinforcement bars, although the worst area noted in the 2009 inspection was not visible as it was covered with cobbles and may have been repaired. Encasement of this reinforcement is advised from a structural perspective, as well as preventing any H&S accidents occurring due to sharp edges of the exposed bars. The toe of the revetment is exposed and undercut in many places, with abrasion of the soft rock on which the wall is founded ongoing, see below left. The toe armour is displaced and not fully protecting the toe; this could be ameliorated by re-profiling and topping up the rock armour protection. The large void under the south side of slipway adjacent to Sandsend Beck, reported in 2012 has been repaired.

Abrasion damage to revetment exposing reinforcement.
(Asset Ref No.1221D901D0701C02)

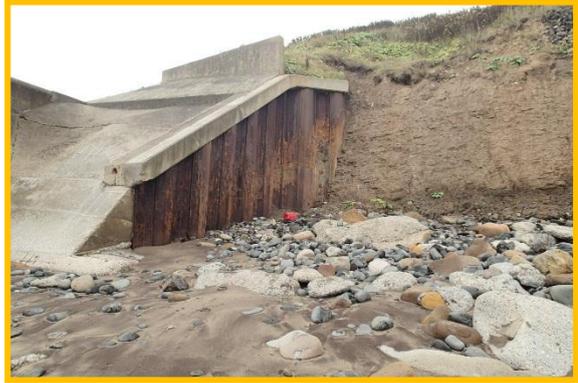
Corroded sheet piling and ongoing erosion at northern end of Sandsend revetment.
(Asset Ref No.1221D901D0701C02)

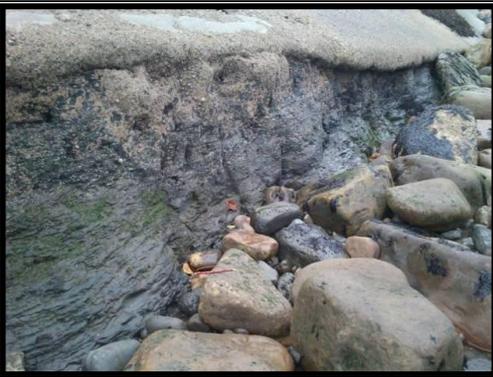
Displaced toe armour, undercutting to concrete revetment and abrasion damage to revetment.
Photo from 2012 report.
(Asset Ref No.1221D901D0701C02)

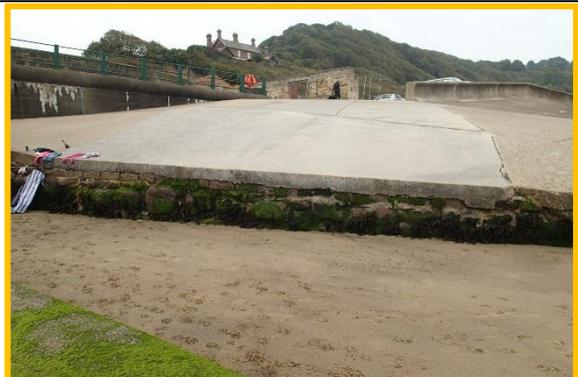
Repairs have been undertaken at the slipway at the north of Sandsend
(Asset Ref No.1221D901D0701C02)

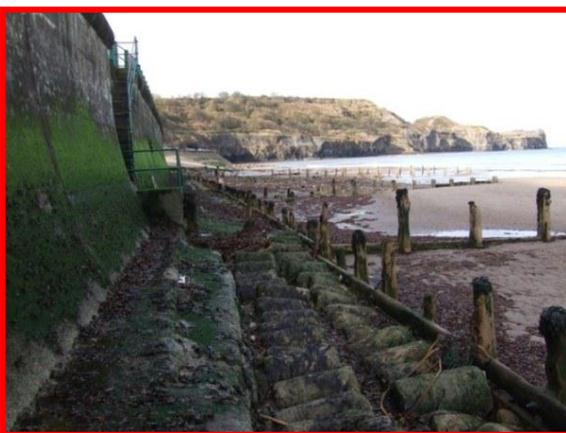
At the time of the September 2014 inspection the beach was higher than it had been during the 2009 and 2012 inspections, so the toe structures in front of the main concrete seawall in front of Sandsend village (Asset Ref. 1221D901D0702C01), were mostly covered, see photos below. The groyne field is derelict and the remains have no significant impact on sand movement. The toe of the seawall was showing evidence of significant damage and movement in 2009 and the defence appeared to have worsened over the three years to 2012, with the timber breastwork deteriorating and allowing the ad hoc toe protection units to move. There are cracks in the wall and significant abrasion at the steps.

Timber toe of sea wall in a poor state - **photo from 2009** (Asset Ref. 1221D901D0702C01)

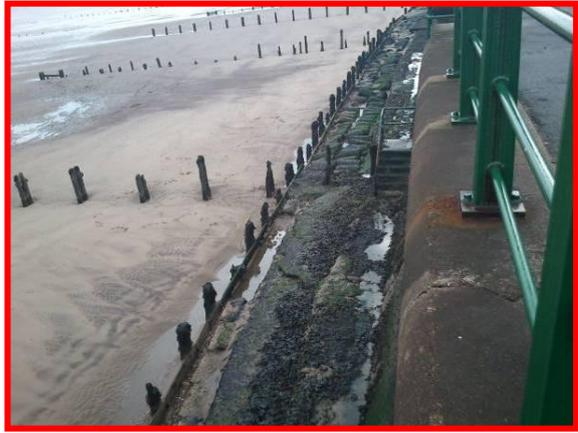
Failed timber groynes and timber breastwork at toe of wall in front of Sandsend **photo from 2012**
(Asset Ref. 1221D901D0702C01)

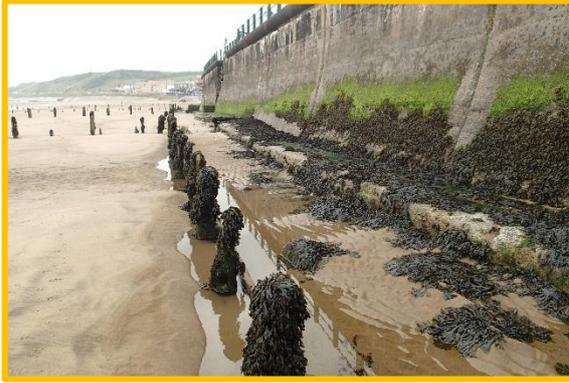
Condition of wall, which was rated as poor in 2012 is similar or worse despite higher beach levels. (Asset Ref. 1221D901D0702C01)

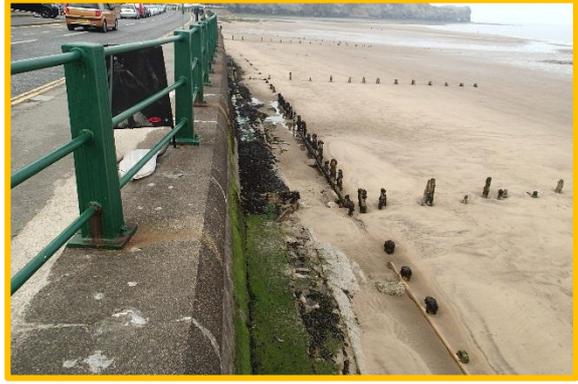
Derelict groynes and timber toe breastwork partly covered due to high beach levels. Ref. 1221D901D0702C01)

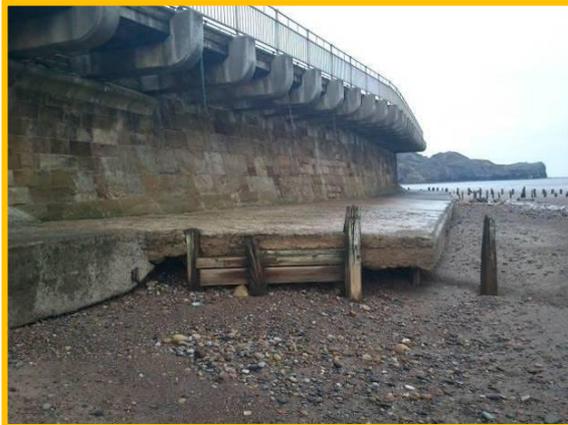
The newer short section of masonry blockwork sea wall (Asset Ref. 1221D901D0702C04) that supports a cantilevered promenade just north of East Row Beck was noted in the 2008 inspection to suffer from undercutting of the toe of the structure with steel sheet piling in need of repair. Although the main wall is in fair condition the defence has an overall rating of poor. The steel toe piling was visible in several locations during the 2012 inspection and is corroded and abraded. There are holes through the piles and voids behind under the apron. The 2012 inspection noted a particularly large void under the southern end of the apron, see below left. The high beach levels at the time of the 2014 inspection meant it was not possible to tell if the damage had been repaired. The timber decking of the cantilever footway was destroyed during the December 2013 surge and repairs were nearing completion in September 2014.

Masonry blockwork sea wall with cantilevered footway, showing large void under toe apron and failed groynes. **Photo from 2012.** (Asset Ref. 1221D901D0702C04)

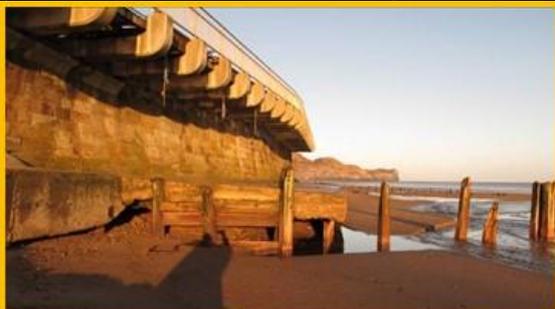
Photo from 17th December 2013, showing larger void under toe apron and failed groynes. (Asset Ref. 1221D901D0702C04)

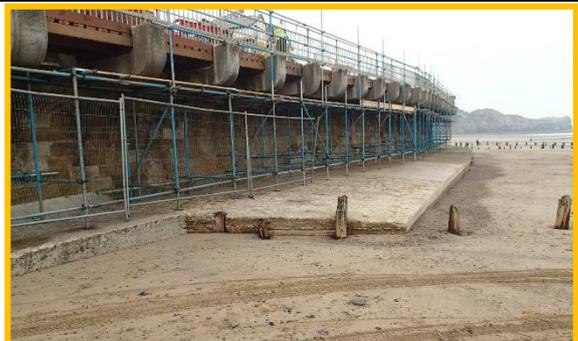
Toe damage not visible due to high beach levels on 12/09/2014 (Asset Ref. 1221D901D0702C04)

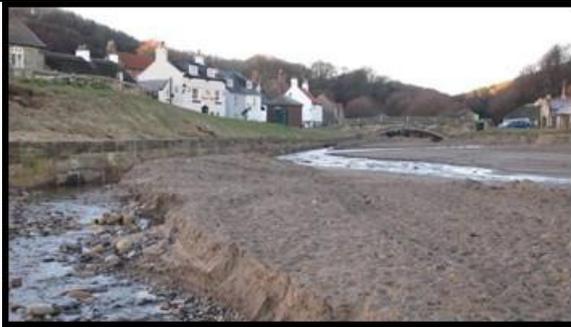
The low masonry wall (Asset Ref. 1221D901D0702C03), below left and right, that returns into both sides of East Row Beck adjacent to the road bridge was previously recorded in overall good condition, although there was minor abrasion damage to some blocks and locally missing sections of mortar. It is notable that following the storm surge of 5th December 2013, extensive beach material accumulated in the East Row Beck inlet area between the retaining walls. There were noted to be some crest blocks missing and missing mortar in more locations in 2014 and the overall condition grading has been reduced to fair.

Low masonry wall at East Row Beck, south bank, **Photo from 17th December 2013**. Note accumulation of sand with the beck cutting through. (Asset Ref. 1221D901D0702C03)

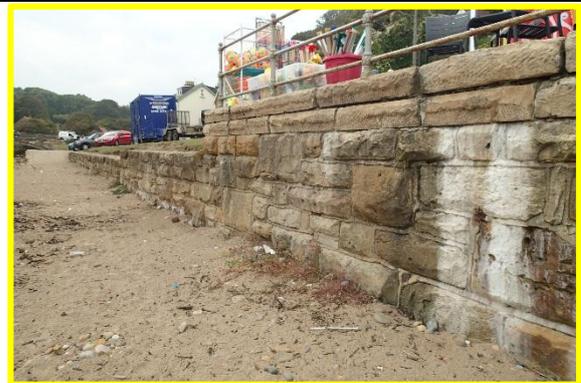
Low masonry wall at east Row Beck, north bank. Damage including missing blocks and mortar adjacent to beach shop. (Asset Ref. 1221D901D0702C03)

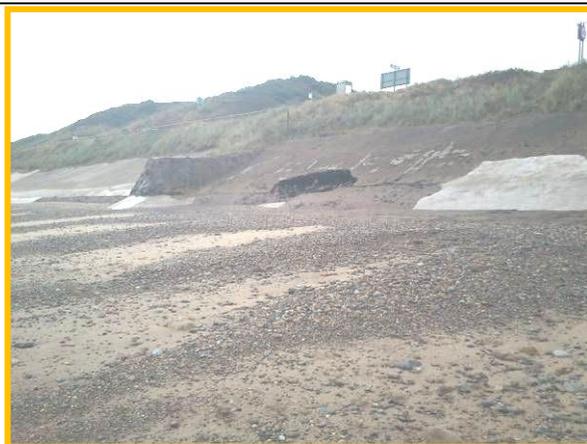
Southeast of Sandsend, a large sloping concrete revetment covering light weight rock armour / rubble runs parallel to the coastal road (Asset Ref. 1221D901D0702C02). This 800m long defence features many significant defects throughout, despite multiple repairs. In 2012 there was a large void > 1.5m across where the revetment had failed and the underlying rubble was being actively eroded, see photo below top left below. There was severe damage to the revetment during the December 2013 storm surge. The photos below show a selection of photos of the damaged revetment in December 2013 when repairs were underway and the status at the time of the 2014 inspection. The whole asset is in poor condition and requires frequent inspection and repairs to hold the shoreline until the capital improvement scheme that is planned can be undertaken in the future.

Large void in revetment adjacent to recent patch repair (Asset Ref. 1221D901D0702C02)

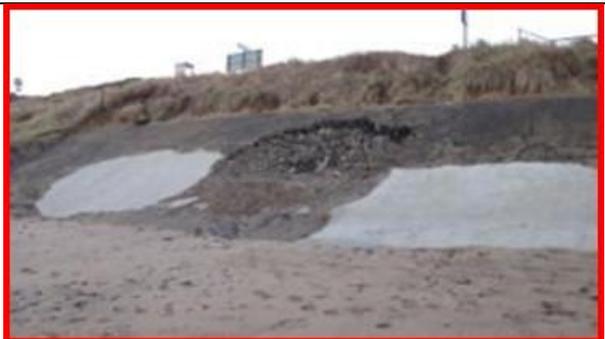
New large void in revetment adjacent to previous and more recent patch repairs, **17th December 2013**. Compare to 2012 inspection (left). (Asset Ref. 1221D901D0702C02)

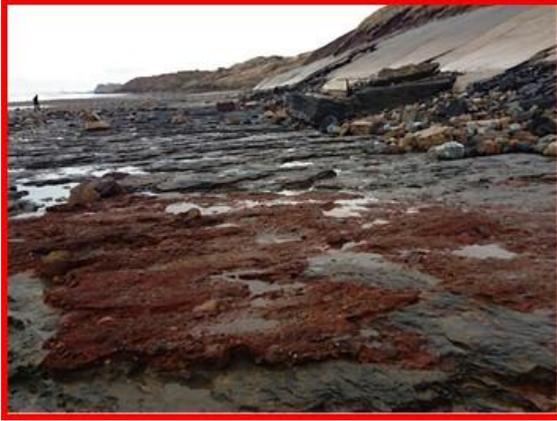
Sandsend seawall revetment and eroded beach following the storm surge of 5th December 2013. **Photo taken on 8th December 2013**, NYCC inspection. (Asset Ref. 1221D901D0702C02)

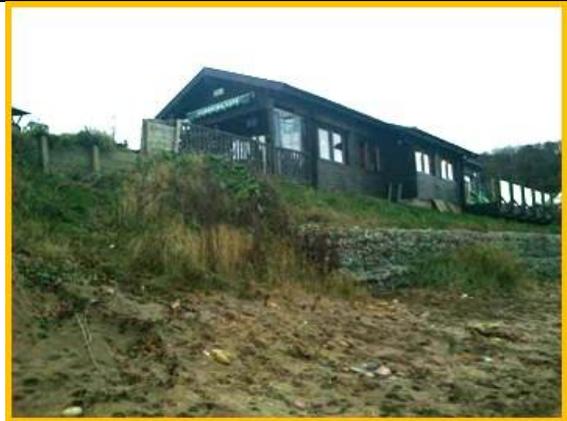
Gabions protecting café at NW end of revetment, **Oct 2012**. (Asset Ref. 1221D901D0702C02)

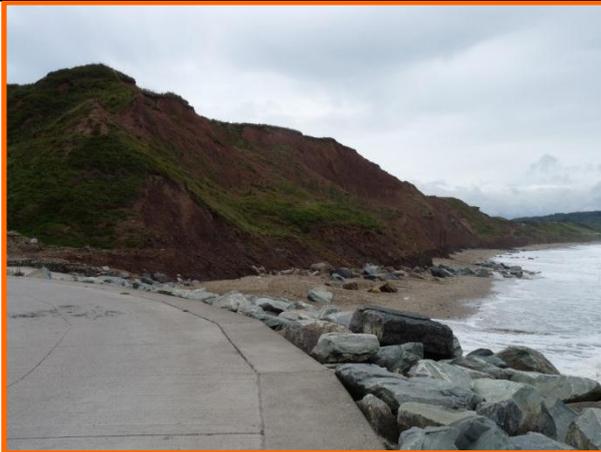
MU10/2 comprises the till cliffs behind Upgang Beach that prone to episodic mudslides and block failures. Vegetation cover is limited along the cliff face and the unit is classified as Partly Active in 2014, unchanged since the December 2013 survey.

MU10/2 – Looking west from eastern end of unit (Partly Active). August 2014.

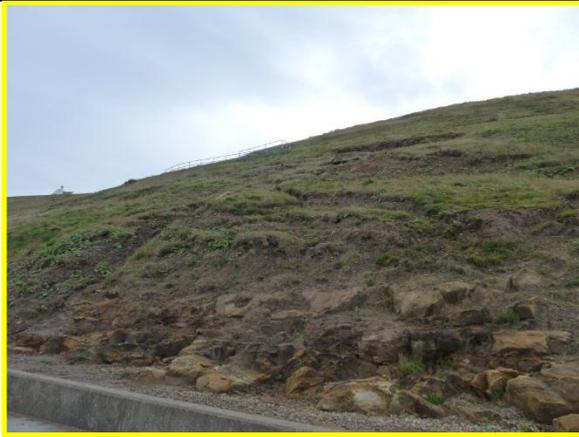
These units are comprised of re-graded slopes protected by a sea wall and promenade. The slopes are well-vegetated, but there is evidence of localised instability, particularly in the lower slope of unit **MU11/2**. Slope stabilisation repairs undertaken before 2010 are still visible either side of one of the paths descending the cliff in unit **MU11/1/** (indicated by an arrows in the unit photograph). Both these units were classified as Inactive in the 2012 survey, but were upgraded to Locally Active during the December 2013 post surge survey. They remain Locally Active in 2014.

MU11/2 – Example of lower slope erosion and instability. August 2014.

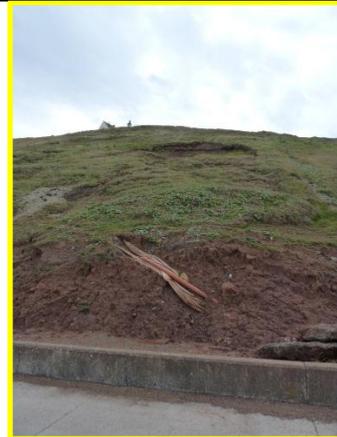
MU11/2 – Example of lower slope erosion and instability. August 2014.

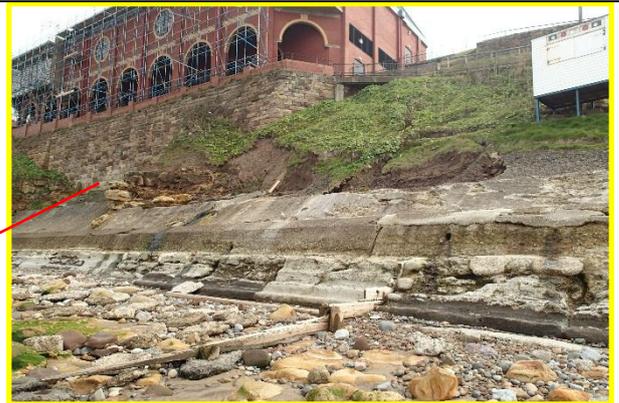
MU11/3 – Failure of both till slope and exposed rocks above defences. August 2014.

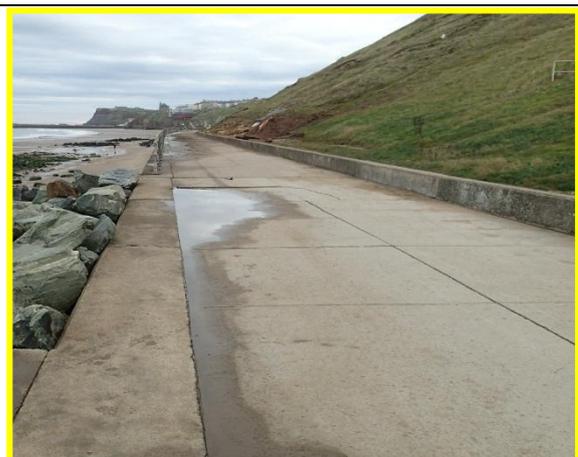
The most westerly defence at Whitby is a rock armour defence fronting the promenade (Asset Ref. 1221D901D0801C01). As in the 2009 and 2012 inspections the armour is in good condition with only minor movement visible. The asset is in overall good condition although the promenade is rated as fair as some slabs appear to be sinking with cracks and standing water, which may be a sign of loss of fill and voids beneath. Further investigation and monitoring is needed, although there was no obvious change between 2012 and 2014, see photos below.

Promenade looking south east showing cracks in slabs and standing water **Photo from 2014, (compare to 2012 photo left)** (Asset Ref. 1221D901D0801C01)

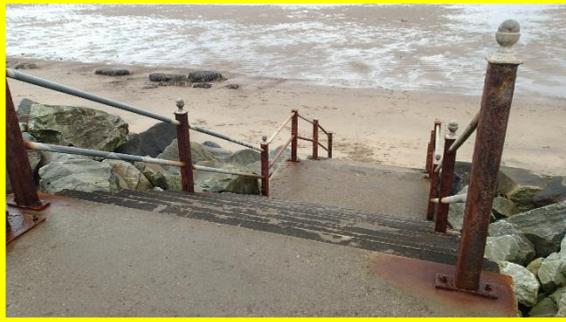
Corroded standards to handrails at steps
(Asset Ref. 1221D901D0801C01)

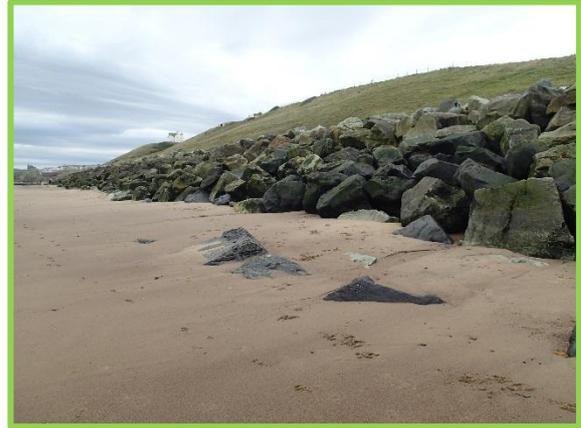
Rock armour in good condition
(Asset Ref. 1221D901D0801C01)

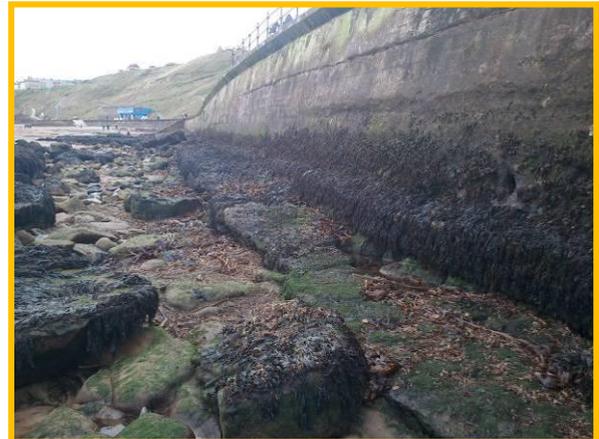
The sections of seawall along the frontage west of the North Beach Café with no protective rock armour, Asset Ref. 1221D901D0802C01, and 1221D901D0802C03 have in many places lost the concrete surface over whole lower half of wall due to abrasion. The toe is exposed and there was undercutting observed in 2012, see below left and right. Although the beach was higher in 2014 and the toe was not visible, there was significant abrasion damage to the lower part of the wall. There is also local damage to the wall capping beam and promenade slabs in a number of locations from wave overtopping damage where there is no rock revetment. The large concrete wall structure (Asset Ref. 1221D901D0802C03) is similar to the wall to the north west, but has no rock armour. The toe is exposed and eroded along its length, leading to significant undercutting, although the beach was higher at the time of inspection that during the previous, 2009 inspection. This defence is currently in a poor condition. Repairs to toe are required to prevent future instability of wall and it is recommended that consideration is given to extending the rock armour to this section. Adjacent sections of wall show similar defects although toe is often less visible.

Undermining of toe in section with no rock armour
Photo from 2012.
(Asset Ref. 1221D901D0802C03)

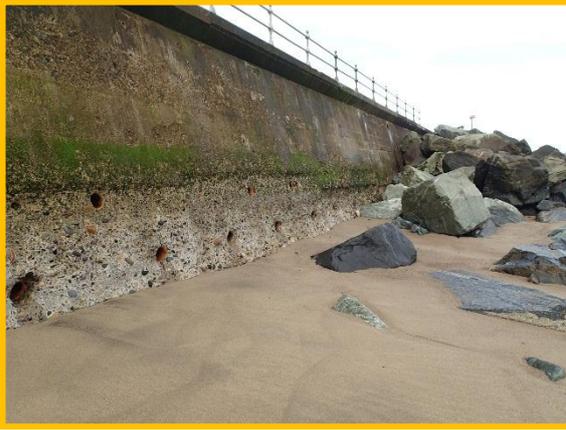
Abrasion damage to lower part of wall
(Asset Ref. 1221D901D0802C01)

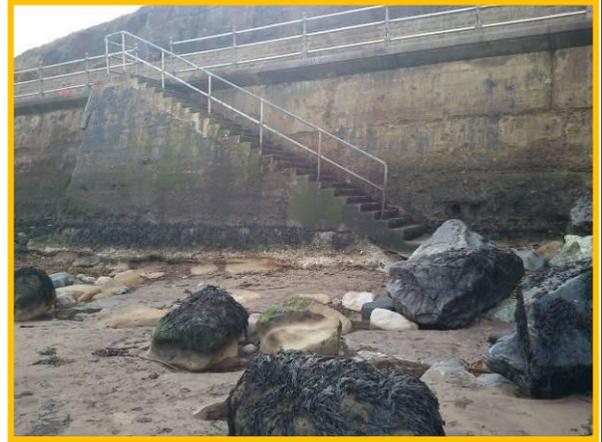
Undermining of wall adjacent to steps – **Photo from 2012** (Asset Ref. 1221D901D0802C03)

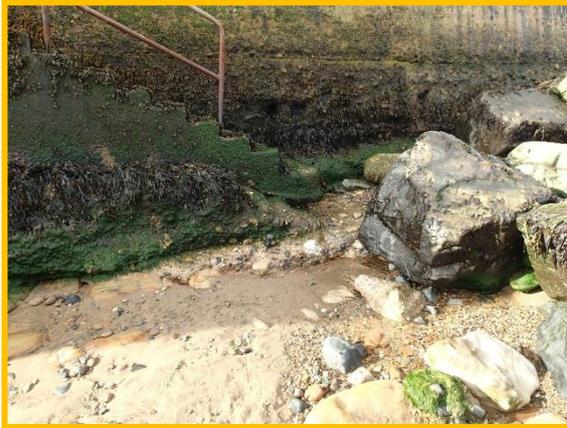
Undermining of wall adjacent to steps – **Photo 25/09/2014** (Asset Ref. 1221D901D0802C03)

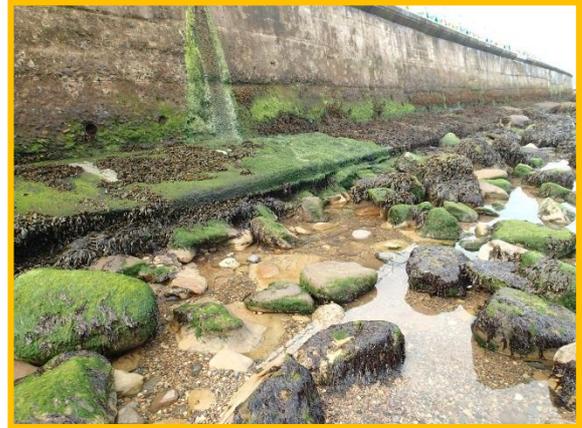
Undermining of toe apron – **Photo 25/09/2014**
(Asset Ref. 1221D901D0802C03)

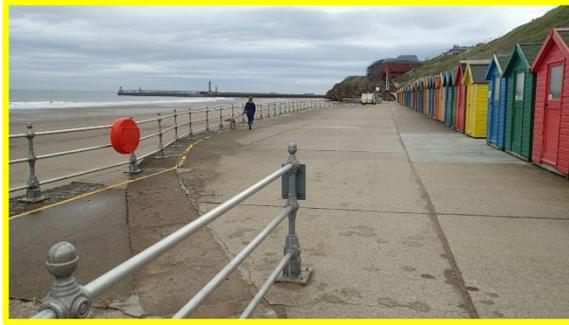
General view of promenade showing new handrails, repaired slab, and open joints. (Asset ref. 1221D901D0802C14)

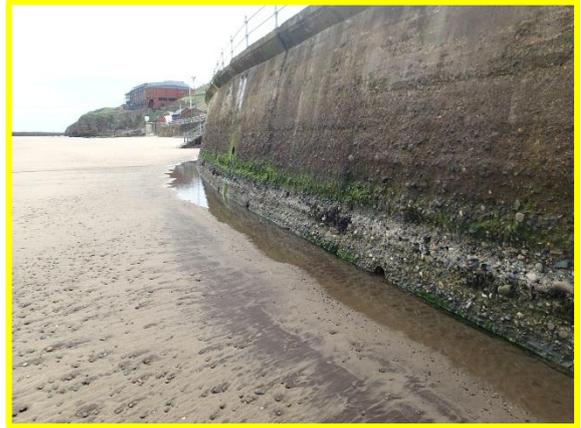
Abrasion damage to wall (Asset ref. 1221D901D0802C14)

The wall adjacent to Argyle Road (Asset ref. 1221D901D0802C14), above right, is in fair condition, and is intact with no toe exposed at the time of the site visit, as in 2012. However, the front face shows extensive abrasion and erosion and there are significant cracks both through the capping and directly beneath it. Although in some places patch repairs are visible, these defects should be monitored and repaired when possible to prevent further degradation in the future.

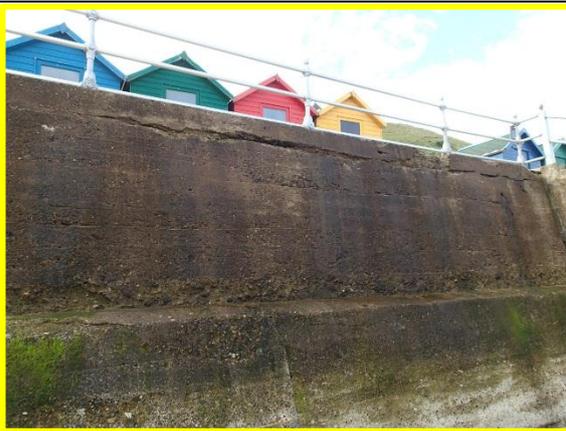
Horizontal cracks in wall (Asset Ref. 1221D901D0802C04)

East of Argyle Road Asset Ref. 1221D901D0802C04, see above, shows similar defects to previous inspections, with extensive abrasion damage and cracking. The new handrails have been set back slightly from the edge, presumably to avoid the defects and anchor to a sound section of wall. The upper level handrails have not been replaced and are corroding.

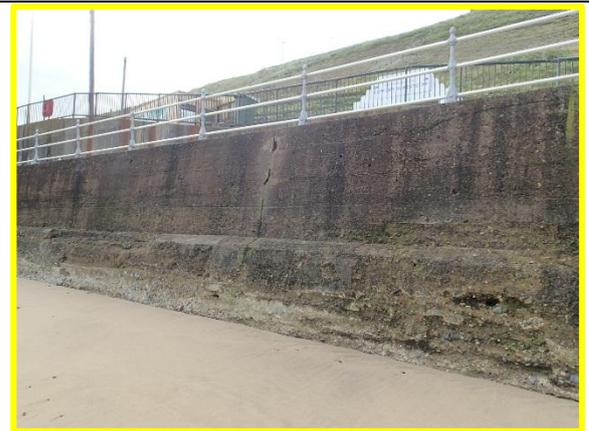
Horizontal and vertical cracks and loss of facing (Asset Ref. 1221D901D0802C04)

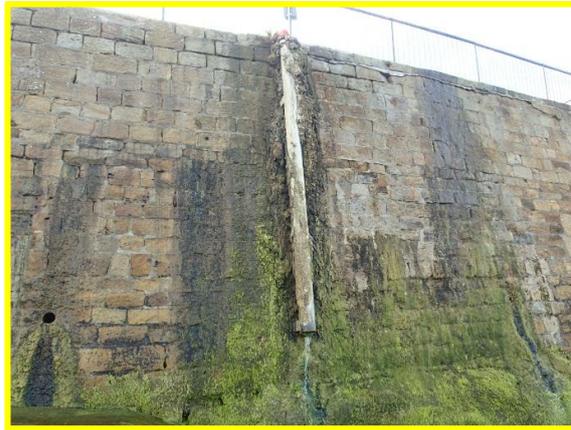
The masonry blockwork walls to the east, Assets Ref. 1221D901D0802C07 and 1221D901D0802C06 are in fair overall, but locally poor condition. There are cracks through blocks, washout along joints and the capping shows damage. The upper level concrete wall is in fair condition. Both assets' lengths have pipes exiting through front face, seepage from which has attracted vegetation growth.

Cracking, mortar loss and vegetation growth due to leaking pipe (Asset Ref. 1221D901D0802C06)

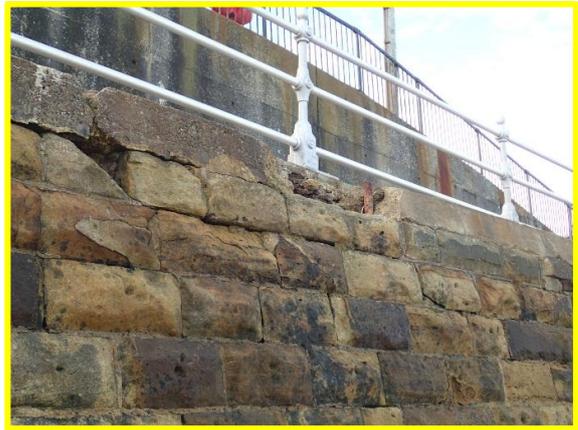
Cracking, mortar loss, damage to capping (Asset Ref. 1221D901D0802C07)

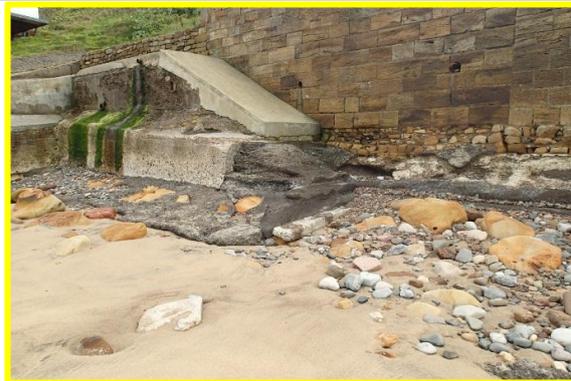
Joint washout abrasion damage and undermining at toe. (Asset Ref. 1221D901D0802C06)

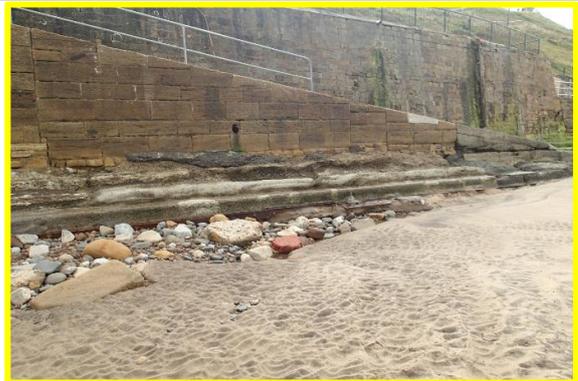
Undermining of toe and damaged blocks (Asset Ref. 1221D901D0802C06)

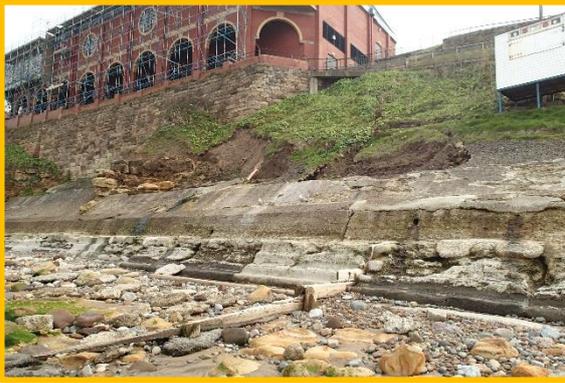
The area below the theatre consists of a variety of defences, which are formed in several vertical stages or layers, with concrete/stone on the beach and with cliff toe protection walls formed of timber breastwork, rock armour and vertical walls. These make up Assets Ref. 1221D901D0802C15 and C05. The beach was low in September, exposing the toe of the defences which have multiple defects and have been downgraded from fair to poor condition.

During the August and September 2014 inspections surface slips and failure of the underlying rocks were noted in this area, see photos below and also MU11/3 above. Concerns over the poor condition of the defences, potential issues with cliff stability and the need for urgent further investigations were highlighted to Scarborough Borough Council immediately after the inspection.

Concrete revetment toe in poor condition and slumps and failures in cliff below building.
(Asset Ref. 1221D901D0802C15)

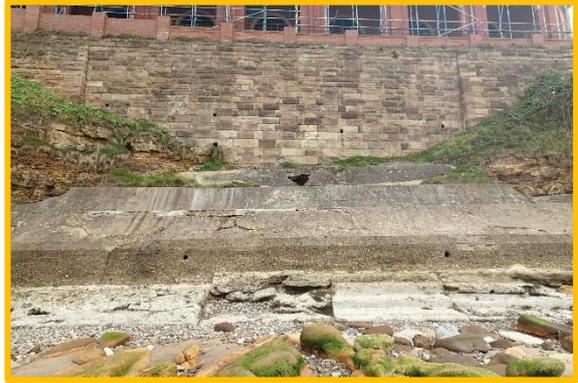
Damage to toe protection and weathering of natural rock below upper wall
(Asset Ref. 1221D901D0802C15)

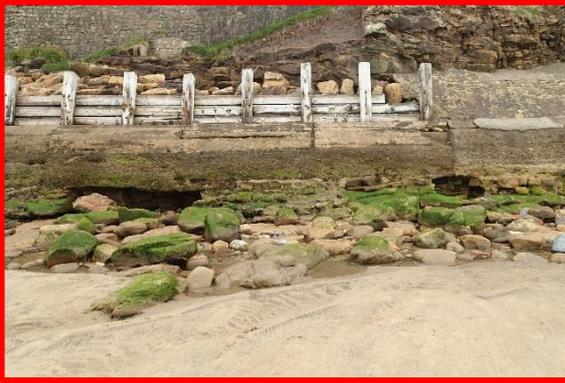
Defence toe undermined with large voids (very poor condition)
(Asset Refs. 1221D901D0802C05)

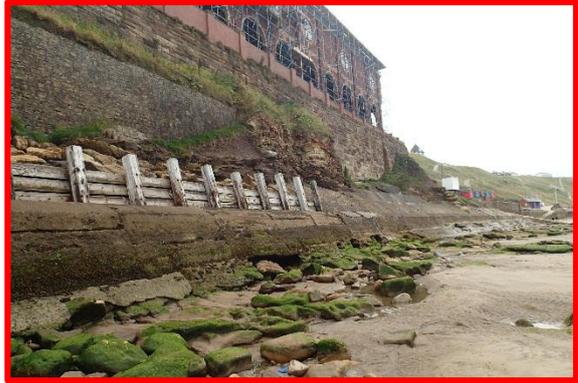
Weathering and loss of cliff material above failed toe protection (Asset Ref. 1221D901D0802C05)

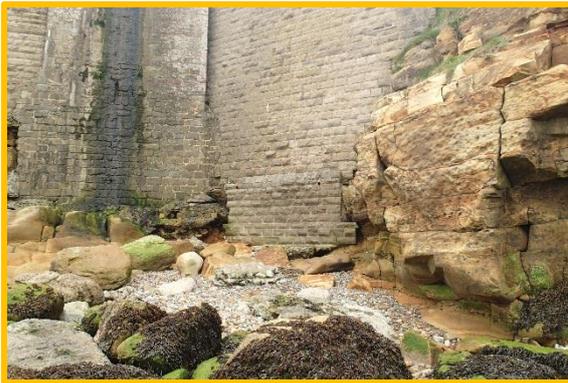
To the east of the theatre the natural cliff is intermittently defended with a series of blockwork and brickwork sections. These vary in construction and are generally in fair to good condition, but there are areas of undercutting and erosion at the interfaces between the blocks and the natural cliff that require repair and which lowers the condition to a 'fair' grading.

Example of undercutting at interface with cliff requires repair -poor condition.
(Asset Ref. 1221D901D0802C09)

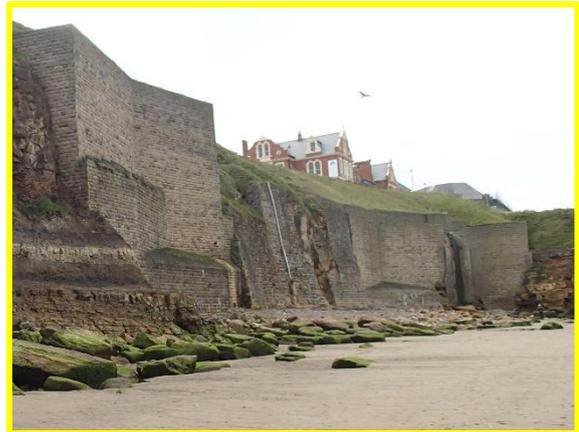
Intermittent cliff protection - fair condition overall
(Asset Ref. 1221D901D0802C09)

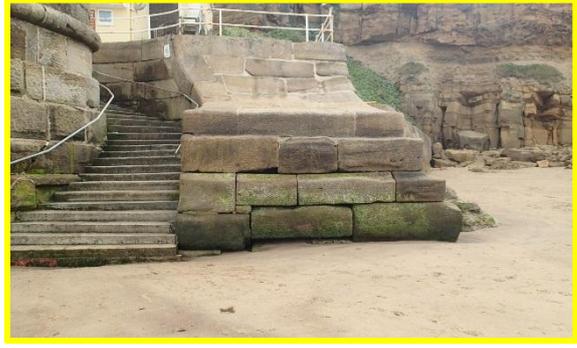
Evidence of repairs and repointing to upper blocks (Asset Ref. 1221D901D0802C12)

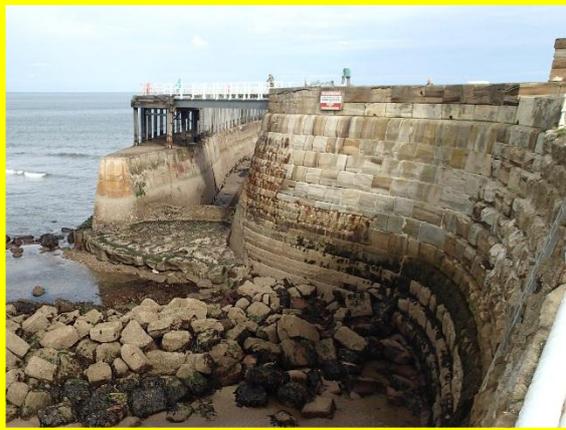
The main eastern and western harbour arms (Asset Refs. 1221D901D0803C02 / C03) have loose blocks and possible vertical movement in at least one location on each arm. It is recommended that the fixity of the loose blocks is investigated urgently, and that any voids are filled with grout. It is possible that loose blocks could displace during a storm and that there

Undermining of apron between main and outer West Breakwater (Asset Ref. 1221D901D0803C02 / 01)

may be a significant quantity of wash-out material behind it, leading to the consequent weakening and collapse of the structure. It is understood that a major capital scheme to improve the piers is under consideration. Longer term detailed monitoring recommendations should be developed as part of the scheme maintenance plan.

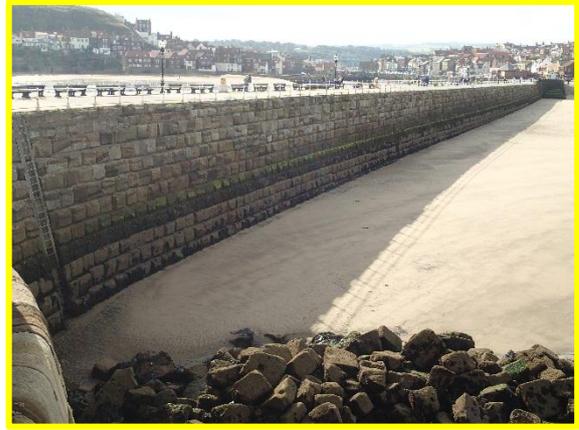
General view of West breakwater (Asset Ref. 1221D901D0803C02)

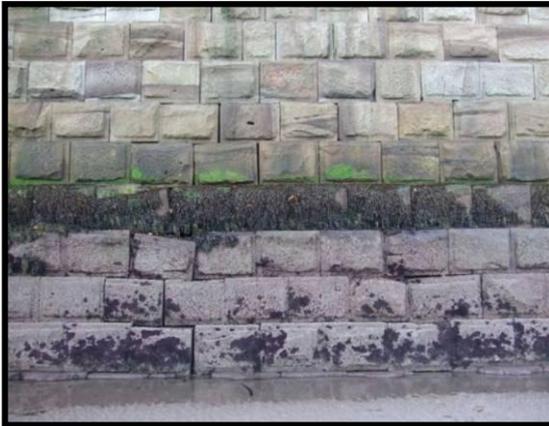
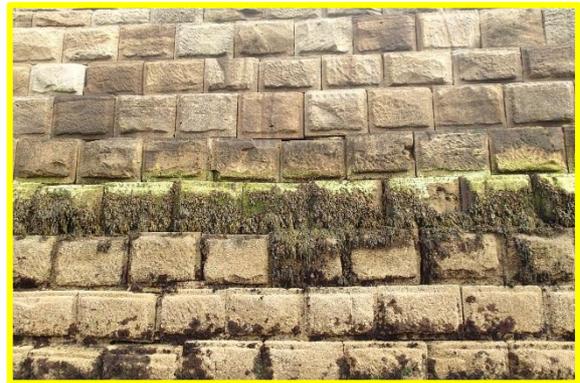
Displacement of block work on west side of West Breakwater - left image from 2009, right from 12/09/14 (Asset Ref. 1221D901D0803C02)

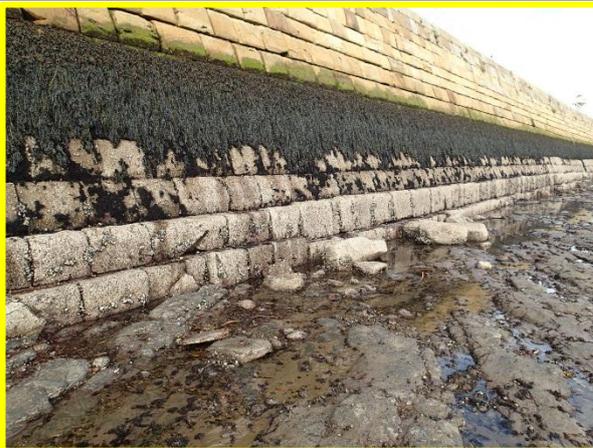
Toe of east side of West Breakwater (Asset Ref. 1221D901D0803C02)

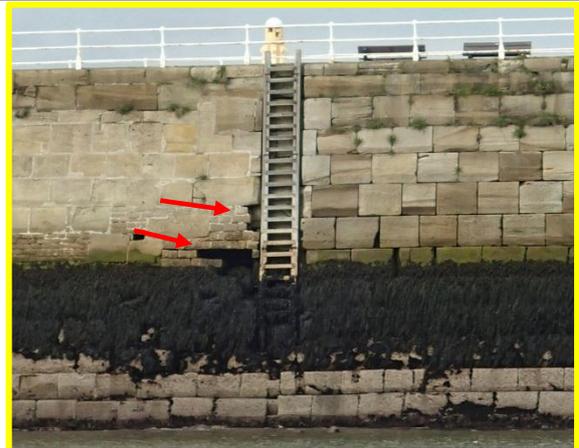
Missing blocks and voids in east face (Asset Ref. 1221D901D0803C02)

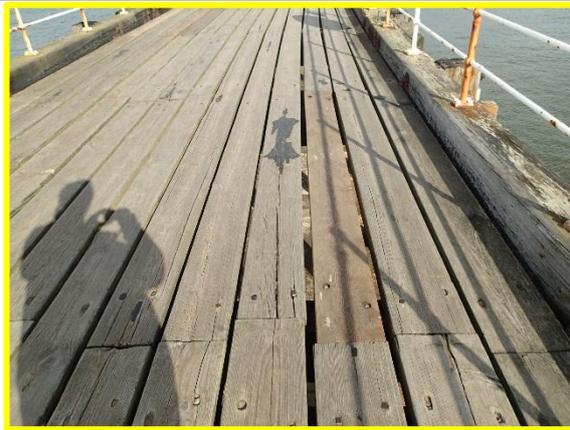
There is a new access bridge, opened in July 2012, between the main and outer western breakwaters. The timber deck of the western outer breakwater (C01) was in a fair condition, with evidence of rot to some ends of some planks (below left). It is slippery when wet so may

Damage to ends of timber desk on West Pier extension and replacement plank (Asset Ref. 1221D901D0803C01)

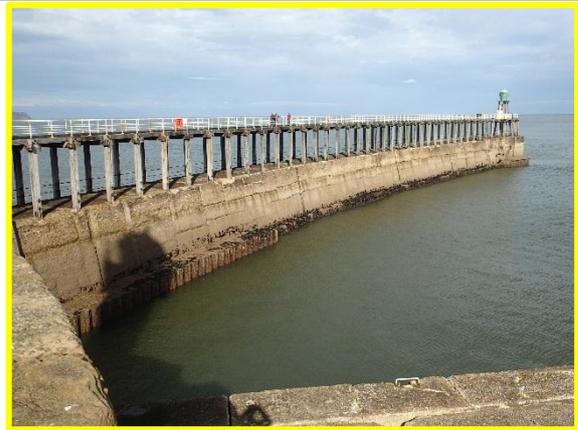
General view of west outer breakwater (Asset Ref. 1221D901D0803C01)

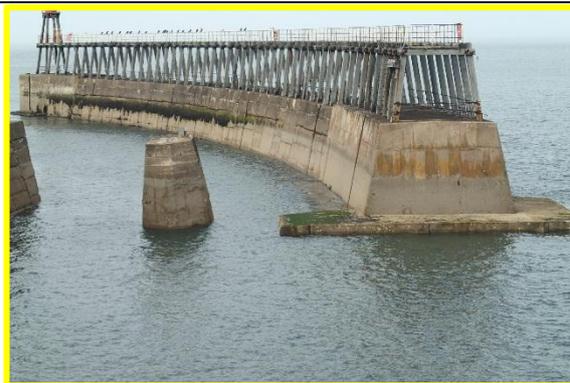
An urgent works scheme was undertaken in 2011/12 to repair the southern end of the outer east breakwater where a large void had formed in the structure behind the sheet pile toe which had failed following corrosion and abrasion. Despite the repair the asset remains in overall poor condition due to corroded toe piling and rotting timber deck structure. This asset was only inspected from the main east breakwater as there is no access on foot even at low water.

General view of outer east breakwater extension arm, on 12/09/2014 showing south end of outer east breakwater extension arm, where failed toe piling was replaced with precast concrete panels in 2012. (Asset Ref. 1221D901D0803C04)

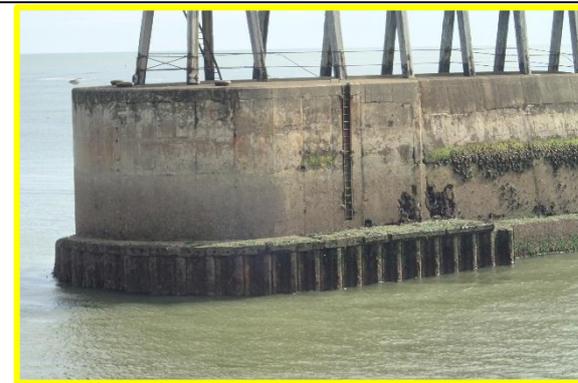
North end of outer east breakwater extension arm on 25/09/2014, showing corroded toe piles. (Asset Ref. 1221D901D0803C04)

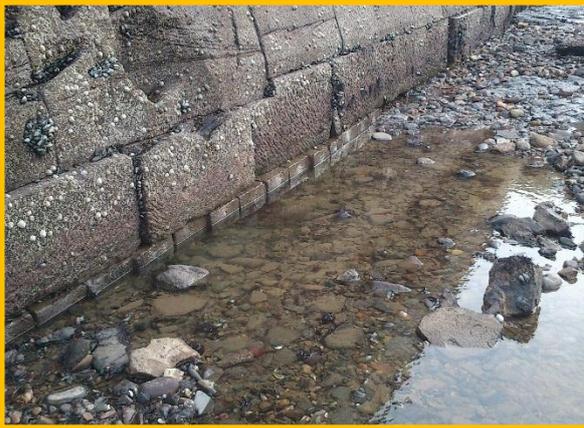
The main east breakwater 1221D901D0803C03 remains in poor overall condition. There are large cracks to the promenade and settlement of poured concrete slabs and erosion to capping beams. Furthermore there is displacement to the sandstone block work, with large cracks at several locations and voids in the blockwork near the NE bend. There are also loose blocks at south end by the rock armour. As was found in 2012, the low beach levels on the harbour side of the breakwater is exposing a section of timber foundation below the stone blockwork, see photos below left and right which may accelerate decay of the timber and destabilise the blockwork.

Exposed timber foundation under inner face of east breakwater **photo from 2012.**
(Asset Ref. 1221D901D0803C03)

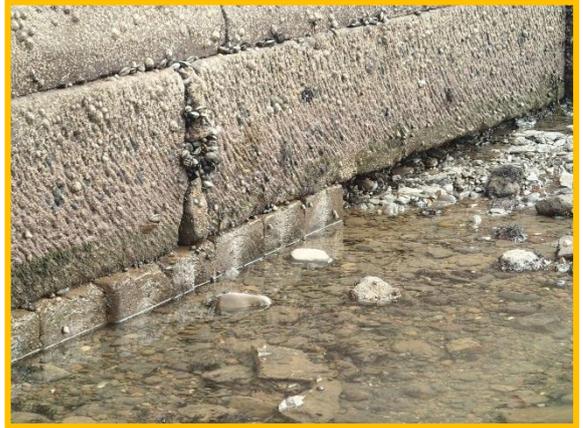
Exposed timber foundation under inner face of east breakwater **photo from 25/09/2014.**
(Asset Ref. 1221D901D0803C03)

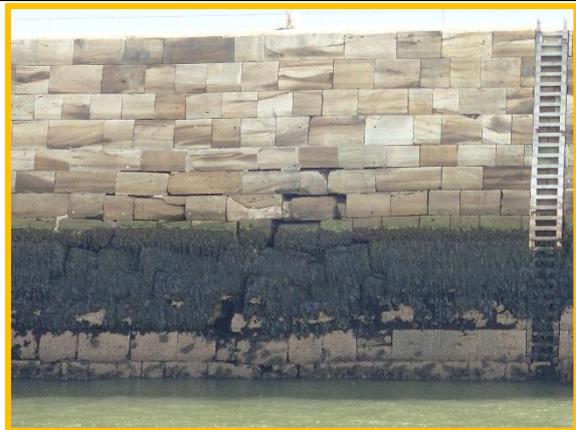
Area of displaced blocks and voids on inner (W) face of East Pier
(Asset Ref. 1221D901D0803C03)

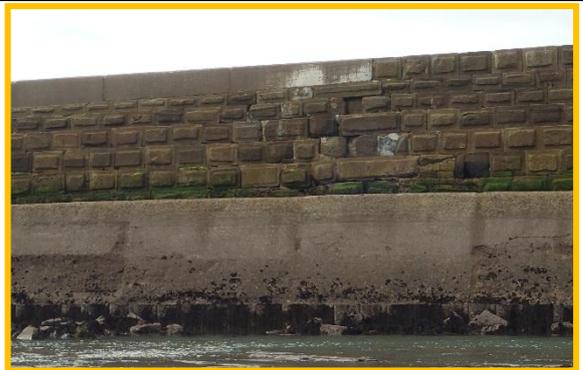
Example area of displaced blocks on outer (W) face of East Pier
(Asset Ref. 1221D901D0803C03)

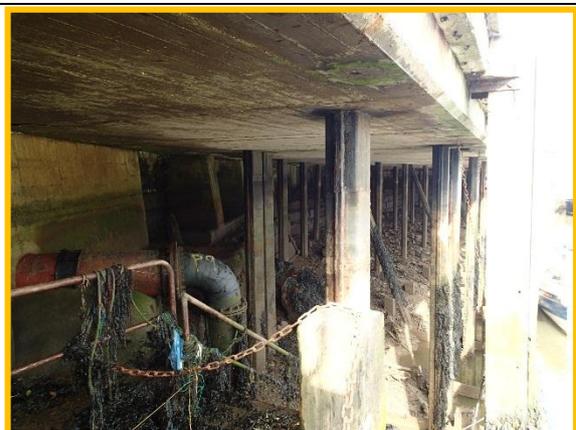
The west harbour pier at the fish quay consists of a concrete slab suspended over the original quay wall with concrete filled vertical and raking steel pile supports, see photos below. There is corrosion to the steel piles, which look rather slender and susceptible to damage. It was not possible to inspect the underside properly as this would require a boat even at low tide. A more detailed structural inspection of the piles is recommended. The original wall where viewed from the ends looks to be in fair condition. The broken vertical timber fender piles at the fuel berth that were noted in 2012 are still in need of urgent repair as they provide protection to the main pier support piles. There are also broken fender piles near mid-length of the quay.

View under west pier from south end
(Asset Ref. 1221D901D0803C06)

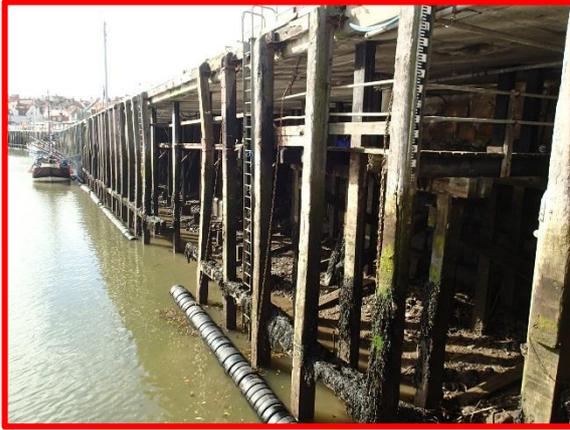
Broken and missing timber fender piles at fuel berth need replacing urgently to protect the deck support piles. Asset Ref. 1221D901D0803C06)

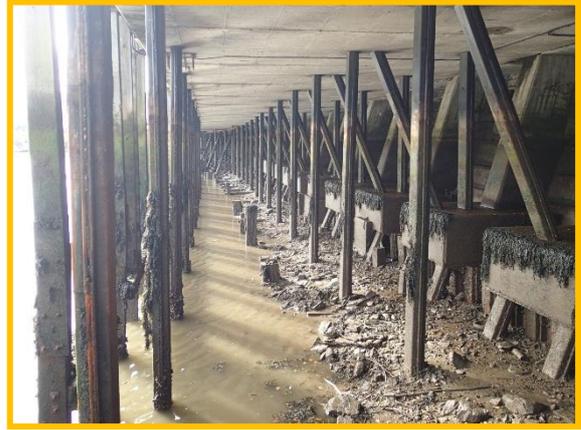
View under west quay, with original wall on right, showing corroded deck support piles Asset Ref. 1221D901D0803C06

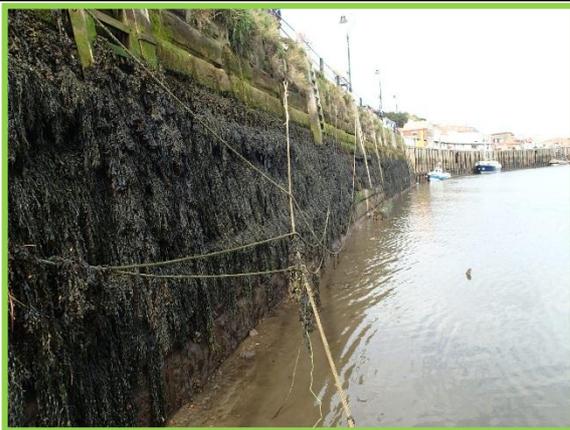
The inner section of the west harbour quay wall (Asset Ref. 1221D901D0803C07), near the swing bridge was largely obscured by seaweed on the lower wall and vegetation growth to the upper wall, see below left, but appears to be in good overall condition. The promenade is in good condition. As noted in 2012 there is wash out of joints at the set of stairs at middle of wall length that requires attention, particularly as these steps are heavily used by trip boat passengers. It was also noted that there was significant corrosion to floating pontoon supports at the steps.

Inner west quay wall near swing bridge, (Asset Ref. 1221D901D0803C07)

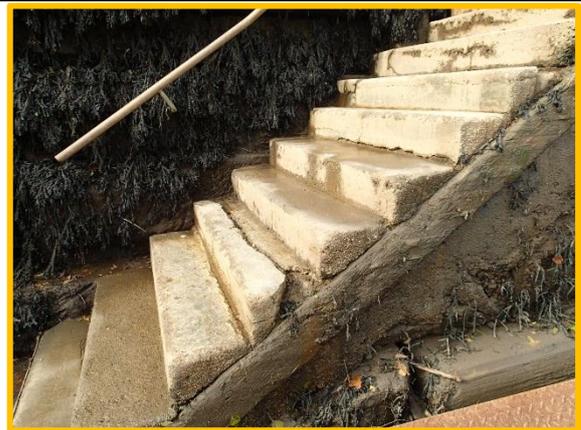
Cracked and loose steps with washed out joints require attention. (Asset Ref. 1221D901D0803C07)
