**Walk-over Visual Inspections of Assets
including Coastal Slopes**

**Scarborough Borough Council
Final Report**

November 2014

Coast Protection Assets and Coastal Slope Condition Analysis

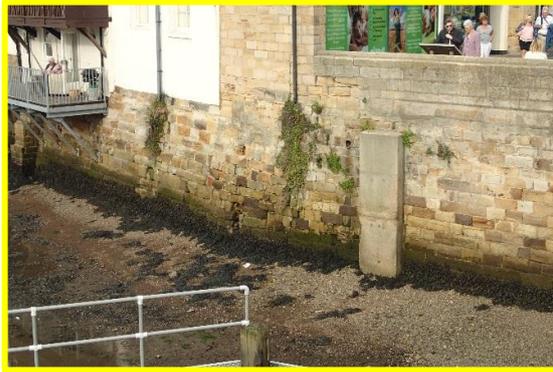
Area of washed out joints seaward of swing bridge (Asset Ref. 1221D901D0803C10)

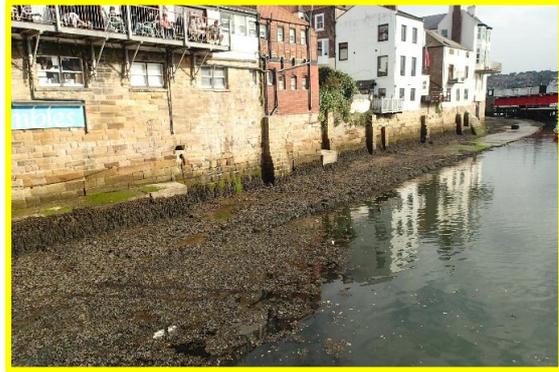
The inner wall on the east side, between the swing bridge and the RNLI berth consists of a variety of riparian property walls, which are protected by concrete apron and a sheet pile toe, below top right (Asset Ref. 1221D901D0803C10). Access is difficult so inspection was from the RNLI berth and swing bridge.

Sheet piling and toe apron protecting property walls (Asset Ref. 1221D901D0803C10)

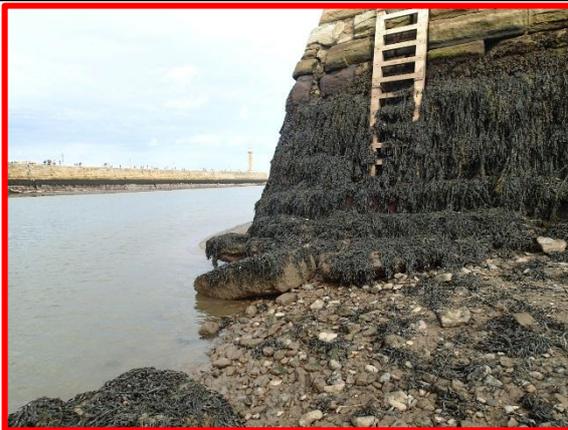
Asset 1221D901D0803C08 includes the pier immediately north of the RNLI pontoon and the larger Tate Hill (or Old RNLI) Pier that projects into the harbour together with the harbour rear wall between them. This asset is in poor overall condition. The south pier is masonry with a timber surround, see below lower right. The deck of the timber surround has been replaced since 2012. There was evidence of repairs to the south pier, including replacement capping blocks. The masonry rear harbour wall between the two piers, consisting of riparian property walls, has missing mortar and blocks in places, see below upper right, and is in poor condition. The longer masonry pier opposite the fish quay, known as Tate Hill Pier has very weathered blocks on south side see below lower left. There also appears to be toe undermining and a void under the NE toe of Tate Hill (old RNLI) pier and displacement of facing/crack to deck slab at the end (below upper left).

Toe undermining and erosion damage at seaward end of Tate Hill (old RNLI) pier. (Asset Ref. 1221D901D0803C08)

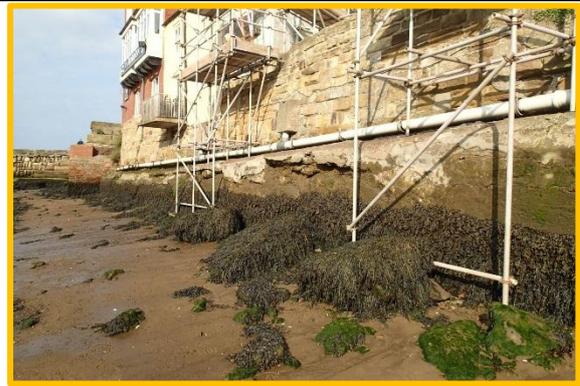
Wall at east side of harbour south of Tate Hill pier (Asset Ref. 1221D901D0803C08)

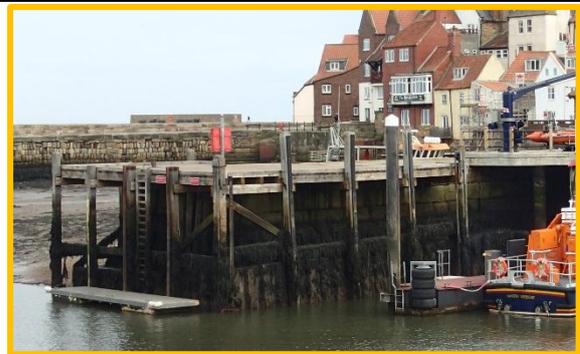
View of southern pier with timber surround and RNLI berth. (Asset Ref. 1221D901D0803C08)

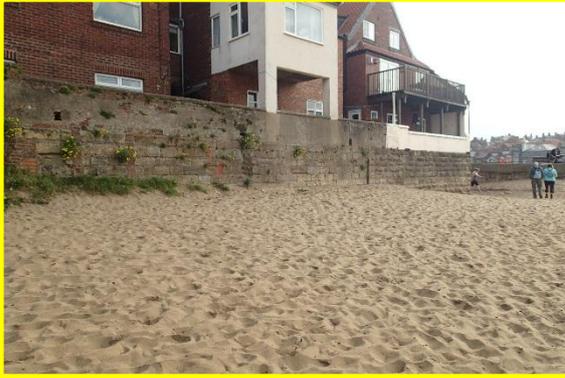
Riparian walls backing sandy beach in east side of harbour, (Asset Ref. 1221D901D0803C09)

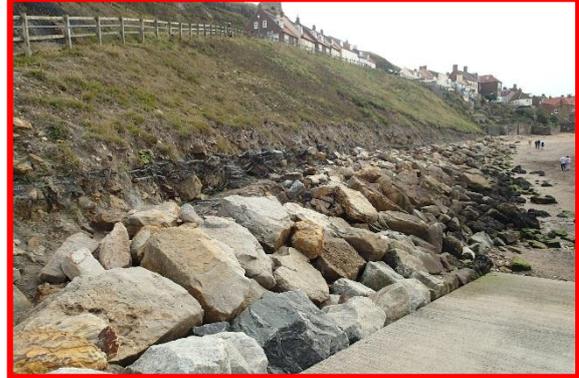
North of Tate Hill pier, the harbour wall is fronted by a sand beach, with a variety of riparian walls at the back, Asset ref. 1221D901D0803C09, below left. Between here and the main harbour East Pier there is a rock revetment protecting the toe of the slope at the Haggerlythe, 1221D901D0803C05. This was constructed in 2001, but was noted in 2012 to be in poor condition and is now very poor. The same asset reference continues outside the East Pier below the abbey for about 200m, and here larger rock was used in the 2001 scheme. Within the harbour the revetment is showing signs of significant damage, with displacement of the armour and exposure of the geotextile netting stabilising the slope above, see photo below right. This armour needs re-profiling and topping up with additional larger armour.

Displaced rock armour and damaged revetment at the Haggerlythe inside harbour adjacent to East pier (Asset Ref. 1221D901D0803C05)

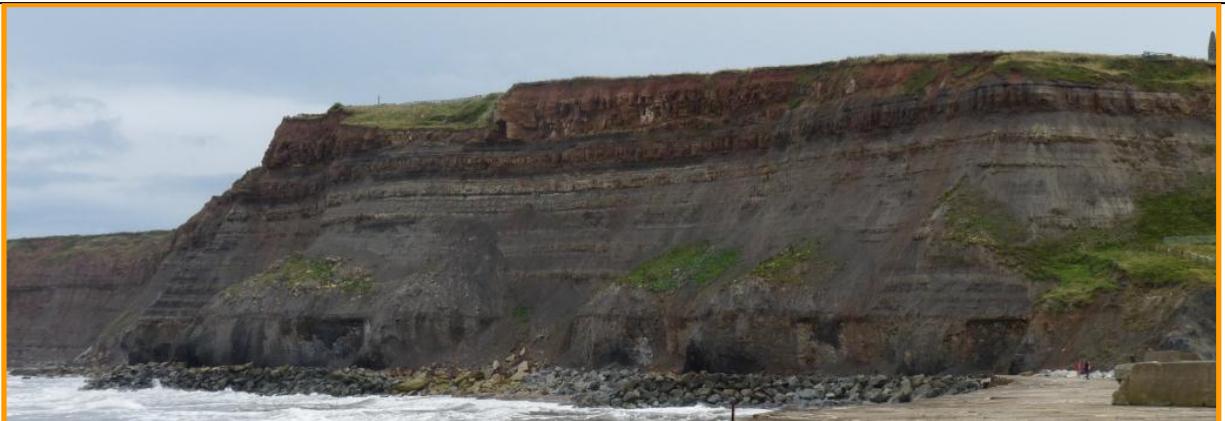
Unit **MU12/2** comprises high cliffs protected by rock armour (Appendix A, Map 2). There is evidence of a large recent rockfall from the upper part of the cliff (centre-left of photo) and ongoing erosion at the headscarp. Almost the entire cliff face is exposed with very little vegetation cover. The cliffs are Partly Active.

MU12/2 The cliff face does not support vegetation and there is evidence of recent rockfalls at a number of points along the unit (Partly Active). August 2014.

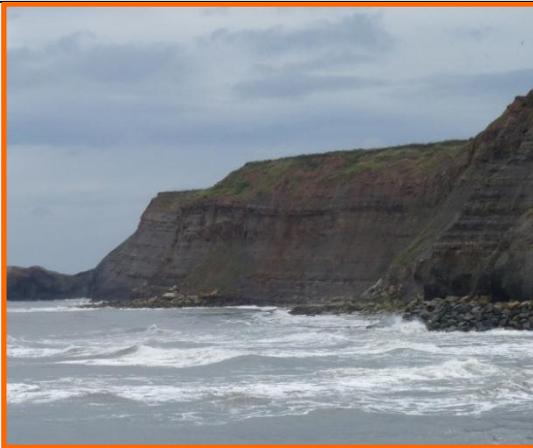
MU13/1 Cliffs east of Whitby (Partly Active).
August 2014.

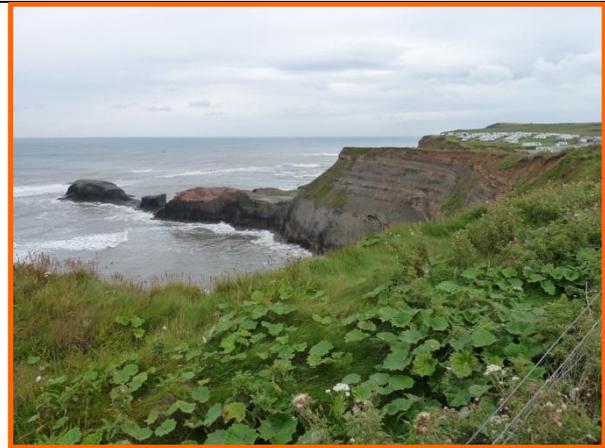
MU13/2 West side of the highly weathered headland of Saltwick Nab (Partly Active). August 2014.

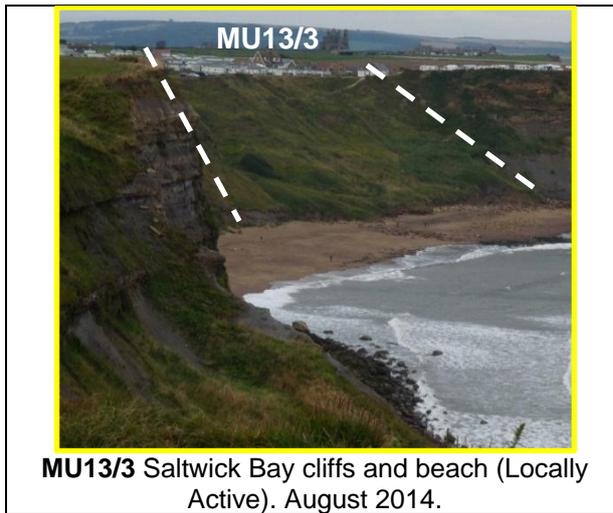
MU13/3 Saltwick Bay cliffs and beach (Locally Active). August 2014.

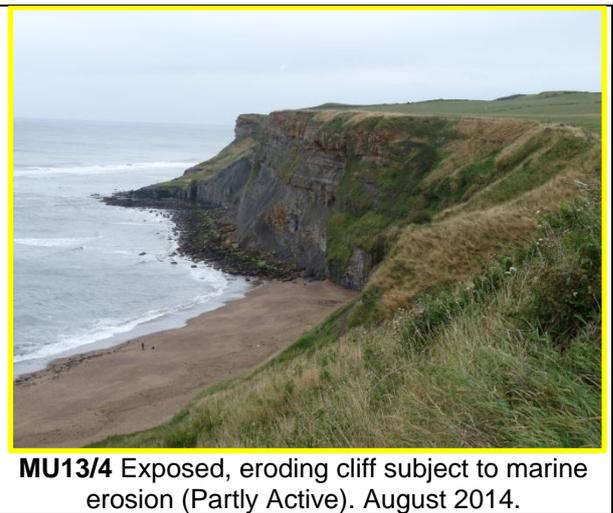
MU13/4 Exposed, eroding cliff subject to marine erosion (Partly Active). August 2014.

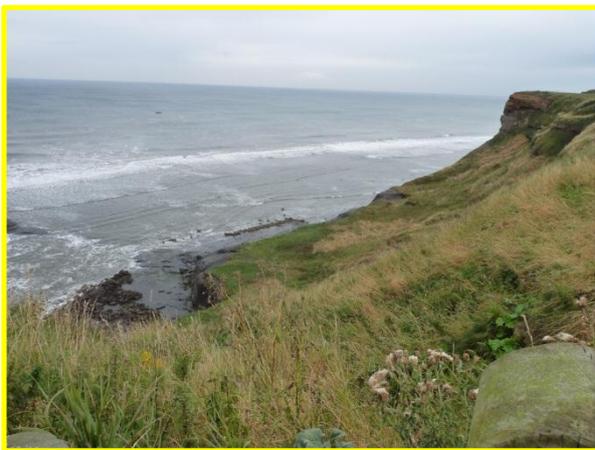
Unit MU13/5 is formed by the shallow, relict debris flow lobe at Black Nab. The slopes of this unit are well vegetated, with localised activity evident at the toe and headscarp. Activity noted at the headscarp and toe meant it was classified as Partly Active in 2012, this appears to have reduced and therefore the unit has been classified as Locally Active in 2014.

MU13/5 The cliff is primarily vegetated with erosion of the toe which has left a stack (just to the left of the photograph) Locally Active. Downgraded to Locally Active as mostly vegetated. August 2014.

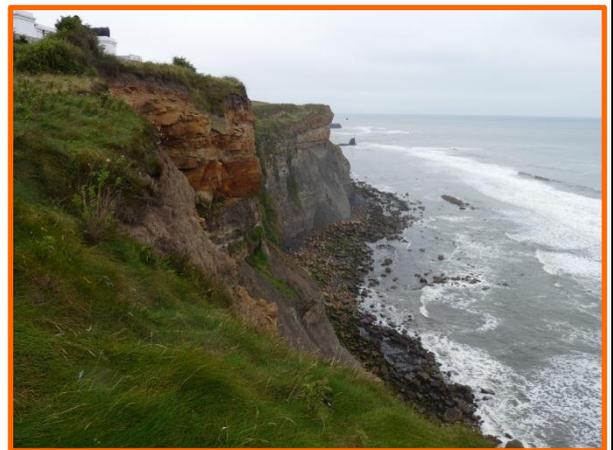
Unit MU13/6 is a long, steep-faced unit near the Whitby Fog Signal and the former lighthouse. The slopes are largely exposed with evidence of rockfalls from the upper cliff. In places the fence on the seaward side of the Cleveland Way was being undermined by this cliff top recession (see photo below). There are also signs of ongoing weathering and marine erosion of the lower layers. This unit is classified as Partly Active in 2014.

MU13/6 Steep faces close to the Whitby Fog Signal, looking north-west (Partly Active). August 2014.

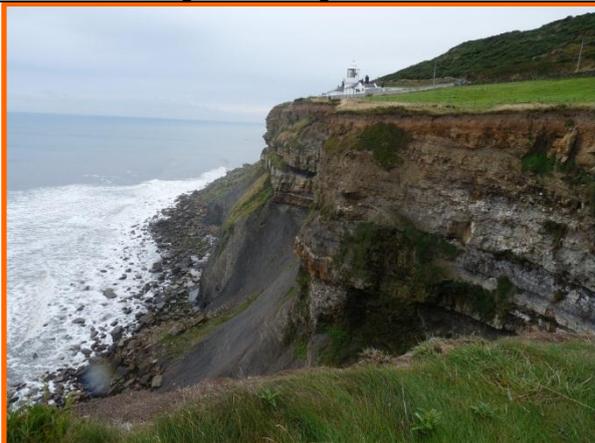
MU13/6 – South-eastern end of unit – unvegetated eroding cliffs (Partly Active). August 2014.

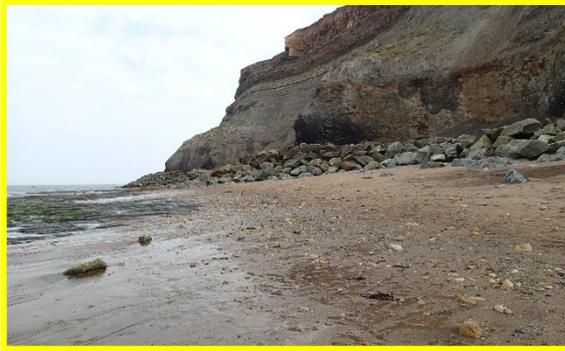
There is a section of rock armour giving limited protection to the eastern side of the harbour and toe of Abbey cliff directly to the east of Whitby harbour East Pier. The rock armour varies in size from 1-4 tonnes to 5-8 tonnes. (Asset Ref No.1221D901D0803C05) and is in fair condition, below left and right, although there are areas that would benefit from topping up with additional armour stone.

Rock armour protection to toe of Abbey Cliff (Asset Ref. 1221D901D0803C05)

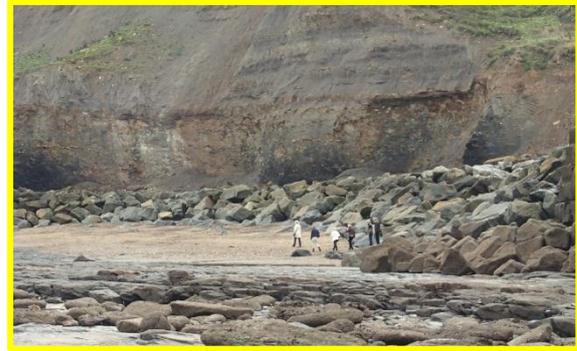
Rock armour at interface between east pier and Abbey cliff (Asset Ref. 1221D901D0803C05)

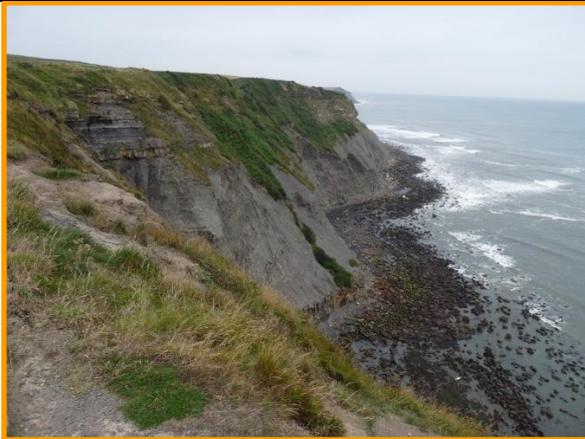
MU15/1 Well vegetated slopes (Locally Active). August 2014.

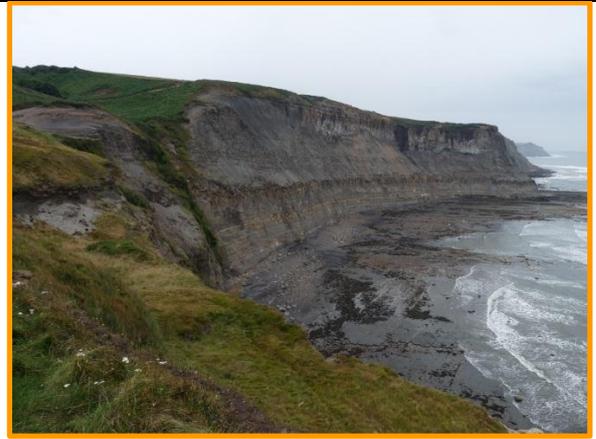
MU15/2 An area of intense erosion (Partly Active). August 2014.

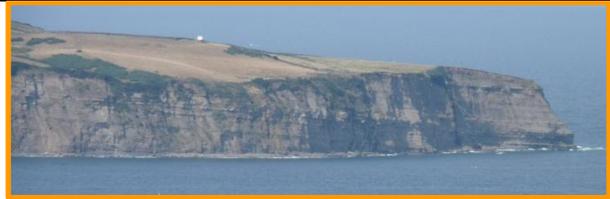
MU15/3 Upper photo - southern side, photo taken from Ravenscar golf course and northern side. Lower photo – northern part of unit (Partly Active). August 2014.

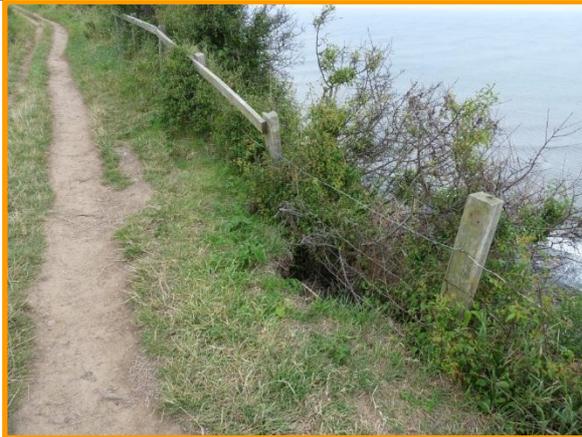
Unit MU15/3 is largely comprised of the headland of Bay Ness, north of Robin Hood’s Bay. The cliffs are subject to ongoing toe erosion and occasional small scale rockfalls and cliff top recession. This recession was evident at grid reference 495709 505886 where the cliff top had receded to such a point that the fence on the seaward side of the Cleveland Way had been undermined (see below). This unit is classified as Partly Active in 2014.

MU15/3 – Fence on seaward side of Cleveland Way being undermined by recession of the cliff top. August 2014.

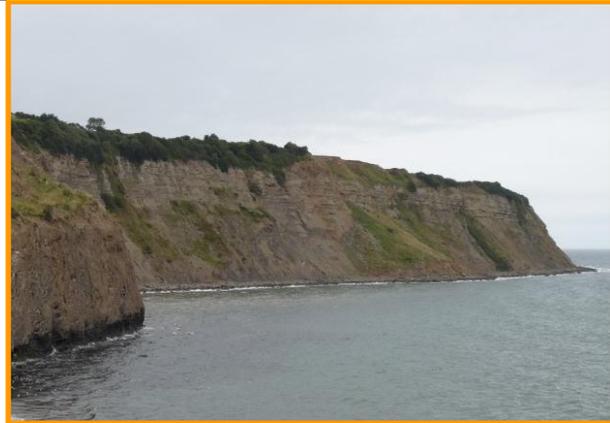
Just north of Robin Hood’s Bay Village is **unit MU15/4**. The cliffs are eroding throughout much of their height. There is evidence of slumping on the cliff face, with active recession of the headscarp. This unit is classified as Partly Active in 2014, unchanged from 2012.

MU15/4 Exposed cliffs with boulders at the toe (Partly Active). August 2014.

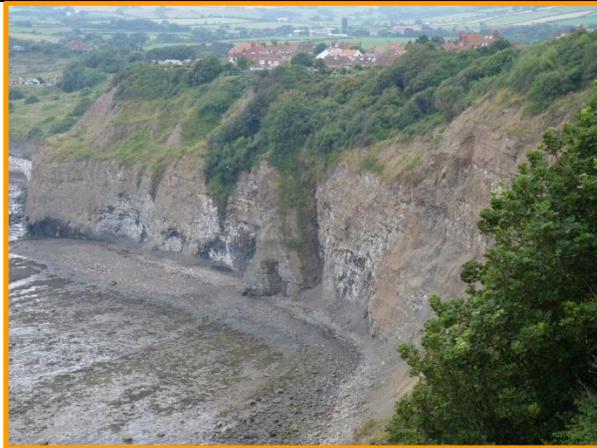
Unit MU16/1 is the cliff fronting the upper part of Robin Hood’s Bay Village and is classified as Partly Active in 2014, the same as during the December 2013 post-surge survey. The upper slopes show evidence of slumping and localised recession of the headscarp. The lower slopes are near vertical. The lower cliff has been undercut by marine erosion.

MU16/1 Cliffs below the upper part of Robin Hood's Bay Village (Partly Active). August 2014.

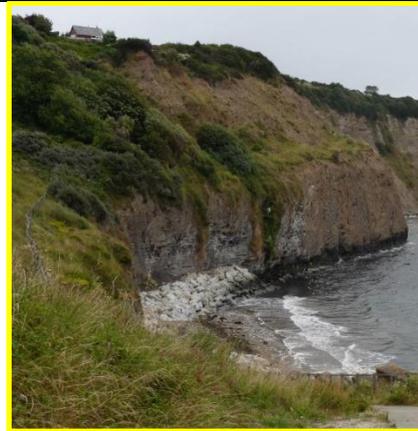
Units MU16/2 and MU16/3 are stabilised landslides that form the lower parts of Robin Hood's Bay Village. MU16/2 is classified as locally active at its northern end, beyond the extent of the defences. These units have not changed status since the post-surge survey in December 2013

MU16/2 Locally Active in August 2014. Evidence of recent rockfalls in the lower cliff and failure of the upper cliff. Recent rockfall scars and failure of the upper cliff are evident in that part of the unit beyond the extent of the sea defences.

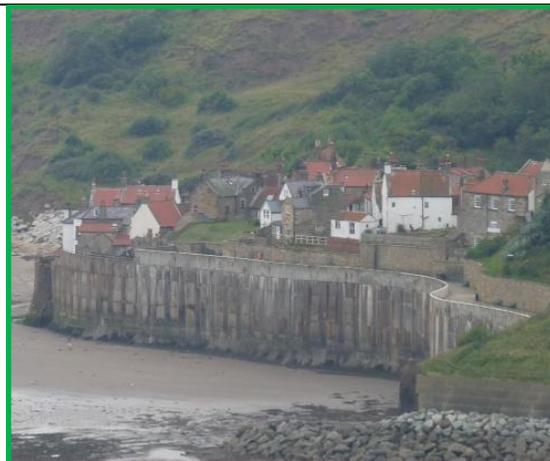
MU16/3 – Robin Hoods Bay Village (Dormant). August 2014.

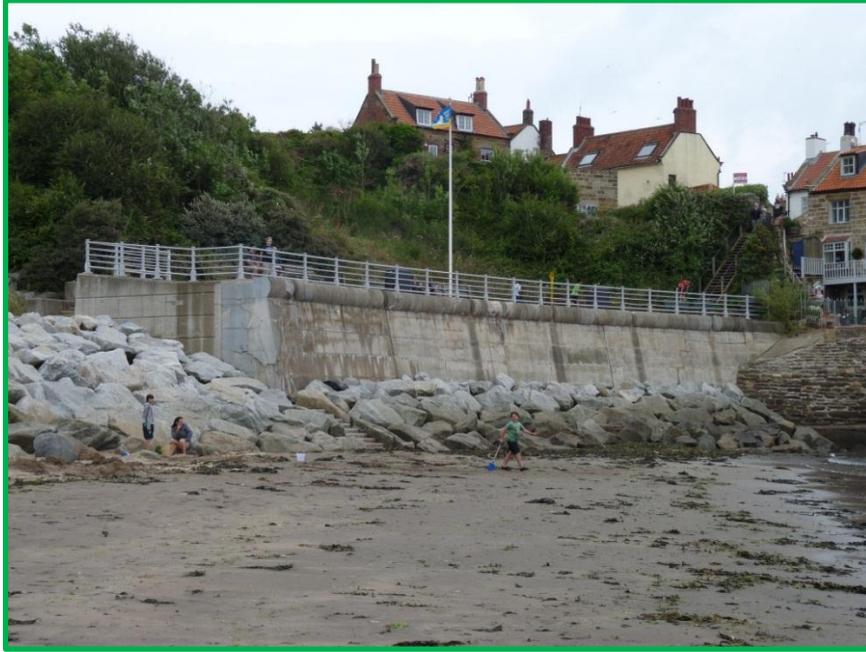
This Sub-Management Unit consists of **unit MU17/1**, which is defended at the toe by a sea wall and rock armour. The slopes show little evidence of recent activity. As a result this unit is classified as Dormant in 2014, a decrease in activity status since earlier surveys.

MU17/1 The defended toe and heavily vegetated slopes show that the unit has been stable (Dormant). August 2014.

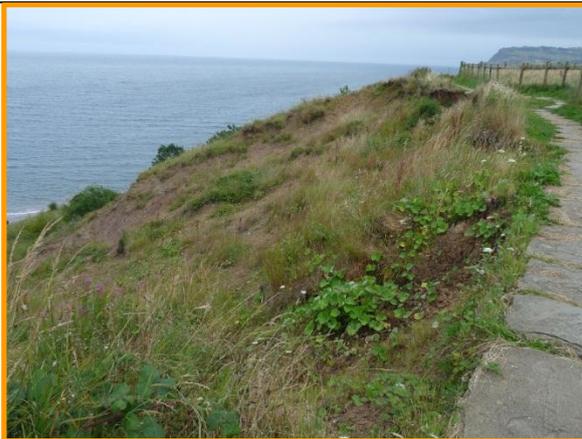
Unit MU17/2 is partly protected in part by rock armour at the toe. The slopes are generally well vegetated with some exposed areas at the head and mid-slope where evidence of sliding and gullies are present. This unit was classified as Partly Active in 2012, due to the evidence of instability throughout the unit. This instability appears to have continued and the rear scarp (i.e. the cliff top) of the mudslide is undermining the paved Cleveland Way.

MU17/2 - The paved Cleveland Way has almost been undermined by recession of the cliff top. (Partly Active). August 2014.

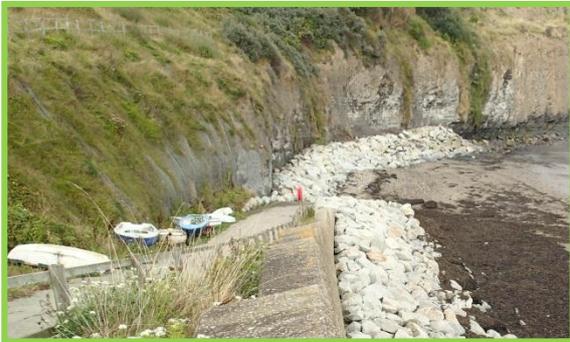
The most northern defence at Robin Hoods Bay is a section of rock armour that gives some limited protection to the cliff toe to the north of the northern slipway / beach access ramp, Asset Ref. 1221D901D1002C02. This rock armour constructed as part of the 2001 scheme is in good condition, see photo below, top left.

Rock armour at north end of defence system in good condition.
(Asset Ref. 1221D901D1003C02)

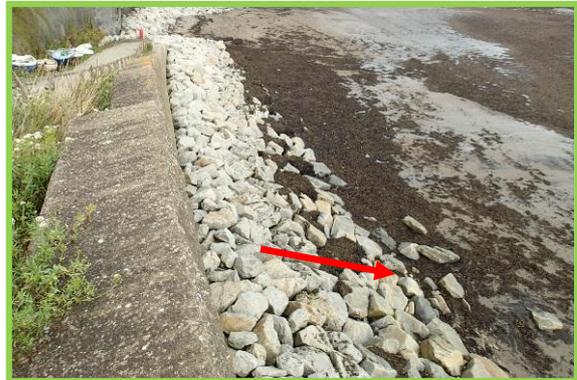
The large sea wall (Asset Ref. 1221D901D1003C01) that was built in 2001 is fronted by rock armour and incorporates a slipway / ramp to its northern end. The wall is in very good condition. Joints and sealant show no signs of damage or minor defects. The rock armour at the toe is also very good, apart from one area near the centre where there are several gaps indicating displaced armour units. The northern slipway has some abrasion damage near the toe and missing joint filler, but is overall in good condition. There has been some erosion / weathering of the cliff at the southern end of the wall that need minor repairs (see photo below lower left).

Section of rock armour with gaps / displaced units in front of 2001 seawall. (Asset Ref. 1221D901D1003C01)

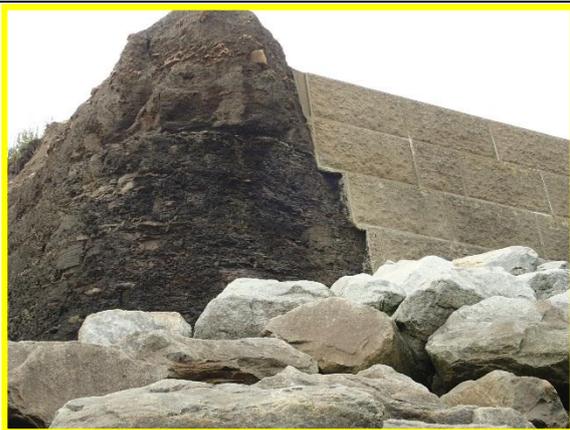
Sea wall with rock armour toe constructed in 2001 (Asset Ref. 1221D901D1003C01)

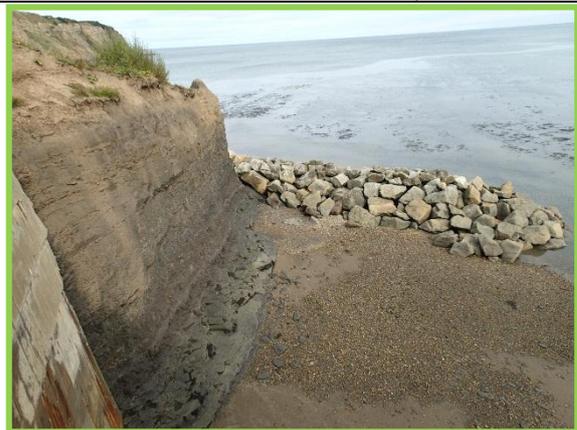
Rock armour extension at the interface between defended and undefended section.
(Asset Ref. 1221D901D1003C01)

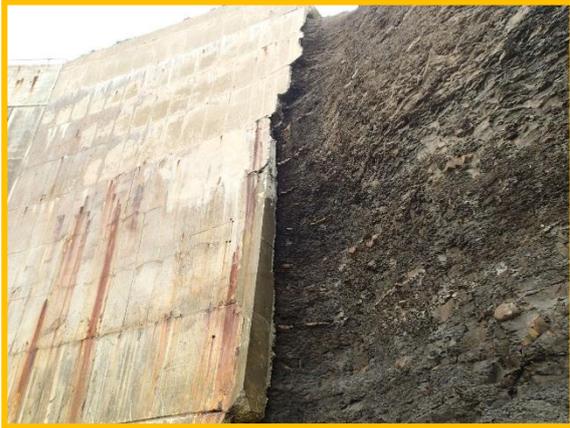
Between the 2001 seawall and the large vertical defence wall built in 1975 further south there is a short 25m length of undefended shale cliff, Asset Ref. 1221D901D1003C03, which is slowly eroding, see photo below right and threatens to undermine the north end of the vertical wall.

Erosion at the north end of the Large vertical wall at Robin Hood's Bay (Asset Ref. 1221D901D1003C02/C03)

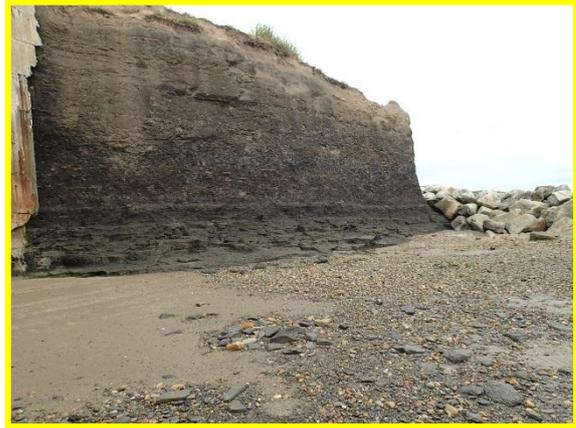
Short section of undefended cliff (Asset Ref. 1221D901D1003C03)

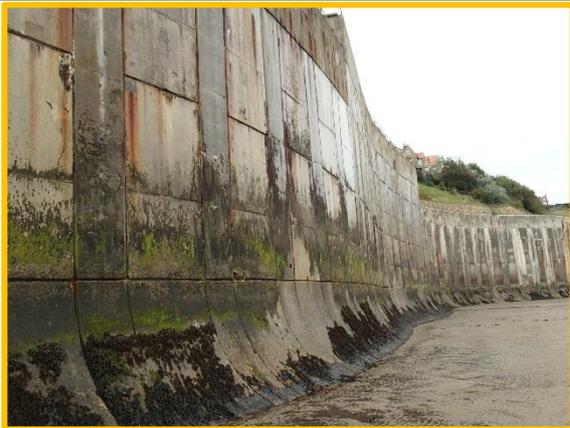
The large vertical concrete wall that was constructed in 1975 (Asset Ref. 1221D901D1003C02) is in poor condition, showing evidence of surface cracking, rust marks indicating corrosion of the reinforcement steel, mineral encrustation, seepage, and extensive cracking and repair work to the crest of the wall. Previous inspections have also noted some evidence of undercutting at the toe, but this was not visible at the time of inspection due to the beach levels. The recently developed strategy has proposed a capital scheme to repair and refurbish this wall and it is understood that a Project Appraisal Report to seek funding is in preparation.

Large vertical wall at Robin Hood's Bay in poor condition (Asset Ref. 1221D901D1003C02)

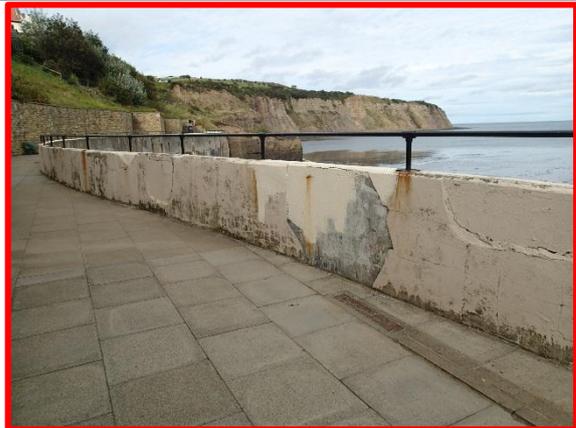
Crest wall locally very poor condition, with evidence of recent cosmetic repairs. (Asset Ref. 1221D901D1003C02)

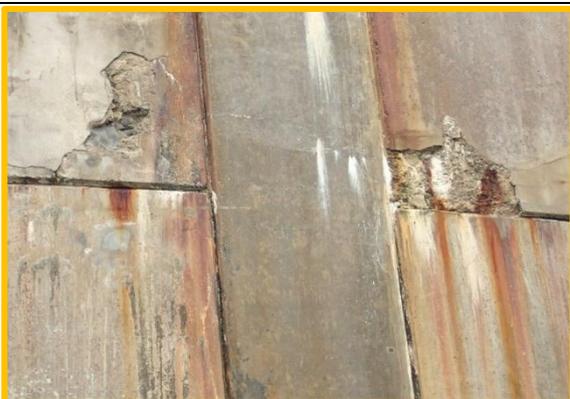
Example of typical damage to precast panels (Asset Ref. 1221D901D1003C02)

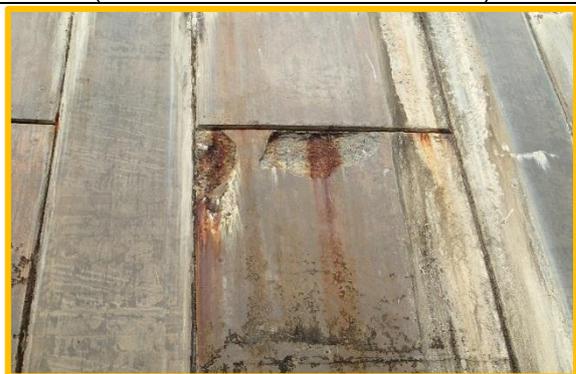
Example of typical damage to precast panels (Asset Ref. 1221D901D1003C02)

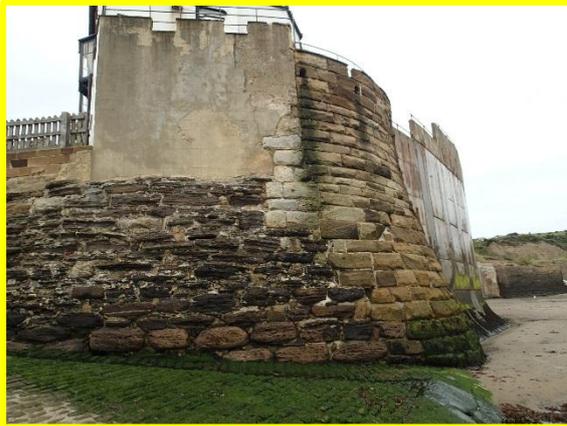
The short section of defence between the central slipway and the vertical wall (Asset Ref. 1221D901D1003C04) had evidence of repairs since 2012, but more are needed. The beach was higher than in 2012 so the toe was not exposed. At the northern end there are washed out joints, voids in the masonry wall and loose blocks, see below right. Above the wall there has been further loss of the render to the upper property wall.

Loose render on property wall to north side of slipway (Asset Ref. 1221D901D1003C04)

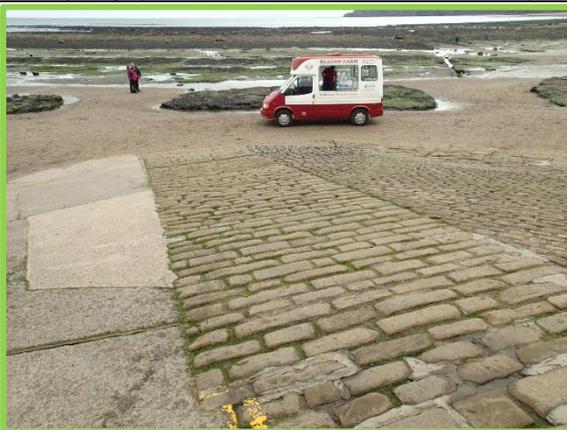
The adjacent central slipway (Asset Ref. 1221D901D1003C05) is in an overall good condition, with signs of wear, minimal cracking and several missing cobbles near to toe and stream outfall. Some cracks/ washed out joints, see photos below, lower left and right. This structure needs regular inspections and minor repairs to keep it in good order.

Central Slipway in overall good condition (Asset Ref. 1221D901D1003C05).

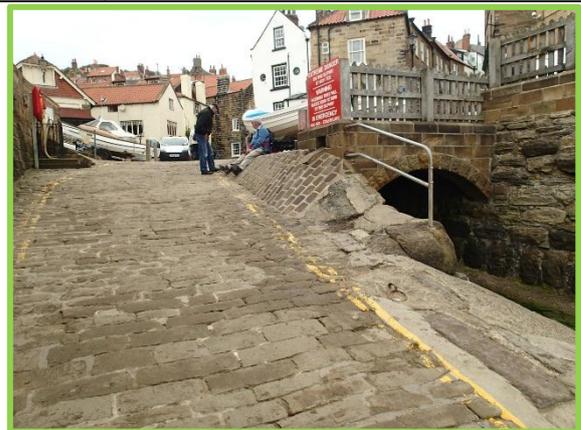
Some loss of mortar in slipway joints, with evidence of multiple previous repairs. (Asset Ref. 1221D901D1003C05)

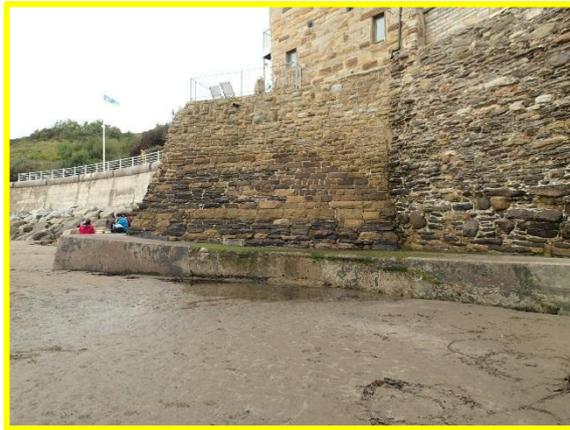
The mixed construction defence (Asset Ref. 1221D901D1003C06) on the south side of the slipway has mass concrete toe at the base with a variety of stone and blockwork above. The defence has a patchwork of previous repairs and repointing throughout and looked better than in 2012, but regular work is needed. There is a large crack visible in south end of the concrete toe and some undermining of the toe was apparent. There were some missing stone blocks in return end at south.

Washed out joints in masonry wall (Asset Ref. 1221D901D1003C06)

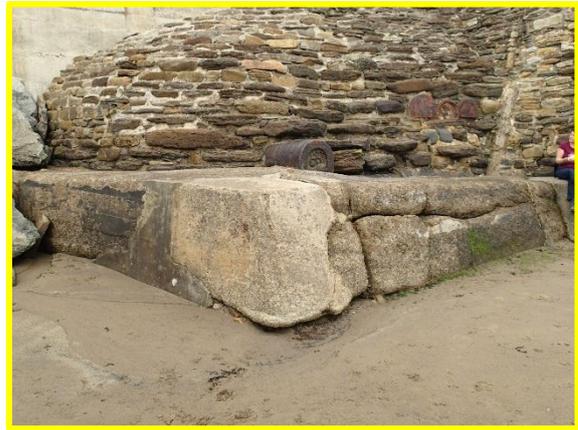
Wide cracks to toe of wall and undermining (Asset Ref. 1221D901D1003C06)

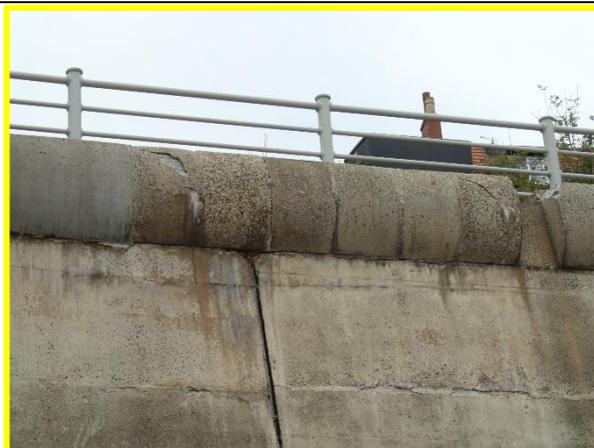
At the south of the village is the concrete sea wall at the Quarter Deck (Asset Ref. 1221D901D1003C10). This was given rock armour toe protection as part of the 2001 scheme. The rock armour is still tightly packed and is providing good protection to the toe of the sea wall behind. The upper sections of the sea wall itself show some evidence of seepage through the blockwork joints, and cracking and erosion to the capping beam and spalling. In 2012 there was evidence of repairs since the 2009 inspection, and the condition in 2014 was the same or slightly worse. The promenade above the sea wall is in a good condition, with only minor defects present. The timber access stairs down onto the Quarter Deck are worn and show signs of previous repairs and will need replacing soon. Several of the timber bench seats on the Quarterdeck had collapsed and need repair or removal.

Quarter Deck sea wall with cracked capping beam with previous repairs (Asset Ref. 1221D901D1003C10)

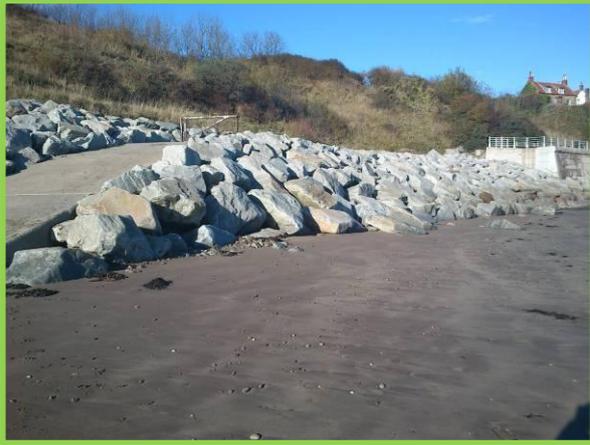
Rock armour and ramp south of Quarter Deck
Photo from 2012
(Asset Ref. 1221D901D1003C09)

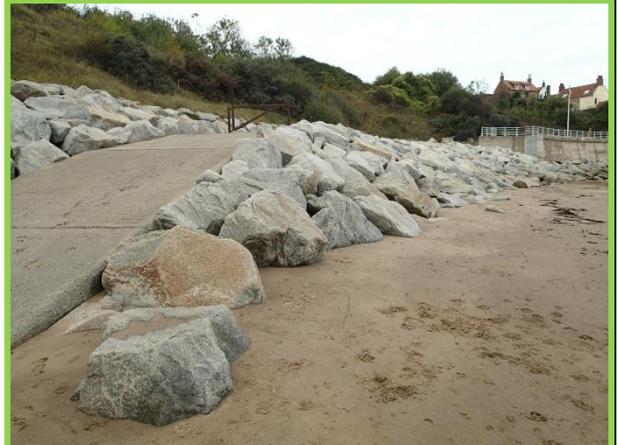
At the south of the Quarter Deck there is a length of rock armour defence with a slipway / ramp, both of which were constructed in 2001, see photo below left. The rock armour is in very good condition, is generally tightly packed and performing well, although there are a few armour units that have moved near the centre and at the edge of the ramp (Asset Ref. 1221D901D1003C09). The barrier gate on the ramp is rusted and needs treating and repainting.

Rock armour and ramp south of Quarter Deck
Photo 25/09/2014
(Asset Ref. 1221D901D1003C09)

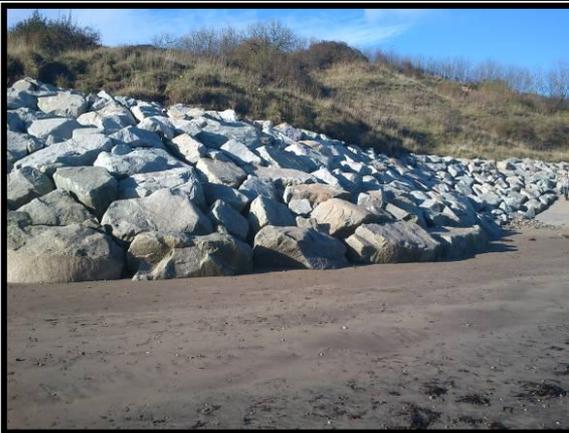
Tightly packed rock armour in good condition in
2012– **photo from 2012**
(Asset Ref. 1221D901D1003C07)

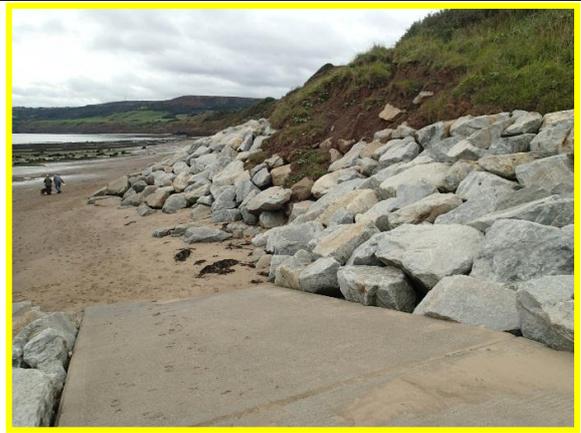
To the south of the southern ramp is a short section of rock armour built in 2001 to stabilise the cliff and prevent outflanking of the Quarter Deck wall, Asset Ref 1221D901D1003C07. At the south end the eroding adjacent cliff is starting to cause some unravelling and it is suggested that in future after further erosion the rock armour should be reprofiled to form a double sided defence, in a similar way to the transition at the south end of the northern section of rock armour (Asset 1221D901D1003C03). The cliff has slumped just south of the ramp, with debris flowing over the armour and displacing some of the rock, see photos below top right and lower left. This should be monitored and the rock reprofiled once the slip has stabilised.

Cliff slump has partially covered and damaged the
revetment. (Asset Ref. 1221D901D1003C07)

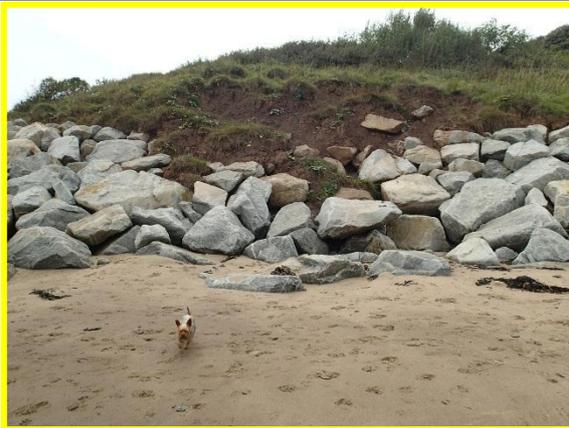
Cliff slump has partially covered and damaged the
revetment. (Asset Ref. 1221D901D1003C07)

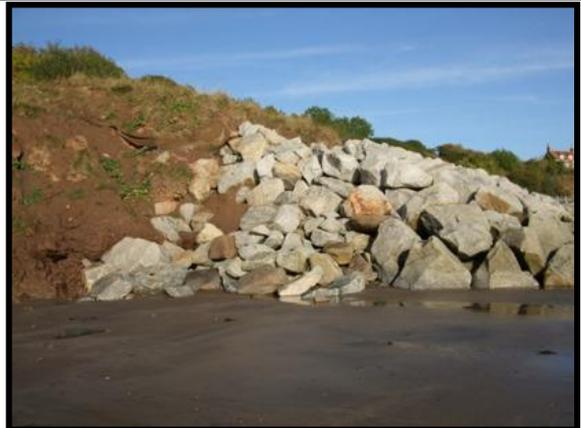
Southern extent of rock armour - photo from 2009
inspection (Asset Ref. 1221D901D1003C07)

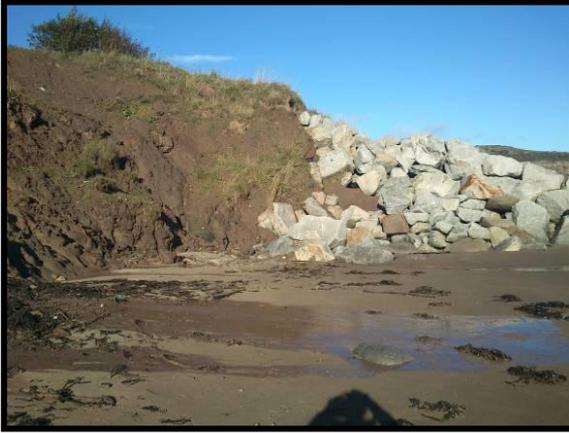
Erosion adjacent to south end of rock armour.
November 2012 (Asset Ref.
1221D901D1003C07)

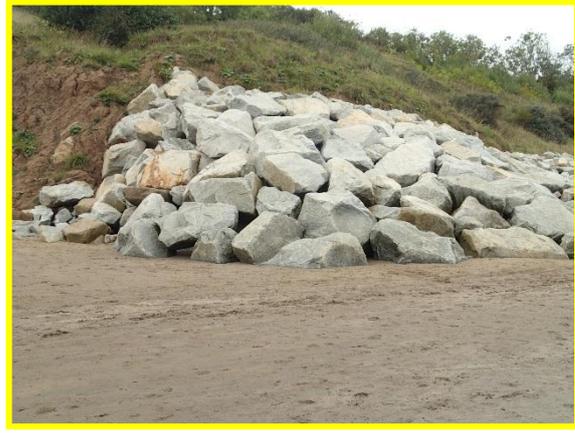
Southern extent of rock armour - **25/09/2014**
inspection (Asset Ref. 1221D901D1003C07)

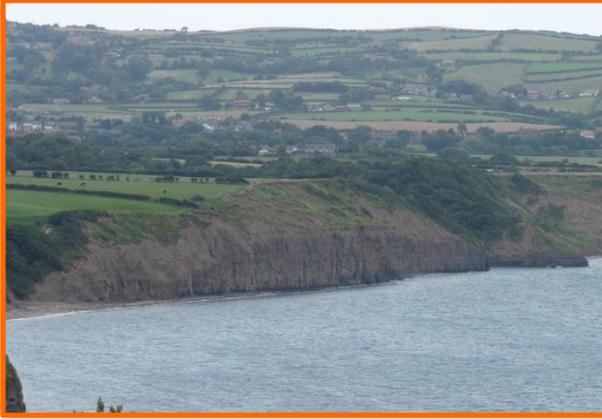
MU17/4 has been subject to marine erosion at the toe of the cliff (Partly Active). August 2014.

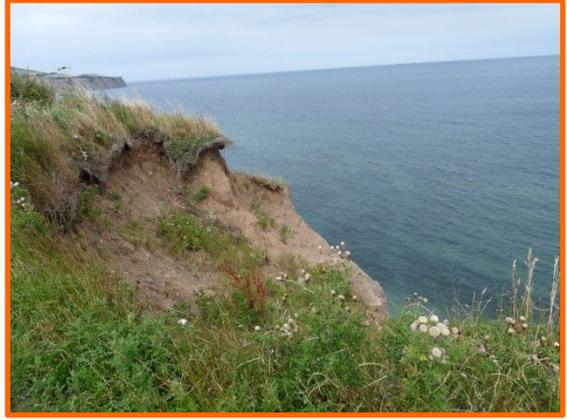
MU17/4 - Active cliff top erosion at in MU17/4. Partly Active. August 2014.

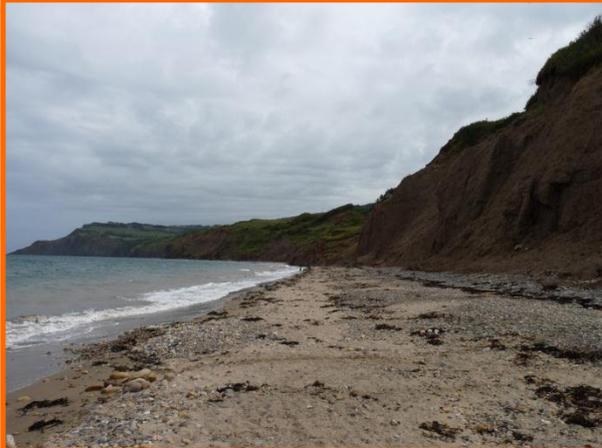
MU17/5 Looking south from Stoupe Beck (Partly Active). August 2014.

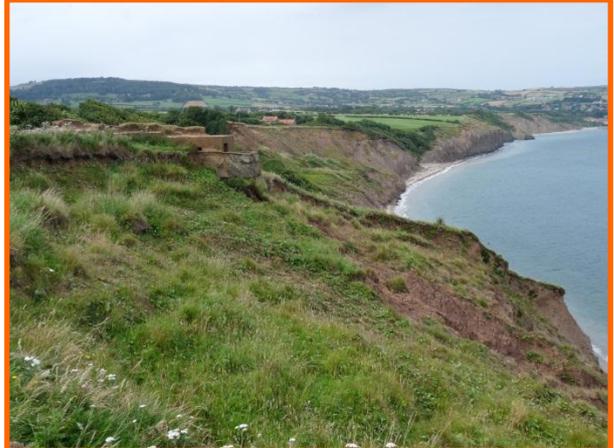
MU17/5 Former WWII defence provides an indicator of cliff top position (Partly Active). August 2014.

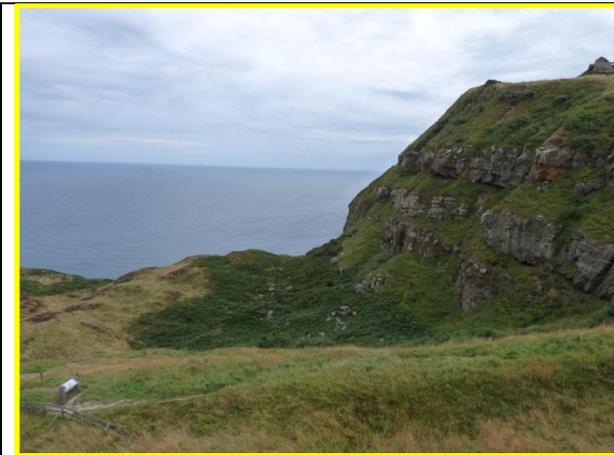
Unit MU18/1 is located at Peak Steel, below Ravenscar. The cliffs in this region have a distinct two-tiered form. Much of the upper headscarp is densely vegetated with little evidence of recent activity. The lower headscarp, exposed to the sea, is more active and subject to episodic slides and falls evident. This unit is classified as Locally Active in 2014, no change from 2012.

MU18/1 Peak Steel (Locally Active). August 2014.

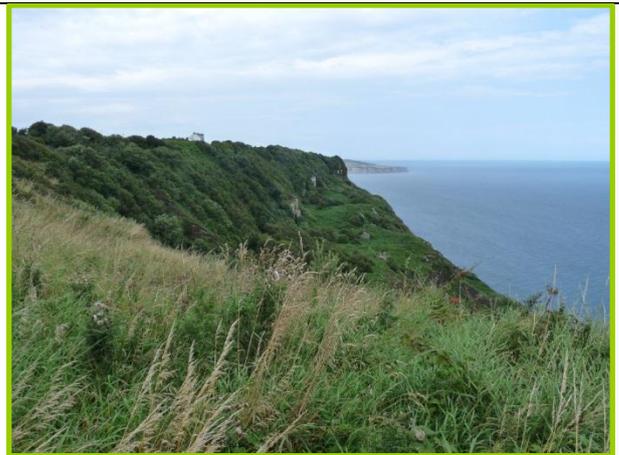
Unit MU18/2 is a well vegetated, relict system with no signs of activity. As a result it is classified as Inactive.

MU18/2 Distinct two-tiered cliffs (Inactive). August 2014.

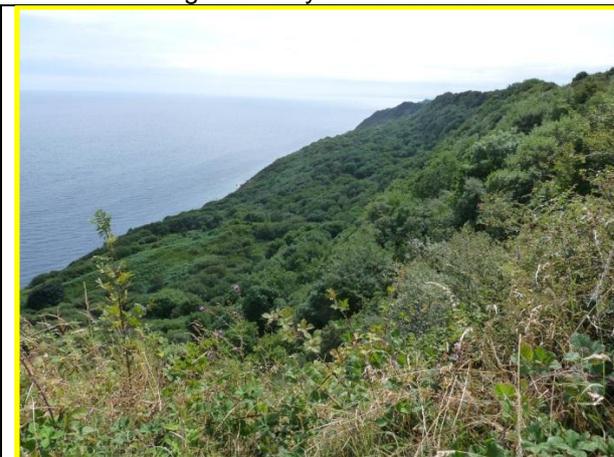
This Sub-Management Unit consists of **units MU18/3 and MU18/4**, both of which are classified as Locally Active. The cliffs have a distinct ‘undercliff’, likely to be formed by seepage erosion and landsliding processes. The slopes show only localised patches of activity. These units have not changed activity status since 2012.

MU18/3 Densely vegetated relict cliffs (Locally Active). August 2014.

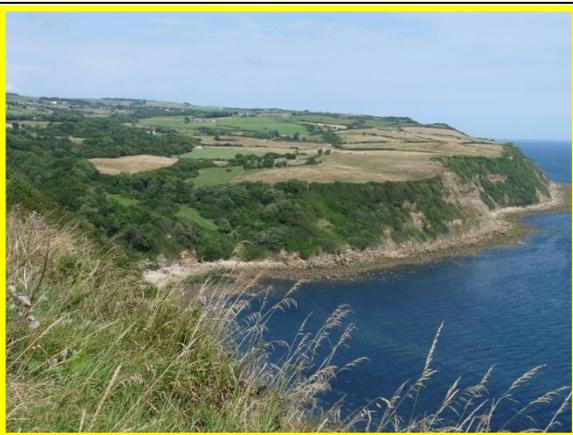
Unit MU19/2 is located on the north side of Hayburn Wyke and is classified as Locally Active in 2014, unchanged since 2012. There is minor activity at the headscarp and some evidence of past rockfalls at the toe. The slopes around the footpath on the northern side of Hayburn Wyke have been susceptible to instability in the past, and the 2012 survey reported that recent stabilisation works had been effective. However, it was noted during the 2014 survey that there was deformation of the steps here, indicating possible renewed movement.

MU19/2 Looking north across Hayburn Wyke at the vegetated cliffs (Locally Active). August 2014.

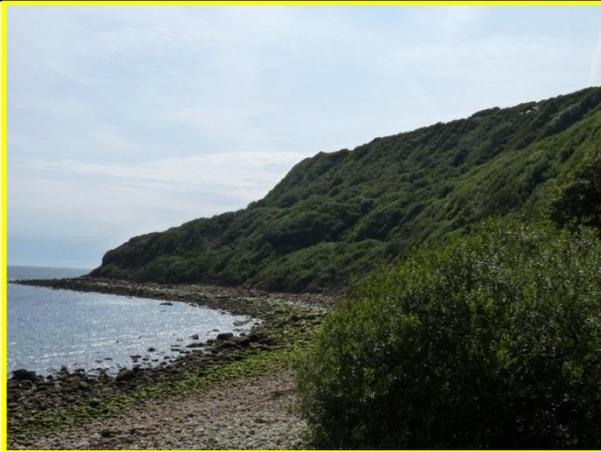
Unit MU19/3 is located around and to the south of Hayburn Wyke. These cliffs are well vegetated, with localised erosion at the toe and headscarp. This unit is classified as Locally Active, unchanged since 2012.

MU19/3 – Well vegetated undercliff on south side of Hayburn Wyke (Locally Active). August 2014.

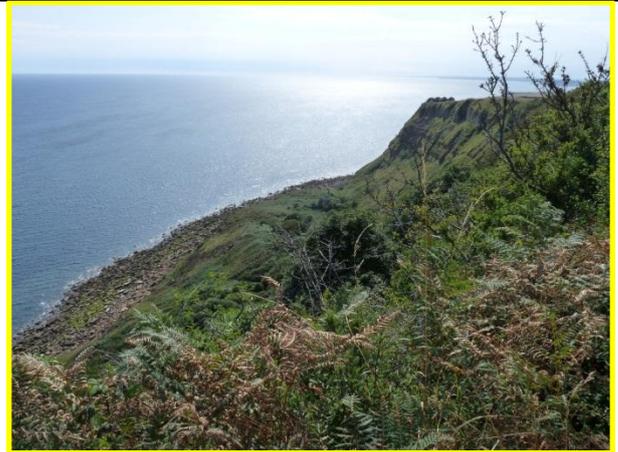
MU19/3 – Southern part of unit – well vegetated undercliff with localised erosion of headscarp (Locally Active)

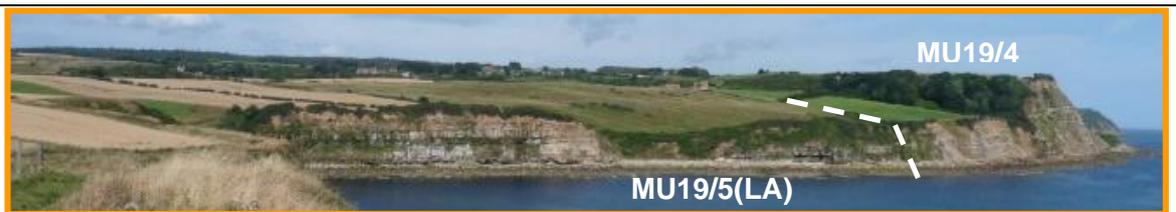
Unit MU19/4 is located immediately to the north of Cloughton Wyke. The unit is characterised by high, steep cliffs which are more active than those cliffs further north and south. There is some recession of the headscarp. This unit continues to be classified as Partly Active in 2014, unchanged since 2012.

Mu19/4 and MU19/5 - The upper slopes are vegetated but the lower slopes are (Partly Active). August 2014.

Unit MU19/5 (see photo above) is located on the northern side of Cloughton Wyke and is classified as Locally Active, unchanged since 2012. The near vertical cliffs are composed of hard rock which have failed through a series of small rockfalls. The cliffs support some vegetation, primarily in the northern end of the unit cover and are subject to ongoing marine erosion at the toe.

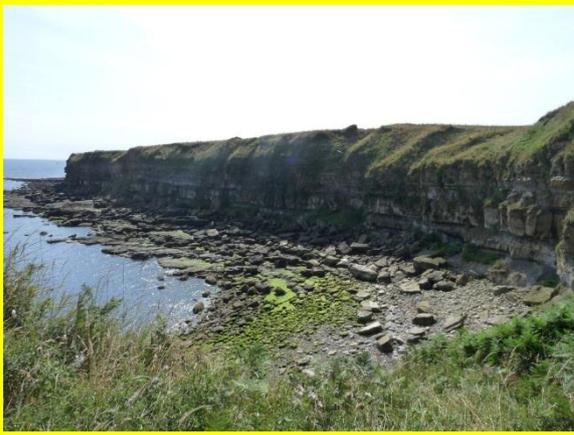
Unit MU19/6 forms the southern part of Cloughton Wyke and extends southwards to Long Nab. The lower cliff is near vertical and actively eroding. There is evidence of rockfall (large, angular boulders) from this part of the cliff onto the shoreline below. The upper part of the cliff is shallower angled and much less active. This unit is classified as Locally Active in 2014, unchanged since 2012.

MU19/6 Southern side of Cloughton Wyke (Locally Active). August 2014.

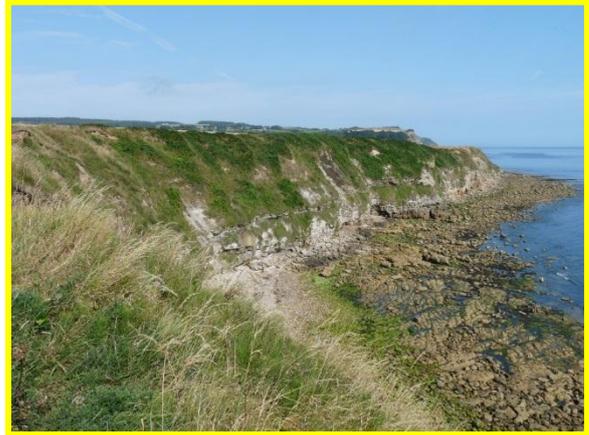
MU19/6 South of headland on southern side of Cloughton Wyke – photo taken from former coastguard station. (Locally Active). August 2014.

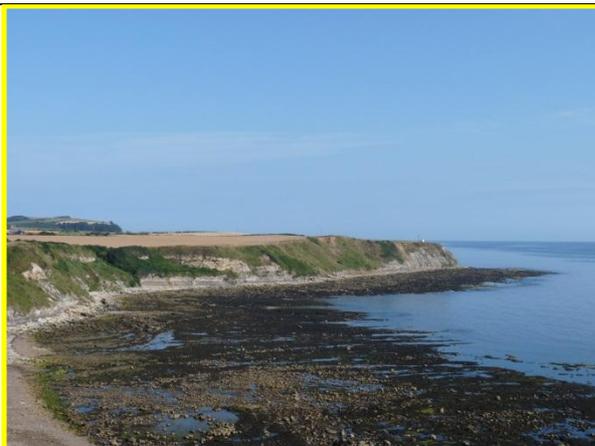
MU19/7 Looking north towards Long Nab (Locally Active). August 2014.

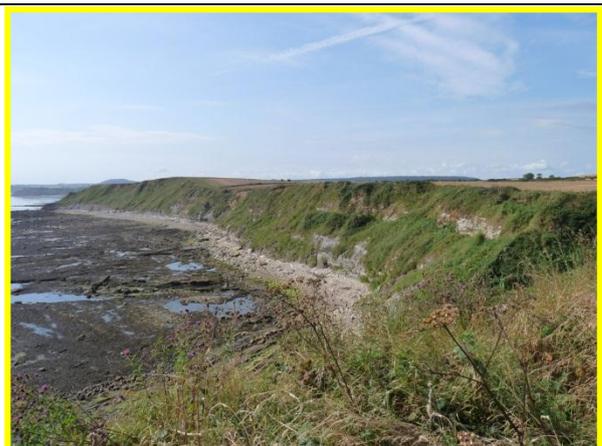
MU19/8 Looking south towards Cromer Point (Locally Active). August 2014.
