**Walk-over Visual Inspections of Assets
including Coastal Slopes**

**Scarborough Borough Council
Final Report**

November 2014

Coast Protection Assets and Coastal Slope Condition Analysis

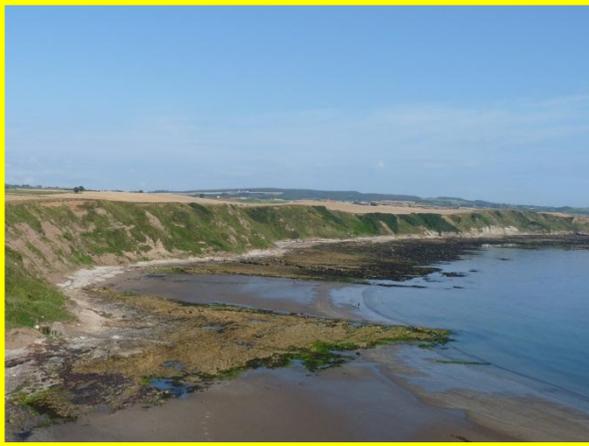
Units MU19/9 and MU19/10 are located between Cromer Point and Scalby Ness. The toe of these units is subject to marine action and the headscarp is steep, exposed and actively retreating at several places throughout the units. Landsliding does occur in the midslope but the cliffs are substantially vegetated and therefore retain a status of Locally Active. However the south side of Cromer Point shows evidence of greater activity than the rest of unit MU19/9 and includes a substantial landslide embayment with a steep, high rear scarp.

MU19/9 There is evidence of headscarp erosion and erosion of the toe (Locally Active). August 2014.

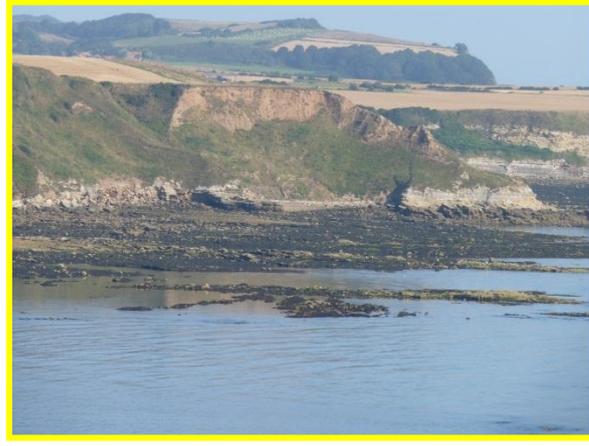
MU19/9 Landslide embayment with large exposed rear headscarp on south side of Cromer Point. (Locally Active). August 2014.

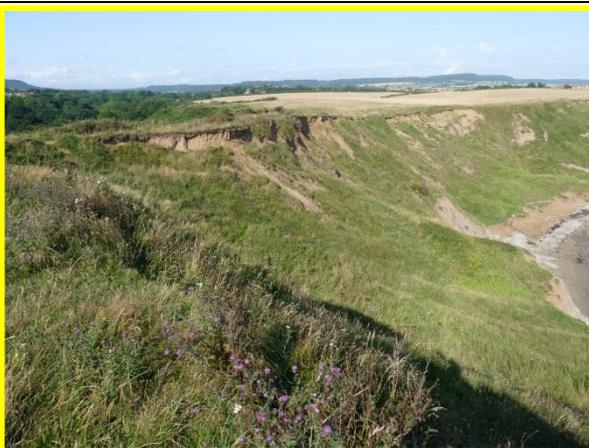
MU19/10 Principally vegetated till cliff but with eroding headscarp (Locally Active). August 2014.

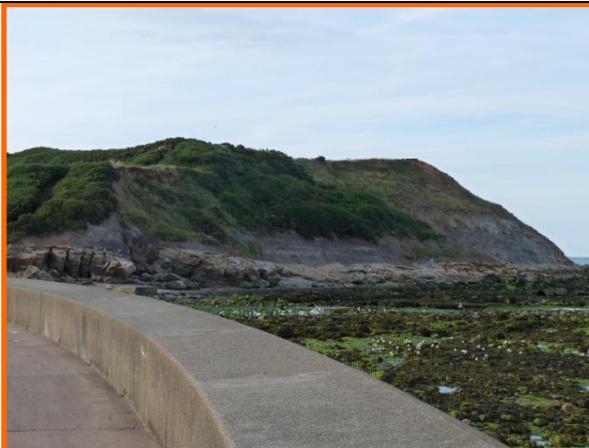
The Scalby Ness headland comprises **unit MU19/11**. This area is well vegetated on its more landward extents, but was noted during the December 2013 inspections to be eroding severely in the lower half of the cliff with some failure in the upper part and was therefore upgraded to Partly Active; this status has been retained following the 2014 inspection.

MU19/11 – Scalby Ness is eroding at the toe and there is evidence of failure in the upper slope. (Partly Active). August 2014.

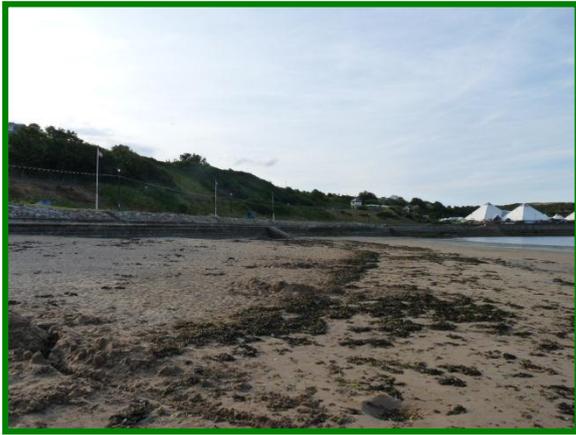
Both of these units are defended at the toe by the sea wall which runs the entire length of North Bay. The slopes are well vegetated, show no evidence of recent activity and are both classified as Dormant, as they were in the 2012 and 2013 surveys.

MU20/1 Dormant. August 2014.

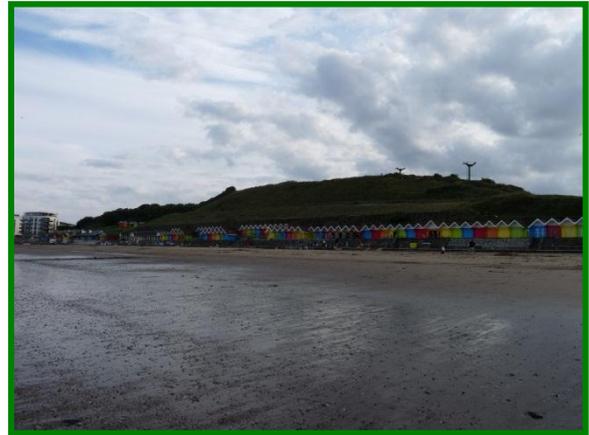
MU20/2 Behind the sea wall (Dormant). August 2014.

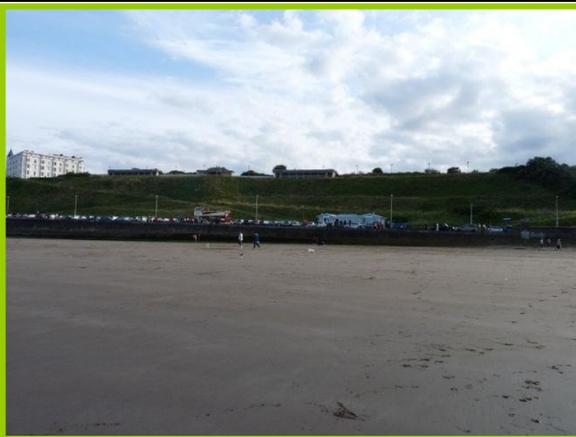
MU20/3 Well vegetated slopes (Dormant). August 2014.

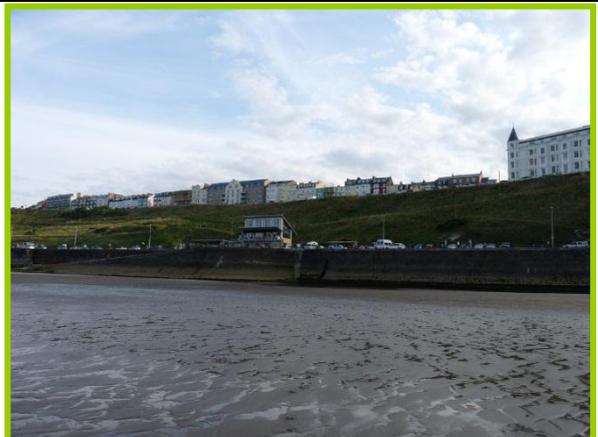
Unit MU20/4a is located to the rear of North Sands and is classified as Inactive. The relict slopes are well vegetated with only minor and localised evidence of erosion at the headscarp, it remains classified as Inactive, unchanged since the 2012 and 2013 surveys.

MU20/4a Relict slopes with localised activity (Inactive). August 2014.

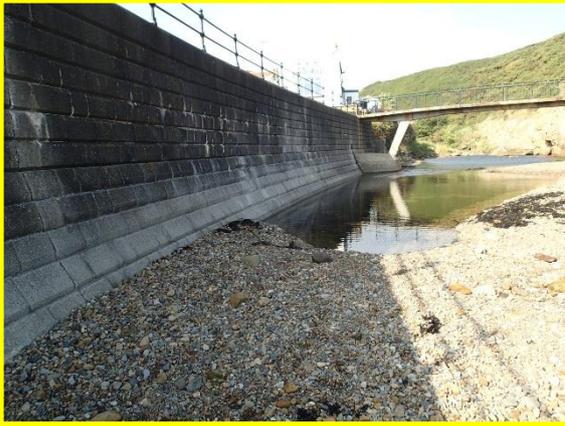
The most northerly defence in the Scarborough Town system, Asset Ref. 1221D901D1201C01, starts adjacent to the footbridge at Scalby Mills and is in fair condition, see below left. There are small cracks throughout and some holes and damage near the bridge where it ties into the river bank.

Wall on south side of Scalby Beck in fair condition (Asset Ref. 1221D901D1201C01)

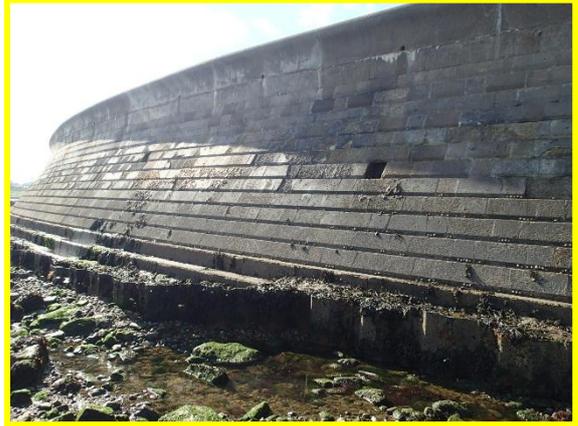
Moving south the wall, Asset Ref. 1221D901D1201C02, around the promontory on which the Sea Life centre is built is in less good, but still overall fair condition, see below top right and bottom left. There is evidence of toe scour and abrasion damage to the face of the wall. At the southern end of this defence there is a beach access ramp / slipway that is unusable due to the low beach levels leaving a large drop and boulders at the bottom. The Promenade in this area is in good condition, below lower right, although in places there is evidence of wave overtopping damage to the vegetation in the Sea Life Centre gardens behind.

Damage to face of blocks on wall at Sea Life Centre (Asset Ref. 1221D901D1201C02)

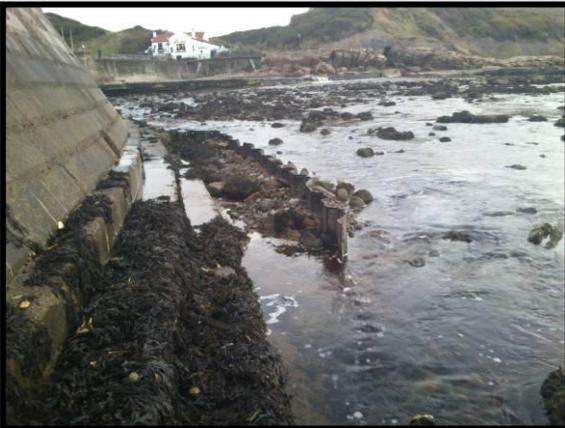
Exposed toe at Sea Life Centre. Note missing infill apron behind end of sheet pile toe. **Photo from 2012** (Asset Ref. 1221D901D1201C02)

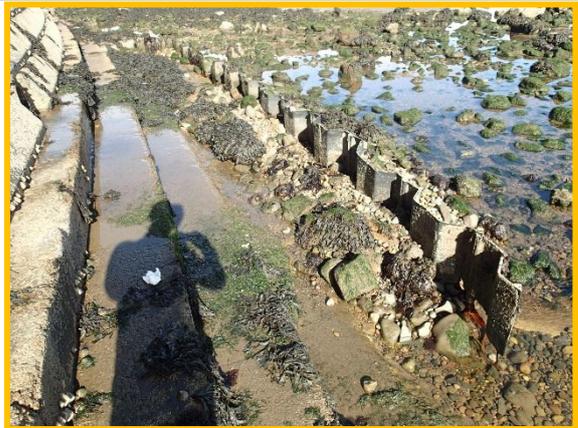
Exposed toe at Sea Life Centre. Very little change since 2012. **Photo 26/09/2014** (Asset Ref. 1221D901D1201C02)

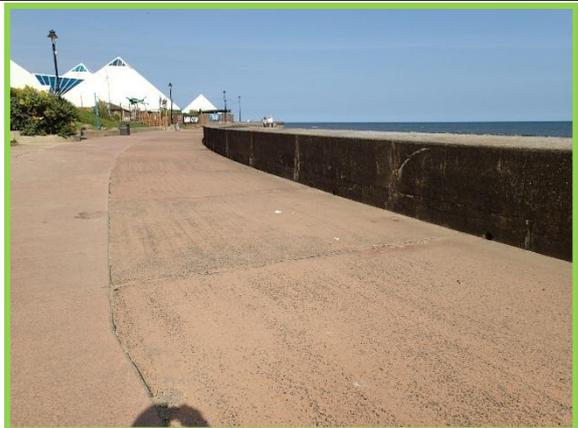
Promenade at Sea Life Centre in good condition. Some cracking to wave wall (Asset Ref. 1221D901D1201C02)

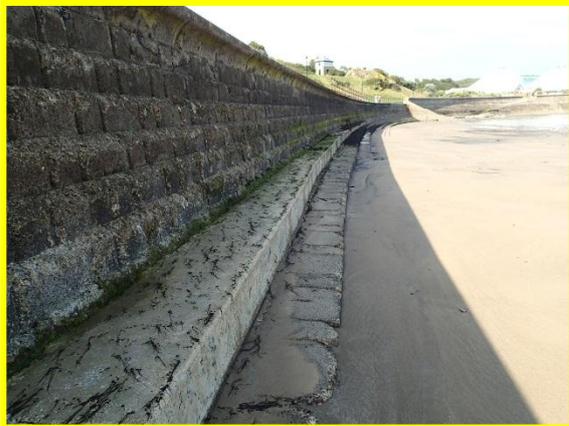
Erosion and spalling of front face of wall. Asset Ref. 1221D901D1201C03

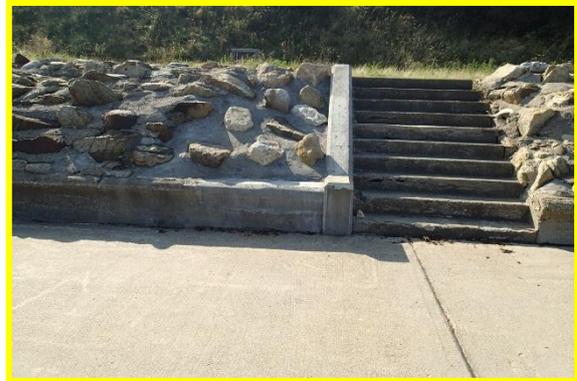
Grouted revetment behind prom has been repaired in many locations Asset Refs. 1221D901D1201C25 & C04

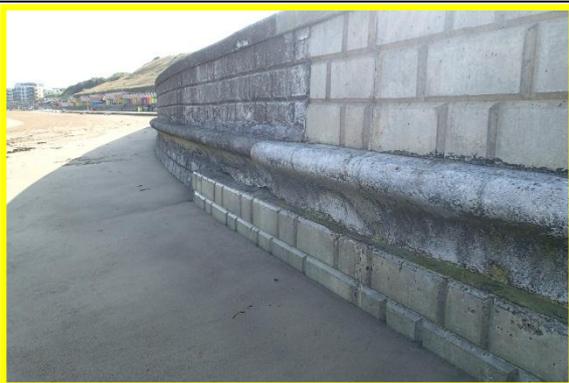
Recent repairs to areas of front face of wall. Asset Ref. 1221D901D1201C04

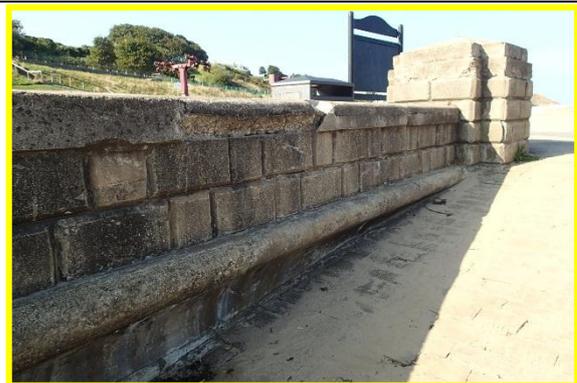
Damage to crest wall at ramp adjacent to promontory. Asset Ref. 1221D901D1201C04

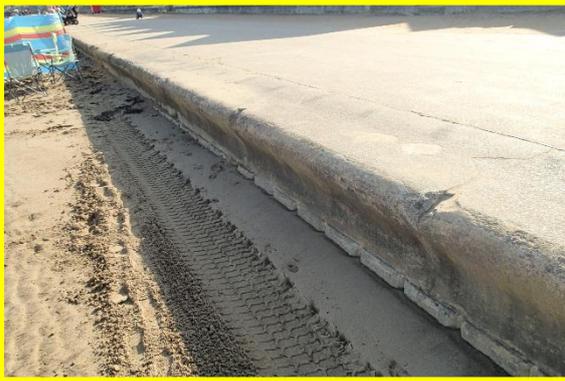
High beach levels in front of beach huts. Minor damage to capping. (Asset Ref. 1221D901D1201C12)

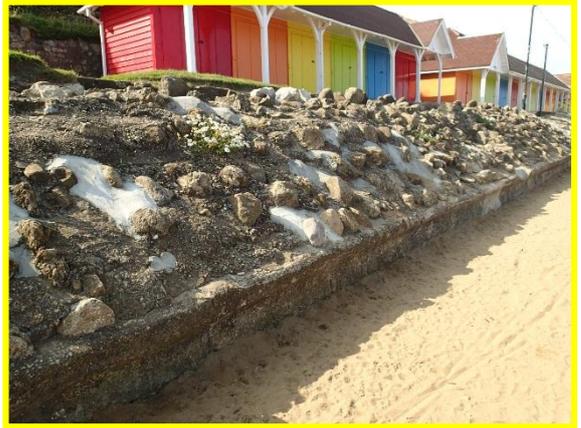
Recent repairs to grouted revetment at rear of promenade. (Asset Ref. 1221D901D1201C05)

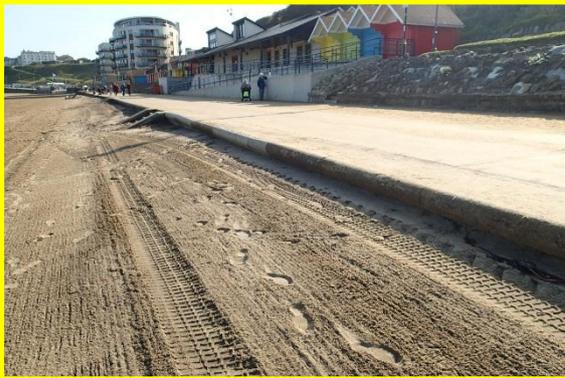
High beach in front of beach management centre, (Asset Ref. 1221D901D1201C15)

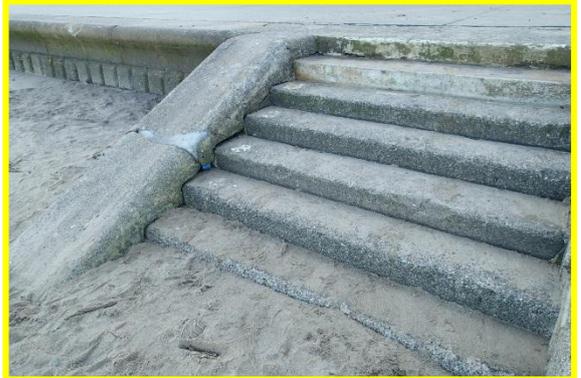
Abrasion damage rounding steps and washout of joints. Asset Ref. 1221D901D1201C17

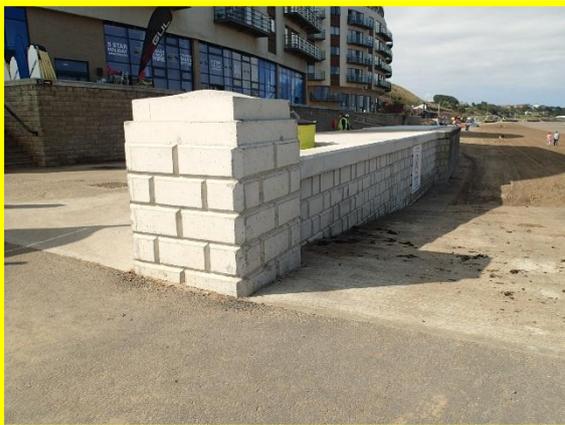
Newly constructed section of wall north of Peasholm Gap (Asset Ref. 1221D901D1201C06)

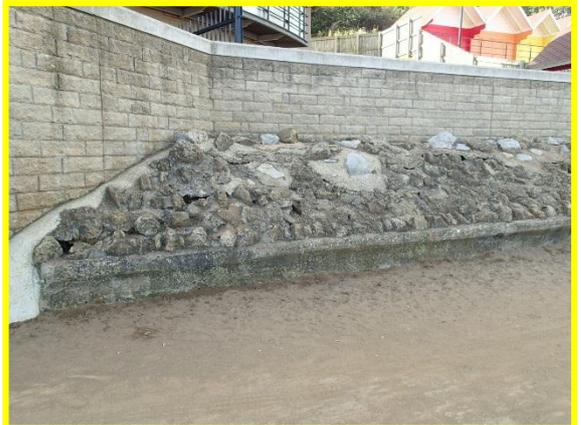
Voids in rear grouted revetment north of Peasholm Gap (Asset Ref. 1221D901D1201C17)

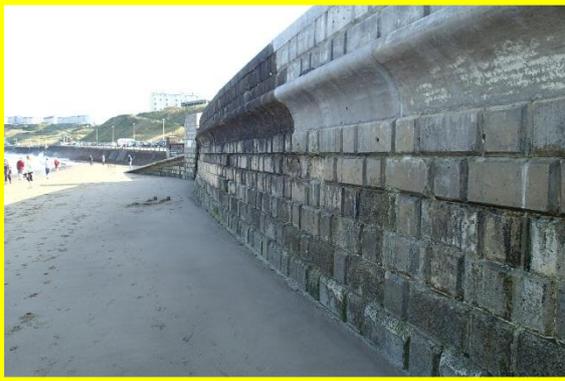
The wall at Peasholm Gap, Asset ref. 1221D901D1201C19 has had significant repairs since 2012, with sections rebuilt or overlaid, presumably after the December 2013 storms. However, there are still some damaged areas of blocks and spalling to the splash beam in areas not yet repaired, see below upper left photo. The promenade and slipway / ramps appeared in fair to good condition, although the mastic sealant had been washed out of the slipway joints, see below lower right.

Damage to lower blocks on southern section of wall at Peasholm Gap.
(Asset Ref. 1221D901D1201C19)

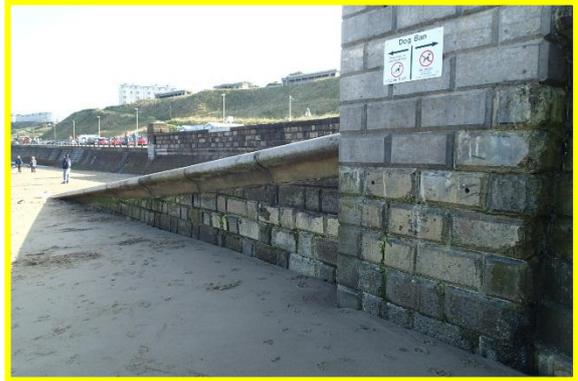
Sloping wall at slipway in fair condition.
(Asset ref. 1221D901D1201C20)

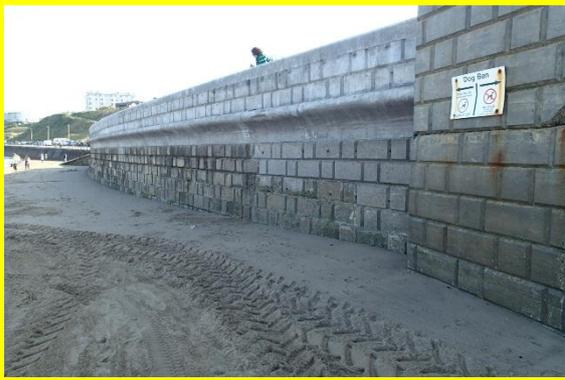
Repaired section of upper wall and splash beam at Peasholm Gap.
(Asset Ref. 1221D901D1201C19)

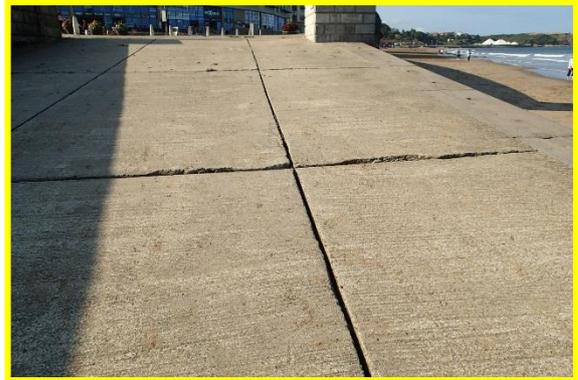
Washed out joints in slipway at Peasholm Gap
(Asset ref. 1221D901D1201C20)

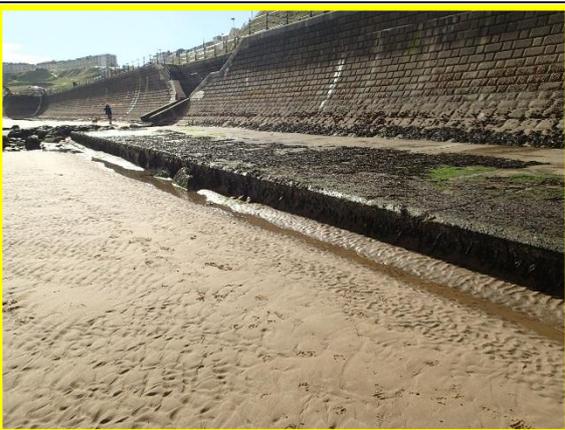
South of Peasholm Gap the beach levels drop and Royal Albert Drive is protected by an increasingly high curve profiled blockwork wall Asset 1221D901D1201C07 and C21 that runs south to the slight promontory at the ramp opposite the recently redeveloped Oasis Café. The promenade along this section was being re-laid at the time of the previous inspection (7th Nov 2012). Beach levels were lower than in 2012, and undermining of the toe was evident north of the central steps, see top photos below.

Low beach levels exposing toe to erosion north of central steps
(Asset Ref. 1221D901D1201C07)

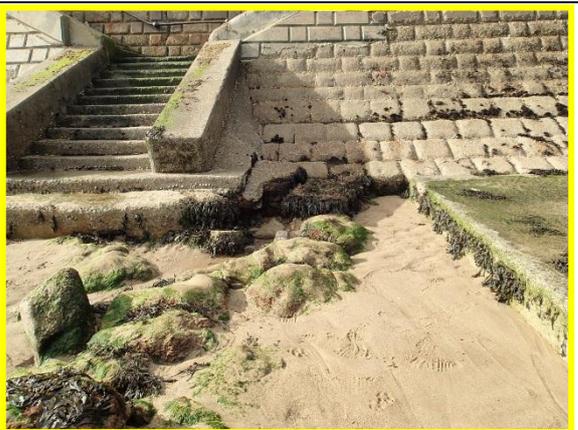
Erosion and undermining at central steps at south end of Asset Ref. 1221D901D1201C07

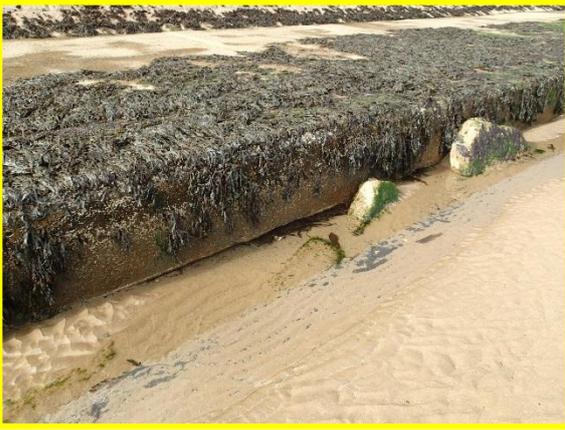
Undermining of toe apron to north of steps
(Asset Ref. 1221D901D1201C07)

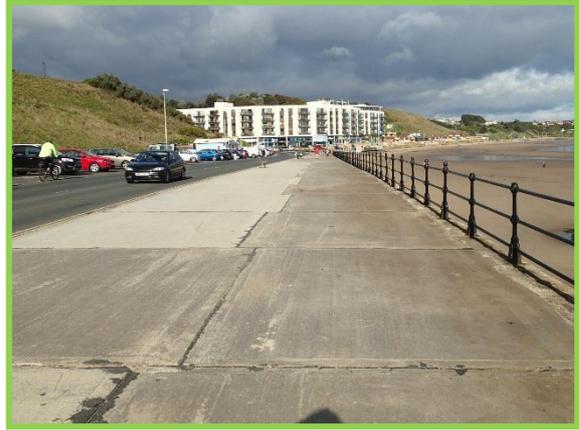
Promenade relaid in 2012 remains in good condition. (Asset Ref. 1221D901D1201C07)

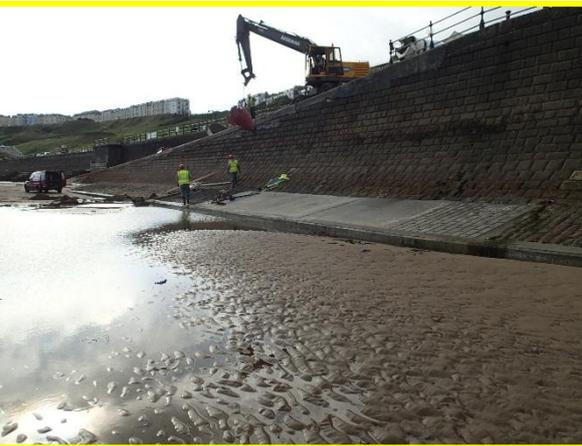
Low beach levels exposing toe apron
(Asset Ref. 1221D901D1201C07)

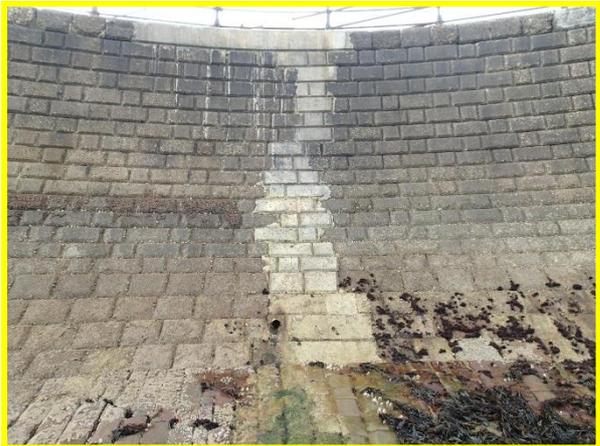
South of the central steps the beach was very low as in 2012 and works were underway to repair the toe apron where it had been undercut and damaged, Asset 1221D901D1201C21. Repairs had been undertaken to a number of vertical cracks and the capping beam where badly damaged, see photo below right. The promenade was partly re-laid in 2012, but the central section remains to be replaced. The joint between the promenade and the wall capping beam needs resealing along some of the length.

Repair to vertical crack and capping beam north of the ramp. (Asset Ref. 1221D901D1201C21)

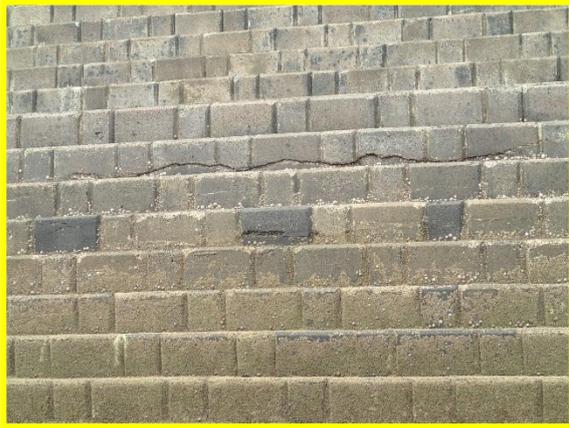
To the southern end of the North Bay, opposite Clarence Gardens to the north of the rock armour there is a large stepped concrete blockwork sea wall structure (Asset Ref. 1221D901D1201C08 – just north of Albert Road) constructed with eight large buttresses/bastions which protrude from the wall out onto the beach. The buttresses/bastions vary in height and length. The 2009 and 2012 inspections noted that the toe of the wall was severely eroded and there was severe cracking to out-built sections particularly at north end. There have been extensive repairs to this asset with some of the steps and toe replaced or overlaid with sections significantly improved. However, the overall condition rating of fair has been kept because there are still sections of original blocks with horizontal cracking. The concrete berm above the buttresses is in good condition. Above this are the sea wall and promenade, and a second wall at the back of the promenade as the road, Albert Drive, is at higher level here. Both the promenade and the second wall show cracking, with open joints and loss of surface to areas of the promenade.

Horizontal cracking in original blocks
(Asset Ref. 1221D901D1201C08)

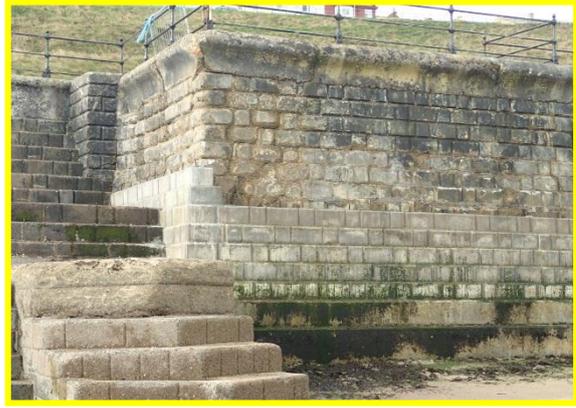
Repairs to lower blockwork on outbuilt section,
upper section still to be repaired.
(Asset Ref. 1221D901D1201C08)

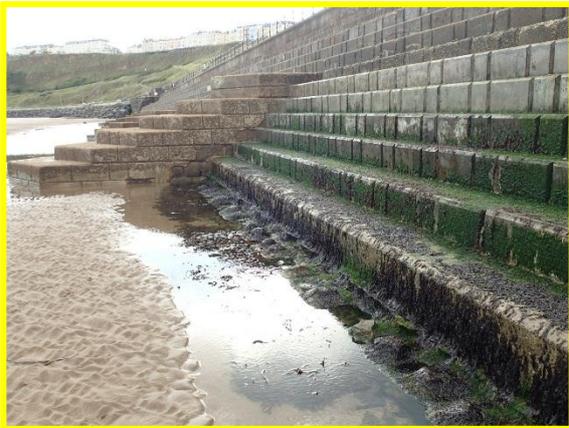
Rebuilt section of steps.
(Asset Ref. 1221D901D1201C08)

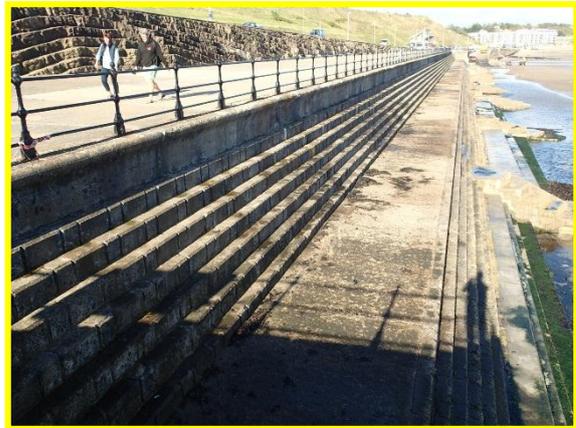
Berm, upper steps and promenade.
(Asset Ref. 1221D901D1201C08)

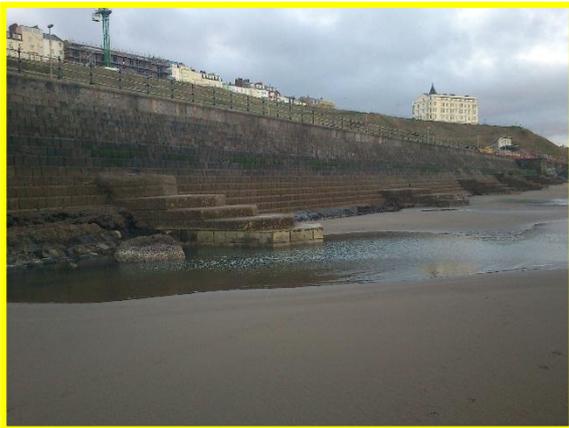
Overview photo looking north showing damage to
lower blocks and defence toe. **Photo from
07/1/2012.**
(Asset Ref. 1221D901D1201C08)

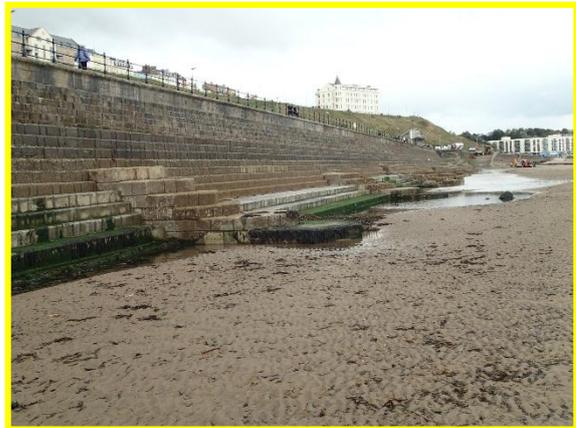
Overview photo looking north showing repairs to
lower blocks and standing water in scour hole at
defence toe. 26/09/2014.
(Asset Ref. 1221D901D1201C08)

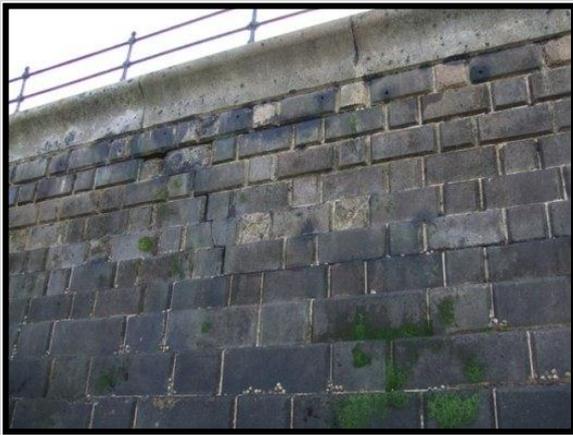
There is a short section of stepped blockwork wall (Asset Ref. 1221D901D1202C23) between the above stepped wall and the rock armour section. This short wall has two large vertical cracks with one crack extending through the capping beam. There is another crack extending half way up the wall. There is missing blockwork in localised areas and the lower part of wall is eroded with exposed aggregate. The secondary wall beyond the promenade and the promenade itself are also cracked. These issues were identified in the 2009 inspections but had changed very little when inspected in 2012 or again in 2014, see photos below.

Example of cracking Photo from 2009
(Asset Ref. 1221D901D1202C23)

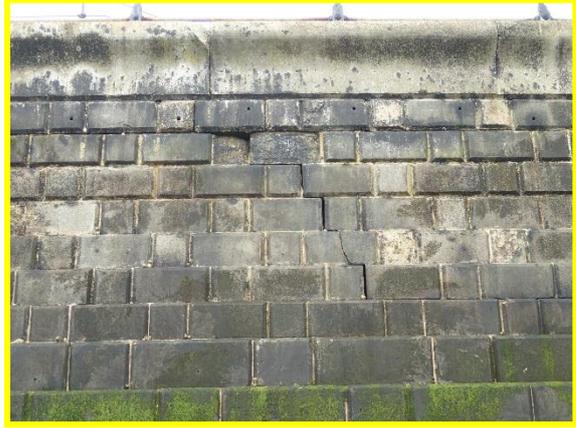
Little change is same crack- Photo from 26/09/14
(Asset Ref. 1221D901D1202C23)

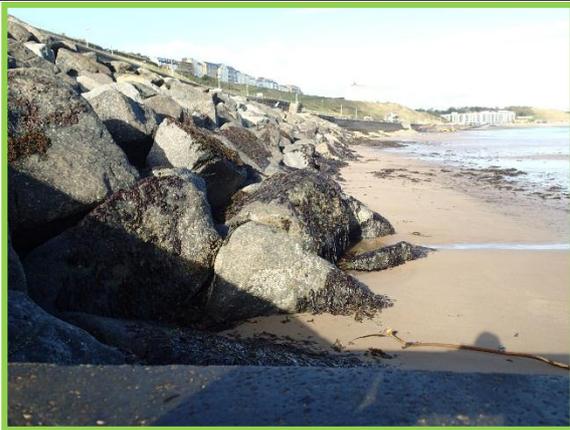
The southern-most section of defence in this unit is the first section of the rock armour at Clarence gardens (south) that was constructed in 2004/5. This is in good condition, protecting the original wall behind, Asset ref 1221D901D1202C01.

Toe of rock armour, looking north from steps
(Asset Ref. 1221D901D1202C01)

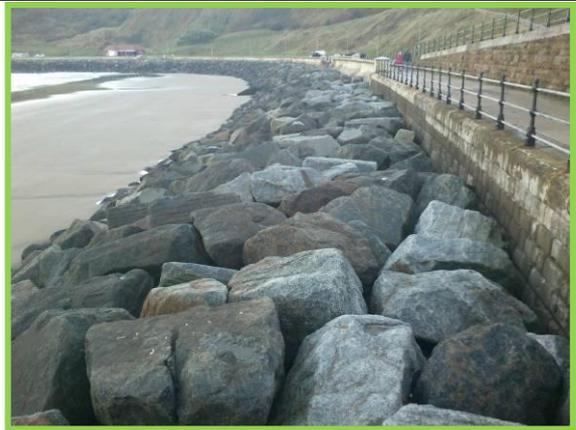
Crest of rock armour – photo from 2012
(Asset Ref. 1221D901D1202C01)

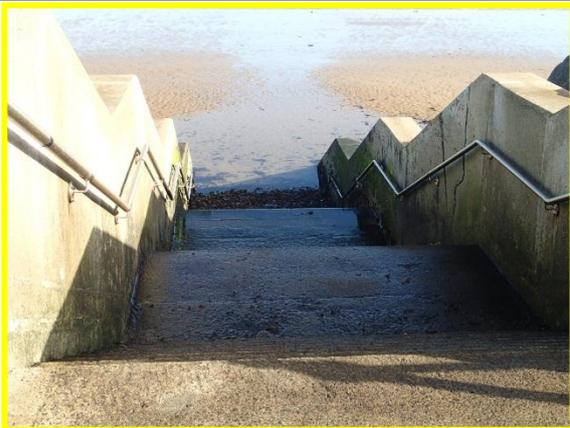
Scour hole at toe of steps prevents use at low tide. Note abraded / corroded steps.
(Asset ref. 1221D901D1202C01)

The two sets of steps through the rock armour in the south part of North Bay both show abrasion damage to the steps and locally scoured areas of the beach which leave a standing pool of water at low tide, making access to and from the beach difficult (see photo of Asset ref. 1221D901D1202C01 above and photo below top right and left).

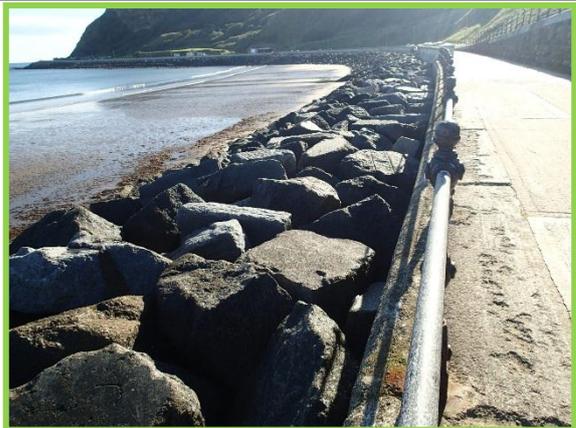
Crest of rock armour. Adjacent promenade showing surface damage.
(Asset ref. 1221D901D1202C01)

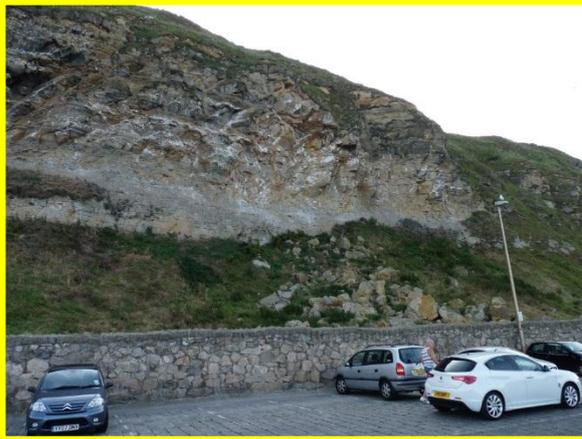
Unit MU21/2 forms the Castle Cliff promontory and continues to be classified as Locally Active, unchanged from 2012 and December 2013. The cliffs are steep with extensive toe protection measures. Locally, bedrock is exposed where it is subject to ongoing weathering and erosion from rainfall. The December 2013 survey report noted, large rock fall debris at the toe of the slope and undermining of competent rock in the upper cliff, causing some of the rockfalls. These observations held true during the 2014 survey. A failure of the talus in the lower slope behind the covered seating area towards the south of the unit. Inspection of photographs from December 2013 confirmed this failure had taken place prior to that inspection.

MU21/2 Well jointed hard rock subject to localised failure – note relatively fresh scar and large boulder size angular debris (Locally Active). August 2014.

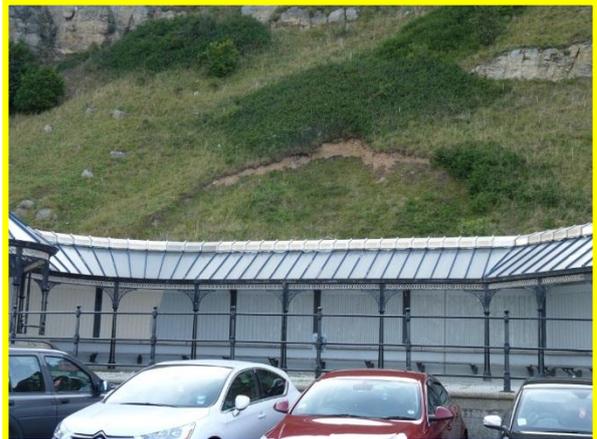
MU21/2 Talus failure in lower slope (Locally Active). August 2014.

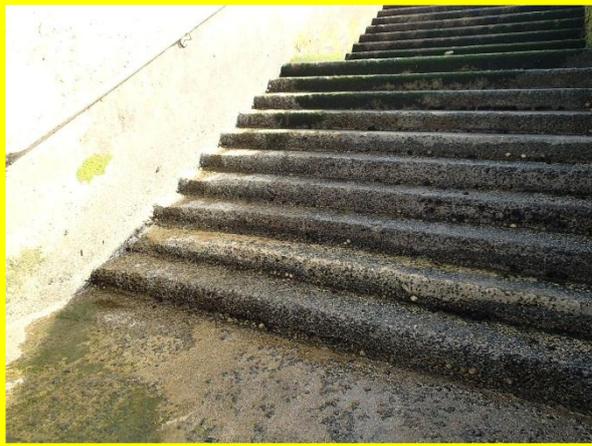
Abrasion damage to steps at south of North Bay
(Asset Refs. 1221D901D1202C03)

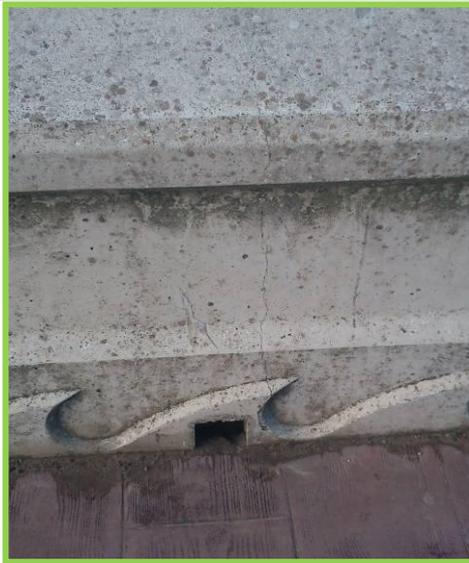
Example of crack through centre of wave wall –
photo from 2012
(Asset Ref. 1221D901D1202C03)

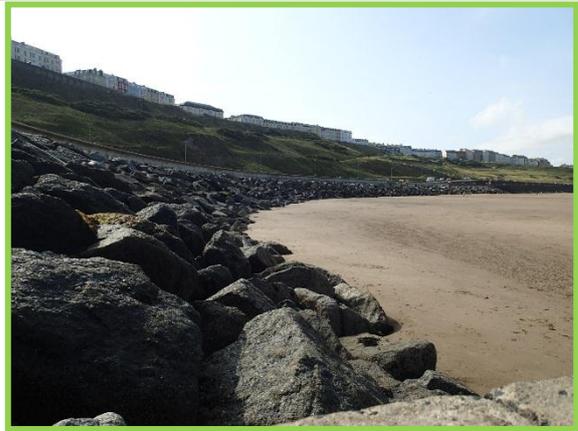
View of rock armour with looking north
(Asset Ref. 1221D901D1202C03)

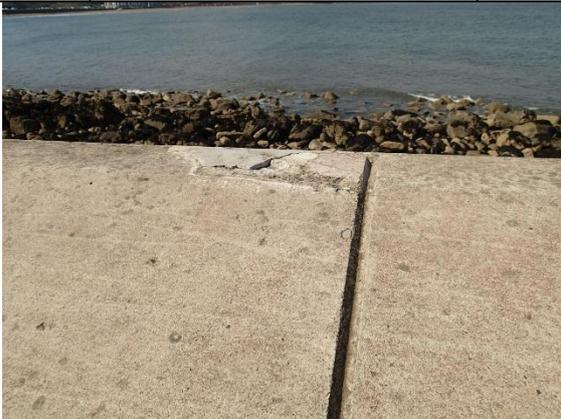
Previous minor repair to crest wall damage in
need of further repair
(Asset Ref. 1221D901D1202C02)

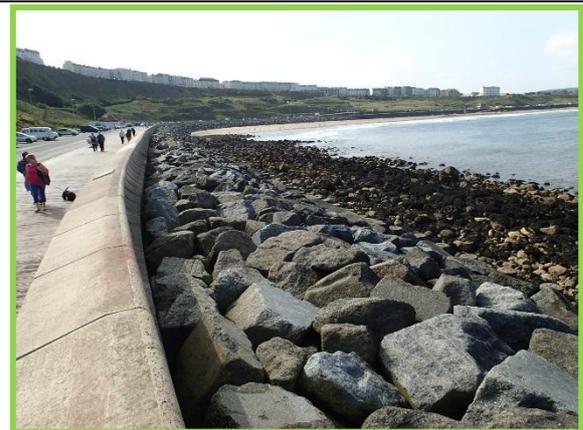
View of crest wall and rock armour with toe piles
just visible.
(Asset Ref. 1221D901D1202C04)

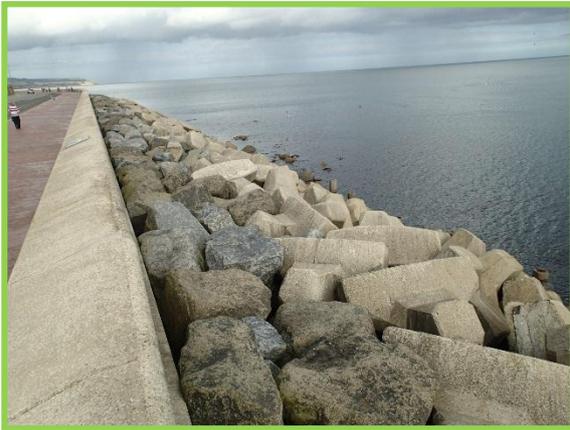
View of crest wall and rock crest and Accropodes with toe piles just visible.
(Asset Ref. 1221D901D1202C02)

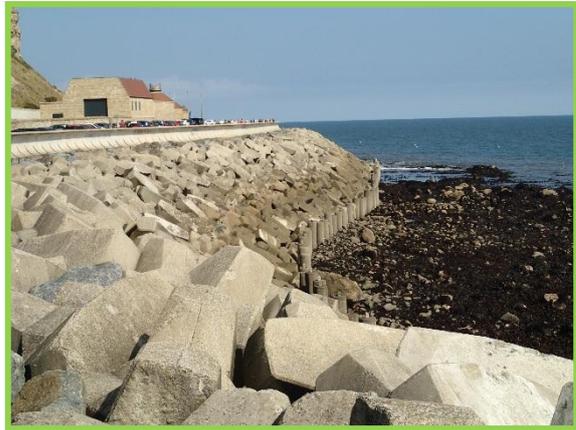
View of Accropode revetment and toe piles at south end near YW pumping station.
(Asset Ref. 1221D901D1202C02)

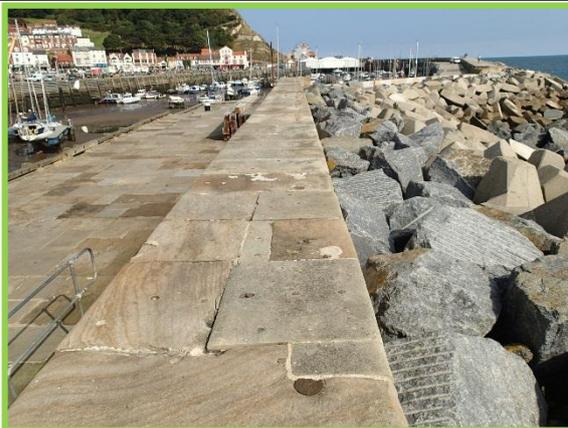
The East Pier outer wall armour (Asset Ref. 1221D901D1301C01) is in good overall condition, with only minor cracking to the crest wall and individual Accropodes. The raised section of stone blocks that was rebuilt along almost the entire length remains in good condition with minor erosion and cracks present. At the seaward (south) end of the harbour arm the armour is less tightly packed than it is along the rest of the pier, but there has been little if any change since the 2009 inspection. It was noted that there is a possible areas of settlement of the armour crest adjacent to the area with the wide rock blanket toe, photo below top left.

East Pier rock armour and Accropodes showing area of possible settlement of crest armour
(Asset Ref. 1221D901D1301C01)

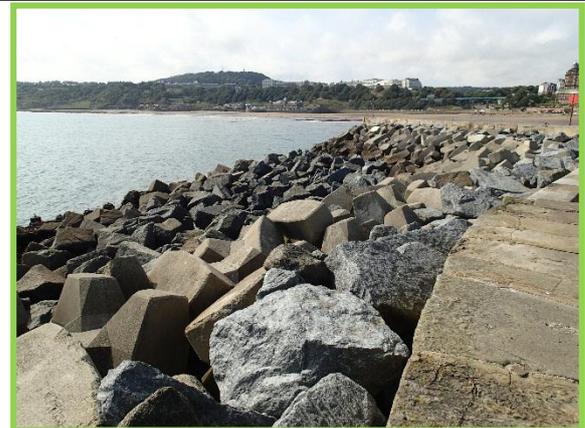
Tightly packed rock armour, Accropodes rock toe blanket and concrete toe piles seaward of East Pier harbour wall
(Asset Ref. 1221D901D1301C01)

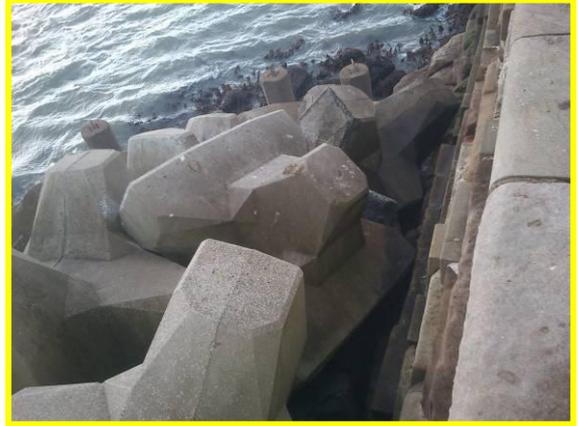
South end of harbour arm showing potential lack of armour fill **Photo taken 16/10/2012** (Asset Ref. 1221D901D1301C01)

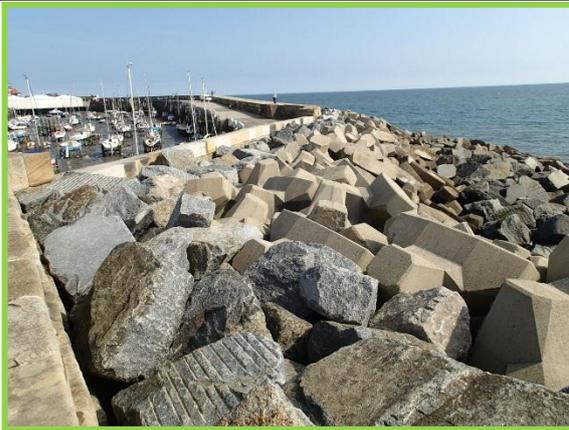
Rock armour, Accropodes and rock toe blanket adjacent to lower part of crest wall (Asset Ref. 1221D901D1301C01)

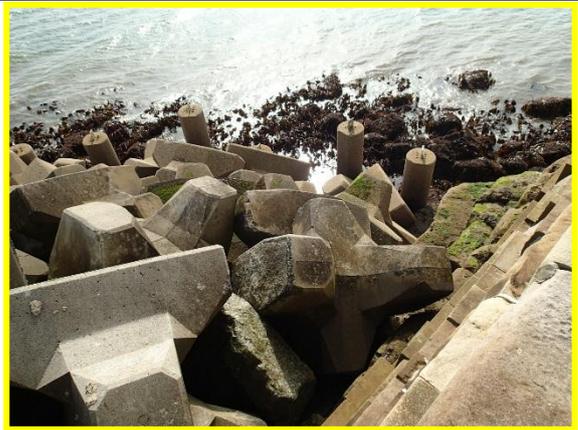
South end of harbour arm showing potential lack of armour fill **Photo taken 10/09/2014 No change.** (Asset Ref. 1221D901D1301C01)

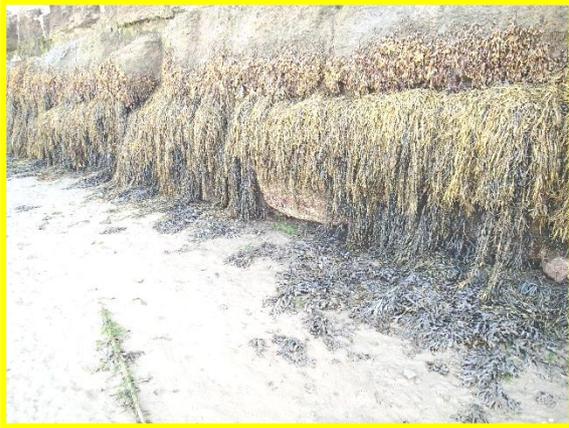
The faces of many blocks are missing or cracked at the seaward end of the original East Pier wall. The inner face of East Pier, Asset ref 1221D901D1301C16 was refurbished as part of the 2005 scheme, with missing blocks replaced and joints filled. Minor missing joints and cracks appear throughout the harbour masonry walls. The inner wall was inspected on a very low tide and it was noted that there are open joints and voids at the toe, see photos below left and right.

Erosion at toe, near mid length of inner face of East Pier. (Asset Ref. 1221D901D1301C16)

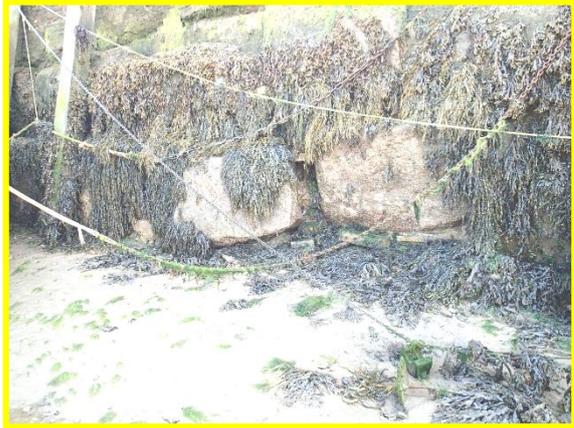
Open joints and voids between blocks in inner face of east Pier below repaired section. (Asset Ref. 1221D901D1301C16)

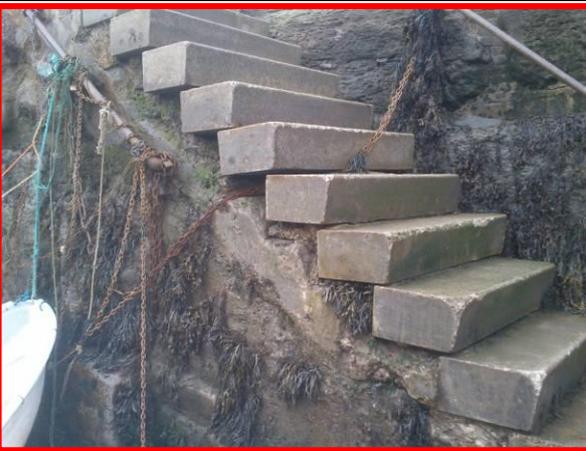
Washout behind steps – **photo from 2012**
(Asset Ref. 1221D901D1301C16)

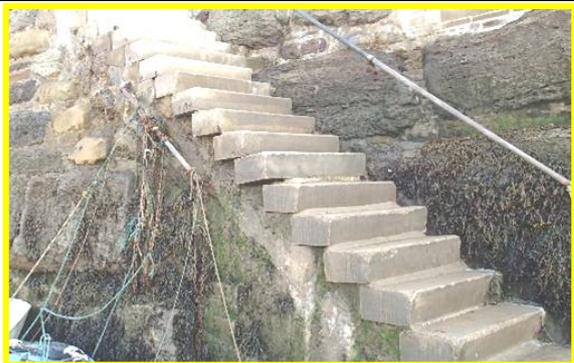
The stone stairs set into this defence noted to have loose treads and washed out joints in the 2012 inspection had been repaired, see lower photos below, although further repairs below the high water line are required. The washout of the joints at this set of steps was noted in the 2009 report and this has deteriorated, threatening collapse of the stone treads.

Steps have been repaired, but mortar is starting to wash out again.
(Asset Ref. 1221D901D1301C16)

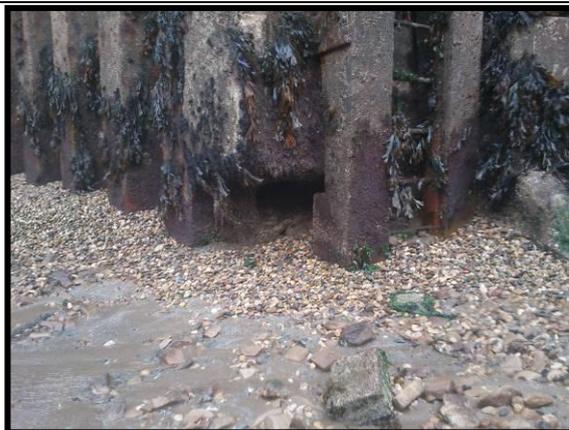
Void under SE corner of breakwater by lighthouse
Photo from 2012
(Asset Ref. 1221D901D1301C17)

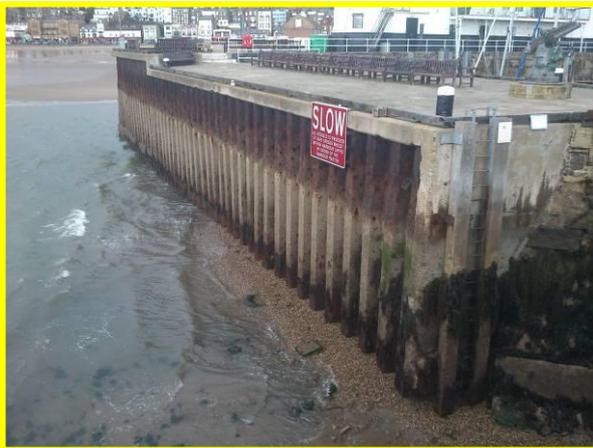
Corroded sheet piles, but overall fair condition
Photo from 2102 (Asset Ref. 1221D901D1301C17)

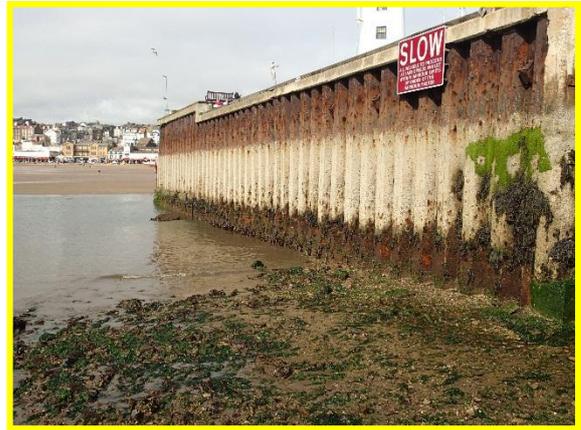
Corroded sheet piles, but overall fair condition
Photo from 10/09/14
 (Asset Ref. 1221D901D1301C17)

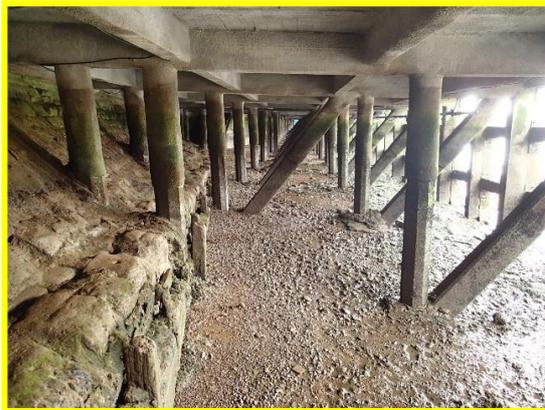
The original quay wall on Sandside (Asset Ref. 1221D901D1301C06) shows signs of deformation; missing joints and movement of blockwork. The newer concrete jetty which has been constructed above also shows signs of movement. The previous inspections noted that there are cracks forming on the columns and beams to the underside of the extended jetty with exposed reinforcement bar in places. The section of steel sheet piling adjacent to the east is heavily corroded. At the east end of Sandside the promenade is supported by several arches built in front of the original quay. These appear in fair condition and the adjacent access ladder appears to have been renewed but there is damage to the concrete capping, see below right.

The original quay wall beneath the newer concrete jetty (Asset Ref. 1221D901D1301C06)

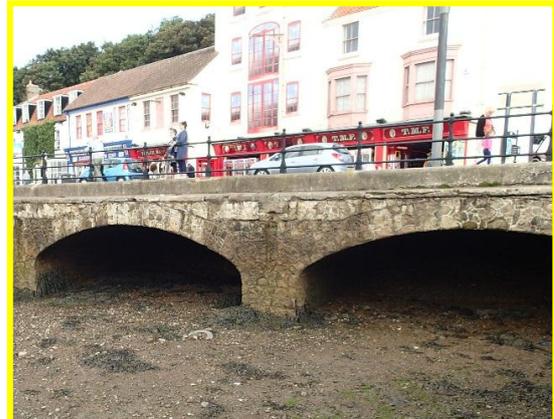
Spalling concrete capping to arched suspended quay at east end of Sandside
 (Asset Ref. 1221D901D1301C05)

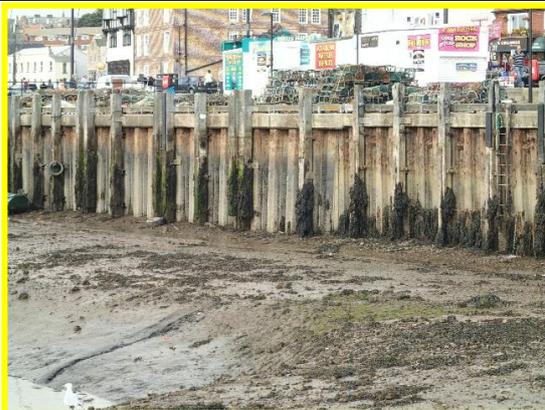
Corroded sheet piles at back of harbour
 (Asset Ref. 1221D901D1301C12)

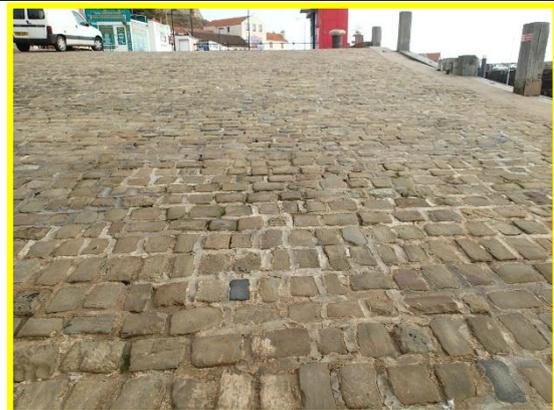
Washout of mortar in masonry blocks on harbour access ramp (Asset Ref. 1221D901D1301C11)

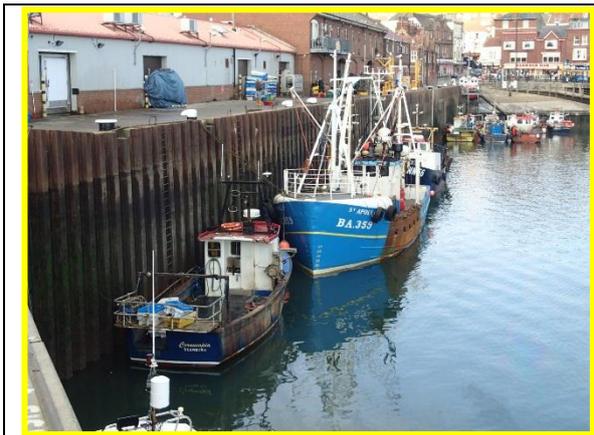
The West Pier appears to be mostly in fair condition, the steel sheet piling on the inner side of the harbour wall and at the seaward end is corroded, although intact (Asset Ref. 1221D901D1301C13 and C18). The outer side (Asset Refs. 1221D901D1301C07 and Asset Ref. 1221D901D1301C19) shows several significant defects including large full height cracks and exposure of aggregates and has been recorded as poor condition since 2009. During the 2012 inspection at low tide the timber toe piling was exposed and seen to be in poor condition with potential undercutting in a number of places with low beach levels. At the time of this years' inspection on 10 September 2014 the beach was higher and the toe piles were not visible. Erosion to the wall and minor cracks to the promenade were also noted during the inspection (Asset Ref. 1221D901D1301C19). These cracks require repair and monitoring to ensure that the structural integrity of the defence is maintained.

Corroded sheet piling of West Pier
(Asset Ref. 1221D901D1301C13)

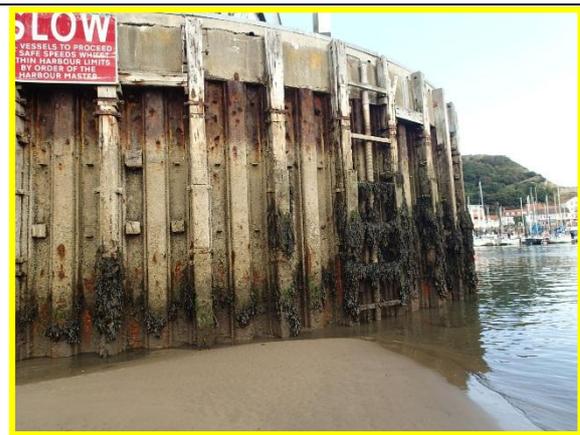
Corroded sheet piling and damaged timber fenders at end of West Pier
(Asset Ref. 1221D901D1301C18)

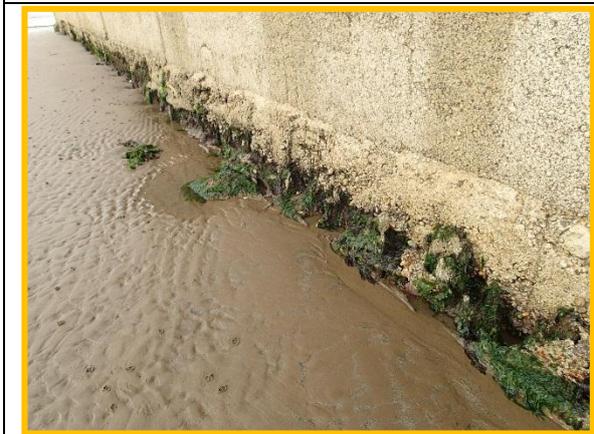
Undermining of toe of concrete encased section at bend where West Pier narrows
(Asset Ref. 1221D901D1301C07)

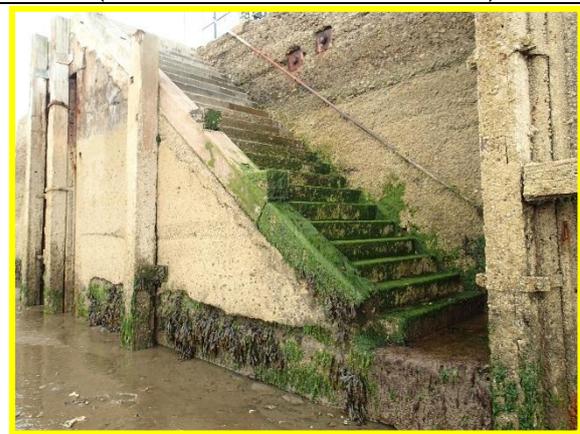
Cracks to concrete facing and exposed toe to steps on West Pier
(Asset Ref. 1221D901D1301C18)
