**Walk-over Visual Inspections of Assets
including Coastal Slopes**

**Scarborough Borough Council
Final Report**

November 2014

Coast Protection Assets and Coastal Slope Condition Analysis

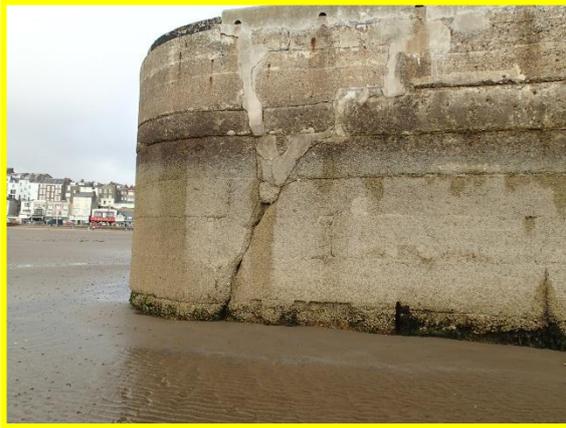
The beach level at the west side of west pier (Asset Ref. 1221D901D1301C19 and C07, see photos below) was lower than during the 2009 inspections, see photos below, exposing the timber toe piles. If the lower levels persist the toe piles may become further undercut so additional toe protection should be considered.

Cracks and repairs in concrete encasement section at narrowing of West Pier (Asset Ref. 1221D901D1301C07)

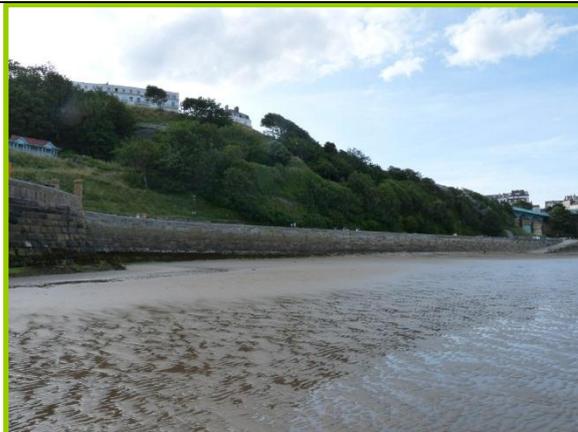
MU22/1 - Well vegetated slopes with large coastal defences at the toe (Inactive). August 2014.

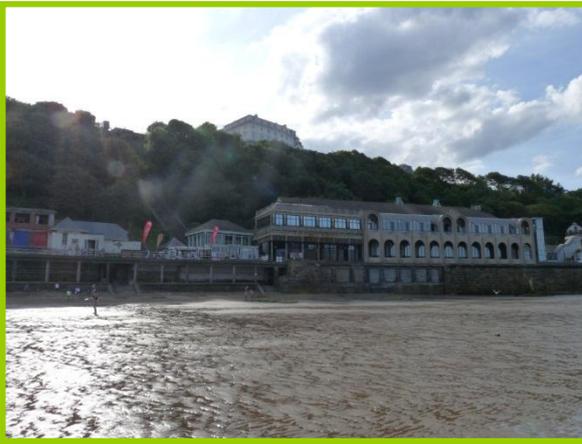
MU22/3 Well-vegetated slopes (Inactive). August 2014.

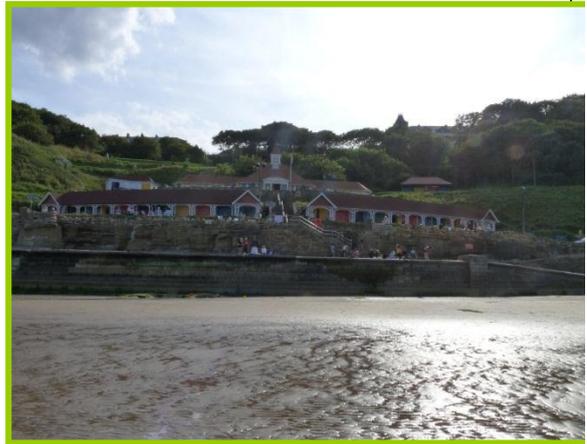
MU22/4 The cliff face shows stability overall (Inactive). August 2014.

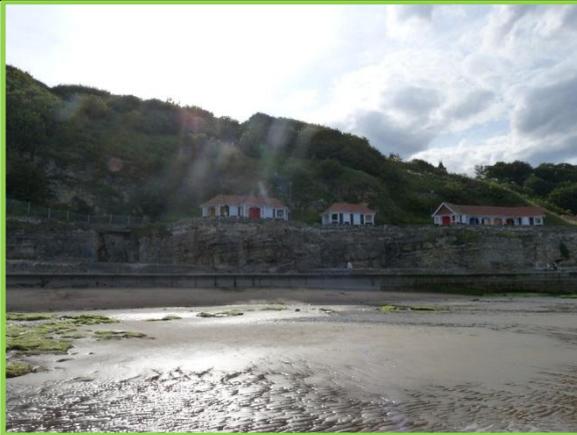
MU22/5 – Vegetated slope (Inactive). August 2014.

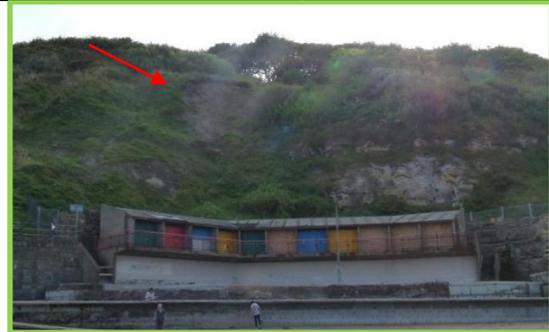
Units MU22/4 and MU22/5 comprise the northern part of the South Cliff Gardens and are both classified as Inactive in 2014, unchanged since December 2013. These units appear to be largely stable. However, a significant unvegetated area was noted in the mid-upper slope at the southern end of unit MU22/5, indicating a shallow failure at this location. This scar was also present during the December 2013 survey so occurred prior to that.

MU22/5 – Note small unvegetated area indicating a shallow slip in the upper cliff (Inactive). August 2014.

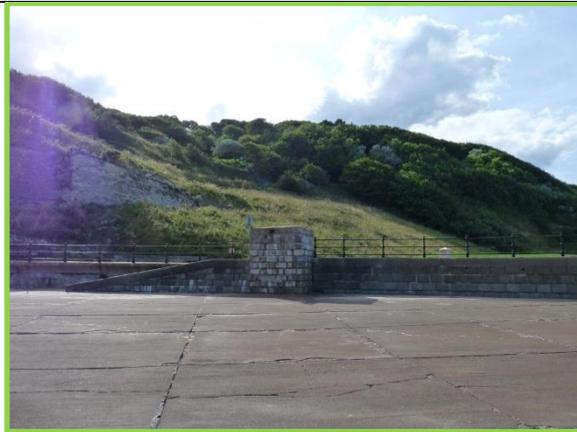
MU22/6 – Vegetated slope behind former South Bay Pool (Inactive). August 2014.

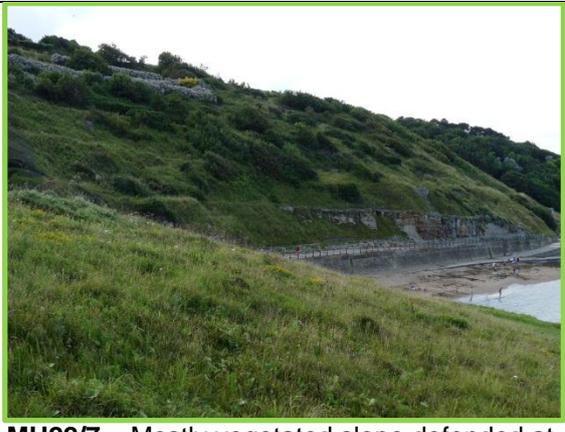
Unit MU22/7 is located at Holbeck Gardens and is classified as Inactive in 2014, unchanged since 2012. A number of footpaths in have previously been closed due to cracking and ongoing instability. Otherwise, the slopes are well vegetated except for an area of exposed bedrock subject to small rockfalls at the cliff toe. The promenade at the base of the cliff is protected by a rockfall catch fence.

MU22/7 – Mostly vegetated slope defended at base but with some exposed bedrock just above sea defence (Inactive). August 2014.

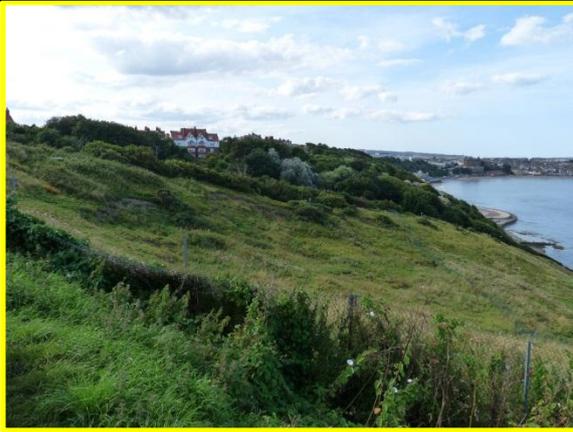
MU22/8 - Upper part of Holbeck Hall landslide. Note small localised areas of exposed rear scarp (Locally Active). August 2014.

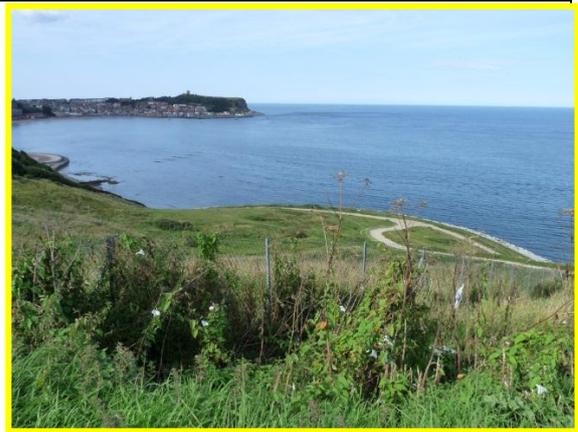
MU22/8 Defended Holbeck Hall landslide run-out lobe (Locally Active). August 2014.

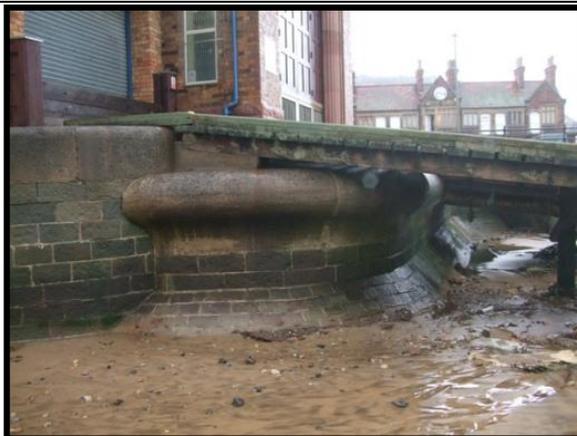
The South Bay defences start at the RNLI station, adjacent to West Pier. As in the 2009 and 2012 inspections the sea wall protecting the Lifeboat Station is in fair to good condition with minor mortar loss of joints and erosion (Asset Ref No.1221D901D1301C08).

View of blockwork wall beneath life boat station
Photo from 2009 (Asset Ref. 1221D901D1301C08)

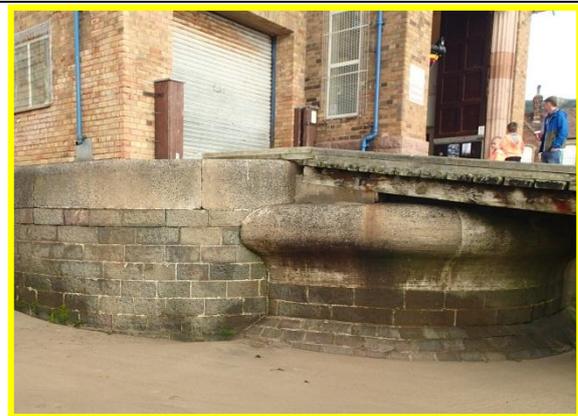
Minimal change to wall since 2009
 (Asset Ref. 1221D901D1301C08)

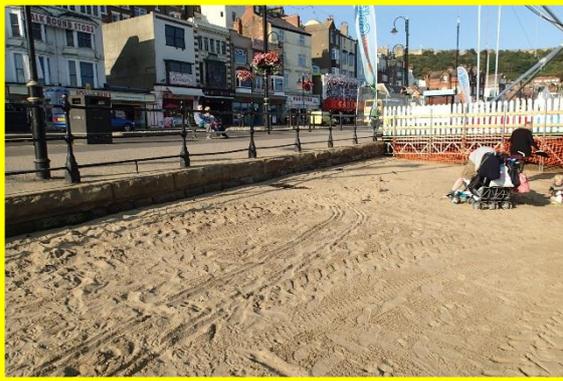
High level beach with only top course of masonry visible, missing mortar. (Asset Ref. 1221D901D1301C22)

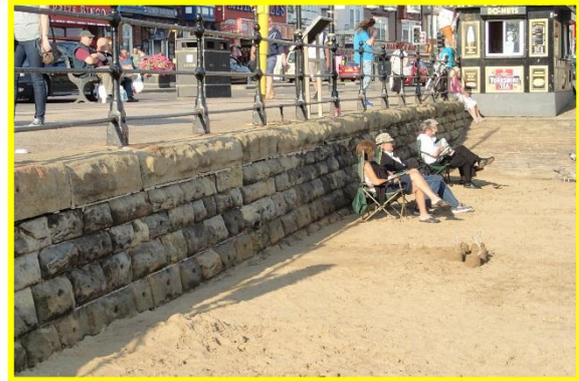
East end of Foreshore Road sea wall where beach was lower, showing washed out joints. (Asset Ref. 1221D901D1301C15)

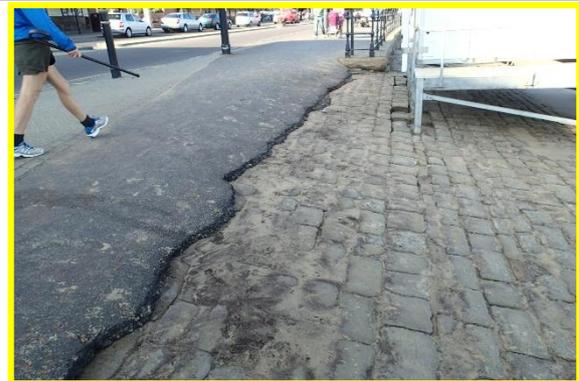
Damage at edge of road and open joints in some of the beach access ramp blockwork. (Asset Ref. 1221D901D1301C23)

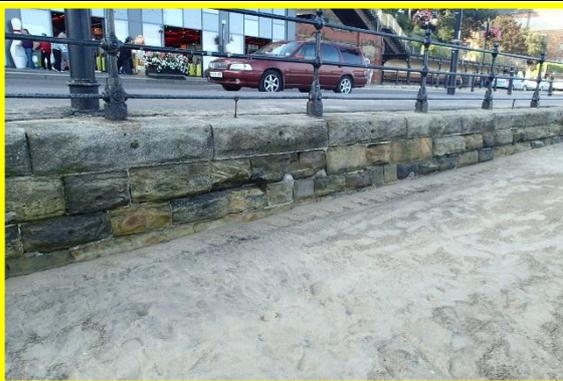
Damaged blocks and washed out joints needing repair. (Asset Ref. 1221D901D1301C24)

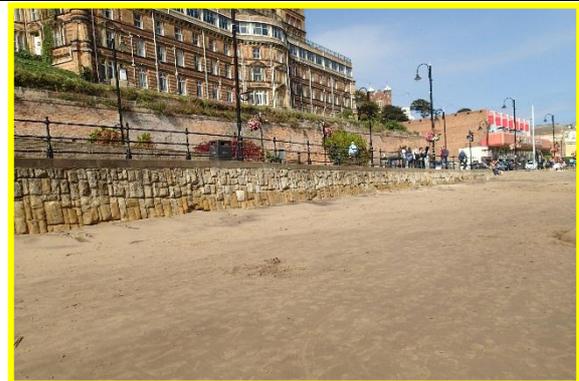
Occasional washed out joints in wall at south end of Foreshore Road. (Asset Ref. 1221D901D1301C25)

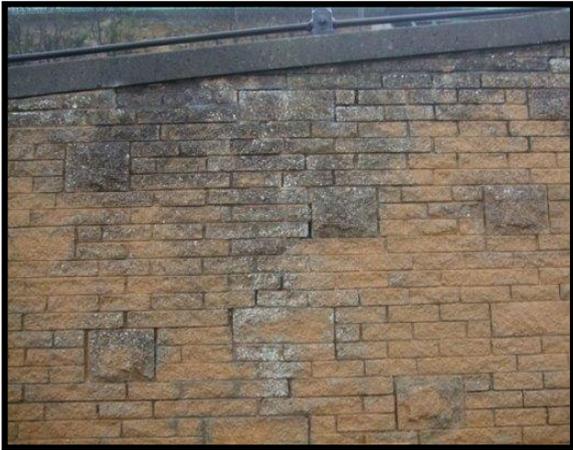
The two stage wall at the end of Valley Road / Aquarium Top has a number of cracks in the retaining wall at the back of the promenade (Asset Ref. 1221D901D1301C25/C09/C10). A vertical crack was observed in 2009 and while that crack does not appear to have deteriorated significantly there are other vertical and horizontal cracks evident. Repair work to the wall is advised to prevent further damage.

Vertical crack to second wall protecting road.
Photo from 2009 (Asset Ref. 1221D901D1301C09)

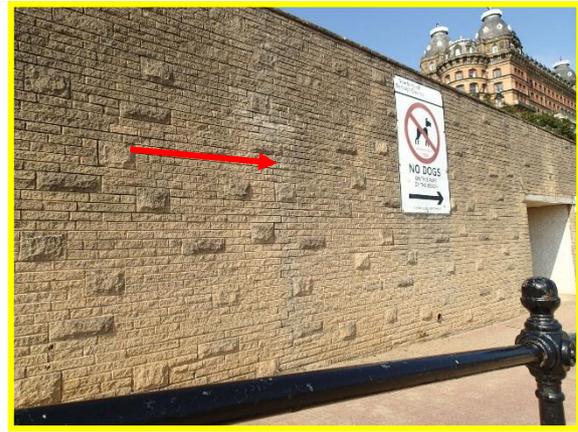
Second stage wall, with vertical crack, 10/09/14
 (Asset Ref. 1221D901D1301C09)

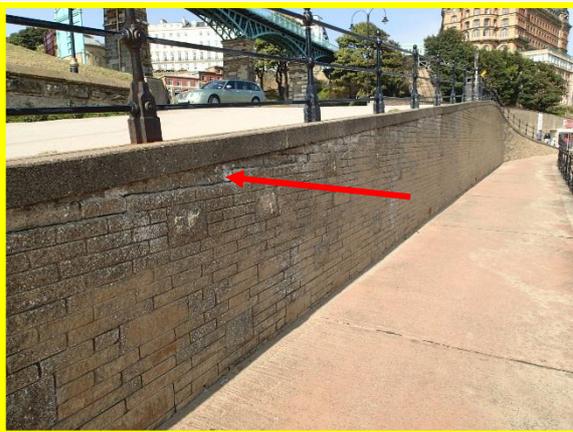
Second stage wall, with horizontal cracks below coping, 10/09/14
 (Asset Ref. 1221D901D1301C10)

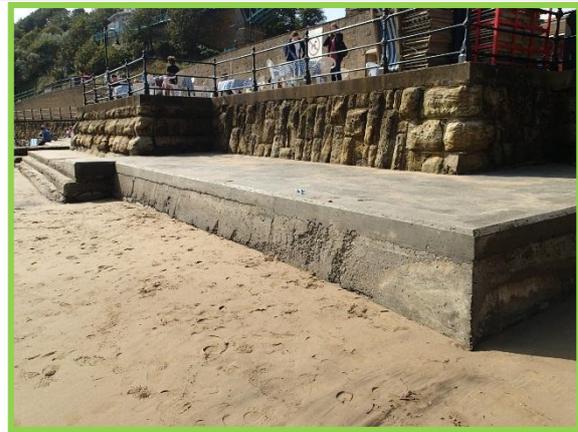
Toe apron has been replaced or overlaid
 (Asset Ref. 1221D901D1301C09)

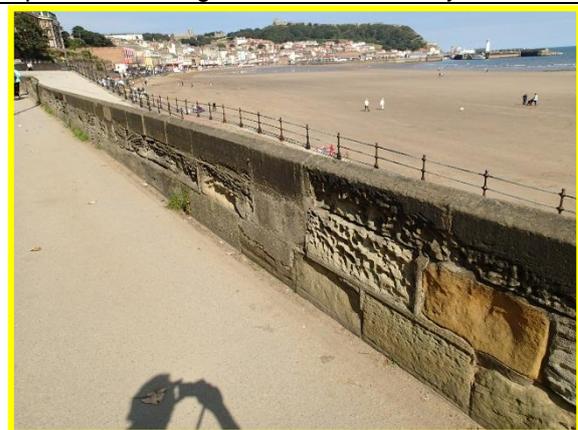
Erosion and weathering to limestone blocks in crest wall
 (Asset Ref. 1221D901D1301C26)

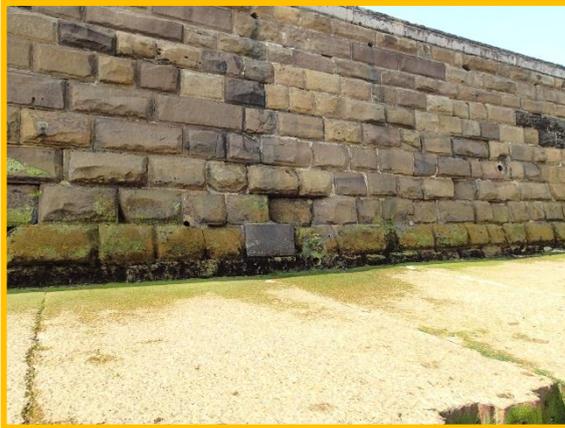
The beach was relatively high for the inspection of the stone blockwork sea wall at “The Spa”, possibly due to beach management operations moving sand to this area from the Foreshore Road beach earlier in the year. However, the toe apron, which is in locally poor condition was still exposed. A capital improvement works scheme is under development for this frontage, although further deterioration should be closely monitored and action taken if necessary until the scheme can be implemented.

Loose blocks set back in void at toe of wall and open joints (Asset Ref. 1221D901D1301C27)

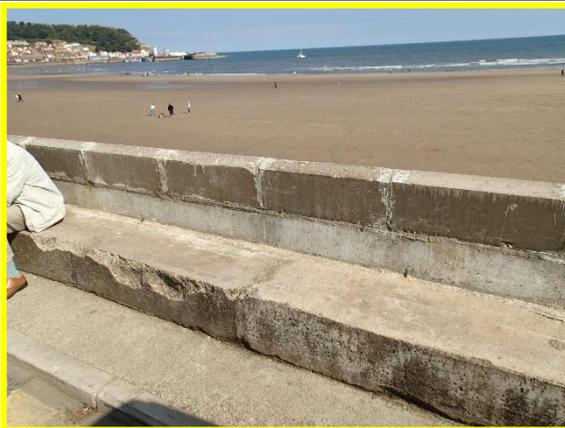
Parapet wall has been rebuilt following December 2013 storm, but crest wall needs constant attention to repairs. (Asset Ref. 1221D901D1301C27)

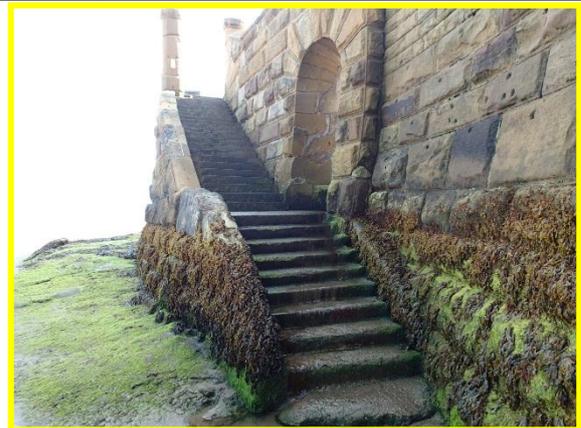
Abraded and slippery steps with rounded edges makes beach access hazardous. (Asset Ref. 1221D901D1301C27)

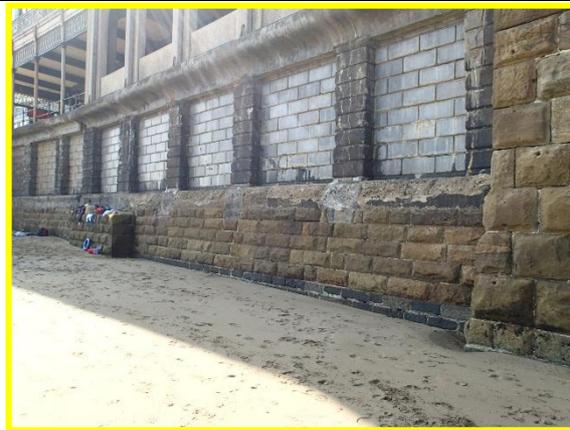
The wall at Spa Colonnade, Asset ref 1221D901D1301C29, while in fair overall condition has major spalling and loss of concrete to lower splash beam bellow in filled openings, see below left. There is also a small void at the toe near to South end.

Abraded and spalling concrete capping to original wall below in filled openings
(Asset Ref. 1221D901D1301C29)

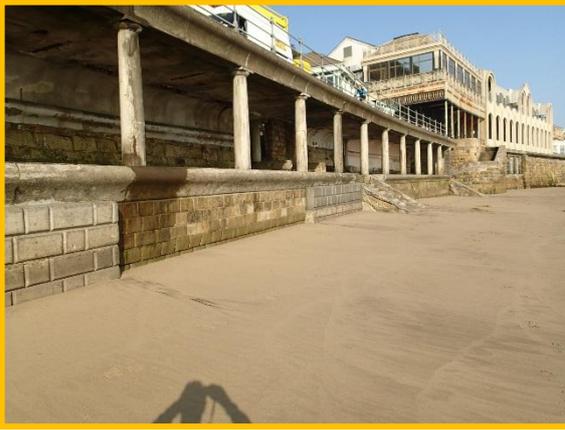
Repairs have been undertaken to lower level wall, but defence remains in poor overall condition (Asset Ref. 1221D901D1302C01)

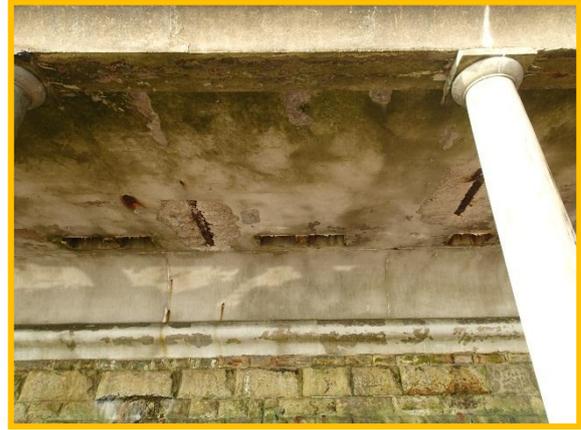
Cracking and corrosion to beams and upper level deck slab (Asset Ref. 1221D901D1302C01)

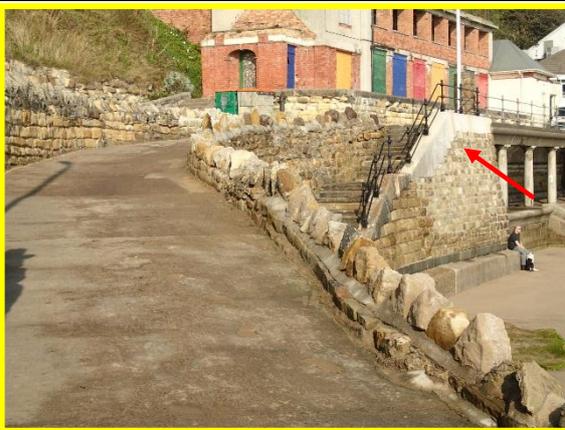
Following major damage in the December 2013 storm a section of wall to south of the Spa has been rebuilt (Asset Ref. 1221D901D1302C03)

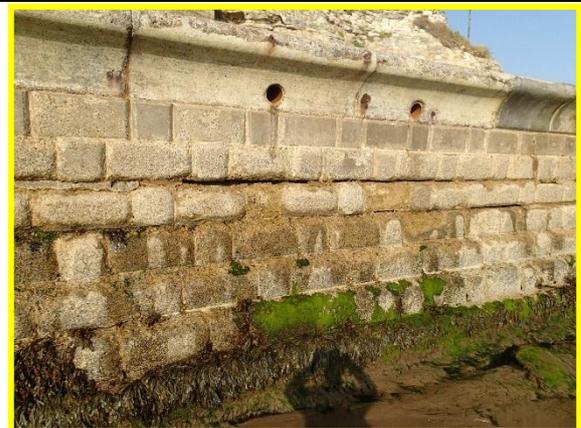
The low wall at South Cliff Gardens, Asset Ref. 1221D901D1302C02, has had a considerable number of repairs over the last few years, with rebuild of sections of the capping beam and front face apparent, significantly improving condition locally. However this wall is very exposed to storm action, due to its low level, with the crest overtopped on many tides each year, so regular ongoing repairs and continuing to rebuild further failing sections is recommended. The wave overtopping has dislodged the joint sealant between some of the promenade slabs, some of which appear to have settled. There is evidence of undercutting due to the erosion of the relatively soft rock on which the wall is founded in a number of places.

Area of washed out joints, abrasion and undercutting. (Asset Ref. 1221D901D1302C02)

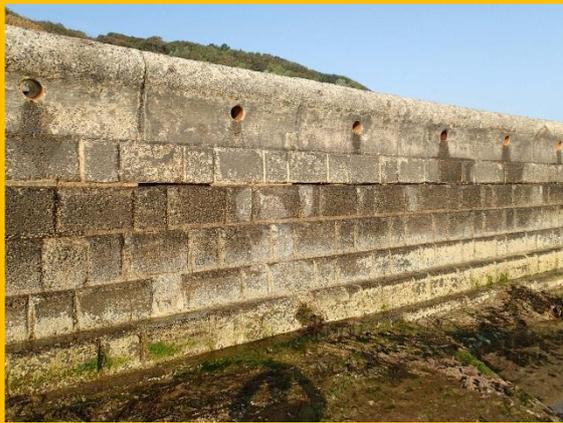
The lower section of the concrete block wall which has offset, slightly stepped blocks and the capping beam is showing evidence of significant surface erosion exposing aggregate throughout the defence. The 2012 inspection noted that there were deep voids/ missing joints in the blockwork that need attention. While repairs do appear to have been undertaken there is more to do. The lower promenade, which is subject to regular heavy wave overtopping, is missing filler between slabs in places. There were washed out joints with deep voids behind in the main wall (see photos below left and right). There was also loss of facing to set back second wall and cracks/spalling to splash beam, although it is noted that a section of the middle level wall had been rebuilt recently. Ongoing repairs and maintenance will be necessary in future due to the age and overall condition of this asset.

Undermining of wall, with voids at South Bay Pool (Asset Ref. 1221D901D1303C02)

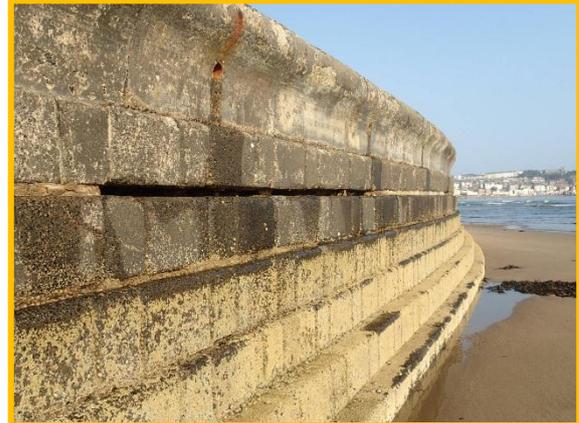
Repaired upper section of upper wall adjacent to re-constructed concrete ramp. (Asset Ref. 1221D901D1303C02)

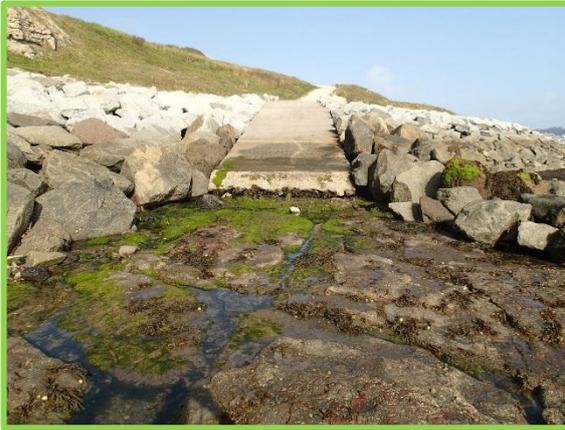
The relatively new rock armour revetment (Asset Ref. 1221D901D1304C01) defending the relict debris flow lobe at the site of the Holbeck Hall landslide remains in good condition, with the armour tightly packed and good coverage. The rock toe was inspected on a very low tide and appears in good condition, with the toe rocks concreted into the soft rock platform. At the southern end of the defence there has been erosion leaving the beach access ramp with a vertical drop to rocks at the end and a crack in the bottom slab.

Vertical drop off ramp at south end of Holbeck revetment (Asset Ref. 1221D901D1304C01)

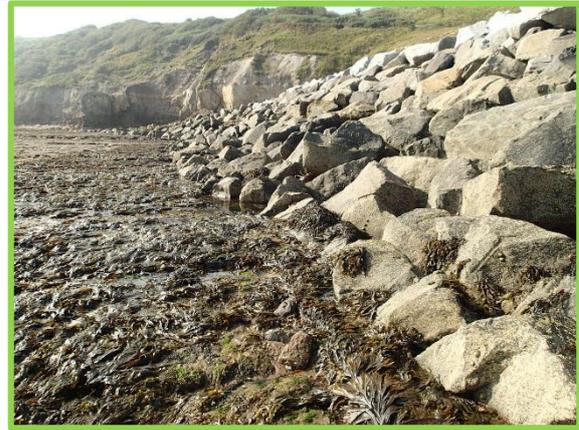
Rock armour revetment at Holbeck landslide (Asset Ref. 1221D901D1304C01)

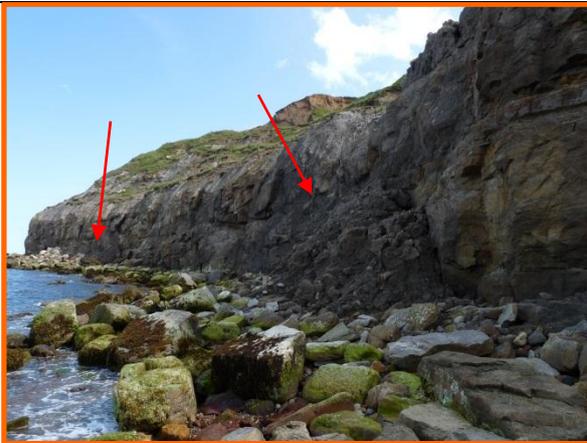
Units MU23/D1, MU23/D2 and MU23/D3 are located at Wheatcroft Cliff above Black Rocks. These units are active down much of their length, with on-going recession of the headscarp, slumping in the mid-slope and erosion of the toe. **MU23/D2 and MU23/D3** were classified as Locally Active in 2012 as activity was more localised than previously seen, but have been returned to partly active due to evidence of recent failures in the upper cliff, the debris from which has not yet been removed from the shore platform.

MU23/D2 The failed material is evident on the shore, as indicated by red arrows (Partly Active). August 2014.

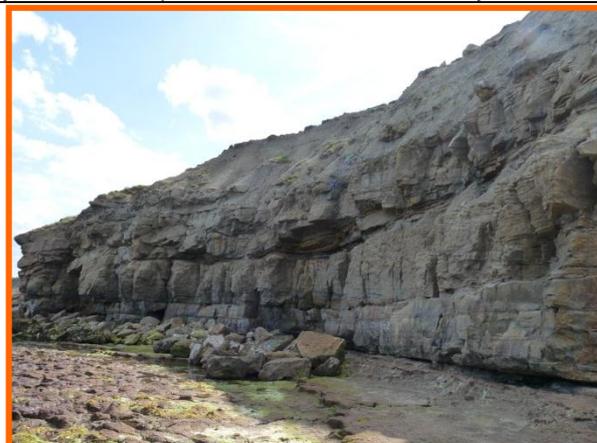
MU23/D3 Joint bound blocks in the cliff face – recently failed block evident nearest to camera, although the source location is not clear (Partly Active). August 2014.

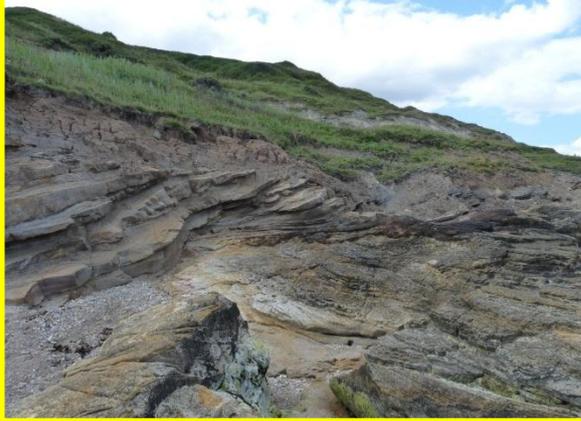
Unit MU23/E is located at White Nab and remains classified as Locally Active in 2014, unchanged from 2012. The slopes of this unit support some vegetation cover with intermittent areas of more intense erosion mid-slope and at the unit toe.

MU23/E Vegetation and localised erosion (Locally Active). August 2014.

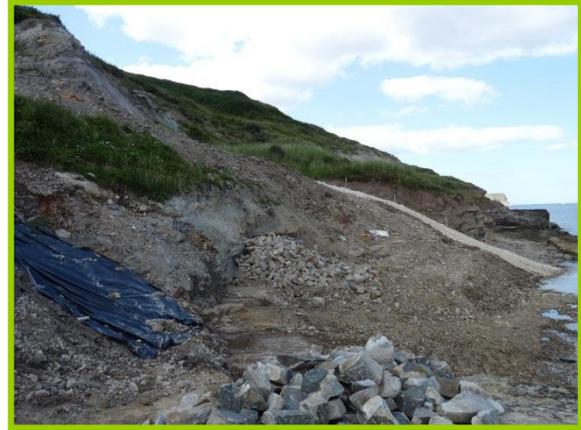
Unit MU23/F is a narrow, thin unit which follows a small valley occupied by an outflow channel for a pipeline and pumping station. The slopes inland are well vegetated and show very little evidence of recent activity. As a result, this unit is classified as Inactive in 2014. However, during the 2014 inspection it was noted that there were ongoing works to repair the infrastructure at this site (which we believe to be controlled by Yorkshire Water), although the stage that the works were at meant it was not possible to tell whether the work had been required because of coastal erosion.

MU23/F Works encountered during the 2014 survey (Inactive). August 2014.

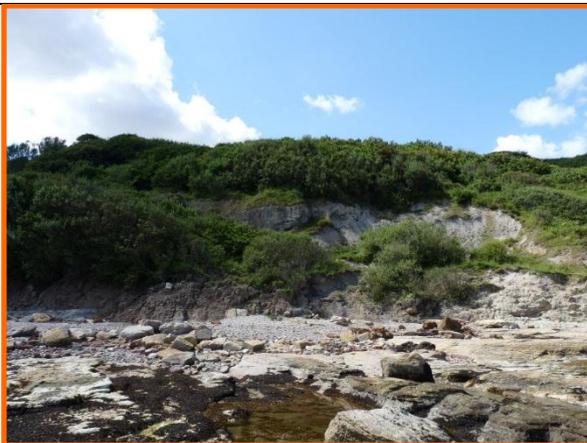
Units MU23/G1 and MU23/G2 form the northern part of Frank Cliff and are both classified as Partly Active in 2014, unchanged since 2012. The upper slopes of these units support some vegetative cover. The unit toes are highly active with evidence of rockfalls, slumping and sliding onto the beach below.

MU23/G1 Partly Active due to widespread toe erosion. August 2014.

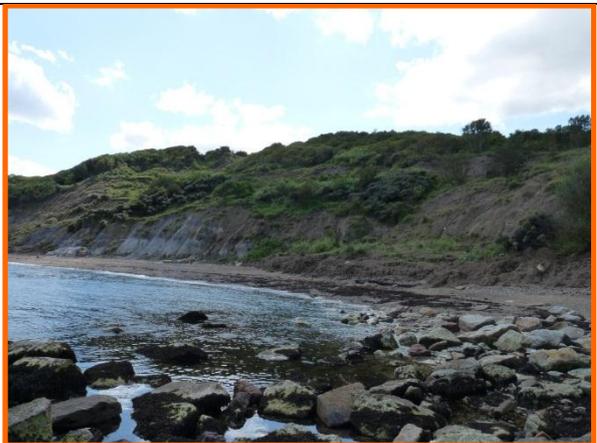
MU23/G2 Partly Active due to widespread toe erosion. August 2014.

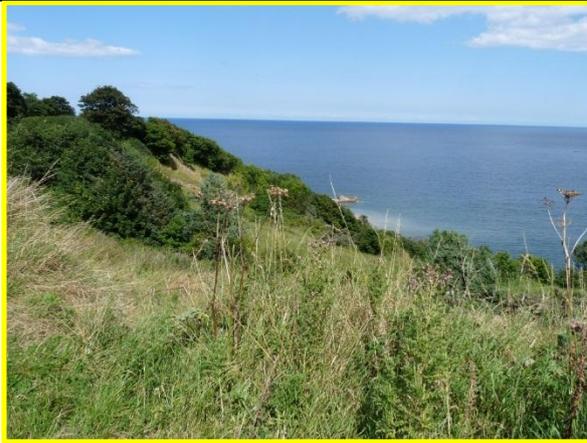
Unit MU23/H forms the headscarp and upper zone of a large mudslide embayment at Frank Cliff. Little erosion is evident and it is classified as Locally Active in 2014. **Unit MU23/H2** forms the main body of the mudslide. It has previously assessed as having a greater level of activity, and classified as Partly Active, but was not accessible during this inspection, so the same status has been retained. The mudslide toe comprises a series of smaller mudslides forming **units MU23/H1, MU23/H2a, MU23/H2b and MU23/H3**. In 2014, Partly Active status has been retained for **MU23/H1** and **MU23/2a** and **MU23/2b** have been elevated in status from Locally Active to Partly Active due to evident toe erosion and a large unvegetated scar further up in the cliff.

MU23/H – Well vegetated headscarp of unit. August 2014.

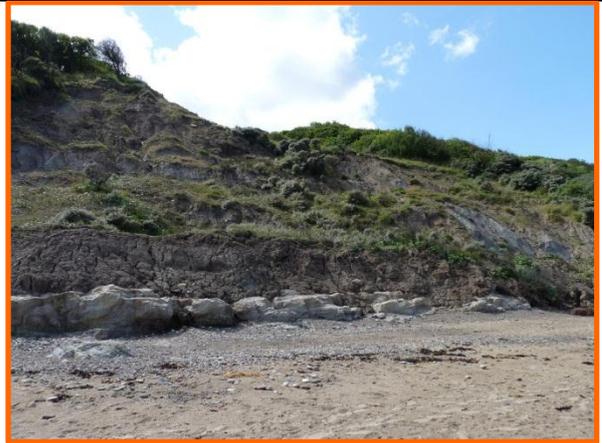
MU23/H1 Mostly vegetated upper sea cliffs with an eroding toe (Partly Active). August 2014.

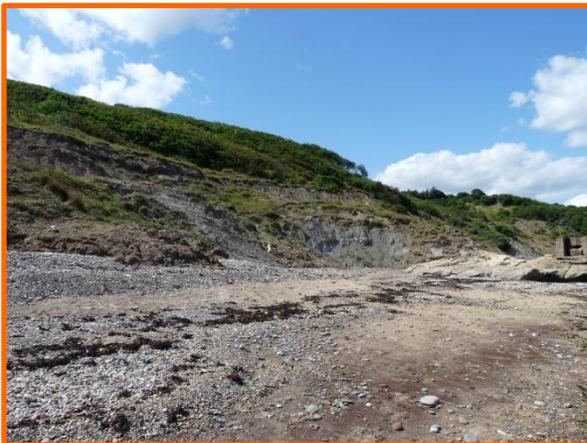
MU23/H2a Well vegetated lower coastal slope but with an eroding toe (Partly Active). August 2014.

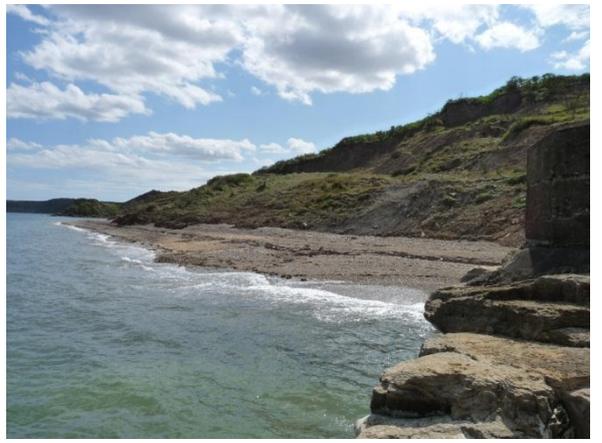
MU23/H2b – Eroding toe with some vegetation in lower cliff but exposed scar towards horizon at top of sea cliff (Partly Active). August 2014.

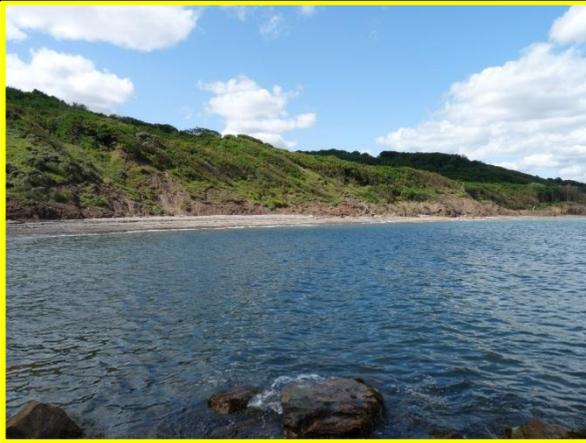
Unit MU23/I comprises the main body of the Cornelian Bay mudslide and was classified as Partly Active in 2012. The majority of this unit is densely vegetated, and previously noted activity at the headscarp, has decreased and therefore this unit has been classified as Locally Active in 2014. **Units MU23/I1, MU23/I2 and MU23/I3** form smaller mudslides at the toe of unit 23/I. All these units have been classified as Locally Active, including MU23/I1 which was classified as Partly Active in 2012 and has therefore been downgraded.

MU23/I1, MU23/I2 and MU23/I3 Activity limited to toe (All Locally Active). August 2014.

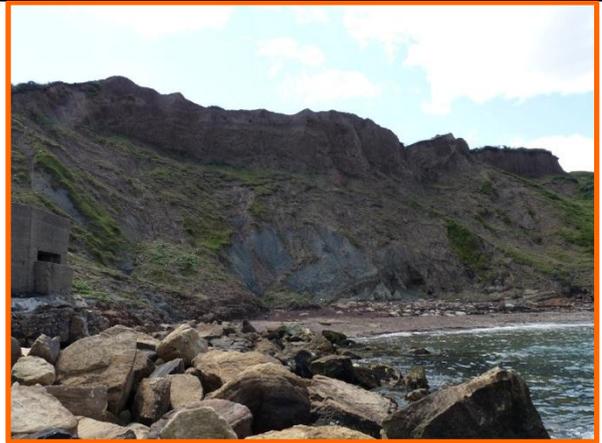
Unit MU23/I4 situated on the north side of the Knipe Point headland and is composed of soft glacial material. The unit was downgraded from Totally Active to Locally Active in 2012. However, activity in this unit appears to have increased throughout much of the cliff. Over-steepening at the toe of this unit is likely to lead to further failure of the upper slopes, which over time may lead to a reactivation of movements in MU23/I.

MU23/I4 Note lack of vegetation and deposits on the beach originating from failure of the upper (Partly Active). August 2014.

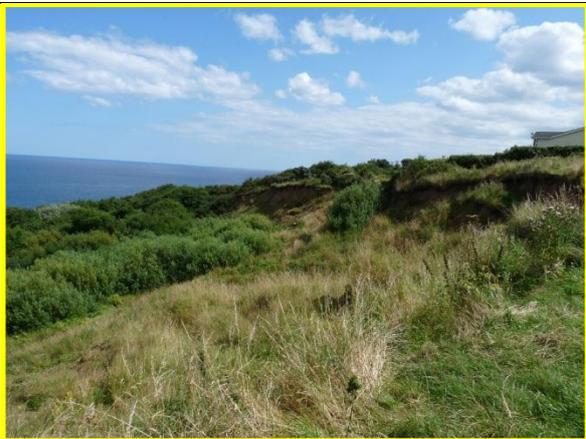
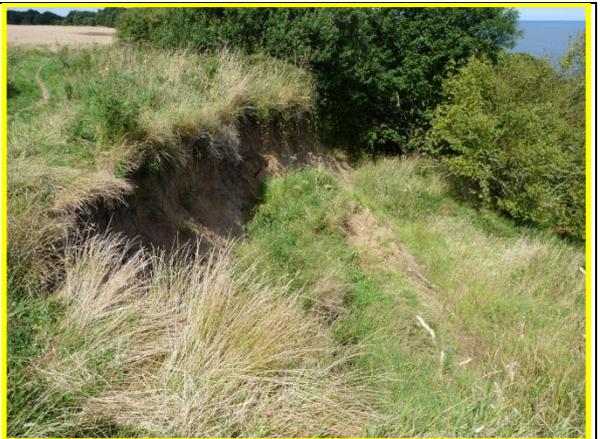
MU23/I Continued revegetation of mudslide source area evident (Locally Active). August 2014.

MU23/I – Continued revegetation of mudslide source area evident (Locally Active). August 2014.

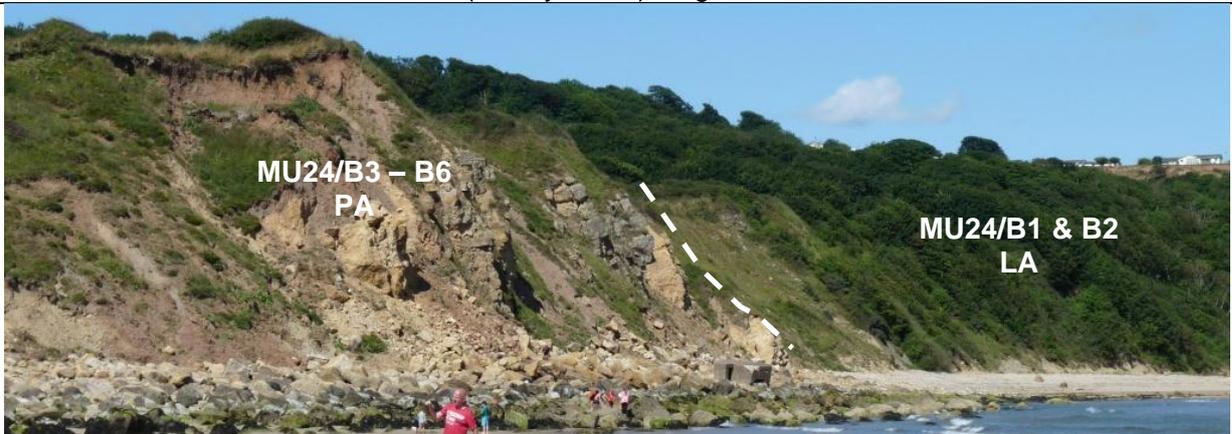
landslide units **MU24/B1 to MU24/B10**. These were all previously classified as Locally Active in 2012. However, during the 2014 survey it was noted that there was a distinct difference in the levels of activity, with the more northerly units (**MU24/1** and **MU24/B2**) being Locally Active, **MU24/B3 to MU24/B8** Partly Active and **MU24/B9** in which there was almost total failure of the upper sea cliff, being classified as Totally Active. **MU24/B10** is protected by the sea wall which extends northwards from the pumping station and has been subject to failure in the past, but during the 2014 survey was noted to be completely vegetated and has been classified as Inactive.

MU24/B and B1 to 10 Tenants' Cliff upper slopes are inactive. Units at the toe are Locally Active. August 2014.

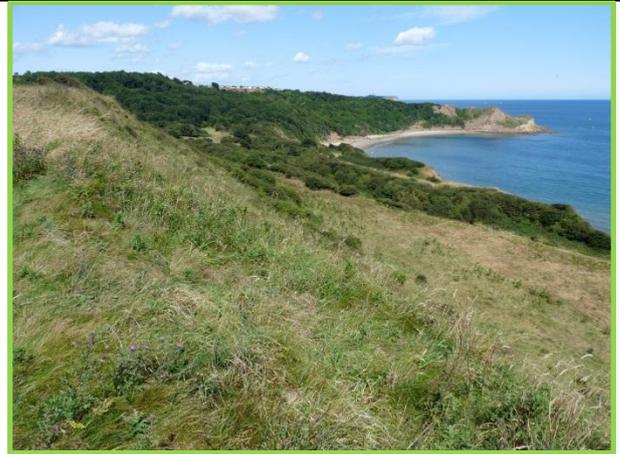
MU24/B – Upper part of unit showing no signs of active instability except minor exposure of superficial materials at the headscarp (Inactive).
August 2014.

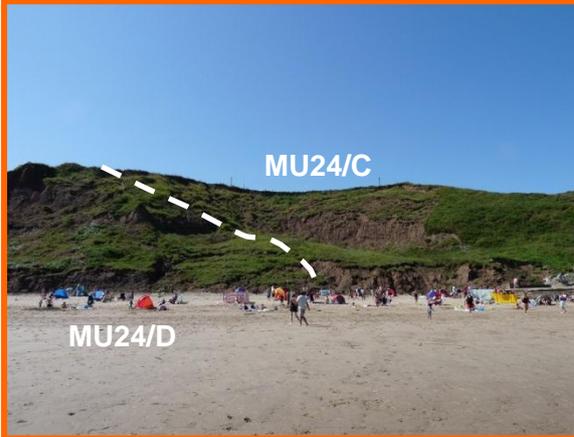
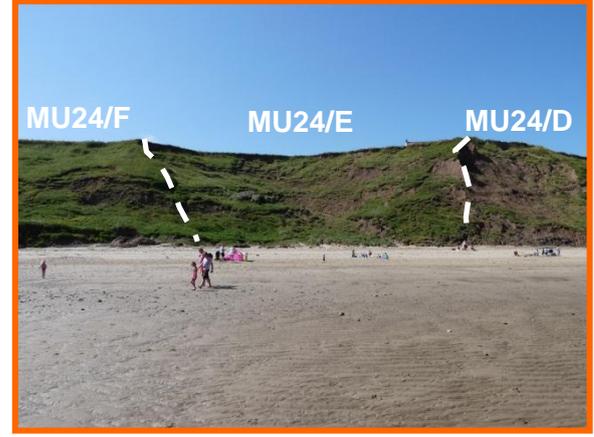
Units MU24/C, MU24/D and MU24/E are located just southeast of the Pumping Station in Cayton Bay and are cut into the soft till cliffs. All units show active recession of the headscarp and slumping and cracking mid-slope. At the unit toes there is evidence of slumping and erosion. The classification of these units has been changed from Locally Active to Partly Active in 2014 due to there being substantial toe erosion and relatively widespread instability features higher in the cliff. However, they should be considered to be closer to the Locally Active classification rather than the Totally Active classification.

<p>MU24/C and D Substantial toe erosion and slumping in the upper cliff (Partly Active). August 2014.</p>	<p>MU24/D and E Evidence of movement throughout height of cliff (Partly Active). August 2014.</p>

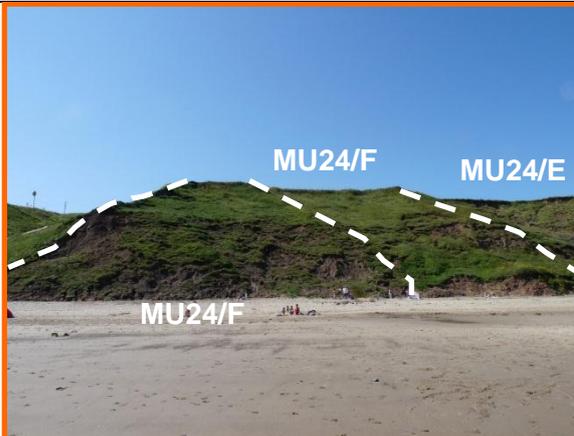
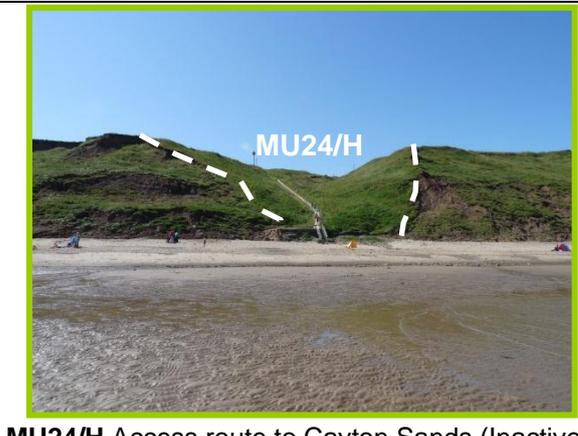
<p>MU24/F and G Evidence of toe erosion and significant movement in lower part of slope (Partly Active). August 2014.</p>	<p>MU24/H Access route to Cayton Sands (Inactive). August 2014.</p>

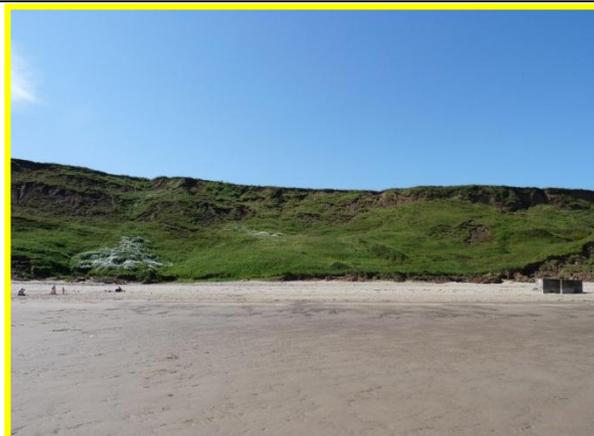
<p>MU24/I Substantial toe erosion and localised headscarp recession (Locally Active). August 2014.</p>	<p>MU24/J The slope is well vegetated with limited toe erosion and headscarp erosion (Locally Active). August 2014.</p>

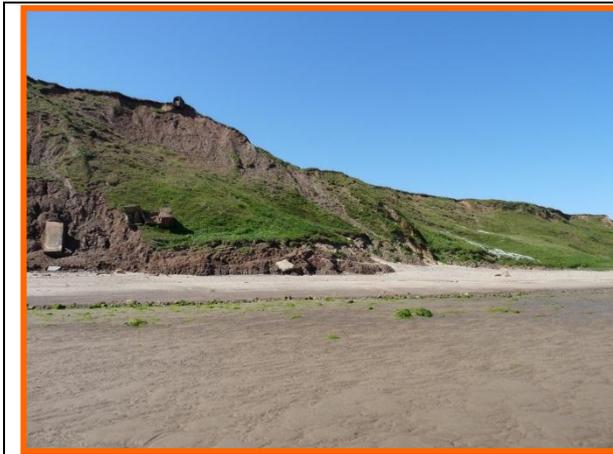
MU24/K, to MU24/O are all formed predominantly in soft glacial sediments but in the more southerly units, failed glacial material is likely masking bedrock in the lower cliff. All these units are classified as Partly Active in 2014 and show substantial evidence of recent instability, although some vegetation is present. This is an increase in activity status for **MU24/K** and **MU24/L** since 2012, but no change for units **MU24/M1** to **MU24/O**.

MU24/M1 Substantial slumping of the cliff exposing large areas of headscarp (Partly Active). August 2014.

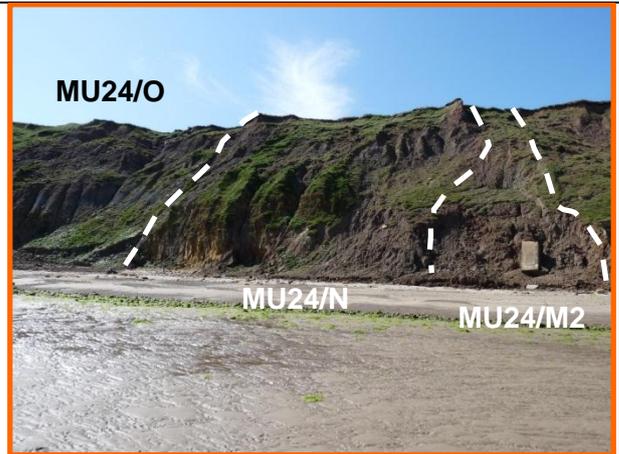
MU24/M2, MU24/N and MU24/O – Partly Active. August 2014.

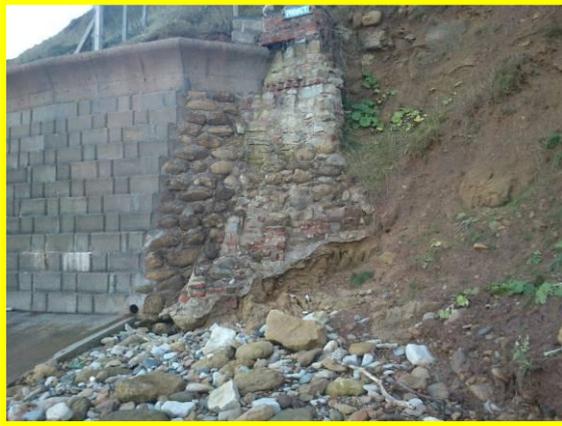
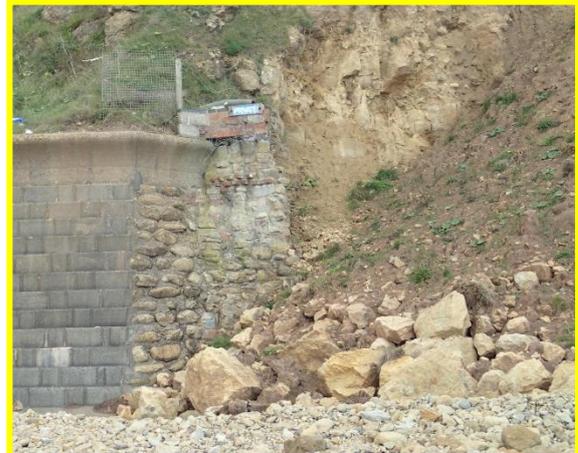
To the north of the pumping station (which is now converted to a private residence) is a private blockwork defence with concrete toe slab, Asset Ref. 1221D901D1402C02, which ties into the eroding cliffs to the north with a mixture of brick, stone blocks and concrete, see below left. This wall is in fair condition and appears newer than the wall to the south, although the toe apron is undermined with voids beneath that need attention. There has been significant erosion of the undefended cliff immediately to the north since 2012, see MU24/B9 above.

Tie in of Pumping station defences at north end.
Photo from 2012.
(Asset Ref. 1221D901D1402C02)

Tie in of Pumping station defences at north end
note erosion of cliff compared to photo on left.
Photo from 26.09.2014.
(Asset Ref. 1221D901D1402C02)

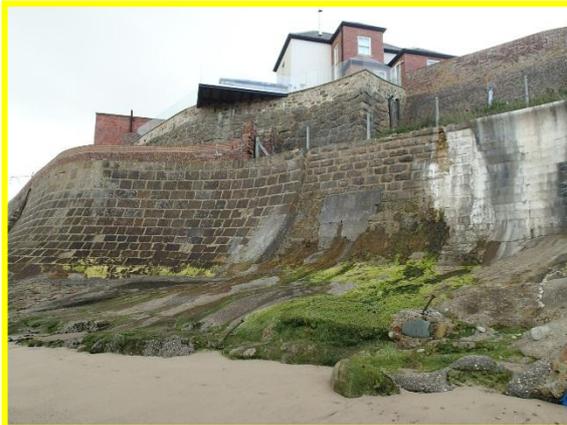
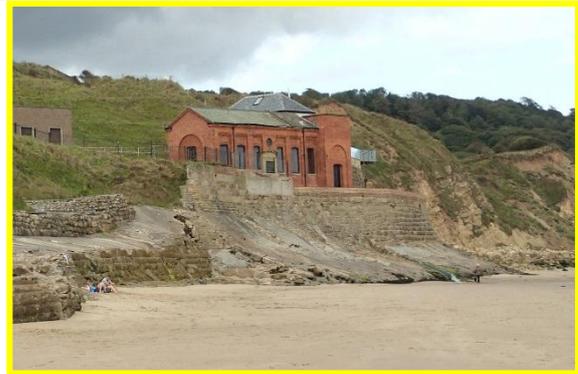
There are a complex series of private blockwork and concrete sea walls (Asset Ref. 1221D901D1402C05) protecting the main pumping station building. As in 2012 the condition of the defences varies from good to very poor and partly relates to the height from the high water mark. The higher, red brick walls appear sound. The lower, concrete and sandstone blockwork is in fair condition with evidence of quite recent repairs to joints. A patchwork of repair work is visible to the blockwork (see photo below lower left). The apron at the toe appears to have had further cosmetic repairs with poured concrete that appears to have been tipped from above. The beach was higher than at the time of the 2012 inspection, so the undermining of the toe noted in 2012 was not visible. There appear to have been repairs since the last inspection but

Walls protecting former pumping station
(Asset Ref. 1221D901D1402C05)

due to the age, exposure and patchwork nature of the defence there will be a need for ongoing maintenance repairs to prevent defects expanding and destabilising the overall wall.

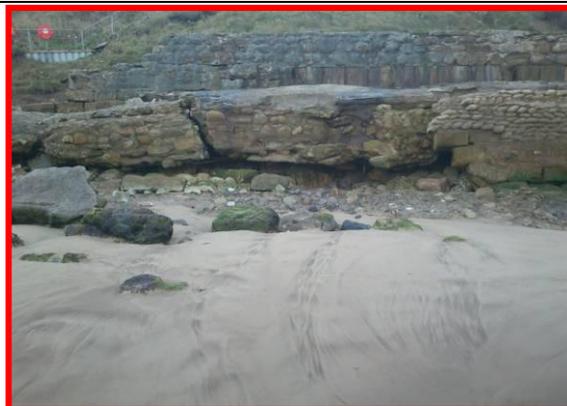
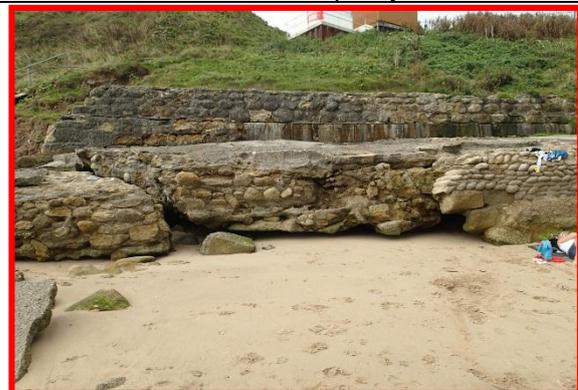
Between the southern end of the pumping station defences and the beach access point there is a derelict length of defence, Asset Ref. 1221D901D1402C04, which exhibits major undercutting, blockwork washout, parts of upper wall missing and significant damage. The condition is slightly worse than reported in 2012. It is advised that the failed southern part of this defence should be made safe or removed in accordance with the SMP policy.

Large voids to makeshift defences to the south
of the pumping station **Photo from 2012.**
(Asset Ref. 1221D901D1402C04)

South end defence of the pumping station. **Photo
from 26.09.2014.**
(Asset Ref. 1221D901D1402C04)

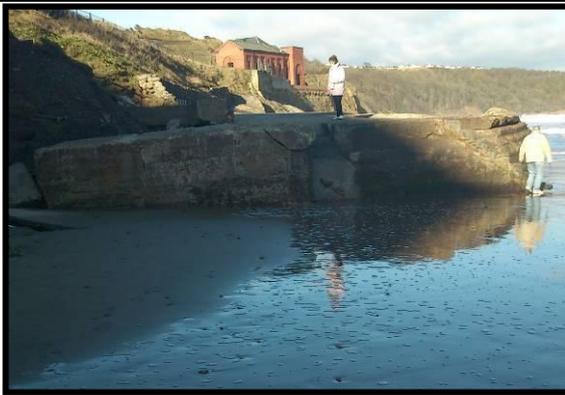
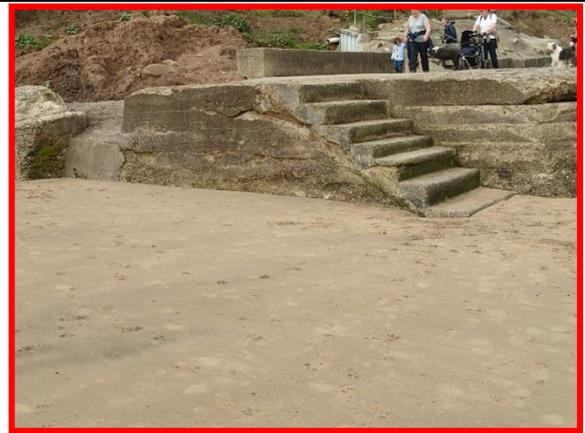
The last defence to the south is the concrete structure at the public beach access point. This is in a failed condition with large cracks and voids throughout (Asset Ref. 1221D901D1402C06). Repair work consisting of poured concrete skim over the voids on the deck has been undertaken since 2012 to make the structure safer for pedestrians and with the higher beach levels the structure appears slightly better than in 2012. However, slumps in the cliff behind are threatening the access onto the structure and as in the 2012 report it is still recommended that this structure is demolished and removed and replaced with a simple safer public access ramp set further back.

Difficult public access at failing beach defence.
Photo from 2012.
(Asset Ref. 1221D901D1402C06)

Repairs have been undertaken to patch up the defence at beach access south of the pumping station. (Asset Ref. 1221D901D1402C06)

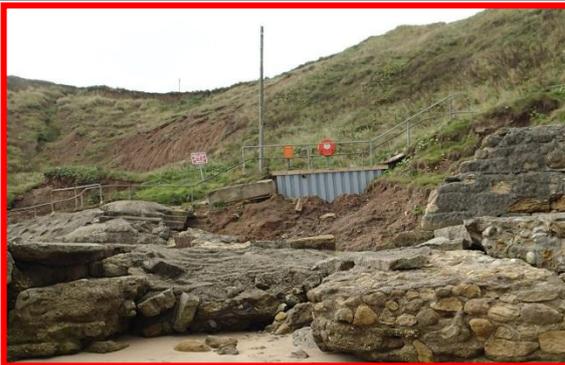
Slumping cliffs threatening path to beach access structure.

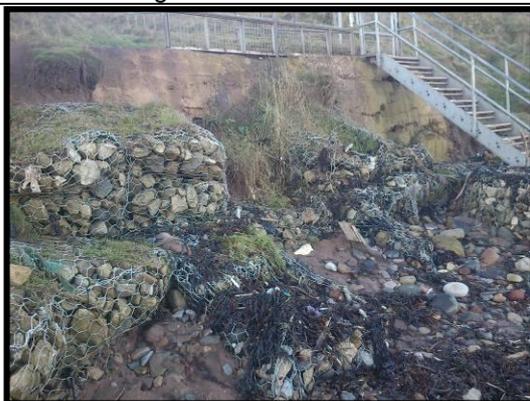
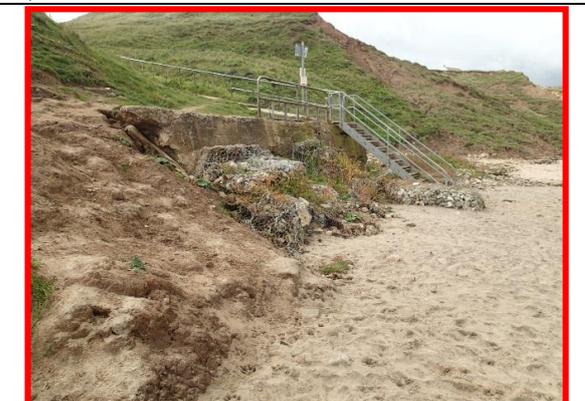
Around 300m south there is a beach access point for the path from the public car park at the surf shop. There are a set of beach access steps that were previously protected by gabion baskets, which have distorted and split under wave action and / or cliff movement, see below left and right. This is not a formal coastal defence, so has no asset number.

(Failed gabion baskets at south beach access.
Photo from 2012)

(Failed gabion baskets at south beach access)
Photo 26.09.2014
