**Walk-over Visual Inspections of Assets
including Coastal Slopes**

**Scarborough Borough Council
Final Report**

November 2014

Coast Protection Assets and Coastal Slope Condition Analysis

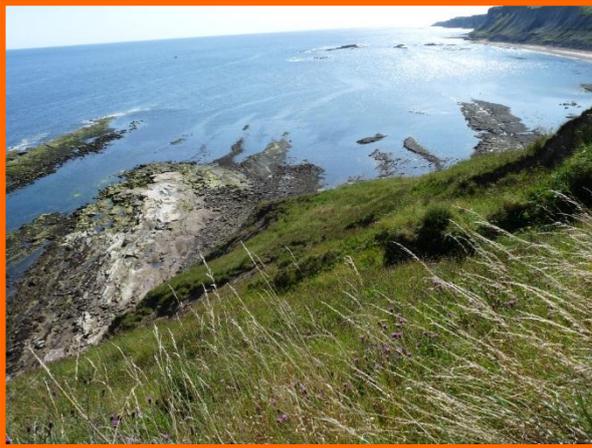
Unit MU25/X is classified as Partly Active in 2014, unchanged since 2012. Despite being well vegetated, the slopes of this unit appear to be subject to ongoing instability, with evidence of mudsliding and recession at the headscarp.

MU25/X - Relatively well vegetated instability in the upper cliff (Partly Active). August 2014.

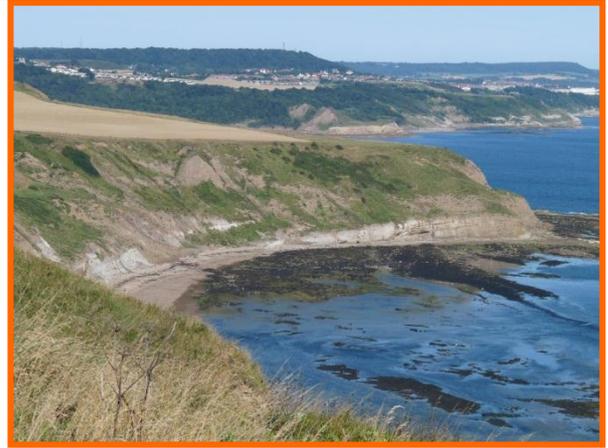
MU25/Y Headscarp recession and mid-slope activity (Partly Active). August 2014.

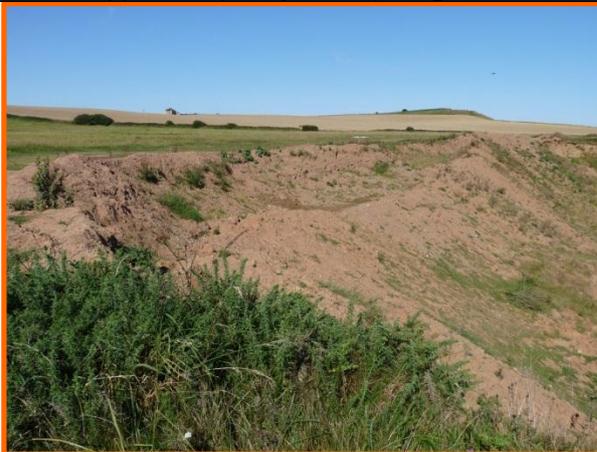
MU25/Y – Large Mudslide Scarp. (Partly Active). August 2014.

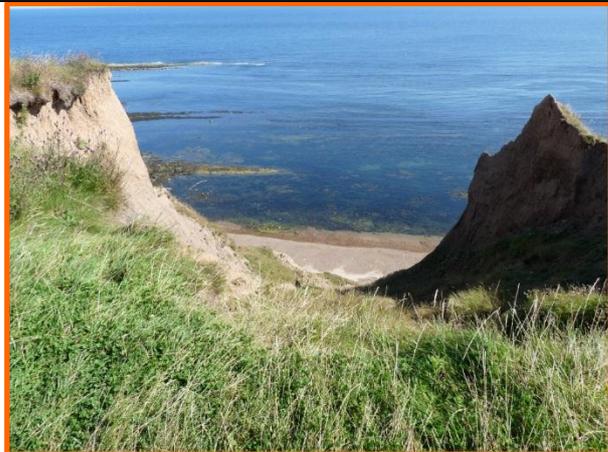
MU25/Z This feature was also present in 2012. Partly Active. August 2014.

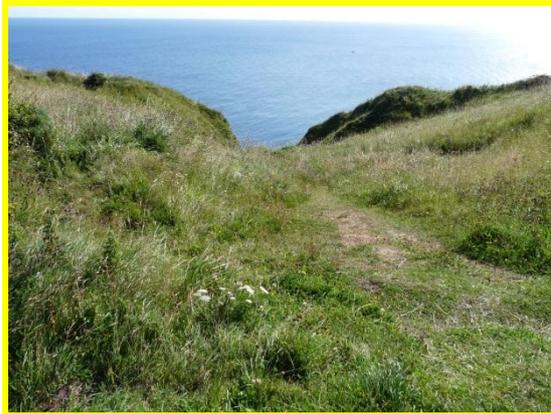
MU26/AG Very well vegetated at the cliff top (Locally Active). August 2014.

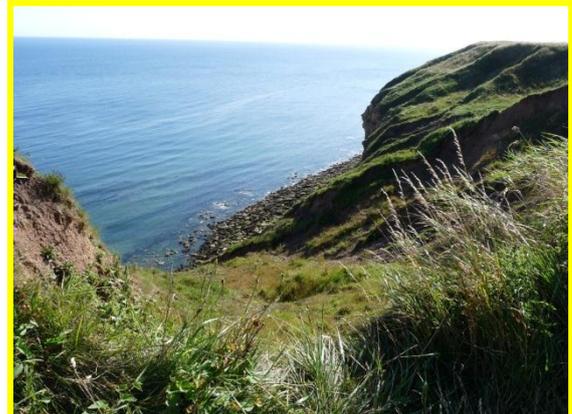
MU26/AH The soft upper layer of this unit (Locally Active). August 2014.

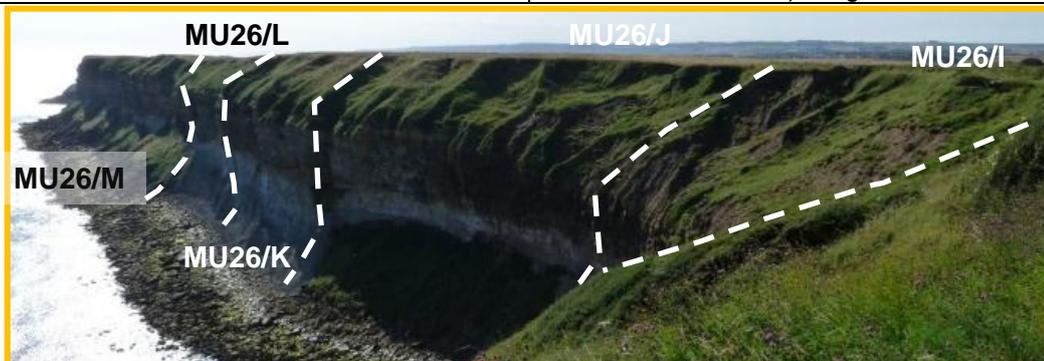
Units MU26/AI and MU26/AJ, form the western part of Newbiggin Cliff and are both classified as Partly Active in 2014, unchanged since 2012. These units are of a similar form to the adjacent Locally Active units, described above. However, they are characterised by a greater level of activity within both the upper and lower cliff layers and less continuous vegetation cover.

MU26/AK and MU26/AL were downgraded from Partly Active to Locally Active in 2012. Both units are heavily vegetated and stable, although not as well protected by a debris apron at the cliff toe as MU26/AM to the east and retain a Locally Active status in 2014.

MU26/AI, AJ (Partly Active), AK, AL and AM (Locally Active) – nearer units show evidence of recent mudsliding in the softer overlying glacial sediments and furthest unit has debris apron protecting the base of the cliff from marine erosion which is not present in MU26/K and MU26/L. August 2014.

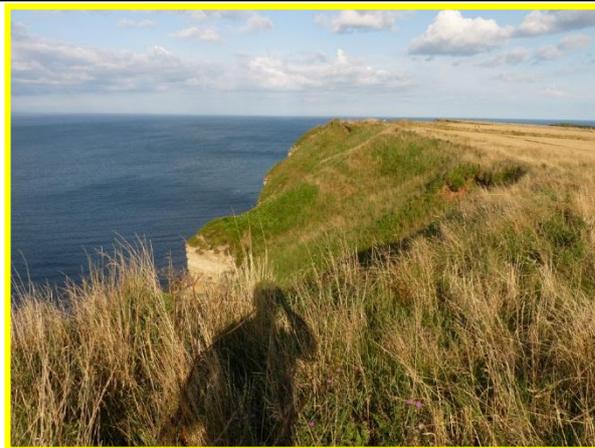
Units MU26/AM, MU26/AN and MU26/AO form the main part of Newbiggin Cliff and are classified as Locally Active in 2014, unchanged since 2012. These cliffs are again characterised by a soft upper layer, a hard rock middle layer and series of debris cones at the unit base. There is localised activity within these units, especially within the soft upper layer.

MU26/AN Locally Active. August 2014.

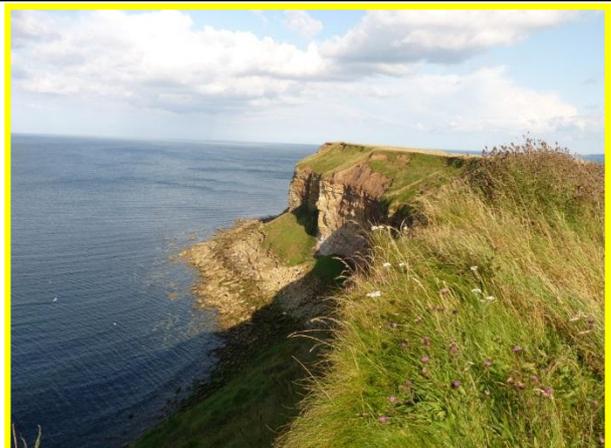
Unit MU26/AQ was downgraded to Locally Active in the 2012 walkover survey. However, failures in much of the upper cliff were noted during the 2014 survey and has therefore returned to Partly Active during the 2014 survey. There is vegetation on the upper and the talus slopes but the cliff face is exposed and eroding.

MU26/AQ Locally Active, with vegetated upper slopes. August 2014.

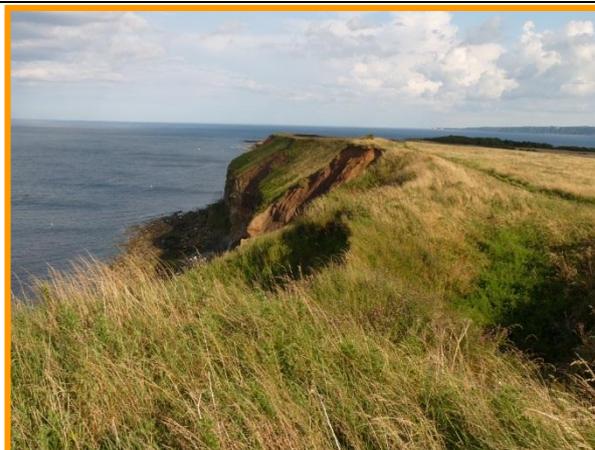
Units MU26/AS and MU26/AT have been assigned a status of Partly Active in 2014 due to recent failures in the soft glacial sediment which forms the upper cliff. This is not a change in status for MU26/AS but is an upgrade for MU26/AT which was classified as Locally Active in 2012. **MU26/AU to MU26/AY** form the main part of North Cliff and all units have been assigned the Locally Active status during the 2014 walkover, which is no change in status from the 2012 survey. The upper part of the cliffs, comprised of soft glacial sediment is exhibiting localised erosion in the form of headscarp recession and mud sliding. There is localised marine erosion of the toe.

MU26/AS and AT Partly Active, with vegetated upper slopes. August 2014.

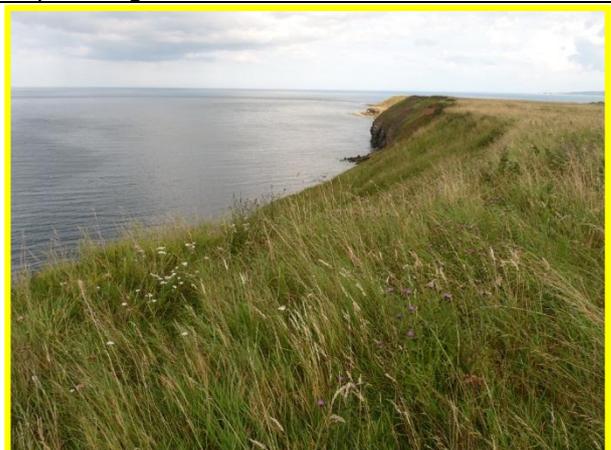
MU26/AW, AX and AY Little activity in the upper cliff (Locally Active). August 2014.

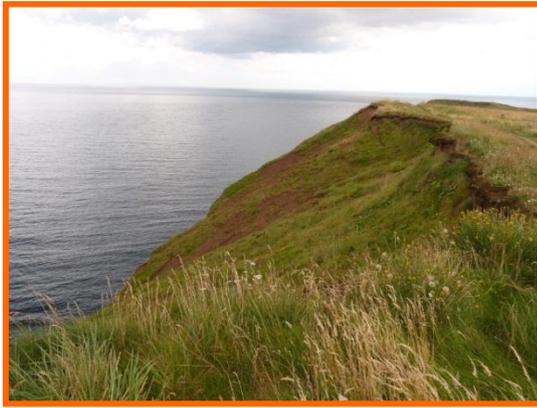
MU27/AZ Well vegetated upper slopes
(Locally Active and Partly Active). August 2014.

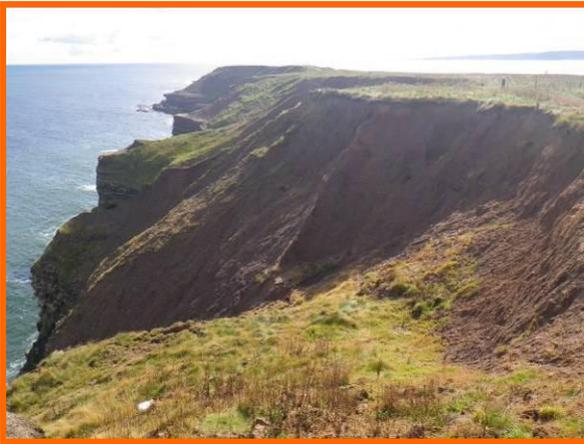
Unit MU27/BA was classified Partly Active in the 2012 survey. Comparison of 2014 photographs to those from 2012 indicate the level of activity remains similar and a status of Partly Active has still been retained. Shallow groundwater was noted to be seeping from the cliff after heavy convective rainfall the previous day during the 2014 survey.

MU27/BA A failure which was beginning to stabilise in 2012 (Partly Active). August 2014.

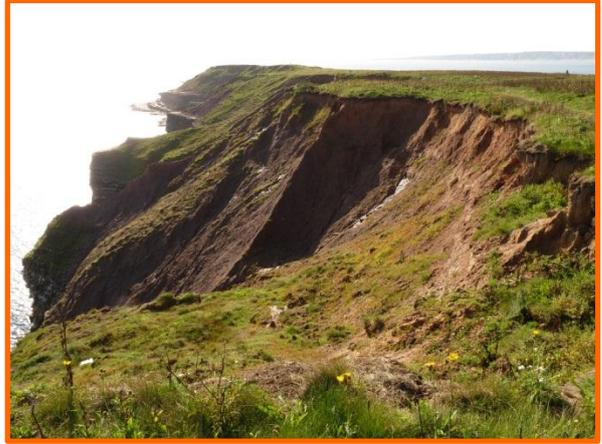
MU27/BA – Very similar in 2014 with little more revegetation and evidence of seepage from the cliff face (Partly Active). August 2014.

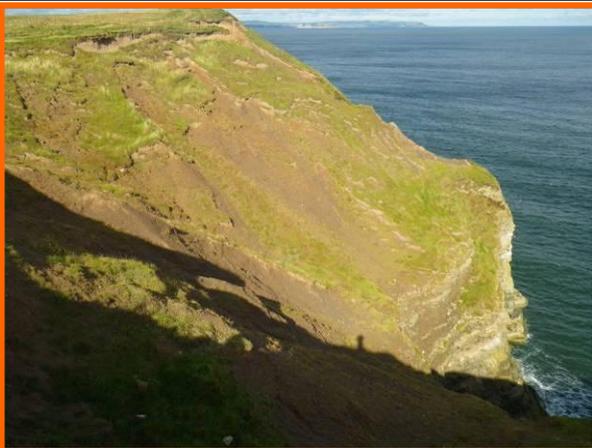
MU27/BB Mass failure of upper layer in 2012
(Partly Active)

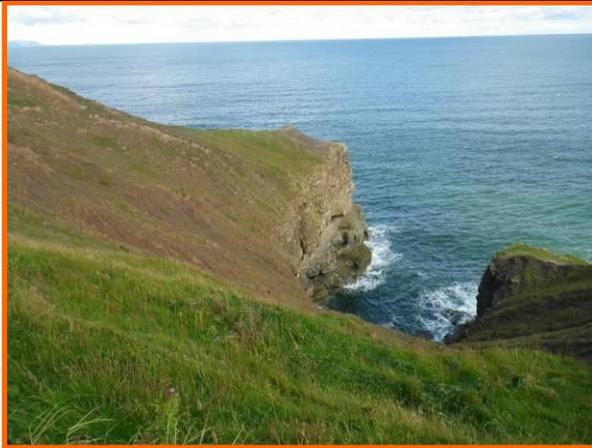
MU27/BC Slumping, sliding and rilling (Partly Active). August 2014.

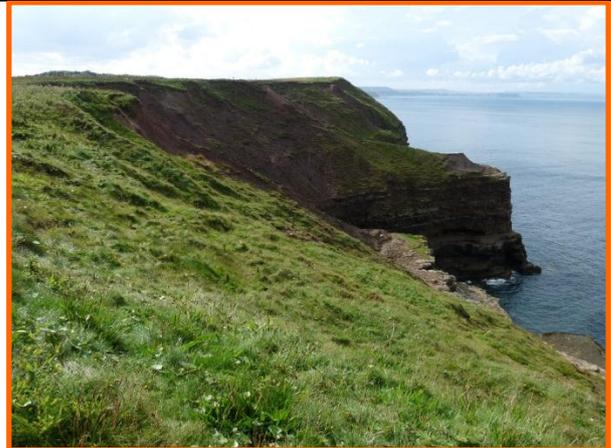
MU27/BC - Slightly increased levels of activity in 2014 (Partly Active). August 2014.

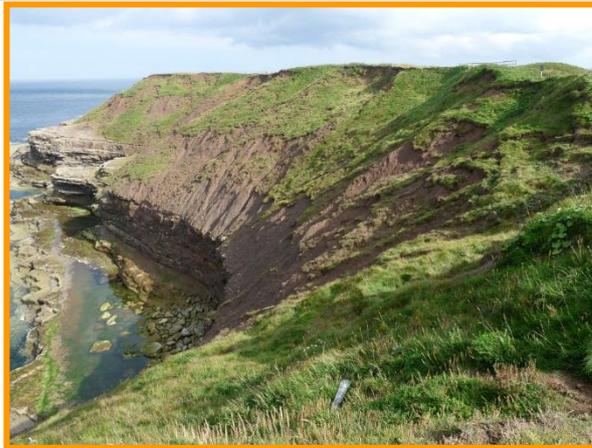
MU27/BD Substantial activity in the soft glacial sediments which form the greater proportion of the cliff (Partly Active)

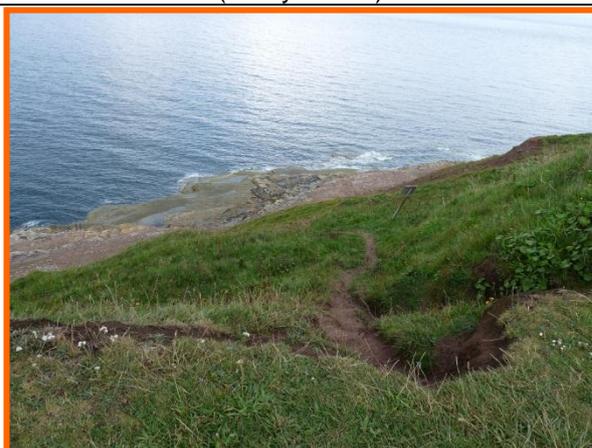
MU27/BF (near) and A (distance) - Relatively well vegetated but evidence of failure (Locally Active). August 2014.

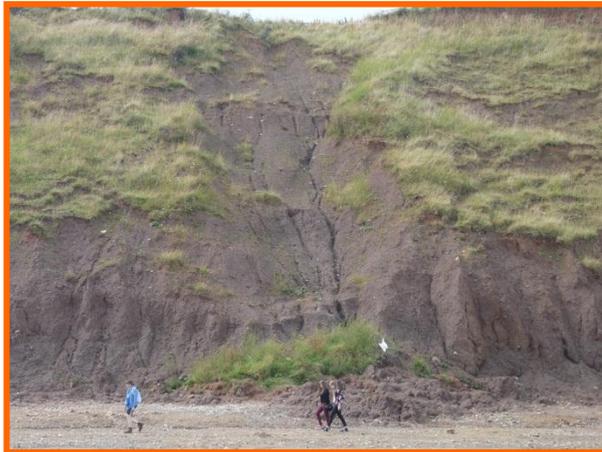
Unit MU27/V, is located just south of the sailing club. The unit was classified as Partly Active again in 2014 because a mudslide incorporating the whole height of the cliff that was first identified during the December 2013 survey was present.

MU27/V Mudslide encompassing the whole height of the cliff with debris lobe on the beach (Partly Active). August 2014.

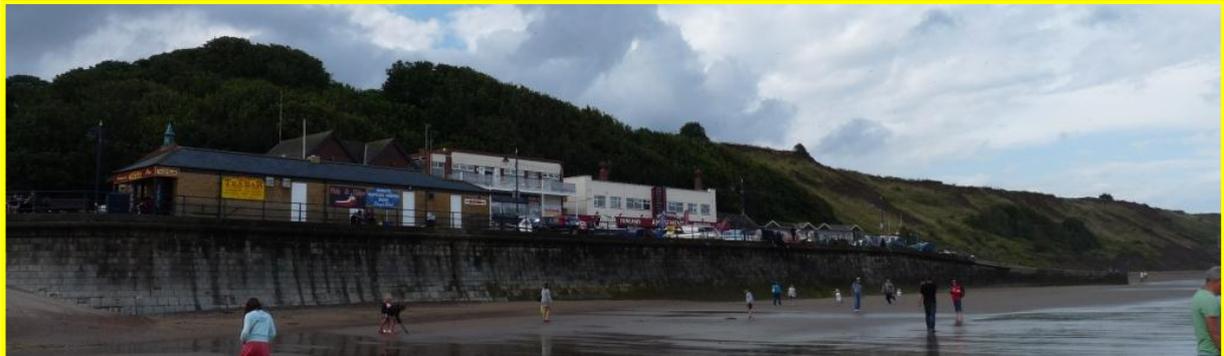
MU26/X - Slopes in this unit show some evidence of instability at their northern end beyond the extent of the Coble Landing sea defences. August 2014.

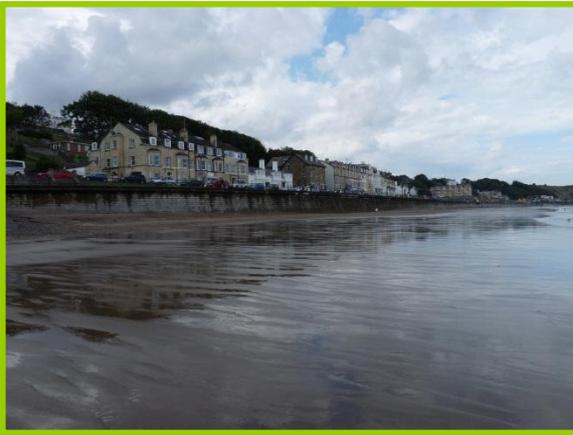
Much of the town frontage lies within **unit MU28/Y**. This unit has retained its Inactive status in 2014 as it is well defended at the toe and it is very much a relict cliff, although in December 2013 indications of minor slope movements were identified in the landscaped gardens in this unit.

MU28/Y - The northern part of Filey town's frontage does not show any signs of slope failure (Inactive). August 2014.

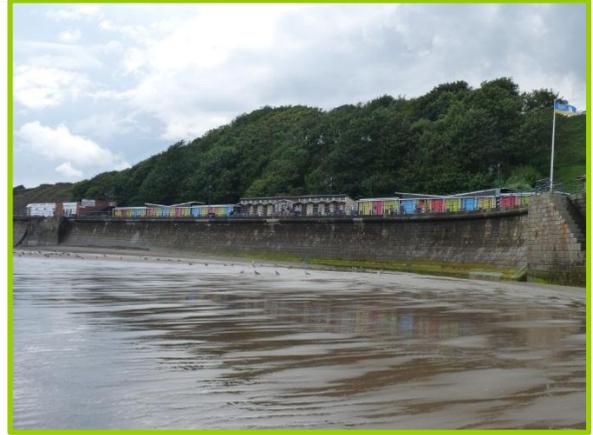
Unit MU28/Z is located at the southern end of Filey Town and is also classified as Inactive in 2014. Inactive status has been retained as only limited signs of instability (such as off-horizontal steps) were noted in December 2013.

MU28/Z – The southern part of Filey town's frontage does not show any signs of failure (Inactive). August 2014.

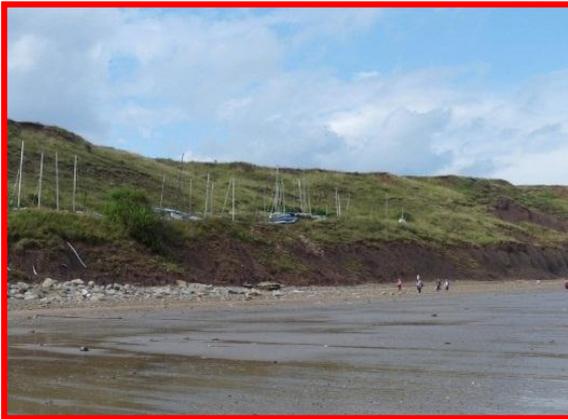
To the north of the town, Filey Sailing Club is located at the back of the beach and is partly protected by some coastal defences. The section of cliff below the boat park (which is located on a terrace part way up the cliff) north of the club building is undefended. In 2012 the eroding face was littered with geotextile debris from previous slope stabilisation works that have failed, see below left.

Eroding cliff at sailing club boat park.
Photo August 2014.
(Asset Ref. 1221D901D1601C01)

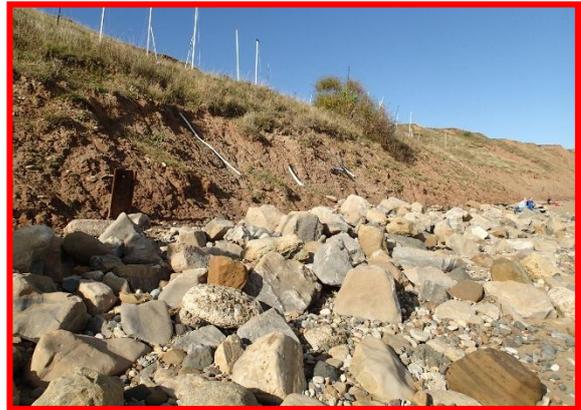
Immediately north of the Sailing Club piled defences there was formerly a defence structure (Asset Ref. 1221D901D1601C02) that consisted of timber breastwork retaining rock armour. This defence failed prior to 2012 and as reported in 2012 it is now totally ineffective with debris scattered on the beach, see photo below top right.

Debris from failed defence and former slope stabilisation at Sailing Club
Photo 26/09/14 (Asset Ref. 1221D901D1601C02)

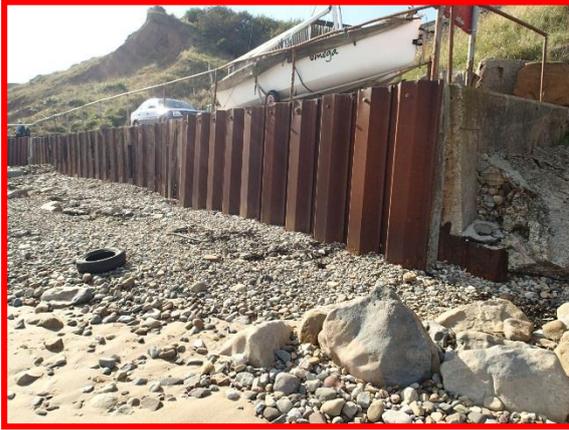
View of sheet piling below Sailing Club house from north.
(Asset Ref. 1221D901D1601C03)

The piles at the northern end of the Sailing Club (Asset Ref. 1221D901D1601C03) show surface corrosion but, as reported in 2012 they are generally in a sound condition. The central section of piles were noted to be badly corroded with large holes and in need of repair in 2012 and they have further deteriorated, see photo above centre right. The southern section of piles at the side of the concrete slipway giving access to the beach to the south were replaced between 2009 and 2012 and as reported in 2012 these piles show surface corrosion but are generally sound. The natural accumulation of pebbles in front of the structures inevitably leads to abrasion damage so this must be an ongoing problem. Minor repair work is needed to the slipway where there are cracks between construction slabs.

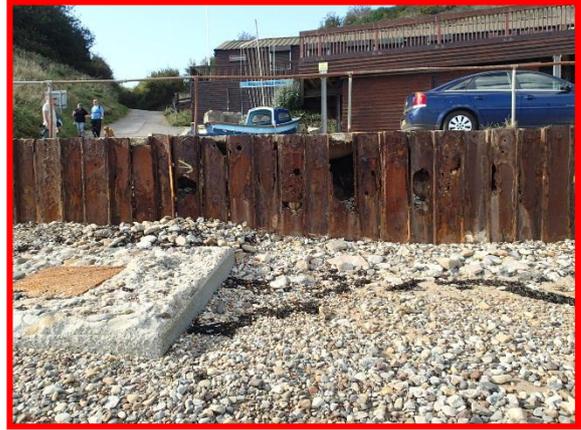
Centre section of sheet piling below Sailing Club house in failed condition.
(Asset Ref. 1221D901D1601C03)

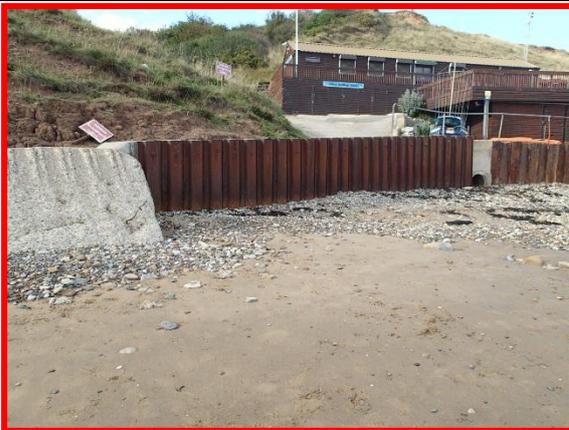
Newer section of sheet piling at Sailing Club ramp in centre of photo.
(Asset Ref. 1221D901D1601C03)

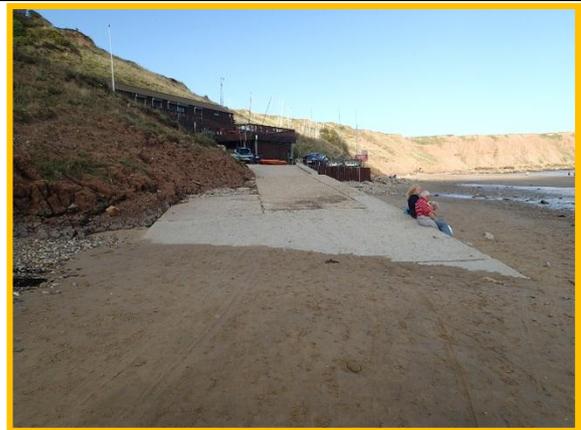
Slipway to south side of sailing club
(Asset Ref. 1221D901D1601C03)

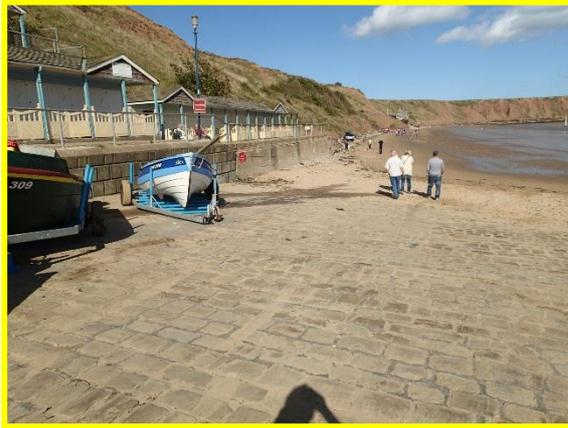
The most northerly asset in the defence system consists of the rear wall and slipway at Cobble landing (Asset Ref. 1221D901D1602C01). The slipway blockwork appeared in good condition with the washed out joints and missing mortar noted in 2012 having been repaired. As noted in 2012 the rear wall below the chalets has a long horizontal crack in the wall and a void in centre of wall near the ramp at the north end of chalets.

Rear wall set back behind slipway at Cobble Landing (Asset Ref. 1221D901D1602C01)

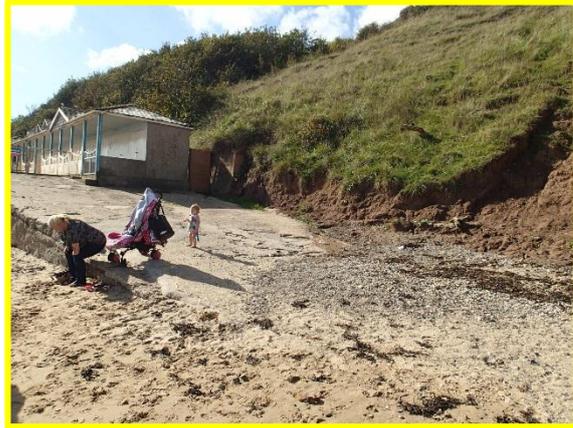
Missing grout in sections of cobbles in slipway (Asset Ref. 1221D901D1602C01)

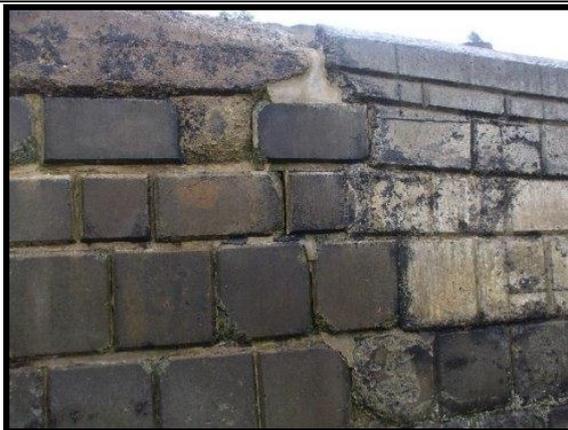
Between the northern slipway at Cobble Landing and the slipway at the end of Ravine Road the seawall is split into two assets. The northern asset, 1221D901D1602C09, is essentially a breakwater or wing wall protecting the slipway. In 2009 and 2012 this section of wall was in poor condition and in need of repair with a major crack and section of loose blocks, see photo below left. This section of wall has been repaired and the overall asset condition has been improved to fair, see below right. The beach levels were higher than in 2012 and the toe apron which was noted to be undercut in 2012 was not visible at the time of the 2014 inspection.

Photo from 2009 inspection of crack at Cobble Landing – (Asset Ref. 1221D901D1602C09)

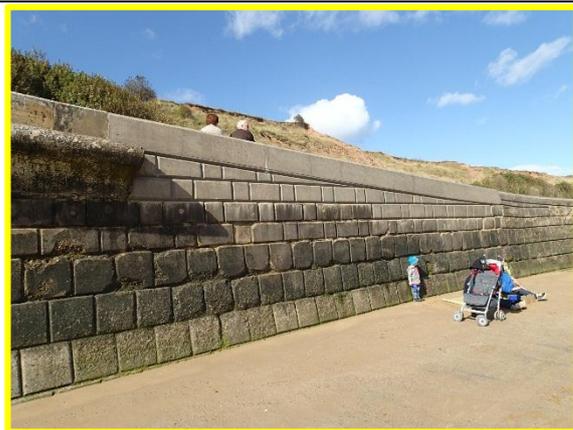
Repaired section of wall adjacent to slipway 26/09/2014. (Asset Ref. 1221D901D1602C01)

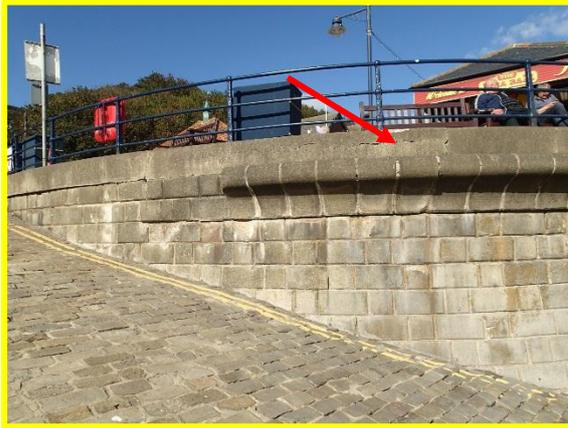
The main part of the wall to the south, Asset ref. 1221D901D1602C06 is in fair overall condition, although there are areas of damage that have been previously repaired, see photos below. There cracks, washed out joints / missing mortar between the masonry blocks in several locations in the slipway / beach access ramp next to the car park.

Cracks in coping and damaged blocks at ramp with evidence of previous repairs. (Asset ref. 1221D901D1602C06)

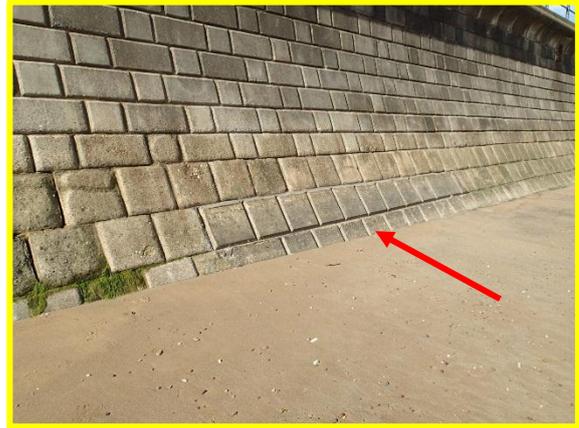
Repaired section of blockwork facing. (Asset ref. 1221D901D1602C06)

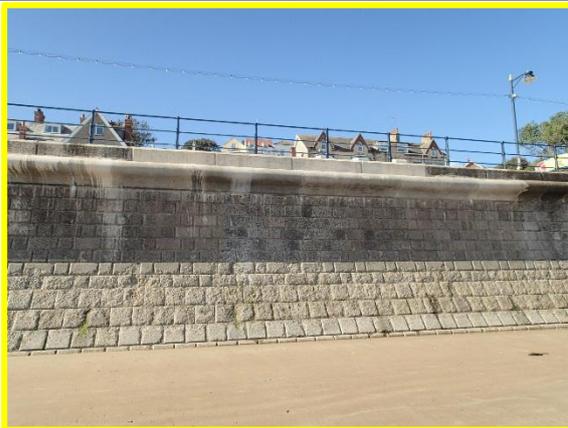
The section of wall between Ravine Road and the access point east of Cargate Hill Road is Asset ref. 1221D901D1602C08. This section is in fair overall condition, although some blocks have abrasion damage to the front face, particularly just above beach level. Many of the bullnose splash coping blocks have been replaced, but others are cracked. The high beach level was covering some of the wall drainage flap valves that were noted to be partly covered with sand in the 2012 report. At both slipway access points there are open joints in the slipway blocks that need re-pointing.

View of wall showing repaired coping and wave return blocks and abrasion damage to blocks near beach level. (Asset Ref. 1221D901D1602C08)

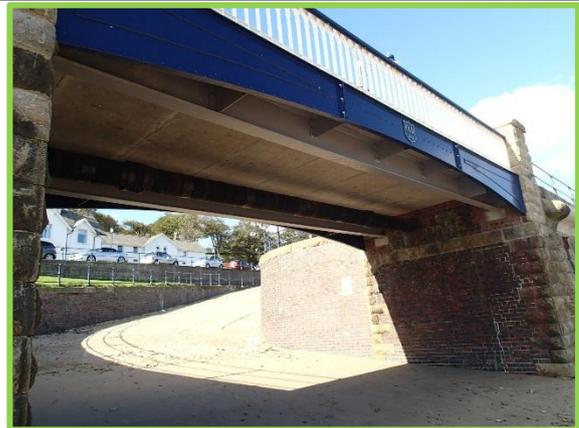
Pedestrian bridge at access slipway from Cargate Hill has been replaced. Open joints in slipway blocks need attention. (Asset Ref. 1221D901D1602C08)

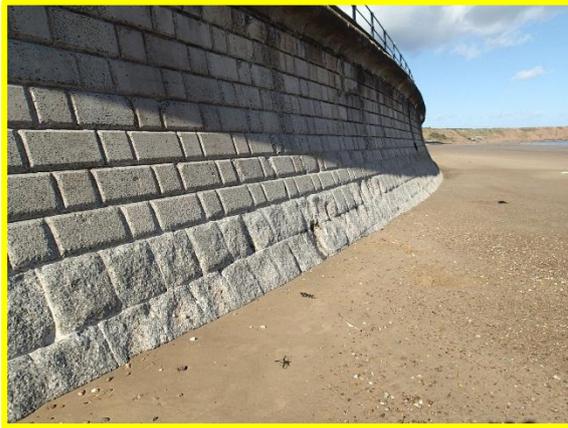
From the promenade pedestrian bridge at Cargate Hill to the next access point at Crescent Hill the wall (Asset Ref. 1221D901D1602C03) is in fair condition. There are several new or repaired coping splash beam blocks, but more are cracked. There are chipped / abraded areas of blocks with loss of face to many blocks throughout, particularly at lower levels at the south end. The south slipway has missing pointing in some joints and vegetation growing through that needs clearing. The hand rails are corroding at many of the joints and one section was broken and had been marked as a hazard with red and white tape. The upper coping near the handrail up-stands is chipped and damaged in many locations.

View of wall looking north from near Crescent Hill access, showing abraded lower facing blocks. (Asset Ref. 1221D901D1602C03)

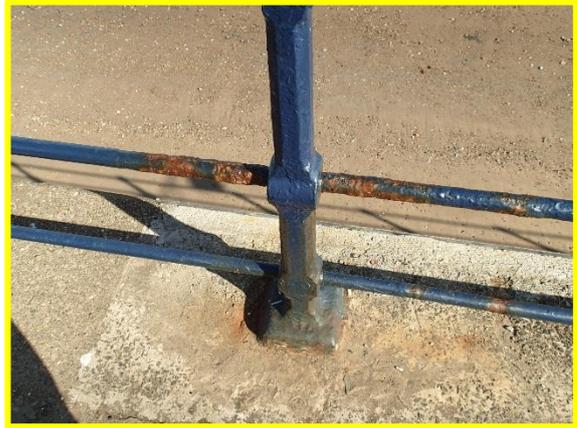
Badly corroded handrails at repaired section of coping. (Asset Ref. 1221D901D1602C03)

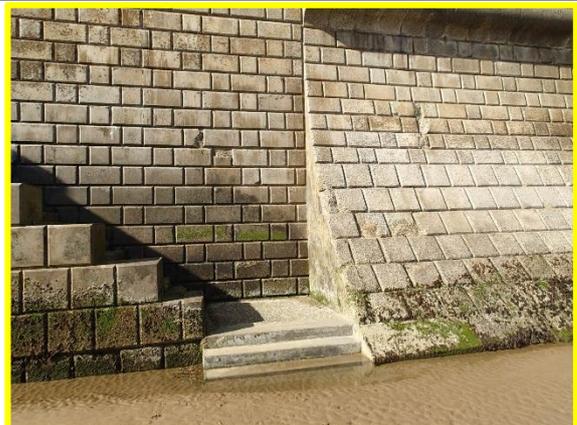
Lower steps have been replaced. (Asset Ref. 1221D901D1602C04)

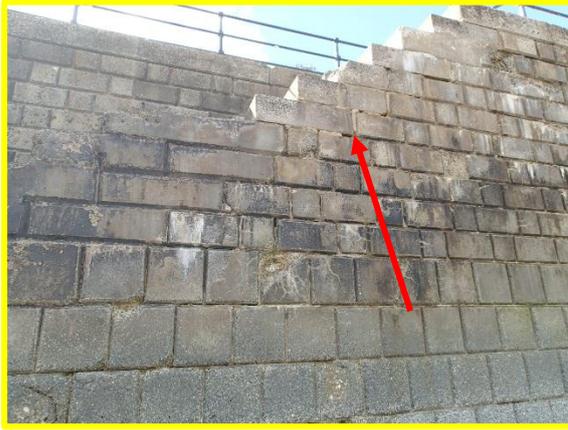
The section of the wall between the two small promontories, Asset ref. 1221D901D1602C07 is again in fair condition. There is cracking to splash beam in several areas and numerous chipped / damaged blocks. There is cracking between the blocks and loose blocks in the buttress to the southern set of steps that needs attention.

Cracking and open joints between blocks at southern set of steps. (Asset Ref. 1221D901D1602C07)

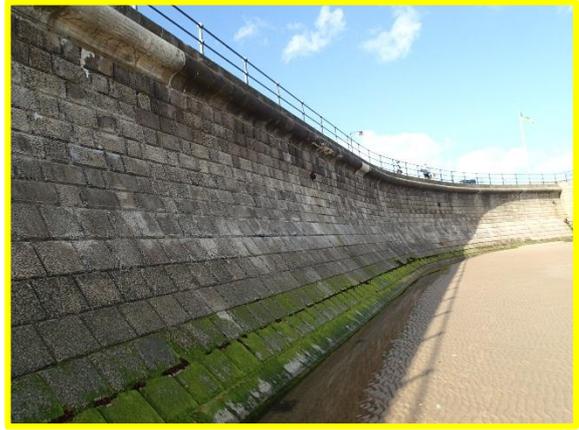
General view of wall showing area of damaged blocks and previous repairs to coping / splash beam. (Asset ref. 1221D901D1602C07)

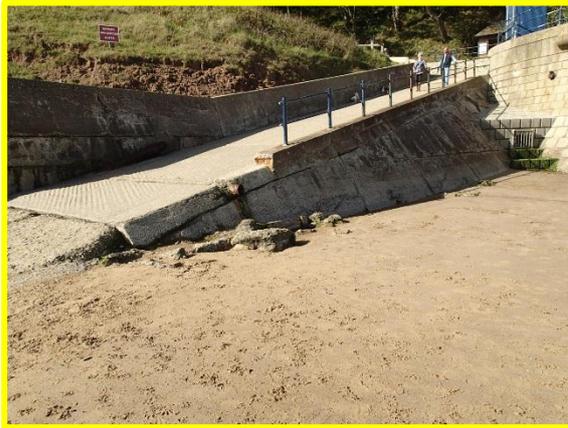
The southernmost section of the main wall including the southern promontory and the return section to Martin's Gill is Asset ref. 1221D901D1602C05 is again overall fair. However, there is chipping and cracking to the coping in small areas throughout length. Numerous lower blocks from beach level to 2m up are damaged on front face. The beach was slightly higher than in 2012. There is a horizontal crack on seaward section (photo below right) extending along 8 blocks (no change since 2012). The retaining wall to the slipway / beach access ramp, below left has cracking below the surface slab and the lower section of handrails is missing.

Ramp at south end of wall showing cracking in side wall and lower section of handrails missing. (Asset Ref. 1221D901D1602C05)

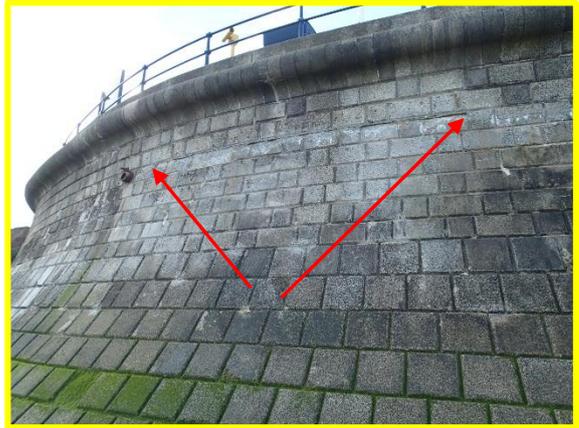
Horizontal crack in upper wall on southern promontory. (Asset Ref. 1221D901D1602C05)

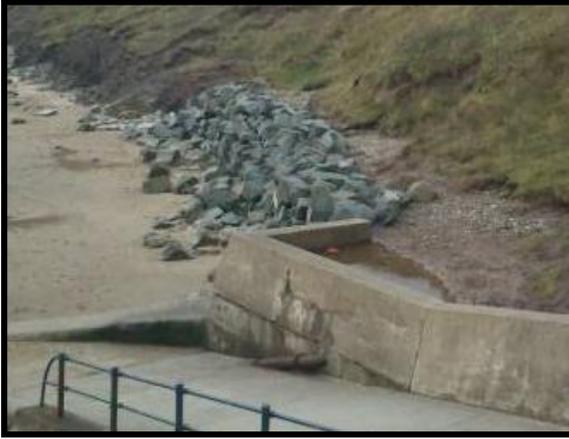
A short section of rock revetment with gabion baskets beneath is located at the southern end of the seawall near Martin's Gill, (Asset Ref. 1221D901D1602C02). This defence extends into Sub-Management Unit Mu29A and is to manage the interface between the hard defences to the north and eroding natural cliff to the south. The gabions have been replaced and the rock armour was re-profiled after the 2012 inspections. However, the rock armouring has been damaged again with some units displaced, see photo below top right. The rock needs maintenance topping up with additional heavier rock units placed to a more stable profile.

General view of rock armour at interface with natural cliff. **Photo from 2012.**
(Asset Ref. 1221D901D1602C02)

The short section of rock armour and gabions at the south end 1221D901D1602C02 has been rebuilt, but subsequent storm damage has displaced some of the rocks and so further re-profiling and topping up of the rock armour is required.

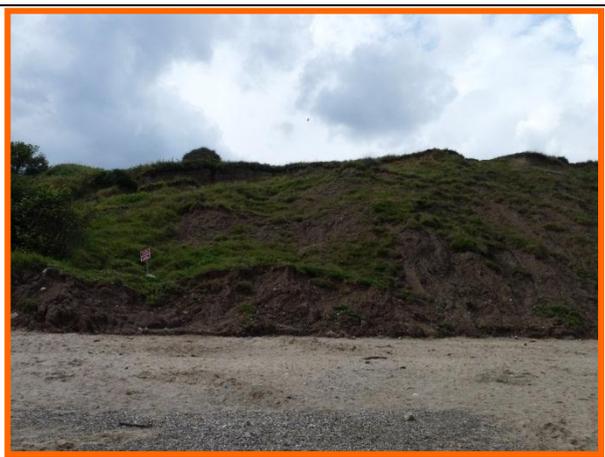
MU29/AB Eroding toe and sliding mid-slope (Partly Active). August 2014.

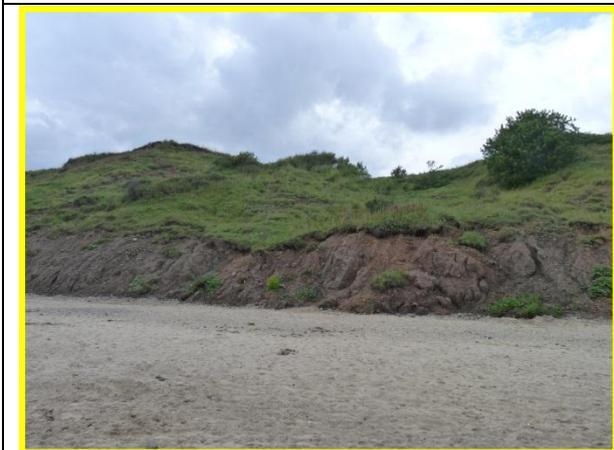
Units MU29/AC was upgraded to Partly Active following the December 2013 storm surge due to intense toe erosion, but has been downgraded back to Locally Active in the 2014 survey as this toe erosion does not appear to have caused any failure in the upper cliff which is still heavily vegetated.

MU29/AC Well vegetated with some toe erosion (Locally Active). August 2014.

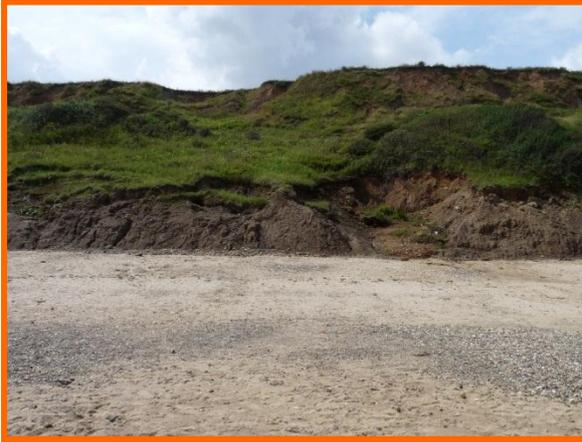
MU29/AD, AE, AF, AG and AH were upgraded from Locally Active to Partly Active following the December 2013 storm surge and have retained this status as there is evidence that the toe erosion sustained during the storm surge is still causing failures to propagate further up the cliff.

MU29/AE/AF Continuous toe and headscarp erosion (Partly Active). August 2014.

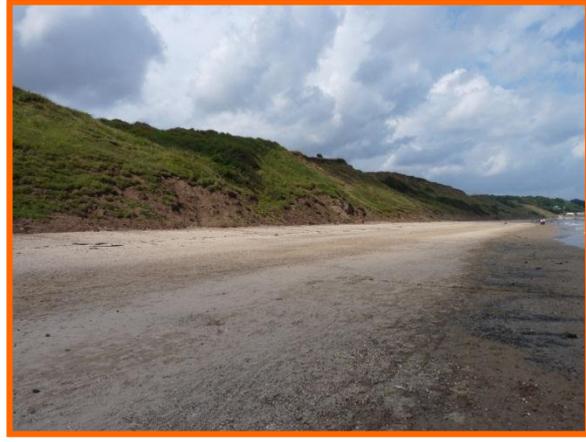
MU29/AF (middle distance), **AG** and **AH** (near) Consistent toe erosion and signs of failure higher up in the cliff (Partly Active). August 2014.

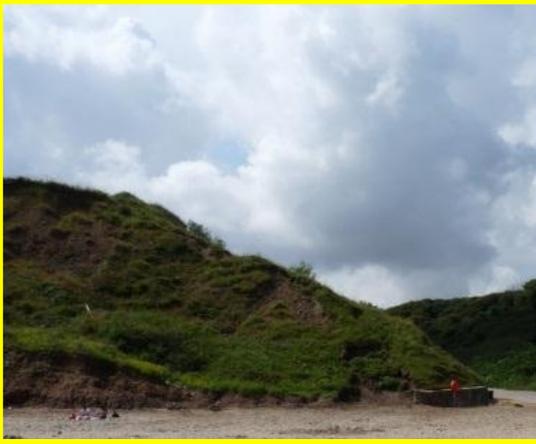
MU29/AJ Some erosion is evident but it is generally well vegetated (Locally Active). August 2014.

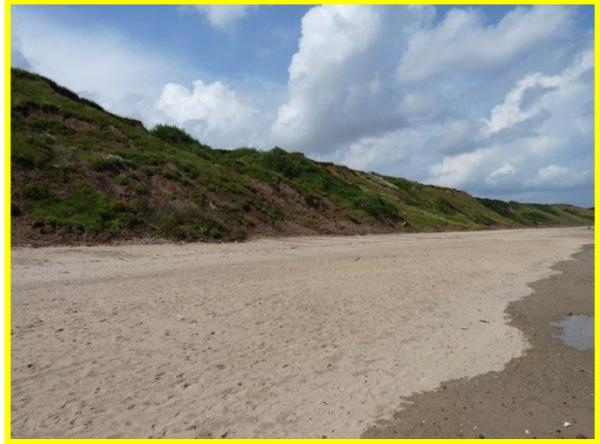
MU29/AK-AO Well-vegetated low lying cliffs, showing some, but not intense toe erosion (Locally Active). August 2014.

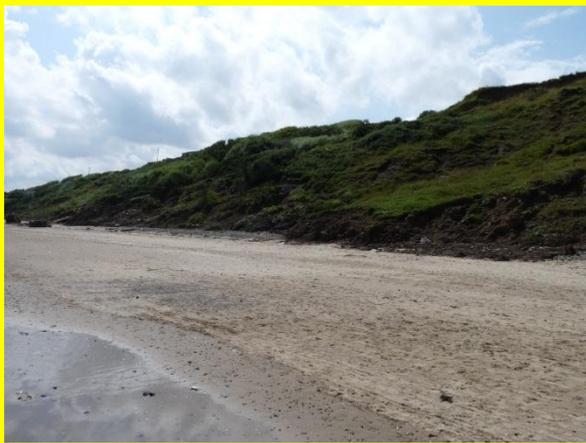
MU29/AP Continuing mudslide activity and toe erosion at Flat Cliffs (Locally Active). August 2014.

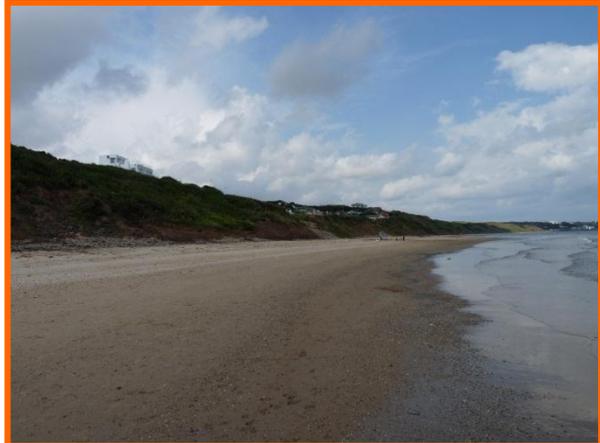
MU29/AR and AS Intense toe erosion at Flat Cliffs (Partly Active). August 2014.

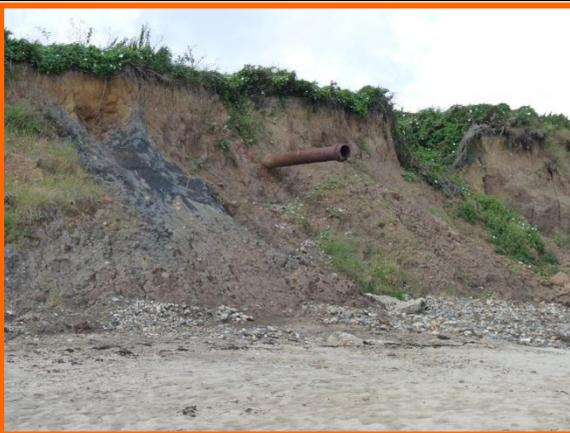
MU29/AS Protruding pipe illustrating ongoing erosion in this unit (Partly Active). August 2014.

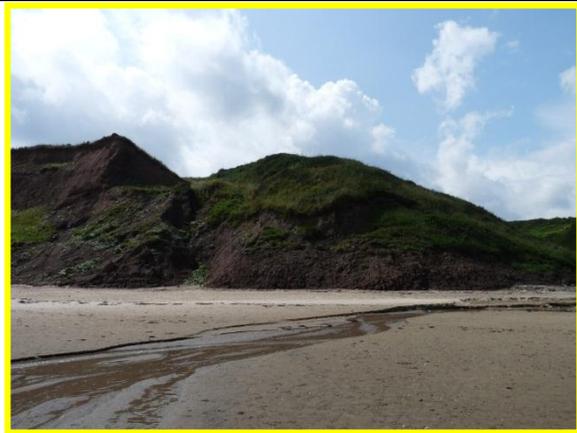
MU29/BA The small unit at Butcher Haven supports substantial vegetation on its upper slopes but is undergoing erosion at its toe. (Locally Active). August 2014.

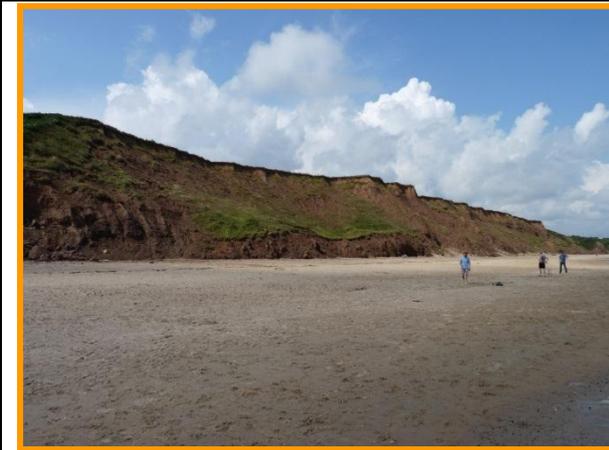
Units MU29/BB to MU29/BE are located between Butcher Haven and Hunmanby Gap and are all classified as Partly Active, unchanged from 2012. These cliffs are generally steeper than those units further north and are characterised by headscarp recession and very common areas of intense erosion. The toes of these units are particularly active with slumping and sliding of materials onto the beach. None of these units have changed classification.

MU29/BB and BE Steeper cliffs with very common areas of intense erosion (Partly Active). August 2014.

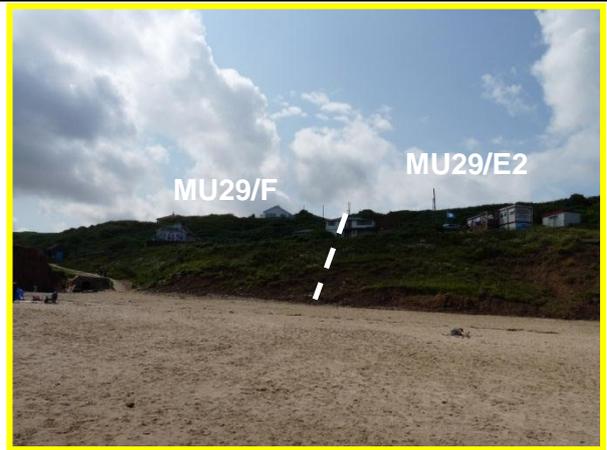
MU29/E2 and EF – Units immediately north of Hunmanby Gap. Erosion is taking place at the toe but is much less evident in the upper cliff than in the units immediately to the north. August 2014.

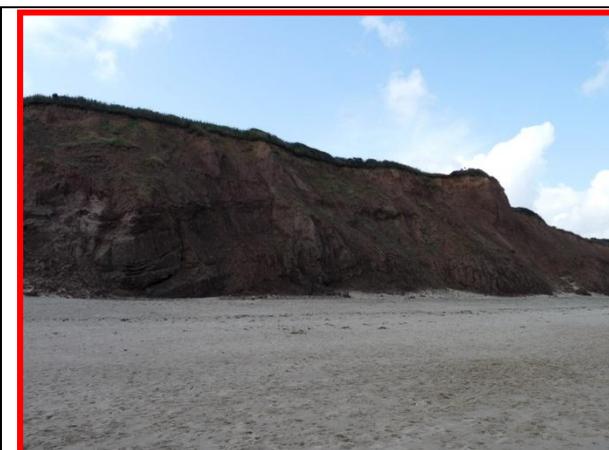
MU29/BG to MU29/BJ are located south of Hunmanby Gap. These cliffs are steep and affected by intense erosion throughout most of their height. The headscarp is retreating and there is some slumping of materials onto the beach. MU/29BG to MU29/BH have been classified as Totally Active in 2014; this is an upgrade for all of these units except MU29/BG which was also classified as Totally Active in 2012.

MU29/BH Steep, intensely eroding cliffs (Totally Active). August 2014.

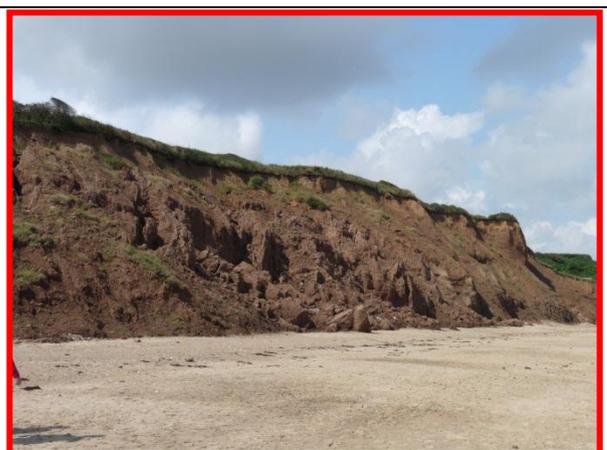
MU29/BJ (left of photo). Steep, intensely eroding cliffs (Totally Active). August 2014.

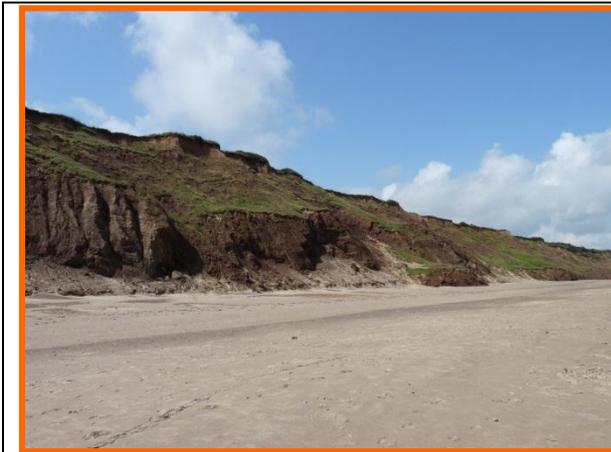
Further south, **units MU29/BK to MU29/BQ** are located above Reighton Sands. All of the units are classified as Partly Active in 2014 and their status is unchanged from 2012, apart from **MU29/BN**, which was previously classified Locally Active. These units are characterised by steep slopes which support some vegetation cover. There is recession of the headscarp, common areas of intense erosion mid-slopes and a steep, eroding toe section.

MU29/BK- BN Steep slopes with patchy vegetation cover (Partly Active). August 2014.

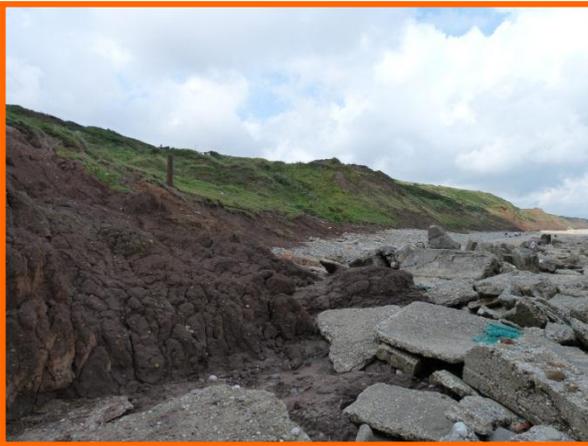
MU29/BR (north) Active toe erosion (Partly Active). August 2014.

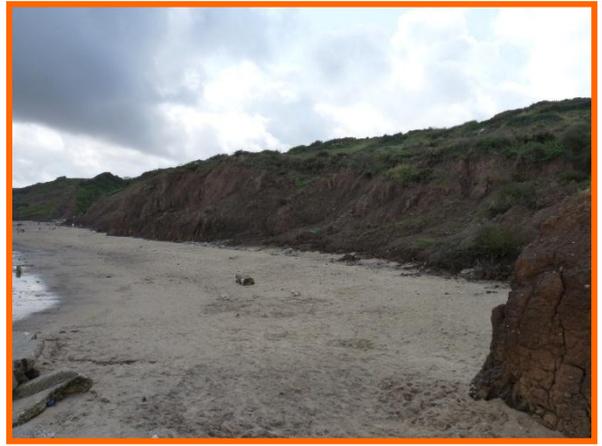
MU29/BR (south) Intense toe erosion (Partly Active). August 2014.

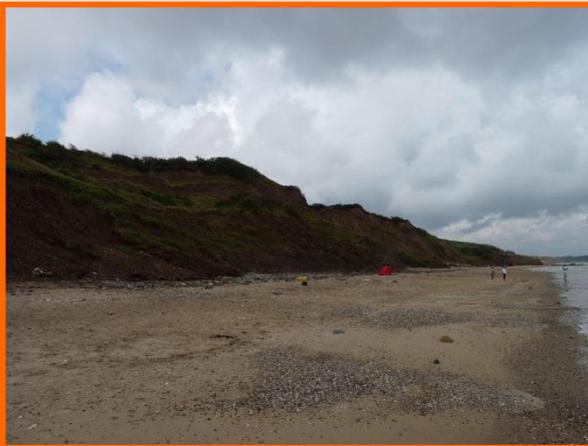
MU29/BS Active toe erosion (Partly Active). August 2014.

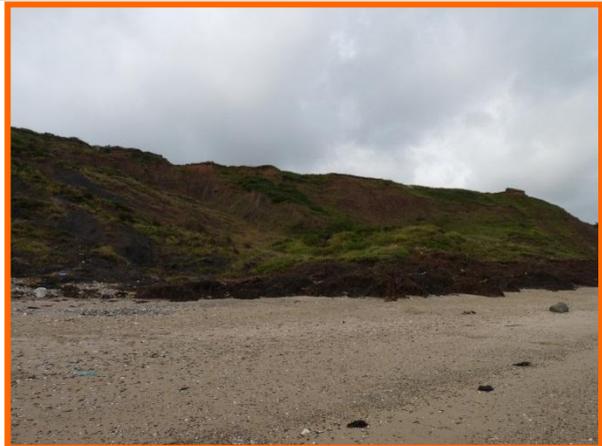
MU29/CA Active toe erosion (Partly Active). August 2014.

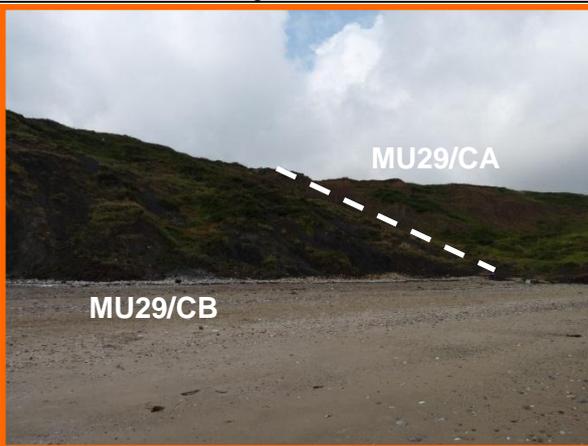
Unit MU29/CB is at the eastern end of the holiday village. The entire unit shows evidence of mudsliding and an eroding headscarp. The unit was classified as Partly Active in 2012 and retains that status in 2014.

MU29/CB. Partly Active. August 2014.

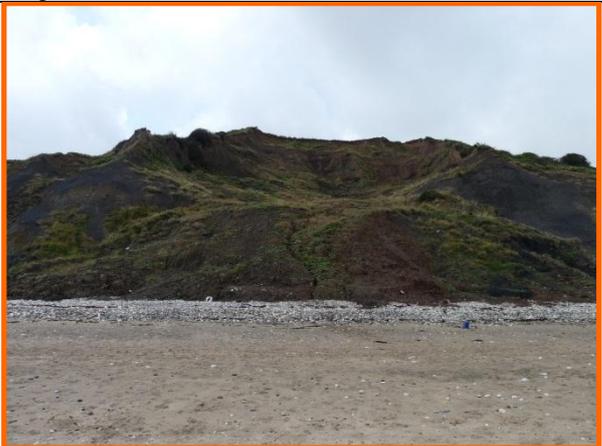
Unit MU29/CCa forms a shallow mudslide embayment. There is evidence of limited marine erosion at the toe but the majority of the slope sustains nascent vegetation indicating a degree of recent stability. The unit was upgraded from Locally Active to Totally Active in 2012, but in 2014 has been downgraded back to Partly Active.

MU29/CCa The mudslide system retains a similar for to previous inspections but is revegetating (Partly Active). August 2014.

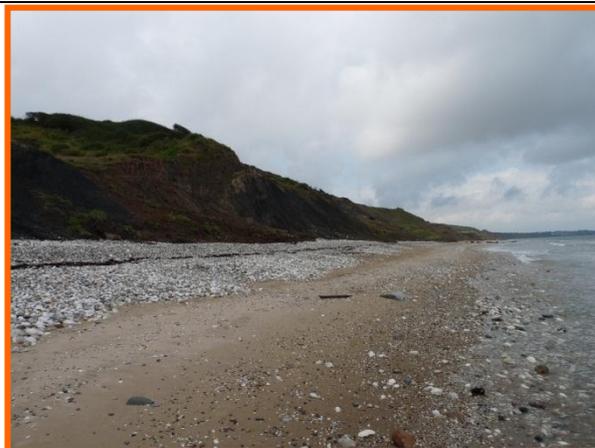
MU29/CC Northern part of unit showing erosion and mudsliding at Middle Cliff (Partly Active). August 2014.
