**Walk-over Visual Inspections of Assets
including Coastal Slopes**

**Scarborough Borough Council
Final Report**

November 2014

Coast Protection Assets and Coastal Slope Condition Analysis

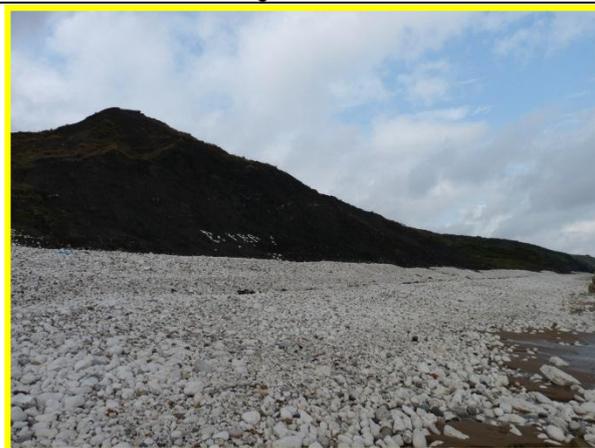
MU29/CE Actively eroding cliff toe (Locally Active). August 2014.

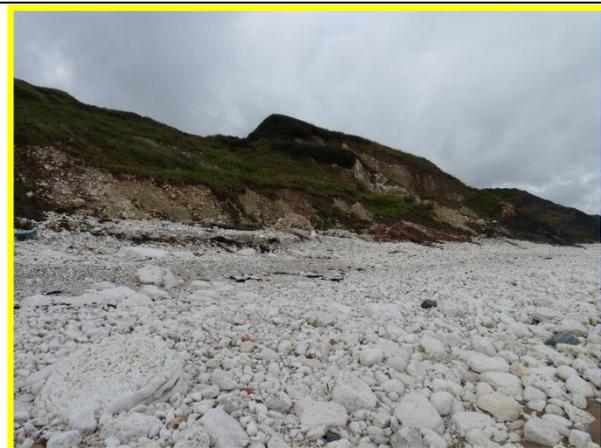
Units MU29/CF to MU29/CI are located at Speeton Cliffs and are all classified as Locally Active in 2014, unchanged from 2012. These units are characterised by outcrops of chalk near the unit toes which are actively eroding onto the beach below. In places the headscarp is near vertical and exposed.

MU29/CF Actively eroding cliff toe (Locally Active). August 2014.

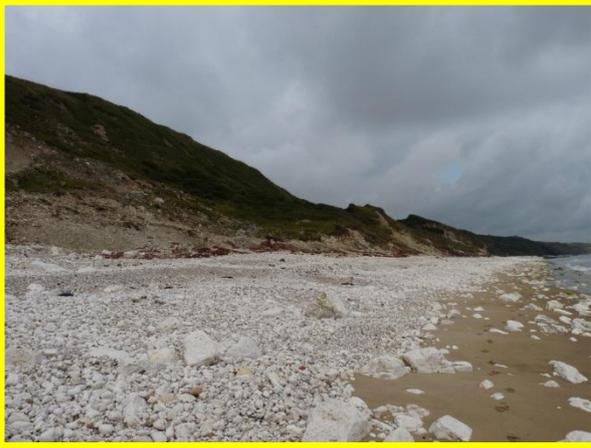
MU29/CG Actively eroding cliff toe (Locally Active). August 2014.
