Cell 1 Regional Coastal Monitoring Programme Walkover Inspection Surveys 2020

Scarborough Borough Council

November 2020

Walkover Inspection Surveys 2020

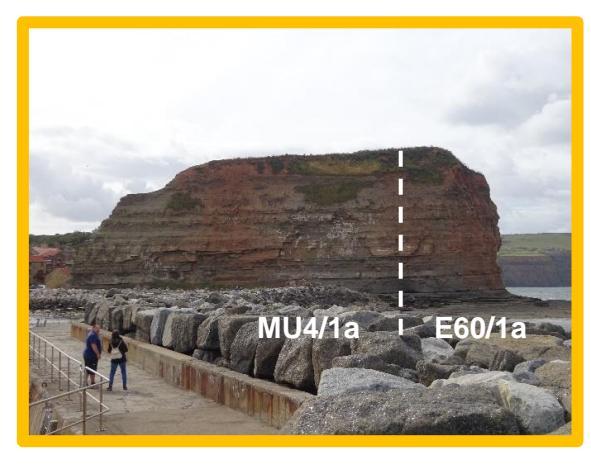
The eastward facing cliff of Cowbar Nab (MU4/1a and E60/1a) is steep and composed of unvegetated sandstone. The cliff exhibits overhangs and scars with some rock falls at its base. This level of activity means that these units are classified as Partly Active, unchanged from 2020. During the survey, small sized material could be heard falling from the cliff. Signage is present to warn people of the danger of falling rocks.

East-facing Cowbar Nab. **E60/1a** (right) and South MU4/1a (left). Partly Active in September 2020 **MU4**/

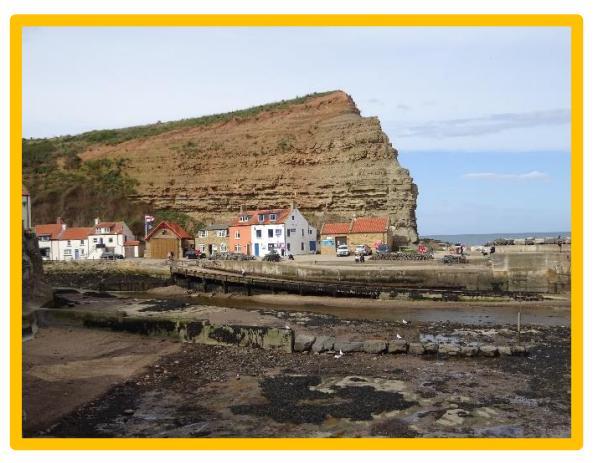
Unit MU4/1b is the south facing side of Cowbar Nab which runs adjacent to the north bank of Staithes Beck. This sandstone unit is sheltered from wave action behind the harbour walls. The cliff fails occasionally and is therefore classified as Locally Active, unchanged from 2018. During the survey, small material could be heard falling from the cliff.

South-facing Cowbar Nab along Staithes Beck *MU4/1b* (Partly Active in September 2020)

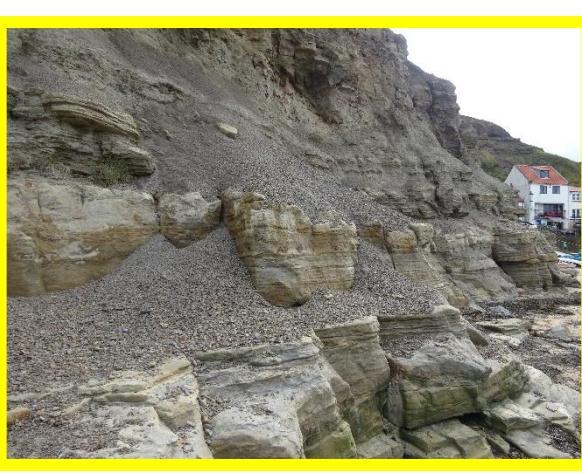
Accumulation of small stone fallen from above. **MU4/2** Locally Active in September 2020

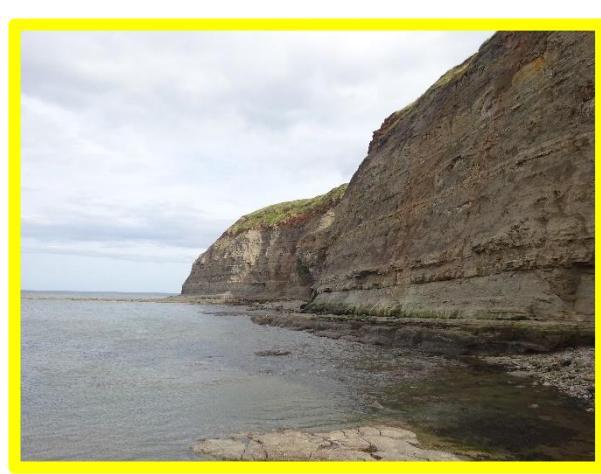
Further east, beyond the extent of Staithes Harbour is unit MU4/3. The cliffs are steep and the unvegetated sandstone is exposed to wave action at the toe. The unit is classified as Locally Active.

MU4/3 Locally Active in September 2020

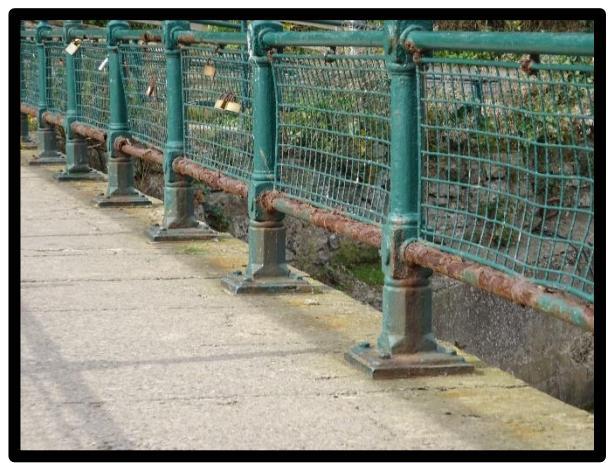
The lower rails of the guardrails crossing the footbridge were observed to be significantly corroded and the steel tubes had rusted through locally.

Footbridge – corrosion of bottom rail (no asset ref).

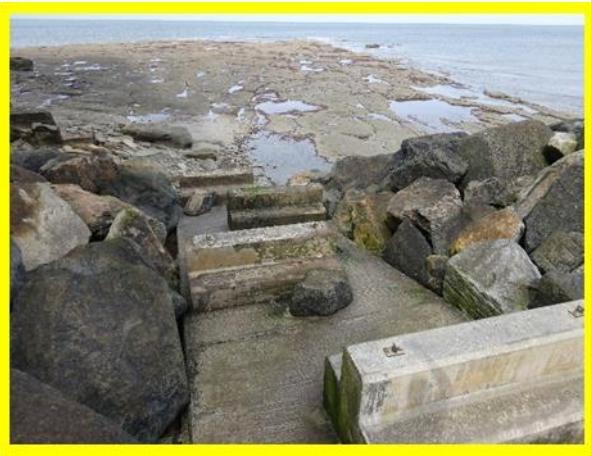
Crack in deck and crest wall (/0402C01). No significant change from 2018.

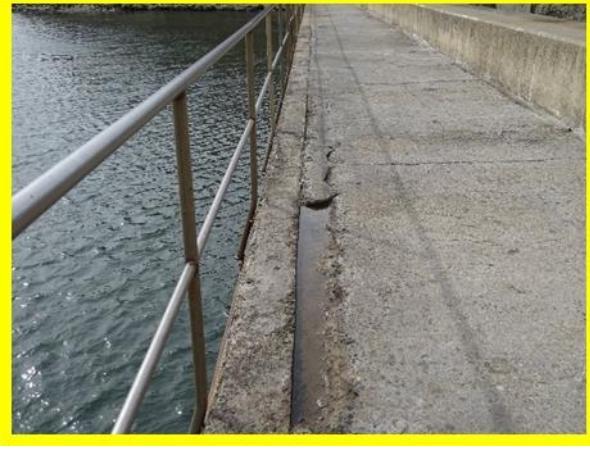
Recess with ponding water adjacent to wall crest (/0402C01)

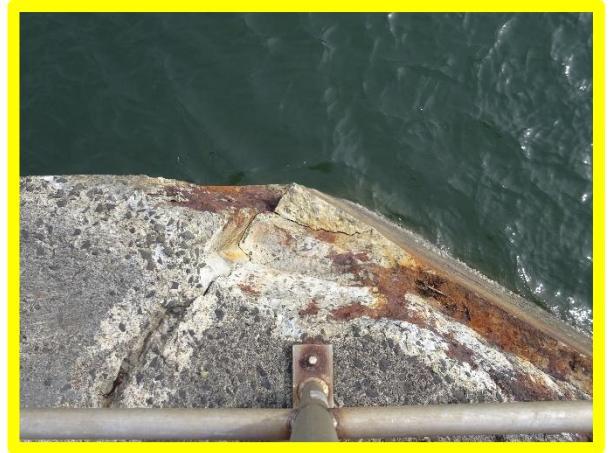
Local abrasion and spalling of the concrete cap/crest along the southern edge may present a health and safety risk as the size of the gap between the bottom rail and the crest is increased locally in combination with a potential trip hazard due to uneven surface. Some areas appear to be ponding water which leaves them susceptible to freeze-thaw action.

Spalling / abrasion along edge of crest locally (/0402C01)

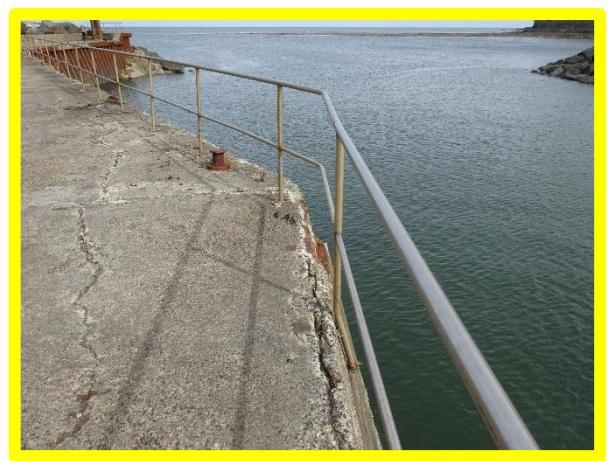
Spalling / abrasion and cracking of crest locally (/0402C01)

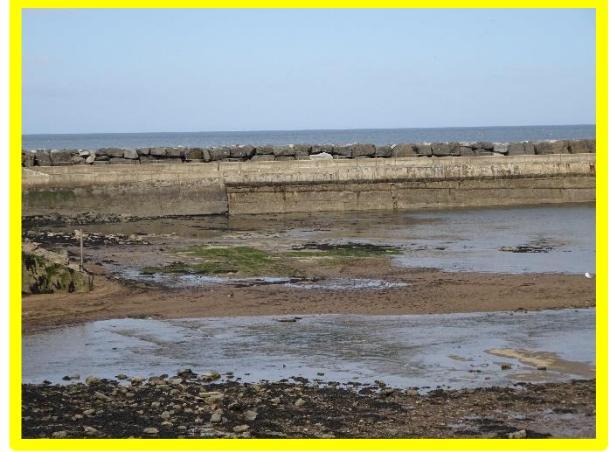
The sheet piling on the inner face and the seaward end of the breakwater is heavily corroded with significant loss of section in the uppermost 2m. It is assumed that this sheet piling served as formwork for *in situ* concrete pours rather than a standalone structural element.

Inside face of breakwater structure (/0402C01)

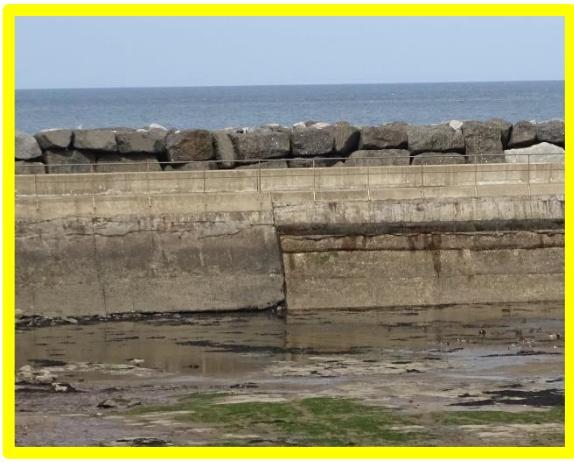
Detail on potential undercutting (left) and opening of construction joint (right) (/0402C01)

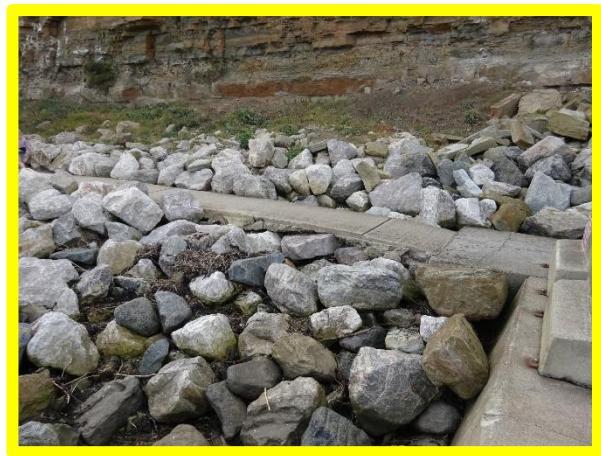
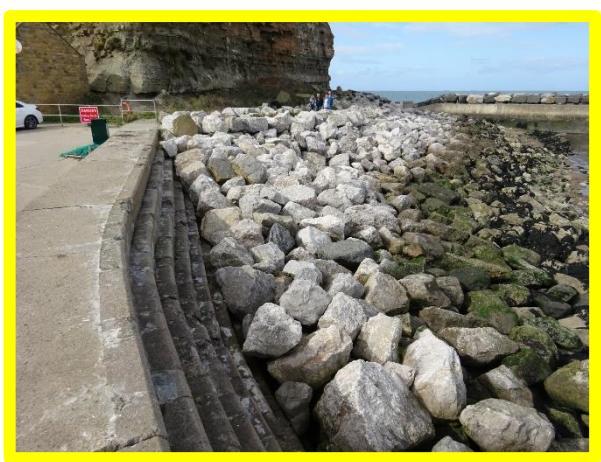
The rock armour revetment running south from the North Breakwater to the end of Cowbar Lane (/0402C02) was constructed after the 2002 upgrade to the main breakwaters and is generally in good condition. The crest level at the northern extent appears to be slightly lower, exposing the concrete walkway to the rear. It is not clear if rock armour has been displaced or if the revetment has undergone a larger scale movement/settlement although this area appears very similar to 2018 so assumed to be stable. The short section of seawall which is exposed at the southern end of the rock armour, adjacent to the slipway, is in fair condition, with evidence of local abrasion of the vertical faces and the crest and cracking and open joints between concrete blocks.

Lower crest level at northern extent of rock Rock revetment (/0402C02) revetment (/0402C02)

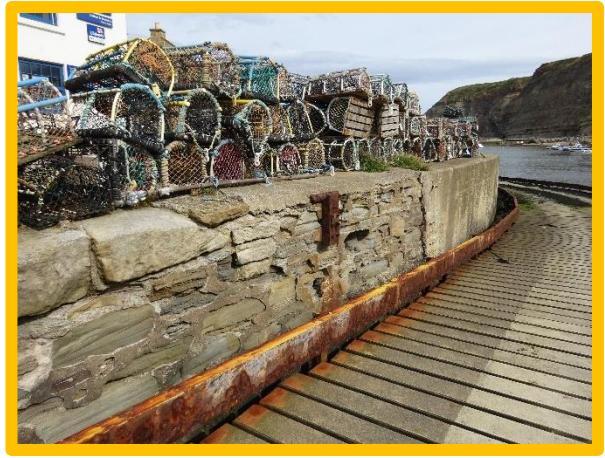
Poor condition masonry wall to rear of slipway (/0402C03)

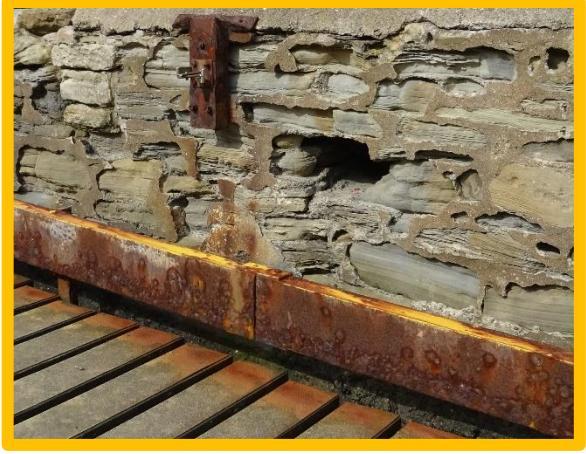
Missing blockwork in masonry wall to rear of slipway (/0402C03)

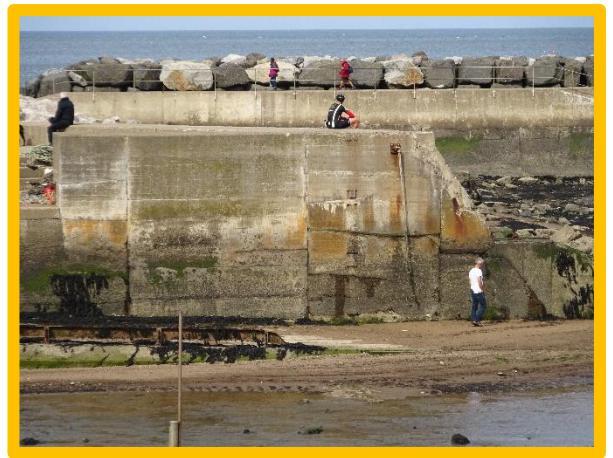
Cracks and cold joints in concrete seawall to rear of slipway (/0402C03)

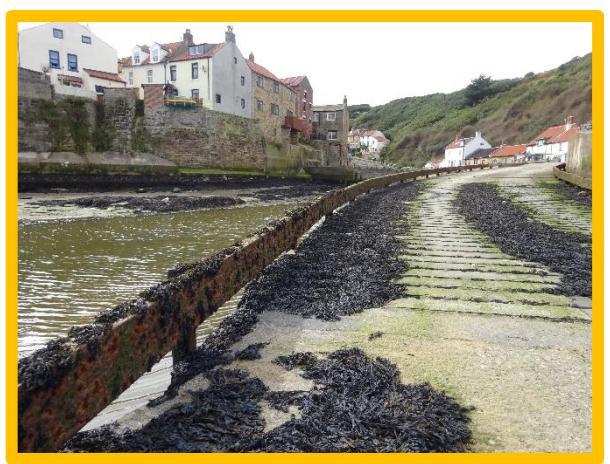
Timber slipway. Minor settlement of blocks within gabions beneath (/0402C03)

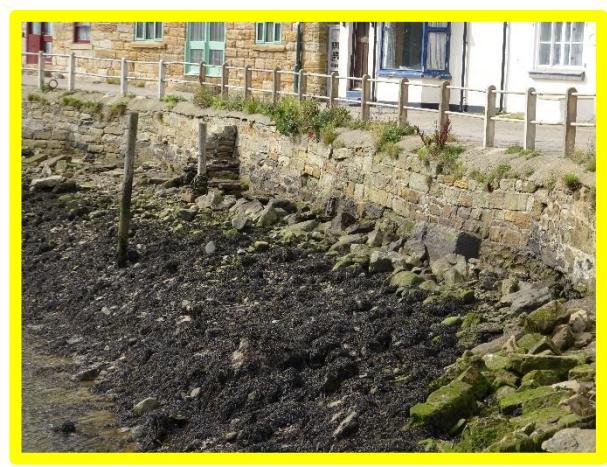
The walls between the RNLI slipway and the footbridge over Staithes Beck (/0402C06) comprise a variety of masonry and concrete blockwork structures and are generally in a fair condition, reduced to poor condition locally with missing mortar, settlement of blockwork and exposure of the toe (previous small boulder sized rock appears to have been largely washed away). The more recently constructed wall immediately in front of the RNLI building is in good condition, but there is a void in the older stone blockwork wall at its interface with the newer wall which could compromise overall stability if voiding occurs behind. The external dimensions of this void do not appear to have increased since first reported in 2016.

Wall on northern side of beck (missing blocks, open joints and voids) (/0402C06)

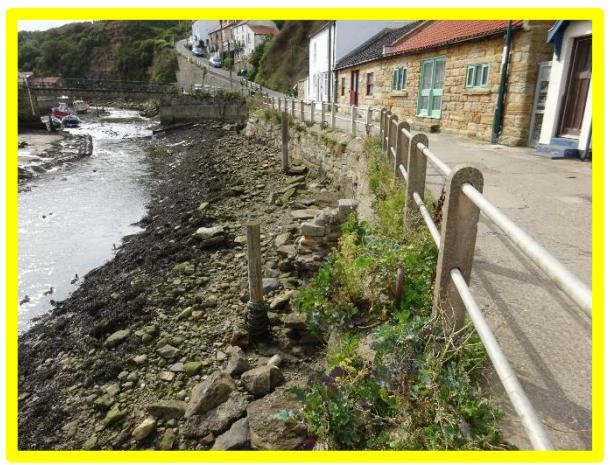
Vegetation growth along crest and into joints in upper part of wall face. (/0402C06)

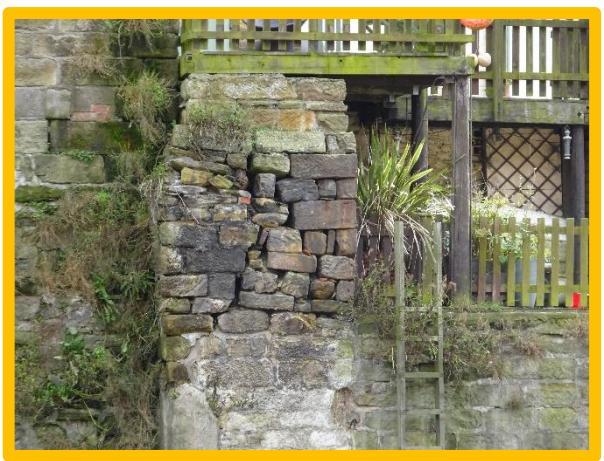
On the south side of the beck, a variety of wall construction details extends from the footbridge over Staithes Beck (/0402C04). There is evidence of previous repairs, with the overall condition of the asset generally fair, locally this reduces to poor, with sections of open joints, loose blockwork, abrasion, cracking and vegetation growth.

Open joints and loose masonry blocks locally (/0402C04)

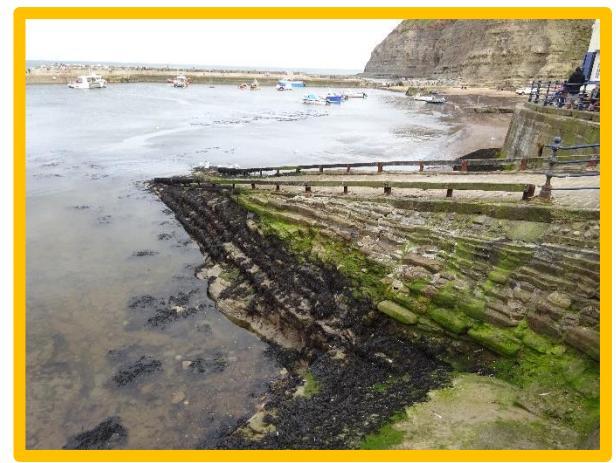
The masonry blockwork side walls to the slipway (/0403C05), are in poor condition, with missing blocks, open joints and undermining at the toe, more apparent at the lower elevations at the seaward extent of the structure. Some of the open joints are in an area of previous repair and need re-filling to prevent further deterioration. A void was observed at the interface between the concrete abutment of the seawall fronting the Crab and Lobster and the south face of the slipway.

North face of slipway (/0403C05)

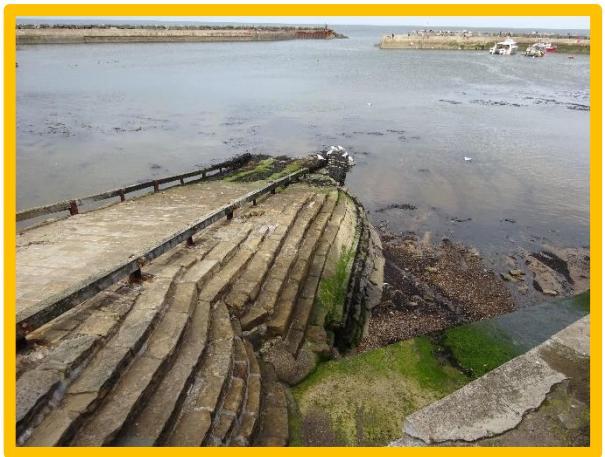
South face of slipway (/0403C05)

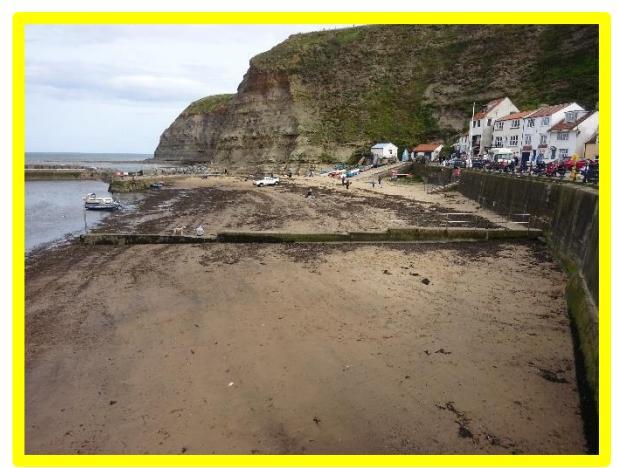
Concrete groyne (/0403C07)

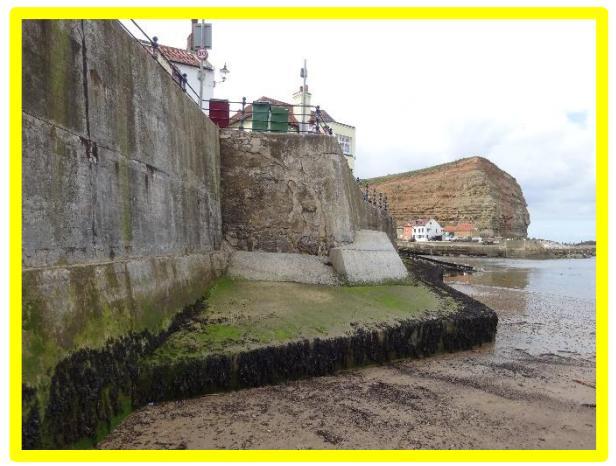
Whilst repairs and improvements have previously been undertaken to the sea wall west of the Cod & Lobster (/0403C05), the wall remains heavily abraded and cracked in places, although in fair overall condition. There is notable cracking and loss of render at the interface between adjacent seawall sections. The concrete groyne (/0403C07) limiting sediment movement within the harbour is in fair condition.

Abrasion and cracking to seawall face and crest at interface between different wall sections (/0403C05)

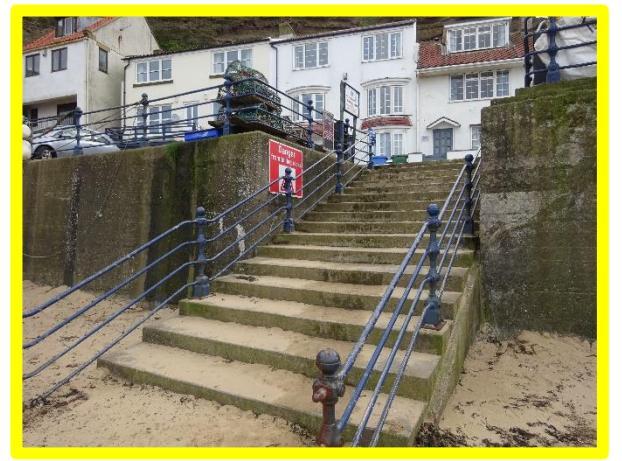
Concrete access steps (/0403C01)

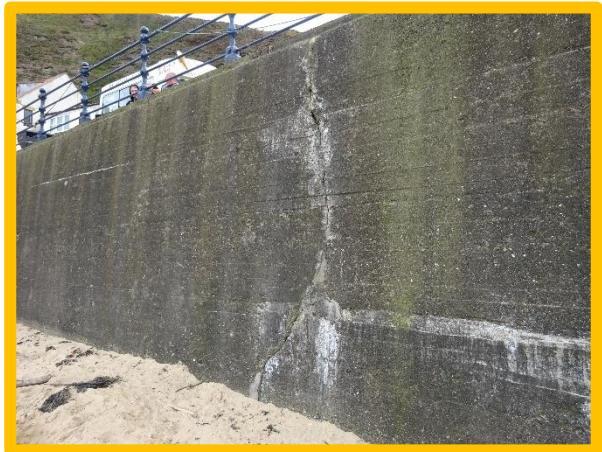
The seawalls extending to the Staithes Harbour Office (/0403C01 and /0403C02) are in fair condition, with previous repairs to cracks holding well. However, there is one full height vertical crack at the interface of adjacent wall sections which needs filling. This was reported in the 2018 inspection and does not appear to have deteriorated significantly although has widened/opened slightly, more apparent in the lower section of the wall. The slipway and adjacent boat storage area at Staithes Harbour Office remain in good condition.

Previous repair to vertical crack washed out (/0403C01)

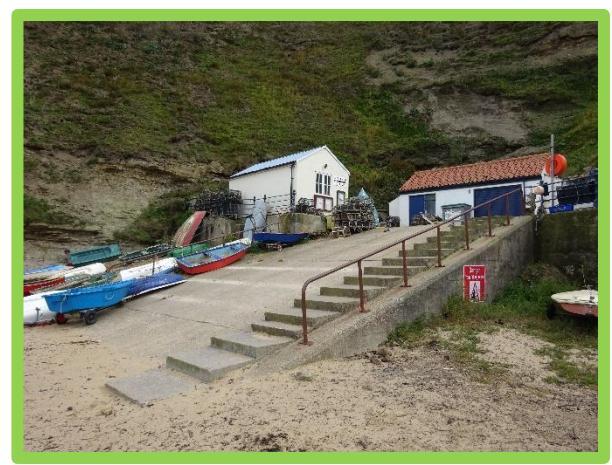
Slipway at Staithes Harbour Office (/0403C01)

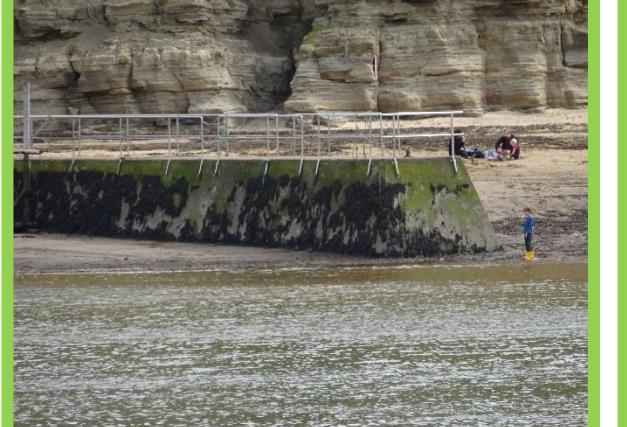
The inner harbour concrete breakwater (/0403C04) remains in good condition. A crack was observed at the crest on the inside/south face. At approximately mid-length, a crack extends the full width of the in-situ deck and aligns with vertical cracks in the walls however these appear to be historic and do not suggest continued global movement/displacement. No apparent changes from 2018 inspection. Steel guardrails appeared to be in good condition.

Inner harbour concrete breakwater (/0403C04) In

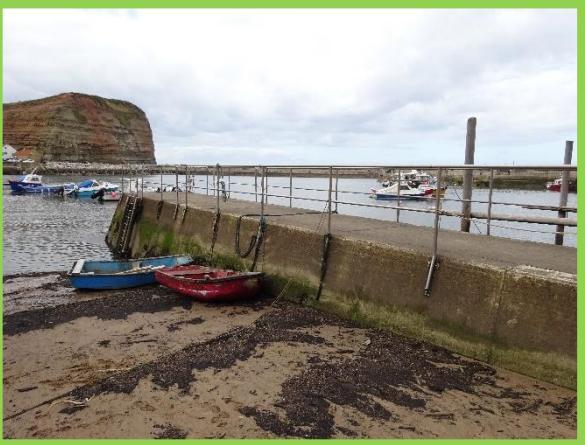
Inner harbour concrete breakwater (/0403C04)

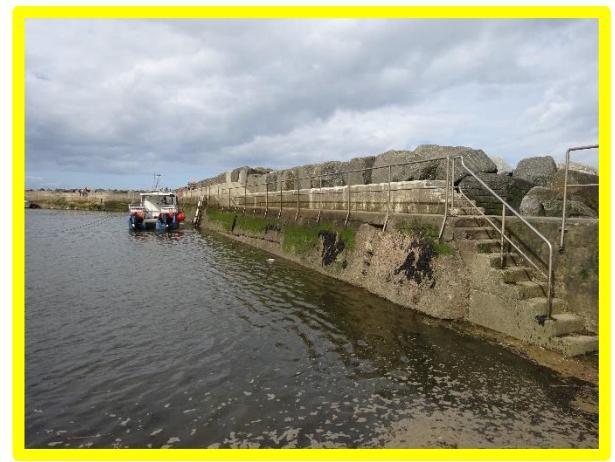
The main South Breakwater of Staithes harbour (/0403C03) is also in good overall condition, although there is minor abrasion and spalling at the access steps and around construction joints and one local area of cracking at the edge of the deck and wall on the lower (inner-most) deck of the structure. This may have been caused by an impact from a vessel (noting local deformation of guardrail tube). This defect has worsened slightly since 2018 inspection as more loose concrete has been washed out. Steel guardrails generally appeared to be in good condition.

Local abrasion, cracking and spalling inside face of South Breakwater (/0403C03)

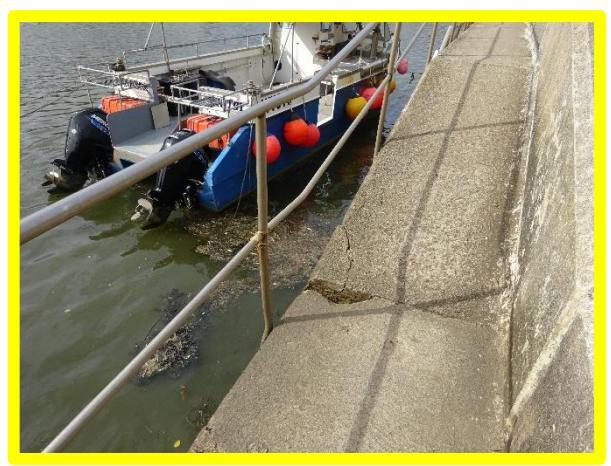
Local damage. Cracking and loose concrete to crest of South Breakwater. (/0403C03)

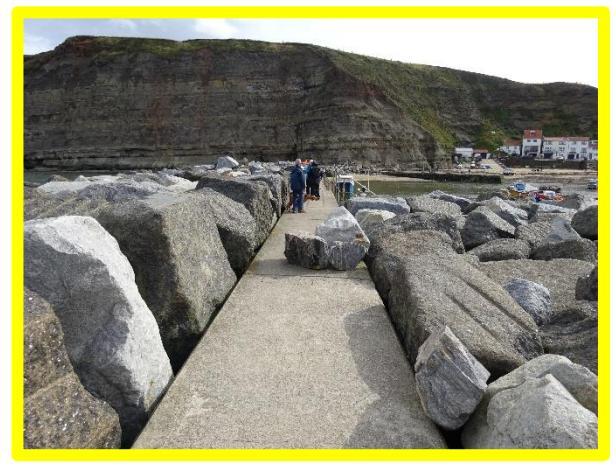
(/0403C03)

The rock armour revetment appears to be in good condition with generally consistent crest level and slope profiles. Several smaller rock armour pieces appear to have been lifted/displaced and are sitting on top of the larger armour and four small rock armour pieces are located on the concrete crest (outer limb of the structure) having been displaced from the rock armour crest. There is no apparent damage to the concrete crest and the absence of these units will not be of significant detriment to the performance of the wider revetment. The rock armour fillet between the two breakwaters has several blocks displaced locally and sitting slightly seaward of the majority of the rock but the defence is generally in good condition.

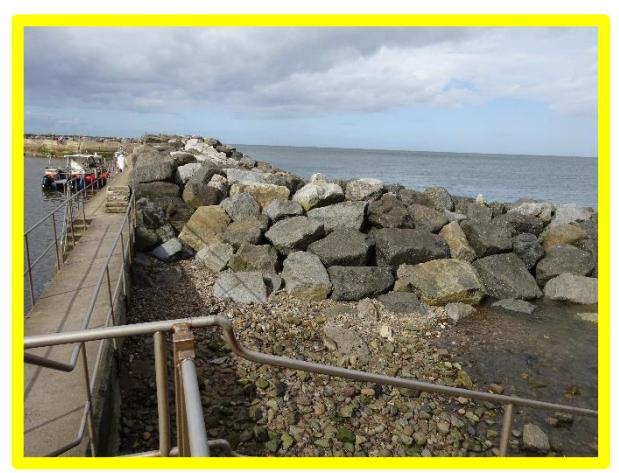
Displaced rock armour on concrete crest Rock armour on East face of breakwater (/0403C03)

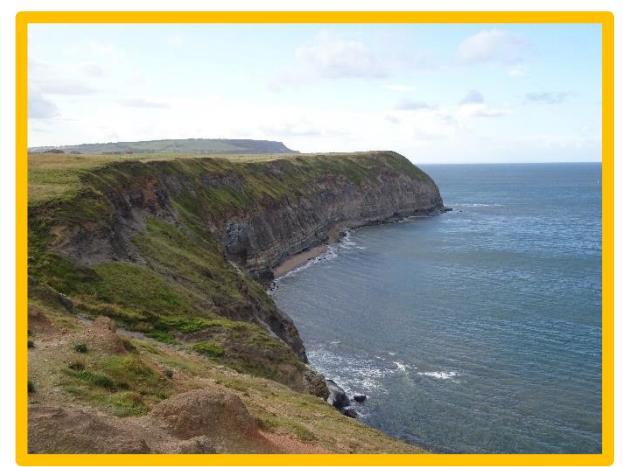
MU5/1 Partly Active in September 2020.

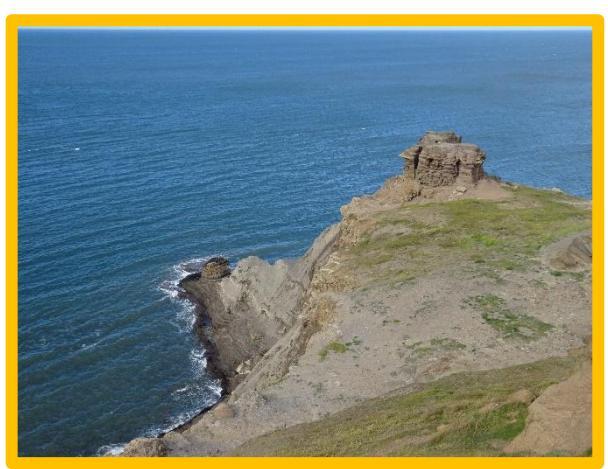
Extensively weathered headland at Old Nab **MU5/1** Partly Active in September 2020.

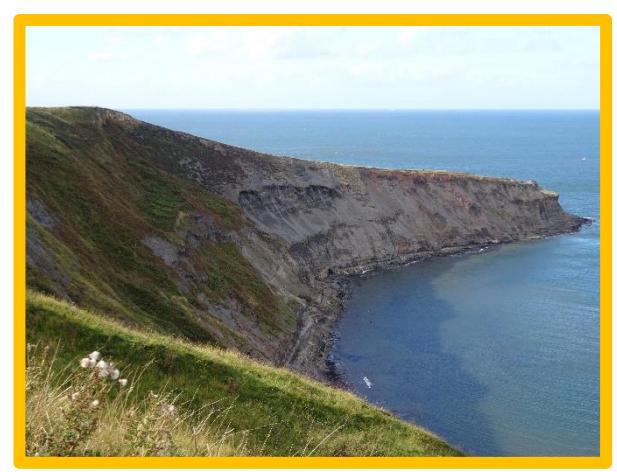
Looking north across Brackenberry Wyke. Looking south across Brackenberry Wyke. MU6/1 Partly Active in September 2020.

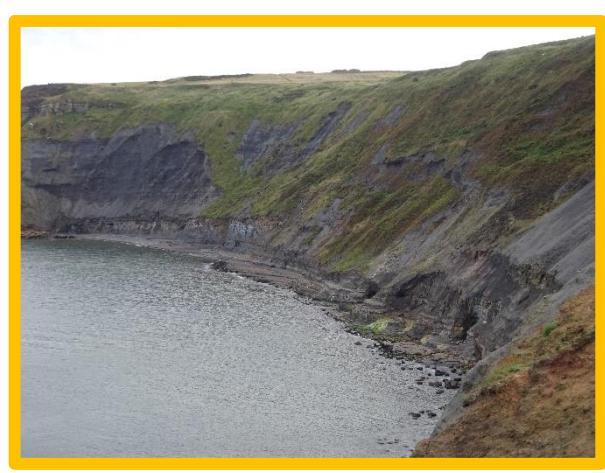
MU6/1 Partly Active in September 2020.

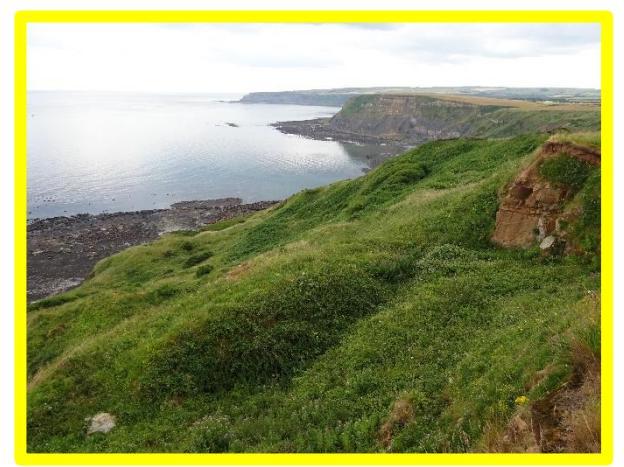
MU6/2 Locally Active in September 2020.

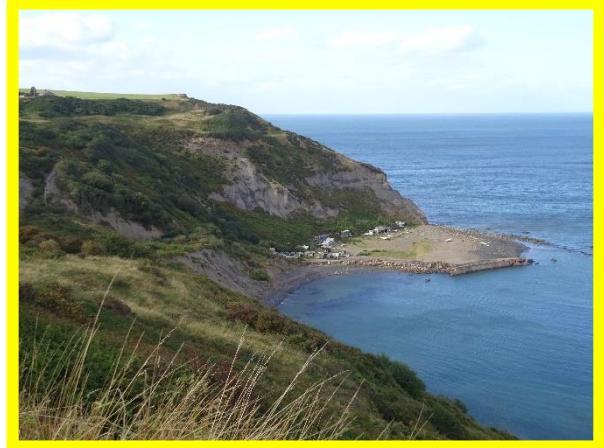
Steepest slopes with no vegetation cover and evidence of minor local activity. MU6/3 Locally Active in September 2020.

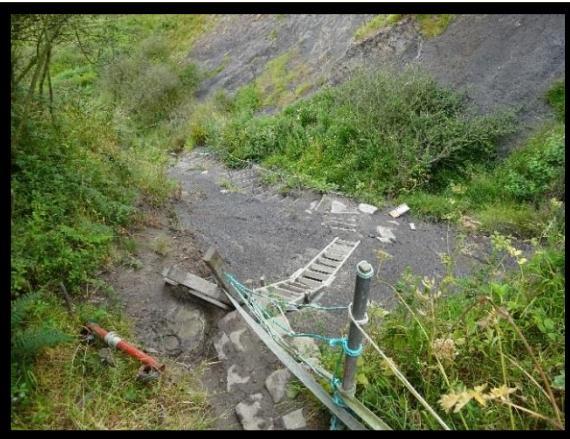
"Unauthorised" access route to foreshore within **MU6/4** July 2018.

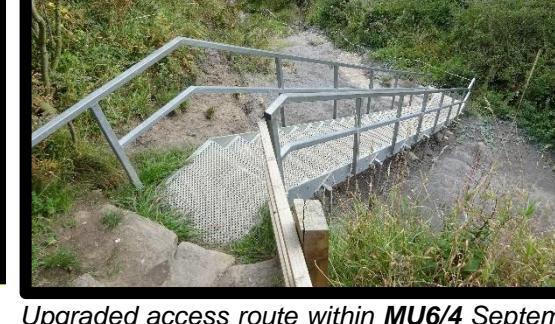
Upgraded access route within **MU6/4** September 2020.

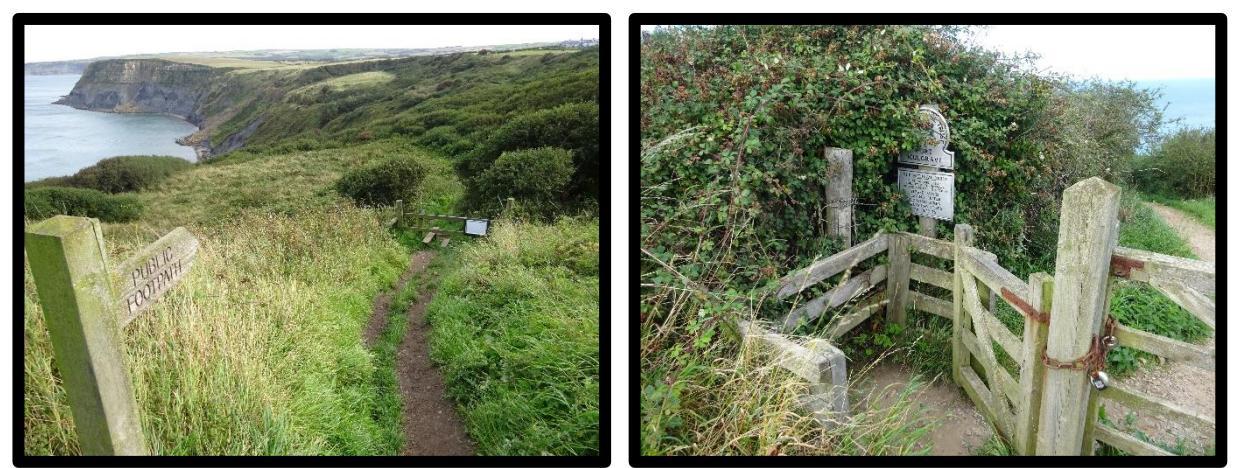
Public footpaths reopened (closed in 2016 and 2018).

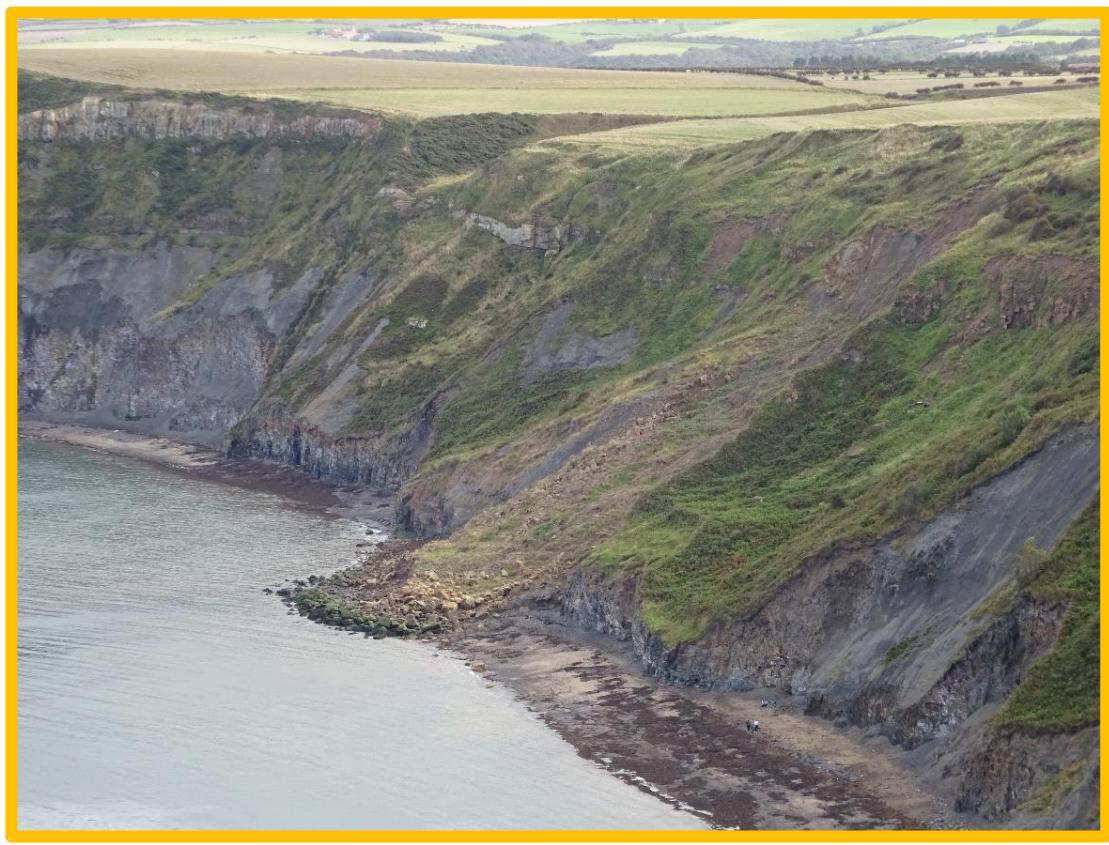
There is a lack of evidence of significant continued activity other than minor changes in the size of debris fan and a reprofiling of the toe section of the failure and this unit remains as Partly Active in September 2020.

MU6/5 – View of the landslip looking across Port Mulgrave from west to east (Partly Active in September 2020).

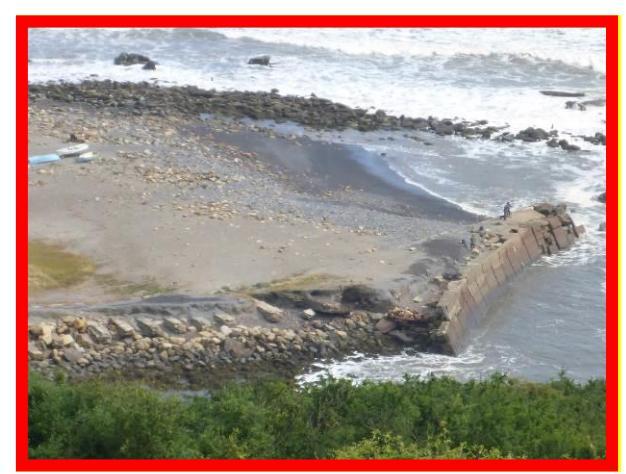
The jetty of the former port and ironstone mine at Port Mulgrave has been derelict for many years and is considered to be redundant. Virtually all coastal defences have been lost to the sea. What is left of the southern breakwater is undergoing large scale cracking, deformation, undercutting and outflanking and failure of more recently added gabions. It is estimated that more than half of its original length has now been eroded. The rate of deterioration appears to have slowed as the remains of the structure appeared very similar to observed in 2016 and 2018 (\0502C01).

Dilapidated asset in 2016 (\D0502C01)

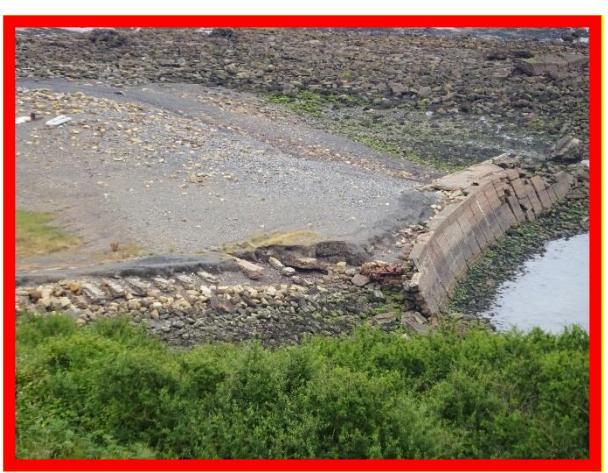
Dilapidated asset in 2018 (/D0502C01)

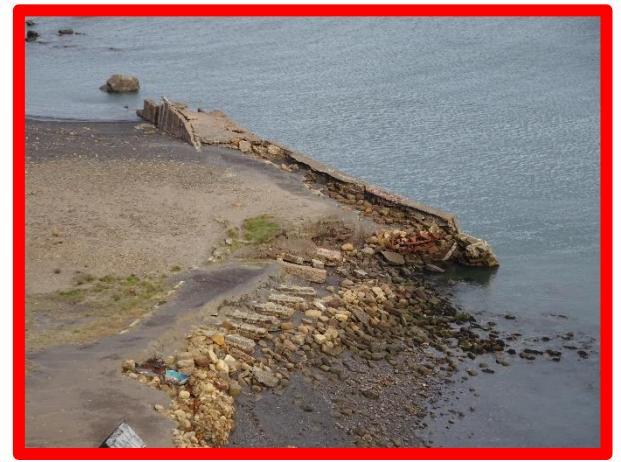
Dilapidated asset in 2020 (\D0502C01)

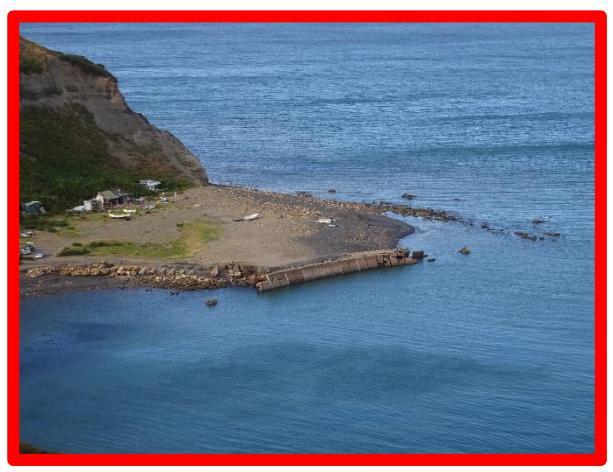
Dilapidated asset in 2020 (/D0502C01)

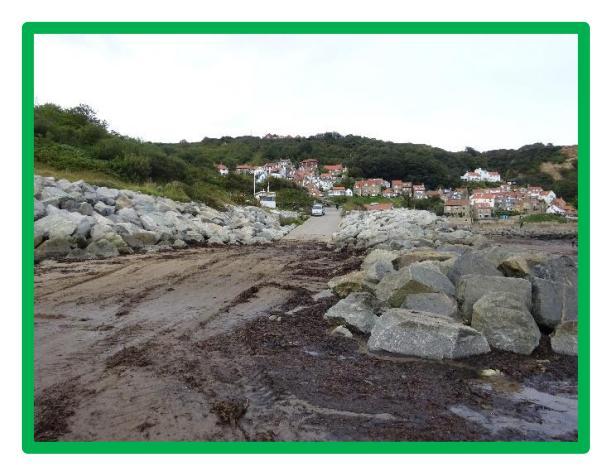
Slopes of Runswick Bay village. **MU7/1** Dormant in September 2020.

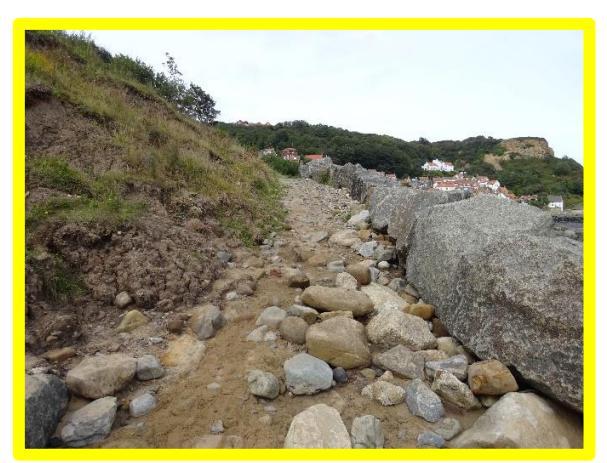
MU7/2 Locally Active behind new rock armour fillet in September 2020.

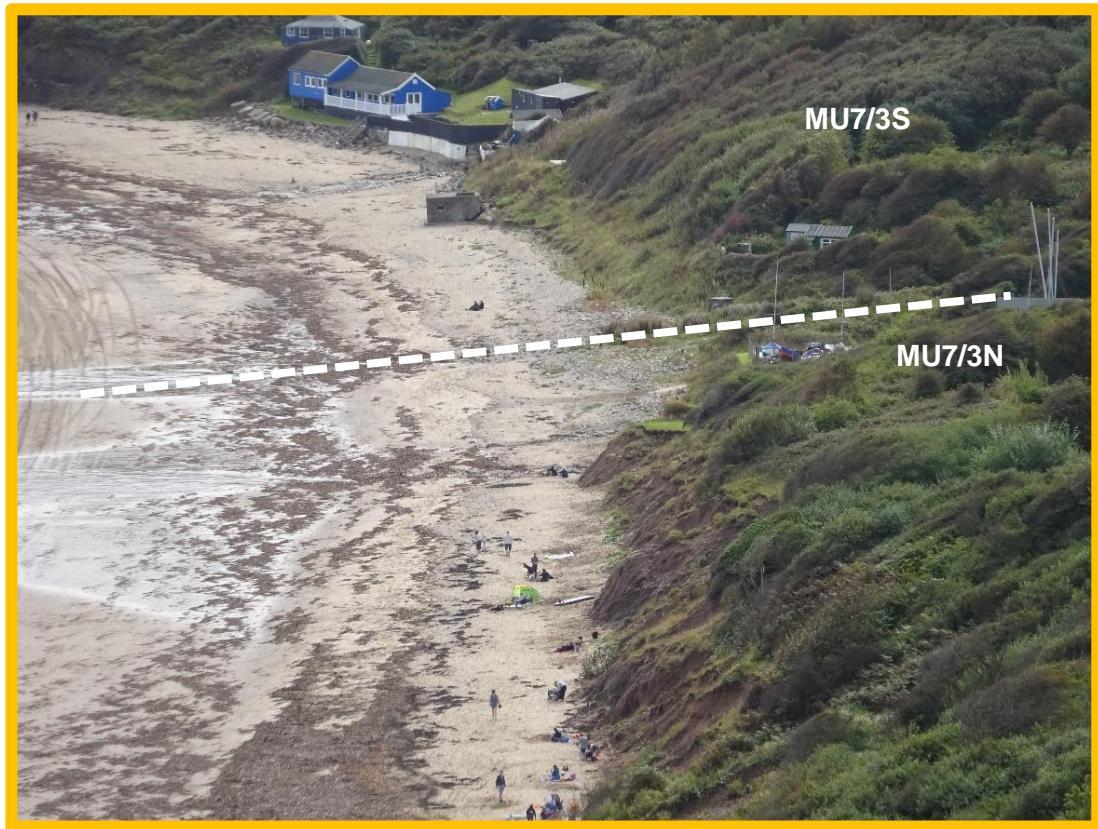
MU7/3N foreground and MU7/3S background.

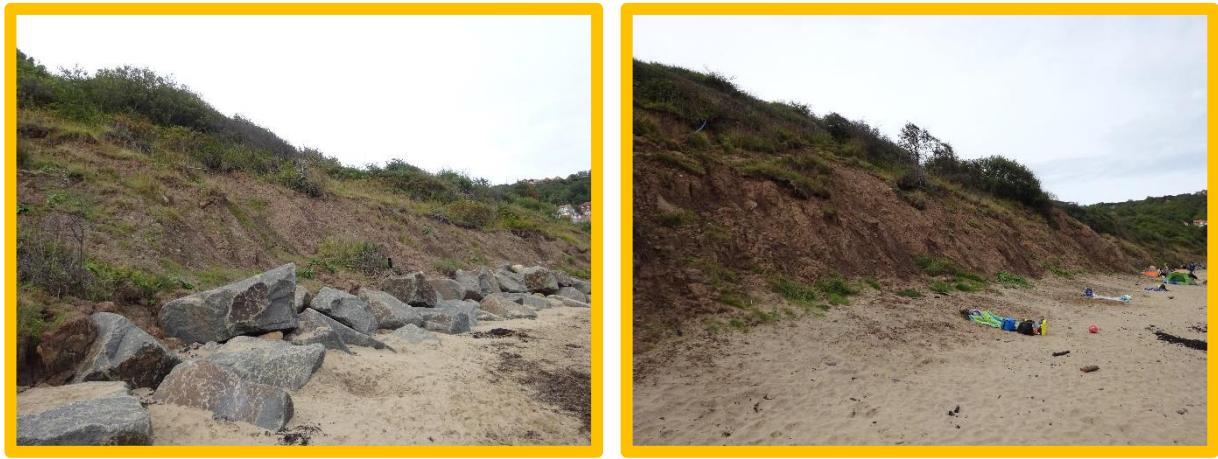
Active toe of till cliffs in Runswick Bay. MU7/3N Partly Active in September 2020.

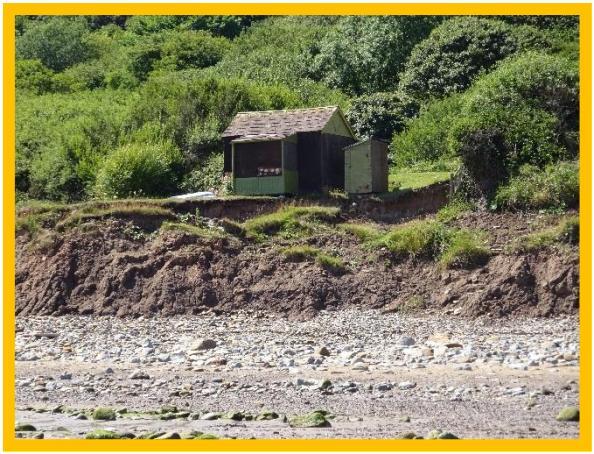
Slips were threatening the stability of timber buildings/sheds (use unknown) **MU7/3N** Partly Active in July 2018.

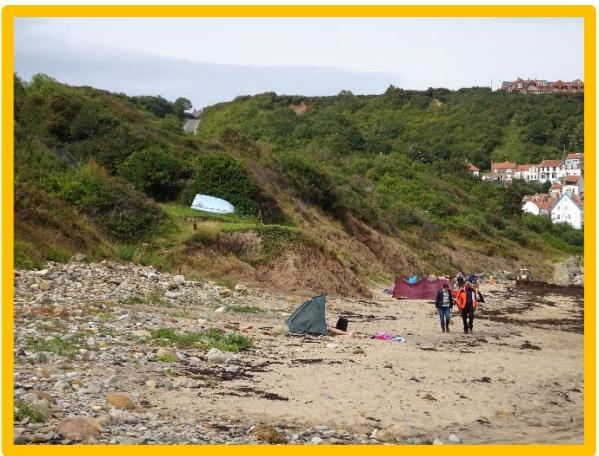
Structures no longer present in September 2020. **MU7/3N** Partly Active in July 2020.

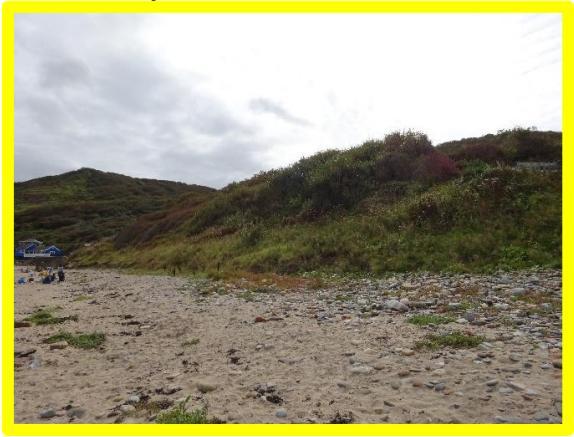
Well vegetated till in Runswick Bay. **MU7/3S** Locally Active in September 2020.

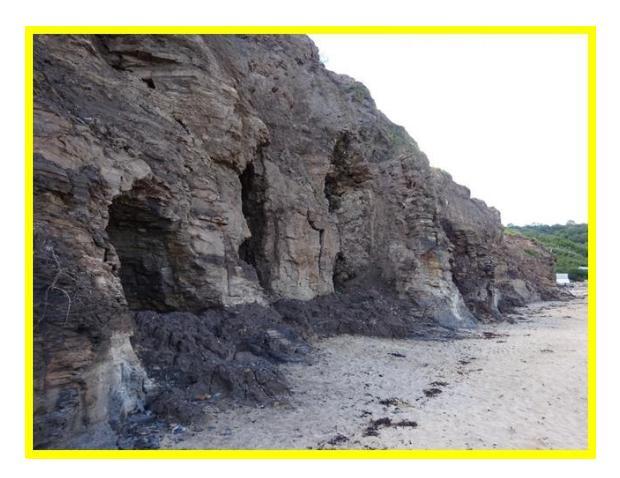
Caves in mudstone cliffs. **MU7/4** Locally Active in July 2018

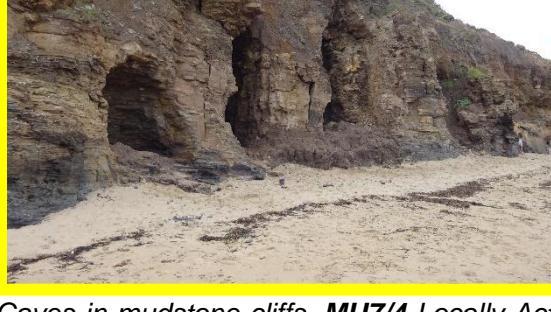
Caves in mudstone cliffs. **MU7/4** Locally Active in September 2020

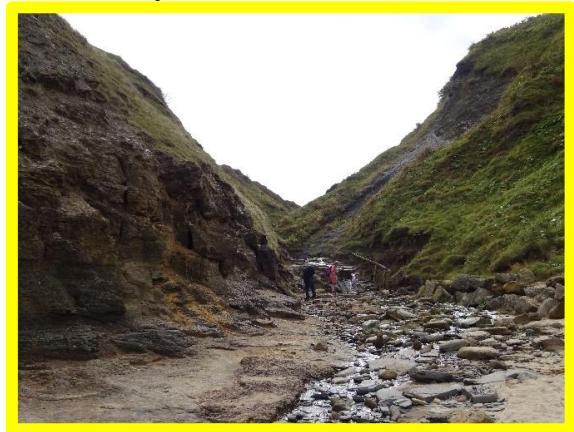
Local slumps in more steeply sloped till. **MU7/4** Locally Active in September 2020

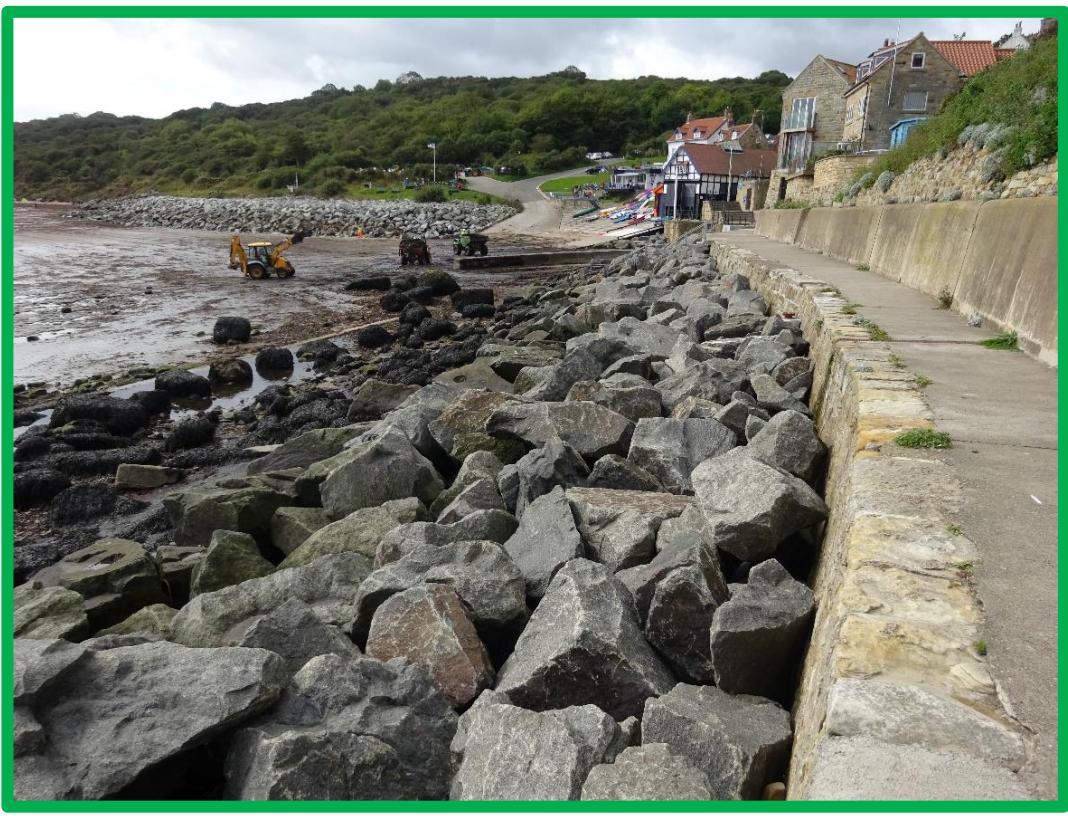
Rock armour fillet at toe of existing seawall

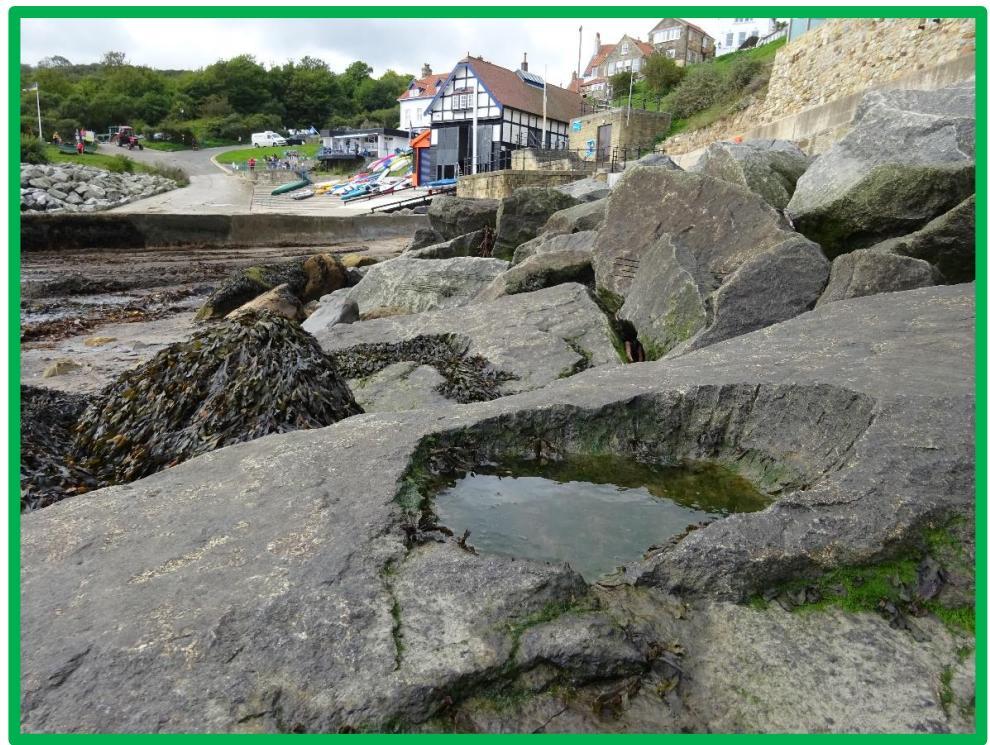
Artificial rock pool, surface scoring and natural seed rocks – ecological enhancement at the toe of the new rock armour fillet.

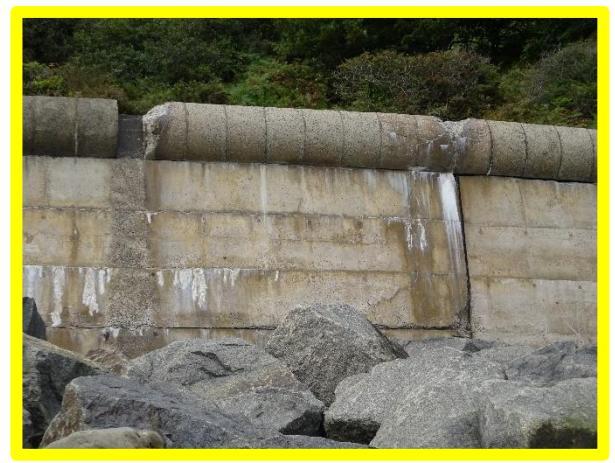
Above the rock armour fillet, the northernmost sea wall (/0601C01) is suffering from heavy surface abrasion on its facing, cracking and spalling to the concrete coping and wash-out of the joints under the coping along most of its length. The flexible sealant in the expansion joints between the capping beam and the deck slabs and separating the deck slabs is brittle and washed out across most of the structure. The joints are open to around 20mm width and there is minor differential settlement between slabs. Vegetation is present in some of the joints.

Loss / wash-out of mortar beneath coping. Local abrasion (/0601C01)
