Cell 1 Regional Coastal Monitoring Programme Walkover Inspection Surveys 2020

Scarborough Borough Council

November 2020

Walkover Inspection Surveys 2020

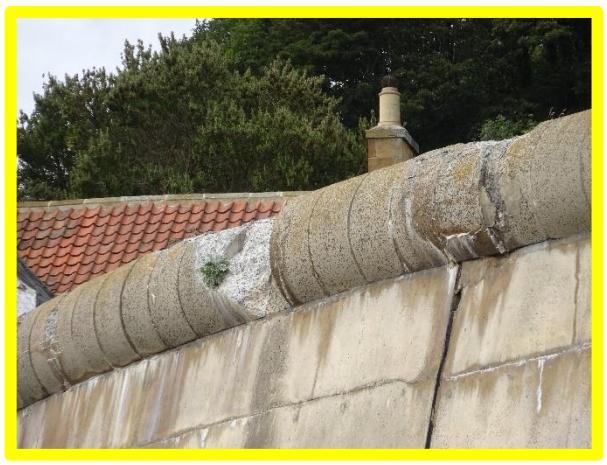
Abrasion and cracking of concrete coping (/0601C01)

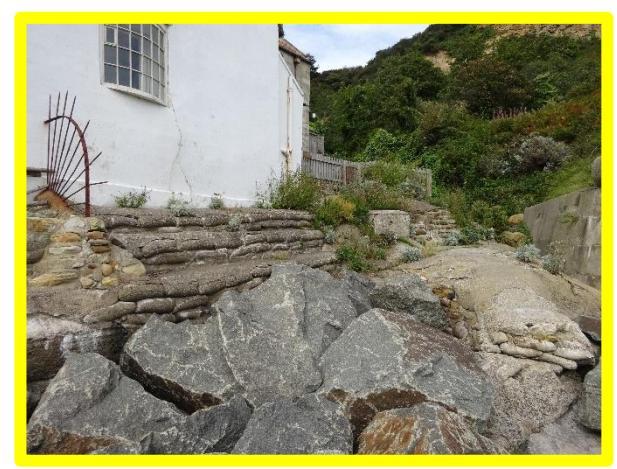
Cracks in the upper masonry seawall were filled and the wall repointed locally with marine mortar. The bag work and mass concrete structures to the rear of the rock armour and moving up the Runswick Beck are generally in Fair to Poor condition with cracking and open joints. The Thatched Cottage has significant cracks running the full height of the gable end, with no significant change observed from the 2018 survey.

Variety of concrete bag work and in situ concrete pours at Runswick Beck (/0601C06)

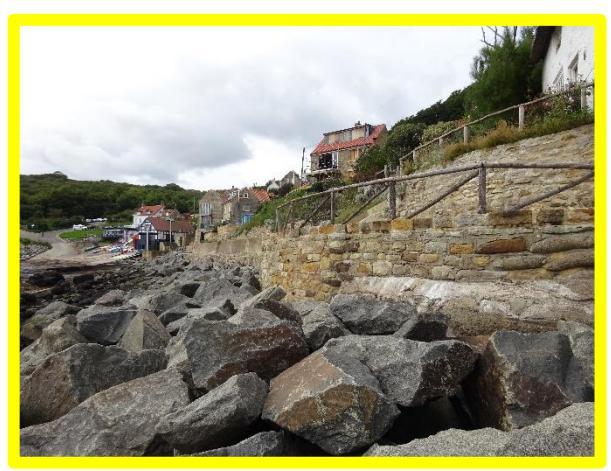
Cracks filled and masonry repointing in front of Thatched Cottage (/0601C06)

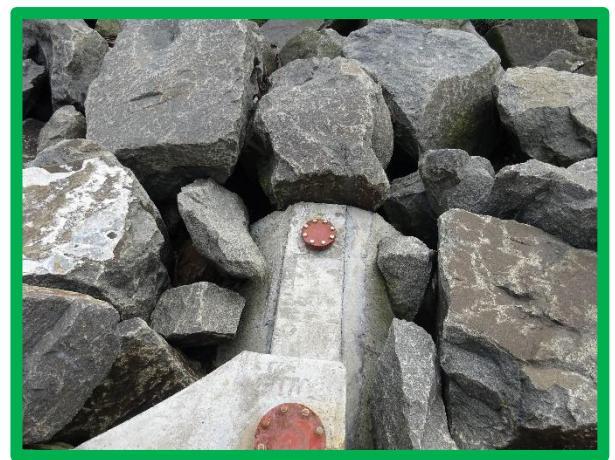
Rock armour pieces around Yorkshire Water rodding eyes.

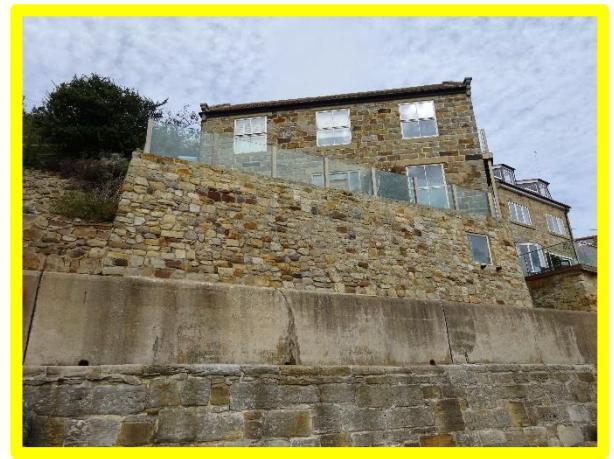
The concrete deck and crest wall above the rock armour and seawall are generally in fair condition with evidence of previous repairs locally which are holding up reasonably well. The flexible sealant in the expansion joints is brittle and missing in places. The structures at the foot of the slope comprise masonry retaining walls/property walls which vary from Good to Fair condition. Minor cracking, open joints and recessed mortar were observed locally.

Concrete crest wall (retaining wall and property walls) (/0601C03)

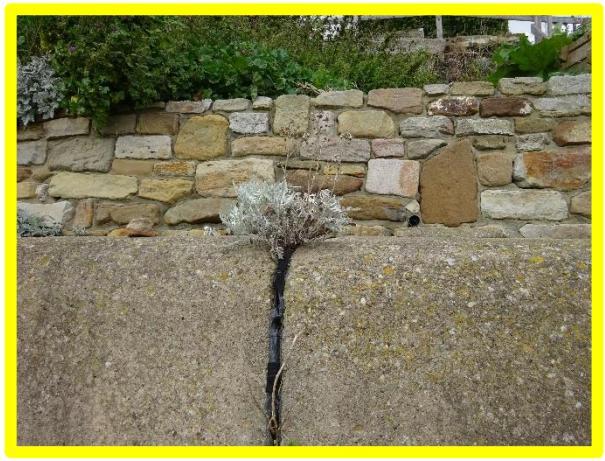
Brittle sealant in expansion joints (vertical and horizontal). Vegetation growth locally. (/0601C03)

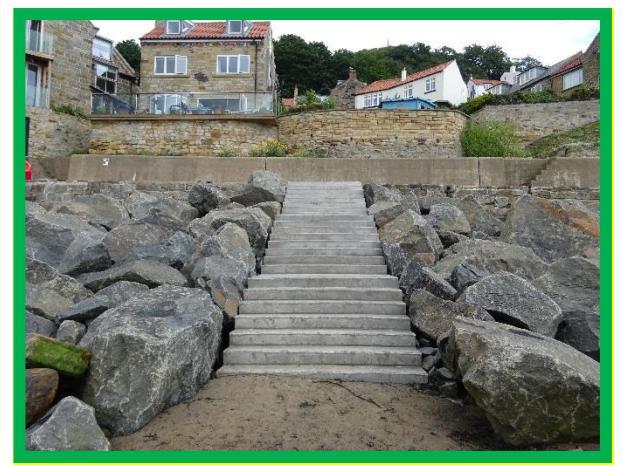
Reinforced Concrete access steps (/060C03)

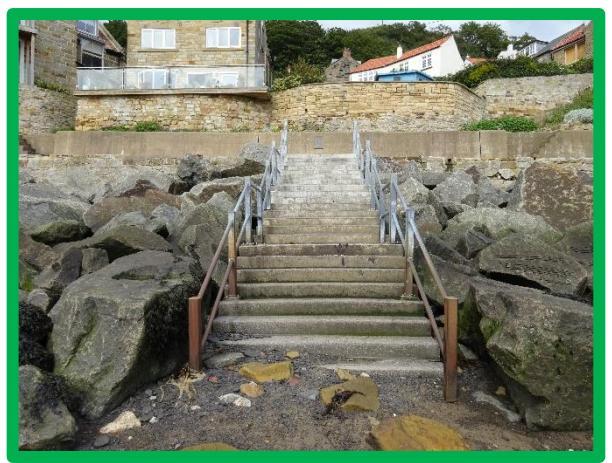
Reinforced concrete access steps, railings added August 2018 (/060C03). Note accumulation of material including cobble/boulder size at foot of steps.

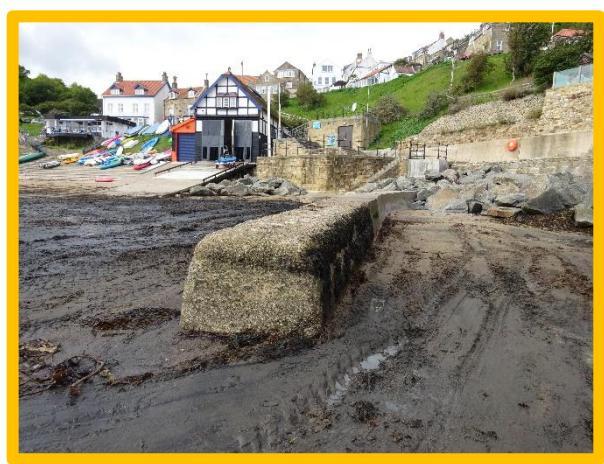
Whilst the new concrete is in Good condition and local repairs/filling of cracks and voids were also carried out in the original concrete at the tie-ins, overall the structure remains in Poor condition due to significant abrasion of concrete, opening of the construction joint between wall and crest concrete and potential undermining of the seaward end (not observed in 2020 as obscured by higher beach levels).

September 2020 – note higher beach levels. Tracks from SBC contractor removing seaweed on day of survey (/0601C02)

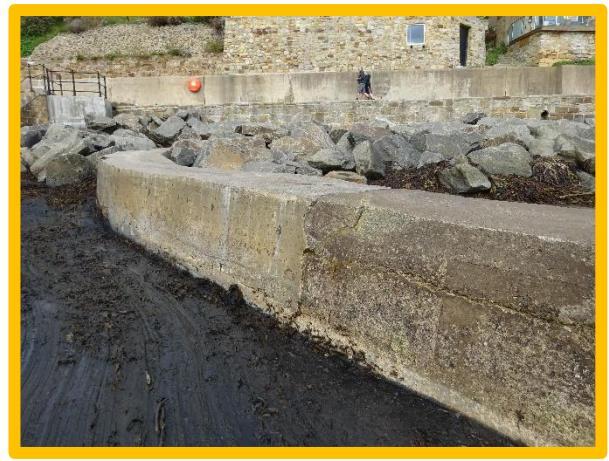
Opening of construction joint, cracking of Fine crack running through all three visible original concrete at interface with repair faces of the structure (/0601C02) (/0601C02)

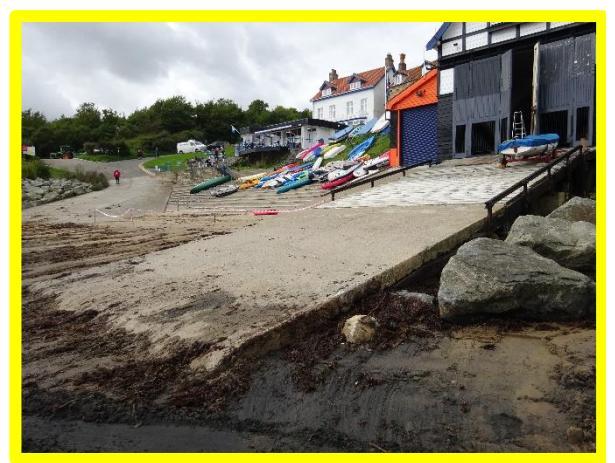
South of the pumping station, the defences comprise the slipway of the former lifeboat station which is generally in Fair condition with abraded concrete piers and severely corroded steel edge protection. The timber decking was generally in good condition. The Runswick Rescue slipway features open joints and cracks in the concrete to the exposed face but overall, the structure appeared in Fair condition. The concrete forming the boat storage area and the access ramp in front of the café is in Good condition with only minor local defects such as abrasion on exposed edges at construction joints, minor cracking and loose timbers/steps. A minor longitudinal crack was observed in the centre of the top two concrete panels of the access ramp.

Former lifeboat slipway. Beach levels and seaweed largely obscure previous repairs/concrete pours at the toe (/1003C04)

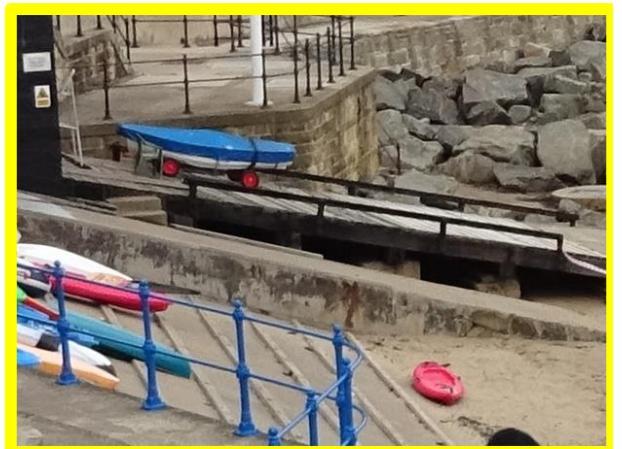
Open joints / cracks in Runswick Rescue slipway (/1003C04)

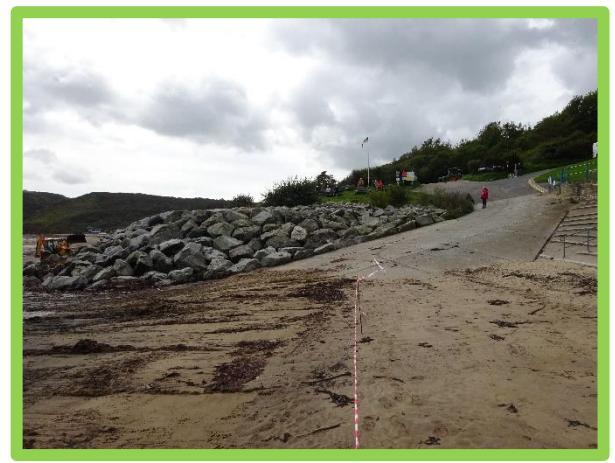
Concrete access ramp (/1003C04)

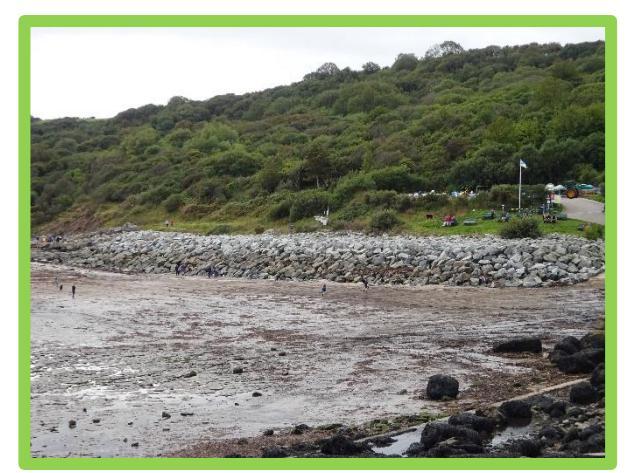
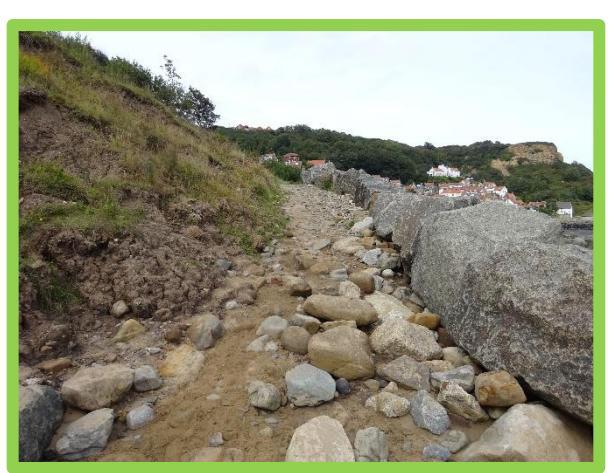
The rock armour revetment (/0602C01) remains generally in Very Good condition, with the rocks tightly packed with no significant voids and consistent crest level and seaward slope profile.

Rock armour revetment (/0602C01)

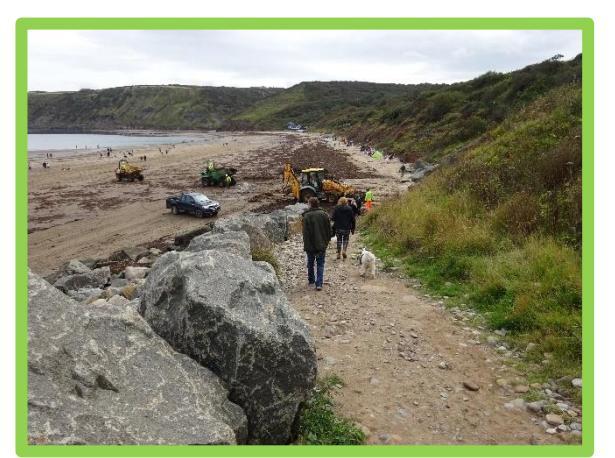
The large rock armour units to the seaward side of the access ramp remain in situ and continue to provide protection to the ramp and the toe of the coastal slope, however it appeared that the surface may require attention with respect to use by pedestrians e.g. through placing smaller rock/sand. It is understood that SBC carry out this work periodically.

High level access ramp (/0602C01)

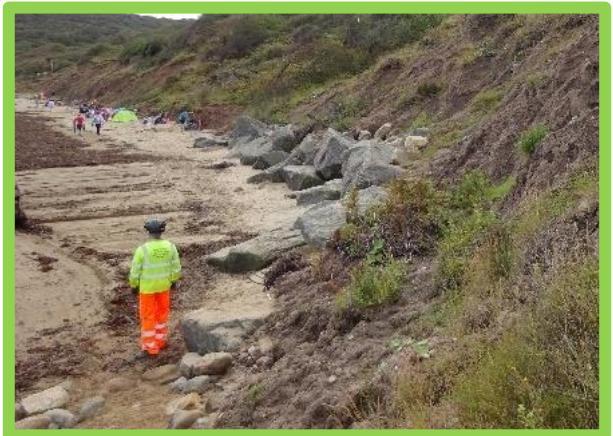
Rock armour toe protection south of high-level access ramp (/0602C01)

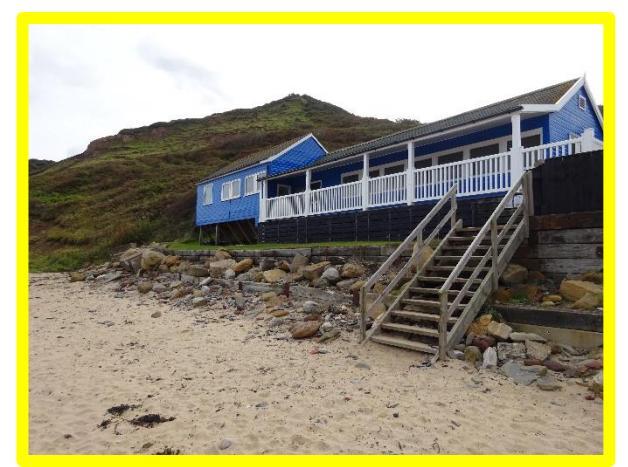
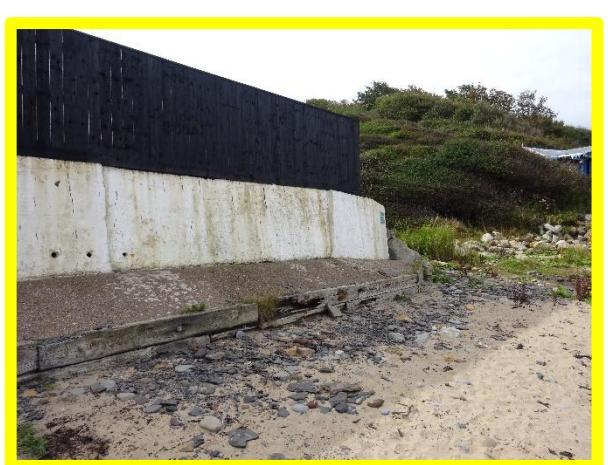
The southern extent of the asset comprises concrete cubes/tank blocks and rock armour. This is not of formal construction detail, however, appears to be offering some protection to the slope and building behind.

Sailing Club defences (/0602C05)

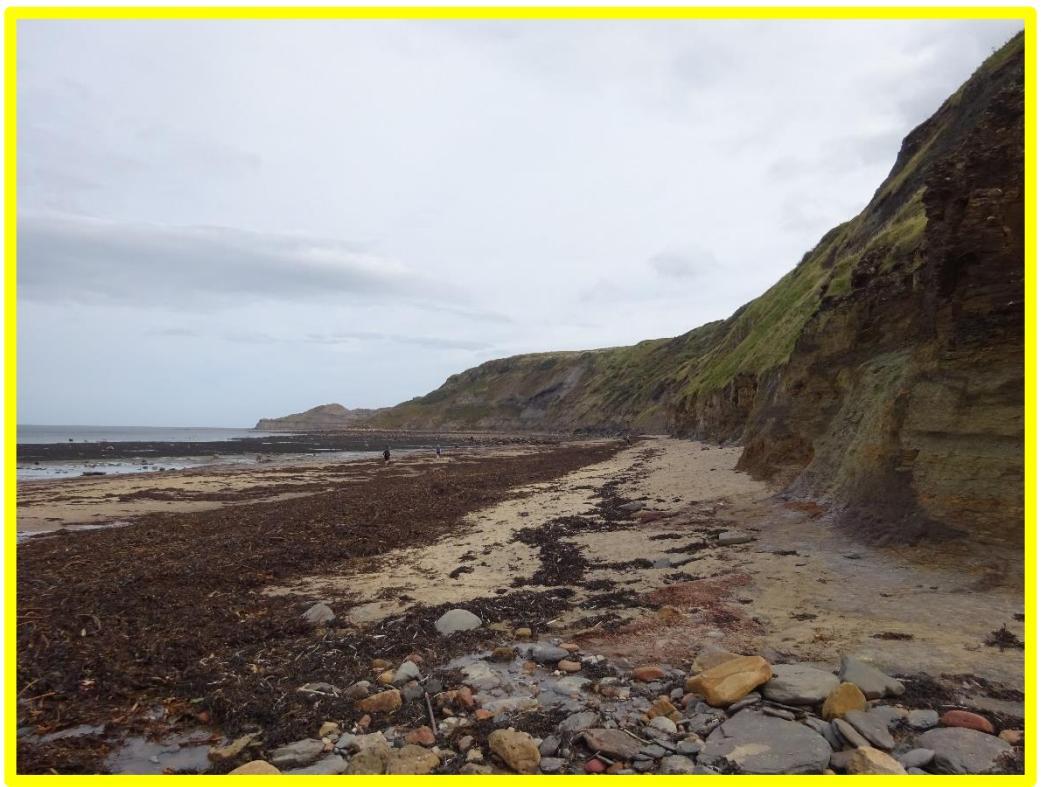
Steep mudstone cliffs with overlying shallower sloping till with local slumps. **MU8/1** Locally Active in September 2020.

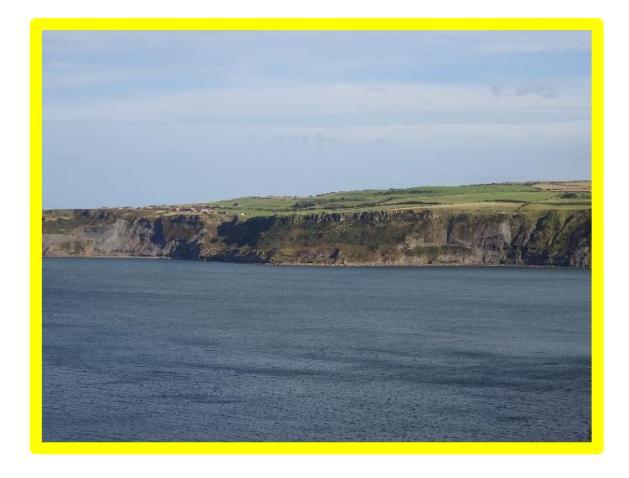
Relict debris run-out lobe. **MU8/2** Locally Active in September 2020.

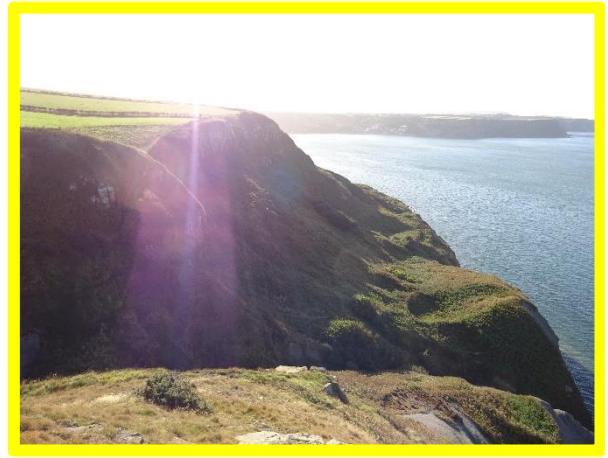
Steeper upper slopes. **MU8/2** Locally Active in September 2020

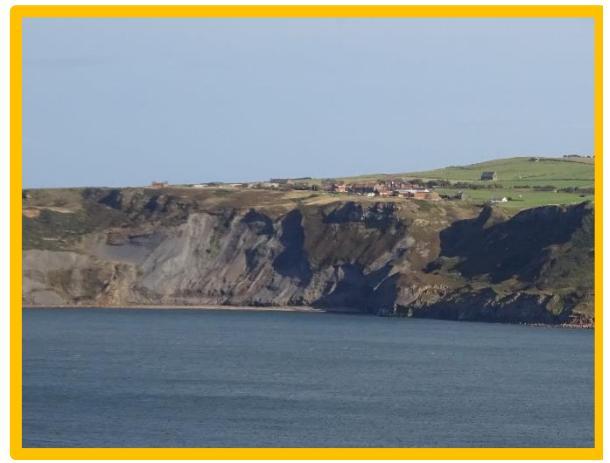
MU8/3 is located in front of the village of Kettleness. The cliff is high and steep with only the very top part covered in vegetation. The cliff slope comprises large debris flows, which extend as fans from near the cliff top to the toe, and slumps. This level of activity means this unit is classified as Partly Active, the same as 2018.

Steep cliff with debris flows. **MU8/3** Partly Active in September 2020.

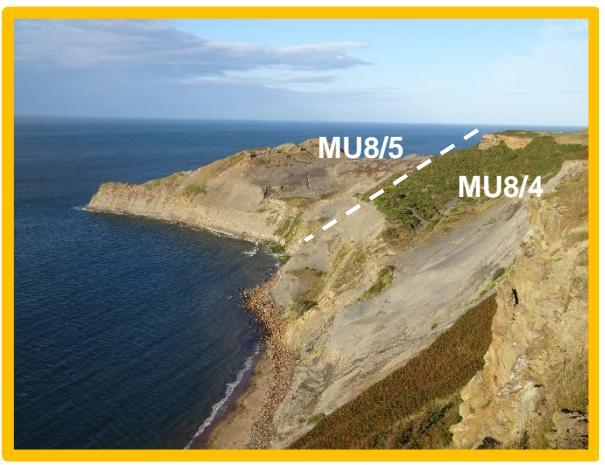
MU8/4 is immediately west of Kettle Ness headland. This unit is classified as Partly Active in 2020, unchanged since 2002.

MU8/4 (foreground) and west side of **MU8/5** (background) both Partly Active in September 2020.

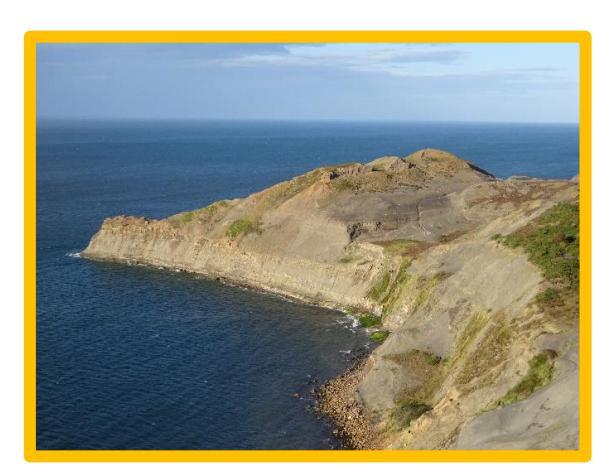
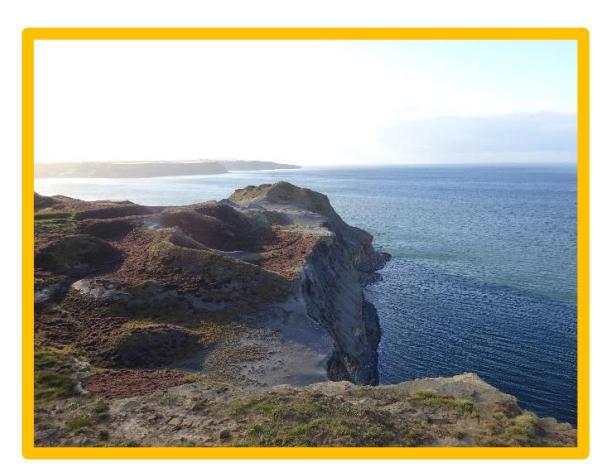
Unit MU8/5 forms the headland of Kettle Ness. This area has historically been extensively quarried for alum and as a result is now subject to ongoing erosion of the exposed weak bedrock. It remains classified as Partly Active in 2020, unchanged since 2018.

West side of Kettleness headland. **MU8/5** Partly Active in September 2020.

East side of Kettleness headland. **MU8/5** Partly Active in September 2020.

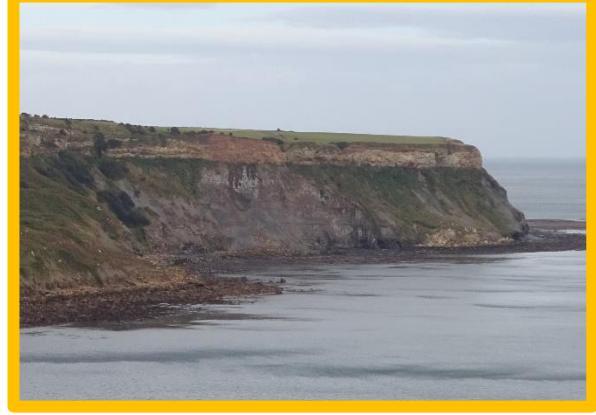
Unit MU8/6 is located to the east of the Kettle Ness headland and remains classified as Partly Active in 2020. Along most of its length this unit is steep with little vegetation cover. Evidence of recent erosion/slips were observed in the headscarp.

MU8/6 Partly Active in September 2020.

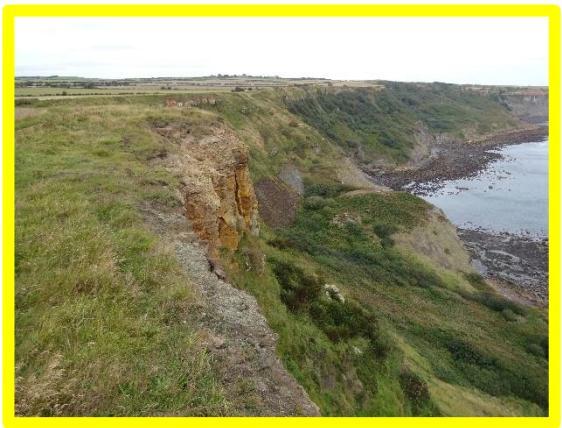
Cracking in exposed headscarp of **MU8/7**, Locally Active in September 2020.

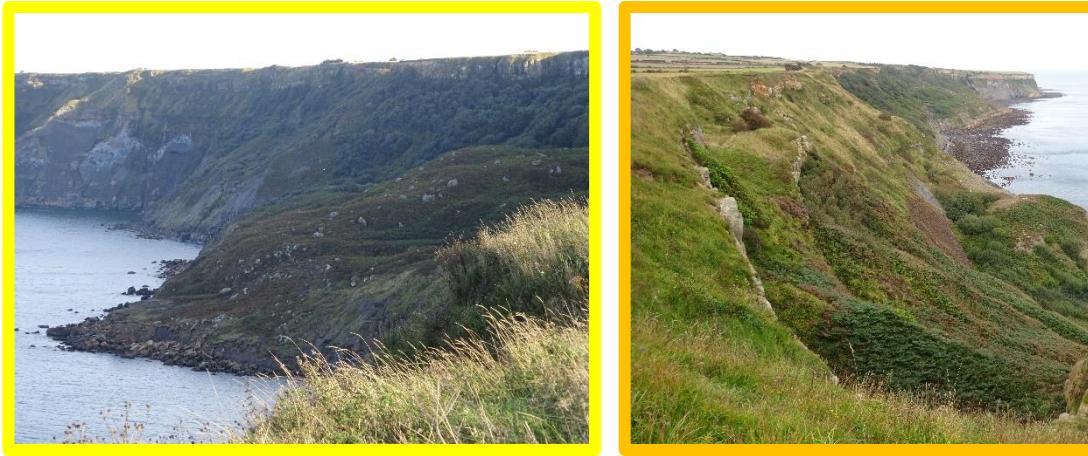
Units MU8/7 and MU8/8 comprise the relict debris run out lobes of Seaveybog Hill and Ovalgate Cliff. They are generally well-vegetated, but localised activity at the toe and headscarp mean the units are classified as Locally Active in 2020.

Unit MU8/9 is located at Loop Wyke and is classified as Partly Active in 2020. The upper slopes support extensive vegetation cover, but the lower slopes are steeper, free of vegetation and subject to on-going toe erosion. The exposed headscarp comprises exposed rock which is steep and heavily weathered.

MU8/8 Locally Active in September 2020.

MU8/9 Partly Active in September 2020.

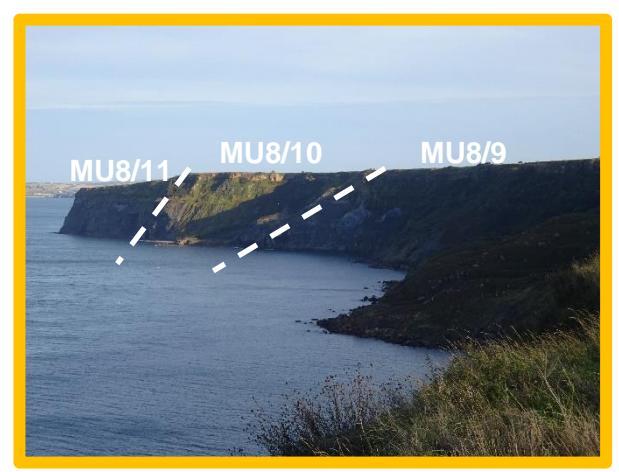
U8/9 and **MU8/11** are Partly Active sea cliffs. **MU8/10** is a debris slide deposit classified as Partly Active in September 2020.

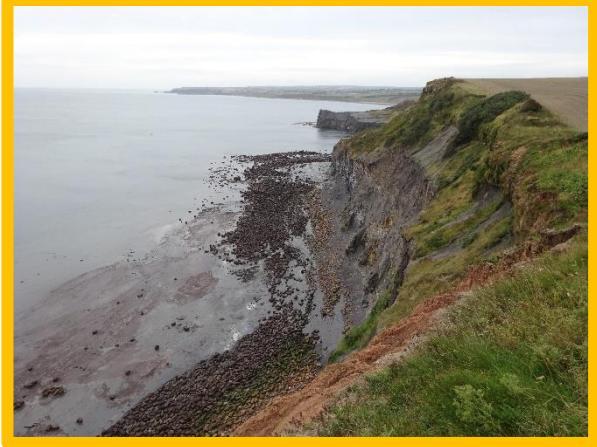
Unit MU8/12 is south of Keldhowe Steel and is classified as Partly Active in 2020. The upper slopes are vegetated, with localised areas of activity at the headscarp. The lower slopes are experiencing on-going toe erosion.

MU8/12 Partly Active in September 2020. MU8/13 Partly Active in September 2020. Evidence of recent headscarp failures.

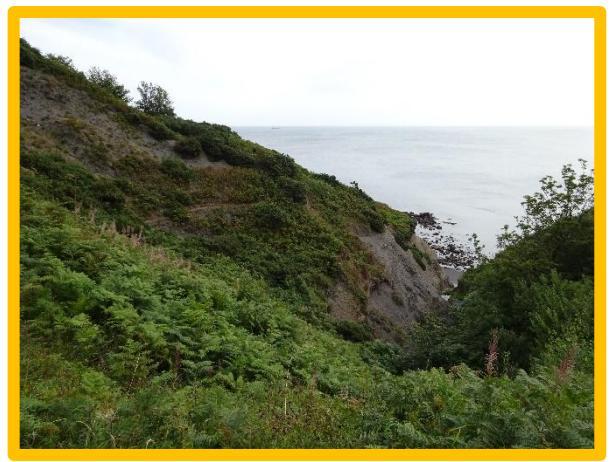
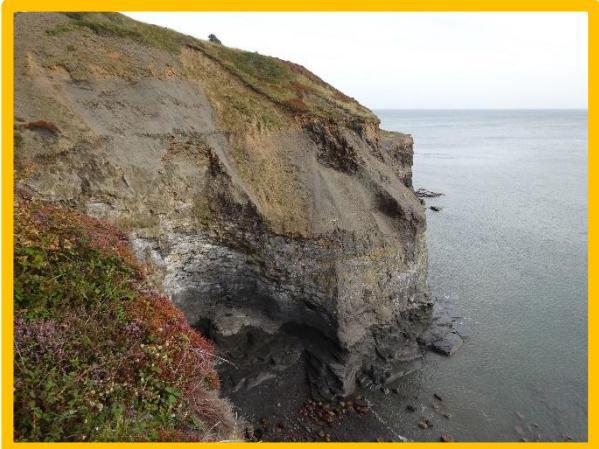
MU8/14 Partly Active in September 2020.

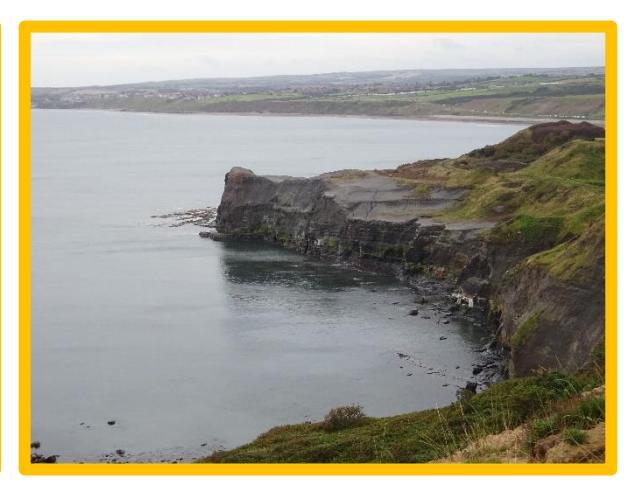
Units MU8/13, MU8/14 and MU8/15 form the headland of Sandsend Ness and its adjacent cliffs. All units remain classified as Partly Active in 2020. The toes of these cliffs are subject to ongoing erosion and there is also evidence of localised erosion on the upper slopes.

MU8/15 Partly Active in September 2020.

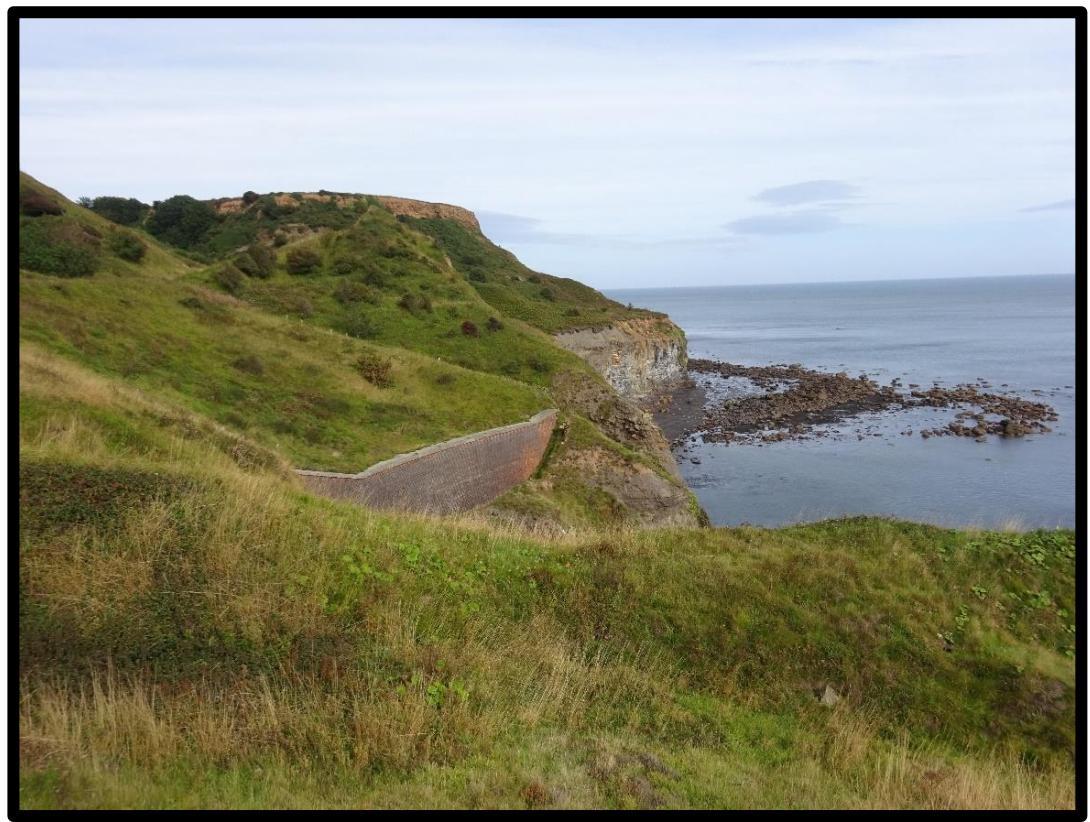
Two short lengths of retaining walls believed to have been originally intended to protect and support the disused railway line were identified along this section of coast in the 2009 inspection report. These are a brickwork wall at Deepgrove Wyke and a masonry wall south of The Scar that was noted to have failed. However, these two walls were not classed as coastal defences and were reported to be redundant in 2010, so as in all inspections since 2010, they have not been included in this inspection report. There is no safe means of access to inspect the structures in detail, however from a distance, there appears to be little change in the structures or their immediate surroundings.

Redundant masonry retaining wall in MU8/14

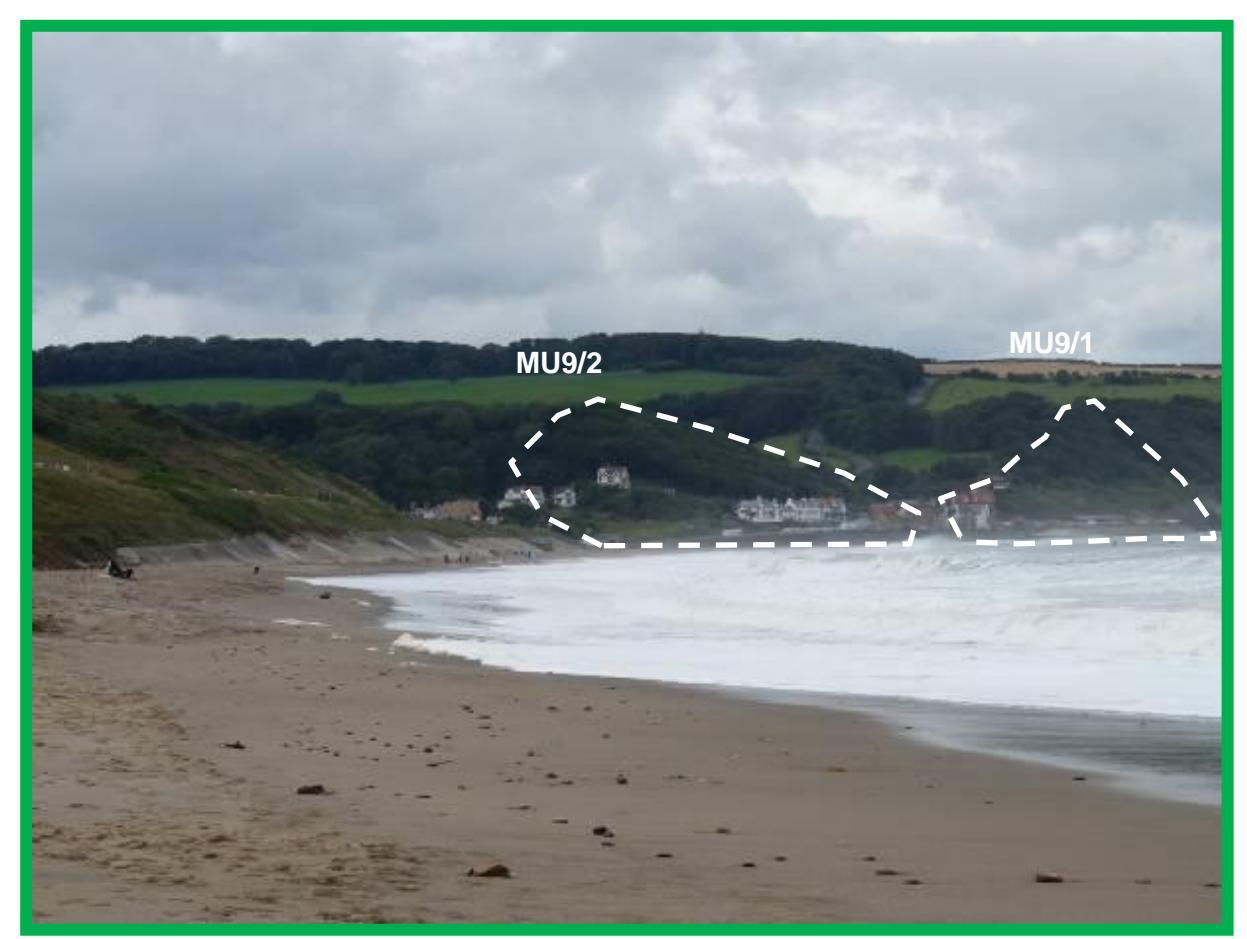
Management units MU9/1 and MU9/2 are Dormant cliffs behind Sandsend village. They are defended at the toe by a sea wall, groynes and rock armour. No evidence of activity was seen in 2020.

MU9/1 and MU9/2 are located close to Sandsend and show no signs of activity (Dormant). (Figure reproduced from August 2014)

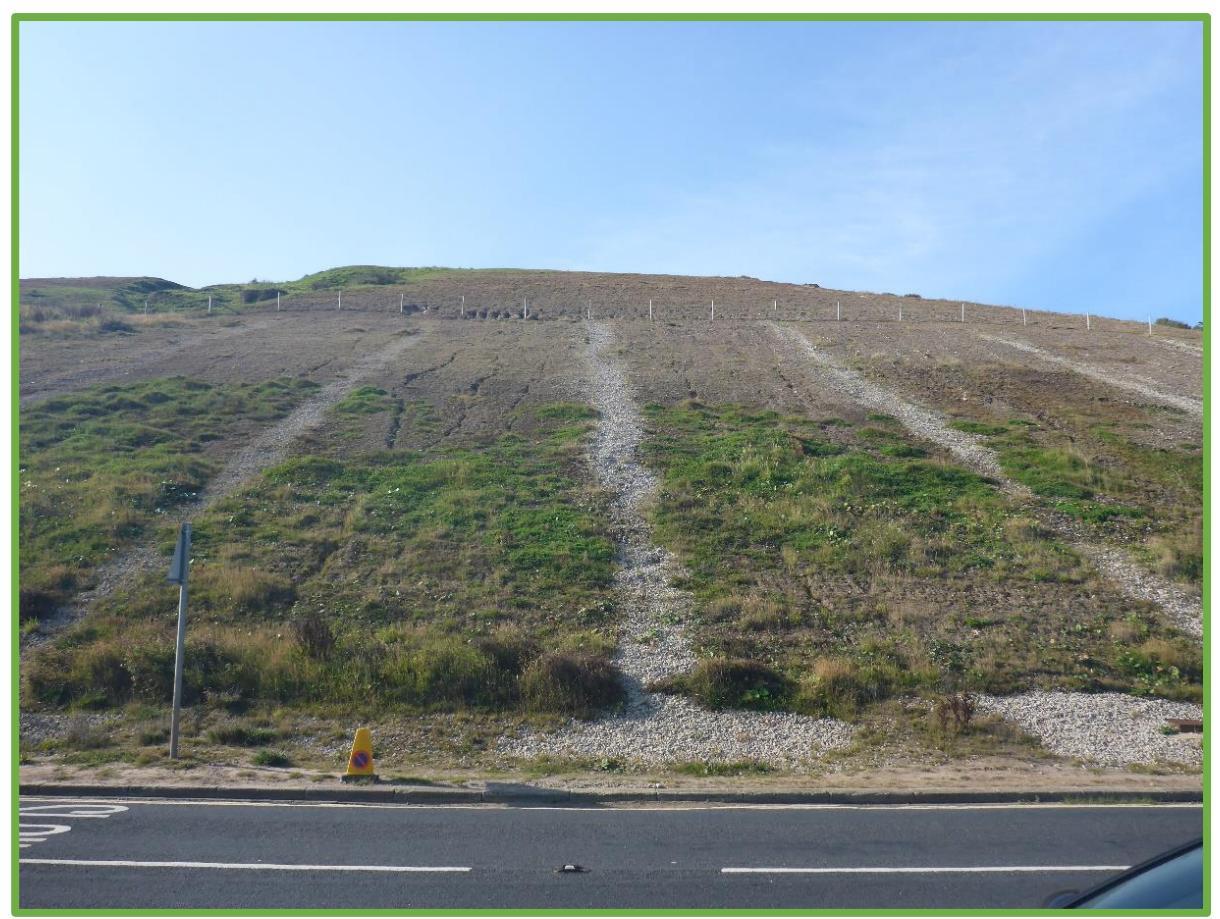
This Sub-management unit consists of unit MU9/3 only. This unit is located above the concrete revetment sea defences immediately to the east of Sandsend. The previously failing sea defences had been replaced by a new stepped concrete apron with upper Dycel units by the time of the 2016 inspections, and the backing slopes had been stabilised. The slopes had historically been subject to slippage which, at times, caused the temporary closure of the A174 Sandsend Road. The intent of the slope stabilisation works is to improve the condition of the slopes to an inactive state through means of re-grading, drainage and seeding. Overall, the stabilisation scheme is working well, and one local area of shallow slippage observed in 2018 has since been remediated.

MU9/3 Coastal slopes to rear of new sea defences generally in an inactive state following capital works involving re-grading, drainage and seeding as part of the Sandsend Road Coast Protection & Slope Stabilisation Scheme

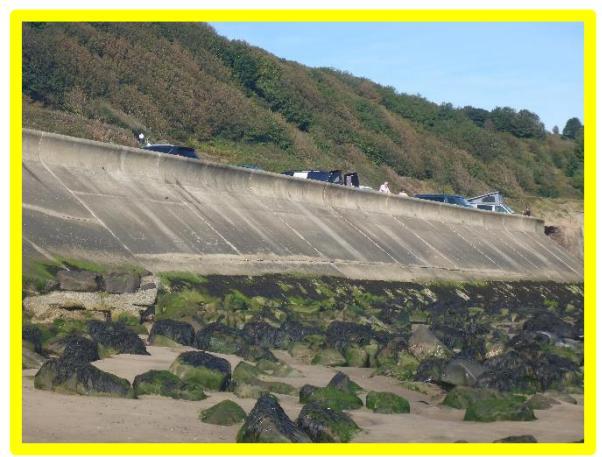
The most northerly defence is located at Sandsend car park. It is a sloping concrete revetment with a recurve crest wall (\D0701C02). The concrete wall remains in fair condition with minimal damage to the surface. At the time of the inspections there were high beach levels and marine growth covering the toe of the structure, but in previous inspections it has been recorded that the revetment has lost thickness of concrete at the base through abrasion, with exposure of reinforcement bars. Encasement of this reinforcement is advised from a structural perspective, as well as preventing any Health & Safety incidents occurring due to sharp edges of the exposed bars on this popular amenity beach. At the northern end of the structure is a tie-in section, comprised of steel sheet piling which is heavily corroded. At the southern end is a slipway adjacent to Sandsend Beck. The slipway is undermined in places, despite previous repairs at this location.

Sandsend car park sea wall (\D0701C02)

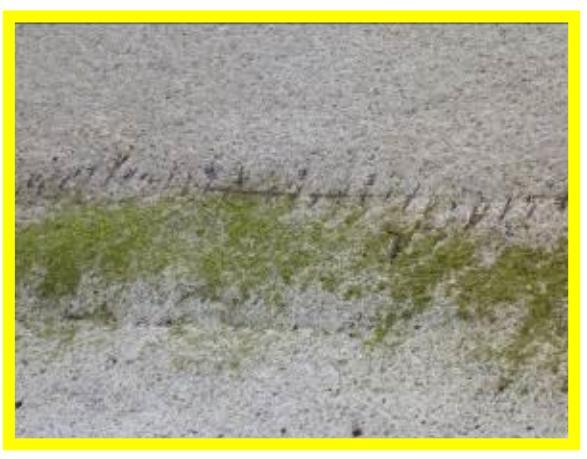
Exposed rebar evident in 2018 (but covered in 2020 by beach sand or marine growth) (\D0701C02)

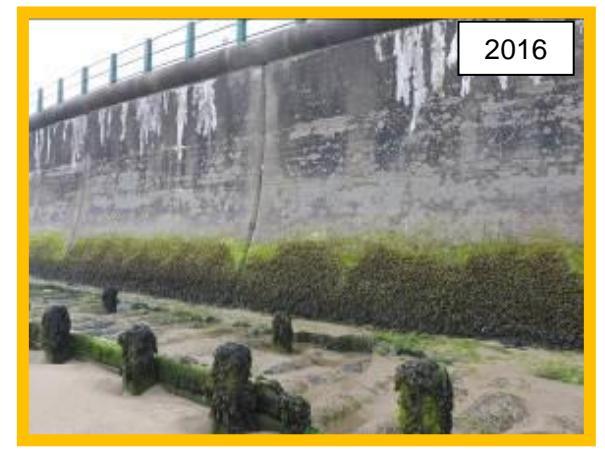
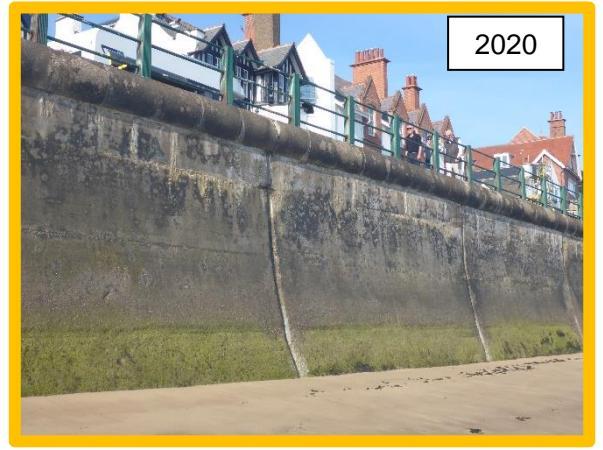
A concrete seawall (\D0702C01) extends from Sandsend Beck towards the east. The groyne field fronting the seawall is derelict and the remains have no significant impact on sand movement. The wall is heavily abraded. Whilst timber breastwork was exposed at the toe in the 2009 survey and has been observed to have progressively deteriorated since to 2016, it was covered by beach sand at the time of the 2018 and 2020 inspections. There are occasional cracks in the wall and significant abrasion at the steps.

Poor condition sea wall (\D0702C01)

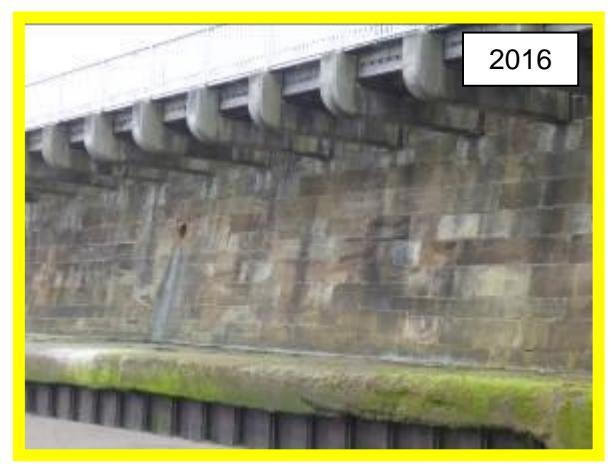
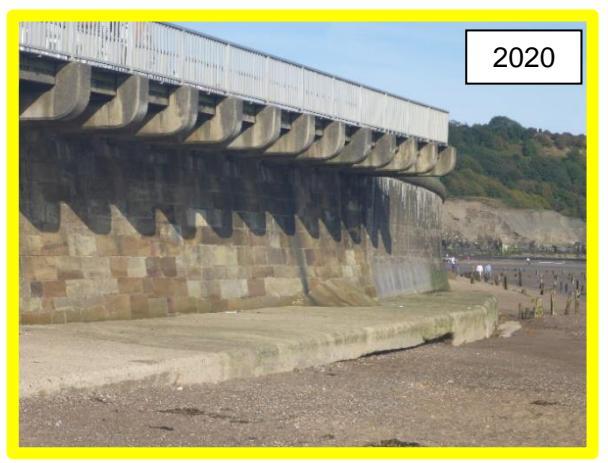
The newer short section of masonry blockwork sea wall (\D0702C04) that supports a cantilevered promenade just north of East Row Beck is in fair condition. Although the steel toe piling was observed in 2016 to be corroded and abraded, it was covered by beach sand at the time of the 2018 and 2020 inspections. Towards the eastern end, there are voids and undermining of a concrete apron which should be further investigated. The timber decking of the cantilever footway was destroyed during the December 2013 surge and repairs were made late 2014.

Masonry blockwork sea wall with cantilevered footway (\D0702C04)

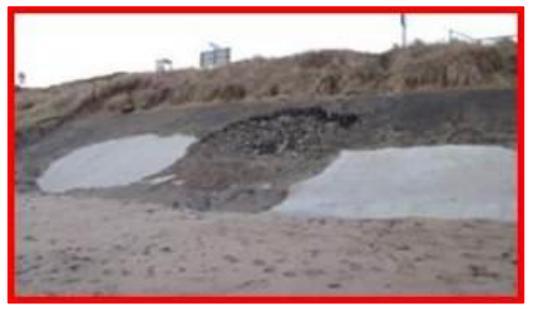
The sloping concrete revetment (\D0702C02) which used to provide the main coastal defence to the A174 Sandsend Road against erosion and overtopping was in a poor and deteriorating condition for many years and became further damage by the December 2013 storm surge, resulting in a previous grading of very poor condition in 2014, despite post-storm repairs.

Previous storm damage and very poor condition of sloping revetment

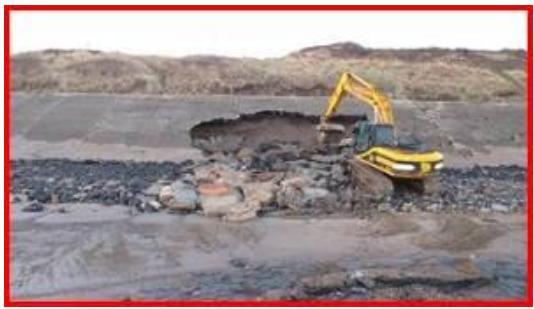
Previous temporary repairs to sloping revetment at Sandsend Road (\D0702C02)

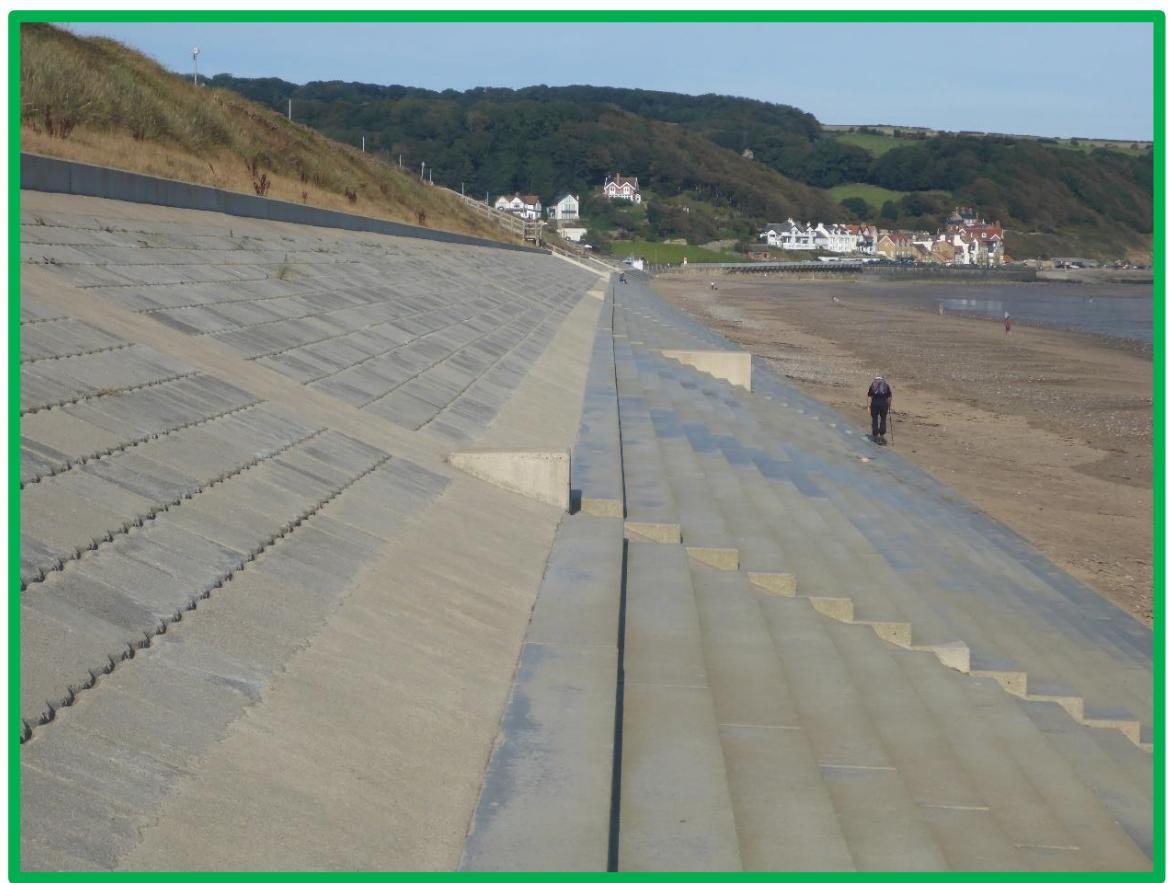
Cross section of coastal defences at Sandsend Road in near 'as built' condition showing stepped pre-cast apron and upper Dycel units (\D0702C02)

- Outfall drains are freely running
- Toe beam and lower steps are covered with beach sand
- Some chipping damage has occurred to the edge of the steps (confined to lower steps at the western end but becoming more frequent and higher up the structure to its central and southern sections).
- Outflanking at the eastern end is being adequately addressed by large beach boulders

With construction of the scheme having been completed in August 2016, the new defences remain in very good (near 'as built') condition, but with some minor (cosmetic) chipping to the step edges.

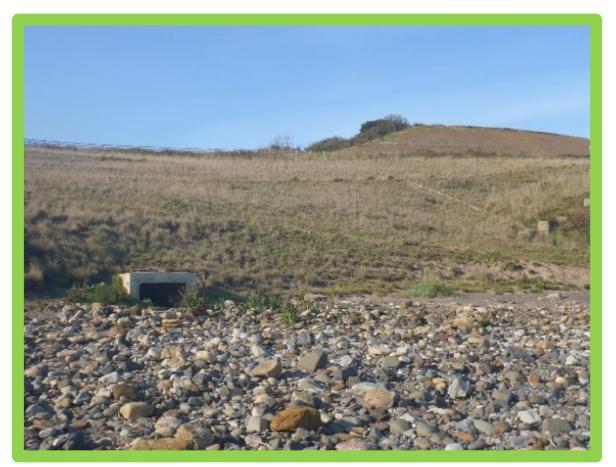
MU9/4 Infilling of Raithwaite Gill at the eastern end of the coastal slopes (Inactive)

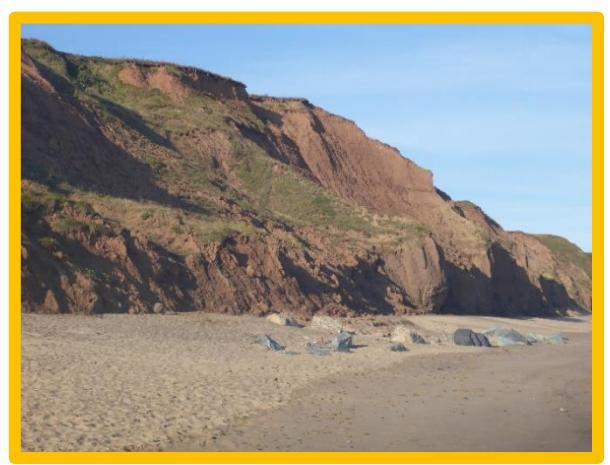
MU10/2 comprises the till cliffs behind Upgang Beach that are prone to episodic mudslides and block failures. Vegetation cover is limited along the cliff face and the unit is classified as Partly Active in 2020, unchanged since the 2005 survey.

MU10/2 Slumping cliffs along Upgang beach (Partly Active) i

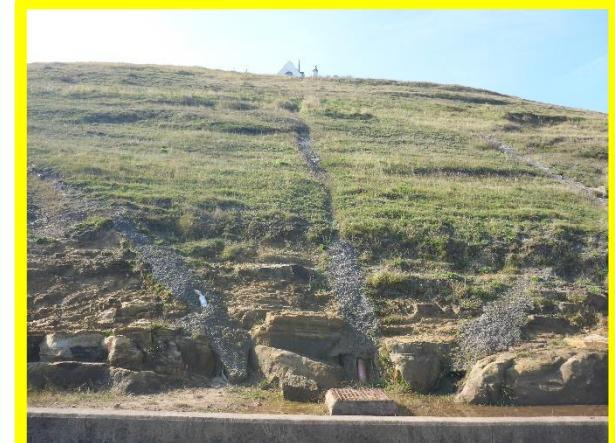
MU11/1 Cliff drainage (Locally Active)

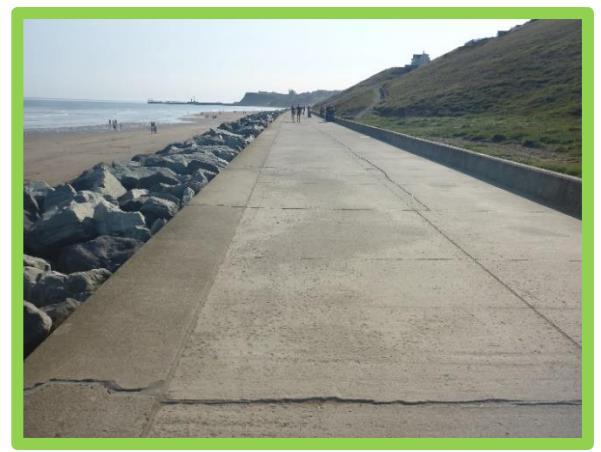
This Management Unit encompasses various sea walls and rock revetment to the west of Whitby Harbour. The most westerly defence is a rock armour revetment fronting the seawall and promenade (\D0801C01). As in previous inspections, the rock armour is in good condition with only minor movement visible. The asset is in overall good condition although the promenade is rated as fair despite areas of repairs, due to previous longitudinal cracking. There is also local damage to the wall to the rear of the promenade.

Rock revetment, promenade and coastal slopes of Whitby West Cliff (\D0801C01)

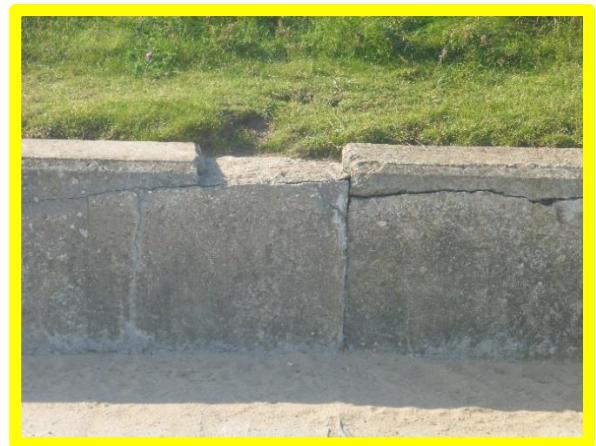
Damage to low wall at rear of promenade (\D0801C01)

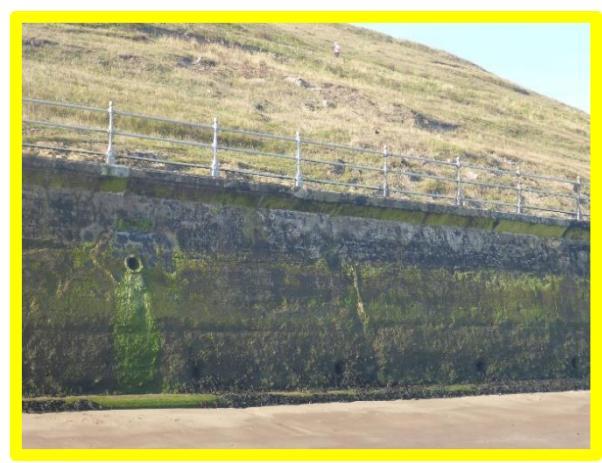
There are two sections of seawall along the frontage with no protective rock armour. One occupies a short gap between the two areas of rock armour, whilst the other is to the east, backed by beach chalets on the promenade. Both sections have experienced considerable abrasion damage to the face. Due to the absence of rock armour, the toe at both sections has also been subject to undercutting. Recent repairs (prior to the 2016 inspection) appear to have cast a new concrete toe over much of the affected sections, but their overall condition remains poor and there are short lengths adjacent to where the new toe ends where boulders and rock outcrops are present and the original toe is still being undercut (although this was not observed in 2020 due to high beach levels). There is also local damage (cracking and abrasion) to the wall coping beam and at each set of access steps along these lengths with no protective rock armour.

Seawall at gap in rock armour revetment (\D0802C01)

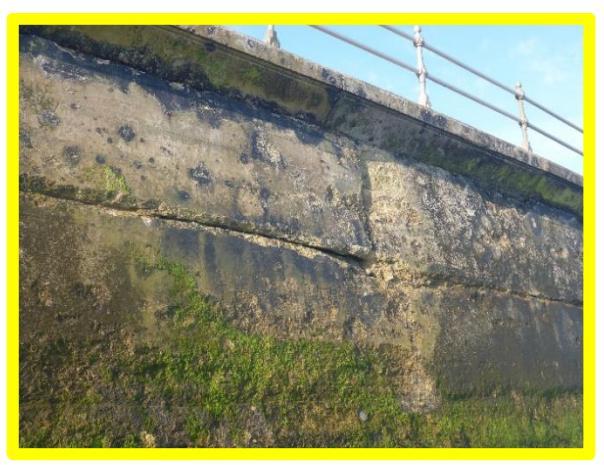
East of the beach chalets the steps and ramps show signs of repairs but are generally in poor overall condition with defects such as undercutting, erosion, cracking, exposure of aggregate and rounding of step edges. In general, all sections of sea wall between the eastern end of the rock revetment and the Whitby Pavilion show extensive damage to the coping and abrasion to the face and are in overall poor condition.

Seawall to east of rock armour revetment (\D0802C01)
