Cell 1 Regional Coastal Monitoring Programme Walkover Inspection Surveys 2020

Scarborough Borough Council

November 2020

Walkover Inspection Surveys 2020

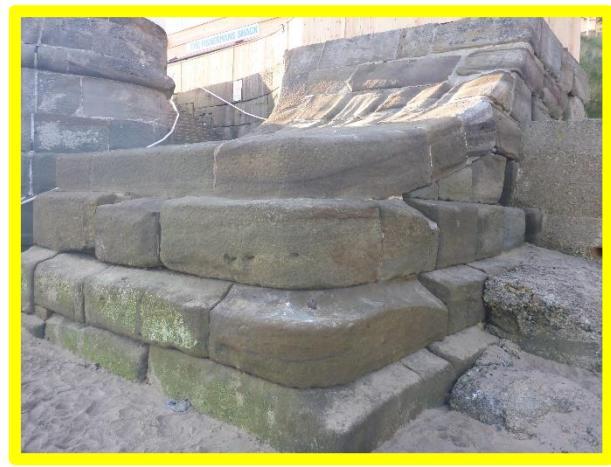
The Battery Wall, just west of Whitby West Pier, is formed of large sandstone blocks. Although repairs to some gaps between blocks are evident, further repairs are deemed advisable pro-active measures, especially at the wing wall of the access steps to the beach. Despite this, the asset remains in overall fair condition.

Open joints in wing wall to access steps (\D0802C12)

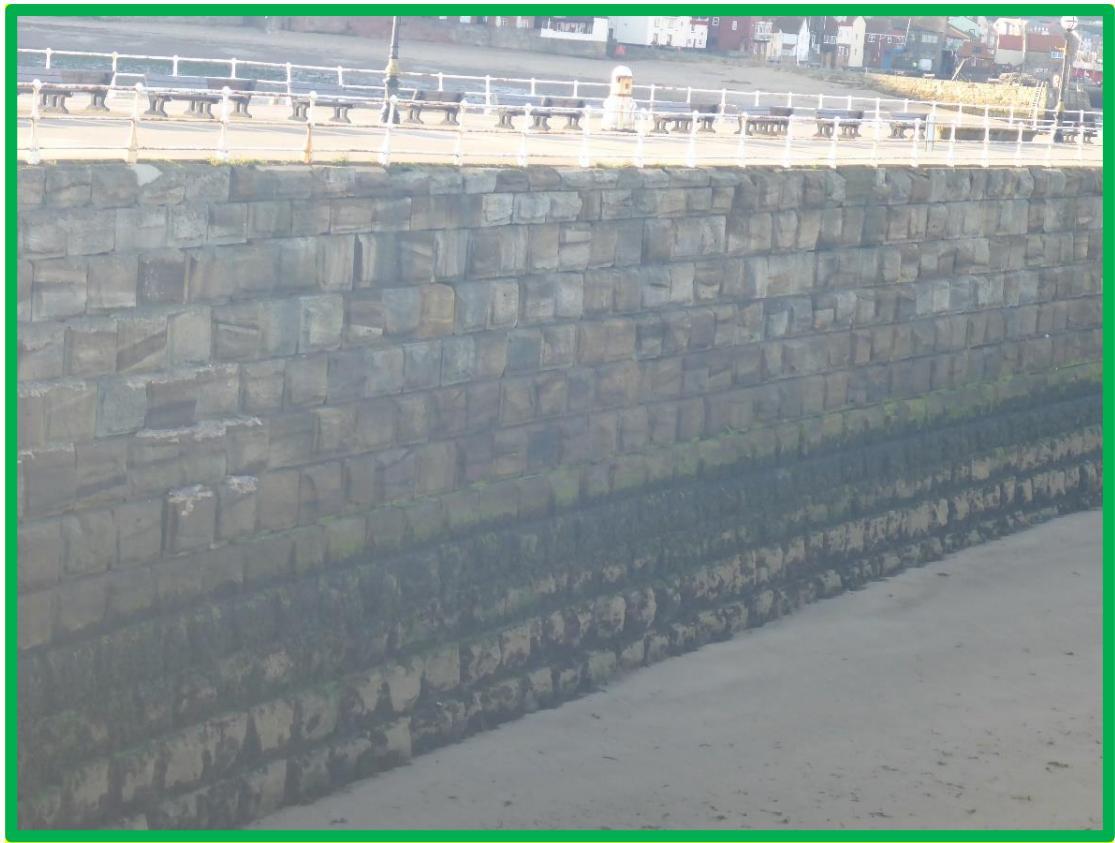
The piers have each been classified as very good following the 2018/19 capital refurbishment works which have rectified many previously identified defects. There are new chain link barriers that can be erected overtopping conditions persist on both piers, and signs on the East Pier warning the public of risks from high winds, sea states (overtopping), uneven surface, trips, and falls from unguarded edges. A new wave run-up deflector wall has been constructed at the top of the Battery Parade slipway, adjacent to the West Pier.

West Pier, very good condition following capital works (\803C02)

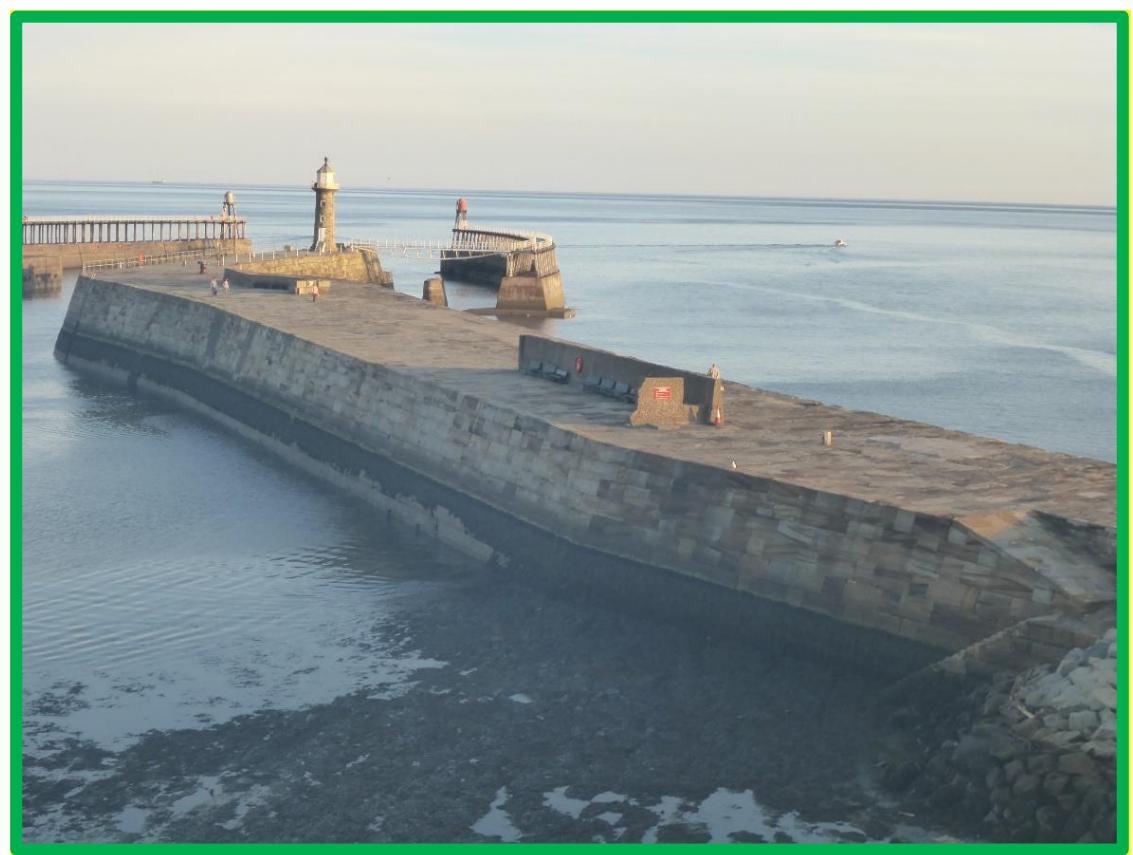
East Pier, very good condition following capital works (\803C02)

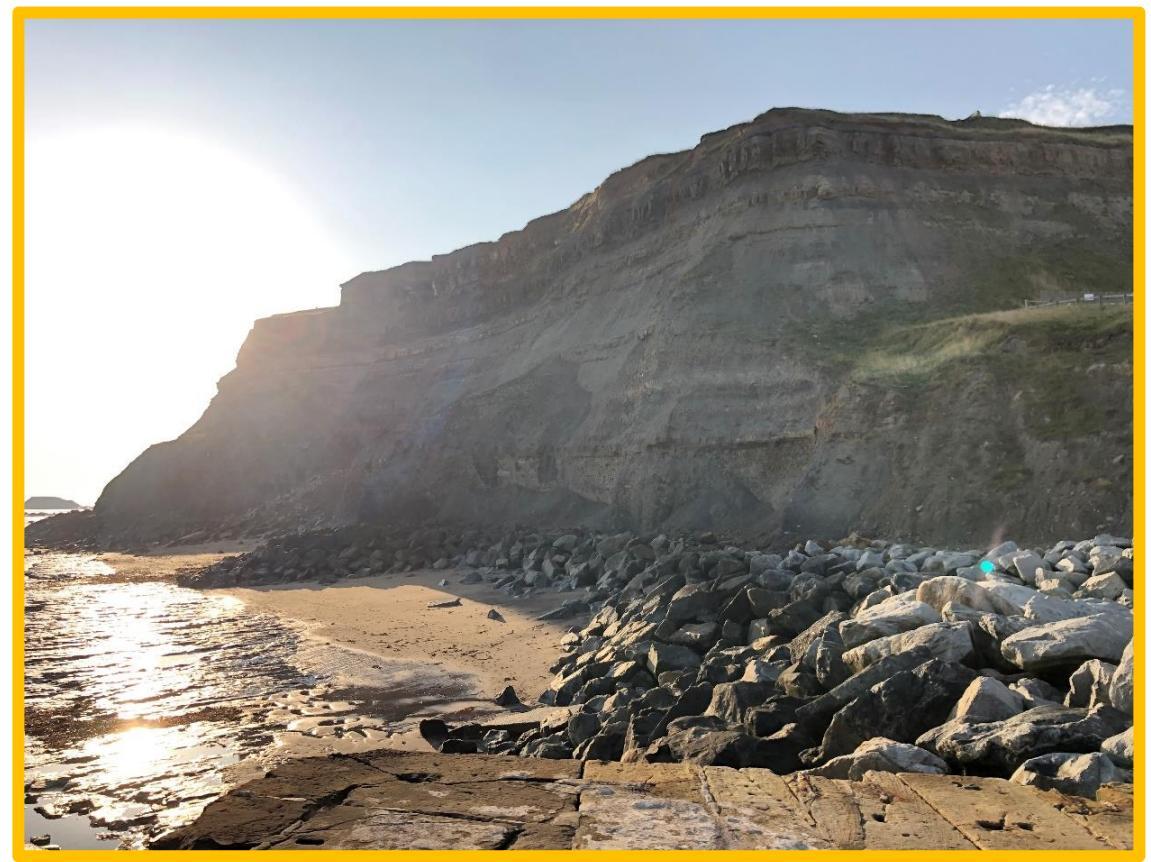
Unit **MU12/2** comprises high cliffs protected by rock armour. There is evidence of a past rockfalls from the upper part of the cliff in the form of debris slopes and almost the entire cliff face is exposed, with very little vegetation cover. The cliffs therefore remain classified as Partly Active.

MU12/2 Cliffs east of Whitby (Partly Active)

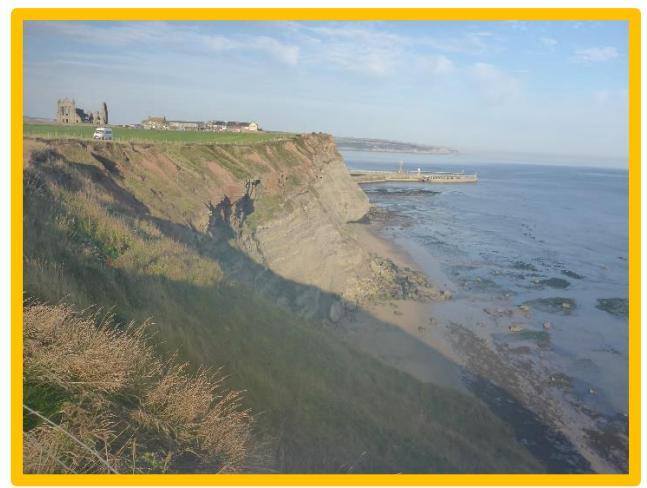
Unit MU13/1 is located immediately east of Whitby and is again classified as Partly Active in 2020. The lower slopes are almost entirely exposed and are subject to marine erosion. The upper slopes are actively retreating through periodic rockfalls. Erosion of the upper slopes is encroaching on the coastal path in several areas and as a result the ongoing diversion of the coastal path is evident. It is recommended that the footpath is again diverted around pinch point sections where there is now no buffer from the coastal footpath to the cliff top (photograph below).

MU13/1 Cliffs east of Whitby (Partly Active)

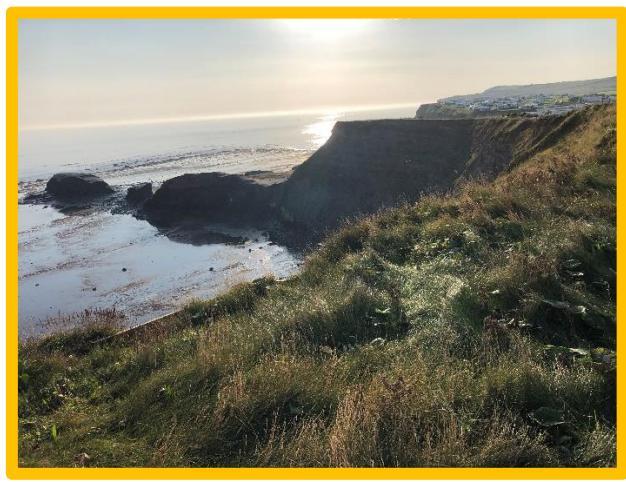
Unit MU13/2 comprises the eroded headland of Saltwick Nab. This unit is continuing to actively erode and supports little vegetation cover. Riling and gullying are evident on the exposed faces. As a result, this unit remains classified as Partly Active in 2020.

MU13/2 Saltwick Nab (Partly Active)

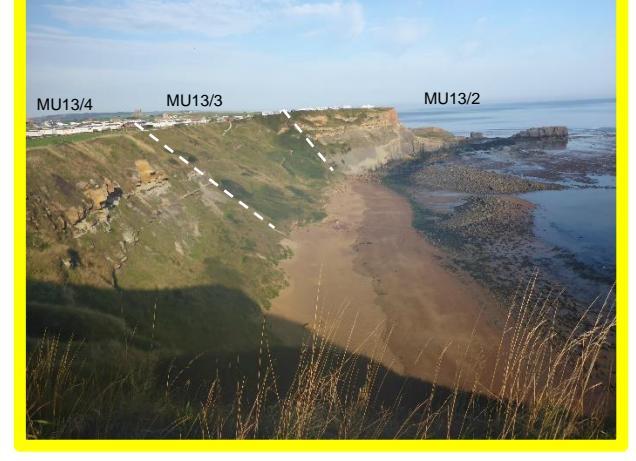
The cliffs within **unit MU13/3** are located within Saltwick Bay and contain access onto the beach. The cliffs in this section are protected to some extent from marine action by the high stable beach. As a result, the unit is generally less active and well vegetated and as a resulted is classified as Locally Active.

MU13/3 Saltwick Bay (Locally Active)

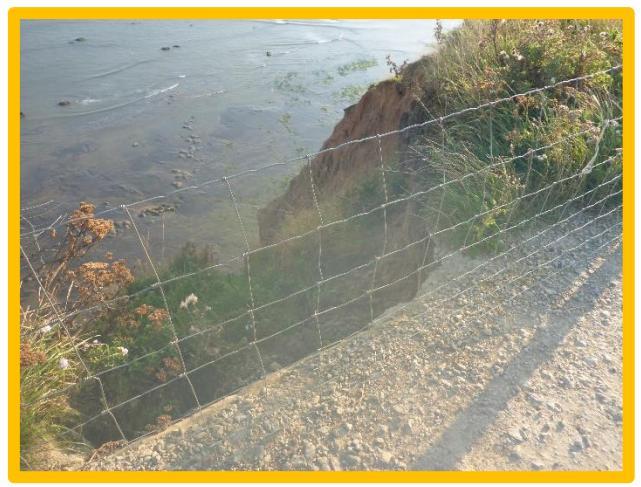
MU13/1 Cliff erosion encroaching coastal path (Partly Active)

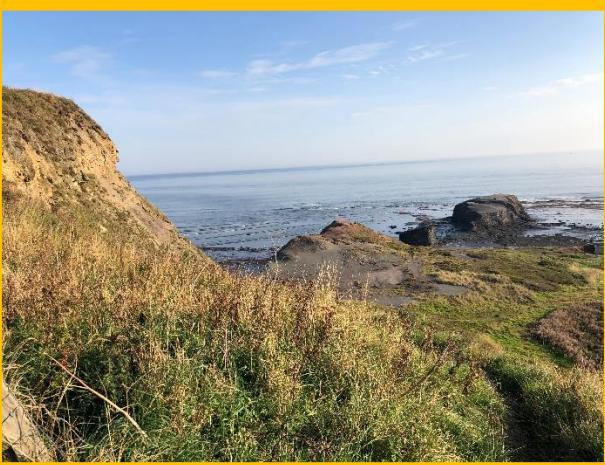
MU13/2 Saltwick Nab (Partly Active)

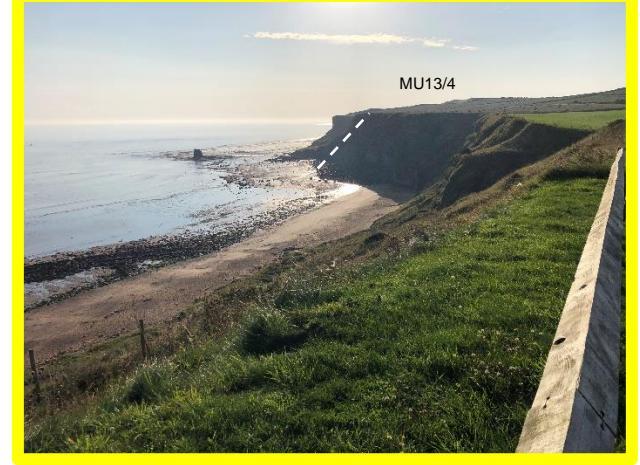
MU13/4 East of Saltwick Bay (Locally Active)

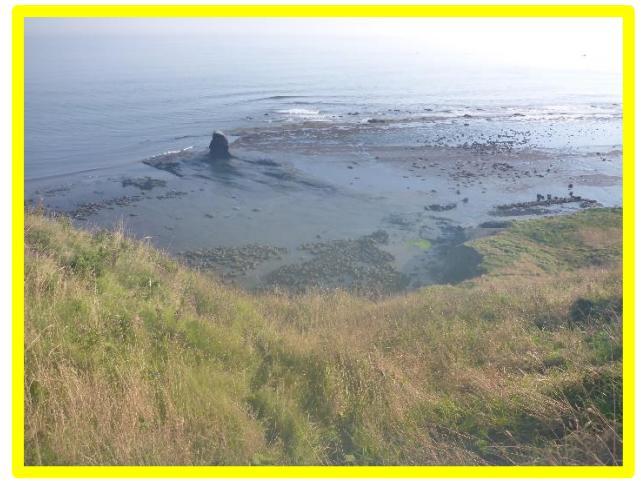
MU 13/5 Black Nab (Locally Active)

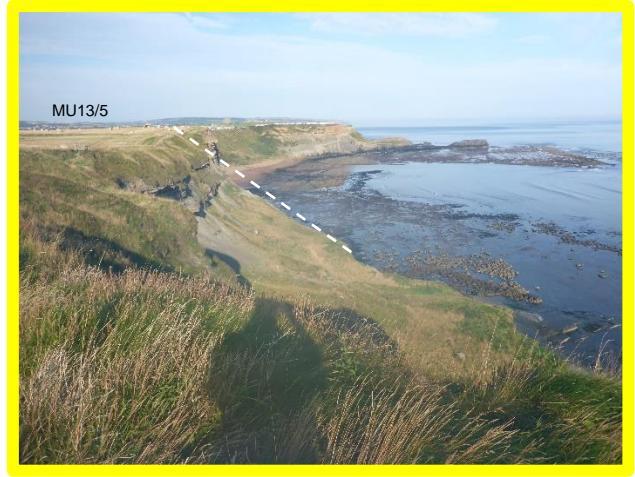
MU13/5 Vegetation covering majority of debris lobe at Black Nab (Locally Active)

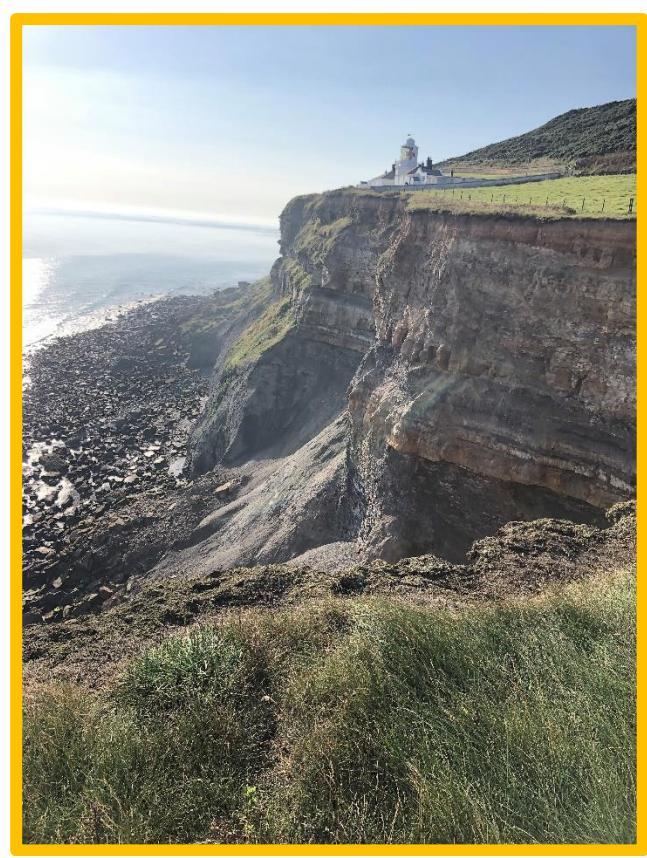
MU 13/6 Unvegetated eroding cliffs at Whitby Lighthouse (Partly Active)

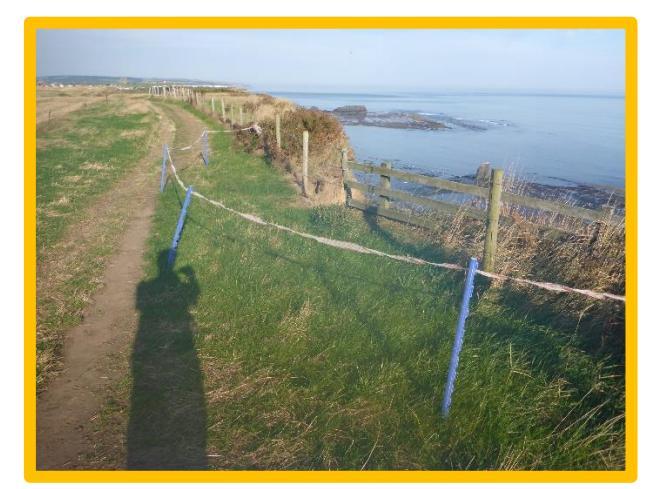
MU13/6 Recent slump encroaching coastal path with temporary fencing present. (Partly Active)

Unit MU13/6 is a long, steep-faced unit near the Whitby Fog Signal and the Lighthouse. The slopes are largely exposed with evidence of rockfalls from the upper cliff. There are also signs of ongoing weathering and marine erosion of the lower layers. This is particular apparent to the North of the lighthouse. This unit remains classified as Partly Active in 2020. It was noted erosion of the upper slopes is encroaching on the coastal path in one area with temporary fencing present. It recommended that this diversion is formalised.

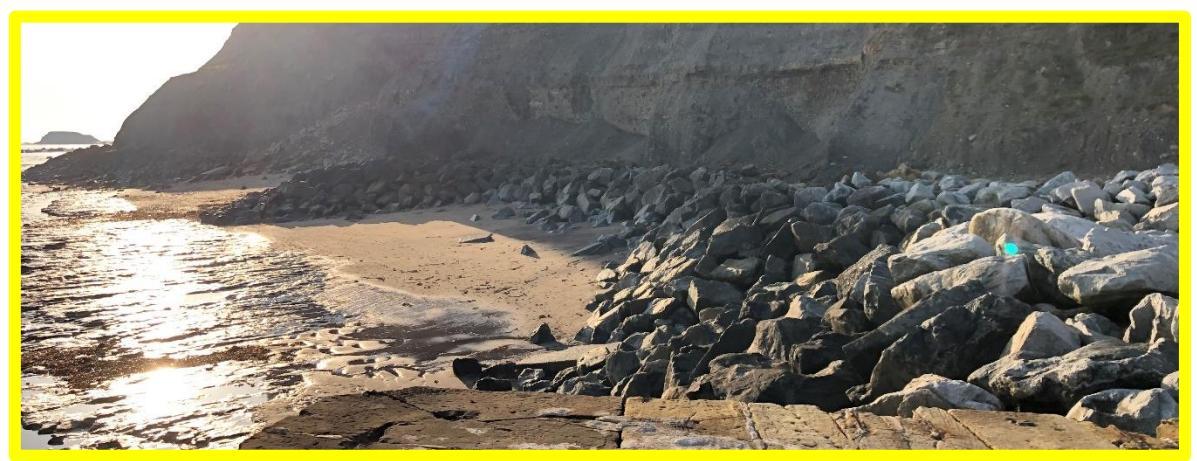
There is a section of rock armour giving protection to the toe of Abbey Cliff directly to the east of Whitby Harbour's East Pier. The rock armour varies in size from 1-4 tonnes to 5-8 tonnes. It remains in fair overall condition in 2020.

Rock armour protection to toe of Abbey Cliff (\803C06)

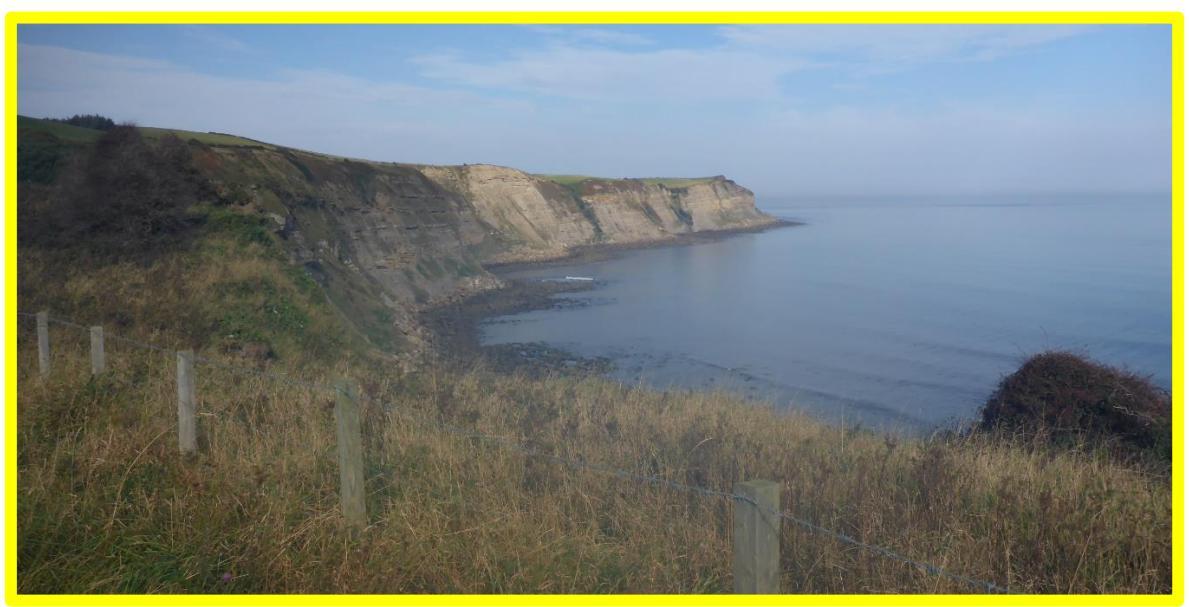
The only unit within this Management Unit is **MU14/1**. The slopes are generally steep and partly vegetated. Small areas of erosion are evident, particular in the upper till layers, despite this the cliffs appear stable. The tension cracks, at the foot of timber steps south of Whitby Lighthouse, noticed in the 2018 inspection were concealed by vegetation growth in 2020. The cliffs within this unit remain classified as Locally Active.

MU14/1 Looking North - Vegetation growing locally on face of cliff (Locally Active)

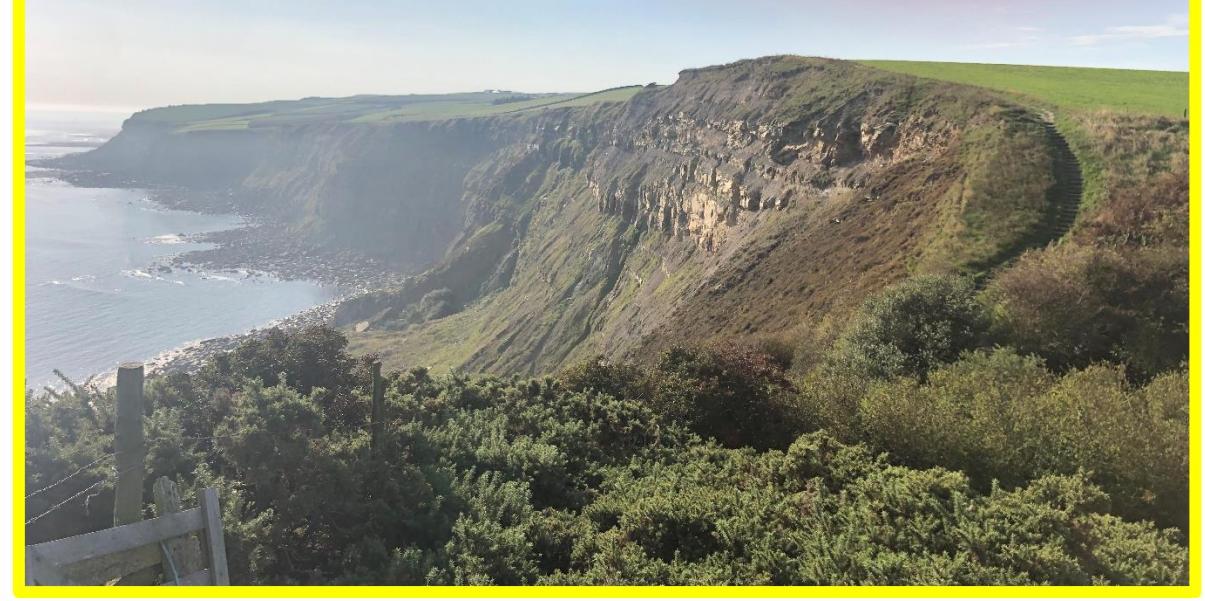
MU14/1 Stable cliffs, upper slopes and debris aprons generally vegetated (Locally Active)

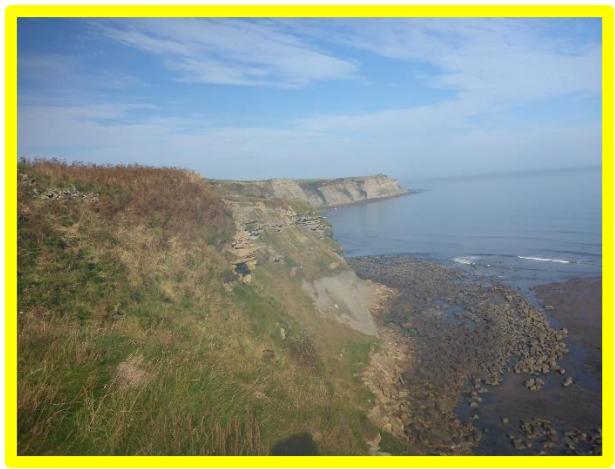
MU15/1 Vegetated slopes at cliff top (Locally Active)

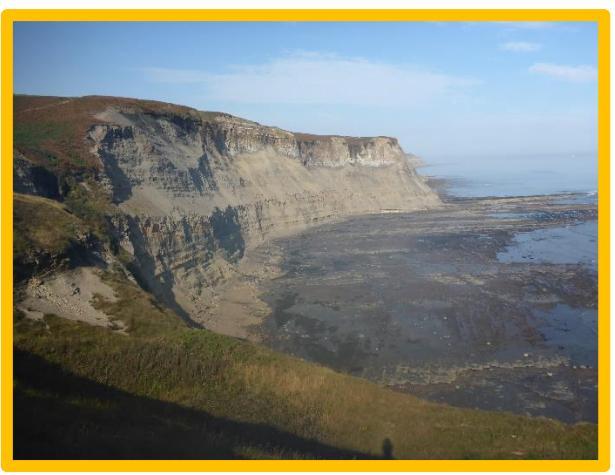
Unit MU15/2 is located at Far Jetticks. This cliff has widespread activity, with ongoing marine erosion evident at the toe and localised activity on the cliff face. It remains classified as Partly Active in 2020. A series of arcuate tension cracks were observed during the 2014 inspections (and seen during the subsequent inspections including 2020) on the cliff top at grid reference 495076 507274, indicating an incipient failure that poses a hazard to walkers on the Cleveland Way. The site has previously been brought to the attention of Scarborough Borough Council who have informed the North York Moors National Park Authority. It appears the tension cracks have not significant worsened since 2018, demonstrated in the comparison photos below. Tension cracks were also observed adjacent to the coastal footpath to the south of Far Jetticks and should be monitored.

MU15/2 Ongoing erosion at Far Jetticks (Partly Active)

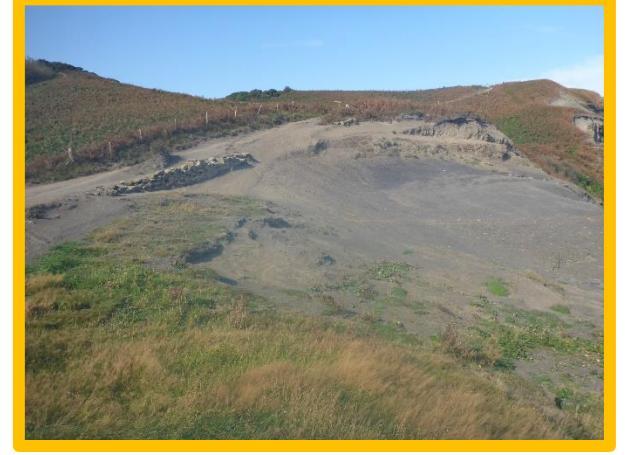
MU15/2 Local erosion at northern part of unit, vegetated upper slope (Locally Active)

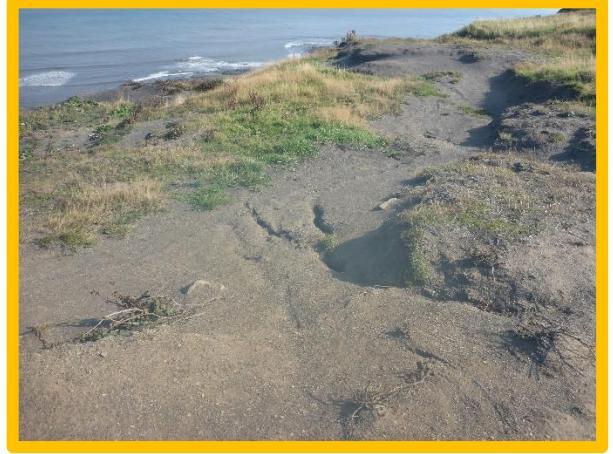
MU15/2 Tension cracks on access path to the south of Far Jetticks

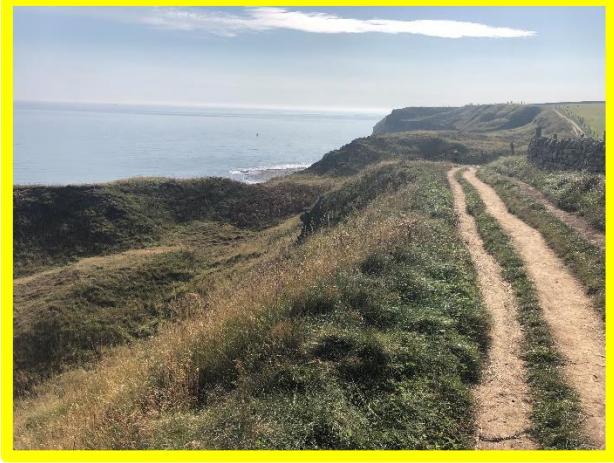
Unit MU15/3 is largely comprised of the headland of Bay Ness, north of Robin Hood's Bay. The cliffs are high and steep and composed mainly of sandstone overlain by a thin cap of glacial till. There is evidence of debris fans in the lower half of the cliff face with localised slumping of the head scarp cut into the till. Several exposed head scarps are going to potentially undermine the Cleveland Way. This unit was downgraded from Partly Active to Locally Active in 2014 and remains classified as Locally Active in 2020.

MU15/3 Vegetated slopes at cliff top (Locally Active)

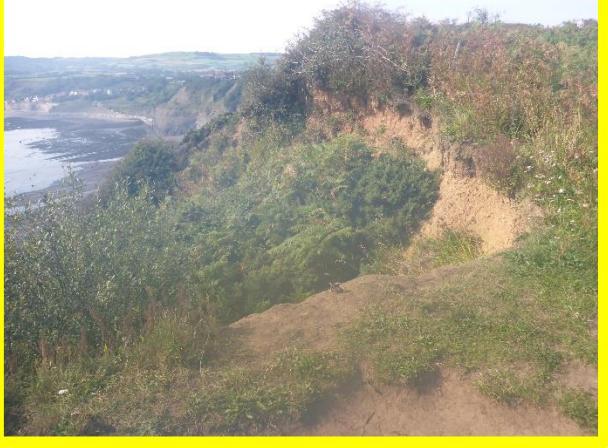
Just north of Robin Hood's Bay village is **Unit MU15/4**, which has a similar geomorphology to MU15/3, although the till cap appears to be less active than further north. A loose debris apron is present locally at the toe of the cliffs towards the south of the unit. This unit remains classified as Locally Active in 2020.

MU15/4 Local slumping of headscarp adjacent coastal path (Locally Active)

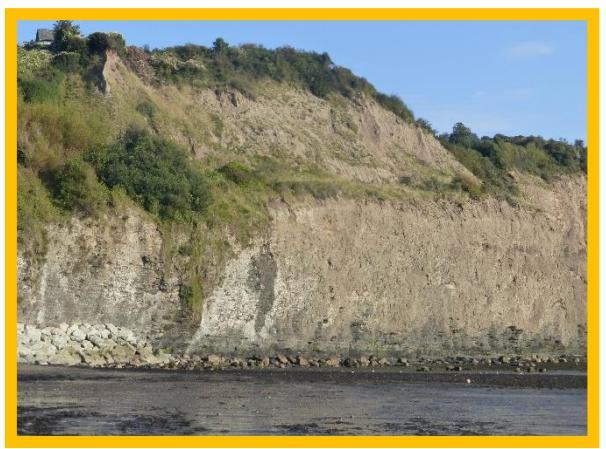
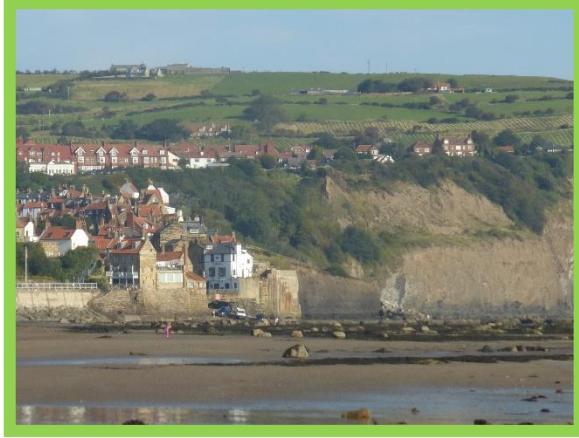
Unit MU16/1 is the composite cliff complex fronting the northern part of Robin Hood's Bay village and is classified as Partly Active in 2020, no change from 2014. The cliff comprises a near-vertical lower cliff of mainly sandstone overlain by shallower sloping heavily vegetated glacial till with evidence of slumping and recession of the head scarp.

Units MU16/2 is a stabilised landslide that forms the southern part of Robin Hood's Bay village. There is little evidence of any activity and so it remains classified as Inactive in 2018. MU16/3 protected by sea defences retains its Dormant status in 2020.

MU16/1 Sandstone cliff overlain by shallow till MU16/2 Stabilised landslide (Inactive) (Partly Active)

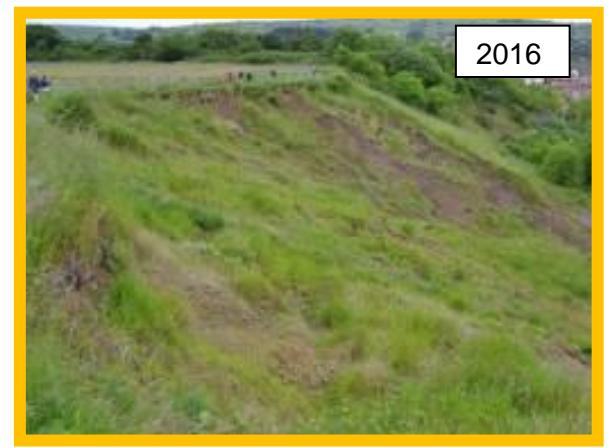
Unit MU17/2 comprises glacial till cliffs to beach level protected by rock armour at their toe. The slopes are vegetated however the levels of activity on the cliff face has increased since the 2016 survey. Generally, the flatter mid-slope is well vegetated whilst the headscarp and toe are exposed with extensive evidence of recent slumping. This unit remains classified as Partly Active in 2020, due to widespread evidence of instability. During the 2020 survey it was noted that the Cleveland Way footpath continues to be undermined along the headscarp of the management unit. This has led to multiple sections of the footpath being lost through landslip. Temporary diversions are in place with flexible jointed plastic matting replacing the stone flagstones which have fallen down the face of the cliff.

Head scarp of **MU17/2** (Partly Active in June 2016)

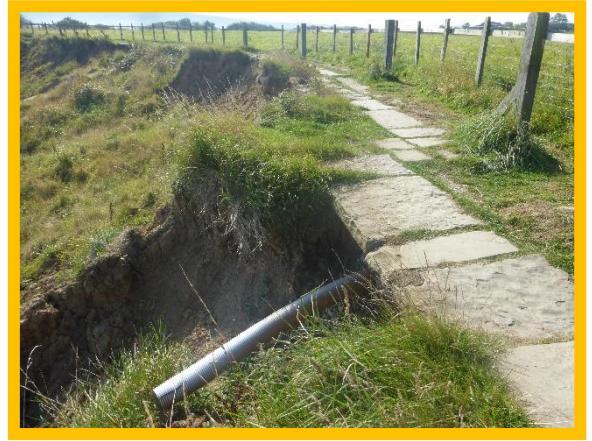
MU17/2 Undermined Cleveland Way footpath route and temporary diversion (Partly Active).

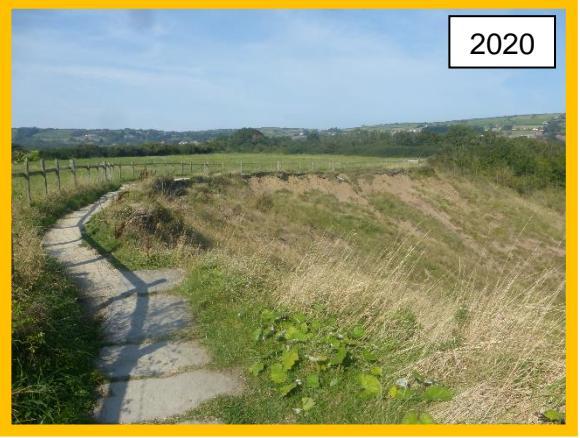
MU17/2 Undermined Cleveland Way footpath route and temporary diversion (Partly Active).

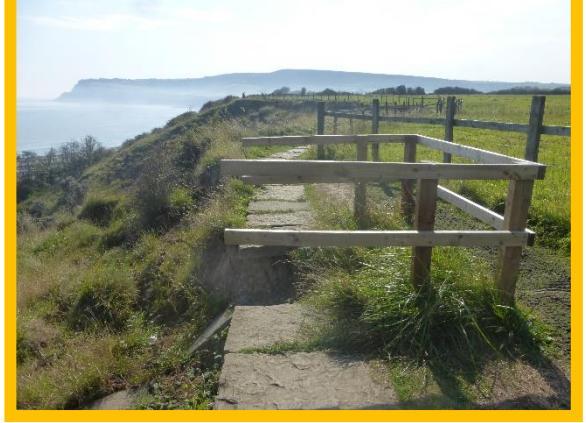
MU17/2 Undermined Cleveland Way footpath route and temporary diversion (Partly Active).

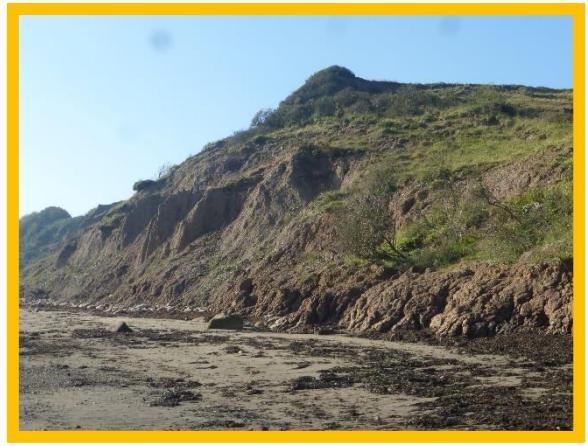
Toe of **MU17/2** showing ongoing slumping (Partly Active).

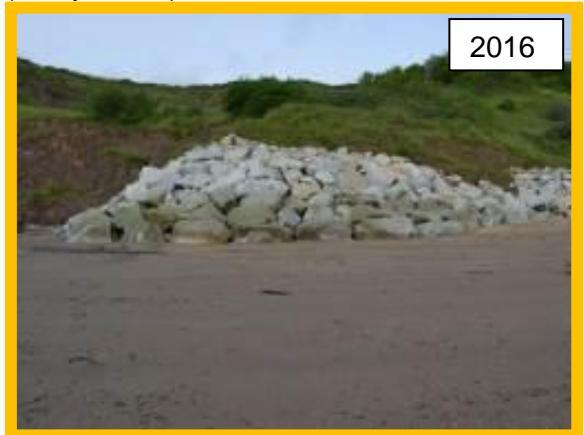
Protected toe of till cliffs in Robin Hood's Bay. **MU17/2** (Partly Active in June 2016)

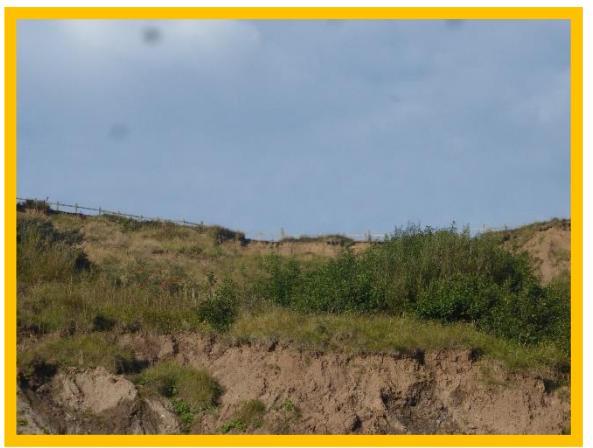
Looking towards headscarp of **MU17/2** note slumping on mid slope (Partly Active).

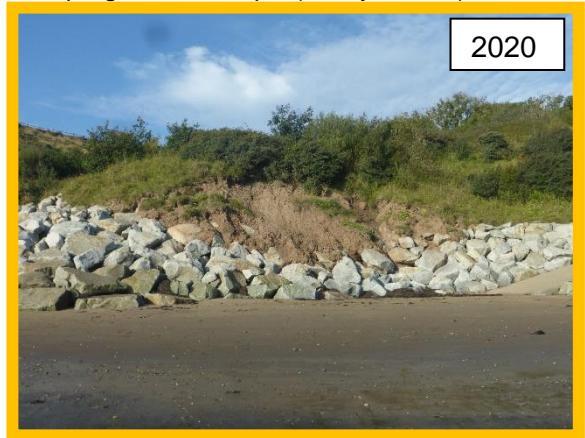
Slumped toe of till cliffs behind revetment. **MU17/2** (Partly Active)

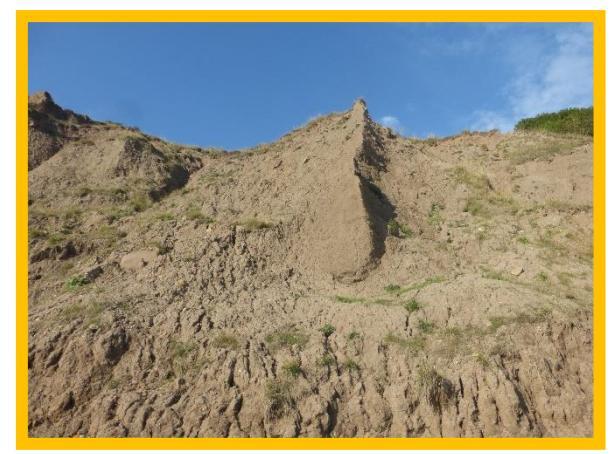
Further south, within unit MU17/3, defences are absent, and the cliffs are active. There is massive slumping at beach level and in the mid to upper slopes. This unit is classified as Partly Active in 2020, no change from 2014.

Active toe of till cliffs in Robin Hood's Bay. **MU17/3** (Partly Active)

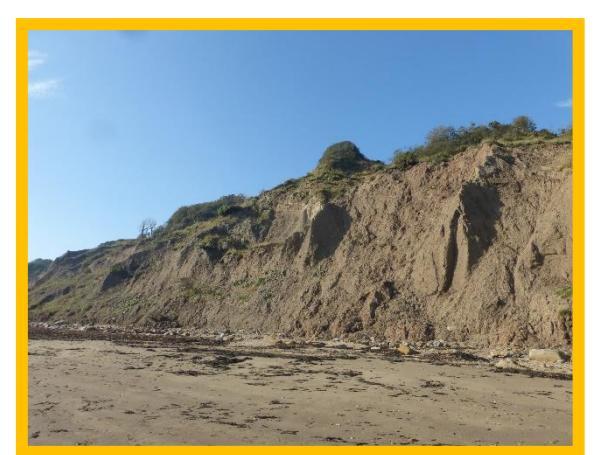
Active toe of till cliffs in Robin Hood's Bay. **MU17/3** (Partly Active)

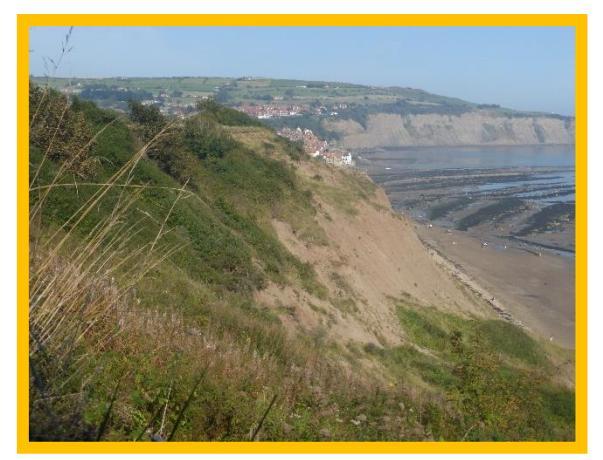
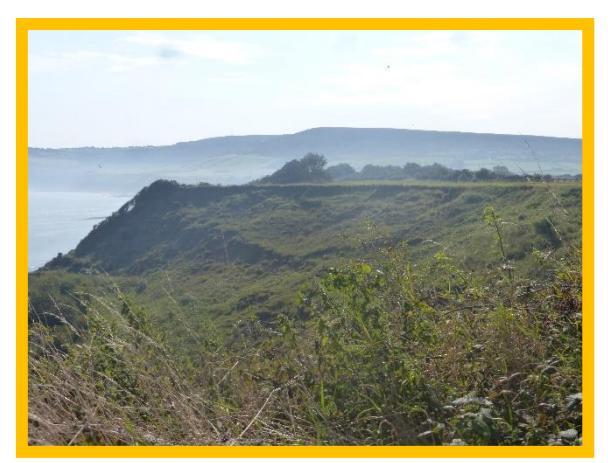
Vegetated mid-slope of MU17/3 (Partly Active)

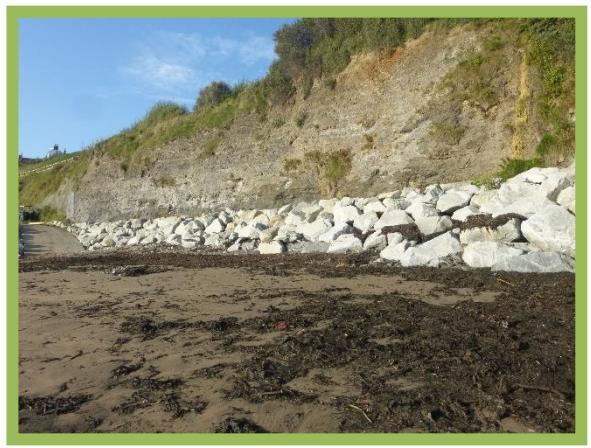
The most northern defence is a section of rock armour that gives some limited protection to the cliff toe to the north of the northern slipway / beach access ramp (/1002C02). This rock armour was constructed as part of the 2001 scheme and remains in good condition. South of the access ramp the rock armour (/1002C01) fronts the wingwall of the slipway / ramp from the boatyard and then a large blockwork sea wall also built in 2001. Overall, both the wall and the revetment are in good condition. Cliffs to the rear of the slipway have rock netting which remains in good condition. There is evidence of small periodic rockfalls from above the slipway, just north of the rock netting. It is recommended that this netting is extended to prevent further activity.

Rock revetment fronting sea cliffs (/1002C02)

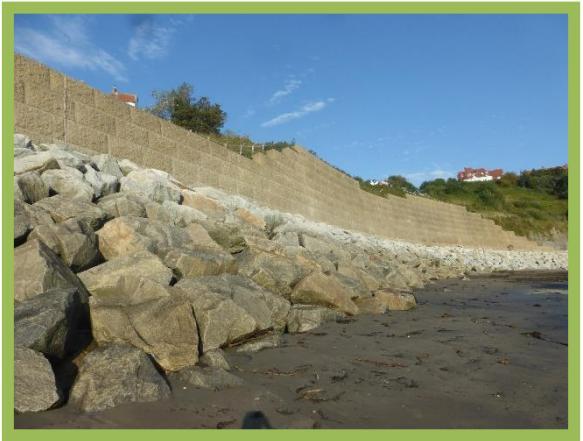
Rock revetment fronting large sea wall (/1003C01)

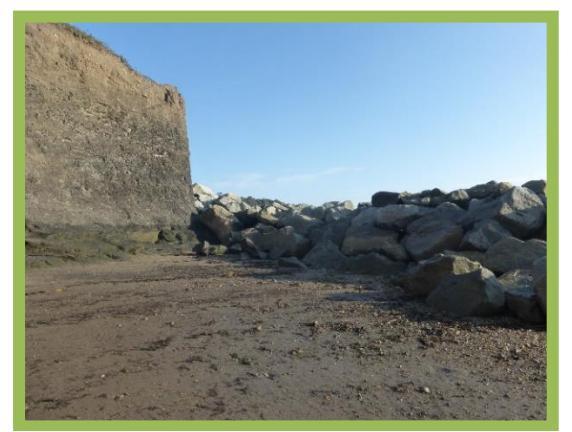
The rock armour extends south of the end of the wall, remaining in good condition, to protrude beyond the toe of the short length (~25m) of adjacent undefended shale cliffs. The cliff (/1003C03) is generally eroding at a slow rate, however there is continued activity adjacent the interface with the sea wall to the south, particularly at the headscarp and also in the lower reaches. Numerous patch repairs have been made to the interface to address outflanking concern. In 2020 it was noted that a large concrete repair had been made at the base of the wall since the previous inspections.

Rock revetment protruding beyond undefended cliffs (/1003C01)

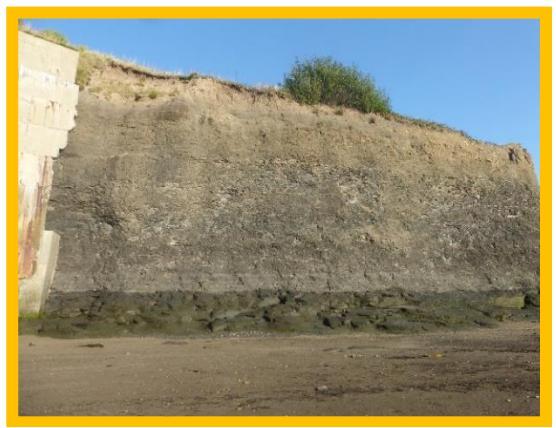
Erosion of cliffs immediately adjacent to northern end of large sea wall (/1003C03)

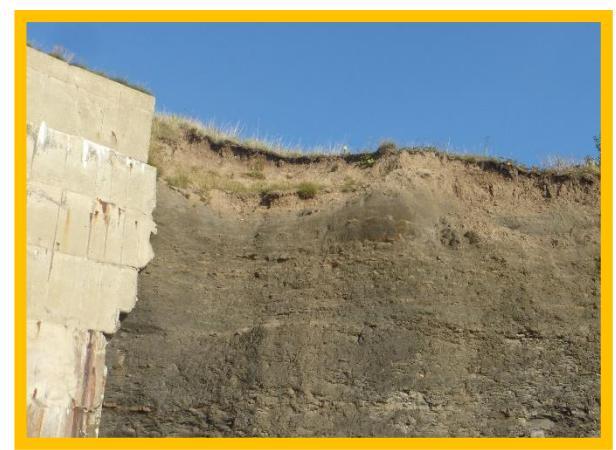
Evidence of ongoing headscarp recession (/1003C01).

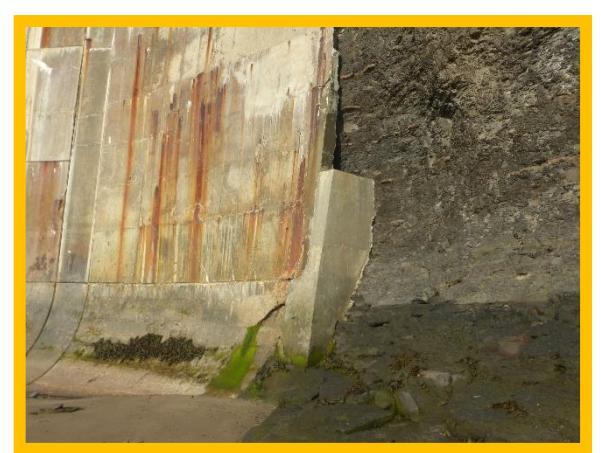
Path repairs to address outflanking at northern end of large sea wall (/1003C03)

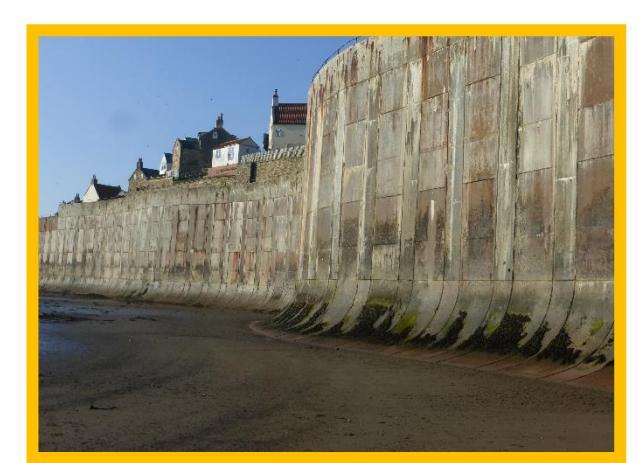
The large vertical pre-cast concrete panel wall that was constructed in 1975 (1003C02) remains in poor condition, showing extensive evidence of surface cracking and spalling, rust marks indicating corrosion of the reinforcement steel, mineral encrustation, seepage, frequent open joints, and extensive cracking and repair work to the crest of the wall. Generally, the wall appeared in similar condition to 2018, however it was noted during the 2020 survey that there was further outflanking of the transition to the shale cliffs at the north end of the wall and additional evidence of spalling across the wall face. During the 2020 inspection maintenance activities to repair spalling and damage to some panels was ongoing.

Large sea wall in poor condition will benefit from future planned capital scheme (/1003C02)

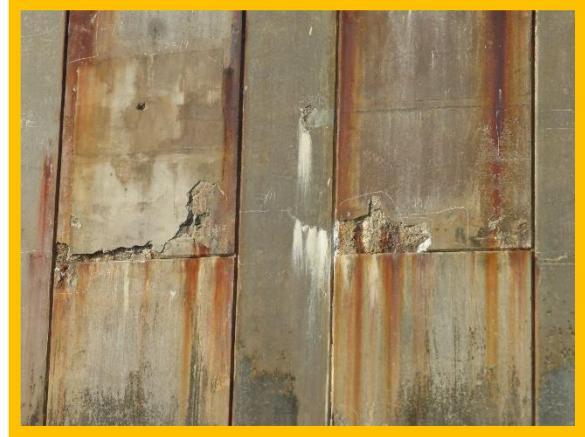
Typical defects on large sea wall (/1003C02)

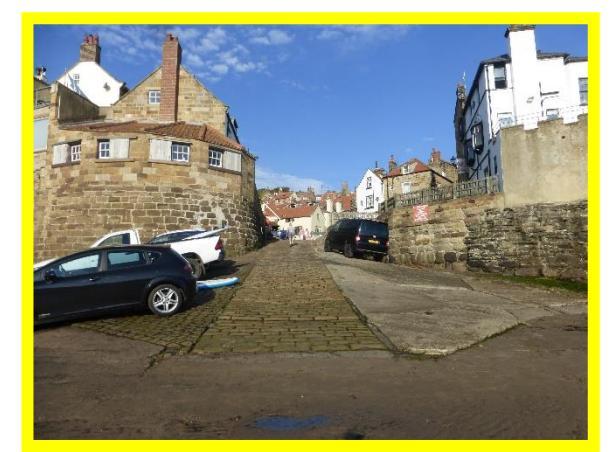
The adjacent central slipway (/1003C05) is in an overall fair condition, with some areas of minor damage, typically cracking and minor voiding of the structure. A larger void reported in the 2018 inspection appears to have been repaired. The concrete apron at the seaward end of the slipway is undercut and generally is in poor condition. Beach levels in 2020 were marginally higher than in 2018 meaning that the extent of undercutting at the apron was difficult to ascertain.

Slipway in fair condition (/1003C05)

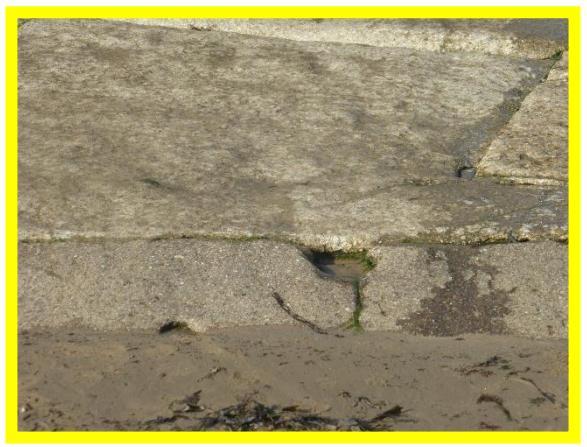
Voiding in slipway toe (/1003C05)

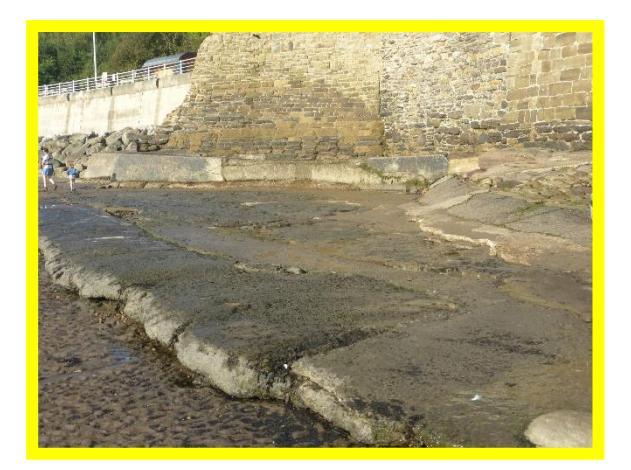
Undercutting of slipway toe (/1003C05)

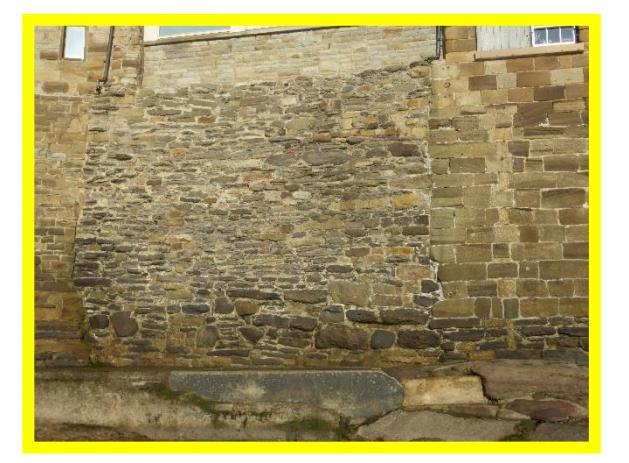
Blockwork wall (/1003C06)

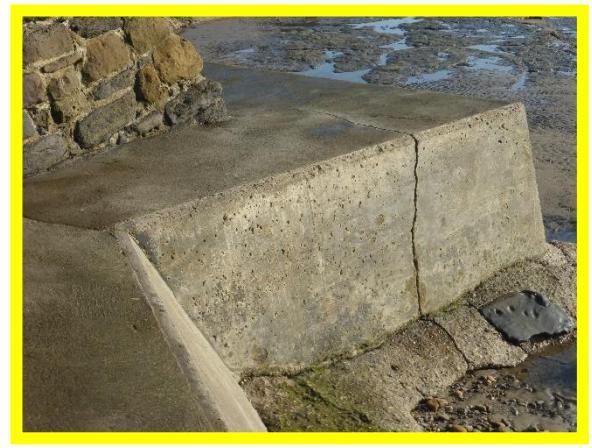
Longstanding crack in toe apron (/1003C06)

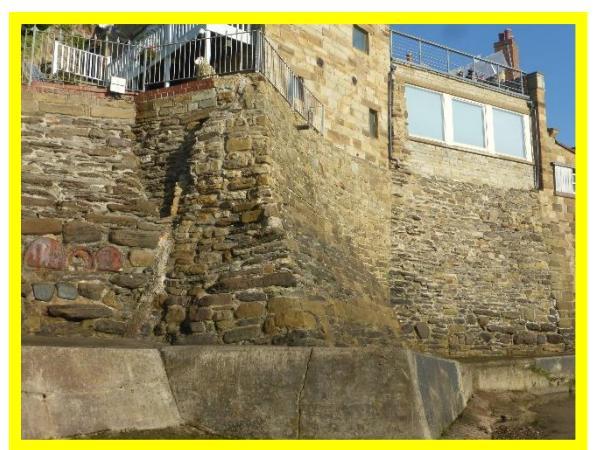
The mixed construction defence (/1003C06) on the south side of the slipway has mass concrete toe at the base with a variety of stone and blockwork above. The defence has a patchwork of previous repairs and repointing throughout but despite this a small number of open joints remain (mostly in areas of previous repairs) and there is one area of cracking in the concrete at the apron. This does not appear to have worsened since the 2018 inspection, although it remains an area of concern. It is recommended that this is repaired to prevent further damage to the structure. Overall, the structure remains in fair condition, but benefits from ongoing ad hoc maintenance activities.

Seawall of mixed construction and concrete toe and apron in in fair condition (/1003C06)

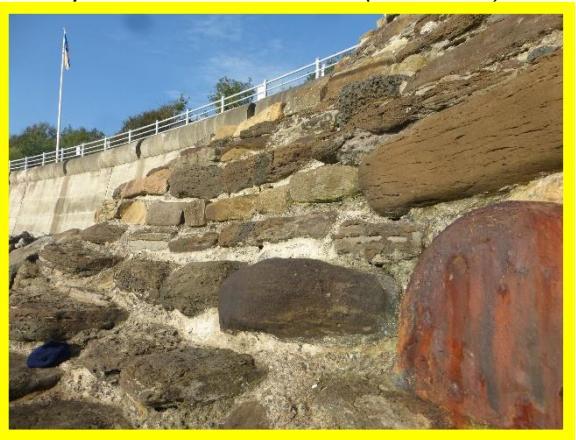
Loose, degraded mortar on blockwork wall (/1003C06)

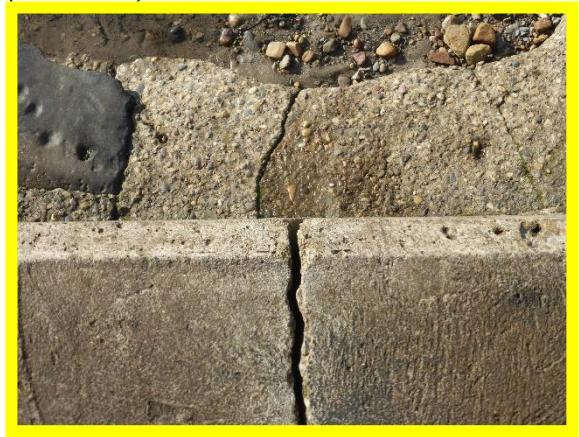
Longstanding crack in toe apron (/1003C06)

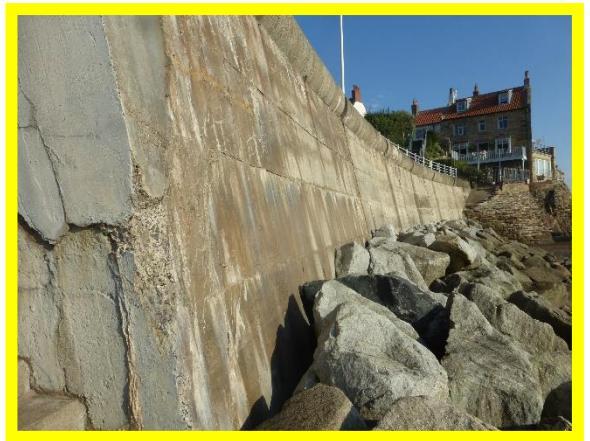
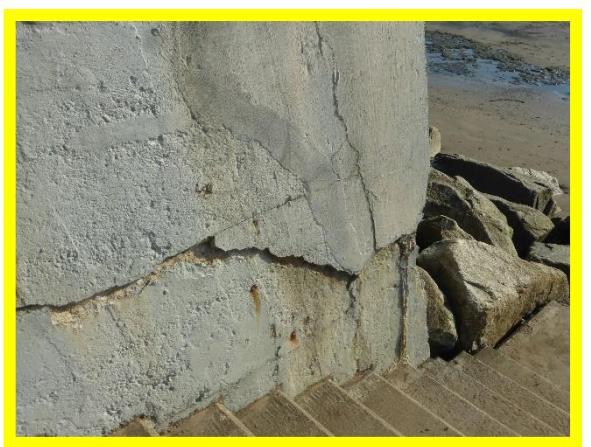
At the south of the village is the concrete sea wall at the Quarter Deck (/1003C10). This structure was given rock armour toe protection as part of the 2001 scheme. The rock armour remains in good condition whilst the sea wall is in fair condition. There has been little change over the previous two years. Some notable defects remain at the access steps at the southern end of the wall, with render cracking and falling away and abrasion of the concrete beneath. There is also some local abrasion and spalling at the coping and around joints. There has been some localised loss of joint sealant, however generally the sealant remains in good condition.

Concrete sea wall generally in fair condition Defects at access steps (/1003C10) (/1003C10)

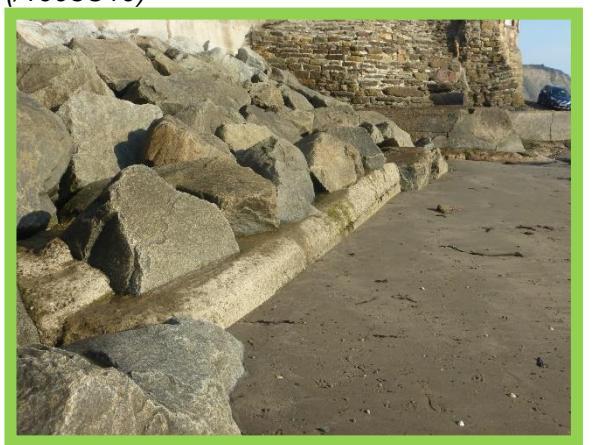
Rock revetment remains in good condition. Note visible concrete toe beam (/1003C09)
