Cell 1 Regional Coastal Monitoring Programme Walkover Inspection Surveys 2020

Scarborough Borough Council

November 2020

Walkover Inspection Surveys 2020

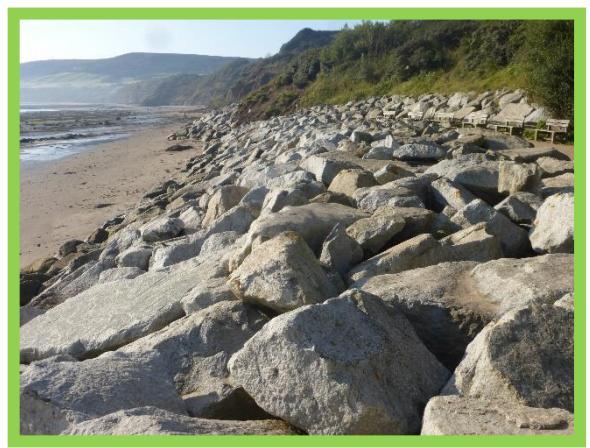
Rock revetment and slipway remain in good condition (/1003C09)

South of the Quarter Deck there is a length of rock armour defence with a slipway / ramp, both of which were constructed in 2001 and remain in good condition in 2018 (/1003C09). One or two displaced armourstones from the revetment are now almost fully buried below beach level.

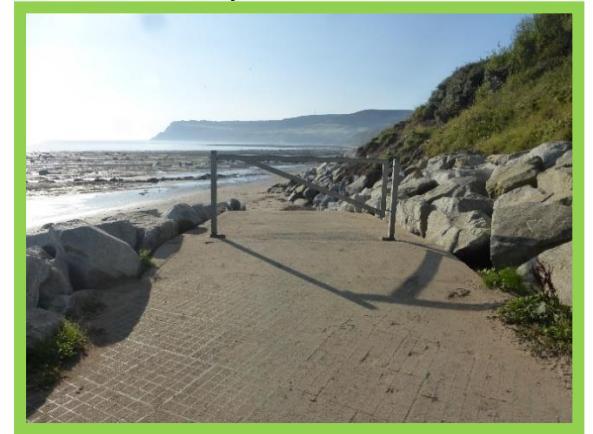
Slipway remains in good condition (/1003C09)

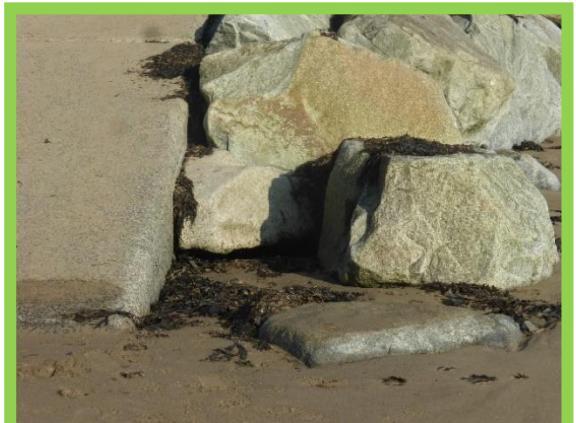
Displaced rock armour stones at the toe of the slipway (/1003C09)

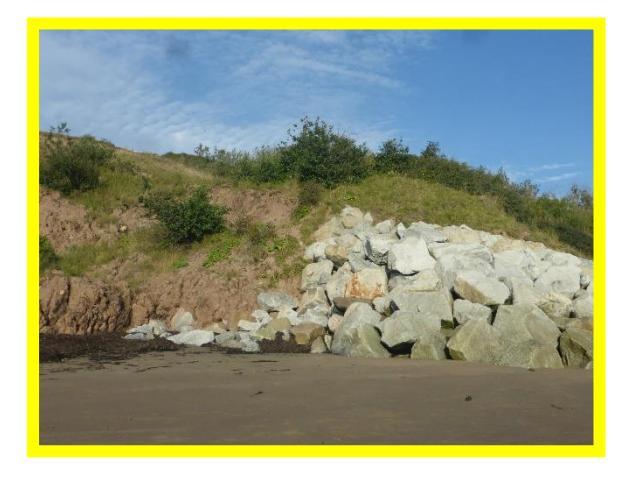
To the immediate south of the ramp is a short section of rock armour built in 2001 to stabilise the cliff (/1003C07). Since 2016 there has been further significant slumping behind the revetment and in one place, just south of the snout of the slipway, the cliff has overtopped the crest. In addition to this, the defence is at risk of being outflanked at its southern end. It is recommended that the situation in this area is monitored and considerations are made for the revetment to be realigned once the cliff has retreated sufficiently.

Outflanking of rock armour (/1003C07)

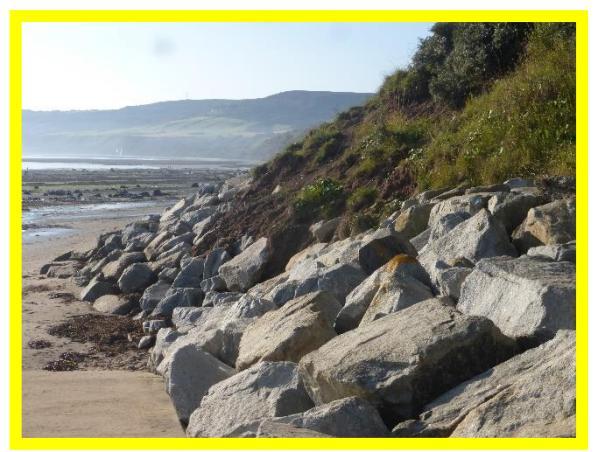
Slumping of cliffs behind rock armour (/1003C07)

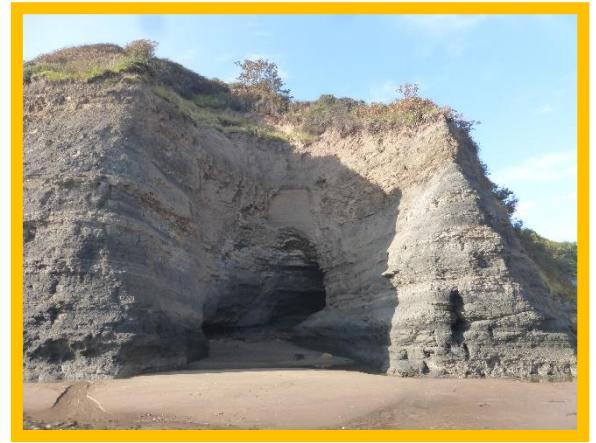
At the northern tip of MU17/4 directly to the south of Boggle Hole is a narrow, steep sided cove with a small cave located at its rear. In early July 2020, a small cliff collapse injured a young girl who was in the cove at the time. The collapse was described as "a square metre of material falling from a height of 30 feet". The child was left with serious, but not life-threatening injuries, and was taken to hospital. Due to the proximity of this location to the beach access and the popularity of Boggle Hole itself it is recommended that MU17/4 is monitored closely. Particularly the small cove area especially following heavy rainfall when the upper till slopes are most vulnerable.

Small cove at northern end of **MU17/4**. Cove formed of steep mudstone cliffs overlain with a shallow glacial till slope. (Partly Active).

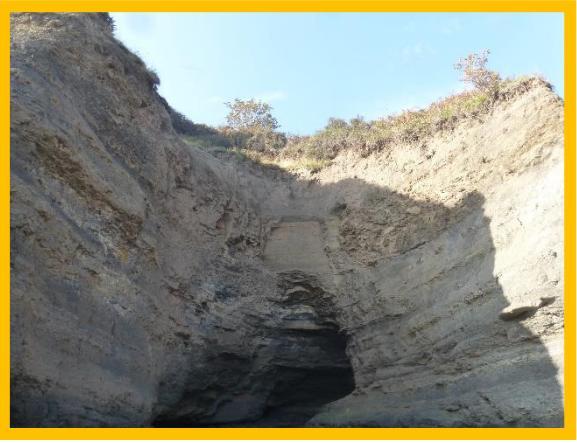
Shallower glacial till slope, note evidence of recent rockfall above cave entrance. **MU17/4** (Partly Active).

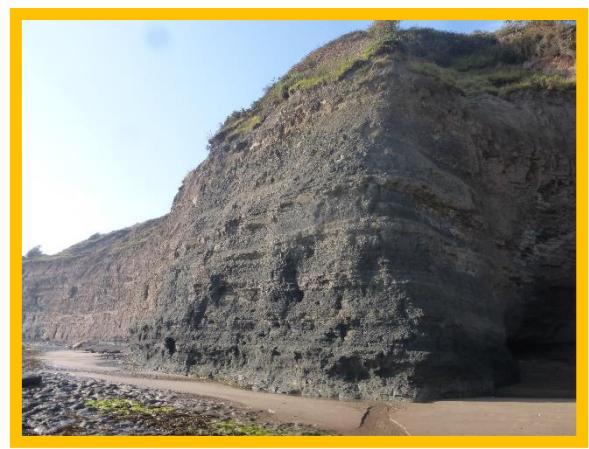
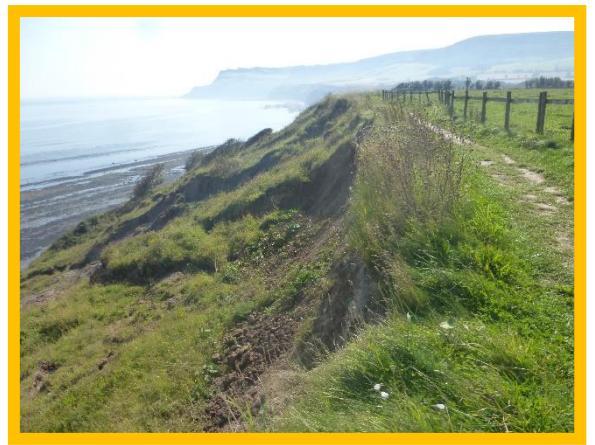
Steep composite cliff of mudstone overlain by till. **MU17/4** (Partly Active).

Active retreat of headscarp undermining footpath. **MU17/4** (Partly Active).

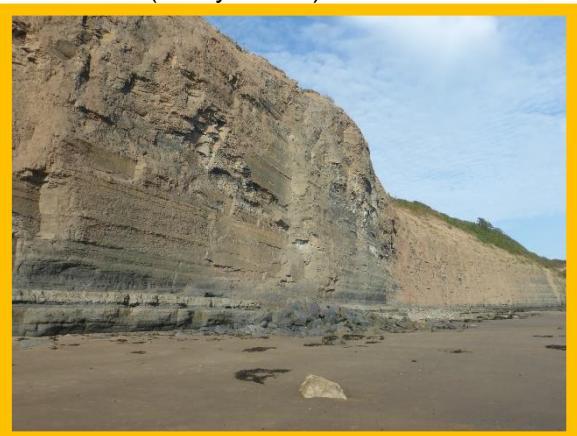
Steep composite cliffs MU17/4 (Partly Active).

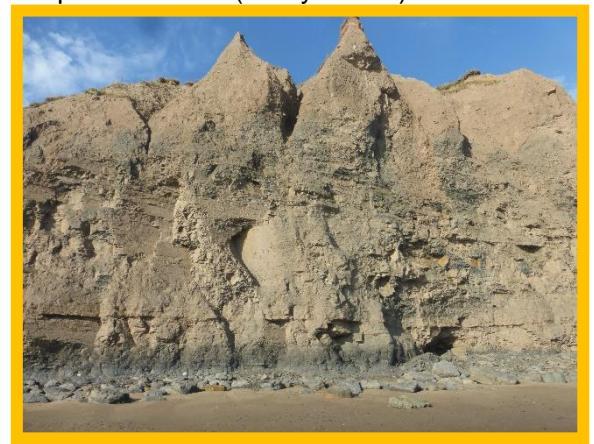
Steep composite cliffs MU17/4 (Partly Active).

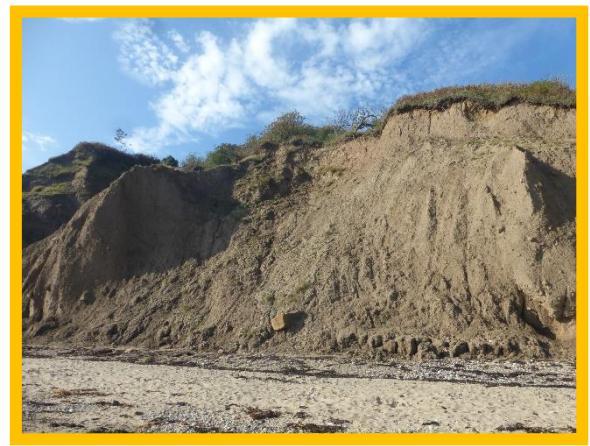
Active till cliffs down to beach level in Robin Hood's Bay. **MU17/5** (Partly Active).

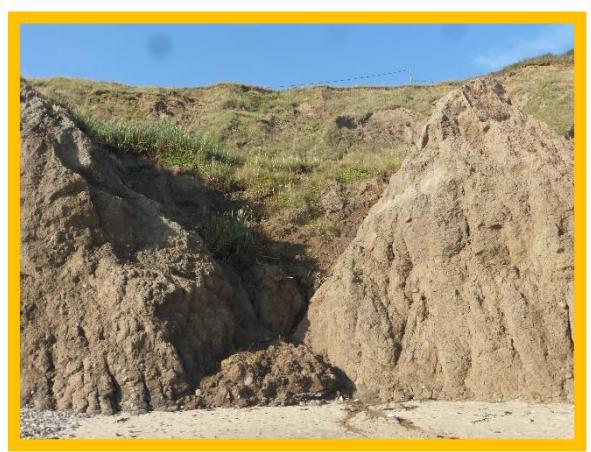
Active till cliffs down to beach level in Robin Hood's Bay. **MU17/5** (Partly Active).

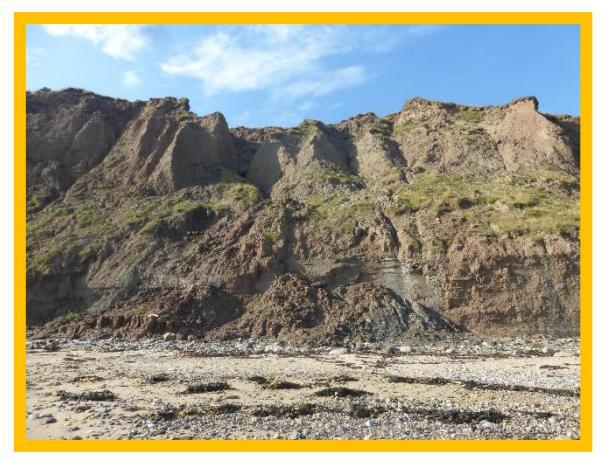
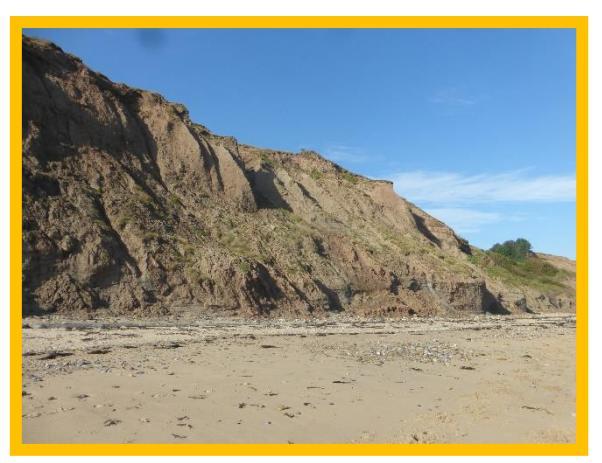
Active till cliffs down to beach level in Robin Hood's Bay. **MU17/5** (Partly Active).

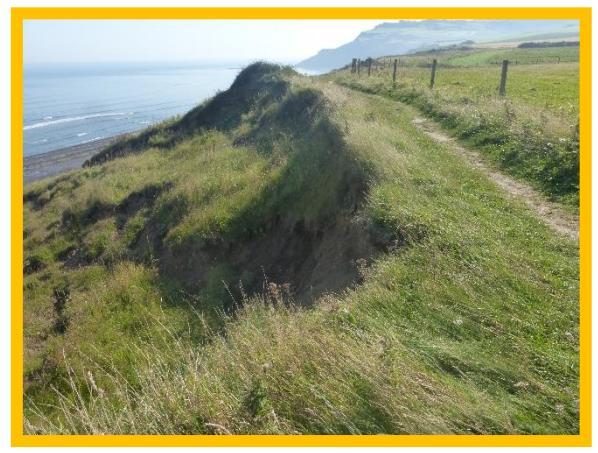
Headscarp recession undermining footpath. **MU17/5** (Partly Active).

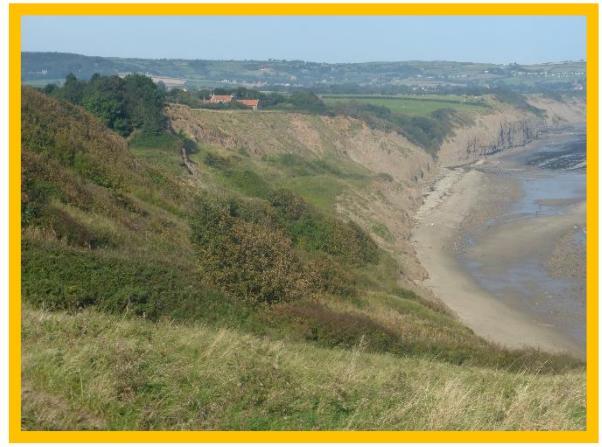
Vegetated mid-slopes. **MU17/5** in the distance (Partly Active).

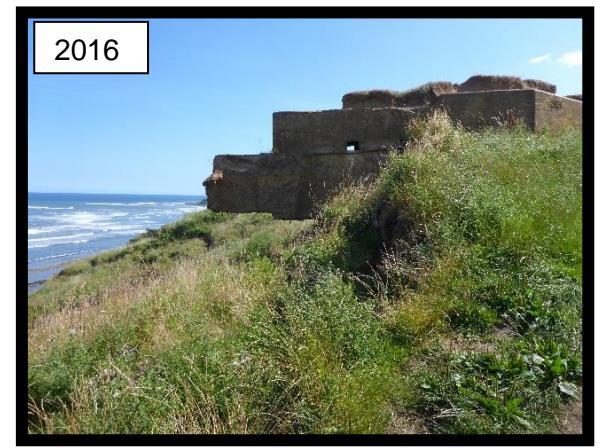
In addition to the cliff activity within MU17/5 it is worth noting that the retreat of the headscarp has undercut a historic WW2 pill box which during the 2016 survey was seen to be at risk of collapse. The structure had been undercut and severed in two in 2018. There has been limited change since 2018. However, the seaward facing section now lies someway down the cliff face. Due to the highly active nature of the cliff in this location both pieces of the structure are at risk of collapsing onto the beach below, with the fully detached section posing a potentially imminent risk to users of the beach. Due to the difficulties associated with placing signage on the beach, and the inherent risks associated with access to the structure, options to minimise the risk to the public are not straightforward and will require some consideration.

Historic WW2 pillbox in 2016. MU17/5.

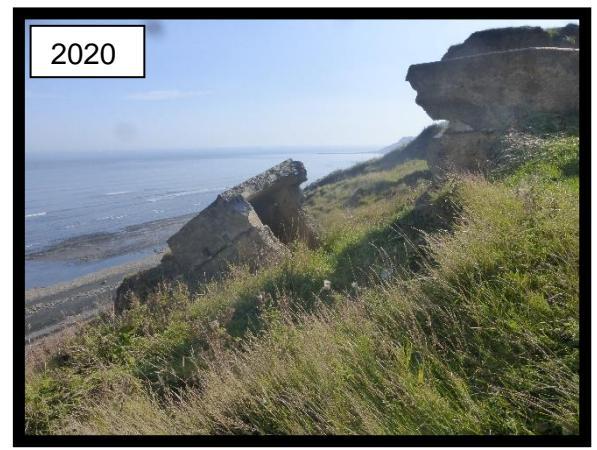
Historic WW2 pill box in 2020. MU17/5.

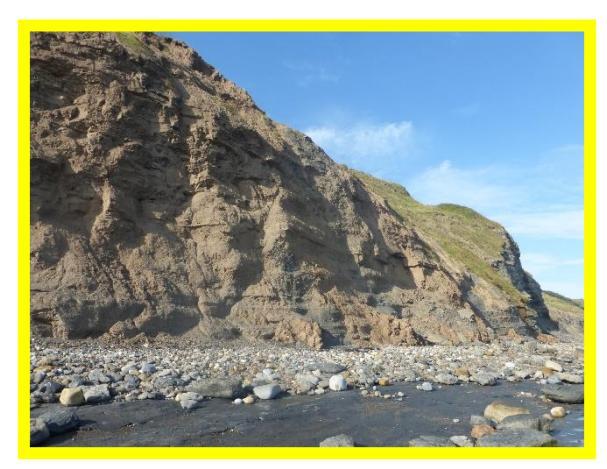
Further southeast, units MU17/6 and MU17/7 remain classified as Locally Active after being downgraded from Partly Active in 2016. The lower slopes are steep cliffs composed of mudstone overlain by shallower sloping till. The cliff face suffers localised rock falls and localised slumping of till from above.

Steep composite cliff of mudstone overlain by till. **MU17/6** Locally Active September 2020

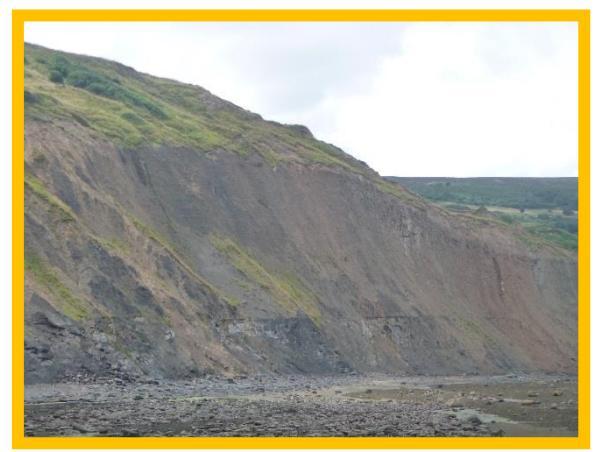
Units MU17/8 and MU17/9 are located immediately west of Peak Steel. **Unit MU17/8** has a steep lower slope which is actively eroding and a shallower upper slope which supports some vegetation cover. **Unit MU17/9** is steep with little vegetation. These units remain classified as Partly Active in 2018, as they have been since 2002.

Some vegetation cover visible along upper slopes of **MU17/8** (Partly Active).

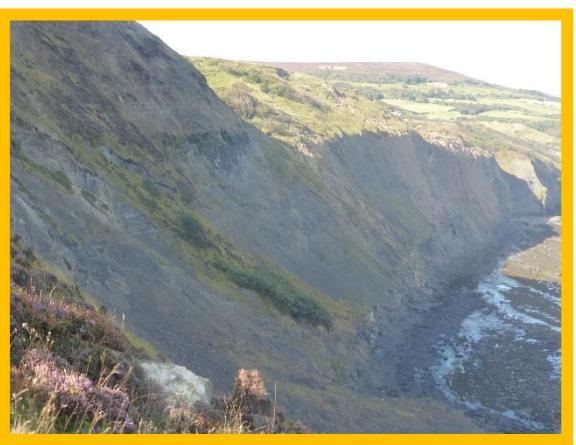
Ongoing erosion of cliff face along **MU17/9** (Partly Active)

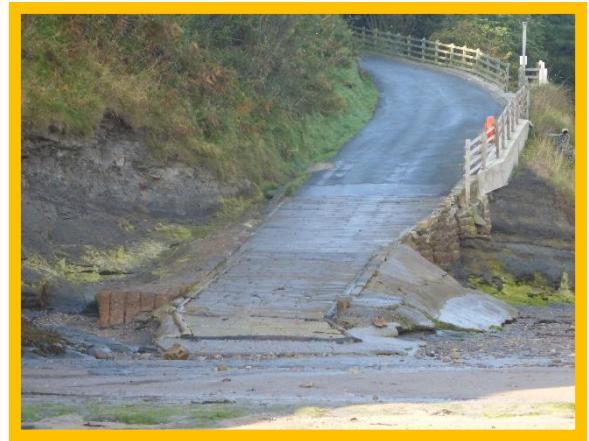
Concrete slipway at Boggle Hole, note voiding and undercutting of concrete apron.

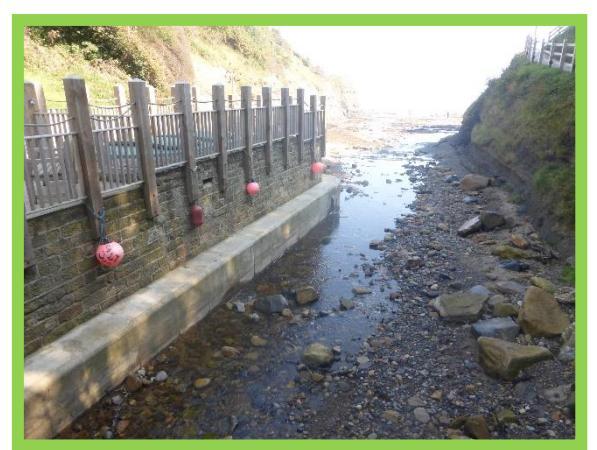
Blockwork wall with concrete toe at Boggle Hole.

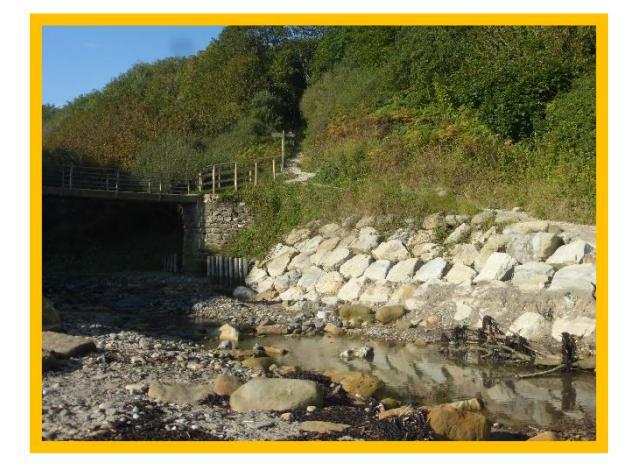
Rock armour revetment on north side of Stoupe Beck.

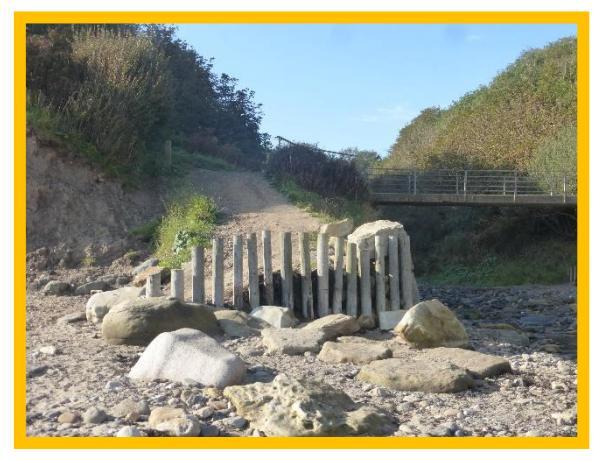
Timber piles in poor condiition. Extensive voiding and undercutting visible.

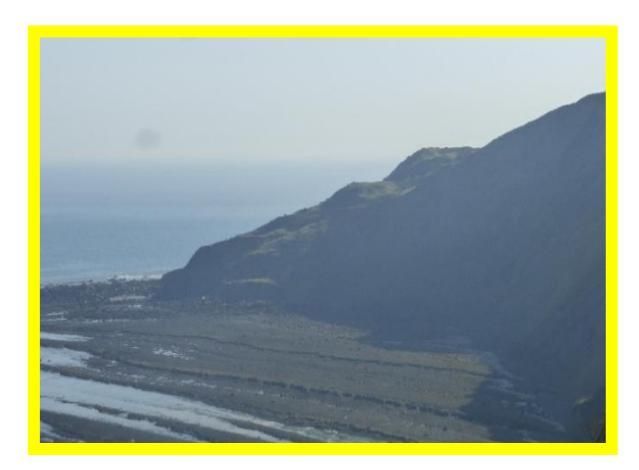
Unit MU18/1 is located at Peak Steel, below Ravenscar. The cliffs in this region have a distinct twotiered form. Much of the upper headscarp is densely vegetated with little evidence of recent activity. The lower headscarp, exposed to the sea, is more active and subject to episodic slides and falls evident. This unit is classified as Locally Active in 2020.

MU18/1 Peak Steel (Locally Active)

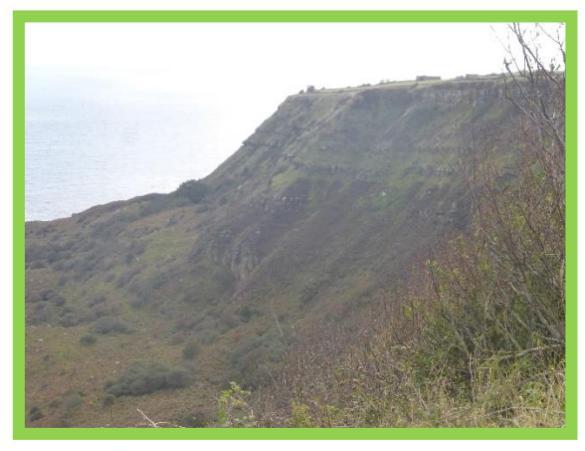
Unit MU18/2 is a well vegetated, relict system with no signs of activity. As a result, it is classified as Inactive.

MU18/2 Distinct two-tiered cliffs (Inactive)

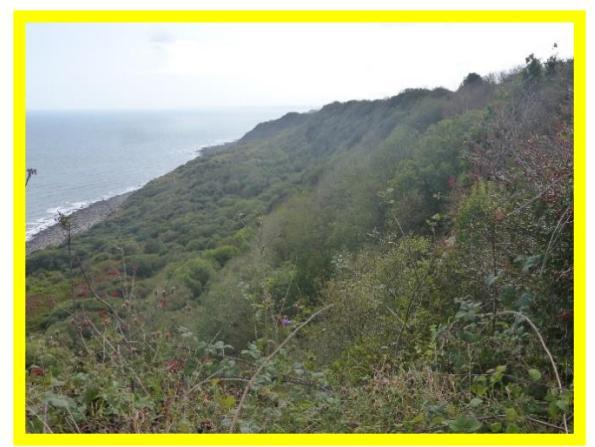
MU18/3 Locally Active in 2020

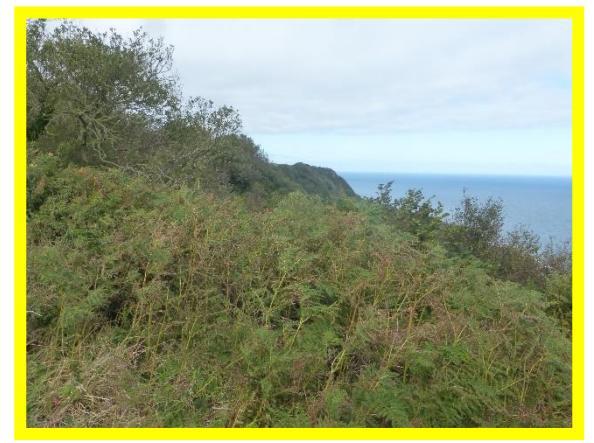
MU18/4 Heavily vegetated upper slopes (Locally Active).

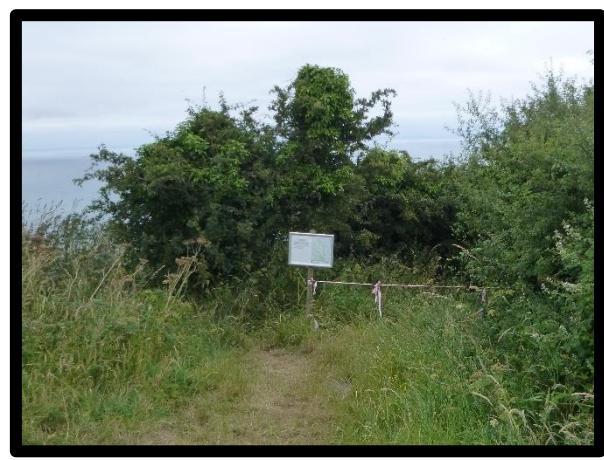
During the 2018 walkover survey a section of footpath between Petard Point and Hayburn Wkye was temporarily closed due to a landslip. The closure was effective for a period of 6 months, between 6th April 2018 and 18 September 2018. During the 2020 inspection the footpath had reopened. The section of footpath between Petard Point and Hayburn Wyke was found to be in good condition during the 2020 walkover inspection and it was not obvious at which point the landslip had occurred. The landslip location may have been obscured by fresh vegetation growth.

Footpath closed during 2018 inspection.

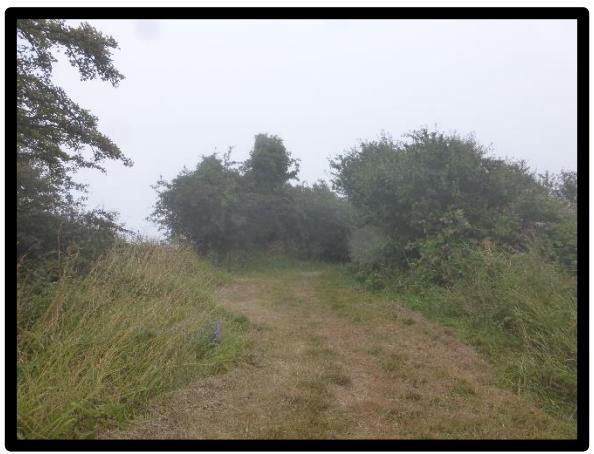
The same location in 2020 with footpath reopened.

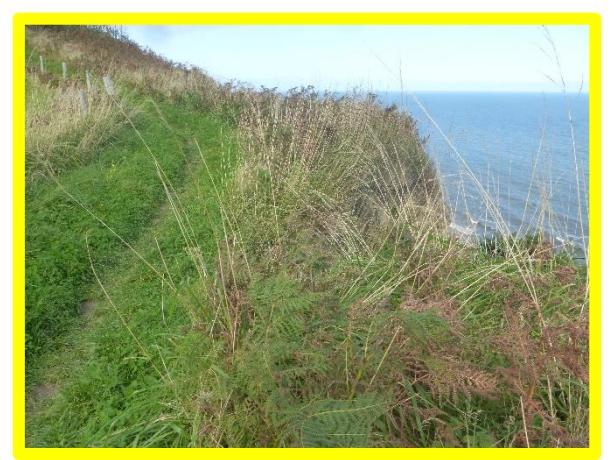
MU19/1 Evidence of historic landslip in MU19/1.

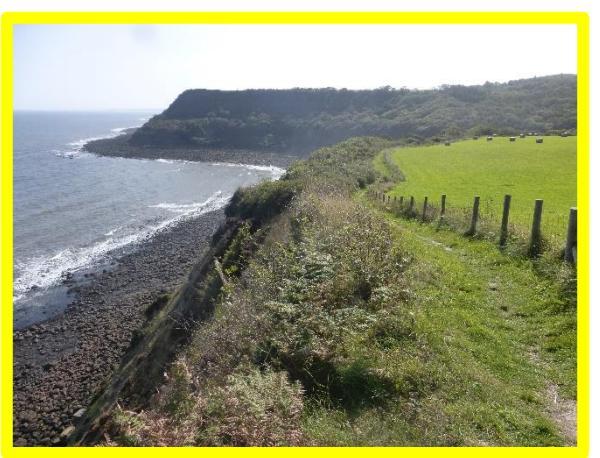
MU19/1 localised recession of headscarp

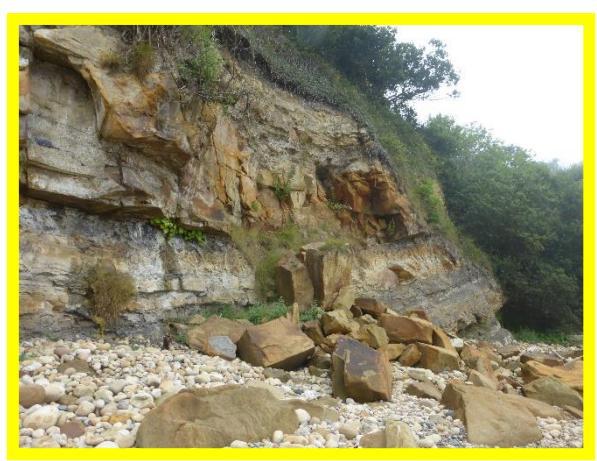
Unit MU19/2 is located on the north side of Hayburn Wyke and remains classified as Locally Active because of minor activity at the headscarp and some evidence of recent rockfalls at the toe. It was noted during the 2020 survey that several large rockfalls near the access to the beach reported in 2018 (see images below) had remained stable. There did not appear to have been further displacement of rock from the face of the cliff. Due to the proximity of the beach access to the cliff face is recommended that MU19/2 is monitored for further change, particularly following periods of adverse weather where the cliffs may become unstable. However due to the localised nature of the activity the overall condition of the unit remains unchanged.

MU19/2 Rockfall at the toe of cliff.

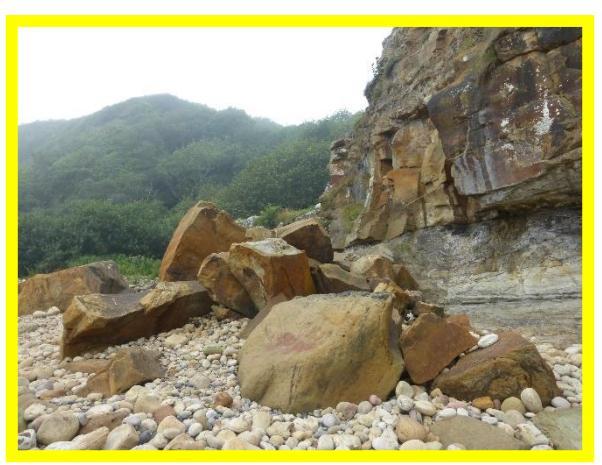
MU19/2 – Rockfall at toe of cliff, adjacent to waterfall.

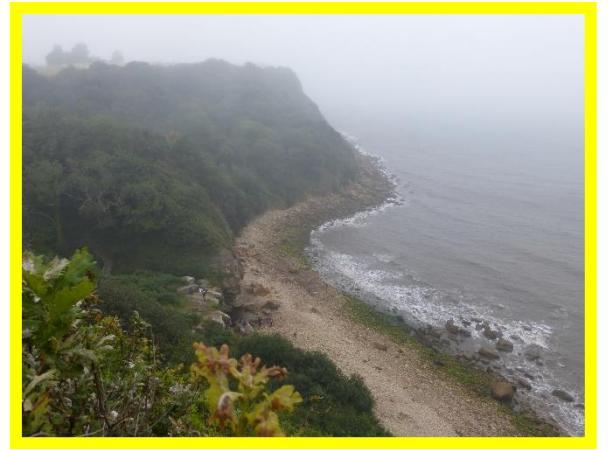
MU19/2 Looking north across Hayburn Wyke at the vegetated cliffs (Locally Active)

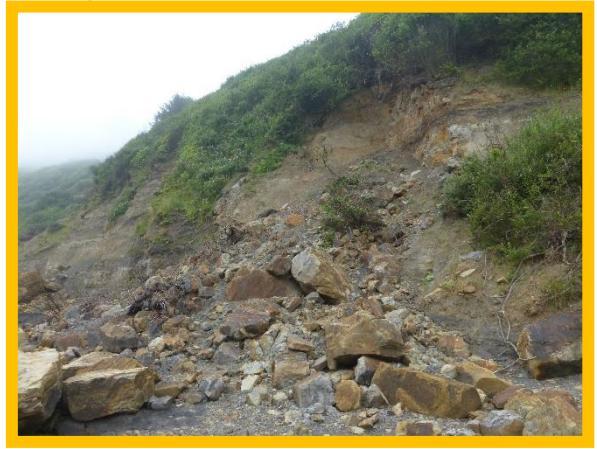
Unit MU19/3 is located around and to the south of Hayburn Wyke. These cliffs are well vegetated, with localised erosion at the toe and headscarp. A new large debris lobe was observed from beach level with some other smaller lobes visible across the southern section of the bay indicating renewed activity on the undercliff. From the Cleveland Way footpath, a much larger rotational slide was visible from the upper cliff. The headscarp of the slide has come very close to undermining the footpath and has a near vertical upper face. Several large mature trees have been displaced by the slide. Due to the increased level of activity at the toe and in the upper cliff the unit has been downgraded to Partly Active in 2020.

MU19/3 – Large new debris lobe on the undercliff on south side of Hayburn Wyke (Partly Active)

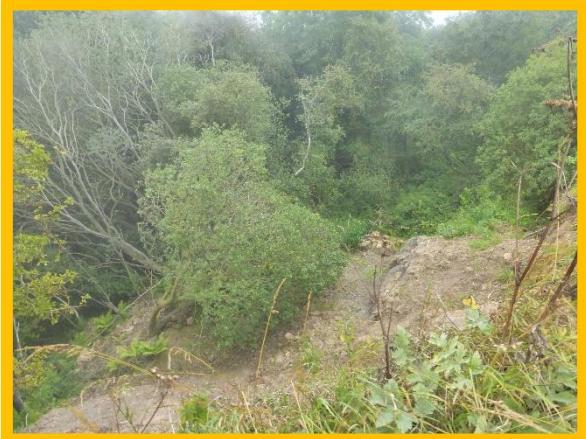
MU19/3 – Large landslide on the upper cliff of on south side of Hayburn Wyke (Partly Active)

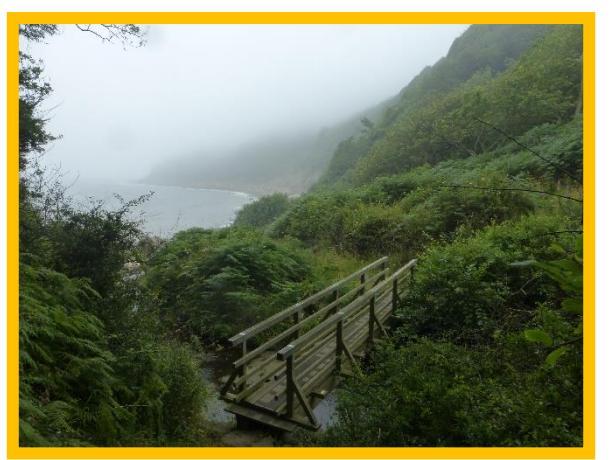
MU19/3 – Well vegetated undercliff on south side of Hayburn Wyke (Partly Active)

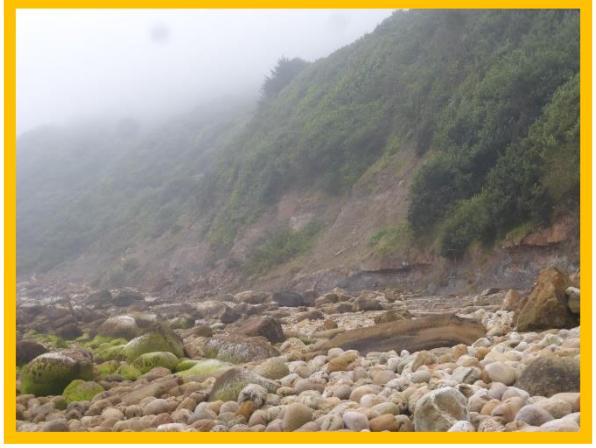
MU19/3 – Several smaller new debris lobes on the undercliff on south side of Hayburn Wyke (Partly Active)

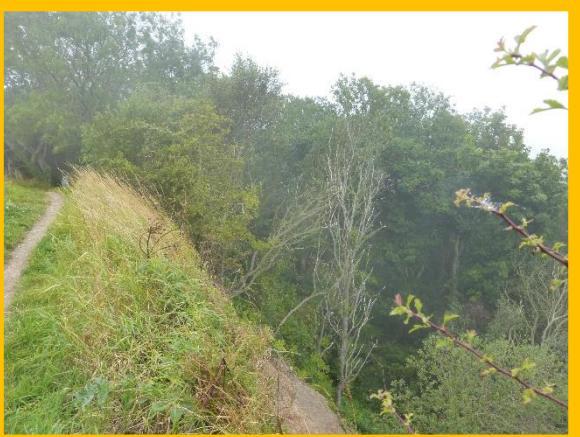
MU19/3 – Looking north along the Cleveland Way footpath. (Partly Active)

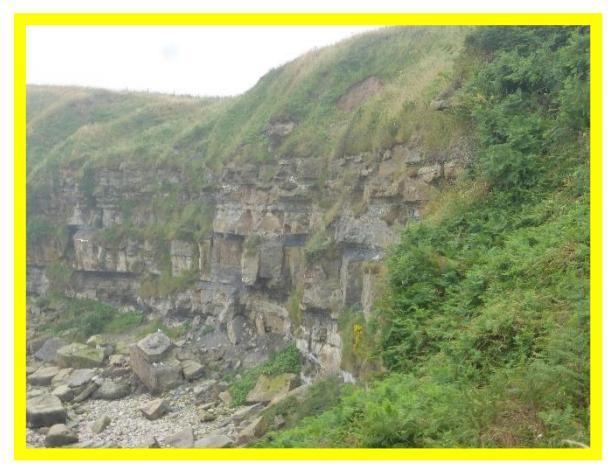
Unit MU19/6 forms the southern part of Cloughton Wyke and extends southwards to Long Nab. The lower cliff is near vertical and actively eroding. There is evidence of rockfall (large, angular boulders) from this part of the cliff onto the shoreline below. The upper part of the cliff is shallower angled and much less active. This unit condition was changed to Locally Active in 2018 and retains that status in 2020. Although some evidence of minor rockfall was still visible, activity on the cliff appears to have become more settled since2016. The stability of the upper reaches of cliff was evidenced by the increased vegetation coverage.

MU19/6 Rockfall on southern side of Cloughton Wyke (Locally Active)

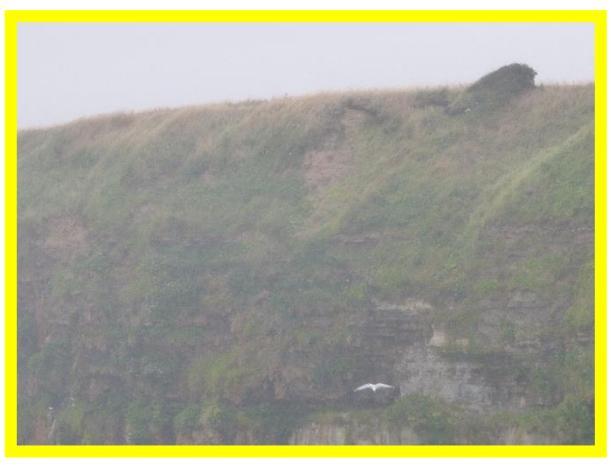
MU19/6 Rockfall on southern side of Cloughton Wyke (Locally Active)

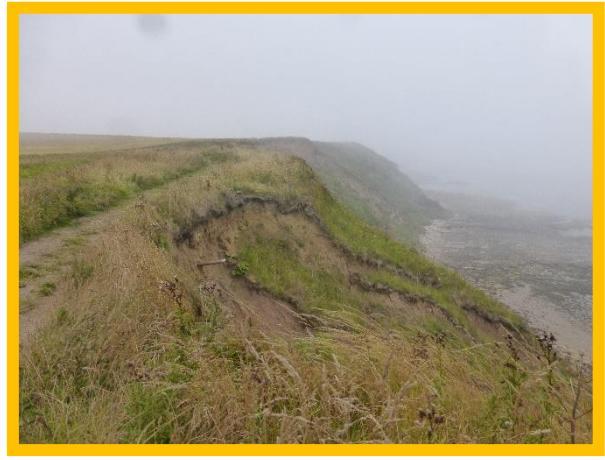
Units MU19/9 and MU19/10 are located between Cromer Point and Scalby Ness. The toe of these units is subject to marine action and the headscarp is steep, exposed and actively retreating through slippages at numerous places throughout the units. The cliffs retain their Partly Active status because of the extent of activity along their lengths being more than simply 'local'.

MU19/9 Retreat of headscarp (Partly Active)

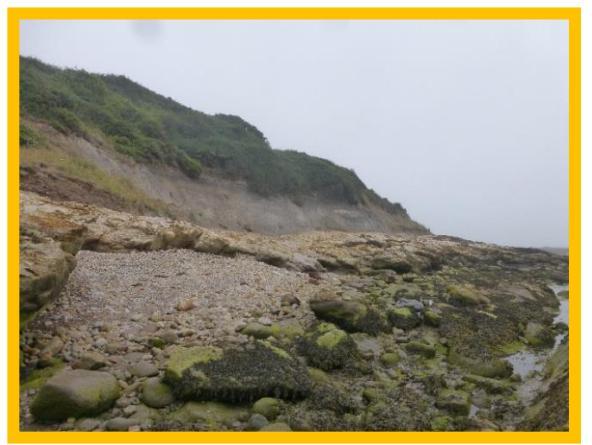
The Scalby Ness headland comprises **unit MU19/11**. This area is well vegetated on its more landward extents, but was noted during the December 2013 inspections to be eroding severely in the lower half of the cliff with some failure in the upper part and was therefore upgraded to Partly Active; this status has been is retained in 2020, unchanged since 2014.

MU19/11 Active undercliff (Partly Active)

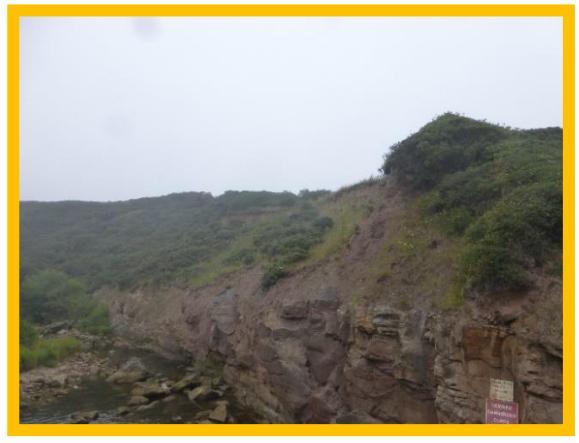
MU19/11 Activity in upper slopes of cliff above Sea Cut at Scalby Ness

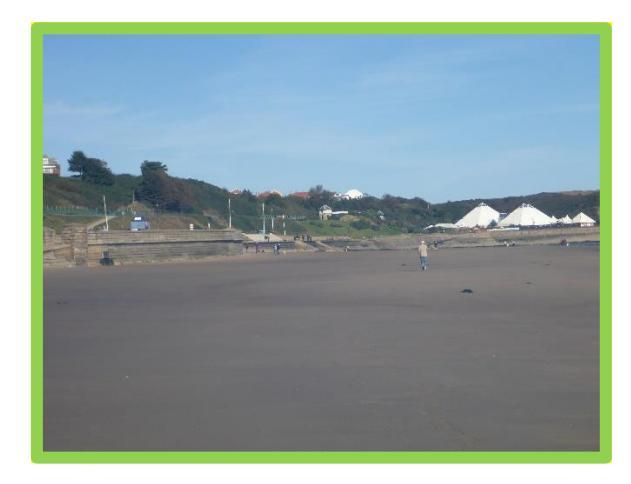
Both units are defended at the toe by the sea wall which runs the entire length of North Bay. The slopes are well vegetated, show no evidence of recent activity and are both classified as Dormant, as they were in previous surveys.

MU20/1 Cliffs in northern North Bay (Dormant)

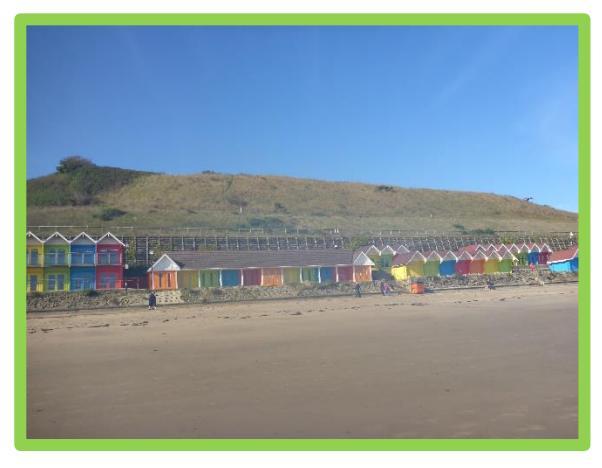
MU20/2 Cliffs in northern North Bay (Dormant)

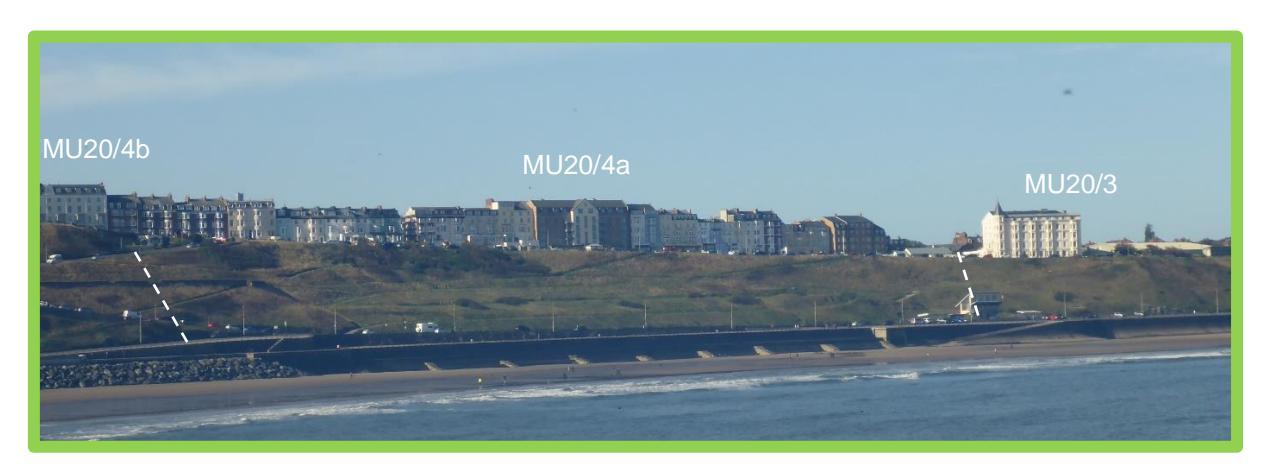
Unit MU20/3 fronts Clifton Hotel and the Scarborough Bowls Centre. As per previous surveys the unit is well vegetated and shows no obvious evidence of recent instabilities. It is again classified as Dormant in 2020

Unit MU20/4a is located to the rear of North Sands. The relict slopes are well vegetated with only minor and localised evidence of erosion, it remains classified as Inactive, unchanged since previous surveys.

Looking across to North Sands Unit MU20/4b MU20/4a & MU20/3

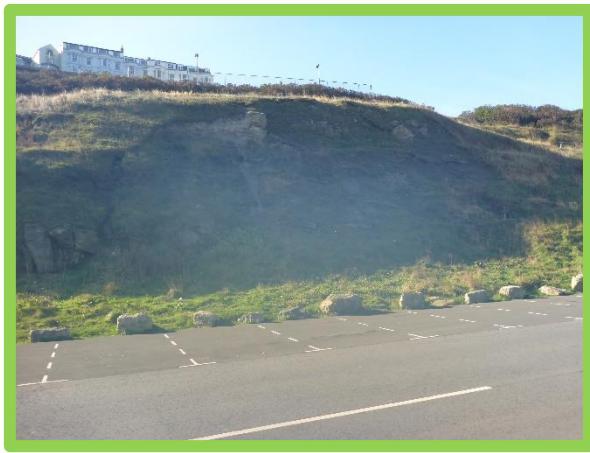
Unit MU20/4b covers the area of Clarence Gardens and has previously been slightly more active than the adjacent unit MU20/4a. However, remediation works have repaired cracks and the slopes are now well vegetated with exposed rock at the headscarp. This unit was downgraded to Inactive in 2012 and retained this status in 2014. However, because of evidence of some (very) shallow slips in one local area near to parking bays, it was altered to Locally Active in 2016 and 2018. No further activity was noted during the 2020 inspection and therefore the condition has been returned to inactive.

MU20/4b Cliffs in southern North Bay (Locally Active)

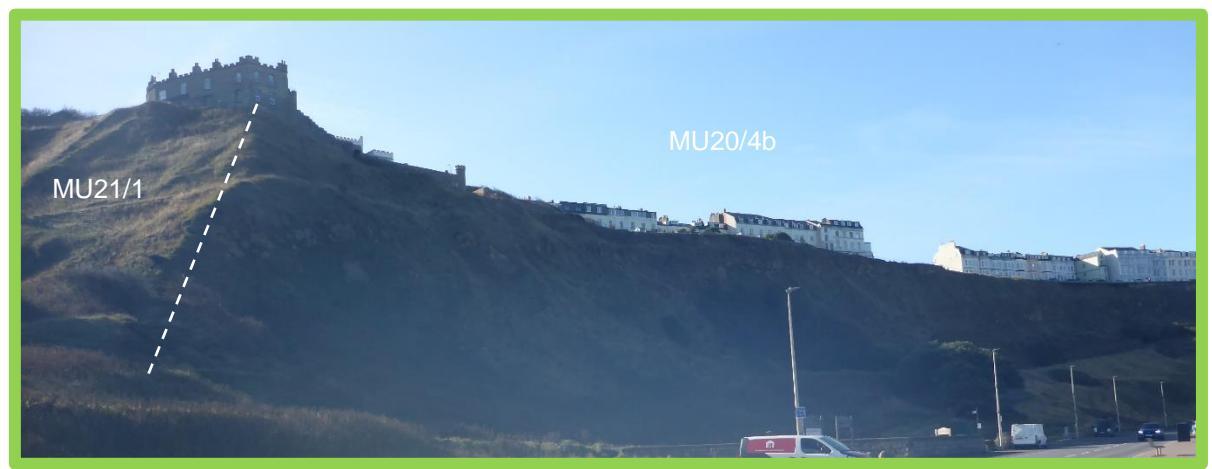
MU20/4b Inactive

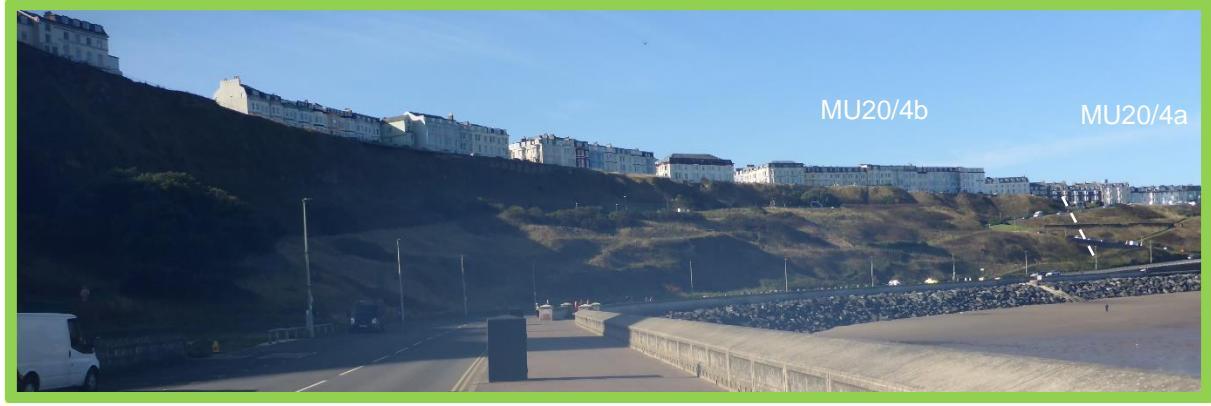
MU20/4b Inactive

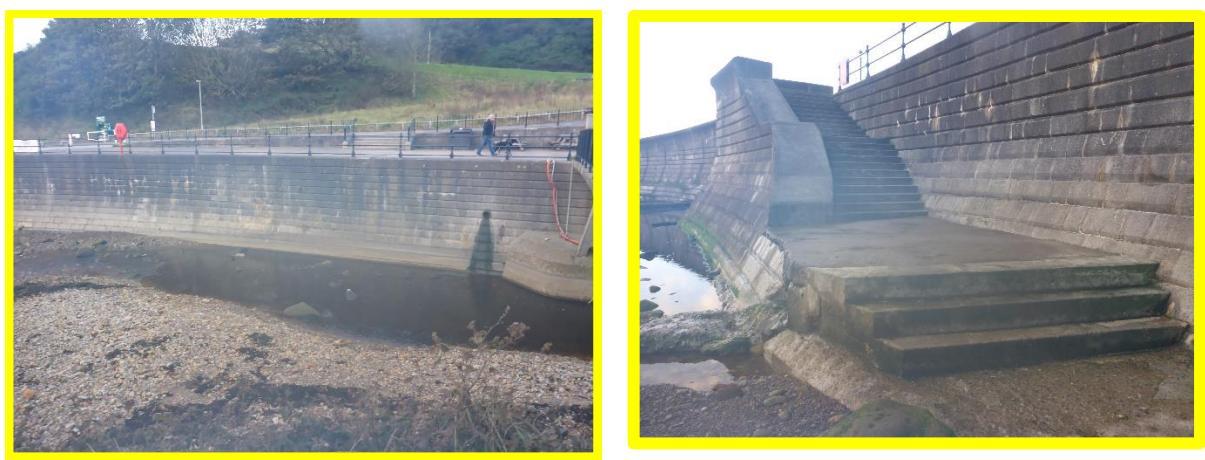
The most northerly seawall (/1201C01) starts adjacent to the footbridge at Scalby Mills and remains in fair condition. Moving south the seawall (/1201C02), around the promontory on which the Sea Life centre is built is in overall fair condition, but with some local areas of abrasion; most notably at the stepped concrete toe, north of the slipway. In the same location there is a failed outlet that has a broken crown although it is not envisaged to affect the performance. There is also heavy abrasion around the access steps at the junction with the adjacent seawall to the south. Previous joint repairs are holding well.

Beck condition Access Steps at Scalby Beck (/1201C01 001) seawall Scalby Fair at (/1201C01)

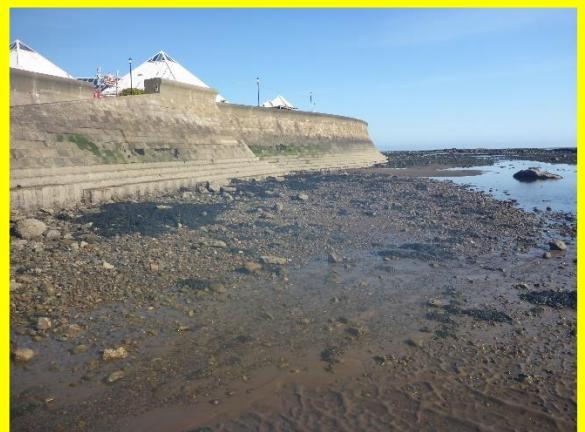
Fair condition seawall at Sea Life Centre Failing outlet through seawall (/1201C02) (/1201C02)

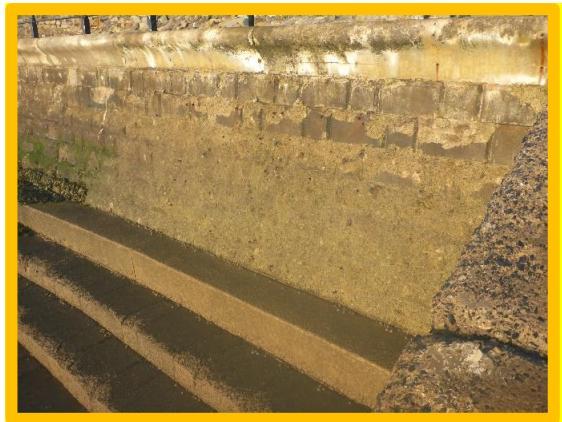
The northernmost section (/1201C03) has a short length of heavily corroded handrailing at the seaward edge of the promenade and notable abrasion damage to the deck. There also is a section (4-5m) of heavily abraded seawall face to the north that is now exposing reinforcement and requires attention. As reported in 2018, the damage to the wave return wall, steps and grouted stone revetment at the rear of the promenade has been repaired.

Heavily abraded seawall face with exposed reinforcement (/1201C03)

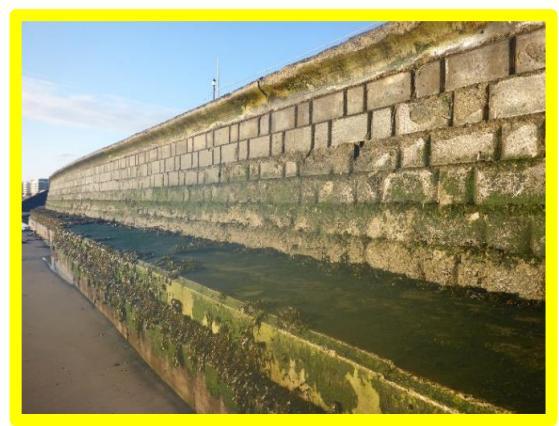
Fair condition seawall with recent repairs to toe apron (/1201C24)

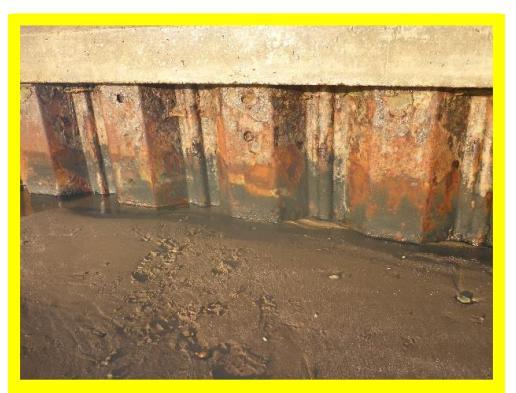
The beach access steps along this frontage are particularly heavily abraded. The southernmost set of steps have been subject to substantial repairs which, to date, are holding well. The beach levels were locally low at the time of the inspections, exposing more of the sheet piled foundations than previously seen. The sheet piles show signs of corrosion at pile head highlighted by colour disfiguration and uneven surface. The side sheet piles appeared to have a minor lean seaward suggesting possible lateral movement, this should be monitored although it is thought that if movement was significant that the concrete would also be showing signs of stress which is was not. The concrete repairs extend northwards from the steps along the toe apron and remain effective.

Corroded sheet pile foundation to access step landing (/1201C24)

The small crack between the repaired steps and the seawall, reported in 2018, did not appear to have deteriorated but should continue to be monitored

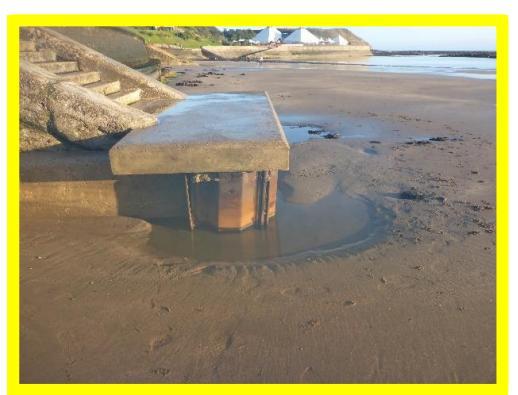
Sheet Piles appear to have minor lean seaward (/1201C24)

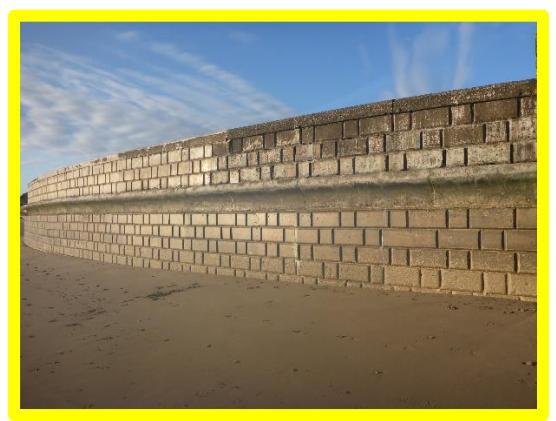
The wall around the promontory (/1201C04) is more exposed and has had relatively recent repairs to both the front face and the low crest wall, these are still holding up well in 2020. It was reported in 2018 that heavy abrasion damage remained in other places (especially on the unrepaired sections of lower wall), although this was buried by high beach levels in 2020. There is damage to the rear promenade wall in two places – notable a section of missing blockwork, approx. four blocks, that requires attention. The new drainage outfall, entry guard and WaStop are in good condition.

Area of recent repairs to promontory wall Missing blockwork in rear wall (/1201C04) (/1201C04)

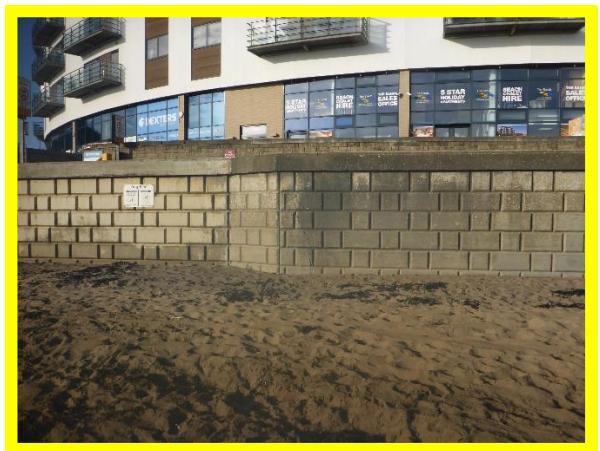
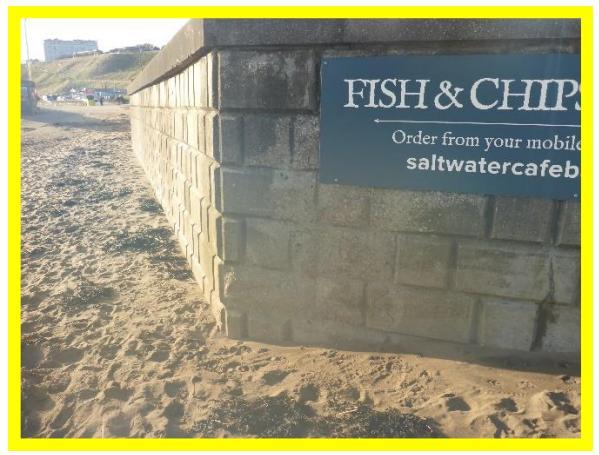
As reported in 2018, the wall to the north of the ramp at Peasholm Gap (/1201C06) continues to show several (currently minor) vertical cracks. These were noted not to have worsened since the previous inspection. There was an area of notable abrasion damage to the facing.

Vertical cracks in wall protecting recent development (/1201C06)

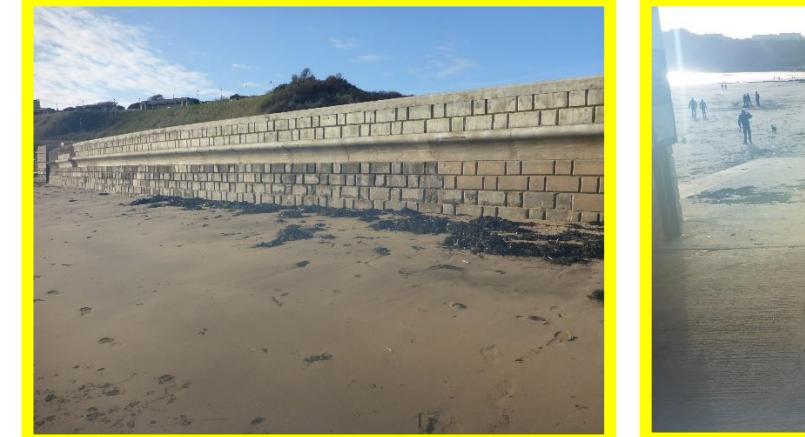
The beach levels at the wall at Peasholm Gap (/1201C19) were significantly higher during the 2020 inspection than on the previous inspection. It is estimated they could be as much 1.5m higher adjacent to the slipway. As a result, much of the lower courses, including the outlet, were buried. The extensive repairs, complete in 2014, are holding well and the core holes observed through blocks in 2018 have been filled. It was however reported in 2018 that there are still some damaged areas of blocks (thought to be buried with sediment in 2020) and spalling to the splash beam in areas not yet repaired. Overall, the wall remains in fair condition.

Previous repairs to wall at Peasholm Gap Slip way in fair condition (/1201C20) (/1201C19)

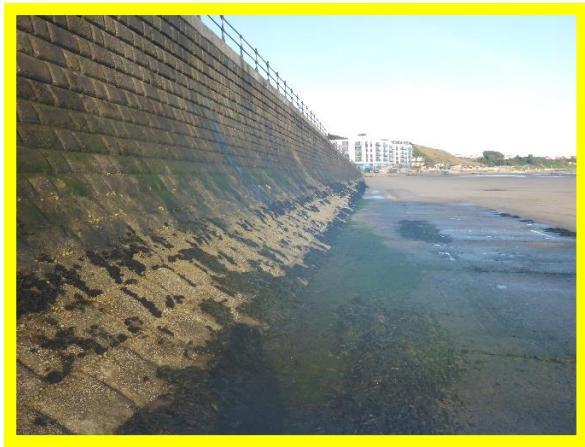
High curved-profile seawall (/1201C07)
