Cell 1 Regional Coastal Monitoring Programme Walkover Inspection Surveys 2020

Scarborough Borough Council

November 2020

Walkover Inspection Surveys 2020

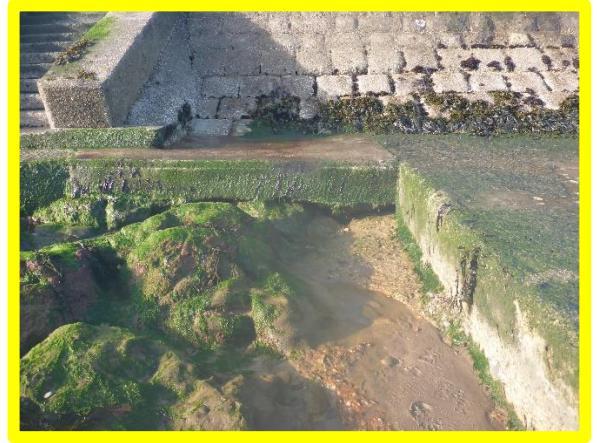
The access steps are in fair condition, however there is some minor undercutting to the lower steps. A full height vertical crack should also be monitored.

Undercutting access steps (/1201C07)

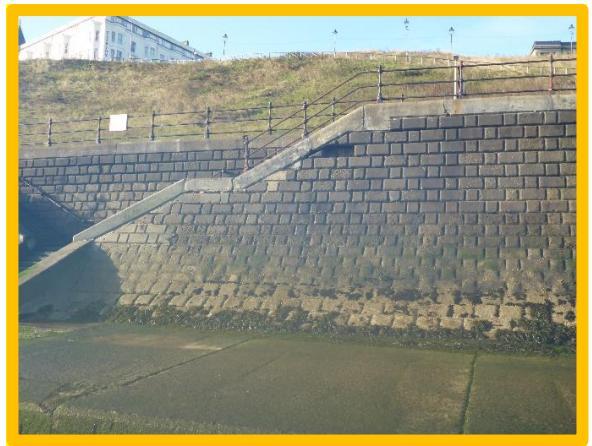
South of Peasholm Gap, Royal Albert Drive is protected by an increasingly high curve-profiled blockwork wall (/1201C07 and C21) that runs south to the slight promontory at the ramp opposite the recently redeveloped Oasis Café. The wall is in a generally fair condition. As reported in 2018, the previous repairs to joints, damaged wing-walls to beach access steps and entire sections of full height wall are holding well. The lower courses of the brickwork are showing signs of abrasion. There a couple of missing blocks adjacent to the access steps, these should be replaced before the defect deteriorates.

Missing blockwork (/1201C07)

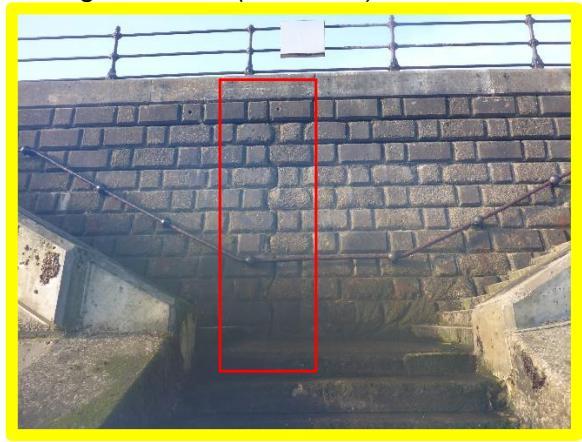
Vertical crack at access steps (/1201C07))

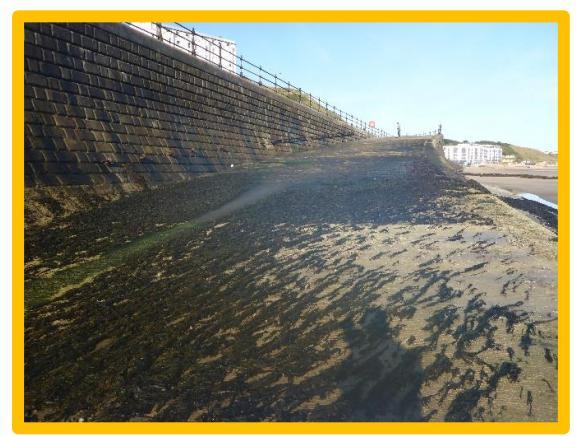
The slipway in front Oasis Café is fenced off to prevent access. However, members of the public were observed still using this ramp during the 2020 inspection. Further measures should be put in place to prevent this. The large vertical crack on the wingwall has deteriorated and a block is now missing adjacent to the crack. Surrounding blocks appear loose and are at risk of being displaced. The crack and blockwork defects appear to correlate to a depression in the deck suggesting settlement issues.

Access ramp still in use despite fencing Wing-wall at access ramp - 2020 (/1201C21)) (/1201C08)

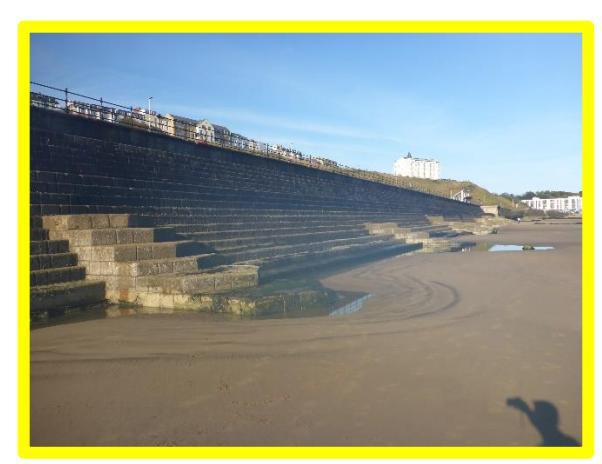
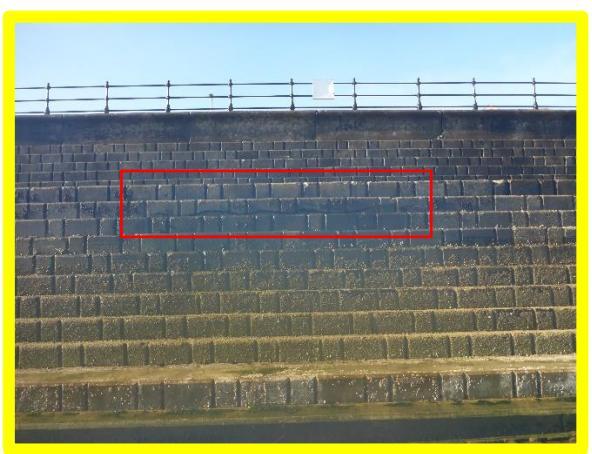
At the southern end of the North Bay, there is a large stepped concrete blockwork sea wall structure (/1201C08) constructed with nine large buttresses/bastions which protrude from the wall out onto the beach. The apron of the structure becomes increasingly exposed with progression north along the wall. There is one longitudinal crack in the blockwork across several adjacent blocks. Although noticeable, this has not deteriorated since the last inspection. The promenade surface is poor in places.

Concrete blockwall wall with buttresses Longitudinal crack in blockwall wall (/1201C08) (/1201C08)

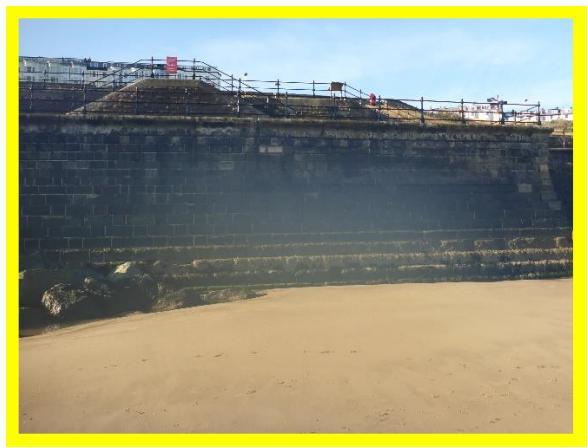
There is a short section of vertical blockwork wall (/1202C23) between the stepped concrete blockwork wall and the rock armour revetment to the south. This short wall is in fair condition overall, the missing blockwork at its southern end has been repaired. However, the lower three courses remain heavily abraded.

Repairs to southern end of wall (/1202C23)

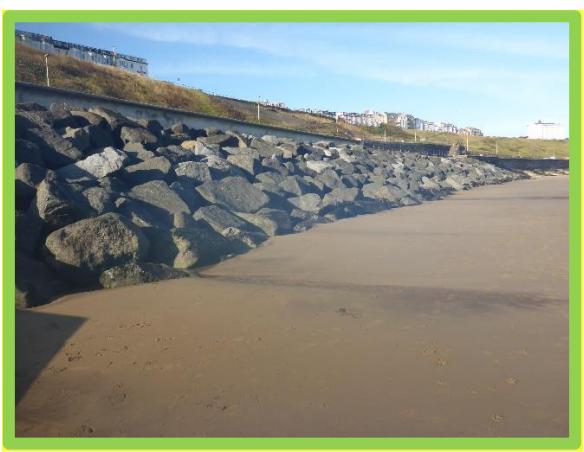
The southern-most section of defence in North Bay is the first section of the rock armour at Clarence Gardens that was constructed in 2004/5 (1202C01). This remains in good condition in 2020, protecting the original wall behind.

Rock revetment fronting seawall remains in good condition (/1202C01)

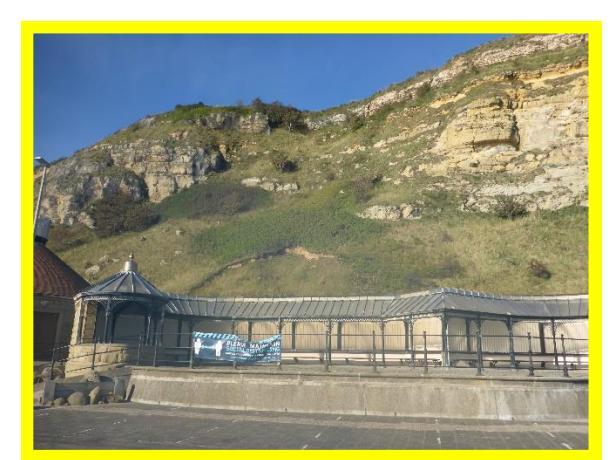
Unit MU21/2 forms the Castle Cliff promontory and continues to be classified as Locally Active, unchanged from recent inspections. The cliffs are steep with extensive toe protection measures and rock netting on exposed faces. Locally, bedrock is exposed where it is subject to ongoing weathering and erosion from rainfall. There are rock fall debris piles at the toe of the cliff highlighting past activity. There is one historic rotational slip behind seating area on Marina Drive.

MU21/2 Historic rotational slip (Locally Active)

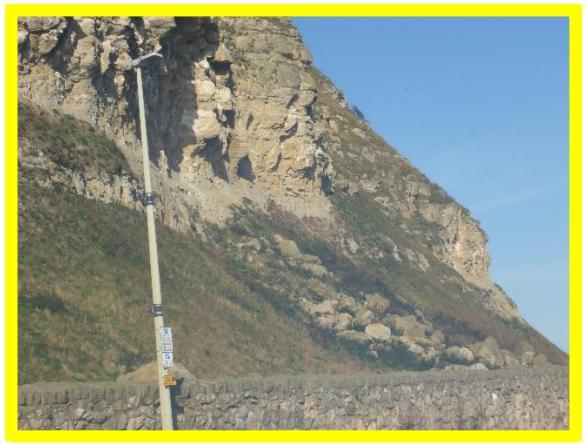
MU21/2 Rock fall debris at toe of cliff

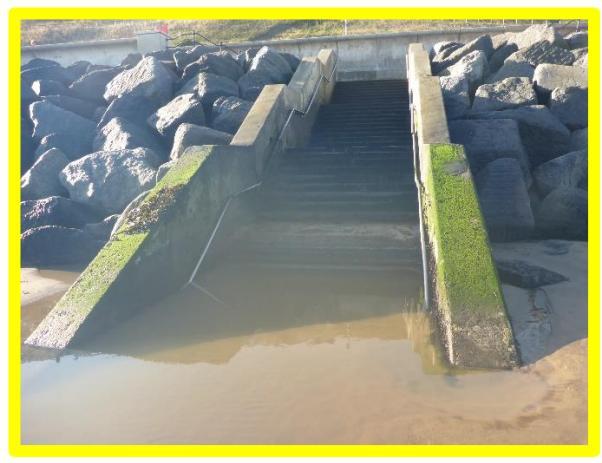
There is a continuous wave return wall along the crest of these defences, which remains in good condition along both asset lengths. Where there are beach access steps through the rock armour in the south part of North Bay (/1202C01), there is considerably more abrasion damage to the steps and locally scoured areas of the beach which leave a standing pool of water at low tide, making access to and from the beach difficult, but the structures themselves remain sound. The lower sections of the access steps (/1202C01) have steel edges in place which are now heavily corroded and starting to become a trip hazard.

Pooling making access diffcult (/1202C01)

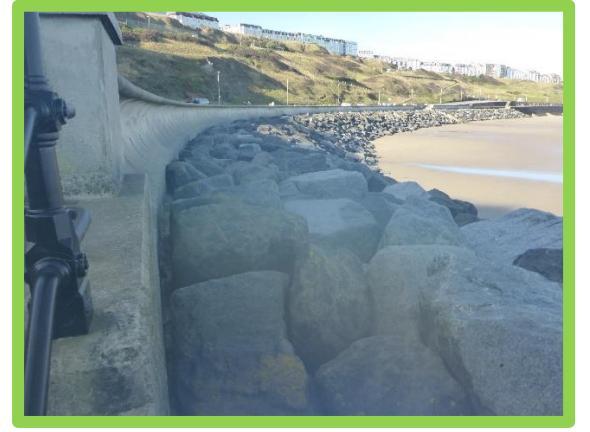
Rock armour revetment and wave return wall Rock armour revetment and with natural rocks (/1202C03)

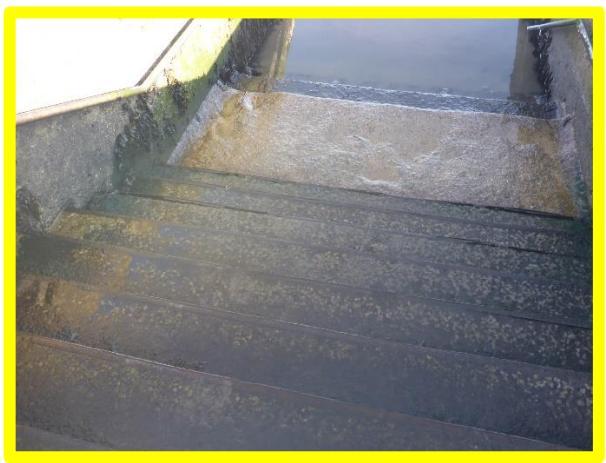
Steel edge corroding (/1202C01)

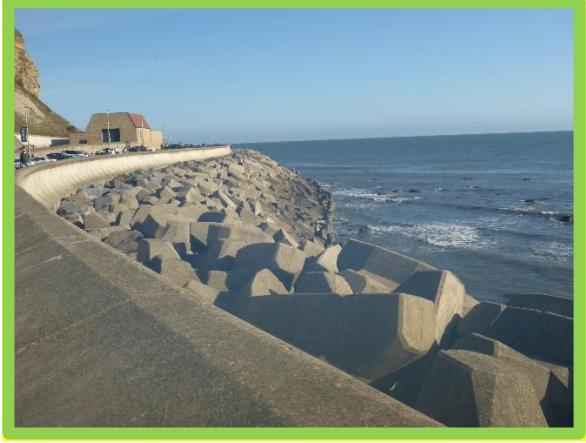
Accropode revetment with concrete toe piles, rock crest and wave return wall (/1202C02)

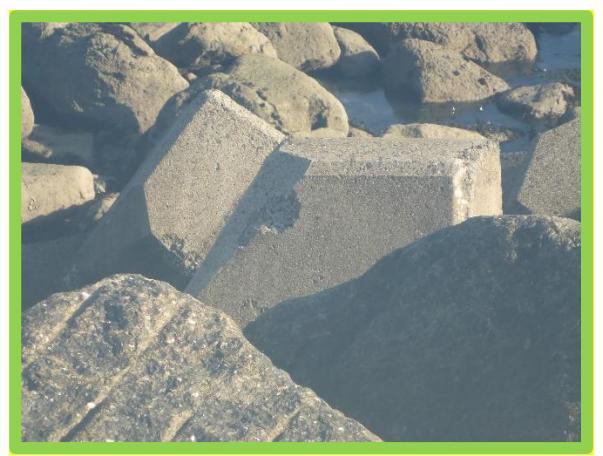
Example of locally abraded Accropode unit but otherwise good condition revetment (/1202C02)

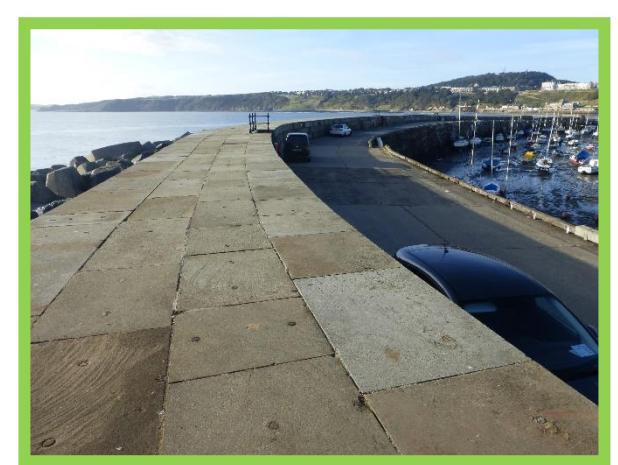
East Harbour outer pier (/1301C01)

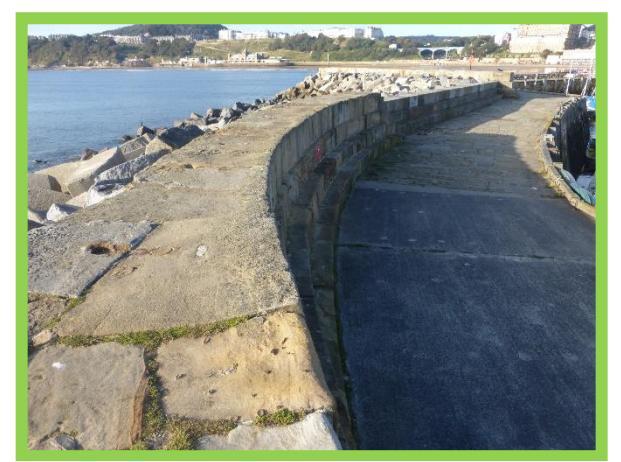
The outer facing pier of East Harbour's outer pier is protected by rock armour and Accropode units (/1301C01) and is in good overall condition. Towards the seaward end of the pier, many of the original wall blocks on the crest of the outer wall are heavily abraded and some are partially cracked.

Abrasion towards seaward end of East harbour outer wall (/1301C01)

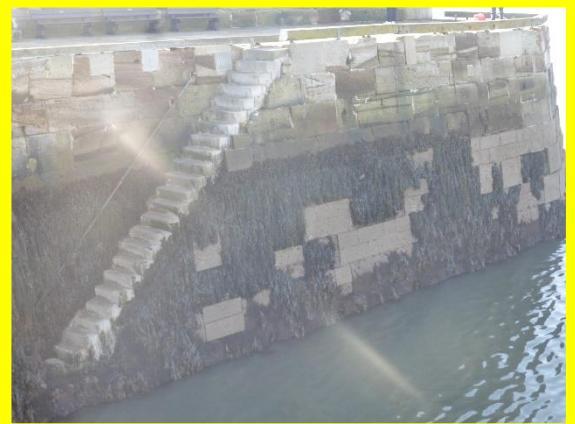
Access steps at nose of East Harbour pier in fair condition. (/01301C01)

Access steps at root of East Harbour pier in fair condition. (/1301C01)

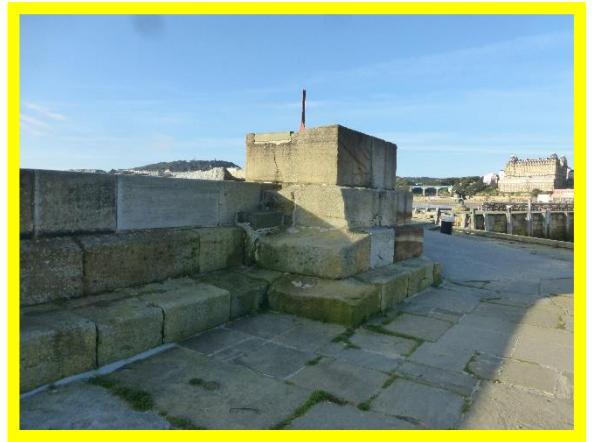
Repairs to the crest of the original wall toward the seaward end of the East Harbour outer pier (/1301C16)

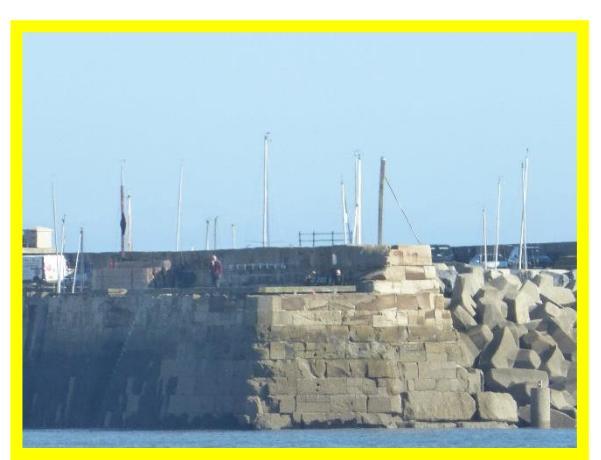
Despite timing the inspection around the low tide, the seaward end of the East Harbour's outer pier could not be inspected as it remained underwater. When looking back towards the pier from the south it was possible to identify several large lateral voids in the seaward face of the structure. These were not visible from the pier itself. A more thorough structural inspection of this area is recommended to determine the size and nature of these voids.

Voids visible around low water mark. (/1301C16)

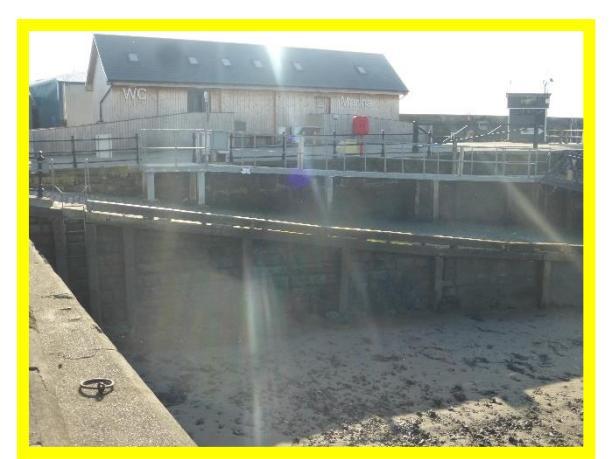
Wall of Vincent's Pier facing west (/1301C04)

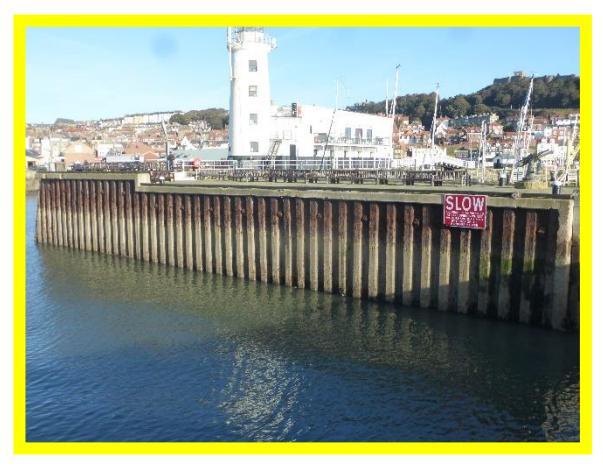
At the harbour arm beyond the Captain Sydney Smith Bridge, near the lighthouse, the steel sheet piling on the outer wall (/1301C17) is corroded but no holes were obviously apparent. It is notable that the blockwork walls at the end and inner facing walls (/1301C03) of this pier have evidence of missing mortar and joints, the overall condition of the pier remains fair.

Corroded steel sheet piling (/1301C17)

Cracks and missing mortar on inner wall at entrance breakwater (/1301C03)

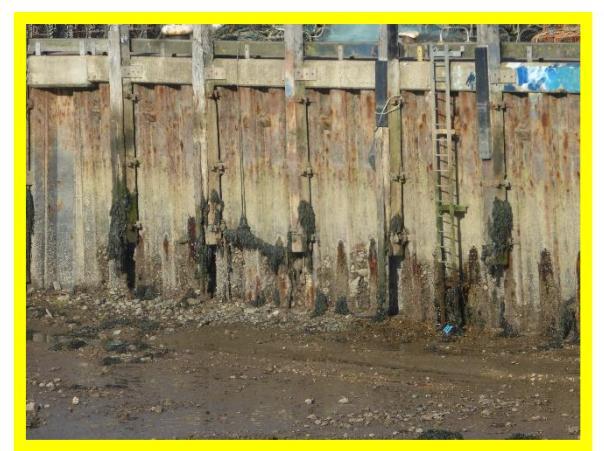
Corrosion and vegetation growth on steel sheet pile wall. (/1301C12)

West of the arches, the quay wall leading to the slipway midway along Sandgate is formed by steel sheet piling (1301C12) which is corroded but otherwise appears in fair condition. The slipway (1301C11) remains in fair condition, as is the short length of visible blockwork quay wall (1301C06) adjacent to the slipway. The handrail running along the edge of the blockwork key wall, above the slipway was damaged and requires repairing in two locations.

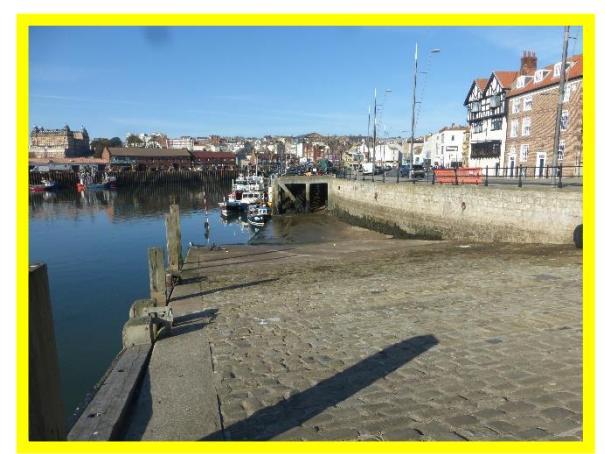
Slipway, quay wall and concrete jetty (/1301C11 and C06)

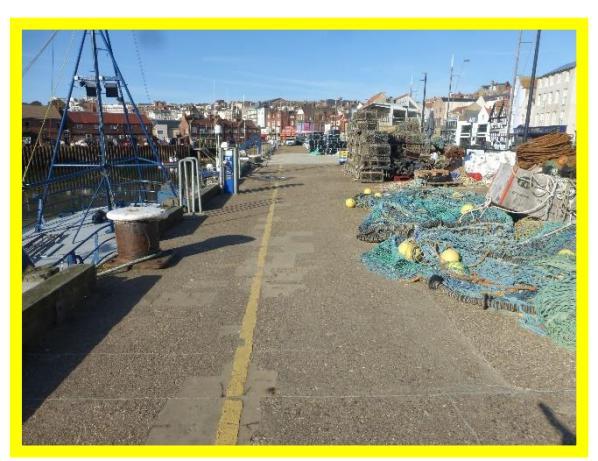
Suspended deck of concrete jetty (/1301C06)

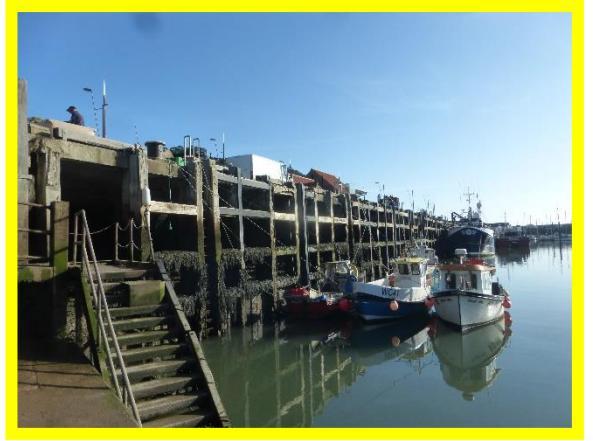
Looking up towards suspended deck of concrete jetty (/1301C06)

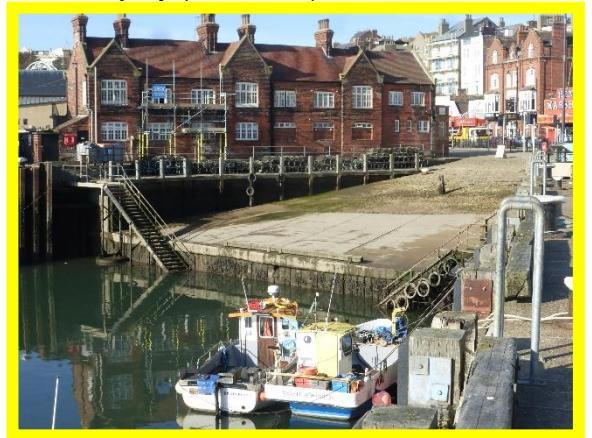
Looking towards slipway at western end of Sandgate (/1301C14)

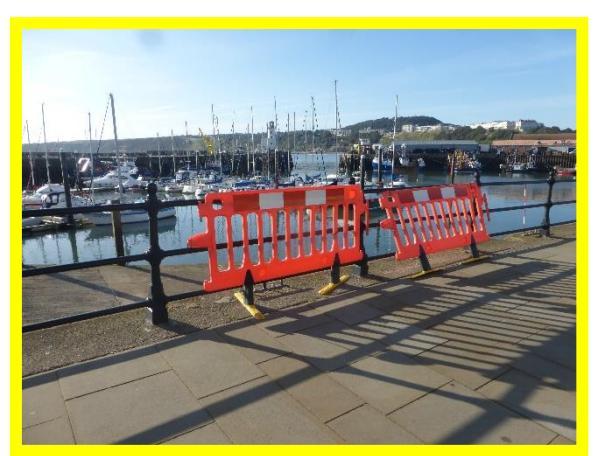
One area of damage to the handrailing along (/1301C06) above the slipway.

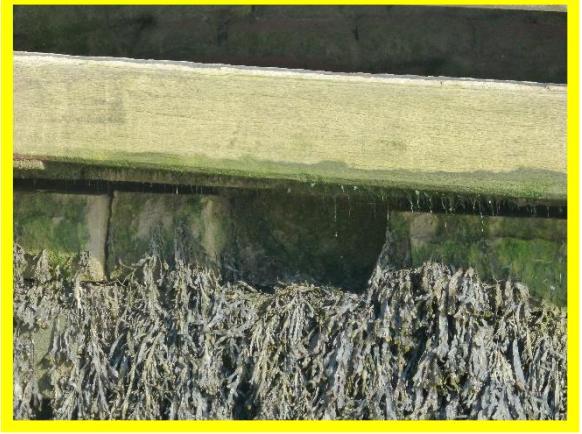
Immediately west of here is a concrete jetty which has been constructed to extend a suspended deck seaward of the wall. Previous inspections have reported signs of movement of the jetty and original quay wall, but this is not obviously apparent as has been reported in recent walkover inspection. There was no sign of cracking or lateral movement across the deck. The slipway and wall at the western end of Sandgate (/1301C14), adjacent to the West Pier, is generally in fair condition however some damage and displacement to the northern blockwork wall was noted during the inspection.

Minor damage and displacement to blockwork wall (/1301C14)

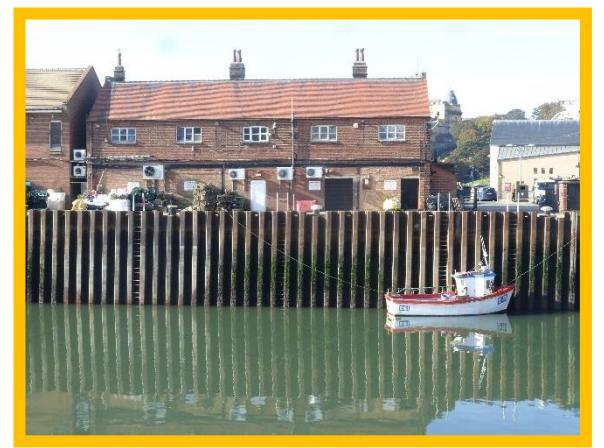
The inner face of the West Pier (/1301C13) appears to be mostly in fair condition, but the steel sheet piling is corroded. The seaward end (/1301C18) also has corroded steel sheet piling and longitudinal cracks in the concrete capping beam, reported in the 2018 inspection remain. As such the poor condition rating is retained following the 2020 inspection. Immediate repairs are recommended to the capping beam.

Corroded steel sheet piling on inner face of West Pier (/1301C13)

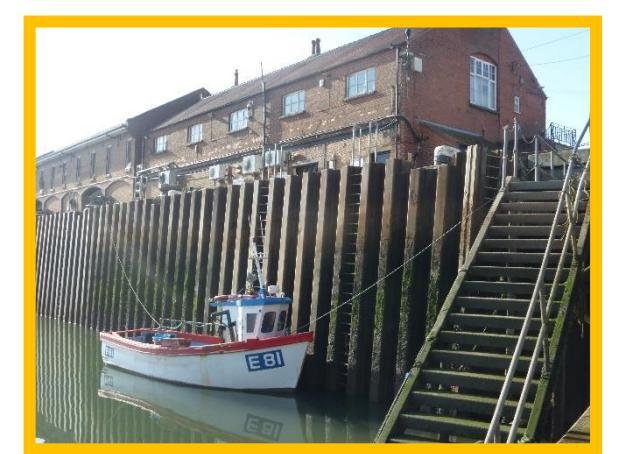
Corroded steel sheet piling notably worse directly adjacent slipway (/1301C13)

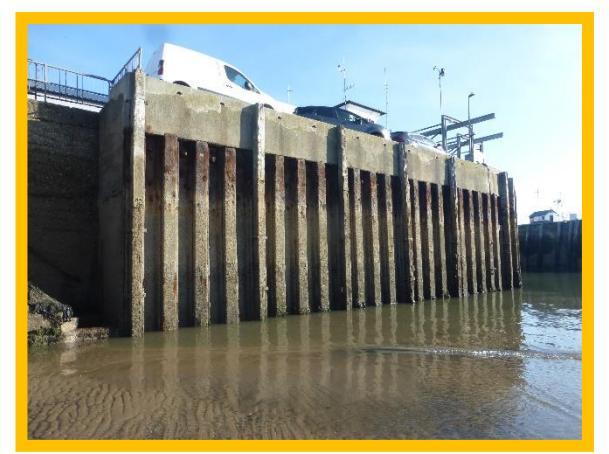
Corroded steel and cracked capping beam on seaward end of West Pier (/1301C1718)

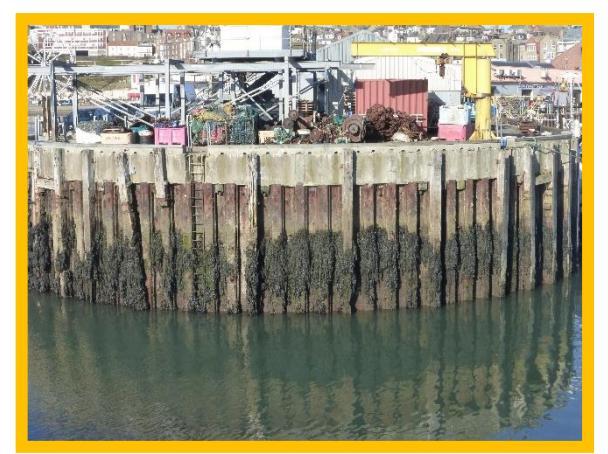
Corroded steel and damage to capping beam on seaward end of West Pier (/1301C1718)

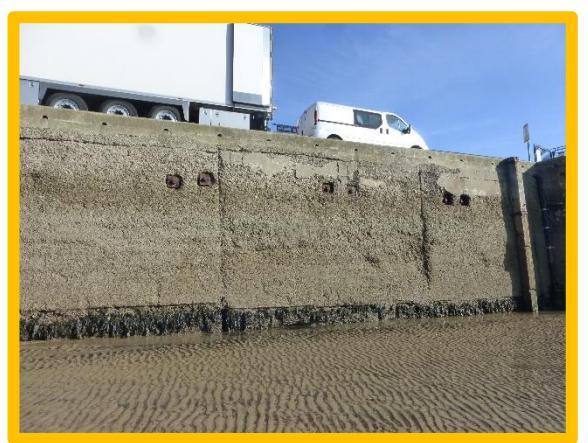
The outer face of West Pier (/1301C07) continues to show several significant defects including numerous longitudinal cold joints, several large full height cracks and exposure of aggregates. Its condition has been recorded as poor since 2009. Some previous repairs are obvious but in places cracks remain partly open. There is one area of voiding near the toe of the wall which was reported in 2018 and remains unchanged. There is extensive spalling and loss of render near the seaward end of this southern face. Repairs are recommended.

Longitudinal cold joints in south face of West Pier wall (/1301C07)

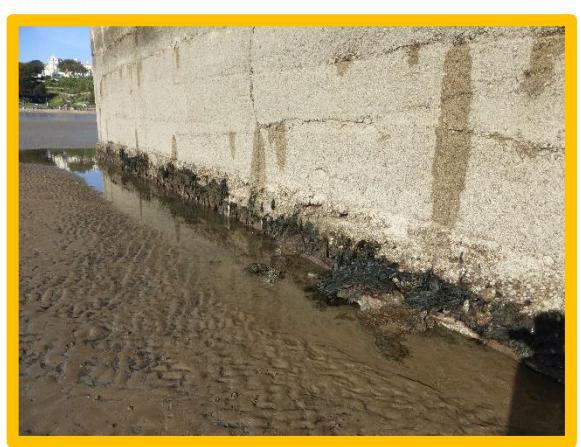
Evidence of spalling at base of south face of West Pier wall (/1301C07)

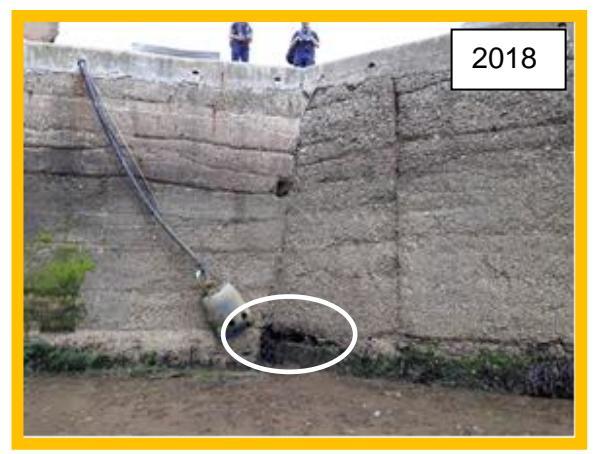
2018: Void at toe in south face of West Pier wall and damaged conduit (/1301C07)

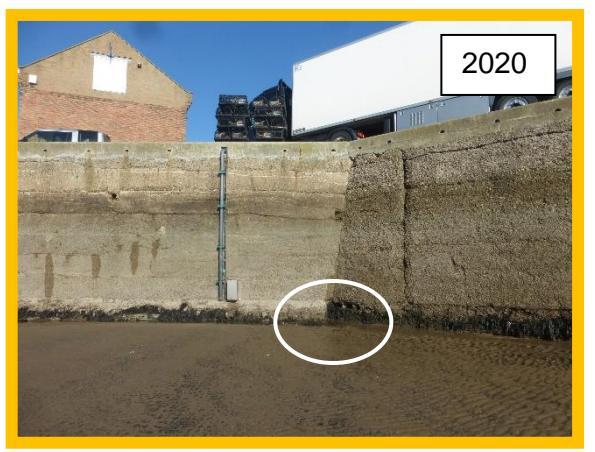
Spalling and loss of render in south face of West Pier wall (/1301C07)

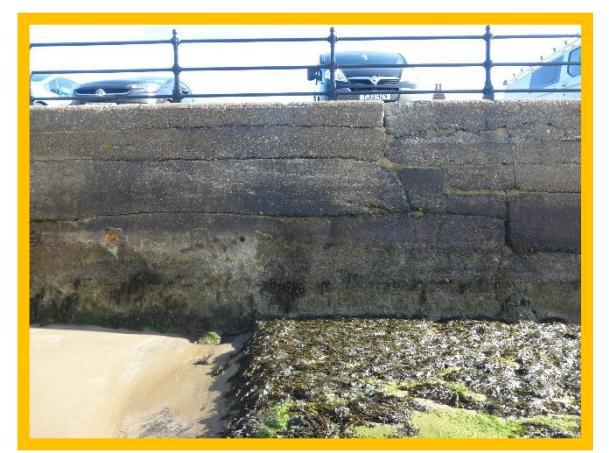
The poor condition of the seawall extends to its landward end (/1301C19), unchanged since 2018 and urgent repairs are recommended now that the RNLI lifeboat station is complete.

Large open joints and cracks are evident from along the wall's full extent (/1301C19)

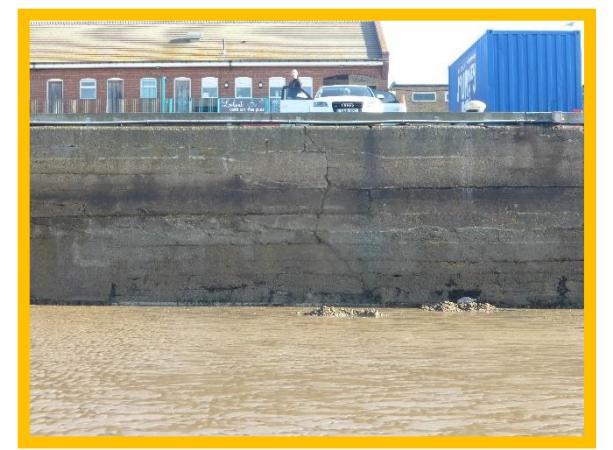
Some evidence of voiding at toe of wall and full height cracks from crest to toe of wall (/1301C07)

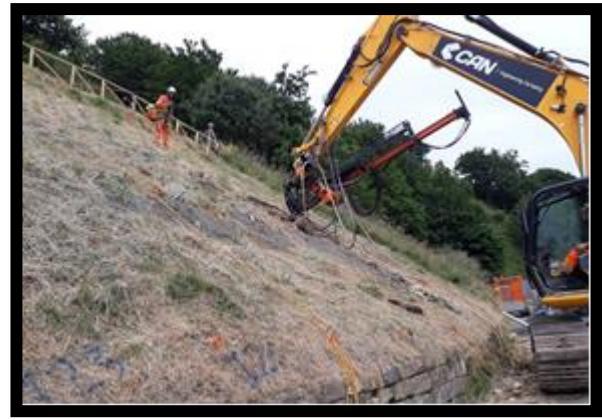
MU22/2 Soil nail installation on coastal slopes near the Spa in 2018

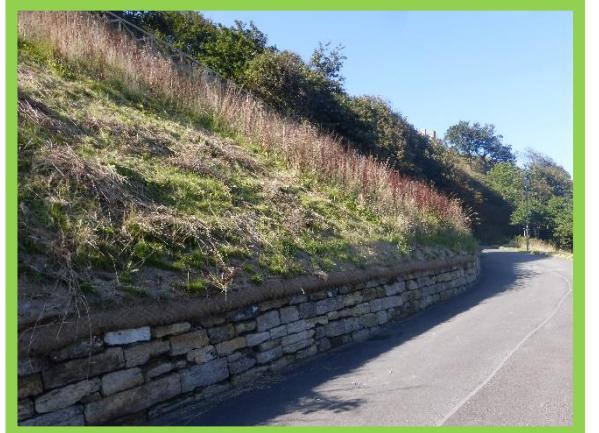
MU22/2 the same slope as above in 2020. Soil nails installed. Vegetation management ongoing.

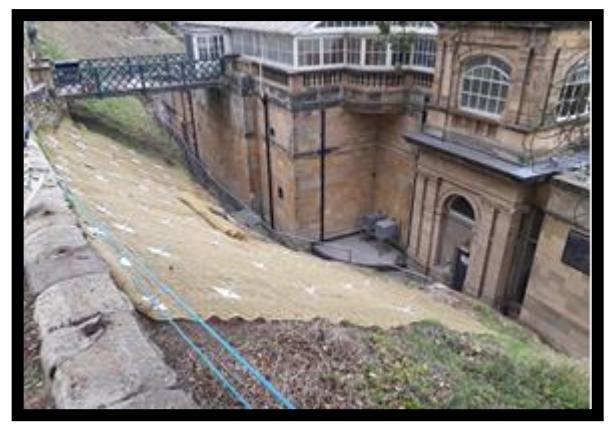
MU22/2 Soil nail and slope mesh installation behind main Spa building in 2018

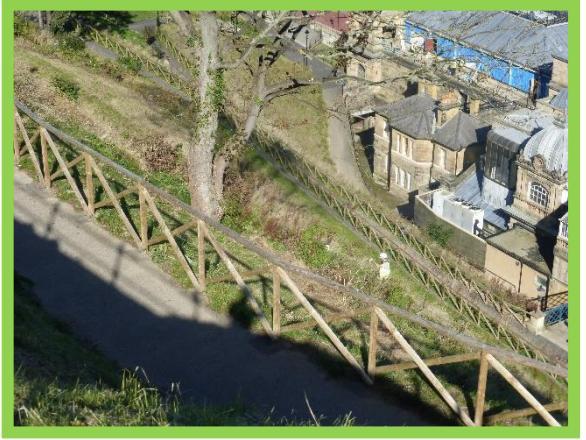
MU22/2 looking down behind main Spa building in 2020. Note vegetation management ongoing.

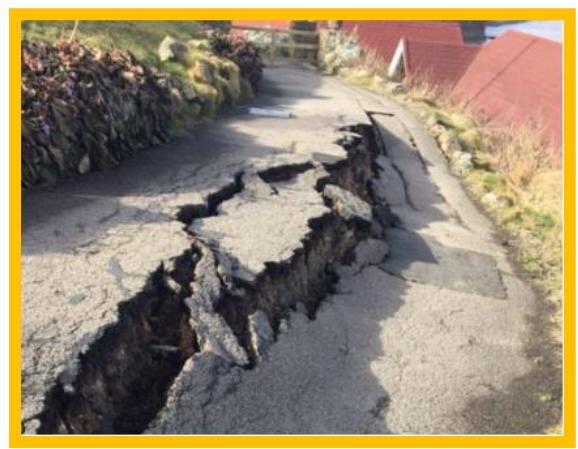
Units MU22/4 and MU22/5 comprise the northern part of the South Cliff Gardens and were both classified as Inactive in 2016, unchanged since previous surveys. In March 2018, a retaining wall at the back of some chalets below the Clock Café failed. This also caused large cracks to appear in the footpath above. During the 2020 inspection slope stabilisation works were ongoing in order reduce the risk of localised failures. MU22/4 has not been classified in 2020 due to the ongoing works within this whilst unit MU22/5 retains its inactive status.

MU22/4 large cracks in footpath above chalets in the location of the wall failure (Photo from 2018 Report).

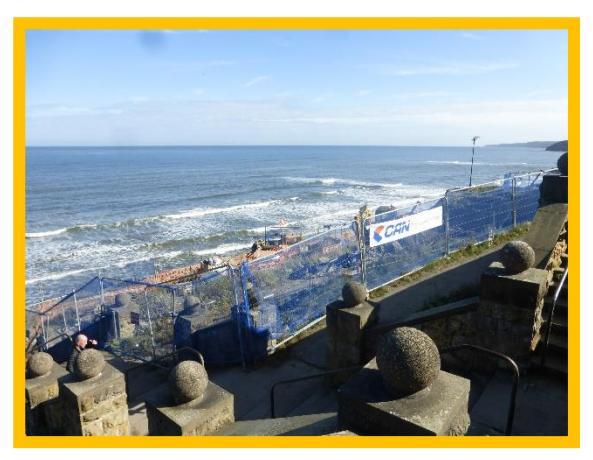
MU22/4 slope stabilisation works ongoing during the 2020 inspection.

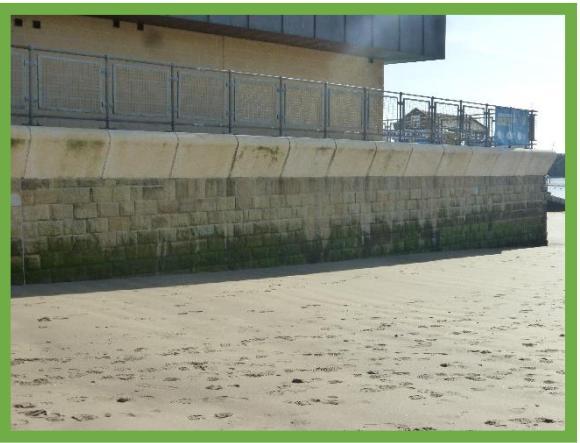
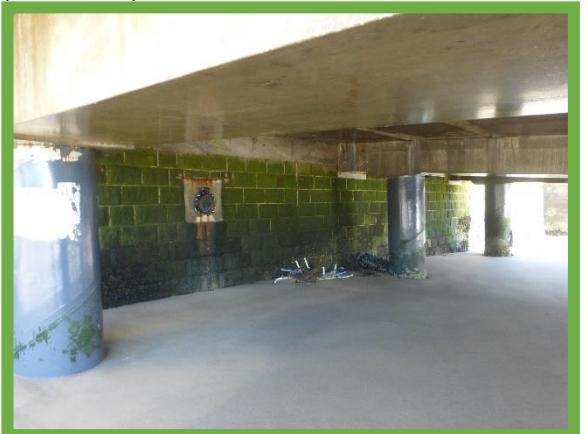
The South Bay defences start at the RNLI lifeboat station, adjacent to West Pier (/1301C08). The construction of the new RNLI Lifeboat Station has been completed since the last inspection. The works were completed in November 2016 and were generally found to remain in As Built condition during the 2020 inspection. Around the full perimeter of the seawall vegetation growth was observed. Although this does not pose an immediate risk to the structure it may lead to defects being missed or not identified. This impact of this is most notable beneath the slipway where vegetation growth now obscures the full height of the wall. Generally, the wall remains in As Built condition however one notable defect was observed adjacent the slipway where a block has come loose from the wall itself. Due to the small voids which have appeared either side of the block the defect poses a risk of water ingress into the structure itself, particularly if the block is further dislodged.

New RNLI lifeboat station wall beneath slipway Dislodged block on new seawall (/1301C08) (/1301C08)

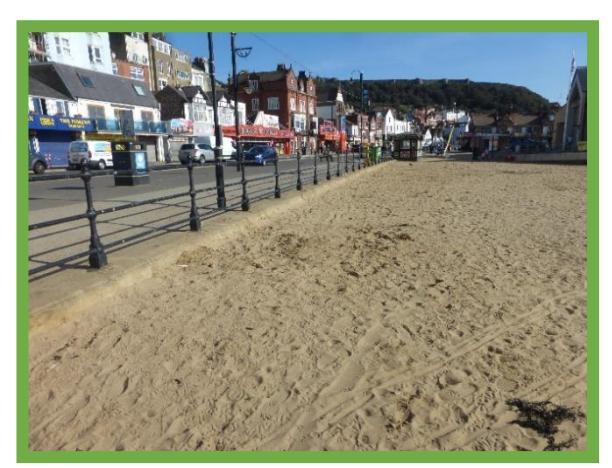
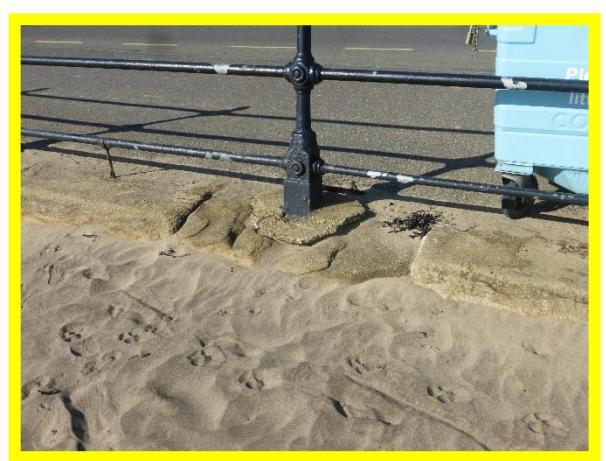
The low defence wall along the east side of Foreshore Road is split into a number of asset lengths between sets of access steps. These are, running from north to south /1301C15, C21, C22, C23, C24 and C25. Due to high beach levels at the time of inspections, sand was often flush with the promenade or, at best, only the top one or two courses of stone blocks were visible along most of this length. Due to the high beach levels, the northern section of frontage is classed as being in good condition, with the wall where exposed around the Olympia Leisure reducing to fair condition because of frequent washed out joints and abrasion to blocks, which would benefit from repair.

Beach levels flush with promenade at north end An area of abrasion at top of wall (/1301C23) of Foreshore Road seawall (/1301C15)

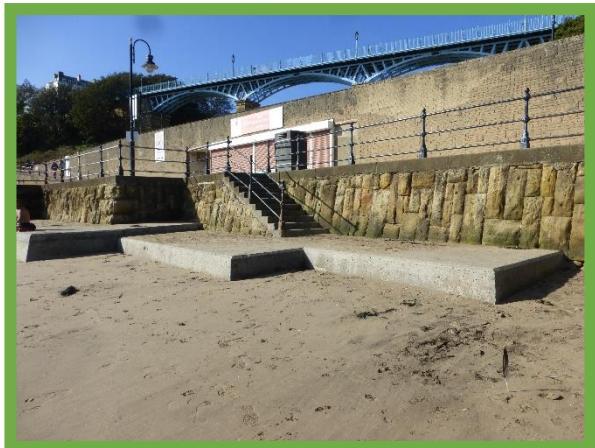
Repairs remain in good condition locally, but overall asset condition is fair (/1301C09)

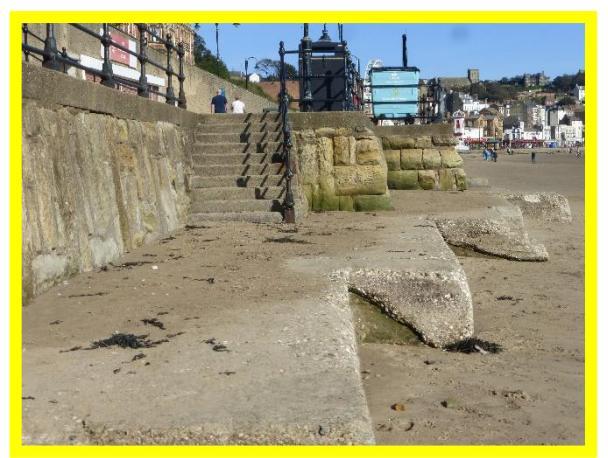
Abrasion of toe apron south of previous repairs beach levels notably higher than 2018 (/1301C09)

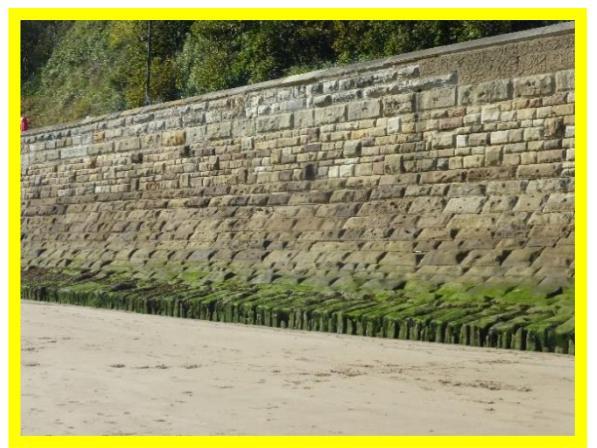
Occasional minor defects but overall fair condition seawall (/1301C26)

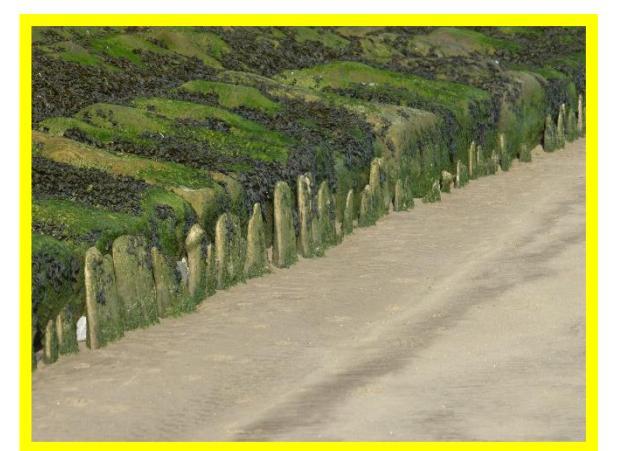
Exposed timber piles on concrete apron. High beach levels obscured view of lower section of apron. (/1301C26)

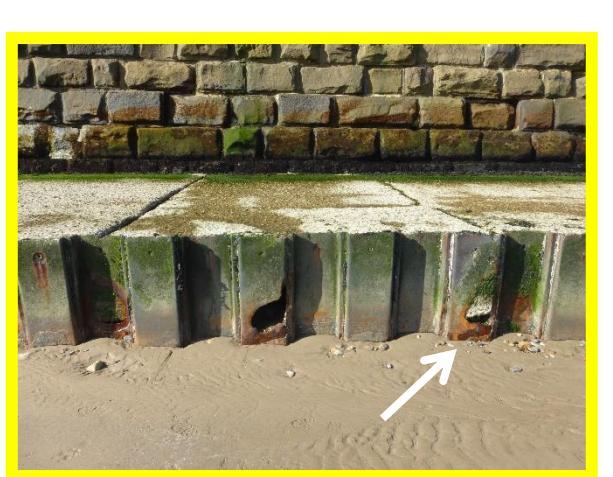
Example of gaps between blocks in sea wall (/1301C27)

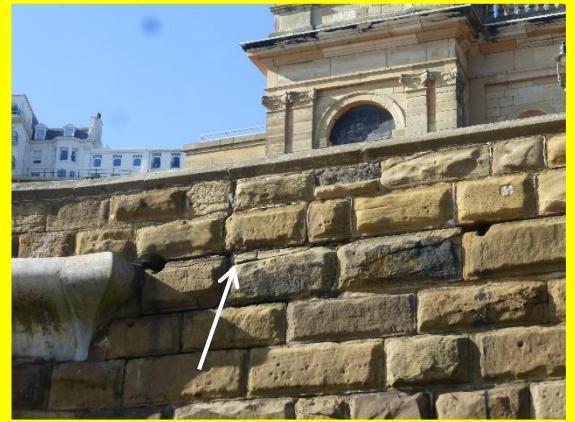
Longitudinal cracks across blocks in sea wall (/1301C27)

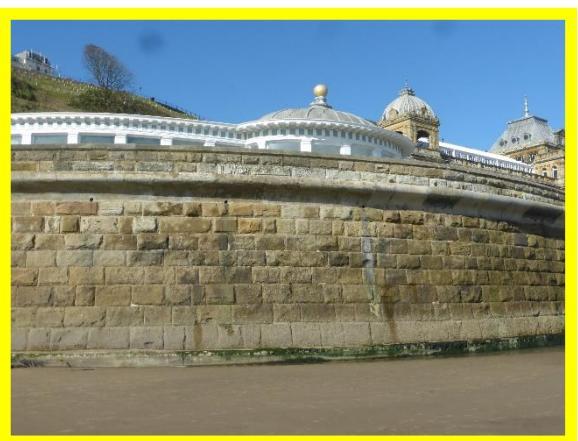
Previous repairs to wave deflector wall in front of the Sun Court & concrete toe submerged beneath high beach levels (/1301C28)

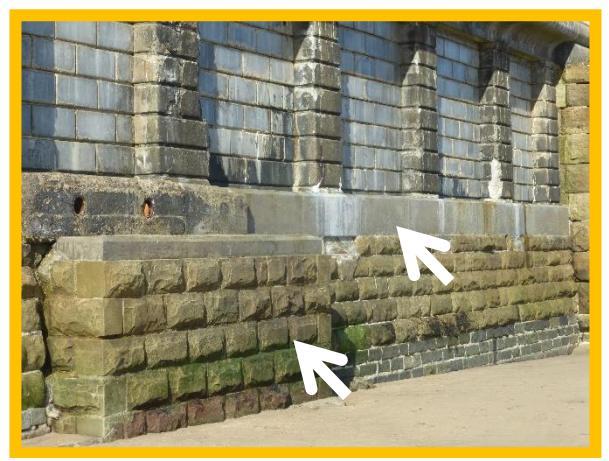
Spalling to the lower splash beam at closed colonnade section and undercutting at toe (/1301C29)

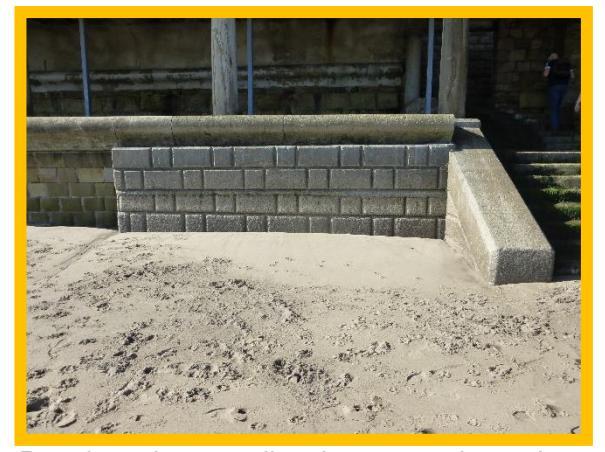
Repairs to lower wall at the open colonnade are in good condition with remaining sections of original wall in fair condition. (/1302C01)

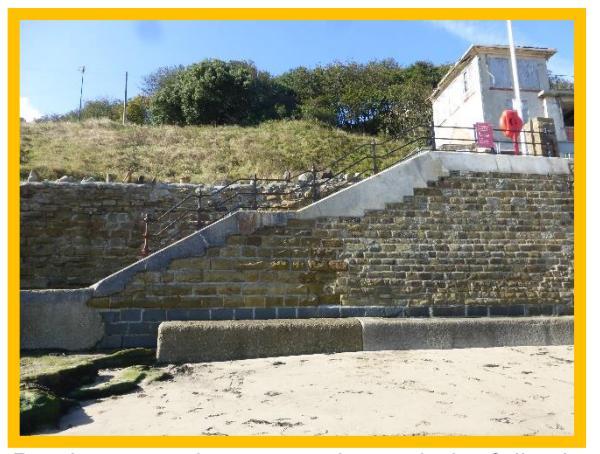
Previous repairs at southern tie-in following December 2013 storm damage (/1302C01)

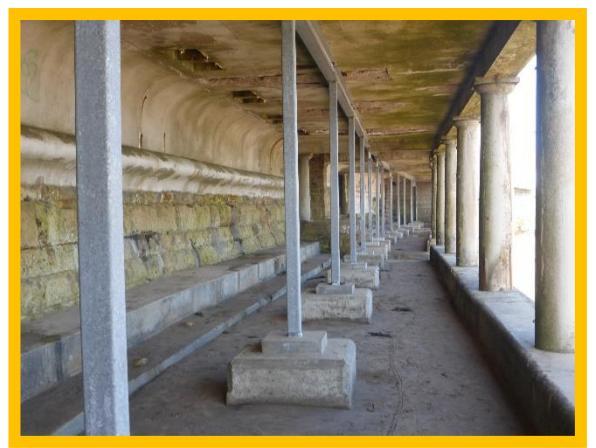
Steel columns and support beam supporting Concrete plinths in as built condition (/1302C01) upper promenade (/1302C01)

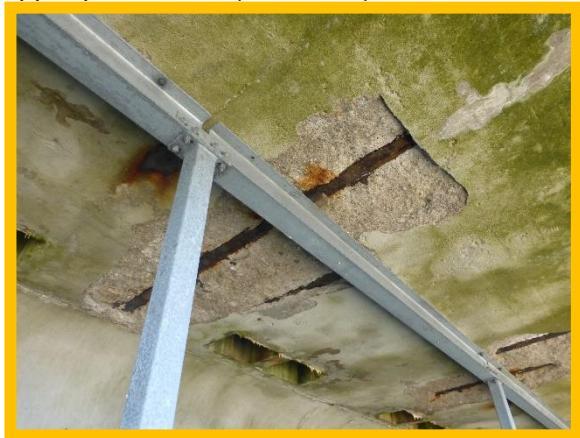
Along the open colonnade section (1302C01) there are three flights of access steps from the lowlevel promenade to the beach, all of which are heavily abraded. The wall itself is in generally in poor condition despite previous December 2013 repairs remaining effective, with significant areas of open joints in other sections of the lower wall. During the 2020 inspection it was noted that works have been undertaken to support the upper promenade from beneath. The works are formed from a framework of galvanised steel columns set into square plinths. A horizontal I-section beam runs the full length of low-level promenade between the galvanised steel columns. The steelwork and concrete works are in as built condition. The concrete support pillars which form part of the original structure remain in a poor condition. The underside of the upper promenade deck is in poor condition with cracking, spalling and corrosion staining visible. Further repairs were noted to the face and toe of the lower wall. The repairs were noted as being in good condition with the original sections in fair condition. The access steps to the beach at the southern tie-in have been subjected to extensive repairs following previous damage in December 2013.

Damage to underside of upper promenade (/1302C01)

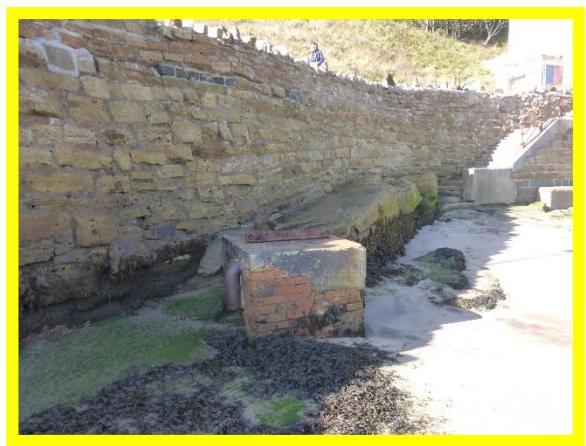
The low stone wall at South Cliff Gardens (/1302C03) has had a considerable number of repairs and rebuilding over the last few years, however notable cracks and gaps remain in need of further attention. The wall remains largely unchanged in 2020.

Overall fair condition of low stone wall (/1302C03)

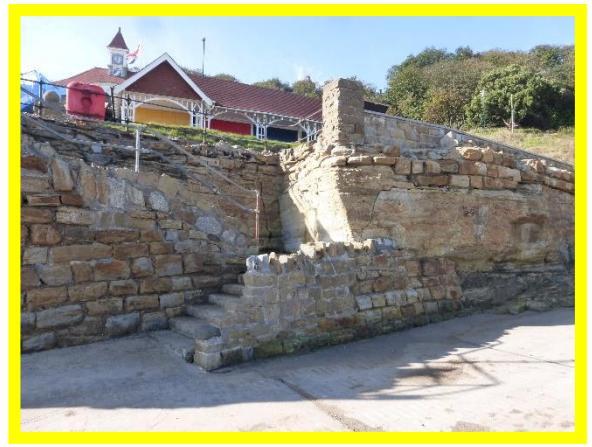
Overall fair condition of low stone wall and access steps (/1302C03)

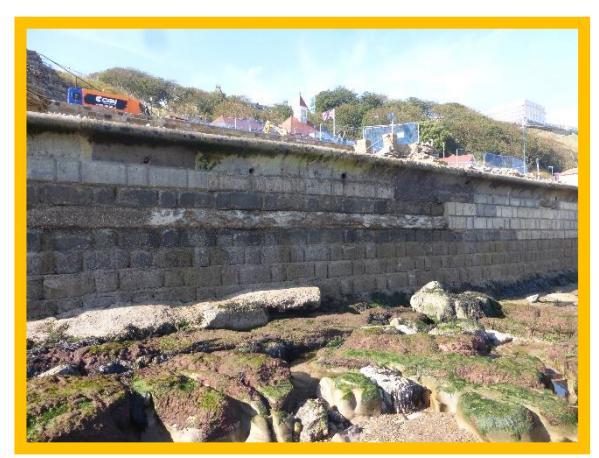
The low stone wall continues at the rear of the promenade around South Cliff Gardens with a seawall in front (/1302C02). The seawall has a considerable number of historic repairs to the blocks and coping. Several repairs have been made since the previous inspection including repairs to a damaged section of the coping, the upper splash wall and at the southern end of the wall to the bagwork tie-in wall. At the southern tie-in the upper courses of the wall have been replaced with a tiered concrete wall which sits upon the original bagwork. The repairs which have been made to the defences have improved the overall condition of the wall to fair with the repairs remaining in good condition.

Overall fair condition seawall is fair (/1302C02)

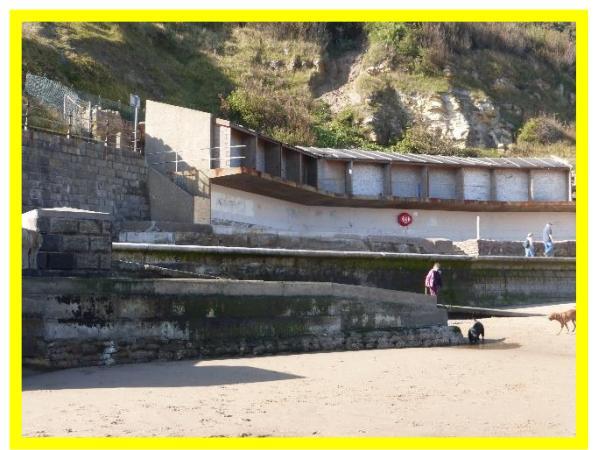
Bagwork/screed wall (/1302C02)

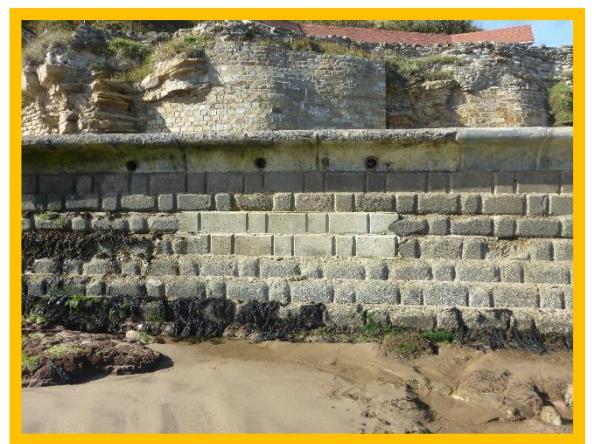
Repairs to wall face (centre) and coping (upper right) in good condition. Further spalling and damage visible (mid right) (/1302C02)

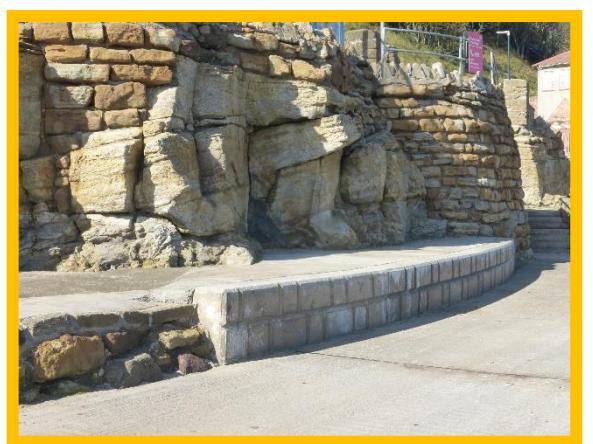
Repairs to splash wall on promenade in good condition (/1302C02).
