Cell 1 Regional Coastal Monitoring Programme Walkover Inspection Surveys 2020

Scarborough Borough Council

November 2020

Walkover Inspection Surveys 2020

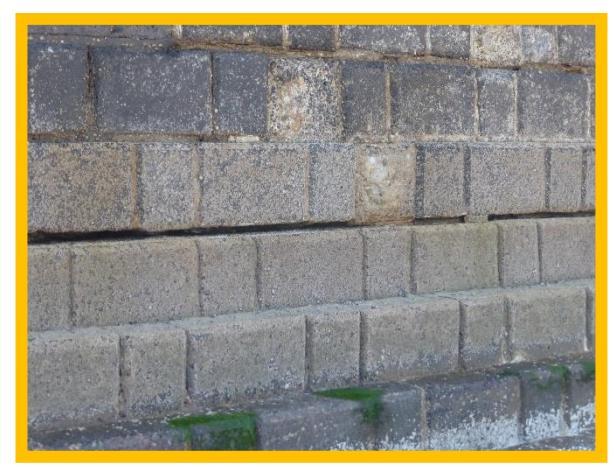
A concrete block wall (/1303C02) extends around the infilled lido pool, which is now used as a Star Disc. This wall has slightly stepped blocks on its face and these blocks and the wave return capping beam showed continued signs of considerable abrasion. Some areas of the wall have been subject to beneficial repairs, but there are numerous other areas of open joints. In one location, a failed outfall pipe extends across the foreshore. The wall's condition has previously been classed as poor and ongoing repairs/maintenance would be beneficial. It was notable in 2020 that one section of the wave return capping beam has been repaired and is in good condition.

Concrete block wall with open joints and heavy abrasion (/1303C02)

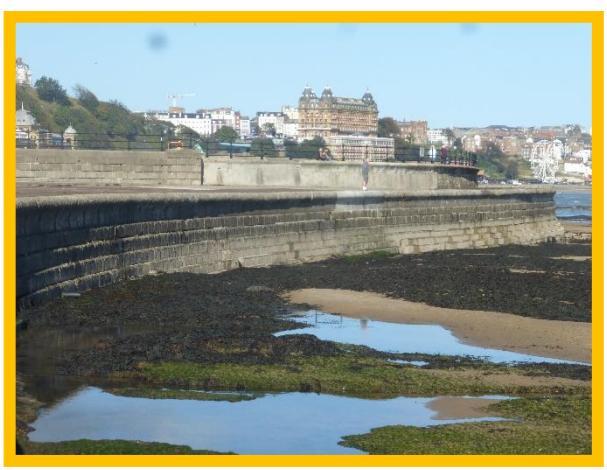
Previous repairs to wave return coping (/1303C02)

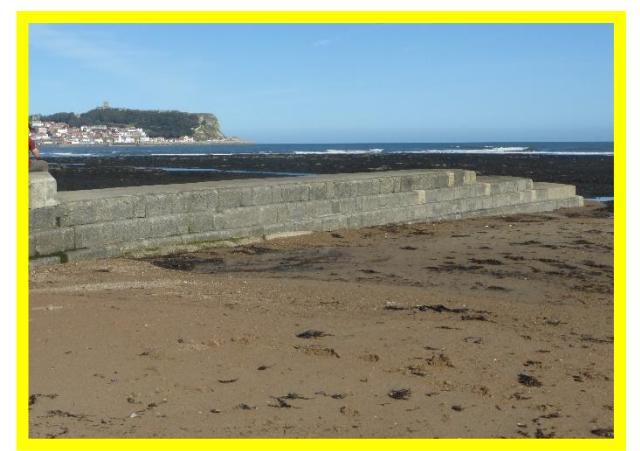
There is a bastion groyne at the north of this frontage (/1304C02) which has trapped sand between here and the rock revetment around the Holbeck Hall landslide to the south. The lower sections of the backing seawall have areas of previously repaired and currently heavily abraded coping, with previous repairs also evident on the upper wall. The promenade deck which sits above the wall has been closed due to rockfall from the cliffs to its rear and as such could not be inspected along its full length. It was possible to view the promenade from a distance from the south and the condition appeared poor with evidence of extensive cracking.

Bastion groyne in overall fair condition (/1304C02)

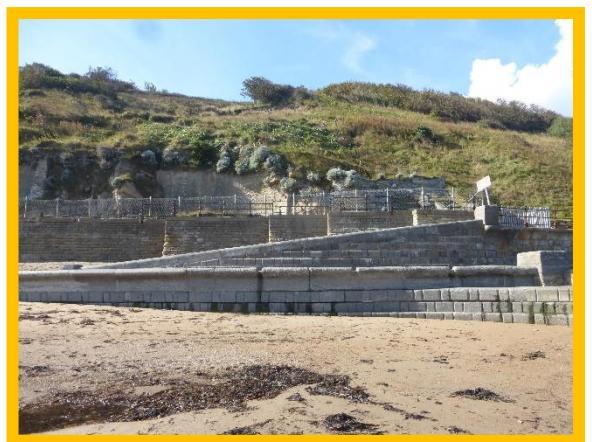
Seawall in overall poor condition Cracks to bastion throughout. Mortar missing between blockwork in lower wall. Corroded handrail with missing sections. Full height cracks through uppermost wall. (/1304C02)

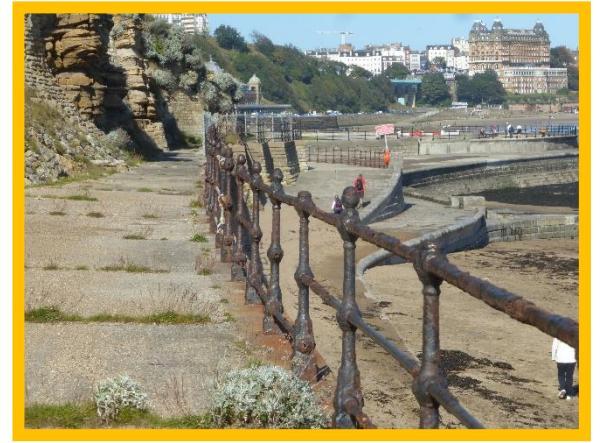
Upper prom has been fenced off and is in poor condition (/1304C02)

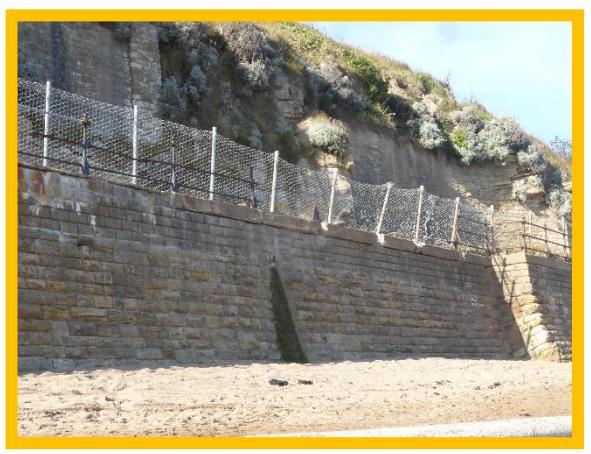
Missing pointing / open joints and damaged parts of upper and lower capping beam (/1304C02)

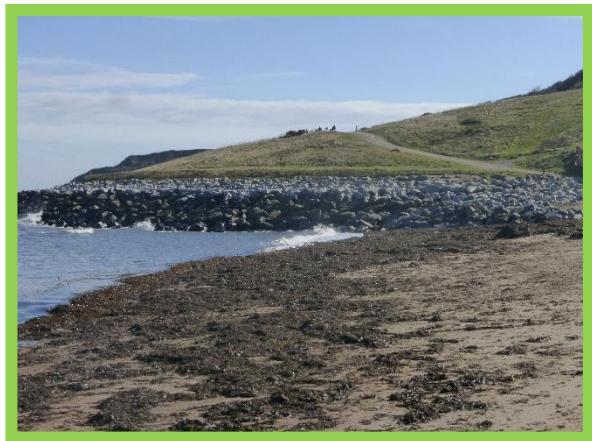
The rock armour revetment (/1304C01) defending the relict debris flow lobe at the site of the Holbeck Hall landslide remains in good condition in 2020, with the armour tightly packed and good coverage. At the southern end of the defence the beach access ramp has a vertical drop to rocks onto the beach making its use difficult and there a crack in the most seaward concrete section which would benefit from repair. The condition of the slipway is such that it does present a health and safety risk to members of the public who may choose to access the beach in this location.

Rock revetment around debris lobe of Holbeck Hall landslide (/1304C01)

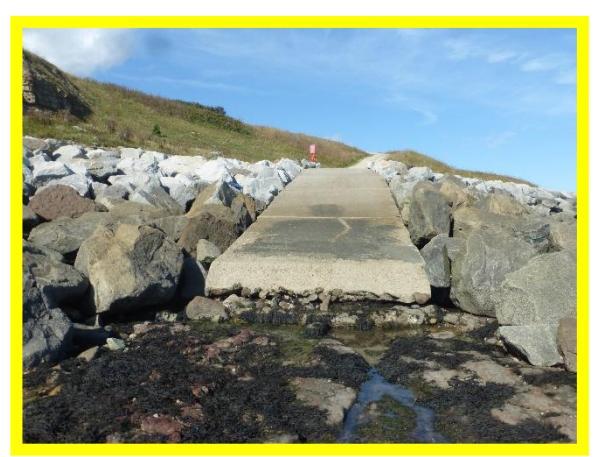
Vertical drop and crack in concrete at end of access ramp at south end of revetment (/1304C01)

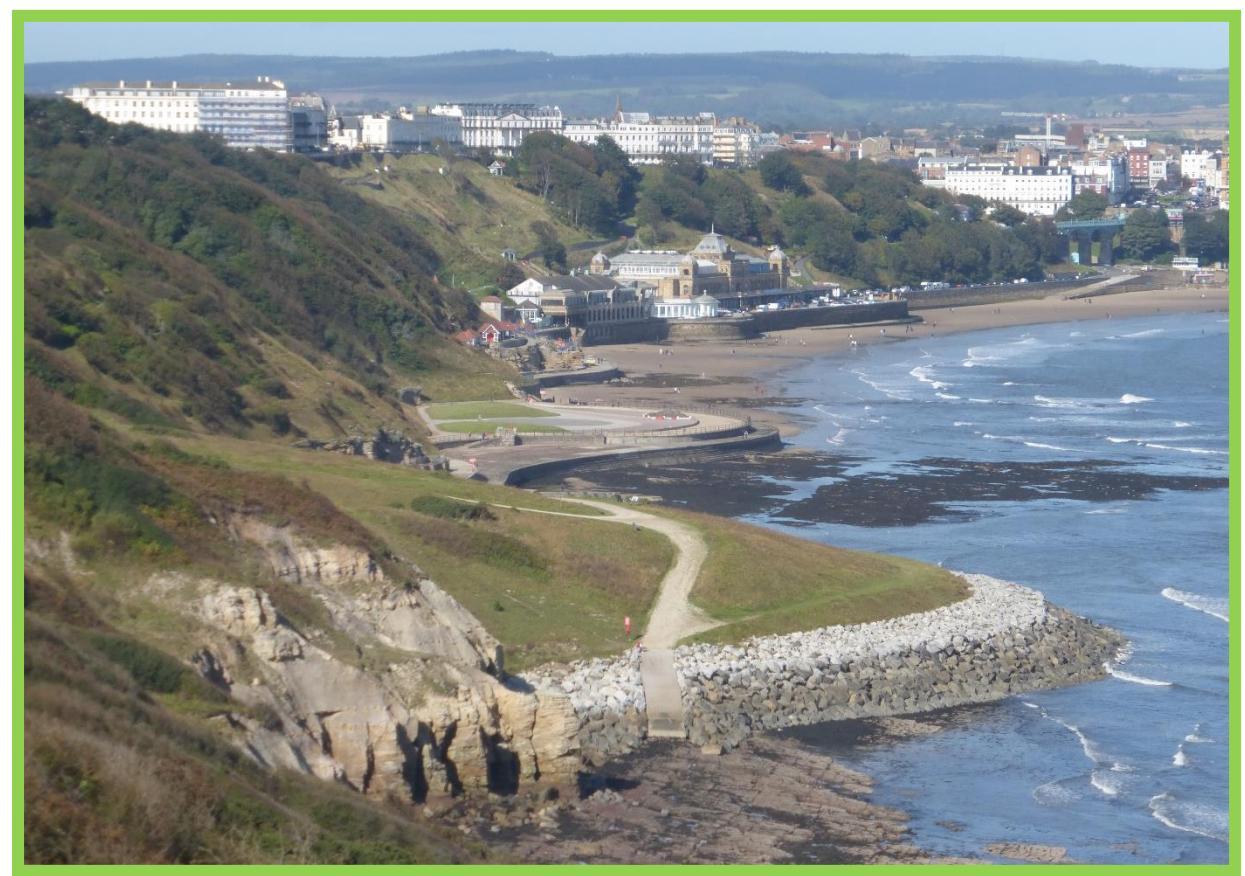
Rock revetment around debris lobe of Holbeck Hall landslide (/1304C01)

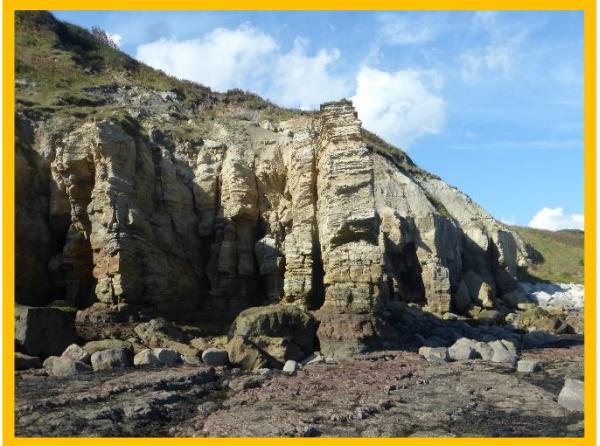
MU23/A Partially active evidence of significant amount of fallen rock at toe of cliff

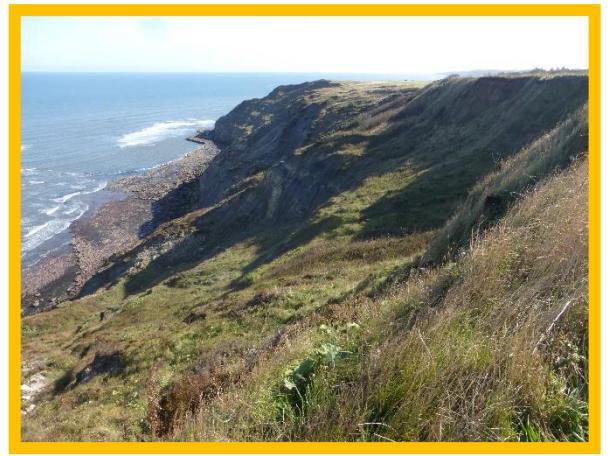
Units MU23/D1, MU23/D2 and MU23/D3 are located at Wheatcroft Cliff above Black Rocks. These units are active down much of their length, with ongoing recession of the headscarp, slumping in the mid-slope and erosion of the toe. They are classified as Partly Active in 2020.

MU23/D Partially active with ongoing recession at the headscarp

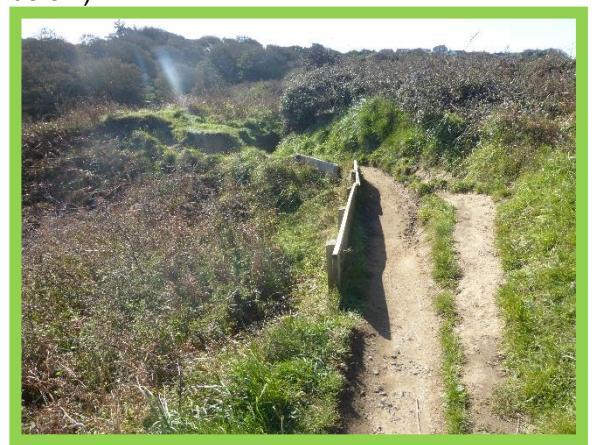
Headscarp recession has encroached on footpath. Note temporary boards to stabilise and mark path edge **MU23/F.**

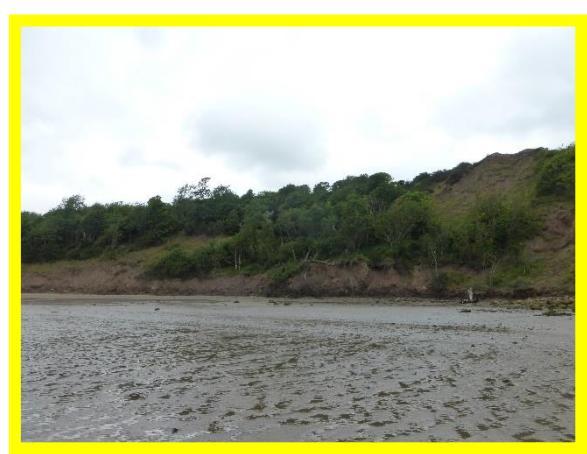
Immediately south of Osgodby Point, unit MU24/A comprises mudstone at beach level of the Cayton Cliff landslide complex. The wide expanse of Cayton Cliff is capped by till which is heavily vegetated. Significant recession of the head scarp occurred during an event in 2008-2009, resulting in the loss of land and properties at Knipe Point Drive. The cliff at the toe of the complex is steep and comprises uplifted debris from deep landslide movement. Only localised activity is evident at the toe and head scarp, with no evidence for movement in the body of the landslide, and so the unit is Locally Active in 2020, unchanged since 2012. The only notable change was that the upper beach levels appeared around 300mm lower around the toe of the debris lobe when comparing with the previous 2018 inspection. This does not seem to be causing an increase rate of erosion at the toe. The southern face of Knipe Point (subunit MU24/A7) was found to be Partly Active in 2020, as it has been since 2008.

Heavily vegetated till of Cayton Cliff. MU24/A Locally Active in August 2020

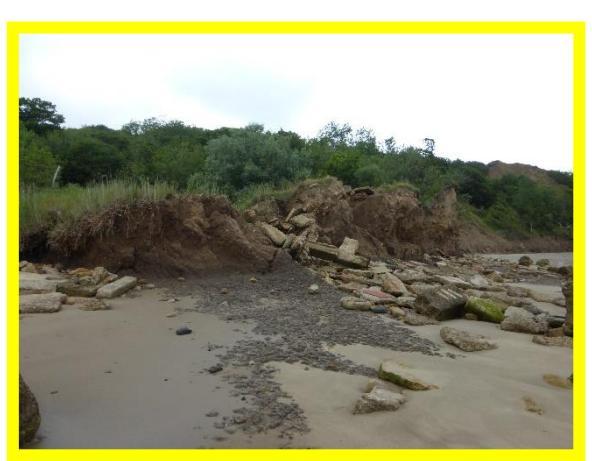
Toe of Cayton Cliff. MU24/A Locally Active in August 2020

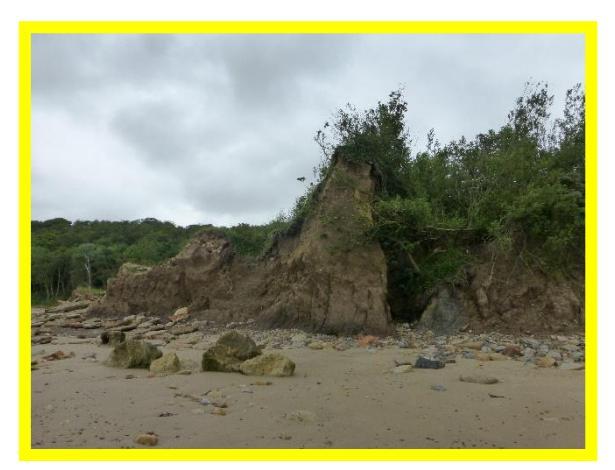
Toe of Cayton Cliff. MU24/A Locally Active in MU24/A7 Partly Active in August 2020 August 2020

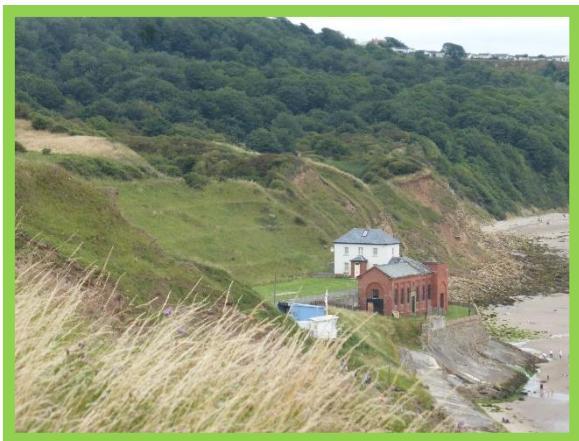
Tenants' Cliff is a complex of terraced landslips in mudstone and sandstone and is divided into 11 units. Unit MU24/B forms the main part of the Tenants' Cliff landslide and is classified as Inactive in 2020, no change from 2016. The toe of Tenants' Cliff is categorised into ten smaller landslide units comprised of massive displaced blocks of sandstone. The most northerly unit (MU24/B1 is classified as Locally Active. Along the toe of these units there is an ongoing accretion of pebbly material with the beach profile increasing in gradient into MU24/B2 which was observed to be Partly Active in 2020, downgraded from Locally Active in 2018. MU24/B3 to MU24/B8 remain classed as Partly Active in 2020. At MU24/B9, where there is intense ongoing erosion of the unit toe, is classified as Totally Active. It was also noted that various ad hoc repairs have been made to the walls northern extent to counteract the outflanking caused by the retreat of this unit. All these units are classified the same as they were in 2020 with the exception of MU24/B2. MU24/B10 is protected by the seawall which extends northwards from the pumping station. During the 2020 survey it was completely vegetated and is classified as Inactive.

Heavily vegetated part of Tenants' Cliff complex. **MU24/B** Inactive in August 2020

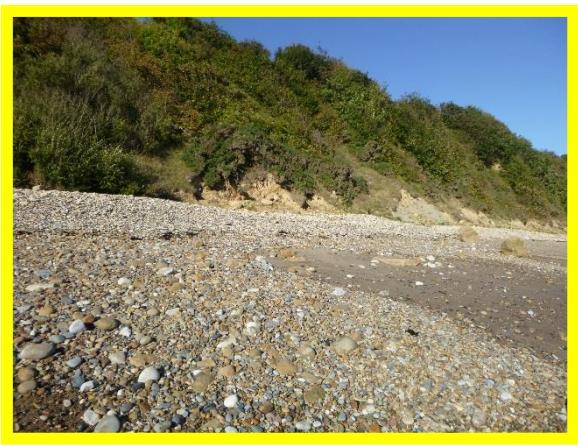
Toe of Tenants' Cliff complex. **MU24/B1** Locally Active in August 2020

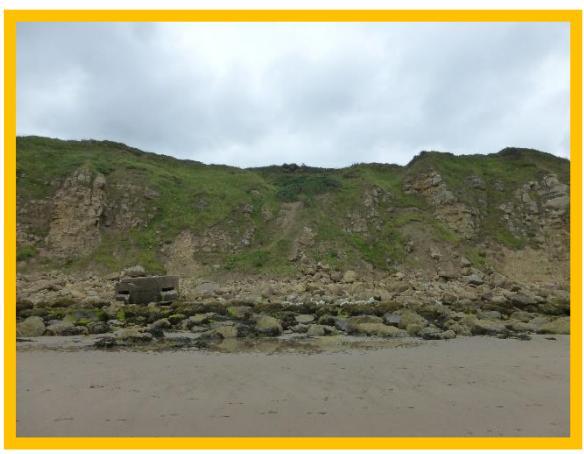
Toe of Tenants' Cliff complex. **MU24/B4** (right) to **MU24/B6** (left) Partly Active in August 2020

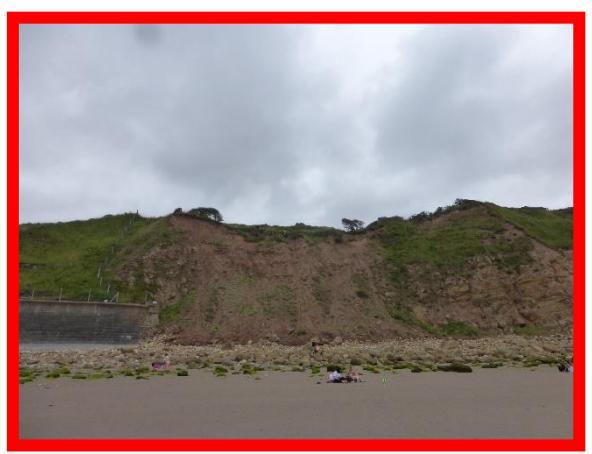
Intense erosion in **MU24/B9** (Totally Active in August 2020)

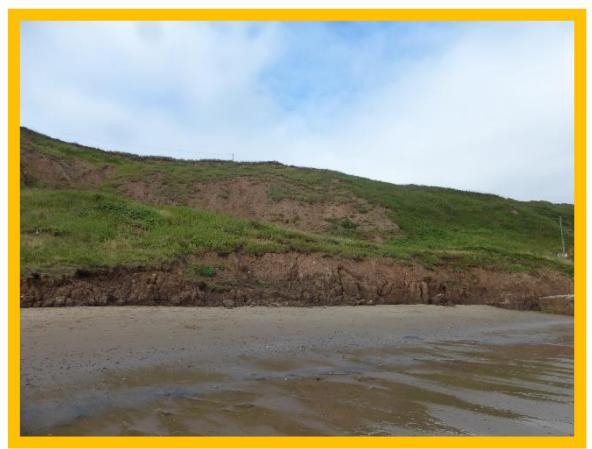
Toe of Killerby Cliffs. **MU24/C** Partly Active in August 2020

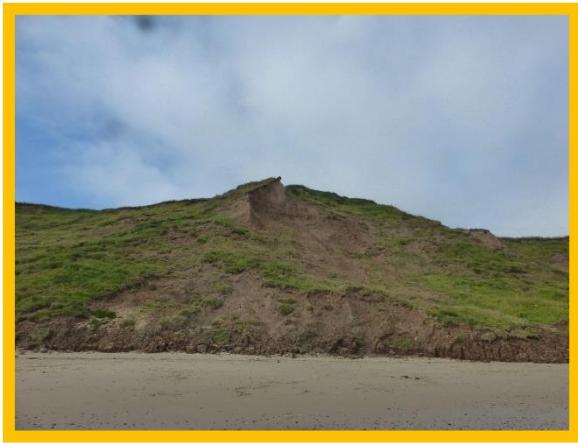
Till of Killerby Cliffs. **MU24/D** Partly Active in August 2020

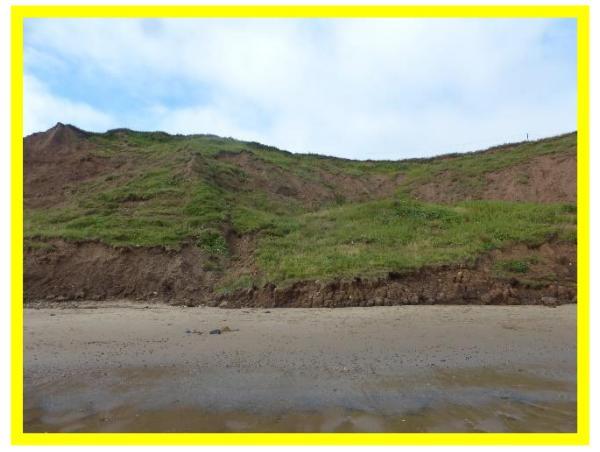
Vegetated till slopes of Killerby Cliffs. **MU24/F** and G Locally Active in August 2020

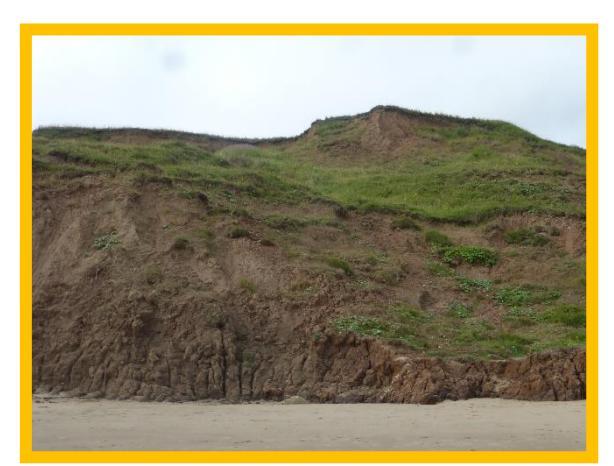
Toe of Killerby Cliffs. **MU24/I** Partly Active in August 2020.

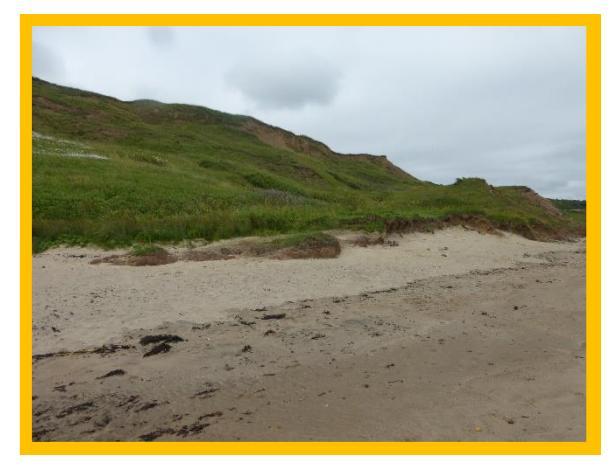
Toe of Killerby Cliffs. **MU24/J** Partly Active in August 2020

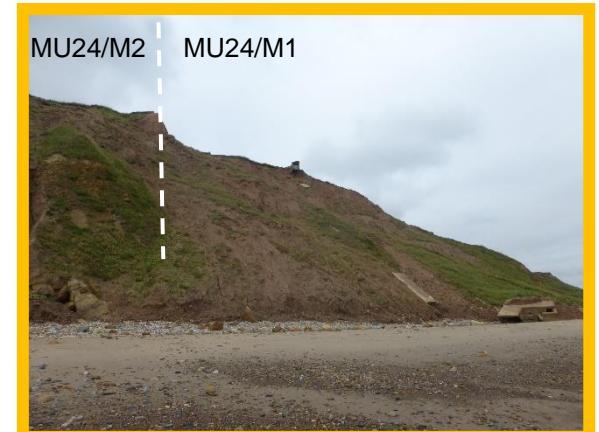
Till of Killerby Ciffs. **MU24/M1** (right) and **MU24/M2** (left) (both Partly Active in August 2020)

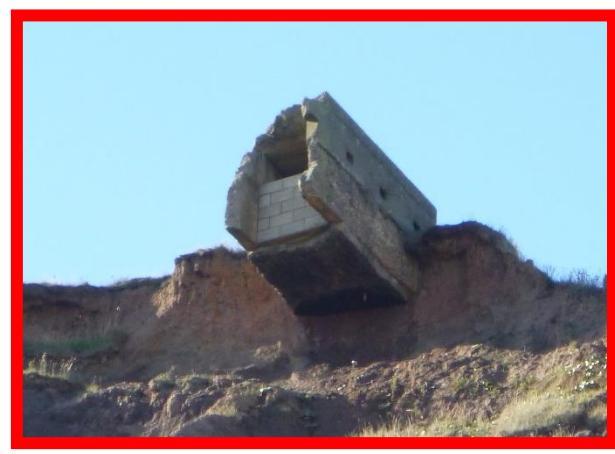
Due to the activity within cliff units MU24/L and MU24/M1 and the retreat of the headscarp at the boundary between the two units a historic WW2 pill box is significantly undercut and at imminent risk of collapse. In the 2020 walkover inspection it was noted that the undercut concrete base of the structure has collapsed and now rests high on the cliff face and is at risk of sliding onto the beach. Due the nature of the cliff units the structure poses a significant imminent risk to beach users. Additionally, the structure is easily accessible from the Cleveland Way path atop the cliff units, and has become a landmark feature. During the 2020 inspection several individual members of the public were seen standing on the structure, seemingly unaware to the degree it was undercut. Due to the high numbers of tourists anticipated to visit British beaches and coastal paths during the summer of 2020 the condition of the pill box presents an immediate concern.

Looking from up from the beach at the base of **MU24/M1** in September 2018.

Due to the difficulties associated with placing signage on the beach, and the inherent risks associated with access to the structure, options to minimize the risk to the public are not straightforward and will require some consideration.

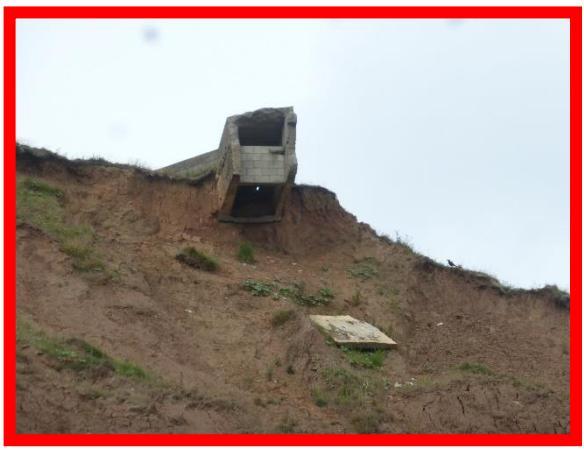
Looking from up from the beach at the base of **MU24/M1** in August 2020.

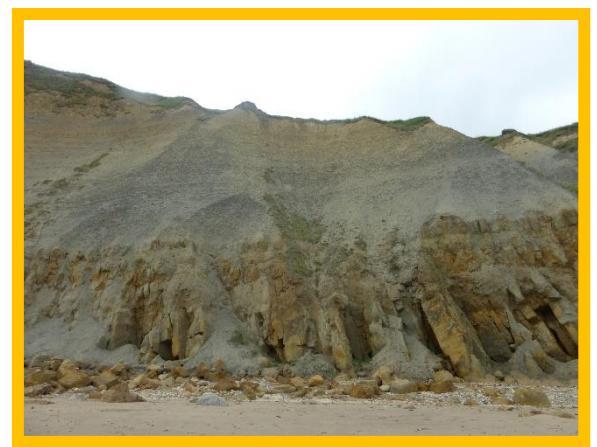
Units MU24/P to MU25/T are predominantly exposed near-vertical sandstone at the toe of a steep cliff overlain by mudstone with a thin capping of till. The sandstone is characterised by local rock falls on to the beach and platform with local small debris cones off the base of the mudstone. In 2016 all units MU24/P to MU25/T were downgraded from Partly Active (in 2014) to Locally Active. In 2018 MU24/P, MU24/Q and MU24/T showed further signs of activity and so regained their Partly Active status. Following the 2020 walkover inspection MU24/R and MU24/S have also regained their Partly Active status, meaning all units return to the same condition rating as 2014.

Composite sandstone and mudstone cliffs in south Cayton Bay. **MU24/P** (right) and **MU24/Q** (left) (both Partly Active in August 2020)

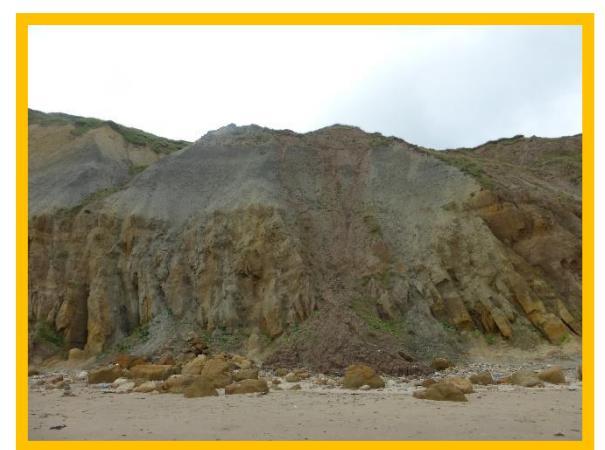
Local rock fall and debris cone in **MU24/P** (Partly Active in August 2020)

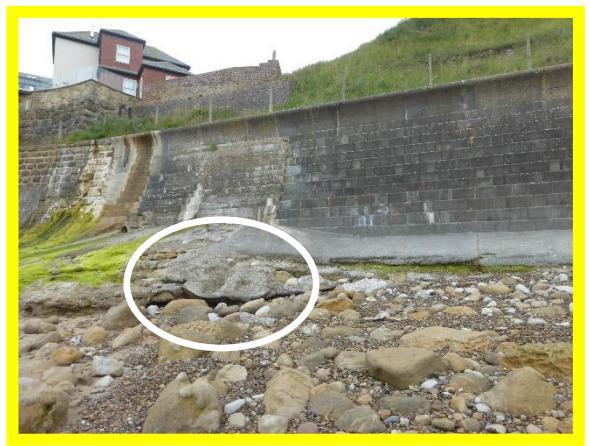
To the north of the pumping station (which is now converted to a private residence) is a private blockwork defence with concrete toe slab (/1402C02), which ties into the eroding cliffs to the north with a mixture of brick, stone blocks and concrete. The wall itself remains in fair condition and appears newer than the wall to the south. At the interface with the adjoining defence to the south there is evidence of leaching and moisture draining down the face of the wall from the cliff unit above. During the 2020 inspection it was noted slightly higher beach levels have in part covered a large void in the apron of 1402C02. The depth of the void is unknown however in the previous inspection it appeared to be in the order of 2 metres and may be encroaching beneath the base of the wall. Despite the higher beach levels in 2020 It is recommended that further investigation of this defect is undertaken determine the risk to the wall's stability. The remainder of the toe is in poor condition and is undercut in several places. The erosion of the undefended cliff immediately to the north of the tie-in appears to have slowed. Between 2012 and 2014, the wall became outflanked but in recent years it does not appear to have worsened. Despite this the northern transition remains at risk of being compromised by rockfall and erosional activity in this cliff unit.

Private sea wall in fair condition. Large void visible in wall apron. (/1402C02)

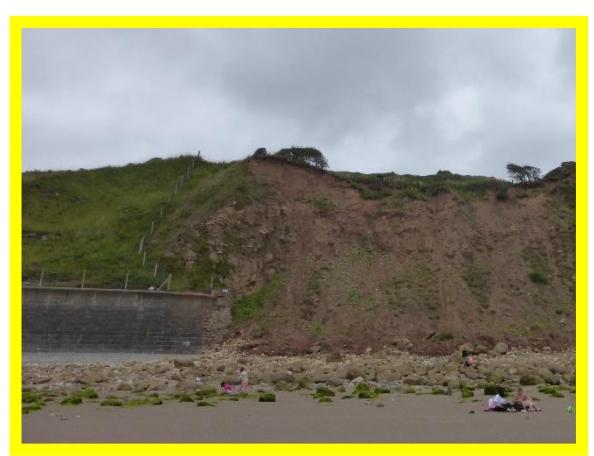
Erosion of undefended cliffs at tie-in of sea wall private sea wall (/1402C02)

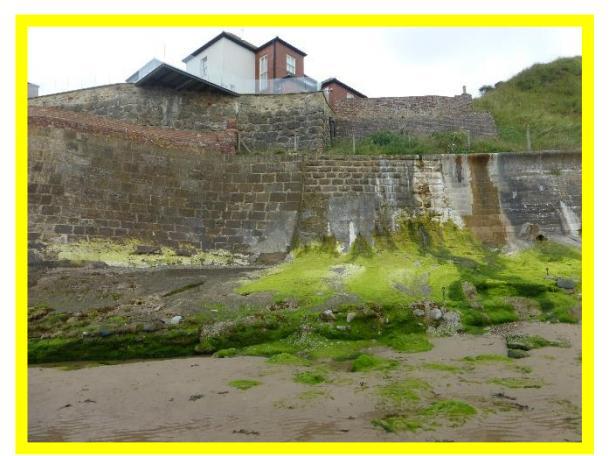
Undercutting of concrete apron to private sea wall (/1402C02)

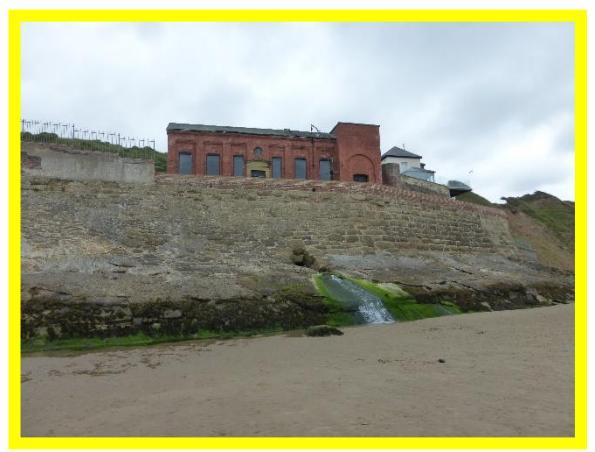
Private sea wall in fair overall condition but with the toe apron subject to ad hoc repairs (/1402C05)

The condition of the defences varies with the higher, red brick walls appearing sound, the lower, concrete and sandstone blockwork remaining in fair condition but the apron at the toe being the worst affected. There was no notable change between the 2018 and the 2020 inspections. Numerous ad hoc repairs were noted as being in a variety of conditions with the lower grouted repairs being the worst affected. In some locations undercutting of the concrete apron is visible, and particularly around the apex of the bend in the structure, marine vegetation may have obscured further voiding. One sizeable void was noted higher up on the apron, the void is not new and does not appear to have increased in size however the depth and size of the void is unknown and requires further investigation.

Overall, the structure remains in fair condition following the 2020 inspection however, it is suggested that the condition is monitored closely if beach levels recede.

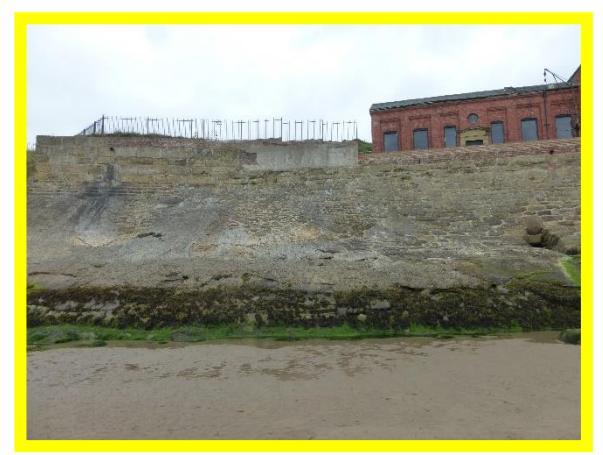
Private sea wall in fair overall condition but with Localised void in apron of private seawall the toe apron subject to ad hoc repairs and localised undermining (/1402C05)

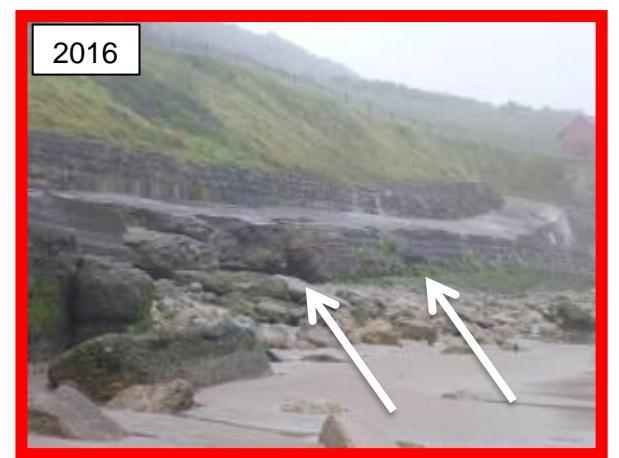
Between the southern end of the pumping station defences and the landing of the beach access steps, there is a length of defence (/1402C04) which exhibited major undercutting and blockwork loss leading to washout of backing material observed during the 2016 inspection. Numerous repairs were made to the defence including a new section of mass concrete wall, repairs to the decking and infilling of the large voids created by washout of fill material. Beach levels along this section are up to 0.4m higher than in 2018, meaning undercutting and voiding which has previously been reported in this location is now partially concealed. Despite the repairs made following the damage in 2016 the defence remains in very poor condition and is considered a risk to the public due to; potential voids within the structure, the great variation in surface condition of the deck's slab and the localised outflanking and undermining of the footpath and upper retaining wall fronting the vegetated slope. It was also noted during the 2020 inspection that the mass concrete repair made to the wall following the 2016 inspection is itself now undercut and outflanked at one end. At the interface with the adjoining asset to the east (/1402C04), the wall continues to be undercut and there are numerous voids in the wall face.

Damage to seawall in June 2016 (/1402C04)

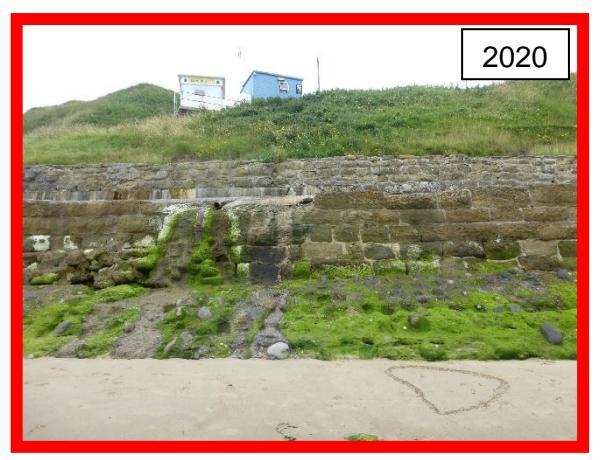
Seawall in August 2020. (/1402C04)

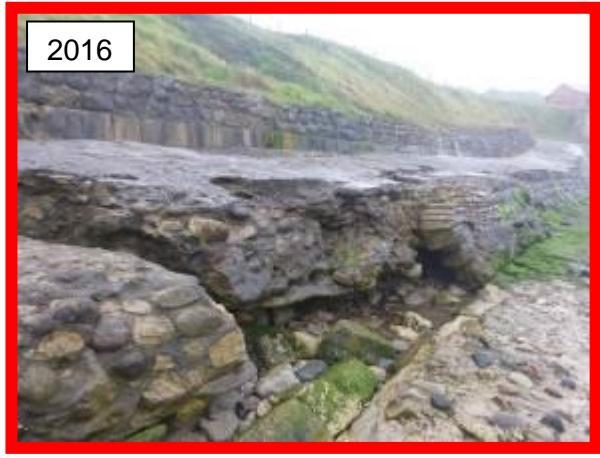
Undercutting at toe leading to voiding behind and break-up of deck (/1402C04)

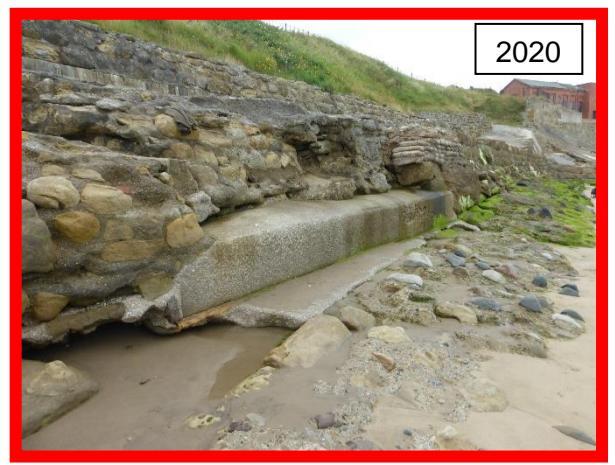
Mass concrete repair to damaged section of wall note undercutting in foreground. (/1402C04)

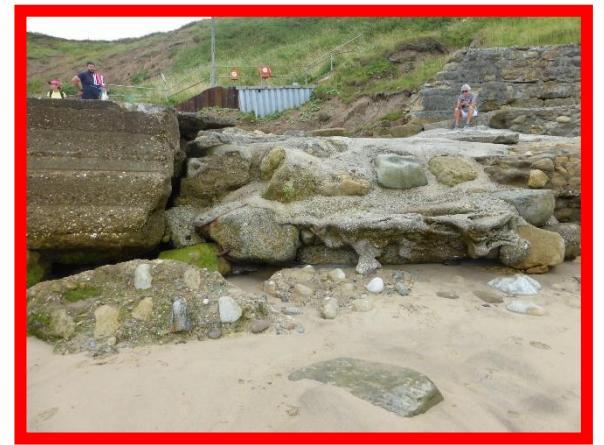
Voiding and undercutting of structure at the interface between (/1402C04) and (/1402C06).

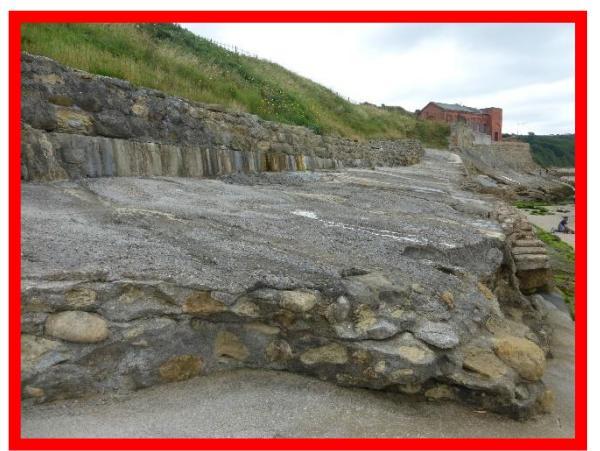
Deckslab repairs in fair condition. (/1402C04)

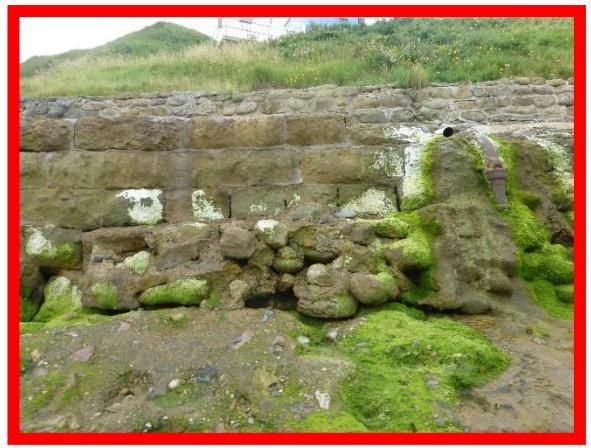
Missing blockwork in August 2020 (/1402C04)

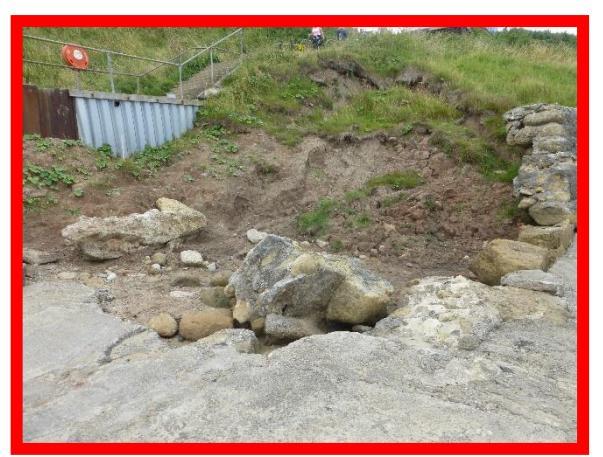
Continued outflanking of upper retaining wall (/1402C04)

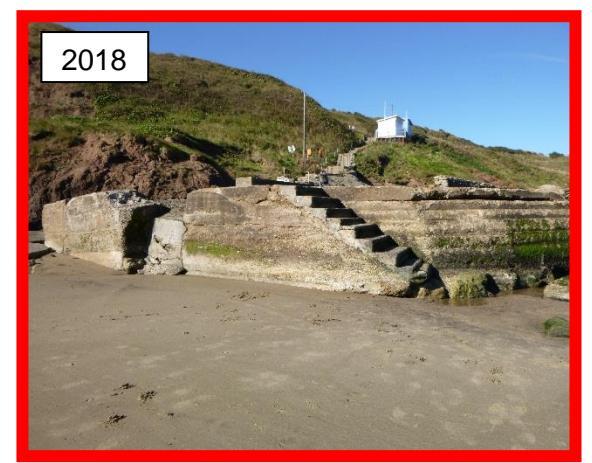
The concrete structure at the beach landing of the public access point remains in a very poor condition with large cracks and voids throughout (/1402C06). Ongoing maintenance activity, comprised of a poured concrete skim over much of the deck of structure, has covered and filled most voids resulting in a reduced the risk to the public. However, slumping and erosion in the cliff at the rear of the structure continue to threaten the upper access steps and structure as a whole. During the 2020 inspection the beach levels across Cayton Bay were found to be higher than in 2018, not quite returning to the 2016 levels. This is evidenced by an approximately 300mm rise in the beach level at the lower access steps, seen in the images below. During the 2020 inspection is was noted that the lower step has been extended at lower beach access steps. This has reduced the risk to members of the public accessing the beach via the steps. Due to higher beach levels it was not possible to examine the base of the platform or whether there is an additional lower step. It is recommended that this structure is urgently demolished, removed and replaced with a simple, safer and more adaptable public access.

Beach access in 2018 (/1402C06)

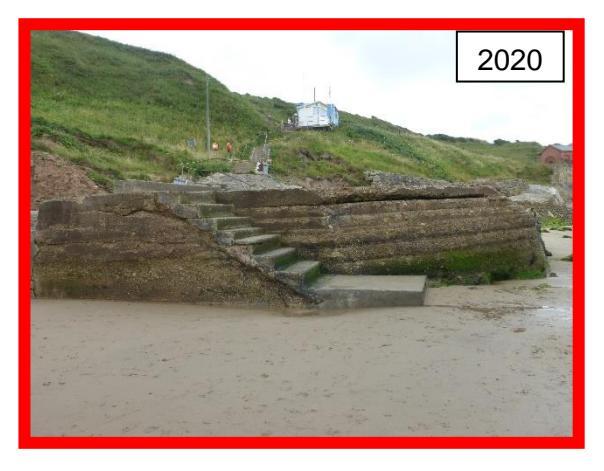
Beach access in 2020 (/1402C06)

Despite recent reactive repair work the condition of the defences at the Cayton Bay pump house access remains classified as very poor in 2020. The structures present a significant health and safety risk to the general public. It is recommended that access arrangements to Cayton Bay at this location are re-evaluated at the earliest opportunity in line with the *Filey & Cayton Bay Coastal Strategy*.

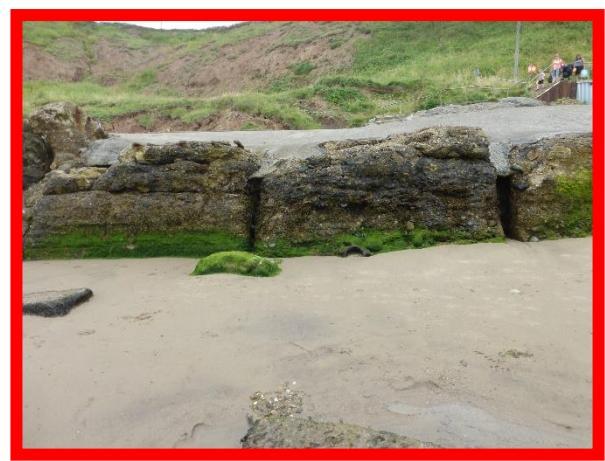
Concrete skim repair has filled voids and cracks (/1402C06)

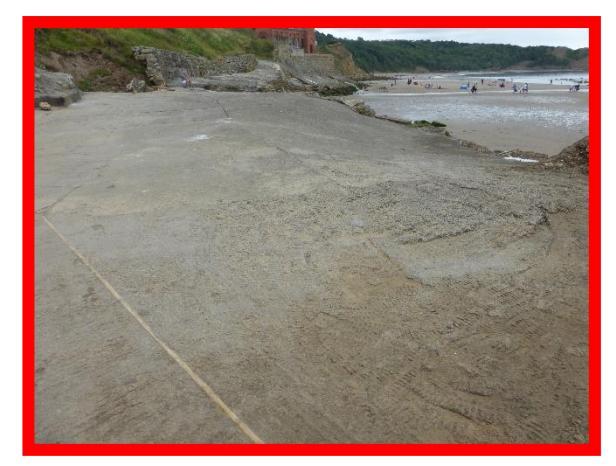
Concrete skim repair to deckslab in fair condition (/1402C04)

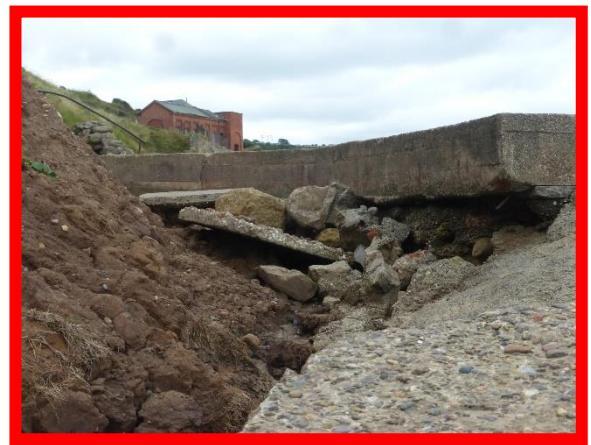
In addition to the damage sustained to the defence to the north of the beach access steps, the structure is also being undercut and outflanked at its western end and towards its rear. The footpath which runs up the bank towards Lucy's Shack is being undercut. A retaining sheet pile wall is effectively supporting the path; however, it can only be a temporary solution due to the risk of further outflanking and undermining.

Damage to rear of structure, washout of fill material (/1402C06)

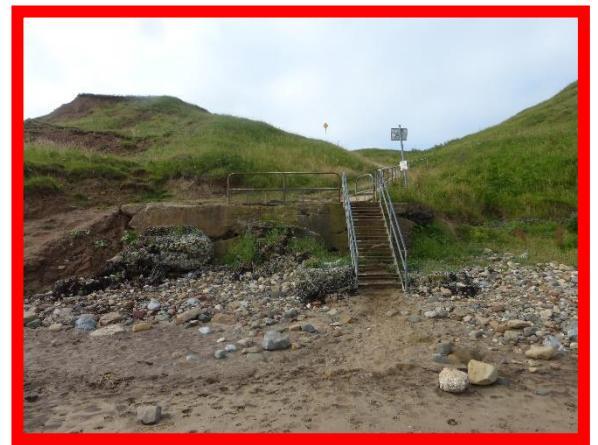
Around 300m south of the pumping station beach access, there is beach access point for the path from the public car park at the surf shop. There are a set of beach access steps that were previously protected by gabion baskets, which have distorted and split under wave action. This is not a formal coastal defence, so has no asset number. The structure presents a health and safety risk to the public due to the partially unprotected edges and is at risk of collapse due to outflanking and undermining.

Failed gabion baskets at surf shop car park beach access (no asset reference)

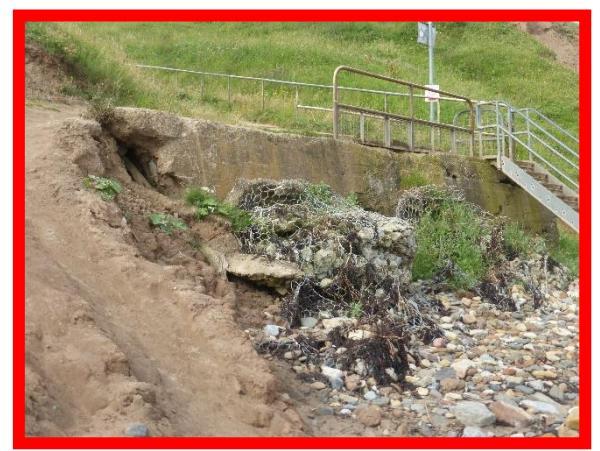
Failed gabion baskets at surf shop car park beach access (no asset reference)

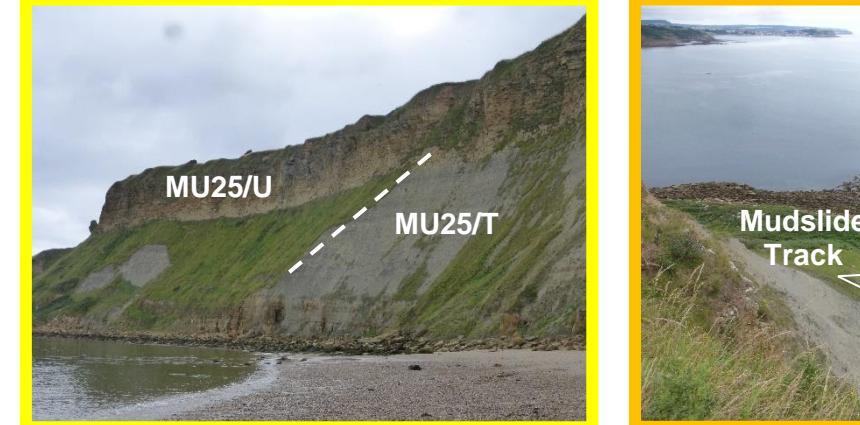
Unit MU25/U is located above Red Cliff Hole and is classified as Locally Active in 2020, unchanged from 2016. The steep cliffs are characterised by localised areas of erosion, but are otherwise well vegetated.

Composite sandstone and mudstone cliffs in south Cayton Bay. **MU24/T** (right) to **MU24/U** (left) (both Locally Active in Au)

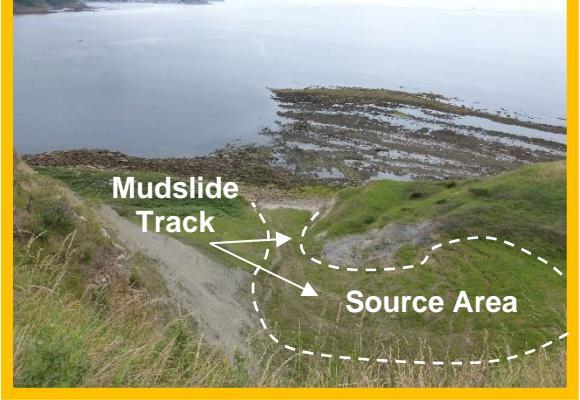
Unit MU25/V is located at Lebberston Cliff and comprises a large, periodically active mudslide system. The unit appears to be prone to regular change and recession. Furthermore, in 2020 the headscarp shows signs of recent activity and now encroaches on the route of the footpath. This unit was downgraded from Totally Active to Partly Active following the 2012 walkover and this grading has been retained for 2020.

MU24/V - view from directly above the mudslide (Partly Active). [Reproduced from August 2014].

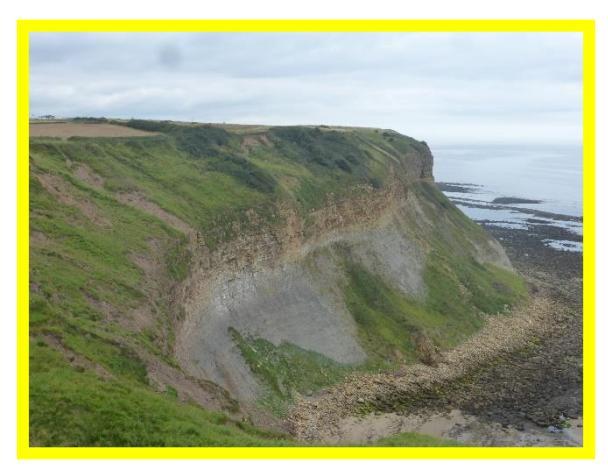
MU26/AF Soft till overlying resistant rock (Locally Active).

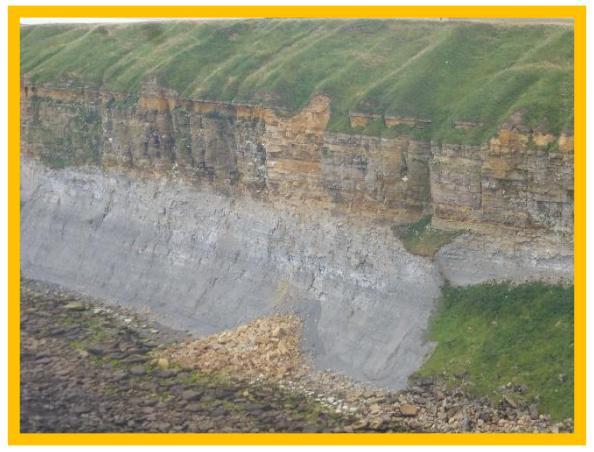
MU26/AK and MU26/AL were changed in grading to Partly Active in 2016, having experienced widespread rockfalls and mudslides along their length. This status has been retained following the 2020 inspection. Recent activity was evident, particularly in MU26/AK where a large rockfall has occurred from the upper cliff, resulting in a large debris cone. it was noted that the debris cones along the base of these units have receded slightly indicating that the cliffs experience some degree of erosion along their toe. This may also indicate that they are not being recharged as regularly from activity in the cliff units above.

MU26/AK and MU26/AL Cliffs experiencing rockfalls and mudslides.

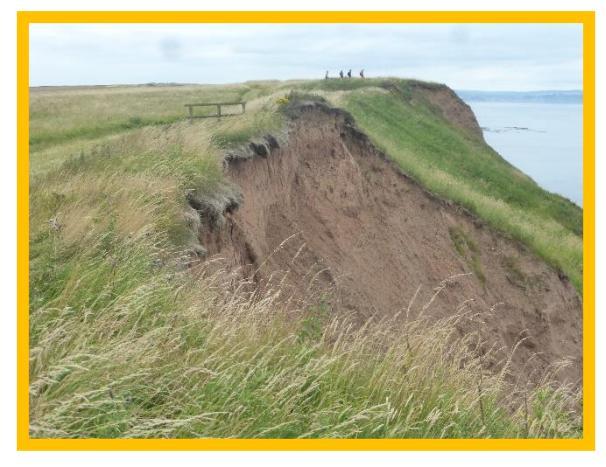
Units MU26/AS to MU26/AT have all been assigned a status of Partly Active in 2020 due to intensive erosion of the headscarp. The remaining Units MU26/AU to MU26/AX retain their Locally Active status in 2020. These cliffs are comprised of soft glacial sediment and exhibit only localized, rather than widespread, erosion in the form of headscarp recession and mud sliding. There is also localised marine erosion of the toe.

MU26/AT Ongoing recession of the headscarp (Partly Active).

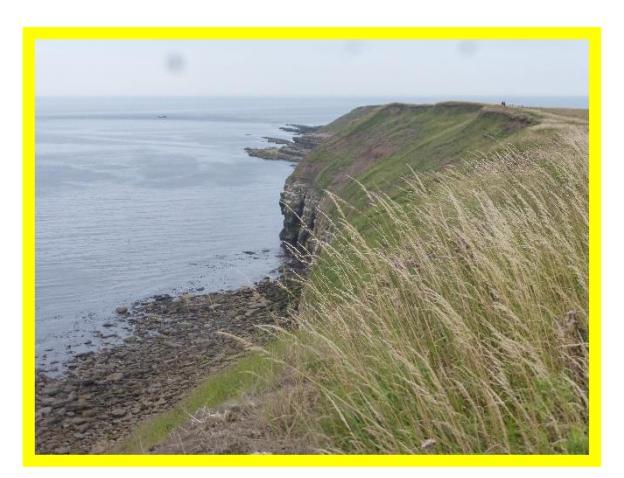
MU26/AZ and MU26/AX Shallower more stable slopes of easternmost assets in MU26.

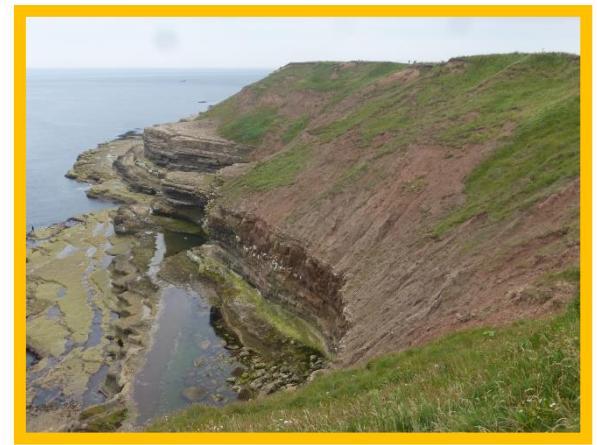
Mainly unvegetated and eroding upper slopes on the north side of Filey Brigg. **MU27/BE** (Partly Active in August 2020)

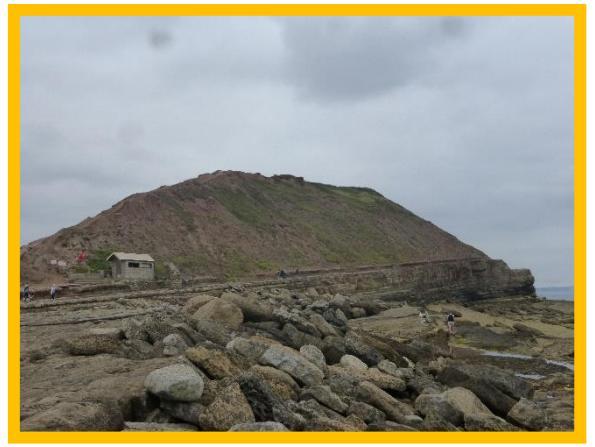
Headscarp recession and mudslides in upper till unit on north side of Filey Brigg. **MU27/B** (Partly Active in August 2020)

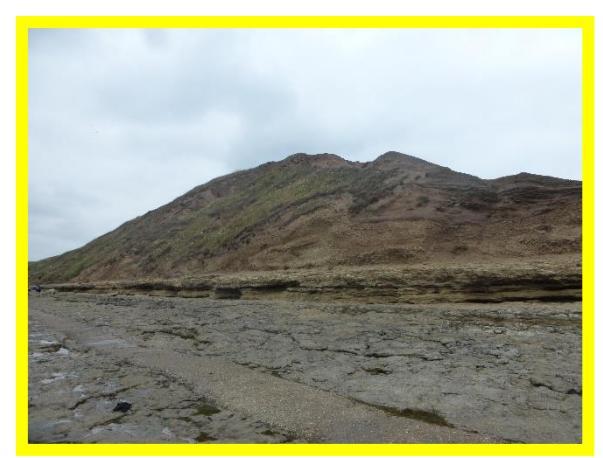
Composite cliffs on the south side of Filey Brigg. **MU27/C** (right) to **MU27/F** (left) (**MU27/C** Partly Active, the remainder Locally Active in August 2020)

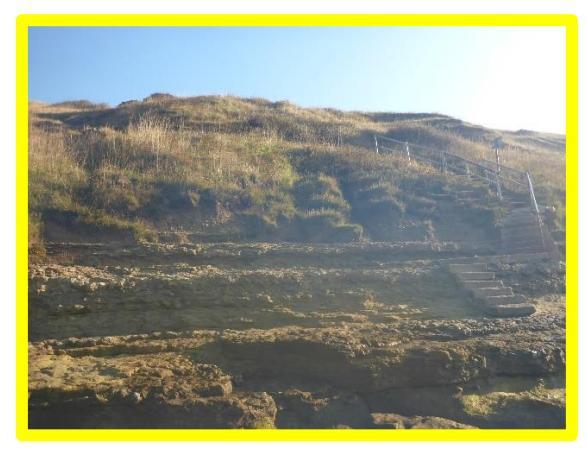
Composite cliffs on the south side of Filey Locally Active around access steps in 2020

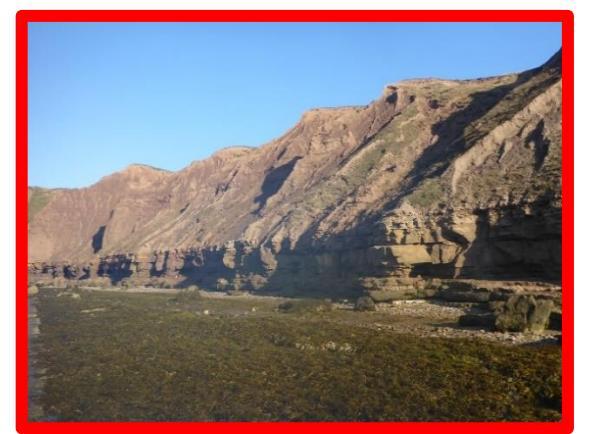
Units MU27/J to MU27/O are also located on the south side of the Brigg at its western end. They are predominantly unvegetated and are undergoing intense erosion. Therefore, they are classified as **Totally Active** in 2020.

Composite cliffs on the south side of Filey Brigg. **MU27/J** (Totally Active in 2020)
