Cell 1 Regional Coastal Monitoring Programme Walkover Inspection Surveys 2020

Scarborough Borough Council

November 2020

Walkover Inspection Surveys 2020

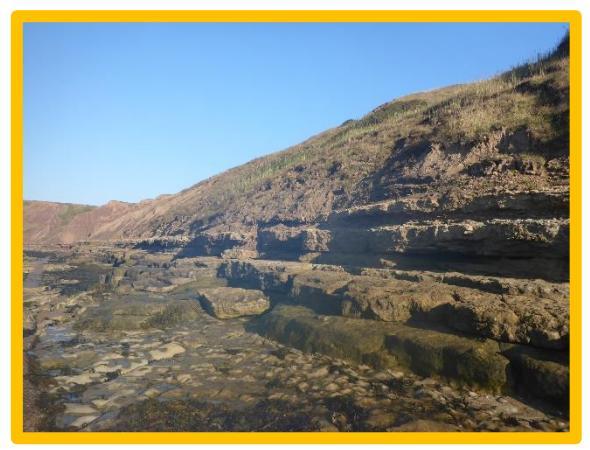
Composite cliffs on the south side of Filey Brigg. Central area Partly Active in 2020.

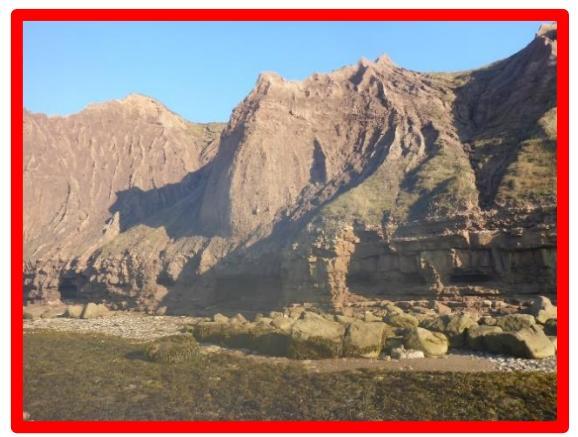
Units MU27/J to MU27/O are also located on the south side of the Brigg at its western end. They are predominantly unvegetated and are undergoing intense erosion. Therefore, they are classified as **Totally Active** in 2020.

Composite cliffs on the south side of Filey Brigg. **MU27/K** (right) to **MU27/N** (left) (all Totally Active in 2020)

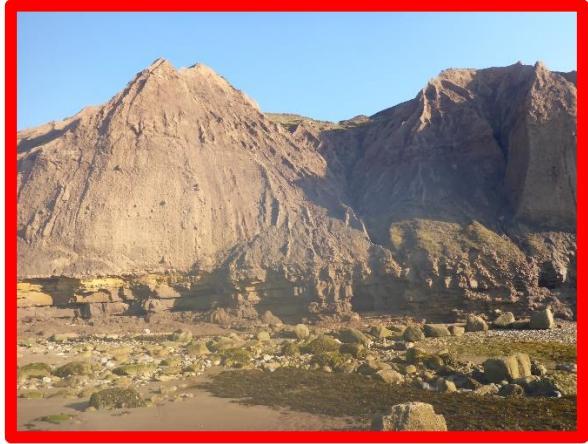
Composite cliffs on the south side of Filey Brigg. (all Totally Active in 2020)

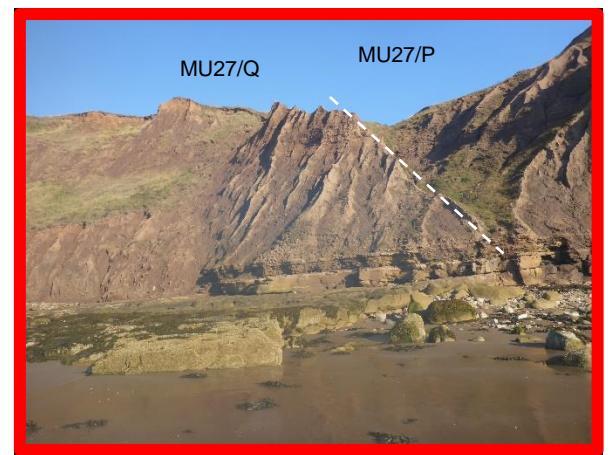
Composite cliffs on the south side of Filey Brigg. (all Totally Active in 2020)

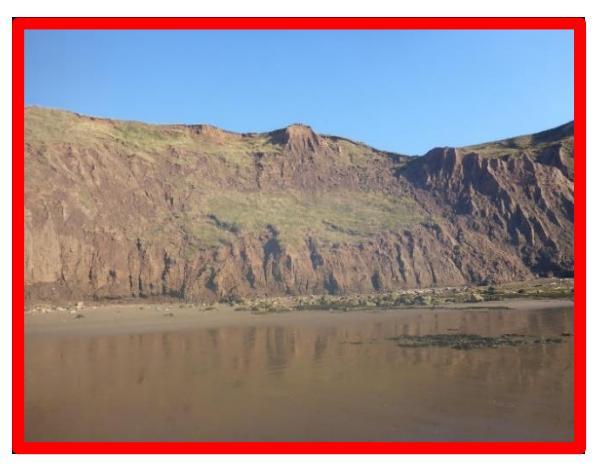
Till cliffs between Filey Brigg and Filey sailing club. **MU27/Q** Partly Active in 2020

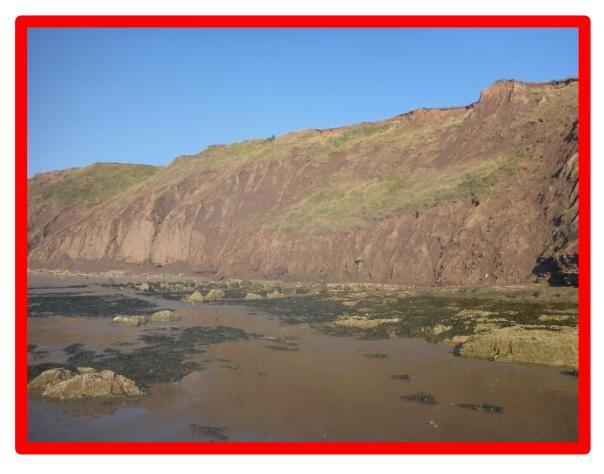
Unit MU27/T surrounds the boat yard storage and comprises glacial till down to beach level. The cliff slope is relatively shallow with an exposed eroding toe, and shallow slumps across better vegetated mid- to upper slopes. This unit is classified as **Partly Active** in 2020, unchanged since 2014.

Till cliffs between Filey Brigg and Filey sailing club. **MU27/R** (right) to **MU27/T** Partly Active in 2020

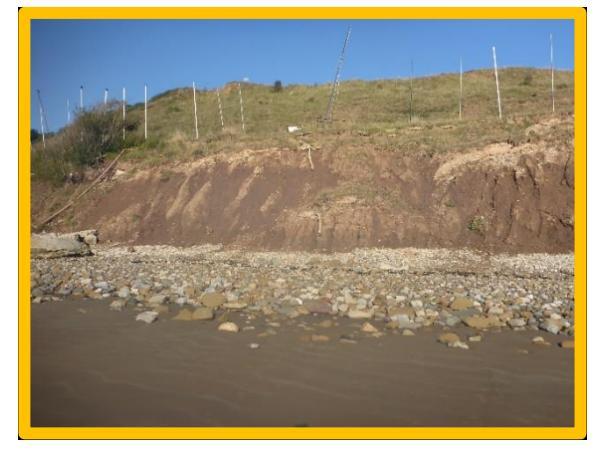
Till cliffs at Filey Sailing Club. **MU27/T** Partly Active in 2020

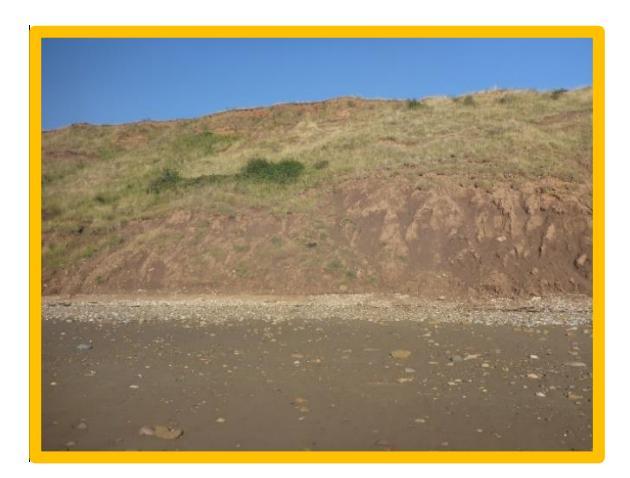
Units MU27/V and MU27/W are located between the sailing club and the north end of Filey seawall. These units are classified as **Partly Active** in 2020 with large-scale head scarp recession, slumping throughout the profile and erosion at the toe. Cliff warning signs have been dislodged indicating slope movement.

Till cliffs between Filey Sailing Club and Filey town. **MU27/V** Partly Active in 2020

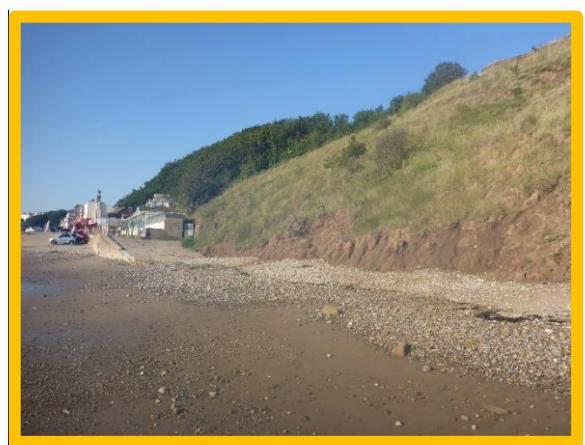
Till cliffs between Filey sailing club and Filey town. **MU27/W** Partly Active in 2020

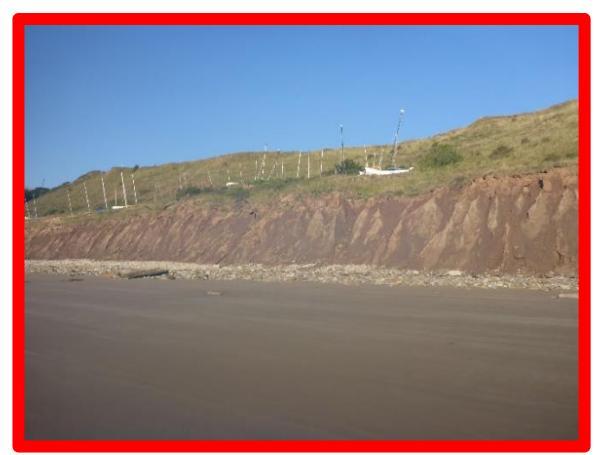
To the north of the town, Filey Sailing Club is located at the back of the beach and is partly protected by some coastal defences. However, the section of cliff below the boat park (which is located on a terrace part way up the cliff) north of the club building is undefended (/1601C01) and suffering active slumping along its length.

Undefended cliffs below boat storage yard R (/1601C01) b

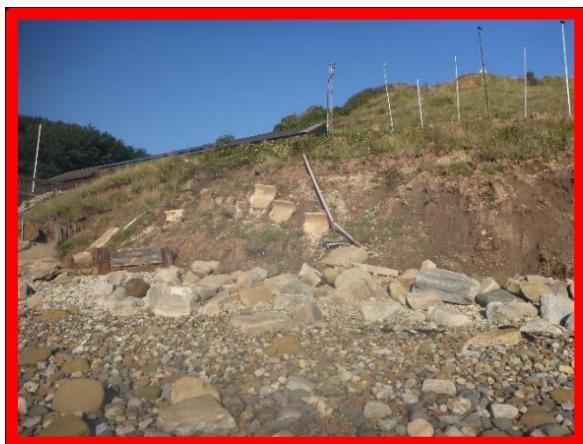
Immediately north of the club building there was formerly a defence structure (/1601C02) that consisted of timber breastwork retaining rock armour. However, all that remains of this now failed structure is the rock debris scattered on the beach. This asset is unchanged since 2018.

Remnants of former defences north of club building (/1601C02)

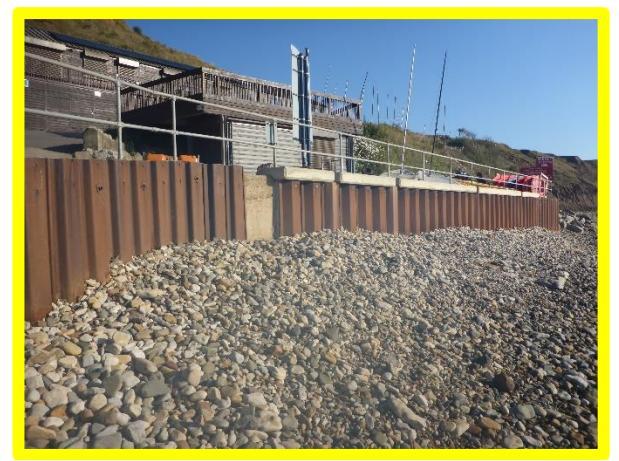
At the club building, there is a section of sheet piling (/1601C03) which showed significant corrosion leading to sizeable holes forming in the steel in the central section and voids behind due to wash out of material in May 2015. At that time, the concrete slipway had been repaired not long before and the southern sections of steel piles had been replaced between 2009 and 2012. However, repairs have been made since May 2015 and the sheet piling is now in good condition, although minor surface corrosion noted. High shingle levels concealed much of the lower sheet piles during 2020 inspection, including the outfall. The scour hole (approx. 2m depth) that was noted at the northern end of the promenade in 2018 has since been repaired with concrete.

High shingle levels obscuring much of the sheet piles (/1601C03)

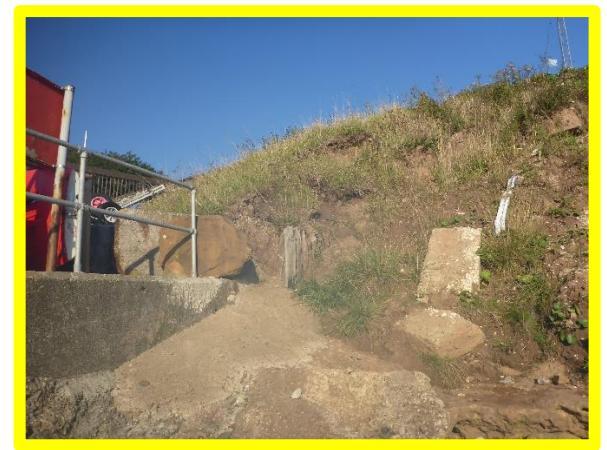
Repaired scour hole at northern end of promenade (/1601C03)

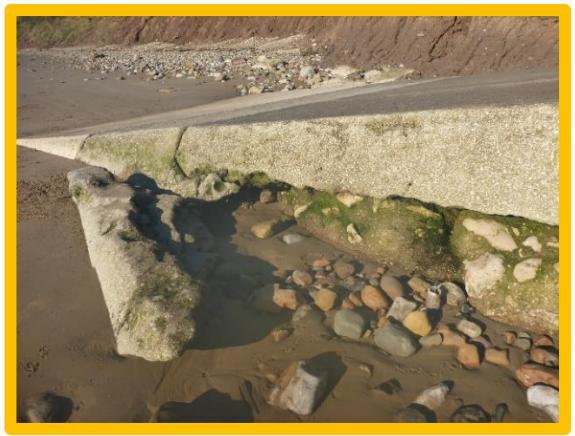
Undercutting of boatyard ramp (/1601C03)

The previously repaired lower section of the access slipway remains in good condition. However, the undercutting of the section above this, reported previously, has deteriorated and requires attention. The earth movement onto the slipway has been cleared.

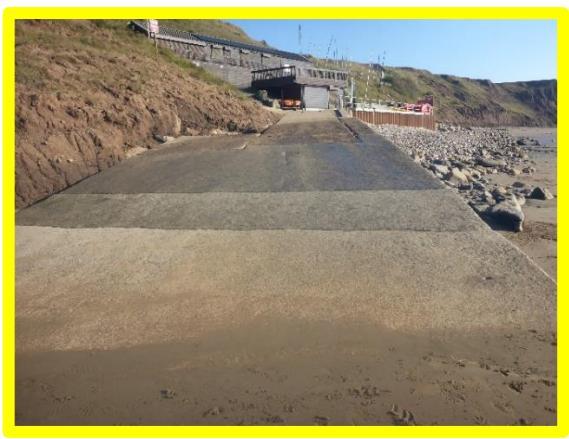
Slipway cleared of cliff debris (/1601C03)

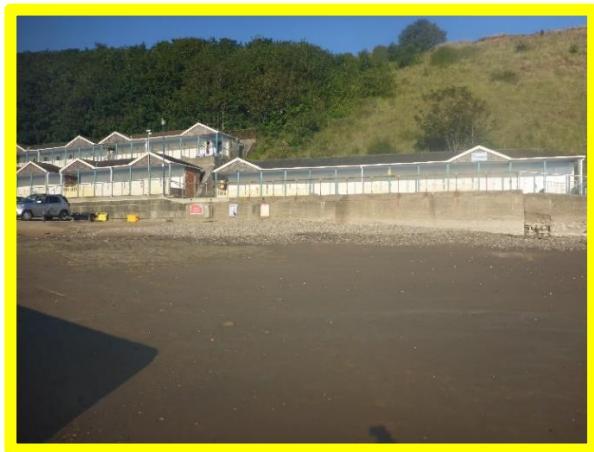
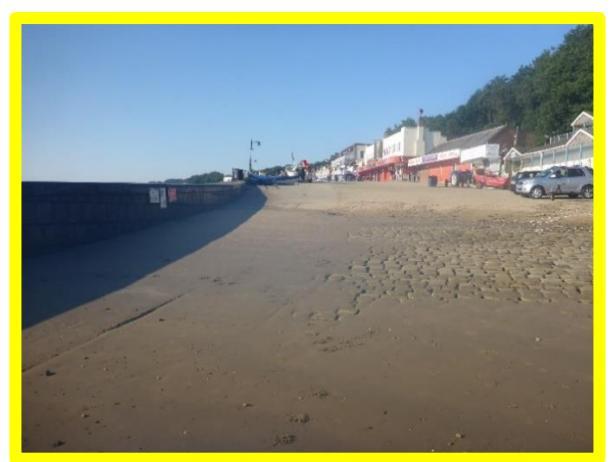
The most northerly asset in the defence system consists of the rear wall and slipway at Coble Landing (/1602C01). The slipway blockwork appeared in fair condition although high sediment levels concealed much of the lower slipway. As noted during previous inspections, the rear wall below the chalets has several horizontal cracks in the wall and is in fair to poor condition. The concrete cope beam, observed being replaced in the 2018 inspection, remains in good condition. The concrete rear ramp/wall is in poor condition with heavy abrasion, particularly at the wall joint, and voids in the deck towards toe of structure.

Longitudinal cracks in rear wall, open joint Coble Landing slipway blockwork in fair condition (/1602C01) (/1602C01)

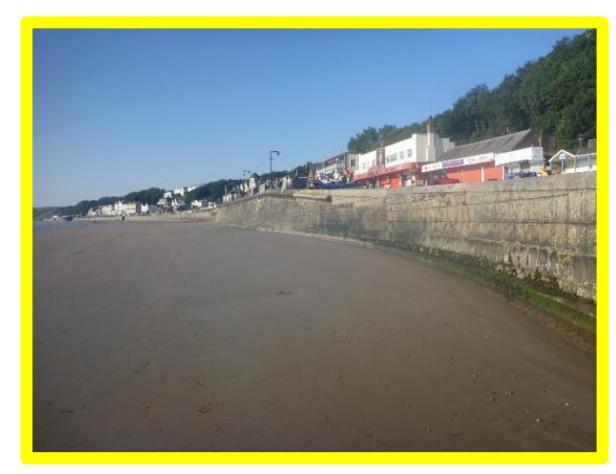
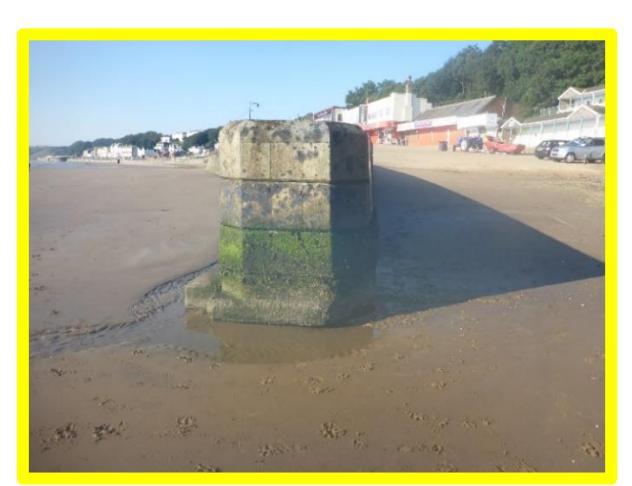
The next asset (/1602C09) is essentially a wing wall protecting the slipway, it remains in fair condition. Repairs to this wall were made between 2012 and 2014 and are holding well. Further repairs to the toe apron were observed in 2018 appear in good condition. The undercutting of the end of wall does not appeared to have worsened.

Previous repairs to slipway 'wing-wall' U (/1602C09)

wing-wall' Undercutting at end of *wing-wall'* (/1602C09)

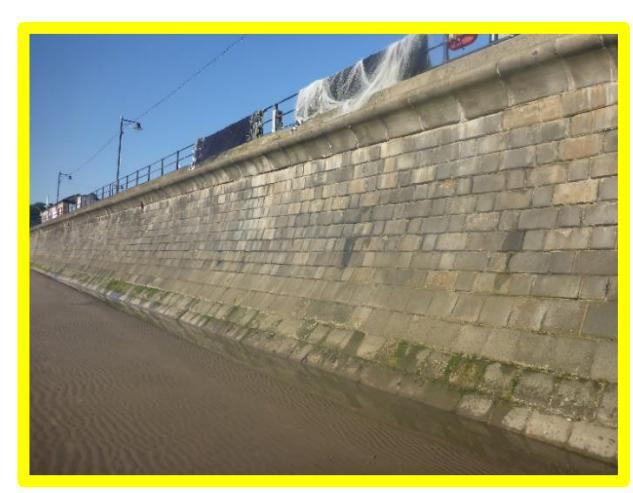
The wall located north of Ravine Road (/1602C06) is in fair overall condition, although there are areas of damage that have been previously repaired. There are cracks / washed out joints / missing mortar between the masonry blocks at several locations.

Sea wall near Ravine Road in fair condition (/1602C06)

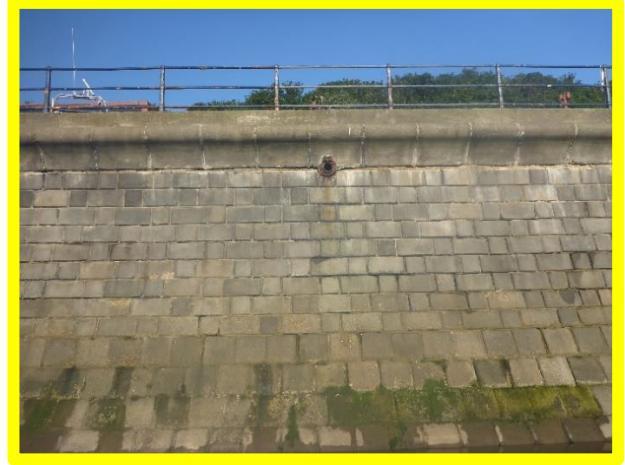
Occasional open joints with missing mortar (/1602C06)

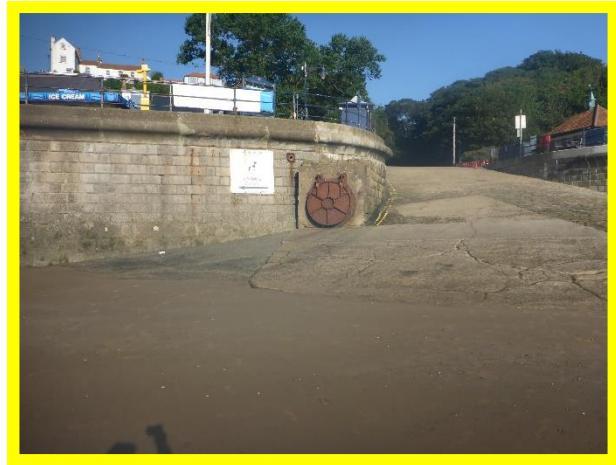
The sections of sea wall between Ravine Road and the access point east of Cargate Hill Road (/1602C08) and between Cargate Hill Road and Crescent Hill (/1602C03) are both in fair overall condition, although in some sections several blocks have abrasion damage to the front face, particularly just above beach level. Many of the splash coping blocks have been replaced along the length of these assets, but others are cracked or damaged. The damage appears to get worse with progression south and is mainly focused around the lower blockwork or upper splash wall / coping.

Damage to coping/wave return on seawall south Previous repairs to coping and wave return of Ravine Road (/1602C08)

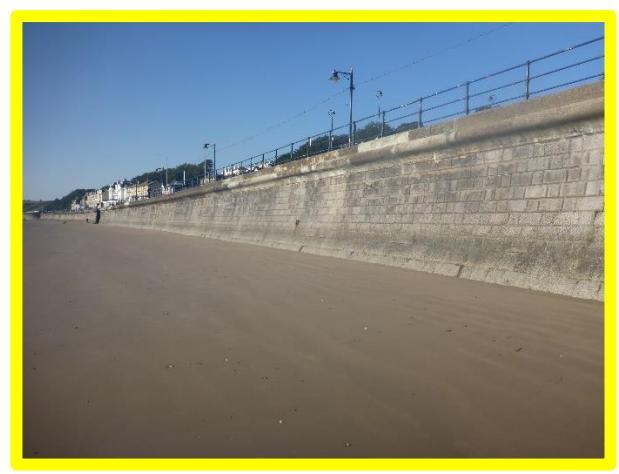
feature (/1602C08)

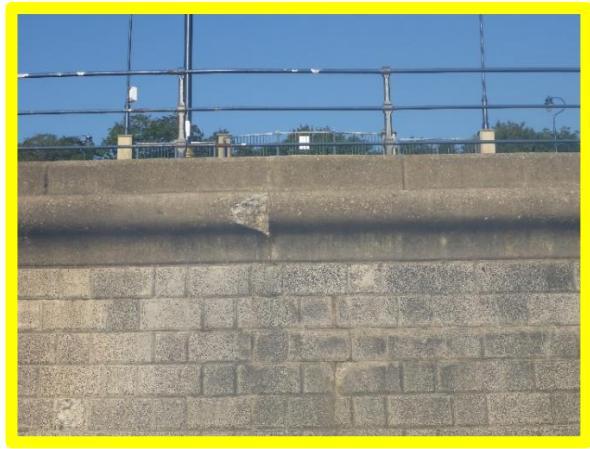
Abrasion damage and open joints in sea wall south of Cargate Hill (/1602C03)

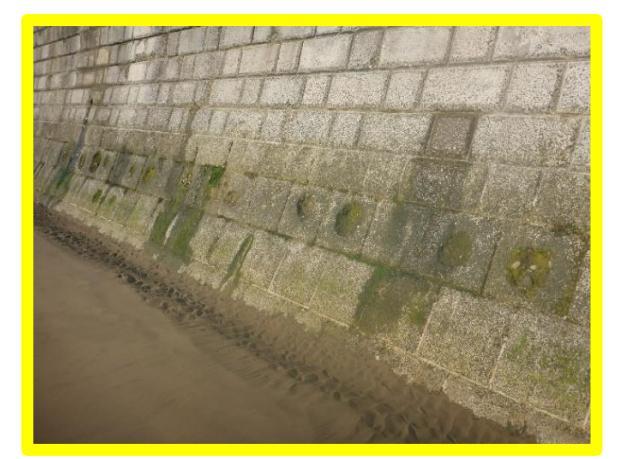
Abrasion damage, several leaking joints (/1602C03)

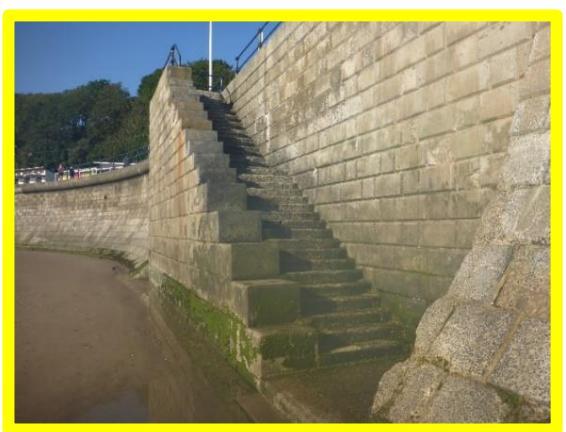
The next defence assets to the south are the wall around the Royal Parade promontory (/1602C04) and the wall between here and the southern-most promontory (/1602C07). These sections of wall are in fair overall condition (including previous repairs to one long vertical gap between adjacent blocks running over half the height of the wall), although there is cracking to the coping and numerous abraded, chipped or damaged blocks. Previous repairs to the lower section of the access steps at Royal Parade are holding well but the cracks and open joints in the southern set of access steps makes it vulnerable to damage during storms.

Access steps in fair condition (/1602C04)

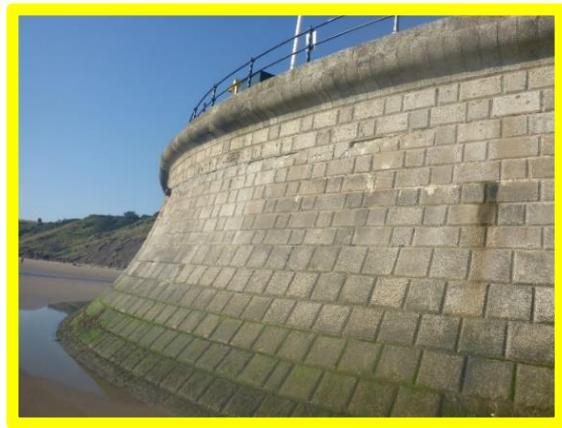
Historic horizontal cracking (/1602C05)

The southernmost section of the main wall includes the southern promontory and the return section to Martin's Gill (/1602C05). This structure is overall in fair condition, although there is chipping and cracking to the coping in small areas throughout length and numerous lower blocks area abraded. Cracks in the side wall to the slipway / access ramp at the southern end of the wall appear to have been filled. A drainage pipe behind the slipway was noted to be broken and it appears there has also been some washout of stone material.

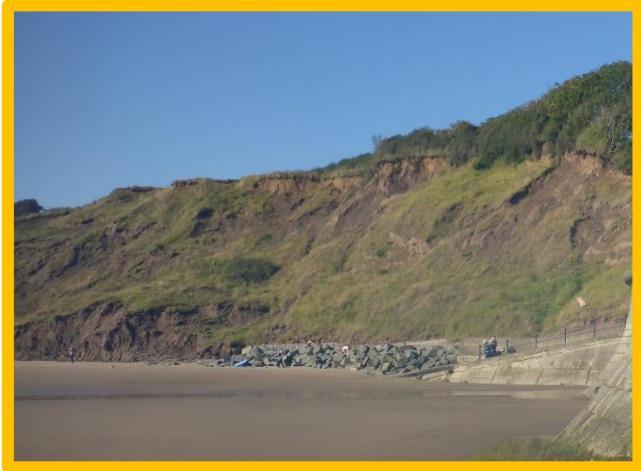
Units MU29/AA and MU29/AI which are composed of glacial till down to beach level and stretch south of Filey town. **MU29/AA** to **MU29/AF** are all classified as Partly Active in 2020, unchanged from 2018. **MU29/AG** to **MU29/AI** have been downgraded to locally active in 2020. The entire length of cliff is partly vegetated and suffers from head scarp erosion and slumps and slides are causing failure throughout the cliff face. The toes are undergoing various degrees of marine erosion and it is for this reason that the units to the south have been downgraded.

Till cliffs adjacent to Filey town. **MU29/AA** Partly Active in 2020

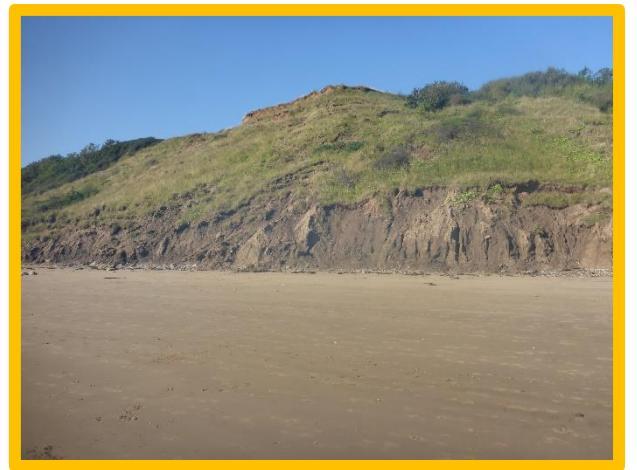
Till cliffs along Muston Sands. **MU29/AC** Partly Active in 2020

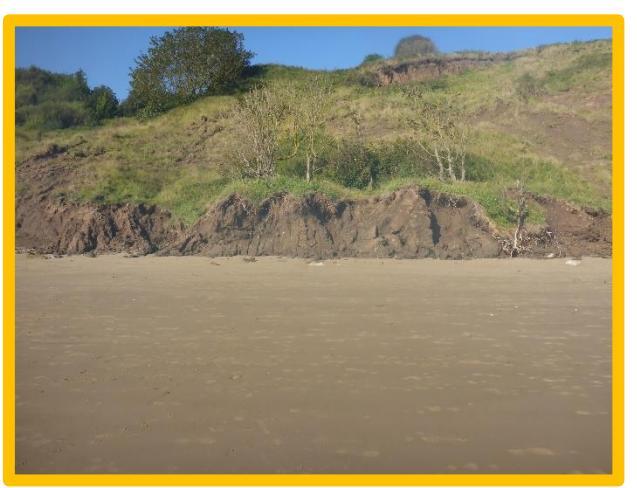
Till cliffs along Muston Sands. **MU29/AB** Partly Active in 2020

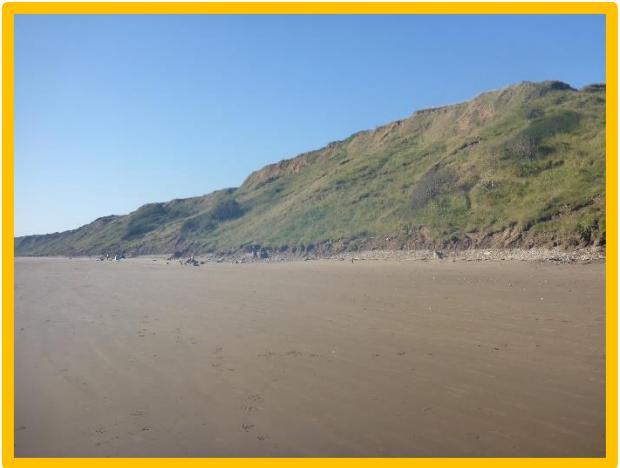
Till cliffs along Muston Sands looking North. **MU29/AD** in foreground Partly Active in 2020

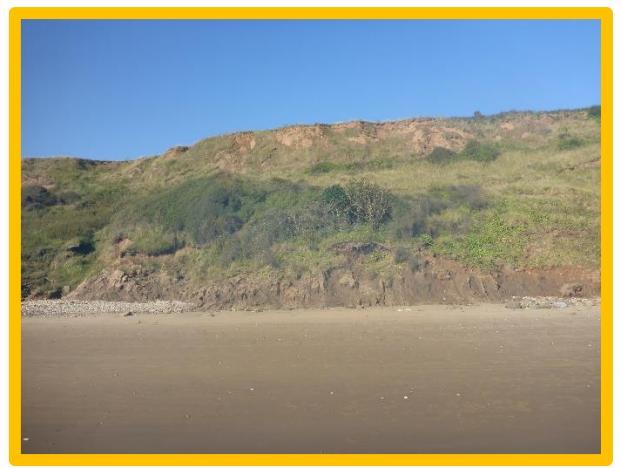
Till cliffs along Muston Sands. **MU29/AE** Partly Active in 2020

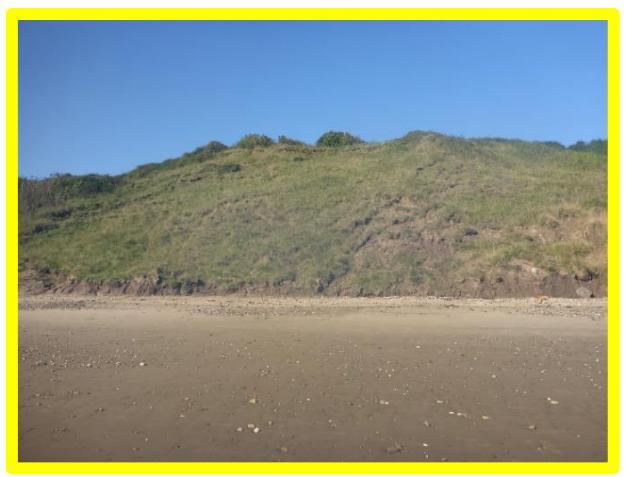
Till cliffs along Muston Sands. **MU29/AH** Partly Active in 2020

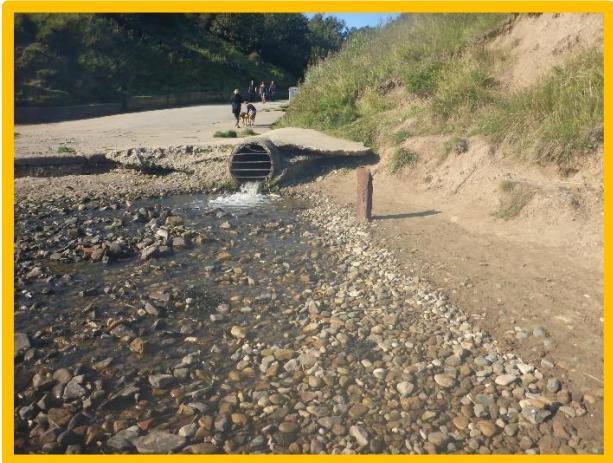
The concrete ramp / outfall structure at the Primrose Valley access MU29/AI and MU29/AJ was notably undermined.

Undermined concrete access ramp at MU29/AI and MU29/AJ

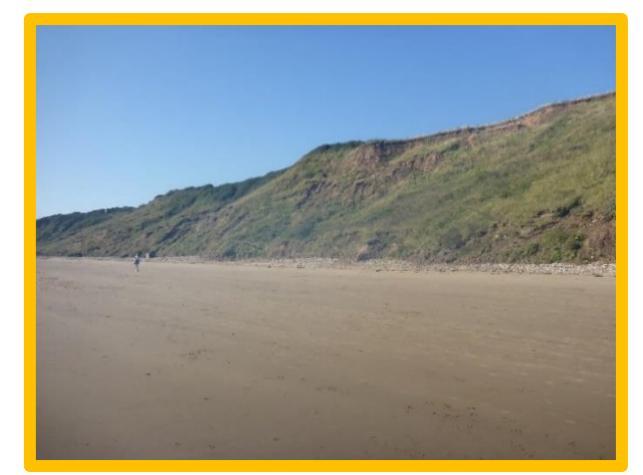
Till cliffs along Muston Sands. **MU29/AF** (left) Locally Active transitioning to **MU29/AG** (right) Partly Active in 2020

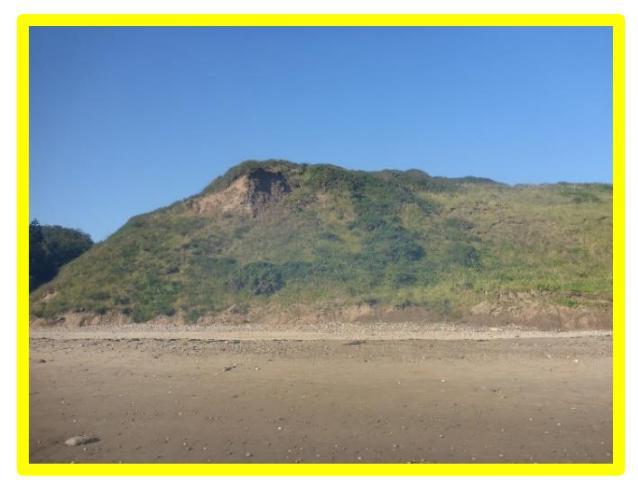
Till cliffs along Muston Sands. **MU29/AI** Partly Active in 2020

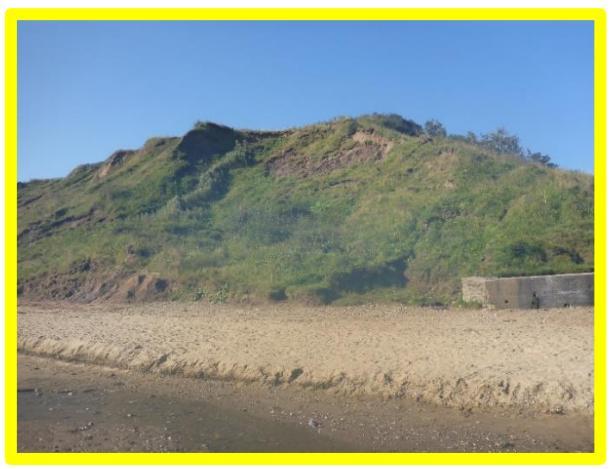
Till cliffs along Hunmanby Sands, outflanking at concrete blocks. **MU29/AJ** Locally Active in 2020

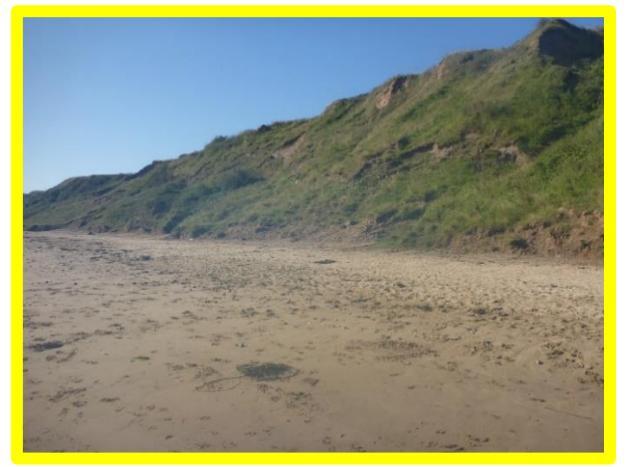
Till cliffs along Hunmanby Sands. **MU29/AK** Locally Active in June 2020

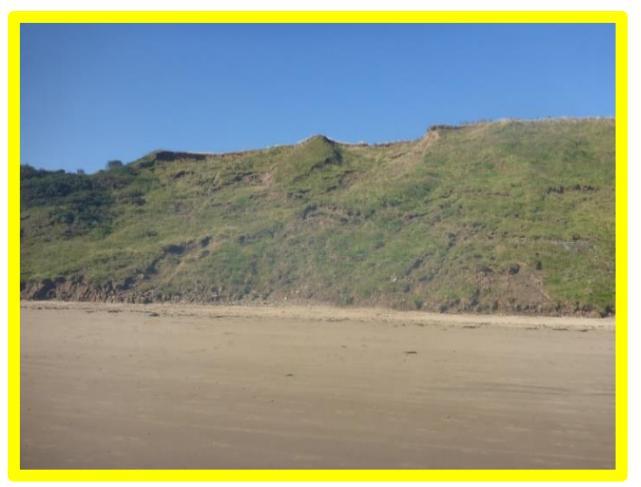
Till cliffs along Hunmanby Sands. **MU29/AP** Locally Active 2020

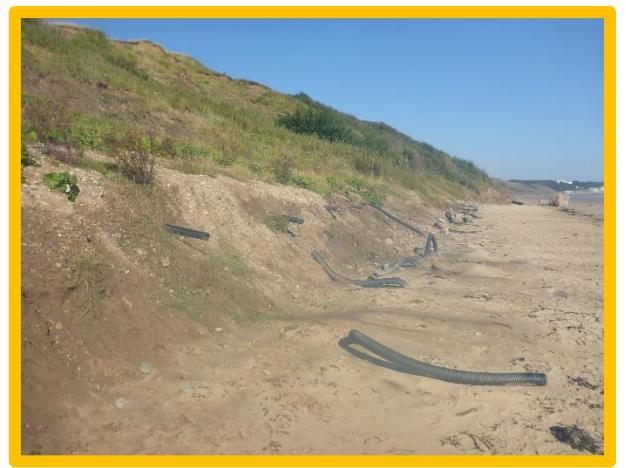
At **MU29/AQ** the Flat Cliffs coastal slope stabilisation project was complete in 2018 which included the installation of inclined sub-horizontal drains in the cliff and geotextile sand containers at the toe. The geotextile sand containers cliffs were fully buried with beach sediment, and therefore were not inspected. The toe of the cliff has continued to slowly retreat exposing, and damaging, the drainage pipes. It was noted that several of the drainage pipes were discharging water at the time of the inspection meaning they are still performing as intended.

Toe of till cliffs at Flat Cliffs. **MU29/AQ** Partly Active in 2020

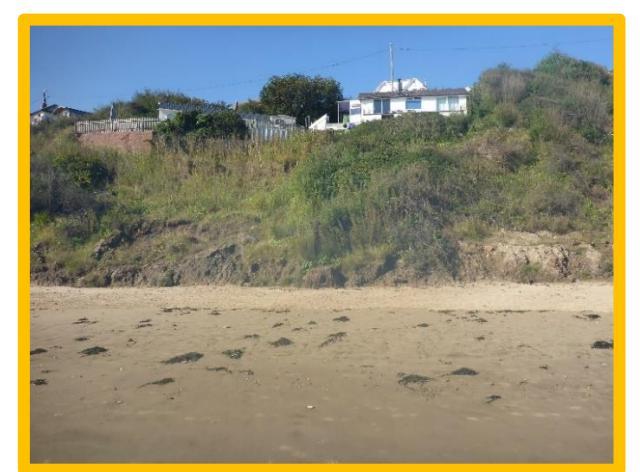
Toe of till cliffs at Flat Cliffs. **MU29/AR** Partly Active in 2020

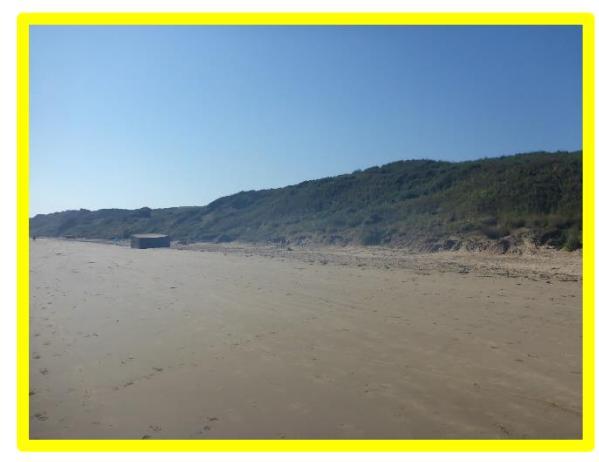
MU29/AT is classified as Locally Active in 2020 (unchanged from 2018) as it is generally well vegetated and there is only local evidence for toe erosion or activity at mid to upper levels. More intense erosion was again present along the full height of the cliff adjacent Butcher's Gap, with evidence of recent mud slips.

Well vegetated till cliffs along Hunmanby Sands. **MU29/AT** Locally Active in 2020

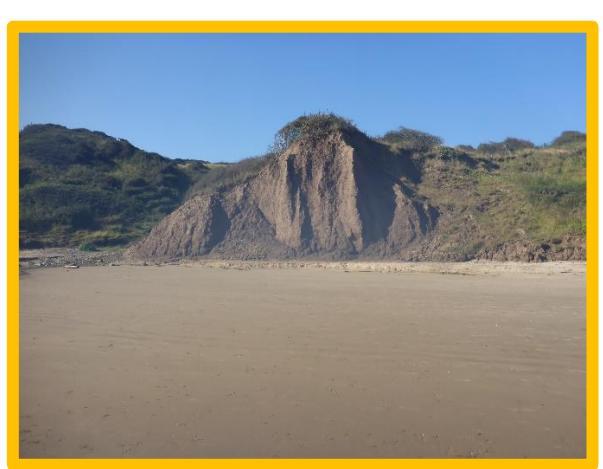
More intense erosion locally at Butcher's Gap. **MU29/AT** Locally Active in 2020

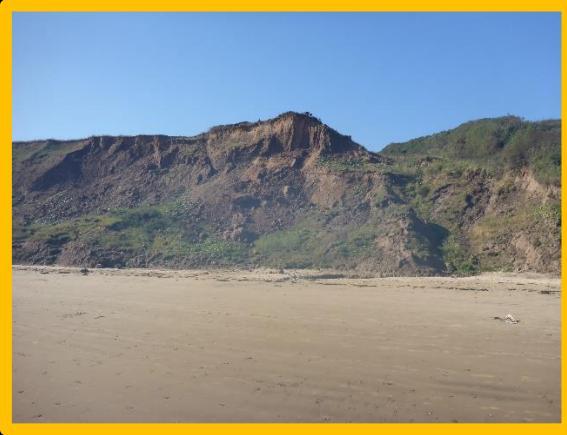
Till cliffs north of Hunmanby Gap. **MU29/BB** Partly Active 2020

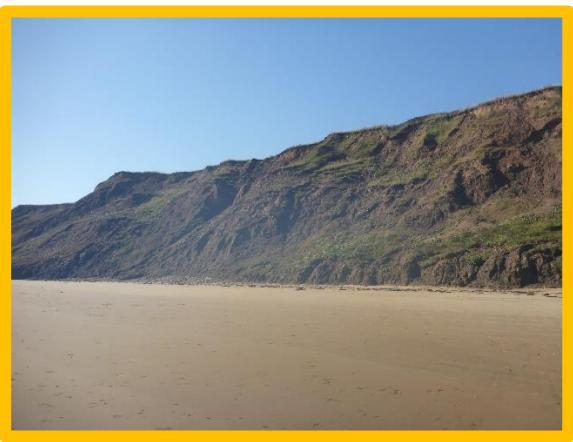
Till cliffs north of Hunmanby Gap. **MU29/BD** Partly Active 2020

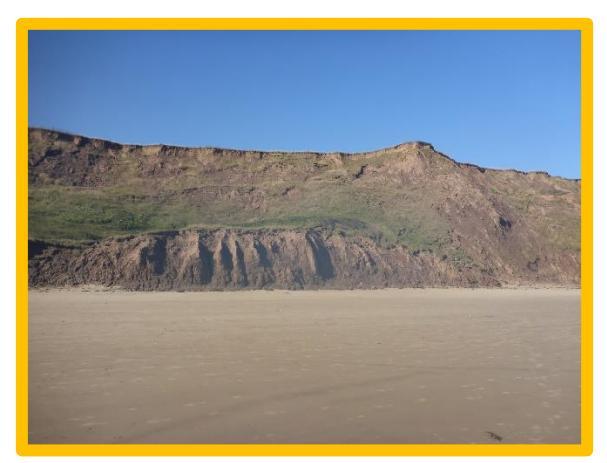
Till cliffs north of Hunmanby Gap. MU29/BE Partly Active 2020

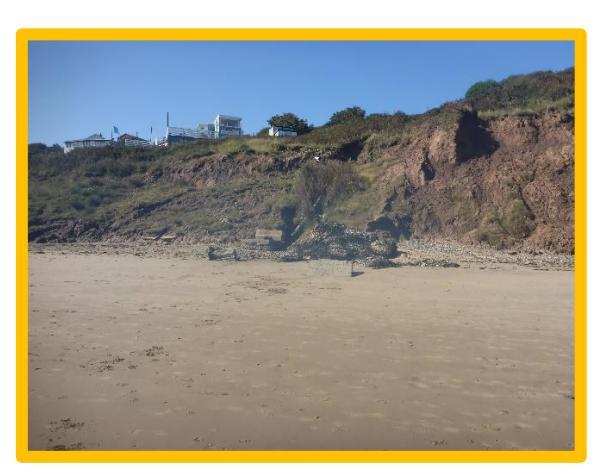
Units MU29/BA to MU29/BE2 are located between Butcher Haven and Hunmanby Gap and are all classified as Partly Active, unchanged from 2018. These cliffs are steeper than further north and are characterised by head scarp erosion and common areas of intense erosion. The toe of the cliffs are active with slumping and sliding on to the beach. A failed gabion structure in management unit **MU29/BE2** should be removed from the foreshore.

Till cliffs at Hunmanby Gap. MU29/BE2 Partly Active 2020

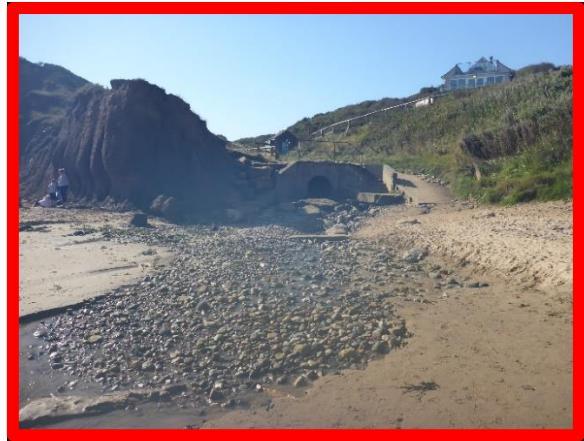
Unit **MU29/BF** includes Hunmanby Gap itself. This unit is partly shielded from wave erosion by unit **MU29/BG** and is classified as Locally Active in 2020, unchanged from 2016. **MU29/BG** to **MU29/BJ** are located south of Hunmanby Gap. These cliffs are steep and affected by intense erosion throughout most of their height. The head scarp is retreating and there is significant slumping on to the beach. **MU/29BG** to **MU29/BJ** are classified as Totally Active in 2020, unchanged from 2016. In **MU29/BH**, a small dilapidated masonry structure at crest of the cliff is at risk of collapsing onto the foreshore.

Intense erosion of till cliffs south of Hunmanby Gap. (MU29/BG – Toally Active) shielding Hunamby Gap itself (MU29/BF - Locally Active)

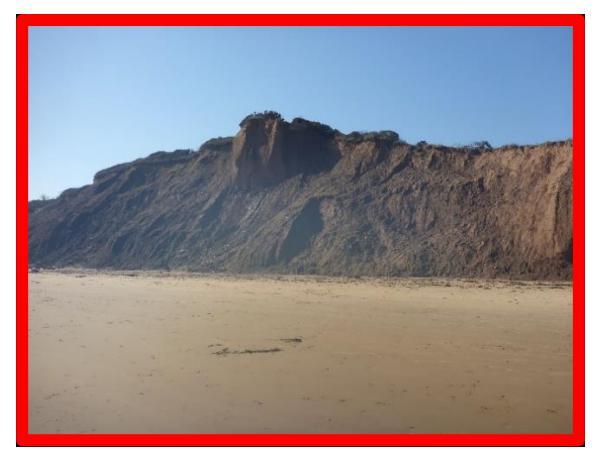
Intense erosion of till cliffs south of Hunmanby Gap. MU29/BH Totally Active in 2020

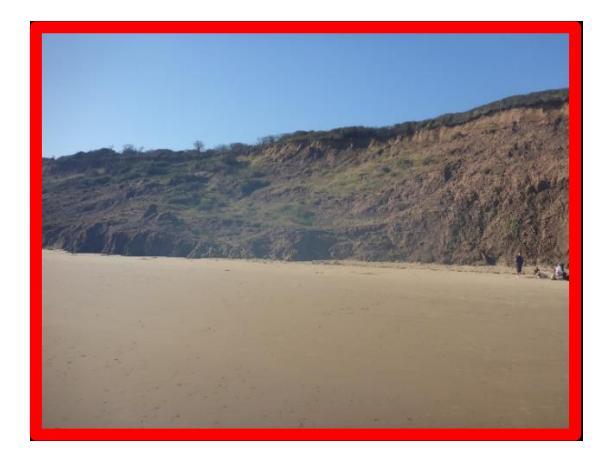
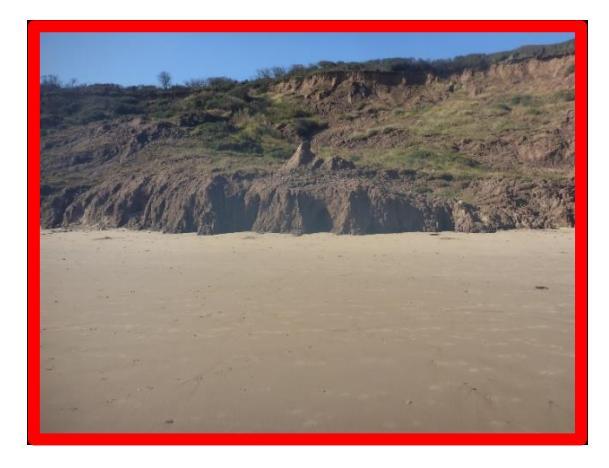
Gap. MU29/BI Totally Active in 2020

Intense erosion of till cliffs south of Hunmanby Intense erosion of till cliffs south of Hunmanby Gap. MU29/BJ Totally Active in 2020

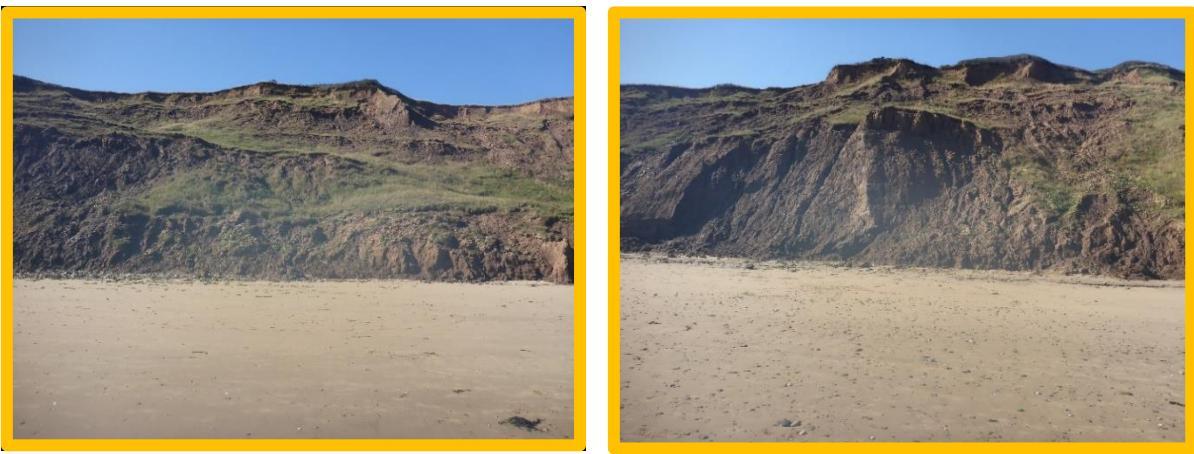
Further south, units MU29/BK to MU29/BQ are located above Reighton Sands. These units are again classified as Partly Active in 2020. They are characterised by steep slopes partially covered in vegetation. There is recession of the head scarp, common areas of erosion in the mid-slopes and slumping on to the beach. The toes are steep and eroding.

Till cliffs at Reighton Sands. MU29/BL Partly Active 2020

Till cliffs at Reighton Sands. MU29/BM Partly Active 2020

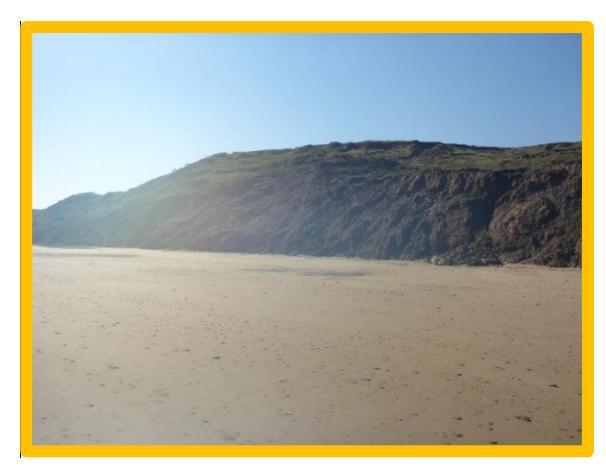
Till cliffs at Reighton Sands. **MU29/BQ** Partly Active 2020

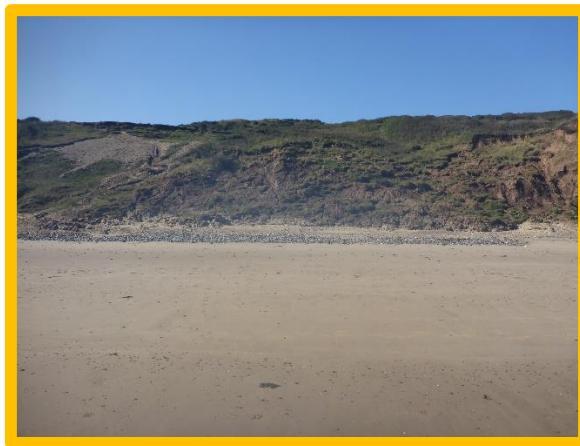
Units MU29/BR, MU29/BS and MU29/CA form the majority of this Sub-management Unit and are classified as Partly Active in 2020. These units are partially vegetated, and contain large slumps, erosion at their head scarp.

Till cliffs beneath Reighton Sands Holiday Village. **MU29/BR** Partly Active 2020

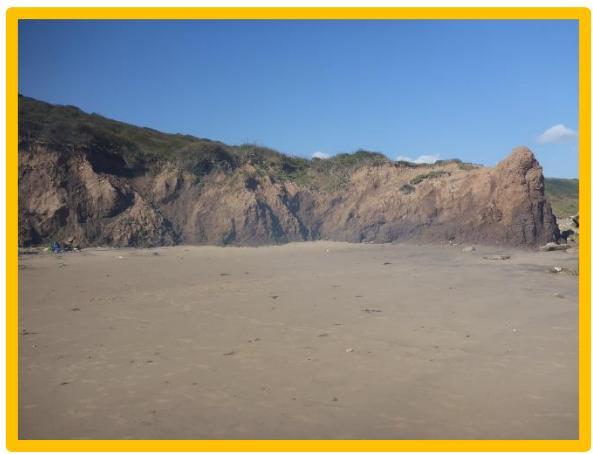
Till cliffs beneath Reighton Sands Holiday Village. **MU29/BR** *Partly Active 2020*

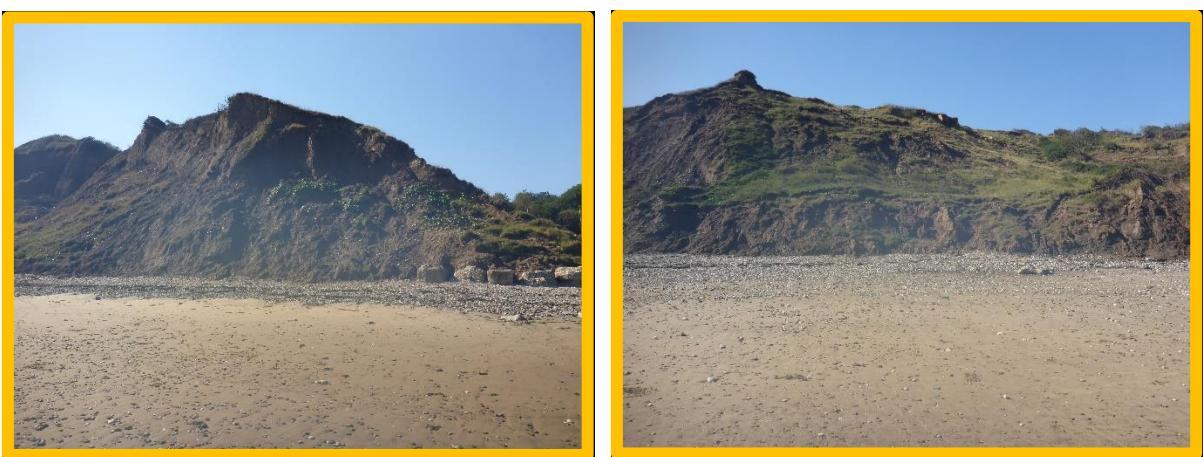
Till cliffs beneath Reighton Sands Holiday Village. **MU29/BS** Partly Active in 2020

Till cliffs beneath Reighton Sands Holiday Village. **MU29/CA** Partly Active in 2020.

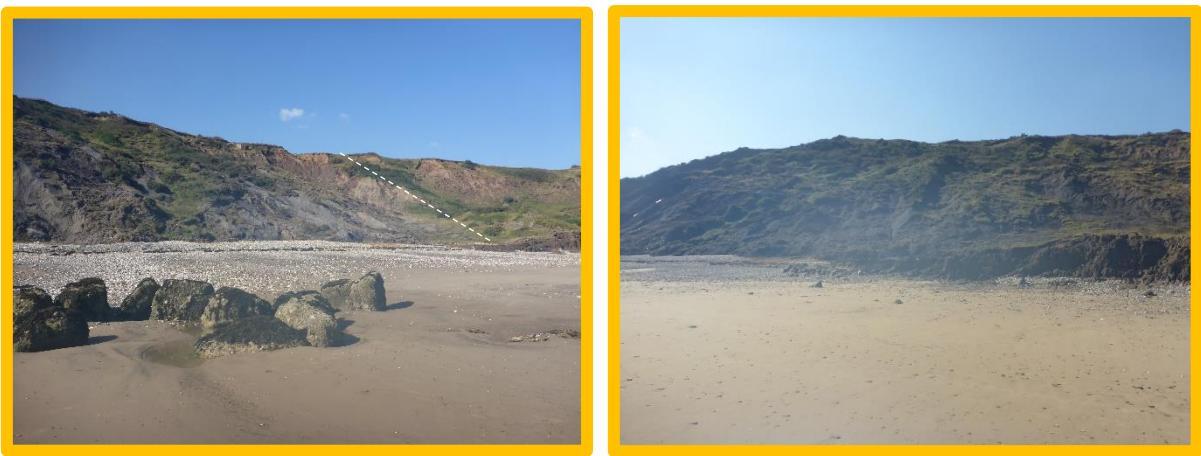
Unit MU29/CB is at the eastern end of the holiday village. The unit exhibits mudslides and an eroding head scarp, and is classified as Partly Active in 2020. The pillbox has been bypassed by the retreating cliff crest and appears at risk of toppling. Unit **MU29/CCa** forms a shallow mudslide embayment extending on to the beach. The unit is classified as Partly Active.

Till cliffs in MU29/CB (Left) Partly Active 2020 Till cliffs in MU29/CCa Partly Active 2020

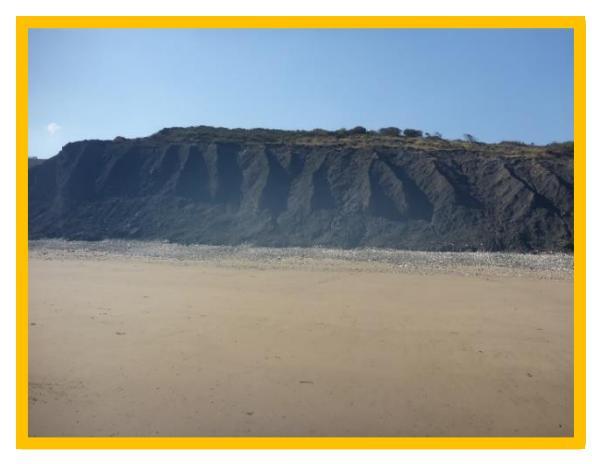
Unit MU29/CC forms a large, shallow, well vegetated embayment known as Middle Cliff with a steep well-defined eroding toe in mud. There is also activity at the unit head and mid slope. The unit is classified as **Partly Active** in 2020.

Toe of mud cliff in MU29/CC Partly Active 2020

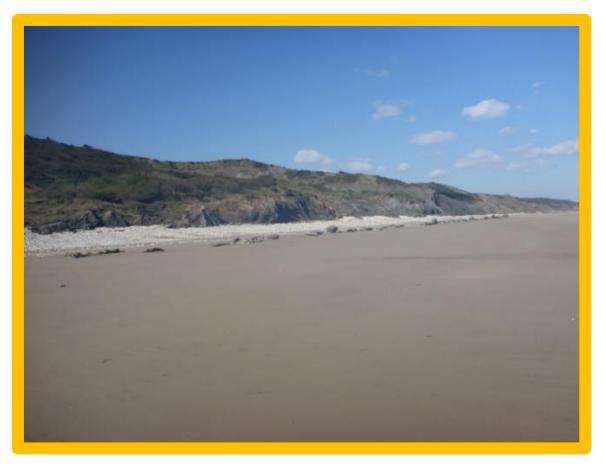
Unit MU29/CD is similar to MU29/CC but with more recent activity in the form of slumps, slides, block failures and mudflows at the toe. As a result, this unit is classified as **Partly Active** (unchanged)

Toe of mud cliff in **MU29/CE** lookings towards **MU29/CD** Partly Active 2020

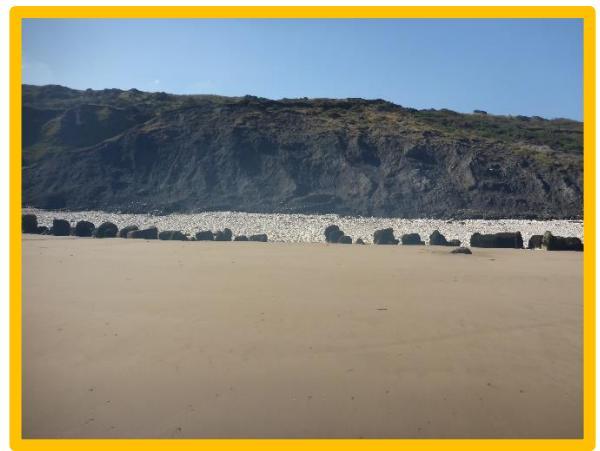
Unit MU29/CE is similar in form to unit MU29/CC. It has been downgraded to Partly Active in 2020 due to the steep eroding toe along sections. The upper slopes remain well vegetated.

Well vegetated upper slope above steep eroding toe **MU29/CE** Partly Active 2020

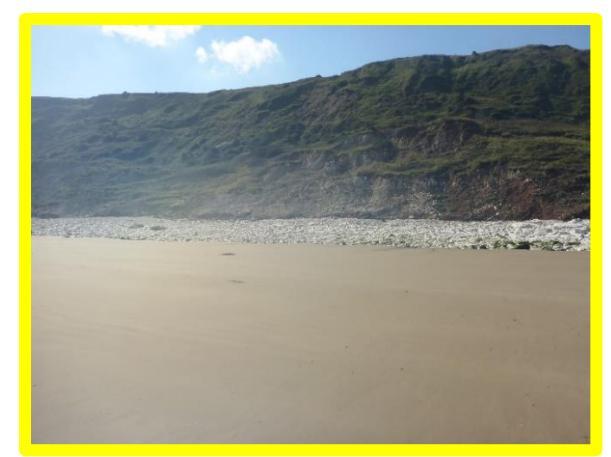
Units MU29/CF to MU29/CI are located at Speeton Cliffs and are all classified as Locally Active in 2020. These units are characterised by outcrops of chalk near the unit toes which are actively eroding onto the beach below. In places, the headscarp is near vertical and exposed.

Eroding chalk outcrop at toe **MU29/CF** Locally Active 2020

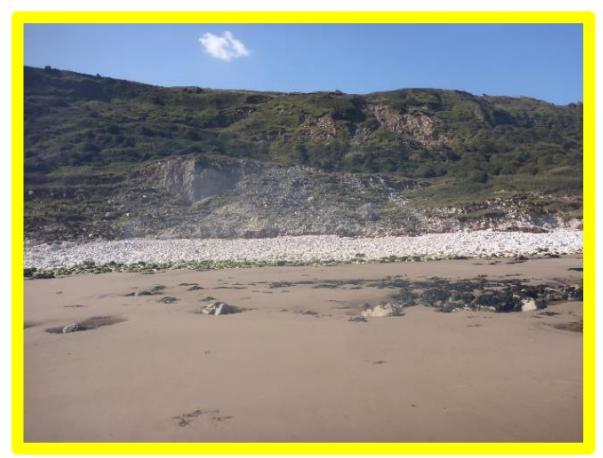
Eroding chalk outcrop at toe **MU29/CG** Locally Active 2020

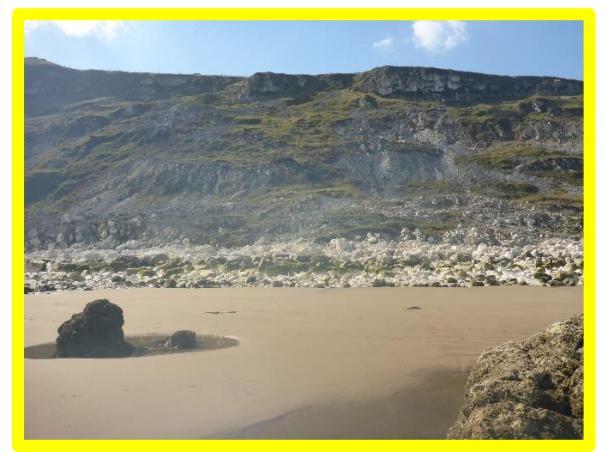
Eroding chalk outcrop at toe **MU29/CH** Locally Active 2020
