Cell 1 Regional Coastal Monitoring Programme Walkover Inspection Surveys 2020

Scarborough Borough Council

November 2020

Walkover Inspection Surveys 2020

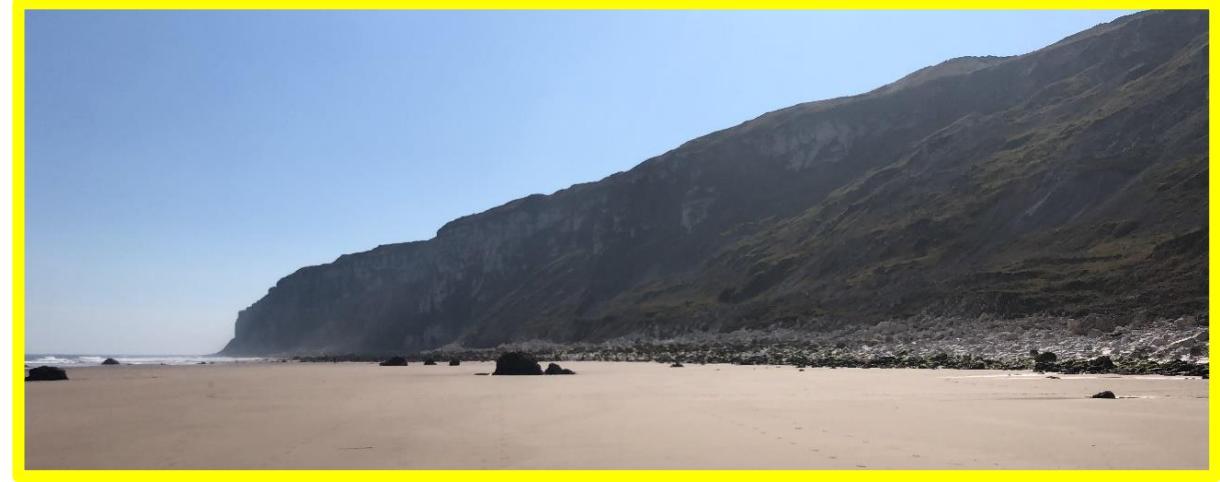
The high chalk cliffs within unit **MU29/CJ** are much steeper than those to the north, with large mantles of slumped material at the unit toe. This unit can only be inspected from afar as the tide reaches the toe of the cliffs even at low tide. As in 2018, there is some evidence of rockfall and marine erosion at the cliff base but otherwise the cliffs appear fairly stable. It is classified as Locally Active in 2020.

View southwards looking towards MU29/CI and MU29/CJ Locally Active 2020
