Cell 1 Regional Coastal Monitoring Programme Walkover Inspection Surveys 2022

**Scarborough
Borough Council**

November 2022

Walkover Inspection Surveys 2022

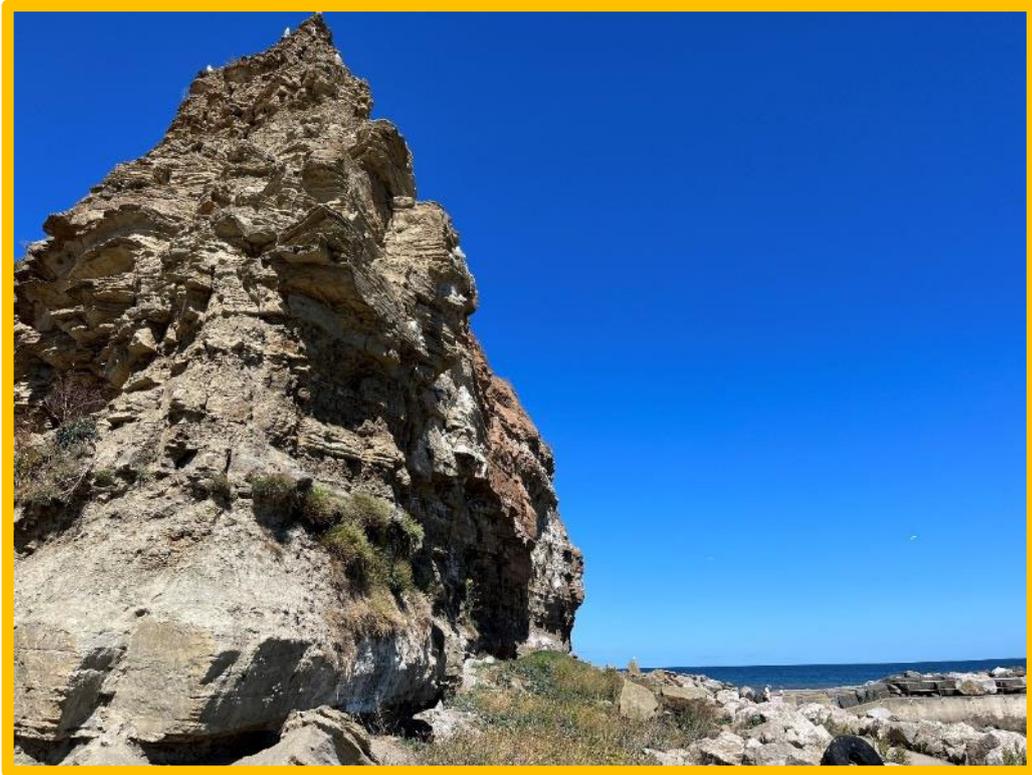
East-facing Cowbar Nab. MU4/1a. Partly Active in July 2022

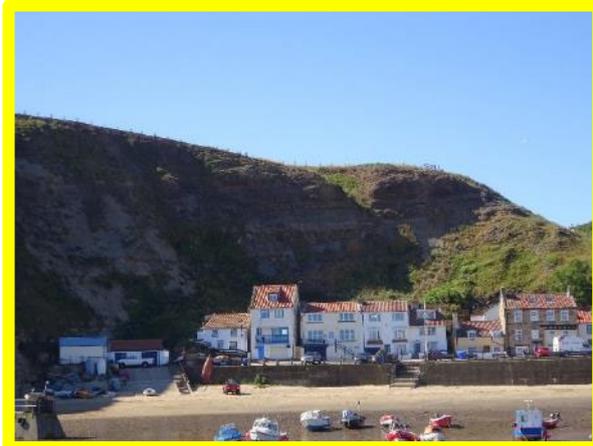
Unit MU4/2 is located behind Staithes Harbour. This sandstone cliff is well vegetated with small localised slumps and is classified as Locally Active, unchanged from 2020.

MU4/2 Locally Active in July 2022

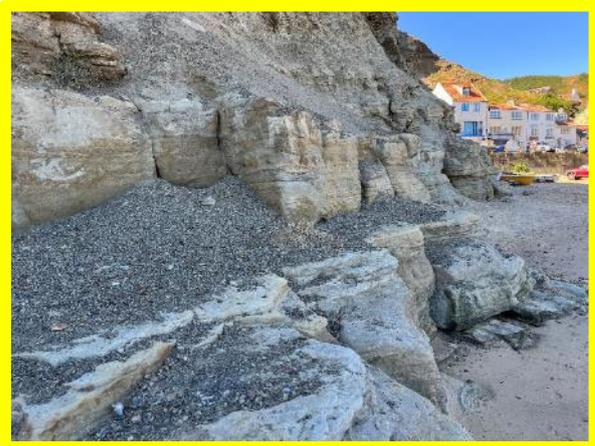
Accumulation of small stone fallen from above.
MU4/2 Locally Active in July 2022

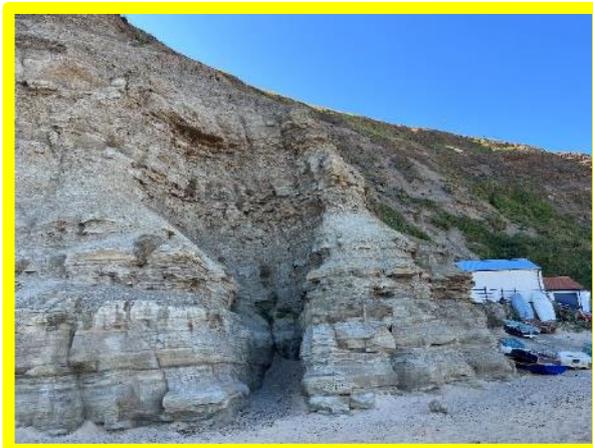
During July and August 2018 some high-profile incidents of cliff activity occurred along the coastline within the north of the borough, including the collapse of a section of cliff to the east of Staithes on 8th August, where tragically a young child was killed. These units are classed as Locally Active and as such are expected to experience some localised occurrences of activity and indeed there are warning signs erected on the cliff face and the approaches to the foreshore to this effect. Despite the signage, on the day of the survey (as on the day of the 2020 survey), people were observed in close proximity to the bottom of the cliffs. This is likely to remain an issue in this area, particularly with children due to the “interesting” cliff face (caves/cracks etc.) which is easily accessible from the popular beach.

“Interesting” cliff face **MU4/2** Locally Active in July 2022

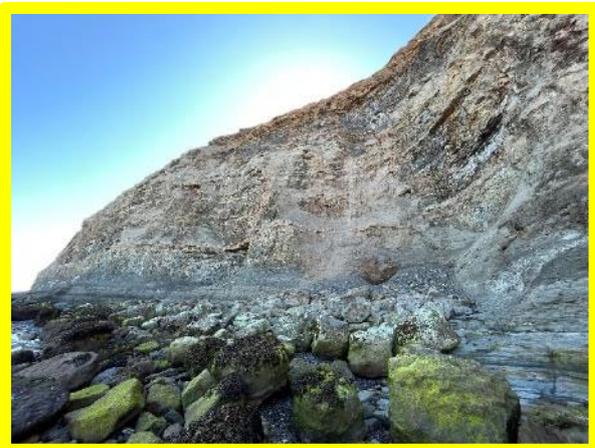
Further east, beyond the extent of Staithes Harbour is unit MU4/3. The cliffs are steep and the unvegetated sandstone is exposed to wave action at the toe. The unit is classified as Locally Active.

MU4/3 Locally Active in July 2022

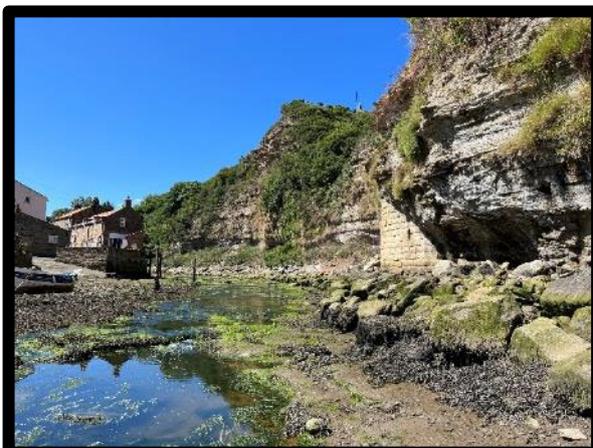
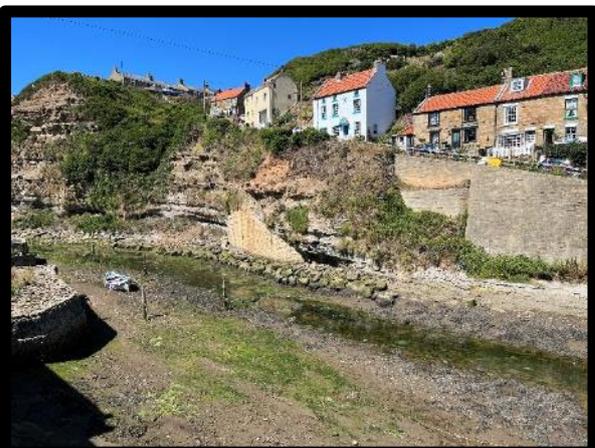
Upstream of the Staithes Beck footbridge, there are two areas of repair which were completed in 2013 and appeared to remain in good condition. These areas do not constitute coast protection assets in the present inspections but are included here for wider interest.

North bank: Works completed in 2013 to repair collapsed cliff (no asset ref)

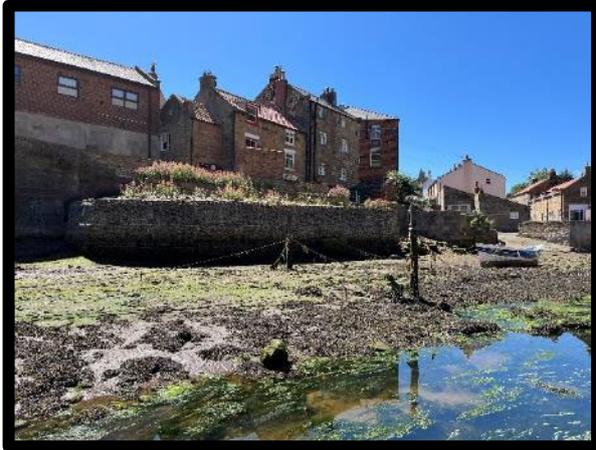
South bank: Stone-filled gabion baskets constructed in 2013 to repair collapsed wall (no asset ref)

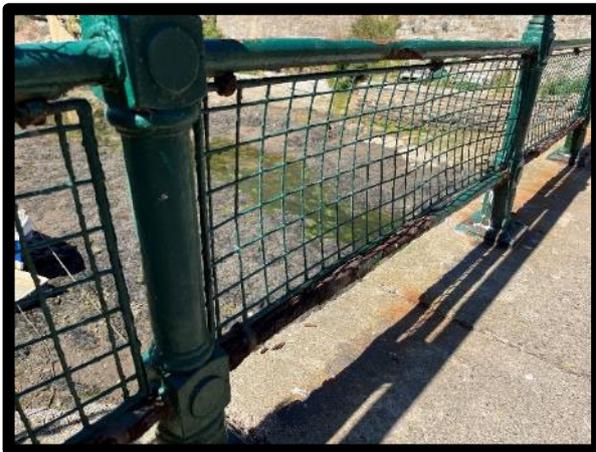
The lower rails of the guardrails crossing the footbridge were observed to be significantly corroded and the steel tubes had rusted through locally.

Footbridge – significant corrosion of bottom rail (no asset ref).

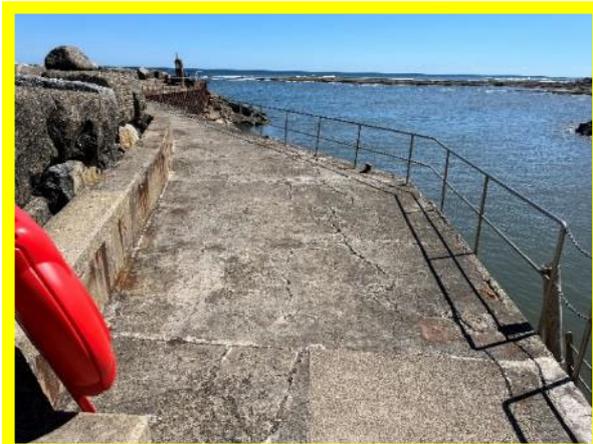
Cracking and abrasion in deck and crest wall (/0402C01).

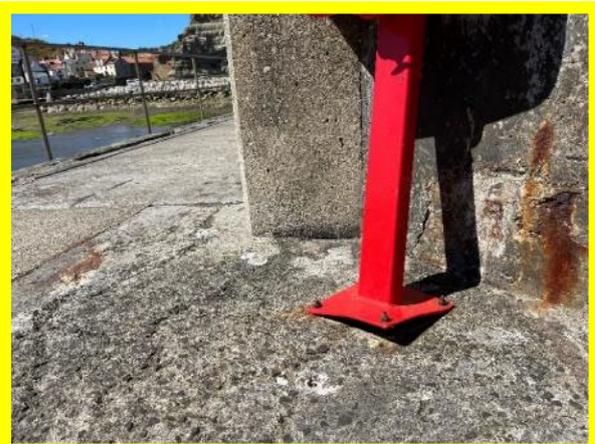
Damage to base fixings of life-ring mount (/0402C01).

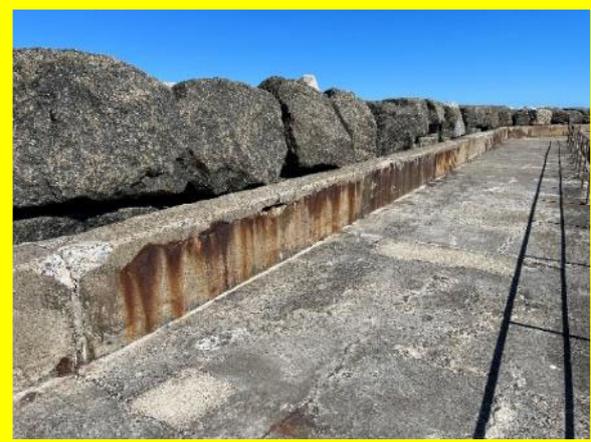
Crack, abrasion and rust staining of crest wall (/0402C01). No significant change from 2020.

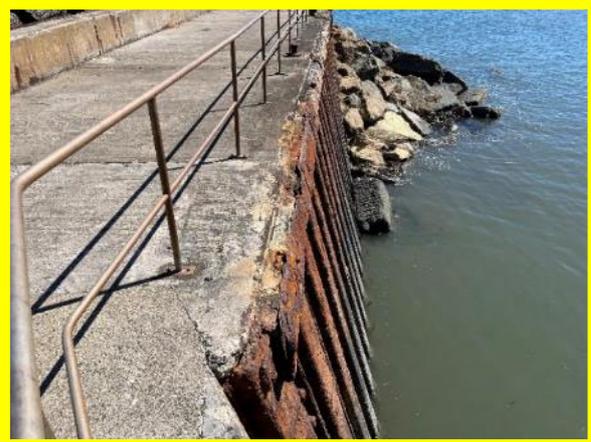
- The North Breakwater has been undercut on the inner-facing side, perhaps caused or exacerbated by propeller thrust. The sheet piles around the seaward end of the structure are significantly corroded although it is assumed that these are permanent formwork for previous *in situ* concrete pours rather than structural elements.

Significant corrosion / loss of section of sheet piles (/0402C01).

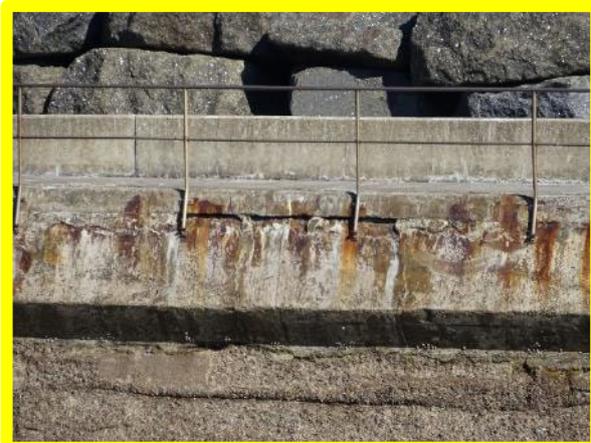
Rust staining and opening of construction joint on inside face of structure (/0402C01)

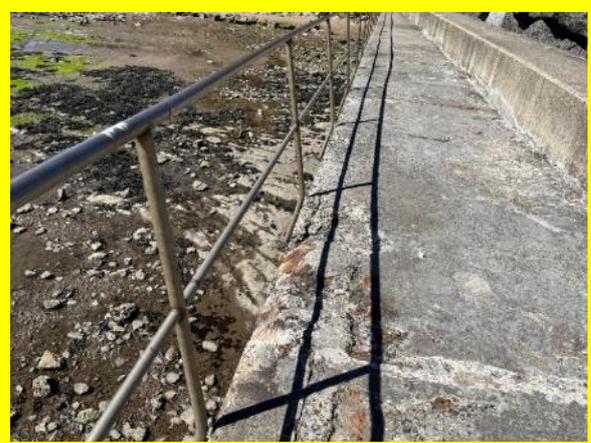
Abrasion to deck along inside edge of structure (/0402C01)

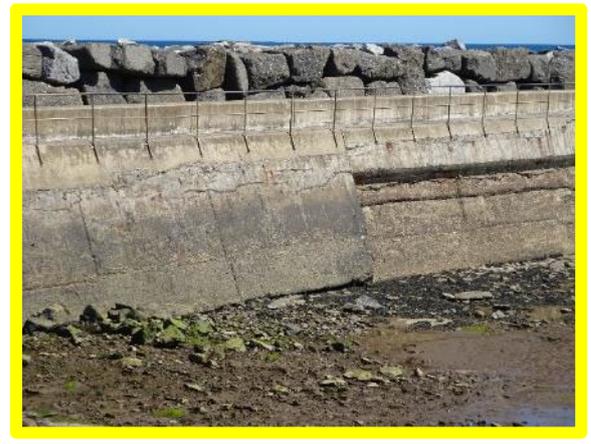
Undercutting / opening of a construction joint along the inner-facing side of the North Breakwater wall was previously reported in 2016 and 2018 inspections although water levels in 2020 and 2022 prevented observation of the same, with the exception of the landward extent of the structure. The undercutting appears to affect the outer concrete cladding of the structure.

Detail on potential undercutting (left) and opening of construction joint (right) (/0402C01)

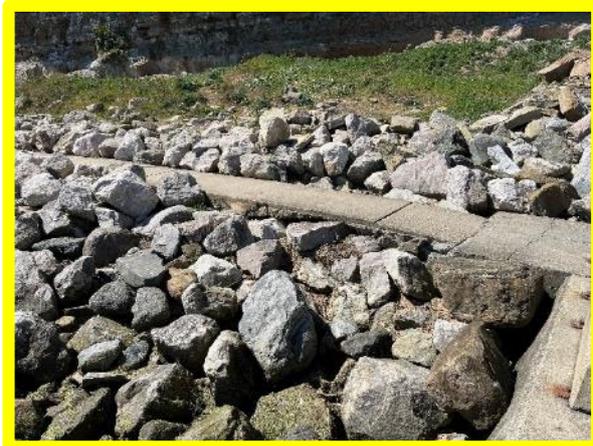
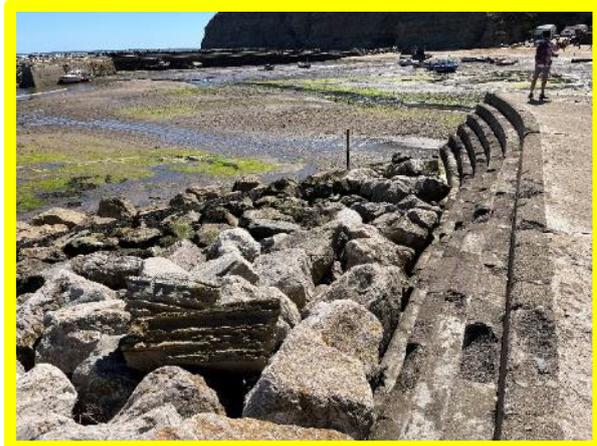
The rock armour revetment running south from the North Breakwater to the end of Cowbar Lane (/0402C02) was constructed after the 2002 upgrade to the main breakwaters and is generally in good condition. The crest level at the northern extent appears to be slightly lower, exposing the concrete walkway to the rear. It is not clear if rock armour has been displaced or if the revetment has undergone a larger scale movement/settlement although this area appears very similar to 2018 and 2020 so assumed to be stable. The short section of seawall which is exposed at the southern end of the rock armour, adjacent to the slipway, is in fair condition, with evidence of local abrasion of the vertical faces and the crest, and cracking and open joints between concrete blocks.

Lower crest level at northern extent of rock revetment (/0402C02) Southern extent of rock revetment (/0402C02)

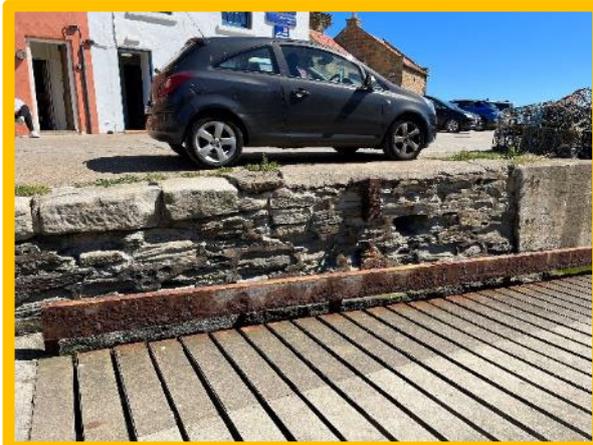
The defences that extend into the northern side of Staithes Beck are split into two asset lengths (/0402C03 and /0402C06), with the intersection at the west side of the RNLI slipway. The eastern section (/0402C03), which is in fair overall condition includes the slipway with gabion baskets beneath and a vertical concrete wall to the rear, tapering into a stone blockwork wall at the landward end of the slipway. High beach levels and vegetation cover largely obscured the gabions however the visible sections suggested these remain in a fair condition despite some potential settlement indicated by variation in crest levels. A timber and masonry training wall structure was largely obscured by vegetation. Small voids were visible, however there were no visual signs of global movement/distress. The masonry wall is in poor condition along its length, with open joints between blocks and one local void caused by a missing block. This void is now approximately 1m deep and 1m below retained ground level. As this area can be loaded by vehicles, it may be prudent to fill this void to avoid further deterioration potentially extending to the surface. Masonry has continued to erode since the 2020 survey, leaving the mortar of previous repointing standing proud. The concrete wall to the rear of the slipway appears in fair condition along its landward section, but in poor condition further seaward with longitudinal cracks and cold joints evident.

Poor condition masonry wall to rear of slipway (/0402C03)

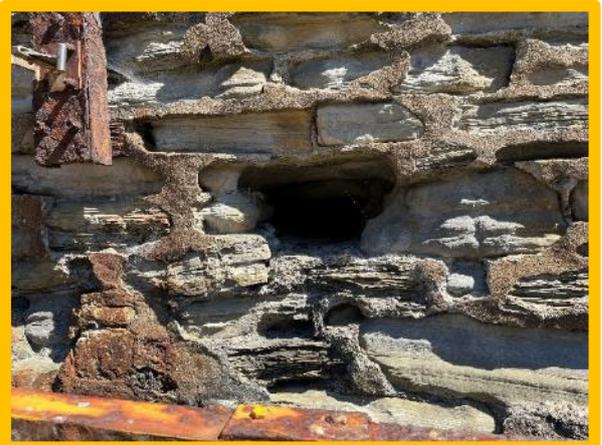
Missing blockwork in masonry wall to rear of slipway (/0402C03)

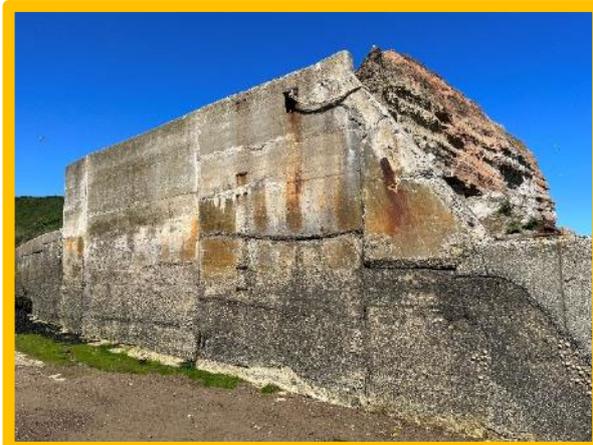
Cracks and cold joints in concrete seawall to rear of slipway (/0402C03)

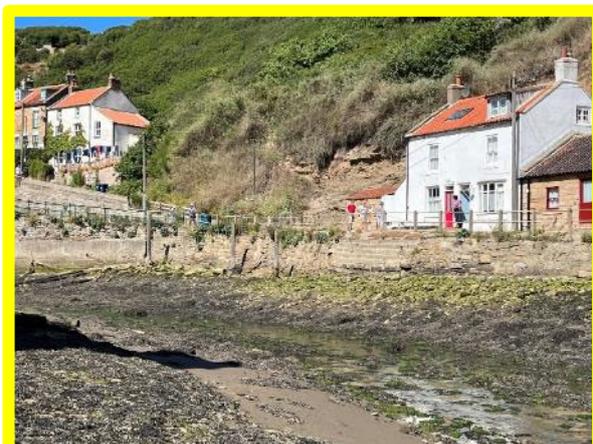
The walls between the RNLI slipway and the footbridge over Staithes Beck (/0402C06) comprise a variety of masonry and concrete blockwork structures and are generally in a fair condition, reduced to poor condition locally with missing mortar, settlement of blockwork and exposure of the toe (previous small boulder sized rock appears to have been largely washed away). The more recently constructed wall immediately in front of the RNLI building is in good condition, however there is a void beneath the un-rendered, older stonewall close to the interface with the newer wall which could compromise overall stability if voiding occurs behind. The external dimensions of this void do not appear to have increased since first reported in 2016.

Wall on northern side of beck (missing blocks, open joints and voids) (/0402C06)

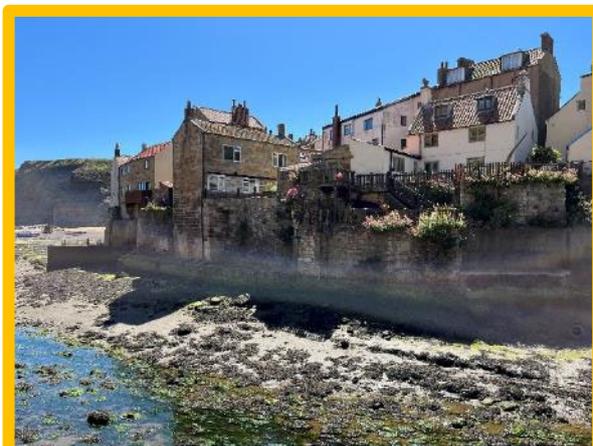
On the south side of the beck, a variety of wall construction details extends from the footbridge over Staithes Beck (/0402C04). There is evidence of previous repairs, with the overall condition of the asset generally fair, locally this reduces to poor, with sections of open joints, loose blockwork, abrasion, cracking and vegetation growth.

Variety of masonry and concrete walls. Vegetation growth locally (/0402C04)

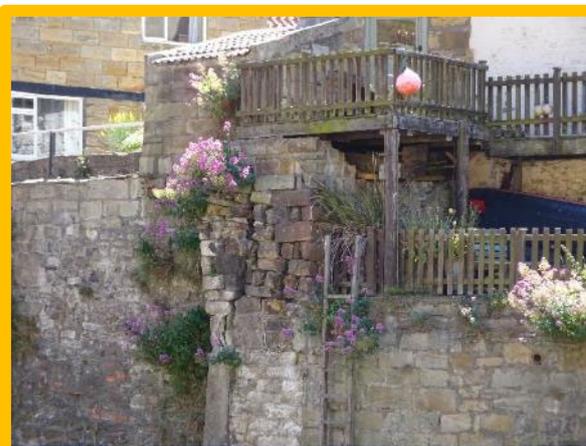
Open joints and loose masonry blocks locally (/0402C04)

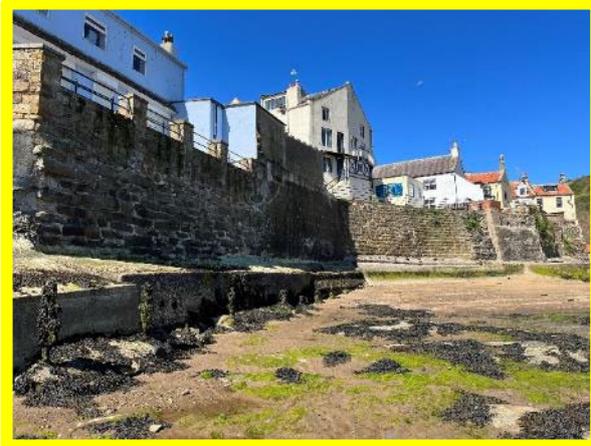
The walls continue as a series of masonry blockwork walls, often exterior walls of private properties (/0402C22), which continue to display visible loss of mortar causing open joints and missing blocks and vegetation growth locally. It is recognised that some previous repairs have been undertaken, but deterioration continues. Undercutting of the toe has previously been reported in several locations, exposing timber piling, this was not observed during the 2018 and 2020 inspections due to high beach levels. During the 2022 survey, a 2m long, 100mm tall, 300mm deep void between the concrete toe wall and the foreshore rock was observed approximately mid-way between the slipway and groyne structures.

Cracking and open joints locally (/0402C22)

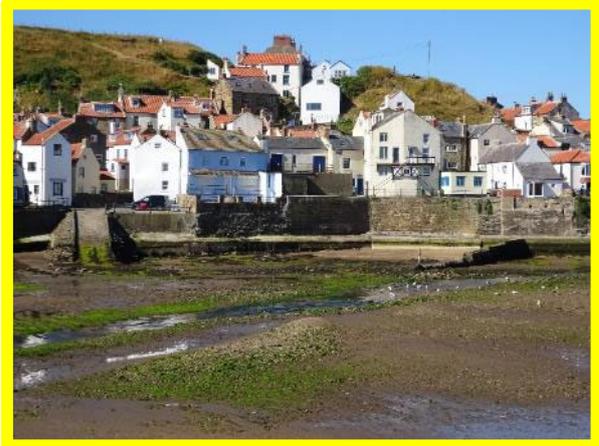
Cracking and open joints locally (/0402C22)

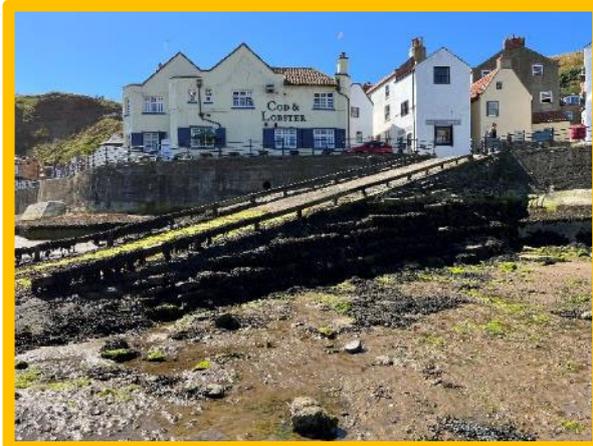
The masonry blockwork side walls to the slipway (/0403C05), are in poor condition, with missing blocks, open joints and undermining at the toe, more apparent at the lower elevations at the seaward extent of the structure. Some of the open joints are in an area of previous repair and need re-filling to prevent further deterioration. A void at the interface between the concrete abutment of the seawall fronting the Crab and Lobster and the south face of the slipway remained visible with a similar appearance to that observed in 2020.

North face of slipway (I0403C05)

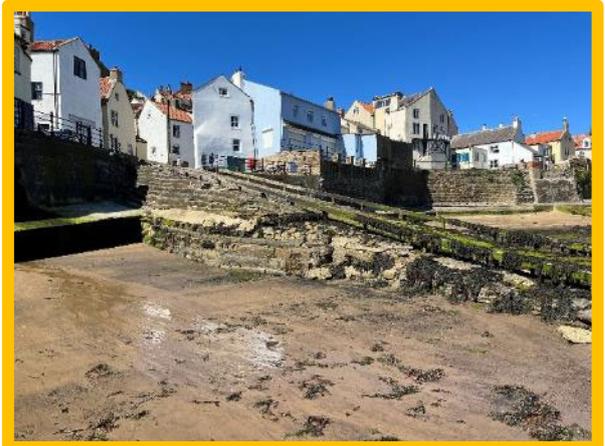
South face of slipway (I0403C05)

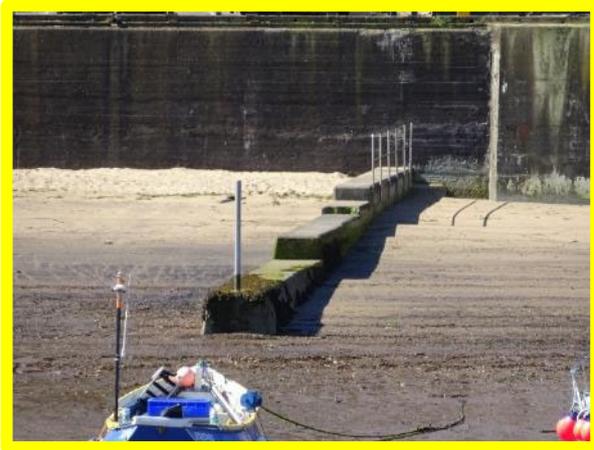
Concrete groyne (/0403C07)

Whilst repairs and improvements have previously been undertaken to the sea wall west of the Cod & Lobster (I0403C05), the wall remains heavily abraded and cracked in places, although generally in fair overall condition. There is notable cracking and loss of render at the interface between adjacent seawall sections. The concrete groyne (I0403C07) limiting sediment movement within the harbour is in fair condition.

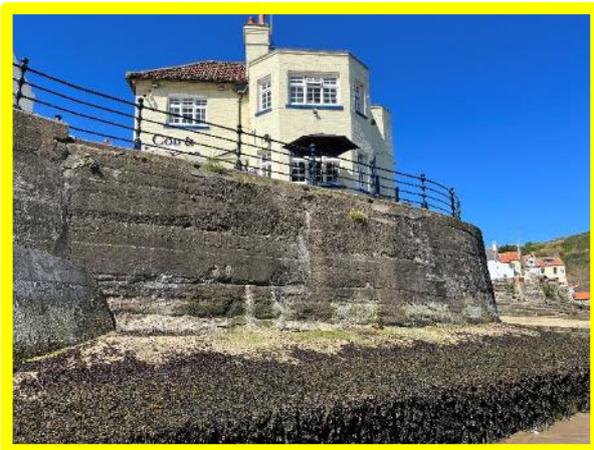
Concrete sea wall in Fair condition (/0403C05)

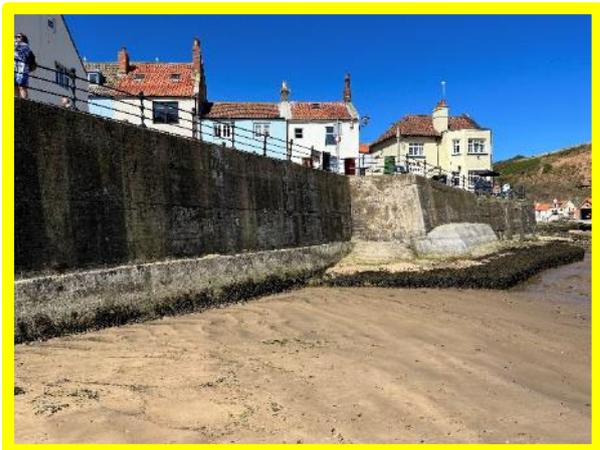
Abrasion and cracking to seawall face and crest at interface between different wall sections (/0403C05)

The seawalls extending to the Staithes Harbour Office (/0403C01 and /0403C02) are in fair condition, with previous repairs to cracks holding well. However, there is one full height vertical crack at the interface of adjacent wall sections which needs re-filling. This was reported in the 2018 and 2020 inspections and does not appear to have deteriorated significantly although has widened/opened slightly, more apparent in the lower section of the wall. The slipway and adjacent boat storage area at Staithes Harbour Office remain in good condition.

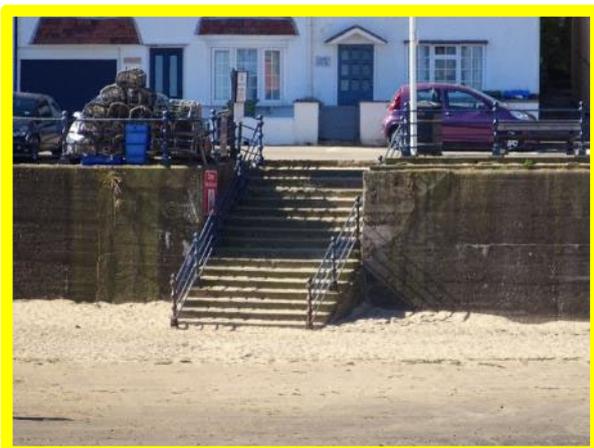
Concrete access steps (/0403C02)

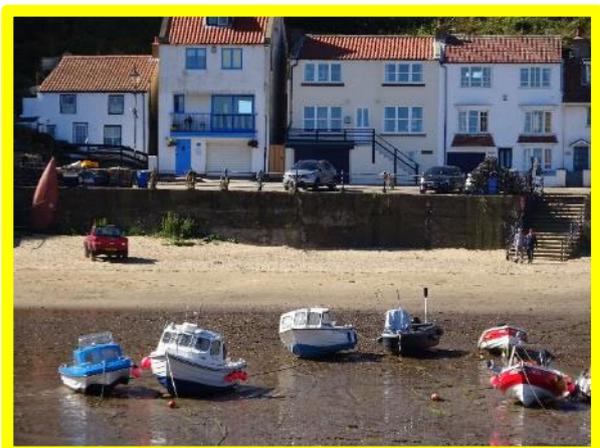
Concrete seawall (/0403C01)

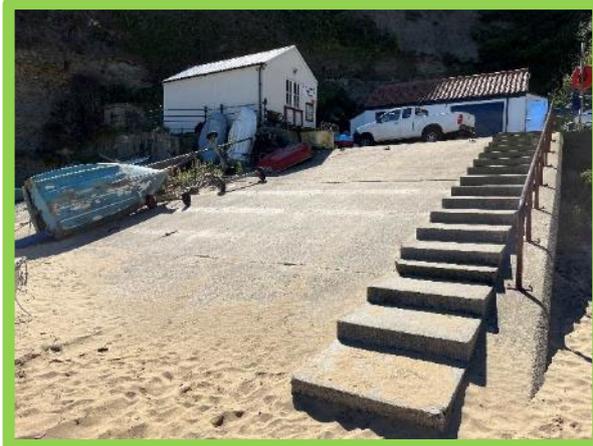
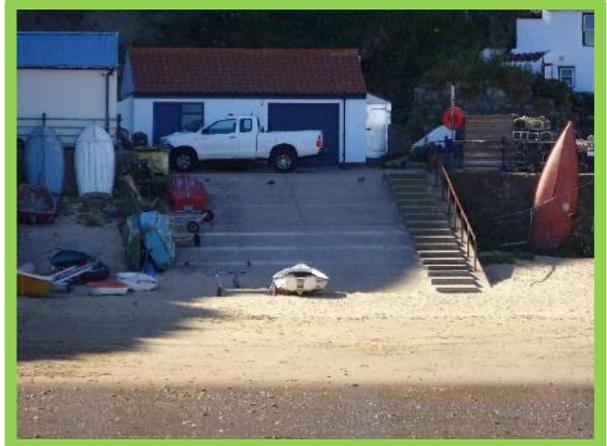
Slipway and access steps at Staithes Harbour Office (/0403C05)

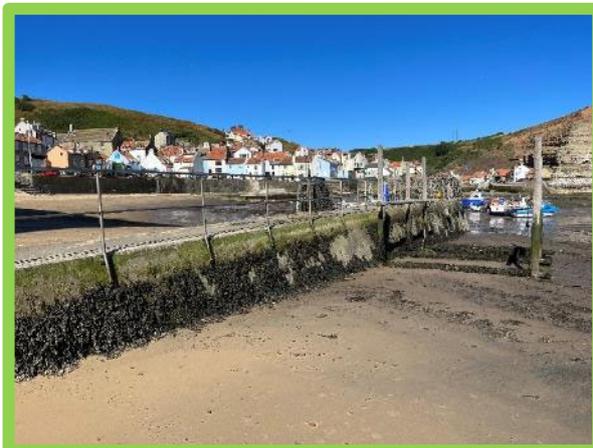
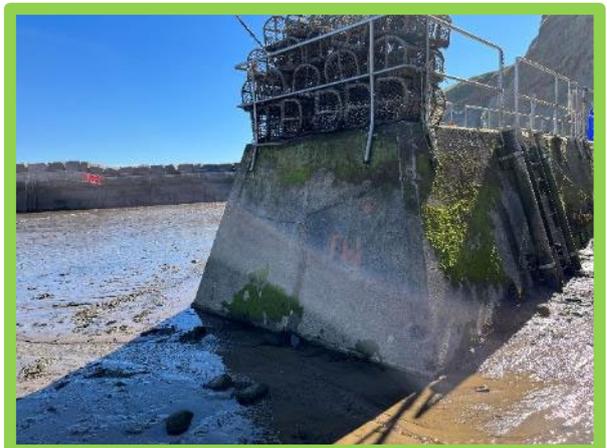
The inner harbour concrete breakwater (/0403C04) remains in good condition. A crack was observed at the crest on the inside/south face. At approximately mid-length, a crack extends the full width of the in-situ deck and aligns with vertical cracks in the walls however these appear to be historic and do not suggest continued global movement/displacement, with no apparent changes from 2020 inspection. Steel guardrails appeared to be in good condition.

Inner harbour concrete breakwater (/0403C04)

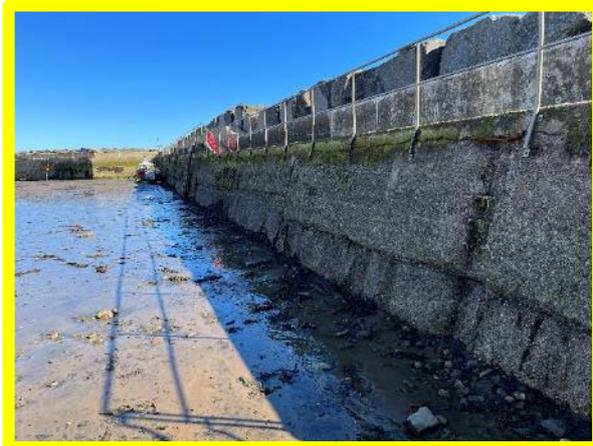
The main South Breakwater of Staithes harbour (/0403C03) is also in good overall condition, although there is minor abrasion and spalling at the access steps and around construction joints and one local area of cracking at the edge of the deck and wall on the lower (inner-most) deck of the structure. This may have been caused by an impact from a vessel (noting local deformation of guardrail tube). This defect has worsened slightly since 2018 inspection as more loose concrete has been washed out. Steel guardrails generally appeared to be in good condition.

Local abrasion, cracking and spalling inside face of South Breakwater (/0403C03)

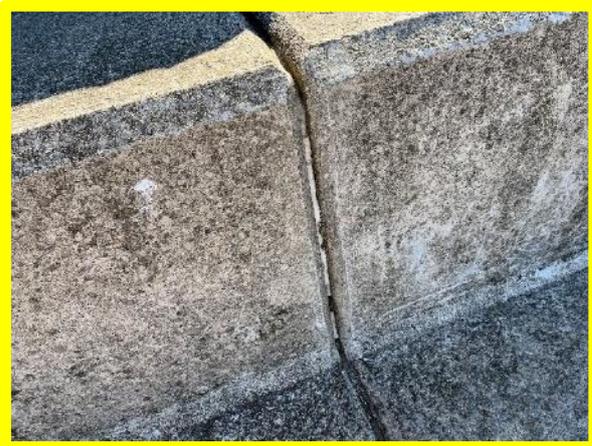
The majority of expansion joints in the concrete structure are missing flexible sealant and where sealant is present, this is cracked/brittle.

Brittle/missing flexible sealant from expansion joints (/0403C03)

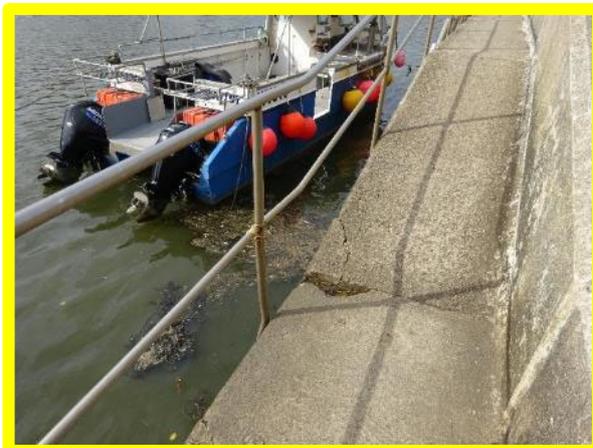
2020 - Local damage. Cracking and loose concrete to crest of South Breakwater (/0403C03)

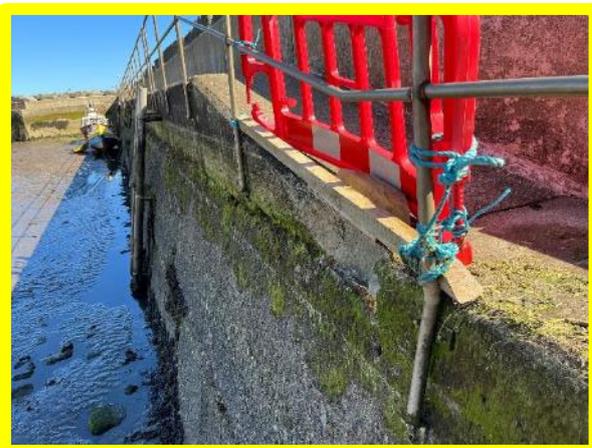
2022 – local repairs underway (/0403C03)

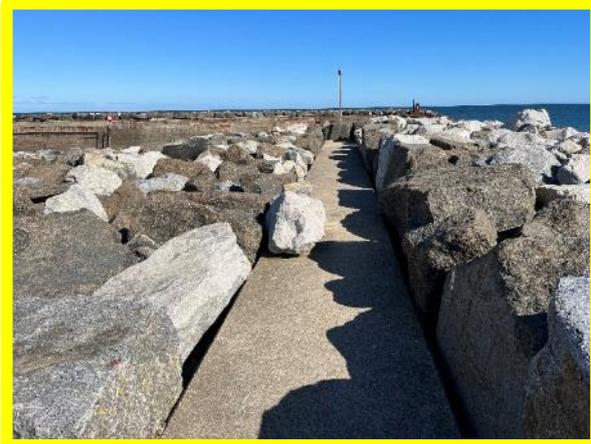
The rock armour revetment appears to be in good condition with generally consistent crest level and slope profiles. Several smaller rock armour pieces appear to have been lifted/displaced and are sitting on top of the larger armour and four small rock armour pieces are located on the concrete crest (outer limb of the structure) having been displaced from the rock armour crest. There is no apparent damage to the concrete crest and the absence of these units will not be of significant detriment to the performance of the wider revetment. No significant change from 2020 inspection. The rock armour fillet between the two breakwaters has several blocks displaced locally and sitting slightly seaward of most of the rock however the defence is generally in good condition.

Displaced rock armour on concrete crest (/0403C03)

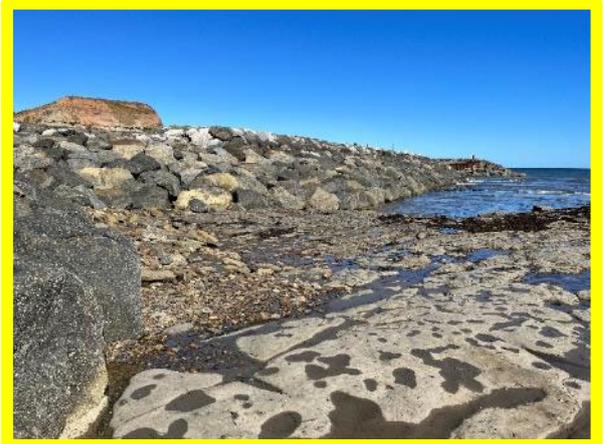
Rock armour on East face of breakwater (/0403C03)

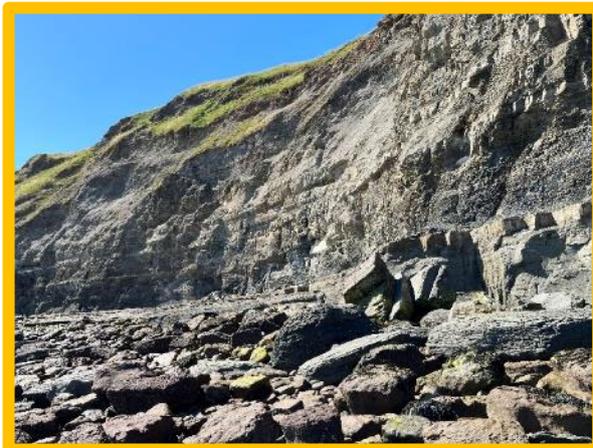
Jet Wyke forms the embayment between Penny Steel and Old Nab and consists of unit MU5/1, which remains classified as Partly Active in 2022. The lower slopes of the cliff are very steep, unvegetated and subject to gradual marine erosion. Evidence of several small-scale local failures, most recent of which appearing towards the northern extent of the CBU. The upper cliff is composed of softer material and supports some vegetation cover, with evidence of small-scale local slumps.

MU5/1 Partly Active in July 2022.

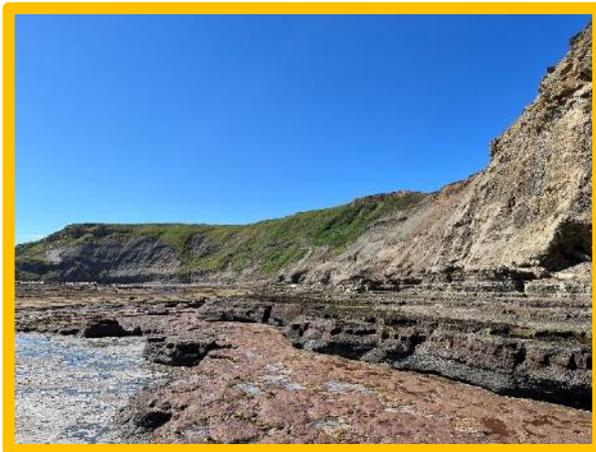
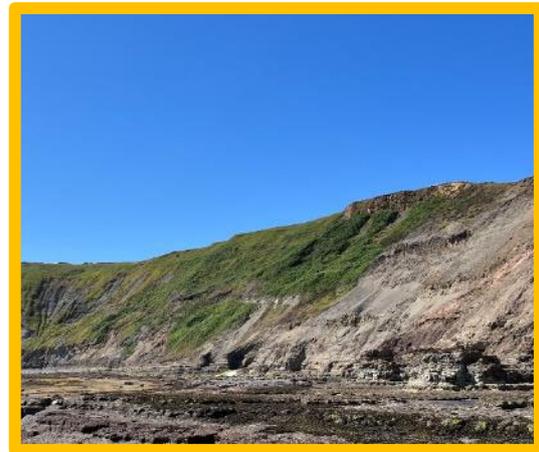
This section of cliff line remains classified as Partly Active in 2020, unchanged since 2012. The northern extent of MU6/1 forms the eastern side of Old Nab, characterised by steep slopes with no vegetation cover. Further south in the bay, some vegetation is supported on the upper slopes with exposed shales lower down showing evidence of on-going erosion. Marine erosion is cutting into the stratified rock at the base of the cliffs.

Looking south across Brackenberry Wyke. MU6/1 Partly Active in July 2022.

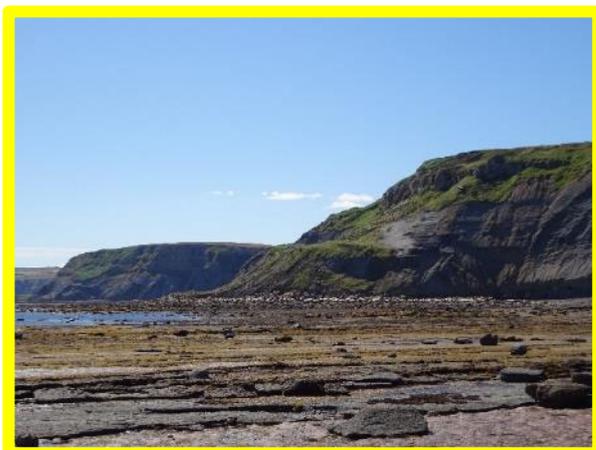
Units MU6/2 (debris lobe), MU6/3 and MU6/4 (coastal slopes) all show evidence of localised instability but also are substantively vegetated and therefore remain classified as Locally Active in 2022.

MU6/2 Locally Active in July 2022.

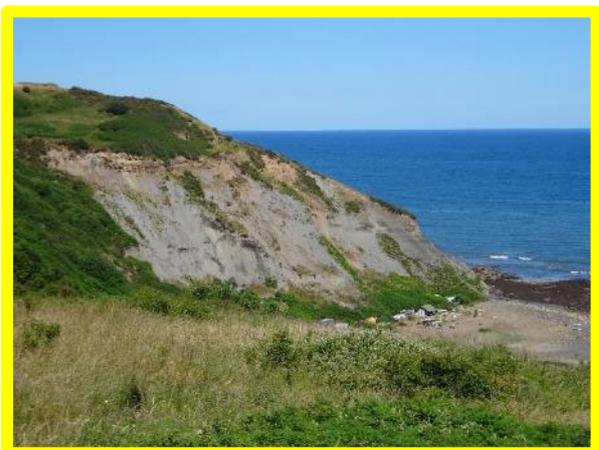
Steepest slopes with no vegetation cover and evidence of minor local activity. MU6/3 Locally Active in July 2022.

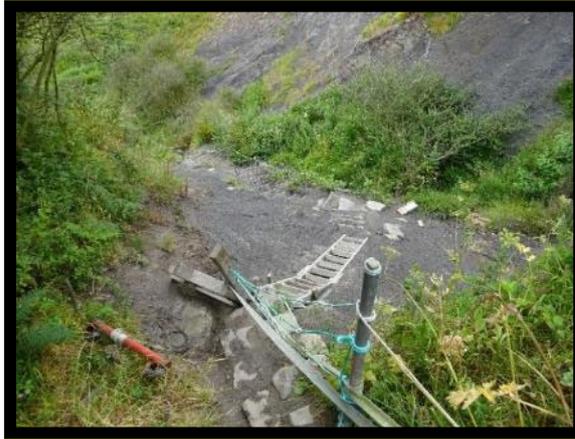
“Unauthorised” access route to foreshore within MU6/4 July 2018.

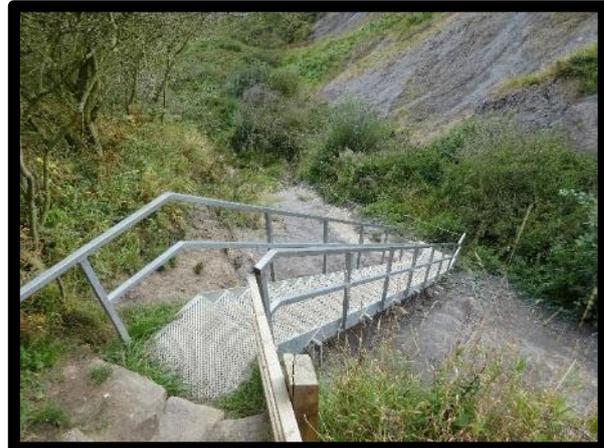
Upgraded access route within MU6/4 September 2020.

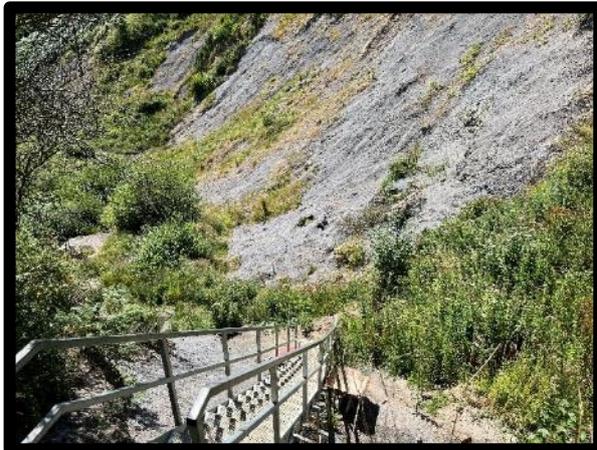
In early 2016, a large landslide occurred within unit MU6/5, rendering the public footpaths unsafe. As a result, the public footpaths in Unit MU6/4 and MU6/5 were temporarily closed by the North York Moors National Park Authority. By the September 2020 survey, the footpaths had been reopened, with addition of some access steps. A landslide occurred in January 2021 following heavy rain and freezing temperatures, leaving the foot of the steel steps suspended 1.5m above ground level and cutting off access to the foreshore. The steel structure appeared to be in good condition with no visual indication of displacement. Temporary barrier/roping off the steps was evident in July 2022, however evidence suggested that these measures were bypassed by visitors.

Landslip at foot of steps MU6/4 July 2022.

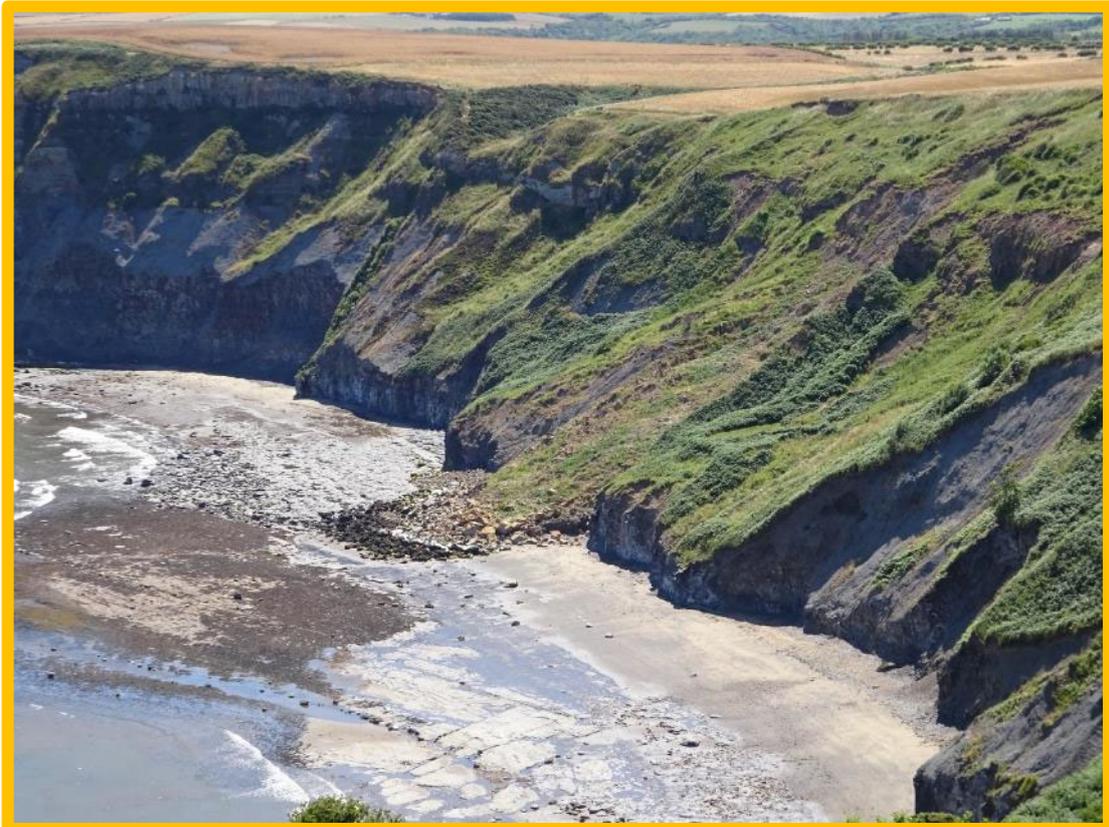
There is a lack of evidence of significant continued activity other than minor changes in the size of debris fan and a reprofiling of the toe section of the failure and this unit remains as Partly Active in July 2022.

MU6/5 – View of the landslide looking across Port Mulgrave from west to east (Partly Active in July 2022).

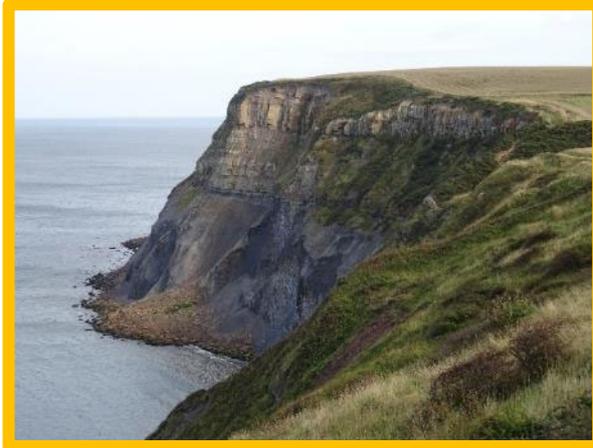
Unit MU6/6 forms the northern part of the Lingrow Cliffs. The upper slopes support some vegetation cover while lower slopes are actively eroding. A debris fan from a localised rock fall observed in the 2018 survey remained largely unchanged. The unit continues to be classified as Partly Active in 2022 due to cracks/fractures in the upper material and evidence of rock falls.

MU6/6 – Localised rock fall and debris fan, Partly Active in September 2020.

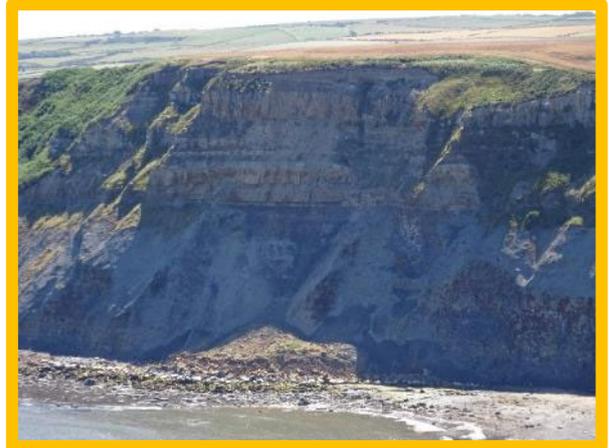
MU6/6 – Localised rock fall and debris. Partly Active in July 2022.

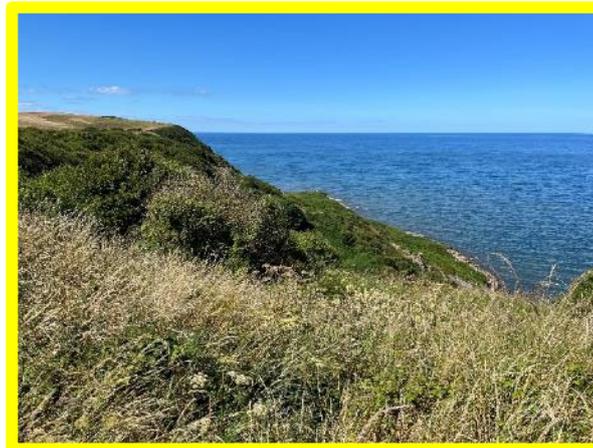
Unit MU6/7 forms the central part of this Sub-management unit and consists of a large relict debris run-out lobe. The cliff is well-vegetated with only localised activity at the toe. It remains classified as Locally Active in 2022, unchanged since 2002.

MU6/7 – Vegetated run-out lobe, Locally Active in July 2022.

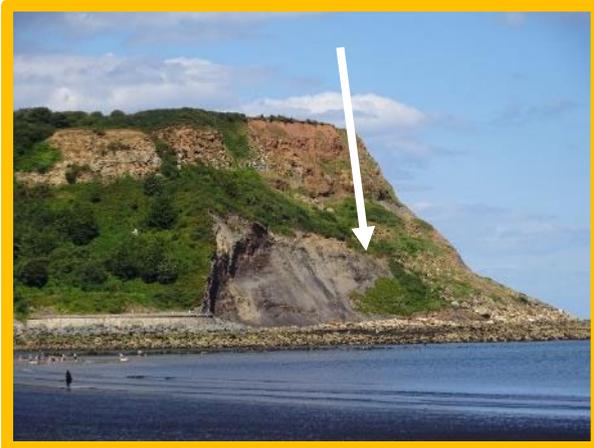
MU6/8, Partly Active in September 2020.

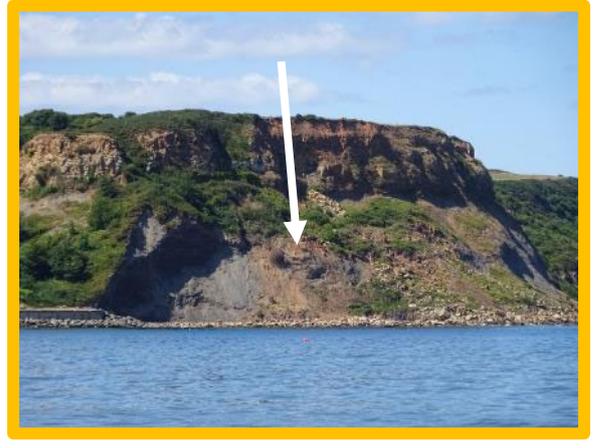
Unit MU6/8 is located north of the hard defence of the Runswick Bay seawall and rock armour. The main bulk of the cliff is mudstone capped by sandstone. The main mudstone part of the cliff is vegetated in its upper part and is eroding in its lower part with debris fans splayed across the toe and occasional rock falls at the base. The sandstone top is a near vertical unvegetated cliff. The activity in the mudstone cliff means the unit is classified as Partly Active in 2022, unchanged since 2002.

MU6/8, Partly Active in July 2022, recent activity indicated

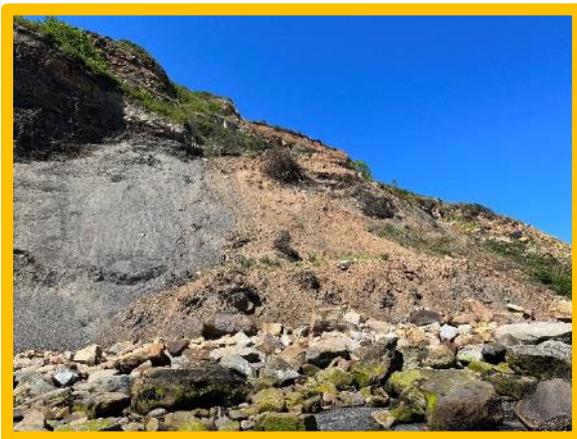
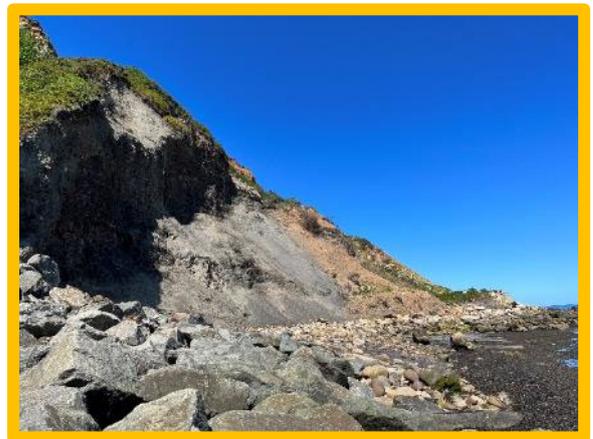
MU6/8 Recent slope failure north of Runswick defences.

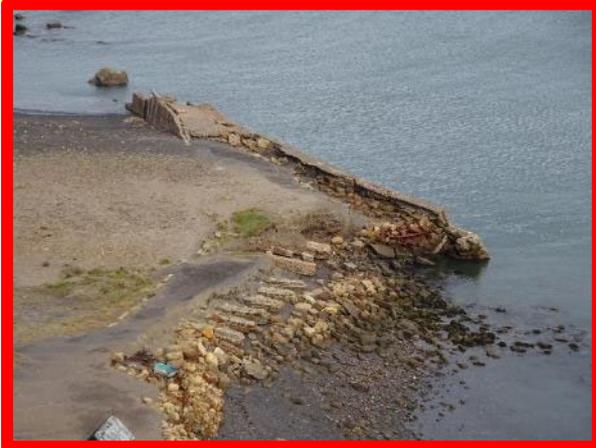
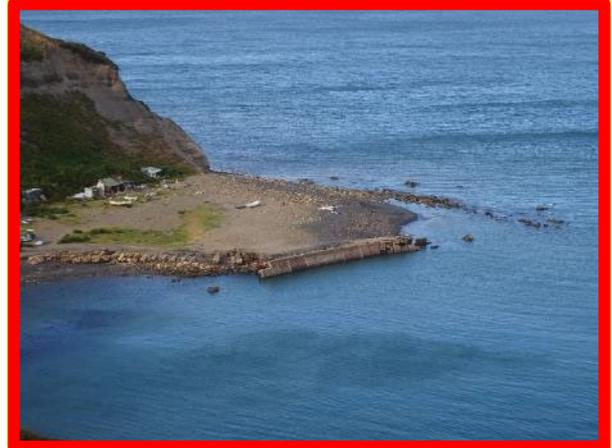
Dilapidated asset in 2020 (\D0502C01)

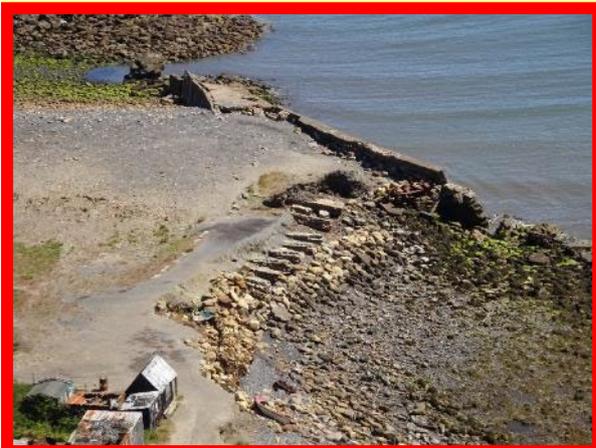
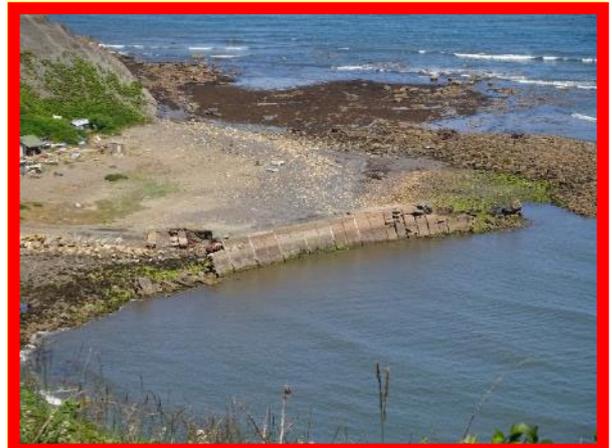
The jetty of the former port and ironstone mine at Port Mulgrave has been derelict for many years and is considered to be redundant. Virtually all coastal defences have been lost to the sea. What is left of the southern breakwater is undergoing large scale cracking, deformation, undercutting and outflanking and failure of more recently added gabions. It is estimated that more than half of its original length has now been eroded. The rate of deterioration appears to have slowed as the remains of the structure appeared very similar to observed in 2018 and 2020 (\0502C01).

Dilapidated asset in 2022 (\D0502C01)
