Cell 1 Regional Coastal Monitoring Programme Walkover Inspection Surveys 2022

**Scarborough
Borough Council**

November 2022

Walkover Inspection Surveys 2022

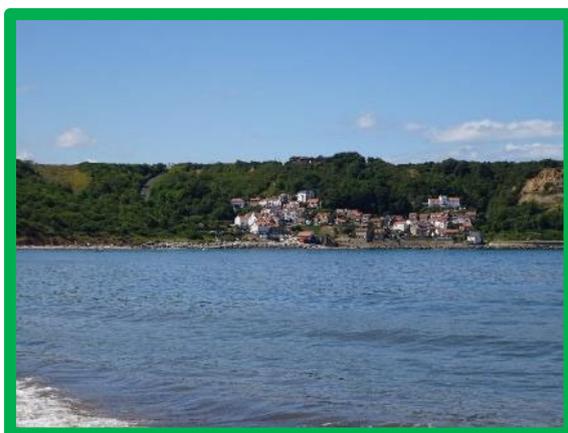
Unit MU7/1 includes Runswick Bay village and the adjacent glacial till slopes. It is well vegetated and defended at the toe by seawalls and rock armour. This unit is classified as Dormant in 2022, unchanged since 2018.

Slopes of Runswick Bay village. MU7/1 Dormant in July 2022.

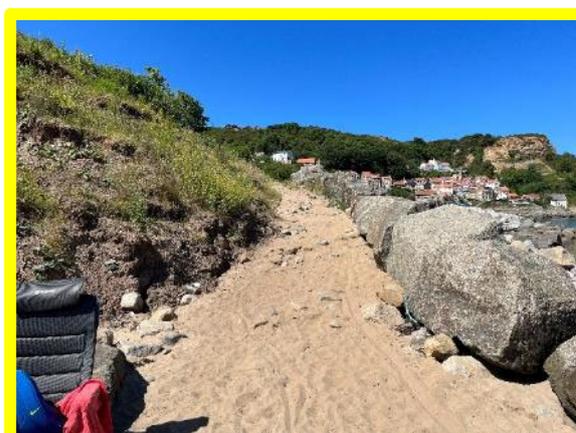
Unit MU7/2 occupies the area adjacent to and south of Runswick Bay village. It is well vegetated glacial till and defended at the toe by rock armour. The southern extent of the existing revetment was strengthened in July 2018 using surplus rock armour from the Coastal Protection works. A rock armour fillet was extended for approx. 30m to the south along the toe of the coastal slopes. There is evidence of minor shallow slumps to the southern extent of Unit MU7/2 and therefore it is classified as Locally Active in 2022, unchanged from 2020.

MU7/2 Locally Active behind rock armour fillet in July 2022.

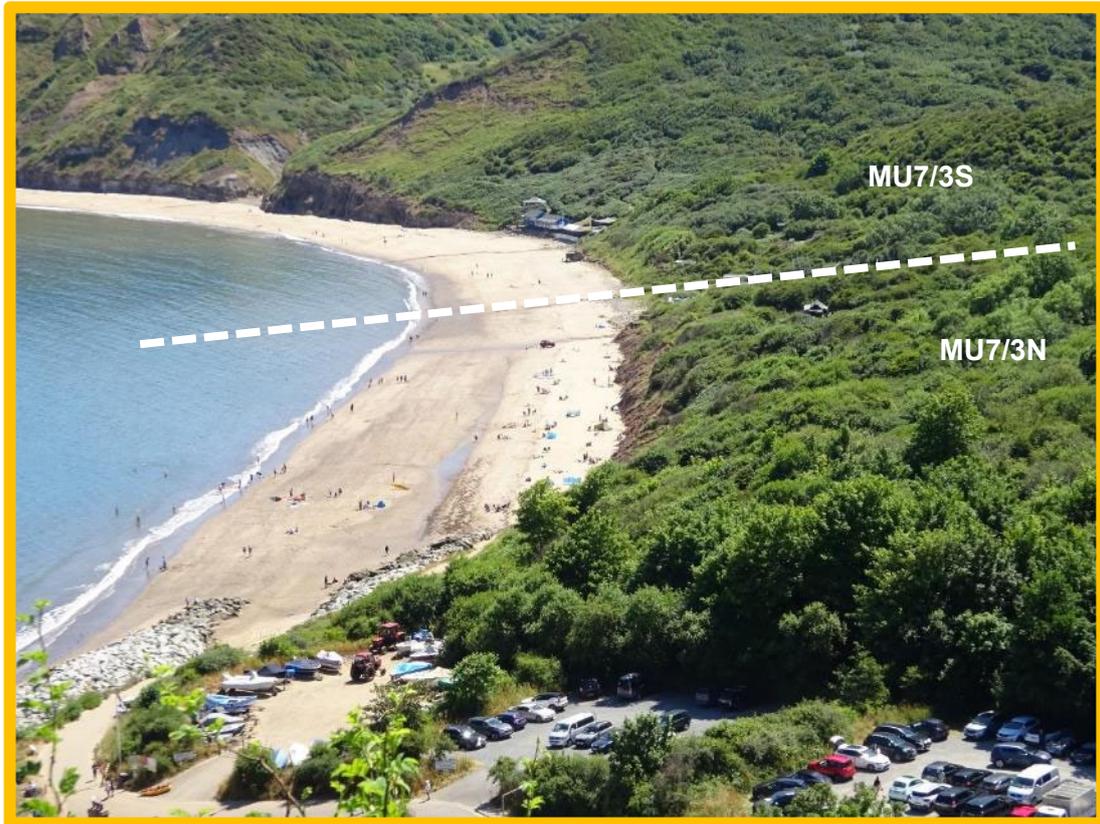
MU7/3N foreground and MU7/3S background.

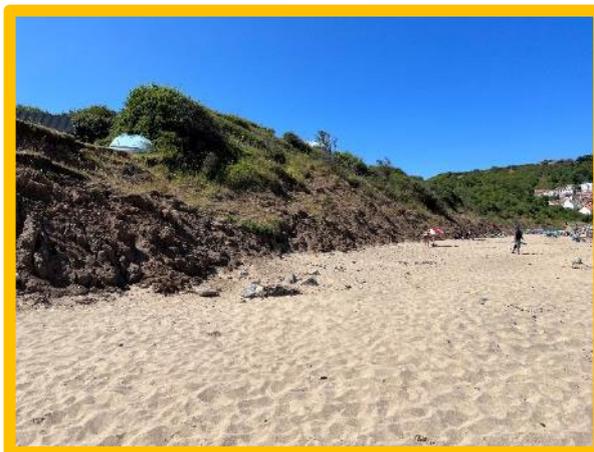
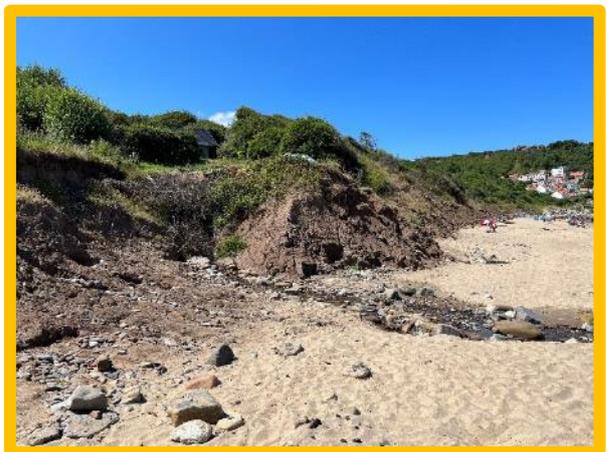
Unit MU7/3N is adjacent to and south of the southern end of Runswick Bay sea defences and comprises glacial till forming a landslide complex down to beach level. A rock armour fillet was formed along the toe of the slope over a length of approximately 30m south of the existing revetment using surplus (8-10 Tonne) rock from the Coastal Protection works (July 2018). The cliff slope is relatively shallow and well vegetated, and erosion is occurring along the active toe. Beach levels were higher than during the 2020 survey, particularly around the rock armour and this will offer some protection to the toe, however mudslides and shallow slumps are evident at the top of the beach, and the unit retains the 2018 grading of Partly Active in 2022.

Active toe of till cliffs in Runswick Bay. MU7/3N Partly Active in July 2022.

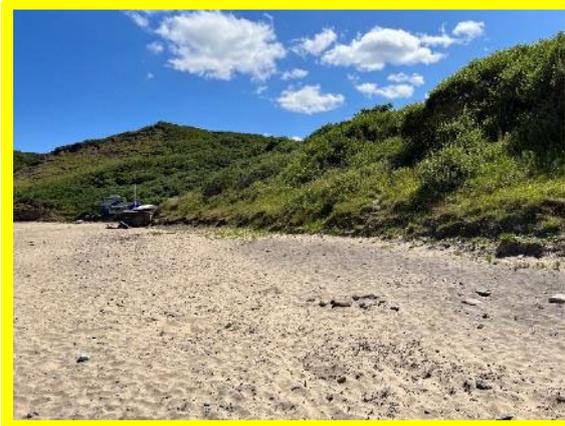
Unit MU7/3S is located to the south of the access to the sailing club boat storage area and is of a similar geomorphology to unit MU7/3N, however the till is well vegetated almost to beach level. Single layer of rock armour (<500kg) used to protect slope at the mouth of the river. Smaller cobbles/beach material also appears to have been used but has been displaced. There is little evidence of significant activity at the toe, and so is classified as Locally Active, the same as 2018.

*Well vegetated till in Runswick Bay. **MU7/3S** Locally Active in July 2022.*

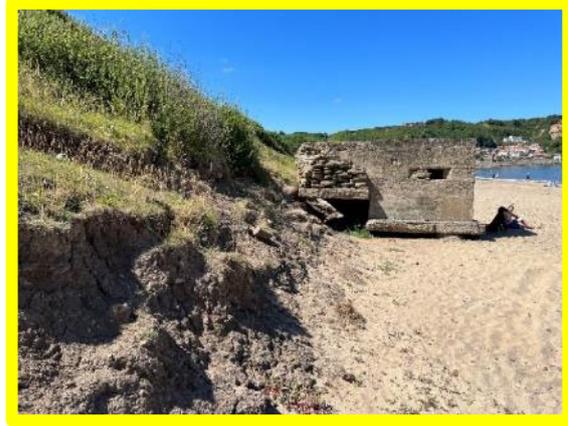
*Localised scour around pill box **MU7/3S**, Locally Active in July 2022.*

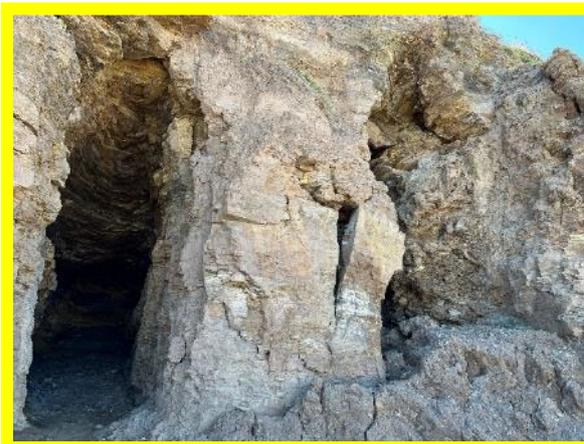
MU7/4 consists of a steep unvegetated cliff toe composed of mudstone, behind which are shallower well-vegetated, mid-to-upper slopes of till with local slumping. The cliff toe is generally steep, and several small caves are evident at the northern extent. The caves do not appear to have changed significantly since the 2018 and 2020 inspections. The unit remains classified as Locally Active.

*Caves in mudstone cliffs. **MU7/4** Locally Active in July 2022*

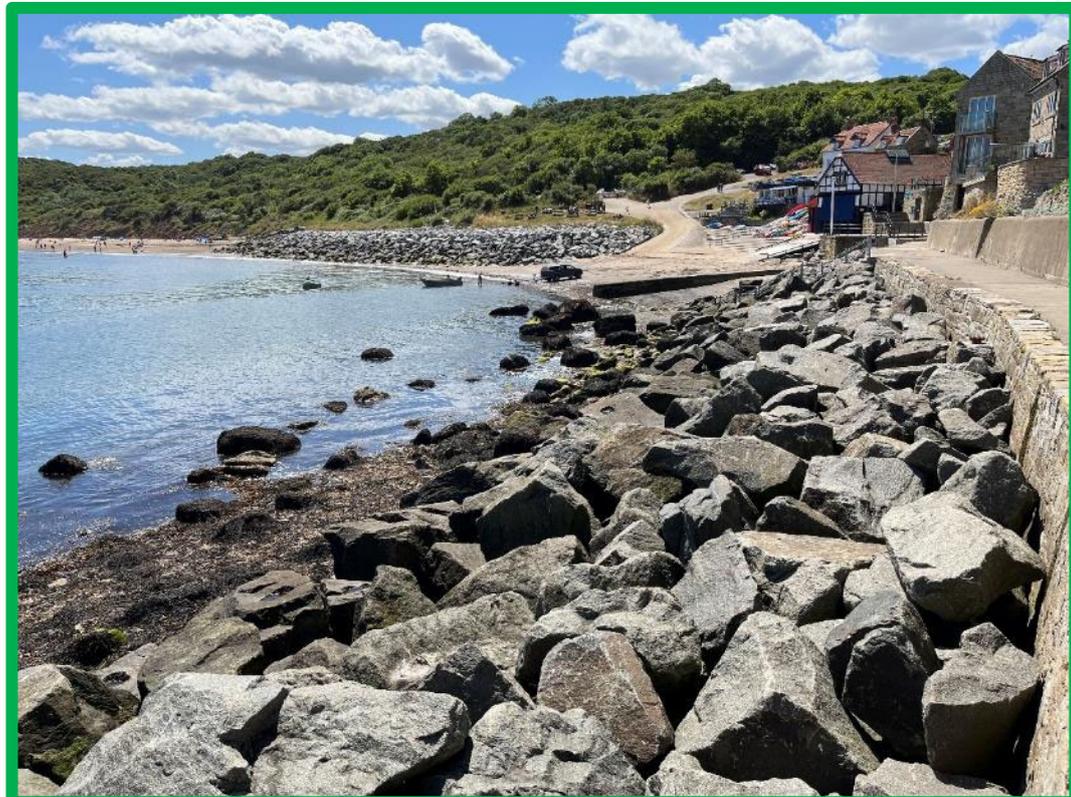
Rock armour fillet at toe of existing seawall, seed rocks seaward of toe as constructed, July 2022.1

The rock armour revetment remains in Very Good condition. The typical detail is a minimum 3.5m wide crest and a 1:3 slope profile to toe rocks which are placed in a trench excavated 0.5m into the bedrock. The foreshore had recovered, and beach levels were similar to those observed in the 2020 inspection. The rock armour retains a consistent seaward slope profile and crest height, with good interlock between armourstone pieces.

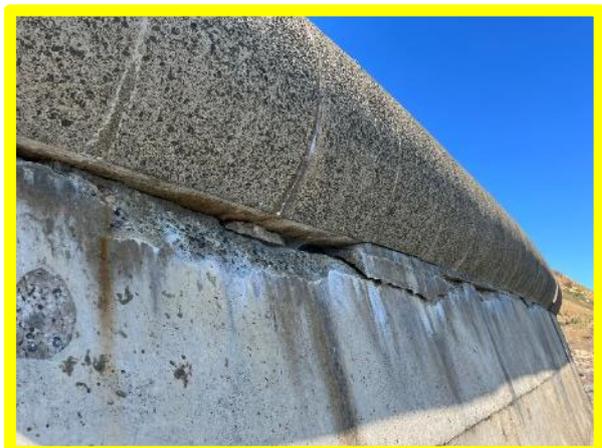
Above the rock armour fillet, the northernmost sea wall (/0601C01) is suffering from heavy surface abrasion on its facing, cracking and spalling to the concrete coping and wash-out of the joints under the coping along most of its length. The flexible sealant in the expansion joints between the capping beam and the deck slabs and separating the deck slabs is brittle and washed out across most of the structure. The joints are open to around 20mm width and there is minor differential settlement between slabs. Vegetation is present in some of the joints. The defects did not appear to have significantly worsened from the 2020 inspection.

Abrasion and cracking of concrete coping (/0601C01)

Surface cracking/abrasion (/0601C01)

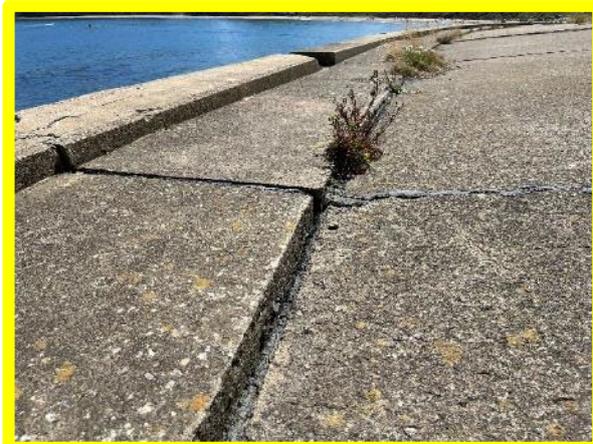
Loss / wash-out of mortar beneath coping. Local abrasion (/0601C01)

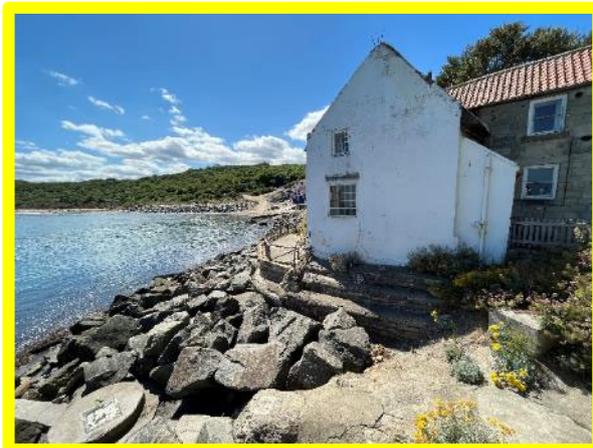
Cracks in the upper masonry seawall were filled and the wall repointed locally with marine mortar. The bag work and mass concrete structures to the rear of the rock armour and moving up the Runswick Beck are generally in Fair to Poor condition with cracking and open joints, with no significant deterioration from 2020 survey, although more vegetation growth was evident. The Thatched Cottage has significant cracks running the full height of the gable end, with no significant visual change observed from the 2018 inspection.

Variety of concrete bag work and in situ concrete pours at Runswick Beck (/0601C06)

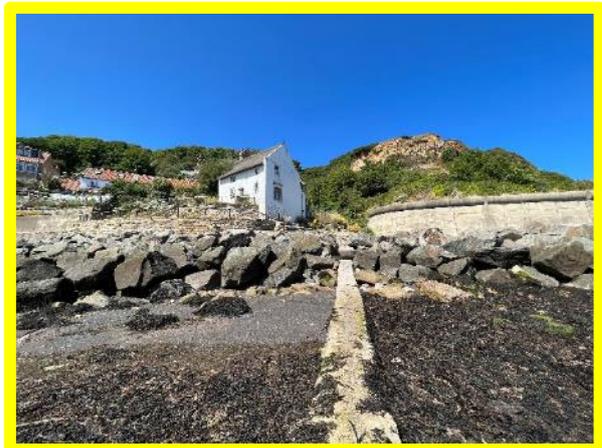
View on Runswick Beck along redundant YW outfall (/0601C06)

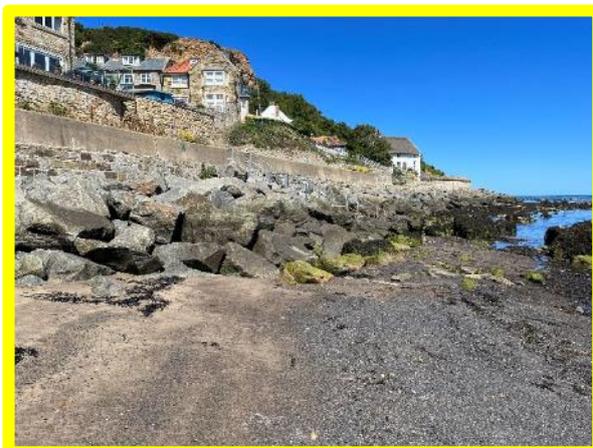
The concrete deck and crest wall above the rock armour and seawall are generally in fair condition with evidence of previous repairs locally which are holding up reasonably well. The flexible sealant in the expansion joints is brittle and missing in places. The structures at the foot of the slope comprise masonry retaining walls/property walls which vary from Good to Fair condition. Minor cracking, open joints and recessed mortar were observed locally.

Concrete crest wall (retaining wall and property walls) (/0601C03)

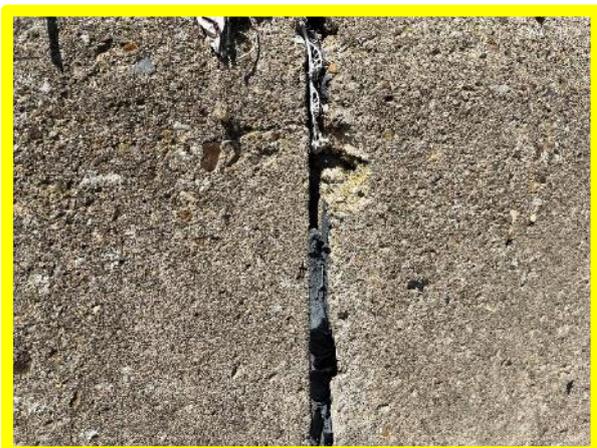
Brittle/missing sealant in expansion joints (vertical and horizontal). Vegetation growth locally. (/0601C03)

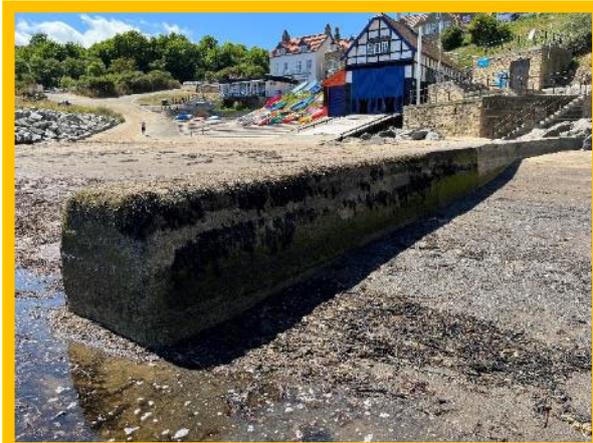
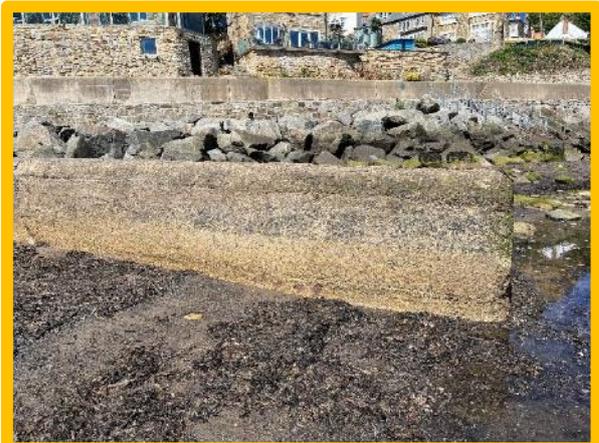
Whilst the new concrete is in Good condition and local repairs/filling of cracks and voids were also carried out in the original concrete at the tie-ins, overall the structure remains in Poor condition due to significant abrasion of concrete, opening of the construction joint between wall and crest concrete and potential undermining of the seaward end (observed in 2018, however not observed in 2020 and 2022 as obscured by higher beach levels).

Significant abrasion of concrete. Opening of joint between wall and crest concrete – largely obscured by vegetation (/0601C02)

High beach levels obscuring undercutting identified in 2018 (/0601C02)

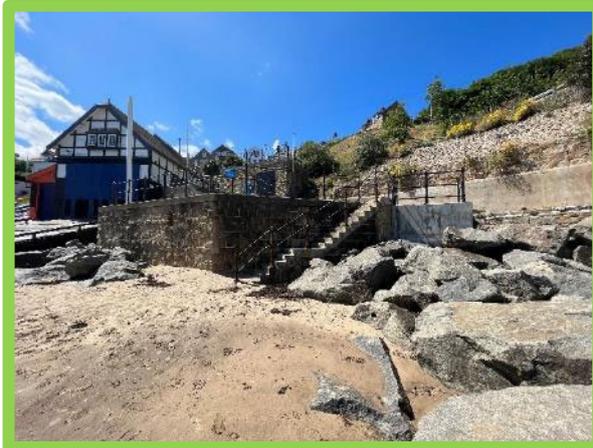
The sea wall around the Yorkshire Water pumping station comprises masonry cladding to a reinforced concrete structure with concrete toe protection and is in Good condition (/0601C07), with minor loss of mortar locally. Immediately to the north of the pumping station, Yorkshire Water raised the existing manhole chamber to match the crest height of the seawall to ensure the chamber was accessible after the construction of the rock armour fillet. The mass concrete surround (to precast concrete manhole rings) is in very good condition as is the new edge protection/handrailing installed at the crest. The rock armour fillet incorporates a break to allow access to the existing steps and then runs to its easternmost extent at which point it ties into the former lifeboat slipway. The two exposed ends of rock armour are in good condition with no evidence of displacement and the access to the steps remains clear. Beach levels are higher than 2020 survey, now burying a significant proportion of the rock armour.

Break in rock armour fillet at pumping station (/0601C07)

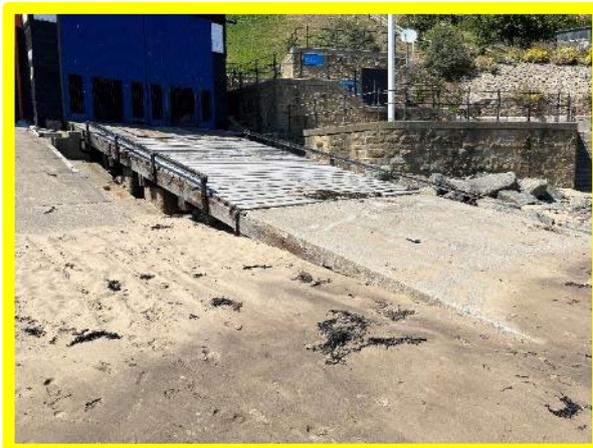
South of the pumping station, the defences comprise the slipway of the former lifeboat station which is generally in Fair condition with abraded concrete piers and severely corroded steel edge protection. The timber decking was generally in good condition. The Runswick Rescue slipway features open joints and cracks in the concrete to the exposed face but overall, the structure appeared in Fair condition. The concrete forming the boat storage area and the access ramp in front of the café is in Good condition with only minor local defects such as abrasion on exposed edges at construction joints, minor cracking and loose timbers/steps. A minor longitudinal crack was observed in the centre of the top two concrete panels of the access ramp.

Former lifeboat slipway. Beach levels and seaweed largely obscure previous repairs/concrete pours at the toe (/1003C04)

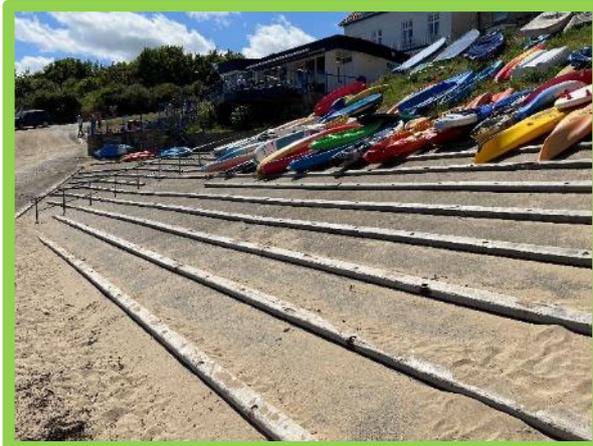
Boat storage area (/1003C04)

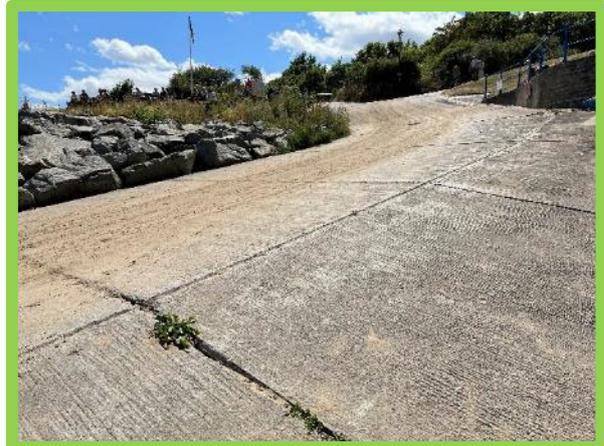
Concrete access ramp (/1003C04)

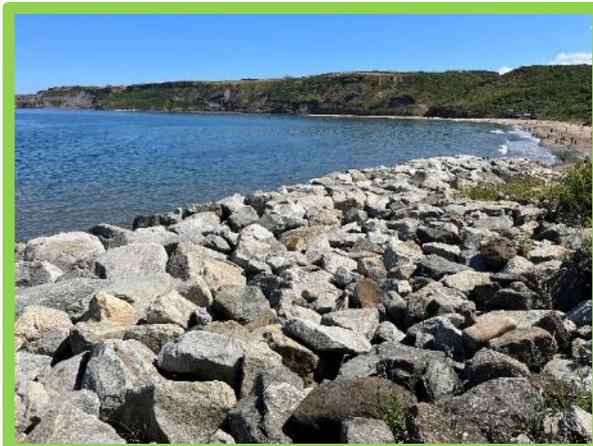
The rock armour revetment (/0602C01) remains generally in Very Good condition, with the rocks tightly packed with no significant voids and consistent crest level and seaward slope profile.

Rock armour revetment (/0602C01)

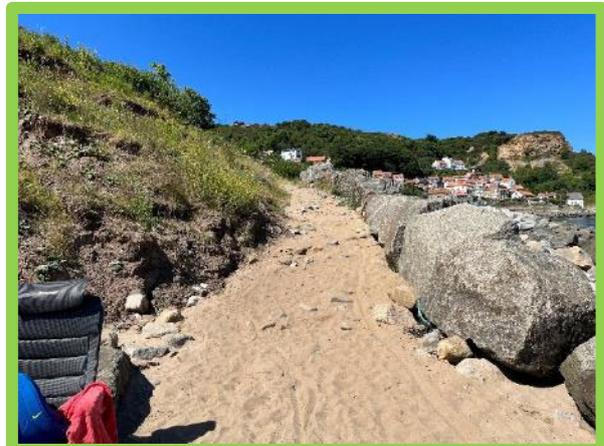
The large rock armour units to the seaward side of the access ramp remain in situ and continue to provide protection to the ramp and the toe of the coastal slope. The surface of the path appeared to have recently been dressed with smaller stone and sand (an activity understood to be carried out periodically by SBC).

High level access ramp (/0602C01)

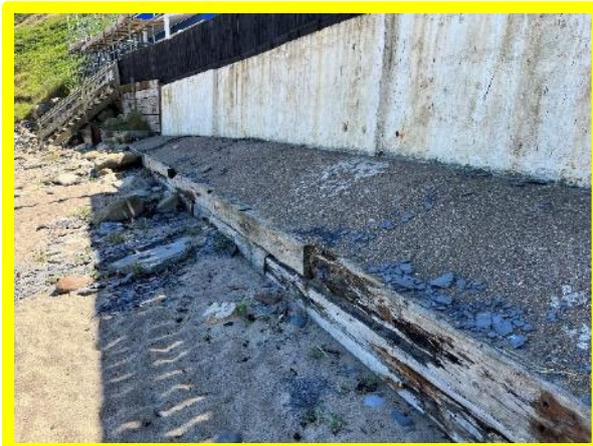
A number of boulders and concrete blocks are present in front of a timber sleeper retaining wall defences. This defence, and the backing white-washed concrete wall to the north, are both in fair condition, however, the condition of several of the timber sleepers appears to have deteriorated since the 2020 inspection. Timber sleepers are exposed and damaged locally, however the concrete

Rotten/missing timber (permanent formwork for concrete behind) (/0602C05)

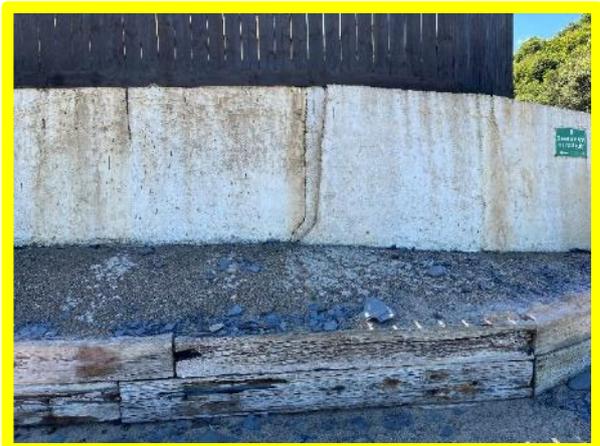
Crack in concrete wall (/0602C05)

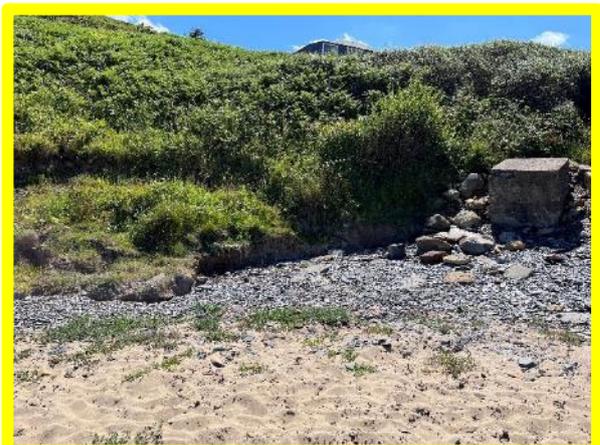
Scour of slopes south of concrete defences (/0602C05)

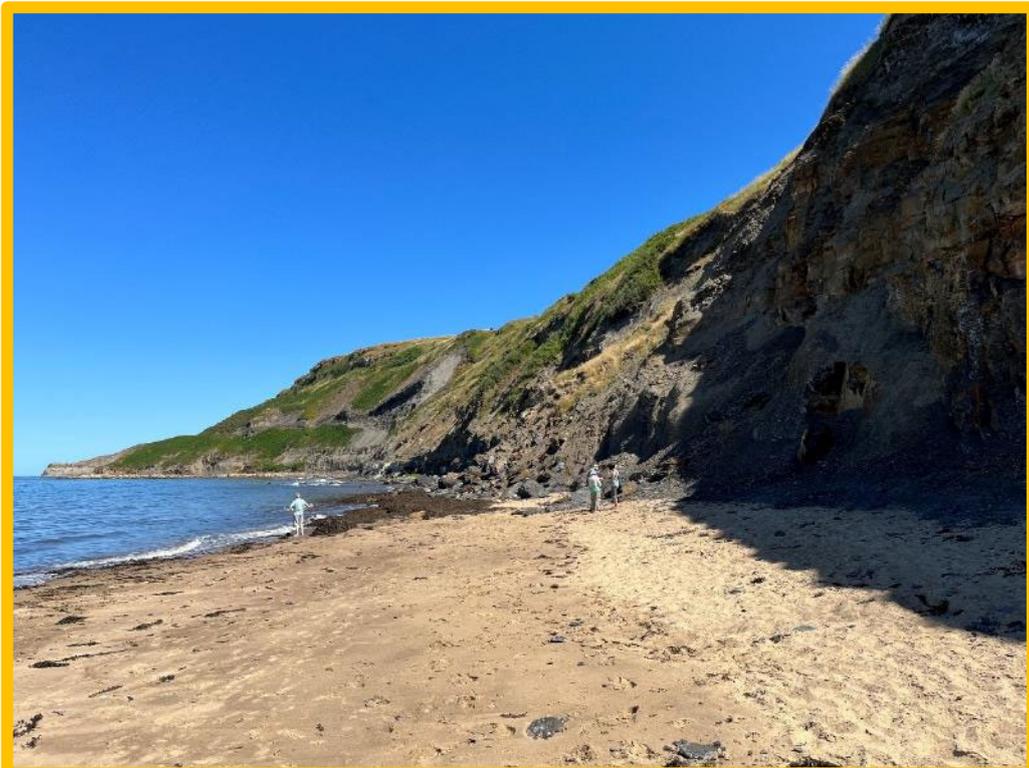
Steep mudstone cliffs with overlying shallower sloping till with significant local slumps. MU8/1 Partly Active in July 2022.

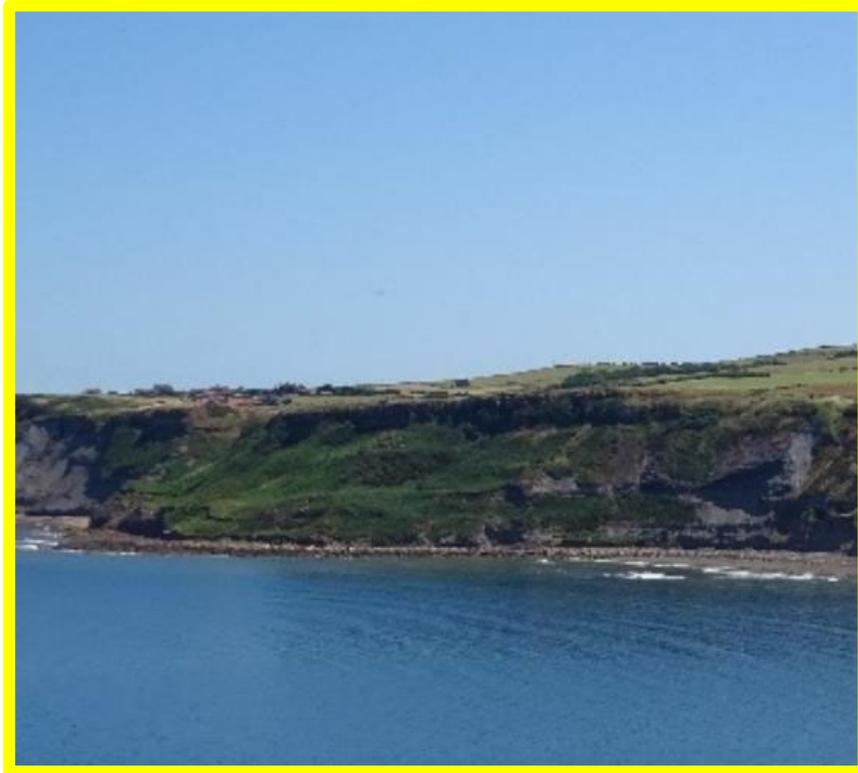
*Relict debris run-out lobe. **MU8/2** Locally Active in July 2022.*

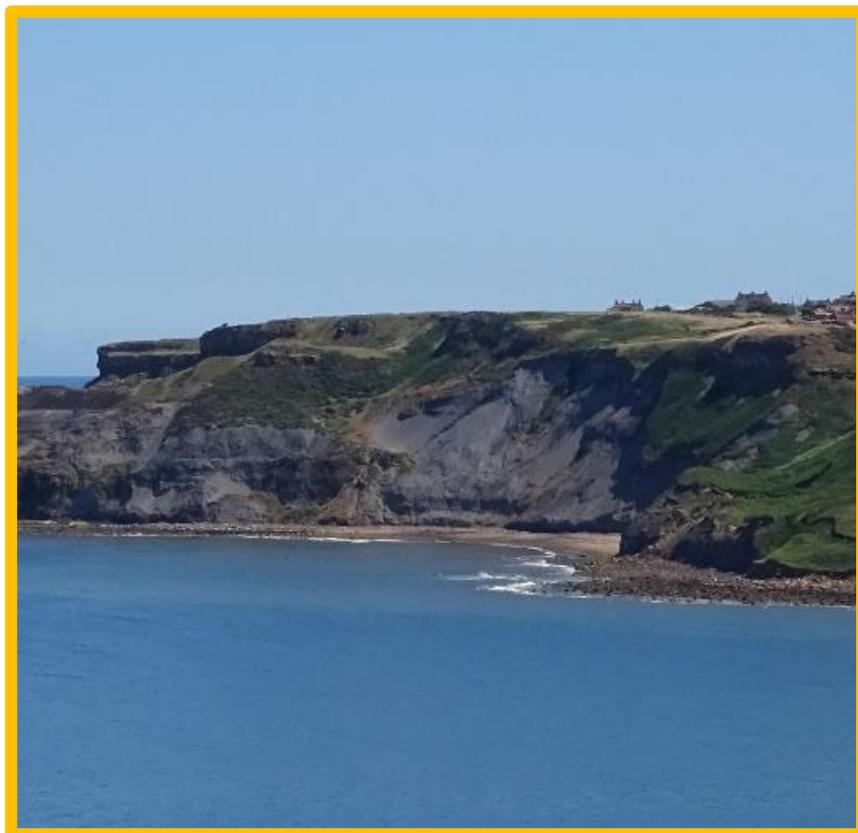
MU8/3 is located in front of the village of Kettleness. The cliff is high and steep with only the very top part covered in vegetation. The cliff slope comprises large debris flows, which extend as fans from near the cliff top to the toe, and slumps. This level of activity means this unit is classified as Partly Active, the same as 2020.

MU8/4 is immediately west of Kettle Ness headland. This unit is classified as Partly Active in 2020, unchanged since 2002.

***MU8/3** and **MU 8/4** steep cliff with debris flows. Partly Active in July 2022.*

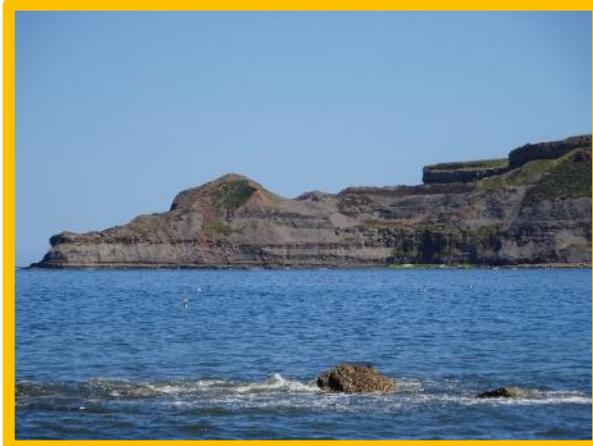
Unit MU8/5 forms the headland of Kettle Ness. This area has historically been extensively quarried for alum and as a result is now subject to ongoing erosion of the exposed weak bedrock. It remains classified as Partly Active in 2022, unchanged since 2020.

West side of Kettleness headland. MU8/5 Partly Active in July 2022.

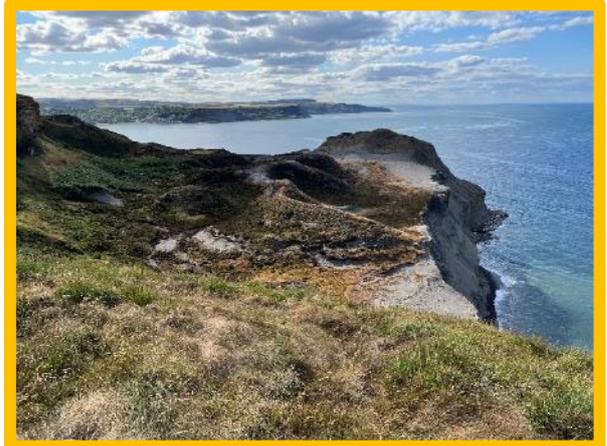
East side of Kettleness headland. MU8/5 Partly Active in July 2022.

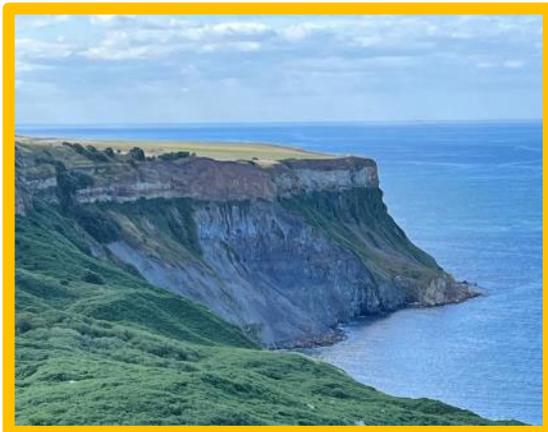
Unit MU8/6 is located to the east of the Kettle Ness headland and remains classified as Partly Active in 2020. Along most of its length this unit is steep with little vegetation cover. Evidence of recent erosion/slips were observed in the headscarp.

MU8/6 Partly Active in July 2022.

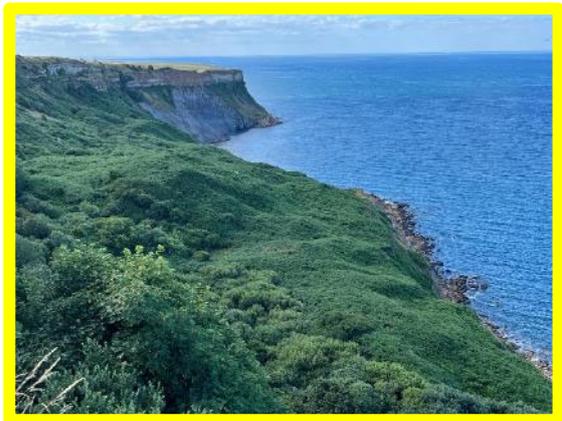
MU8/7, Locally Active in July 2022.

Units MU8/7 and MU8/8 comprise the relict debris run out lobes of Seaveybog Hill and Ovalgate Cliff. They are generally well-vegetated, but localised activity at the toe and headscarp mean the units are classified as Locally Active in 2022.

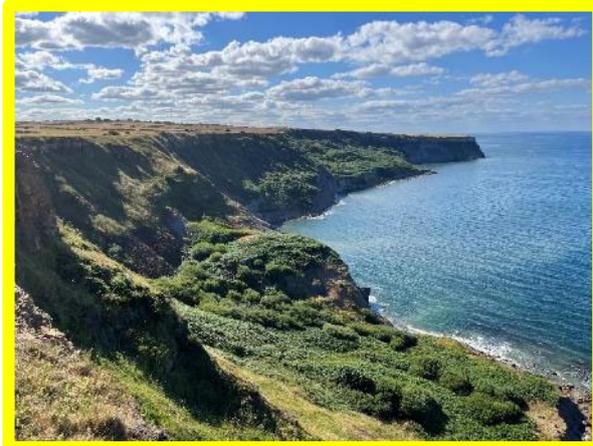
MU8/8 Locally Active in July 2022.

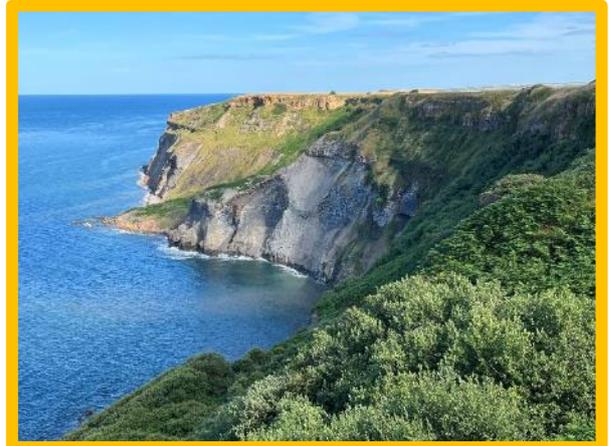
Unit MU8/9 is located at Loop Wyke and is classified as Partly Active in 2022. The upper slopes support extensive vegetation cover, but the lower slopes are steeper, free of vegetation and subject to on-going toe erosion. The exposed headscarp comprises exposed rock which is steep and heavily weathered.

MU8/9 Partly Active in July 2022.

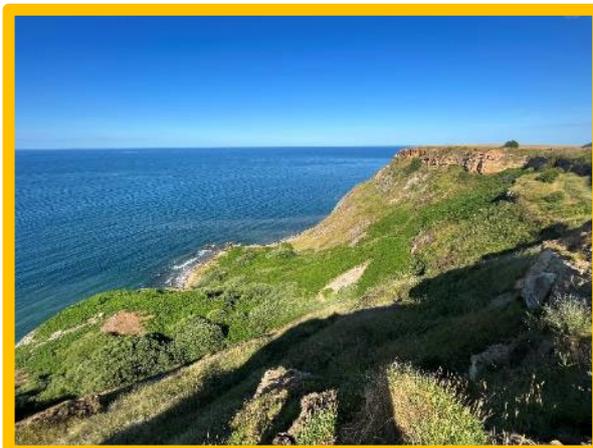
Unit MU8/10 forms a relict debris slide lobe. The unit is well-vegetated with localised erosion at the headscarp and the toe. This unit is classified as Locally Active in 2022.

MU8/10 is a debris slide deposit classified as Partly Active in July 2022.

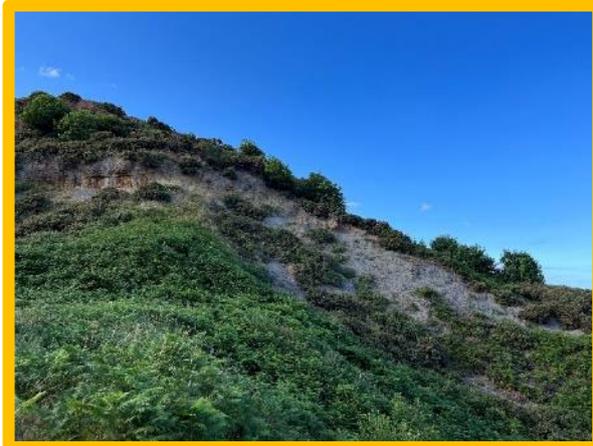
Units MU8/13, MU8/14 form the headland of Sandsend Ness and its adjacent cliffs. All units remain classified as Partly Active in 2022. The toes of these cliffs are subject to ongoing erosion and there is also evidence of localised erosion on the upper slopes.

MU8/13 Partly Active in July 2022.

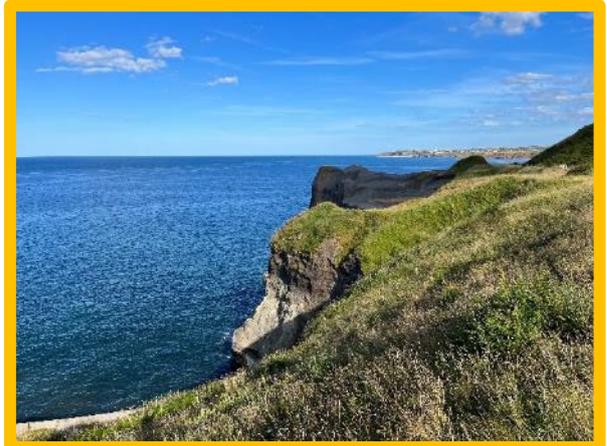
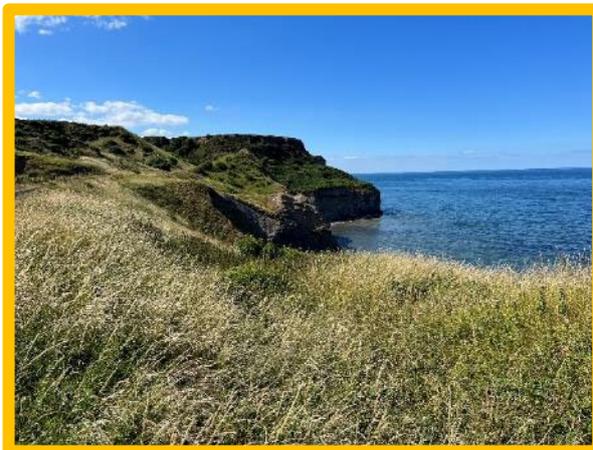
MU8/14 Partly Active in July 2022.

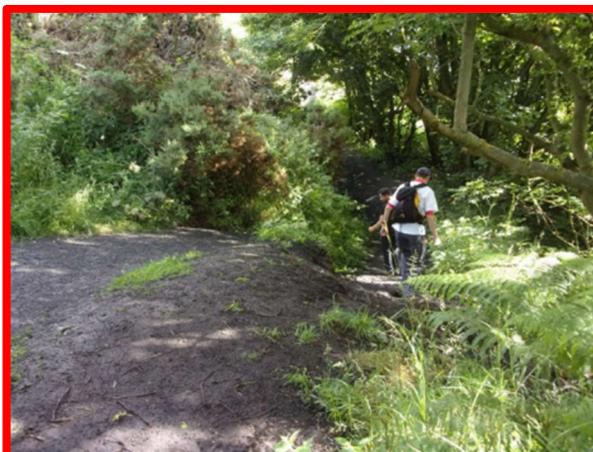
Unit MU8/15 experienced a landslip In January 2021 along part of the Cleveland Way located around 400m north of the car park at the northern end of Sandsend. This caused North York Moors National Park Authority (NYMNPA) to divert the footpath inland while a temporary and permanent solution is being investigated. This has caused reclassification of this cliff behaviour unit to Totally Active in 2022, pending stabilisation works.

MU8/15 Totally Active in July 2022 following January 2021 landslip (southern end of slip)

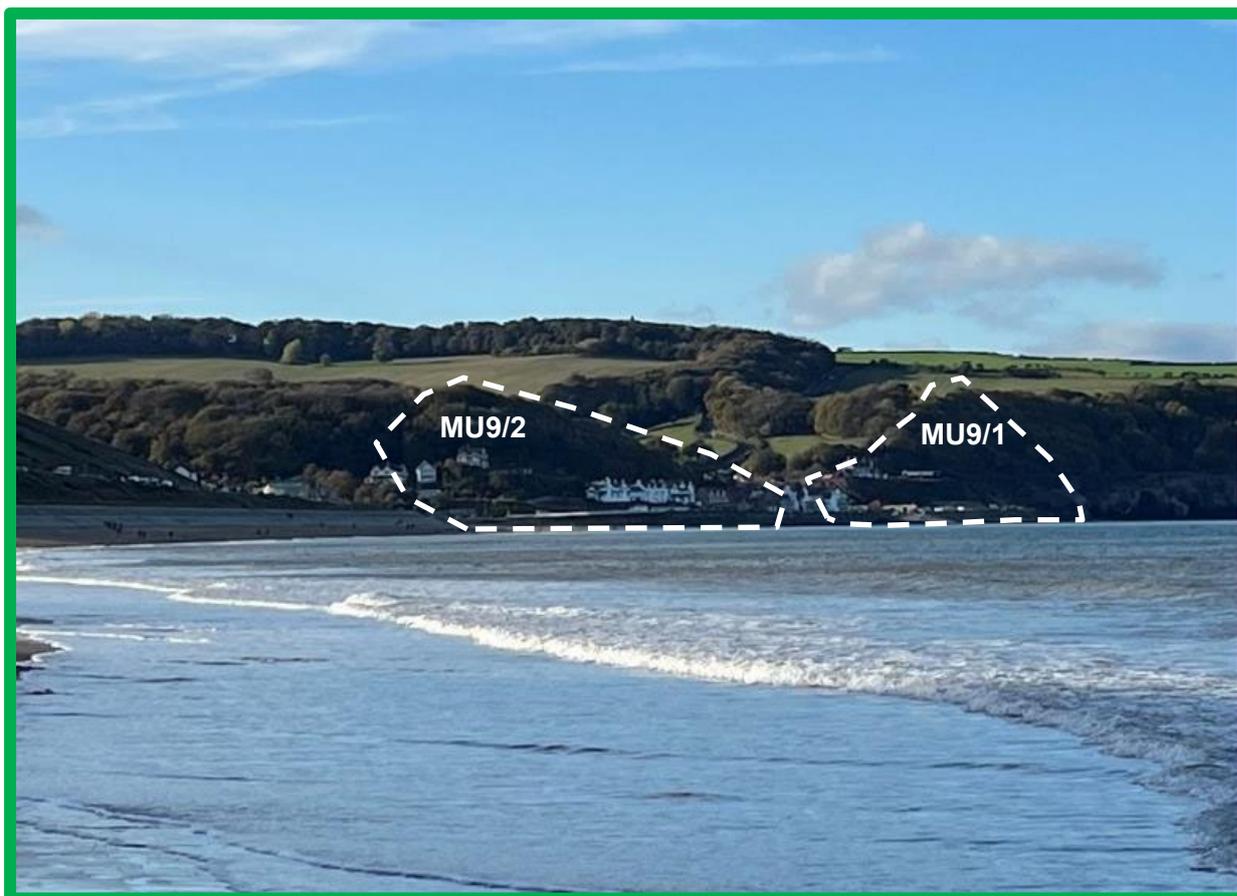
Management units MU9/1 and MU9/2 are Dormant cliffs behind Sandsend village. They are defended at the toe by a sea wall, groynes and rock armour. No evidence of activity was seen in 2022.

MU9/1 and MU9/2 are located close to Sandsend and show no signs of activity (Dormant).

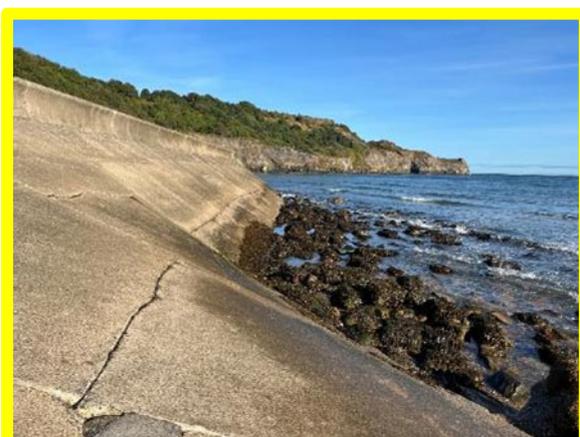
The most northerly defence is located at Sandsend car park. It is a sloping concrete revetment with a recurve crest wall (D0701C02). The concrete wall remains in fair condition with minimal damage to the surface. At the time of the inspections there were low beach levels, revealing that the revetment has lost thickness of concrete at the base through abrasion, with exposure of reinforcement bars. Encasement of this reinforcement is advised from a structural perspective, as well as preventing any Health & Safety incidents occurring due to sharp edges of the exposed bars on this popular amenity beach. At the northern end of the structure is a tie-in section, comprised of steel sheet piling which is heavily corroded. At the southern end is a slipway adjacent to Sandsend Beck. The slipway is undermined in places, and there are a number of cracks and areas of minor displacement, despite previous repairs at this location.

Sandsend car park sea wall (D0701C02)

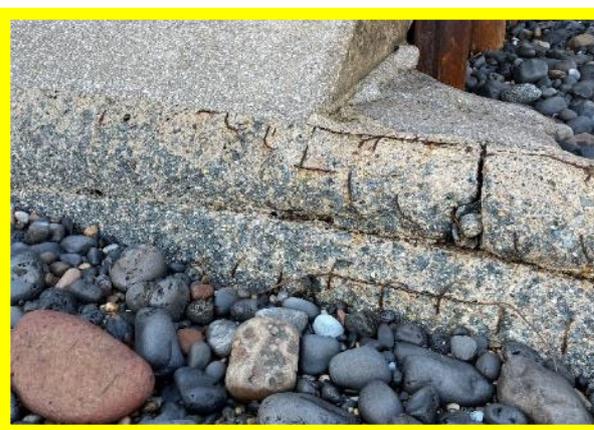
Exposed rebar evident at toe (D0701C02)

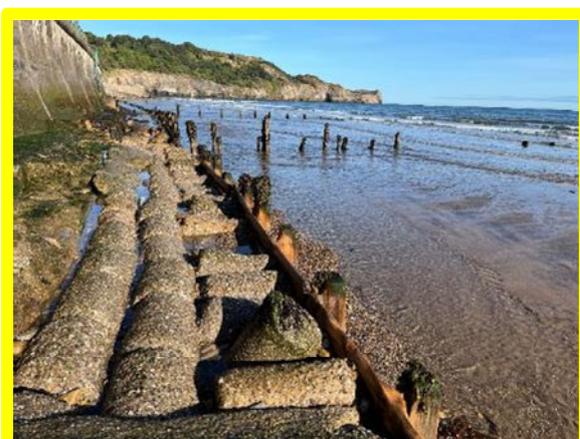
A concrete seawall (D0702C01) extends from Sandsend Beck towards the east. The groyne field fronting the seawall is derelict and the remains have no significant impact on sand movement. The wall is heavily abraded. The timber breastwork and concrete-filled barrel toe structure was exposed at the toe, as it was previously during the 2009 and 2016 surveys and continues to deteriorate, having been covered by beach sand at the time of the 2018 and 2020 inspections. There are occasional cracks in the wall and significant abrasion at the steps.

Toe structure formed from concrete-filled barrels (D0702C01)

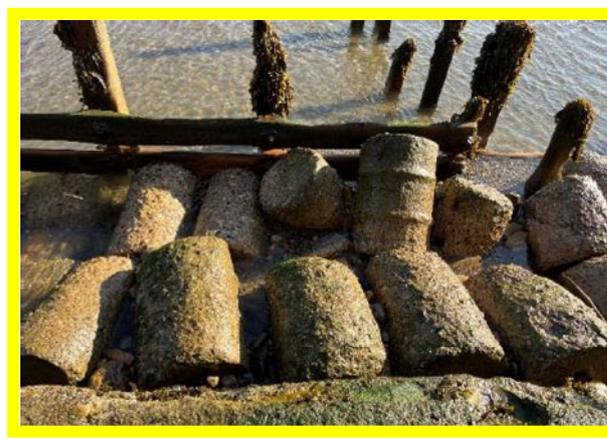
Displacement of some parts of the toe structure (D0702C01)

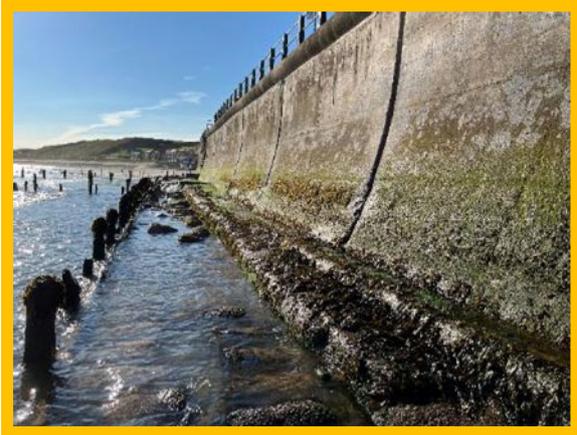
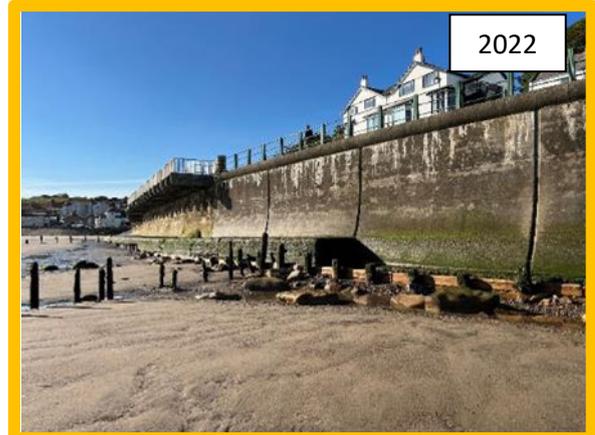
Poor condition sea wall (D0702C01)

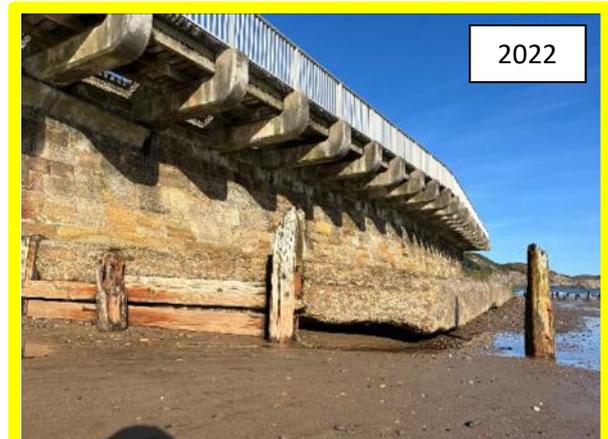
The newer short section of masonry blockwork sea wall (D0702C04) that supports a cantilevered promenade just north of East Row Beck is in fair condition. The steel toe piling is corroded and abraded, and the concrete toe structure is subject to undercutting it was covered by beach sand at the time of the 2018 and 2020 inspections. Towards the eastern end, there are voids and undermining of a concrete apron which should be further investigated. The new cantilever footway constructed to replace the previous structure that was destroyed during the December 2013 remains in good condition.

Toe structure undercut below masonry blockwork sea wall with cantilevered footway (D0702C04)

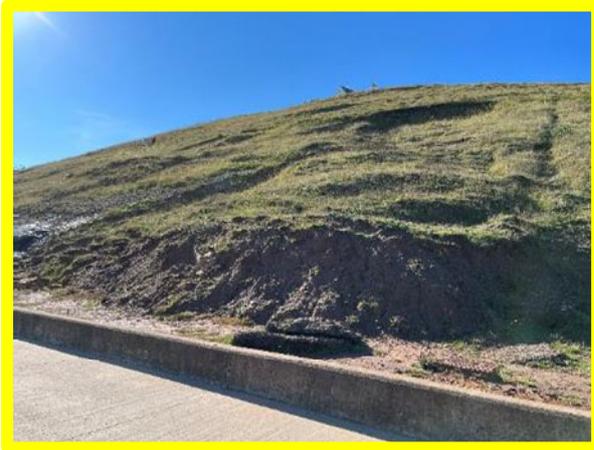
These units are comprised of re-graded slopes protected by a sea wall and promenade. The slopes are well-vegetated, and whilst they are generally stable, with very little change since the 2020 survey, there is evidence of localised instability in the slope in places within both units. There is evidence of some previous stabilisation works and in one location within MU11/1 these have become exposed and the stone-filled plastic baskets have split, requiring repair or replacement. Both these units are classified Locally Active.

MU11/1 Evidence of slumping and broken pipe in the lower coastal slopes (Locally Active)

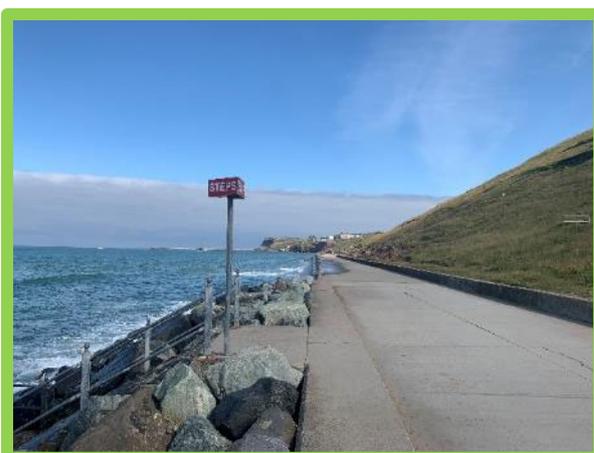
Rock revetment, promenade and coastal slopes of Whitby West Cliff (D0802C02)

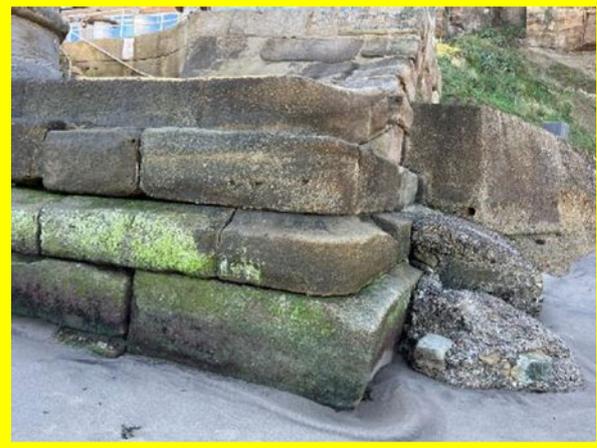
The Battery Wall, just west of Whitby West Pier, is formed of large sandstone blocks. Although repairs to some gaps between blocks are evident, further repairs are deemed advisable pro-active measures, especially at the wing wall of the access steps to the beach. Despite this, the asset remains in overall fair condition.

Open joints in wing wall to access steps (D0802C12)

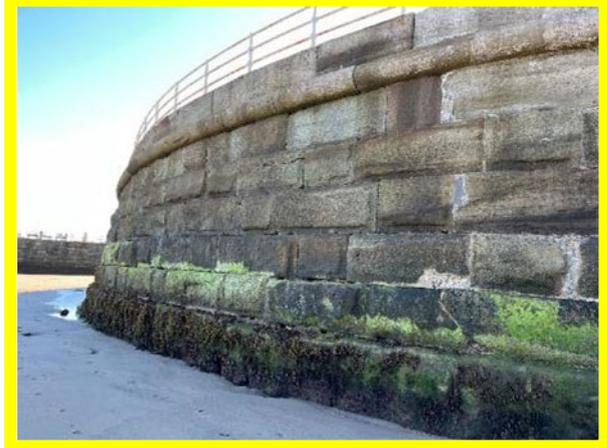
Battery Wall, with some open joints between blocks (D0802C12)

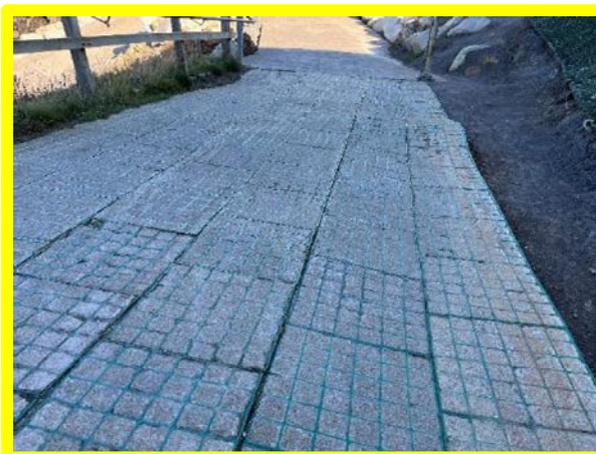
The steep access ramp to the East pier indicates a degree of movement, though remains in fair condition. The adjacent slopes have geotextile slope protection netting in place.

Access ramp to the East Pier (D0803C05)

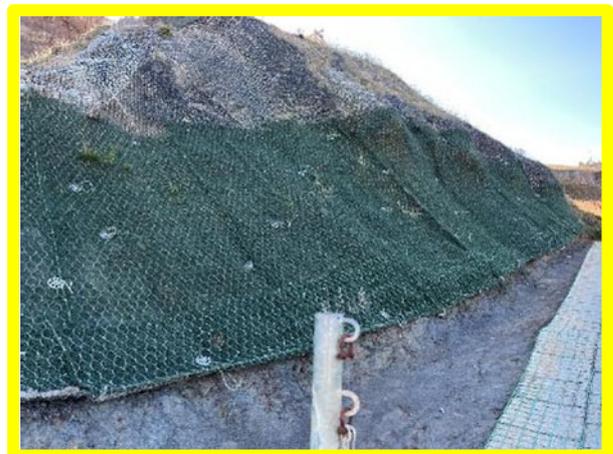
Slope protection netting above the access ramp (D0803C05)

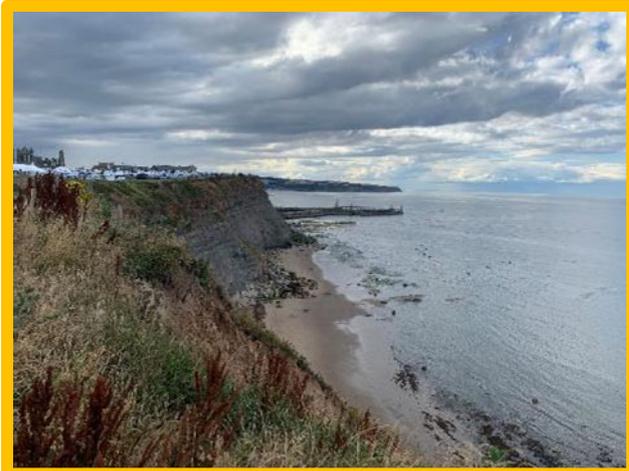
MU13/1 Cliffs east of Whitby (Partly Active)
