Cell 1 Regional Coastal Monitoring Programme Walkover Inspection Surveys 2022

**Scarborough
Borough Council**

November 2022

Walkover Inspection Surveys 2022

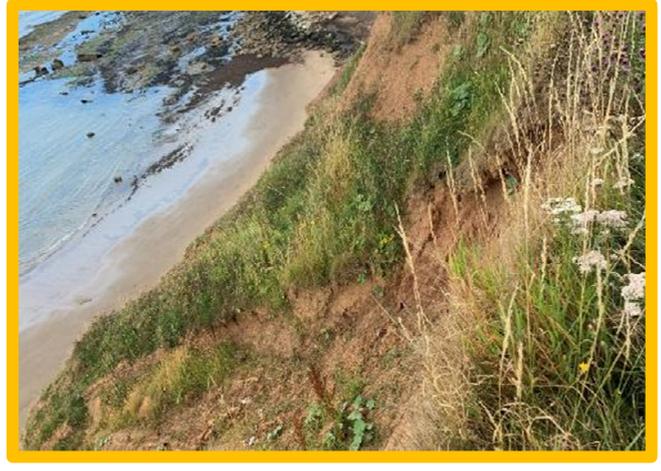
MU13/1 Cliff erosion close to coastal path (Partly Active)

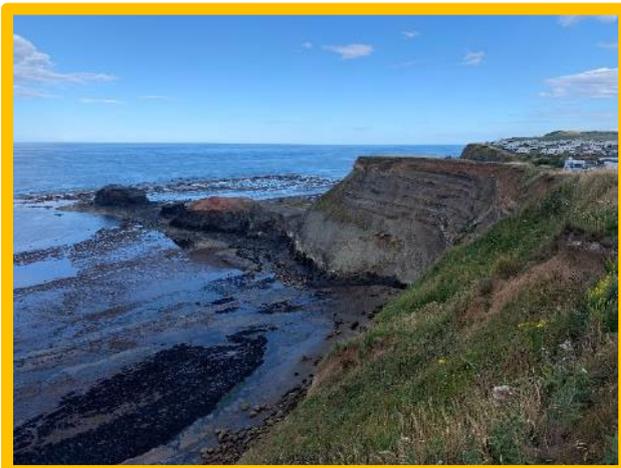
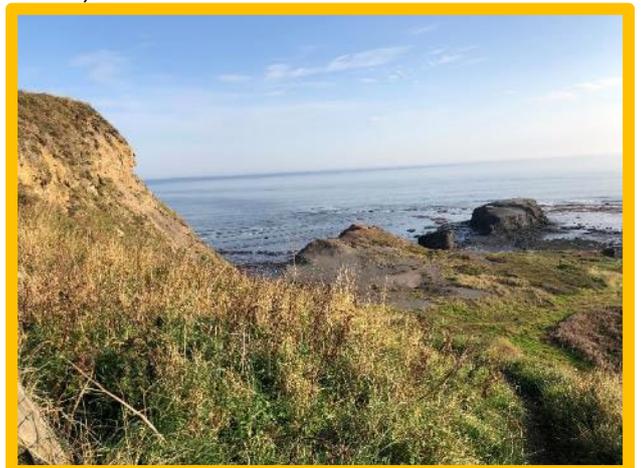
Unit MU13/2 comprises the eroded headland of Saltwick Nab. This unit is continuing to actively erode and supports little vegetation cover. Riling and gulying is evident on the exposed faces. As a result, this unit remains classified as Partly Active in 2022.

MU13/2 Saltwick Nab (Partly Active)

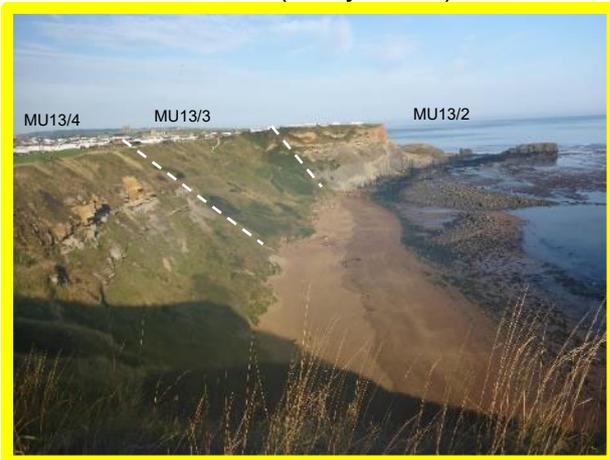
The cliffs within **unit MU13/3** are located within Saltwick Bay and contain access onto the beach. The cliffs in this section are protected to some extent from marine action by the high stable beach. As a result, the unit is generally less active and well vegetated and as a result is classified as Locally Active.

MU 13/3 Saltwick Bay (Locally Active)

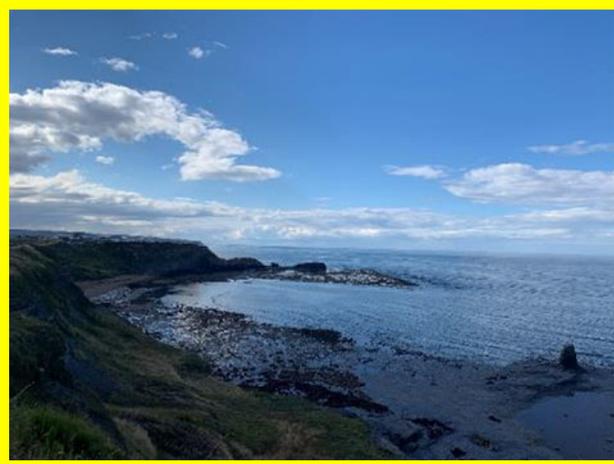
MU 13/5 Black Nab and Saltwick Nab (Locally Active)

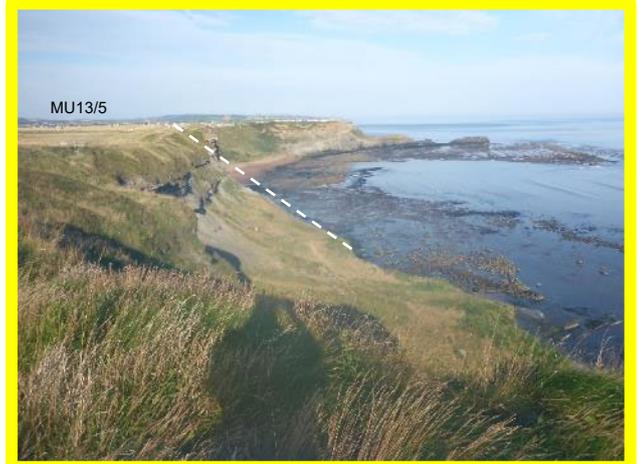
MU13/5 Vegetation covering majority of debris lobe at Black Nab (Locally Active)

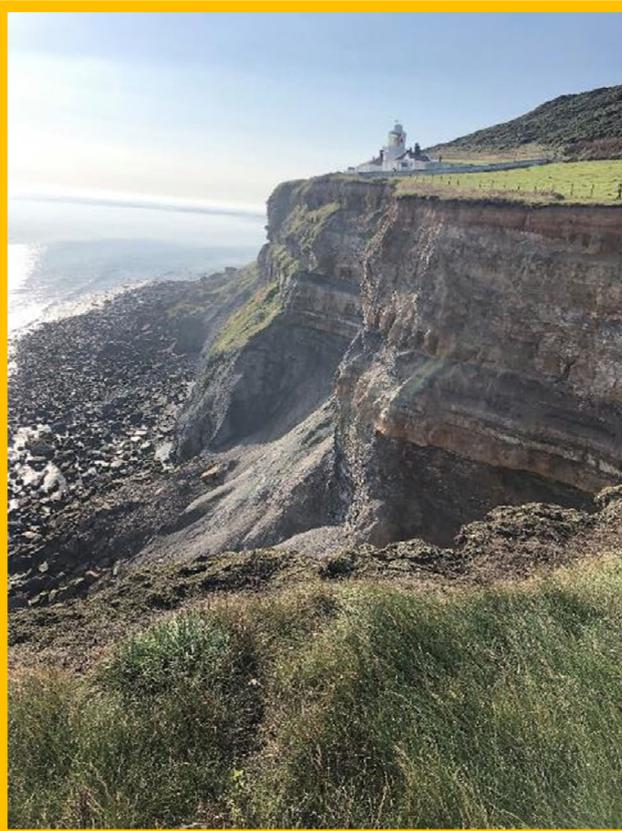
MU 13/6 Unvegetated eroding cliffs at Whitby Lighthouse (Partly Active)

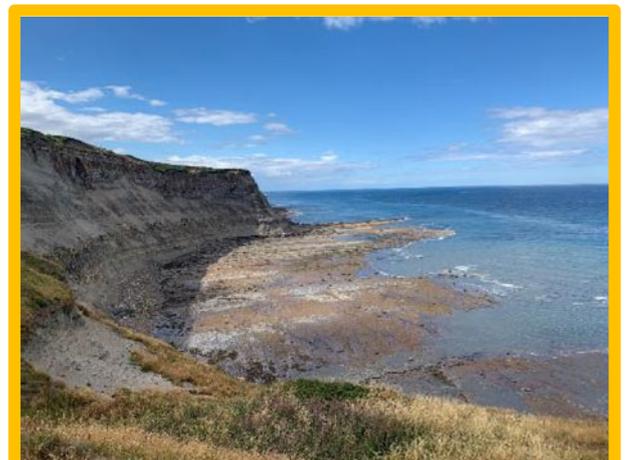
Unit MU15/2 is known locally as Far Jetticks. This cliff has widespread activity, with ongoing marine erosion evident at the toe and localised activity on the cliff face. It remains classified as Partly Active in 2022. A series of arcuate tension cracks were observed during the 2014 inspections (and seen during the subsequent inspections including 2022) on the cliff top at grid reference 495076 507274, indicating an incipient failure that poses a hazard to walkers on the Cleveland Way. The site has previously been brought to the attention of Scarborough Borough Council who have informed the North York Moors National Park Authority. It appears the tension cracks have not significantly worsened since 2018, demonstrated in the comparison photos below. Tension cracks were also observed adjacent to the coastal footpath to the south of Far Jetticks and should be monitored.

MU15/2 Ongoing erosion at Far Jetticks (Partly Active)

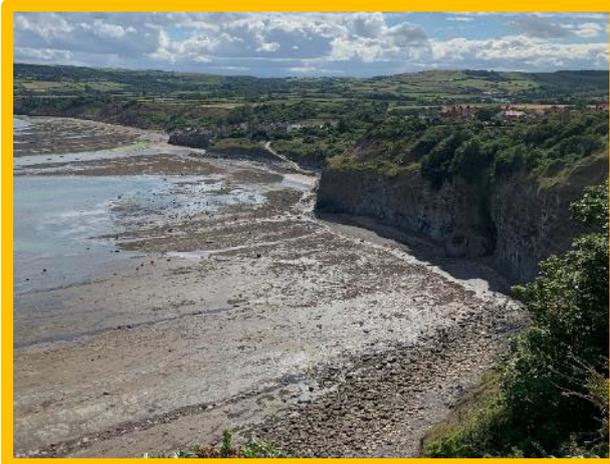
Just north of Robin Hood's Bay village is **Unit MU15/4**, which has a similar geomorphology to MU15/3, although the till cap appears to be less active than further north. A loose debris apron is present locally at the toe of the cliffs towards the south of the unit. This unit remains classified as Locally Active in 2022, downgraded from Partly Active in 2014.

Stable upper cliffs with debris aprons MU15/4 (Partly Active)

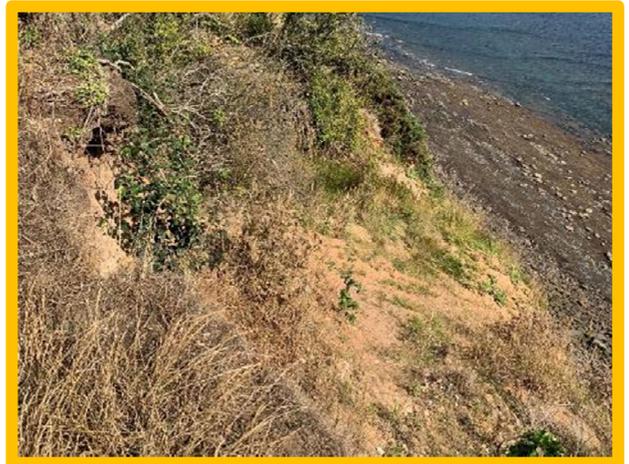
Local Slumping at MU15/3 (Partly Active)

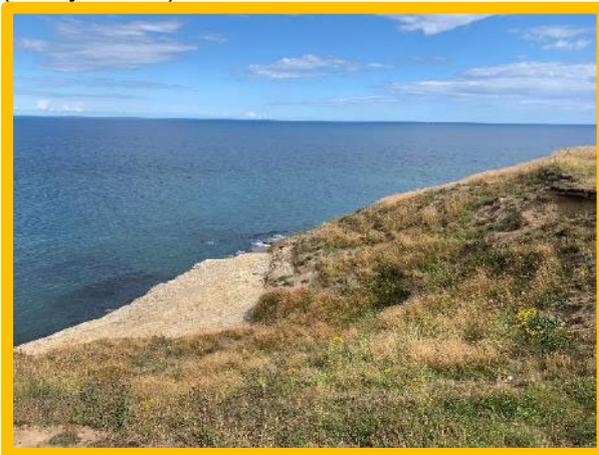
MU15/3 Vegetated slopes at cliff top (Locally Active)

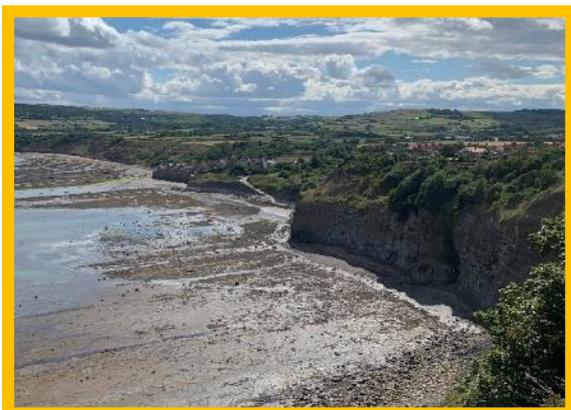
Unit MU16/1 is the composite cliff complex fronting the northern part of Robin Hood’s Bay village and is classified as Partly Active in 2022, no change from 2014. The cliff comprises a near-vertical lower cliff of mainly sandstone overlain by shallower sloping heavily vegetated glacial till with evidence of slumping and recession of the head scarp.

MU16/1 Sandstone cliff overlain by shallow till (Partly Active)

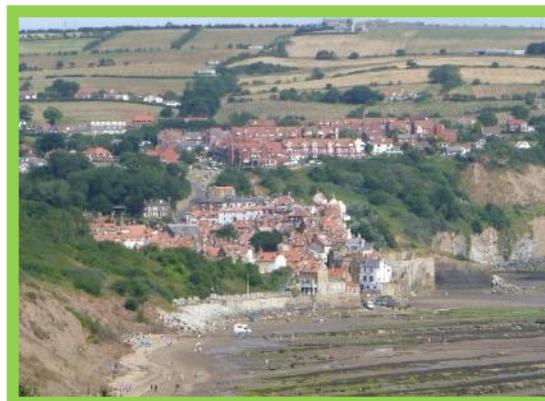
Units MU16/2 is a stabilised landslide that forms the southern part of Robin Hood’s Bay village. There is little evidence of any activity and so it remains classified as Inactive in 2022. MU16/3 protected by sea defences retains its Dormant status in 2022.

MU16/2 Stabilised landslide (Inactive)

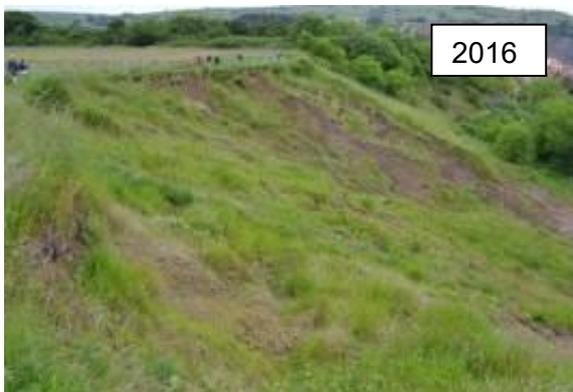
Unit MU17/2 comprises glacial till cliffs to beach level protected by rock armour at their toe. The slopes are vegetated however the area of exposed cliff has steadily increased since the 2016 survey. Generally, the flatter mid-slope is well vegetated whilst the headscarp and toe are exposed with extensive evidence of recent slumping. This unit remains classified as Partly Active in 2018, due to widespread evidence of instability. During the 2018 survey it was noted that the Cleveland Way footpath has been severely undermined along the headscarp of the management unit. This has led to a section of the footpath being lost through landslip. A series of temporary and permanent diversions have been necessary in recent years as the headscarp continues to retreat. Stone flagstones which have fallen down the face of the cliff highlight the rapid erosion on this stretch. Erosion is significantly more pronounced in locations where local field drainage issues onto the coastal slope.

Head scarp of MU17/2 (Partly Active in June 2016)

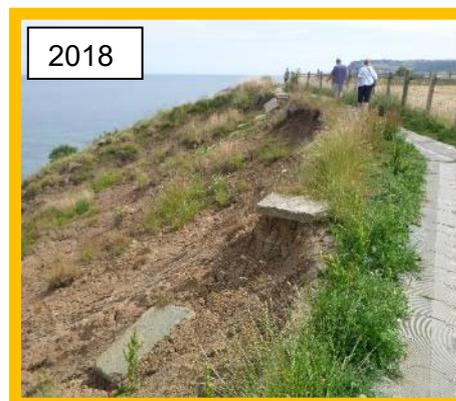
MU17/2 Undermined Cleveland Way footpath route and temporary diversion (Partly Active).

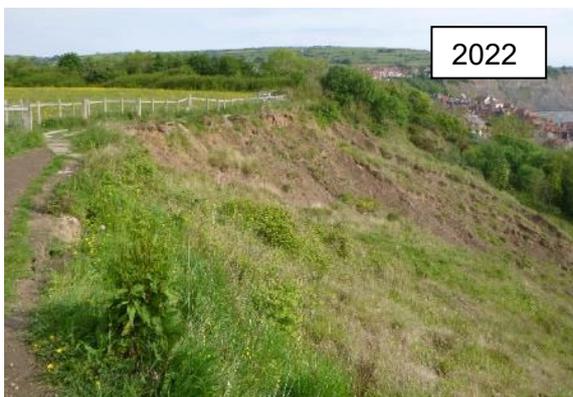
Head scarp of MU17/2 (Partly Active in August 2022)

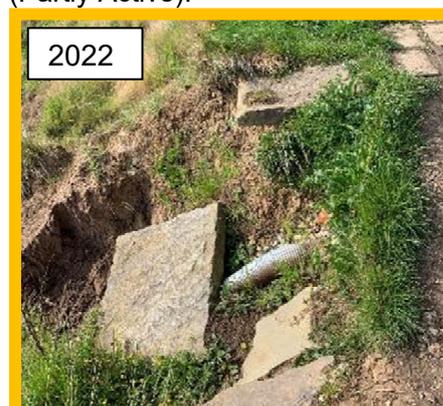
MU17/2 Undermined Cleveland Way with exposed land drainage (Partly Active).

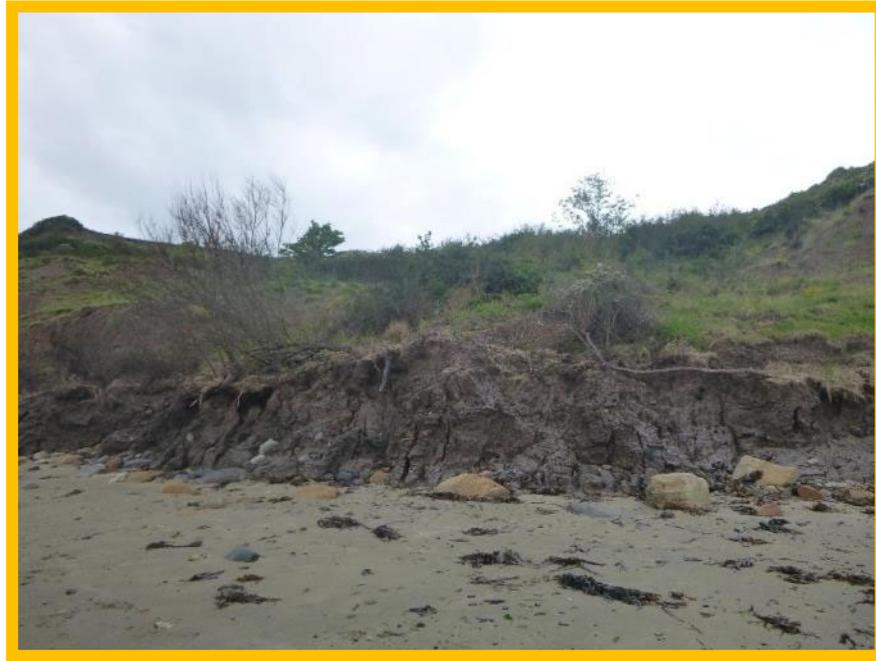
Toe of MU17/2 showing extensive activity (Partly Active).

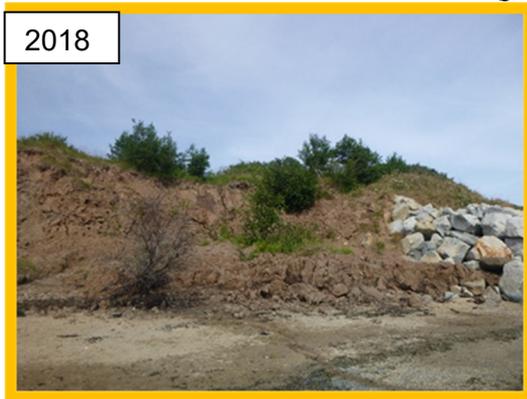
2018

Slumped toe of till cliffs adjacent revetment.. MU17/2 (Partly Active in June 2018)

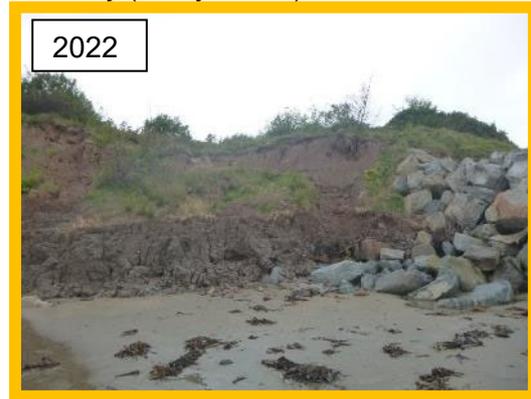
2022

Continued Slumping at toe of till cliffs adjacent revetment. MU17/2 (Partly Active August 2022)

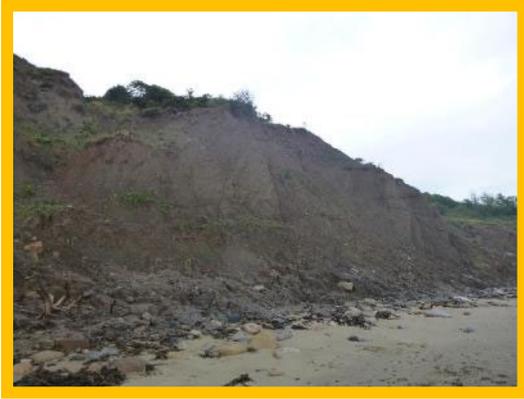
Further south, within unit MU17/3, defences are absent and the cliffs are active. There is massive slumping at beach level and in the mid to upper slopes. This unit is classified as Partly Active in 2022, no change from 2014.

Active toe of till cliffs in Robin Hood's Bay.
MU17/3 (Partly Active)

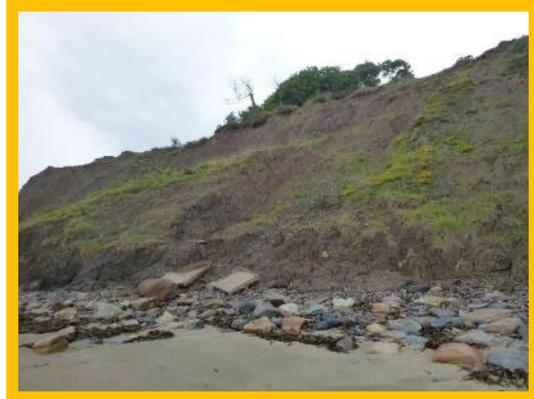
Active toe of till cliffs in Robin Hood's Bay.
MU17/3 (Partly Active)

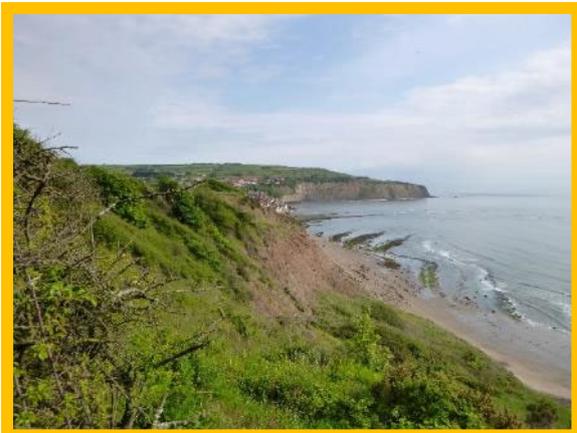
Vegetated mid-slope above exposed glacial till
lower slope - MU17/3 (Partly Active)

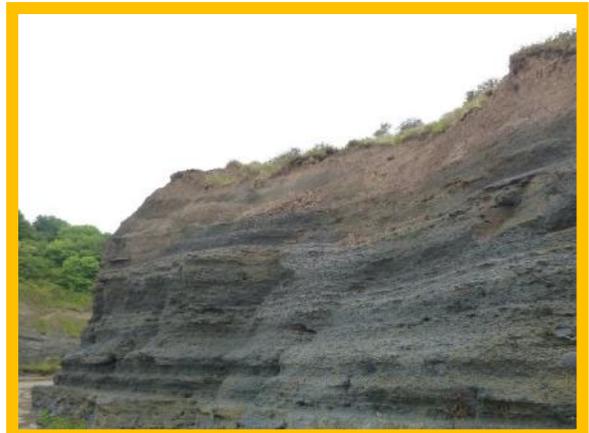
Redcar Mudstone' formation North of Boggle
Hole - MU17/3 (Partly Active)

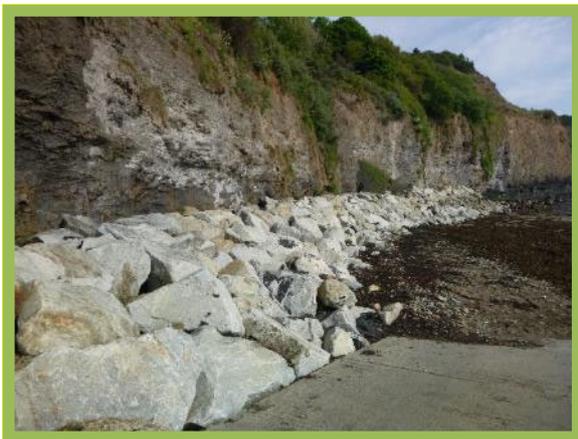
The most northern defence is a section of rock armour that gives some limited protection to the cliff toe to the north of the northern slipway / beach access ramp (/1002C02). This rock armour was constructed as part of the 2001 scheme and remains in good condition. As the rock armour extends south (/1002C01) it fronts the wingwall of a slipway / ramp from the boatyard and then a large blockwork sea wall that was built in 2001. Overall, both the wall and the revetment are in good condition. Cliffs to the rear of the slipway have rock netting which remains in good condition. It was noted during the 2018 inspection that there had been a small rockfall above the slipway just north of the rock netting. It is recommended that this netting is extended to prevent further activity.

Rock revetment fronting sea cliffs (/1002C02)

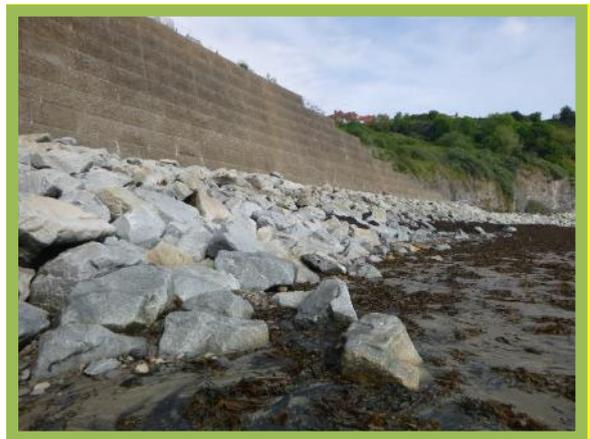
Rock revetment fronting large sea wall (/1003C01)

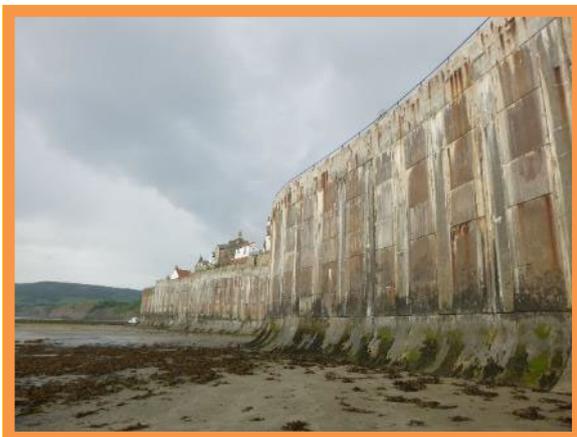
The large vertical pre-cast concrete panel wall that was constructed in 1975 (1003C02) remains in poor condition, showing evidence of surface cracking, rust marks indicating corrosion of the reinforcement steel, mineral encrustation, seepage, frequent open joints, and extensive cracking and repair work to the crest of the wall. Generally, the wall appeared in similar condition to 2018, when it was noted that there was further damage and outflanking of the transition to the shale cliffs at the north end of the wall.

Large sea wall in poor condition will benefit from future planned capital scheme (/1003C02)

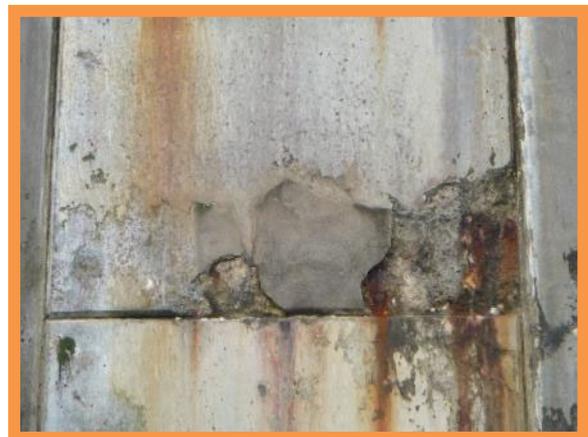
Typical defects on large sea wall (/1003C02)

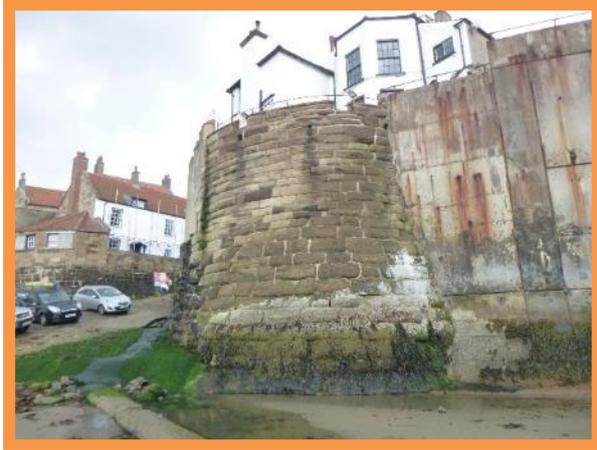
Immediately south of the large concrete sea wall, a private blockwork wall fronts the Bay Hotel (/1003C04). This wall extends south to the central slipway and is in overall poor condition. Some repairs have been undertaken since the 2016 inspection. These include grouting of open joints and sealing the open interface with the precast concrete seawall to the north. Generally, the repairs appear to be working effectively, however there are still a number of open joints visible in the wall face. Additionally, the low beach levels exposed voids in the concrete toe at beach level.

Blockwork wall in poor condition fronting the Bay Hotel (/1003C04)

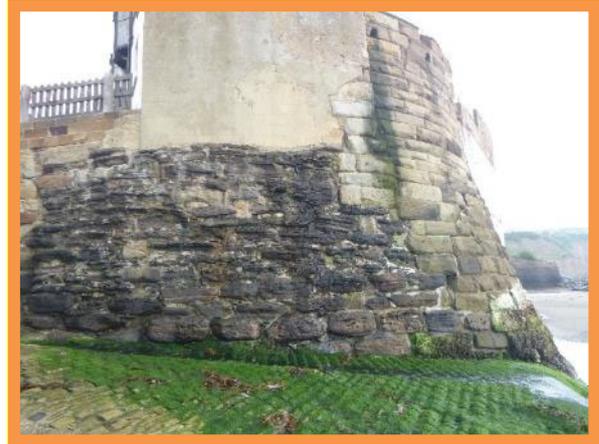
Blockwork wall flanking the slipway and culvert outfall (/1003C04)

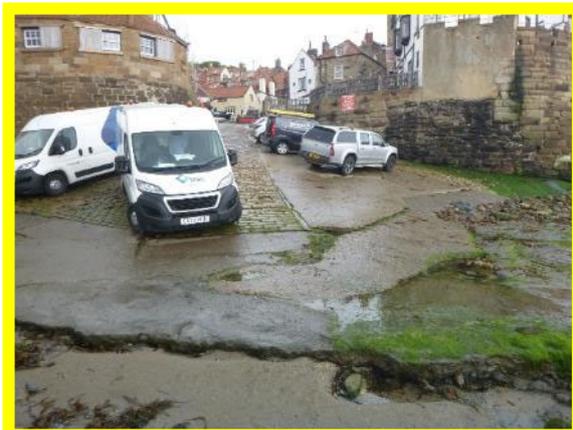
The adjacent central slipway (/1003C05) is in an overall fair condition, with minor damage and undercutting to an area of previous concrete repairs near one corner. The concrete apron at the seaward end of the slipway is presently being undercut and generally is in poor condition.

Slipway in fair condition, but with undercutting at the toe (/1003C05)

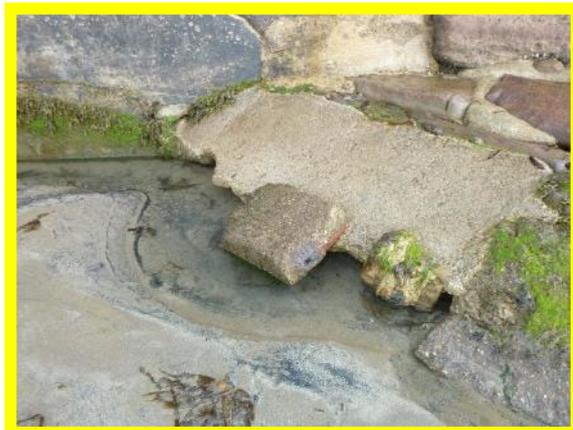
Undercutting of slipway toe and damage to previous repairs. (/1003C05)

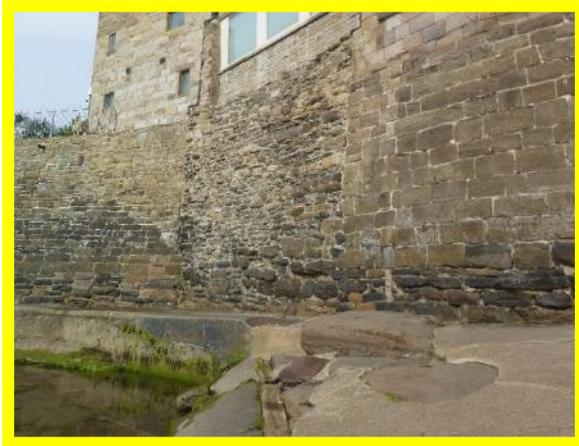
The mixed construction defence (/1003C06) on the south side of the slipway has mass concrete toe at the base with a variety of stone and blockwork above. The defence has a patchwork of previous repairs and repointing throughout but despite this a small number of open joints remain (mostly in areas of previous repairs) and there is one area of cracking in the concrete at the apron. This does not appear to have worsened since the 2018 inspection, but it is recommended that this is repaired to prevent further damage to the structure. Overall the structure remains in fair condition, but it would benefit from some minor maintenance.

Blockwork wall (/1003C06)

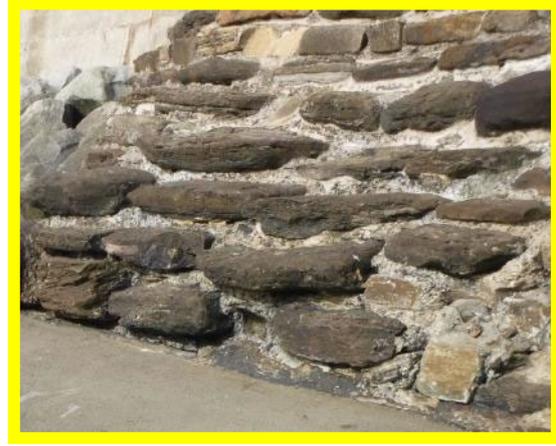
Typical defects (gaps) on blockwork wall (/1003C06)

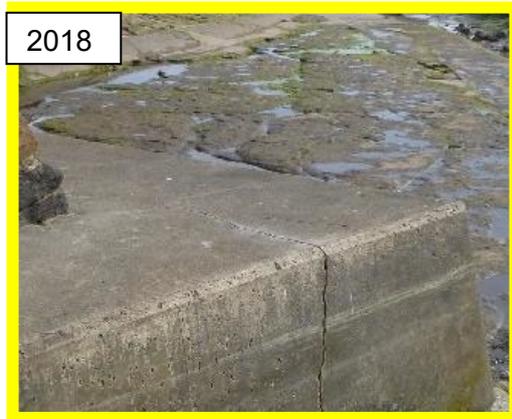
Typical defects (cracking) on toe apron (/1003C06)

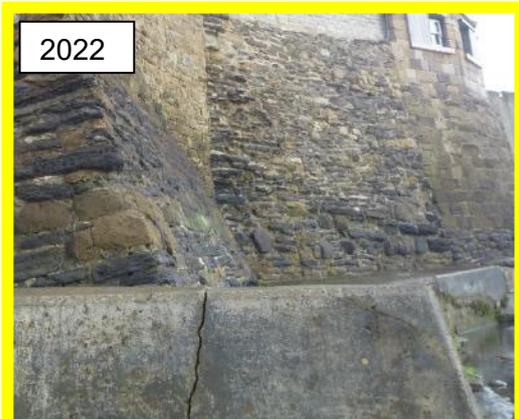
Typical defects (cracking) on toe apron (/1003C06)

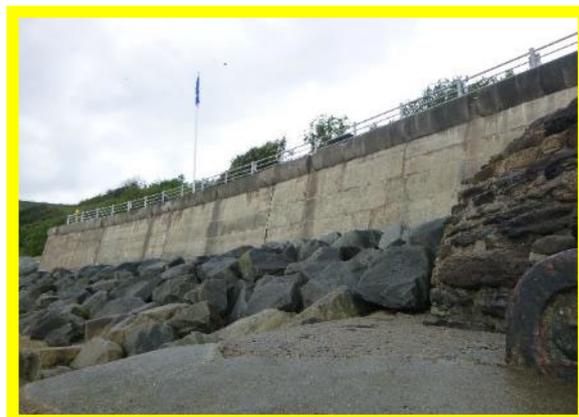
At the south of the village is the concrete sea wall(/1003C10). This structure was given rock armour toe protection as part of the 2001 scheme. The rock armour remains in good condition with the sea wall in fair condition. There are some notable defects at the access steps at the southern end of the wall, with render cracking and falling away and abrasion of the concrete beneath and this has deteriorated further since the last inspection. There is also some local abrasion and spalling at the coping and around joints. There has been some localised loss of joint sealant, however generally the sealant remains in good condition.

Concrete sea wall generally in fair condition (/1003C10)

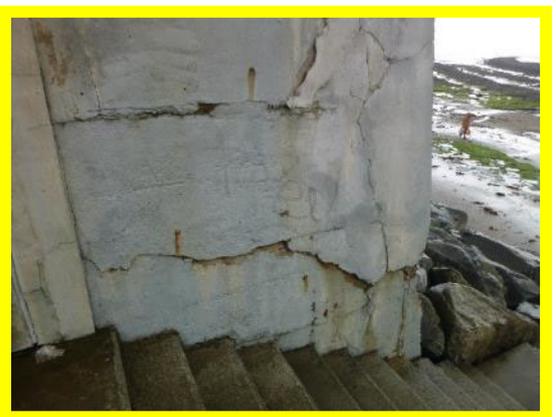
Defects at access steps (/1003C10)

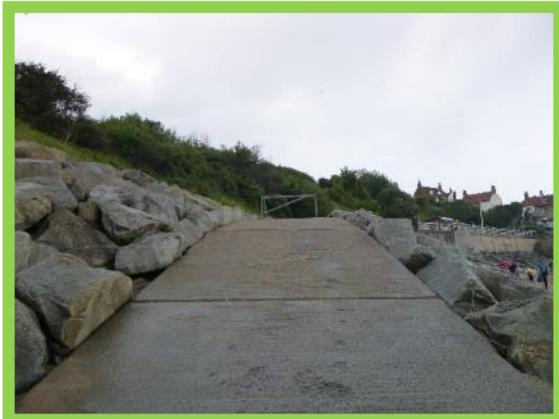
South of the sea wall there is a length of rock armour defence with a slipway / ramp, both of which were constructed in 2001 and remain in good condition in 20122 (/1003C09).

Rock revetment and slipway remain in good condition (/1003C09)

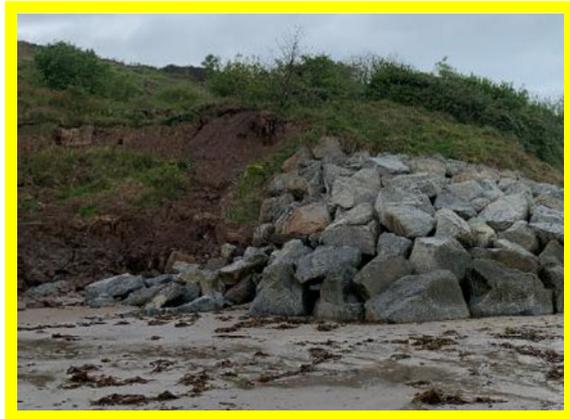
To the immediate south of the ramp is a short section of rock armour built in 2001 to stabilise the cliff (/1003C07). Since 2016 there has been further significant slumping behind the revetment and in one place, just south of the snout of the slipway, the cliff has overtopped the crest. In addition to this, the defence is at risk of being outflanked at its southern end, though this has not increased since the last inspection. It is recommended that the situation in this area is monitored and considerations are made for the revetment to be realigned once the cliff has retreated sufficiently.

Slumping of cliffs immediately adjacent to southern end of rock armour (/1003C07)

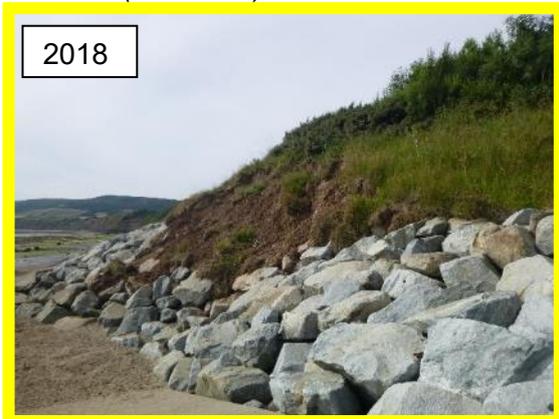
Slumping of cliffs behind rock armour (/1003C07)

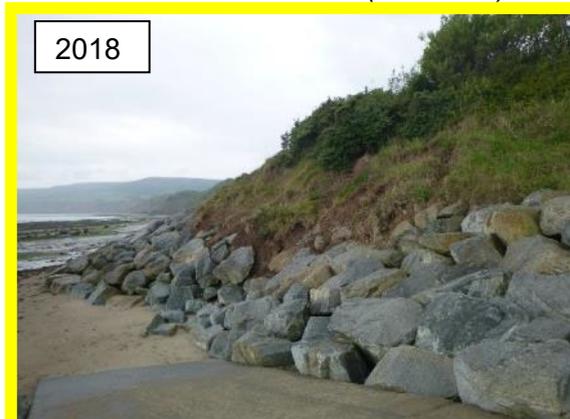
Slumping of cliffs behind rock armour (/1003C07)

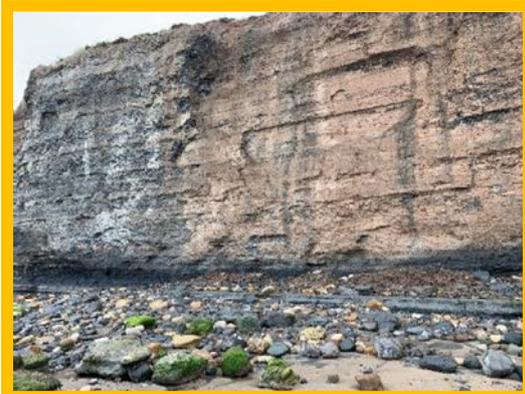
Units MU17/4 is located between Boggle Hole and just west of Stoupe Beck and has a near-vertical lower cliff formed in mudstone and an upper shallower part formed in glacial till. The unit was downgraded from Partly Active in 2014, to Locally Active in 2016, during the 2018 survey it was noted that there appears to have been significant and ongoing activity. As such, the unit returned to Partly Active in 2018. This classification was confirmed by the 2022 survey.

Mudstone cliff overlain by till. MU17/4 (Partly Active).

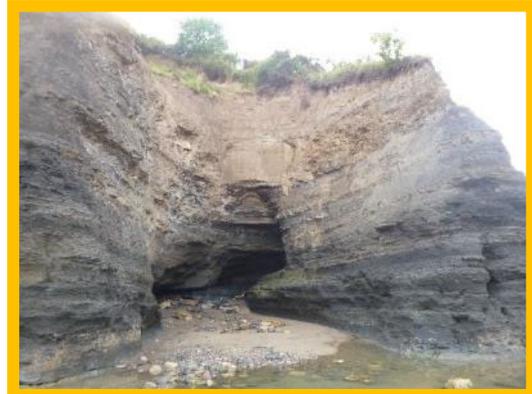
Cave forming on the southern flank of Mill Beck MU17/4 (Partly Active)

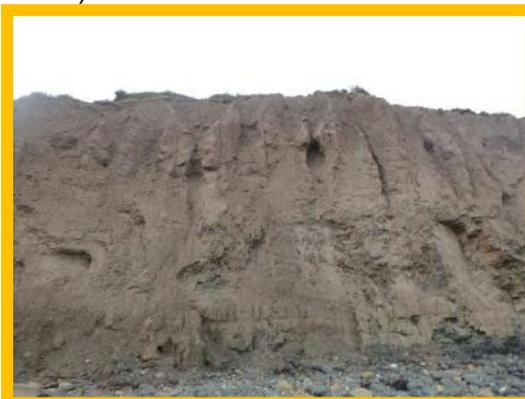
Steep composite cliff of mudstone overlain by till. MU17/4 (Partly Active).

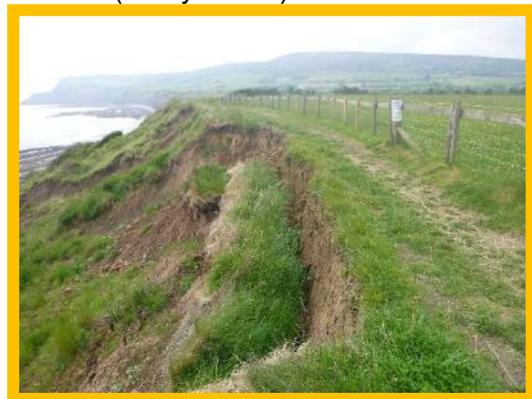
Active retreat of headscarp undermining footpath . MU17/4 (Partly Active).

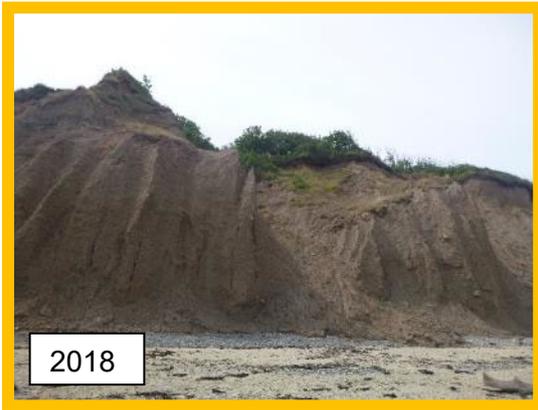
MU17/5 is located south of Stoupe Beck and is classified as Partly Active, no change since 2014. The cliff toe is slumped till at beach level nearer Stoupe Beck becoming bedrock with overlying till to the southeast, which is regularly slumped over the cliff face and on to the beach. The mid and upper slopes of the composite cliff are shallower gradient. There is an ongoing active retreat of the unit headscarp undermining the Cleveland Way footpath, which in parts appears to have been diverted and stabilised since the last inspection.

Active till cliffs down to beach level in Robin Hood's Bay. MU17/5 (Partly Active).

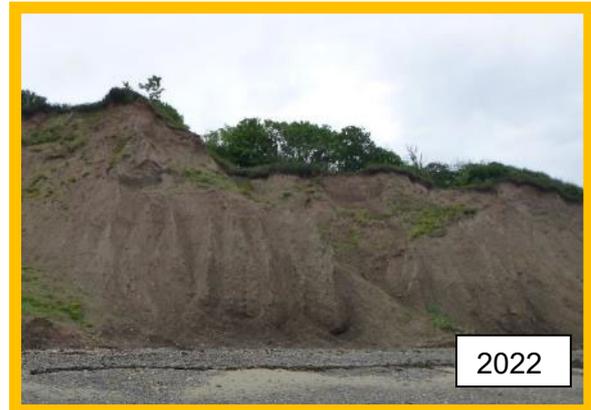
Active till cliffs down to beach level in Robin Hood's Bay. MU17/5 (Partly Active).

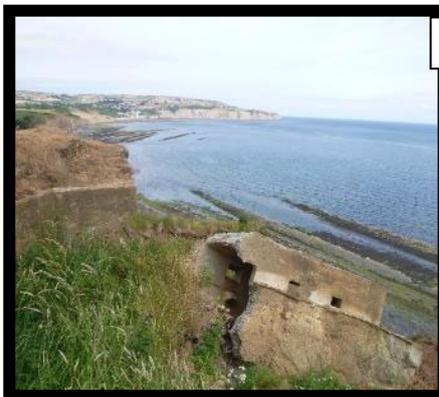
Historic WW2 pill box in 2018. MU17/5.

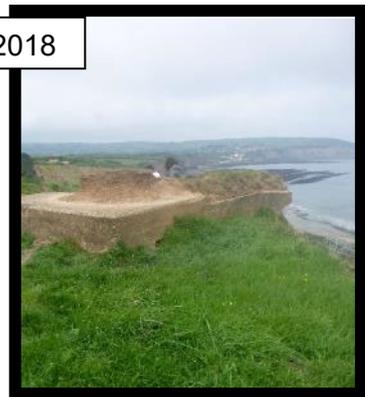
Historic WW2 pill box in 2022. MU17/5.

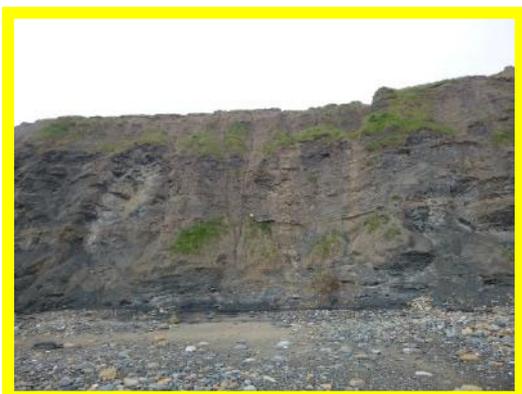
Further southeast, units MU17/6 and MU17/7 remain classified as Locally Active after being downgraded from Partly Active in 2016. The lower slopes are steep cliffs composed of mudstone overlain by shallower sloping till. The cliff face suffers localised rock falls and localised slumping of till from above.

Steep composite cliff of mudstone overlain by till. MU17/6 (Locally Active August 2022)

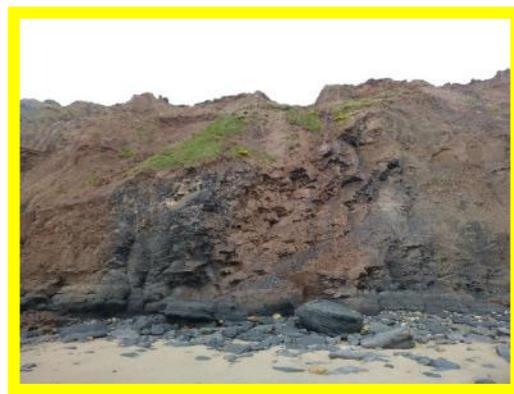
Recent local rock fall in the mudstone cliff. MU17/5 (Locally Active).

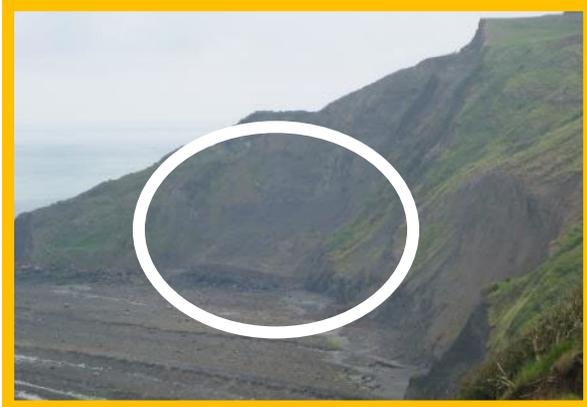
Units MU17/8 and MU17/9 are located immediately west of Peak Steel. **Unit MU17/8** has a steep lower slope which is actively eroding and a shallower upper slope which supports some vegetation cover. **Unit MU17/9** is steep with little vegetation. These units remain classified as Partly Active in 2018, as they have been since 2002.

Significant recent slip MU17/9 (Partly Active).

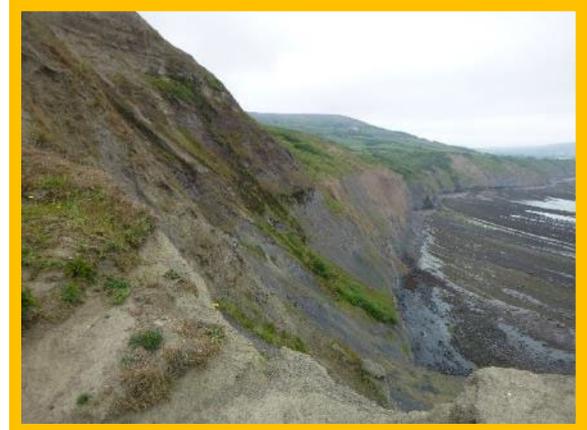
Ongoing erosion of cliff face along MU17/9 (Partly Active)

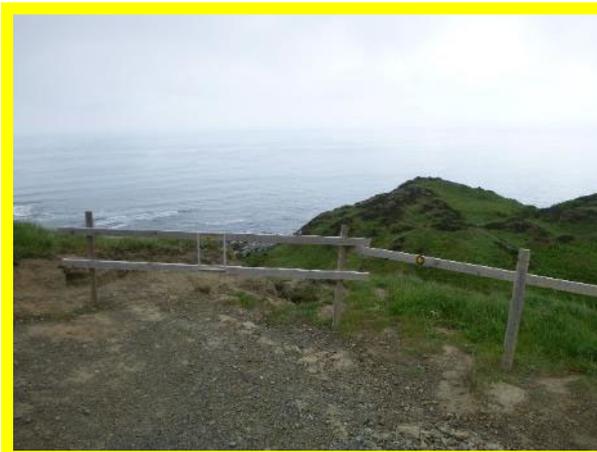
Unit MU18/1 is located at Peak Steel, below Ravenscar. The cliffs in this region have a distinct two-tiered form. Much of the upper headscarp is densely vegetated with little evidence of recent activity. The lower headscarp, exposed to the sea, is more active and subject to episodic slides with localised falls evident. This unit is classified as Locally Active in 2022

MU18/1 The footpath has been diverted on Peak Steel away from the recent landslip on the Northern face (Locally Active)

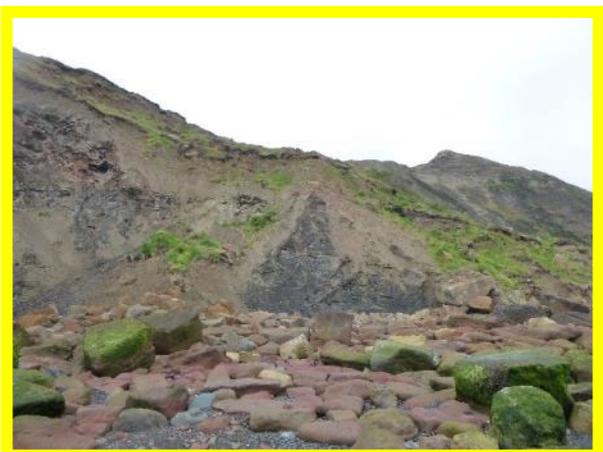
MU18/1 Peak Steel recent activity on lower slopes (Locally Active)

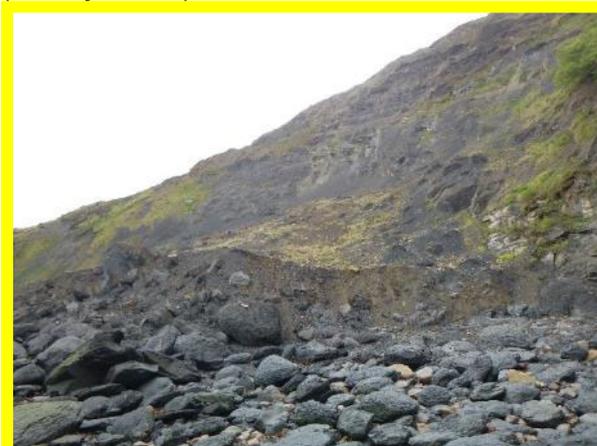
MU18/1 Peak Steel recent activity (Locally Active)

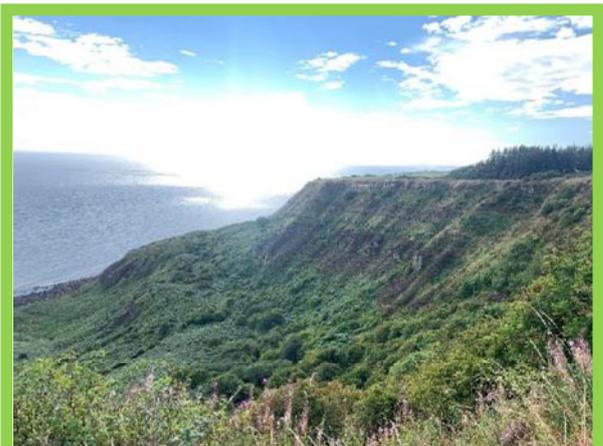
Unit MU18/2 is a well vegetated, relict system with no signs of activity. As a result, it is classified as Inactive.

MU18/2 Distinct two-tiered cliffs (Inactive)

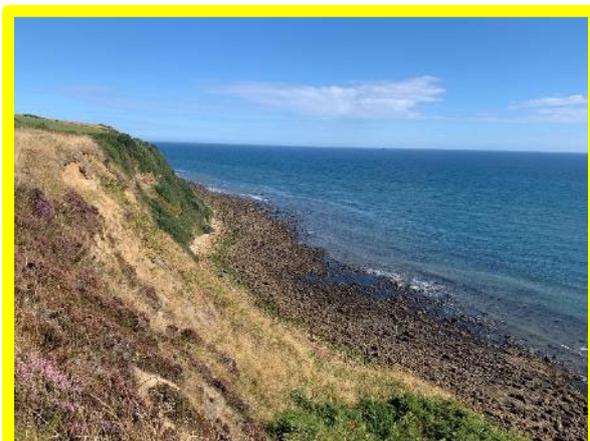
Vegetated slopes and debris apron (Partially active)

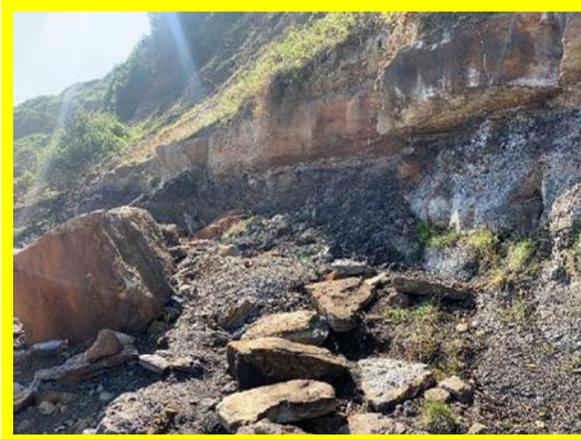
Unit MU19/2 is located on the north side of Hayburn Wyke and remains classified as Locally Active because of minor activity at the headscarp and some evidence of recent rockfalls at the toe. It was noted during the 2018 survey that there had been several large rockfalls near the access to the beach (see images below). Due to the proximity of the rockfalls to the access and the significance of the risk associated with rockfalls of such a magnitude it is recommended that MU19/2 is monitored for further change, particularly following periods of adverse weather where the cliffs may become unstable. However due to the localised nature of the activity the overall condition of the unit remains unchanged.

MU19/2 Rockfall at the toe of cliff.

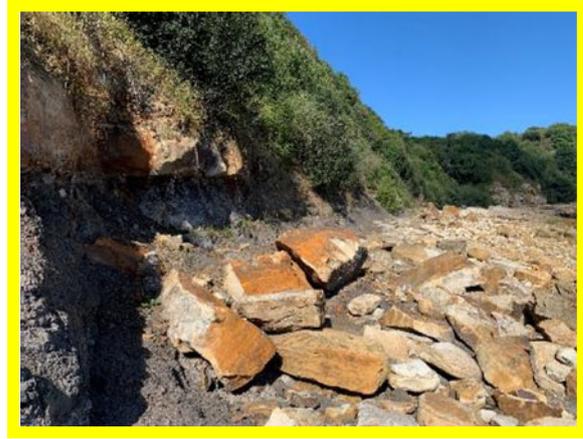
MU19/2 – Rockfall at toe of cliff, adjacent to waterfall.

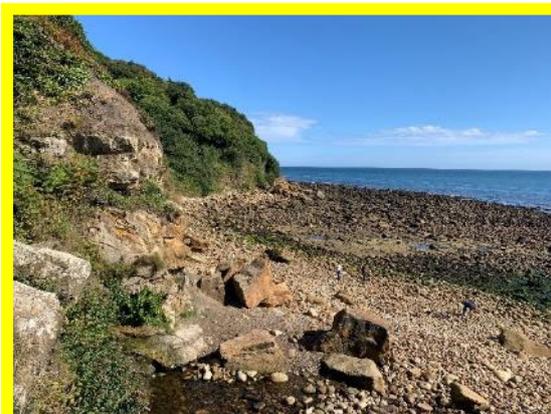
MU19/2 Looking north across Hayburn Wyke at the vegetated cliffs (Locally Active)

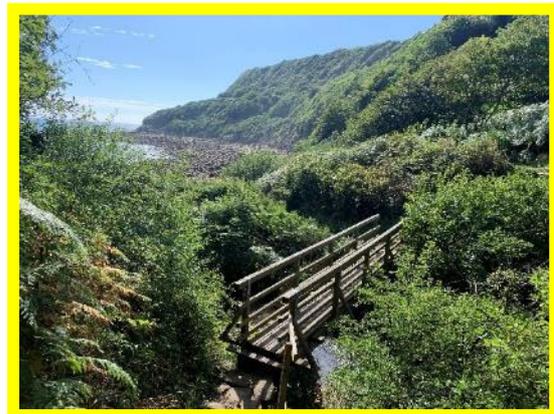
Unit MU19/3 is located around and to the south of Hayburn Wyke. These cliffs are well vegetated, with localised erosion at the toe and headscarp. This unit remains classified as Locally Active.

MU19/3 – Well vegetated undercliff on south side of Hayburn Wyke (Locally Active)

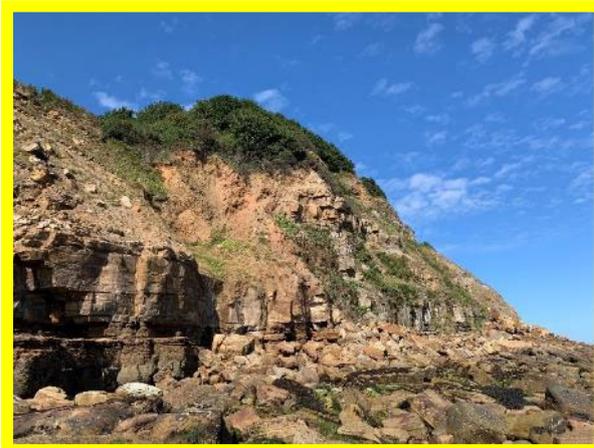
Unit MU19/4 is located immediately to the north of Cloughton Wyke. The unit is characterised by high, steep cliffs which are more active than those cliffs further north and south. There is some recession of the headscarp. This unit condition was noted as being Locally Active in 2022. Although there is evidence of some minor rockfall along the head scarp

MU19/4 Rockfall on southern side of Cloughton Wyke (Locally Active)

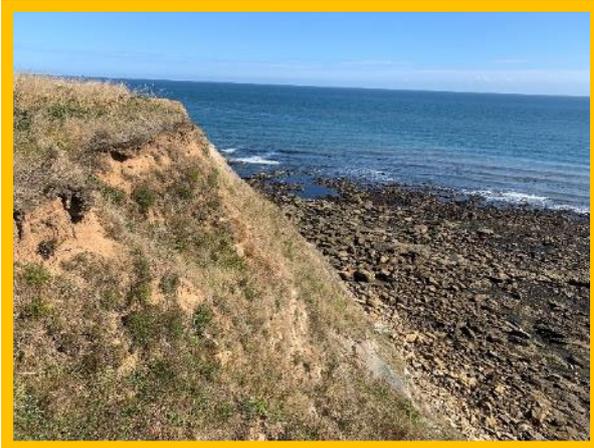
MU19/7 Long Nab (Partly Active)

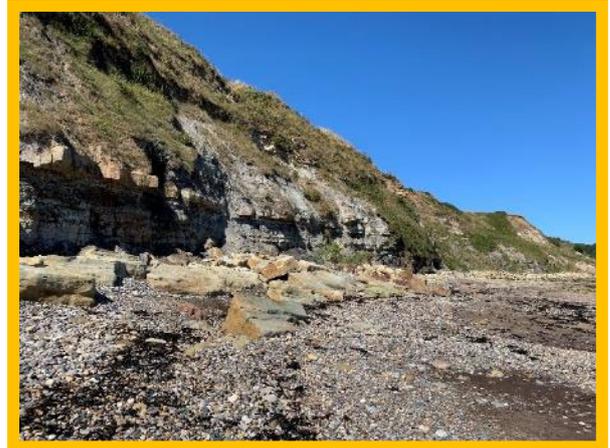
MU19/8 Rockfall on southern side of Long Nab (Partly Active)

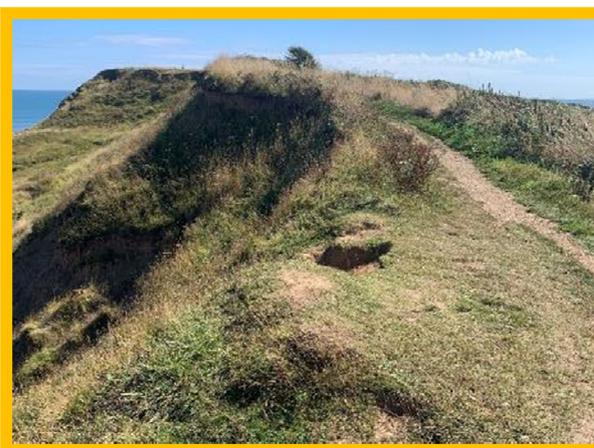
Units MU19/9 and MU19/10 are located between Cromer Point and Scalby Ness. The toe of these units is subject to marine action and the headscarp is steep, exposed and actively retreating through slippages at numerous places throughout the units. The cliffs have been given a worsened status of Partly Active because of the extent of activity along their lengths being more than simply 'local'.

During the 2022 survey it was noted that the headscarp was continuing to actively undercut the footpath and there was a significant risk to users of the path along several sections. This was due to the instability of the ground, evidenced by many minor landslips across the cliffs upper reach.

MU19/9 Retreat of headscarp (Partly Active)

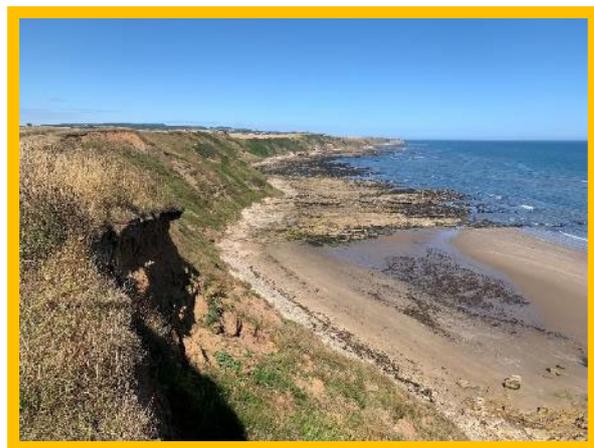
MU19/9 Landsliding and retreat of headscarp (Partly Active)

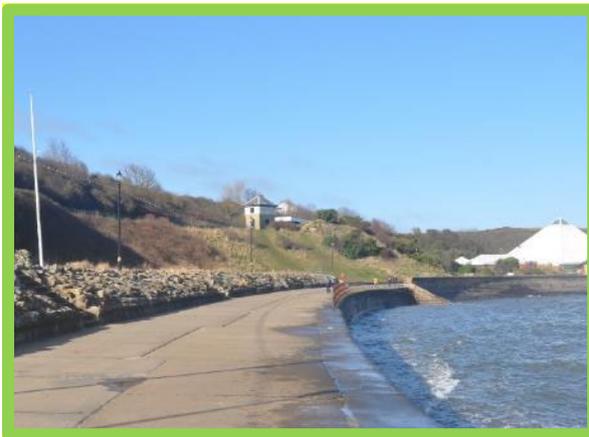
MU20/1 Cliffs in northern North Bay (Dormant)

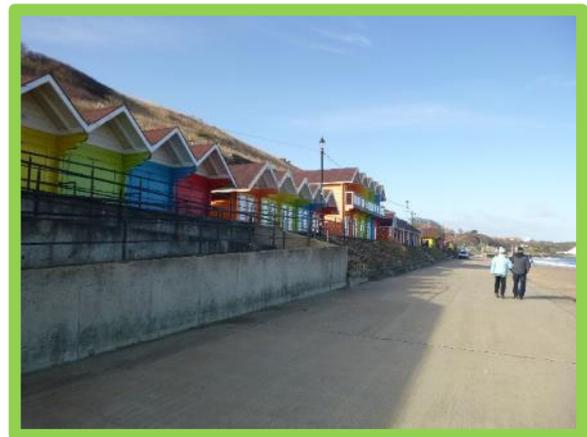
MU20/2 Cliffs (to rear of beach huts) in northern North Bay (Dormant)
