Cell 1 Regional Coastal Monitoring Programme Walkover Inspection Surveys 2022

**Scarborough
Borough Council**

November 2022

Walkover Inspection Surveys 2022

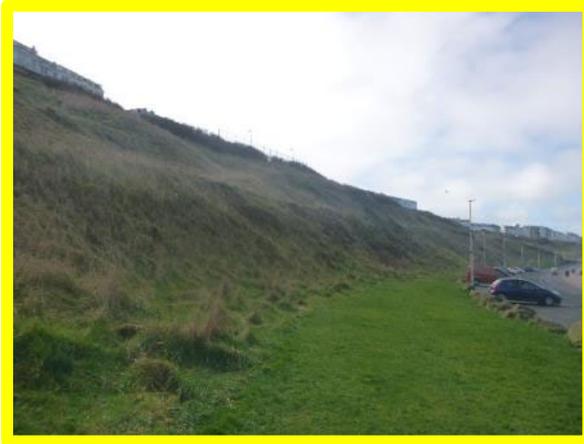
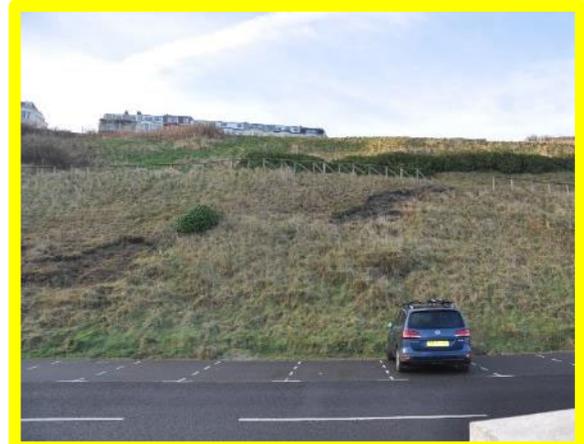
Unit MU20/4b covers the area of Clarence Gardens and has previously been slightly more active than the adjacent unit MU20/4a. However, remediation works have repaired cracks and the slopes are now well vegetated with exposed rock at the headscarp. This unit was downgraded to Inactive in 2012 and retained this status in 2014. However, because of evidence of some (very) shallow slips in one local area near to parking bays, it was altered to Locally Active in 2016 and 2018. In 2020, the cliff unit was classed as inactive. However, during the inspection in 2022 a number of very shallow localised slips were noted and as such the unit is now classed as Locally Active.

MU20/4b Cliffs in southern North Bay (Locally Active)

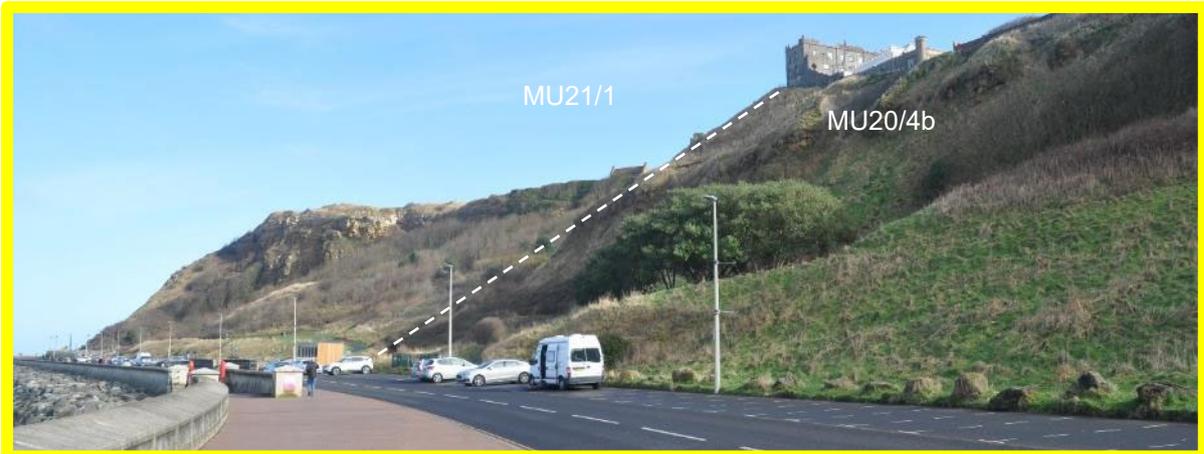
MU20/4b Locally Active, **MU21/1** Inactive

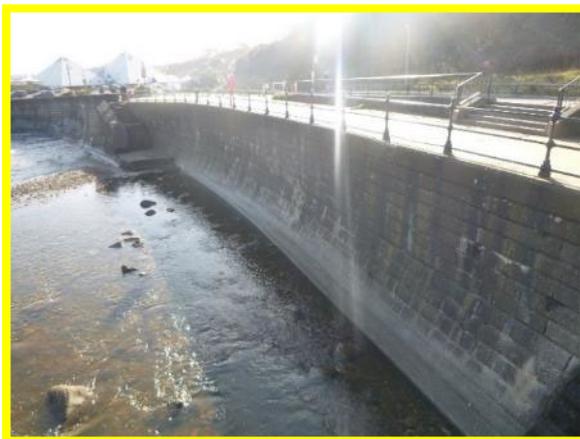
Fair condition seawall at Scalby Beck (/1201C01)

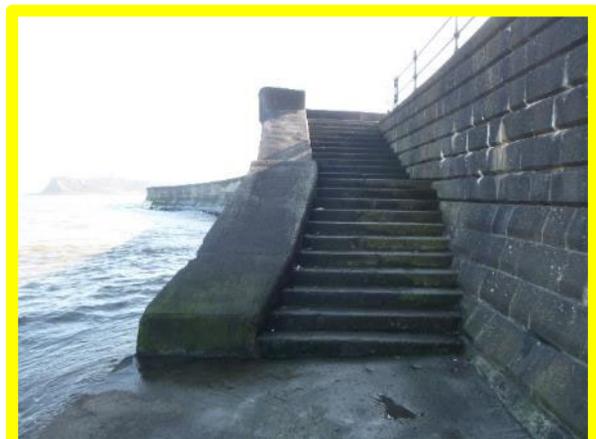
Access Steps at Scalby Beck (/1201C01 001)

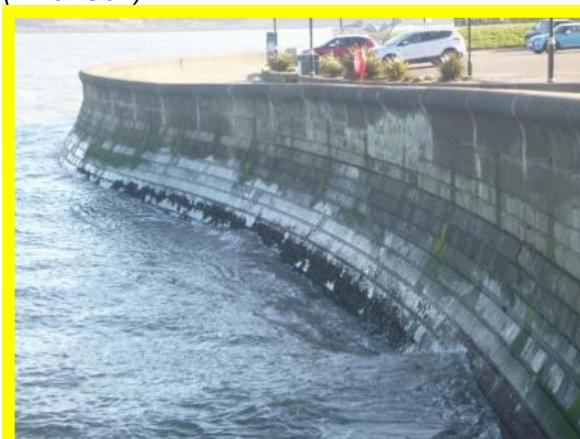
Fair condition seawall at Sea Life Centre (/1201C02)

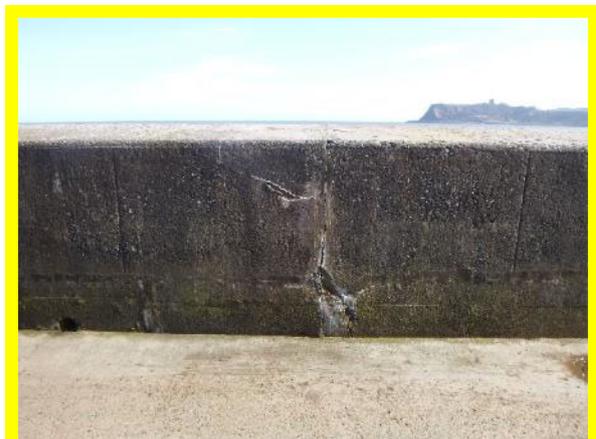
The most northerly seawall (/1201C01) starts adjacent to the footbridge at Scalby Mills and remains in fair condition. Moving south the seawall (/1201C02), around the promontory on which the Sea Life centre is built is in overall fair condition, but with some local areas of abrasion; most notably at the stepped concrete toe, north of the slipway. In the same location there is a failed outlet that has a broken crown although it is not envisaged to affect the performance. Due to the tide it was not possible to inspect the outlet during the 2022. There is also heavy abrasion around the access steps at the junction with the adjacent seawall to the south. Previous joint repairs are holding well however, it was noted that there were a number of new open cracks in the crest wall some of which had not yet been repaired.

Cracking in crest wall (/1201C02)

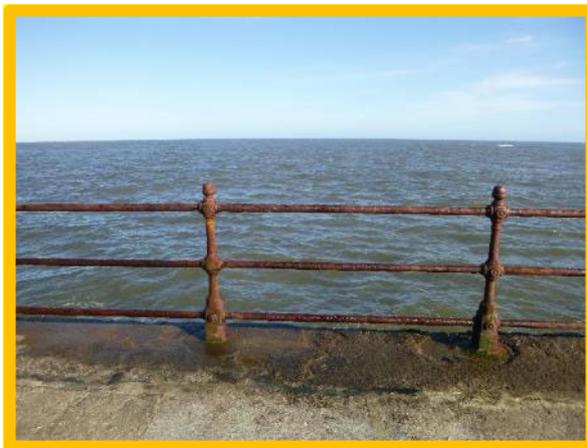
The northernmost section (/1201C03) has a short length of heavily corroded handrailing at the seaward edge of the promenade and notable abrasion damage to the deck. There also is a section (4-5m) of heavily abraded seawall face to the north that is now exposing reinforcement and requires attention. The grouted stone revetment at the rear of the promenade has a number of ad hoc in-situ concrete repairs, many of which have failed.

Heavily corroded handrail (/1201C03)

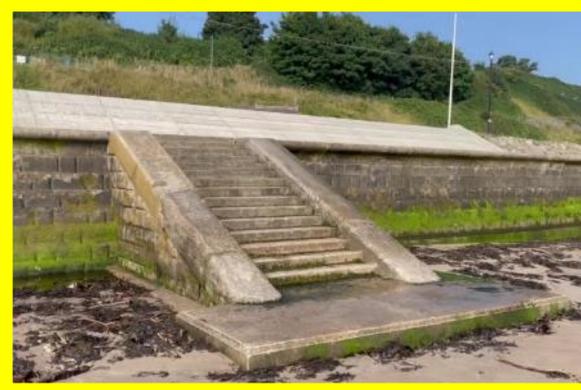
Concrete foundation to access step landing. Sheet piles not visible in 2022 (/1201C24)

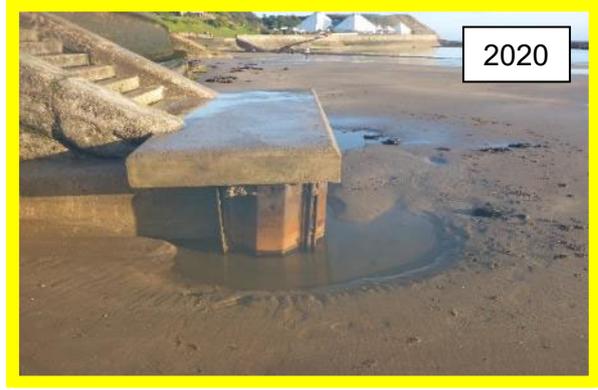
Corroded sheet Piles with minor seaward visible in 2020 (/1201C24)

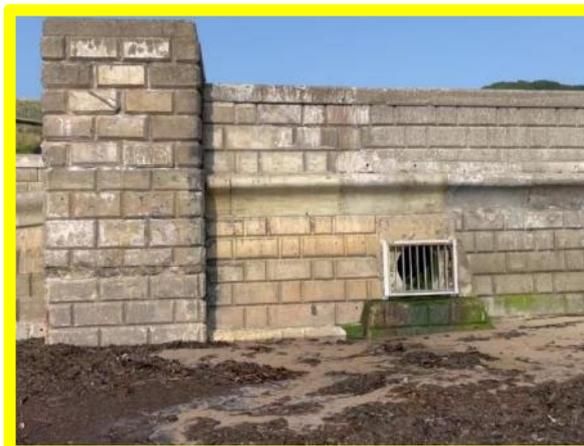
The wall around the promontory (/1201C04) is more exposed and has had relatively recent repairs to both the front face and the low crest wall, these are still holding up well in 2022. It was reported in 2018 that heavy abrasion damage remained in other places (especially on the unrepaired sections of lower wall), although this was buried by high beach levels in 2022. There is damage to the rear promenade wall in two places – notable a section of missing blockwork, approx. four blocks, that requires attention, this remains unchanged in 2022. The new drainage outfall, entry guard and WaStop are in good condition were not visible due to the tide levels.

Area of recent repairs around outfall and to promontory wall (/1201C04)

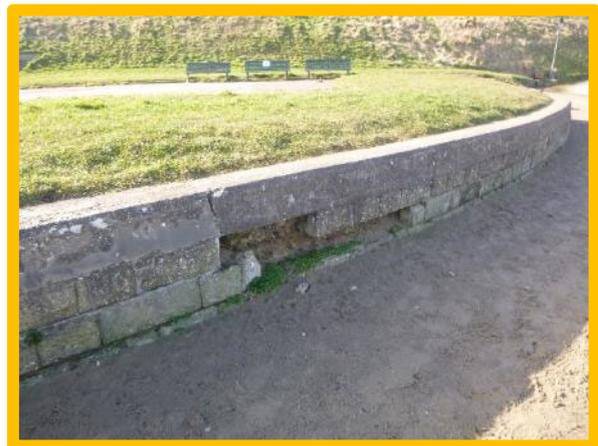
Missing blockwork in rear wall (/1201C04)

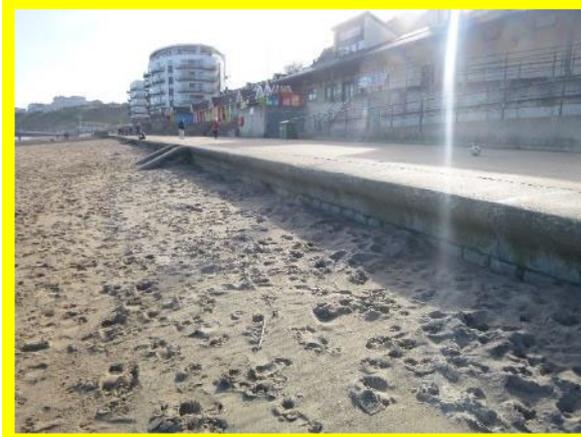
High beach levels cover most of wall (/1201C15)

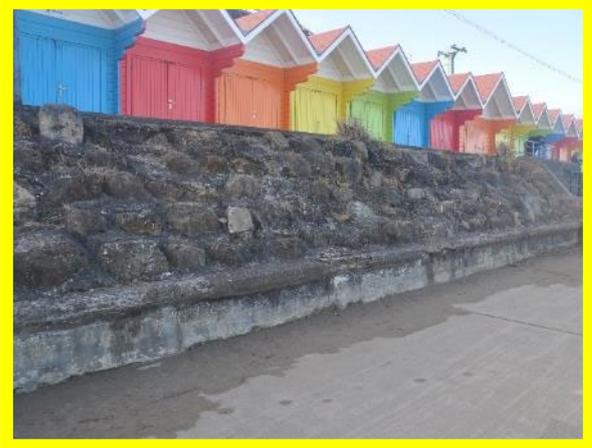
Previous repairs to the grouted stone revetment to the rear of the promenade, below the beach huts, remained generally effective, however locally there are a number of loose or missing stones. Furthermore, there is vegetation growth noted on the crest and face of the revetment, it is recommended that this is removed. Abrasion damage continues to be evident to the access steps along this section, although several sets have been repaired and are in good condition.

Vegetation growth in crest (/1201C12)

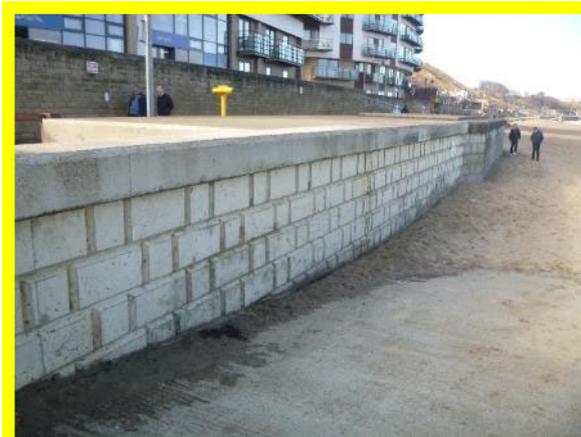
As reported in 2018, the wall to the north of the ramp at Peasholm Gap (/1201C06) shows several (minor) vertical cracks. These were noted not to have worsened since the previous inspection. There was an area of notable abrasion damage to the facing.

Vertical cracks in wall protecting recent development (/1201C06)

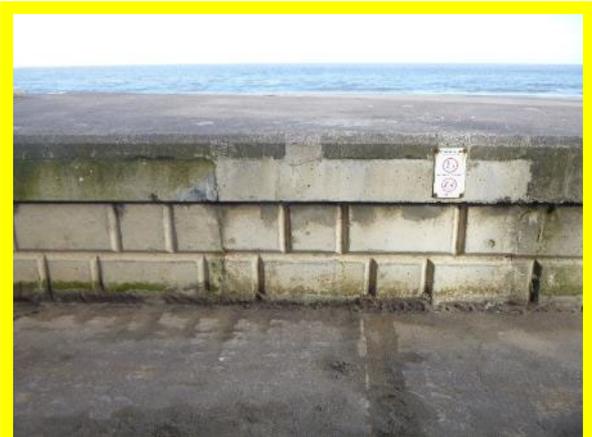
Vertical crack (seen from rear of crest wall) (/1201C06)

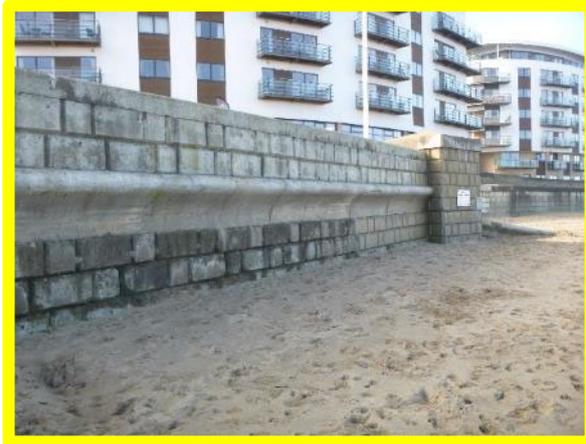
The beach levels at the wall at Peasholm Gap (/1201C19) were lower in 2022 than during the 2022 inspection, although these are still significantly higher than the 2018 inspection before that. As a result, much of the lower courses of blockwork, including the outlet, were buried. The extensive repairs, completed in 2014, are in good condition and holding well. Elsewhere along the face of the wall, there are locally some areas of damaged blockwork including abrasion, spalling and missing joint sealant. The recurve feature and crest wall are in fair condition with local evidence of abrasion and spalling. Overall, the wall remains in fair condition.

Previous repairs to wall at Peasholm Gap (/1201C19)

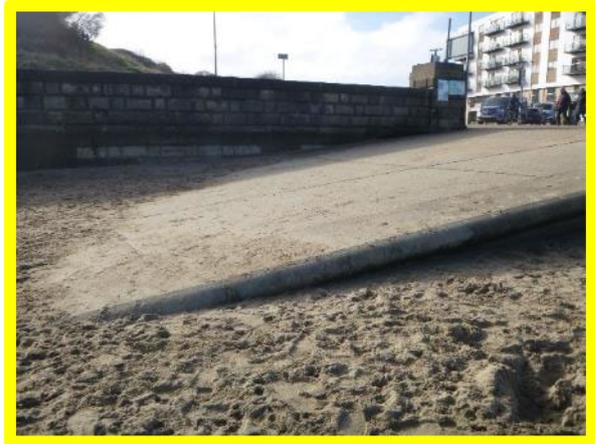
Slip way in fair condition (/1201C20)

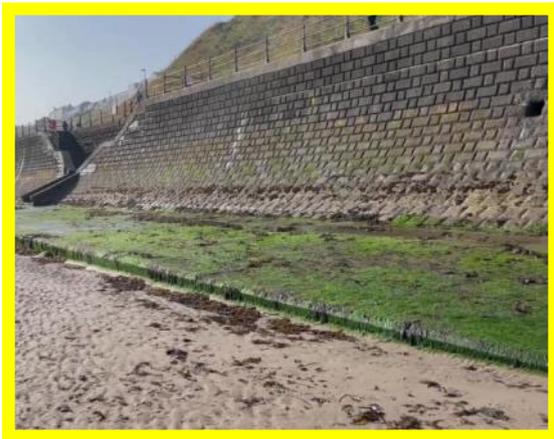
South of Peasholm Gap, Royal Albert Drive is protected by an increasingly high curve-profiled blockwork wall (/1201C07 and C21 respectively) that runs south to the slight promontory at the ramp opposite the recently redeveloped Oasis Café. The wall is in a generally fair condition. As reported in 2020, previous repairs to joints, damaged wing-walls to beach access steps and entire sections of full height wall are in good condition. The lower courses of brickwork show signs of abrasion. There are a couple of missing blocks adjacent to the access steps, these should be replaced before the defect deteriorates.

High curved-profile seawall (/1201C07)

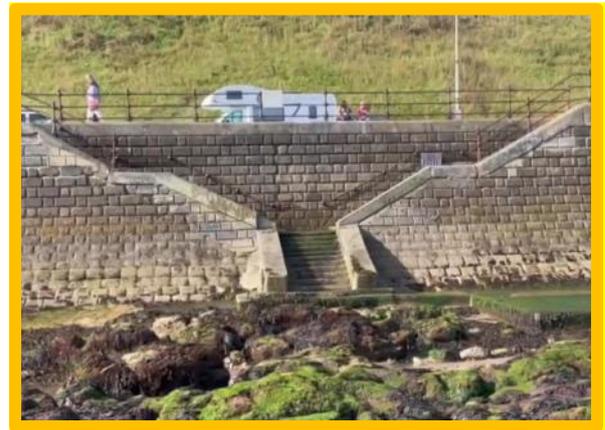
Missing blockwork (/1201C07)

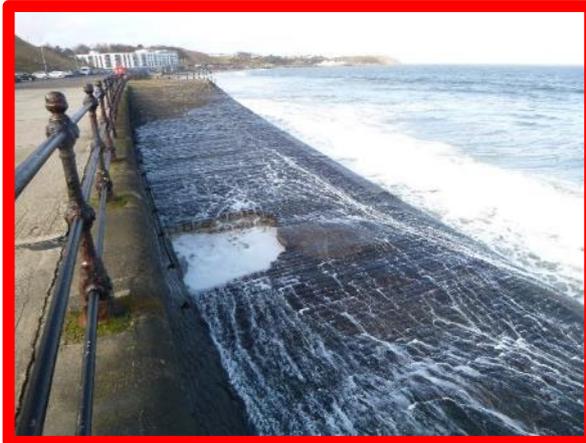
The slipway in front Oasis Café is fenced off to prevent access. However, it is understood that members of the public do still use the slipway by climbing over the fence. During the 2022 inspection a large void was discovered in the surface of the slipway. Due to the extent and depth of the void this was immediately reported to Scarborough Borough Council, who later that day (01/03/2022) came to site to assess the defect.

Access ramp still in use despite fencing (/1201C08)

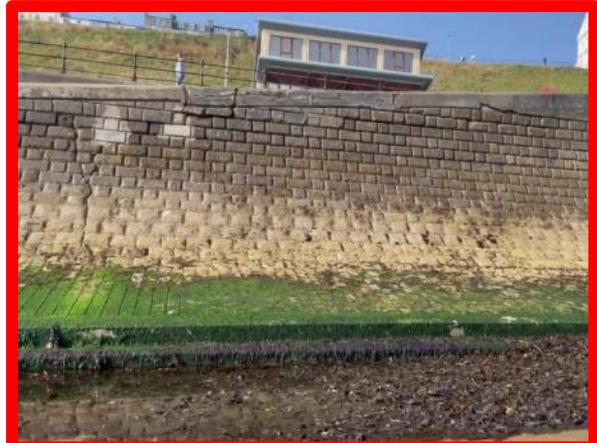
The large vertical crack on the wingwall has deteriorated and a block is now missing adjacent to the crack. Surrounding blocks appear loose and are at risk of being displaced. The crack and blockwork defects appear to correlate to a depression in the deck suggesting settlement issues.

Wing-wall at access ramp - 2020 (/1201C21)

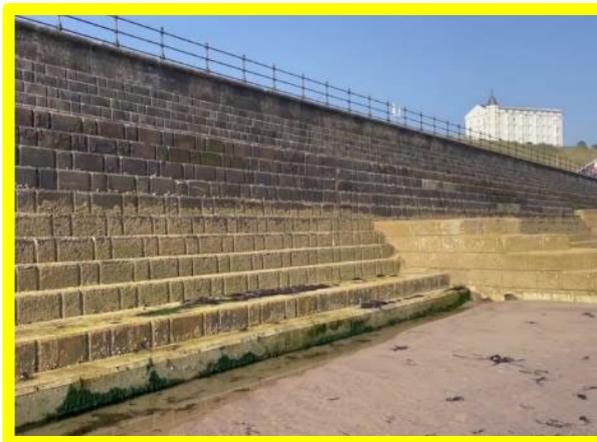
At the southern end of the North Bay, there is a large stepped concrete blockwork sea wall structure (/1201C08) constructed with nine large buttresses/bastions which protrude from the wall out onto the beach. The apron of the structure is most exposed at the northern end of structure. There is one longitudinal crack in the blockwork across several adjacent blocks. Although noticeable, this has not deteriorated since the last inspection. The promenade surface is poor in places.

Concrete blockwall wall with buttresses (/1201C08)

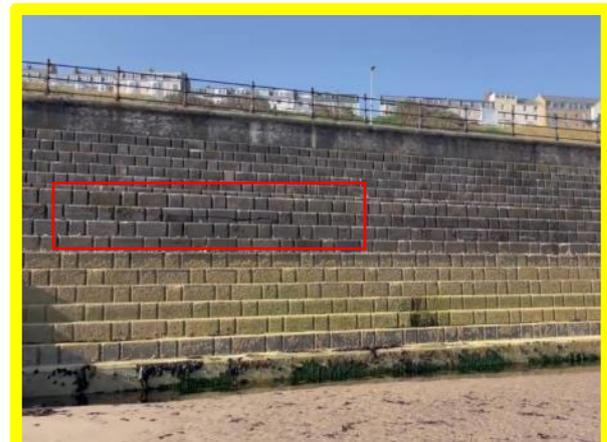
Longitudinal crack in blockwall wall (/1201C08)

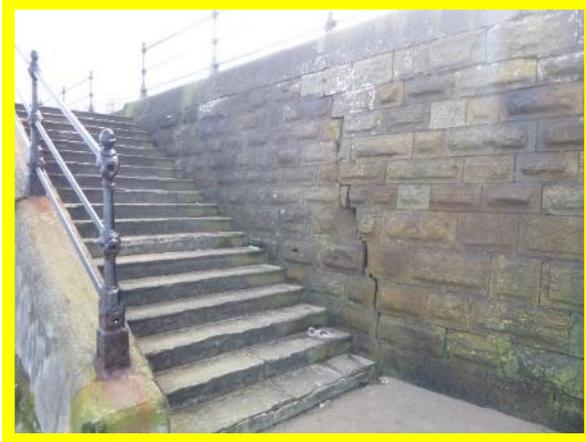
There is a short section of vertical blockwork wall (/1202C23) between the stepped concrete blockwork wall and the rock armour revetment to the south. This short wall is in fair condition overall, the missing blockwork at its southern end has been repaired. However, the lower three courses remain heavily abraded. A secondary wall which sits to the rear of the promenade and adjoins the access steps has a notable full height crack.

Repairs to southern end of wall (/1202C23)

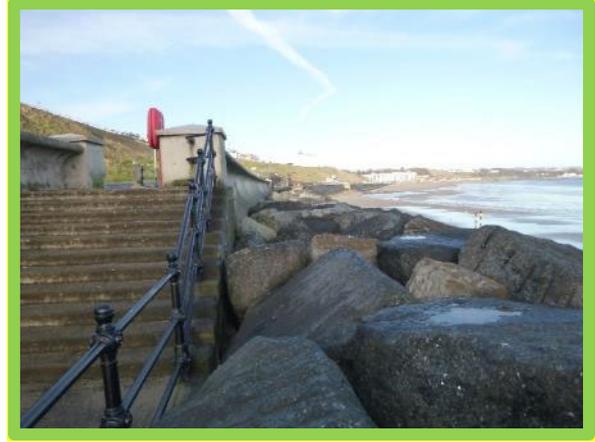
The southern-most section of defence in North Bay is the first section of the rock armour at Clarence Gardens that was constructed in 2004/5 (1202C01). This remains in good condition in 2020, protecting the original wall behind.

Rock revetment fronting seawall remains in good condition (/1202C01)

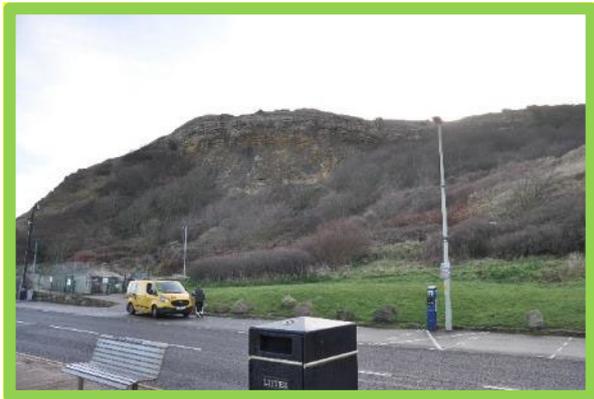
Unit MU21/1 is located at The Holms and continues to be classified as Inactive, unchanged from previous surveys. The unit comprises a series of relict rotational landslides and is prone to rockfalls. However, there was no evidence during the 2022 inspection of recent rockfall activity.

MU21/1 Historic rotational slip (Inactive)

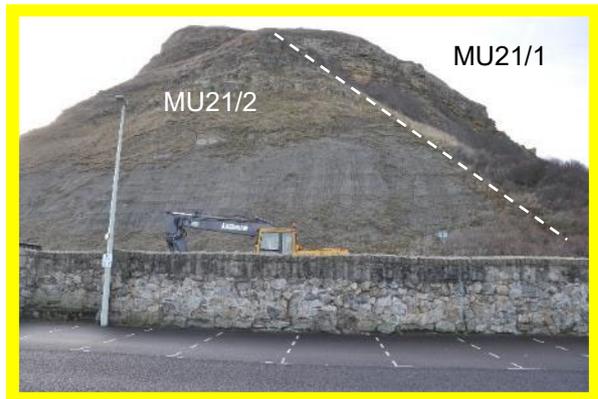
MU21/1 and MU21/2 Rock fall debris at toe of cliff

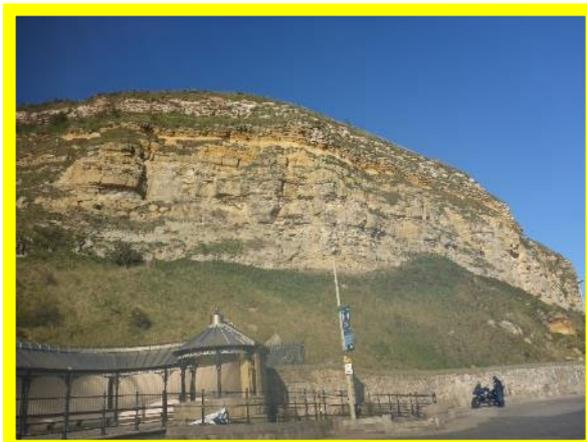
Unit MU21/2 forms the Castle Cliff promontory and continues to be classified as Locally Active, unchanged from recent inspections. The cliffs are steep with extensive toe protection measures and rock netting on exposed faces. Locally, bedrock is exposed where it is subject to ongoing weathering and erosion from rainfall. There are rock fall debris piles at the toe of the cliff highlighting past activity. There is one historic rotational slip behind seating area on Marina Drive.

MU21/2 Historic rotational slip (Locally Active)

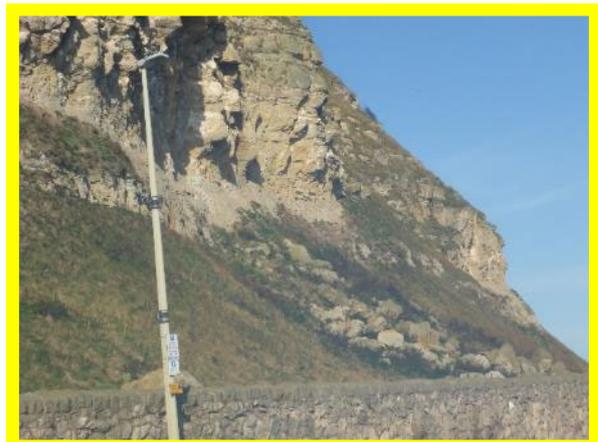
MU21/2 Rock fall debris at toe of cliff

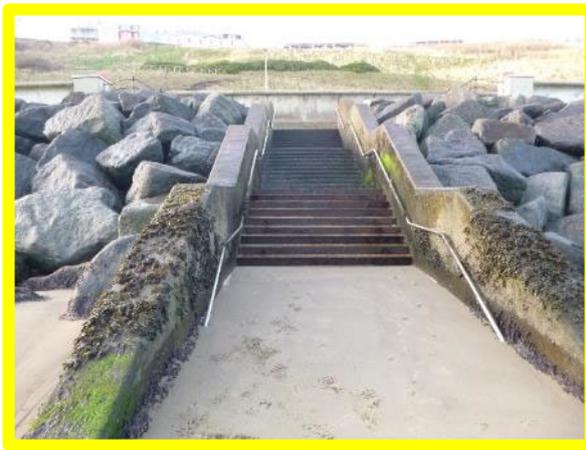
There is a continuous wave return wall along the crest of these defences, which remains in good condition along both asset lengths. Where there are beach access steps through the rock armour in the south part of North Bay (/1202C01), there is considerable abrasion damage to the steps although the structures themselves remain sound. Scour holes at the foot of several sets of the steps were not observed in 2022, as it appeared that high beach levels and the local accretion of beach material had filled these in. The lower sections of the access steps (/1202C01) have steel edges in place which are now heavily corroded and are a trip hazard.

Steps in fair condition (/1202C01)

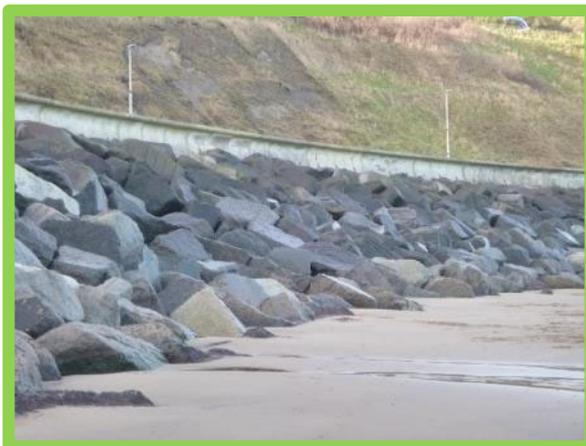
Rock armour revetment and wave return wall (/1202C03)

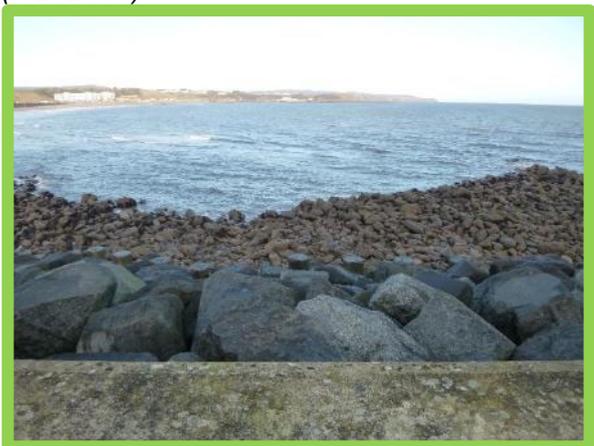
Rock armour revetment and with natural rocks offering protection (/1202C04)

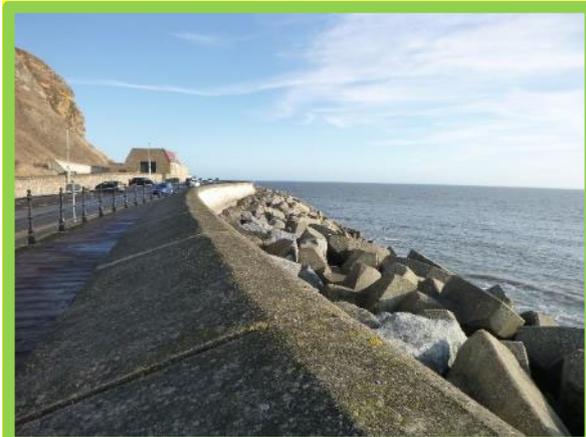
The section of defence continuing around the Castle Headland to the harbour is an Accropode revetment with concrete toe piles and a rock armourstone crest, with a concrete wave return wall (/1202C02). As reported previously, the inspection was limited to views from the crest wall and it was not possible to inspect the toe as along most of the length it is below water in all tide conditions. Overall, these defences remain in good condition with only localised evidence of concrete abrasion and cracks in the Accropodes. There was one notable example of cracking and subsequent movement of several Accropode units on the northern apex of the headland. Given the location and potential risk further movement this should be monitored. The crest wall is generally sound with only minor cracking and good joint seals. The promenade remains in overall good condition in the 2022 inspection.

Accropode revetment with concrete toe piles, rock crest and wave return wall (/1202C02)

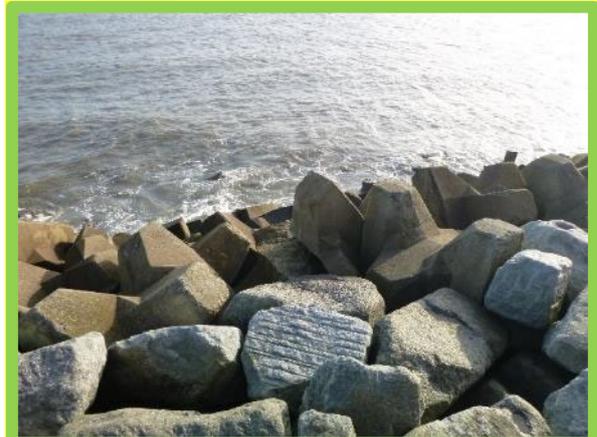
Example of locally cracking and movement of Accropode units, but otherwise revetment in good condition (/1202C02)

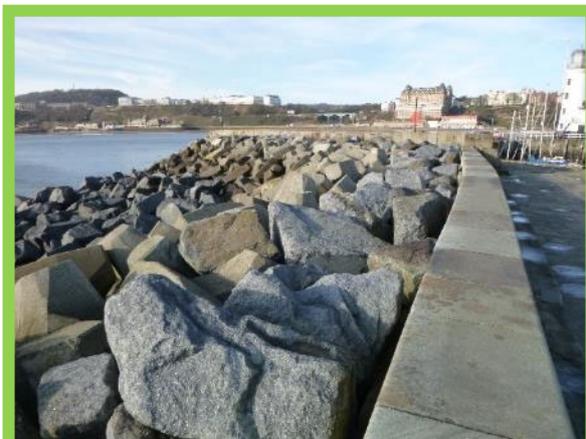
The outer face of East Harbour’s outer pier is protected by rock armour and Accropode units (/1301C01) and is in good overall condition. Towards the seaward end of the pier, many of the original wall blocks on the crest of the outer wall are heavily abraded and some are partially cracked.

East Harbour outer pier (/1301C01)

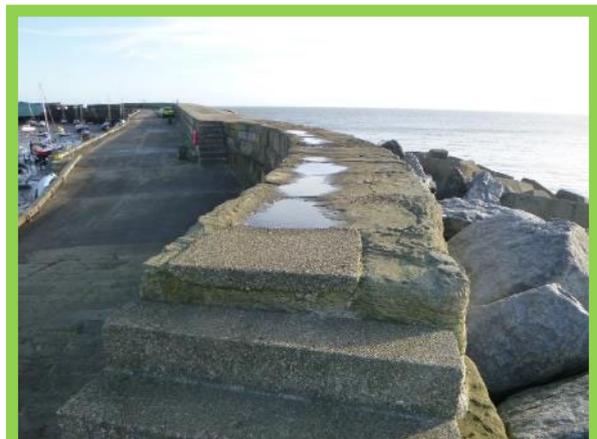
Abrasion towards seaward end of East harbour outer wall (/1301C01)

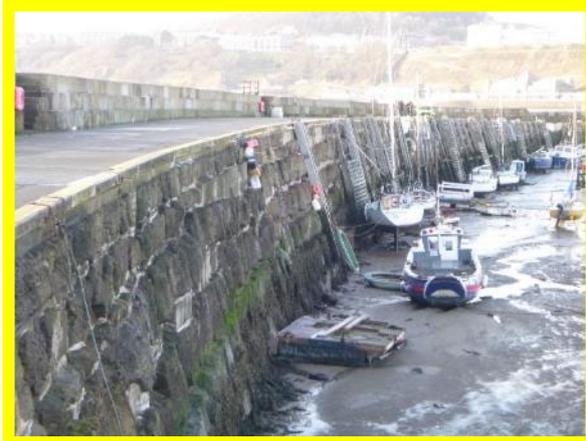
East Harbour inner pier, historically repaired joints visible (/1301C16)

The inner facing wall of East Harbour's outer pier (/1301C16) was refurbished as part of the 2005 scheme, with missing blocks replaced and joints filled. The 2022 inspection of this asset was timed around a low spring tide and a thorough inspection of the inner wall face was possible from the harbour bed. The inspection notes that there was extensive evidence of missing mortar from joints, heavily abraded sections of masonry blockwork, movement or failure of access steps and deterioration of previous repairs. However, there did not appear to be any significant movement of blocks in the wall face. The overall condition of the inner face remains fair.

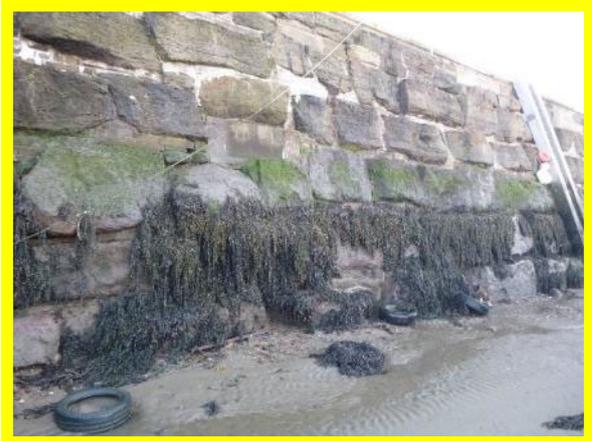
Open joints at base of wall, principal blockwork appears in fair condition (/1301C16)

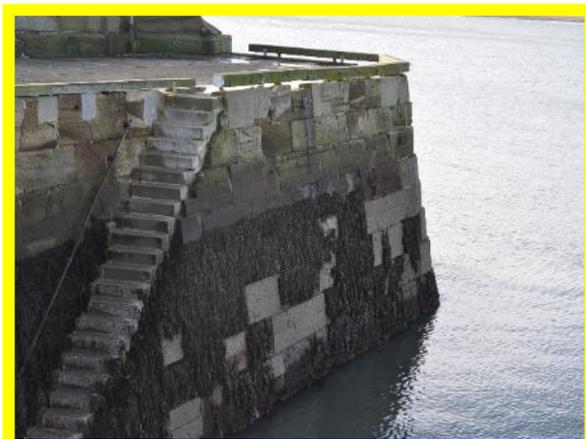
Access steps at nose of East Harbour pier in fair condition. (/01301C01)

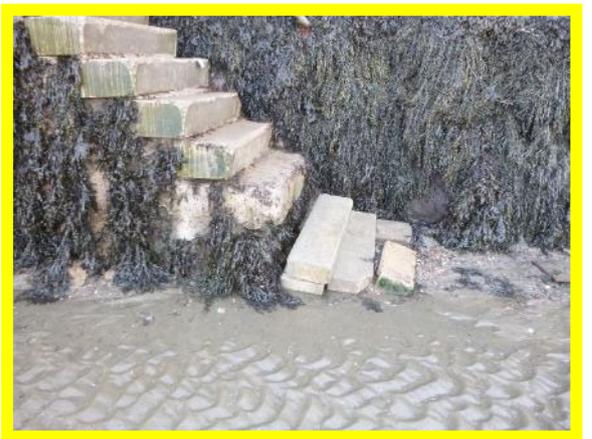
Access steps at root of East Harbour pier in poor condition. (/1301C01)

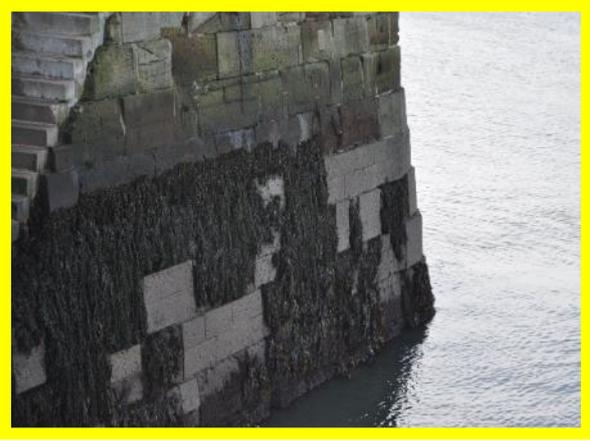
Despite timing the inspection around the low tide, the seaward end of the East Harbour's outer pier could not be inspected as it remained underwater. When looking back towards the pier from the south it was possible to identify several large lateral voids in the seaward face of the structure. These were not visible from the pier itself. A more thorough structural inspection of this area (by boat) is recommended to determine the size and nature of these voids.

voids visible around low water mark. (/1301C16)

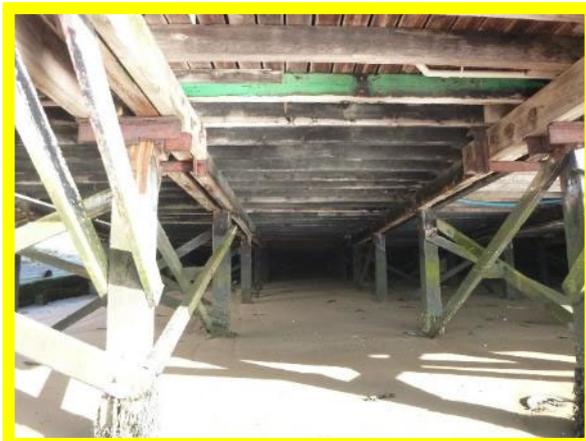
At the landward end of East Harbour is a short section of low wall (/1301C02) which is largely obscured by an overhanging platform which houses fairground attractions and arcades. As such the wall could not easily be inspected. However, as this wall is not subject to marine influence, its condition is somewhat less critical than other harbour structures. Where observable, the pointing between blocks was in good condition but render on the upper section of wall is starting the break away in places. This wall extends to a slipway to East Harbour which is located on the inner side of Vincent's Pier and remains in fair condition with some evidence of abrasion missing mortar between cobbles.

Low masonry wall underneath overhanging wooden promenade. (/1301C02)

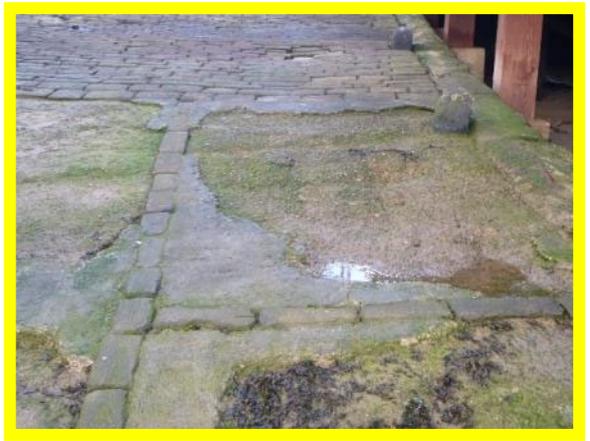
Slipway which separates (/1301C02) and (/1301C04) in fair condition.

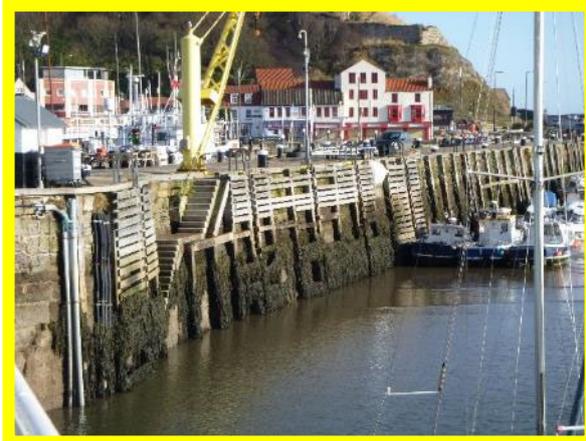
Vincent's Pier (/1301C04) separates East Harbour from Old Harbour and is in overall fair condition. The wall facing East Harbour is largely covered by timber boarding and algae growth, making inspection difficult, but where visible the blockwork and joints are sound. The pier deck is in good condition.

Wall of Vincent Pier facing east (/1301C04)

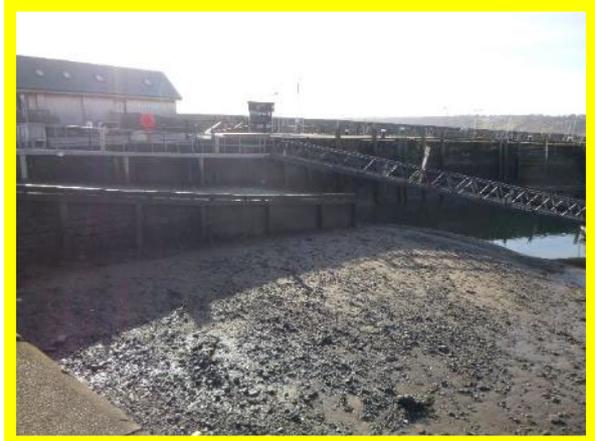
Wall of Vincent's Pier facing west (/1301C04)

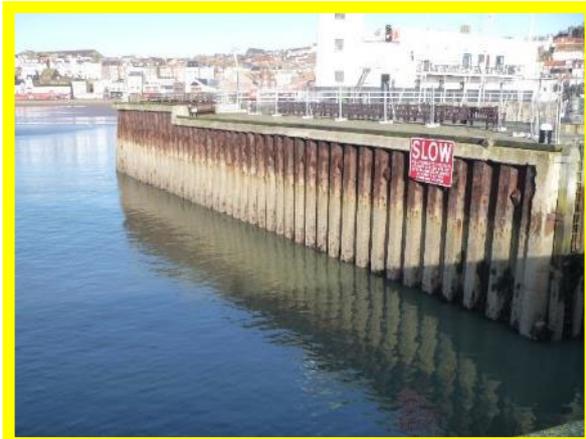
At the harbour arm beyond the Captain Sydney Smith Bridge, near the lighthouse, the steel sheet piling on the outer wall (/1301C17) is corroded but no holes were obviously apparent. It was noted in the 2022 inspection that the seaward edge of the structure was fenced off with Heras fencing, which restricted inspection of the access steps on the western face of the wall. It is notable that the blockwork walls at the end and inner facing walls (/1301C03) of this pier have evidence of missing mortar and joints, the overall condition of the pier remains fair. The floating pontoons are constrained by vertical guide posts which are mounted onto the masonry wall (/1301C03). In several locations the pontoons appeared to be sagging. This may locally increase loading on the guide post and the connections into the masonry wall. It is recommended that the pontoons, guide posts and connections are inspected in detail.

Corroded steel sheet piling (/1301C17)

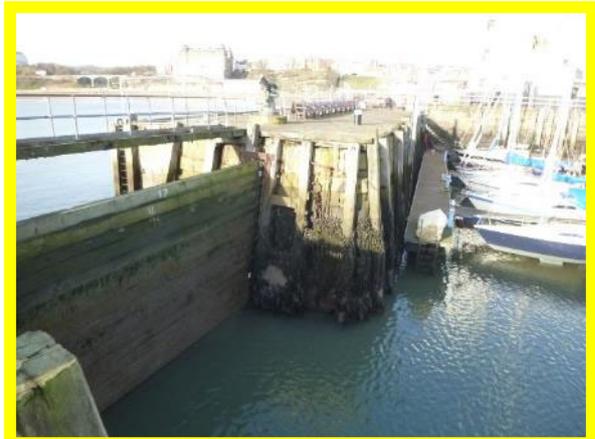
Cracks and missing mortar on inner wall at entrance breakwater (/1301C03)

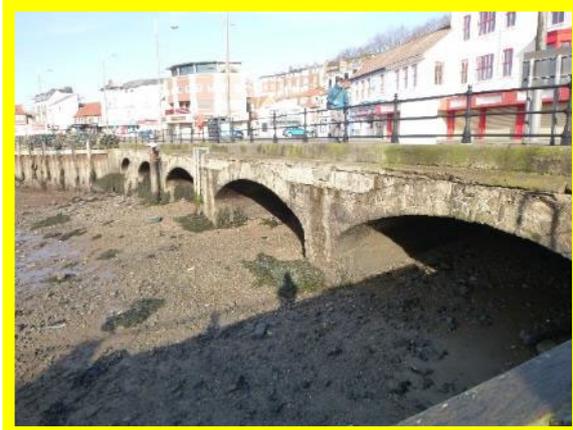
Moving westwards from the landward end of Vincent's Pier, the temporary portable cabins used by the RNLI have been removed upon completion of the new lifeboat station immediately adjacent to West Pier at the northern end of Scarborough South Bay. The promenade eastwards of here is supported by several arches built in front of the original quay. These remain in fair condition with well pointed stonework, however the previously reported damage to the concrete capping apron remains unrepaired and is in poor condition.

Some Cracking and missing joints to capping apron to wall south of roundabout opposite arcade. (/1301C05)

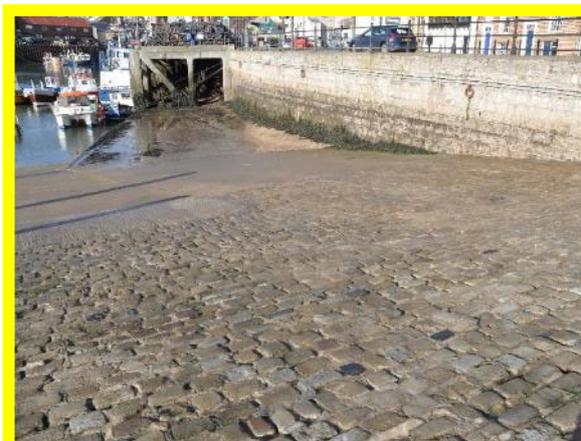
Immediately west of here is a concrete jetty which has been constructed to extend a suspended deck seaward of the wall. Previous inspections have reported signs of movement of the jetty and original quay wall, but this is not obviously apparent as has been reported in recent walkover inspection. There was no sign of cracking or lateral movement across the deck. The slipway and wall at the western end of Sandgate (/1301C14), adjacent to the West Pier, is generally in fair condition. The sheet piles at the toe of the slipway show signs of vegetation growth and some minor corrosion but appear in fair condition. As has been reported in previous inspections the low blockwork wall on the northern edge of the slipways has experienced some localised displacement resulting in movement of the blocks and coping.

Slipway, quay wall and concrete jetty (/1301C11 and C06)

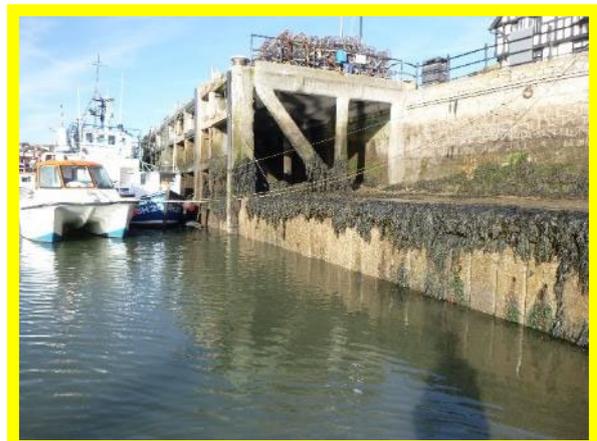
Suspended deck of concrete jetty (/1301C06)

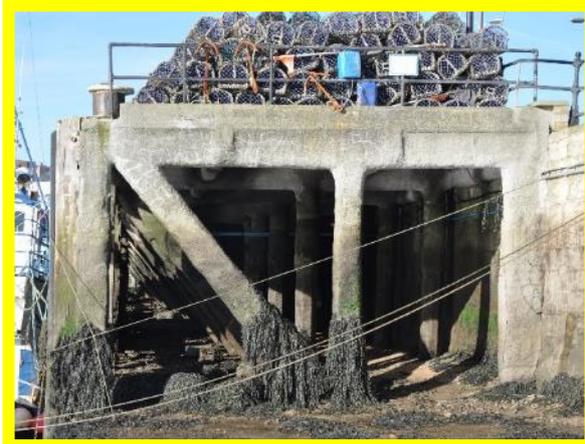
Suspended deck of concrete jetty (/1301C06)

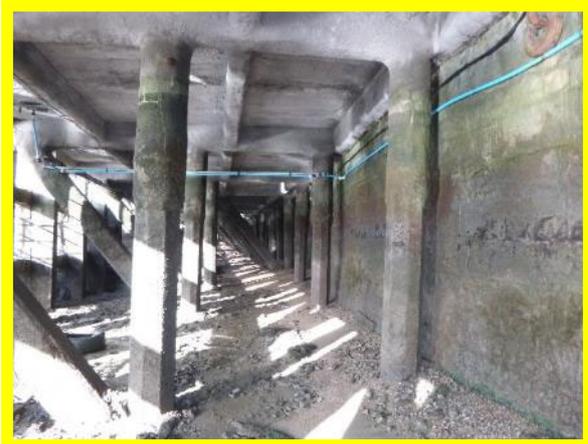
Abrasion to quay wall beneath suspended deck (/1301C06)

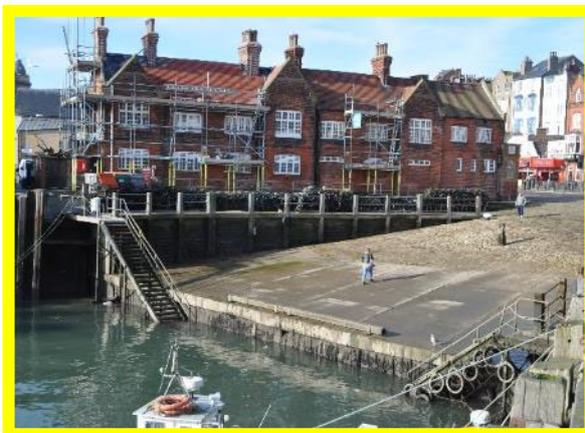
Looking towards slipway at western end of Sandgate (/1301C14)

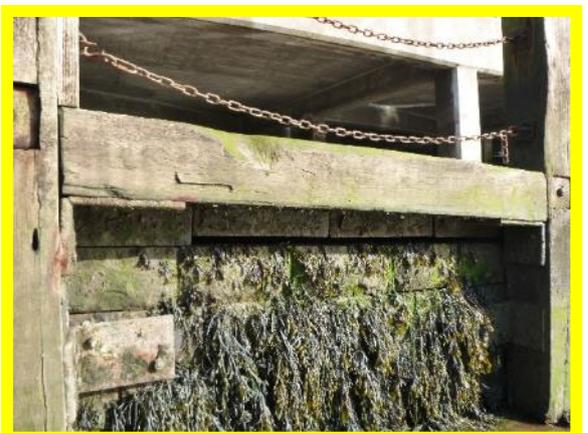
Minor damage and displacement to blockwork wall (/1301C14)

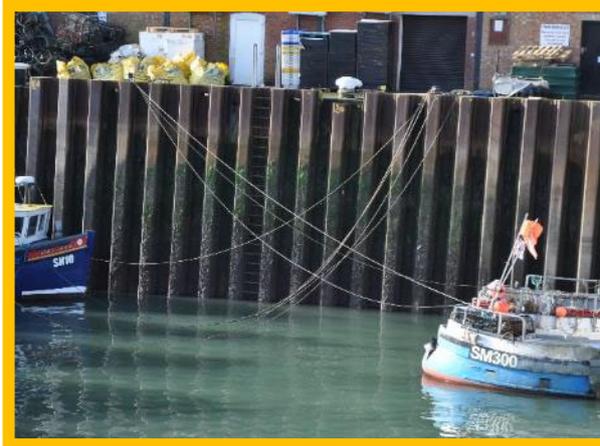
The inner face of the West Pier (/1301C13) appears to be mostly in fair condition, but the steel sheet piling is corroded. In particular at the landward end directly adjacent the slipway where a void was visible. This instance of corrosion may be indicative of the levels of corrosion elsewhere and should be monitored. The seaward end (/1301C18) also has corroded steel sheet piling and longitudinal cracks in the concrete capping beam, as reported in the 2018 inspection. As such the poor condition rating is retained following the 2022 inspection. Immediate repairs are recommended throughout the structure. It is understood that recent dive surveys have recorded large voids around the seaward end of the structure and there is a weight limit for vehicles in place on the structure. It is recommended that the deterioration is monitored before a capital scheme is in place.

Corroded steel sheet piling on inner face of West Pier (/1301C13)

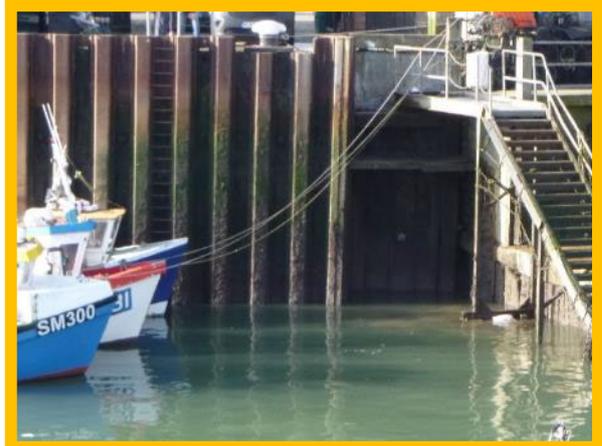
Corroded steel sheet piling notably worse directly adjacent slipway (/1301C13)

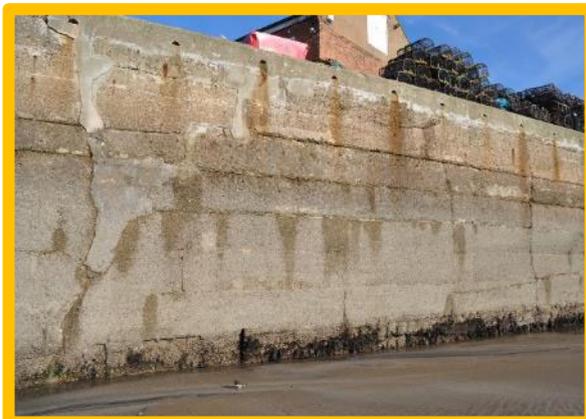
The outer face of West Pier (/1301C07) continues to show several significant defects including numerous longitudinal cold joints, several large full height cracks and exposure of aggregates. Its condition has been recorded as poor since 2009. Some previous repairs are obvious but in places cracks remain partly open. There is one area of voiding near the toe of the wall which was reported in 2018 and remains unchanged. During the 2022 inspection the timber piles at the toe of the structure were visible. There is extensive spalling and loss of render near the seaward end of this southern face. Repairs are recommended.

Longitudinal cold joints in south face of West Pier wall (/1301C07)

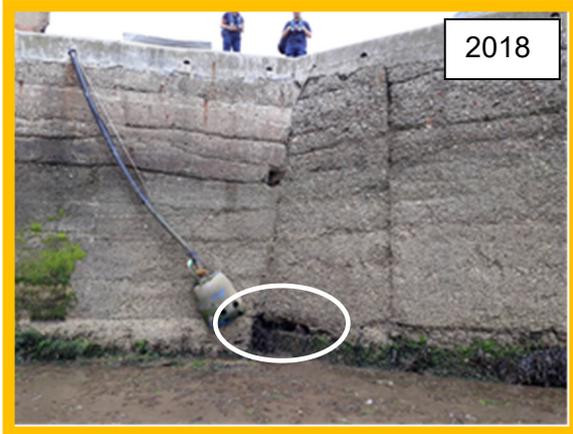
2018: Void at toe in south face of West Pier wall and damaged conduit (/1301C07)

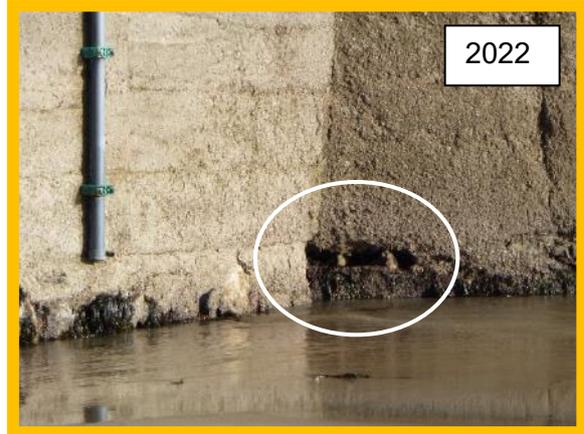
Spalling and loss of render in south face of West Pier wall. Void remains unchanged (/1301C07)

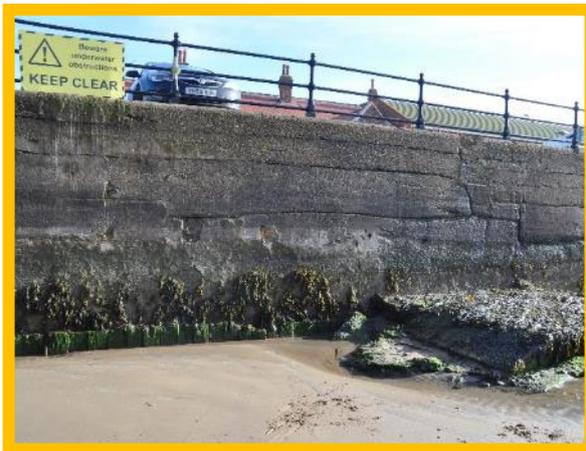
The poor condition of the seawall extends to its landward end (/1301C19), unchanged since 2020 and urgent repairs are recommended now that the RNLI lifeboat station is complete. During the 2022 inspection the timber piles at the base of the structure were visible.

Large open joints and cracks are evident from along the wall's full extent (/1301C19)

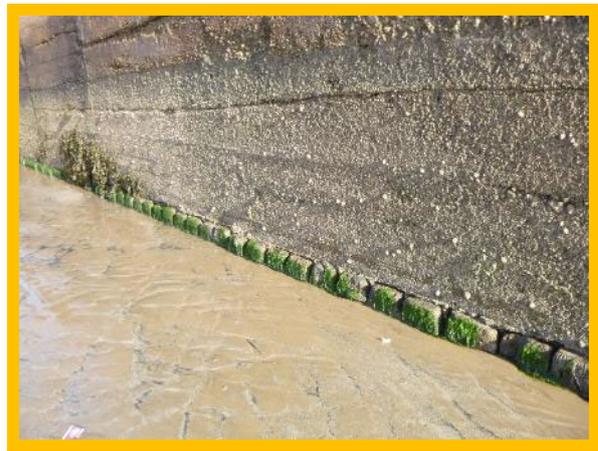
timber piles visible at toe of wall (/1301C07)

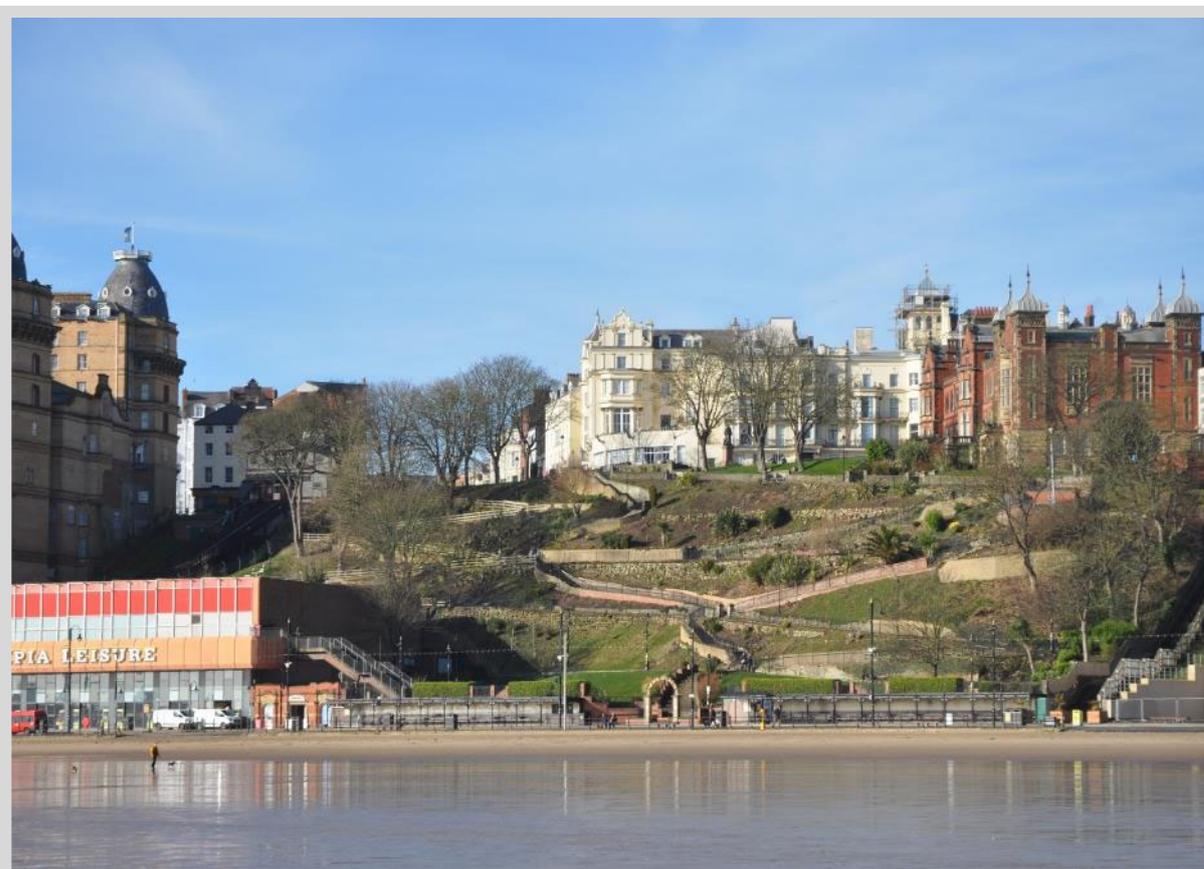
Terraced gardens at St. Nicholas Cliff
