Cell 1 Regional Coastal Monitoring Programme Walkover Inspection Surveys 2022

**Scarborough
Borough Council**

November 2022

Walkover Inspection Surveys 2022

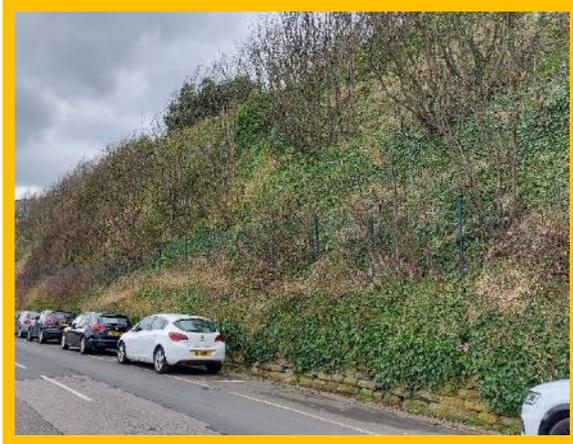
MU22/1 Inactive

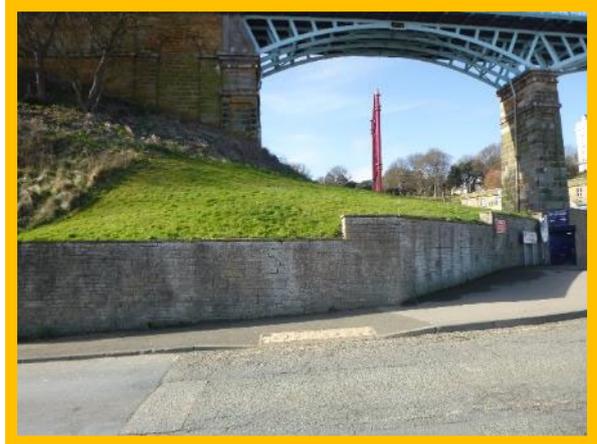
MU22/1 Inactive

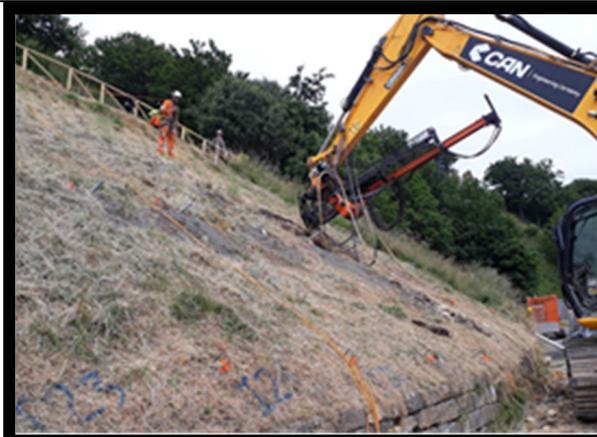
MU22/2 Soil nail installation on coastal slopes near the Spa in 2018

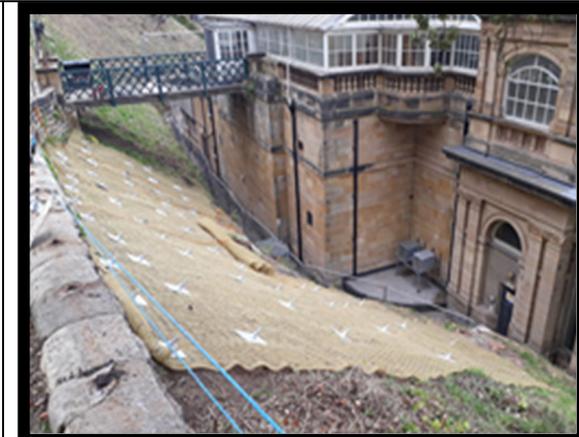
MU22/2 Soil nail and slope mesh installation behind main Spa building in 2018

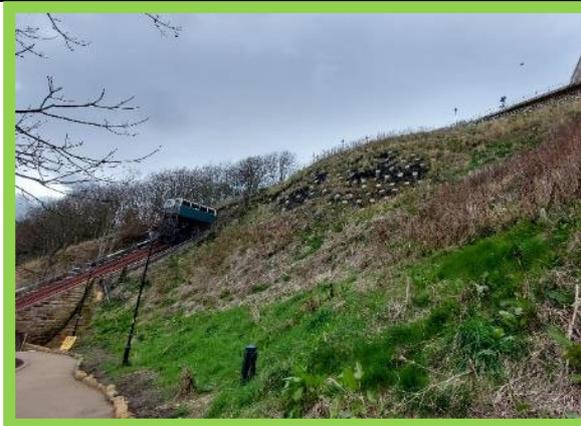
MU22/2 in 2022 the vegetation on the upper slopes was found to be well established.

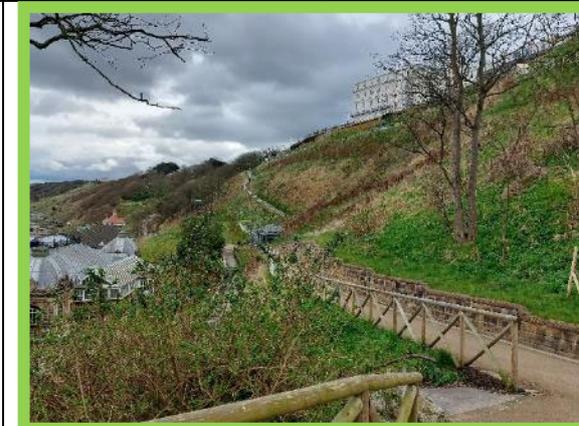
MU22/2 looking down behind main Spa building in 2022.

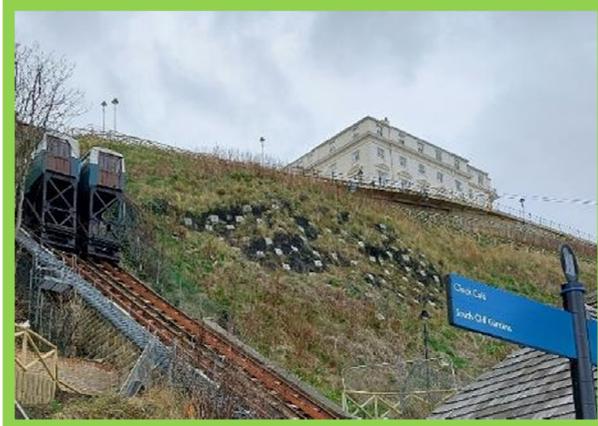
MU22/3 Coastal slopes behind Spa adjacent cliff lift

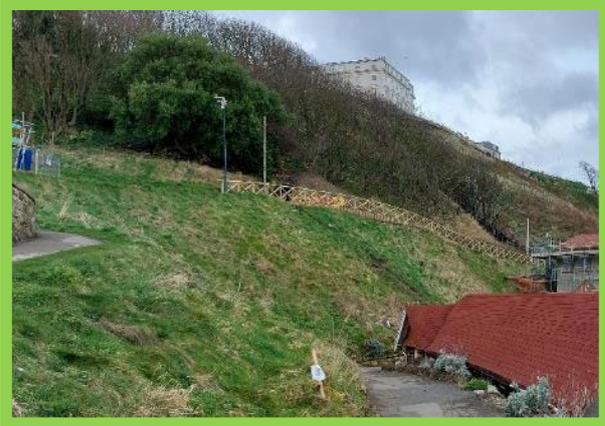
MU22/4 Inactive in 2022.

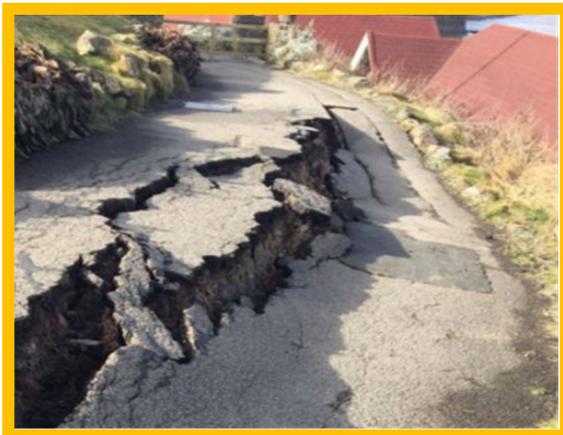
Units MU22/4 and MU22/5 comprise the northern part of the South Cliff Gardens and were both classified as Inactive in 2016, unchanged since previous surveys. In March 2018, a retaining wall at the back of some chalets below the Clock Café failed. This also caused large cracks to appear in the footpath above. A capital scheme which comprised slope stabilisation works to reduce the risk of localised failures was completed in late 2020. MU22/4 was not classified in 2020 due to the ongoing works, however in 2022 the unit was found to be inactive. MU22/5 also retains its inactive status. The slope stabilisation works involved the construction of a new retaining wall and the installation of soil nails. The works (where visible) were generally found to be in as-built (very good) condition. However it was noted that a low (non-retaining) wall had missing and loose coping stones. These presented a health and safety hazard and over time may result in the deterioration of the wall due to seepage.

MU22/4 large cracks in footpath above chalets in the location of the wall failure (Photo from 2018 Report).

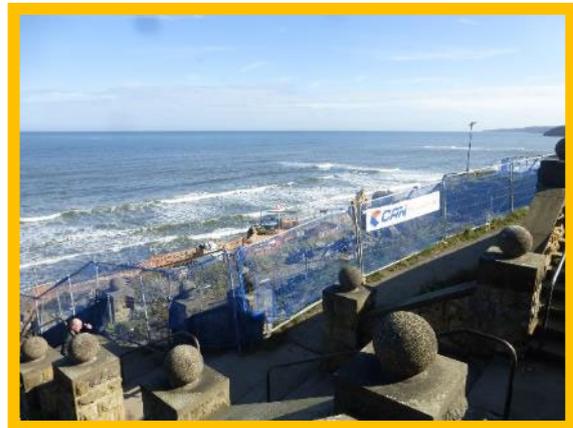
MU22/4 slope stabilisation works ongoing during the 2020 inspection.

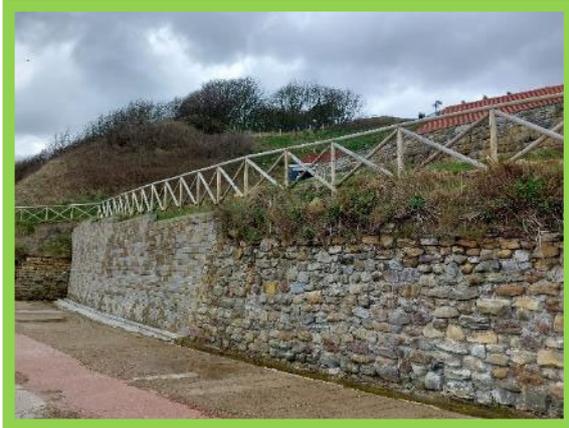
MU22/4 - recently completed retaining wall (left) transitioning into repointed pre-existing masonry retaining wall (right)

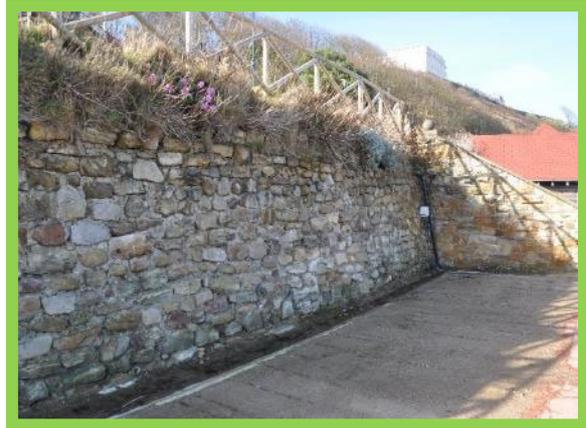
MU22/4 – recently refurbished retaining wall and newly constructed

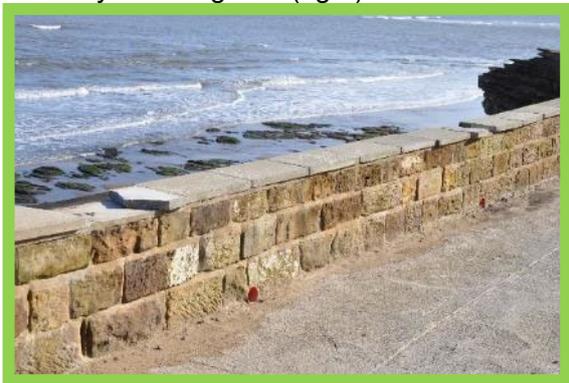
MU22/4 wall coping found to be loose, damaged and missing in places.

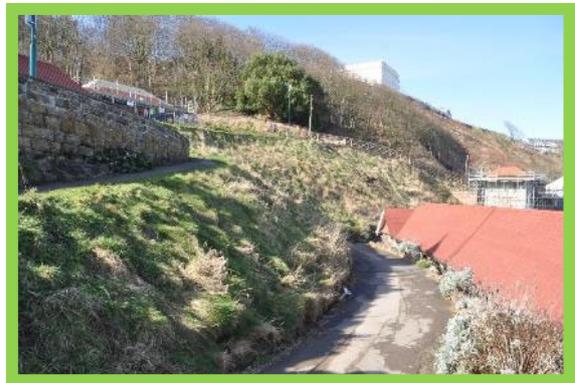
MU22/4 – Inactive in 2022.

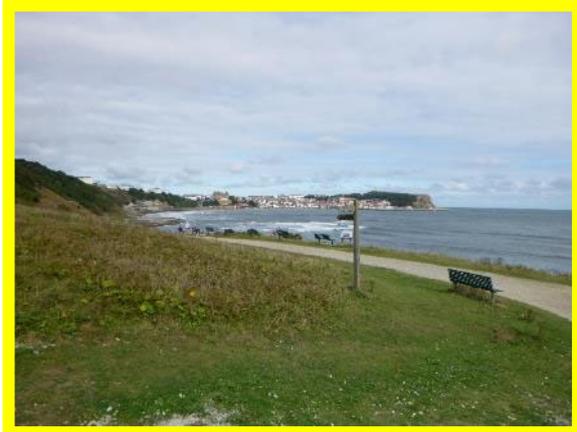
Unit MU22/8 comprises the stabilised Holbeck Hall landslide run-out lobe and is protected at the toe by boulder armour. Localised sections near the headscarp are exposed. This unit is classified as Locally Active in 2022, unchanged since 2016.

MU22/8 The lower section of the slope at Holbeck Hall landslide (Locally Active)

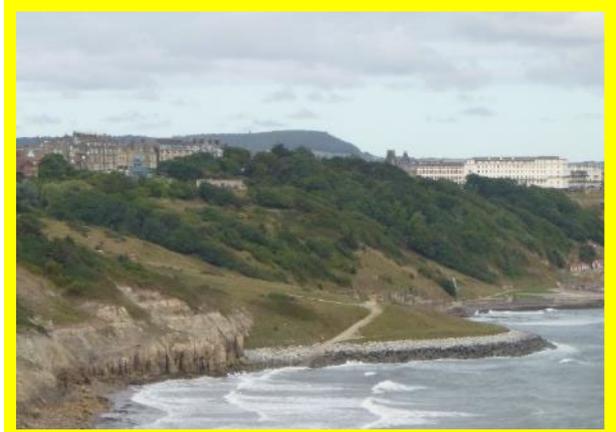
MU22/8 Holbeck Hall landslide (Locally Active)

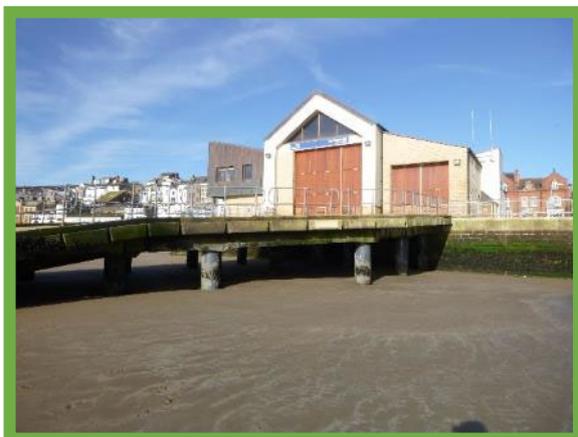
New RNLI lifeboat station and slipway (/1301C08)

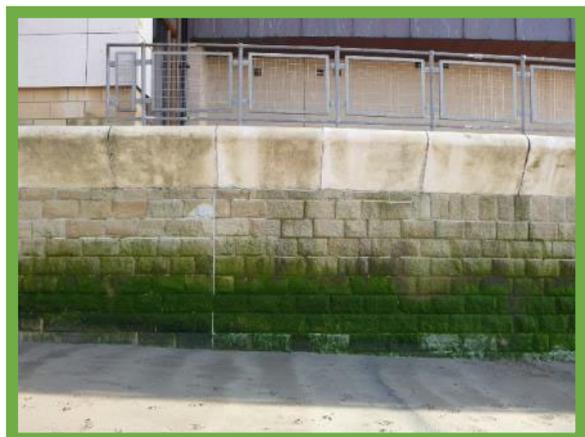
New RNLI lifeboat station wall (/1301C08)

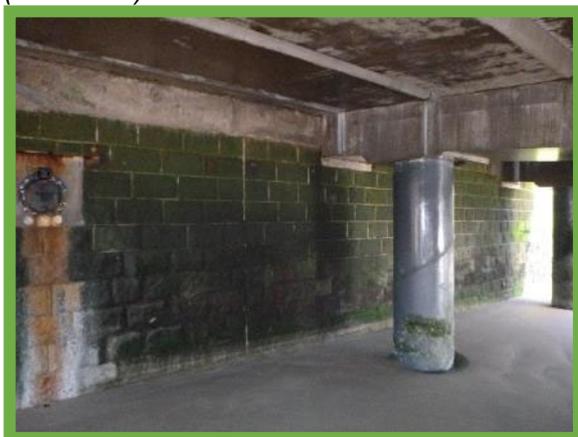
New RNLI lifeboat station wall beneath slipway (/1301C08)

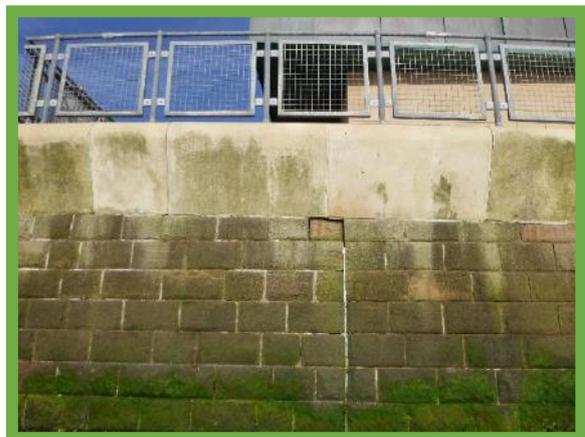
The South Bay defences start at the RNLI lifeboat station, adjacent to West Pier (/1301C08). The construction of the new RNLI Lifeboat Station was completed in November 2016 and were generally found to remain in As Built condition during the 2022 inspection. Around the full perimeter of the seawall vegetation growth was observed. Although this does not pose an immediate risk to the structure it may lead to defects being missed or not identified. This impact of this is most notable beneath the slipway where vegetation growth now obscures the full height of the wall. One small defect was observed adjacent the slipway where a block has come loose from the wall itself. Due to the small voids which have appeared either side of the block the defect poses a risk of water ingress into the structure itself, particularly if the block is further dislodged.

Dislodged block on new seawall (/1301C08)

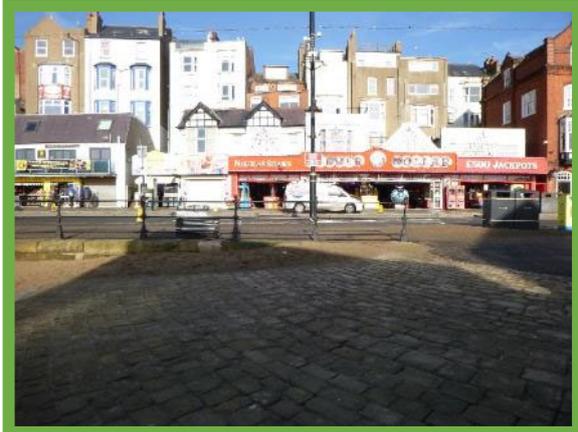
Slipway next to RNLI station (/1301C20)

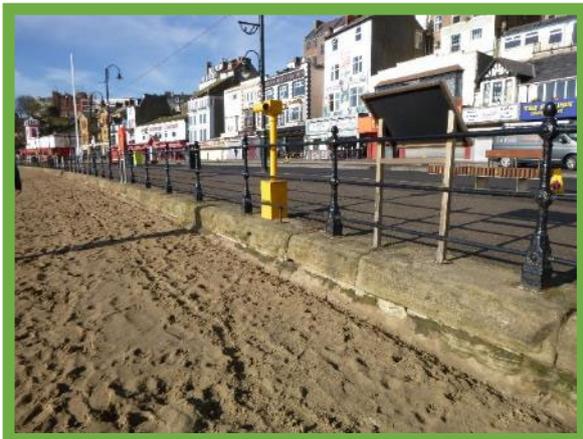
The low defence wall along the east side of Foreshore Road is split into a number of asset lengths between sets of access steps. These are, running from north to south /1301C15, C21, C22, C23, C24 and C25. Due to high beach levels at the time of inspections, sand was often flush with the promenade or, at best, only the top one or two courses of stone blocks were visible along most of this length. Due to the high beach levels, the northern section of frontage is classed as being in good condition, no change since 2020. The wall, where exposed, around the Olympia Leisure facility was in fair condition because of frequent washed out joints and abrasion to blocks, which would benefit from repair.

Beach levels flush with promenade at north end of Foreshore Road seawall (/1301C15)

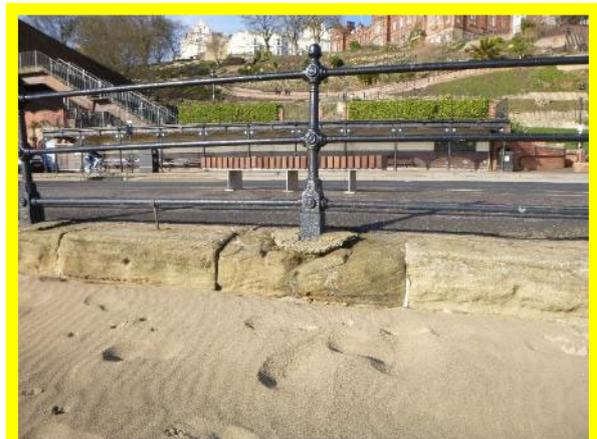
An area of abrasion at top of wall (/1301C23)

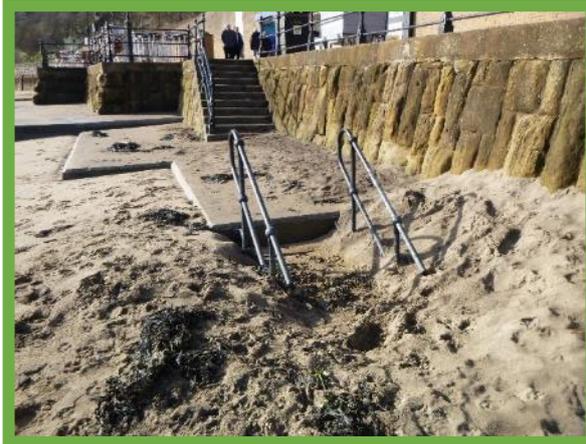
At the subway beach access in the vicinity of the Spa Bridge (1301C09), repairs have previously been made to the northern section of beach landing apron to the access steps and these remain in good condition. Prior to the 2020 repairs were made to the northern access steps and apron. The repairs remain in good condition and appear to have increased the resilience of the apron and access steps. During the 2022 inspection it was noted that a new pair of handrails have been installed from the apron down to beach level. Due to the high beach levels at the time of the inspection these were partially buried as can be seen in the photograph below. The new handrails appeared in good condition. The central and southern section of the concrete apron remain in fair condition but with signs of abrasion and cracking. Beach levels in 2022 appeared similar to those observed in this location in 2020.

Repairs remain in good condition locally, but overall asset condition is fair (/1301C09)

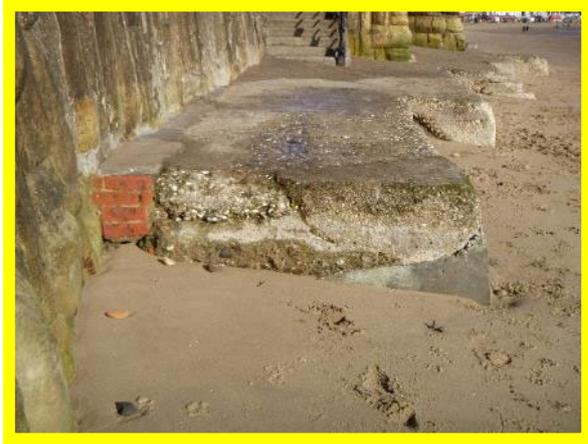
Abrasion of toe apron south of previous repairs beach levels notably higher than 2018 (/1301C09)

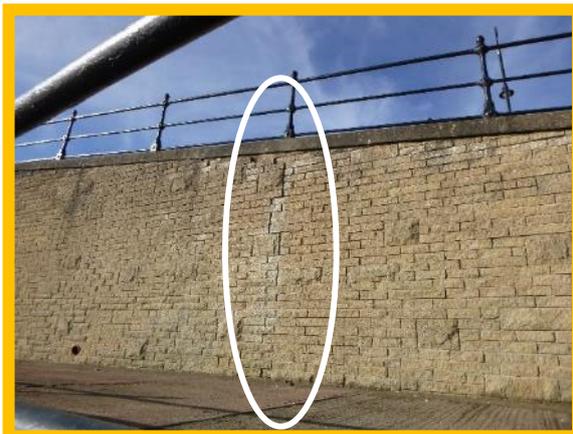
Immediately south of the beach access steps, this wall continues alongside a beach access ramp (1301C10) and there is a vertical crack in the brick retaining wall to the rear of the ramp which needs monitoring for further movement and repair. It was noted in the 2022 inspection that there is now a second vertical crack to the south of the previously reported crack. Recent repairs have been undertaken on the main wall where significant defects were identified in the 2020 inspection. In particular the missing blocks around the spa feature fountain have been replaced along with extensive repointing at the southern end of the wall. The coping stone of the adjacent slipway has also undergone repair and is now in good condition. There are however some remaining defects including missing mortar, longitudinal and vertical cracks, gaps between the wall and its coping stone. Due to the repair work undertaken since the previous inspection, the wall has been upgraded to fair condition. Previous repairs to the seaward end of the slipway remain in good condition.

Original vertical crack in wall above access ramp (/1301C10)

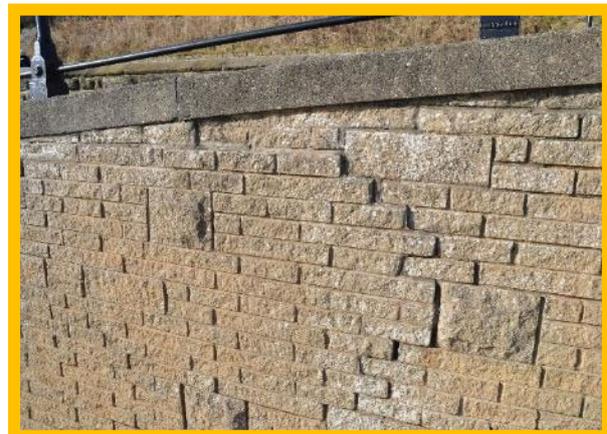
New vertical crack (/1301C10)

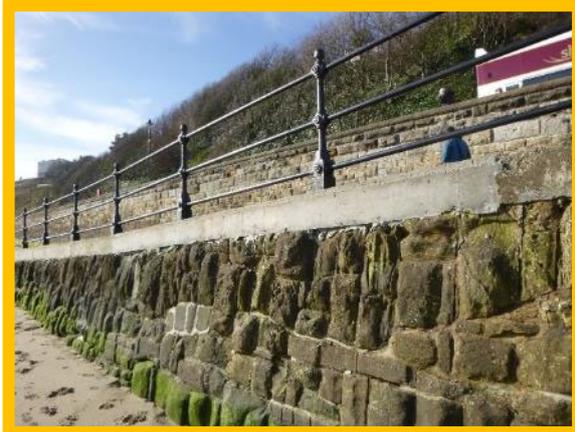
Repaired section of coping (/1301C10)

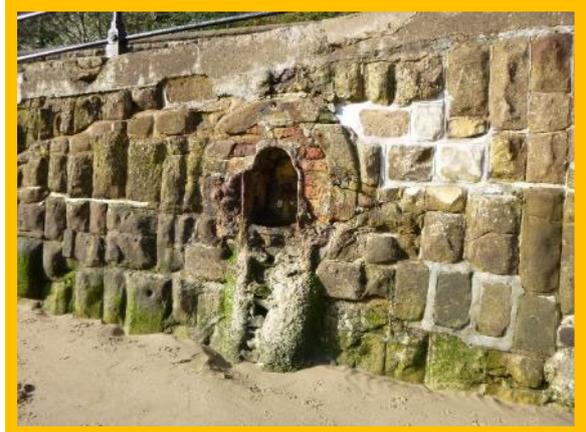
Repairs around Spa feature (/1301C10)

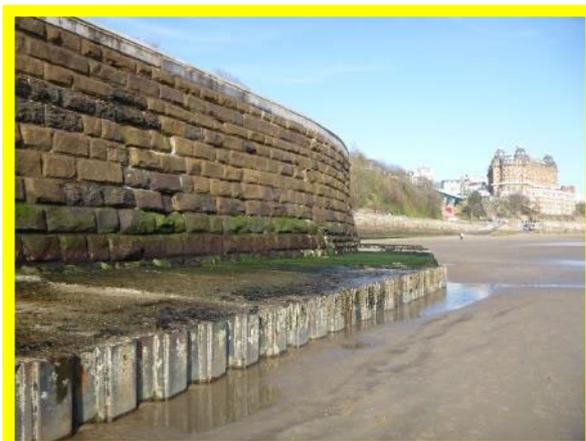
The remainder of the wall remains in fair condition. Beach levels were low enough in places to show that some of the toe piles on the more northern section are severely corroded with some voiding visible, although there was no notable change from 2018 or 2020.

Masonry sea wall with exposed piles at The Spa access steps in fair overall condition (/1301C27)

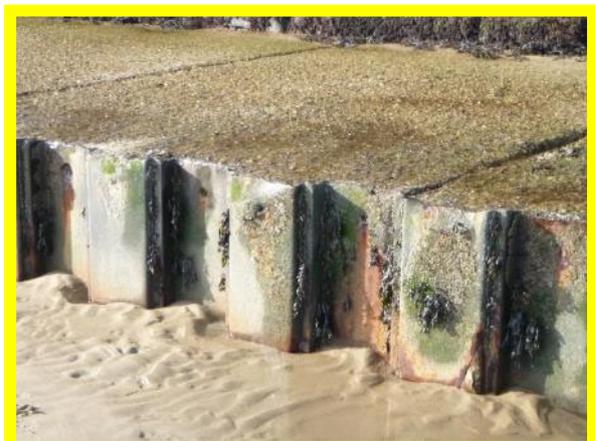
Corroded sheet piling along concrete apron(/1301C27)

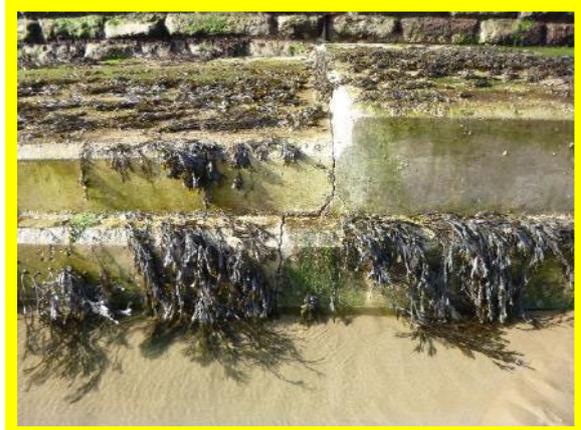
Crack along joint in concrete apron (/1301C28)

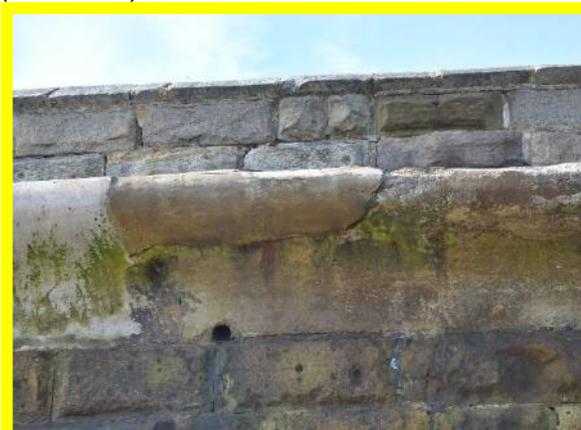
In front of the Sun Court (/1301C28), the wall has a concrete 'nosing' intended to act as a wave deflector below the parapet. Previous repairs to this element remain effective. There was one new section of damage noted on the wave deflector nosing. It is recommended that this is repaired. The concrete toe beam was partially exposed along the length of the Sun Court and visible sections appeared in fair condition.

One remaining section of damage to the bullnose wave deflector (/1301C27)

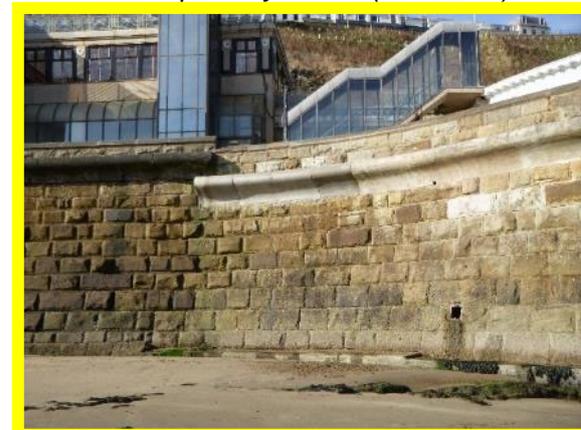
Previous repairs to the bullnose wave deflector in good condition (/1301C28)

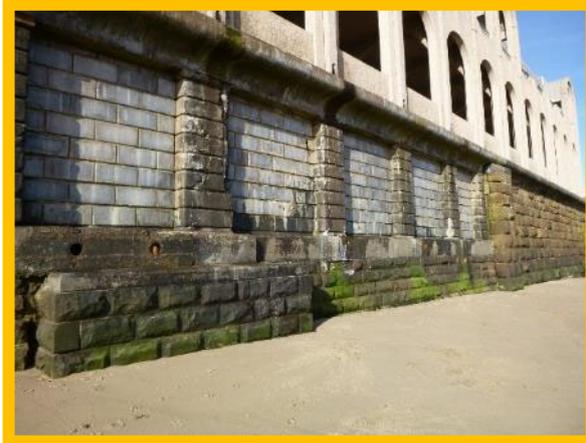
The wall between the Sun Court and the closed colonnade (/1301C29), remains in fair overall condition but has several small open joints. Along the closed colonnade section (/1301C29) there have been a number of patch repairs undertaken in recent years. The lower splash beam, below the bricked-up openings has been repaired and the repairs appear to remain in good condition. Elsewhere however along this wall the condition remains fair due to evidence of spalling, loss of concrete and open joints. Previously, repairs have been undertaken to the adjacent steps. The pillars between adjacent in-filled openings show some minor cracking and spalling.

Closed colonnade section of wall in fair condition (/1301C29)

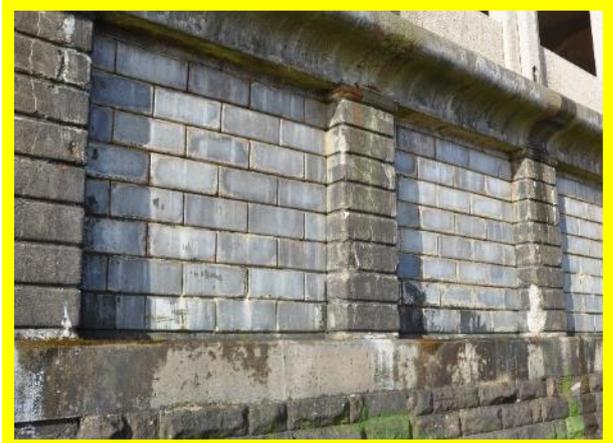
Repaired sections of beam in good condition (/1301C29)

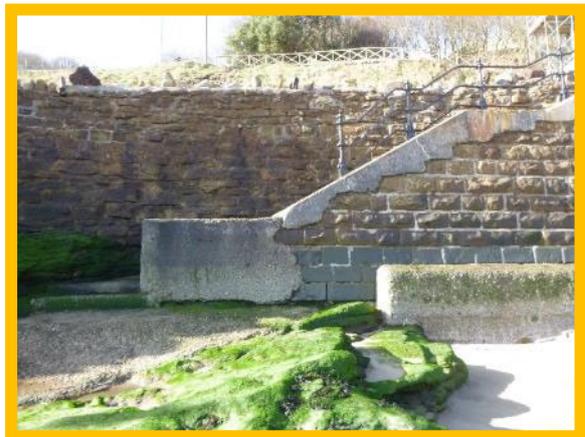
Previous repairs at southern tie-in following December 2013 storm damage (/1302C01)

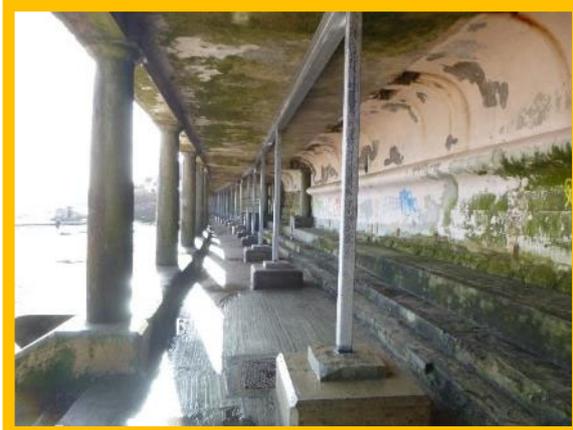
Steel columns and support beam supporting upper promenade (/1302C01)

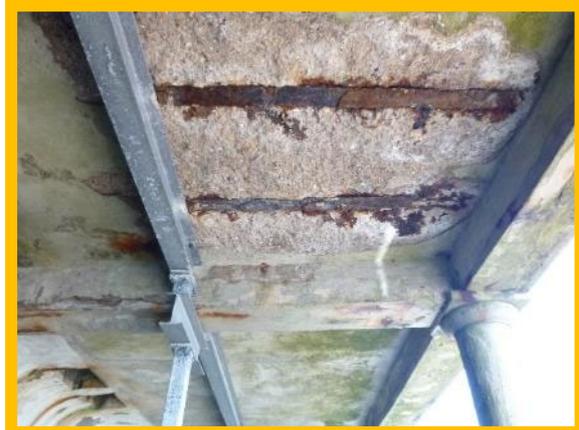
Damage to underside of upper promenade (/1302C01)

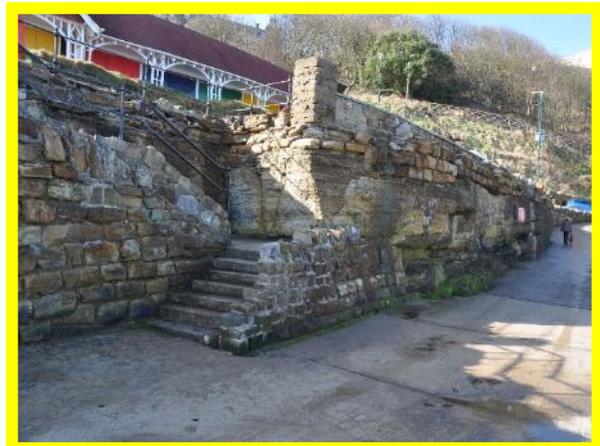
Overall fair condition of low stone wall and access steps (/1302C03)

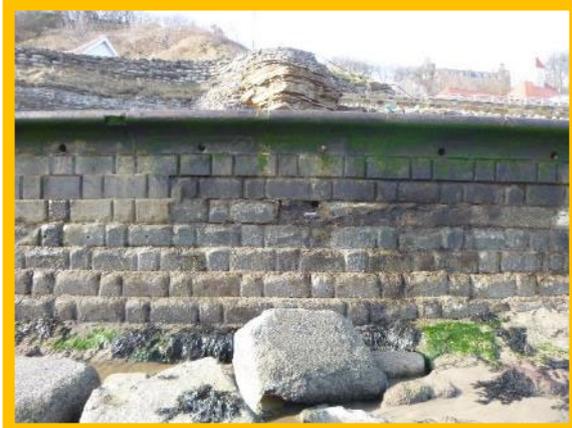
The low stone wall continues at the rear of the promenade around South Cliff Gardens with a seawall in front (/1302C02). The seawall has a considerable number of historic repairs to the blocks and coping. The repairs, undertaken between 2018 and 2020, to a damaged section of coping, upper splash wall and at the southern end of the wall to the bagwork tie-in wall appeared to be in good condition. At the southern tie-in the upper courses of the wall have been replaced with a tiered concrete wall which sits upon the original bagwork. Elsewhere the wall is showing signs of age-related deterioration such as heavy abrasion of the facing blockwork, open joints and further localised damage (cracking and abrasion) of the coping stone. Overall the wall is in fair condition and would benefit from a programme of capital maintenance to address the deterioration of the blockwork before further major defects occur.

Overall fair condition seawall is fair (/1302C02)

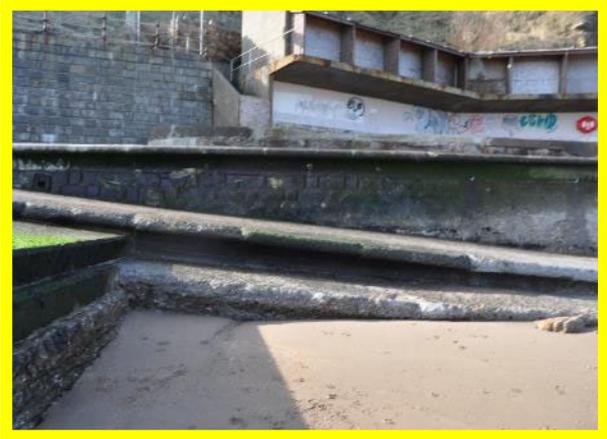
Bagwork/screed wall (/1302C02)

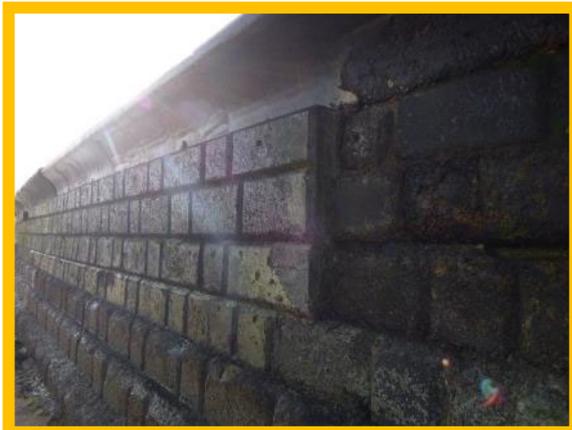
Repairs to wall face and coping in good condition. Extensive abrasion of adjacent blocks (/1302C02)

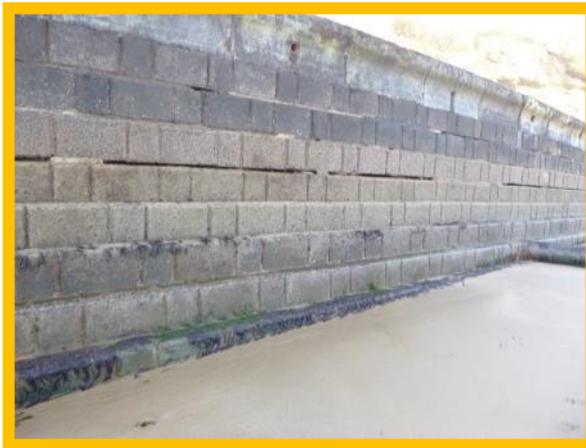
A concrete block wall (/1303C02) extends around the infilled lido pool, which is now used as a Star Disc. This wall has slightly stepped blocks on its face and these blocks and the wave return coping show extensive signs of age-related deterioration including abrasion and rounding of block edges and cracking and chipping of blocks and coping. There are also a number of lateral open joints where the joint sealant has washed out. Some areas of the wall have been subject to beneficial repairs, but there are numerous other areas of open joints. In one location, a failed outfall pipe extends across the foreshore. The wall's condition has retained its poor condition rating in 2022. It is recommended that a programme of capital repair work is undertaken to address the ongoing deterioration in the structure prior to any significant defects occurring. The wave return coping stone has been sporadically repaired and in these places it is in good condition, however elsewhere it remains poor.

Concrete block wall with open joints and heavy abrasion (/1303C02)

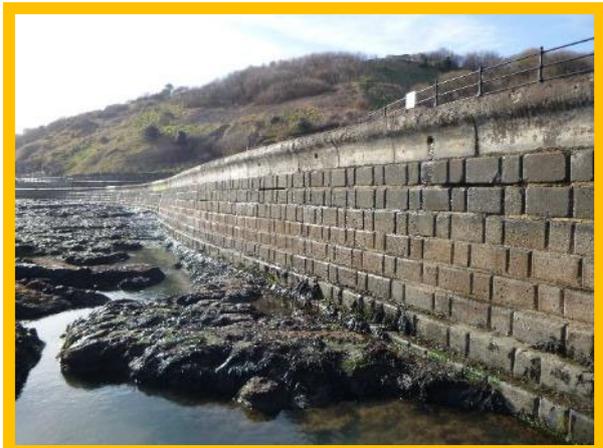
Previous repairs to wave return coping (/1303C02)

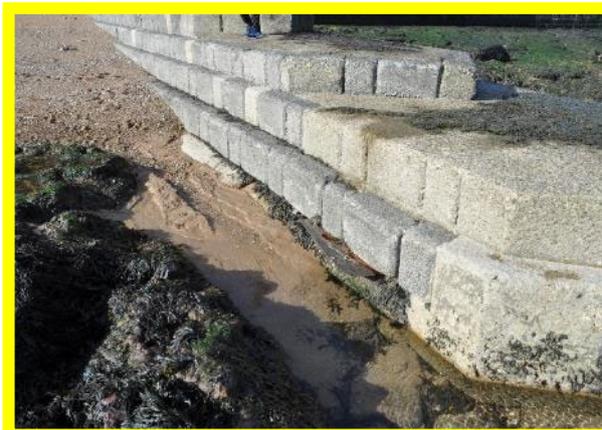
There is a bastion groyne at the north of this frontage (/1304C02) which has trapped sand between here and the rock revetment around the Holbeck Hall landslide to the south. The groyne is in fair condition, showing some signs of abrasion a small degree of undercutting on its northern aspect. The lower sections of the backing seawall have historic repairs however the majority of the wall, in particular the coping is heavily abraded. The upper wall also has a number of previous repairs however is also in poor condition due to a large number of remaining defects including cracking, abrasion, damage to the coping, corroded handrail and extensive corrosion staining. The promenade deck which sits above the wall remains closed due to rockfall from the cliffs to its rear and as such could not be inspected along its full length. It was possible to view the promenade from a distance from the south and the condition appeared poor with evidence of extensive cracking and vegetation growth from cracks and between slabs.

Bastion groyne in overall fair condition (/1304C02)

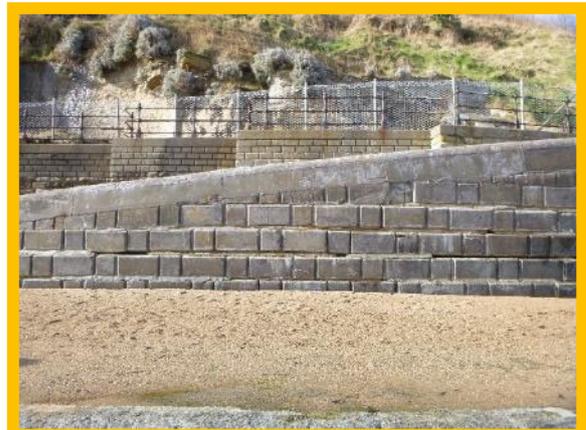
Seawall in overall poor condition Cracks to bastion throughout. Mortar missing between blockwork in lower wall. (/1304C02)

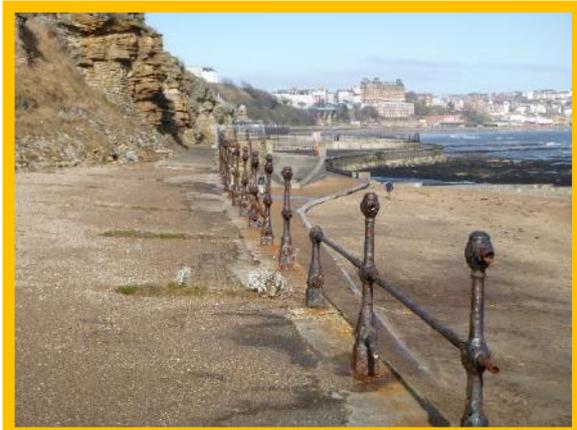
Upper prom has been fenced off and is in poor condition, heavily abraded and damaged handrail (/1304C02)

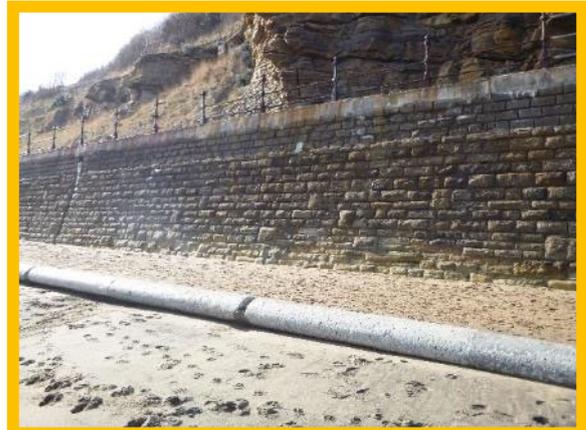
Missing pointing / open joints and damaged parts of upper and lower capping beam (/1304C02)

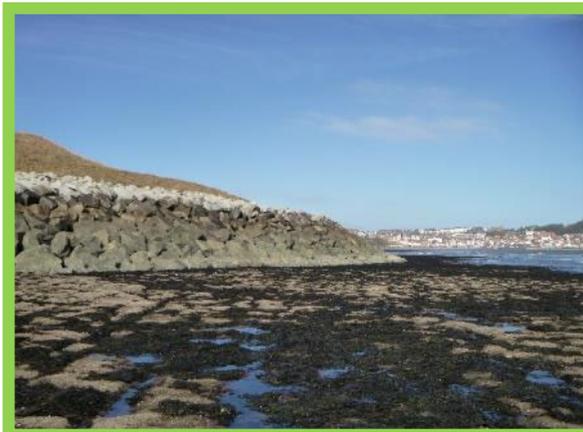
The rock armour revetment (/1304C01) defending the relict debris flow lobe at the site of the Holbeck Hall landslide remains in good condition in 2022. The armour remains tightly packed and with a good coverage and no evidence of movement. It was noted that there appeared to be some washout of the material at the crest of the embankment, likely due to wave overtopping of the revetment. This may increase the risk of localised settlement to the rock armour. At the southern end of the defence the beach access ramp has a vertical drop onto the rocky foreshore making its use difficult. Furthermore, during the 2022 inspection it was noted that there appeared to be undercutting and cracking of the most seaward concrete slab. The condition of the slipway is such that it does present a health and safety risk to members of the public who may choose to access the beach in this location.

Rock revetment around debris lobe of Holbeck Hall landslide (/1304C01)

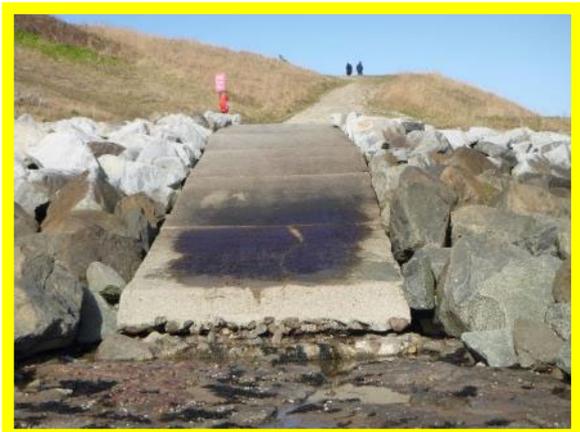
Vertical drop and crack in concrete at end of access ramp at south end of revetment (/1304C01)

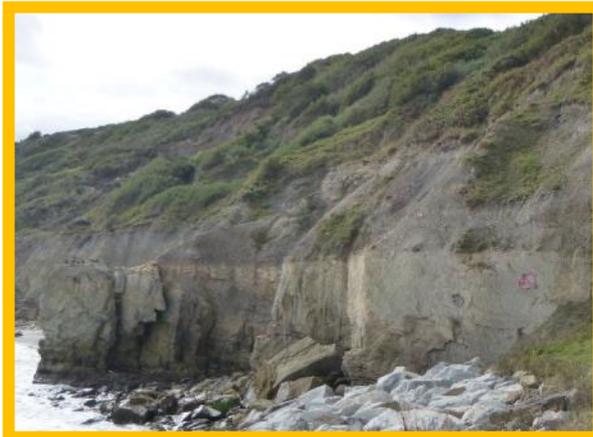
Unit MU23/A is located immediately south of the Holbeck Hall landslide run-out lobe and is classified as Partly Active in 2022. This unit has well-vegetated upper slopes, but the cliff experiences ongoing marine action and rockfalls with evidence of recent activity on the cliff section of the slope. At the interface between MU23/A and MU23/B a recent landslip and debris lobe was observed. Evidence of the slip is also present in arial imagery from 2021 of the frontage.

MU23/A Partially active evidence of significant amount of fallen rock at toe of cliff

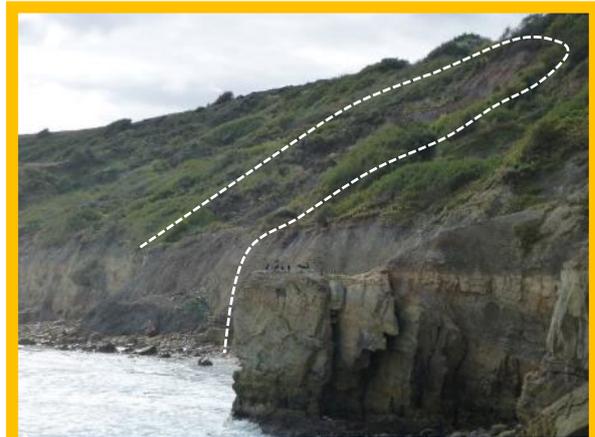
MU23/A & B Partially active landslip and debris lobe visible

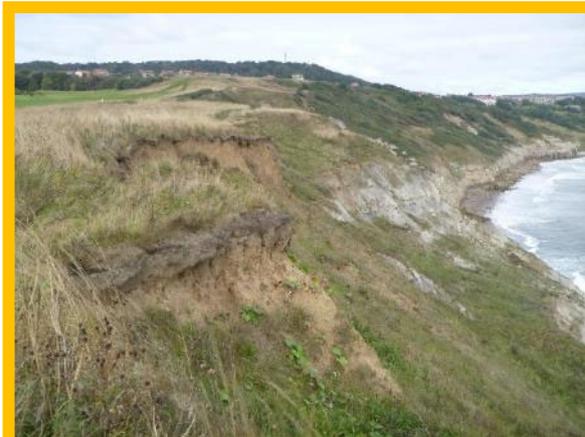
Unit MU23/C is well-vegetated in the upper cliff but with a steep and eroding cliff toe and remains classified as Partly Active in 2022.

MU23/C Partially active with ongoing recession at the headscarp

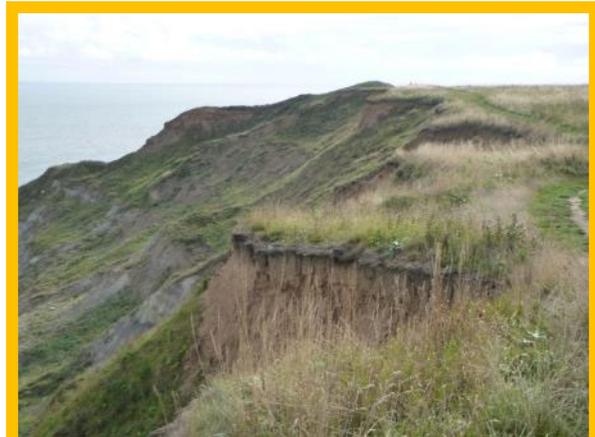
Units MU23/D1, MU23/D2 and MU23/D3 are located at Wheatcroft Cliff above Black Rocks. These units are active along much of their length, with ongoing recession of the headscarp, slumping in the mid-slope and erosion of the toe. They are classified as Partly Active in 2022.

MU23/D Partially active with ongoing recession at the headscarp and evidence of activity on mid and lower slopes

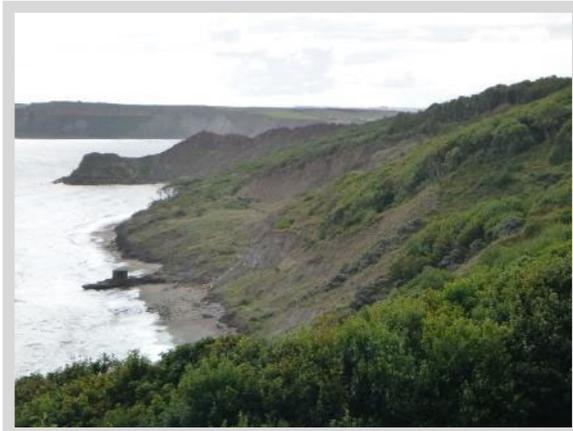
View from **MU23/F** to **MU23/J** (status varies as below)

MU23/I4 and **MU23/J** (Knipe Point).

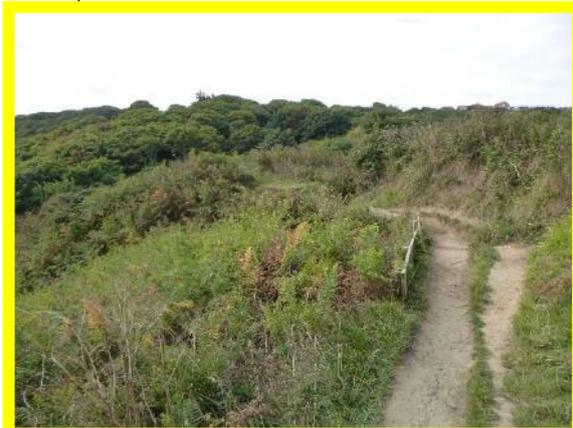
Unit MU23/F is a narrow, thin unit which follows a small valley occupied by an outflow channel for a pipeline and pumping station. The slopes inland are well vegetated and show very little evidence of recent activity. As a result, this unit has been classified as Locally Active in 2022. Works have been undertaken to repair the Yorkshire Water outfall at this site relatively recently (with a replacement long sea outfall scheduled to be built in the future).

Headscarp recession has encroached on footpath. Note temporary boards to stabilise and mark path edge **MU23/F**.

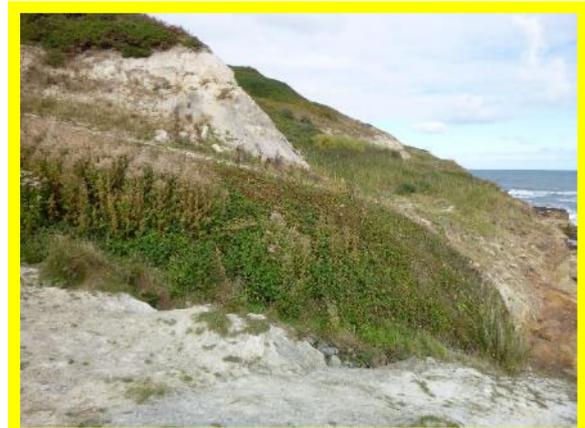
Localised activity across mid slope of **MU23/F** (Locally Active in 2022).

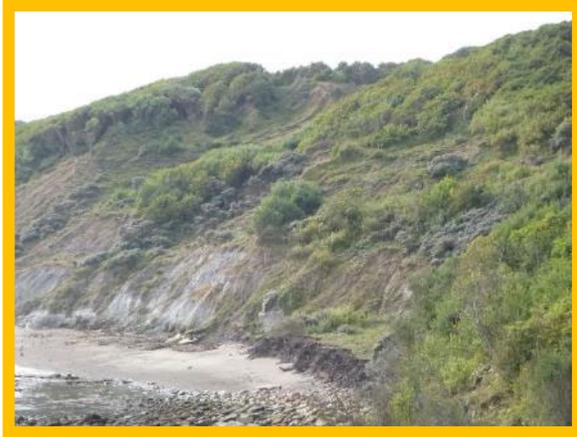
Localised erosion at toe of MU23/G1 and G2.

Units MU23/G1 and MU23/G2 form the northern part of Frank Cliff and are both classified as Partly Active in 2022. The upper slopes of these units support some vegetative cover. The unit toes are highly active with evidence of rockfalls, slumping and sliding onto the beach below.

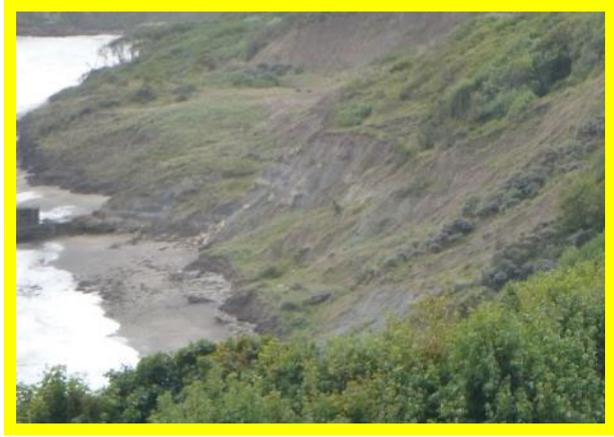
Erosion of toe and evidence of activity across mid-slope along **MU23/I**.

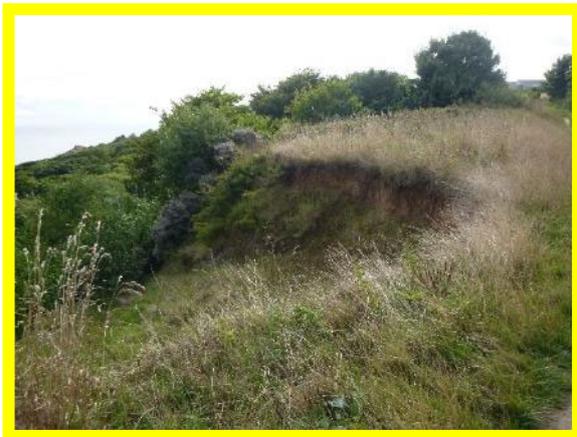
Headscarp recession has encroached on footpath **MU23/I**.

Unit MU23/I comprises the main body of the Cornelian Bay mudslide and was classified as Locally Active in 2020. Although the overall condition of this management unit remains unchanged in 2022 it is worth noting that ongoing headscarp recession within the unit continues to pose a risk to the footpath however there was no evidence of recent activity. **Units MU23/I1, MU23/I2 and MU23/I3** form smaller mudslides at the toe of unit 23/I. All these units have been classified as Locally Active.

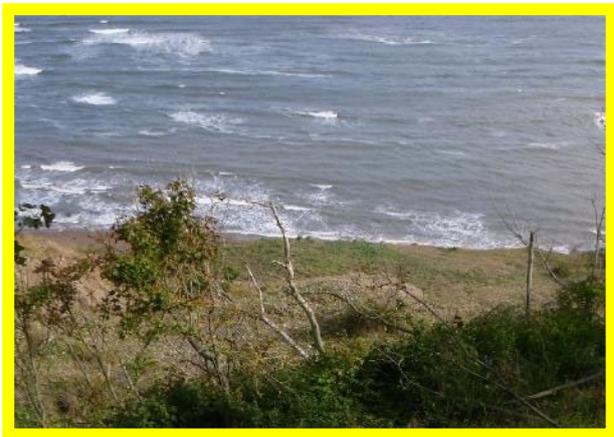
Evidence of localised activity along toe of **MU23/I1, 2 and 3**.

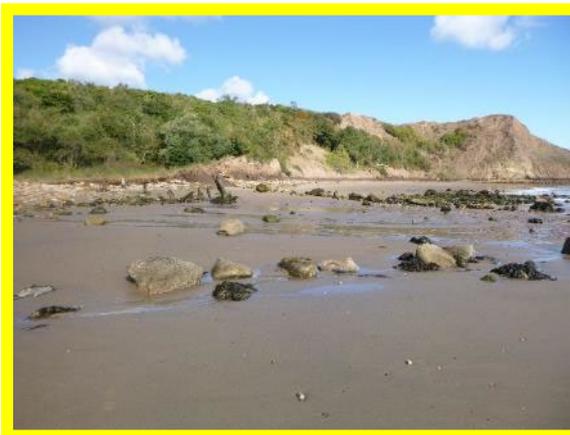
Immediately south of Osgodby Point, unit MU24/A comprises mudstone at beach level of the Cayton Cliff landslide complex. The wide expanse of Cayton Cliff is capped by till which is heavily vegetated. Significant recession of the head scarp occurred during an event in 2008-2009, resulting in the loss of land and properties at Knipe Point Drive. The cliff at the toe of the complex is steep and comprises uplifted debris from deep landslide movement. Only localised activity is evident at the toe and head scarp, with no evidence for movement in the body of the landslide, and so the unit is Locally Active in 2022, unchanged since 2012. The only notable change was that the upper beach levels appeared lower around the toe of the debris lobe when comparing with the previous 2018 and 2020 inspections. This appears to be locally increasing rates of erosion along the toe. The eastern and southern faces of Knipe Point (sub-unit MU24/A7 and A8 respectively) were found to be Partly Active in 2022, as they have been since 2008.

Heavily vegetated till of Cayton Cliff. **MU24/A** Locally Active in September 2022

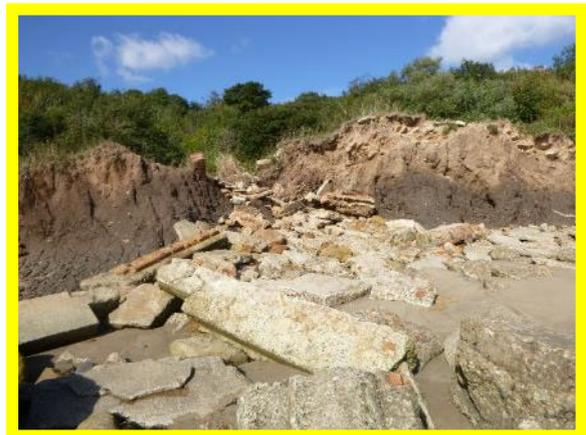
Toe of Cayton Cliff. **MU24/A** Locally Active in September 2022

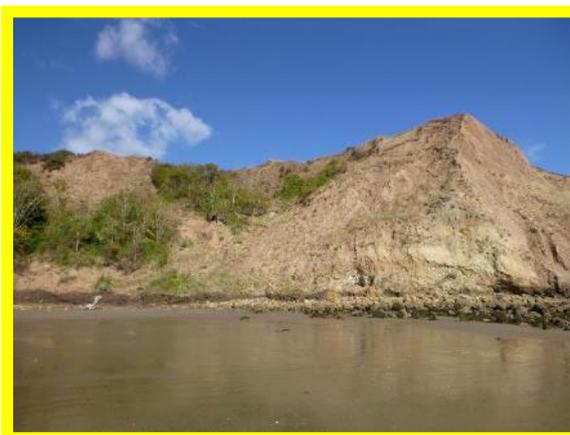
Toe of Cayton Cliff. **MU24/A & A7** Locally Active in 2022

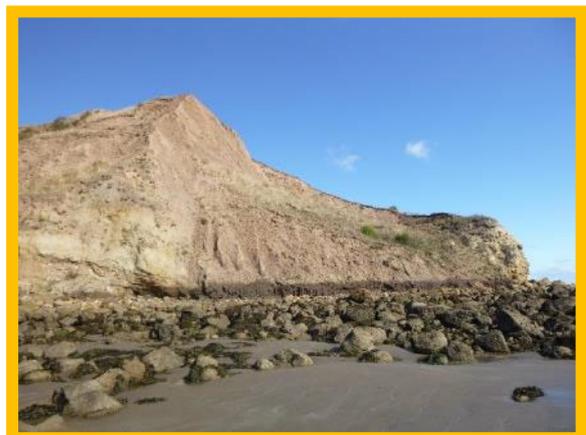
MU24/A7 Partly Active in 2022

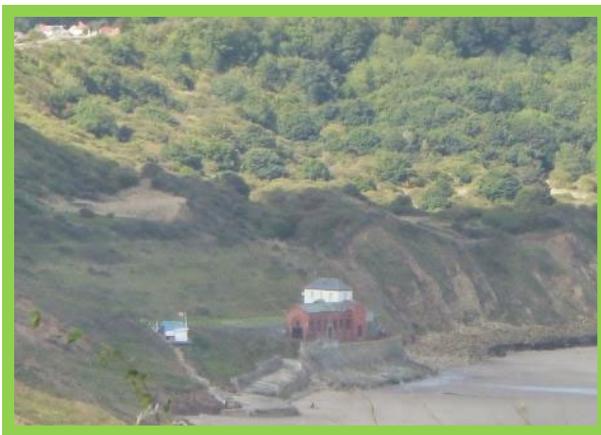
Tenants' Cliff is a complex of terraced landslips in mudstone and sandstone and is divided into 11 units. Unit MU24/B forms the main part of the Tenants' Cliff landslide and is classified as Inactive in 2022, no change from 2016. The toe of Tenants' Cliff is categorised into ten smaller landslide units comprised of massive displaced blocks of sandstone.

Heavily vegetated part of Tenants' Cliff complex. **MU24/B** Inactive in August 2020

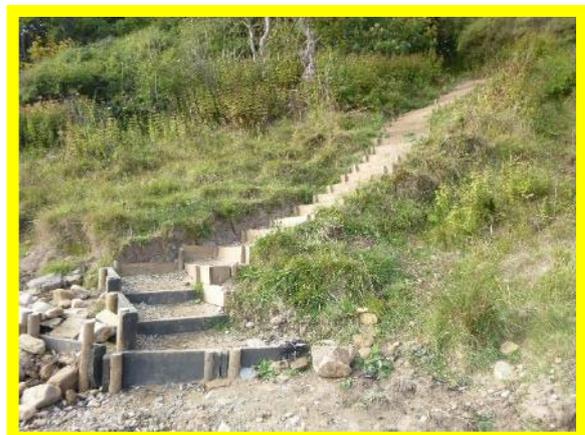
The most northerly unit (MU24/B1) is classified as Locally Active. Along the toe of these units there is an ongoing accretion of pebbly material with the beach profile increasing in gradient into MU24/B2 which was observed to be Partly Active in 2022. along with MU24/B3 to MU24/B8 which all remain classed as Partly Active in 2022. It was noted in the 2022 inspection that a set of timber access steps onto the foreshore had been repaired and were in good condition, providing a safe access onto the beach.

Steps at toe of Tenants' Cliff complex. **MU24/B1** in good condition

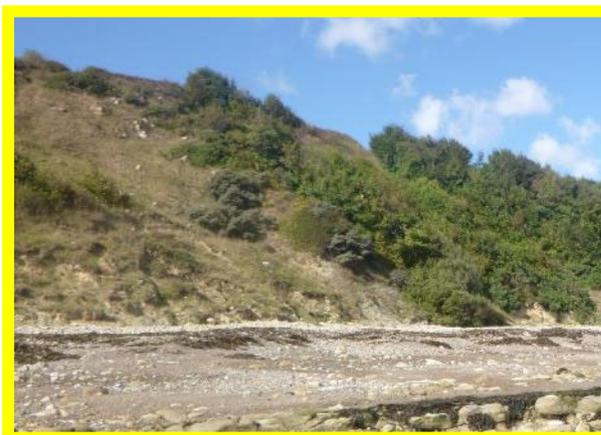
Toe of Tenants' Cliff complex **MU24/B1** Locally Active in 2022
