Cell 1 Regional Coastal Monitoring Programme Walkover Inspection Surveys 2022

**Scarborough
Borough Council**

November 2022

Walkover Inspection Surveys 2022

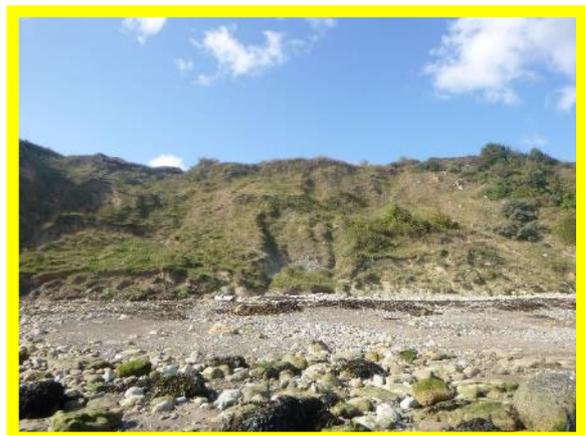
Toe of Tenants' Cliff complex. **MU24/B2** Locally Active in 2022

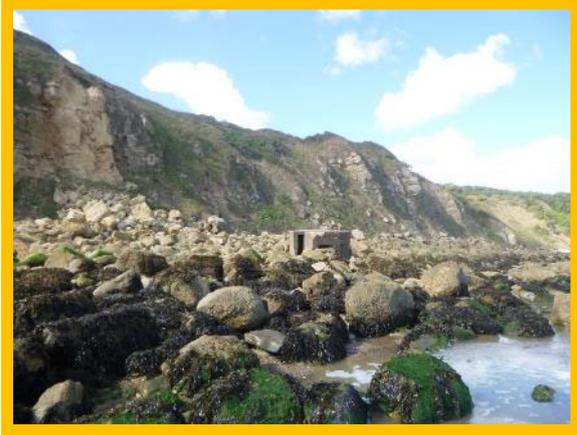
Toe of Tenants' Cliff complex. **MU24/B6** (left) to **MU24/B3** (right) Partly Active in 2022

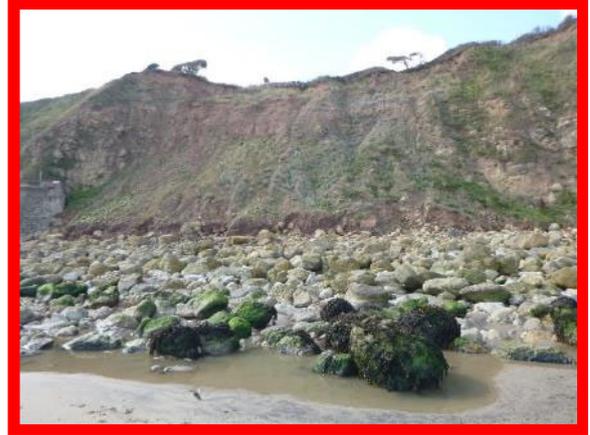
At MU24/B9, there is intense ongoing erosion of the unit toe, and the unit retains its Totally Active status in 2022. It was also noted that various ad hoc repairs have been made to the northern end of the adjacent coastal defence wall to counteract the outflanking caused by the retreat of this unit. All these units are classified the same as they were in 2020. MU24/B10 is protected by the seawall which extends northwards from the pumping station. During the 2022 survey it was completely vegetated and is classified as Inactive.

Intense erosion in **MU24/B9** (Totally Active in 2022)

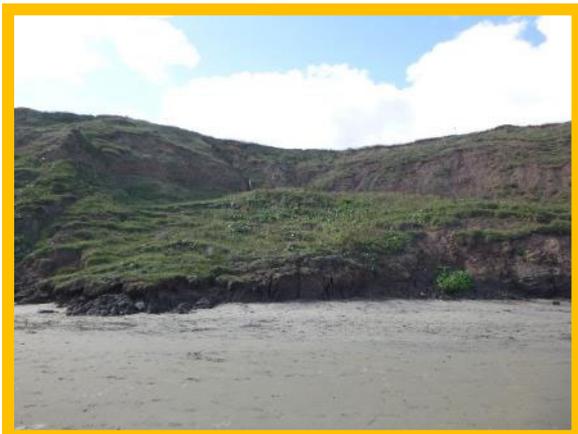
Toe of Killerby Cliffs. **MU24/C** Partly Active in September 2022

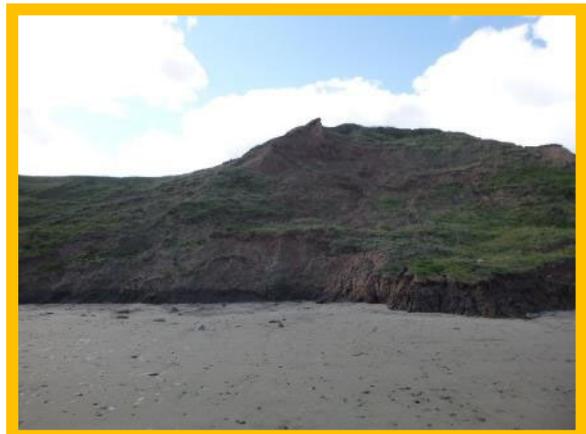
Till of Killerby Cliffs. **MU24/D** Partly Active in 2022

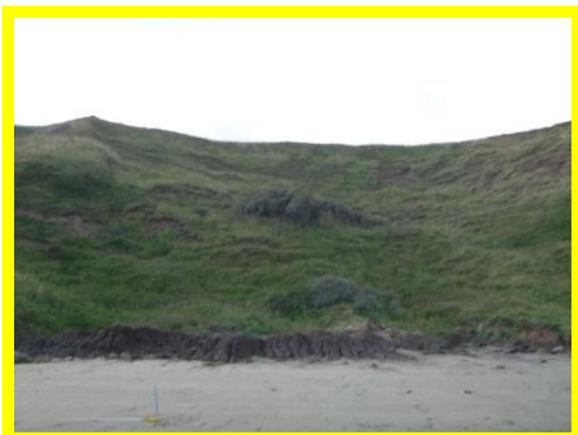
The large bowl to the west of the beach access comprising of MU24/F and MU24G was noted as being well vegetated in 2022 with only some minor erosion of the toe, as such these units are classed as Locally Active. To the east of the beach access at MU24/I and MU24/J there is activity along the head scarp, and so both units are classified as Locally Active.

Vegetated till slopes of Killerby Cliffs. **MU24/F** Locally Active in 2022

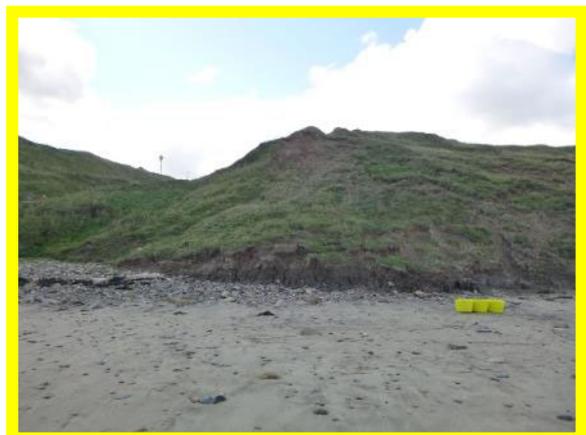
Toe of Killerby Cliffs. **MU24/G** Locally Active in 2022.

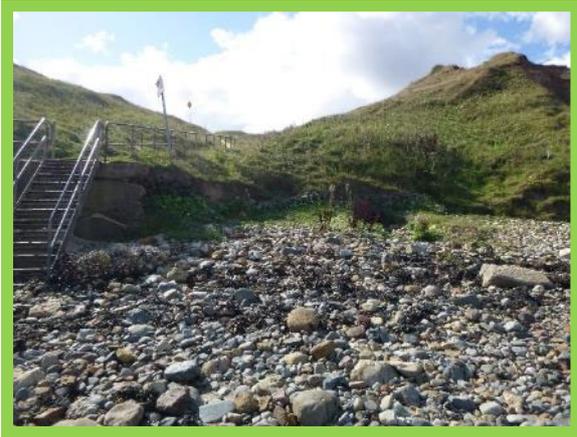
MU24/H Inactive in 2022

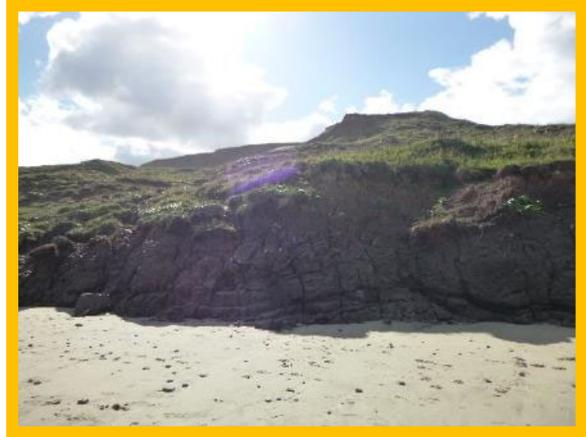
Toe of Killerby Cliffs. **MU24/I** Partly Active in 2022.

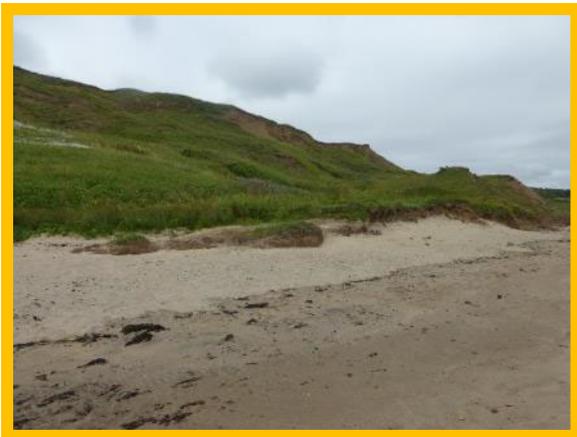
Toe of Killerby Cliffs. **MU24/J** Partly Active in 2022

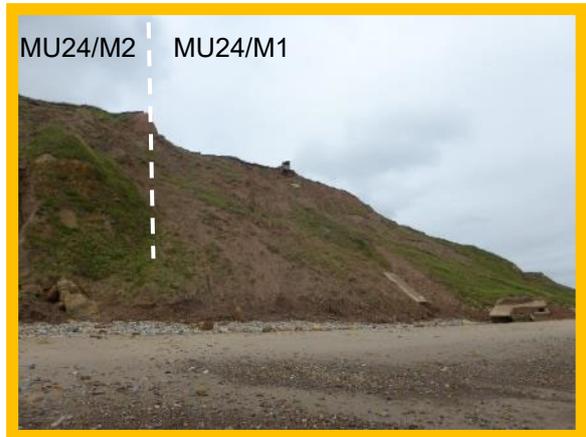
Till of Killerby Cliffs. **MU24/M1** (right) and **MU24/M2** (left) (both Partly Active in 2022)

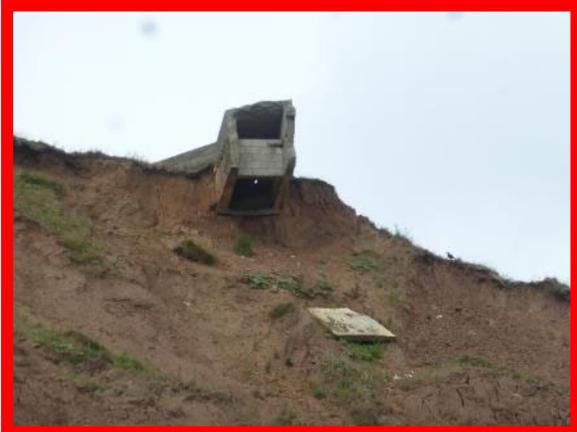
In 2020 due to the activity within cliff units MU24/L and MU24/M1 and the retreat of the headscarp at the boundary between the two units a historic WW2 pill box was significantly undercut and at imminent risk of collapse. In the 2020 walkover inspection it was noted that the undercut concrete base of the structure has collapsed and now rests high on the cliff face and is at risk of sliding onto the beach. Following the 2020 inspection, the pill box has been demolished and removed from the headscarp. This has mitigated the risk of the dilapidated structure collapsing onto the cliff / beach below. In 2022 the condition of units MU24/L and MU24/M1 remains as Partly Active due to the high degree of activity across the full cliff profile.

Looking from up from the beach at the base of **MU24/M1** in September 2018, note undercutting of Pill Box.

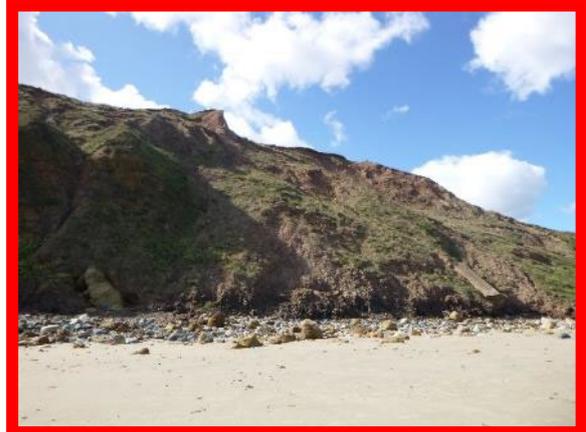
Looking from up from the beach at the base of **MU24/M1** in August 2022.

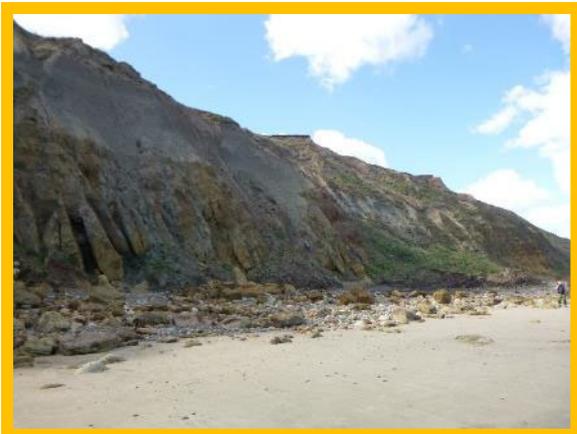
Composite sandstone and mudstone cliffs in south Cayton Bay. **MU24/N** (right) and **MU24/O**(left) (both Partly Active in 2022)

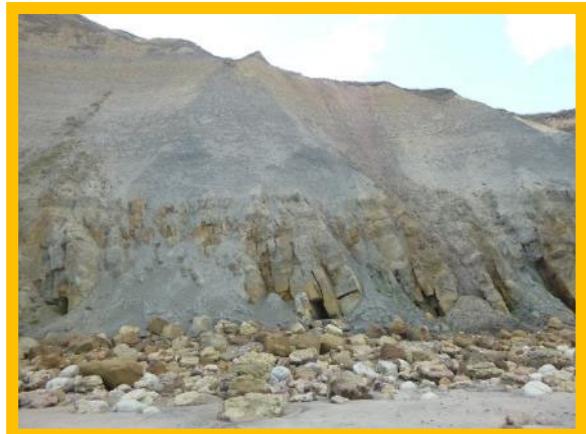
Units MU24/P to MU25/T are predominantly exposed near-vertical sandstone at the toe of a steep cliff overlain by mudstone with a thin capping of till. The sandstone is characterised by local rock falls on to the beach and platform with local small debris cones off the base of the mudstone. In 2016 all units MU24/P to MU25/T were upgraded from Partly Active (in 2014) to Locally Active. In 2018 MU24/P, MU24/Q and MU24/T showed further signs of activity and so regained their Partly Active status. Following the 2020 walkover inspection MU24/R and MU24/S also regained their Partly Active status. All units retain the same status Partly Active status as observed in 2020.

Local rock fall and debris cone in **MU24/P** (Partly Active in 2022)

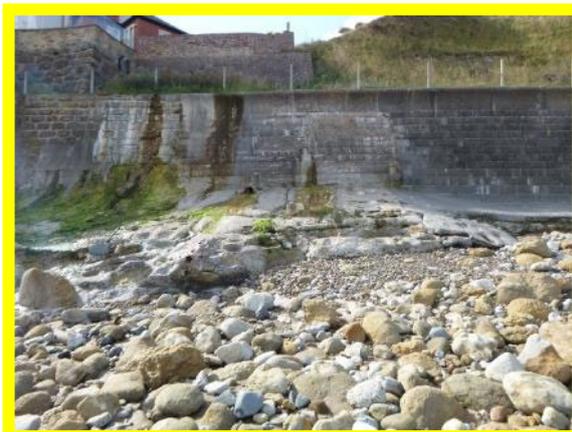
To the north of the pumping station (which is now converted to a private residence) is a private blockwork defence with concrete toe slab (/1402C02), which ties into the eroding cliffs to the north with a mixture of brick, stone blocks and concrete. The wall itself remains in fair condition and appears newer than the wall to the south. At the interface with the adjoining defence to the south there is evidence of leaching and moisture draining down the face of the wall from the cliff unit above. During the 2022 inspection it was noted that high beach levels in part covered a large void in the apron of 1402C02. The depth of the void is unknown however in previous inspections it appeared to be in the order of 2 metres and may be encroaching beneath the base of the wall. Despite the higher beach levels in 2022 it is recommended that further investigation of this defect is undertaken determine the risk to the wall's stability. The remainder of the toe is in poor condition and is undercut in several places. The erosion of the undefended cliff immediately to the north of the tie-in appears to have slowed. Between 2012 and 2014, the wall became outflanked but in recent years it does not appear to have worsened. Despite this the northern transition remains at risk of being compromised by rockfall and erosional activity in this cliff unit.

Private sea wall in fair condition. Large void visible in wall apron. (/1402C02)

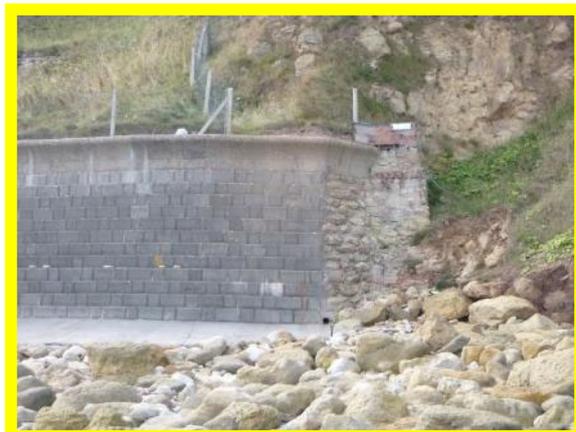
Erosion of undefended cliffs at tie-in of sea wall private sea wall (/1402C02)

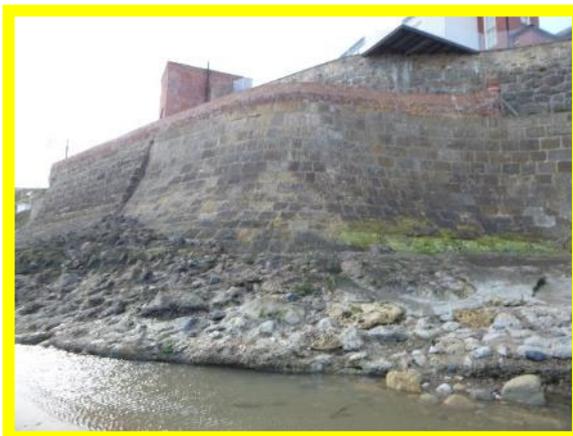
Private sea wall in fair overall condition but with the toe apron subject to ad hoc repairs and localised undermining (/1402C05)

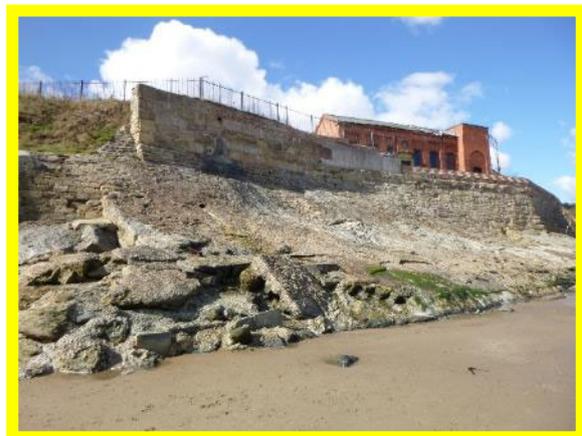
Evidence of voiding and deteriorations of grouted revetment at southern end of defence(/1402C05)

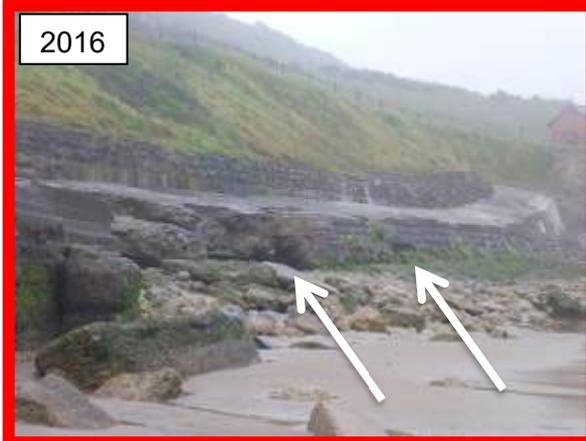
Between the southern end of the pumping station defences and the landing of the beach access steps, there is a length of defence (/1402C04) which exhibited major undercutting and blockwork loss leading to washout of backing material observed during the 2016 inspection. Numerous repairs were made to the defence including a new section of mass concrete wall, repairs to the decking and infilling of the large voids created by washout of fill material. Beach levels along this section are up to 0.7m higher than in 2018 (0.3m higher than in 2020), meaning undercutting and voiding which has previously been reported in this location is now fully concealed. Despite the repairs made following the damage in 2016 the defence remains in very poor condition and is considered a risk to the public due to; potential voids within the structure, the great variation in surface condition of the deck's slab and the localised outflanking and undermining of the footpath and upper retaining wall fronting the vegetated slope. It was noted during the 2020 inspection that the mass concrete repair made to the wall following the 2016 inspection was undercut and outflanked at one end. In 2022 the undercutting was no longer visible due to the higher beach levels. At the interface with the adjoining asset to the east (/1402C04), the wall continues to be undercut and there are numerous voids in the wall face.

Damage to seawall in June 2016 (/1402C04)

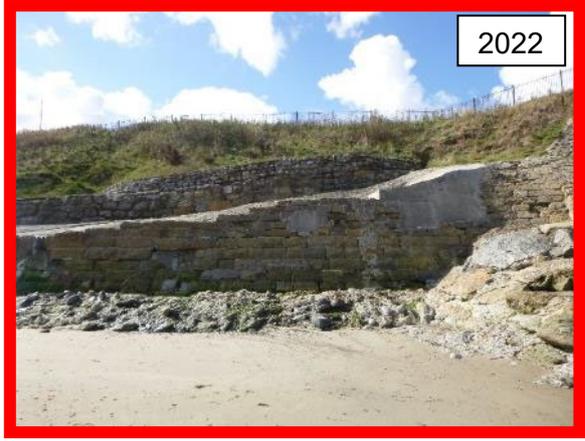
Seawall in August 2020. (/1402C04)

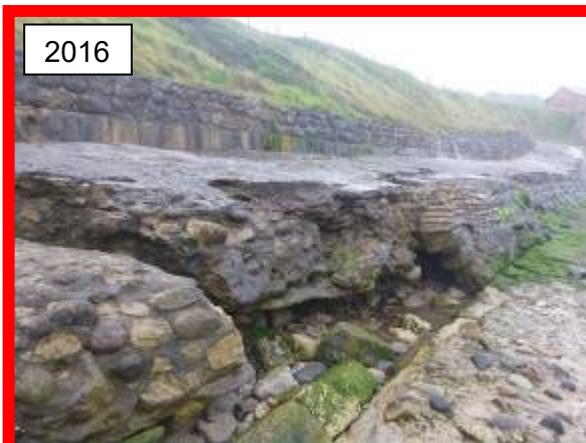
Undercutting at toe leading to voiding behind and break-up of deck (/1402C04)

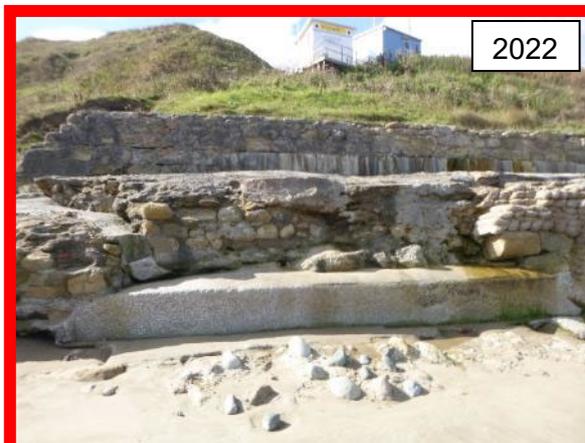
Mass concrete repair to damaged section of wall note undercutting in foreground. (/1402C04)

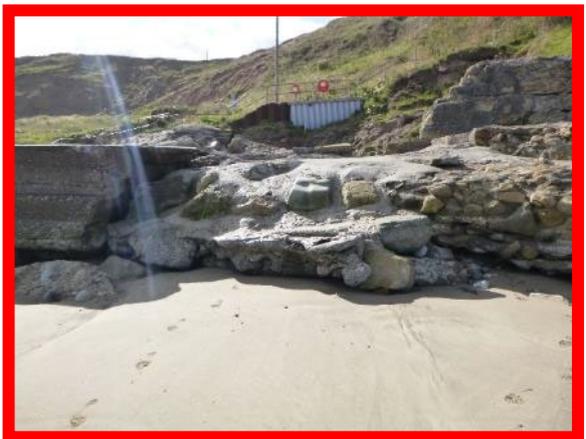
Voiding and undercutting of structure at the interface between (/1402C04) and (/1402C06).

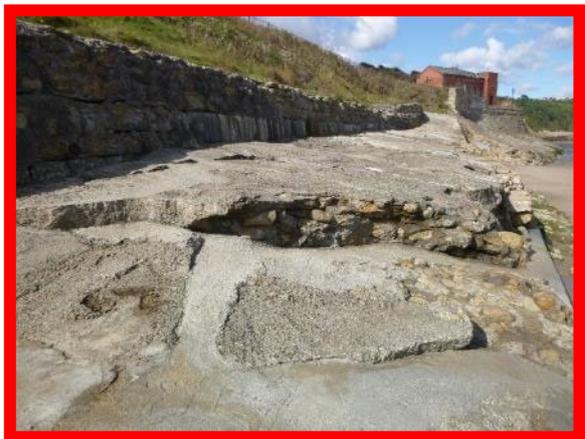
Deck slab repairs in fair condition. (/1402C04)

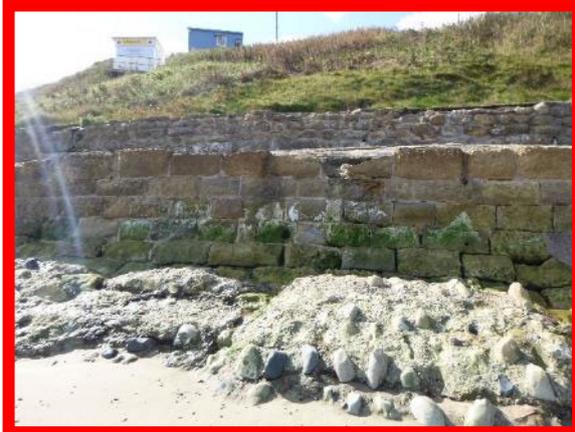
Missing mortar and damaged blockwork (/1402C04)

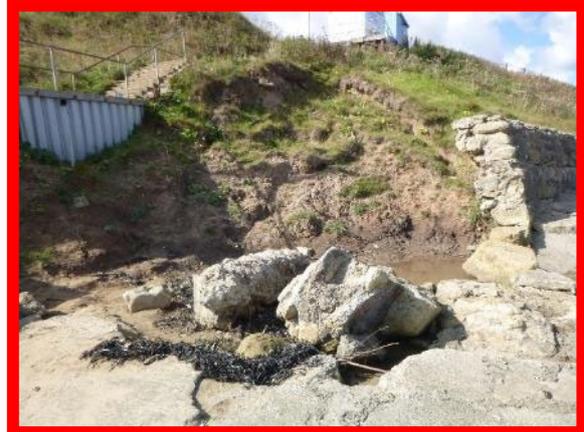
Continued outflanking of upper retaining wall (/1402C04)

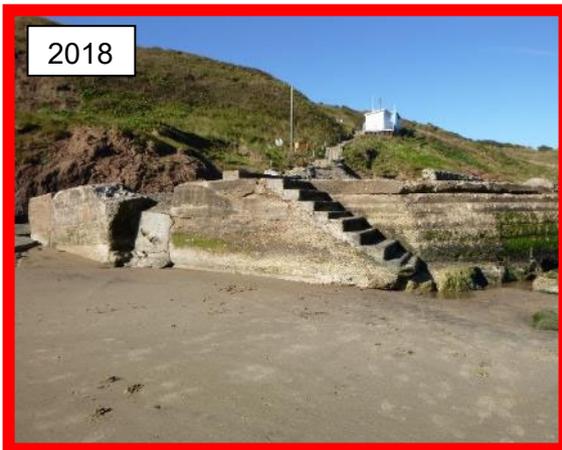
Beach access in 2018 (/1402C06)

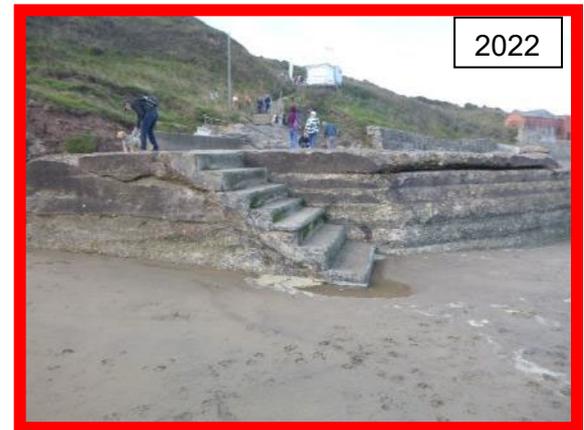
The concrete structure at the beach landing of the public access point remains in a very poor condition with large cracks and voids throughout (/1402C06). Ongoing maintenance activity, comprised of a poured concrete skim over much of the deck of structure, has covered and filled most voids resulting in a reduced the risk to the public. However, slumping and erosion in the cliff at the rear of the structure continue to threaten the upper access steps and structure as a whole. During the 2020 inspection the beach levels across Cayton Bay were found to be higher than in 2018, not quite returning to the 2016 levels. This is evidenced by an approximately 300mm rise in the beach level at the lower access steps, seen in the images below. During the 2020 inspection it was noted that the lower step has been extended at lower beach access steps. This has reduced the risk to members of the public accessing the beach via the steps. Due to higher beach levels it was not possible to examine the base of the platform or whether there is an additional lower step. It is recommended that this structure is urgently demolished, removed and replaced with a simple, safer and more adaptable public access.

Beach access in 2022, notably higher than 2020 and 2018 (/1402C06)

Despite recent reactive repair work the condition of the defences at the Cayton Bay pump house access remains classified as very poor in 2022. The structures present a significant health and safety risk to the general public. It is recommended that access arrangements to Cayton Bay at this location are re-evaluated at the earliest opportunity in line with the *Filey & Cayton Bay Coastal Strategy*.

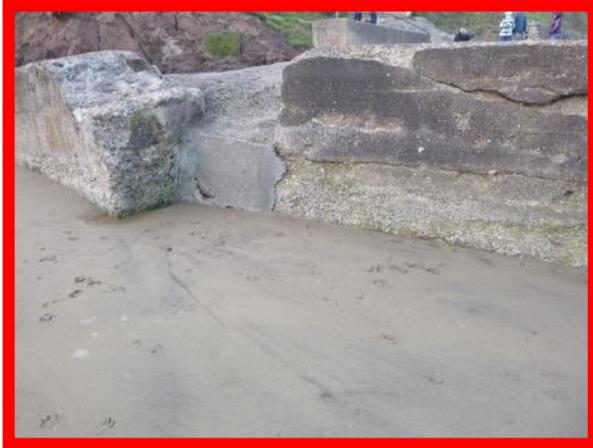
Concrete skim repair has filled voids and cracks (/1402C06)

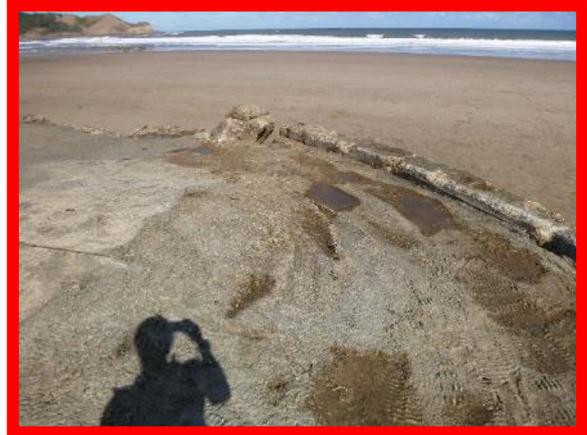
Concrete skim repair to deck slab in poor condition (/1402C04)

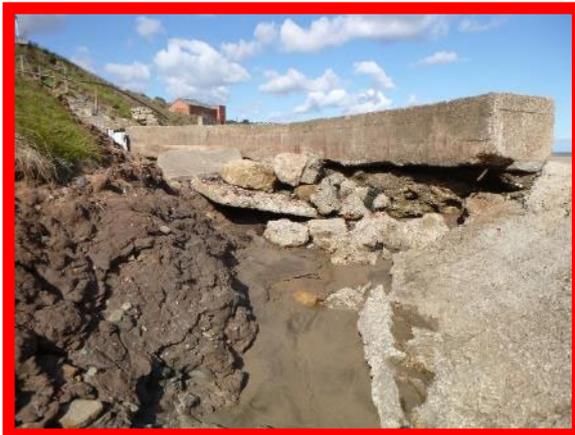
In addition to the damage sustained to the defence to the north of the beach access steps, the structure is also being undercut and outflanked at its western end and towards its rear. The footpath which runs up the bank towards Lucy's Shack is being undercut. A retaining sheet pile wall is supporting the path; however, it can only be a temporary solution due to the risk of further outflanking and undermining.

Damage to rear of structure, washout of fill material (/1402C06)

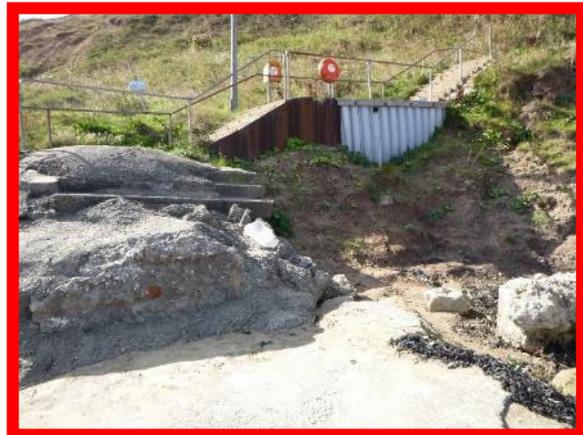
Undermining of footpath beneath 'Lucy's Shack' (/1402C04)

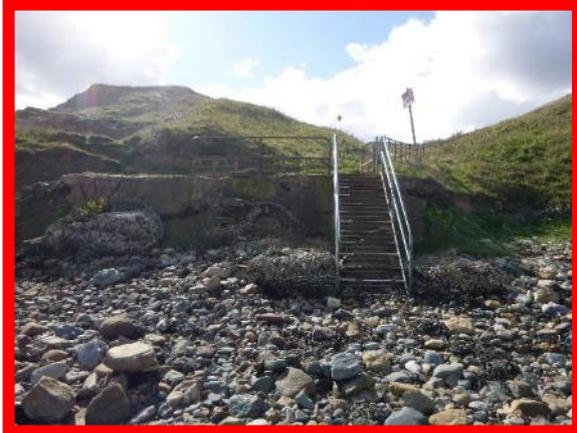
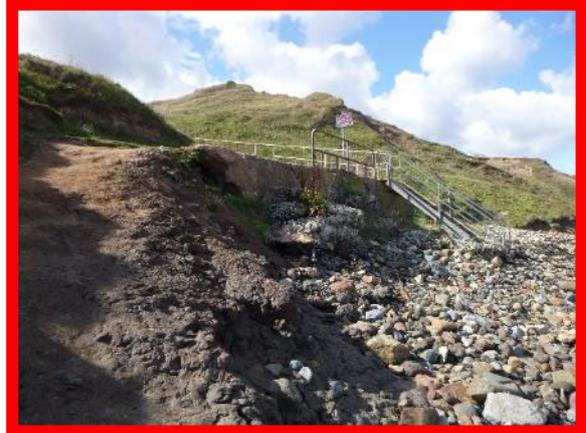
Around 300m south of the pumping station beach access, there is beach access point for the path from the public car park at the surf shop. There are a set of beach access steps that were previously protected by gabion baskets, which have distorted and split under wave action. This is not a formal coastal defence, so has no asset number. The structure presents a health and safety risk to the public due to the partially unprotected edges and is at risk of collapse due to outflanking and undermining.

Failed gabion baskets at surf shop car park beach access (*no asset reference*)

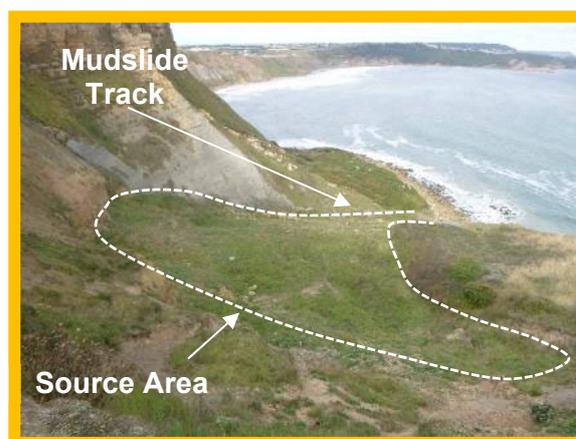
Unit MU25/V is located at Lebberston Cliff and comprises a large, periodically active mudslide system. The unit appears to be prone to regular change and recession. In 2022 the headscarp shows signs of continuing activity and now encroaches on the route of the footpath. This unit was downgraded from Totally Active to Partly Active following the 2012 walkover and this grading has been retained in 2022.

MU24/V - view from directly above the mudslide (Partly Active). [Reproduced from August 2014].

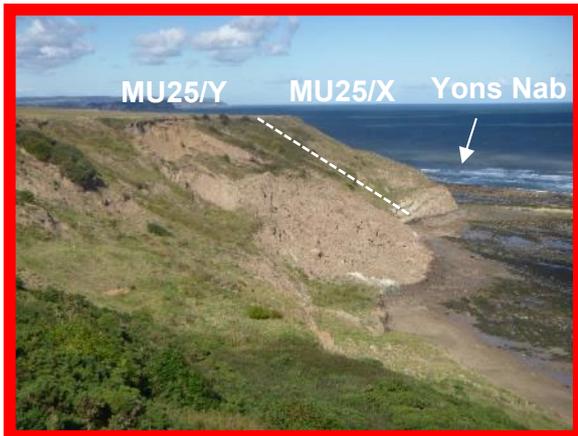
Unit MU25/Y is located south of Yons Nab at the north western end of Gristhorpe Cliff. In 2022 it was noted that there had been a large landslide approximately 85m across and spanning from the toe of the cliff right up to the cliff top. The headscarp of the slip has retreated across the footpath resulting in path users creating a 'desire line' diversion over a length of approximately 50m. Due to this intense level of large scale activity in this unit the condition has been upgraded to Totally Active in 2022. The unit has typically been characterised by numerous areas of activity, with a general trend of headscarp recession and slump across the mid-slope. This landslide appears to be the most significant incidence of activity in recent times within this and its neighbouring units.

Unit **MU25/Y** with Yons Nab protruding seawards.

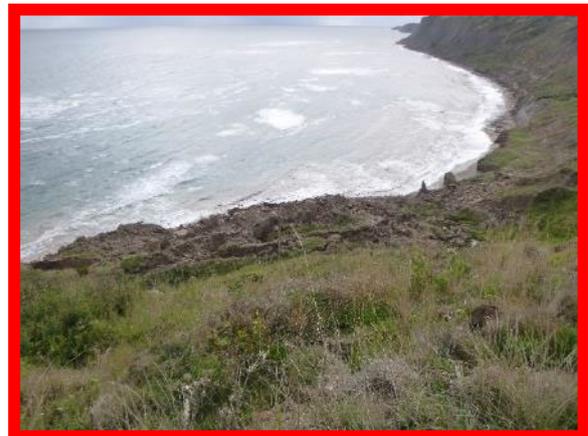
View looking down onto debris lobe (**MU25/Y**).

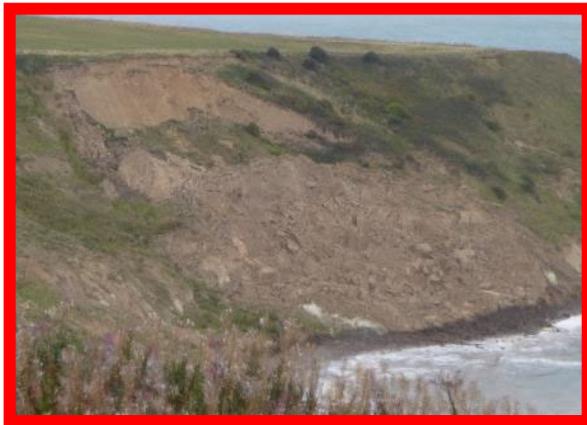
Large scale landslide in **MU25/Y**.

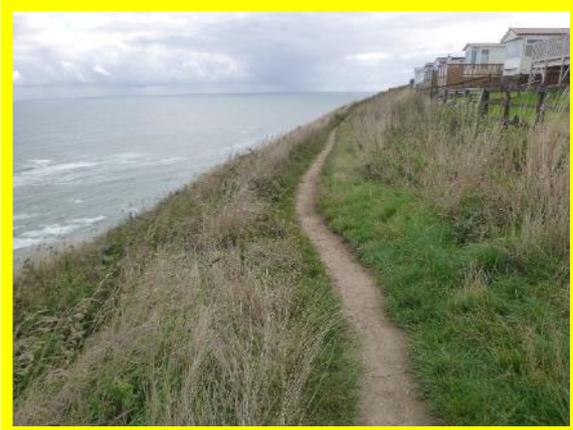
Looking eastwards along upper slope of MU25/AC.

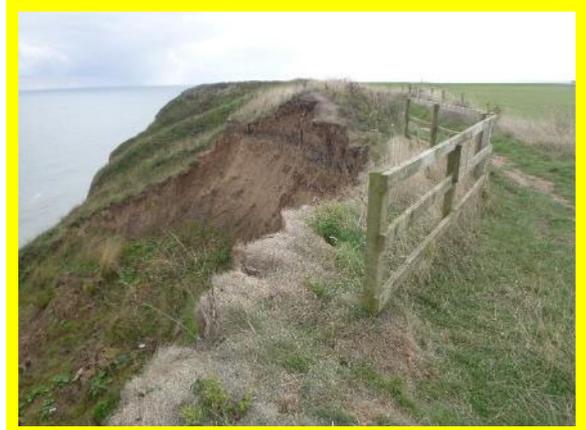
Units MU25/AD and MU25/AE are similar in form to adjacent units MU25/AB and AC. There is some erosion of the headscarp and localised areas of more intense erosion on the lower slopes. These units are classified as Locally Active in 2022, unchanged since 2012.

Headscarp recession along unit MU25/AD.

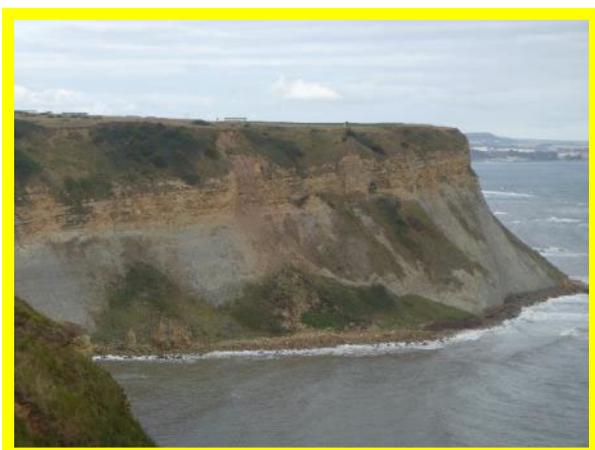
MU26/AF and MU26/AG Soft till overlying resistant rock (Locally Active).

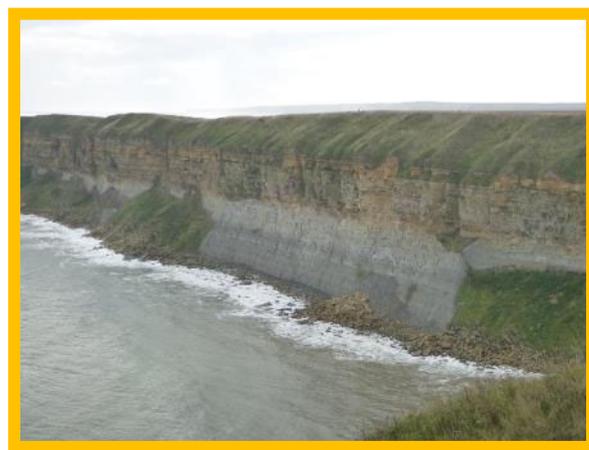
MU26/AK and MU26/AL were changed in grading to **Partly Active** in 2016, having experienced widespread rockfalls and mudslides along their length. This status has been retained following the 2022 inspection. Recent activity was evident, particularly in **MU26/AK** where a large rockfall has occurred from the upper cliff, resulting in a large debris cone. It was noted that the debris cones along the base of these units have receded slightly indicating that the cliffs experience some degree of erosion along their toe. This may also indicate that they are not being recharged as regularly from activity in the cliff units above.

MU26/AJ to MU26/AN Cliffs experiencing rockfalls and mudslides.

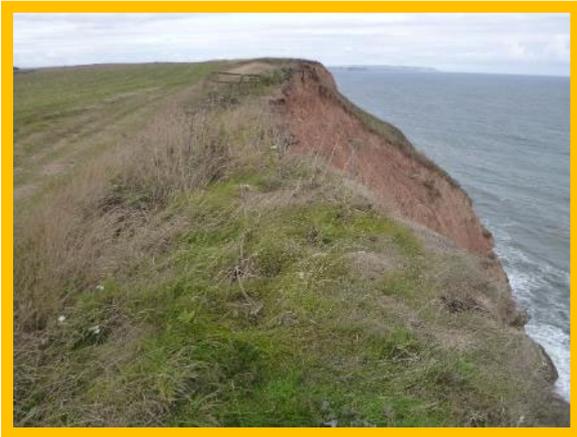
Units MU26/AS to MU26/AT have all been assigned a status of Partly Active in 2022 due to intensive erosion of the headscarp. The remaining Units **MU26/AU to MU26/AX** retain their Locally Active status in 2022. These cliffs are comprised of soft glacial sediment and exhibit only localized, rather than widespread, erosion in the form of headscarp recession and mud sliding. There is also localised marine erosion of the toe.

MU26/AT Ongoing recession of the headscarp (Partly Active).

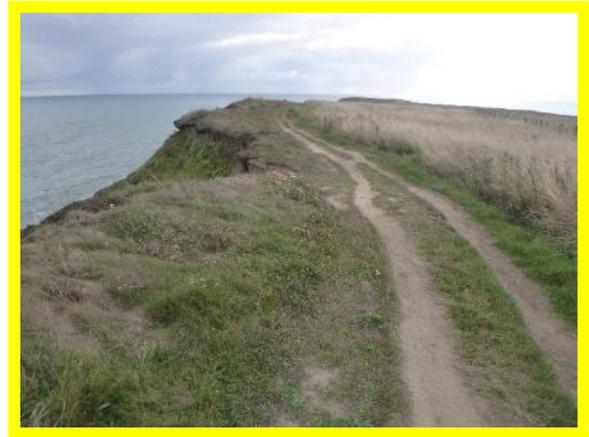
MU26/AY and MU26/AZ Locally Active headscarp overlying stable rock cliff in eastern end of **MU26**.

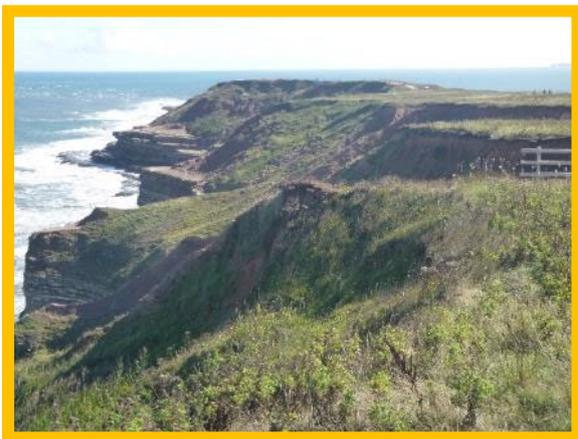
Mainly unvegetated and eroding upper slopes on the north side of Filey Brigg. **MU27/BC to MU27/BF** (Partly Active in 2022)

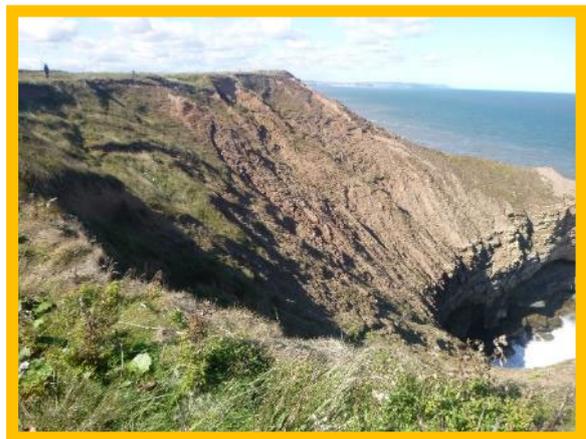
Headscarp recession and mudslides in upper and mid till unit on north side of Filey Brigg. **MU27/BC** (Partly Active in 2022)

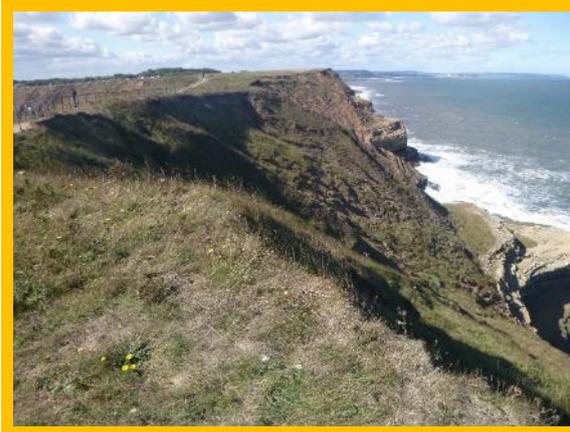
Unit MU27/BE, and 27/BF are also located on the northern side of Filey Brigg but until 2012 were less active than adjacent units. However, much of the upper slopes have been unvegetated and eroding since then and both retain classification of Partly Active in 2022.

Steep partially vegetated eroding till slope on north side of Filey Brigg, slumping evident on midslope. **MU27/BE** (Partly Active in 2022)

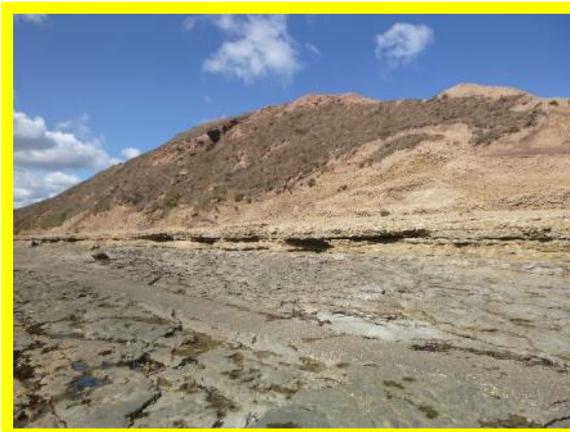
Composite cliffs on the south side of Filey Brigg. **MU27/C** (right) to **MU27/F** (left) (**MU27/C** Partly Active, the remainder Locally Active in 2022)

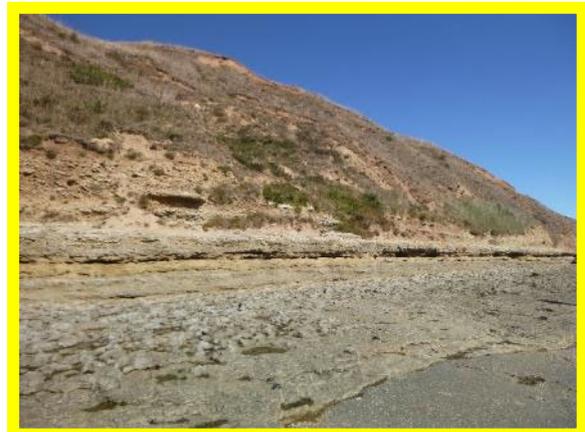
Composite cliffs on the south side of Filey Brigg **MU27/E** (Partly Active in 2022)

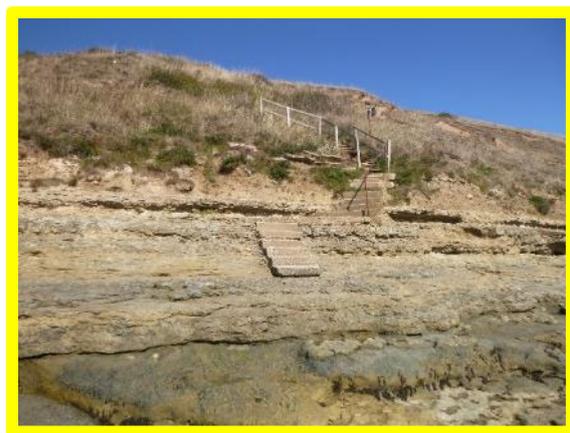
Composite cliffs on the south side of Filey. Locally Active around access steps in unit **MU27/F** in 2022.

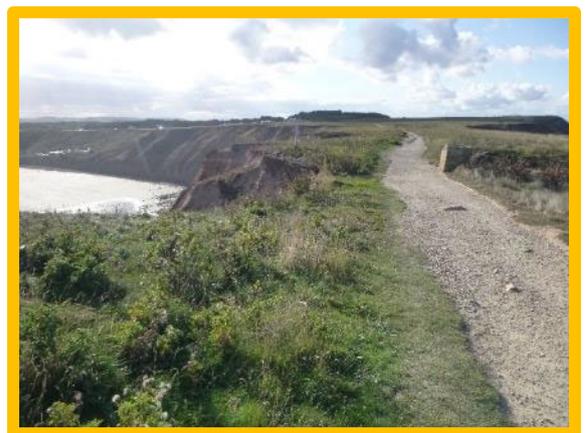
MU27H and MU27/I are in the central part of the south side of Filey Brigg and are variously vegetated and unvegetated. These units comprise simple mudslides, each with an arcuate head scarp and elongate flow tracks. They are classified as **Partly Active** in 2022, unchanged since 2016.

Active headscarp recession along **MU27/I** and **MU27/H**, Partly Active in 2022.

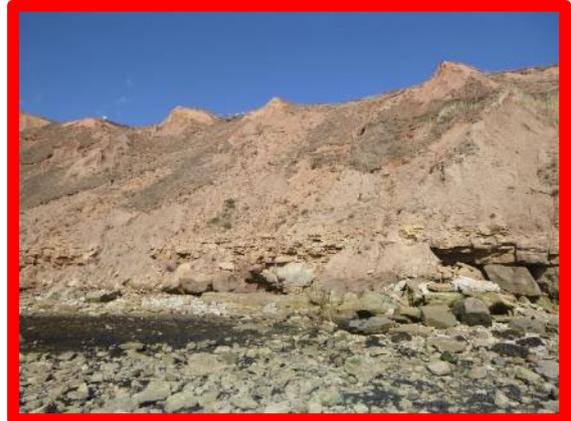
Units MU27/J to MU27/O are also located on the south side of the Brigg at its western end. They are predominantly unvegetated and are undergoing intense erosion. Therefore, they are classified as **Totally Active** in 2022.

Composite cliffs on the south side of Filey Brigg. **MU27/K** (Totally Active in 2020).

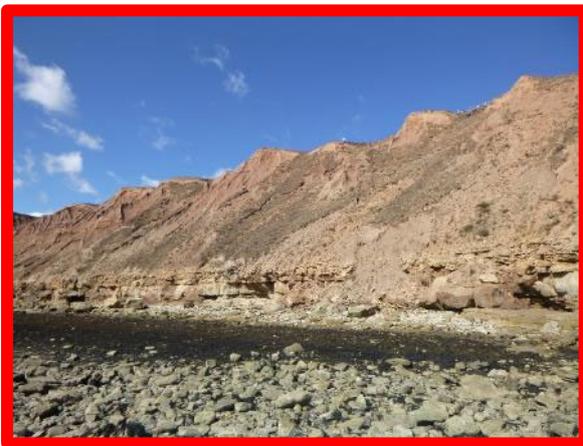
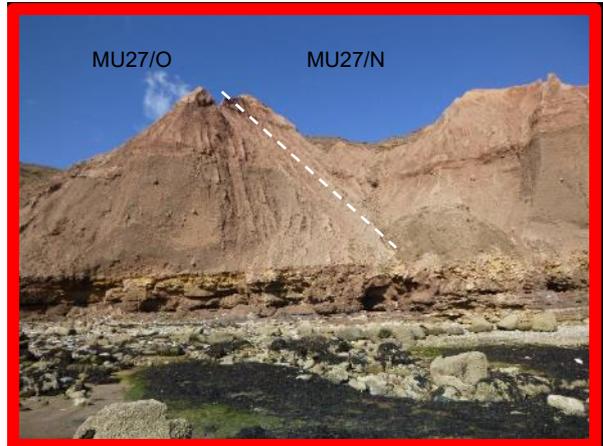
Composite cliffs on the south side of Filey Brigg (all Totally Active in 2020).

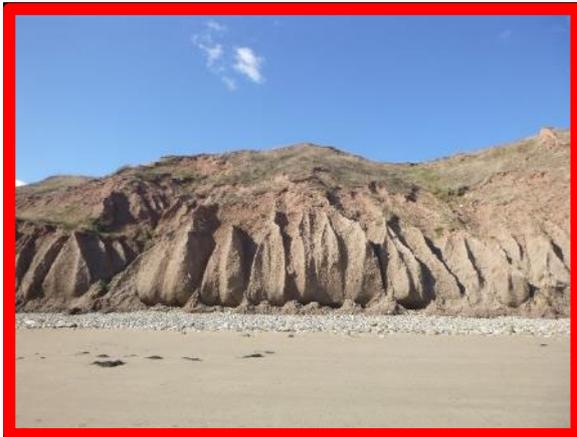
Till cliffs between Filey Brigg and Filey sailing club (**MU27/Q** Totally Active in 2022).

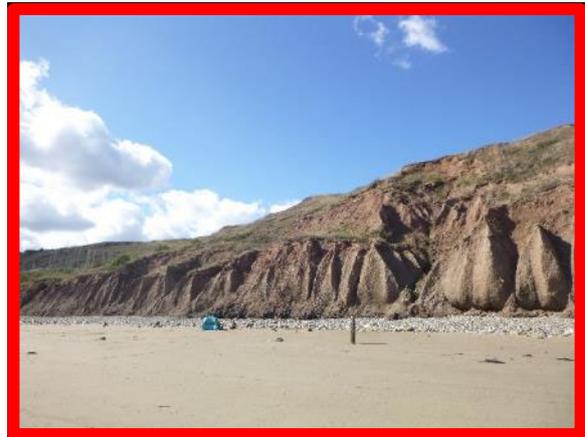
Till cliffs between Filey Brigg and Filey sailing club (**MU27/R** Totally Active in 2022).

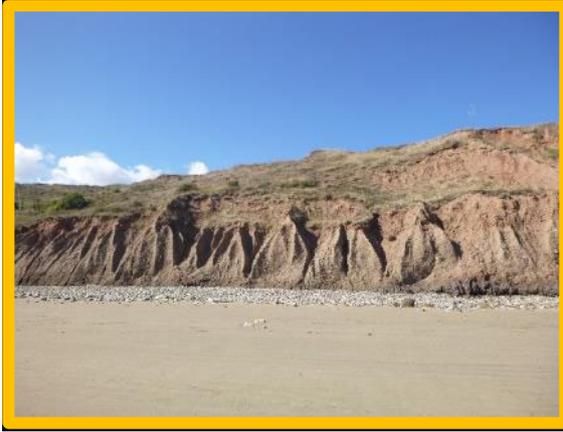
Till cliffs between Filey Brigg and Filey sailing club **MU27/S** Partly Active in 2022

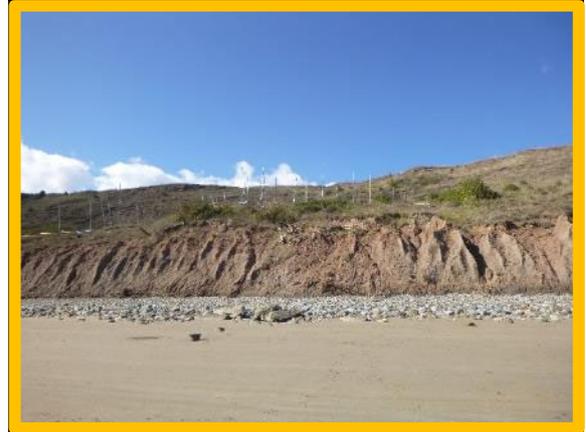
Unit **MU27/T** surrounds the boat yard storage and comprises glacial till down to beach level. The cliff slope is relatively shallow with an exposed eroding toe, and shallow slumps across better vegetated mid- to upper slopes. This unit is classified as **Partly Active** in 2022, unchanged since 2014.

Till cliffs fronting Filey Sailing Club and boat yard **MU27/T** Partly Active in 2022

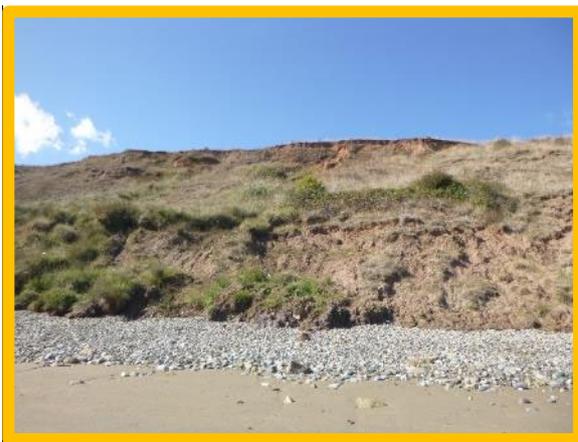
Units MU27/V and MU27/W are located between the sailing club and the north end of Filey seawall. These units are classified as **Partly Active** in 2022 with ongoing large-scale head scarp recession, and evidence of slumping throughout the profile. The units also experience ongoing erosion along their toe. Cliff warning signs have been dislodged indicating slope movement.

Ongoing slumping and erosion along toe of till cliffs between Filey Sailing Club and Filey town. **MU27/V** Partly Active in 2022. Note evidence of headscarp recession at cliff top.

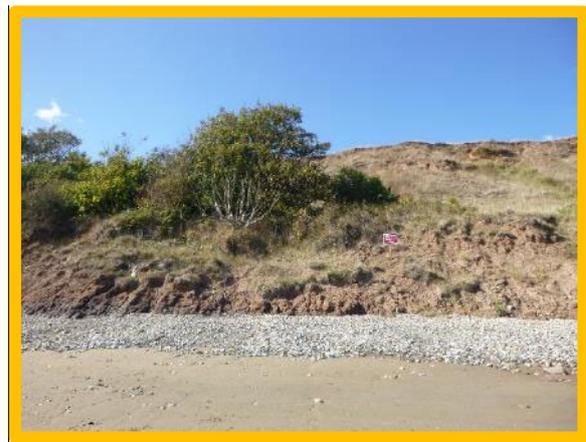
Till cliffs between Filey sailing club and Filey town. **MU27/W** Partly Active in 2022

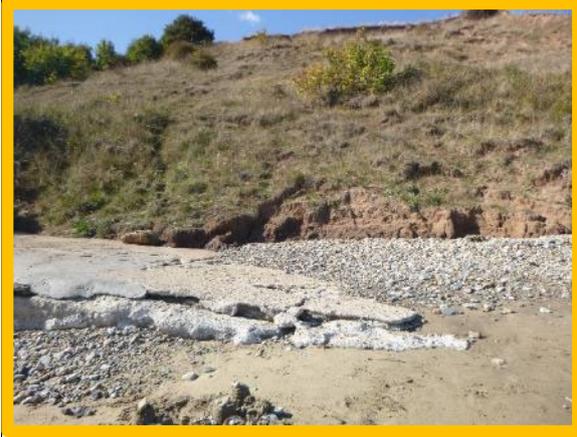
Unit MU27/X is located behind the northern end of Filey seawall and town. It is classified as **Locally Active** in 2022, upgraded from Inactive in 2020, returning to the same status it held in in 2014.

Toe of **MU27/X** Locally Active in 2022.

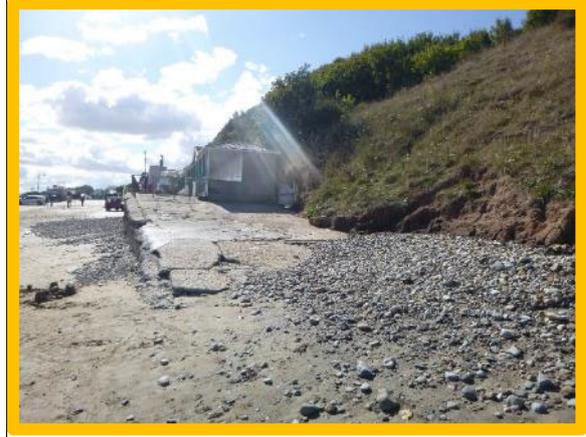
Toe of **MU27/X** showing signs of some localised recession adjacent to the Filey sea defences increasing the risk of outflanking.

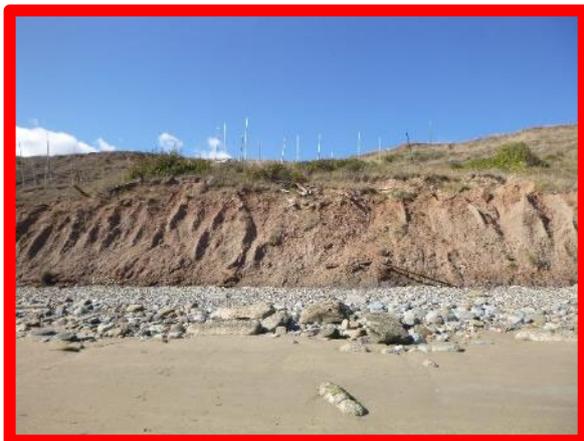
To the north of the town, Filey Sailing Club is located at the back of the beach and is partly protected by some coastal defences. However, the section of cliff below the boat park (which is located on a terrace part way up the cliff) north of the club building is undefended (/1601C01) and suffering active slumping along its length.

Undefended cliffs below boat storage yard (/1601C01)

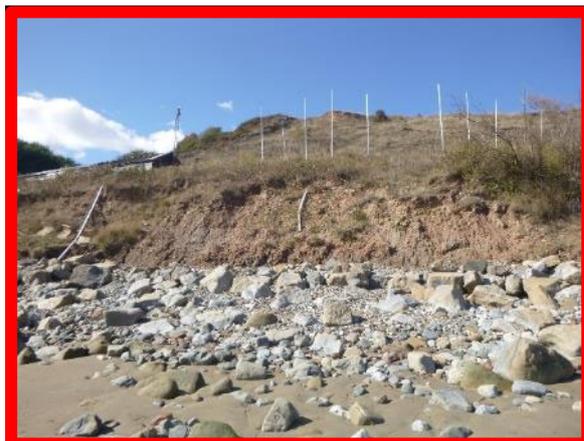
Immediately north of the club building there was formerly a defence structure (/1601C02) that consisted of timber breastwork retaining rock armour. However, all that remains of this now failed structure is the rock debris scattered on the beach. This asset is unchanged since 2018.

Remnants of former defences north of club building (/1601C02)

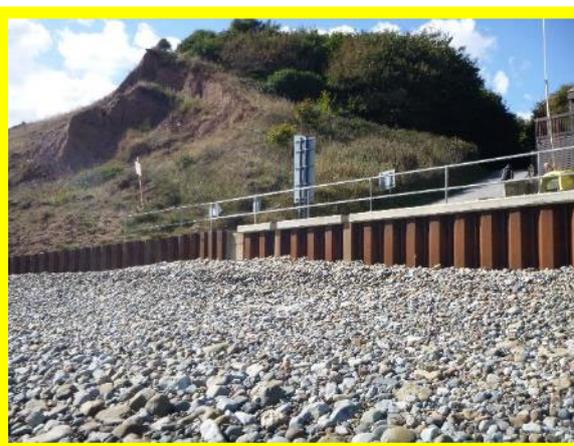
High shingle levels conceal much of the sheet pile wall (/1601C03).

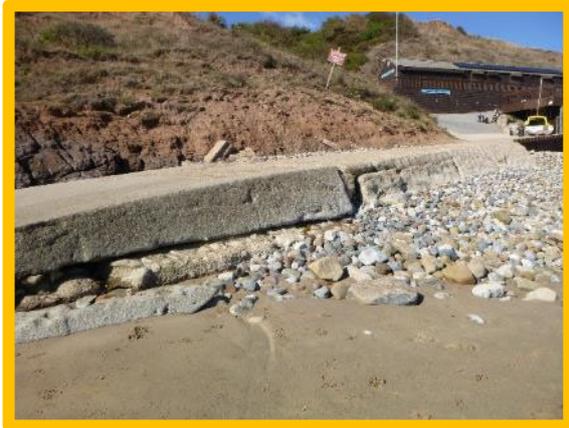
Evidence of voids forming beneath boatyard ramp (/1601C03)

The previously repaired lower section of the access slipway remains in good condition. However, the ongoing undercutting and voiding along the ramp, as reported previously, is deteriorating and requires attention. There was a small amount of debris on the upper portion of the slipway ramp, indicating some ongoing, localised movement in the lower cliff unit.

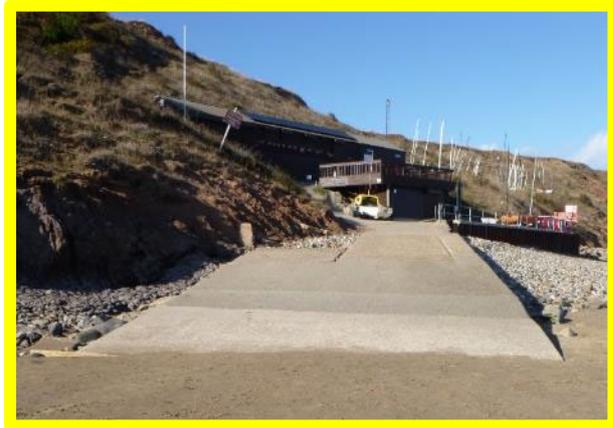
Some localised slumping of soft till onto upper section of slipway (/1601C03)

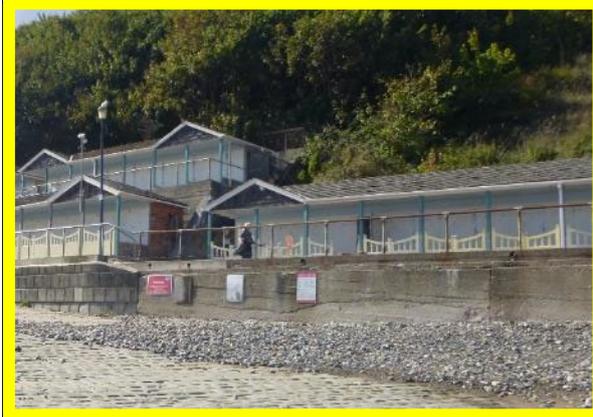
The most northerly asset in the defence system consists of the rear wall and slipway at Coble Landing (/1602C01). The slipway blockwork appeared in fair condition although high sediment levels concealed much of the lower slipway. As noted during previous inspections, the rear wall below the chalets has several horizontal cracks in the wall and is in fair to poor condition. The concrete cope beam, which was replaced prior to the 2018 inspection, remains in good condition. The concrete rear ramp/wall is in poor condition with heavy abrasion, particularly at the wall joint, and voids in the deck towards toe of structure.

Longitudinal cracks in rear wall, open joint (/1602C01)
