Cell 1 Regional Coastal Monitoring Programme Walkover Inspection Surveys 2022

**Scarborough
Borough Council**

November 2022

Walkover Inspection Surveys 2022

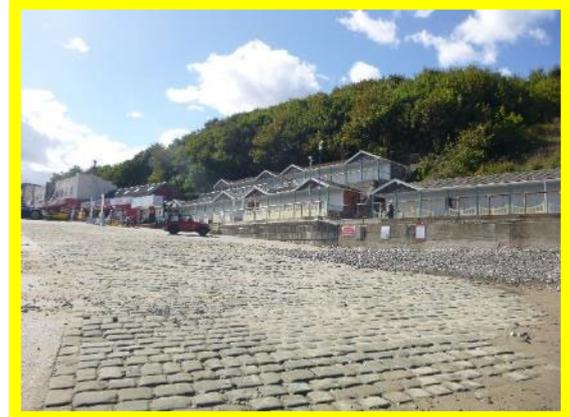
Coble Landing slipway blockwork in fair condition (/1602C01)

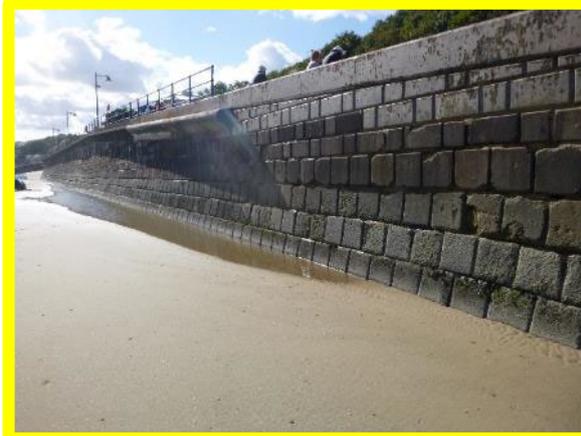
The next asset (/1602C09) is essentially a wing wall protecting the slipway, it remains in fair condition. Repairs to this wall were made between 2012 and 2014 and are holding well. Further repairs to the toe apron were observed in 2018 appear in good condition. The undercutting of the end of wall does not appear to have worsened.

Previous repairs to crest of slipway 'wing-wall' (/1602C09)

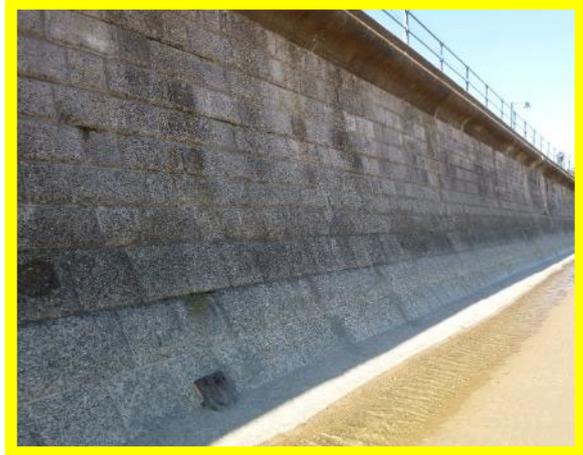
Evidence of ongoing abrasion on wall face. Low beach levels expose concrete toe (/1602C08)

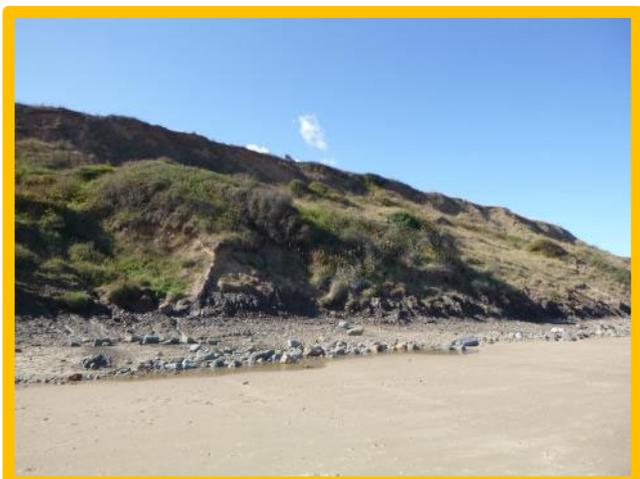
Till cliffs along Muston Sands looking North. **MU29/AD** in foreground Partly Active in 2022

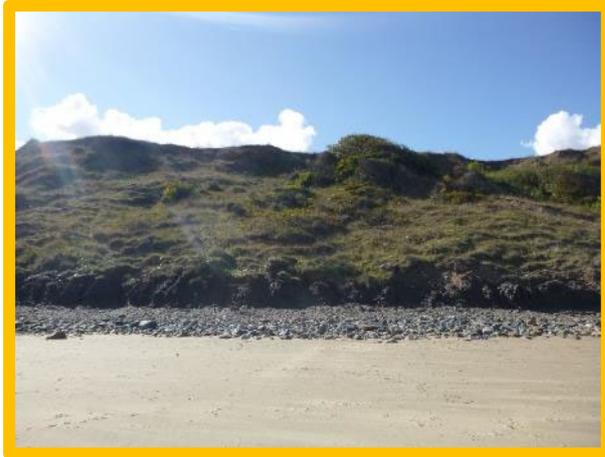
Till cliffs along Muston Sands **MU29/AE** Partly Active in 2022

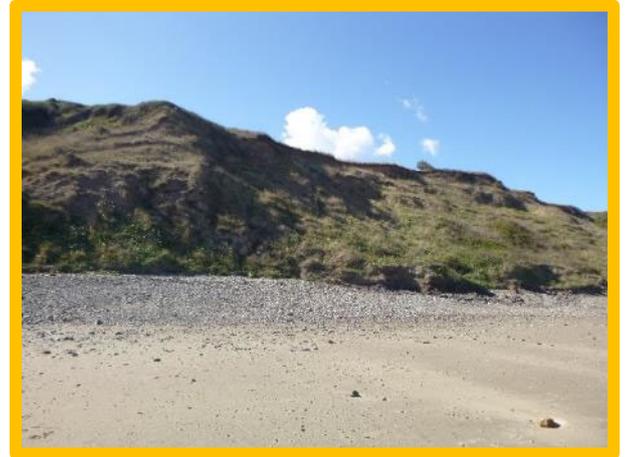
Till cliffs along Muston Sands **MU29/AF** (right) Locally Active transitioning to **MU29/AG** (left) Partly Active in 2022

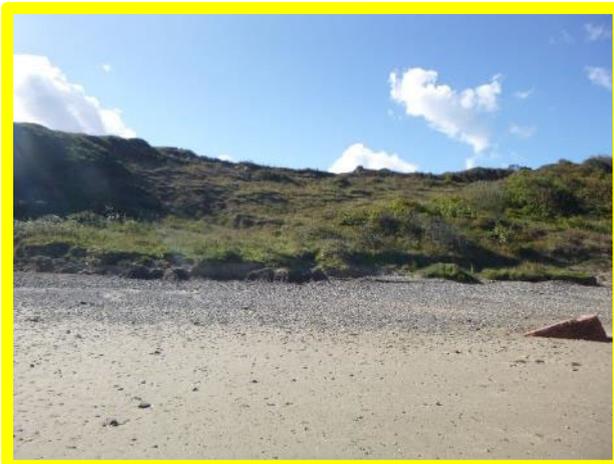
MU29/AG to MU29/AI were downgraded to locally active in 2020, a status they retain in 2022. The entire length of cliff is partly vegetated and suffers from ongoing headscarp erosion and slumps and slides are causing failure throughout the cliff face. The toe undergoes a varying degrees of marine erosion and it is for this reason that the units to the south have been downgraded.

Till cliffs along Muston Sands **MU29/AH** Locally Active in 2022

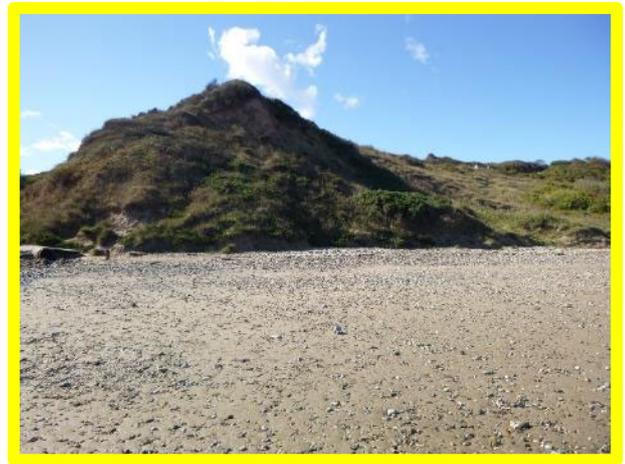
Till cliffs along Muston Sands. **MU29/AI** Locally Active in 2022

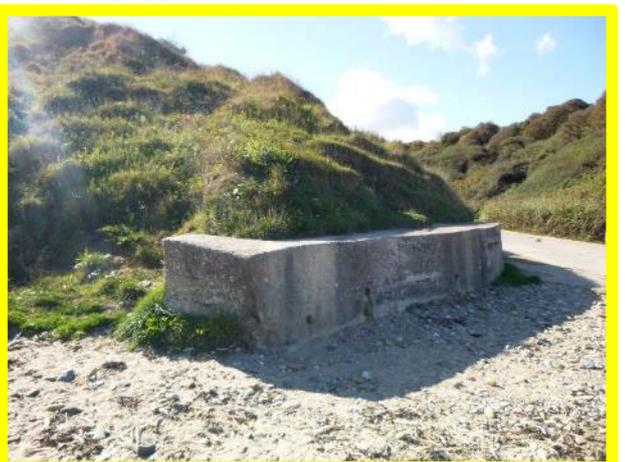
Low concrete retaining at toe of **MU29/AJ**. Evidence of localised slumping at rear of wall.

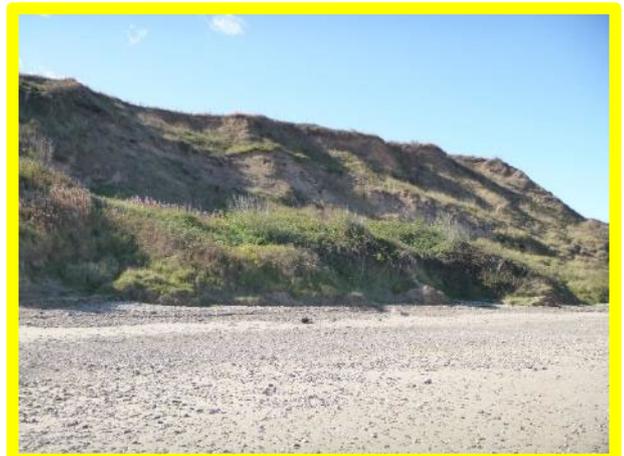
Till cliffs along Hunmanby Sands. **MU29/AK** Locally Active in 2022

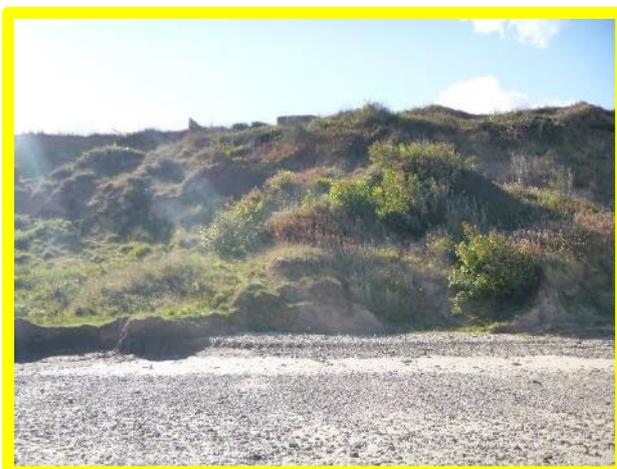
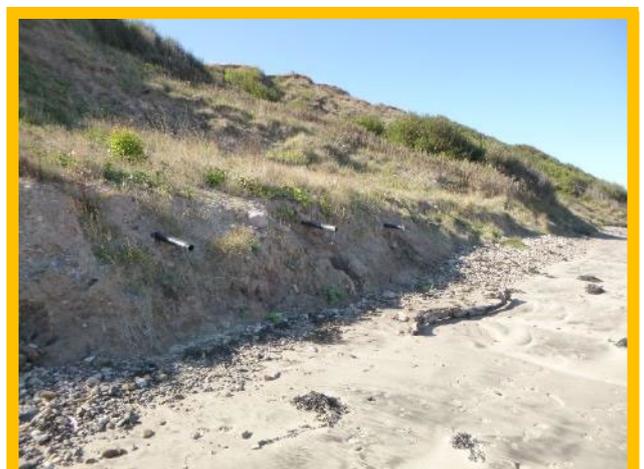
Till cliffs along Hunmanby Sands. **MU29/AP** Locally Active 2022

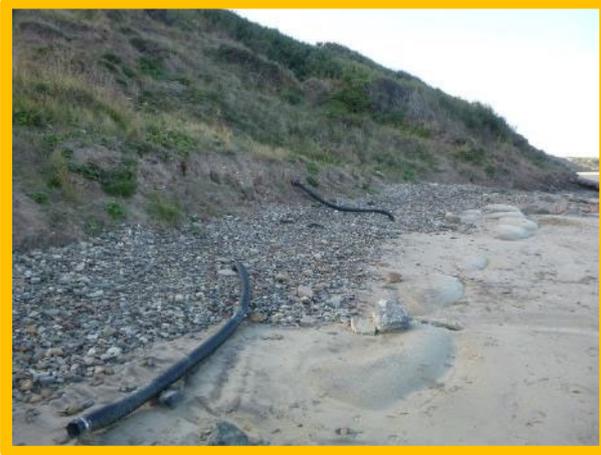
At **MU29/AQ** the Flat Cliffs coastal slope stabilisation project was complete in 2018 which included the installation of inclined sub-horizontal drains in the cliff and geotextile sand containers at the toe. During the 2022 inspection it was noted that the cliff toe has continued to recede in this location. The sub-horizontal drains are now exposed, and in some cases are damaged. The geotextile sand containers now stand approximately 6m seaward from the toe. The sand containers were largely buried with beach sediment, and therefore were not inspected. It was noted that several of the drainage pipes were discharging water at the time of the inspection meaning they are still performing as intended.

Eroded toe of till cliffs exposing sub-horizontal drains at Flat Cliffs. **MU29/AQ** Partly Active 2022

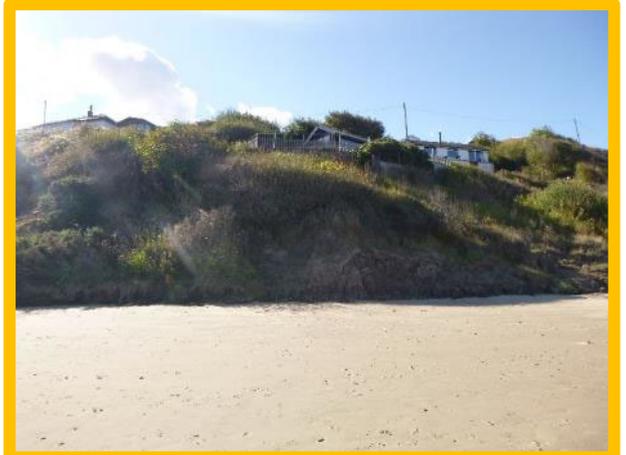
Toe of till cliffs at Flat Cliffs **MU29/AR** Partly Active in 2022

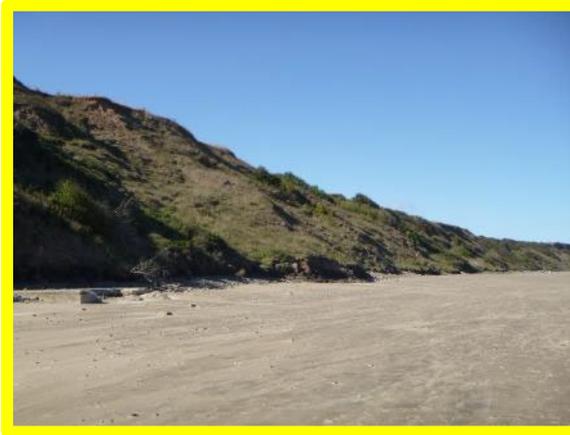
MU29/AT is classified as Locally Active in 2022 (unchanged from 2018) as it is generally well vegetated and there is only local evidence for toe erosion or activity at mid to upper levels. More intense erosion was again present along the full height of the cliff adjacent Butcher's Gap, with evidence of recent mud slips.

Well vegetated till cliffs along Hunmanby Sands. **MU29/AT** Locally Active in 2022

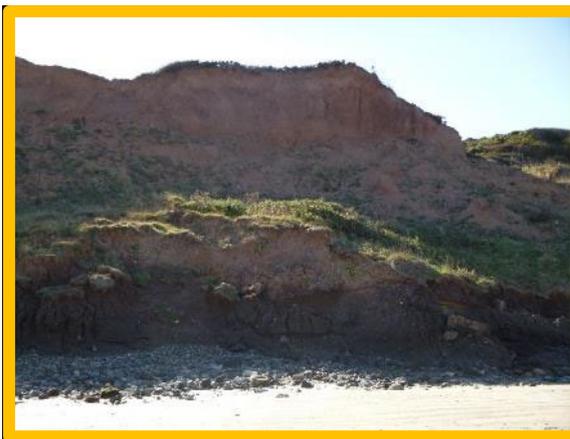
Till cliffs north of Hunmanby Gap. **MU29/BB** Partly Active in 2022

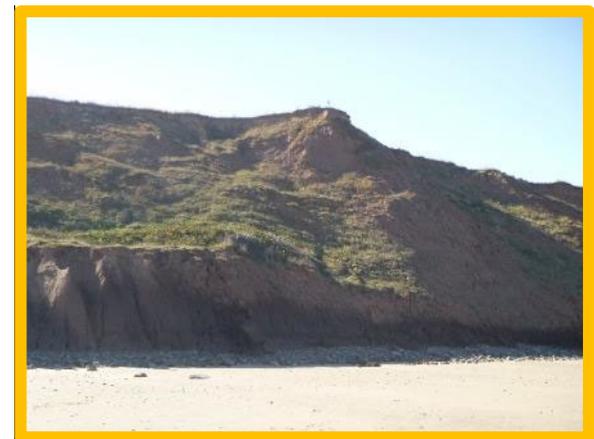
Till cliffs north of Hunmanby Gap. **MU29/BD** Partly Active 2020

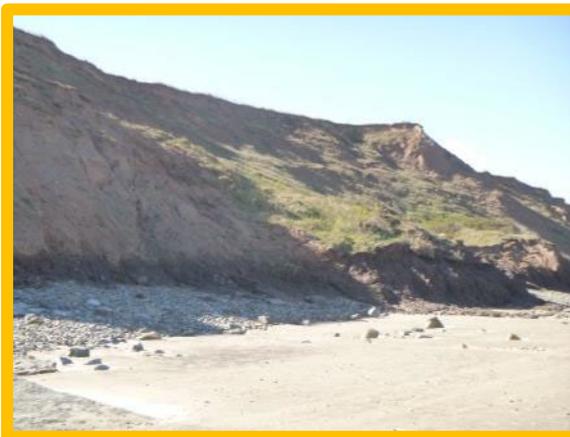
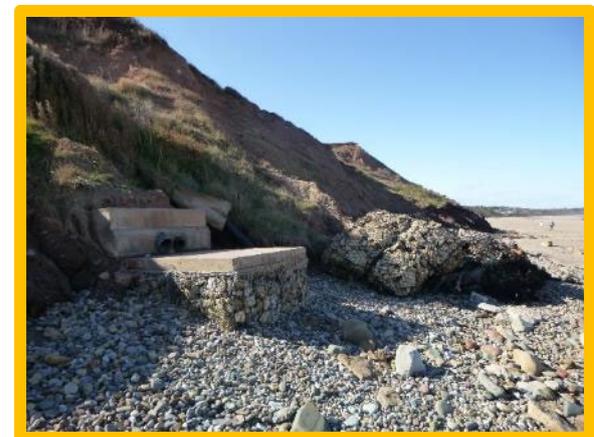
Till cliffs north of Hunmanby Gap. **MU29/BE** Partly Active 2022

Till cliffs at Hunmanby Gap. **MU29/BE2** Partly Active 2022

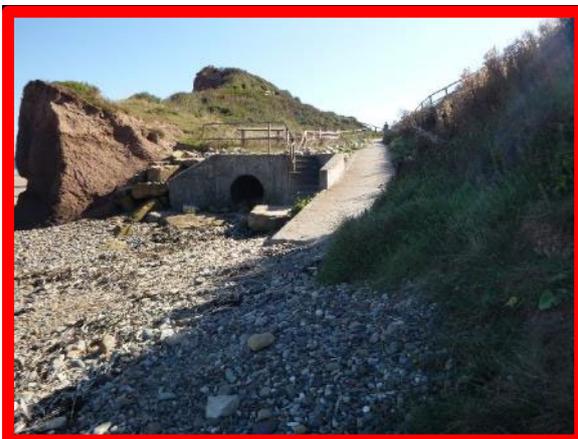
Unit **MU29/BF** includes Hunmanby Gap itself. This unit is partly shielded from wave erosion by unit **MU29/BG** and is classified as Locally Active in 2022, unchanged from 2016. **MU29/BG** to **MU29/BJ** are located south of Hunmanby Gap. These cliffs are steep and affected by intense erosion throughout most of their height. The head scarp is retreating and there is significant slumping on to the beach. **MU29/BG** to **MU29/BJ** are classified as Totally Active in 2022, unchanged from 2016. In **MU29/BH**, a small dilapidated masonry structure at crest of the cliff is at risk of collapsing onto the foreshore.

Intense erosion of till cliffs south of Hunmanby Gap. (**MU29/BG** – Totally Active) shielding Hunmanby Gap itself (**MU29/BF** – Locally Active)

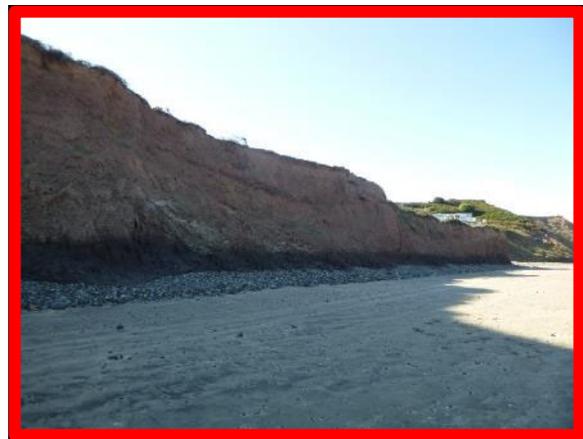
Intense erosion of till cliffs south of Hunmanby Gap. **MU29/BH** Totally Active in 2022

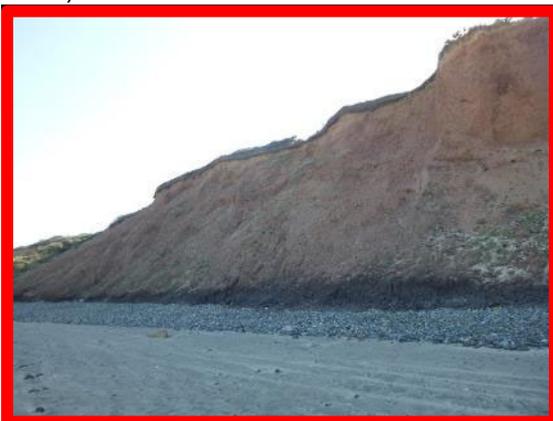
Intense erosion of till cliffs south of Hunmanby Gap. **MU29/BI** Totally Active in 2022

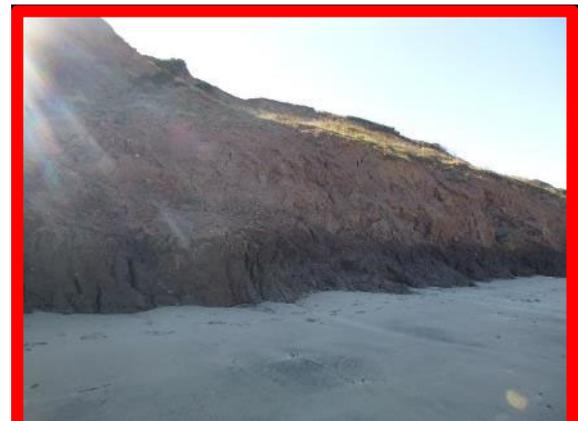
Intense erosion of till cliffs south of Hunmanby Gap. **MU29/BJ** Totally Active in 2022

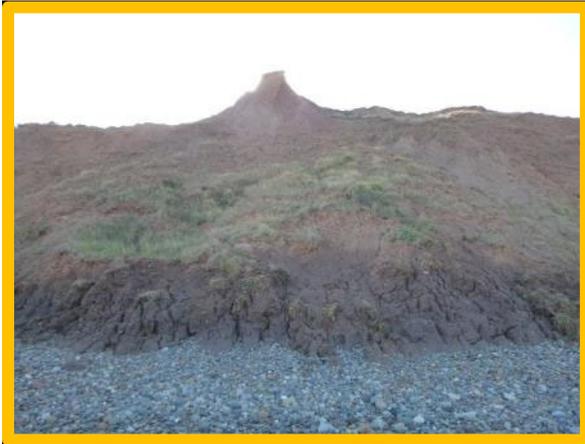
Further south, units **MU29/BK** to **MU29/BQ** are located above Reighton Sands. These units are again classified as Partly Active in 2022. They are characterised by steep slopes partially covered in vegetation. There is recession of the headscarp, common areas of erosion in the mid-slopes and slumping on to the beach. The toes are steep and eroding.

Till cliffs at Reighton Sands. **MU29/BL** Partly Active 2022

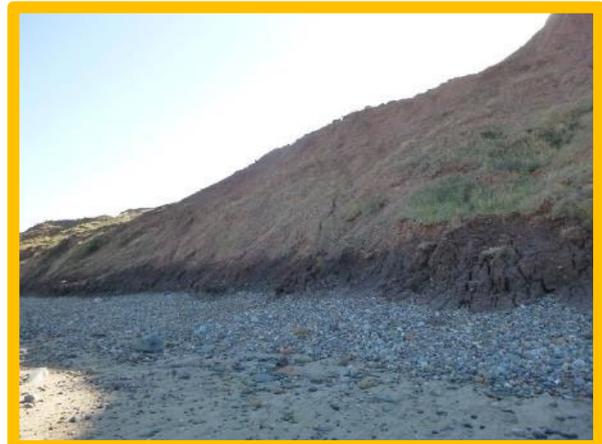
Till cliffs at Reighton Sands. **MU29/BM** Partly Active 2022

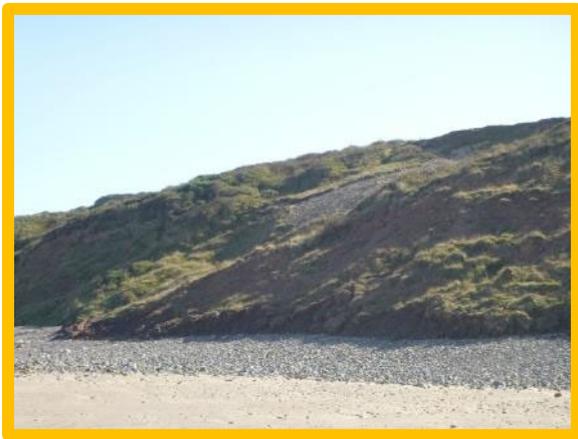
Till cliffs at Reighton Sands. **MU29/BQ** Partly Active 2022

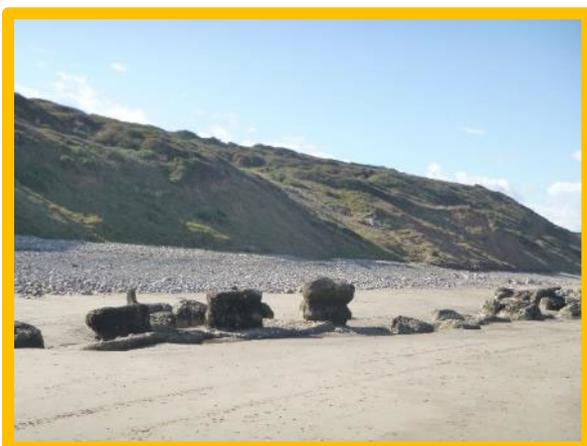
Units **MU29/BR**, **MU29/BS** and **MU29/CA** form the majority of this Sub-management Unit and are classified as Partly Active in 2022 with no change to status since 2020. These units are partially vegetated, and contain large slumps, erosion at their head scarp.

Till cliffs beneath Reighton Sands Holiday Village. **MU29/BR** Partly Active 2022

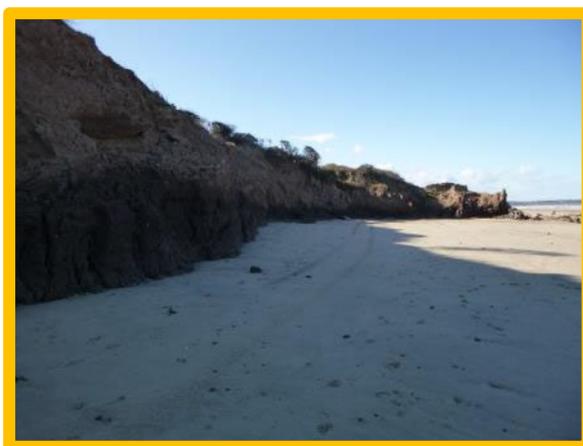
Till cliffs beneath Reighton Sands Holiday Village. **MU29/BR** Partly Active 2022

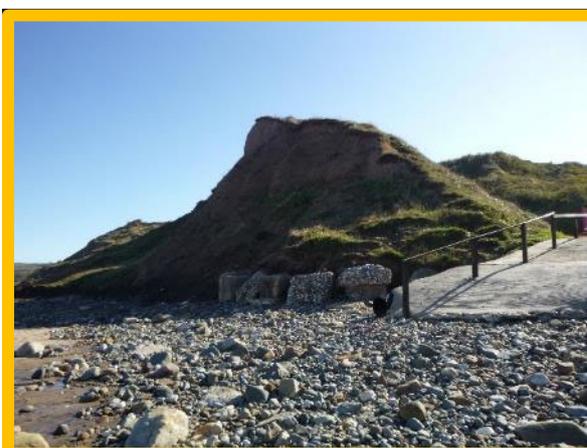
Till cliffs beneath Reighton Sands Holiday Village. **MU29/BS** Partly Active in 2022

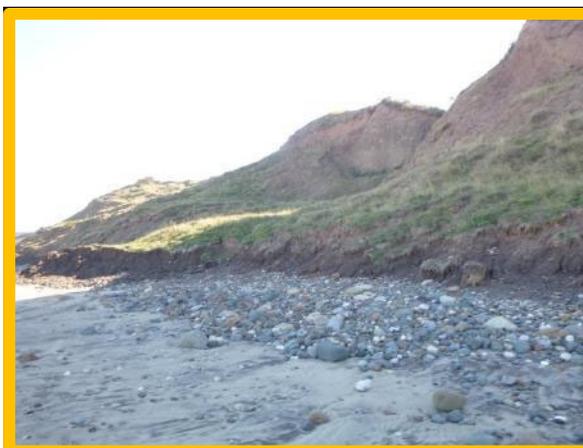
Till cliffs beneath Reighton Sands Holiday Village. **MU29/CA** Partly Active in 2022.

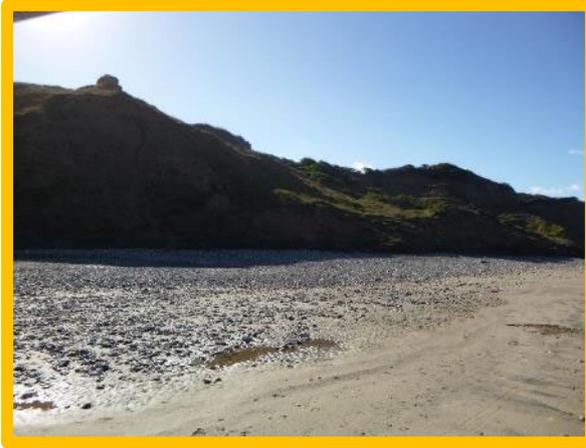
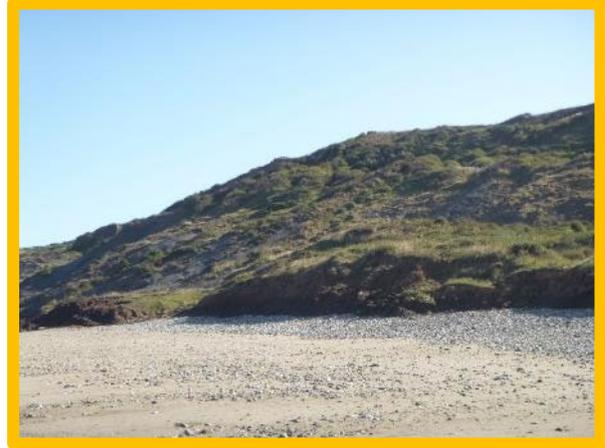
Unit **MU29/CB** is at the eastern end of the holiday village. The unit exhibits mudslides and an eroding head scarp, and is classified as Partly Active in 2022. The pillbox has been bypassed by the retreating cliff crest and appears at risk of toppling. Unit **MU29/CCa** forms a shallow mudslide embayment extending on to the beach. The unit is classified as Partly Active.

Till cliffs in **MU29/CB** (Left) Partly Active 2022 Till cliffs in **MU29/CCa** Partly Active 2022

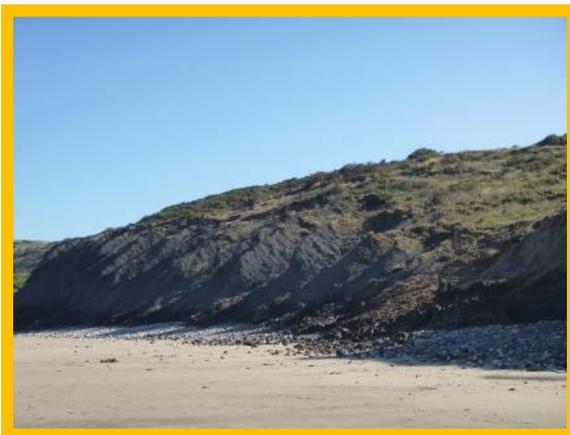
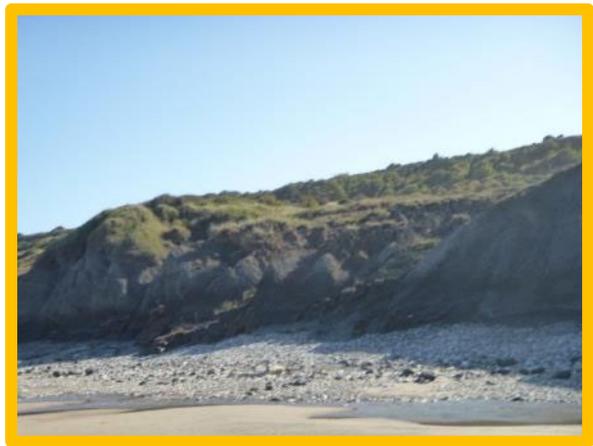
Unit MU29/CC forms a large, shallow, well vegetated embayment known as Middle Cliff with a steep well-defined eroding toe in mud. There is also activity at the unit head and mid slope. The unit is classified as **Partly Active** in 2022.

Unit MU29/CD is similar to MU29/CC but with more recent activity in the form of slumps, slides, block failures and mudflows at the toe. As a result, this unit is classified as **Partly Active** (unchanged)

Toe of mud cliff in **MU29/CC** Partly Active 2022 Toe of mud cliff in **MU29/CE** looking towards **MU29/CD** Partly Active 2022

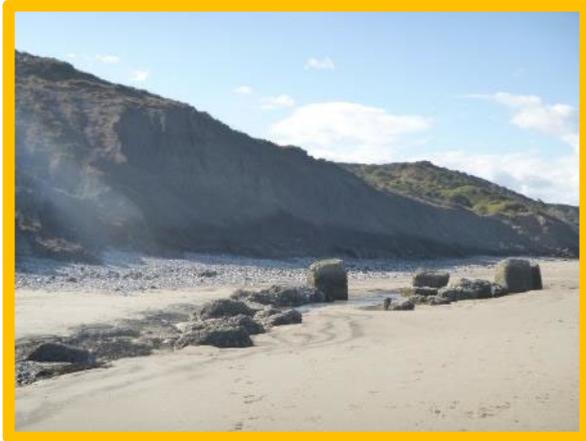
Unit MU29/CE is similar in form to unit MU29/CC. It has been downgraded to Partly Active in 2022 due to the steep eroding toe along sections. The upper slopes remain well vegetated.

Well vegetated upper slope above steep eroding toe **MU29/CE** Partly Active 2022

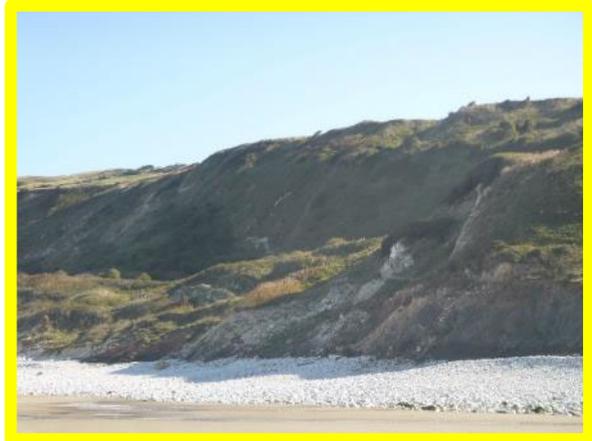
Units MU29/CF to MU29/CI are located at Speeton Cliffs and are all classified as Locally Active in 2022. These units are characterised by outcrops of chalk near the unit toes which are actively eroding onto the beach below. In places, the headscarp is near vertical and exposed.

Eroding chalk outcrop at toe **MU29/CF** Locally Active 2022

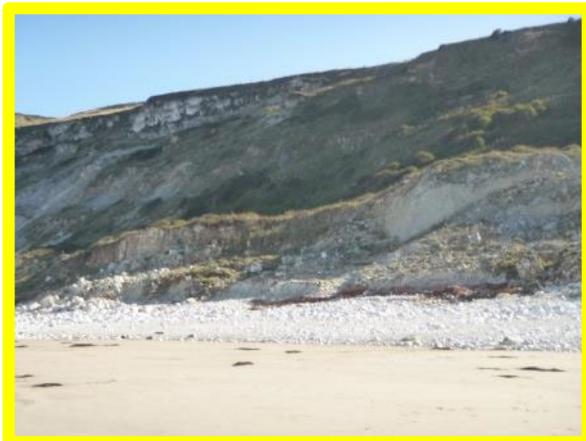
Eroding chalk outcrop at toe **MU29/CG** Locally Active 2022

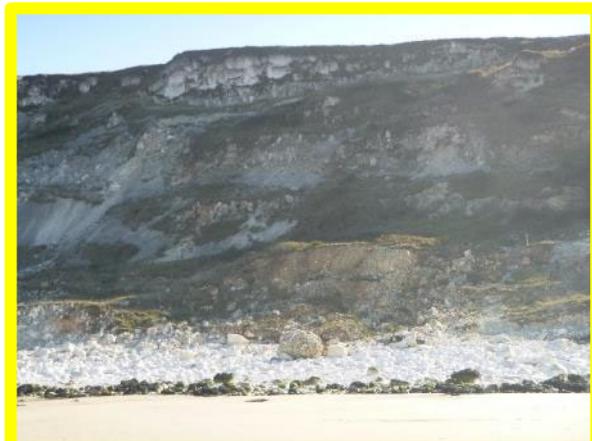
Evidence of ongoing erosion and activity on lower and mid-slope **MU29/CH** Locally Active 2022
