Ongoing Analysis and Interpretation of Coastal Monitoring Data

Review of First Additional Suite Monitoring

Geotechnical Interpretative Report

February 2010

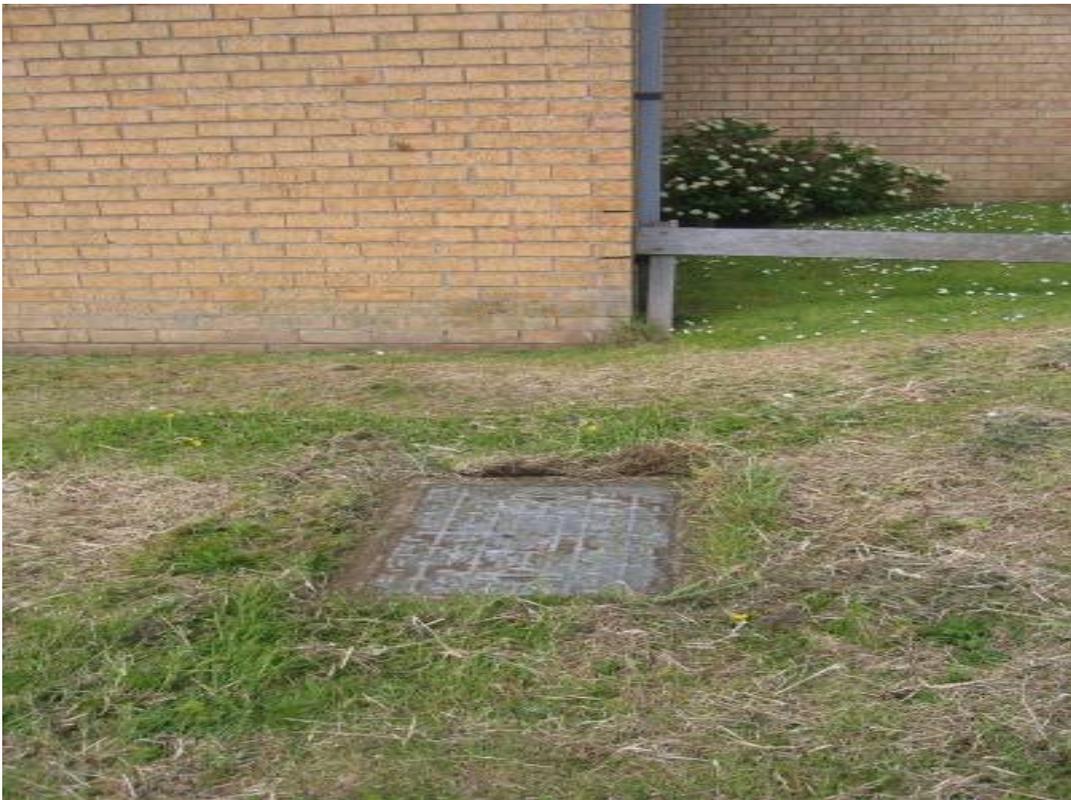
Plate 13 Scalby Ness P1

On the north east over-steepened slopes, fresh spalling and minor slumping (Appendix H, Plate 13 and 14) has occurred immediately below the headscarp although not to the same extent as the north west slopes. In the mid-slope

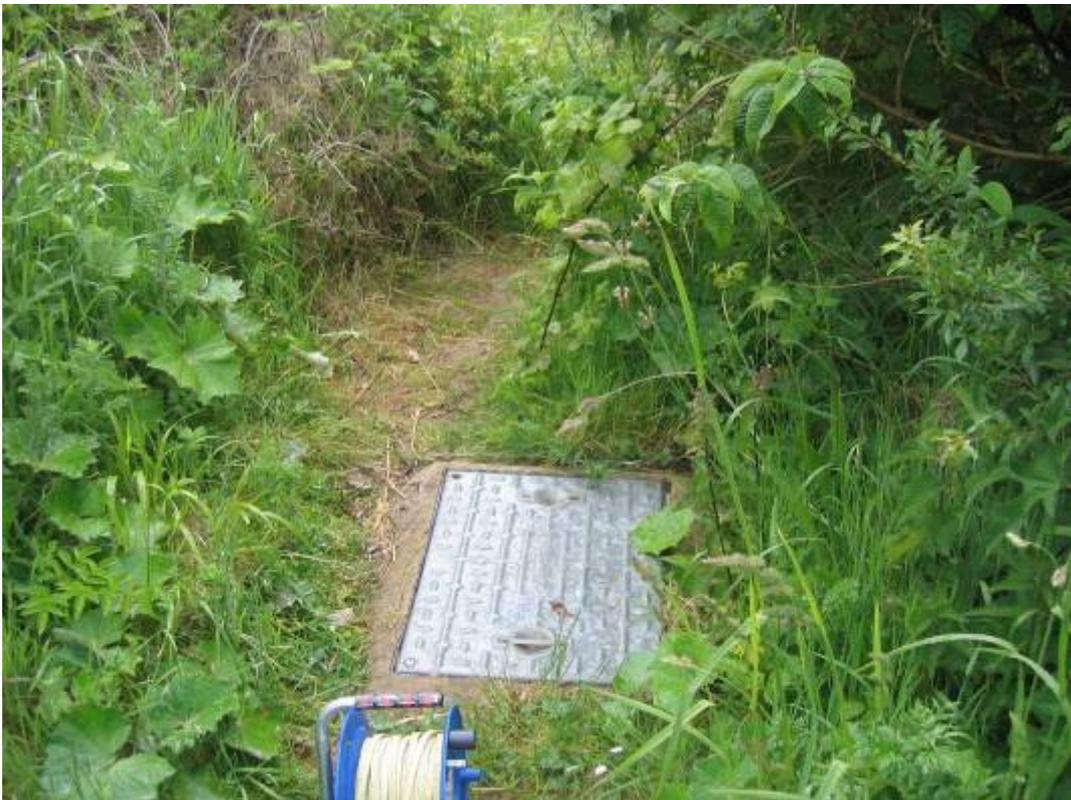
Plate 15 Scalby Ness P3

area large ponds of rain water have formed between the backscarp and the mid-slope deep seated, back-tilted block (Appendix H, Plate 17) and widened tension cracks accompanied by slope collapse were observed lower down the slopes (Appendix H, Plate 15 and 16). It is evident that recent periods of heavy rain have resulted in some degradation of the slopes of Scalby Ness.

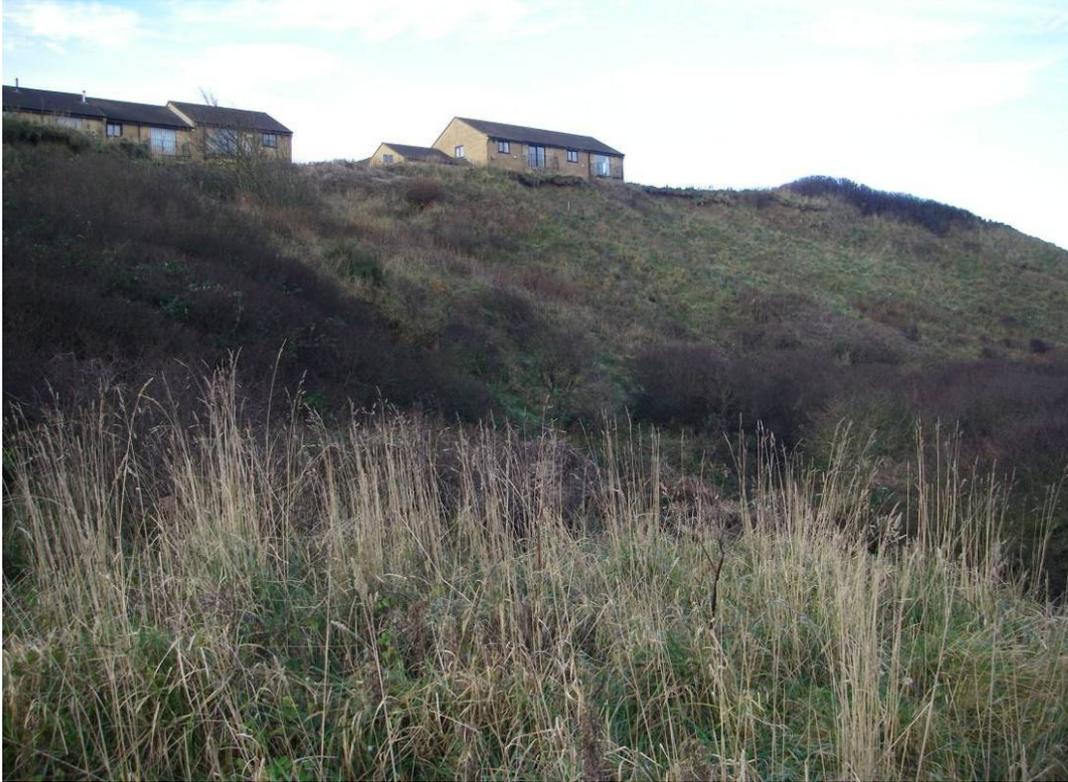
Plate 7 Site view of Behaviour Unit II showing over steepened back-scarp below Upper Plateau (November 2008).

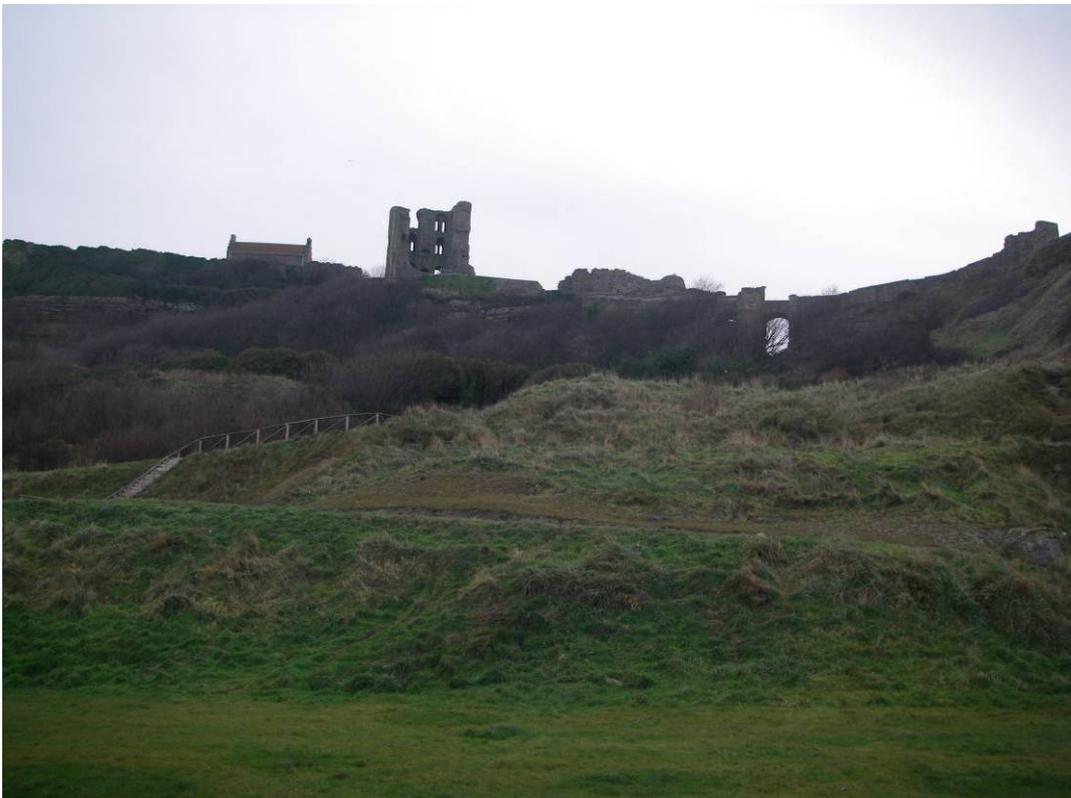
Plate 12 Site view of The Holms towards Castle Cliff.

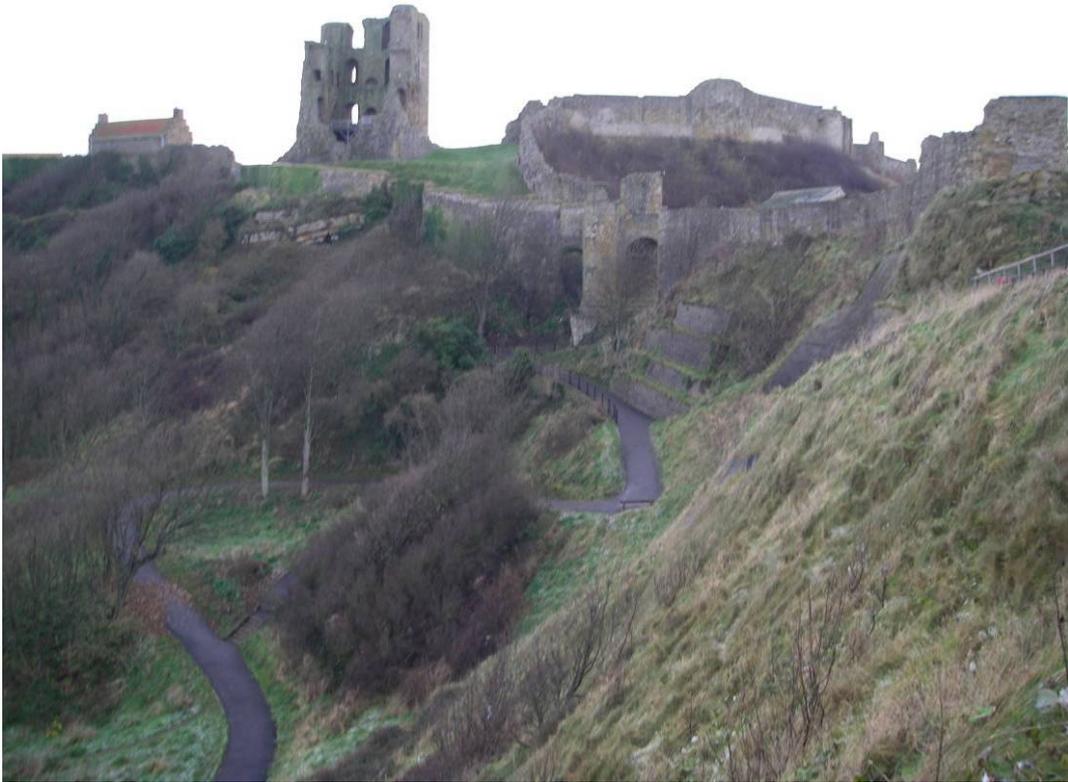
Plate 13 Site view of The Holms looking up towards Scarborough Castle.

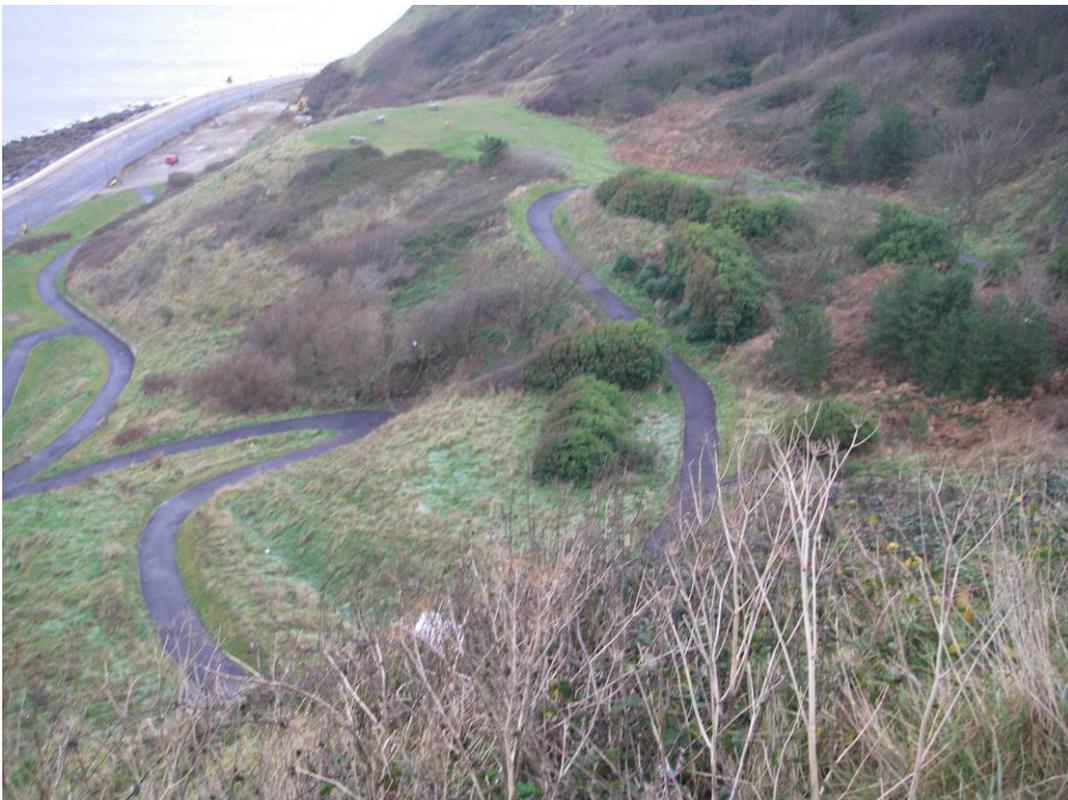
Plate 14 Site view of the Castle from Castle-by-The-Sea. (Note retaining walls in the mid-ground).

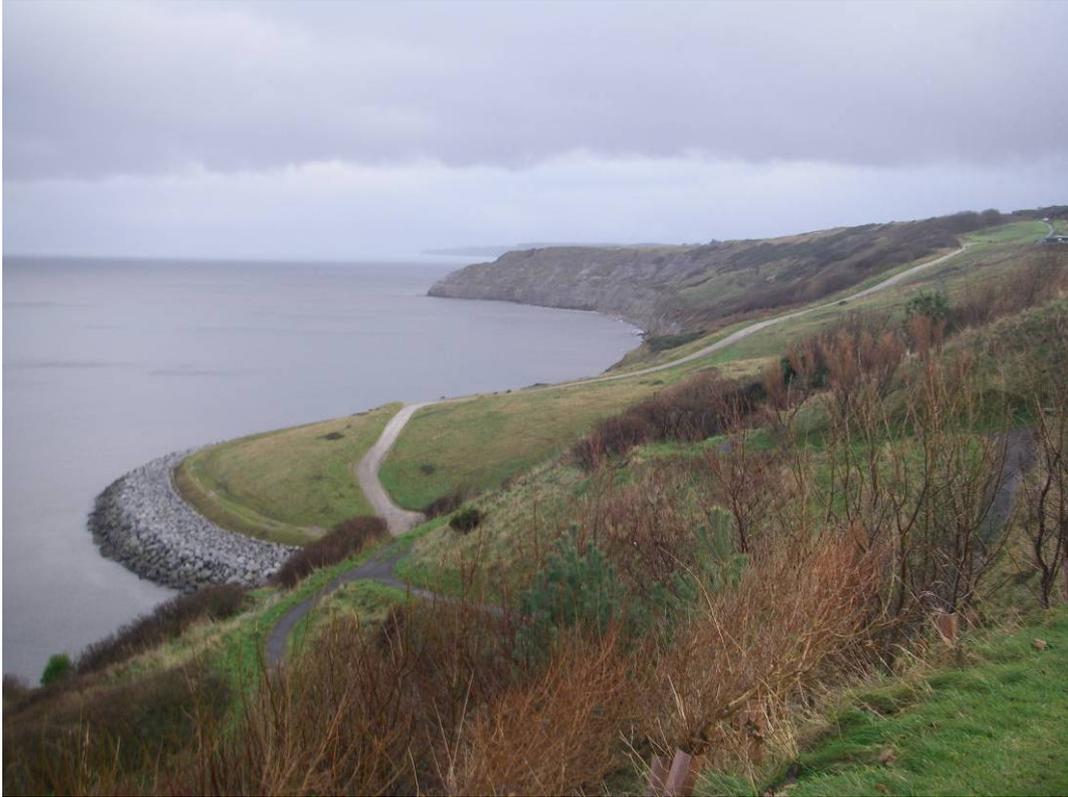
Plate 15 Site view of The Holms

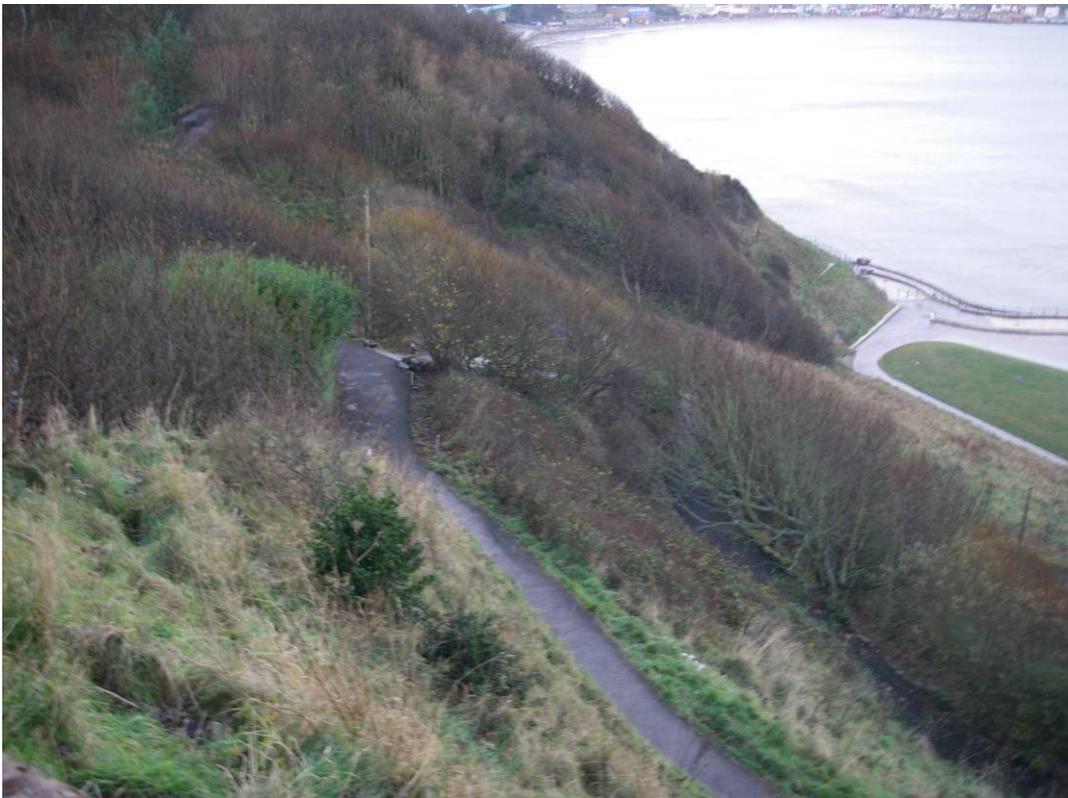
Plate 16 Site view looking south towards Holbeck Gardens and Holbeck Cliff.

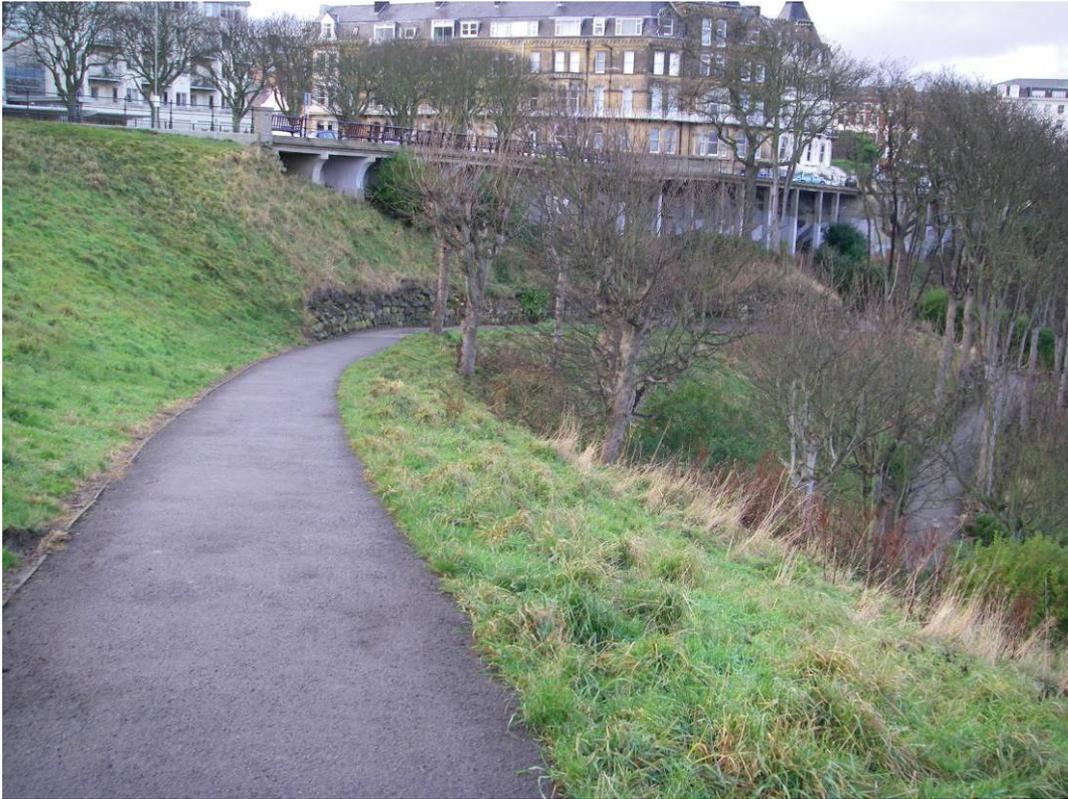
Plate 17 Site view showing steep slope angles above South Bay Pool Cliff.

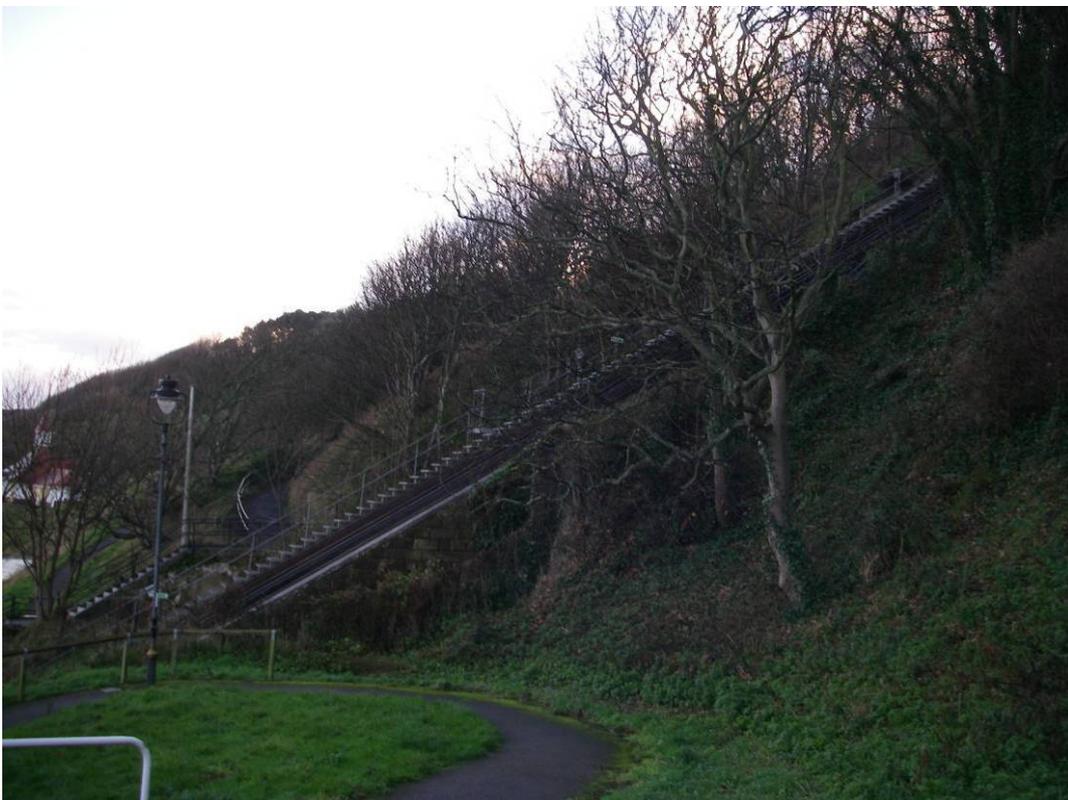
Plate 18 Site view looking north at arcuate embayment at South Cliff Gardens.

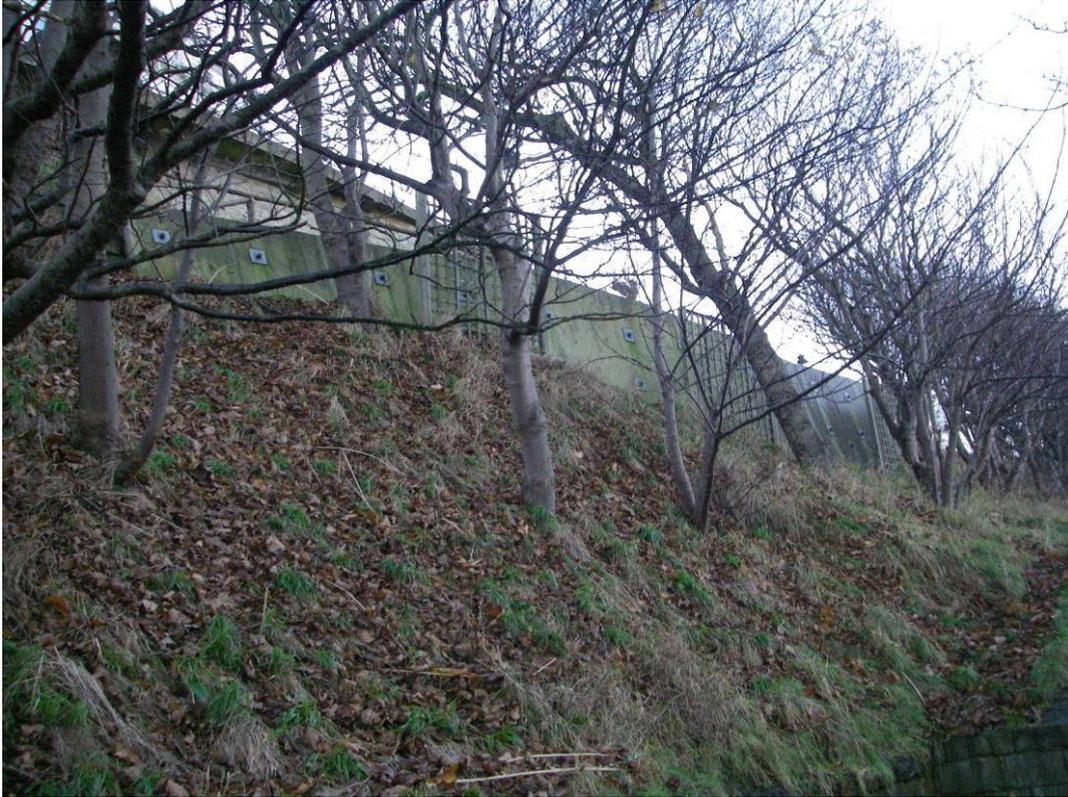
Plate 19 Site view looking south at the cliff railway and slopes of Prince of Wales Cliff.

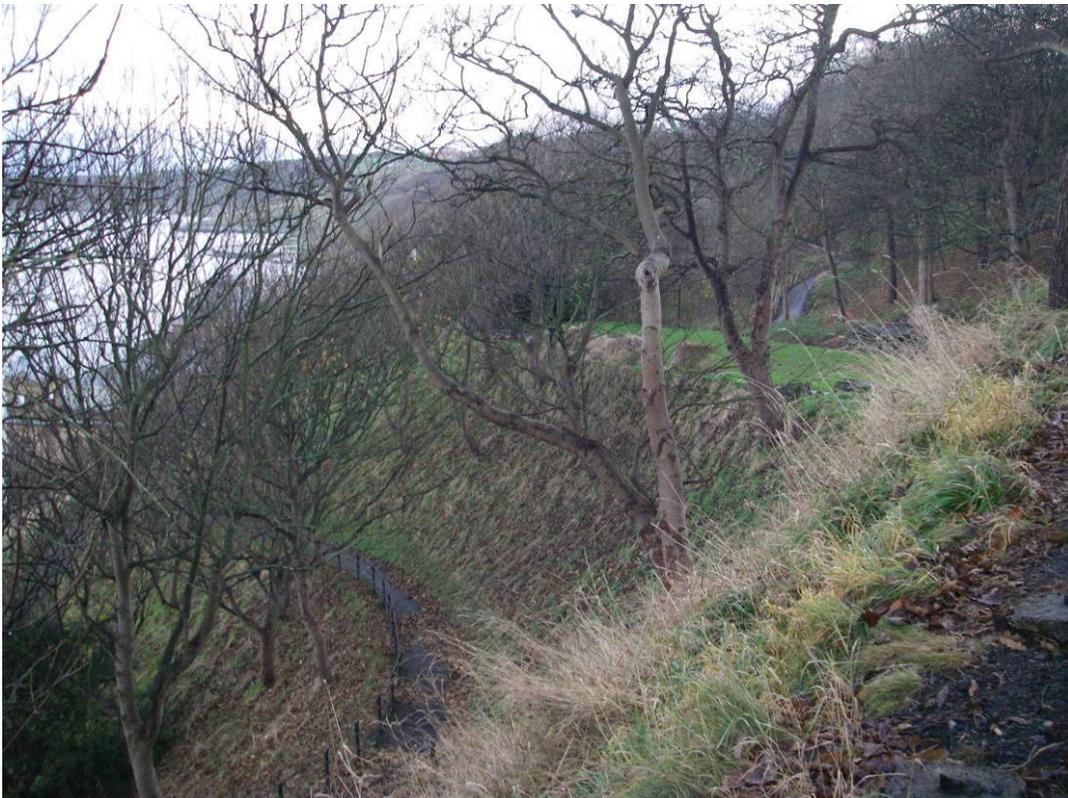
Plate 20 Site view of slope crest retaining walls at Prince of Wales Cliff.

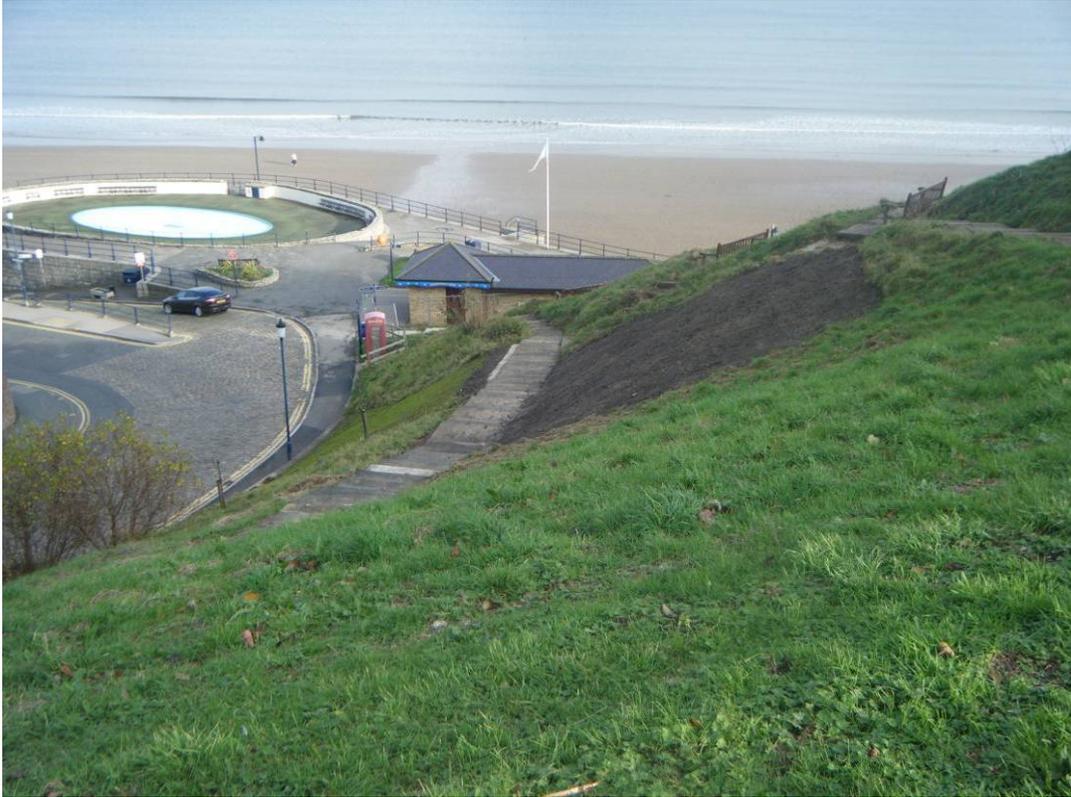
Plate 21 Site view looking south across Spa Cliff showing steep slope angles and bench-cut paths.

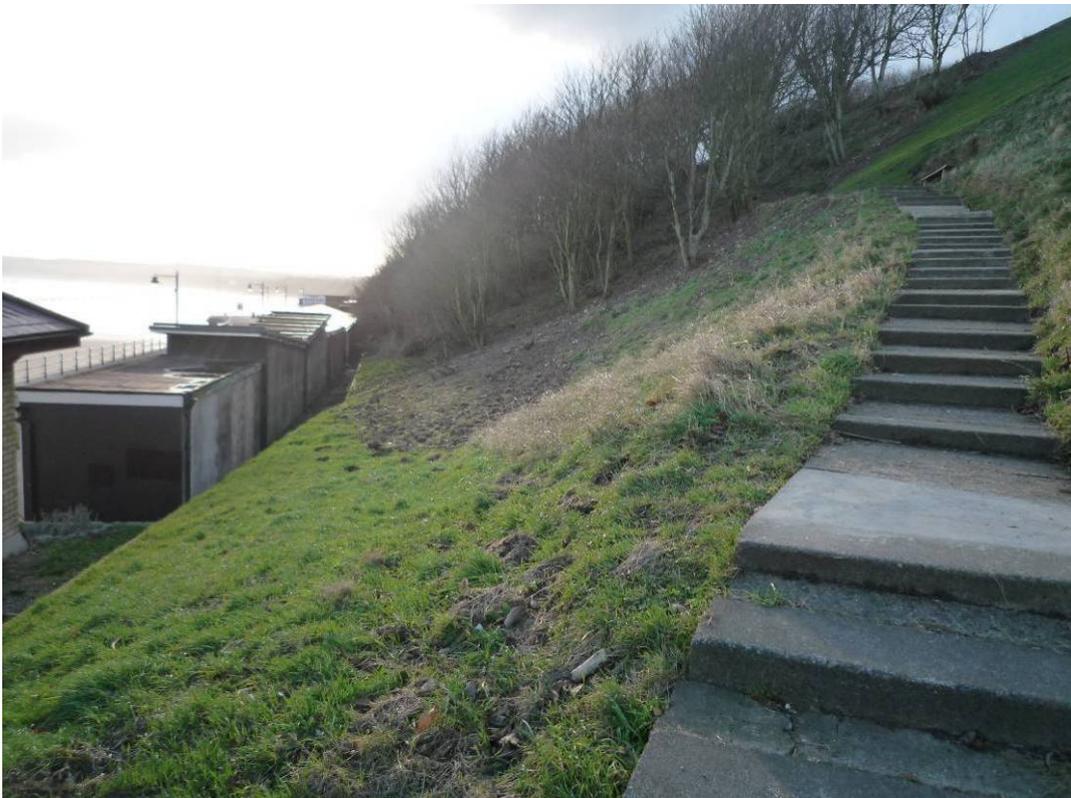
Plate 22 Site view of Crescent Hill from Glen Gardens.

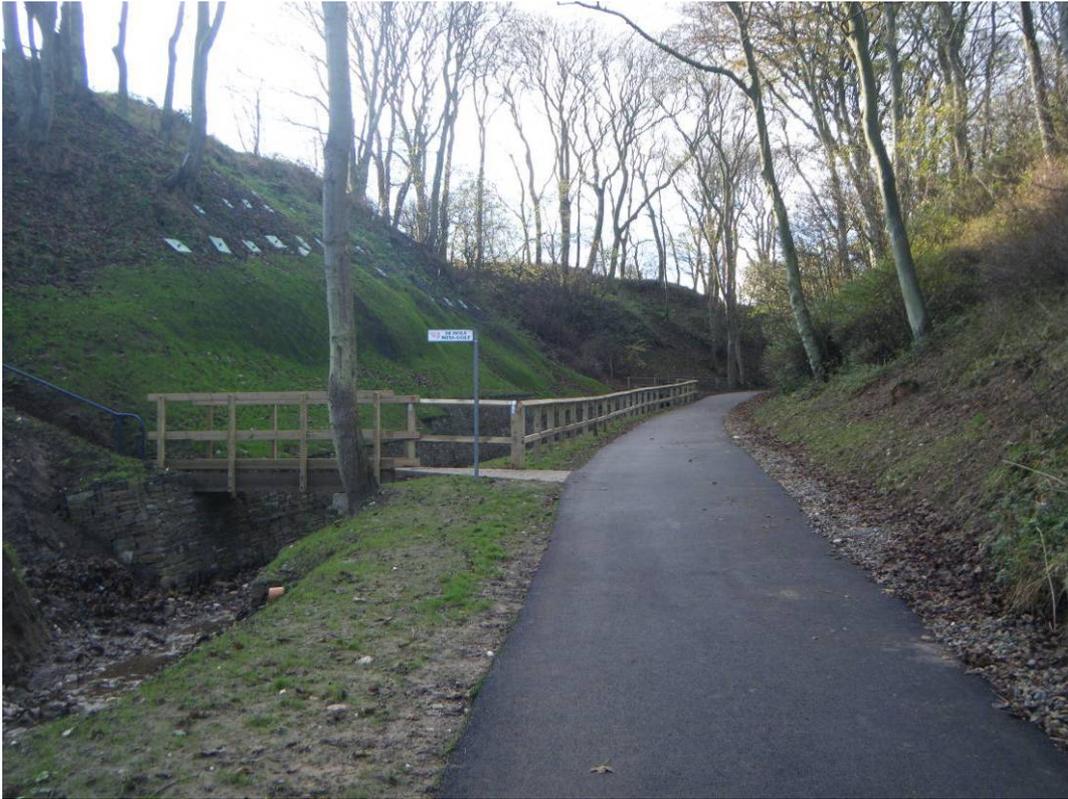
Plate 23 Site view of slopes behind chalets on Royal Parade.

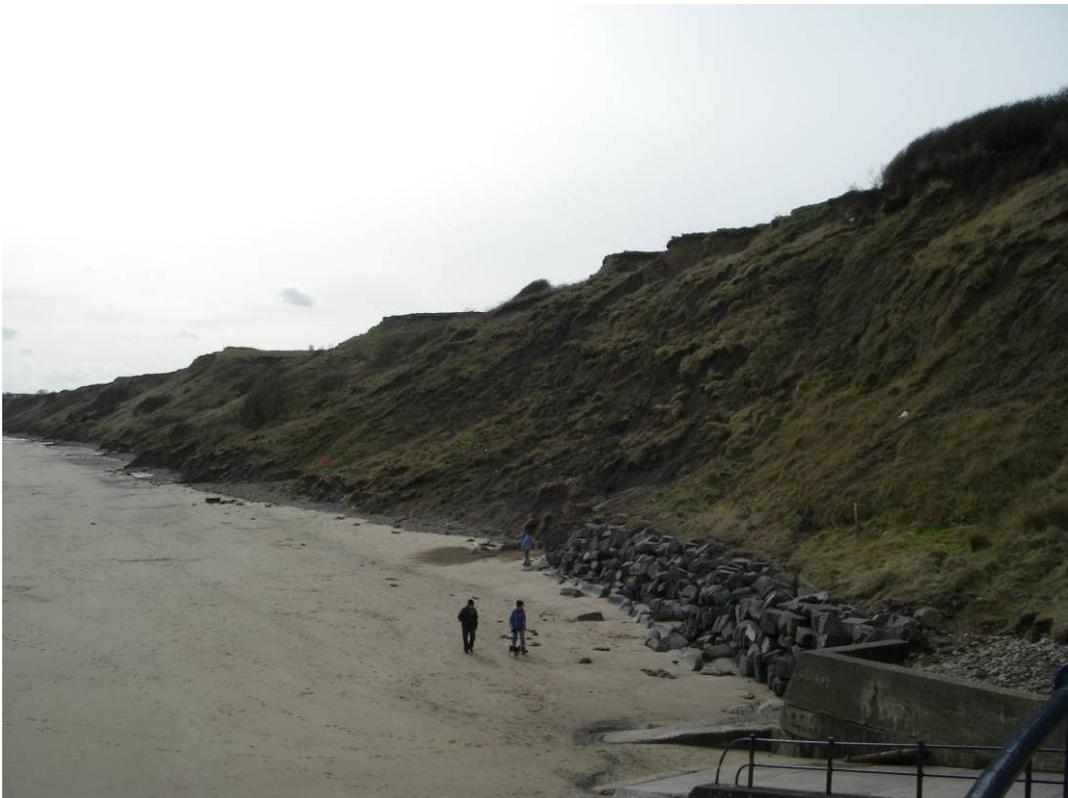
Plate 24 Site view looking up Martin's Ravine. (Remediated slopes on left).

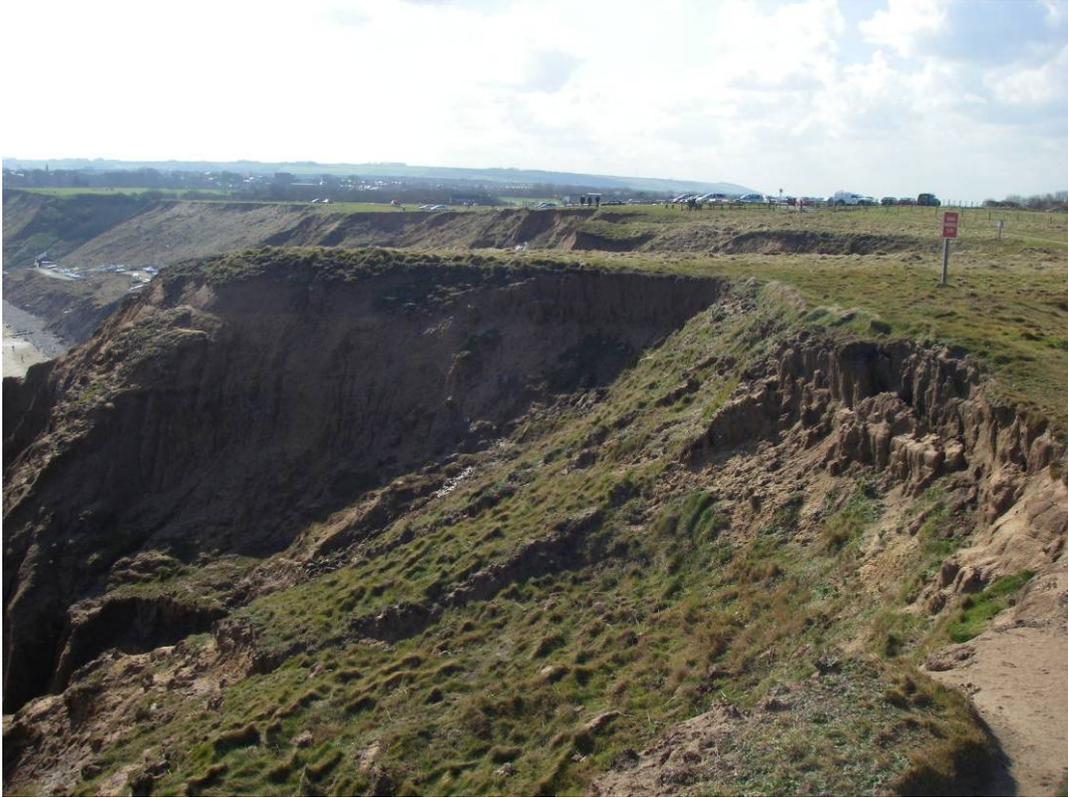
Plate 25 Site view of coastal slopes immediately south of Martin's Ravine.

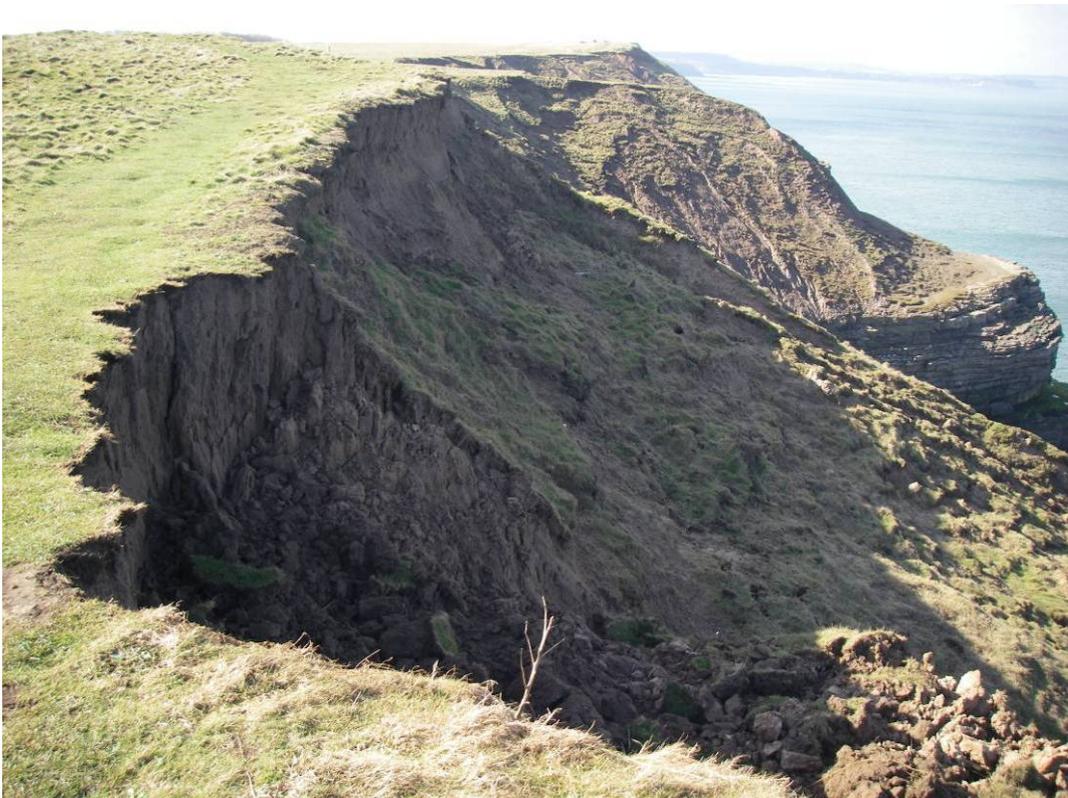
Plate 26 Site view of Filey Brigg looking west.

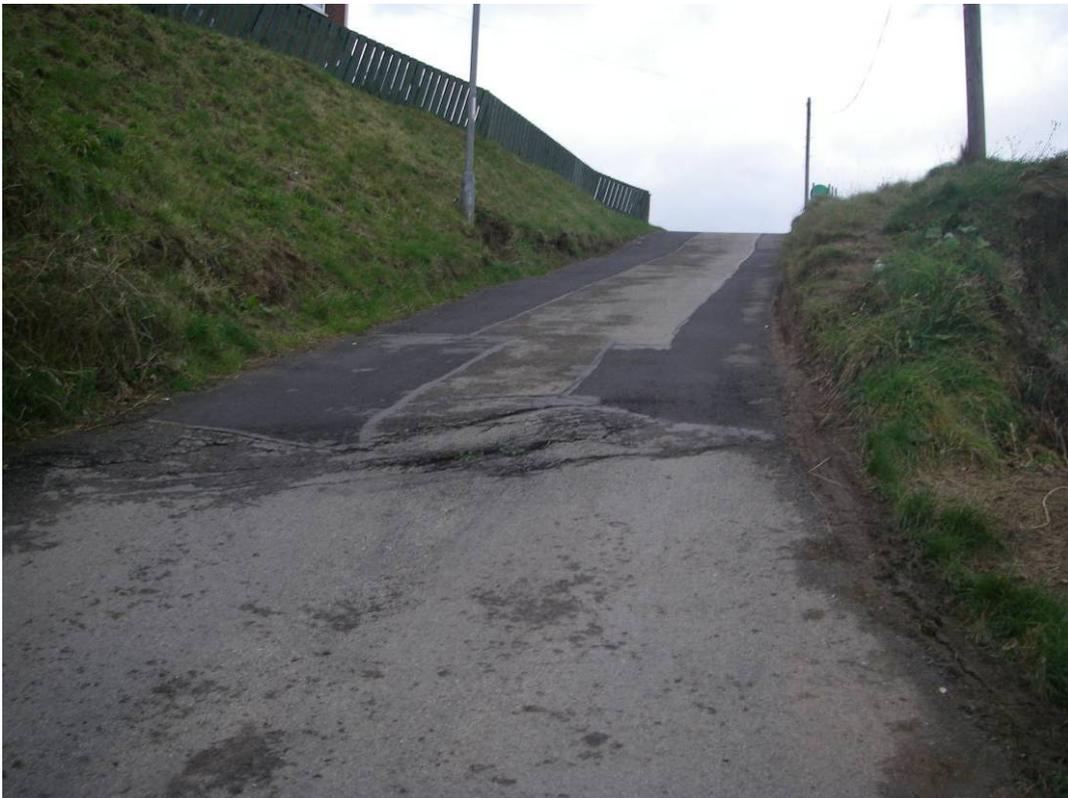
As porewater pressures increase within the slopes, this can lead to a decrease in the stability of the slopes by causing a reduction in shear strength. These effects are more pronounced during periods of intense, heavy rainfall and where such an event follows a dry period this can cause a sudden increase in pore water pressures in the slopes. Any desiccation and tension cracks which may have developed will permit the ingress of rainwater into the slopes quickly leading to slope instability. Further evidence of slight ground movements is provided in the form of cracking within the surface tarmac of the access road which has advanced over a short period of time. Plates 32 and 33 (Appendix L) show surface cracking and a repair composed of tar poured into the developed cracks. The repair was carried out some time during August 2009 and since then it is apparent that the cracks have continued to develop in line with ground movements. Other evidence of ground movements is a ridge that has developed across the road near the top of the access road. This has noticeably increased in size over the period monitoring visits have taken place. Plate 29 (Appendix L) shows this bulge although its development is not very apparent from the photograph.

Plate 28 Site view looking south across Filey Bay towards Flamborough Head.
