Ongoing Analysis and Interpretation of Coastal Monitoring Data

Review of Second Additional Suite Monitoring

Geotechnical Interpretative Report

Document Ref. No. 721229/021/GIR/002/Final

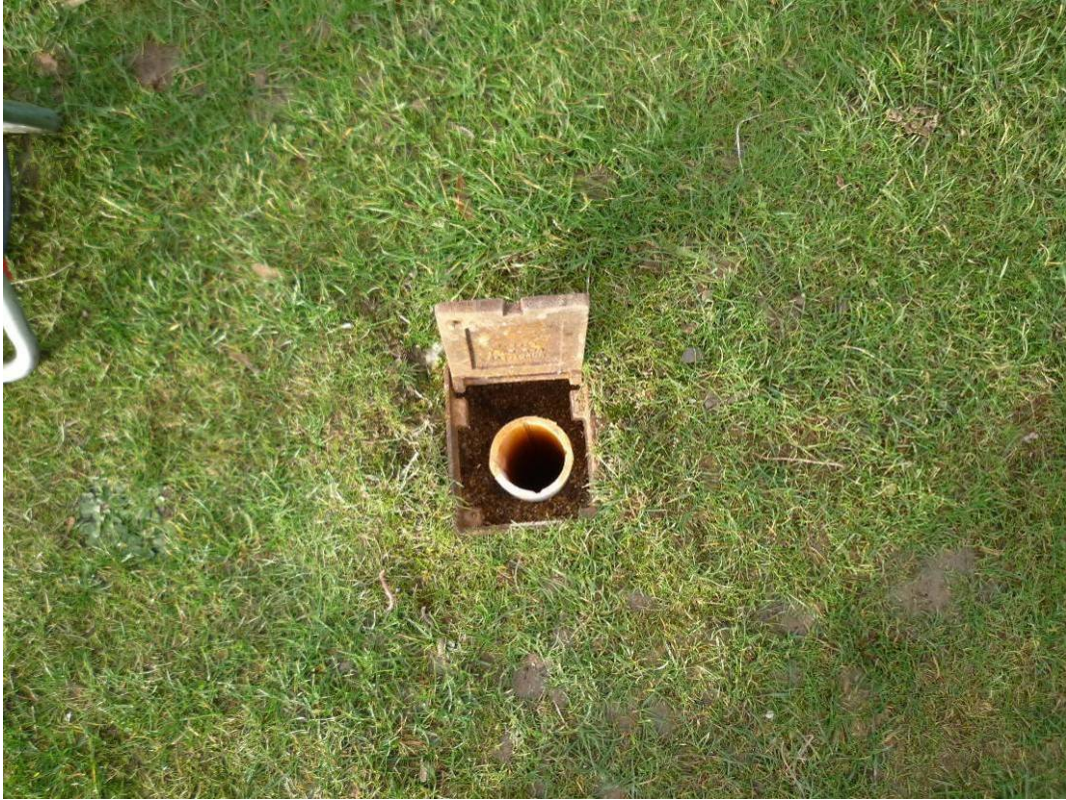
Plate 93 Filey Town BH02 (Flooded Headworks)

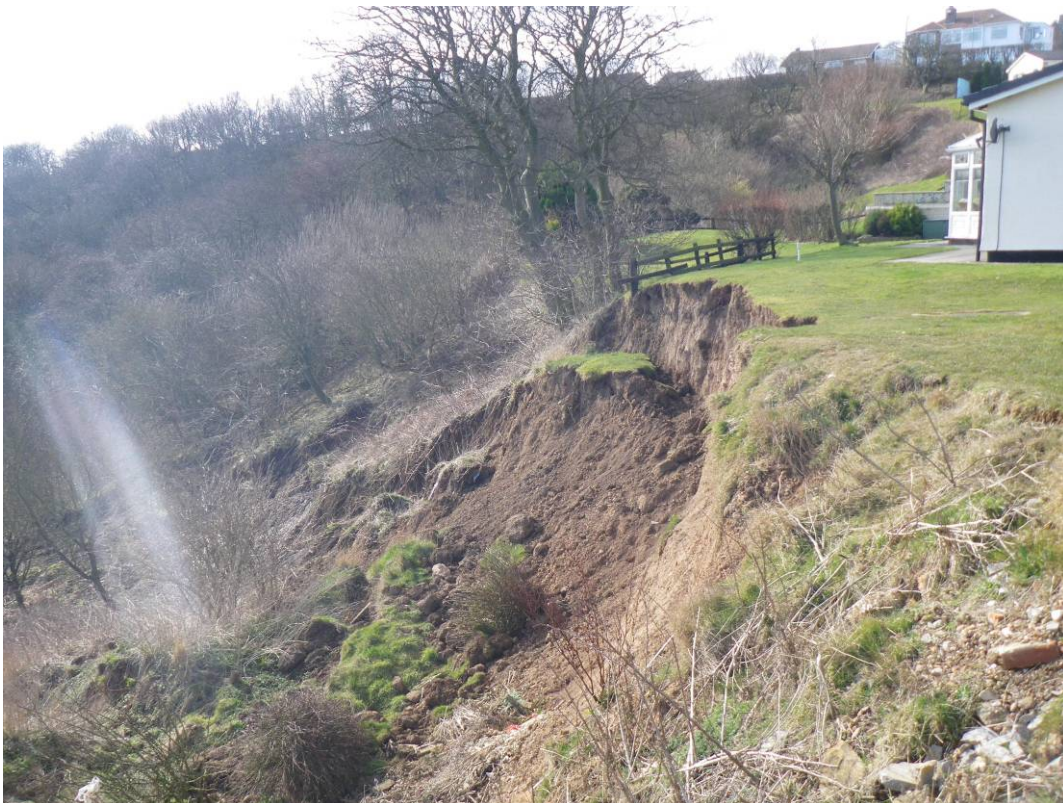
Plate 27 Cliff recession at Knipe Point Headland (16th March 2010)

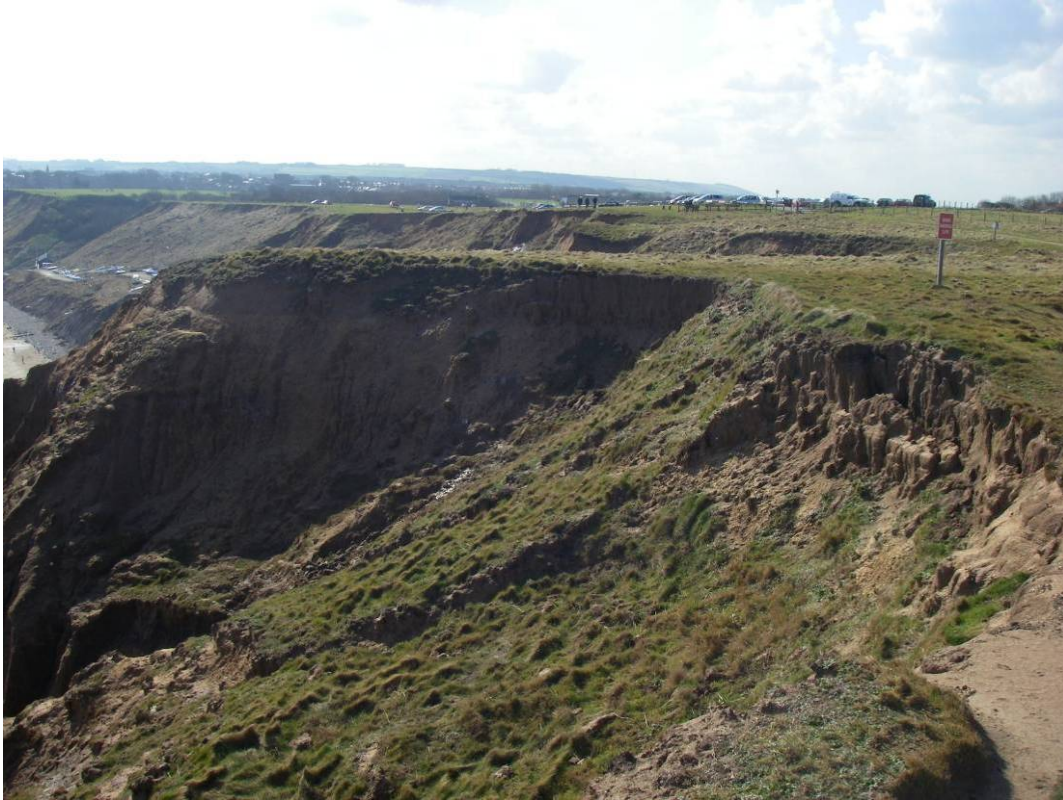
Plate 36 Site view of Filey Brigg looking west.

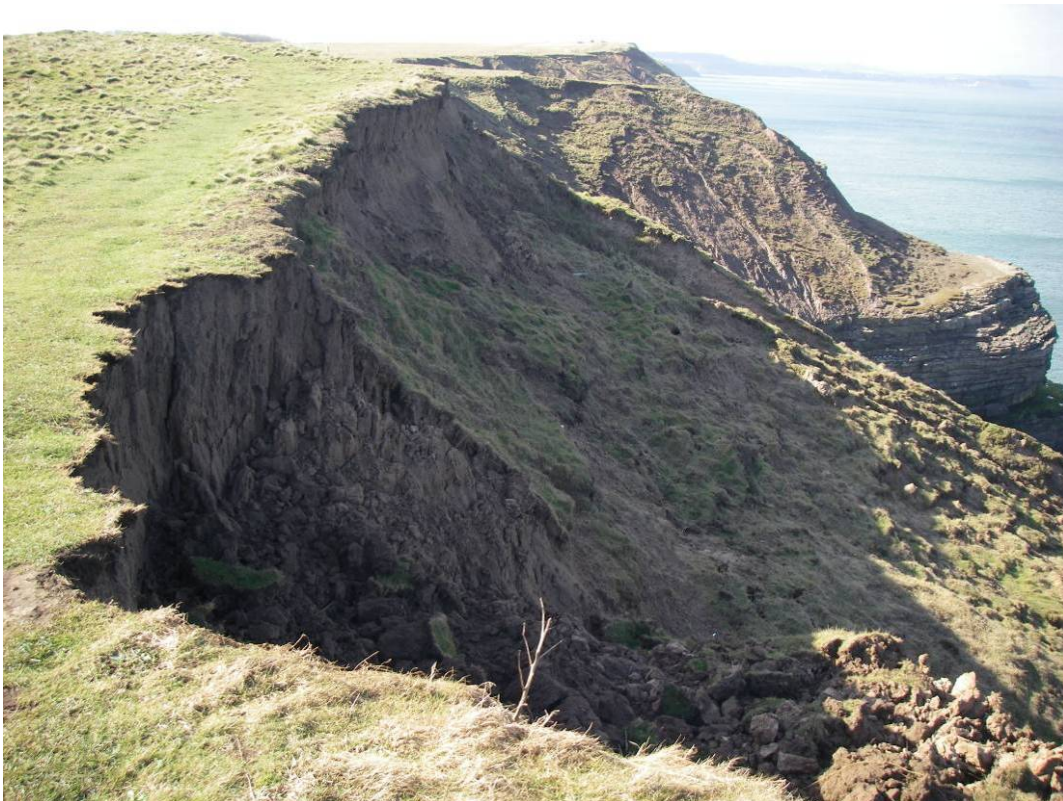
Plate 37 Site view looking east at slumped glacial tills along Filey Brigg.

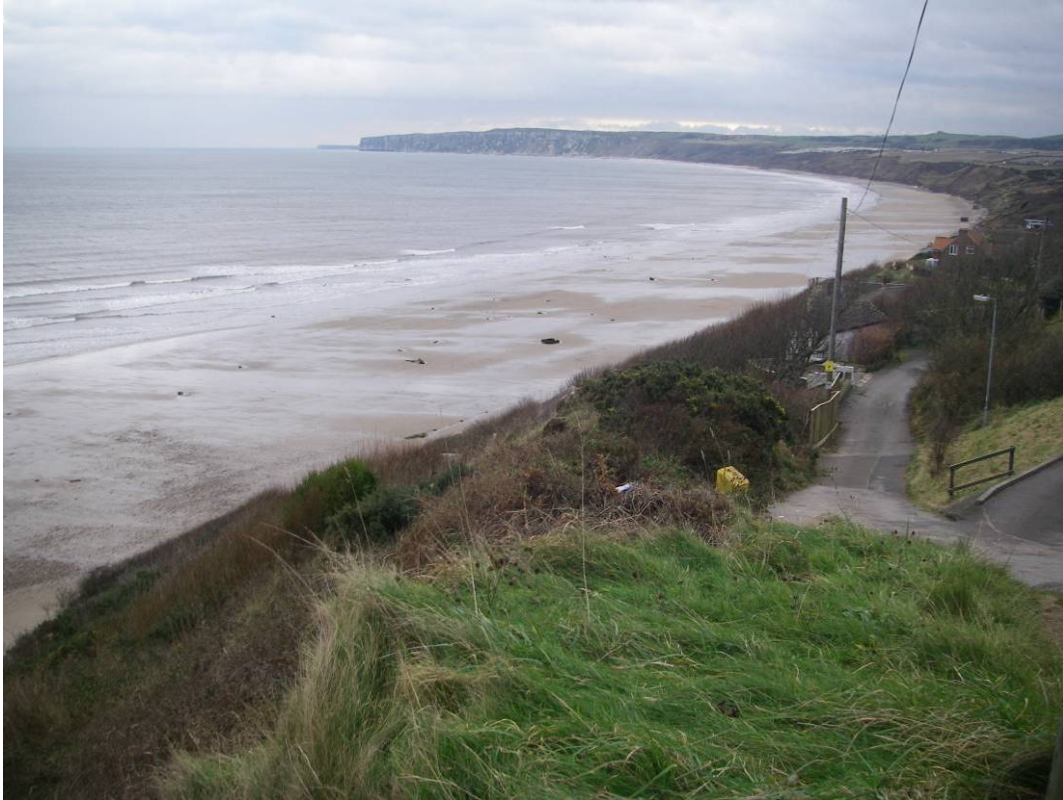
Plate 38 Site view looking south across Filey Bay towards Flamborough Head.

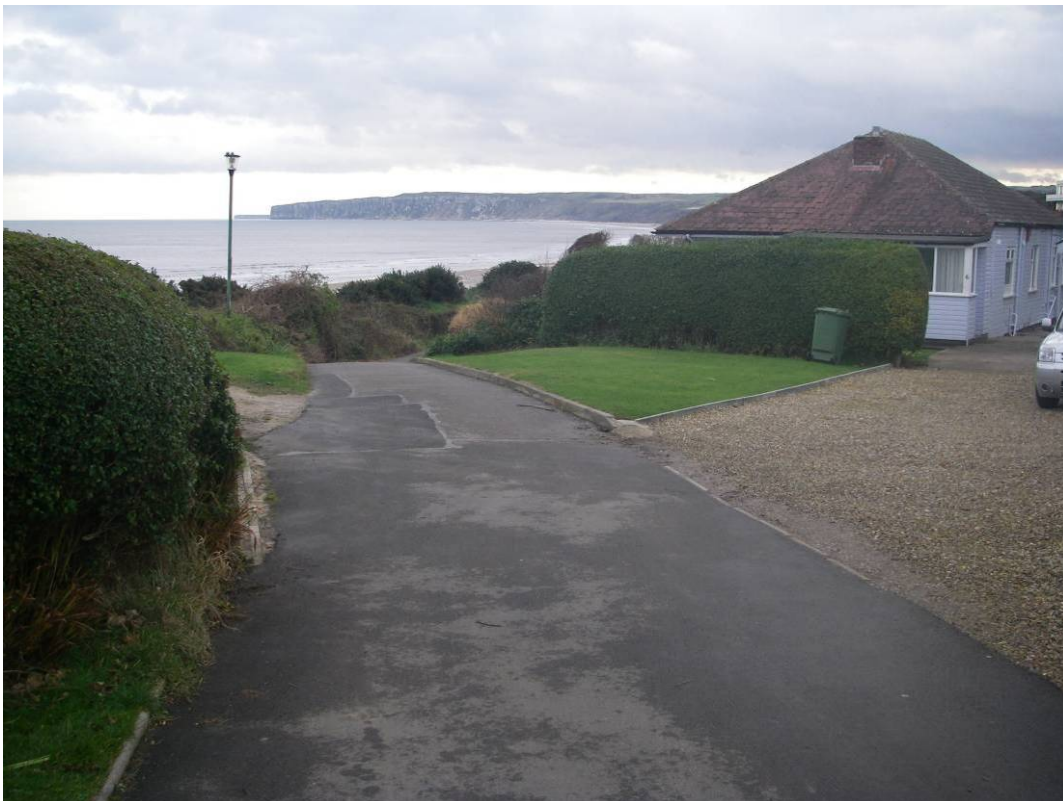
Plate 41 Site view looking down slope from 'level' mid-slope bench.

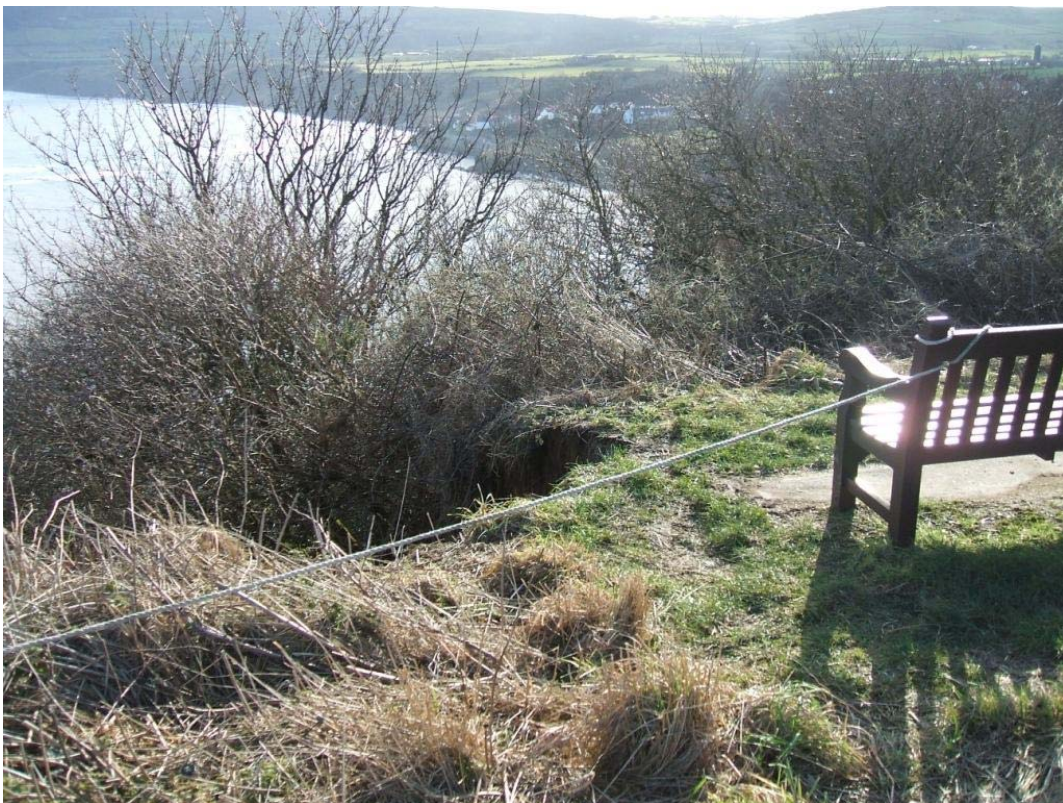
Plate 4 Cliff erosion at Robin Hood's Bay

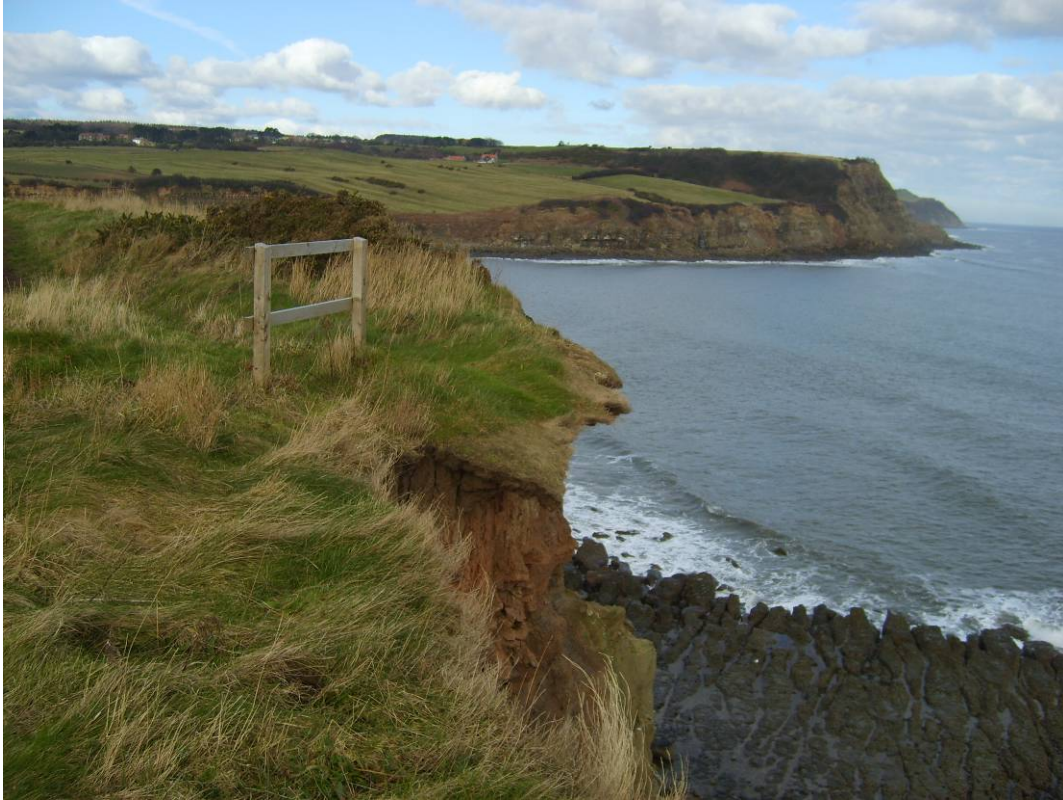
Plate 7 Cliff erosion at Hundale

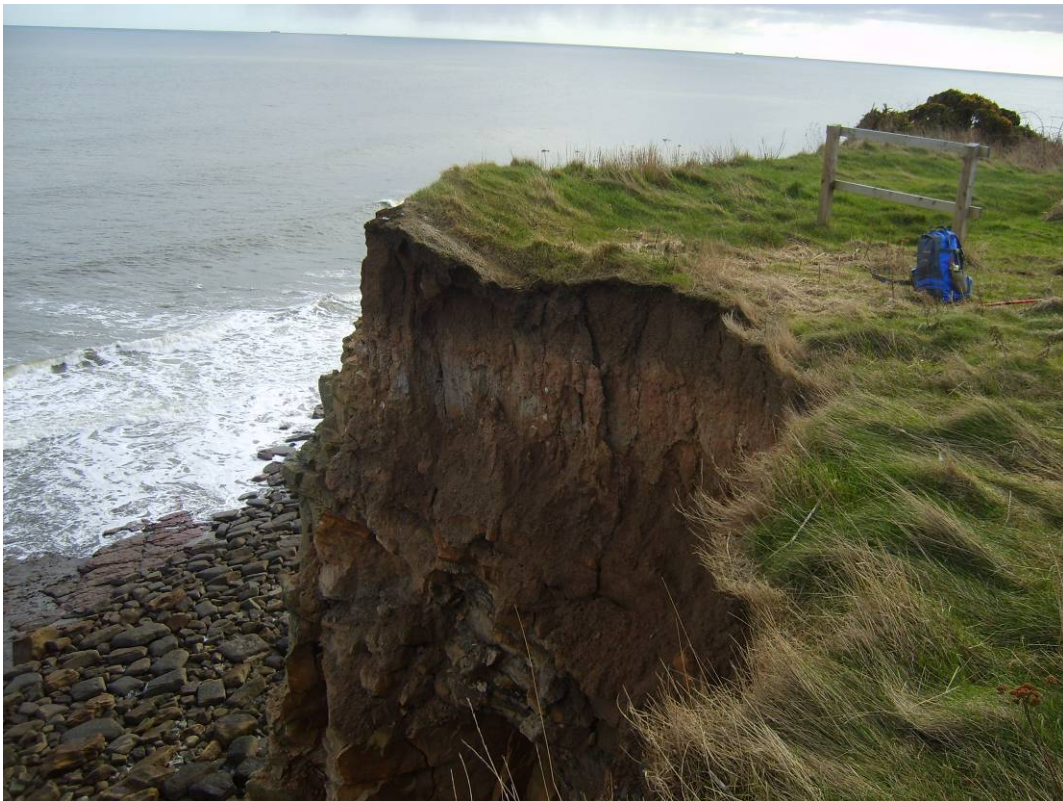
Plate 8 Cliff erosion at Hundale
