Ongoing Analysis and Interpretation of Coastal Monitoring Data

Fourth Review of Full Suite Monitoring

Geotechnical Interpretative Report

Document Ref. No. 721229/002/GIR/011/Final

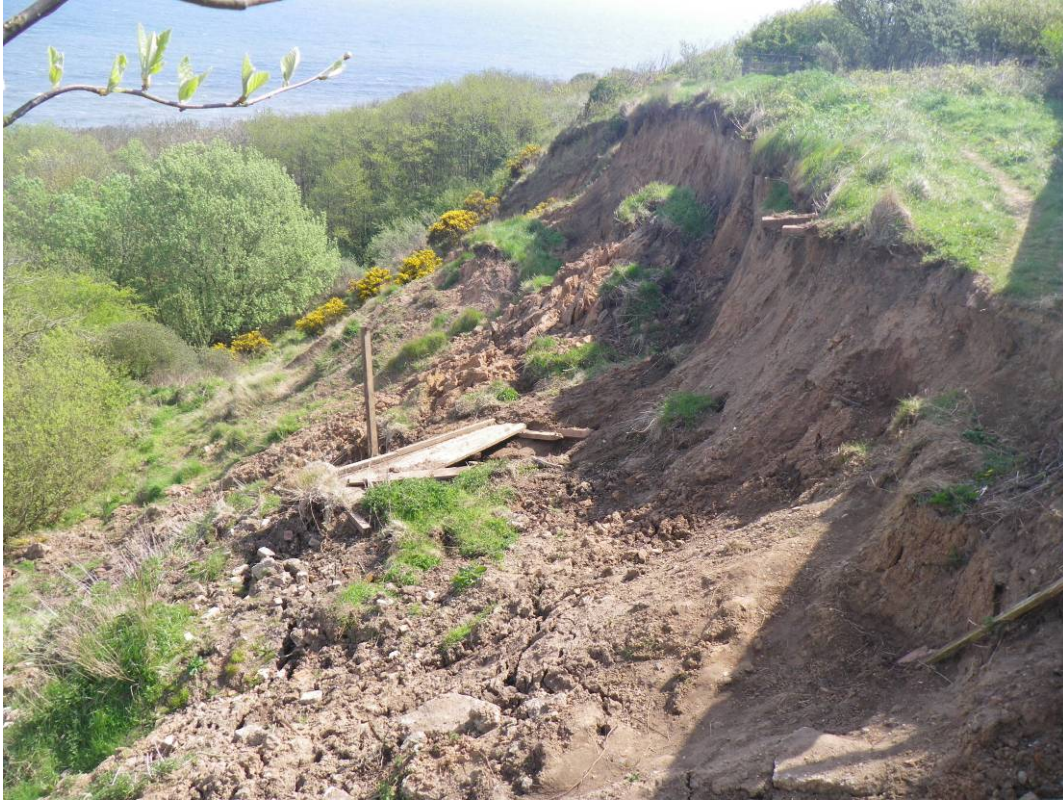
Plate 3 Cornelian Bay side of Knipe Point looking east (5th May 2010)

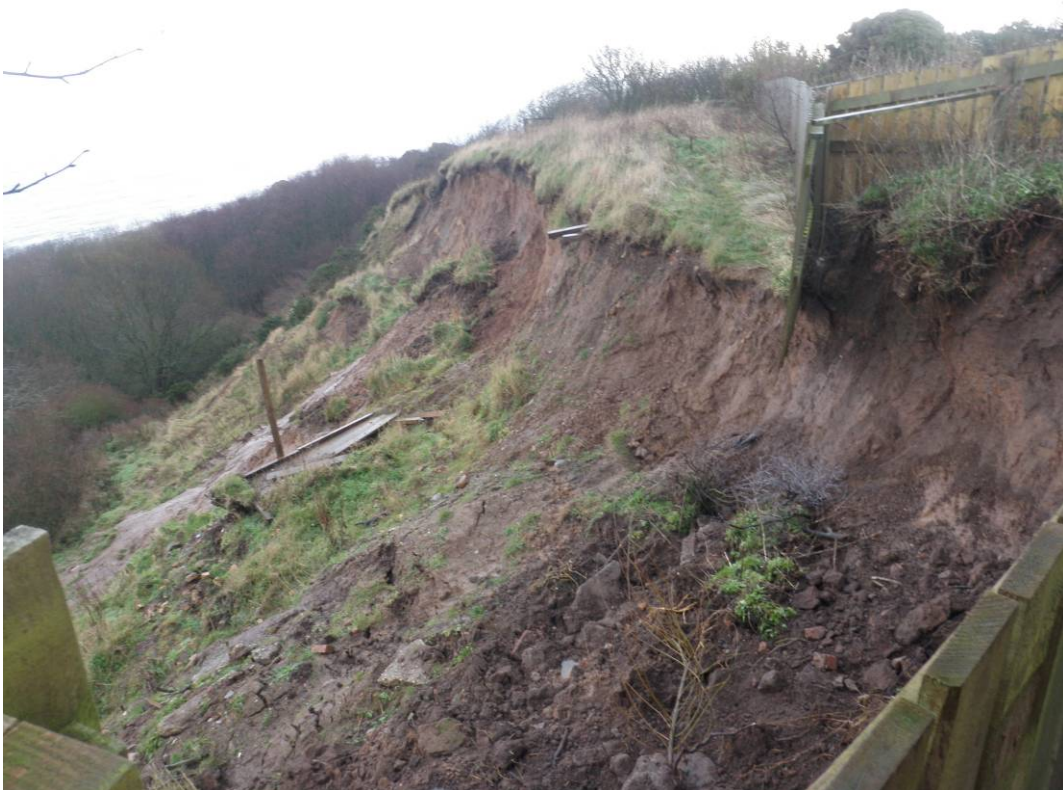
A photographic record of the site, presented in Appendix J, shows the degradation of the headscarps under observation particularly the areas around monitoring points C01 to 08 and H04 to 11. At Cornelian headland most of the original monitoring points have been lost to cliff recession, C01 and C04 are still used although C08 has been repositioned inland and measurements are taken in a northerly and easterly direction. Recession at C08 continues in a northerly direction although eastwards, recession rates have significantly accelerated since June 2010 with approximately 2.0 metres of land being lost to cliff recession (see Plates 1 to 4, Appendix J).

Plate 4 Cornelian Bay side of Knipe Point looking east (13th December 2010)

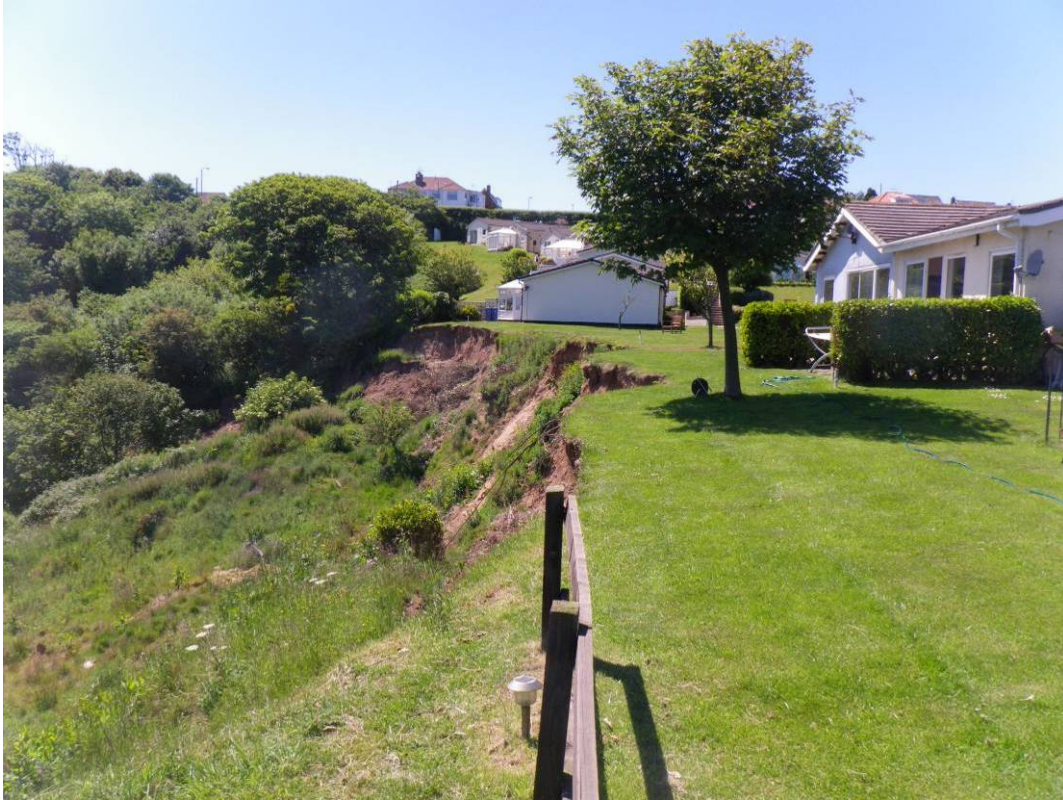
Plate 7 Cliff recession at Knipe Point Headscarp (17th June 2010)

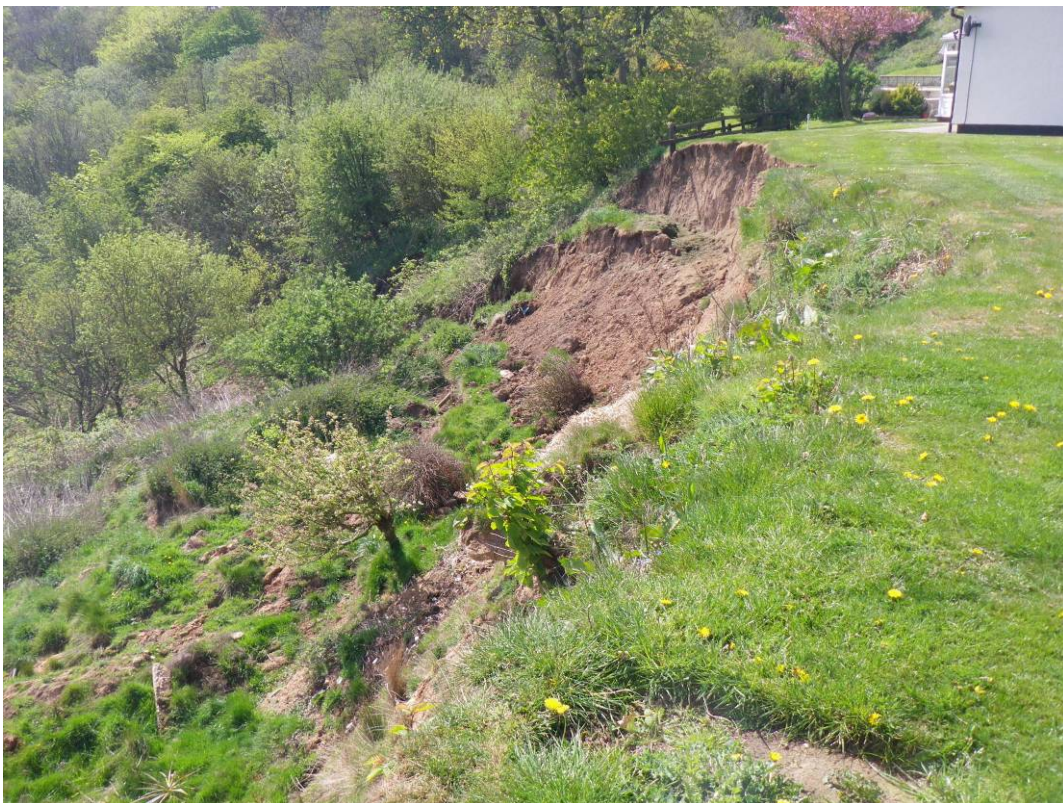
Plate 12 Cliff recession at Knipe Point Headland (5th May 2010)

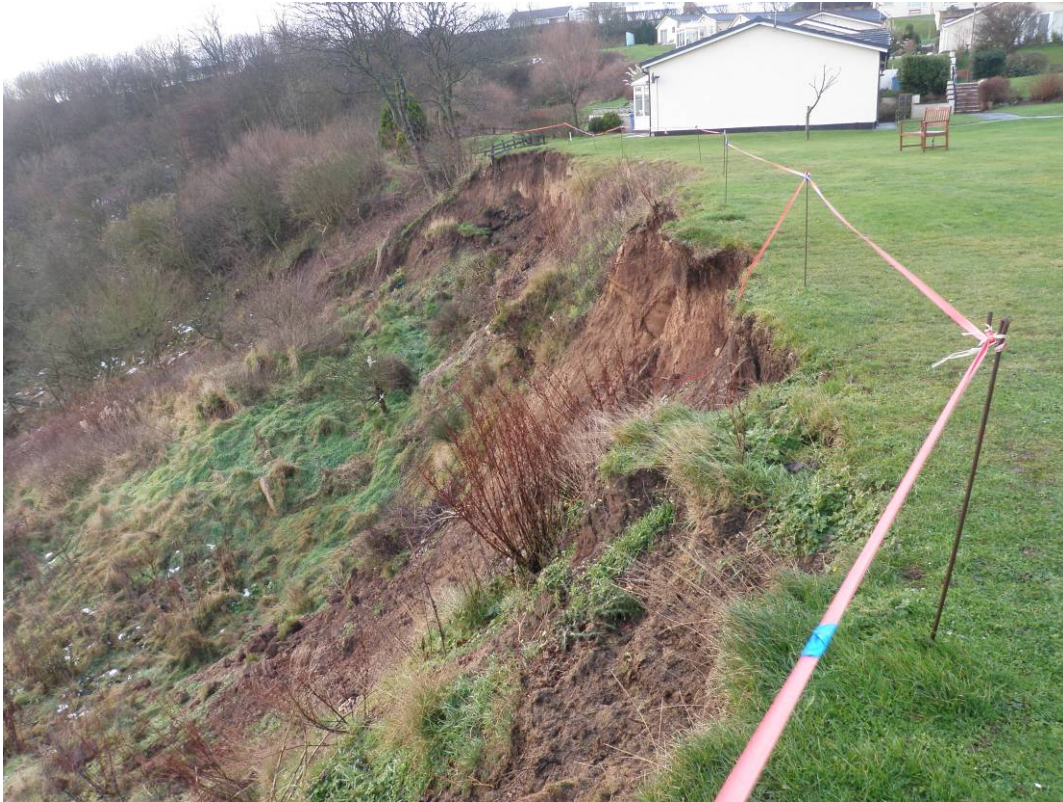
Plate 13 Cliff recession at Knipe Point Headland (13th December 2010)

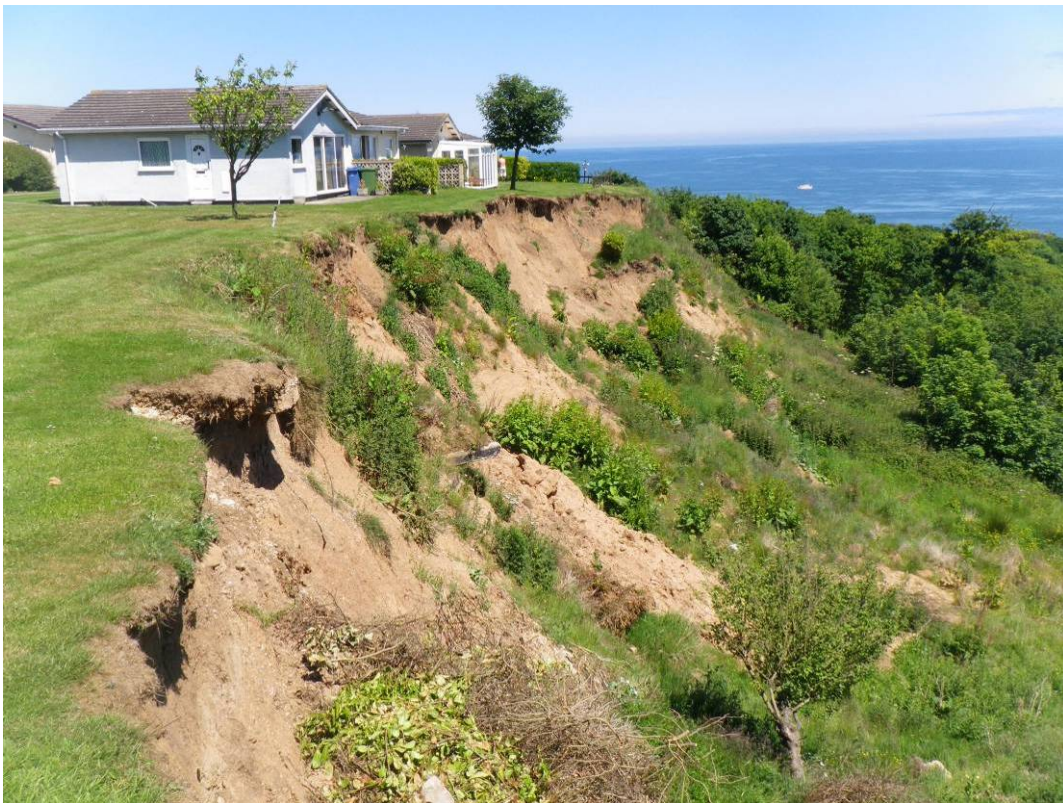
Plate 14 Cliff recession at Knipe Point Headland looking east (17th June 2010)

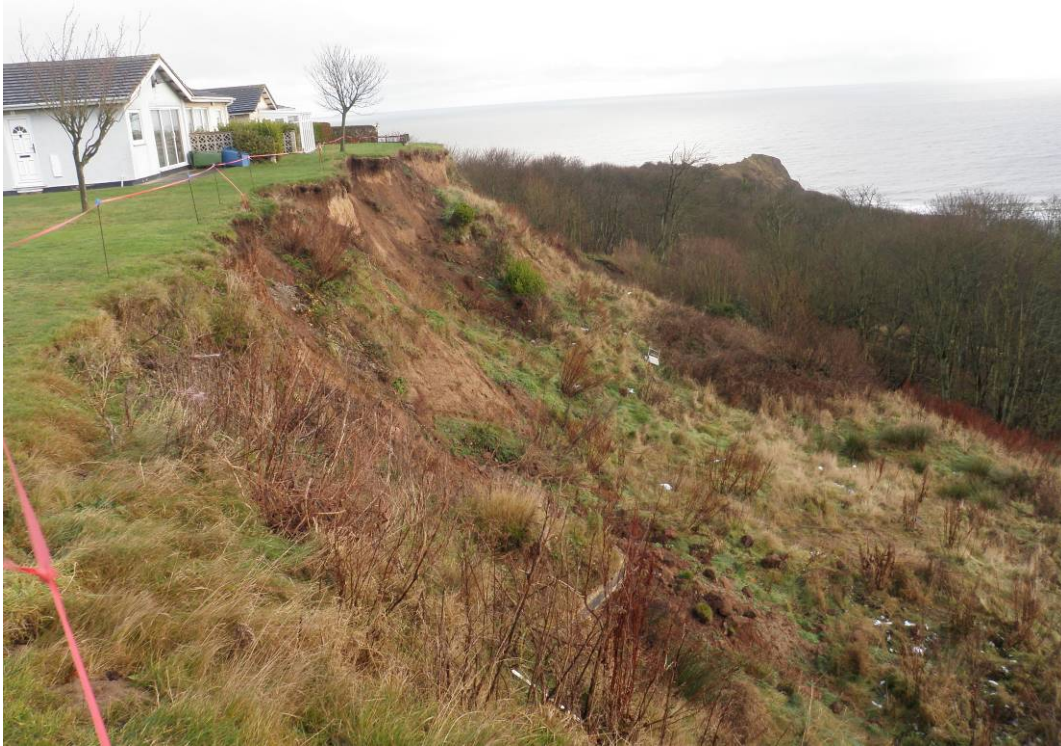
Plate 15 Cliff recession at Knipe Point Headland looking east (13th December 2010)

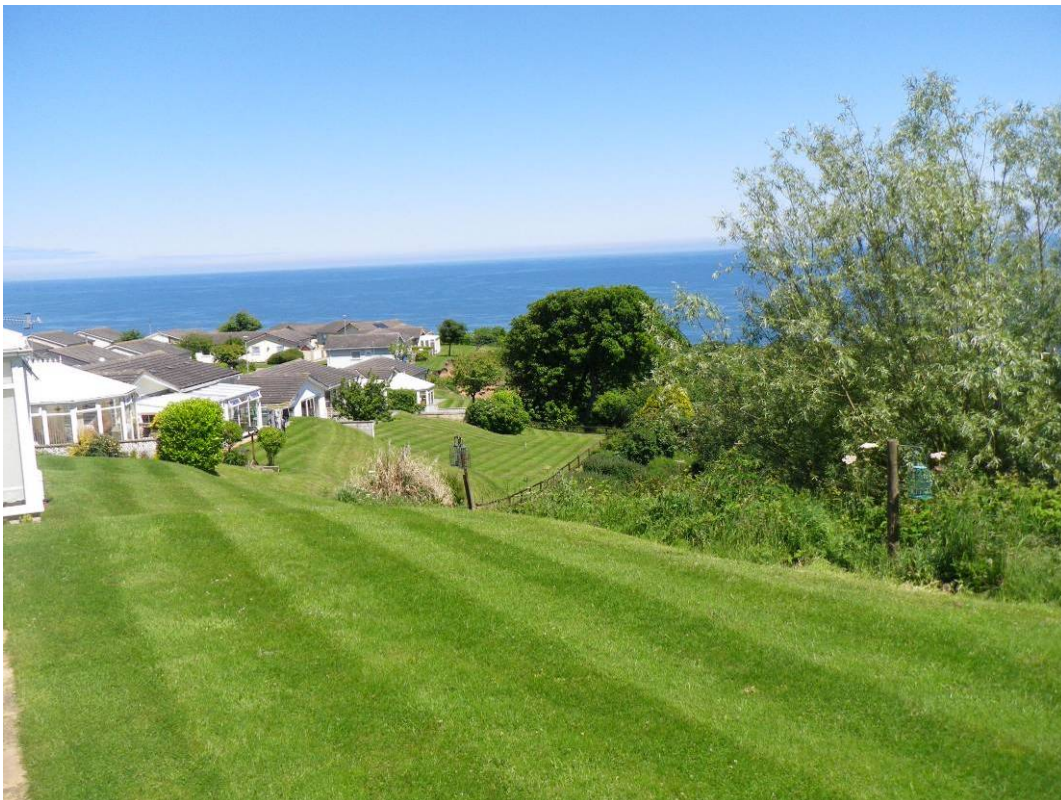
Plate 16 Cliff recession at Knipe Point Headland looking east (17th June 2010)
