# Ongoing Analysis and Interpretation of Coastal Monitoring Data

Fifth Review of Full Suite Monitoring

## Geotechnical Interpretative Report

Document Ref. No. 721229/002/GIR/012/Final

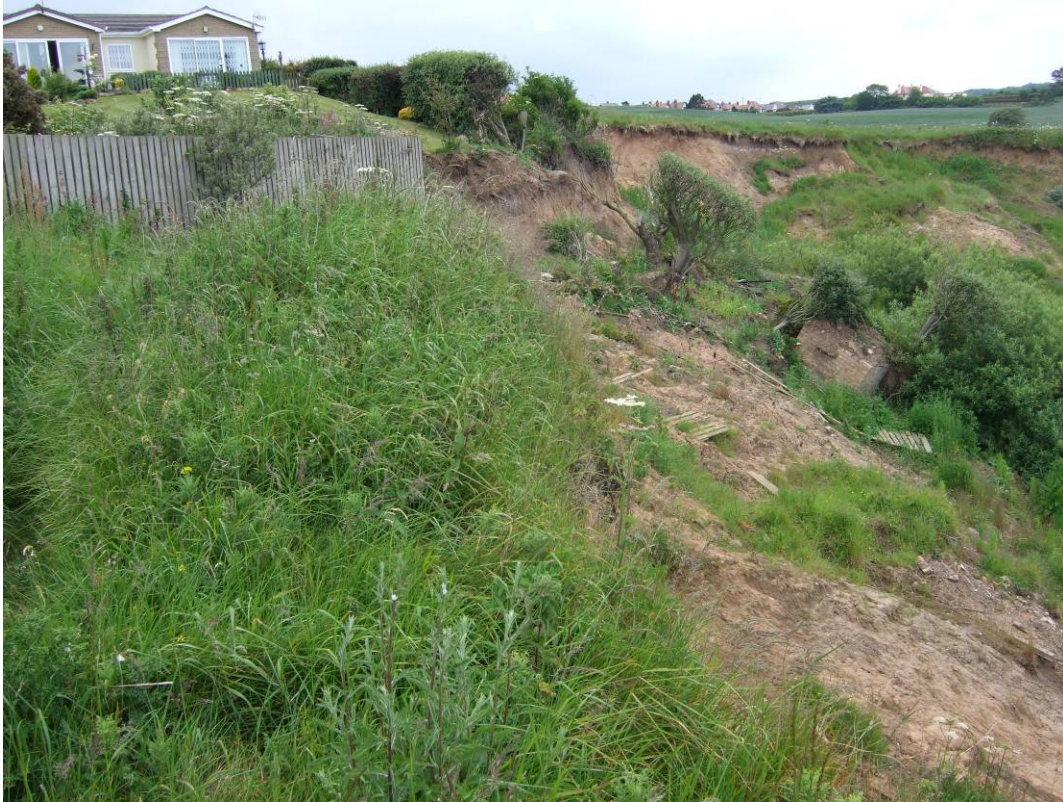
A photographic record of the site, presented in Appendix J, shows the degradation of the headscarps under observation particularly that of Cornelian Bay headland. Recession at C08 had previously been noted to continue in a northerly direction and eastwards, recession rates had significantly accelerated since June 2010 with approximately 2.0 metres of land being lost to cliff recession (see Plates 1 to 6, Appendix J). This rapid rate of recession has continued with up to 5 metres of the headland being lost to recession since December 2010.

Plate 1 Cornelian Bay side of Knipe Point looking northwest (17<sup>th</sup> June 2011)

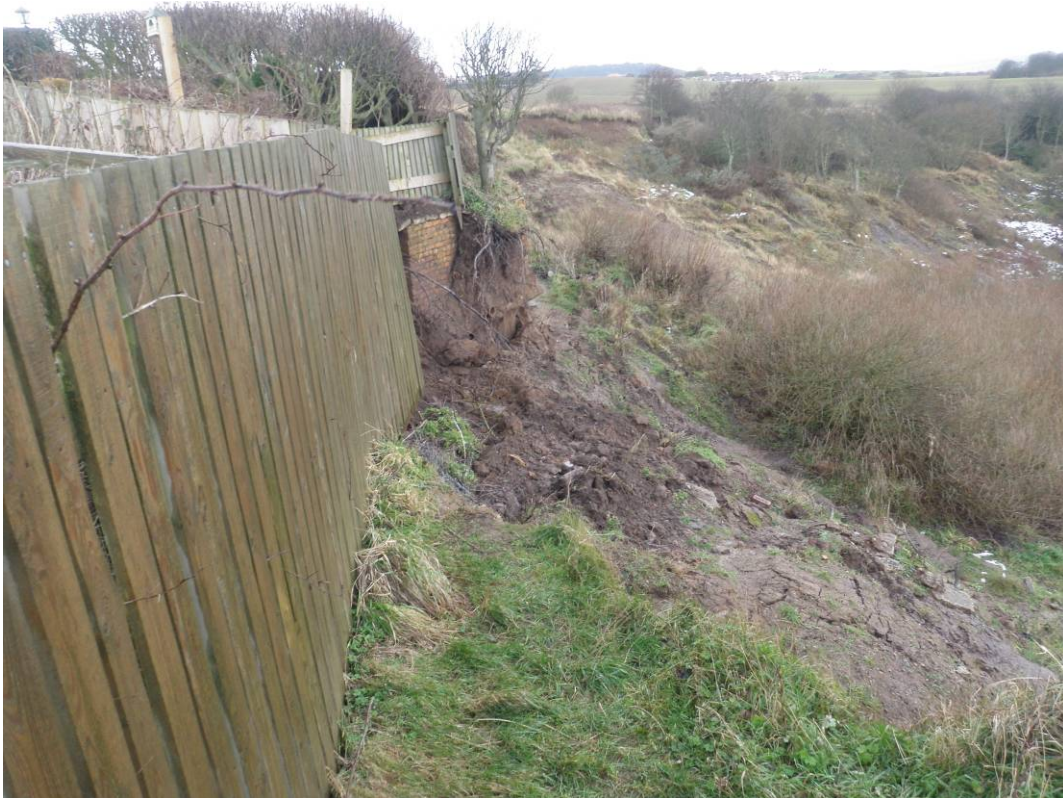
Plate 2 Cornelian Bay side of Knipe Point looking northwest (13<sup>th</sup> December 2010)

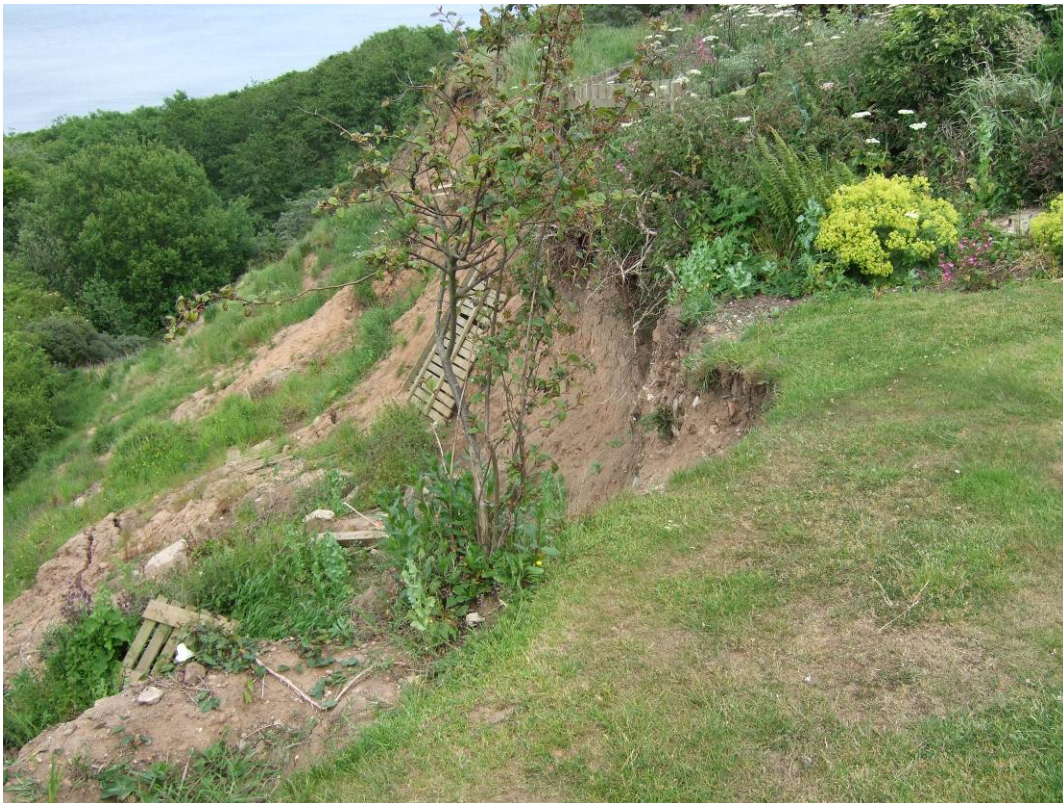
Plate 4 Cornelian Bay side of Knipe Point looking east (17<sup>th</sup> June 2011)

*(Note loss of survey pin C08, C04 and boundary fence)*

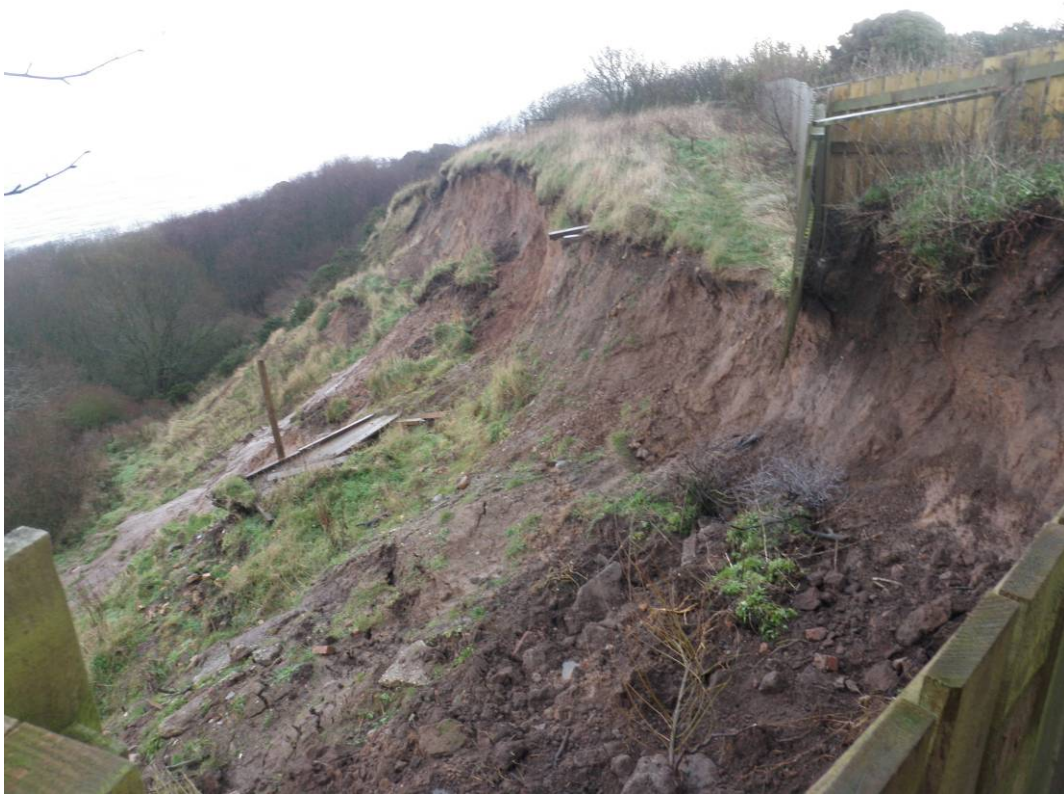
Plate 5 Cornelian Bay side of Knipe Point looking east (13<sup>th</sup> December 2010)

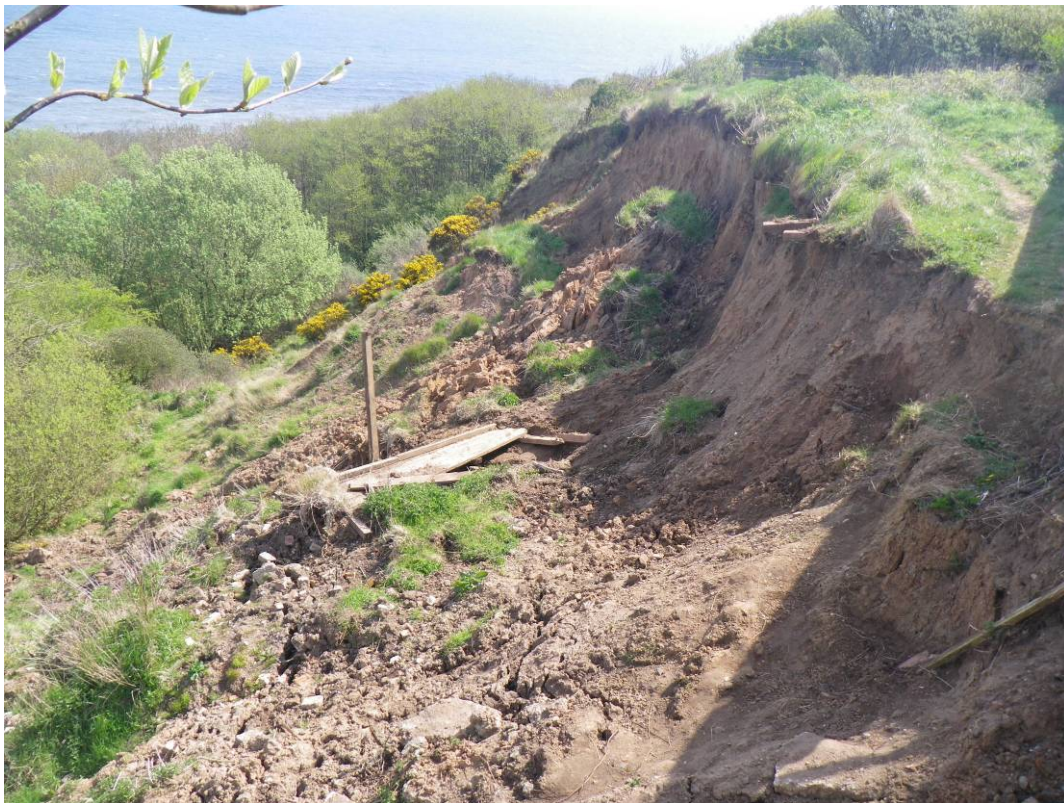
Plate 6 Cornelian Bay side of Knipe Point looking east (5<sup>th</sup> May 2010)

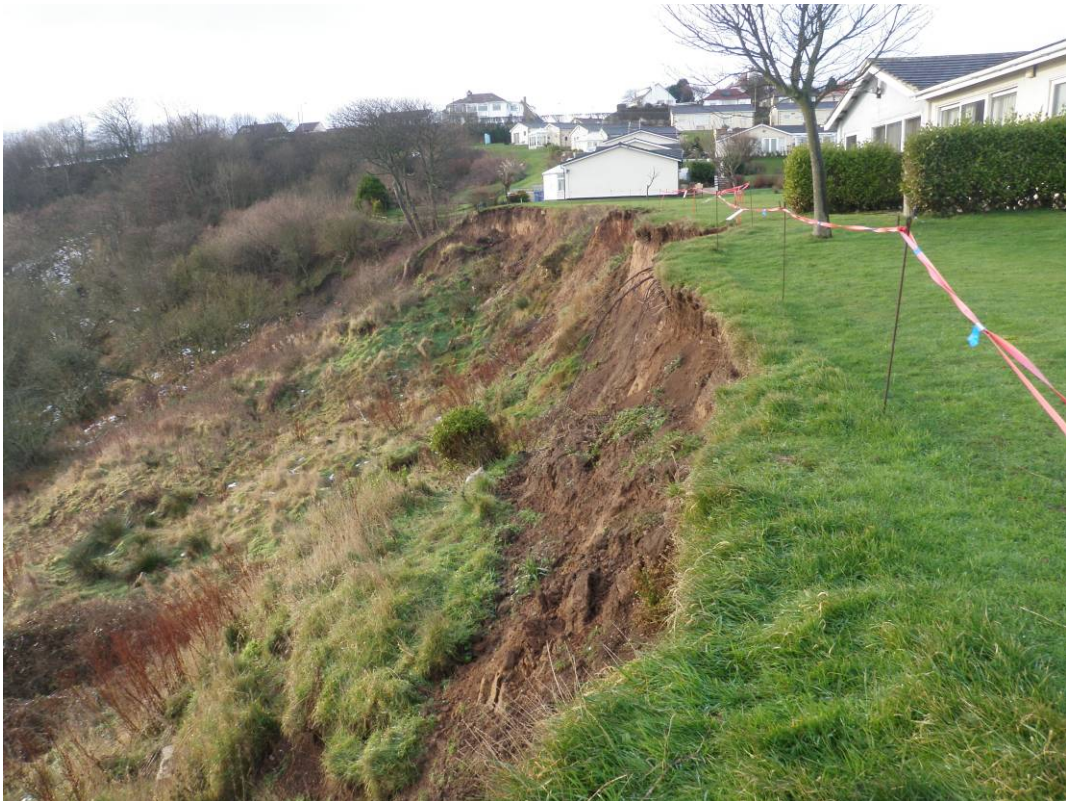
Further along this headscarp cliff recession rates, particularly at H11 which has shown high recession rates, have reduced between December 2010 and June 2011. Recession rates at this locale had coincided with groundwater seepages in the early part of 2010, which were present approximately 5 metres below cliff crest level (Plates 12 to 17, Appendix J); these lead to the development of mudslides and headscarp recession. However, since the previous monitoring event of December 2010, recession rates at H11 have shown no further recession evident along this scarp. H11 appears to have become less active from October 2010 up to June 2011. This condition has reflected the drier Spring and early Summer months of 2011.

Plate 8 Cliff recession at Knipe Point Headscarp (13<sup>th</sup> December 2010)

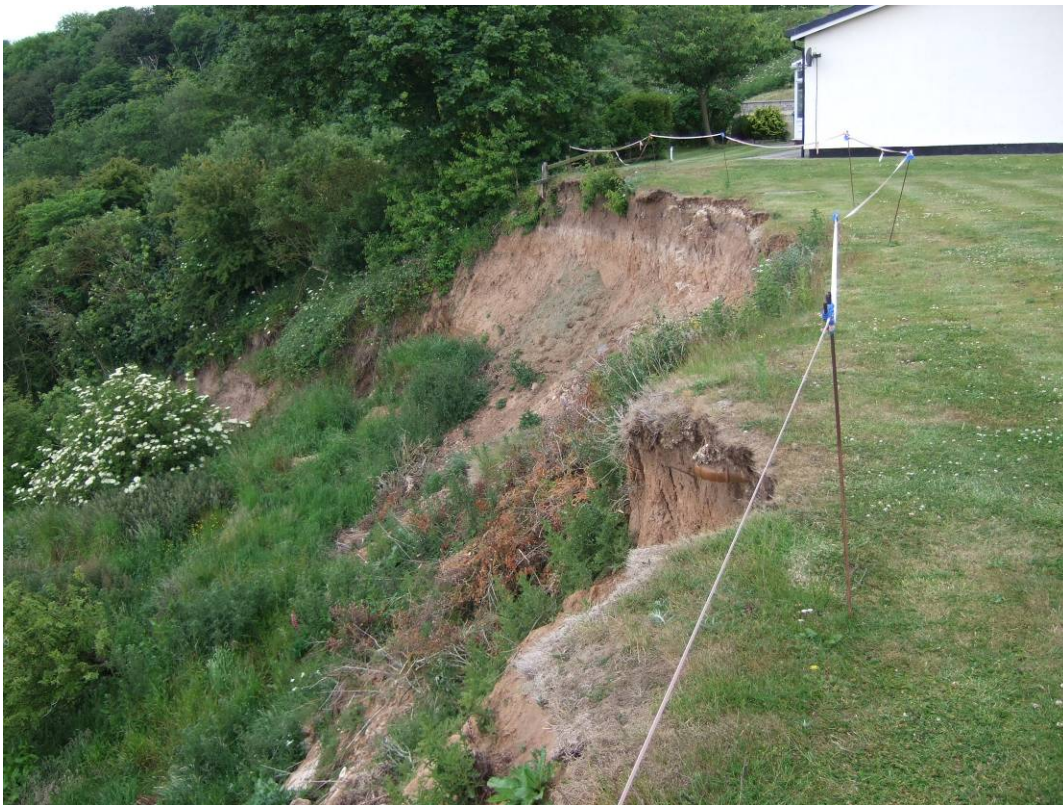
Plate 14 Cliff recession at Knipe Point Headland (17<sup>th</sup> June 2011)

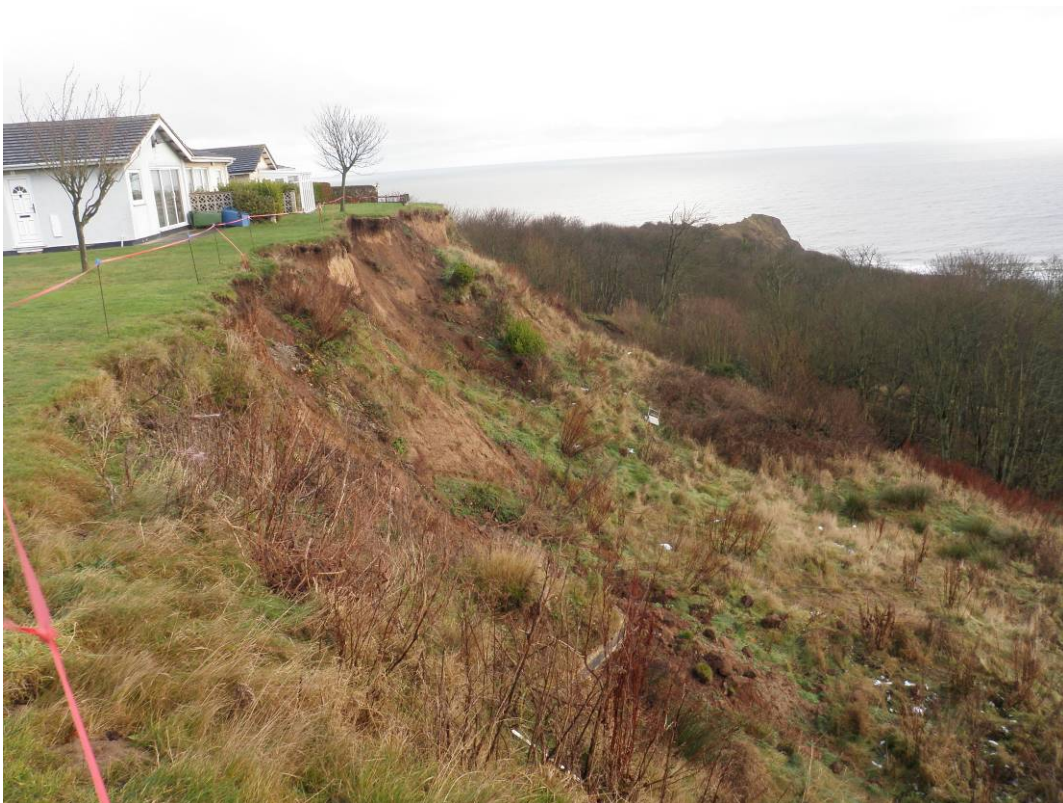
Plate 16 Cliff recession at Knipe Point Headland looking east (13<sup>th</sup> December 2010)
